**ARDGATHEN
ALFORD
ABERDEENSHIRE**

Standing Building Survey
Carried out 17th November 2014
by
Murray Archaeological Services Ltd

Report No: MAS 2014-45
by
H K Murray and J C Murray

- Standing Building Survey -

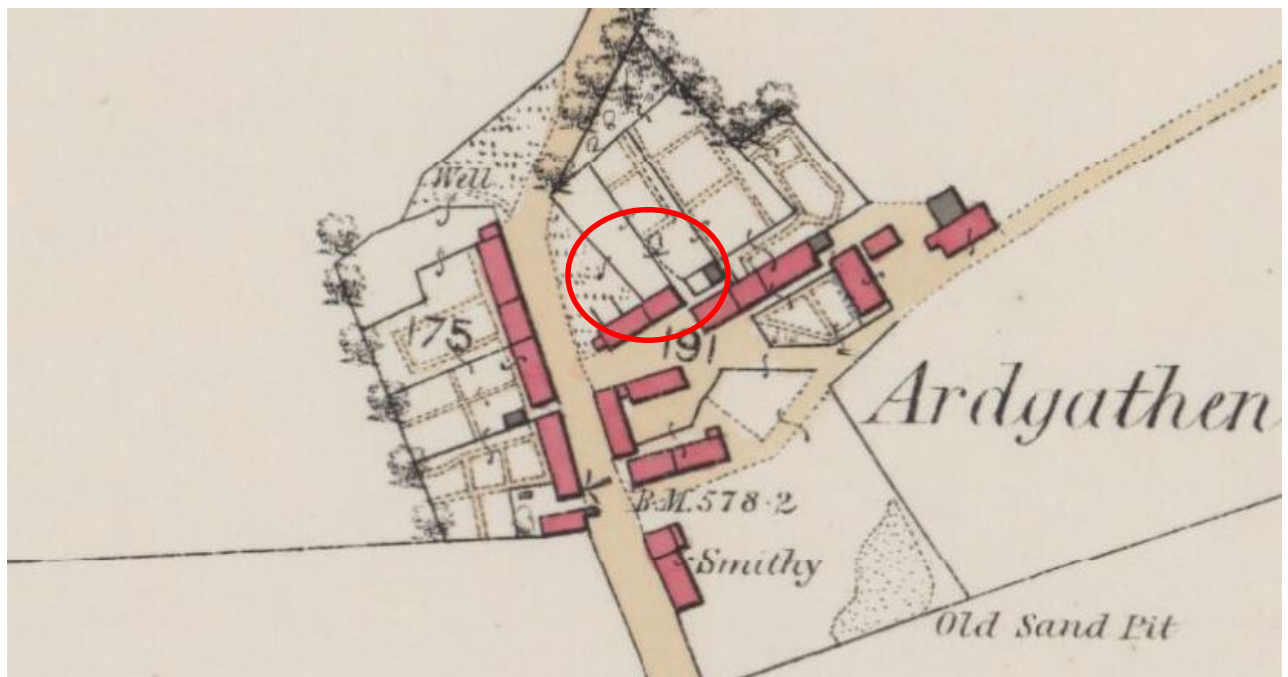
- 4.1 **Aberdeen Sheet LXII.3 (Alford) 1867 (pub 1869)** shows two properties in the survey area. To the W, a long narrow building lying approximately E/W and divided into two parts, the E part being slightly smaller. A small outshot is attached to the W gable. A garden plot lies to the N of the E part but an apparently unfenced triangle of land to the N of the W part of the building. A small unroofed structure lies in the adjacent plot to the E.

Illus 1 Detail of the 1st edition Ordnance Survey 25" map, surveyed in 1867 (published 1869) Sheet lxii.3 (Alford) www.nls.ac.uk

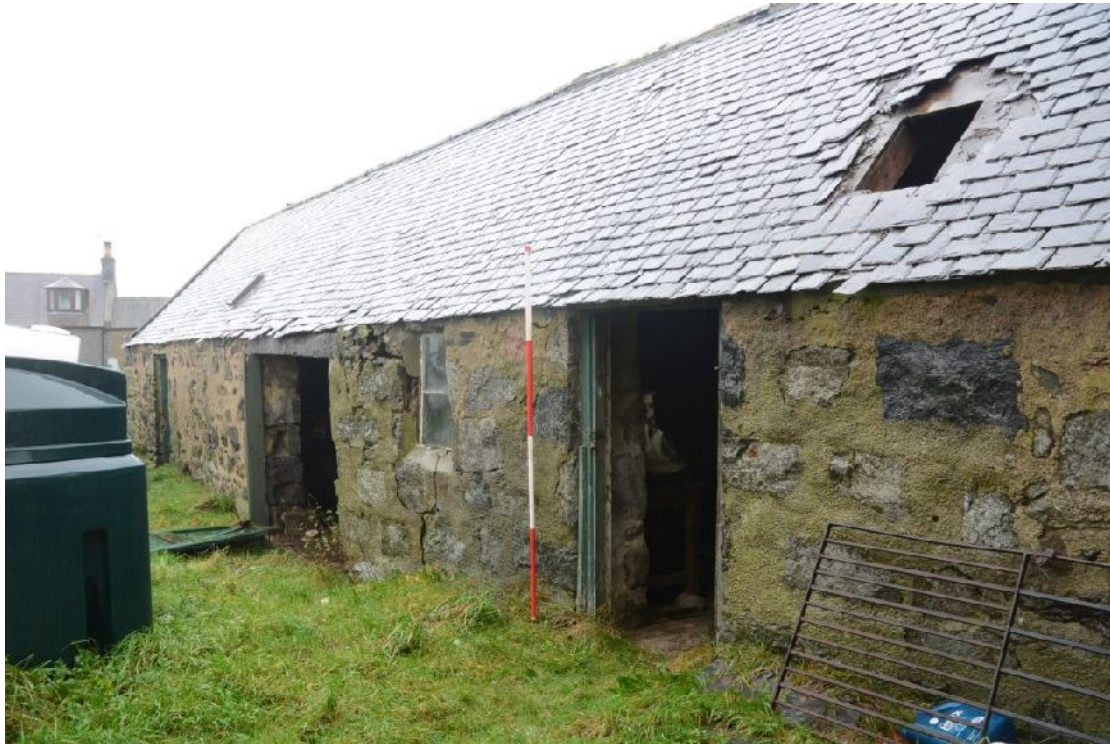
Illus 5 S wall of building looking W

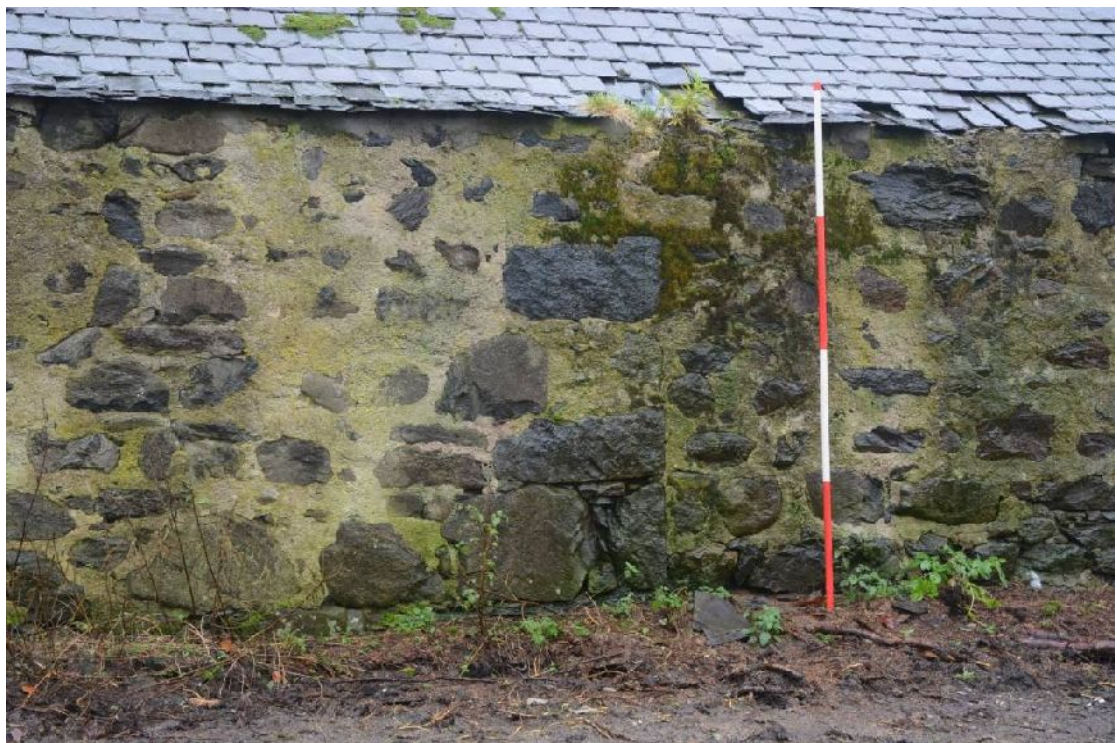
Illus 6 Detail of N wall (F3) showing the original NW corner of the E building to LHS of ranging rod.

F3 Vertical line in wall- this is the original W end of the E part of the building, with the rougher stonework of W part abutting it.

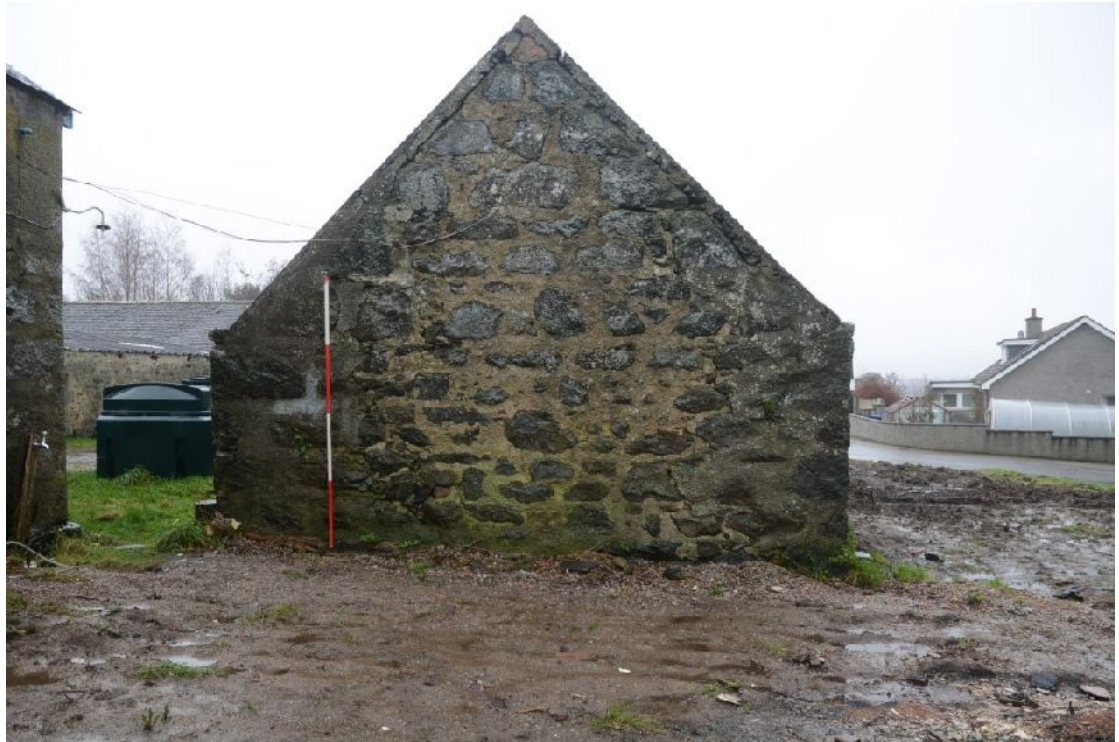
Illus 7 E gable. Note large well placed stones at apex and slight raising of wall height with secondary concrete and stone skews

E wall Gable. No features. The gable slightly raised when roof slated?

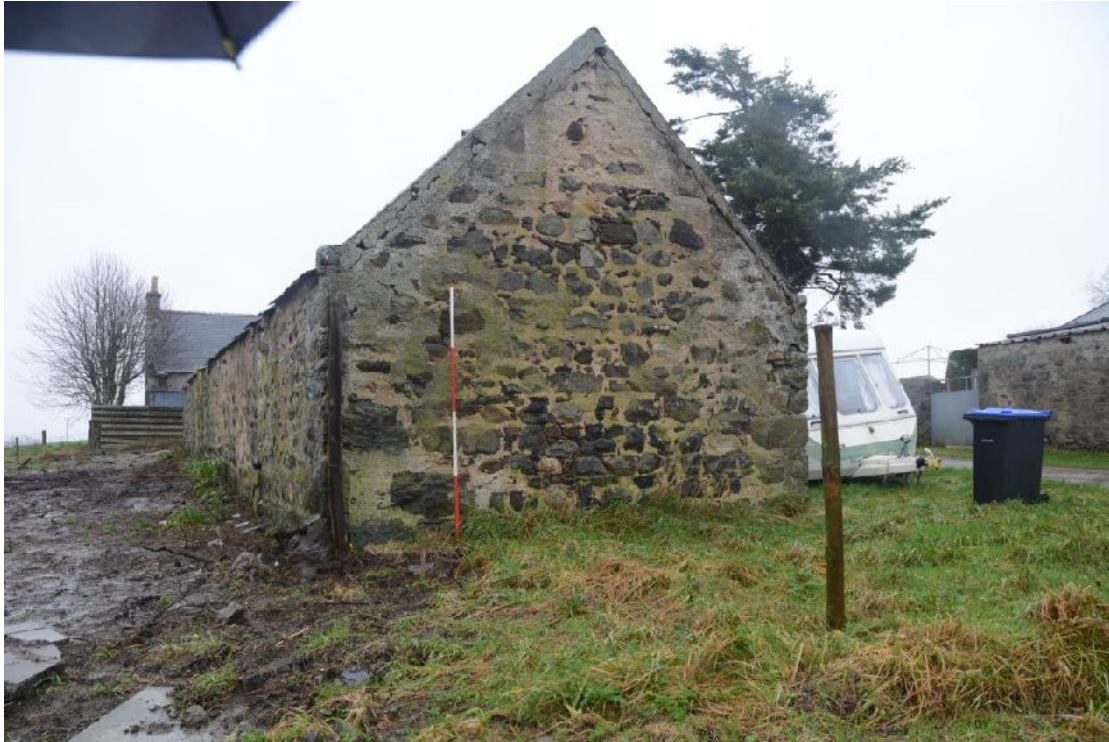
Illus 8 W gable. Note rougher stonework than in E gable

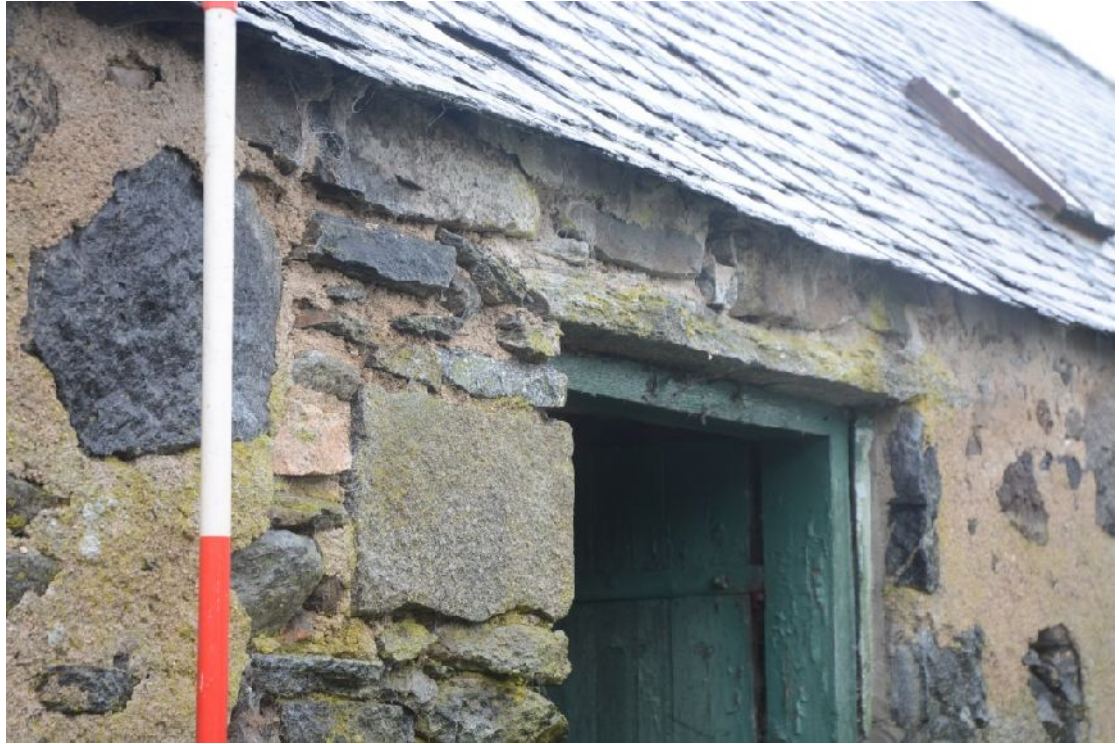
D1 W: 1.10m H: 2.00m Rough stone lintel

Illus 9 Detail of D1

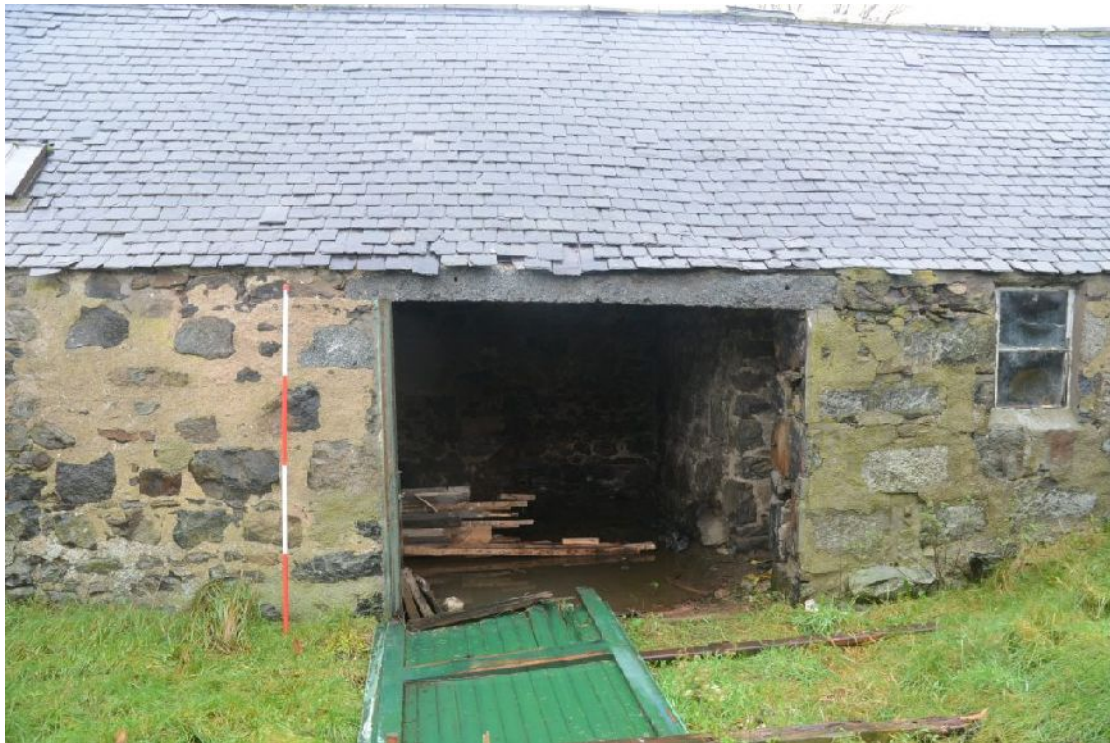
D2 W: 2.52m H: 1.90m Granite lintel. Fallen sliding wooden door

W1 W: 630mm H: 800mm Widens internally. Rough stone lintel. Sill obscured by concrete. 2-pane window.

Illus 10 Detail of D2 and W1

The W part of the building was built after the croft house and abuts it, the floor being a lower level (even allowing for the later concrete in the E part.). The small building attached to the W gable in 1867 may have been the privy. The W building with its lower cobbled floor and lack of windows appears to have been a byre. The wide doorway (D2) with a dressed granite lintel is secondary and possibly replaced a second doorway similar to D1.

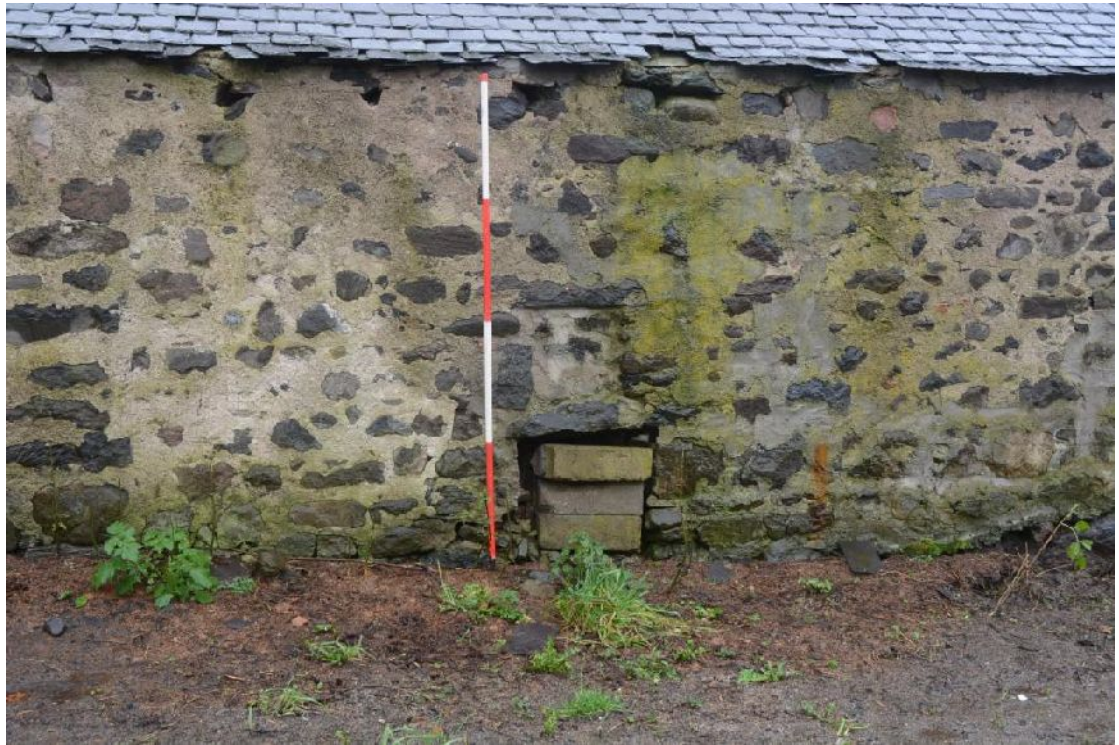
F4 Double rectangular break-through in wall. Base: 600 x 500mm loosely blocked with 3 concrete blocks. Top: 400 x 420mm. These were obscured on the inside by a stack of pallets.

Illus 11 N wall. Break-through F4

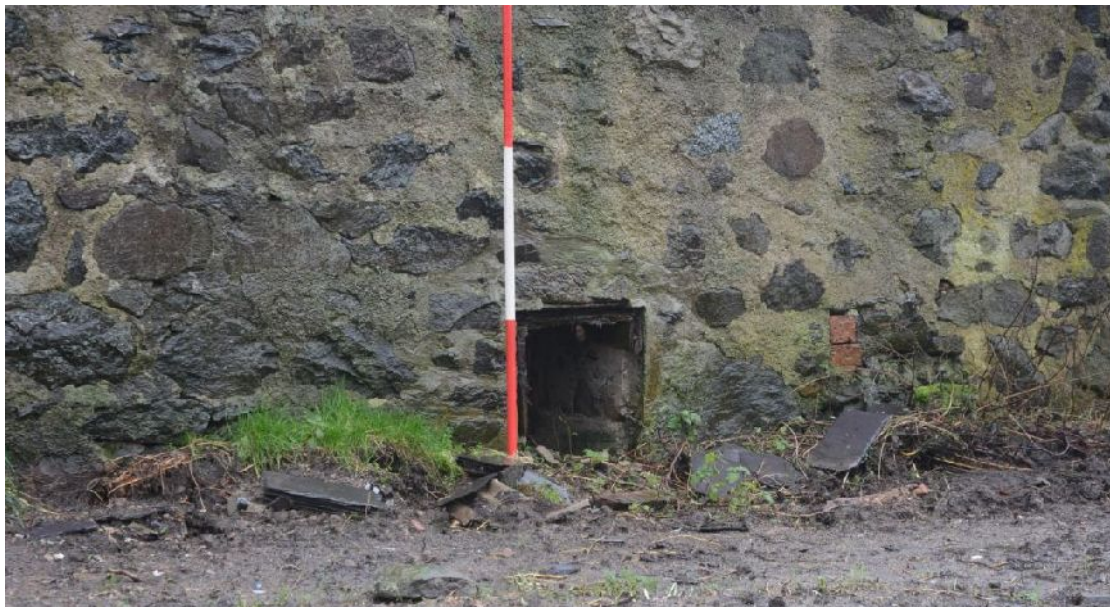
F2 470 x 500mm break-through at base of wall. Sliding hatch on inside.

Appears to have been used for poultry.

Illus 12 N wall break-through F2

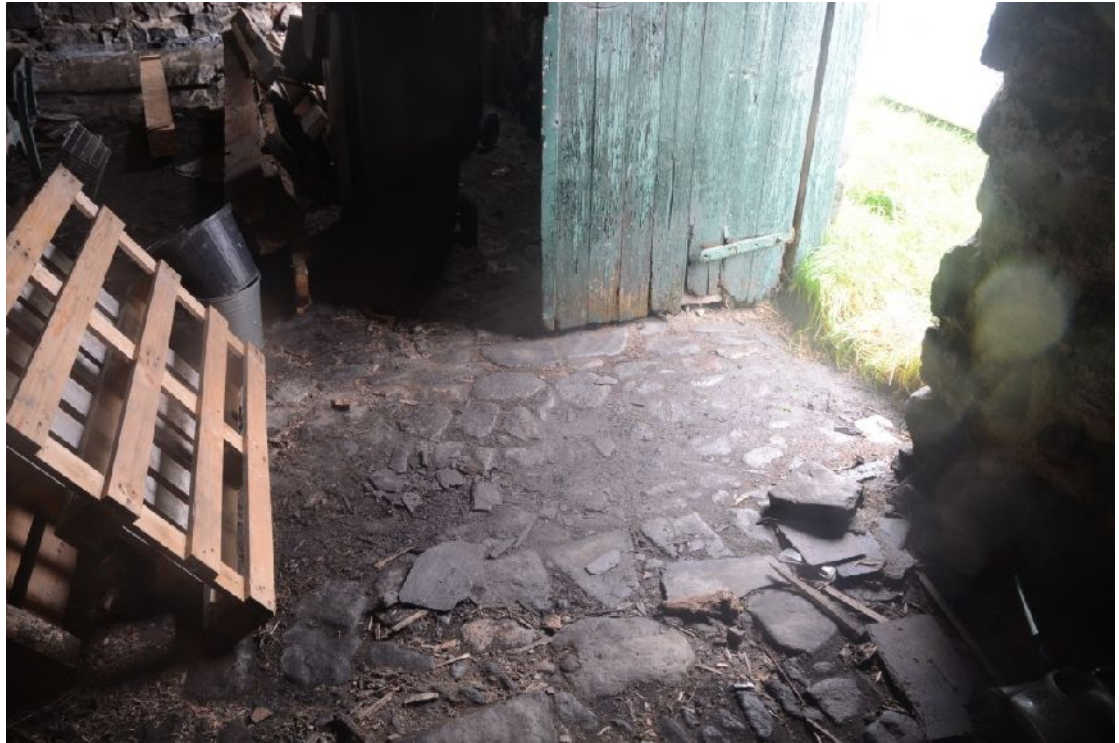
W part: c. 10.5m long. Cobbled floor remaining. No other original features.

Illus 13 Cobbles in W end of building

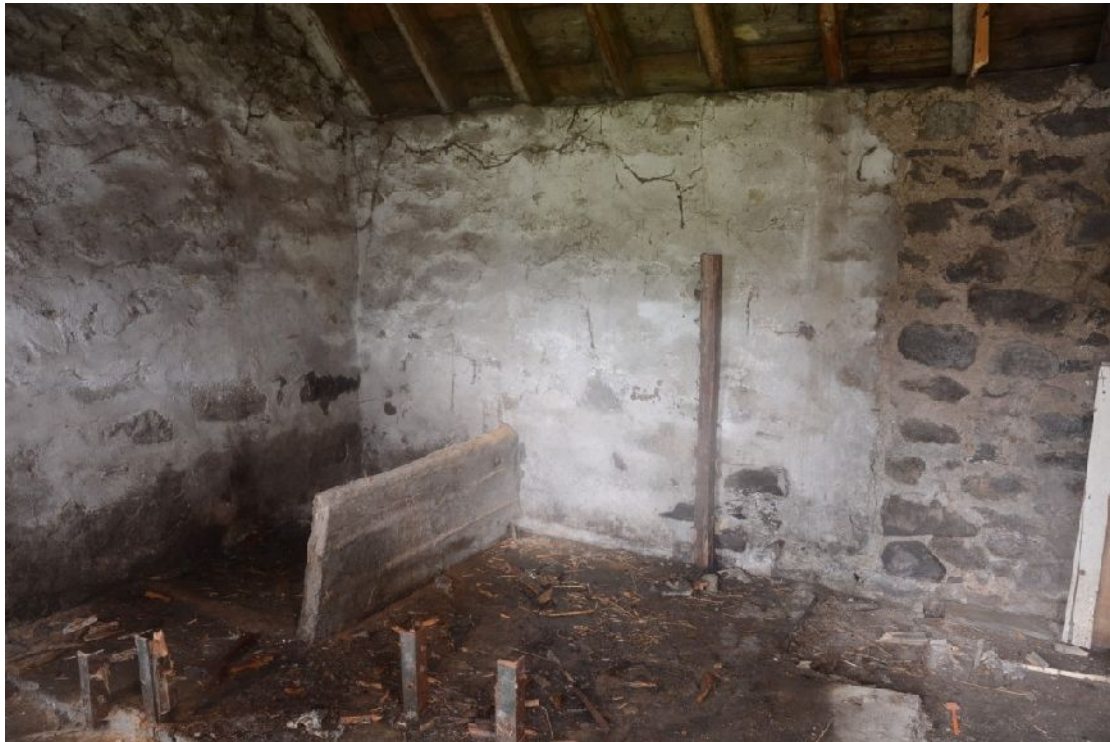
E part: c. 6.2m long. Remains of small pen in NW corner. Differences in render suggest it was at some point divided into two rooms/areas.

Illus 14 NW interior of E part of building. Note small pen in corner and render suggesting former division into two rooms/ areas.

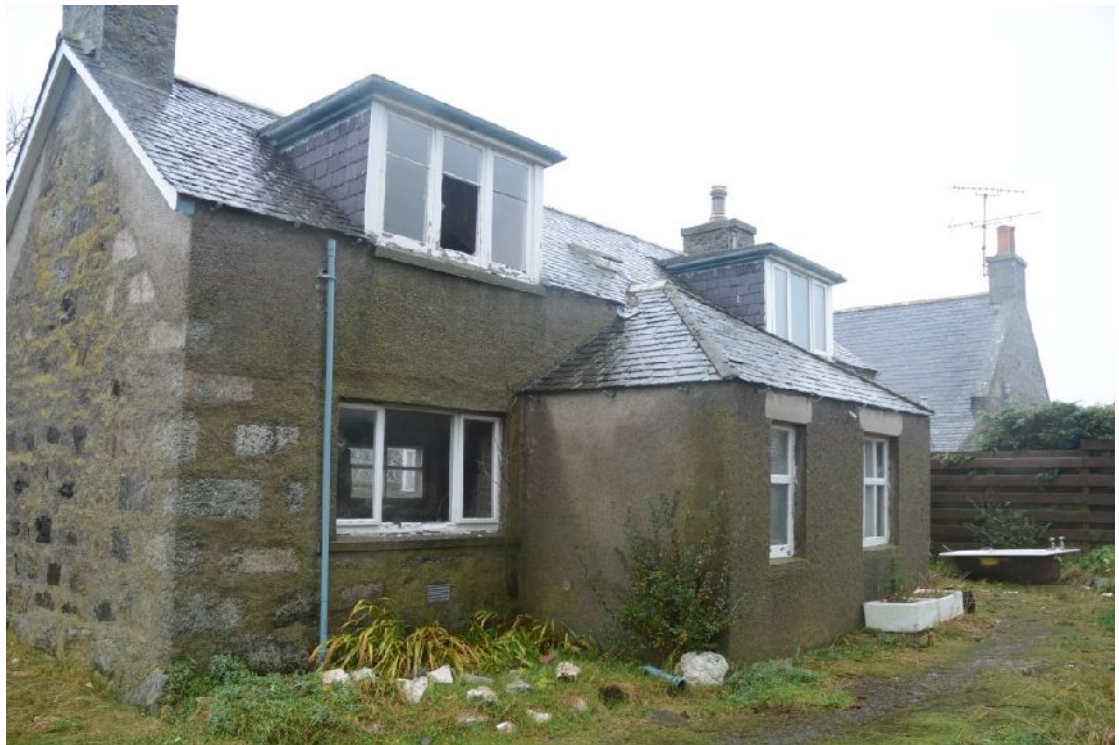
The house faces S. Gables have been raised to insert square slated dormers.

Rectangular outshot at S for bathroom and lobby.

Illus 15 South and West walls of house, showing raised walls and gable, modern windows, dormers and outshot.

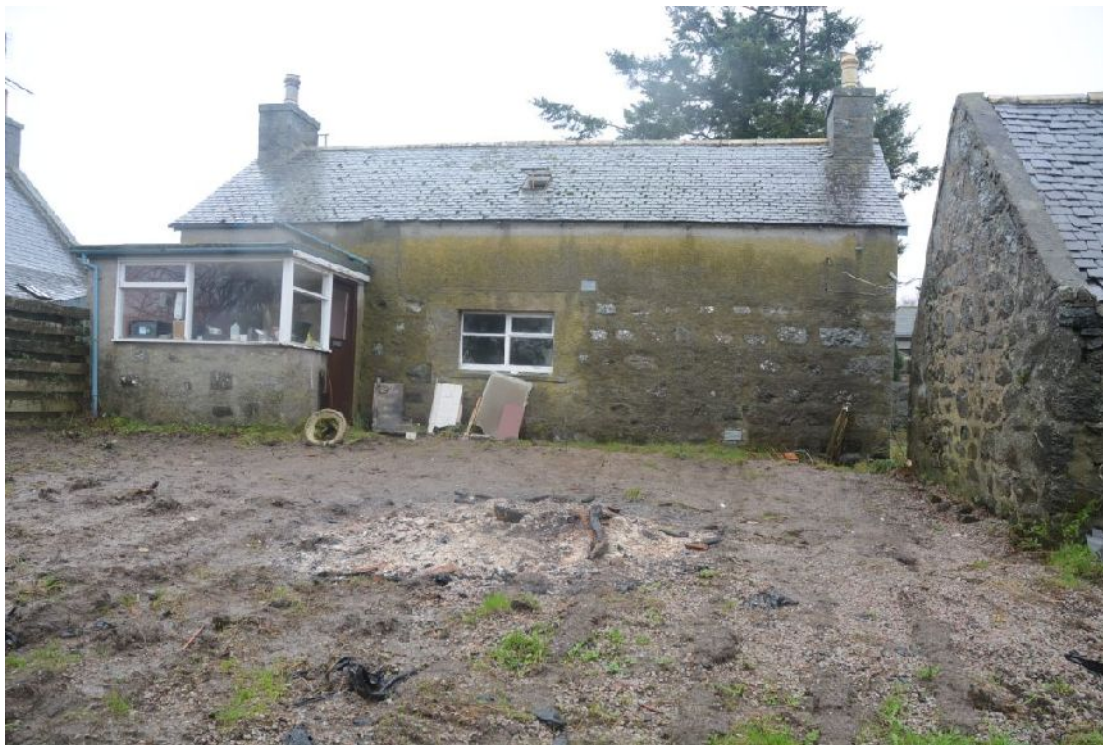
Rectangular outshot at N for kitchen.

Illus 16 North wall of house showing raised wall, modern window and modern outshot.
