GARDEN WALL PITMEDDEN HOUSE ABERDEENSHIRE

- Structural Recording -
Carried out 15th January 2015
by
Murray Archaeological Services Ltd

Report No: MAS 2015-2
by
H K Murray

PITMEDDEN HOUSE ABERDEENSHIRE RECORDING OF GARDEN WALL

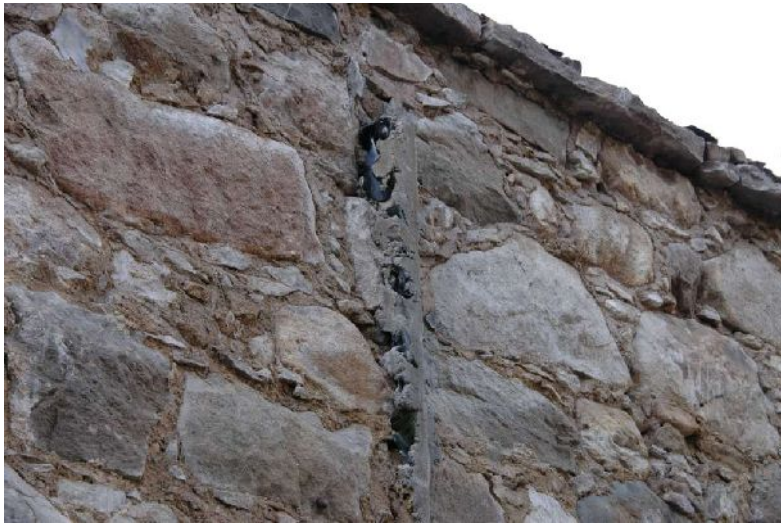
Illus 3 Glass bottle fragments in cement raggle (for position see illus 2: 8)

Raggles of cement against the outer face of the garden wall (Illus 2: feature 8), one of which incorporated glass bottle fragments as filler (Illus 3) are likely to be internal details of the 1950s workshop as the cement looks quite modern.

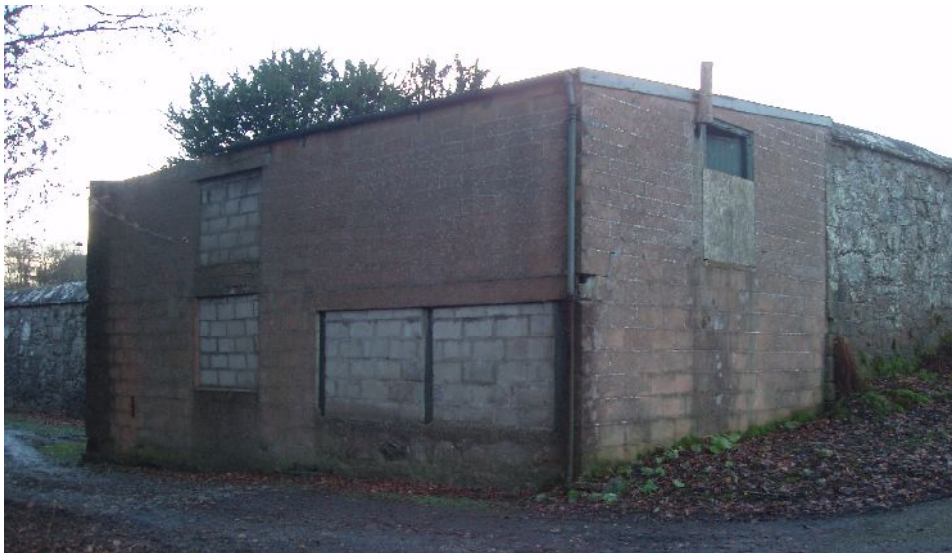
Illus 4 1950s shed prior to demolition (Photograph courtesy of Susan Burgess)

However both the N wall (below external ground level) and the N end of the E wall were set on earlier stone wall footings (Illus 1, 2: feature 2); the stonework of the E wall can be clearly seen below the blocked windows in the pre-demolition photograph

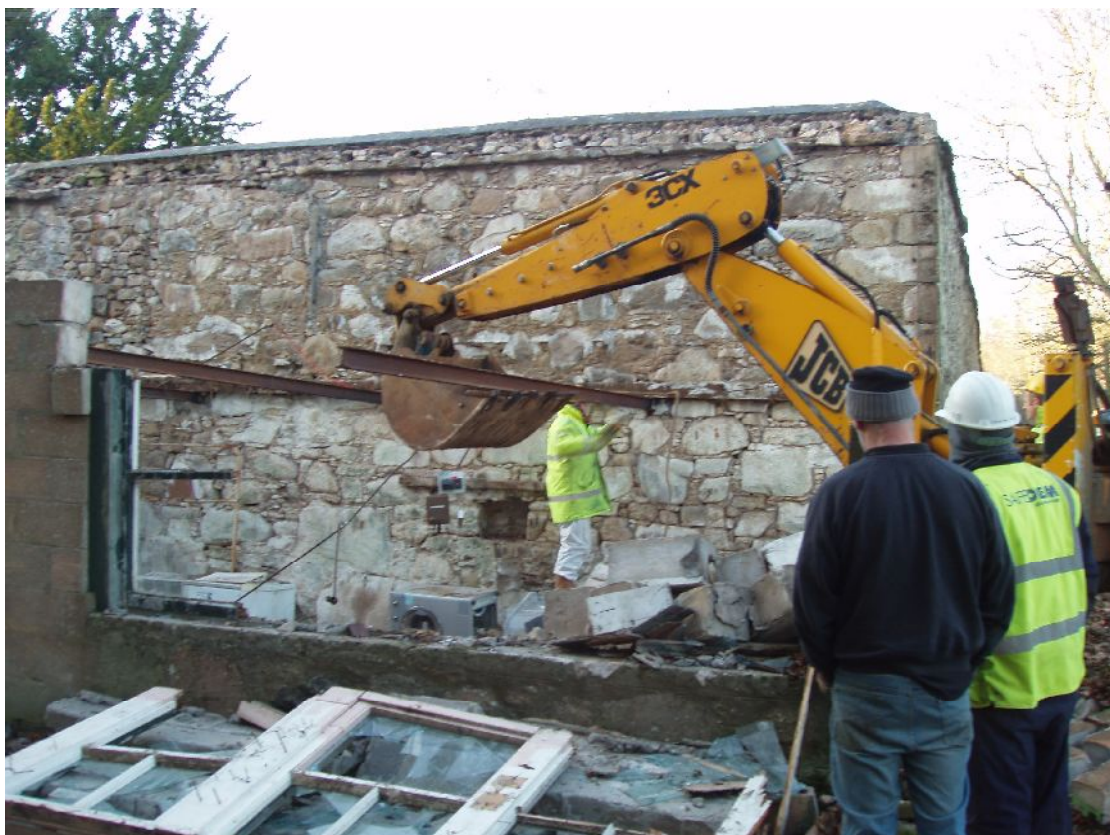
Illus 5 1950s shed during demolition (Photograph courtesy of Susan Burgess) with detail below.

It was a two-storied structure with the internal floor resting on a series of E/W metal beams that had been set into the outer face of the garden wall. The beam holes (Illus 2: feature 6) are visible in the wall face. In the same line there were a number of iron brackets (Illus 2: feature 5) which held a horizontal timber at the W side of the 1950s floor. These features can be seen clearly in a photograph taken at the time of the demolition (Illus 5).

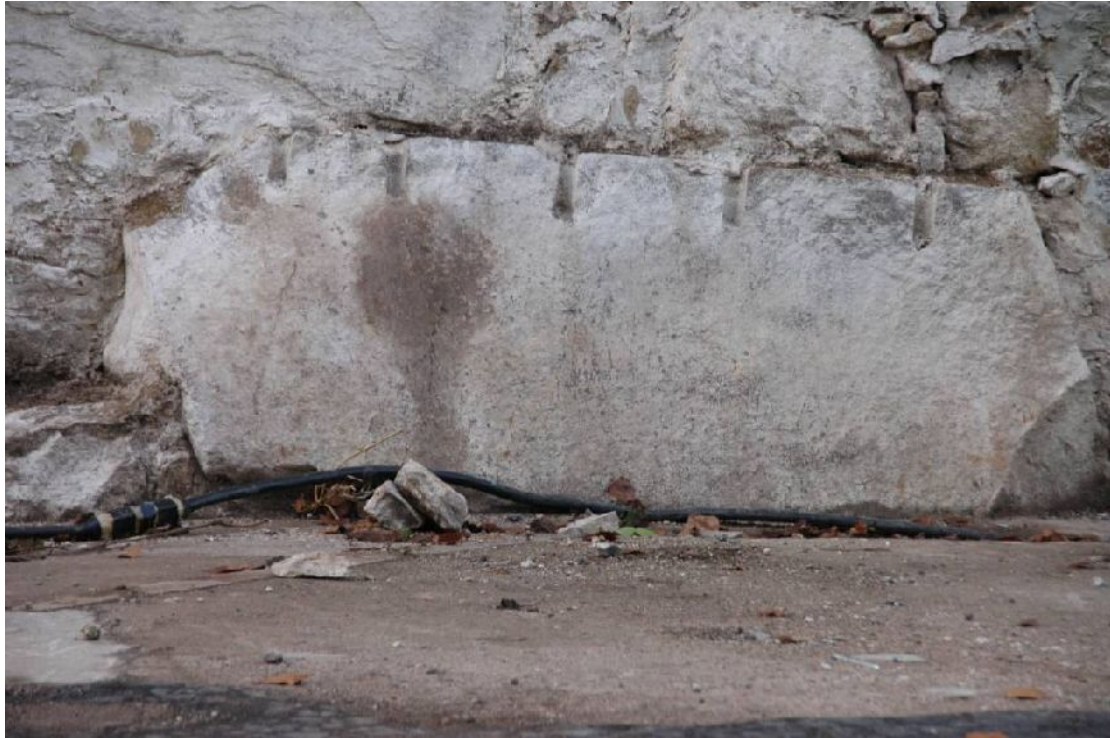
Illus 9 Base stone in garden wall showing quarry drill marks.

Of some significance are the large projecting stones in the base course of the garden wall (Illus 2: feature 1, Illus 8); on this stretch of wall this appears to be the only place where the wall stones project. This may indicate that there was a structure here from the date of the wall's construction in the 17th century and that this part of the outer face of the wall was not intended to be seen. Significantly one of the stones even displays the quarry drill marks along one edge (Illus 9). It might be worth looking for similar features elsewhere on the wall perimeter.

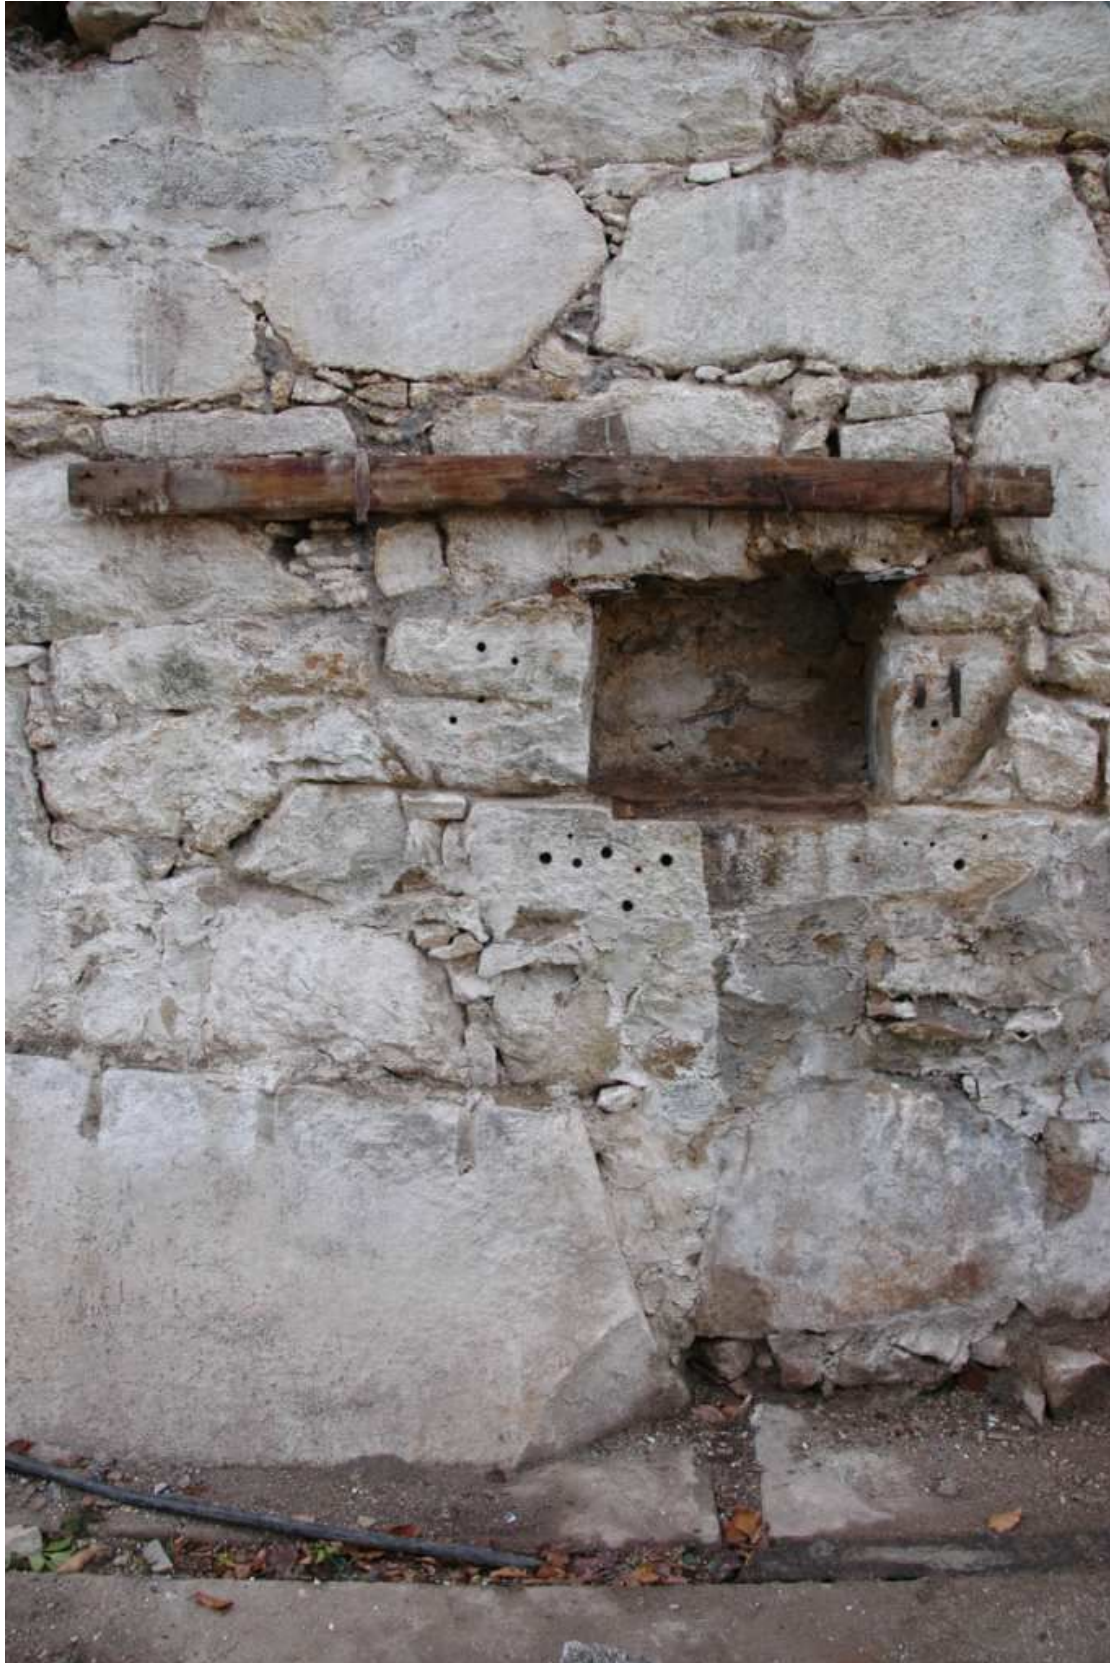
Of considerable interest is feature 3, a small rectangular recess (W: 480mm, H: 380mm, depth: 260mm) in the face of the wall c 1m above (existing) floor level. This had a stone sill with a vertical drilled hole (2.5mm diam) for a bolt on either side of a strip of iron or ferrous corrosion 70mm wide. There were remnants of a slate lintel at the top of the recess.

Illus 11 Detail of recess (For position see Illus 2: feature 3)

A number of bolt holes and two corroded bolts in the stones around the recess may derive from a sequence of different uses of the recess. A wooden bar (L: 1.5m. 80 x

40mm) above the recess is likely to date from the 1950s workshop as it is held with iron clamps similar to those used on the internal floor.

This feature almost certainly held one end of an iron shaft clamped into position and held by the bolts; possible interpretations will be discussed below.

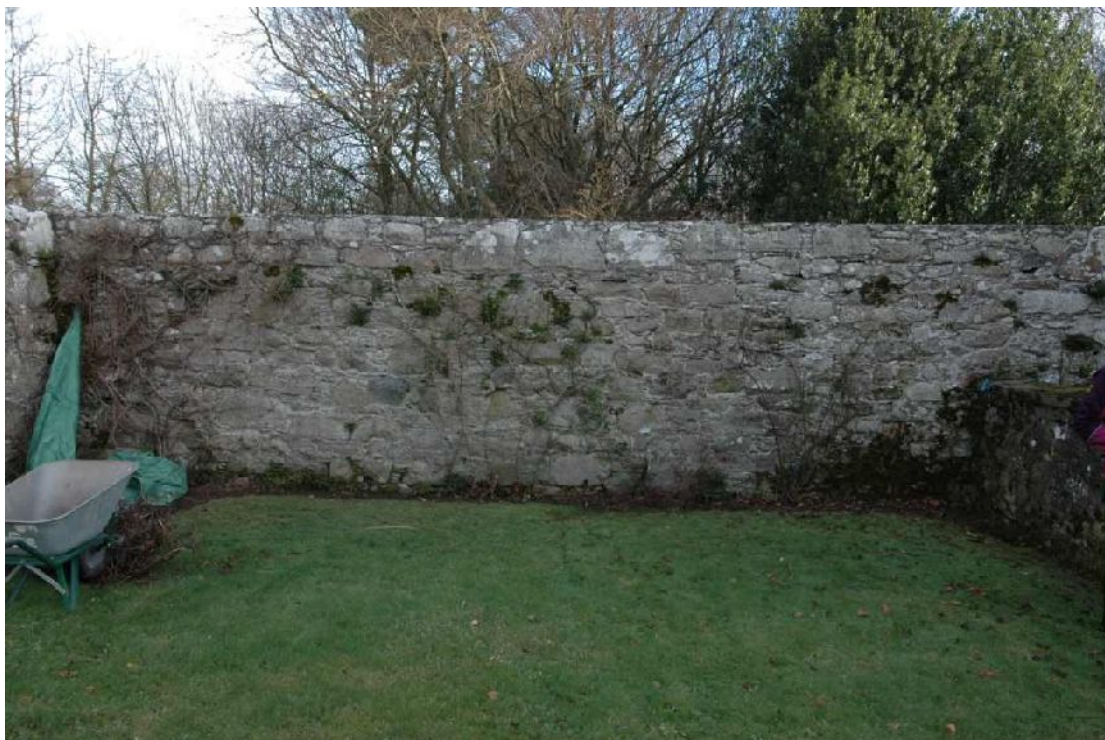
although that area of wall does appear to be of more varied construction than the wall on either side (Illus 13).

Illus 13 Inner face of the section of garden wall.

This blocking is intriguing- it was clearly in use until, although not necessarily dating from, quite a late date as there is concrete along the base. While it is tempting to suggest this had been a door through to the garden, there is little evidence of this on the inner wall face and no evidence on either side of the stone lintel and sill one would expect (by comparison with features such as the bee boles – or even the recess in this wall).

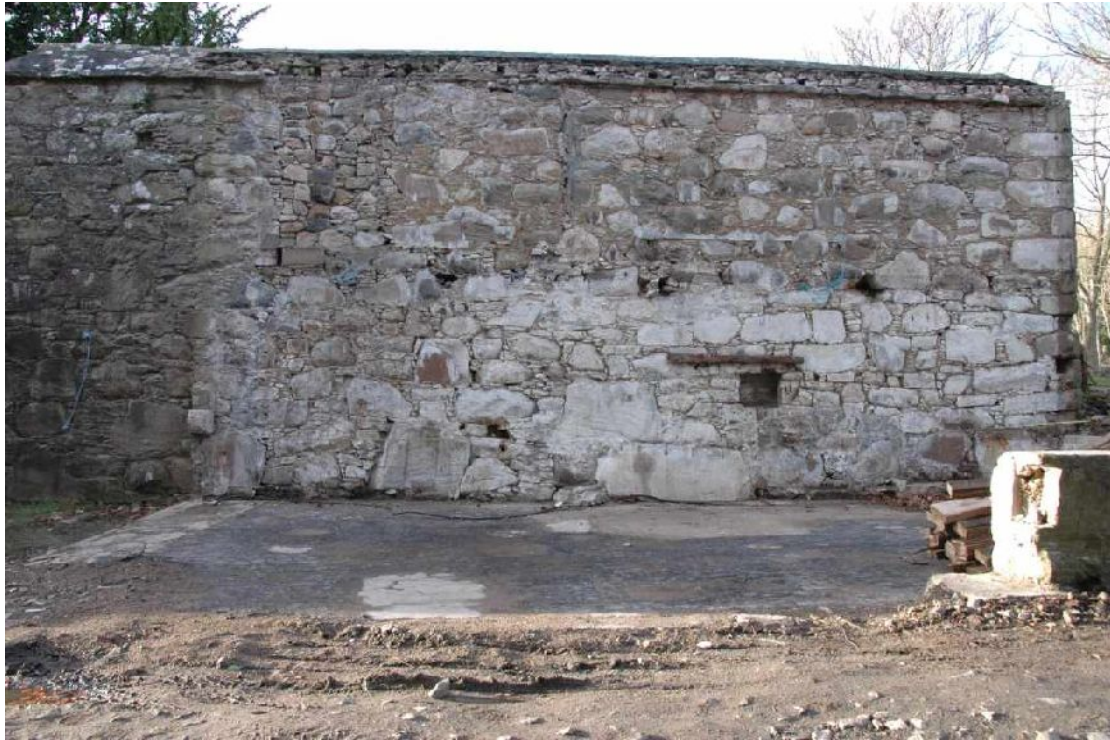
Illus 14 General view of the garden wall and the foundations of the workshop.

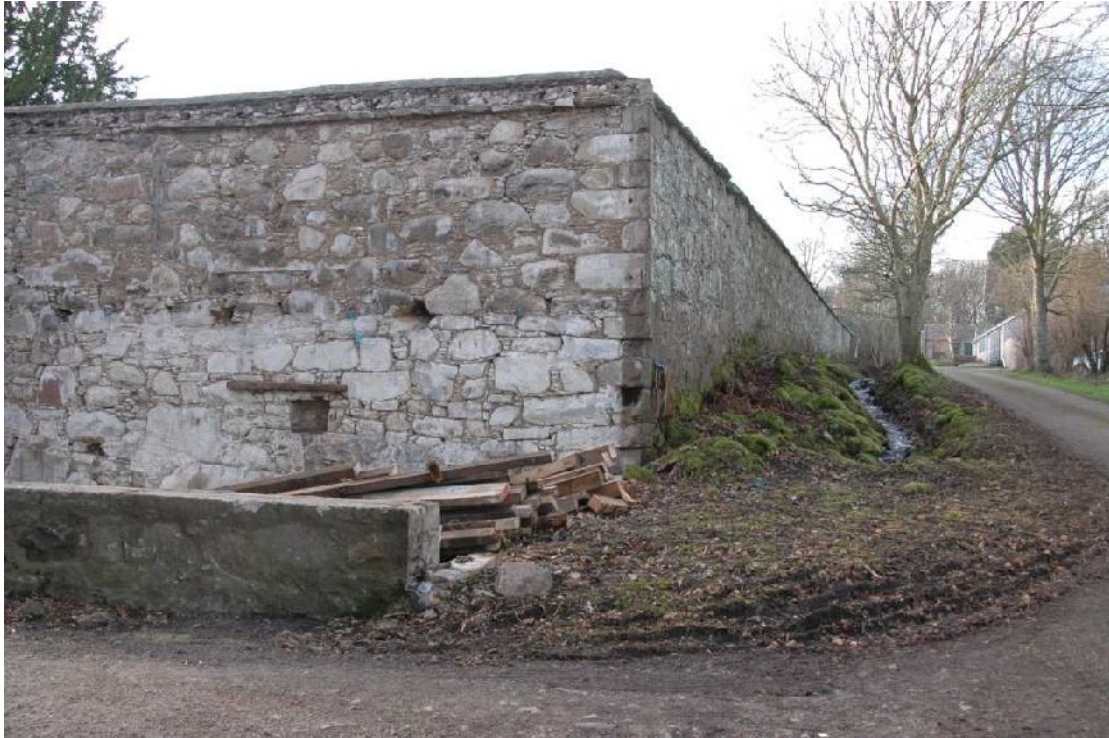
Illus 15 General view looking W showing the foundations in relation to the stream to N

There is a local oral tradition of there having been a mill on this site prior to the 1950s (pers. comm Susan Burgess). The map evidence supports this as, in both 1867 and 1899, a line to the N gable of the building on site at the time can be interpreted as a diversion of the burn to form a lade to power a mill or other machinery. The detail on the 1899 map shows a channel coming in at the W end of the N gable and an underground (dotted) channel coming out at the E side of the N gable. Were any work to be done on the bank E of the building it would be worth some investigation to see if stone-lined lades survive.

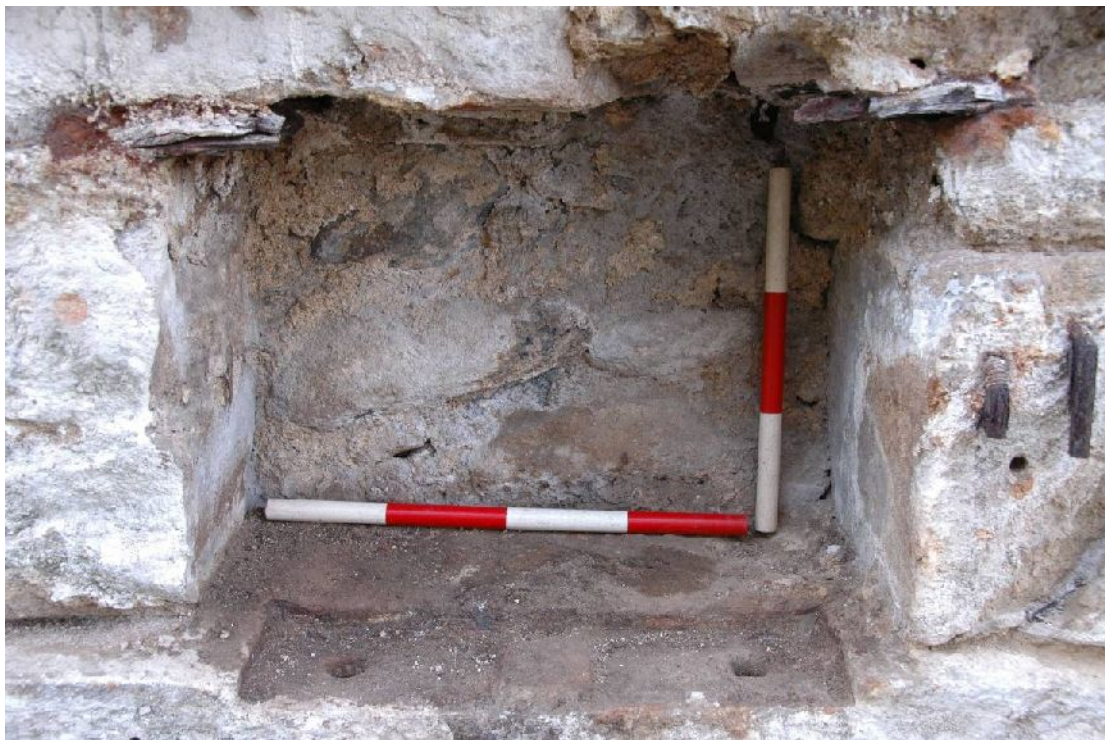
Illus 16 Detail of feature 3

The recess in the garden wall (Illus 2: feature 3, Illus 16) would have held one end of an iron shaft that rotated, secured by a semi-circular bracket held by the bolts- the holes of which survive. The line in relation to the water makes it unlikely to have held a wheel shaft, but more probably the shaft of related machinery. An example from the 17th-century mill at Caie's Mill, Kinellar, Aberdeen (Murray & Murray 2008) (Illus 17) shows a very similar feature relating to a mill.

The later wooden bar above the recess and the numerous bolt holes around it suggest that the recess may have had a different, secondary use to hold equipment for the carpenter's workshop.

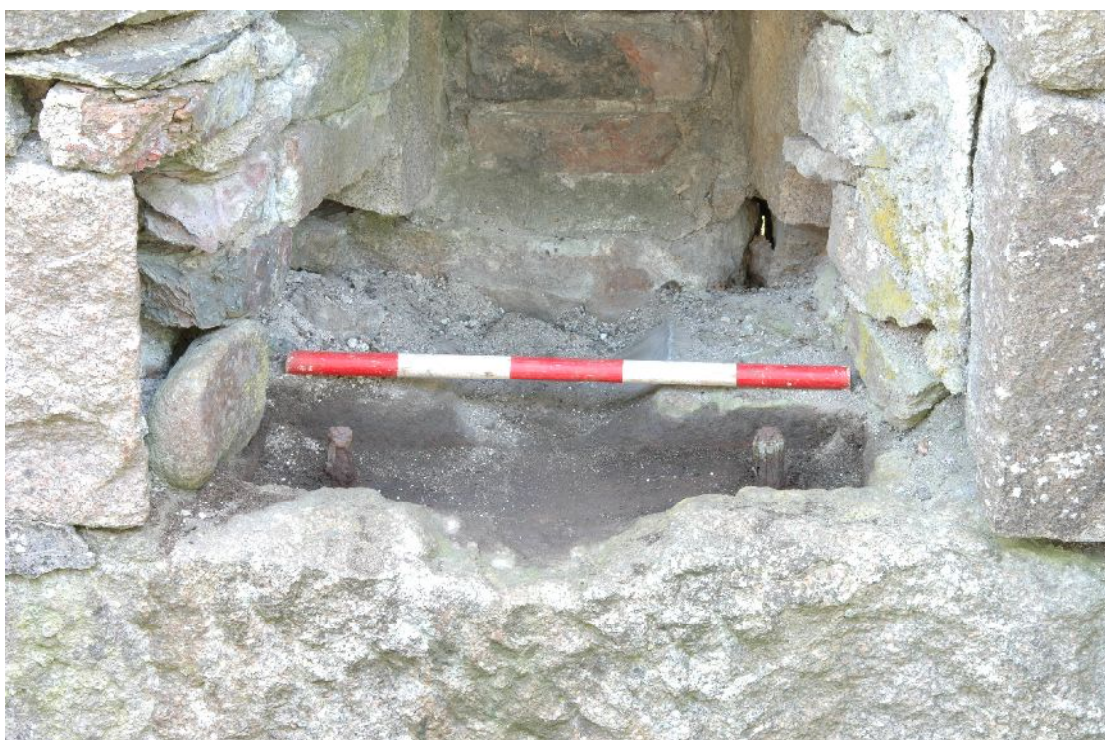
Illus 17 Caie's Mill, Kinellar, Aberdeen
