**BOGENJOHN
WHITE COW WOOD
STRICHEN
ABERDEENSHIRE**

**- Archaeological Watching Brief -
Carried out 19th and 21st January 2015
by
Murray Archaeological Services Ltd**

**Report No: MAS 2015-04
by
H K Murray**

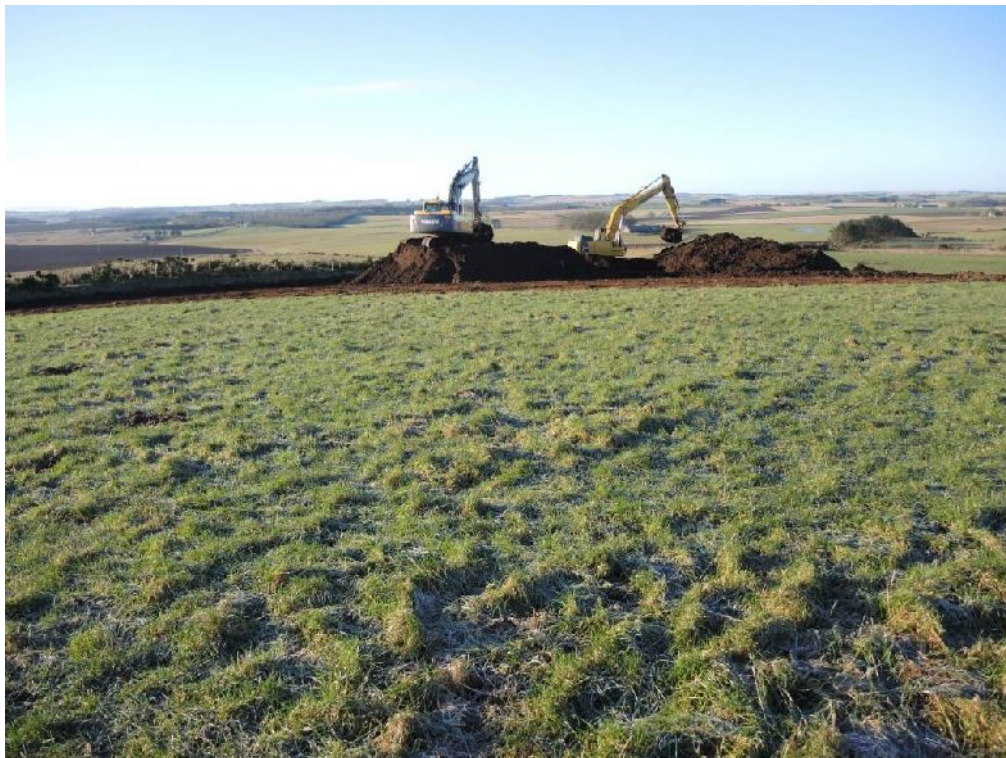
- 4.1 The turbine site and crane pad standing are located on a level ridge with higher ground to the E and S but commanding long clear views. The track runs from the S side of the crane pad E/W alongside the S dyke of the field, then turning at the SW corner of the field to run N/S alongside the W edge of the field to the gate at the N end.

Illus 2 View of crane pad looking W showing open views

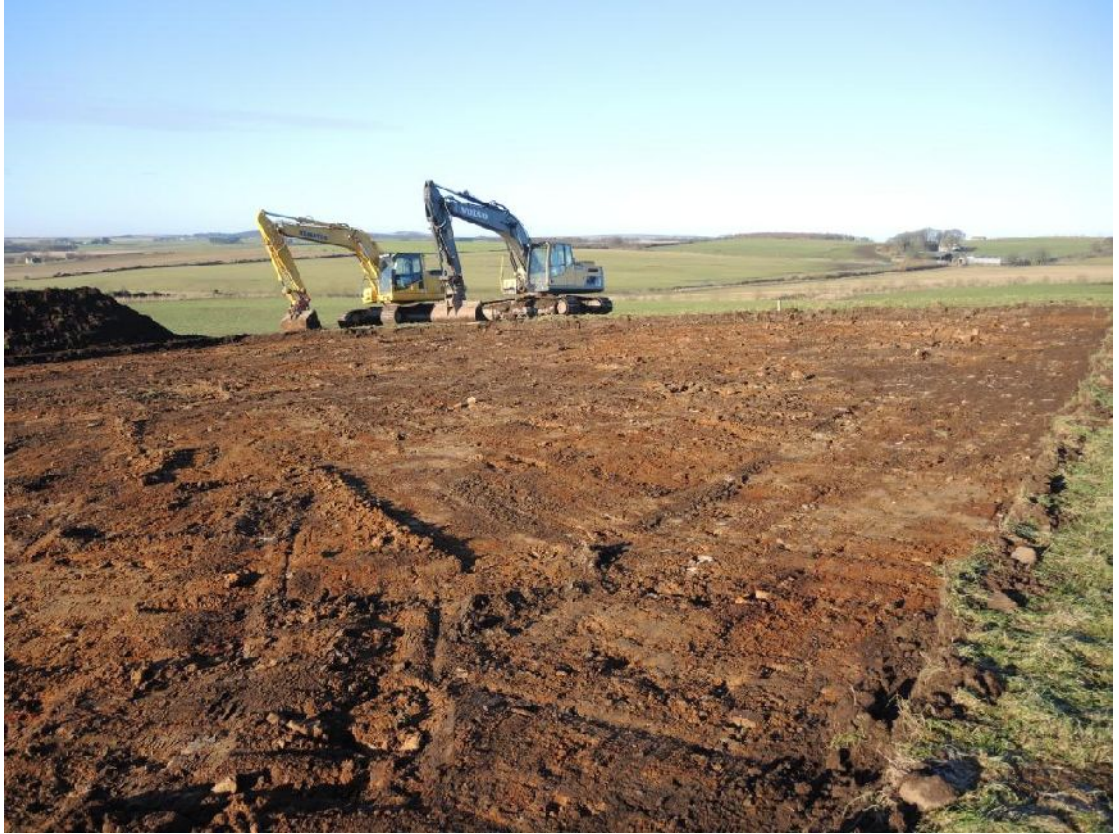
Illus 4 Crane pad after soil strip, looking NNW

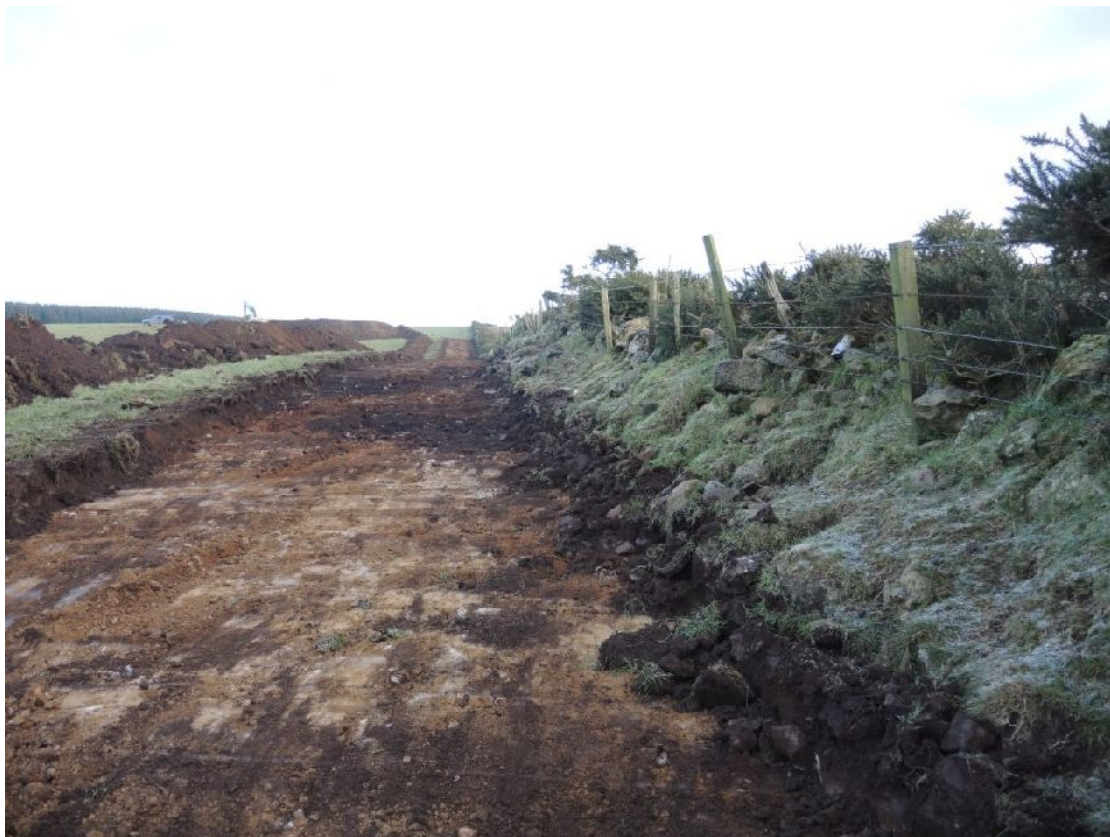
Illus 5 E/W section of track looking E showing tumble from drystone dyke on RHS

- 4.4 A number of field drains were encountered crossing the line of the N end of the track and fallen stones from the dyke lay alongside the S field dyke in the E/W section of the track.

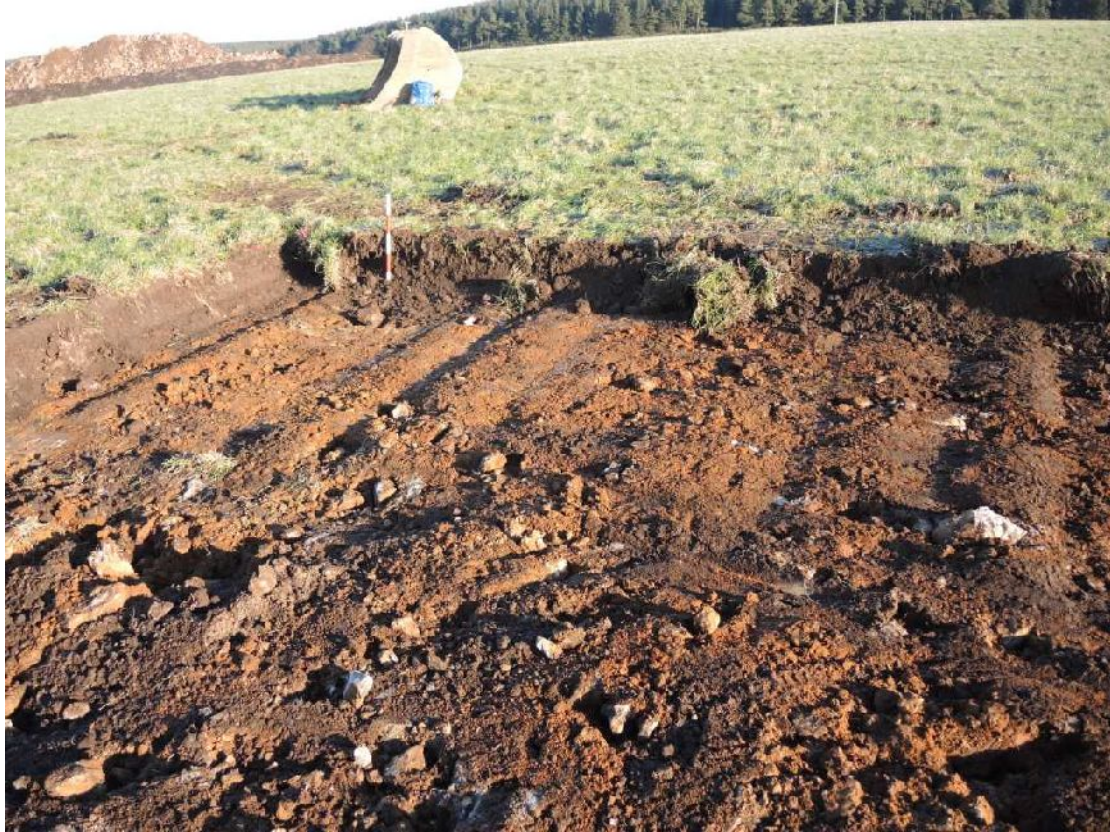
- 4.3 Topsoil depths varied between 250mm on the tops of the ridges to c 400mm in some of the hollows. Topsoil overlay a hard gritty clay with frequent stones throughout.

Illus 6 Detail of shallow stratigraphy in area of crane pad

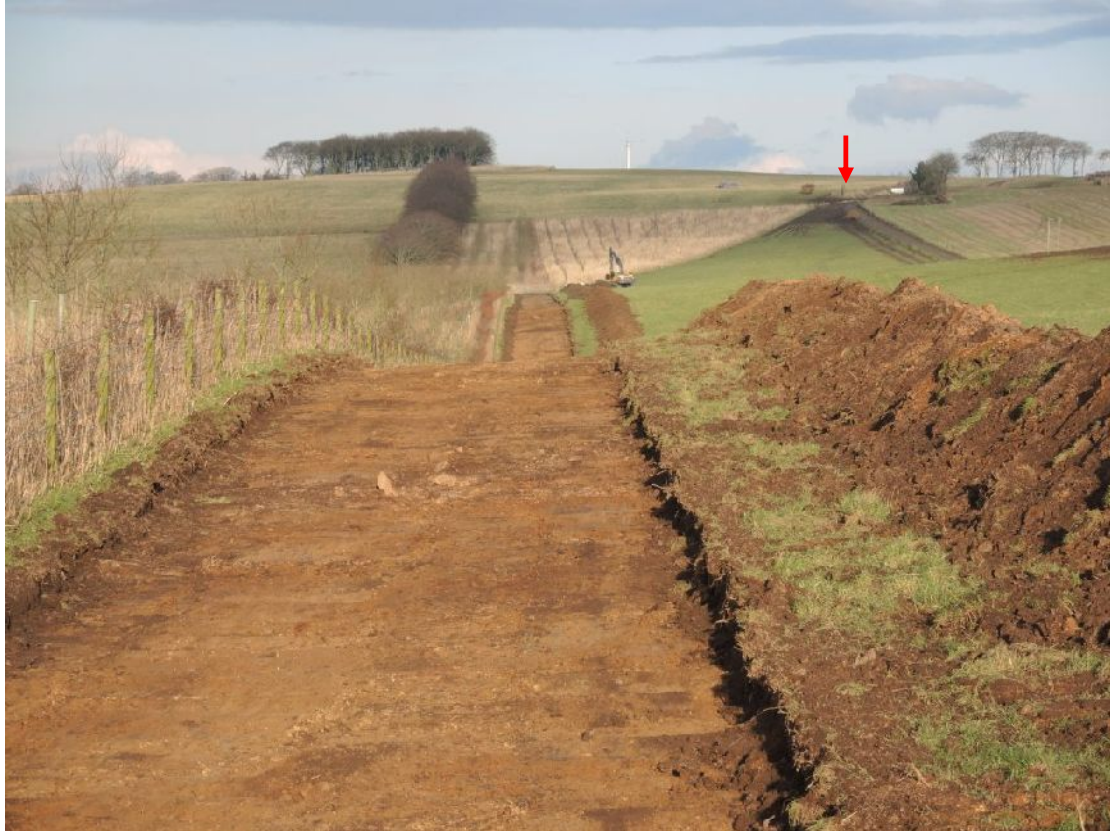
Illus 7 S end of N/S section of track looking N. Red arrow indicates N end of track

4.5 No archaeological features or finds were evident.
