**MILTON OF WHITEHOUSE
LOGIE COLDSTONE
ABERDEENSHIRE**

Standing Building Survey
Carried out 13th February 2015
by
Murray Archaeological Services Ltd

Report No: MAS 2015-8
by
H K Murray and J C Murray

- Standing Building Survey -

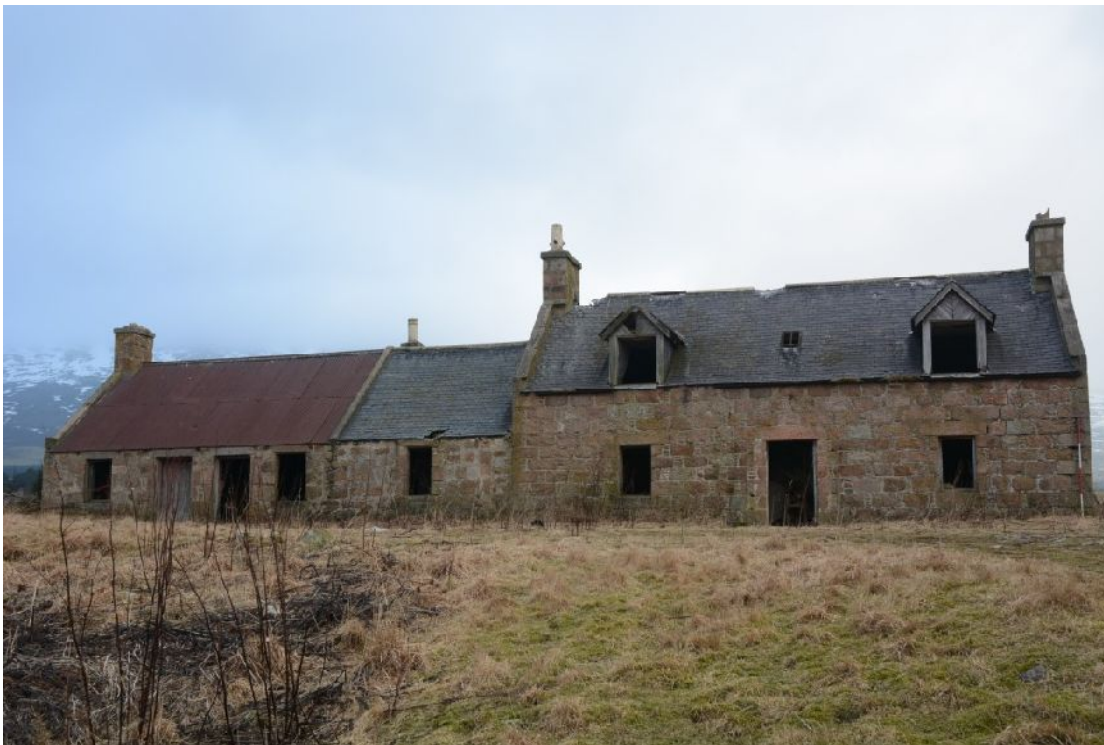
Illus 1 The buildings from the front (E) with Morven behind.

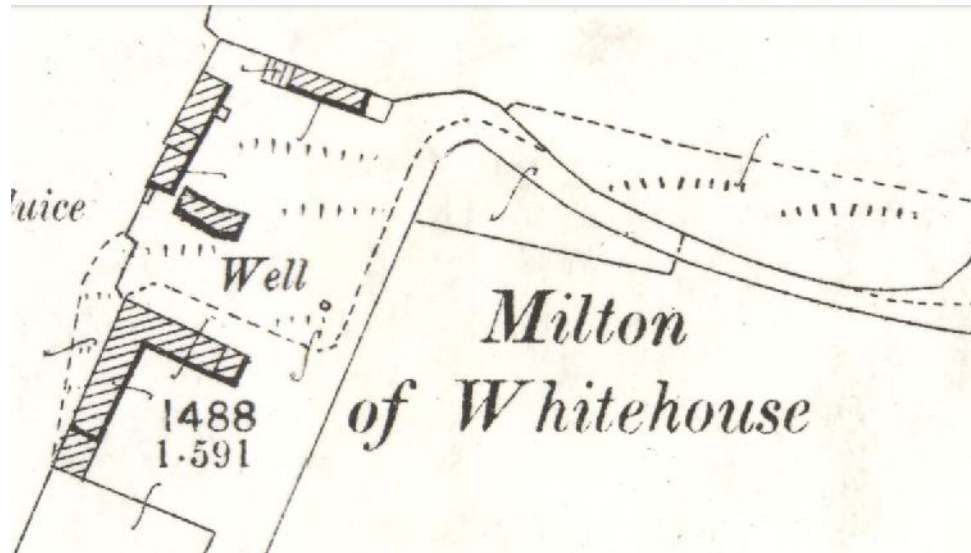
Aberdeenshire Sheet 081.01) the building on the N side has been foreshortened at the W end. The curved or angled S building remains. On the W side (the area of this survey) the unroofed structure at the S end has been removed, the central building

appears to have been rebuilt as two units and the N building has a porch on the E face.

Illus 3 Detail of the 2nd edition 25th/mile Ordnance Survey of 1900 (published 1902. Aberdeenshire Sheet 081.01) www.nls.ac.uk

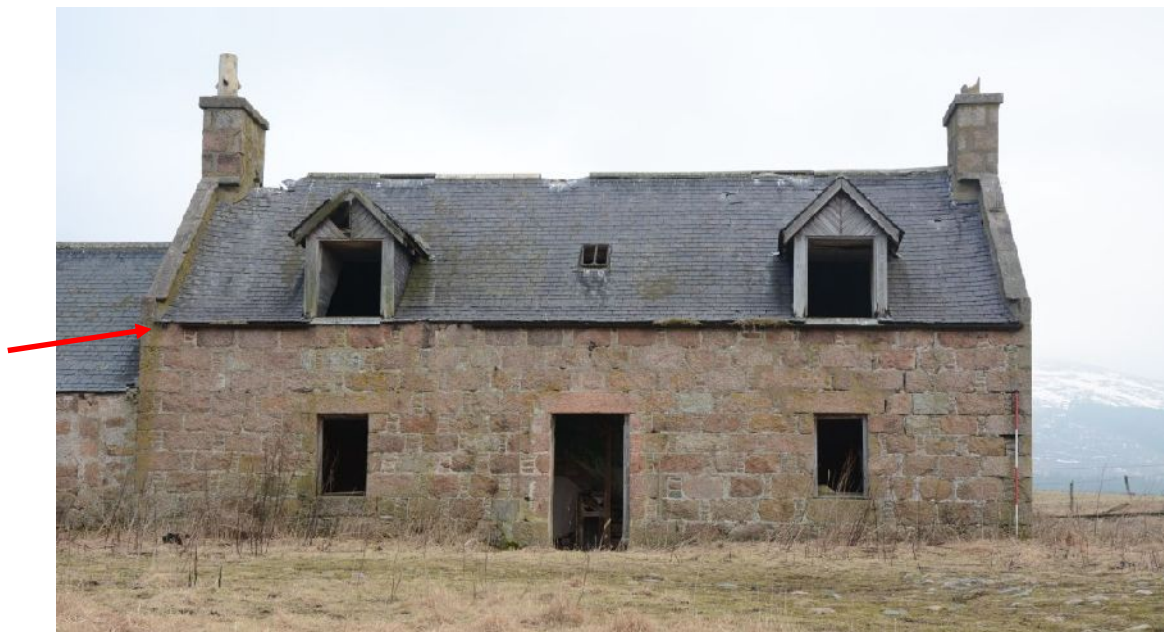
Illus 5 Building 1 E wall. Arrow indicates position of date stone

Walls Front (E) wall of regular squared rough-dressed pink granite blocks with regular stacked pinnings. Gable (N) wall appears similar but is obscured by render. Back (W) wall similar stone but lacks the stacked pinnings. Wall thickness: c 600mm.

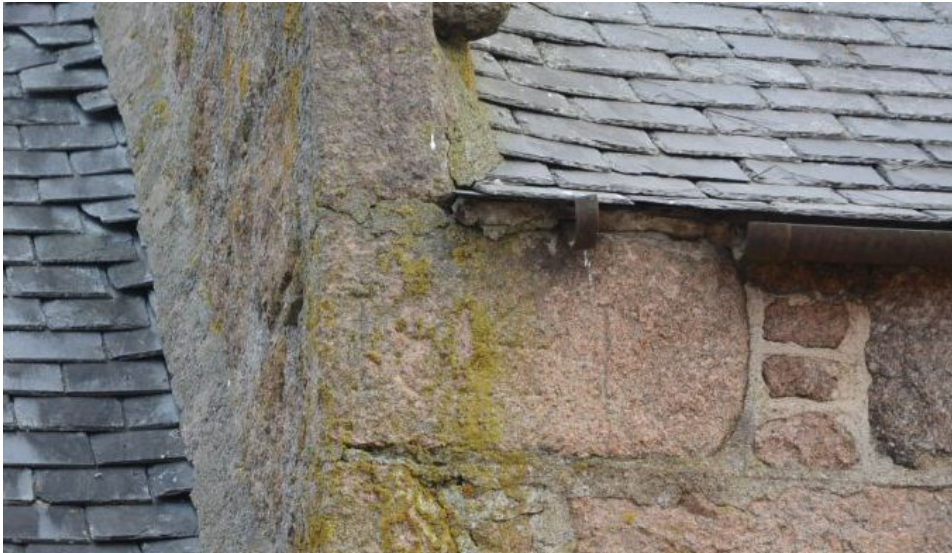
Date stone 1841 at top of E wall on S end below skew.

Illus 6 Datestone '1841'

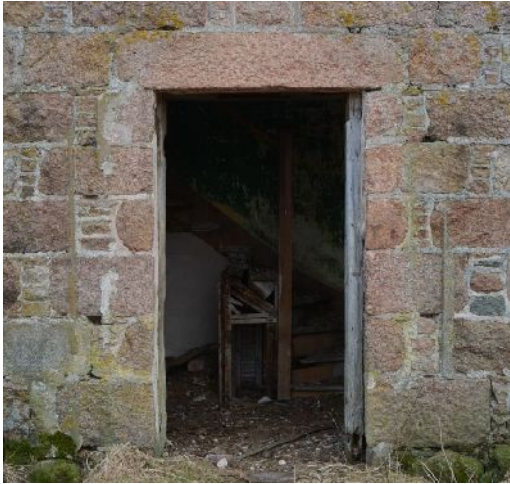
D1 H: 1.90m W: 1.08m. Pinkish rough-dressed granite rybats, lintel and sill.

Illus 7 (LHS). Building 1. D1.

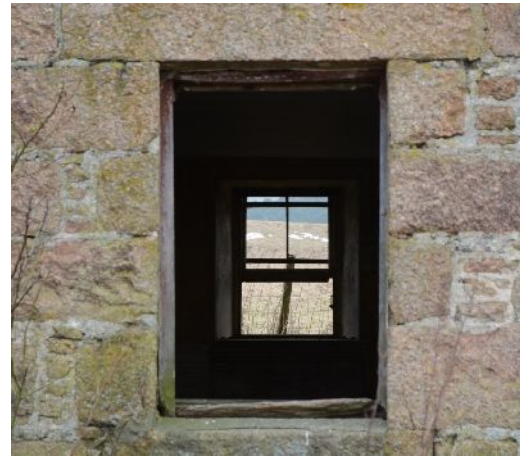
W2 H: 1.15m W:0.72m. Pinkish rough-dressed granite rybats, lintel and sill.

Illus 8 (RHS). Building 1. W2 .

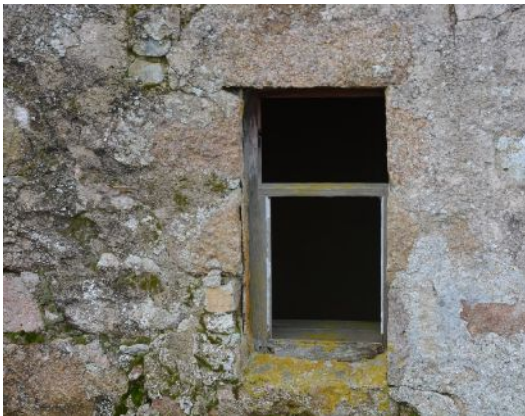
W11 H:0.92m. W:0.46m. Pinkish rough-dressed granite rybats, lintel and sill.

Illus 9 (LHS). Building 1. W11.

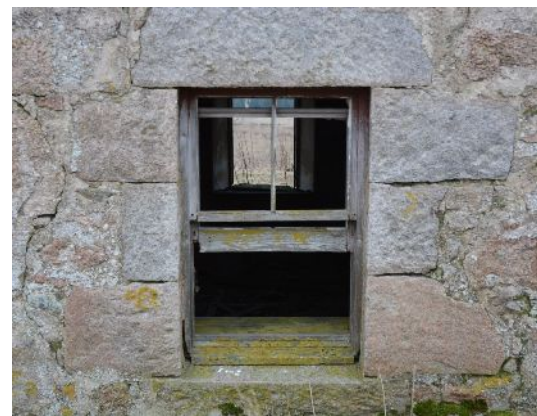
W12 H:1.13m. W:0.73m . Greyer granite lintel, sill and rybats. Sash window surviving.

Illus 10 (RHS). Building 1. W12- different stonework- possible insert

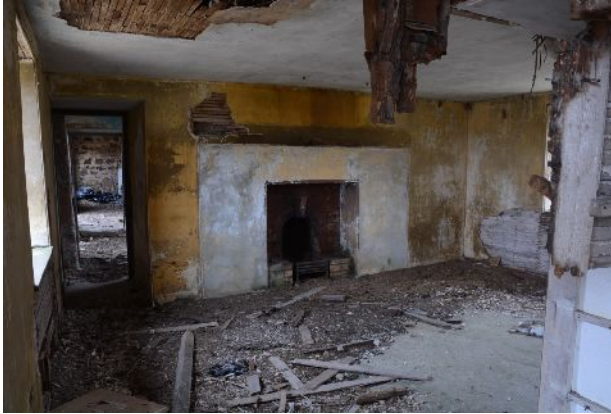
B: Lathe and plaster. Small brick fireplace probably secondary in larger opening.

Concrete floor. Door into Building 2. (Illus 11)

Illus 11 (LHS). Building 1. Interior of Room B looking W.

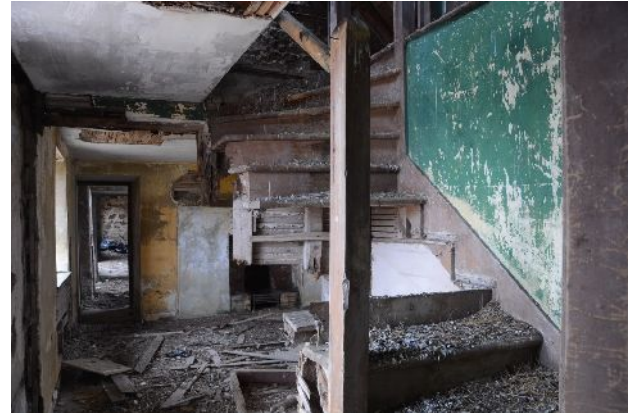
Illus 12 (RHS). Building 1 stair

As the stair was broken it was not possible to enter the upper floor (Illus 12).

Looking up the stairwell it was clearly divided into three rooms- one at each gable and a smaller room at the top of the wooden stairs.

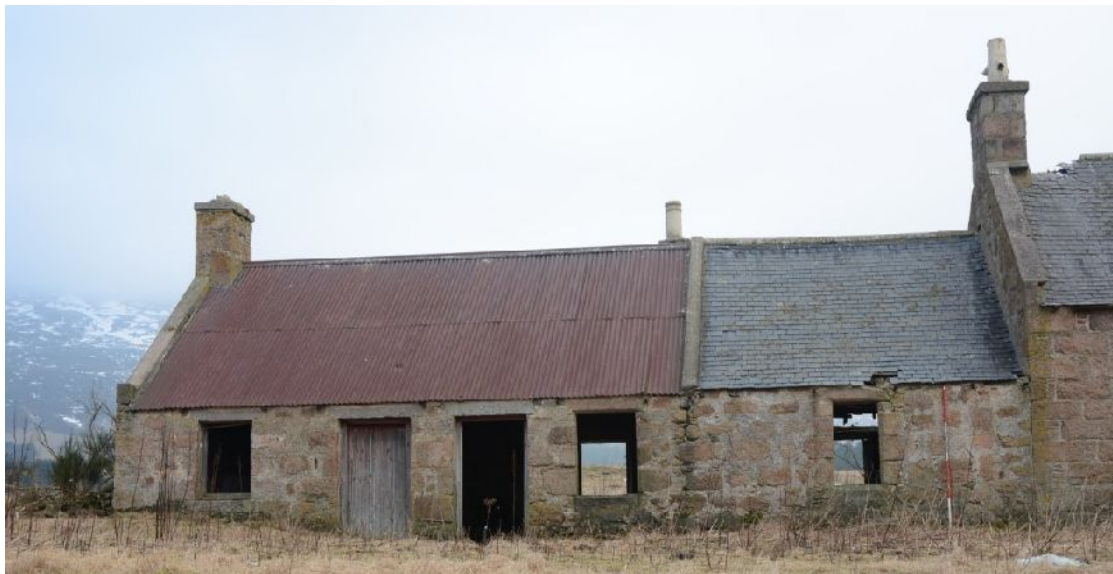
Illus 13 Buildings 2 (centre) and 3 (LHS)

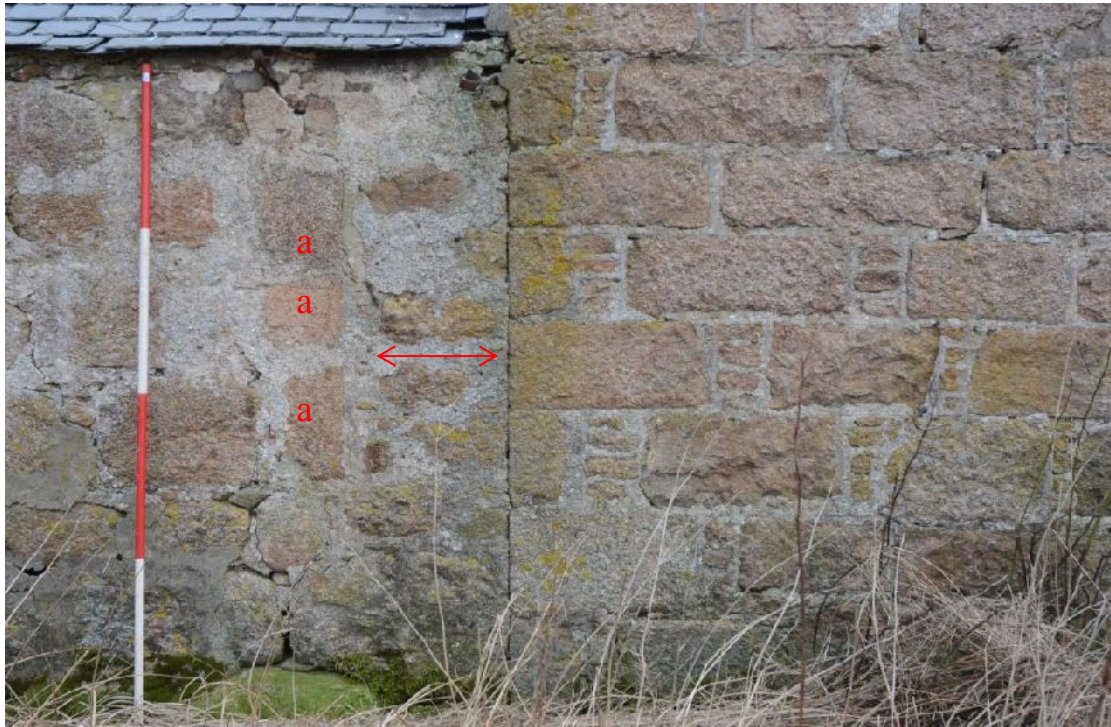
F1: c. 0.50m from the SE corner of Building 1, there was a line of three chamfered rybats in the E wall. To the S of this the wall was c. 0.80m thick with roughly dressed reddish granite blocks in good horizontal courses. To the N of this, between it and Building 1, there was infill of smaller stones (Illus 14).

Illus 14 Wall between Building 1 (RHS) and Building 2 (LHS) with infill between (marked by arrows). Three chamfered rybats marked 'a' denote original end or opening in Building 2.

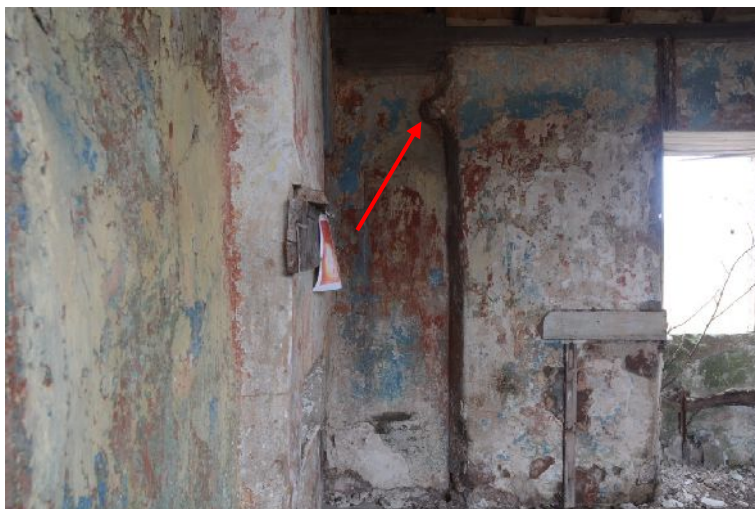
There was an odd projection at the wall head on the inside of the N end of the thicker section of the E wall (Illus 15). This might indicate that there had been a door at this point, rather than the corner of a building.

Illus 15 Inside of thick section of E wall of Building 2. Note projecting stone marked by arrow

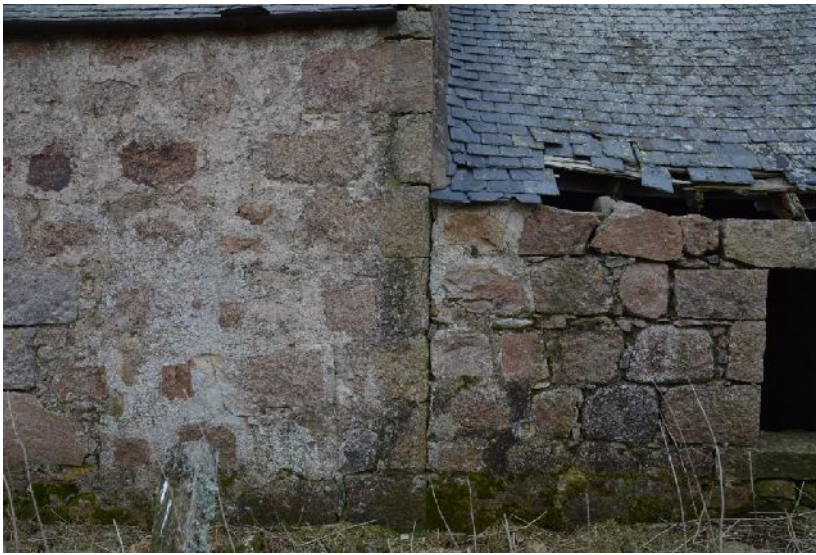
Illus 16 Back (W) wall of Building 2 abutting gable of Building 1

The back (W) wall of this central building was of similar granite blocks but was only c. 0.50m thick. Also unlike the front wall, the back wall abutted the gable of Building 1 (Illus 16).

The wall between Buildings 1 and 2 was extremely thick- up to 1.12m and may indicate that the gable of Building 1 was built against an existing wall.

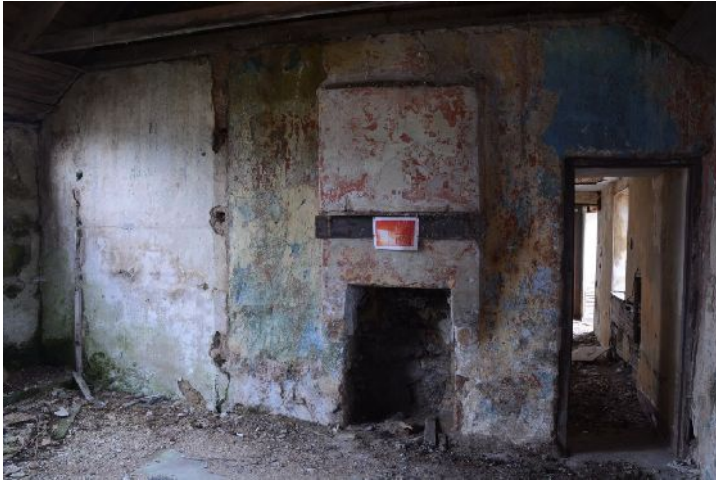
Small blocked fireplace (H: 1m. W: 0.69m) on the face of the N wall (Illus 17).

Illus 17 Fireplace in N wall of Building 2 Room D

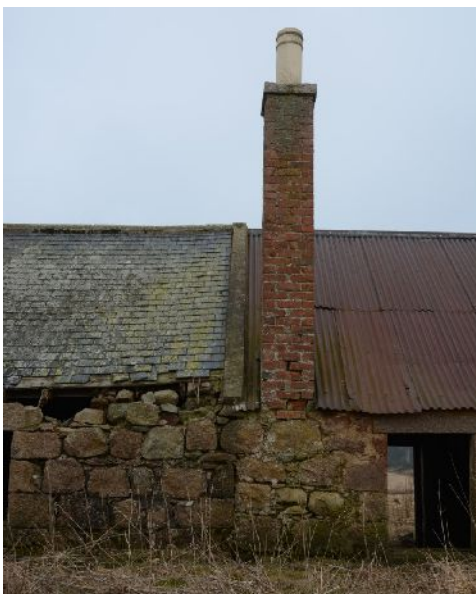
Chimneys Chimney at S end of squared granite with flat table. Brick chimney (0.50m square) in W wall to stove (?) in room E (Illus 18).

Illus 18 Brick chimney

E: Concrete blocked setting/fireplace in W wall at N end. Metal flue through the wall above the blocking. This connects to the brick chimney.

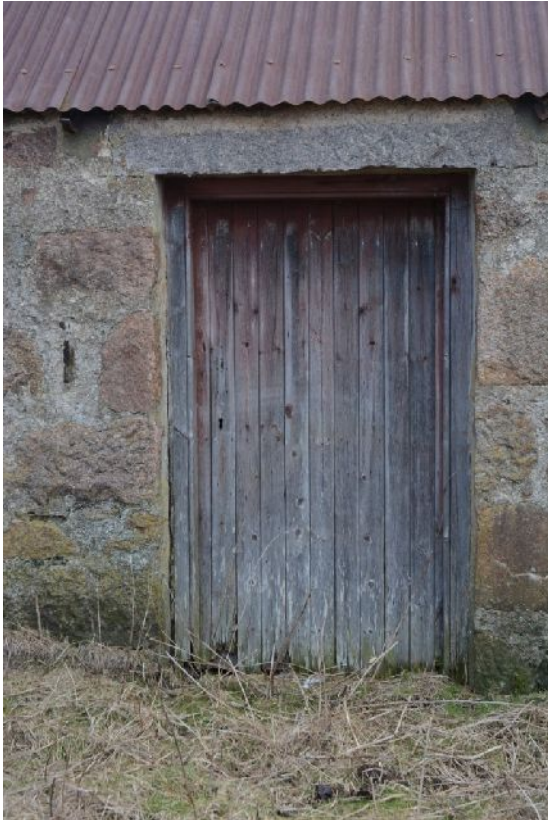
Illus 19 Building 3 D2. showing use of grey granite lintel with quarry marks

D2 H: 1.80m W: 1.07m Rough-dressed granite rybats. Lintel of grey granite with quarry marks showing (Illus 19).

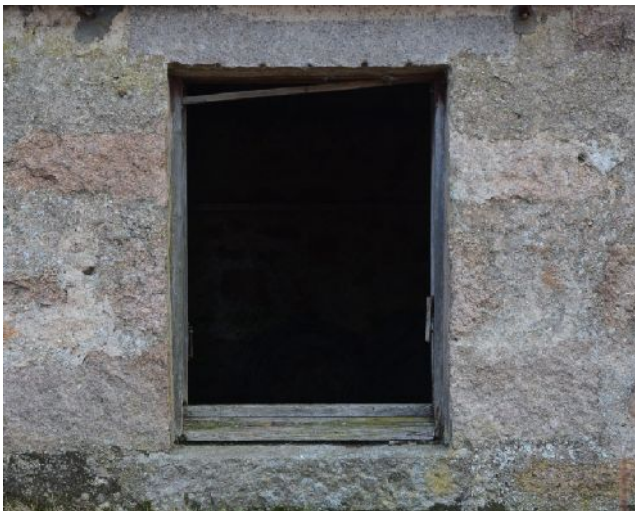
Illus 20 (LHS). Building 3. W5 showing grey granite lintel with quarry marks

W5 H: 1.15m W: 0.85m Rough-dressed granite rybats. Lintel and sill of grey granite (Illus 20).

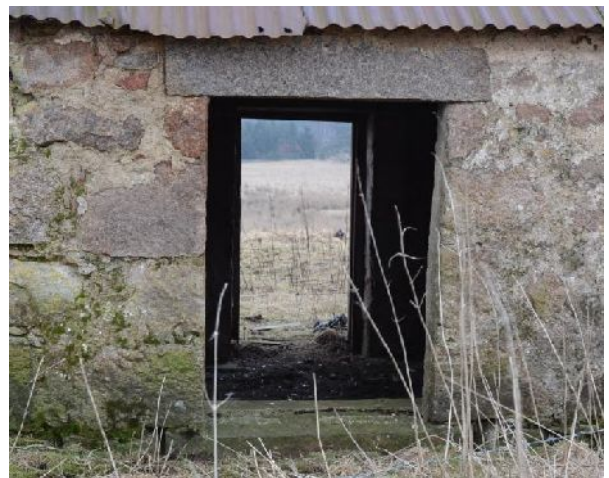
Illus 21 (RHS). Building 3. W 14 showing grey granite lintel.

W14 H: 1.17m W: 0.86m. Rough-dressed granite rybats. Lintel and sill of grey granite.

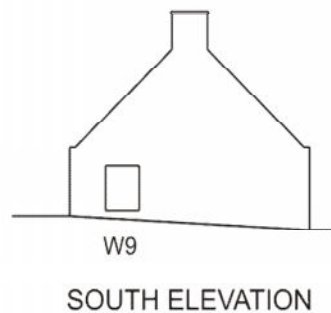
Illus 22 Elevations annotated from drawing courtesy of Gerry Robb Architectural Design Services (brick chimney in orange)

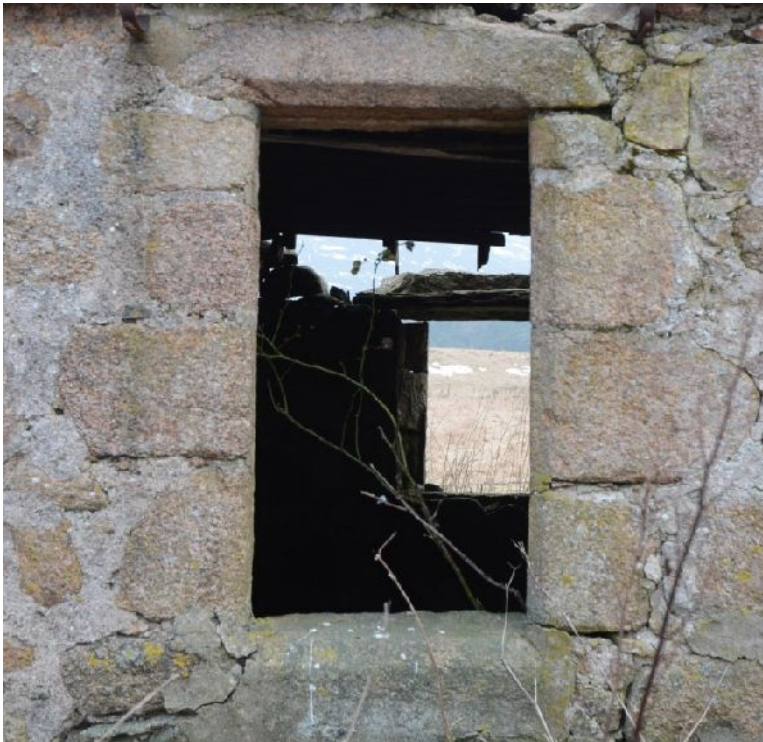
W3 H: 1.12m W: 0.60m. Buff/pinkish granite rybats, lintel and sill. All with well-dressed chamfer.

However, examination of the wall construction and the windows and doors in each section shows a more complex development. The most significant features are the well-dressed chamfered rybats and lintels of window W3 and the rybats at the N end of the thick section of the E wall in Building 2. Identical stonework was re-used for the rybats and lintel of window W4 at the S end of the thick section of the E wall and for the rybats of window W9 both in Building 3. Both of these windows also used grey granite which elsewhere in Building 3 was used for all openings and at the skews (Illus 23-25).

Illus 23 Building 2, W3 showing well dressed chamfered stones at margins.

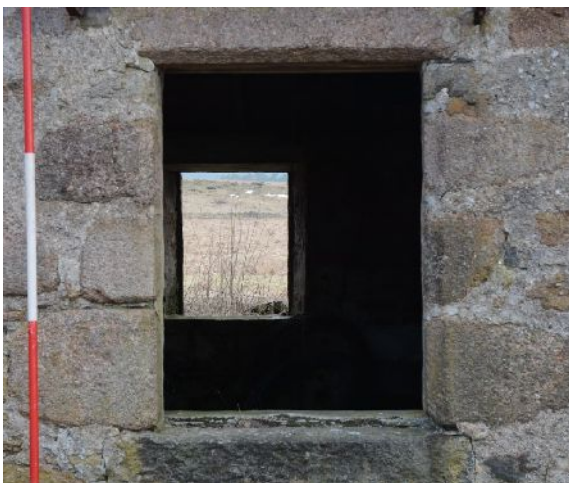
W4 H: 1.15m W: 0.84m Buff/pinkish granite rybats and lintel. All with well dressed chamfer. Sill of grey granite.

Illus 24 (LHS). Building 3. W4 showing re-use of chamfered stones at sides and lintel but replacement granite sill.

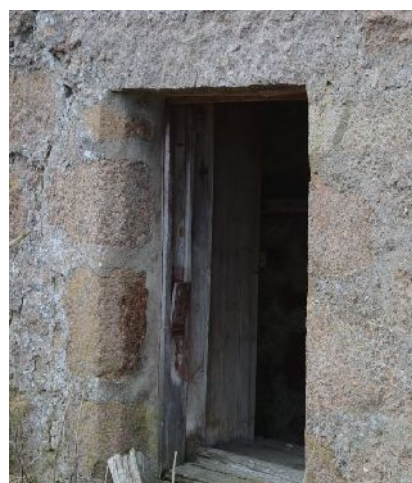
W9 H: 1.16m W: 0.84m. Buff/pinkish granite rybats with well dressed chamfer. Sill and lintel of grey granite (Illus 21).

Illus 25 (RHS). Building 3. W9 showing re-use of chamfered stones at sides but with grey granite lintel and sill.
