**MOSSTOWN BRAES  
LOGIE COLDSTONE  
ABERDEENSHIRE**

**Standing Building Survey**

Carried out 21<sup>st</sup> February 2015

**Report No: MAS 2015-13**

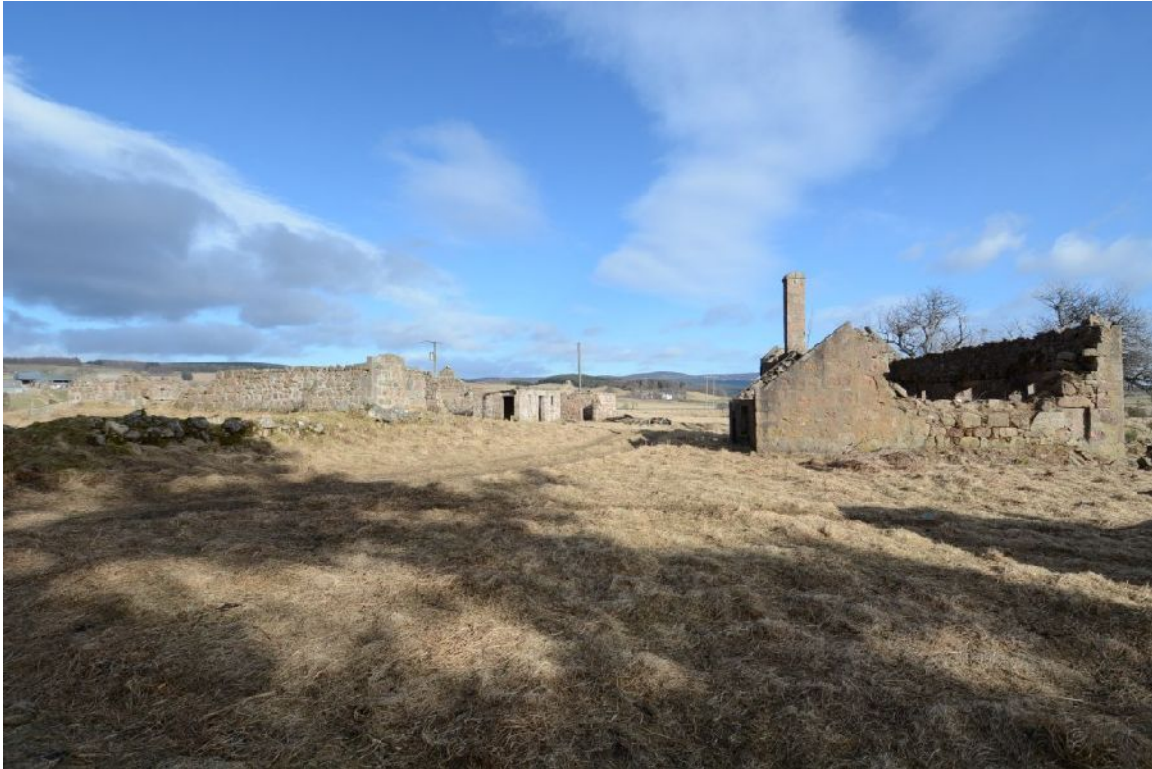
**Illus 2 The buildings looking W. The steading lies to the LHS of track, the house to the RHS**

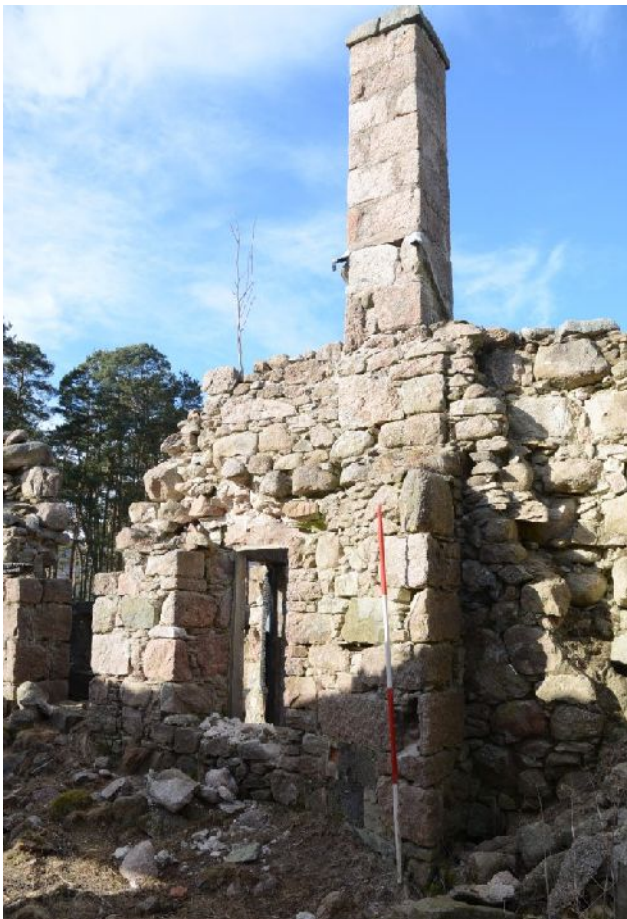
**Illus 7 Chimney F1 abutting inside of N wall.**

A third chimney in the centre of the N wall (F1) was a secondary insertion against the inner face of the N wall. It was square and built of pink granite with an angled table.

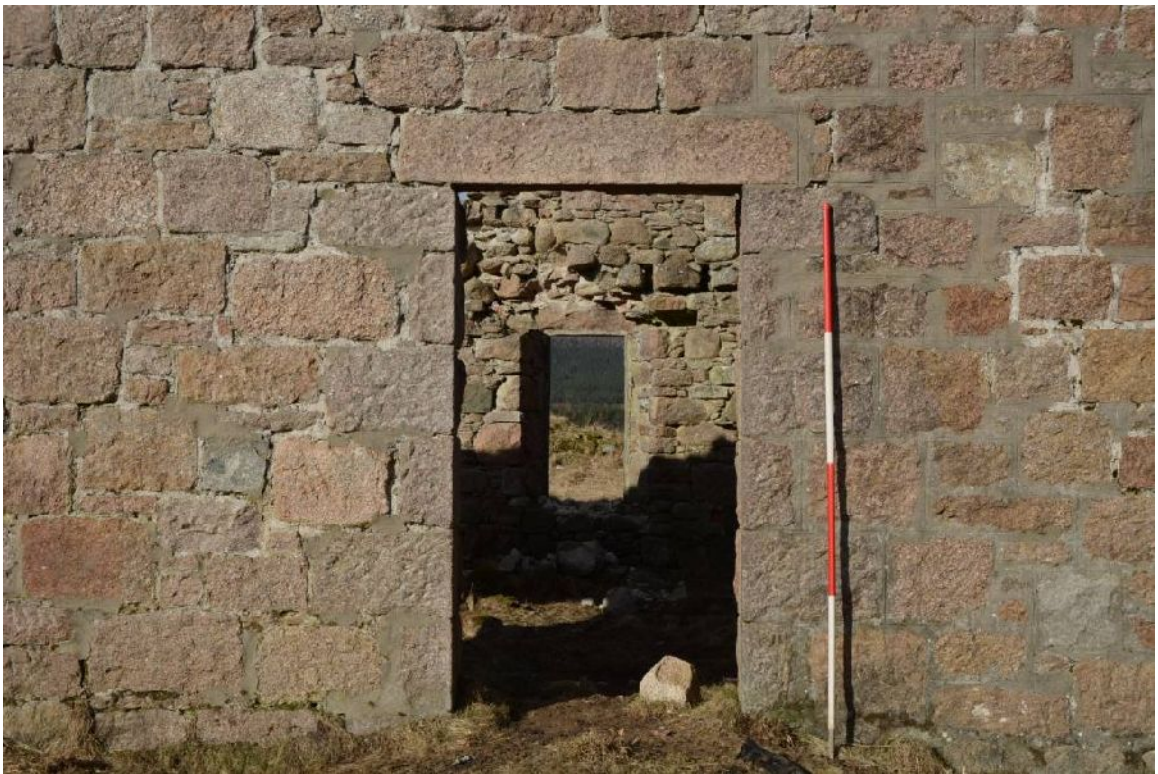
D1 H: 2.10m+ (build up of soil) W: 1.12m Lintel, sill and rybats of dressed pink/grey granite.

**Illus 8 Door D1**

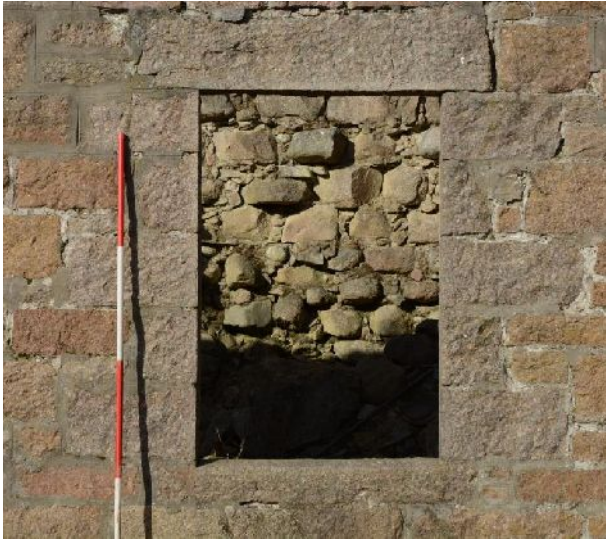
W1 H: 1.63m W: 1.08m Lintel, sill and rybats of dressed pink/grey granite. Sides have rebate 80mm deep at 120mm from outer face of window surround. Interior splayed to 1.45m width.

**Illus 9 Window W1 exterior**

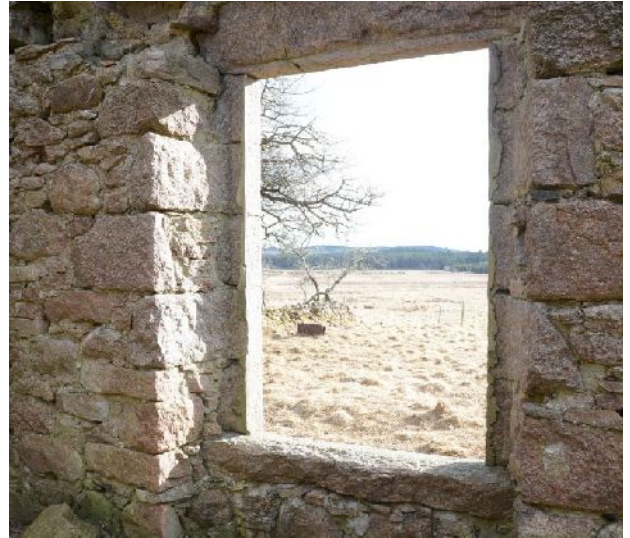
**Illus 10 Window W1 interior**

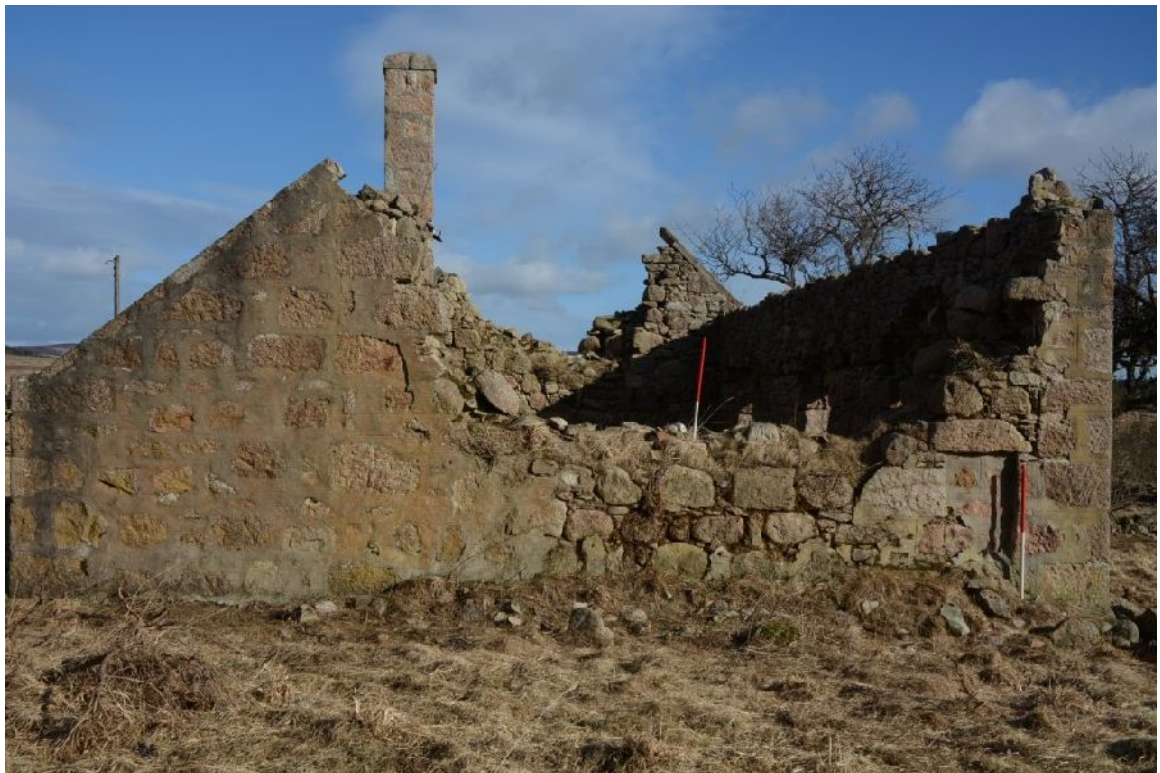
**Illus 11 W wall**

The centre of the W wall appeared rougher as if it had been rebuilt but traces of the cement render that was elsewhere on the wall suggest this appearance was due to the fire.

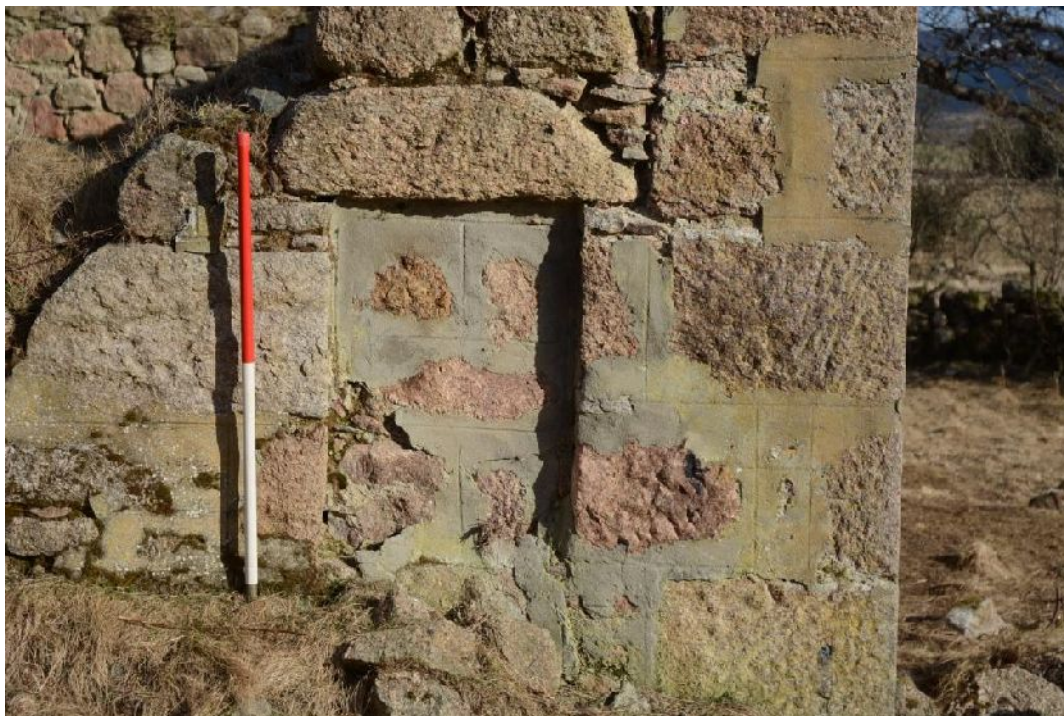
W3 Opening blocked with pink granite. H: 0.84m. W: 0.56m. Rybats and lintel of field stone.

**Illus 12 W wall detail of W3**

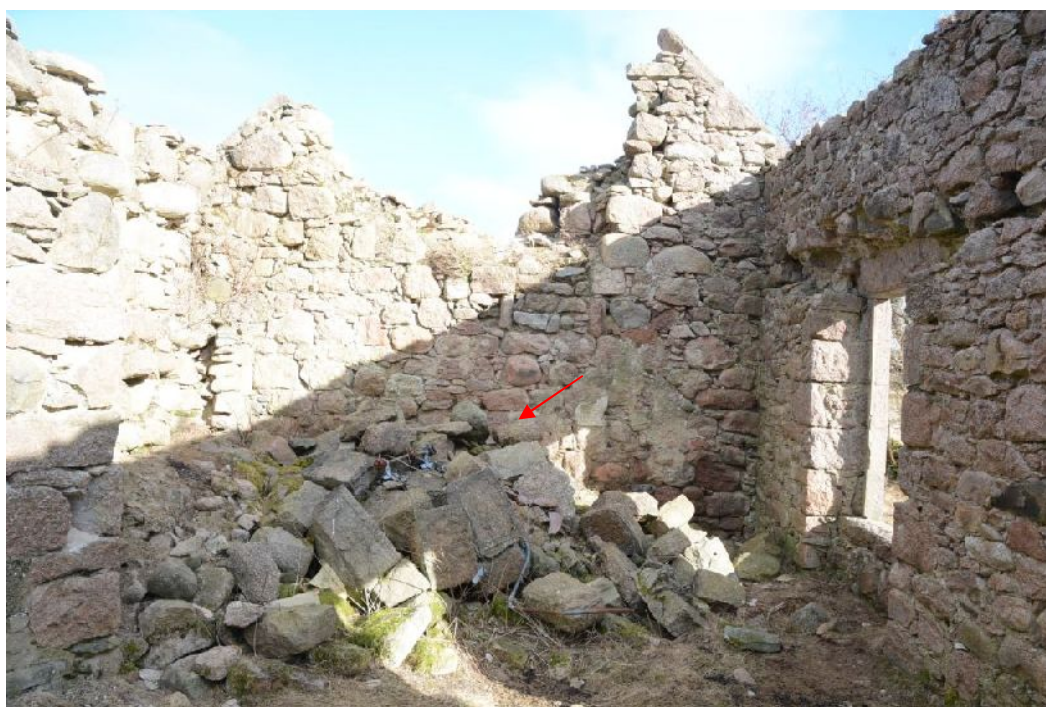
**Illus 13 Interior of E end of building. Arrow to fireplace**

E gable: the lintel of a fireplace could be seen in the centre of the E gable wall, corresponding to the position of the flue lining within the wall (Illus 13). The fireplace was obscured by rubble.

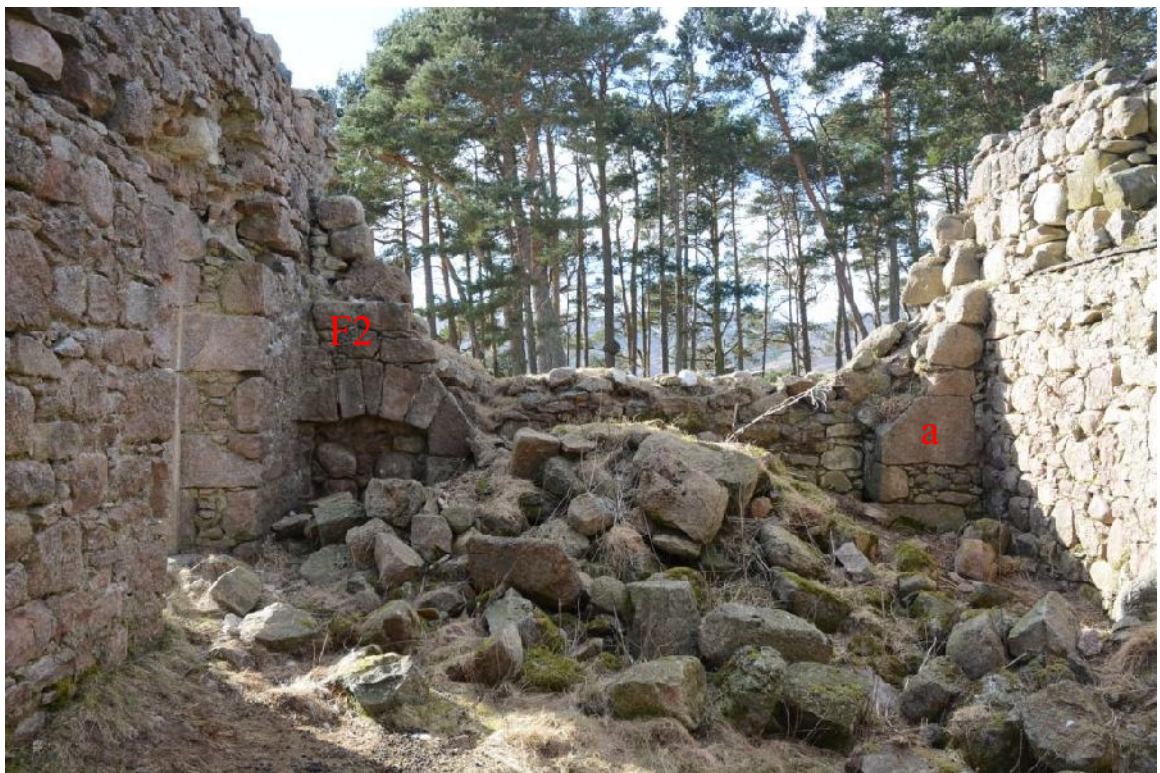
To the N of the fireplace the wall was c300mm thicker (Illus 14: a), this was possibly a secondary inner feature but it was too obscured by rubble to interpret further.

To the S of the fireplace, there was a similar and clearly secondary additional 300mm thickness to the inner face of the wall, which formed an arch (Illus 14: F2, Illus 15) across the blocked window opening W3. This may have been a cupboard utilising the earlier window space.

**Illus 14 Interior of W end of building**

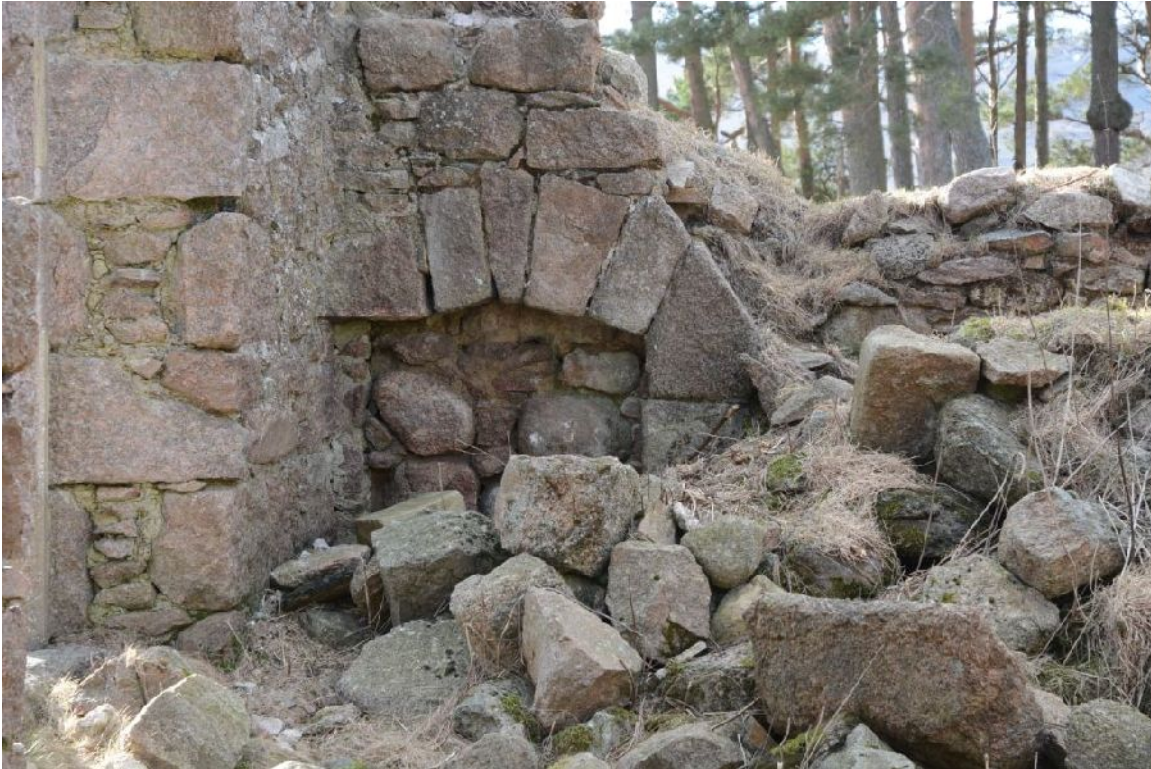
**Illus 15** Detail of F2 at W end of building. Note the slightly smaller blocking of W3 partly hidden by F2.

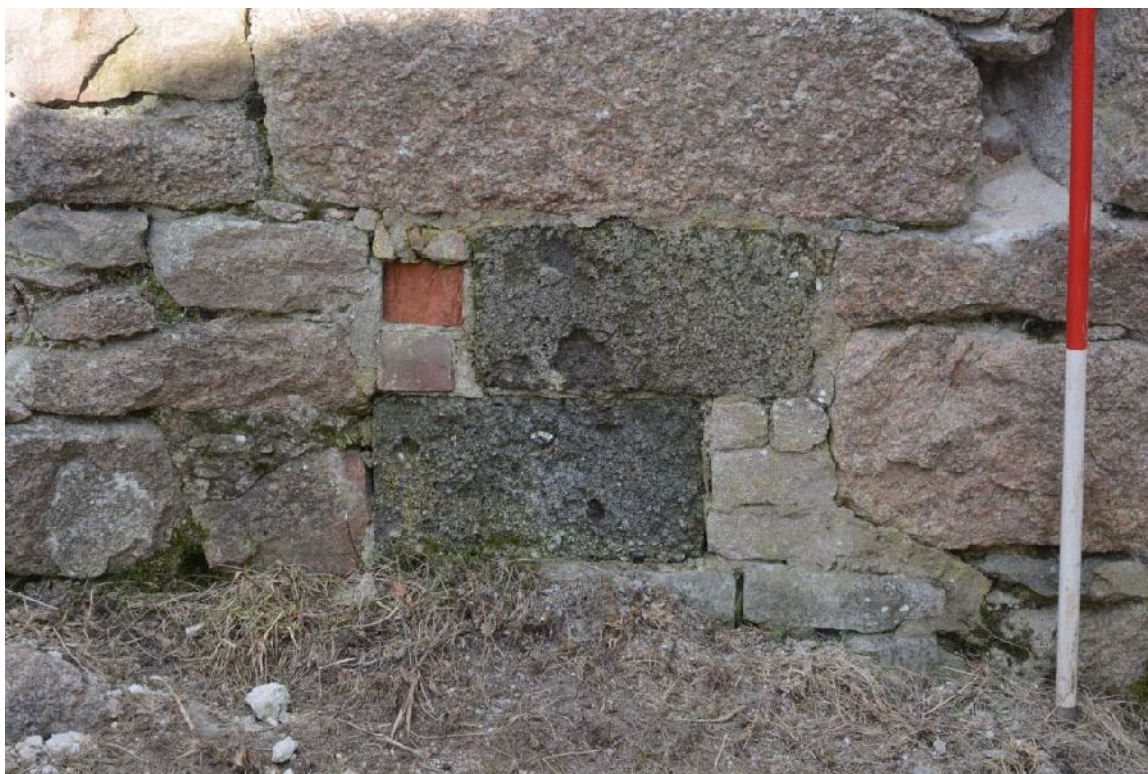
F1 The secondary chimney F1 had been built at an odd angle (1.47m x 0.62m) abutting the inner face of the centre of the N wall. The fireplace using this chimney was in the W facing side of this triangle and was 0.60m wide and 0.41m from the E edge. It was blocked with cement blocks and brick and had a granite lintel (Illus 7, 16, 17)

**Illus 17** Detail of blocked fireplace at base of F1

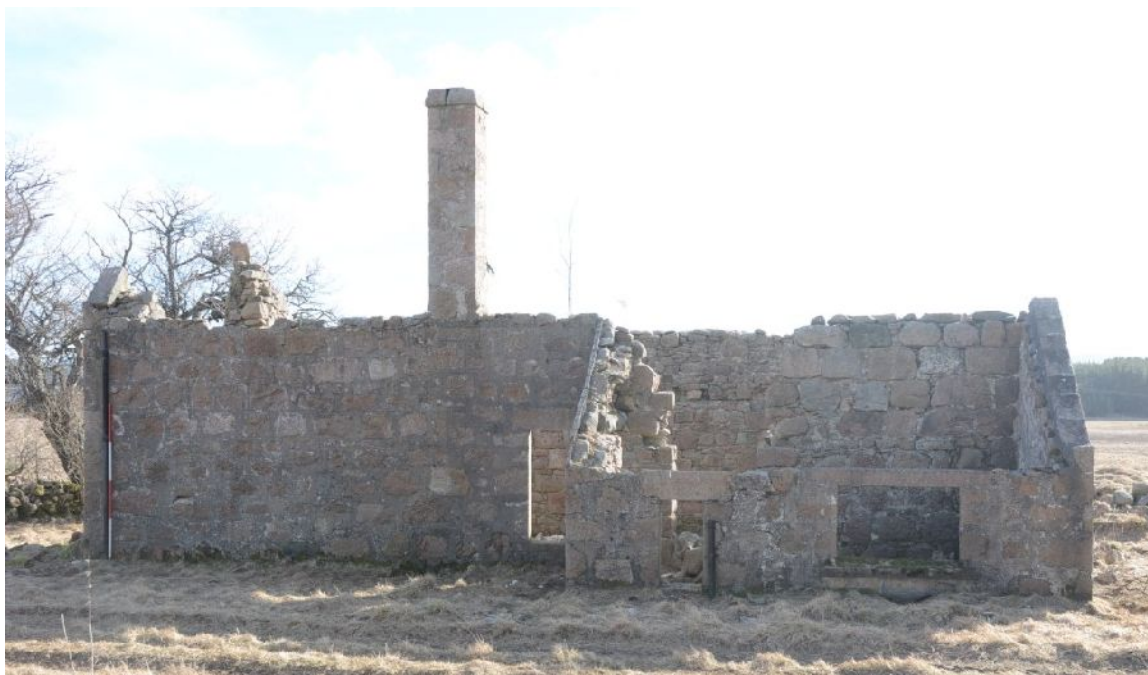
**Illus 18** Outshot looking S

Roof Missing. Lean-to roof. Had been slate. Slates in rubble and in concrete at gable.

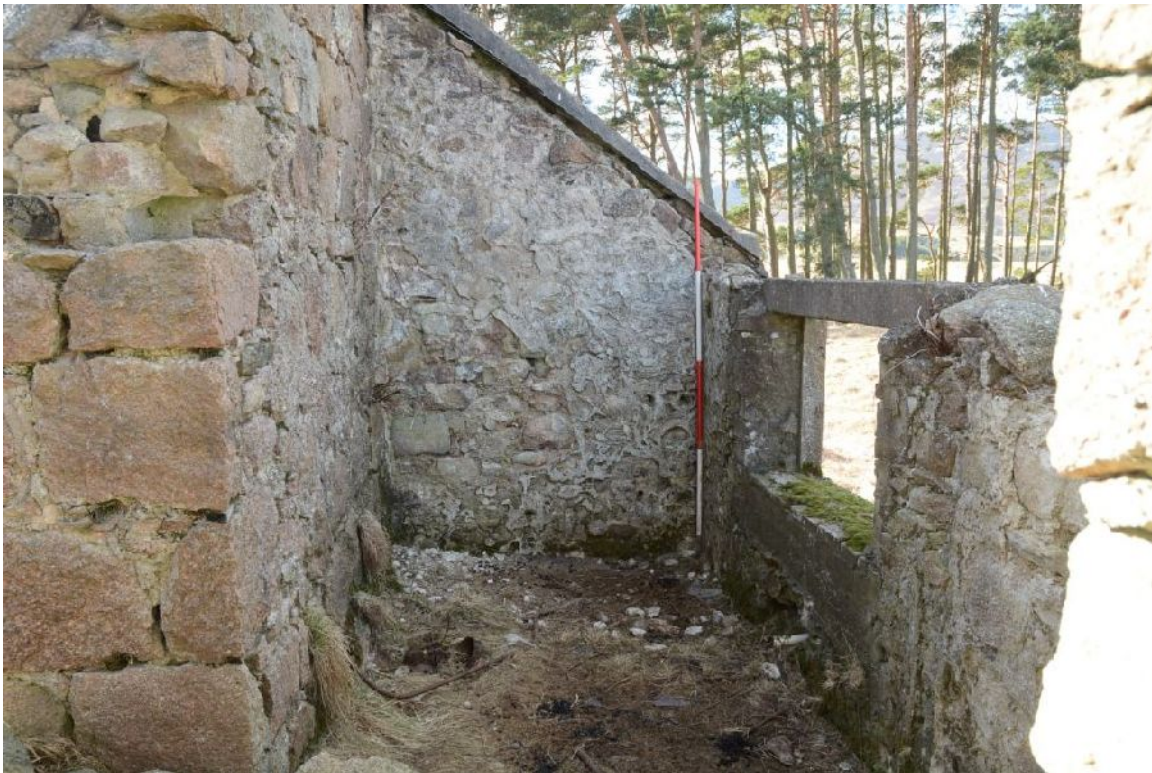
Plastered internally. Vertical raggle 150mm wide in N wall plaster at 1.70m from inside of E wall indicates this had been partitioned into two rooms.

**Illus 19** Outshot looking W. D3 on LHS. Raggle of partition on RHS
