**CHAPLAIN'S COURT
20 THE CHANONRY
OLD ABERDEEN**

**Standing Building Recording
and Watching Brief**

Report No: MAS 2013-13

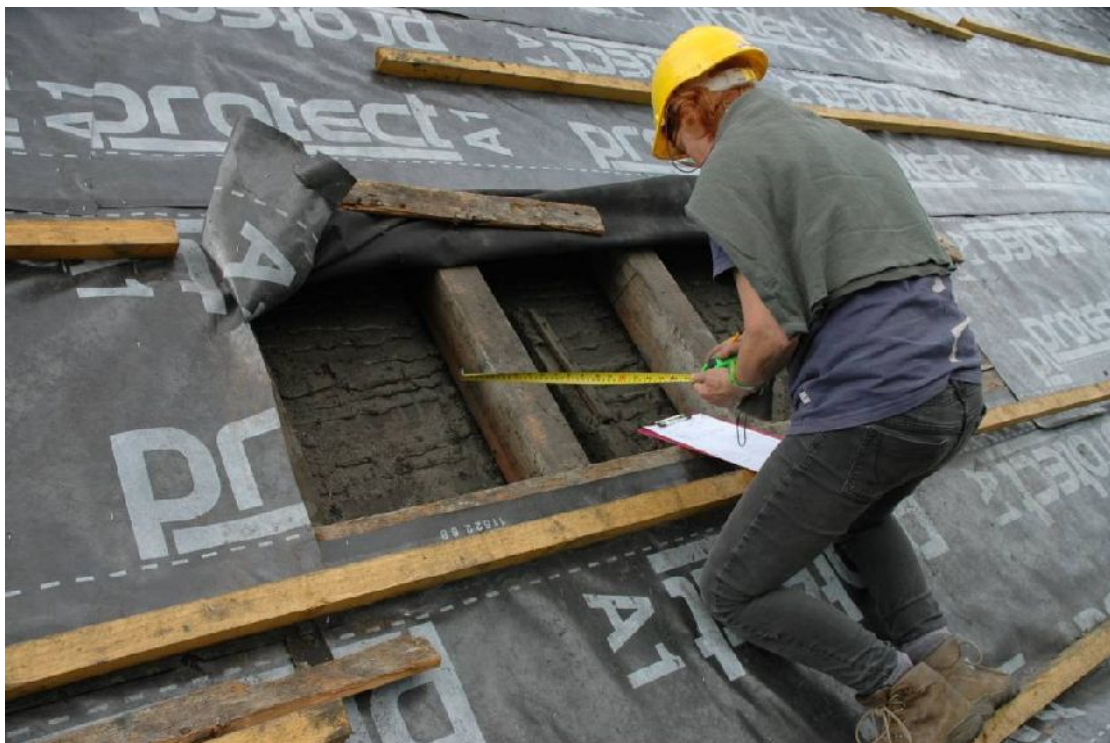
Illus 2 Recording of the roof

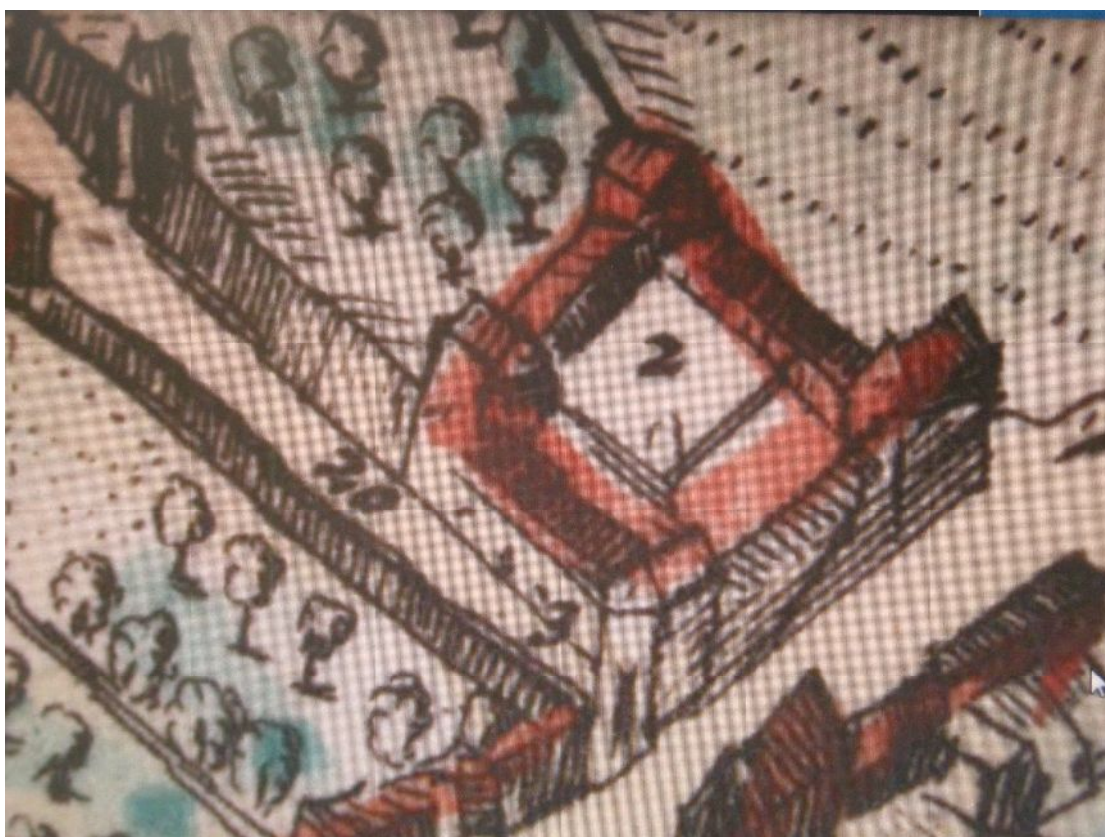
Illus 3 Chaplains Court: Detail from Gordon's map of 1661 <http://maps.nls.uk/towns>

1661 Gordon's Map. Shows quadrangle with S range possibly derelict. Corner towers- W and N towers with gables set N/S. Possible windows shown on street (W) side of W tower. W (surviving) range central pend arch shown, window each side. No impression of 2 stories. N and E ranges drawn as single story. E range appears to have series of doorways facing into the court, with smaller windows between them. Path E/W across court (from pend) and another ? path parallel to the W range (these are miscoloured as if they were roofs) S

and E towers have gables E/W, the S tower all or partly hidden by the Chaplains Port across The Chanonry roadway. S range (Don Street) shown with long crack across the face- possibly derelict. S end of W range, slight change of roof line at pend, possibly derelict S of this. Land to N still all Bishop's garden. Land to E is Bishop's Dovecot Green.

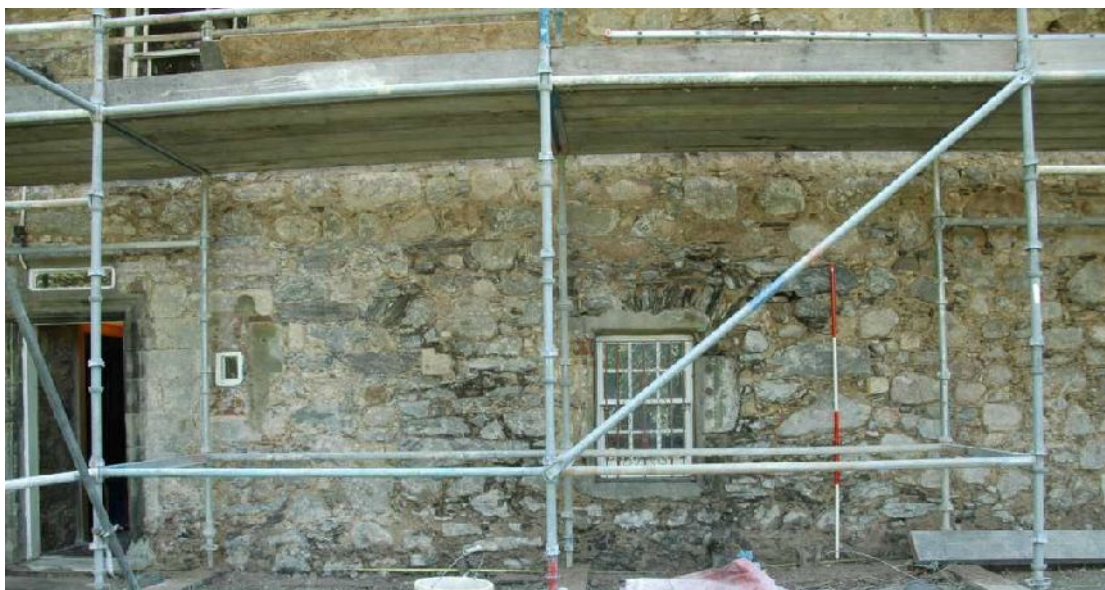
Upper part of wall between pend and tower. Rubble stone but more rounded and with stronger sense of horizontal coursing.

This upper walling is the raising of the wall head in the 18th century and corresponds to the change in the upper walling on the street facade.

Illus 9 Detail of wall between pend and tower when harling removed. Note the more regular courses begin just below the scaffolding planks

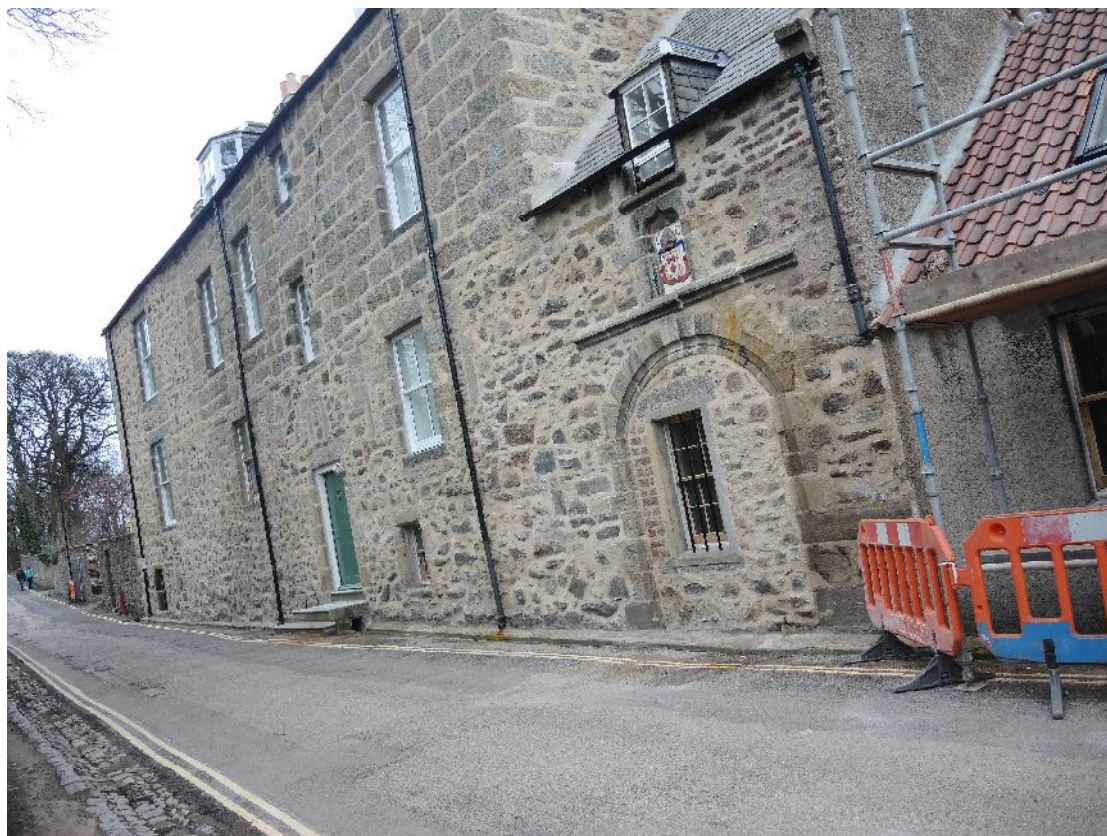
Illus 10 Street elevation showing difference in upper and lower wall

The front, street elevation showed a complete change with the upper part of the wall built with regular rustic dressed rectangular granite blocks (Illus 10).

While this corresponds to the height at which there is a change in wall material on the garden facade and can be attributed to the raising of the wall head in the 18th century, the use of dressed stone emphasises the new emphasis on the outward, street appearance of the building.

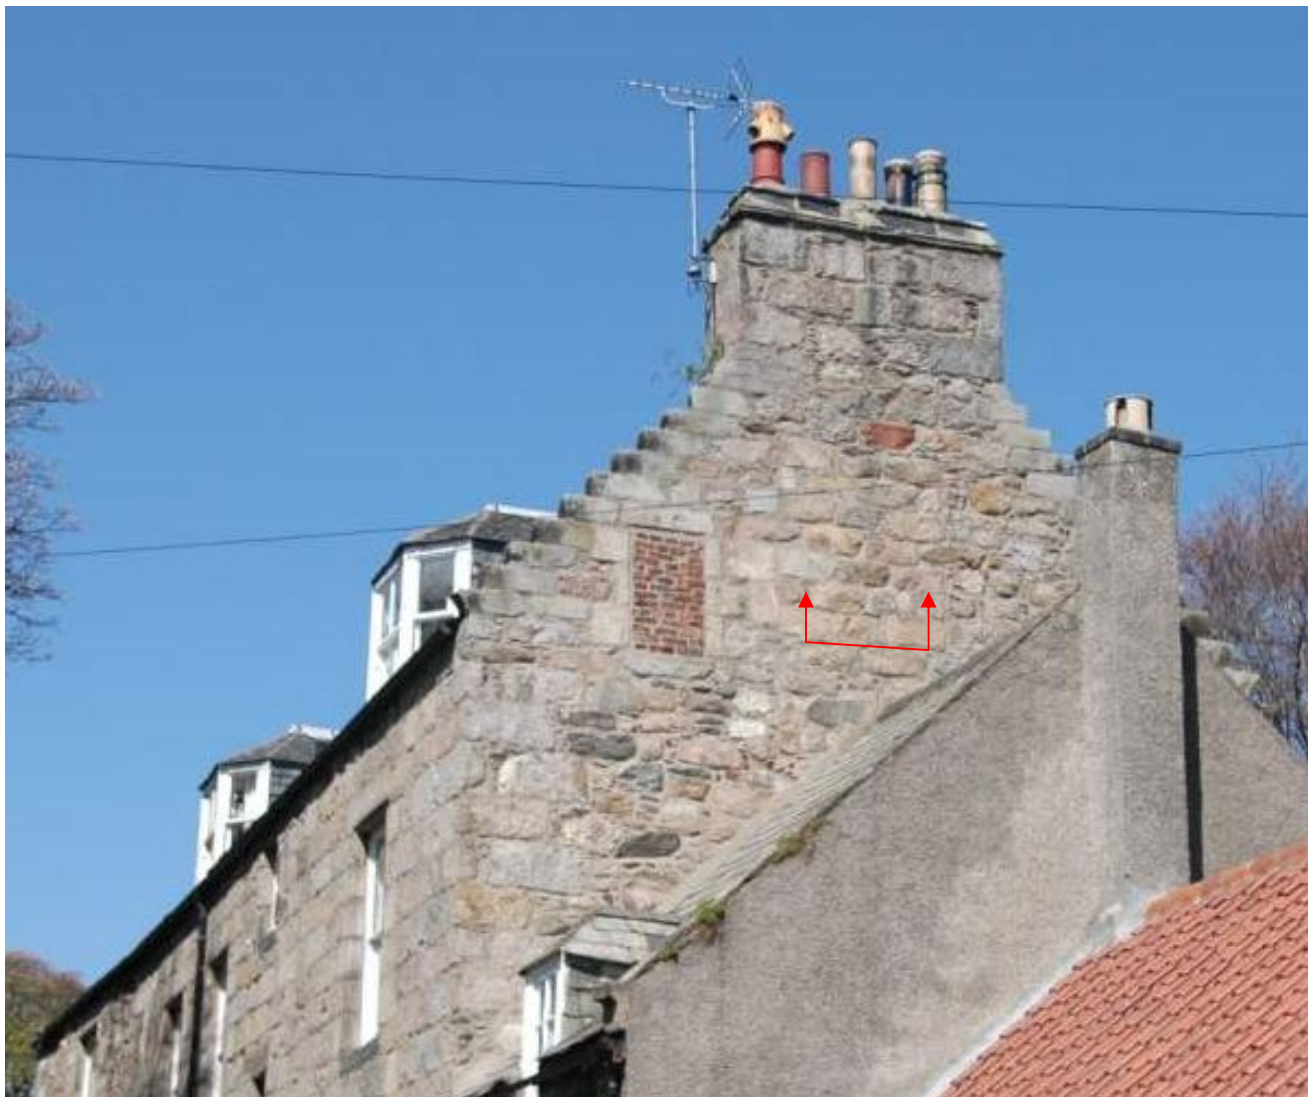
Illus 11 S gable of W range with blocked window W41 and in centre to RHS of window, the more regular blocks of old chimney marked by red arrows.

The upper, visible part of the S gable appears to be of coursed rubble stone similar to the upper part of the east garden facade wall, with the exception of the very regular blockwork of the earlier part of the chimney (Illus 11).

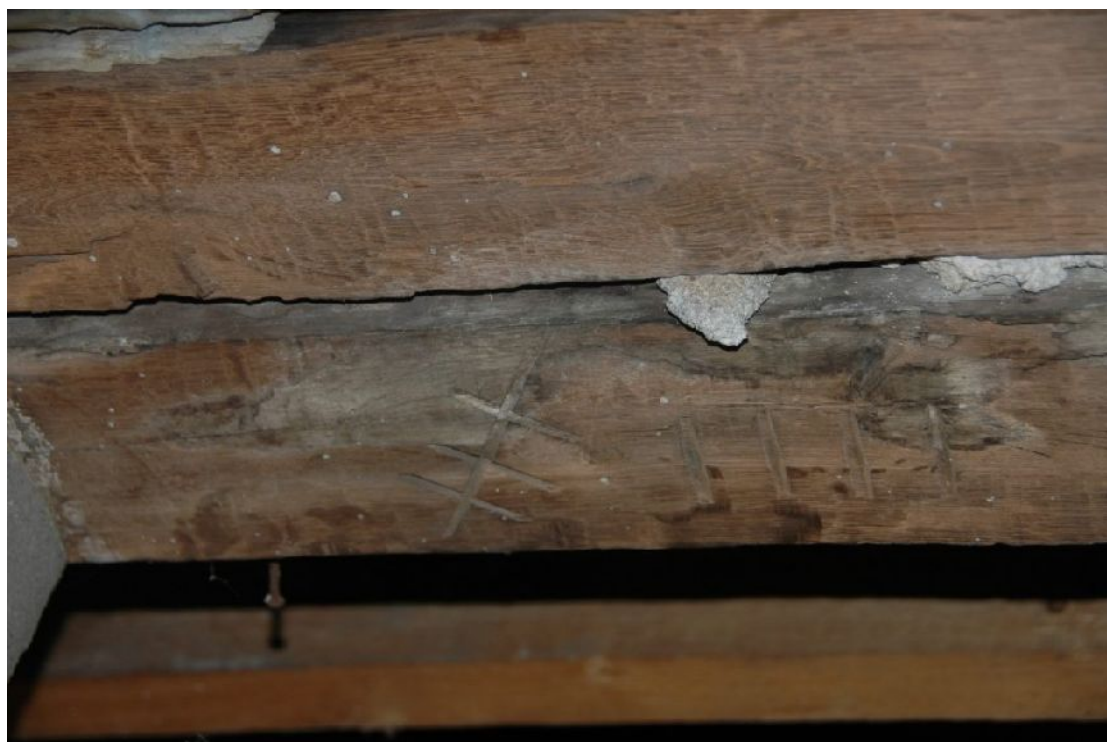
Illus 13 Re-used timbers across hatch through wall of tower into roof space. Carpenter's marks.

Tower roof internal view The roof timbers were not examined in detail but were observed and photographed through the (very small!) hatch through the original S stone gable wall of the tower. The hatch break-through was topped by five horizontal timbers, all appearing to be re-used and two with carpenter's marks from their primary use. (Chisel cut XXX IIII and knife cut XII. Illus 13)

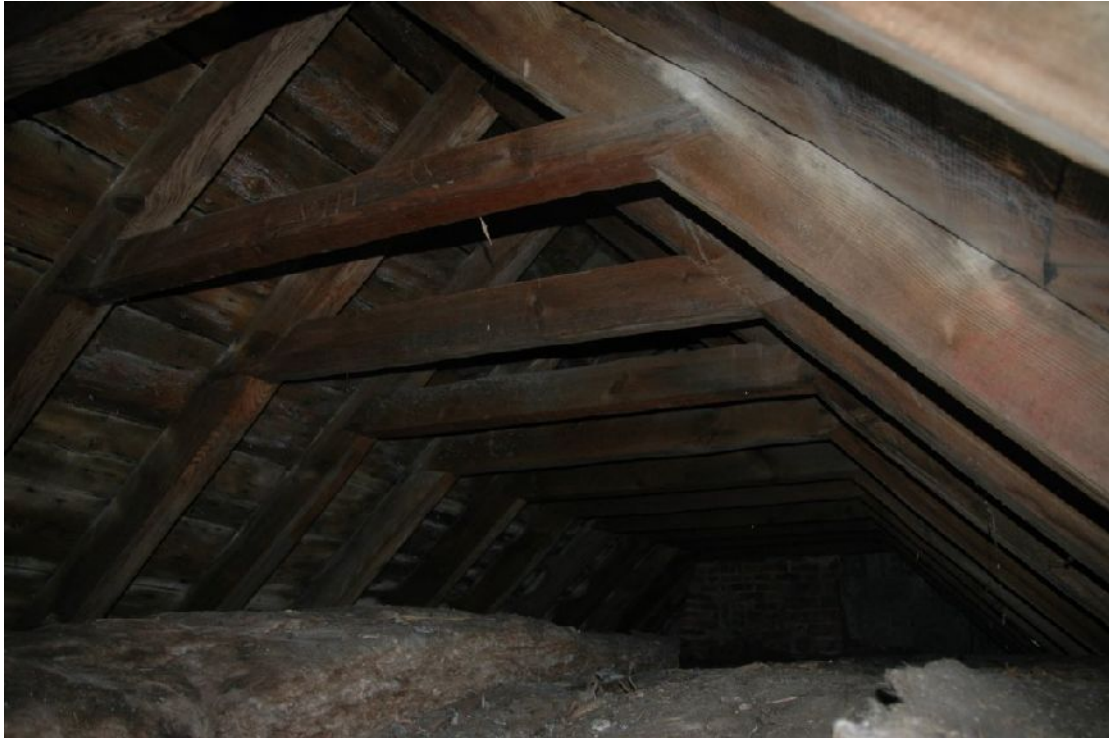
Illus 14 View of tower roof looking through hatch (looking N)

The roof itself had paired rafters with collar timbers apparently half-jointed and dowelled. Two of the collars had chisel cut carpenter's marks in sequence on the visible side (VII and VIII. Illus 14, 15). The rafters were covered with wide sarking boards.

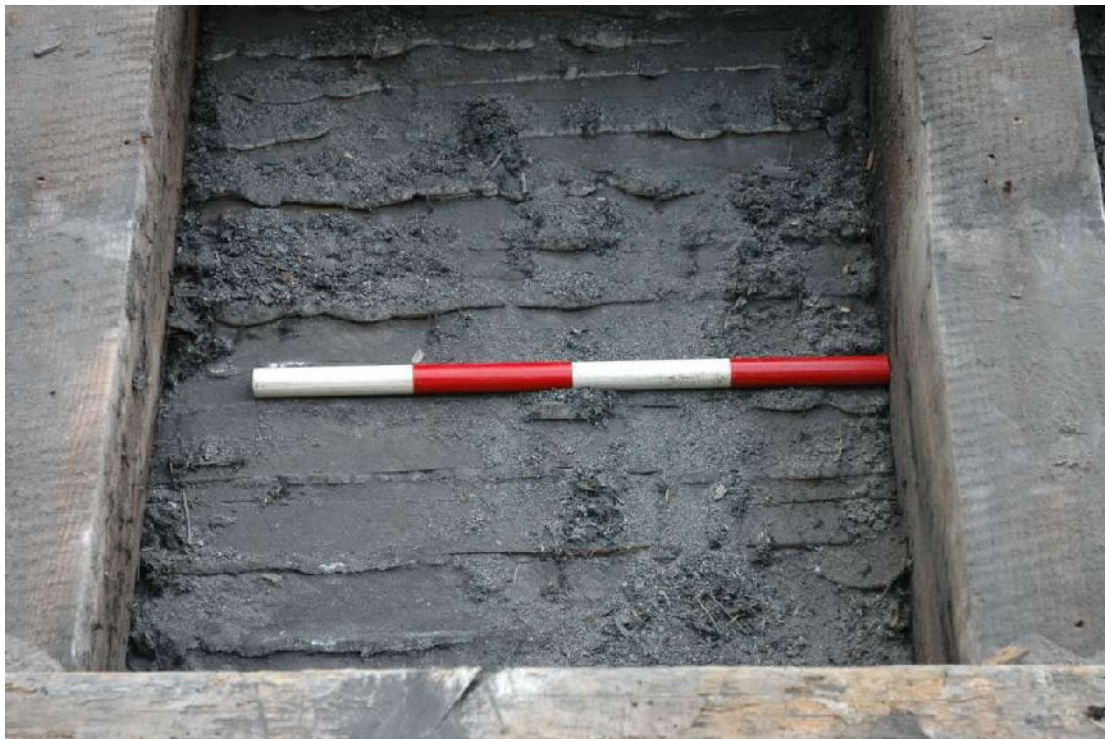
Illus 16 Roof of main block at cut through for new dormer (W13), 2103.

pine/softwood, each approx 140 x 104mm. One had a knife cut carpenter's mark III. There were sarking boards below the slates. Below the rafters there were the backs/ upper side of ceiling planks plastered with a mixture incorporating horse/cow hair.

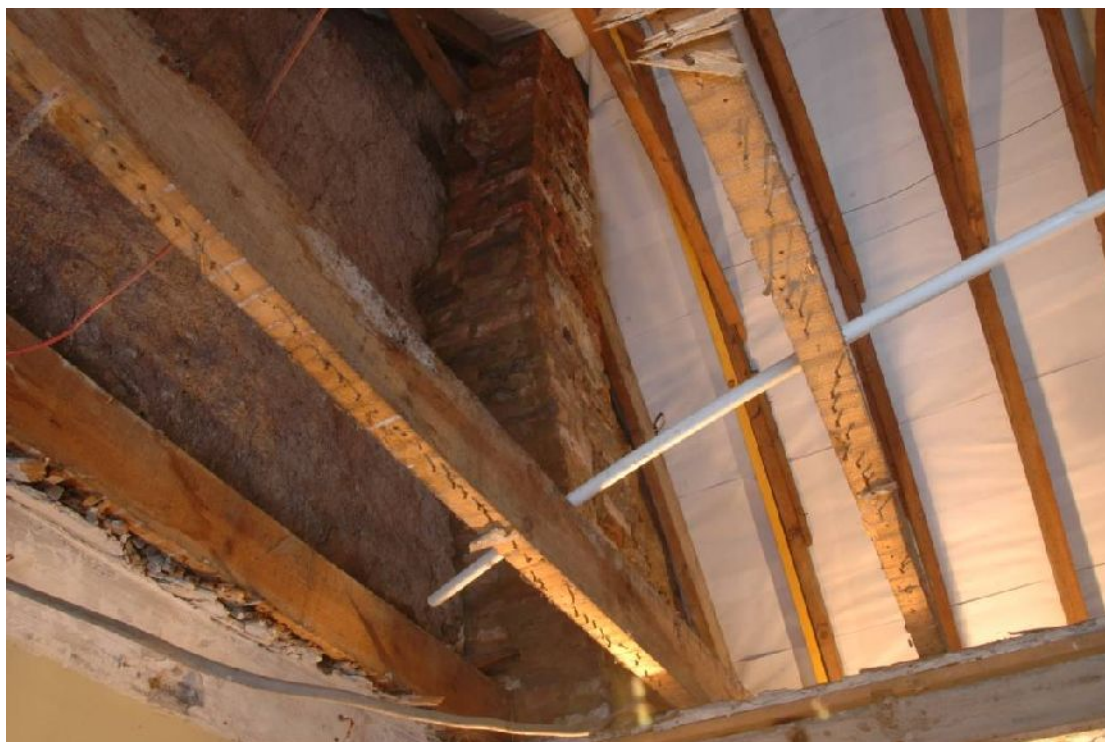
Illus 17 Secondary brick chimney at N end of kitchen, abutting outer wall of pend.

Kitchen N chimney Square harled brick chimney, built against the outer face of S gable of the pend and pended chamber. Internally this chimney was recorded abutting the pend wall, angling up from an off-centre brick fireplace to the E of the centre of the kitchen N wall (Illus 17). It was very unstable and was removed in 2013.

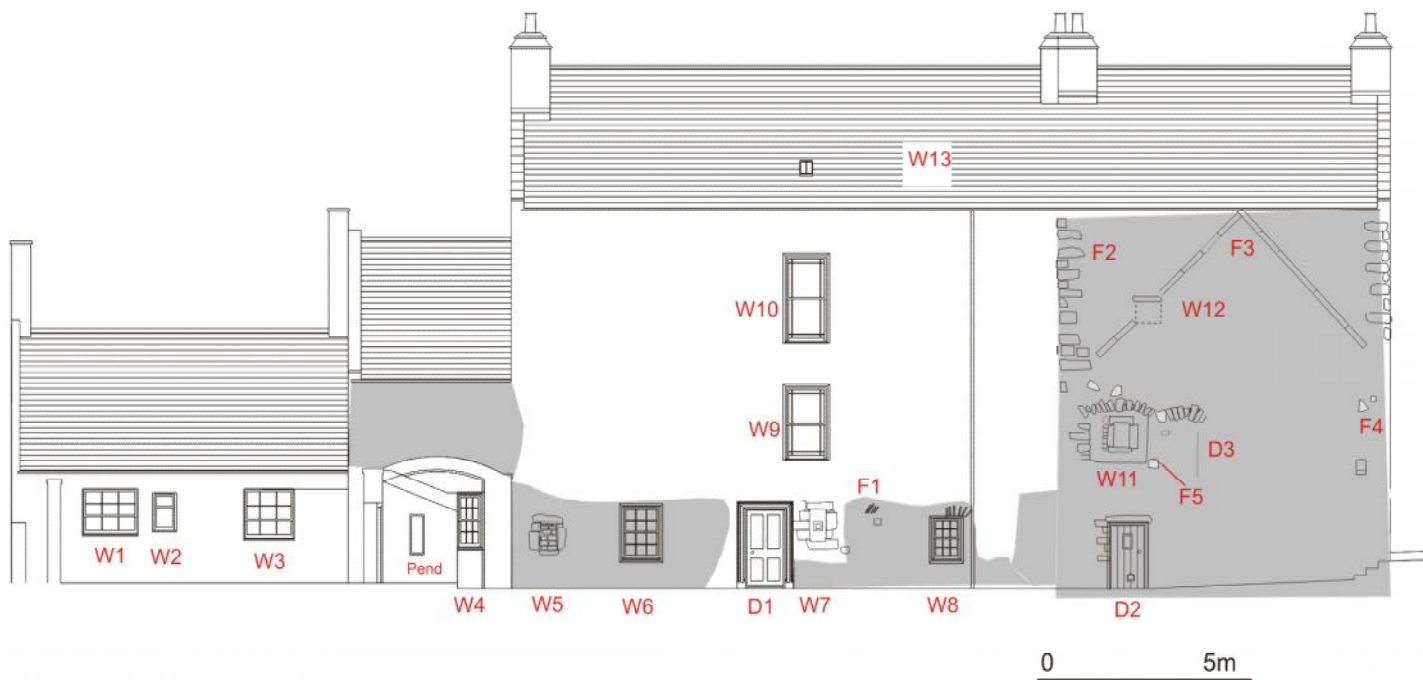
Illus 18 E (garden) elevation. Based on elevation courtesy of David Chouman, with details recorded when harling removed drawn by MAS Ltd. (Grey denotes earlier stonework).

During the course of the building works in 2013, the existing harling was removed from the E (garden) wall as it was found to be extensively detached from the masonry substrate. This revealed a number of blocked features and changes in the stonework, which are recorded in the annotated section (Illus 18).

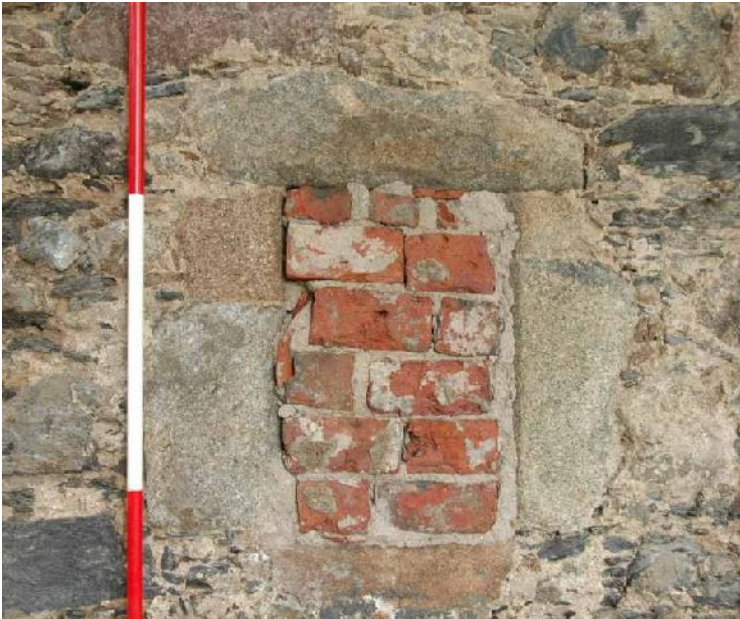
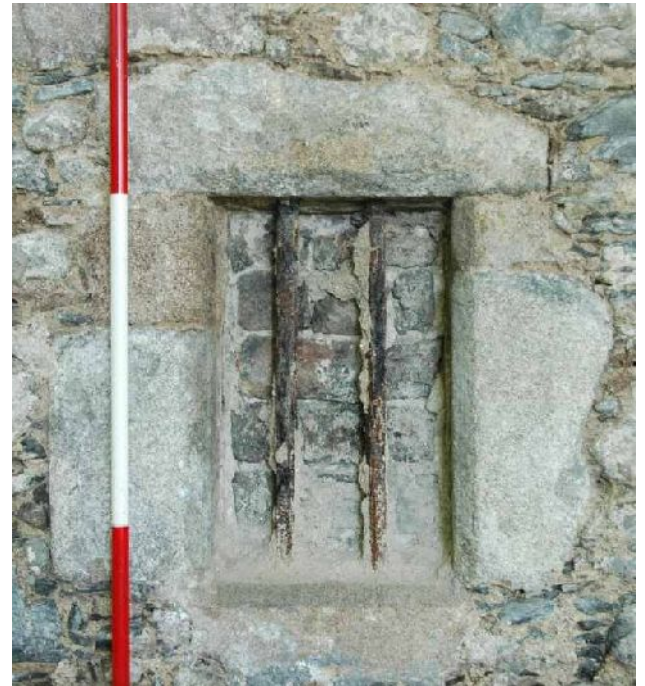
Illus 19 Blocked window W5. Above, as revealed when harling removed. RHS after removal of outer bricks. Bottom LHS debris in the hole behind window; bottom RHS inner bricks being removed.

splays to W: 0.78m. H: 0.89m. Through the thickness of the wall (820mm at this point) there were wooden lintel beams carrying the wall across the window opening. Two of the timbers were clearly re-used as they had non-functional dowels/dowel holes. The space between the inner brick blocking of the window and the hearth had been filled in with loose brick and some rubbish (see 7.2 below).

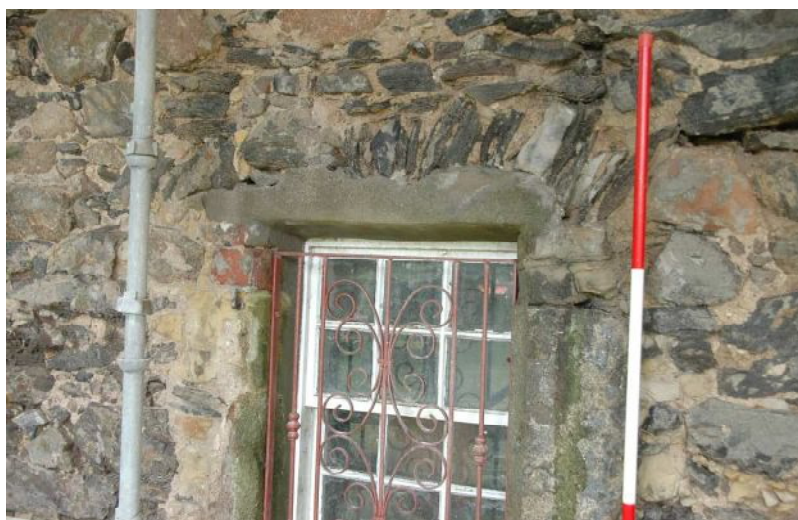
Illus 22 Window W8 after harling removed 2013. Relieving arch visible.

W8 W: 0.69m H: 1.10m. Splays internally to 1.15-1.18m wide. Mixture of granite and sandstone used for rybats, lintel and sill. When harling removed it showed top LHS rybat had been replaced with brick and both top LHS and RHS have in 2013 been replaced with stone. Sash window with 6 over 6 panes. Pivots to S side and hole to N, possibly from earlier bars. Wrought iron grating. Relieving arch visible internally and externally revealed above RHS of window when harling removed (Illus 22).

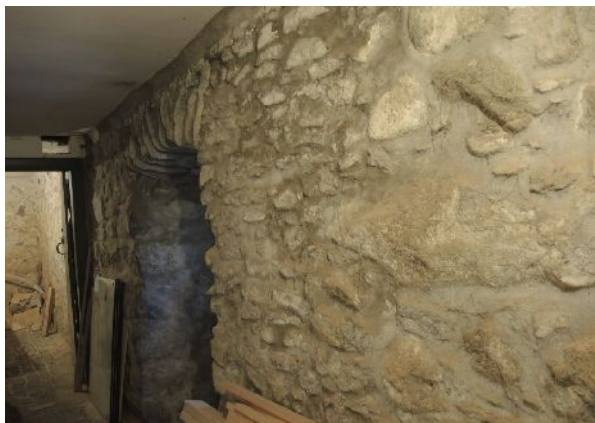
Illus 23 D2 Relieving arch on inside

D2 W: 0.82m H: 1.53m. Splays internally to W: 1.2m. Square headed. Sandstone lintel and rybats with plain wide chamfer. Relieving arch above door on inside (Illus 23).

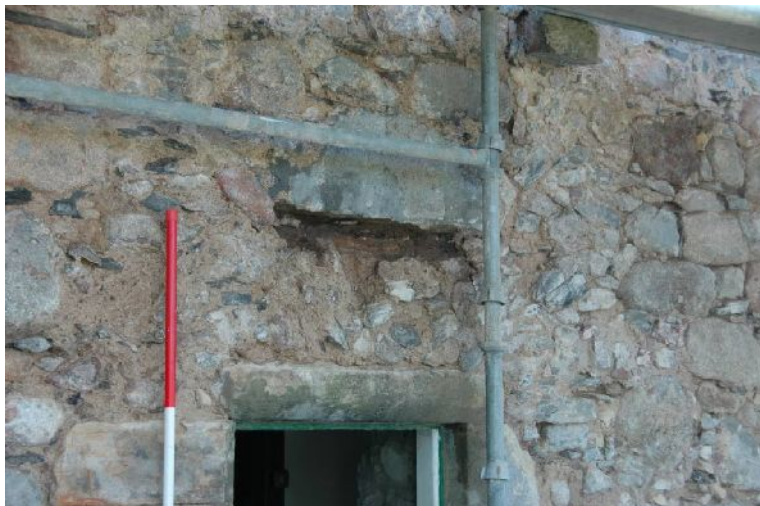
Illus 24 F5 visible top at RHS of scaffolding. Stone above D2 just below horizontal scaffolding

F5 Projecting stones A stone projecting some 150mm from the wall face was exposed below the LHS of blocked door D3. It is possible this related to an internal feature such as a stair. This could also link to a slightly odd stone just above the door D2 (Illus 24).

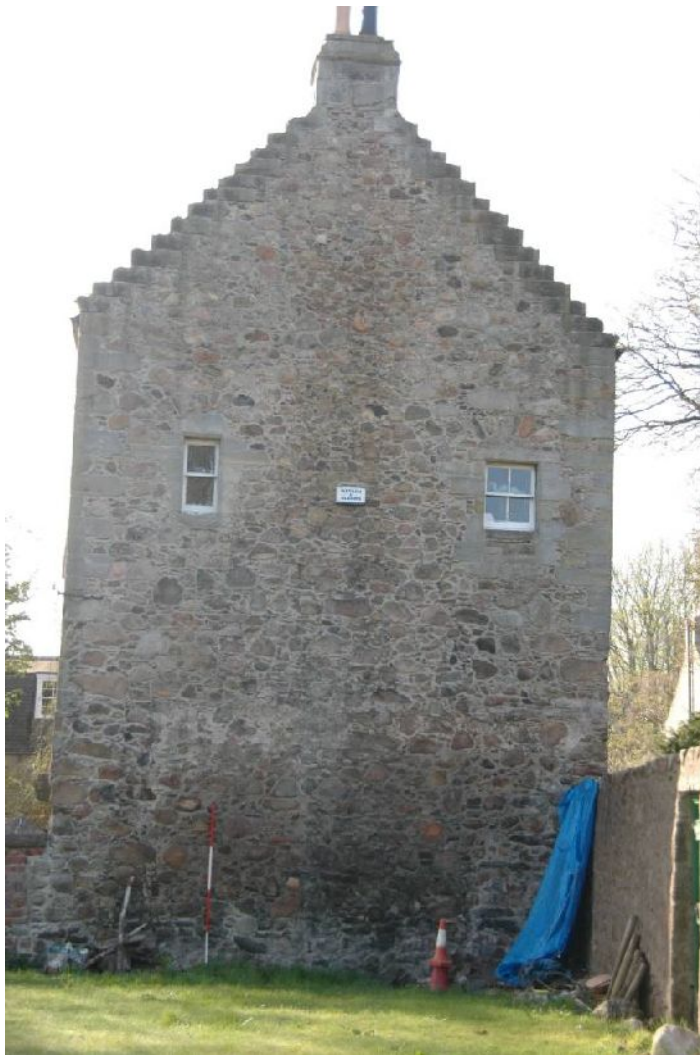
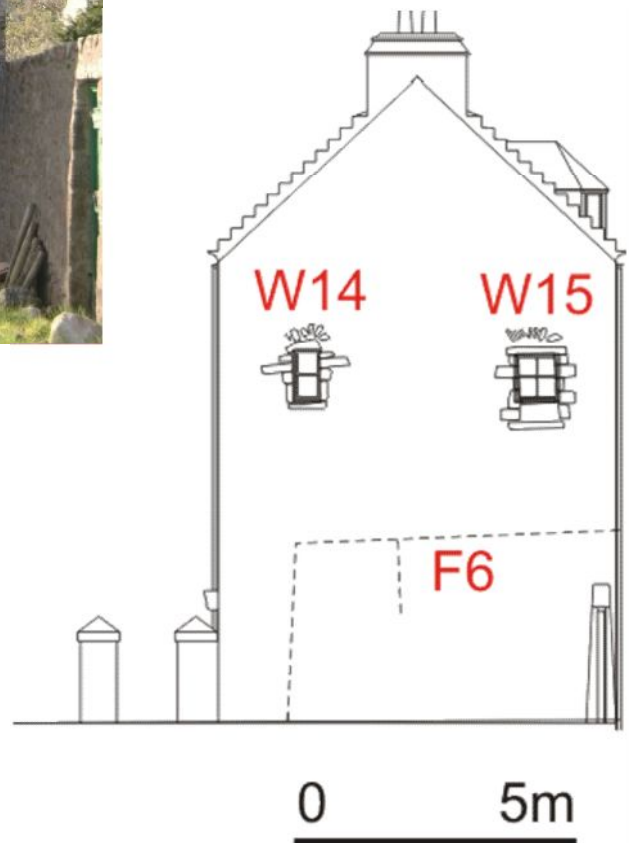
Illus 25 N gable of W tower and elevation (based on elevation courtesy of David Chouman).

W15 (Not measured) Sash window with 2 over 2 panes. Replacement granite lintel and sill with some of (?) original sandstone rybats with plain chamfer. Built within a blocked earlier, slightly narrower window, visible below. The earlier opening blocked with granite and slate to level. Relieving arch.

F6 Raggle of lean-to. Shadow of the late 19th century building shown in mortar on wall. Building c 5.2m wide (E/W) and c 3m high with a possible internal division and a lean-to roof. Ground disturbance suggests it was c 5.8m N/S to level with gateway. When ground works for new garage were observed, no foundations of this building were surviving. This building first appeared on the 1899 Ordnance Survey map and remained until the late 1990s.

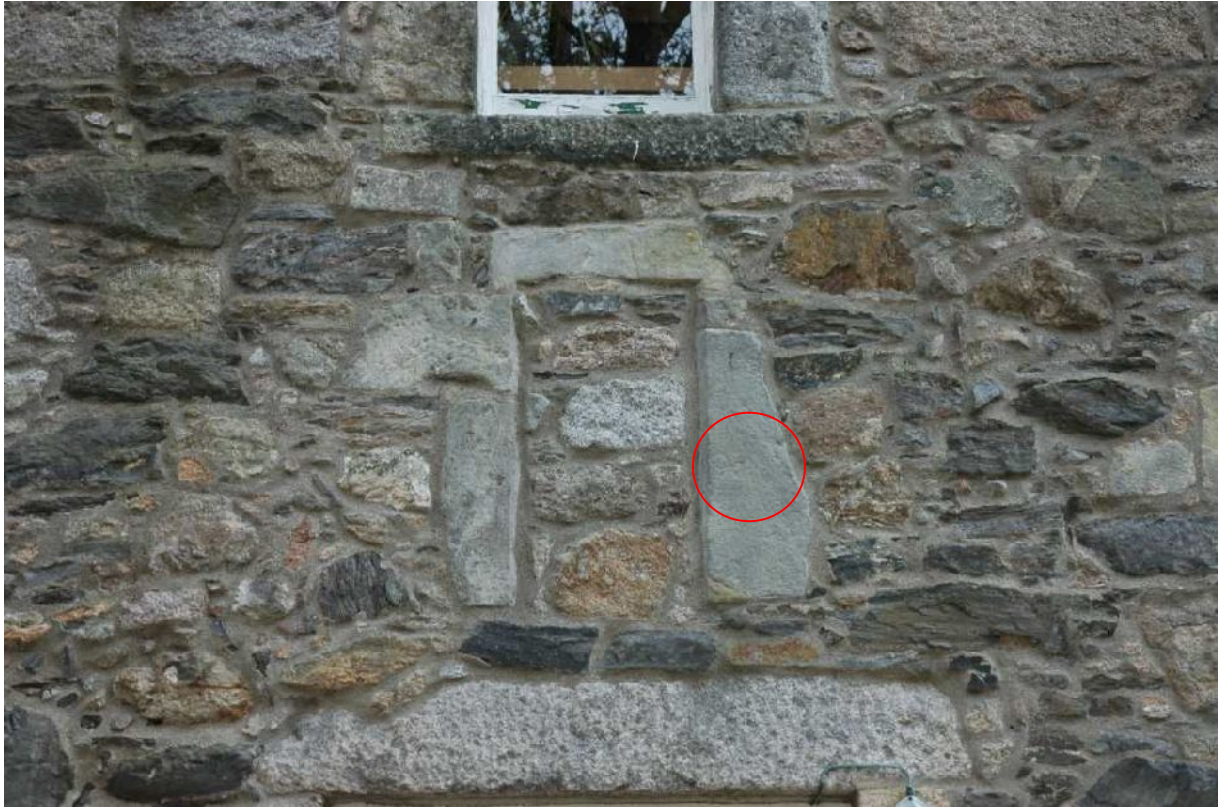
Illus 27 Blocked window F7. Red circle shows mason's mark

- F7** Blocked opening/window. W: 0.46m H: 0.80m. Sandstone rybats, and lintel. Lintel shaped. Sill missing. Stone blocked. -Mason's mark on RHS jamb (Illus 27, 28).

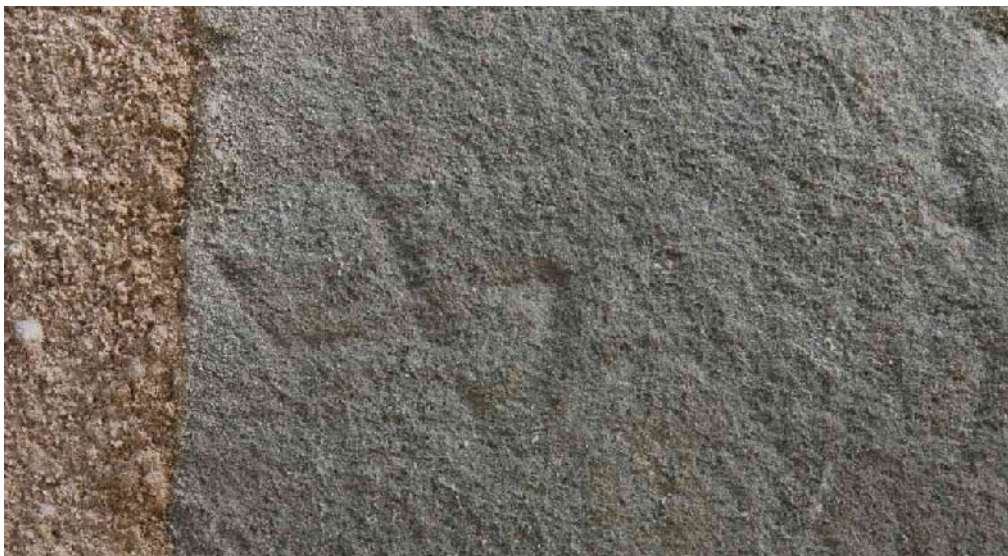
Illus 28 Detail of mason's mark on window F7

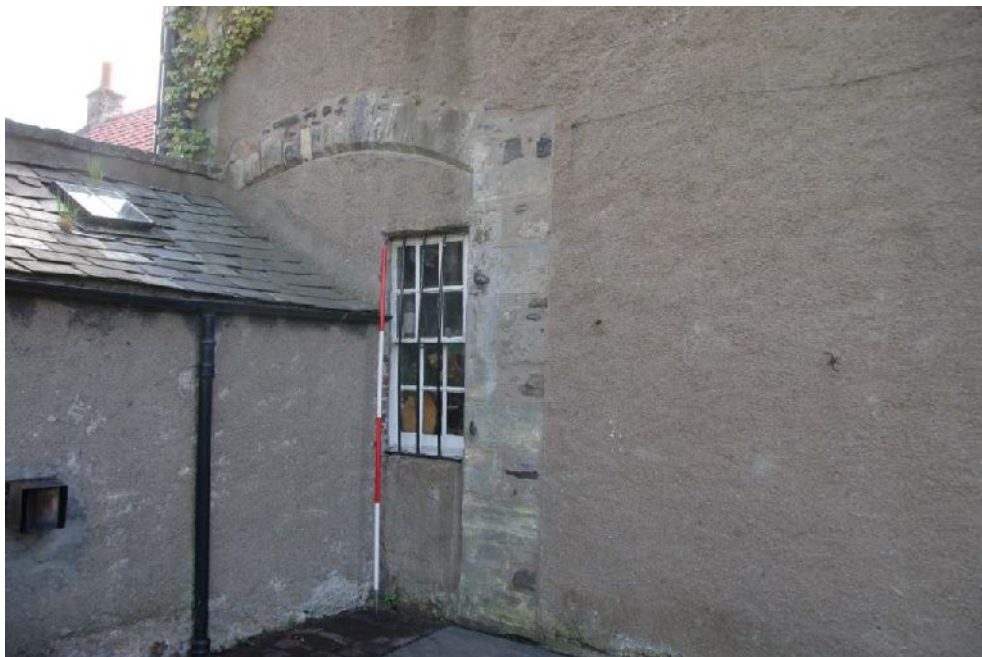
A small outbuilding had been built in the angle between the garden wall and the wall blocking the garden side of the pend. It was removed in 2013 when the pend was re-opened at this end. It was 1.75m x 2.96m and built partly of brick and partly of stone and was cement rendered. Entry was through a doorway in the blocking wall of the pend but at the time of survey the roof was unstable and it could not be entered. The roof had been a slate lean-to against the garden wall. There was a single window (H: 0.93m W: 0.30m) in the E wall. This building is first recorded on the Ordnance Survey map of 1866. At that time there was another small building just to the E, also built against the garden wall; this does not survive.

Illus 29 The outbuilding abutting the blocked pend arch.

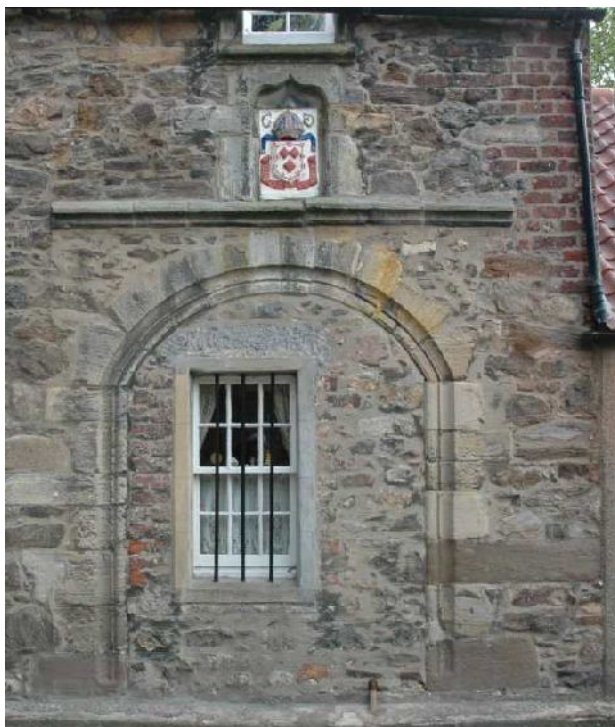
Illus 31 Street pend arch and detail of possible repairs on RHS

The street arch has a rolled moulding (Illus 31) with a string course above the arch forming a drip stone and above the string course a panel with Bishop Dunbar's coat of arms set in a ogee -headed recess. This stresses the importance of the outer great gate. The voussoirs of the arch and most of the side stones are weathered but on the RHS (facing) two of the side stones (the top and 4th from top) are lighter in colour and less weathered and may be repairs; if so they are likely to pre-date the blocking; they are certainly pre- 1933 as they are identifiable on the photograph of that date. The upper iron pivot of the gate was revealed after removal of plaster on the inner side of the arch.

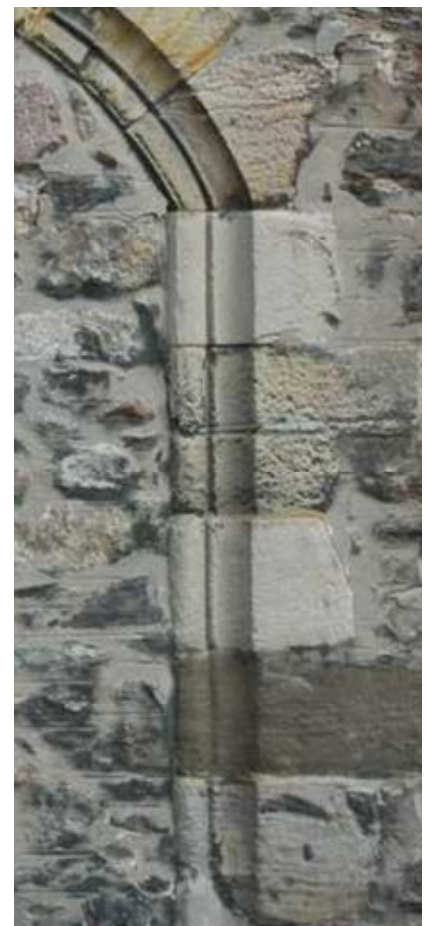
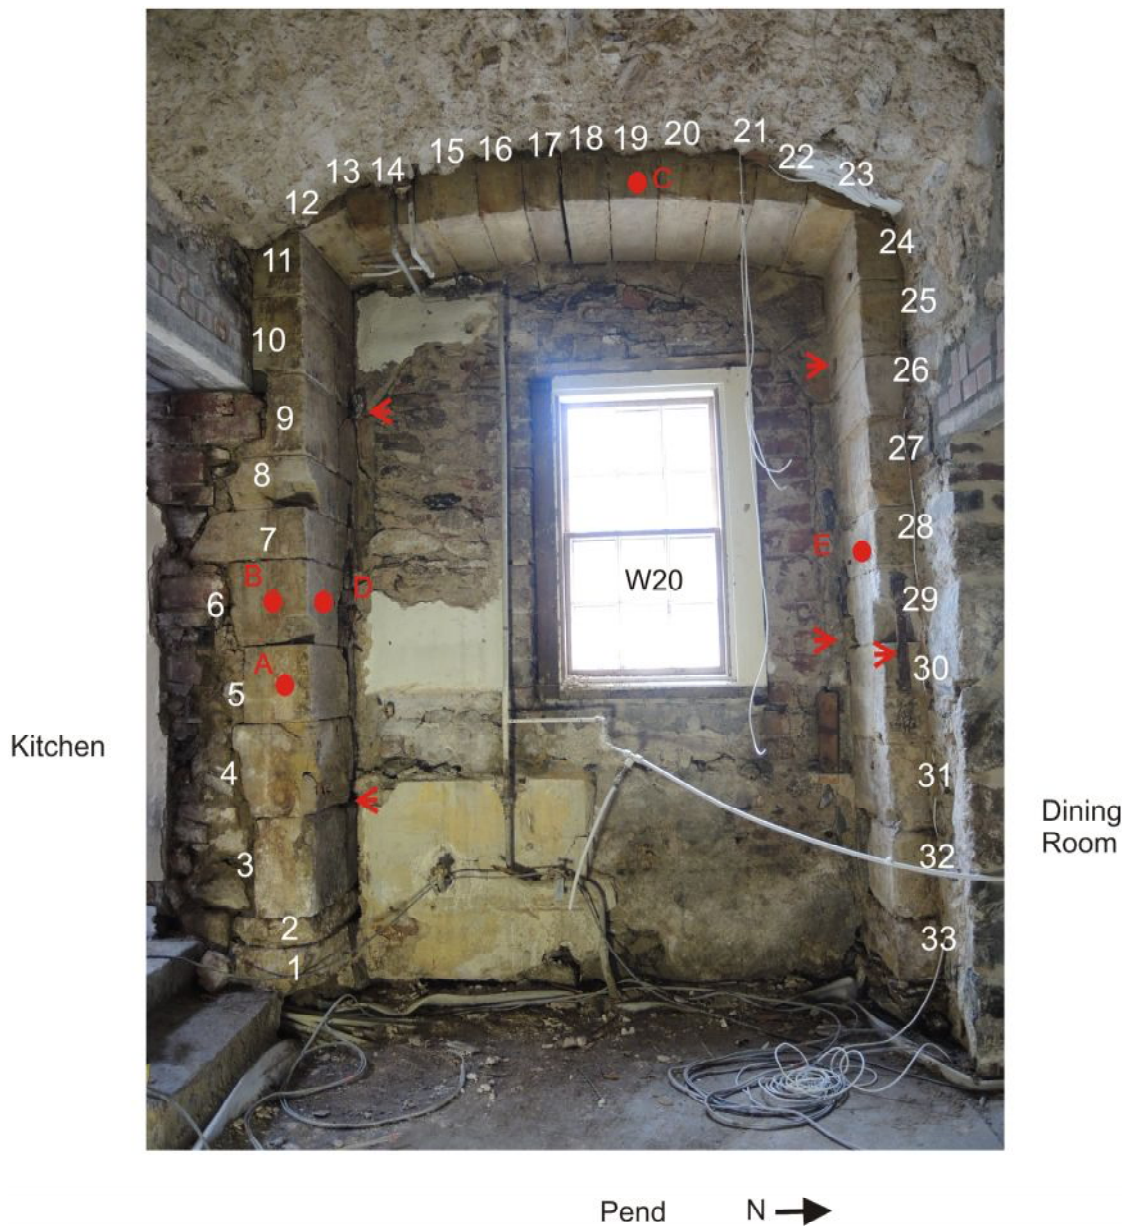
Illus 32 Detail of inside of W (street) pend arch after removal of plaster. Red dots indicate position of mason's marks and graffiti. Red arrows indicate the position of pivots (LHS) and receivers (RHS).

Stone	Detail	Photo
Mason's marks		
5 Illus 32: A	Mason's mark on E face. mark worn but appears similar to one on stone 19. Possibly 5 radiating lines with triangle formed between top pair- where the stone is damaged.

6 Illus 32:B	Mason's mark on E face. Triangle over diamond. L:62mm. Same mark as on E elevation window F7

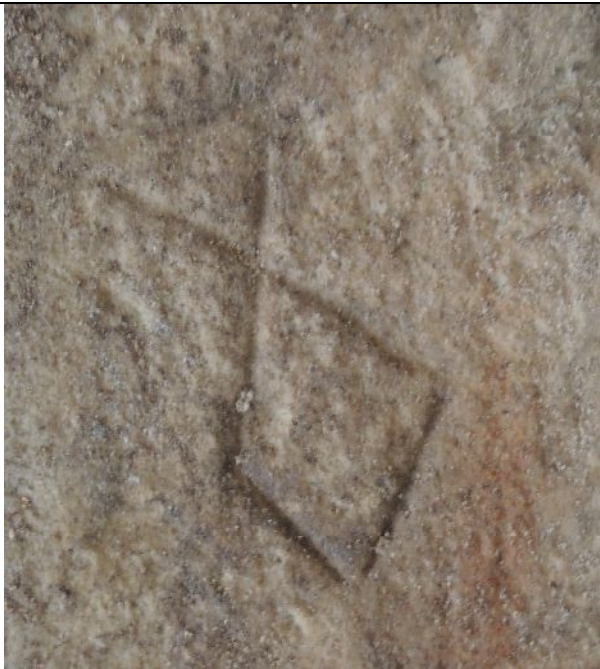
19 Illus 32:C	Mason's mark on E face. Possibly 5 radiating lines with triangle formed between top pair. Diamond to one side. L:80mm

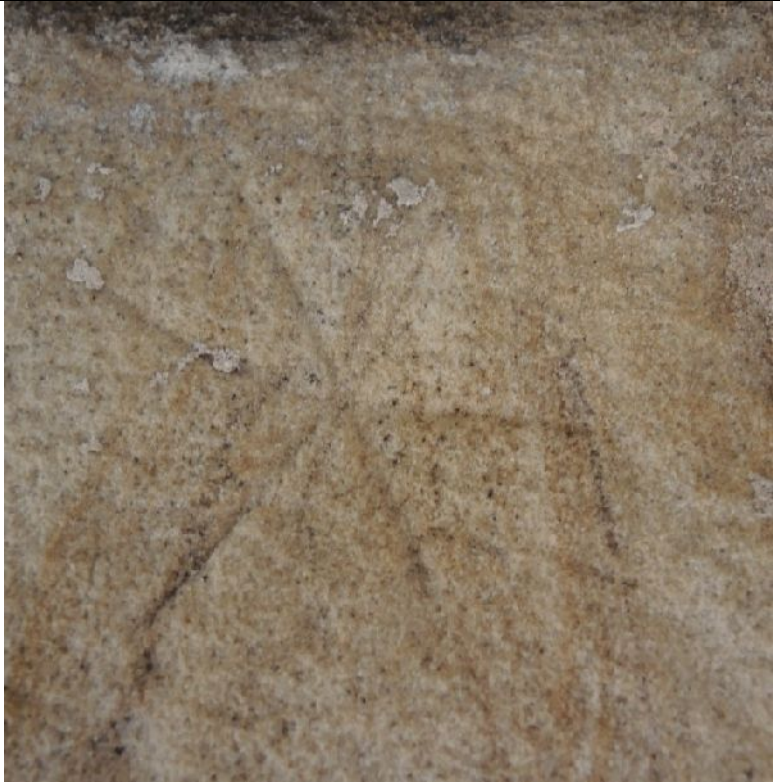
Graffiti		
6 Illus 32: D	1.7 or 7.7 with small 1 (?) below. Much wider than the mason's marks.

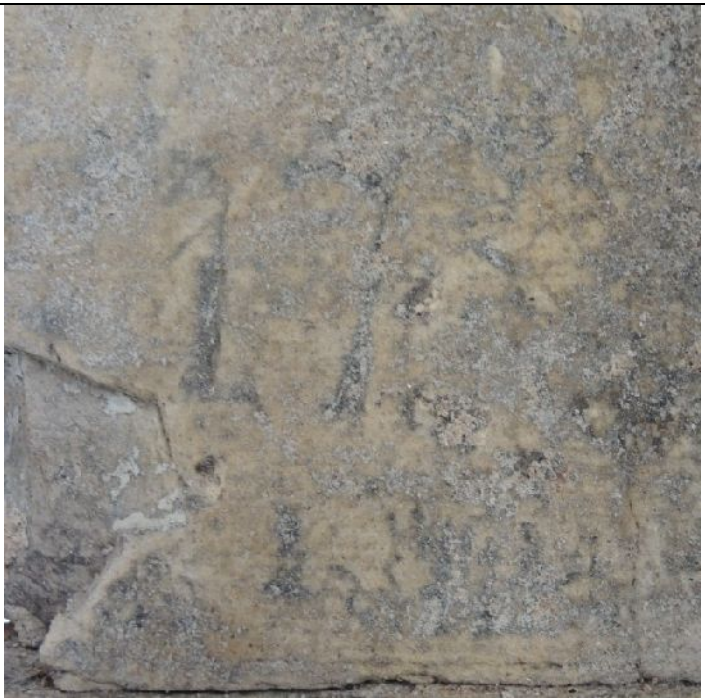
<p>28 Illus 32:E</p>	<p>D.J above '77'</p>

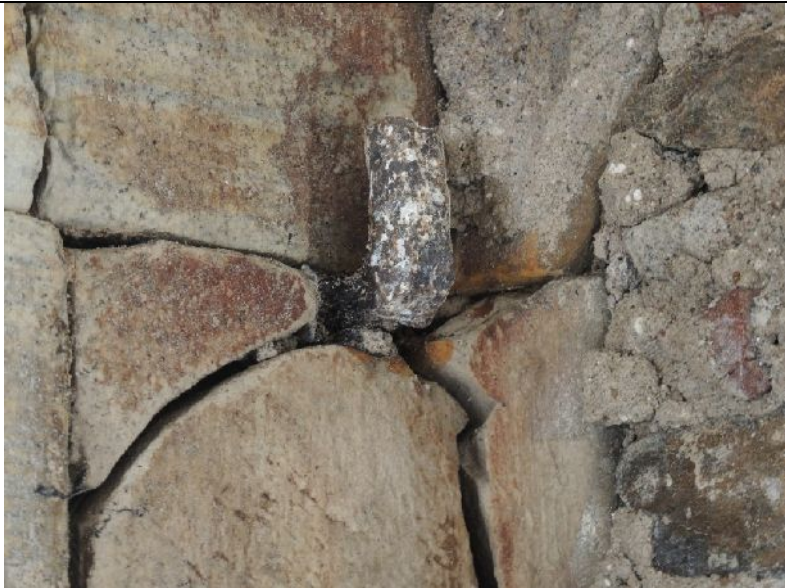
<p>Bolt fittings</p>

<p>Stones 29 and 30</p>	<p>N side of arch. Two iron fittings- probably receivers for two bolts. H:90mm W:60mm. Iron 70-150thick. Both filled in with stone and cement. Between them is square hole (135 x 135mm, 95mm deep), possibly for a bar. A brick-filled hole in stone 6 on the S side of arch may be the opposing bar-hole.</p>

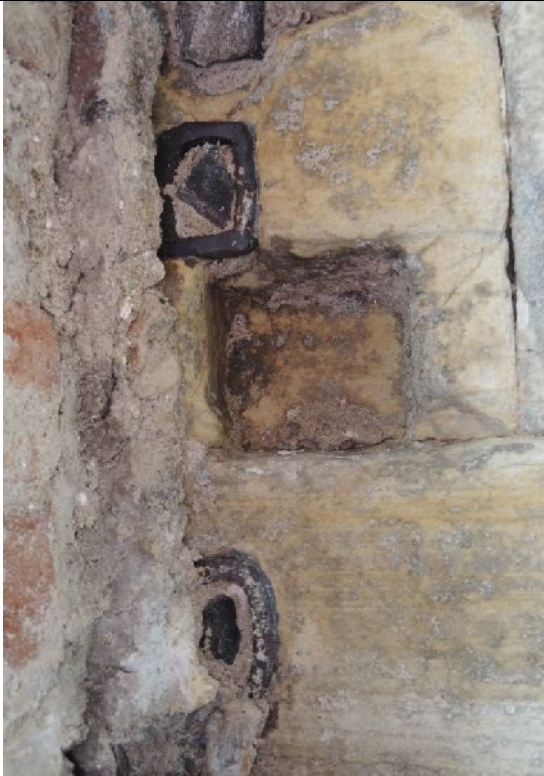
<p>Stones 29 and 30</p>	<p>Secondary hole? N side – a rather rough hole (H:150mm, W:125 x 100mm on E face of stone. A vertical flat iron bar with two holes in it is fixed across the E side of the hole</p>

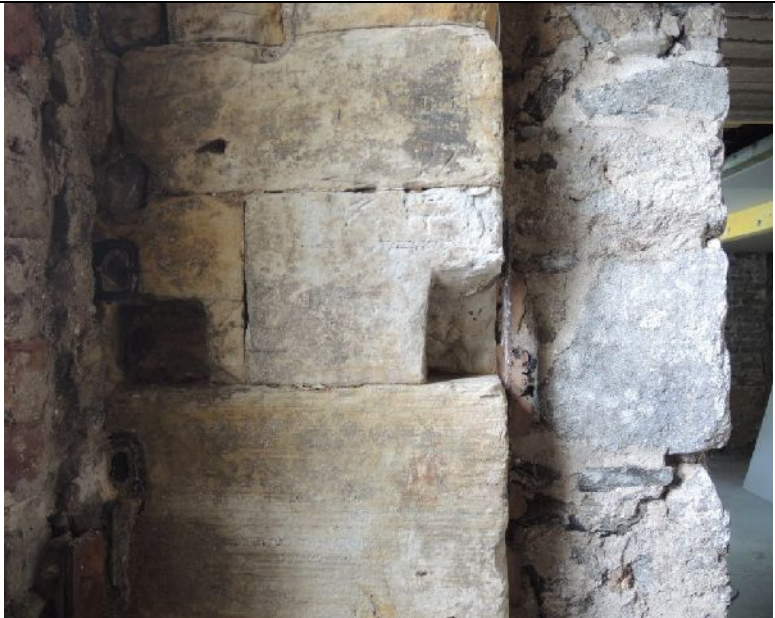
<p>25</p>	<p>Hole 850 x 700mm and 40mm deep. Seems very high for a bar but may be related to gate fittings.</p>

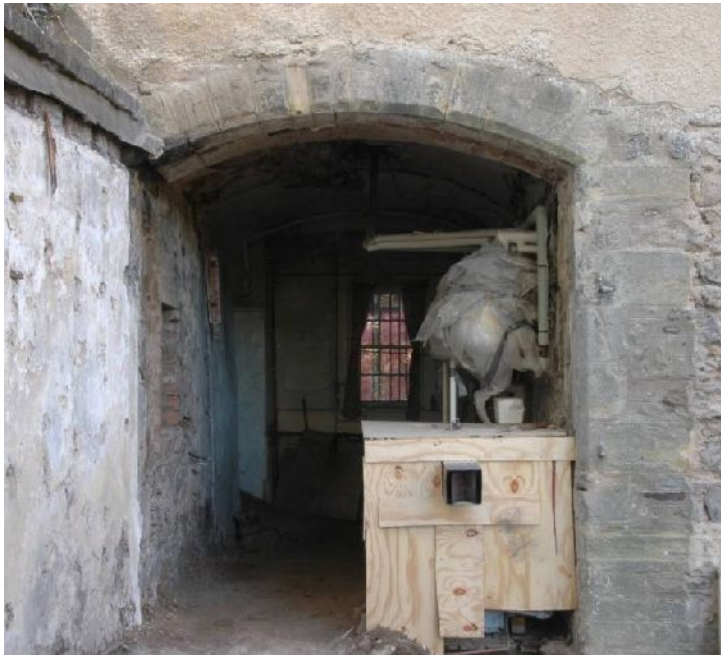
In contrast, the garden/courtyard arch has plain flat dressed voussoirs and rybats (Illus 33). By at least 1866 the garden wall abutted the S side of the arch and the outbuilding had been built, blocking the arch and abutting the garden wall. The line of this garden wall appears to have been a boundary from at least the 18th century so it may have abutted the arch prior to 1866.

Illus 33 Garden side pend arch after removal of outbuilding, with garden wall at LHS
