**CHAPLAIN'S COURT
20 THE CHANONRY
OLD ABERDEEN**

**Standing Building Recording
and Watching Brief**

Report No: MAS 2013-13

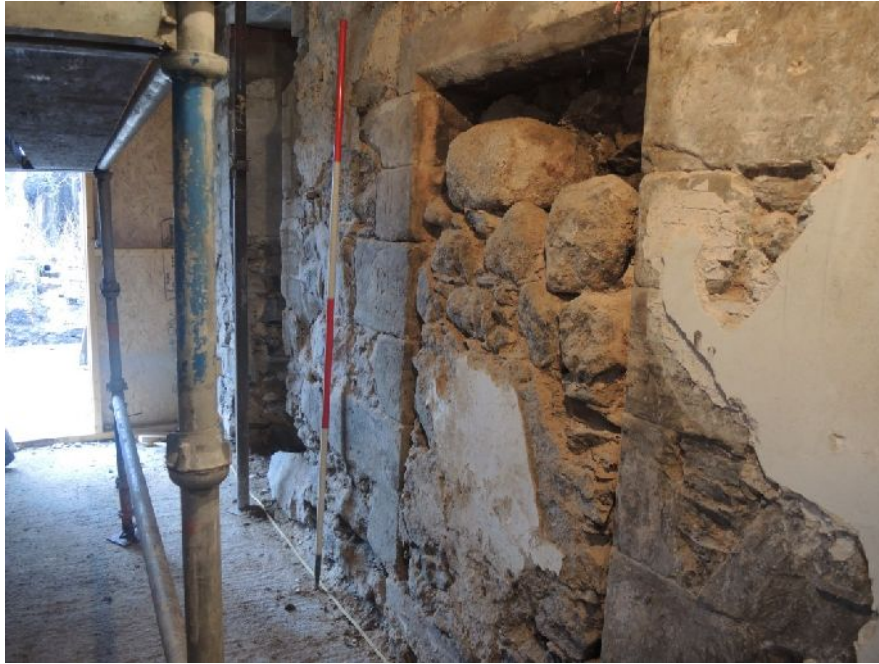
Illus 35 Pend blocked doorway D7 with outer stone blocking and plaster partly removed. Looking towards the garden end of pend.

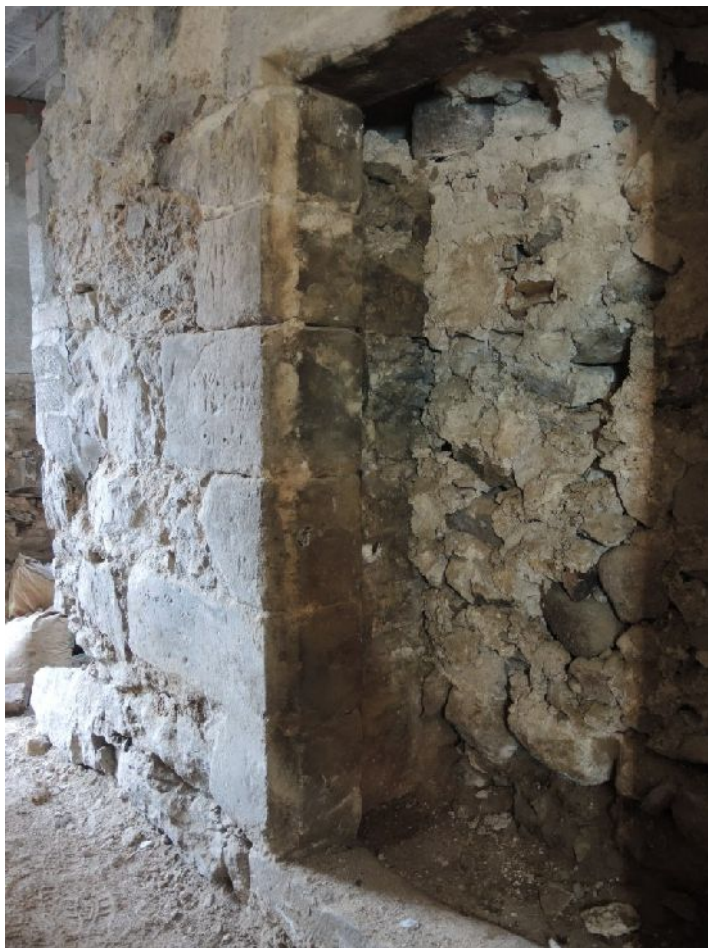
Illus 36 Pend doorway D7 with pend blocking removed, showing rough inner blocking on kitchen side.

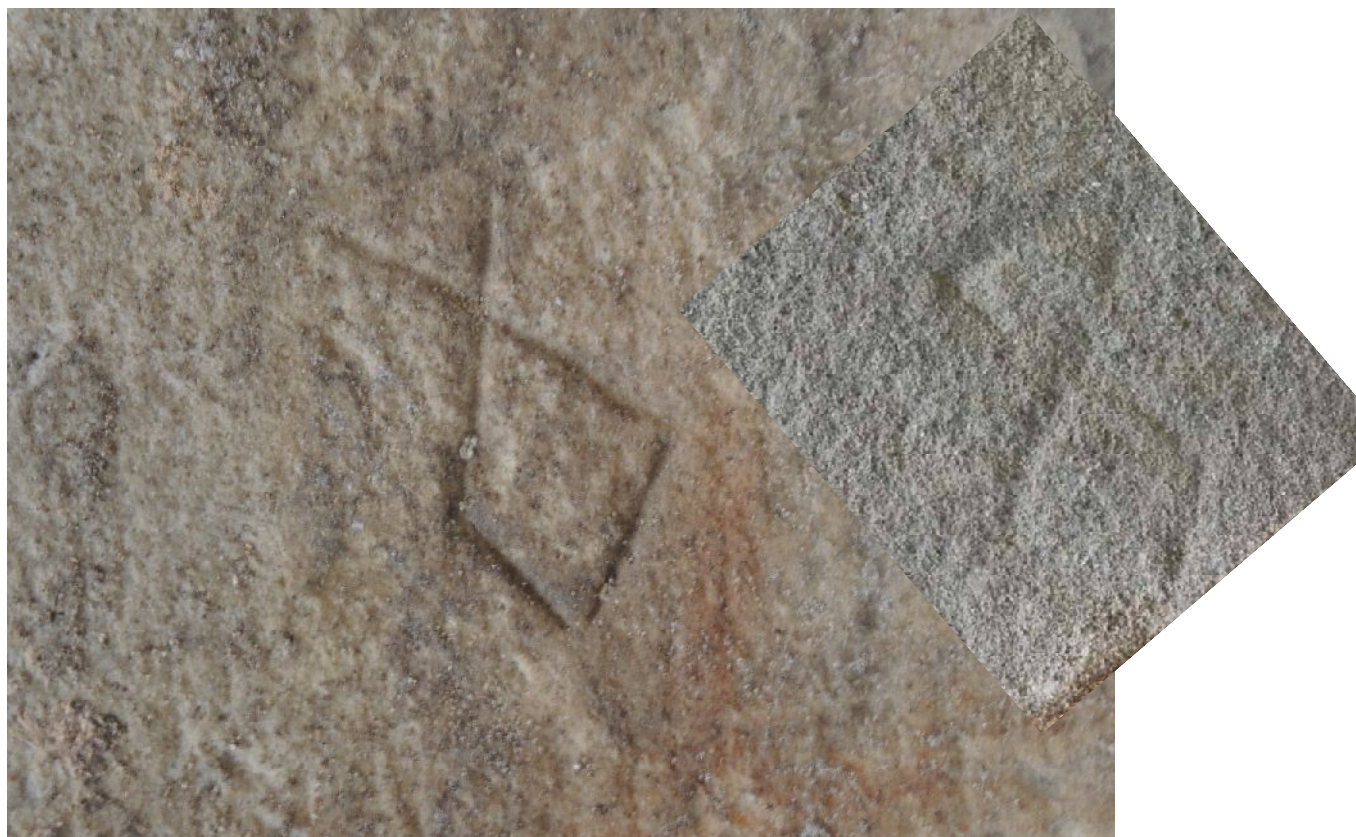
Illus 39 Mason's mark 1, on S side of inner face of W pend arch (Illus 32: Stone 6:B.) Inset: the same mark from W elevation, window F7

This mark does not appear among those recorded on St Machar's Cathedral by Gibb (1868) but St Machar's has not yet been covered by the presently ongoing survey of mason's marks in NE Scotland <http://www.masonsmarkproject.org.uk/>. The survey has recorded a similar mark of probable 16th -century date at Delgatie Castle; Arbuthnott church (?15th-16th C); Craig Castle (16thC); Old Bridge of Dee (16thC) (pers. comm Moira Greig). Construction of the Bridge of Dee began under Bishop Gavin Dunbar in 1520, ending in 1527, and it is possible that one or more of the masons who worked on the bridge may have worked on the Chaplain's Court. However, it must be noted that mason's marks were adopted by different masons at different periods and this mark is also known in later contexts.

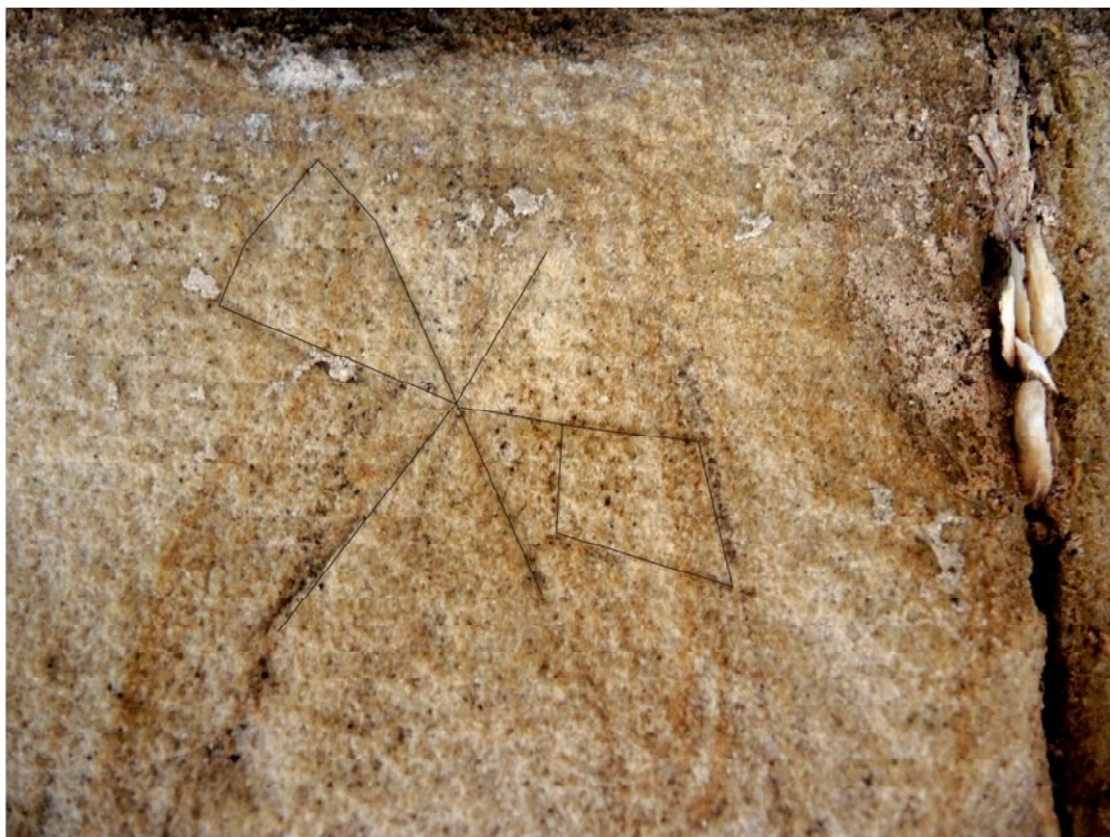
Illus 40 Mark 2 from top of inner face of W pend arch (Illus 32 Stone C) , with lines marked on the photograph

To date no parallel has been found for this mark with the diamond, but a mark of six radiating lines with a triangle between two of them is also found on the 16th-century Bridge of Dee.

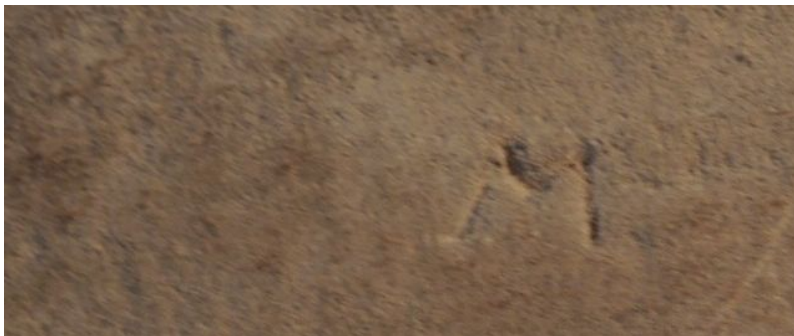
Illus 42 Graffiti M and ? NE (Illus 38:4)

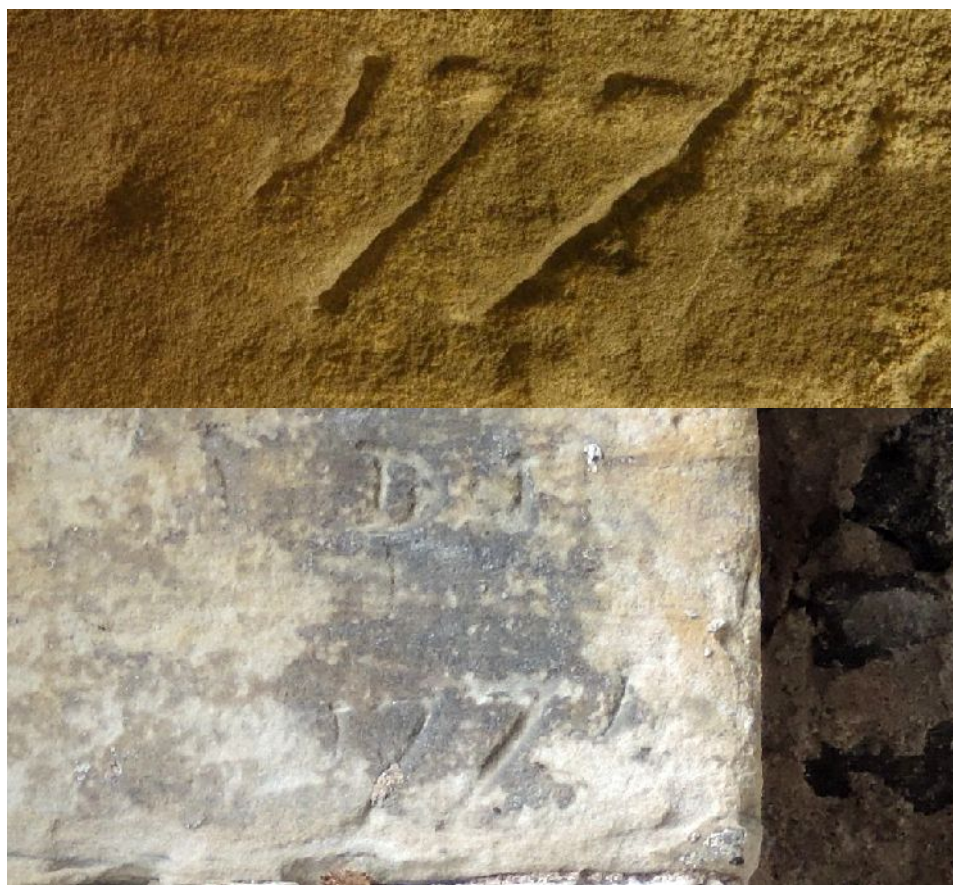
Two stones on the garden side pend arch also had graffiti- one was not easily readable (Illus 38:2), the other had clear numbers '77' (Illus 43, 38:1). The latter is incomplete but it looks unlikely to be a formal date stone- though it is possible that it was written to mark the date that the graffiti was incised. This same mark appears on the N side of the inner face of W (street) pend arch just below the initials D.J, and less clearly also possibly on the S side of the same arch (Illus 32).

Illus 43 Above: detail of '77' on E pend arch (Illus 37:1) and below: same mark on N side of W pend arch

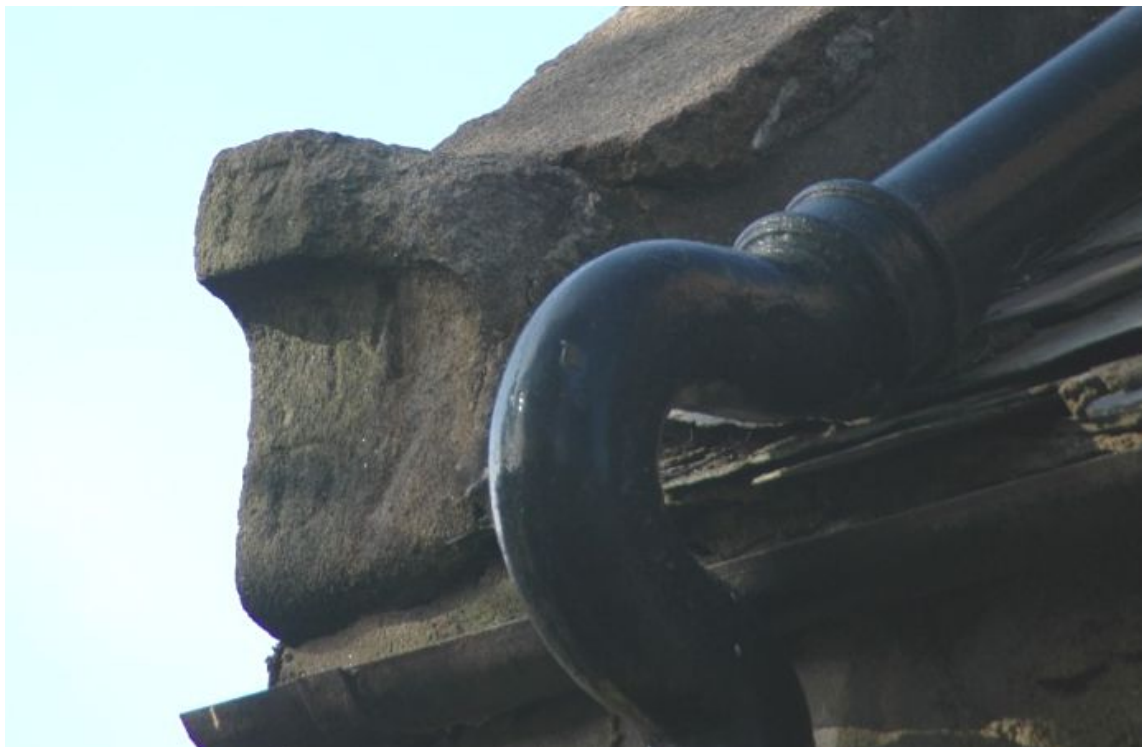
Illus 44 Date stone on pend SE skewputt

Pend roof Pitched slate roof, N end abuts S gable of main block. S end has stone skewes with a ball finial and skewputts with projecting moulding. At the front of the house the skewputt is plain but at the back it had been used as a date stone which, although partly fractured bears the date 17.. over the initials *M D A* (only part of *A* survives- Magister(?) David Anderson) (Illus 44).

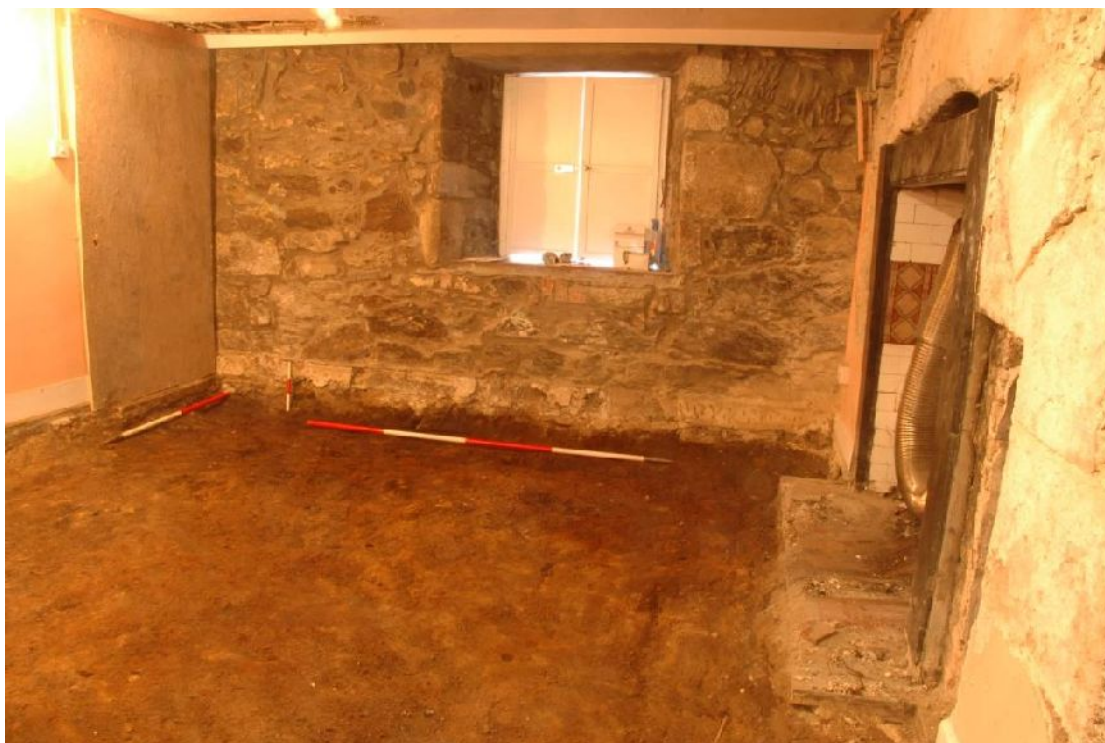
The internal floor level was reduced to allow a new floor to be laid. When the existing tiles were removed, they were seen to be set on a 180-200mm make-up of broken brick and sand above clean yellow natural boulder clay. This was cleaned by hand but no wall trenches or earlier features were indentified. There were patches of a skim of black humic material < 10mm thick and containing a few fragments of animal bone and shell, this contained no datable artefacts and although it might relate to the 16th - century structure it could equally have been part of the floor make-up (Illus 46).

Illus 46 Dining room with floors removed. Patches of dark humic material visible near ranging rods.

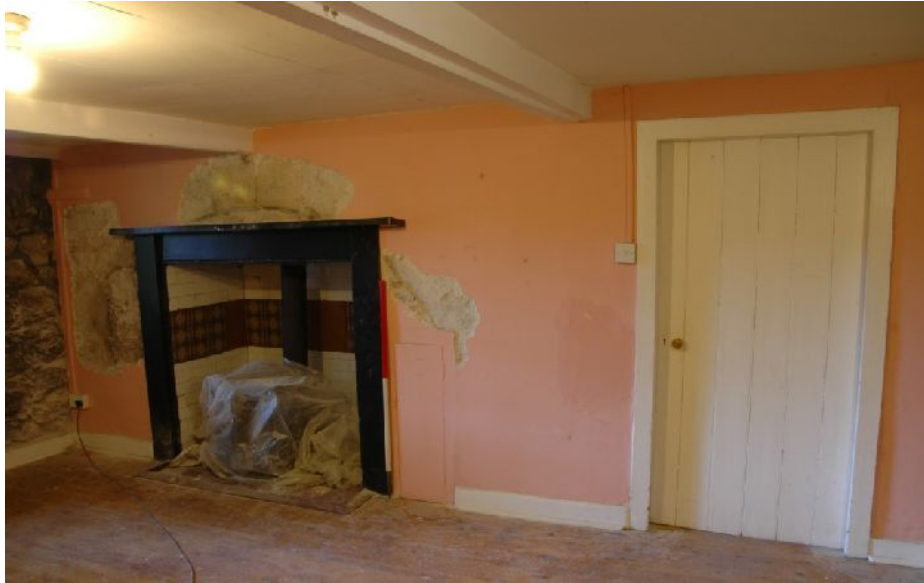
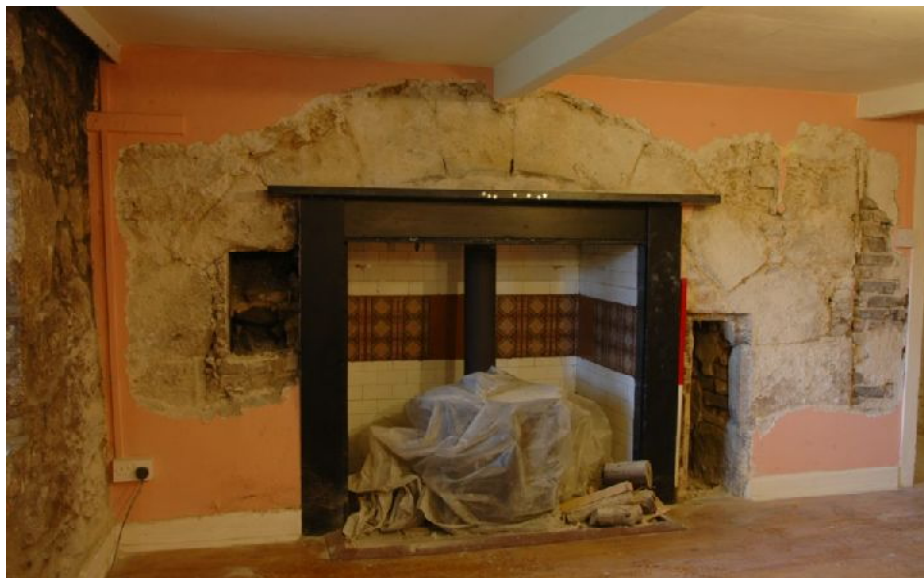
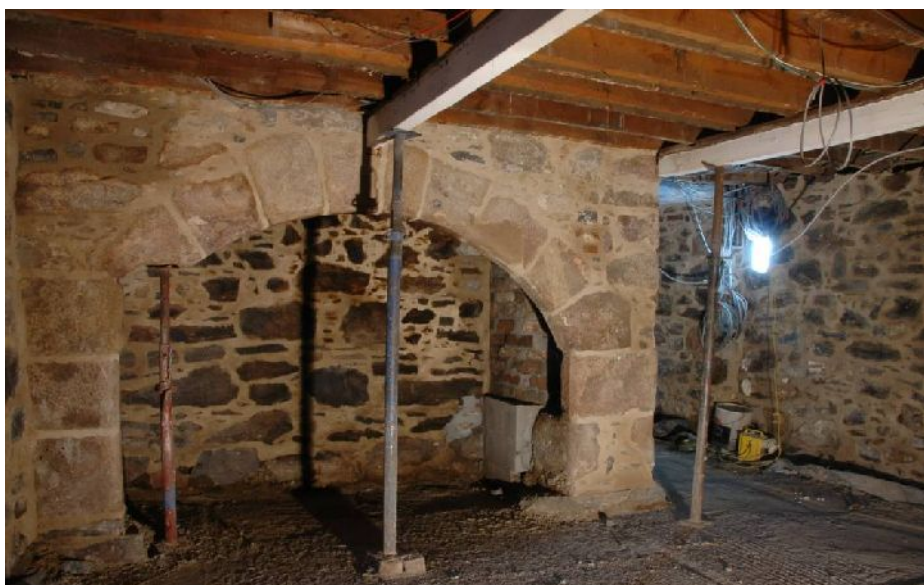
Illus 49 Top and centre, the modern fireplace with 16th-century fireplace emerging. Bottom, the 16th-century fireplace. Note the low ceiling cut into top of fireplace

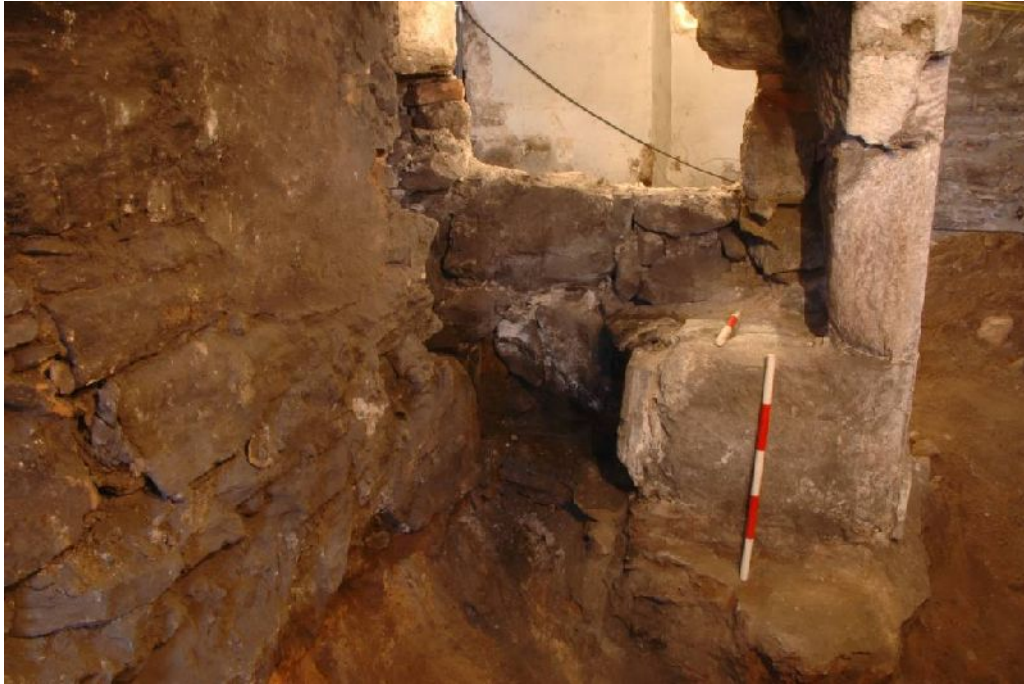
Illus 50 Measuring rods indicate position of possible bread oven F18 (Opening behind is break-through of later alcove F16 from passage)

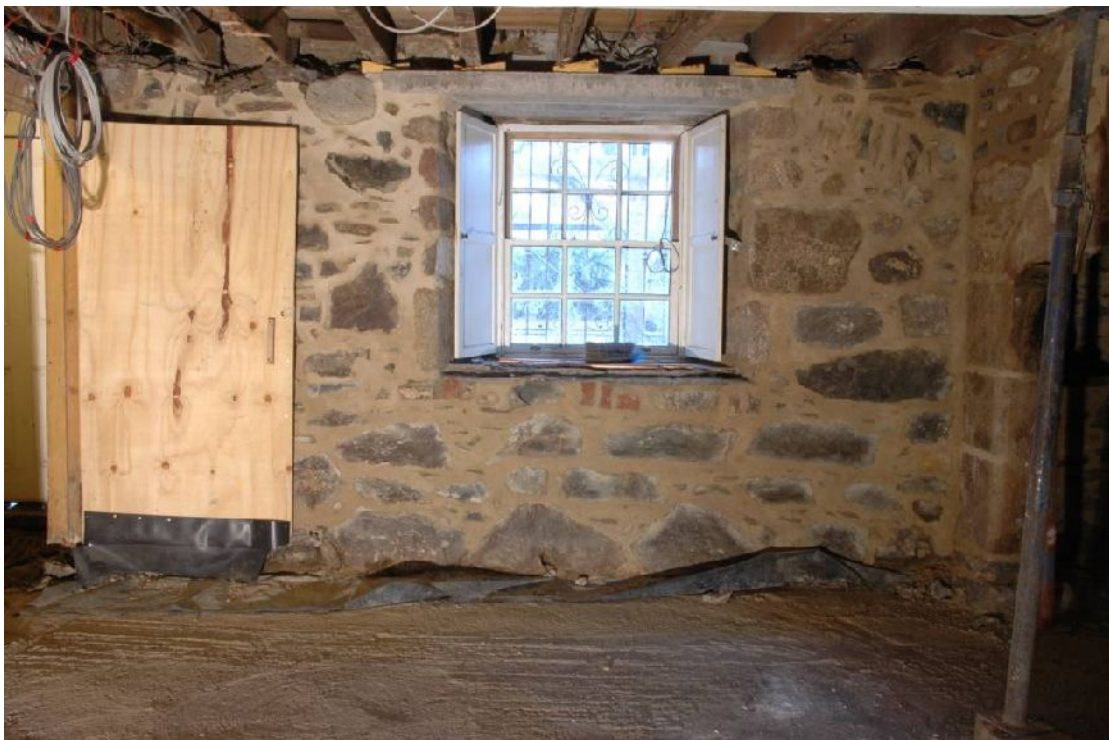
Windows The original fenestration is unclear, although on the street side window W19 had a mixture of granite rybats but with sandstone on one side, suggesting the possibility of an earlier, replaced window. A few voussoir stones in the inside of the E wall to the RHS of the later window W6 do not relate to any blocking in the external wall and are unconvincing as part of a relieving arch (Illus 51).

Illus 51 Dining room, E wall. Note voussoir stones to RHS of window as viewed.

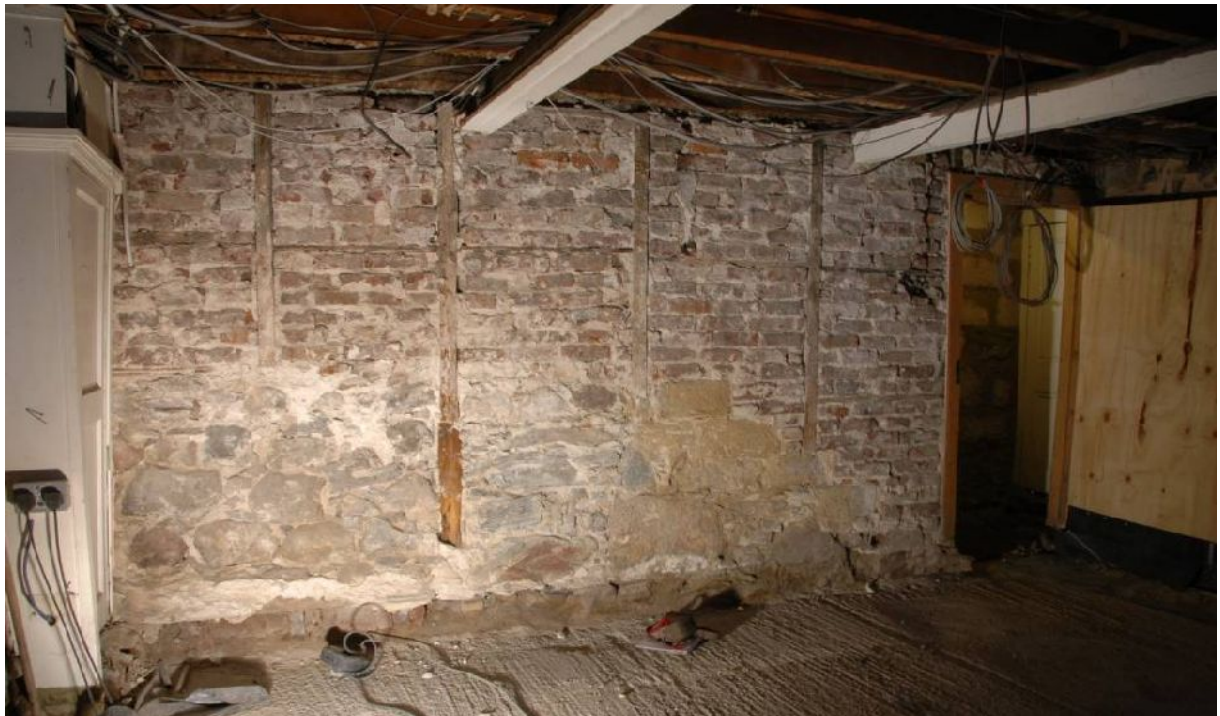
Illus 53 Dining room N wall elevation showing steps

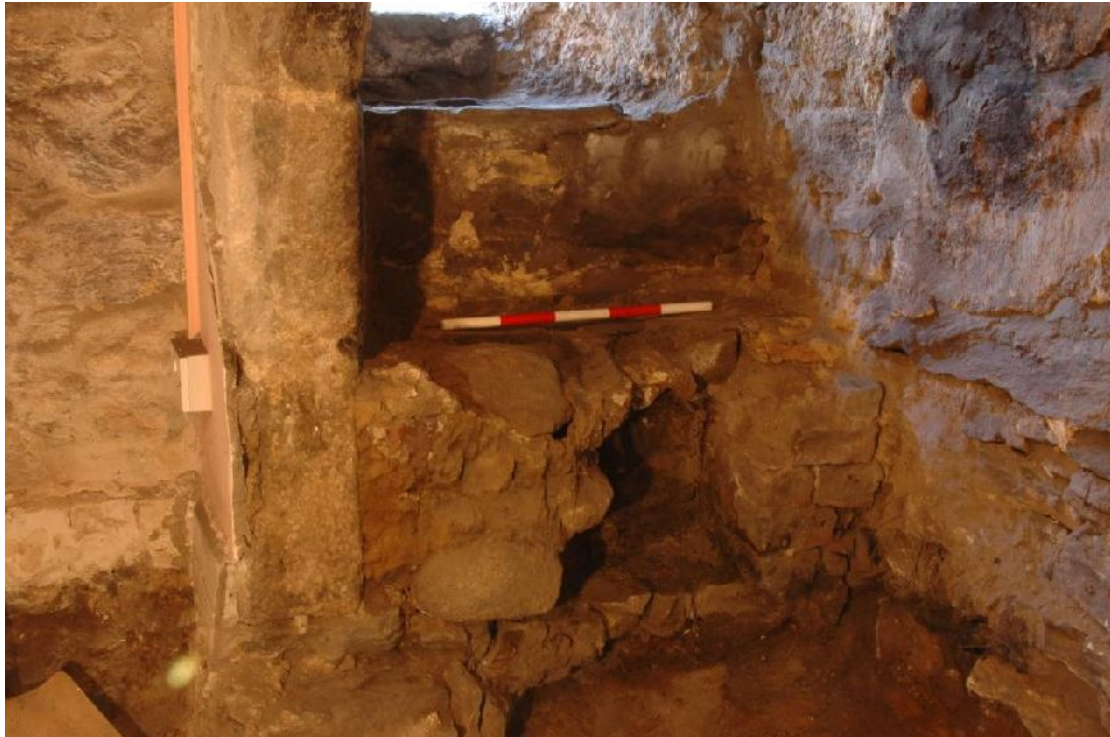
When this loose rubble was removed, it became clear that the window had an internal stone ledge formed by the wall thickness and that at 360mm below the stone window ledge there was a ledge (c 480mm wide) of mortared brick infill – which may have, for some period, formed a seat (Illus 54). When this lower brick filling was removed to floor level, this exposed the inner face of the main house wall, within the alcove on the E side of the hearth (Illus 55).

Illus 54 Window W5 from inside showing possible seat, after removal of rubble

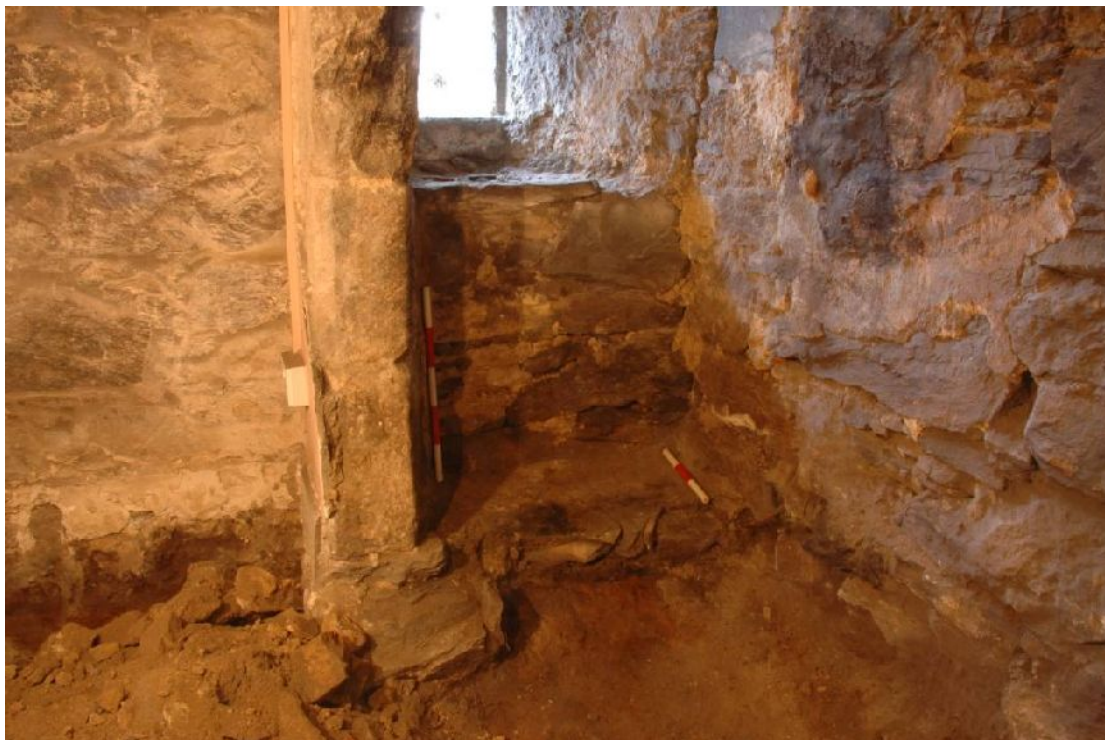
Illus 55 Window W5 after removal of 'seat'

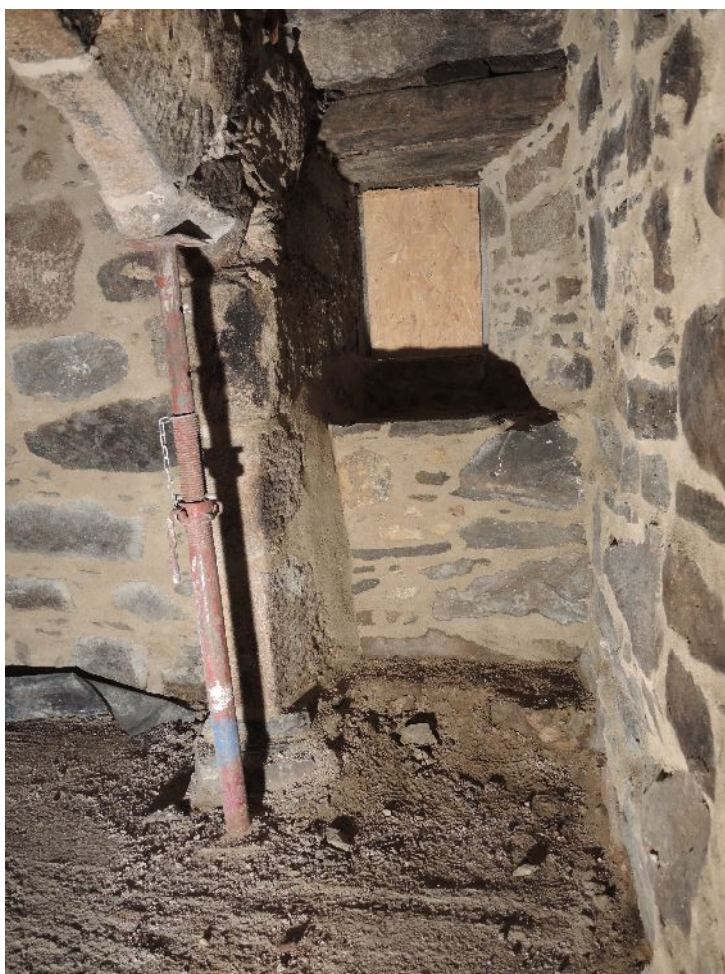
Illus 56 Window W5 as consolidated 2014

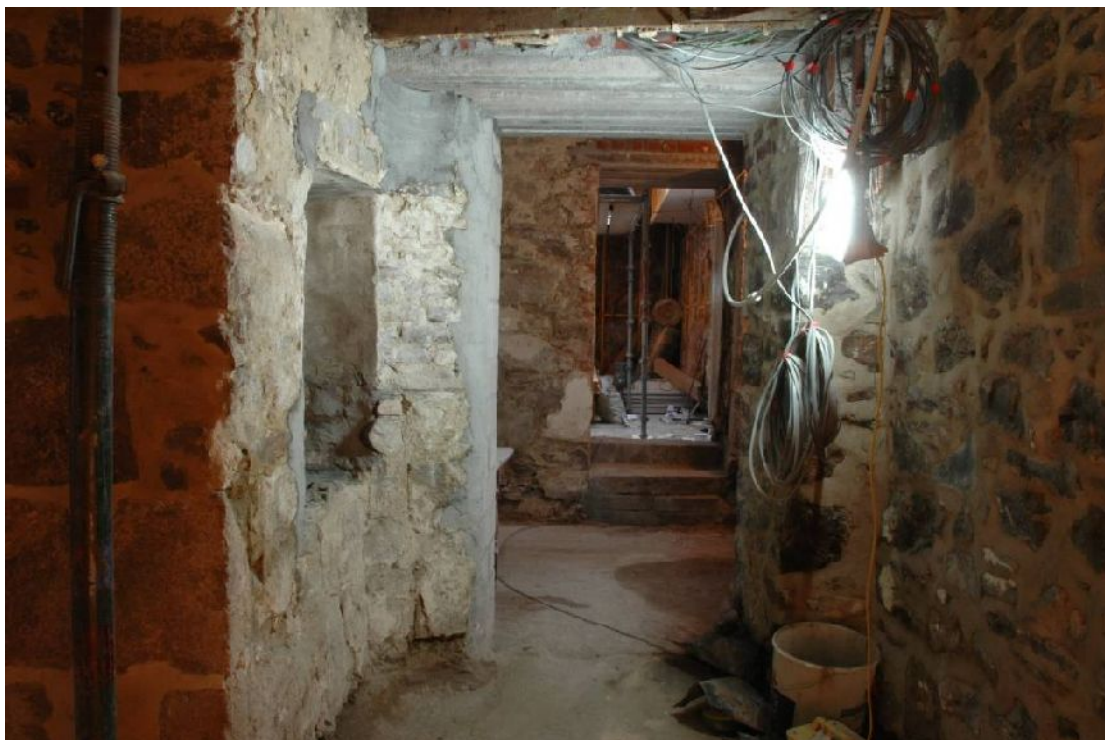
D9 When first observed, the dining room door was hung between two short brick partition walls, in line with the front edge of the fireplace, leaving a rather odd passage formed through the pend wall and alongside the W side of the fireplace. The break in the pend wall appeared probably secondary as there were no signs of an original arch or rybats; if an earlier doorway had existed here it would appear to have been both widened and raised in height. The sides of the opening had been restructured with brick and there were seven horizontal timbers inserted to carry the weight of the pend arch at this point. The timbers were between 115mm x 80mm and 10mm x 50mm. All appeared to have been re-used, one with a redundant mortise, another two with out of sequence carpenters' marks (II, XI). They had been plastered over. (These timber lintels have been replaced with concrete lintels as they were found to be structurally compromised due to extensive decay and loose fitting). At the same time, or possibly later, door D9 was placed blocking the N end of this short 'passage'.

Illus 62 Looking towards the Pend from the Dining Room showing passage after D9 removed.

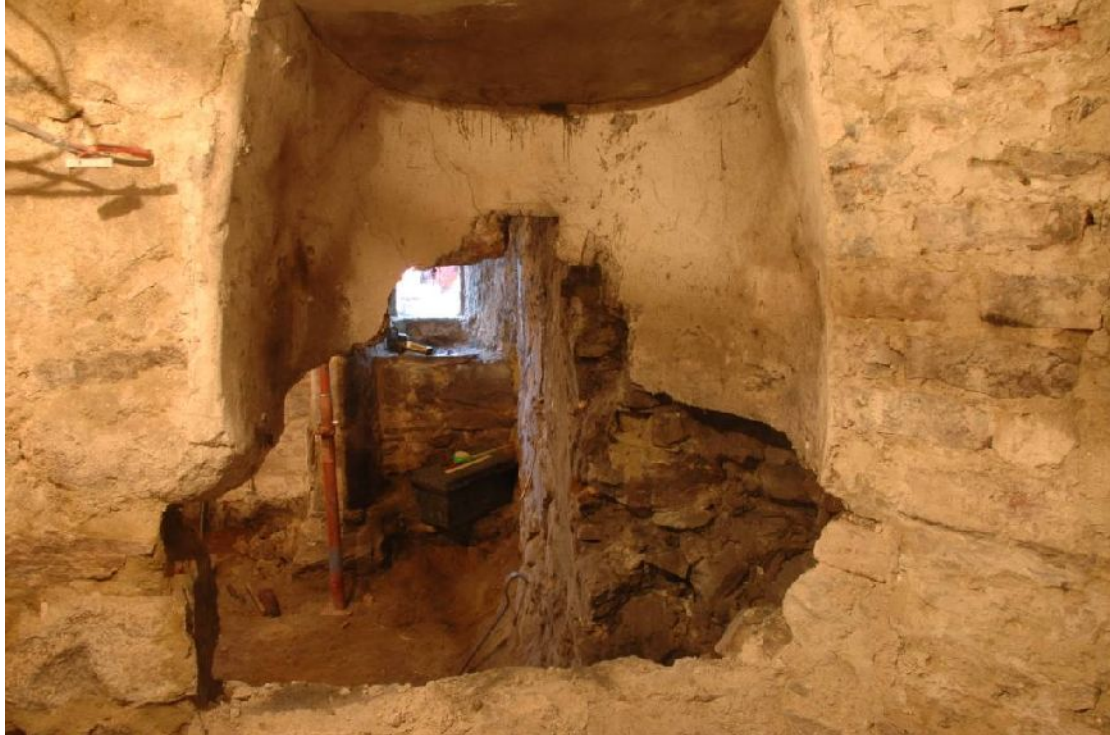
F16 On the E side of the 'passage' there was an alcove (F16) with curved sides and a straight top and base (Illus 47, 63, 64). It had a height of 560mm, depth of at least 620mm and front width of 750mm at the base narrowing to 660mm at the top and the

base was at c1m above the floor. The inner face had been carefully plastered. This had later been blocked with brick and stone. It had been built into the hollow of the original fireplace at some point after it was no longer in use.

Illus 63 Alcove F16 broken through to fireplace

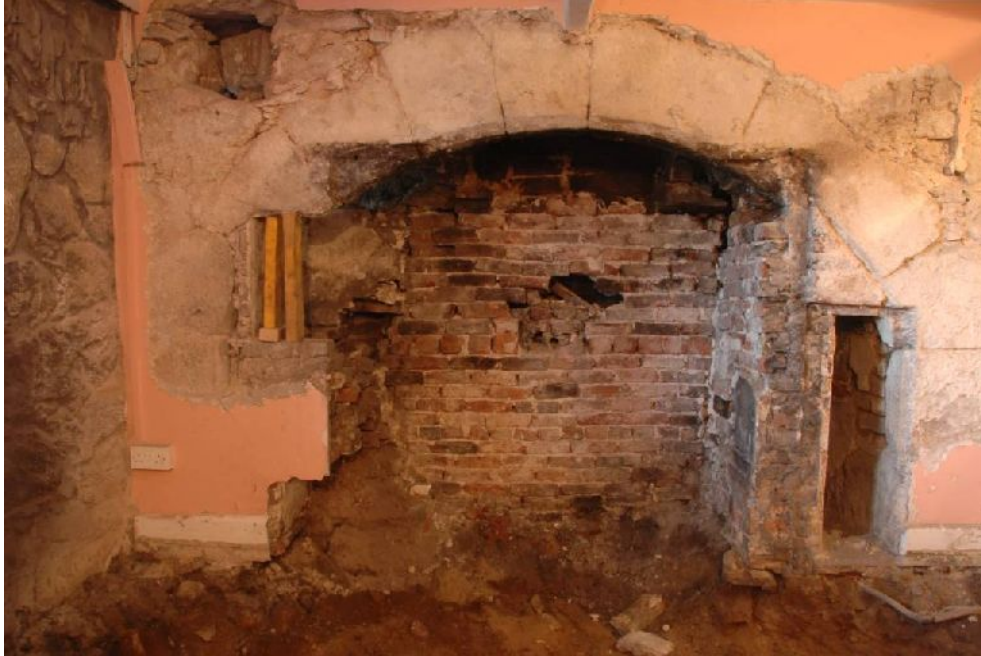
Illus 65 Later fireplace with tiles removed to show brick (F15). F17 to RHS. F20 by prop to LHS.

Fireplace F15 and related cupboards post-date the blocking of the inglenook window W5. These various features are likely to date between the late 18th/early 19th century and the 20th century. The chimney and back of hearth had been brick-lined.

F15 Within the original stone fireplace a smaller rectangular tiled recess, 1.32m wide, 0.70m deep and 1.27m high had been built with a reduced brick-lined chimney inside the stone chimney (Illus 48, 66). In turn this fireplace had been blocked to hold a wood-burning stove, the pipe of which was inserted into the chimney. The fireplace was enclosed by a high plain rectangular wooden surround with a wooden mantel. While the coloured ceramic tiles were put in by the present owner, the plain white tiles may have been those put in by the University in 1931, when the property was leased by them to Douglas Simpson – a letter of 18/12/31 details that they will ‘fit in new grates with tiled surrounds in the drawing room, dining room and study’ (Simpson, notes).

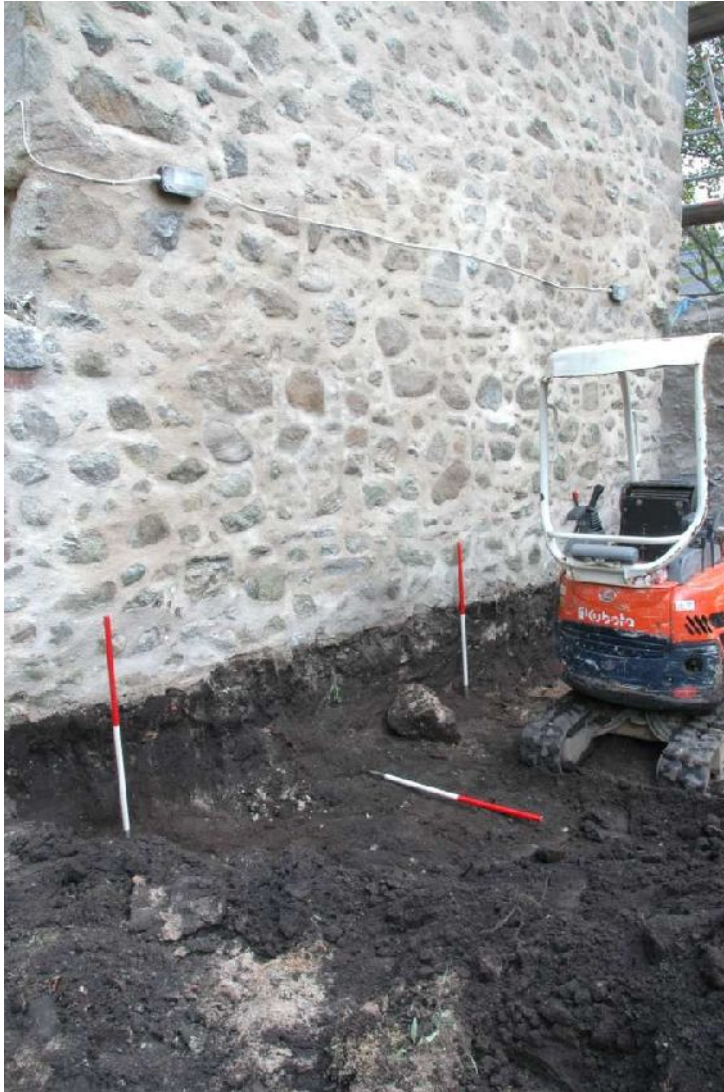
Illus 76 Garage area after soil removed

An area c 6 x 8m was excavated by machine on the N side of the N gable of the tower. No foundations were observed relating to the former late 19th/20th -century building, although the shadow of the structure was visible on the N gable (Section 6.5). The building is first documented on the 1899 Ordnance Survey map. This part of the garden, originally part of the Bishop's Palace grounds, was added to the present property in 1873 (see Section 5 above), so the building is likely to have been constructed between 1873 and 1899.

The excavation showed that, prior to the construction of that building, there had been considerable build-up of garden earth in this area with c700mm of garden earth containing 19th -century glass and china.

Below this there was c100mm of grey silt above natural yellow clay; the natural here appeared level with the natural in the garden beside the E side of the present building. The wall of the tower was visible down to the level of the natural substrate.

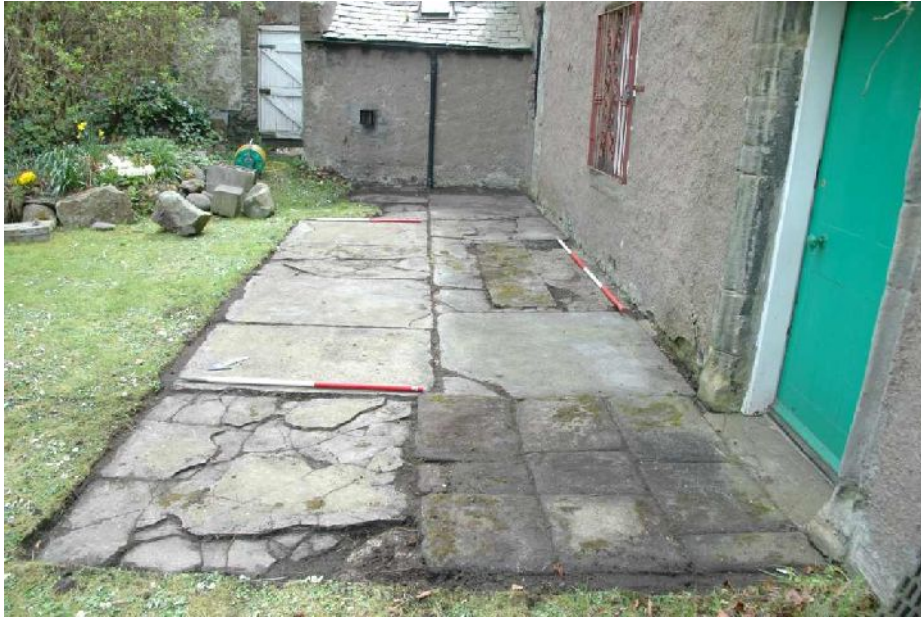
Illus 79 Paving of slate slabs

An area of large slate slabs c 2.5m wide and 7.7m long ran along part of the E facade of the building; this was recorded prior to removal of the slabs (Illus 78). The large slate slabs were cracked and heavily spalled and ranged in size from 1.24m x 1.09m to 1.25 x 1.22m. They may have been re-used from elsewhere in the building – possibly even having initially been internal flooring. In their current position however, they were part of an area of hard surface which ran between door D1 and the outbuilding abutting the blocked pend. The surface was also made up of an area of old bricks and a patch of thicker stone slabs, two of which had drilled holes in them and also appeared to be re-used from elsewhere.

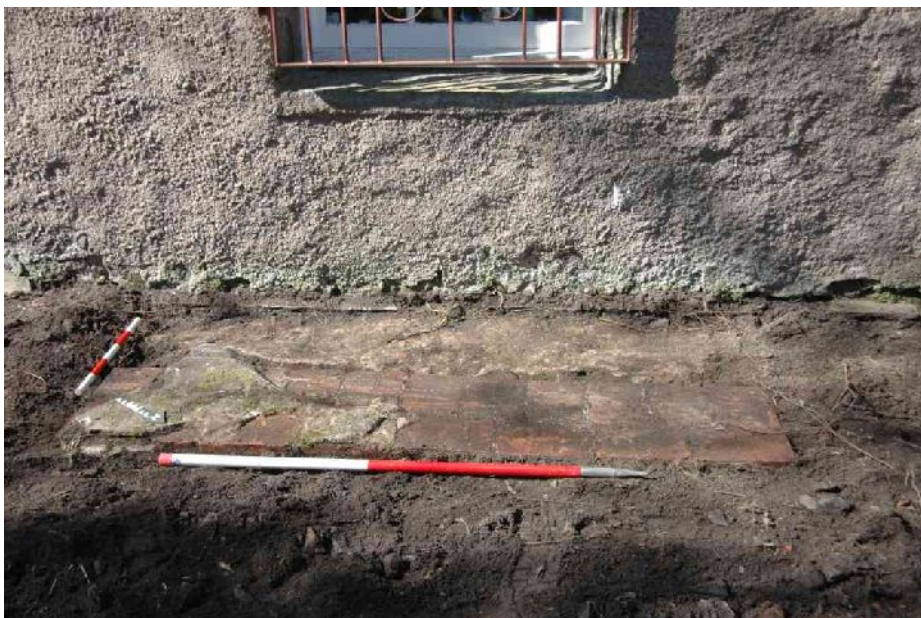
Illus 80 Brick feature F21 below window W6

Below window W6 there was a rectangle (F21), 1.8m x 0.39m, formed of 2 courses of brick and concrete. This was centred on the window and may have been a garden feature- possibly to hold a raised planter below the window.

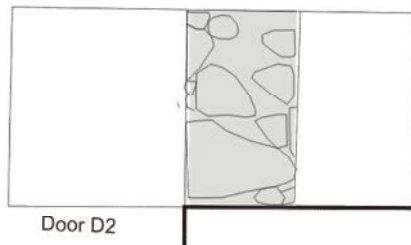
Sondage 3

Sondage 2 400mm x 1.6m. Excavated on the line of the covered walkway, to expose and record any foundation of the S wall of the N range. The stratigraphy comprised c. 80mm sand (1) which sealed the foundation of the wall (3). On either side of the wall there was c 320mm (2) loose earth with occasional stone, slate and 19th/20th century china and glass fragments. Over the wall, layer (2) was only c 20-30mm in depth. The wall was 850mm wide of mortared rubble stone construction, the inner edge being partly removed. Only < 250mm surviving height.

Plan

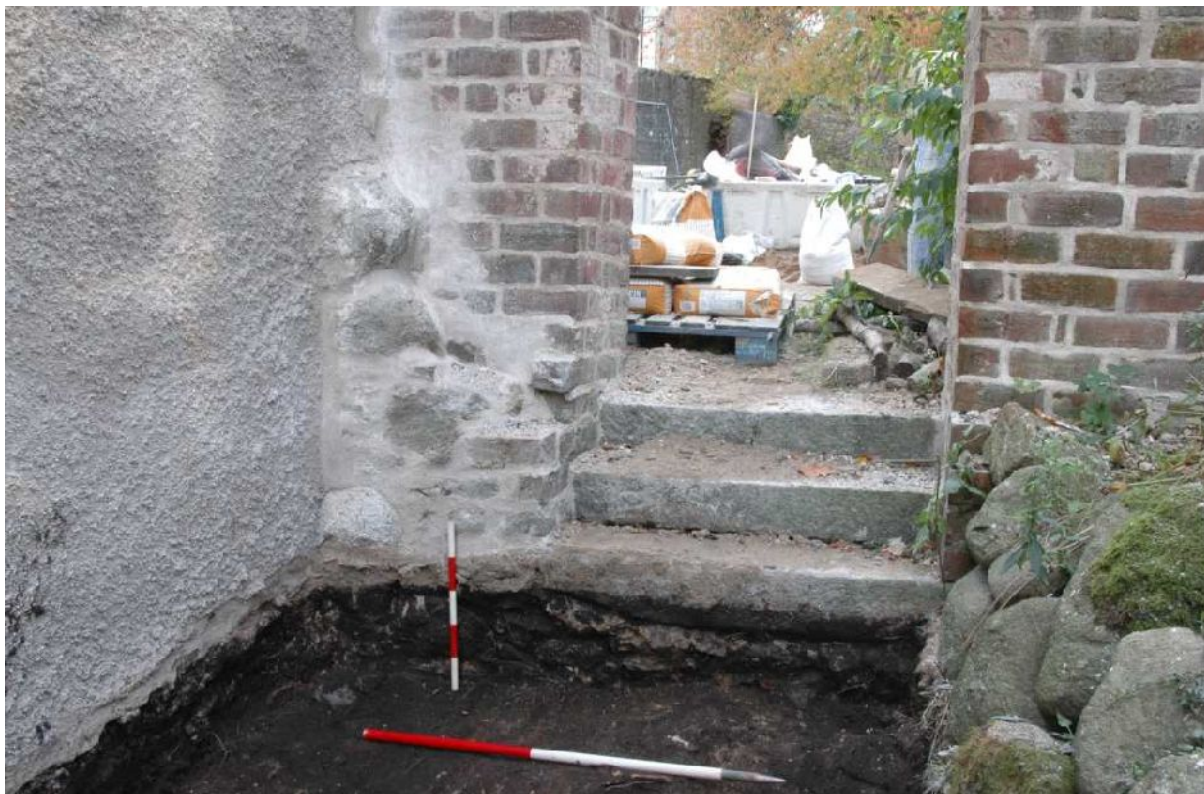
Illus 84 Fragment of N wall of N range surviving below brick pillar and steps to upper garden

Observation of ground clearance for the covered walkway When the ground was cleared back to the step at the outer NE corner of the tower, up to the higher garden to the N, part of the foundations of the N wall of the N range were exposed. The steps and the brick pillar beside the steps were built on this wall which appeared to be c 800/ 850mm wide.
