**CHAPLAIN'S COURT
20 THE CHANONRY
OLD ABERDEEN**

**Standing Building Recording
and Watching Brief**

Report No: MAS 2013-13

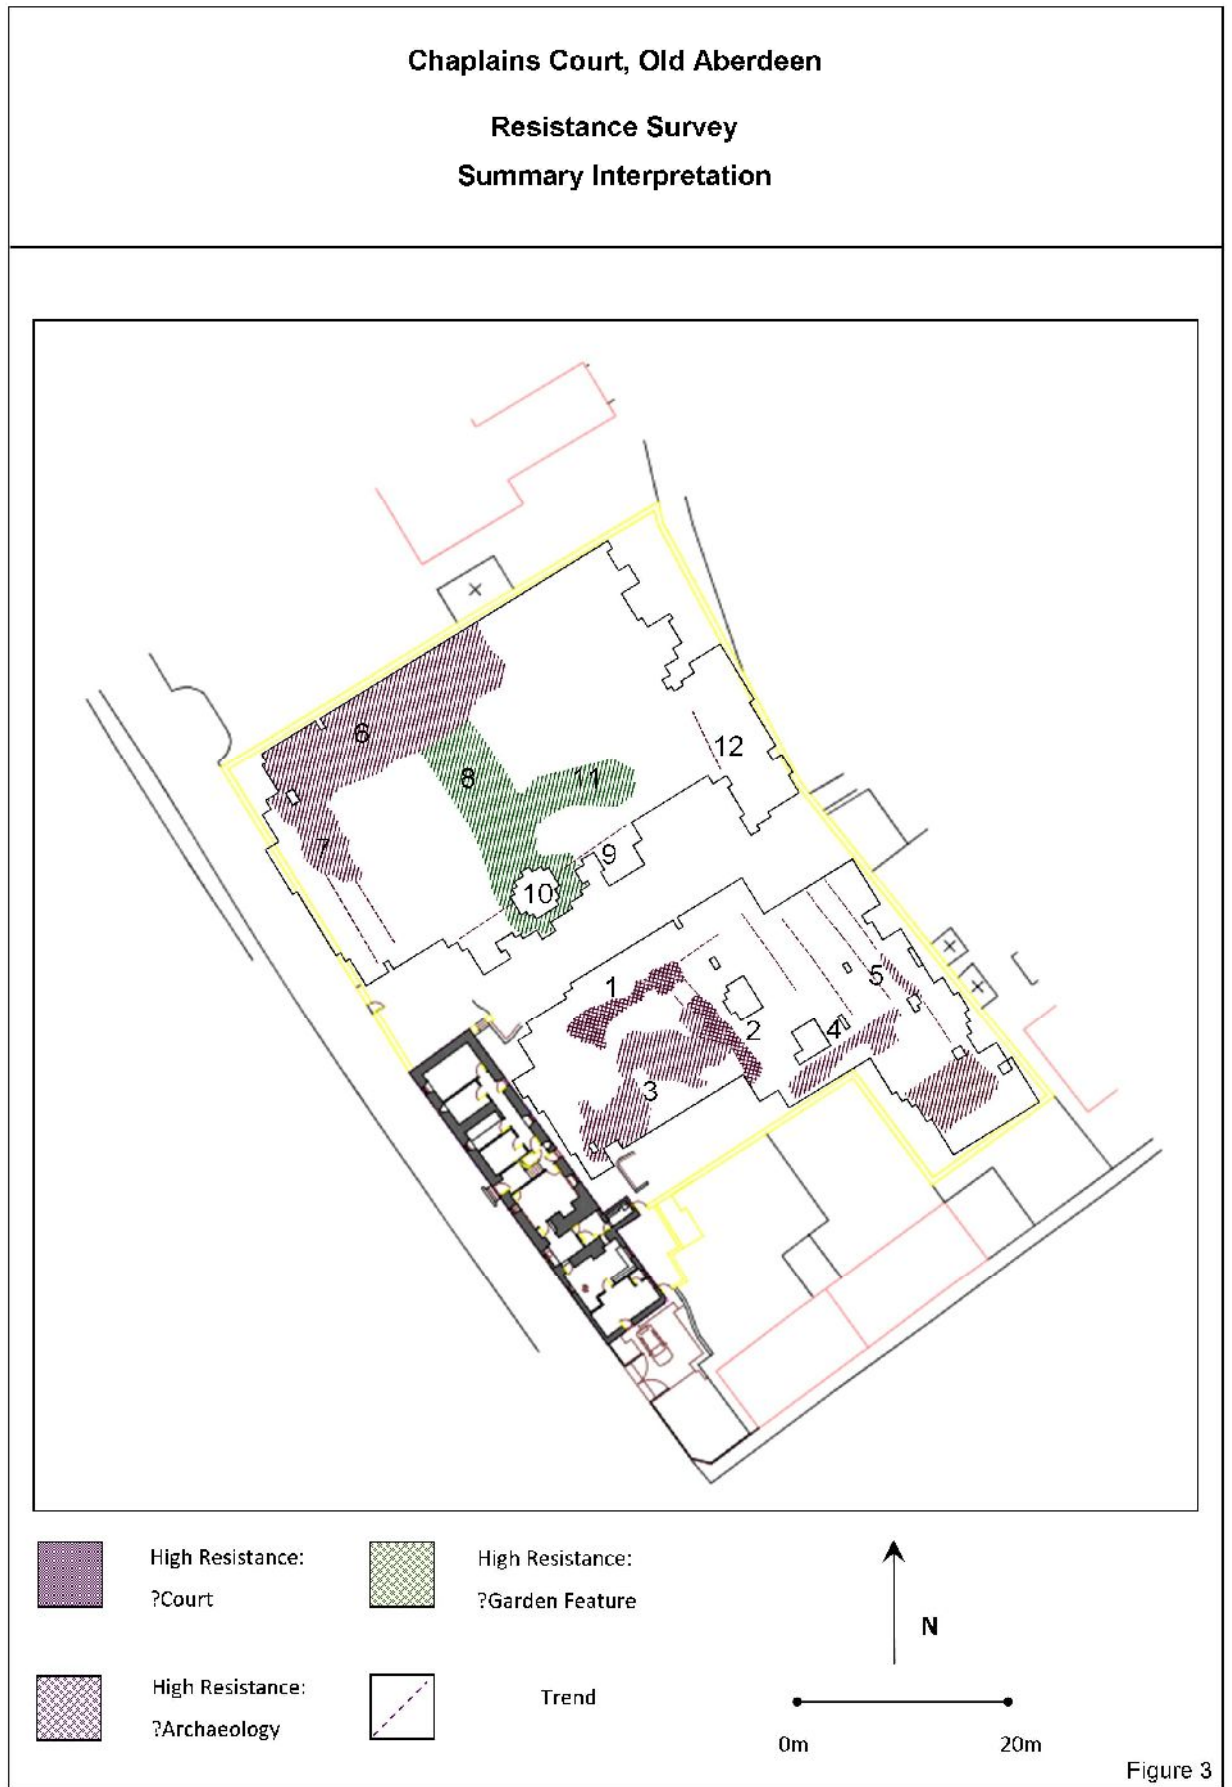
Illus 86 Summary interpretation of resistance survey from Ovenden 2013, fig 3.

In the lower garden, covering the area of the N end of the original property of Chaplain's Court, the aim was to identify any remaining elements of the N and E ranges. The full report by Rose Geophysical Consultants LLP (Ovenden 2013) will be supplied to the City of Aberdeen SMR. However, fig 3 of the report, which gives a summary interpretation of the results, is included here (Illus 86). It clearly shows two lines of high resistance (1 and 2) which are interpreted as the walls of the N and E ranges. This interpretation is supported by the excavated sections of the N range walls reported above. Initially it was not clear how this related to the map evidence, but after greater examination of the map sources, it appears that 2 is on the line of the inner (W) wall of the E range.

The geophysical survey would appear to indicate that the foundations of much of the N range and of the N part of the E range exist below the garden. The large area of high resistance within the court was interpreted by Ovenden (2013: 3.3) as either a possible surface or a rubble spread. There is no evidence for the draw well within this area

Part of the E range is within the garden of the present property and the line of the W wall of it was identified by the geophysical survey (Ovenden, 2013, fig 3- reproduced above as Illus 86). Replicating the sizes of the known ranges and tower to reproduce the plan of the S and E sides of the quadrangle forms a plan that fits both with the later property lines and with the geophysical evidence for the E range.

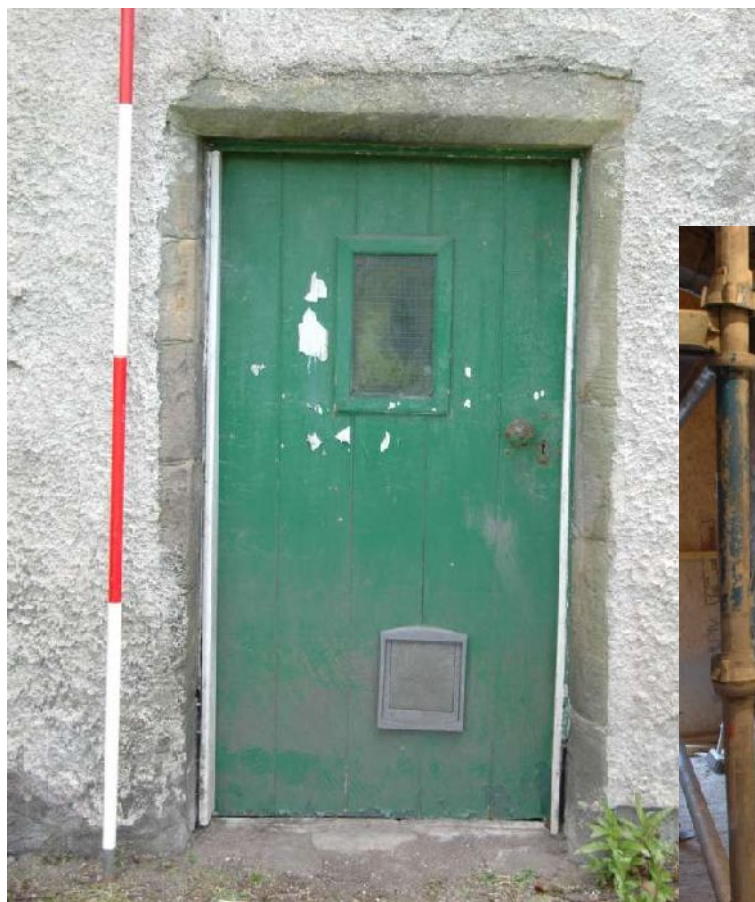
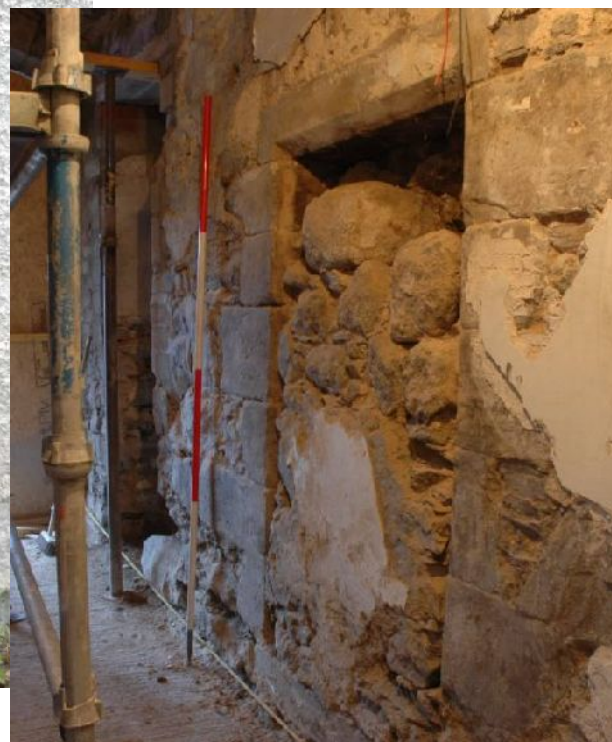
Illus 90 Door D2 (above) and blocked door D7 (RHS)

Identification of original doors and windows is difficult as in many instances they will have been removed by later, larger replacements. However, in addition to the Great Gate at the outer pend arch, there are four doorways that are almost certainly part of the 16th -century fabric; two of these, blocked D7 (from pend to S end of W range), and D2 (from W tower into N range at ground level) are both c 1.5m high and c 0.80m wide, with a square-headed sandstone surround with a plain chamfer, and both have a relieving arch above.

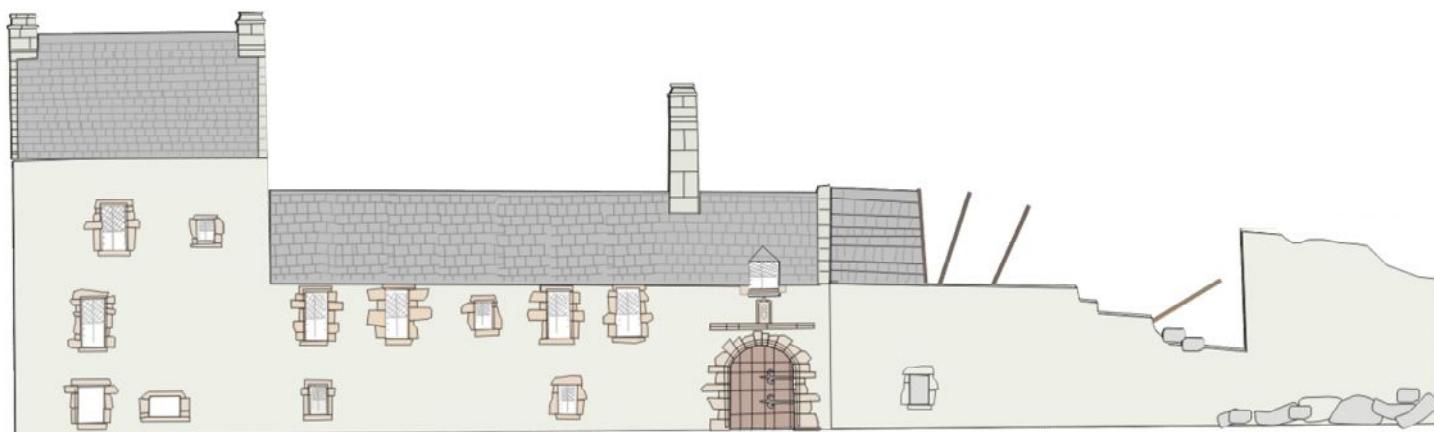
Illus 94 Reconstruction of street elevation in the 17th century

From the 17th century, larger sheets of glass could be produced and window sizes increased with windows generally becoming taller and narrower. However, the glazing in the reconstruction drawing is based on the representation of the windows on Kings College depicted on Gordon's map of 1661, with a large opening, but the upper part of the window of smaller, probably leaded panes. It seems possible that it is at this point that the sandstone surrounded windows were added on the street facade of the hall and kitchen (W23, W25, W26, W28 in the W range) and on the upper floors of the W tower, which may have included the family's chambers (W30, W31). It is possible that on the garden side, the central door (D1), which is sandstone, may have been restructured and window W7 inserted. If these changes were the work of Forbes, then it is likely they would have been done in the 1620s or early 1630s before Forbes, and Aberdeen, became caught up in the troubles surrounding the Wars of the Covenant (DesBrisay 2002, 247-61). It seems less likely that they were done after the 1644 *Mortification*, by any of the later Professors of Divinity.

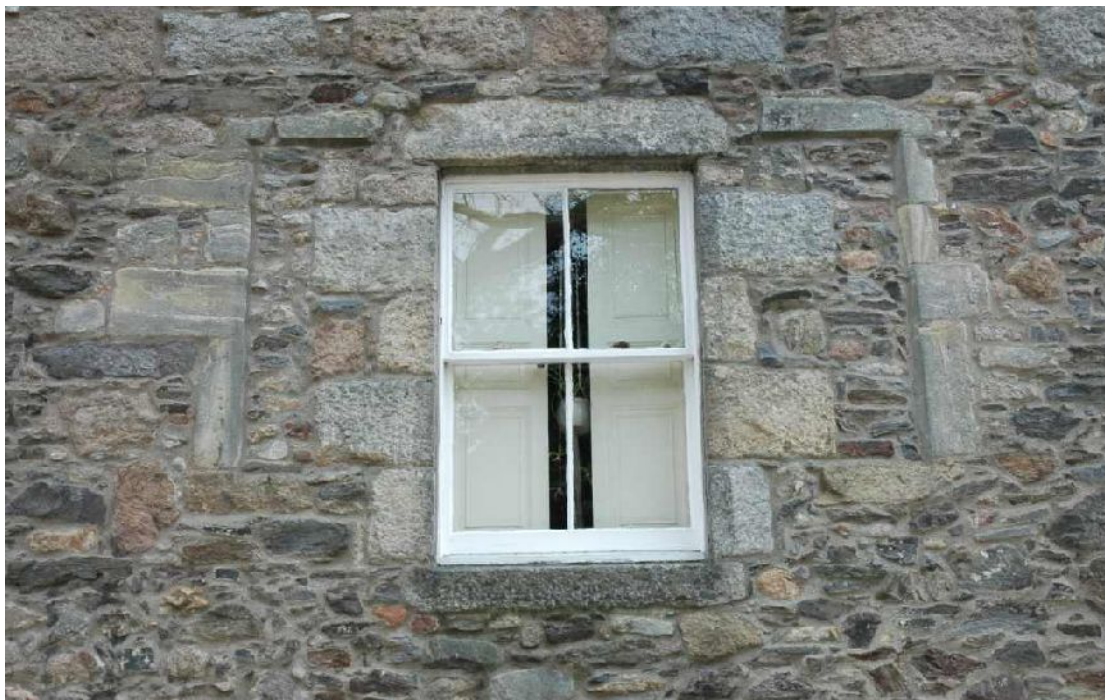
Illus 95 Blocked sandstone windows W23 and W25, replaced by granite window W24

W23 Blocked window replaced by W24. Chamfered sandstone rybats and lintel. Rubble blocking. W: c 0.70m H: 1.38m (W23, W25, W26, W28 and W30 match).

W25 Blocked window replaced by W24. Chamfered sandstone rybats and lintel. Rubble blocking. W: c 0.70m H: 1.38m (W23, W25, W26, W28 and W30 match).

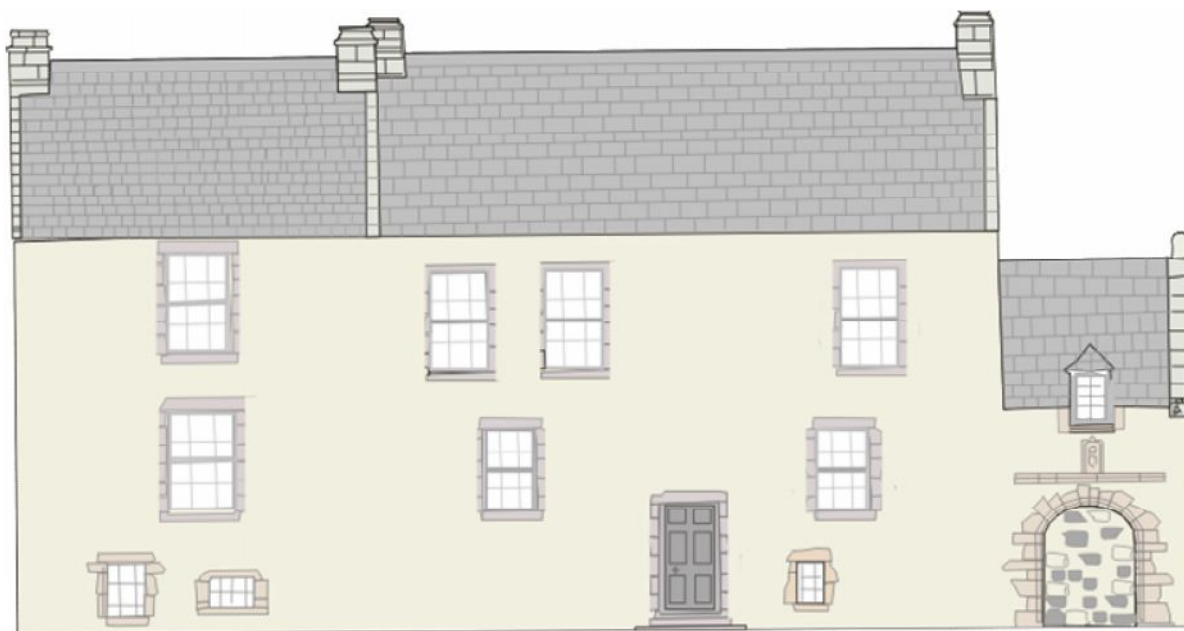
Illus 97 Reconstruction of street elevation in the 18th century

From Orem's description, it would appear that part or all of the N range (where the chaplains' kitchen had been) had burnt down and was rebuilt at this time. Changes to the W range can most clearly be seen on the street frontage. It is at this time that an additional storey was built and the roof line built up level with the tower. The upper part of the wall was rebuilt with ashlar blocks on the street side, although as was common at the time, plainer materials were used on the less visible garden side—although here too the difference in stonework is marked by the more regular horizontal coursing. It is probable that at this stage, if not before, the external walls were harled, with earlier blockings being concealed.

An additional chimney was added to the N end of the main block and the S chimney built higher when the roof was raised. The chimneys are shown without pots as these were not common until the 19th century (Curtis, 2013).

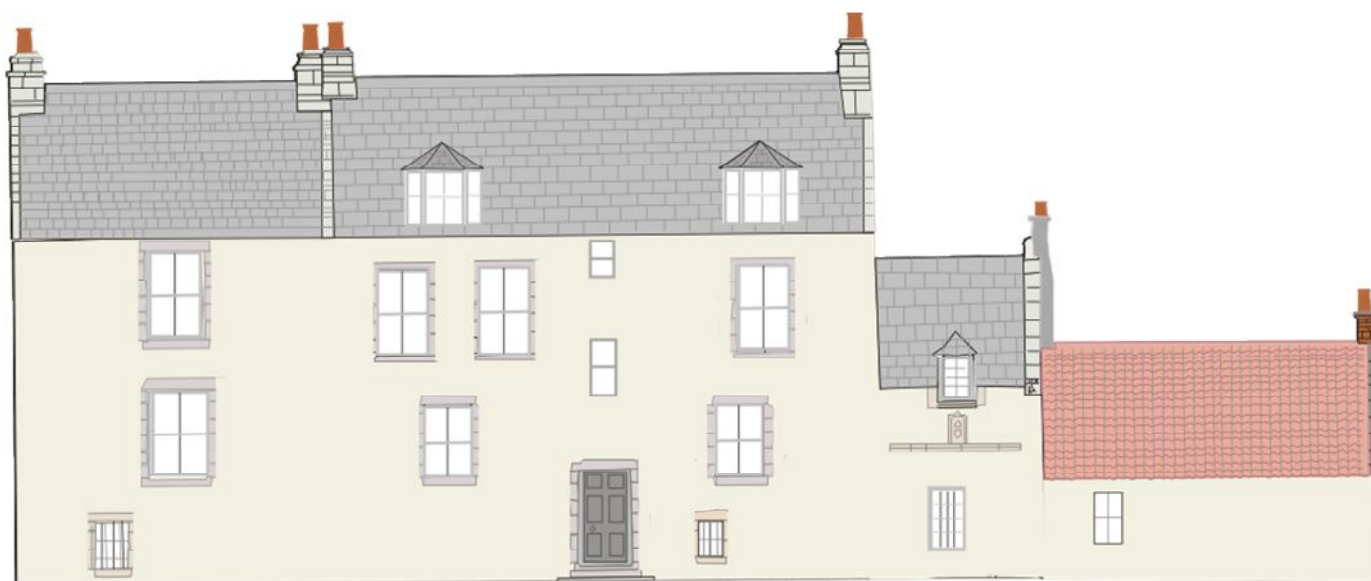
Illus 98 Street elevation in the 19th – 20th century. This has been based prior to 1933 when the harling was removed from the pend archway

The blocking of the pend can be regarded as one of the most later important changes to the building as it totally changed the focus away from the courtyard to the street frontage. As discussed this may have happened as part of the 1718 alterations, or may have been later. It was certainly blocked by time the 1st Ordnance Survey map of 1866

was surveyed; when the outbuilding had been built on the garden side of the blocked pend. On the street side the whole wall, including the stone blocking of the pend arch, was harled over and the arch obscured. At some point a window (W20) was broken through; this is clearly later than the original blocking as it was set into bricks. In April 1933 the harling over the arch was removed and the pend arch re-exposed. As the *Press and Journal* photograph of the arch shows, the rest of the frontage was still harled at this point.
