DRUM CASTLE
TOWER OF DRUM MAJOR REPAIRS PROJECT
DRUMOAK
ABERDEENSHIRE

Archaeological Excavation
Carried out May-June 2014
by
Murray Archaeological Services Ltd

Report No: MAS 2014-07
by
H K Murray and J C Murray

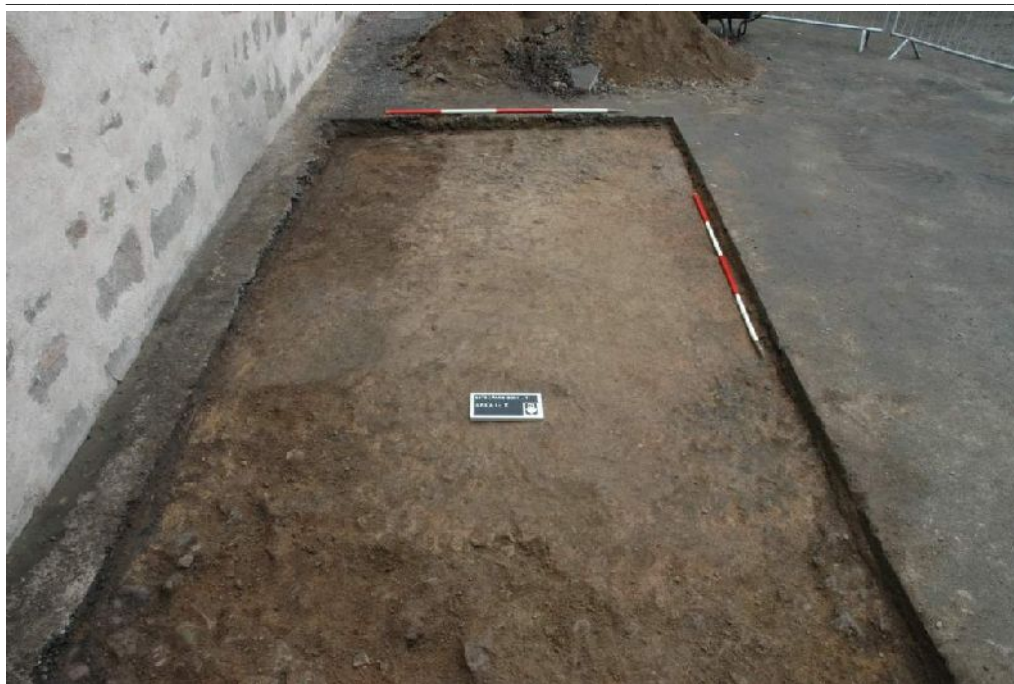
Illus 2 Area 1 looking S. 19th-century yard surface (7). Cut 49 visible as darker band along LHS.

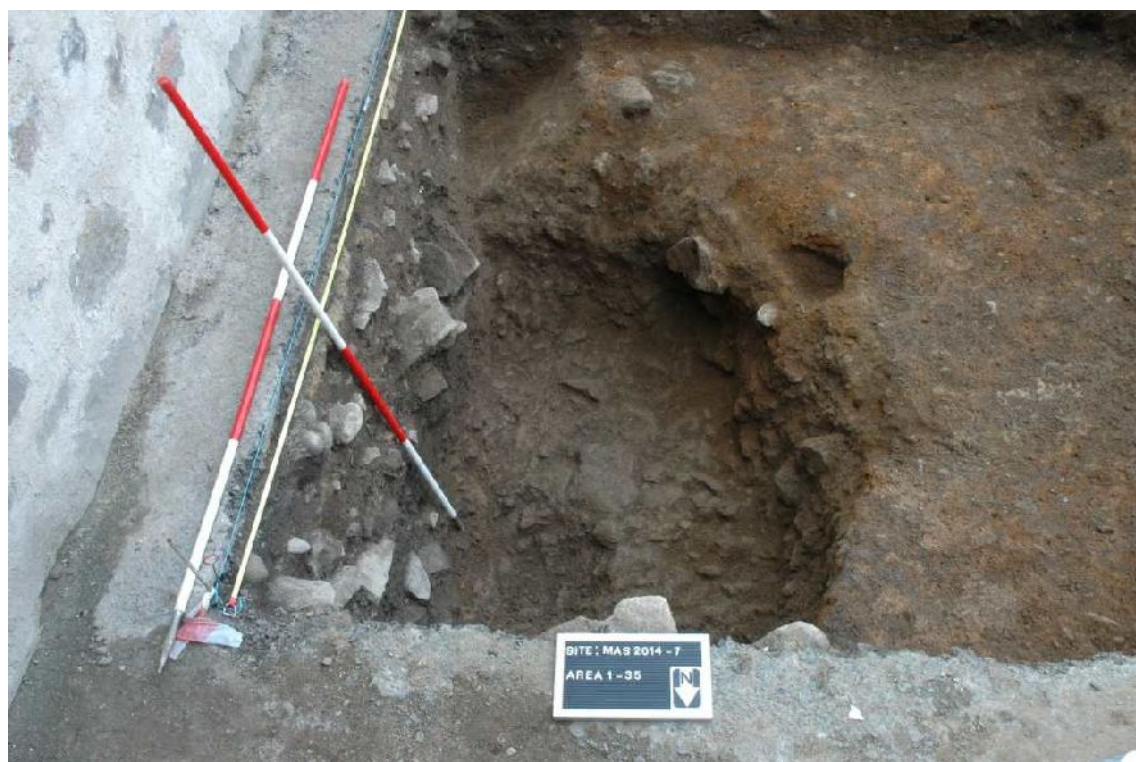
Illus 3 Area 1. Cess pit fully excavated. Looking S

As excavated the upper external diameter of the pit was 1.8m E/W by 2.4m N/S; assuming the pit extended to near the wall face, the original outer top diameter would have been c 2.4-2.5m. The internal diameter was c 1.5m and the depth c 1m cut into yellow natural clay. The natural at the base of the pit had been loosened, probably by earlier cleaning out of the pit contents (39).

Sadly the original pit appears to have been regularly emptied with only patchy traces of possible original fill (38) remaining as a light fawn residue with a maximum thickness of 200mm at the base and part of the side of the pit. Environmental analysis of a bulk

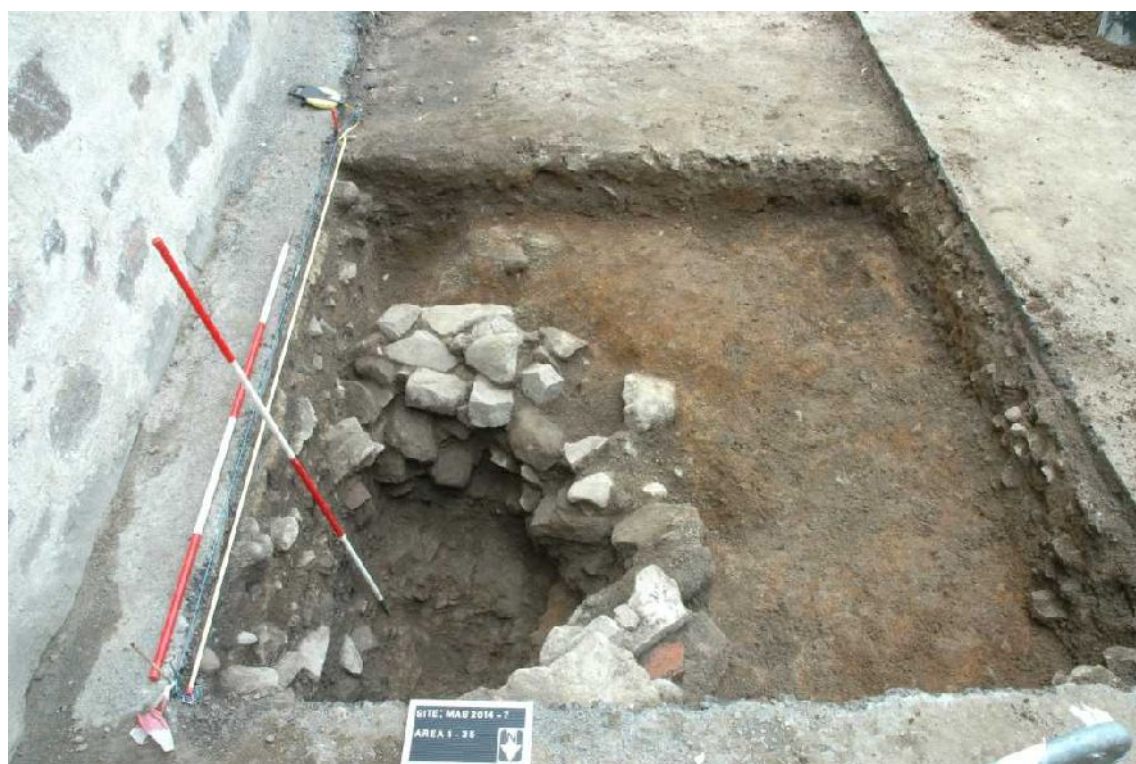
Illus 4 Area 1. Cess pit partially excavated showing stones (40) in edge fill. Looking S.

Above and partially sunken into 36 there were a number of large field stones (40), many focusing around the edges of the pit but not structured. These seem to have been tipped in from the sides directly before the deposition of another grey gritty layer which contained large amounts of mortar (34) – this being part of the general yard layer (32) sunken in over the earlier pit fills as they compacted. It can be postulated that the stones (40) may originally have formed a kerb around the top of the pit; they were not a lining.

It would appear the kerb was pushed in as part of a final leveling of this part of the yard at a time when building work was being undertaken. Five sherds of 14th-15th century pottery from contexts 34 and 40 showed little sign of re-deposition wear and suggest that this deliberate sealing of the pit occurred in the 14th or 15th century.

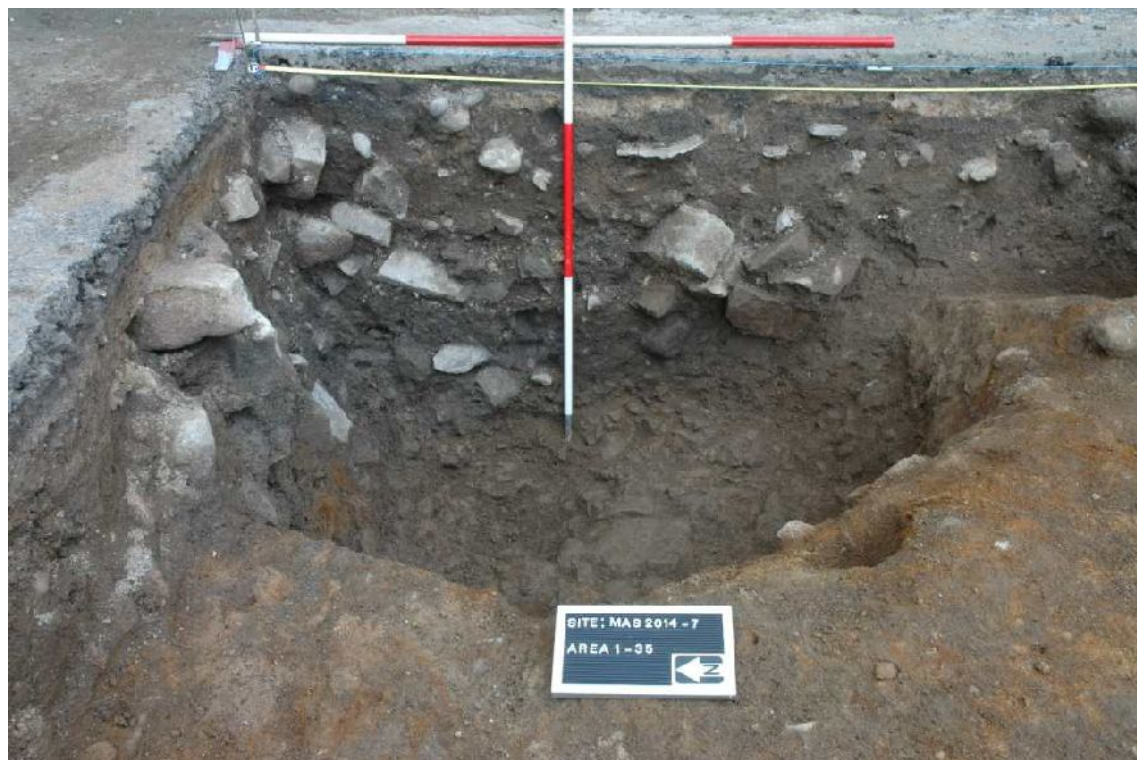
Illus 6 Area 1. Section of cess pit

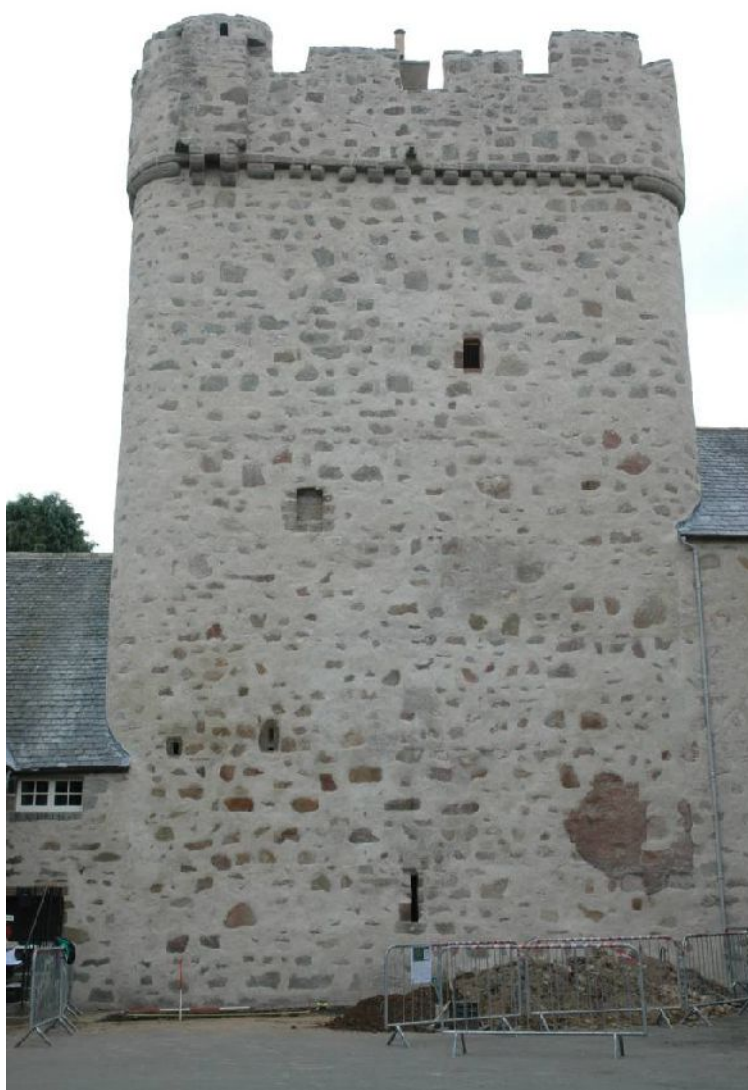
Illus 7 View of W wall of tower with garderobe at NW/ Ranging rods mark position of cess pit in Area 1.

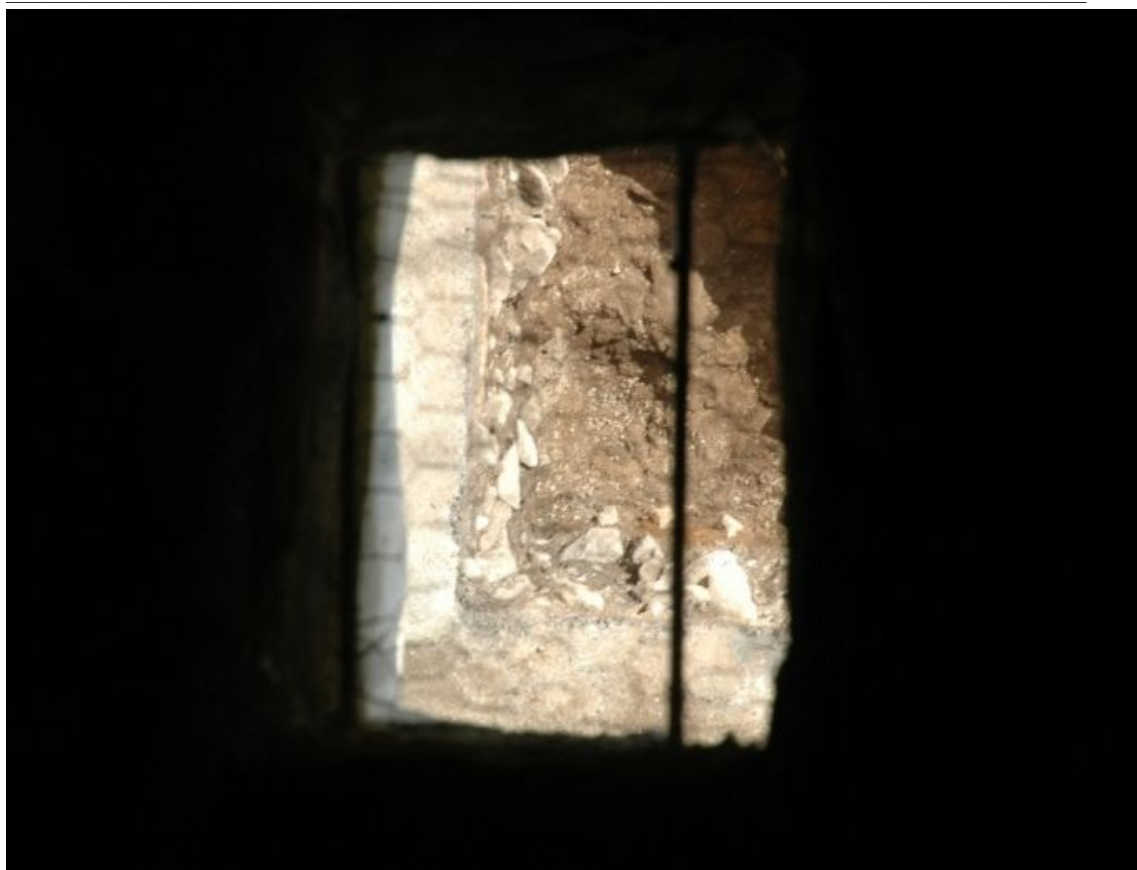
Illus 8 View of pit in Area 1 through hole of garderobe

The cess pit (35) associated with the garderobes on the tower was probably cut from layer 47 but due to the later disturbance of the pit edge this was unclear. The pit was directly in line with the uppermost garderobe. It was assumed that an outlet from the lower garderobes ran through the wall thickness to an outlet into the pit; unfortunately the outlet could not be revealed during the excavation without extending the Area to the face of the tower wall which would potentially have damaged the new harling. However, when the yard levels were reduced in advance of laying new tarmac in November 2014, a blocking was recorded directly below the small window of the lowest garderobe (Appendix 6).

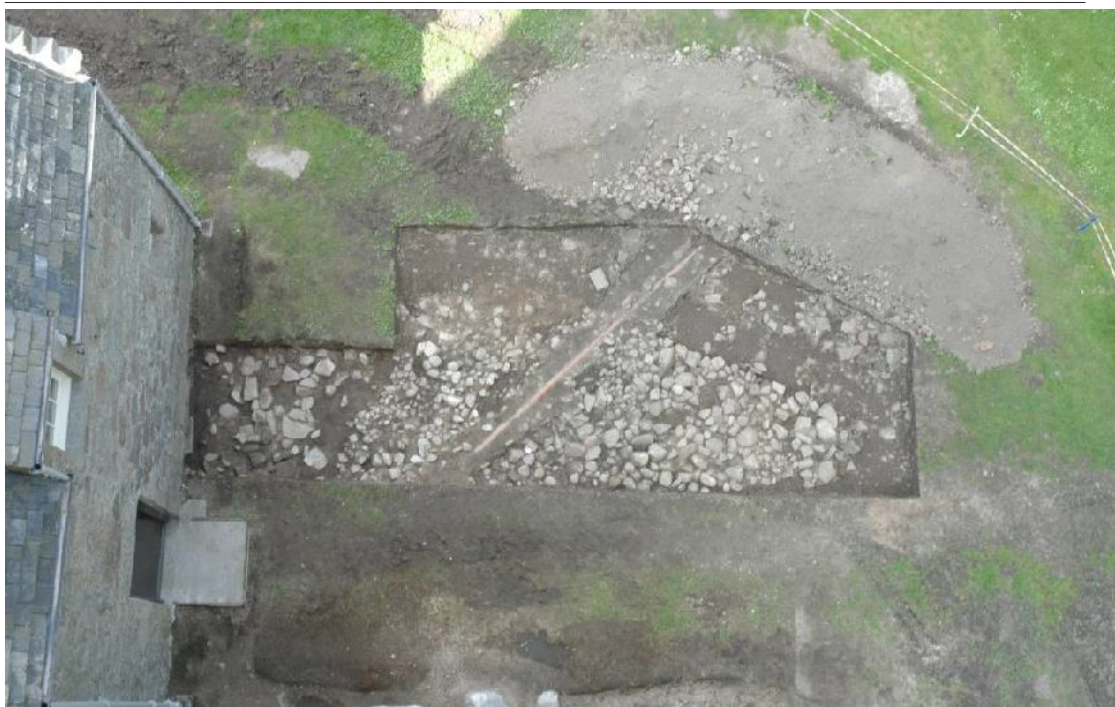
Illus 11 Area 2 from the Tower, showing rubble spread

The rubble covered all of Area 2 (illus 11) and overlay the floors and wall foundations of an earlier, destroyed, building. Most of the area was 'inside' the building, with only some 2.5m at the E end of the area being 'outside' the building. Directly over the internal floor, which was partly burnt (see below), there was a thin layer (68), 2-3mm deep, of burnt material with tiny laminated slate fragments and frequent nails or nail fragments. Externally, there were some burnt fragments in a layer, 8mm deep, with slate and mortar fragments (80). Both internally (65) and externally (79) this burnt horizon was sealed by grey gritty silt with mortar and slate fragments through it. The rubble of small to medium sized angular stones (22, 26) and spreads of gritty clay and stones (10) lay over these earlier horizons and together all these layers can be interpreted as stages in the demolition process. There was a total depth of between c.300 and 500mm of debris, which had been used to level up within the foundations of the building to provide a relatively level surface for the grass.

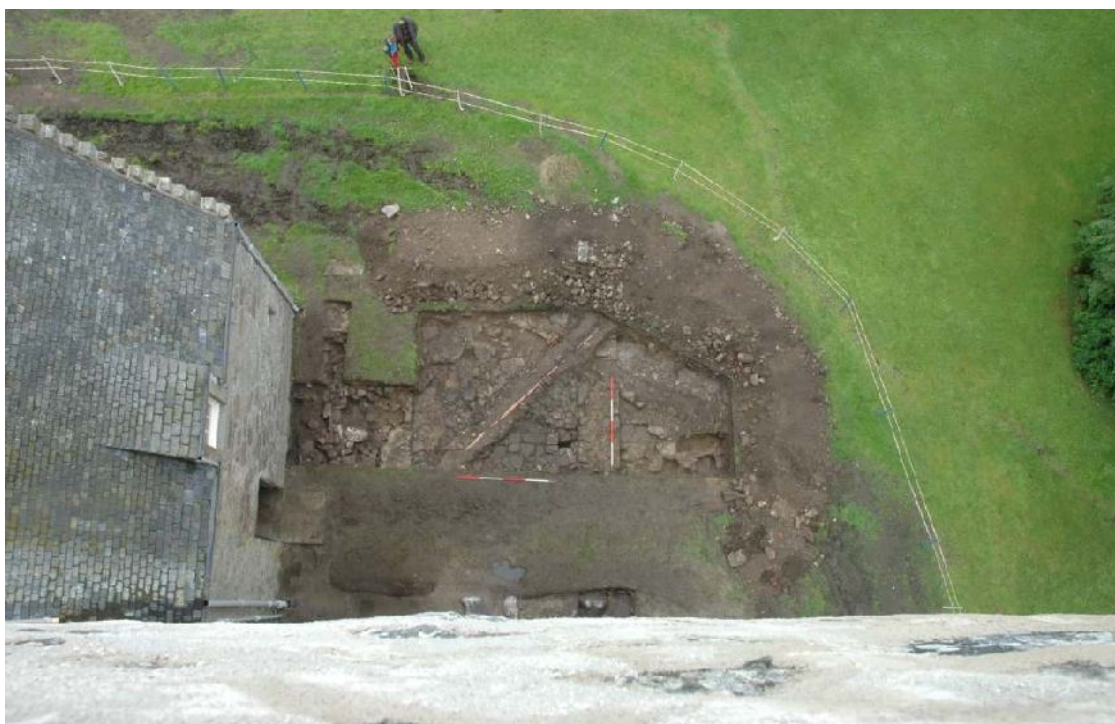
Illus 12 Area 2 from the Tower, after excavation of rubble

The building itself appears to have been almost square in plan with its slightly longer axis running E/W; being 7.4m E/W and c.7.1m N/S externally and 6.5m x 6.2m internally. It abutted both the N wall of the tower and the E wall of the Brewhouse.

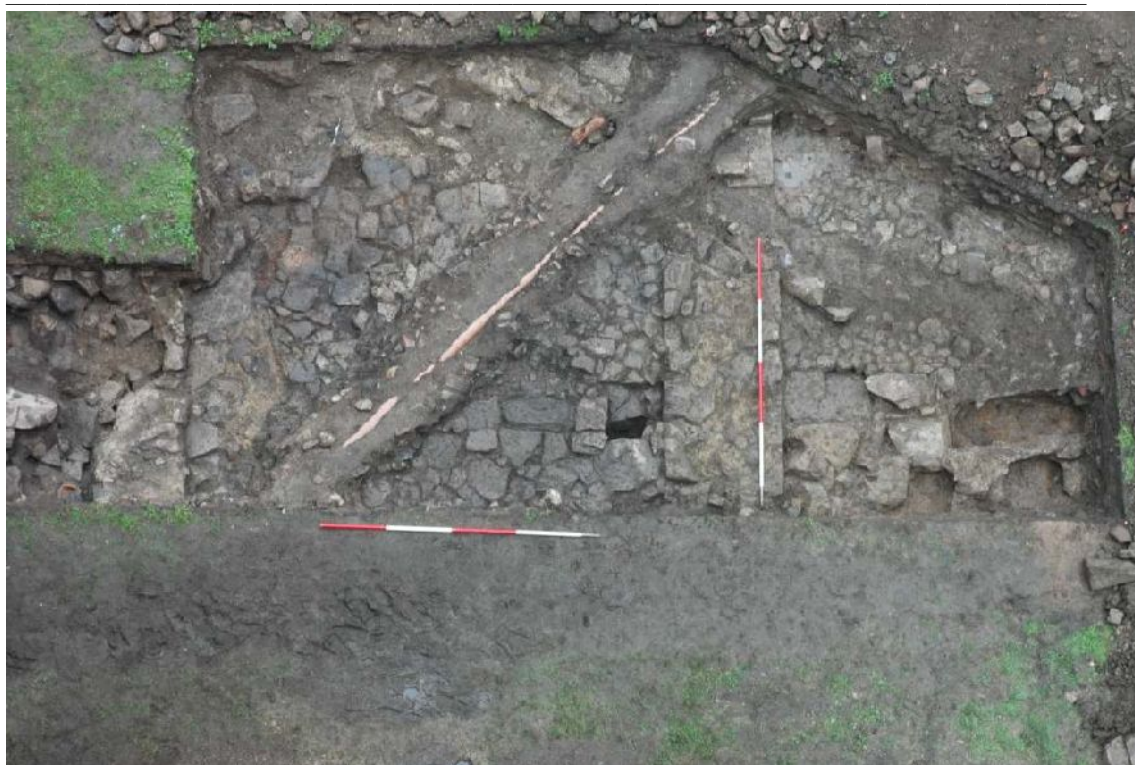
Illus 14 Area 2. Detail of building

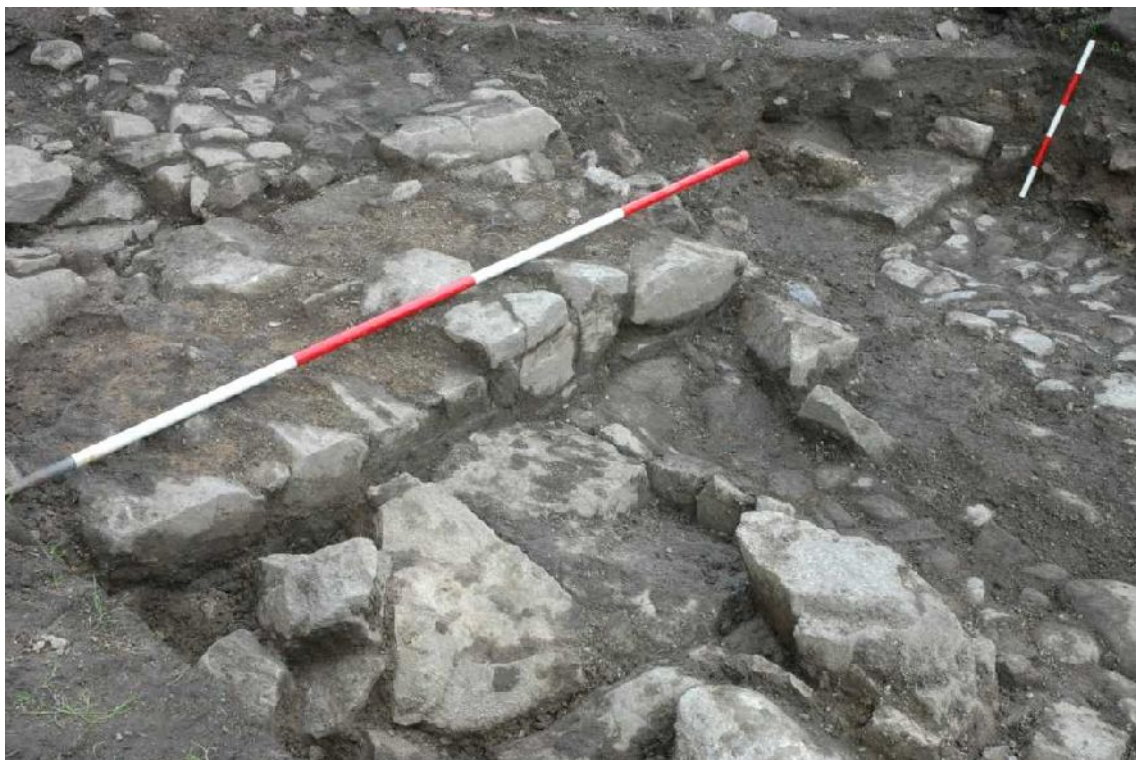
Illus 15 Area 2. Outer face of E wall (70)

The E wall (70: illus 15) was of field stone bonded with gritty yellow clay, it was level with the internal floor but on the outside, where the ground was lower it survived to 2 courses and c260mm in height. A small additional Area (2A: illus 16) was excavated in line with this wall adjacent to the N wall of the tower. This revealed two large boulders and some smaller stones with traces of mortar between them, abutting the base of the tower wall. This can be regarded as the continuation of the E wall of the building and was sealed by 200-300mm of small rubble and grey gritty silt which equate to demolition layers 65, 79, 22 and 26 in the main Area. The N end of this E wall had been cut by two modern drains (illus 10) but the line is continued by a block of surviving masonry between the two drains (70A), which appears to include part of the internal corner with the N wall. Unlike the central part of the E wall, this fragment and the rest of the E wall were bonded with a white gritty mortar rather than clay. The N wall had been largely removed by drains 71 and 23 but was identified in three areas (76A, B, C); it was also identified in 2002 when the lightning mat was put in here and this section of the wall has been traced and added to the present plan. Both it and wall fragment 76B give an inner face up to the edge of the internal cobbled floor. The outer edge was not identified but the N wall was at least 850mm wide. The W end of the N wall was excavated to within 900mm of the Brewhouse wall and it is assumed that it abutted it,

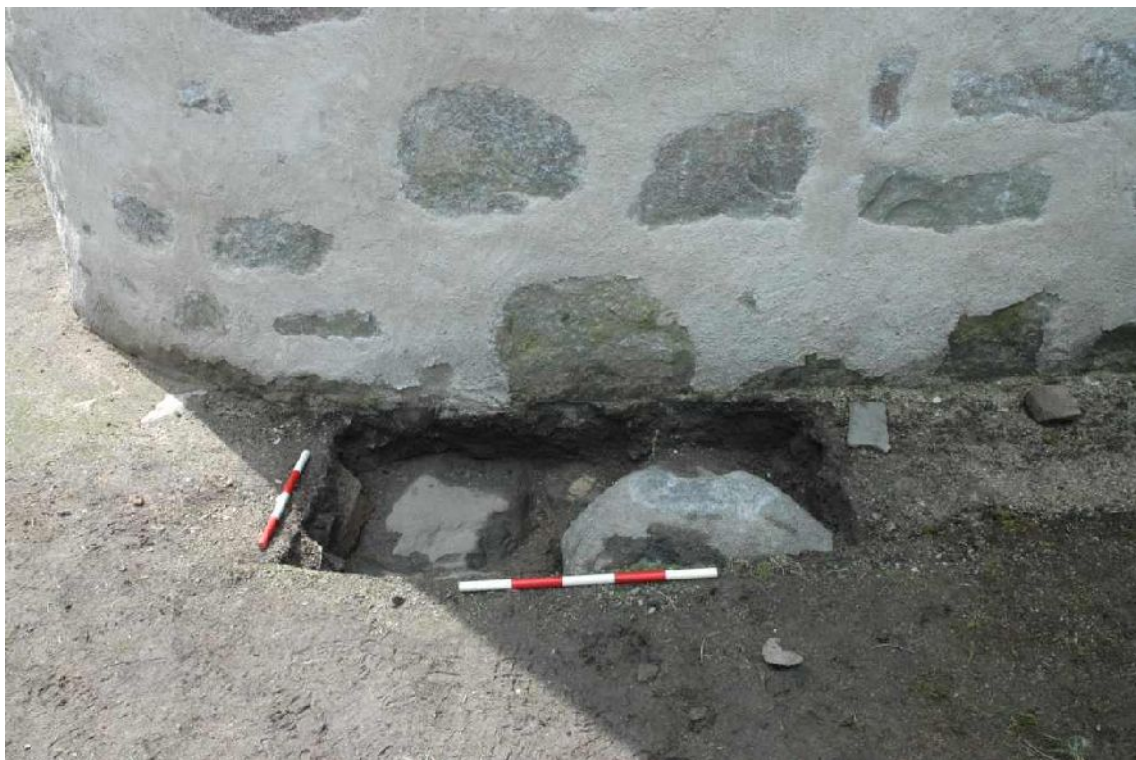
Illus 16 Area 2A. Wall 70 beside Tower, looking S

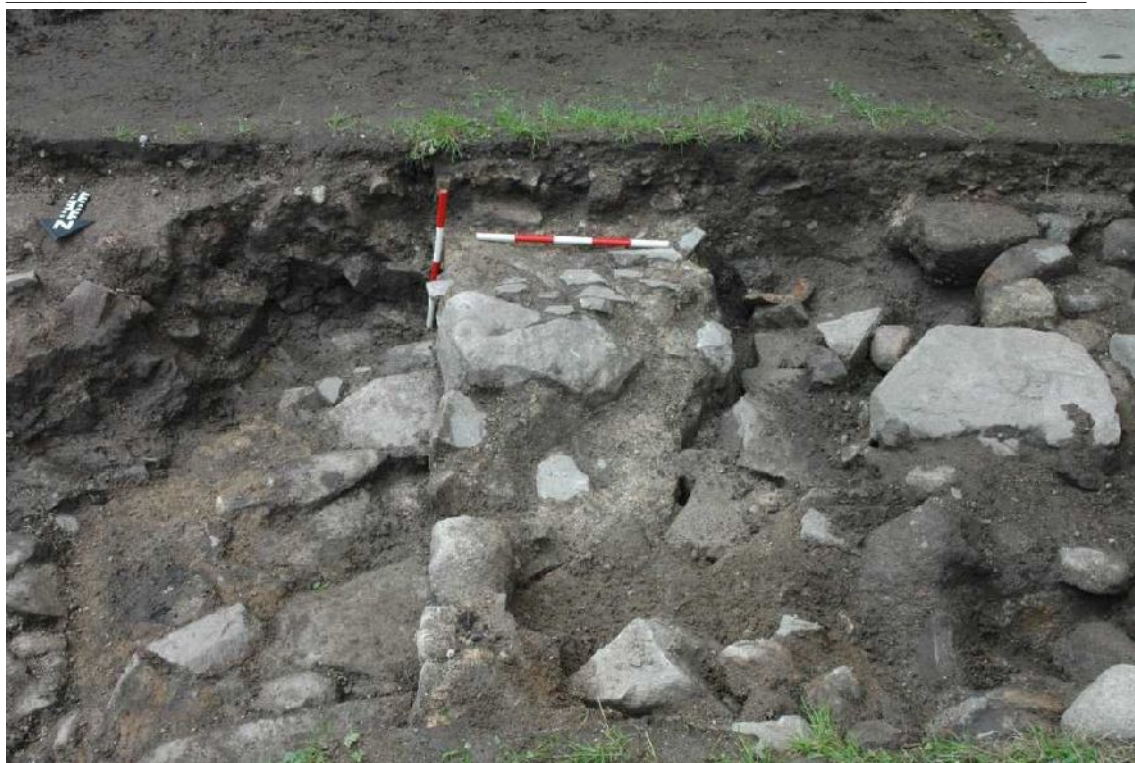
Illus 17 Area 2. Detail of internal wall (74) looking S

Internally the building was divided into two rooms by wall 74 (illus 17), a mortar bonded stone wall 660mm wide, surviving to a height of 250mm above the internal floor. The W room, which was 2.05m wide, had been almost totally destroyed by the cutting and re-cutting of drains; only a linear patch of clay may be a relict of an original floor. The E room, which was 3.7m wide, retained much of its original floor (67) of flattish angular stones (average 100 x 150mm to 250 x 300mm but with some larger stones) set in a clay base.

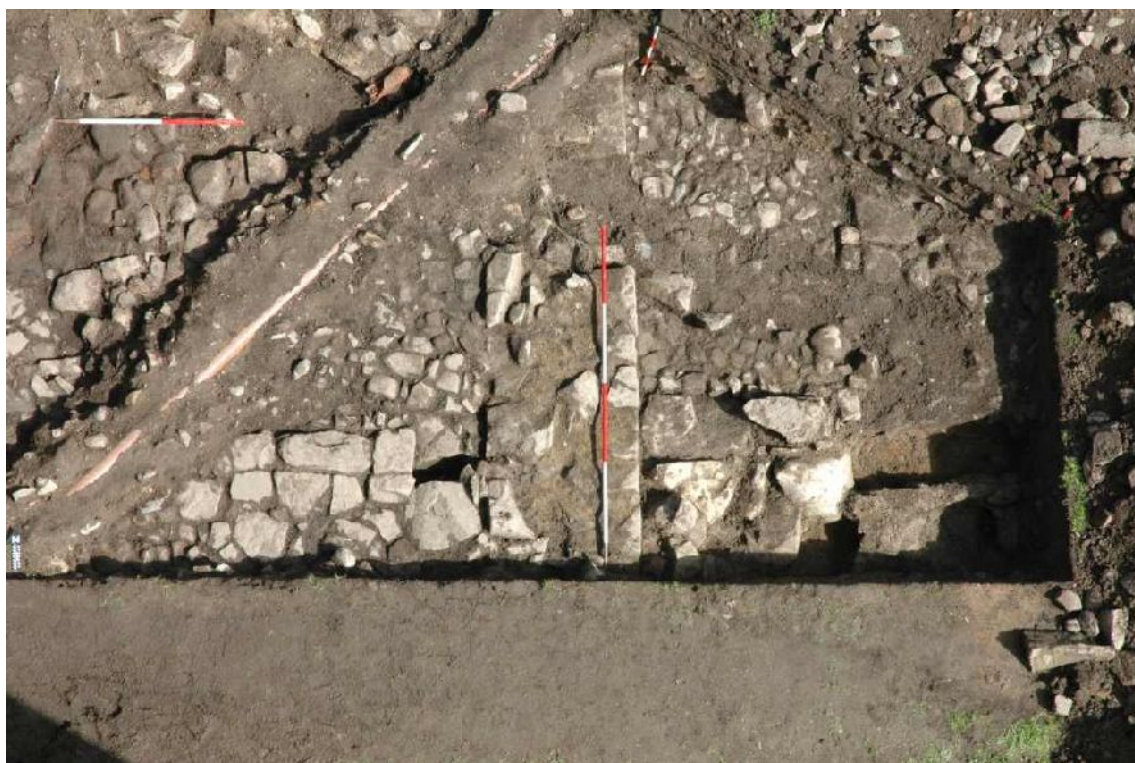
Illus 18 Area 2. Detail of paving 66 to LHS of wall and stone setting 82 to RHS of wall. Looking N

Outside the E end of the building there was a band of paving of small wear-worn cobbles (77: c.50 x 50mm to 200 x 200mm) some 1.4m wide between the outside of the building and a surface of larger, not so smooth stones (78). The cobbles were bordered to the S by a roughly square setting of large natural boulders set in thick clay (82). This was built on a thin layer of the original topsoil above natural. It should be noted that the position of this external feature coincided with the position of the square setting on the inside of the building.

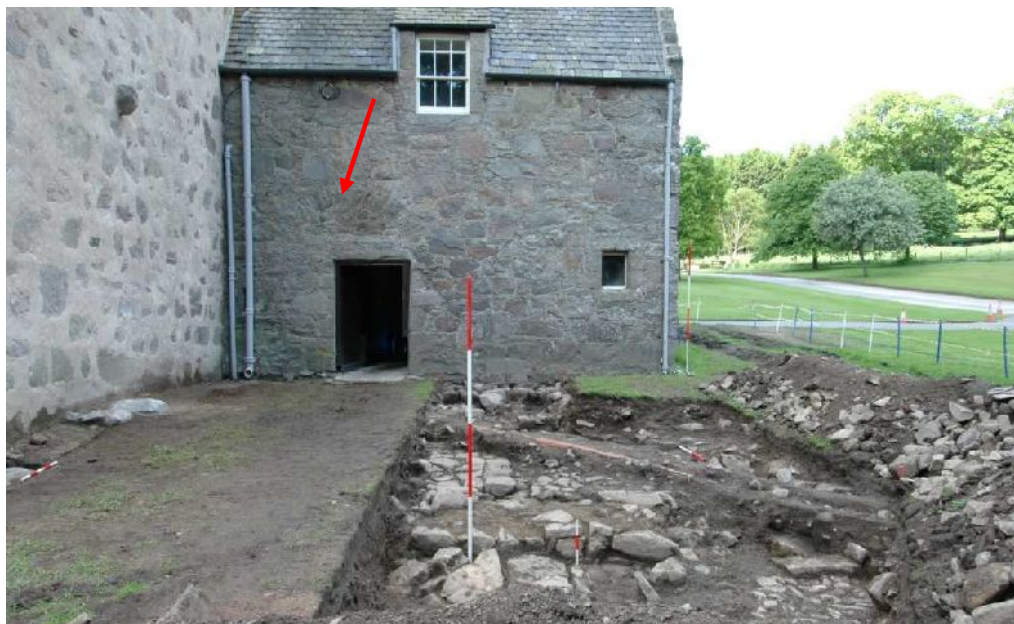
Illus 19 Area 2 looking W. Building in relation to Brewhouse. Red arrow marks arch. Vertical ranging rod marks the possible hearth

analysis also argued (Clark, 2011, 52, fig 17) that the blocked arch in the E wall of the Brewhouse (illus 19) represents an earlier door opening into a ‘lost’ building.

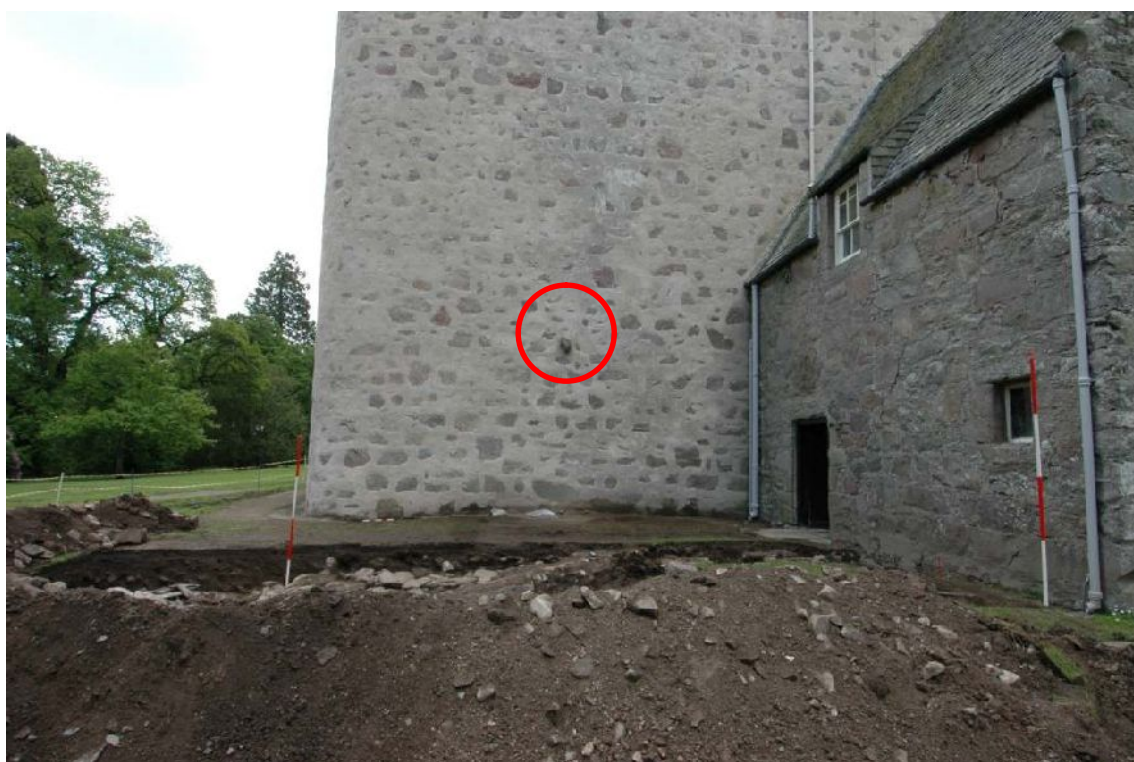
Illus 20 Area 2 looking S. Building in relation to Tower. Red circle around corbel. Vertical ranging rods mark the E and W ends of the excavated building.

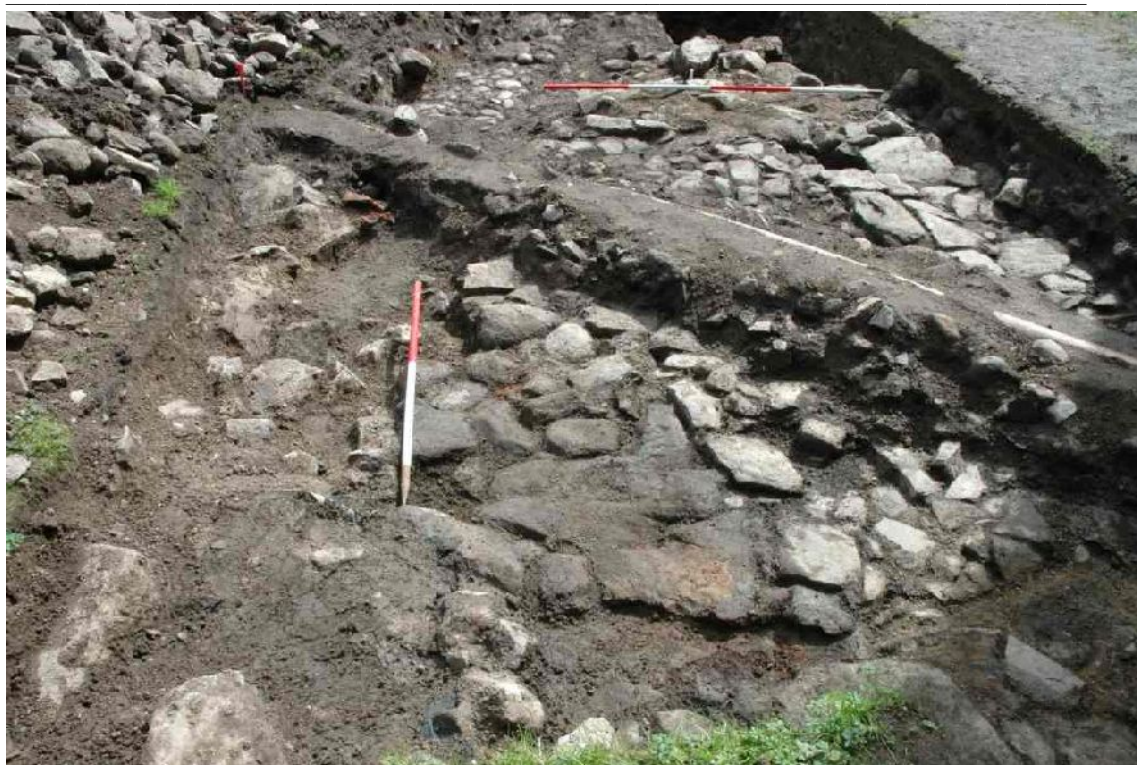
Illus 22 Area 2. Detail of burnt paving in foreground

In the NW corner of the room the tops of the stones had been burnt black and red and some were heat crazed (illus 22); in one area where a couple of stones were lifted, the heat had been sufficiently intense to burn the clay beneath the stones red. A distinct area of the flooring (66), formed a rectilinear setting against the inner face of the E wall (illus 18). It was formed of larger stones (c. 280 x 300mm to 200 x 550mm) and was c.50mm higher than the rest of the flooring (67). It measured c.1.5m E/W and c. 1m width was in the excavated area. If this had been a square setting at 1.5m it would have been exactly central along the inner face of the N wall. A small rectangular slot (72: 200 x 300mm, Depth: 390mm) in the NE corner of paving 66 may have been nothing more than the socket of a removed stone or could have held an upright stone or timber; it was filled with demolition rubble 65.

It is possible therefore that the building was a roofless ruin by 1831 and was cleared away by the 1850s prior to the later 19th century building works. Examination of the sequence of demolition layers within and outside the E end of the building suggests that, prior to its final demolition and leveling and the removal of re-usable stone (rubble 22, 26,10), there had been a period when a substantial layer of grey gritty silt with mortar and slate fragments (65, 79) accumulated. This can convincingly be interpreted as the accumulation derived from slow processes of dereliction within a roofless ruin – possibly over many years. In this context the burnt layers (68, 80) may well represent a roof fire which resulted in the deposition of laminated sherds of burnt slate and slate nails – and probably in the severe fire damage on the flooring in the NW corner of the E room.

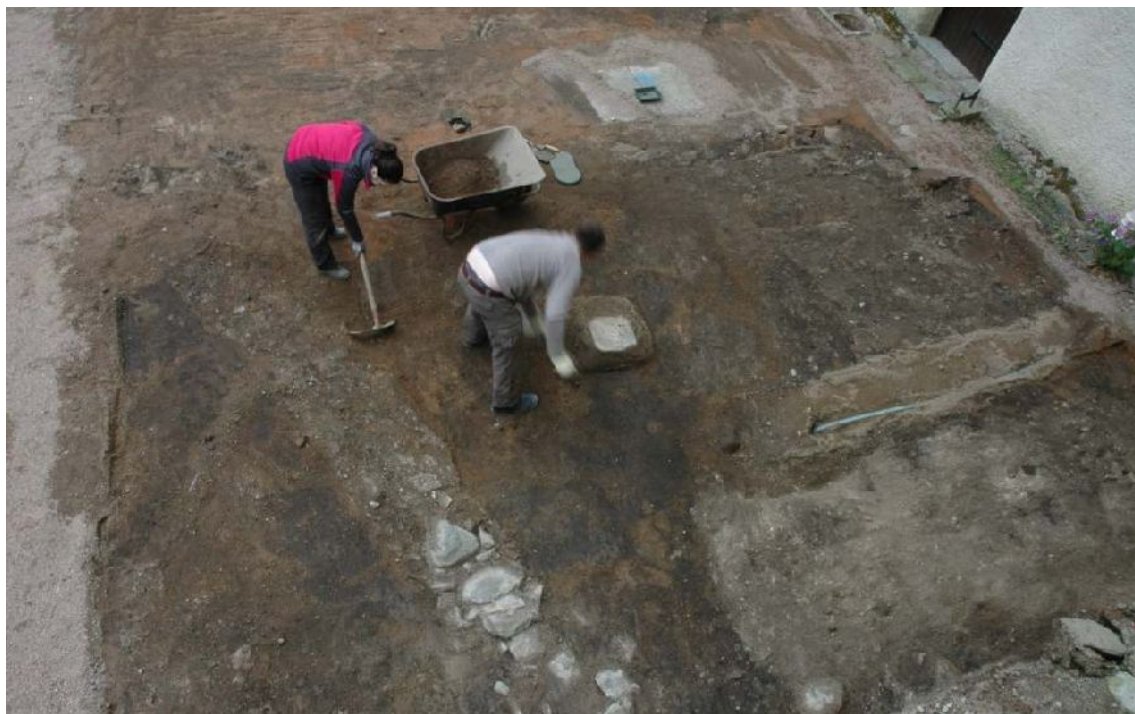
Illus 25 Area 3. Main concentration of mortar visible in bottom RHS . Drain 13 to LHS and centre

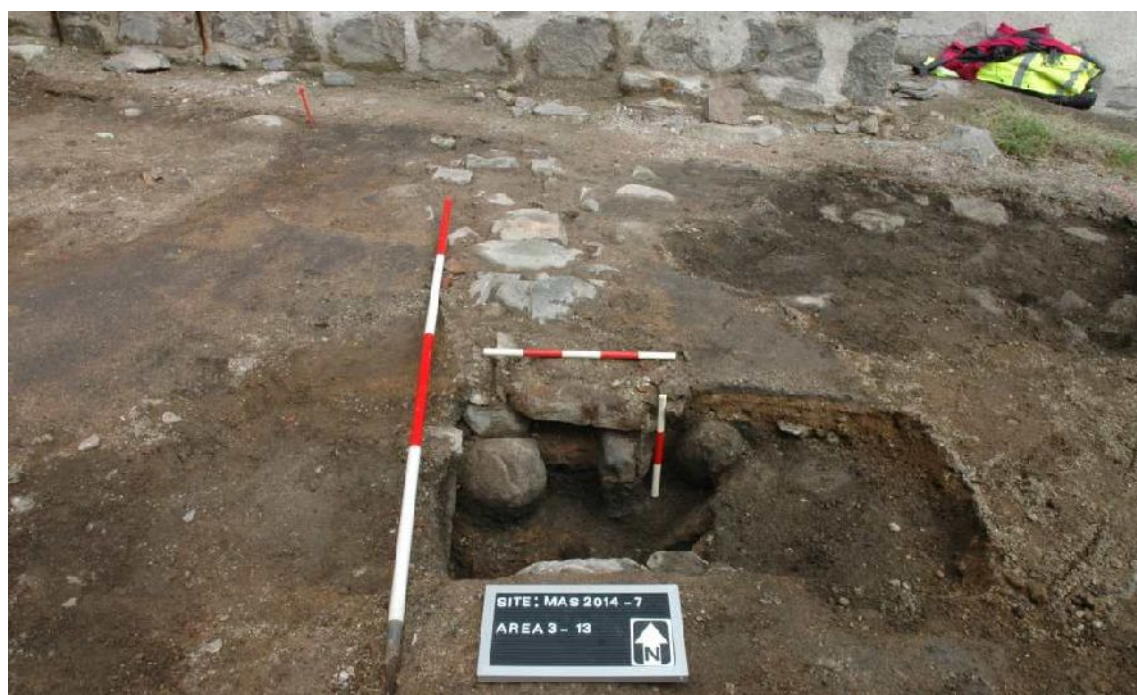
Illus 27 Area 3. Drain 13 looking N

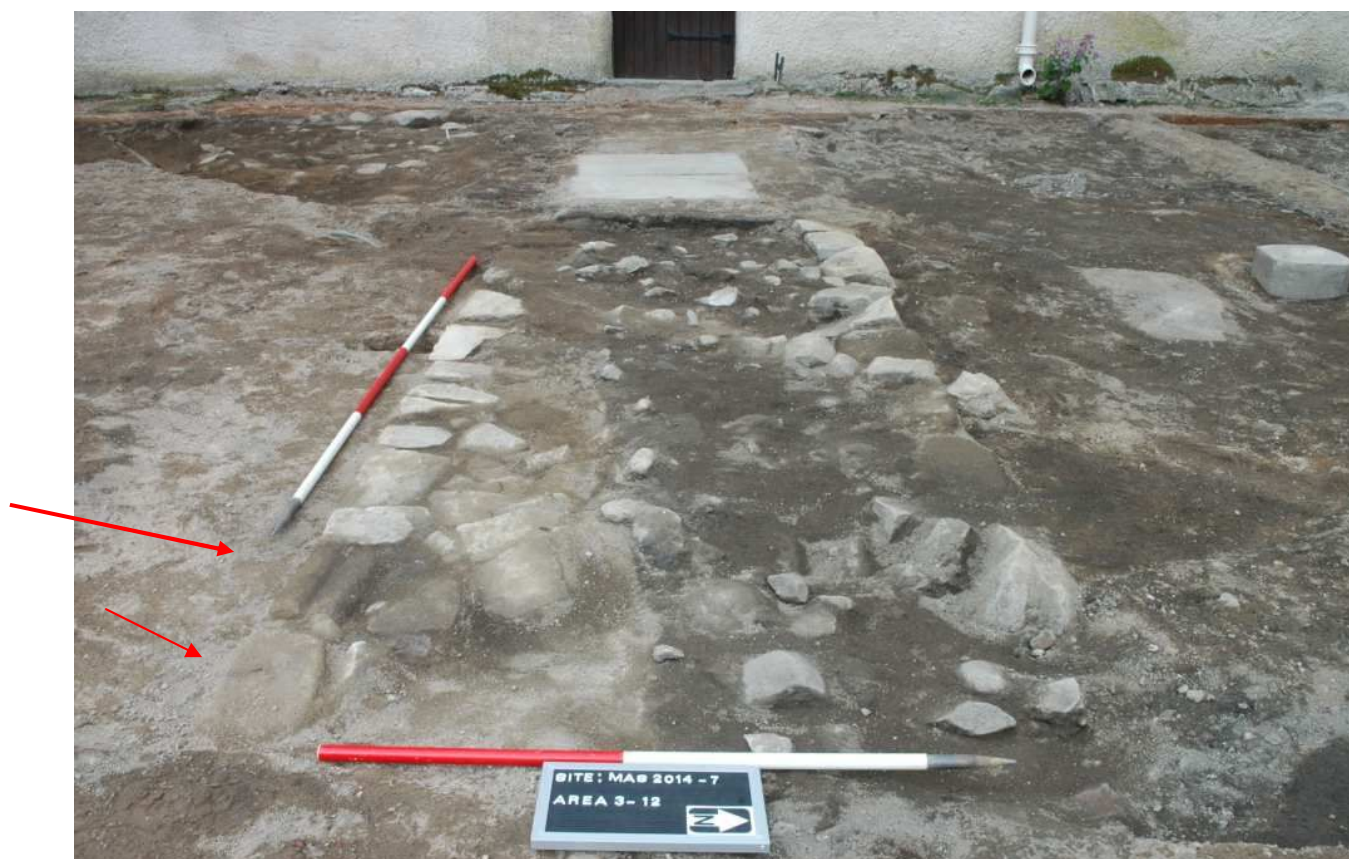
Illus 28 Path looking W towards door in Cross Range . Arrows mark 2 re-used dressed stones in kerb (stones 12A, 12B. Appendix 4).

The path was 1.55-1.6m wide with a well-built stone kerb on both sides and flat paving stones. It had been badly damaged at the W end where the later drains had cut through it and one of the drains extended E between the kerbs, cutting the centre of the path. Two of the kerb stones were re-used dressed granite stones with rolled mouldings (Illus 24: A, B shaded on plan; Appendix 4: 12A, 12B. illus 41-42. These were replaced on site).

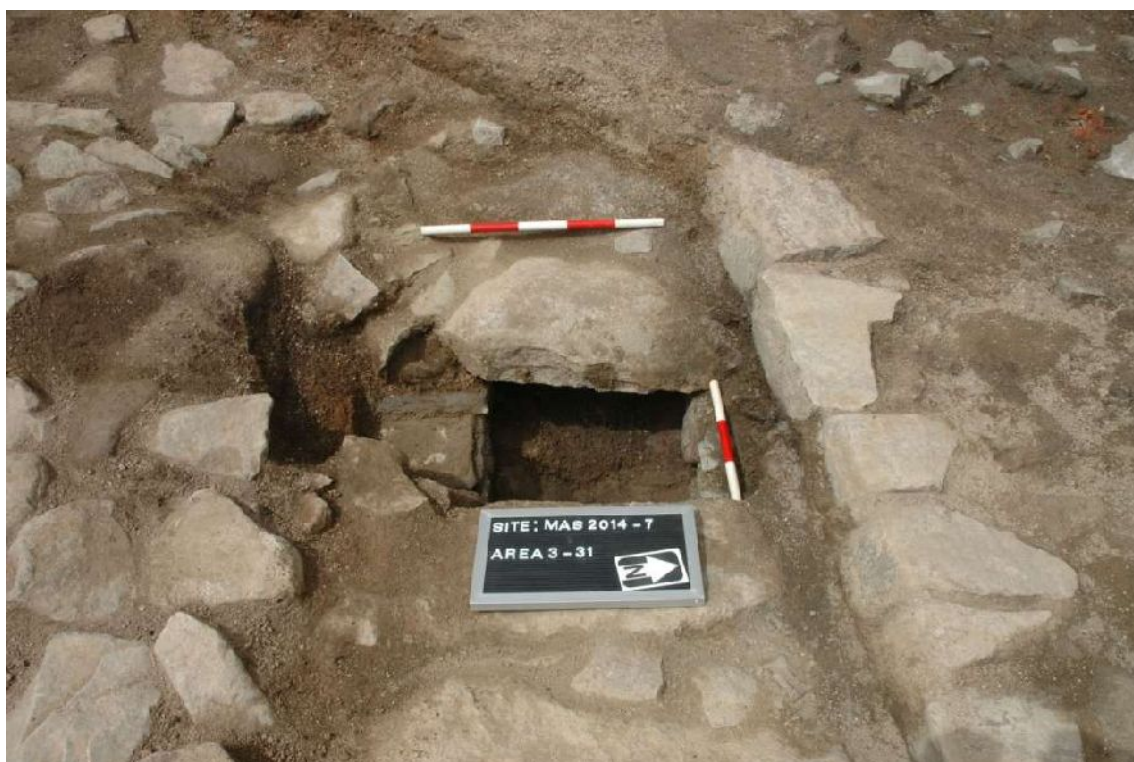
Illus 31 Area 3. Drain 31 with path 12 to RHS

A V-sectioned stone drain (31: illus 30, 31) which ran along the S side of the path was contemporary with it, some of the capstones and the side stones on the N side of the drain lying just below the kerb stones of the path. The W end of this drain had been destroyed by modern drain 27 which re-used this earlier cut through natural.

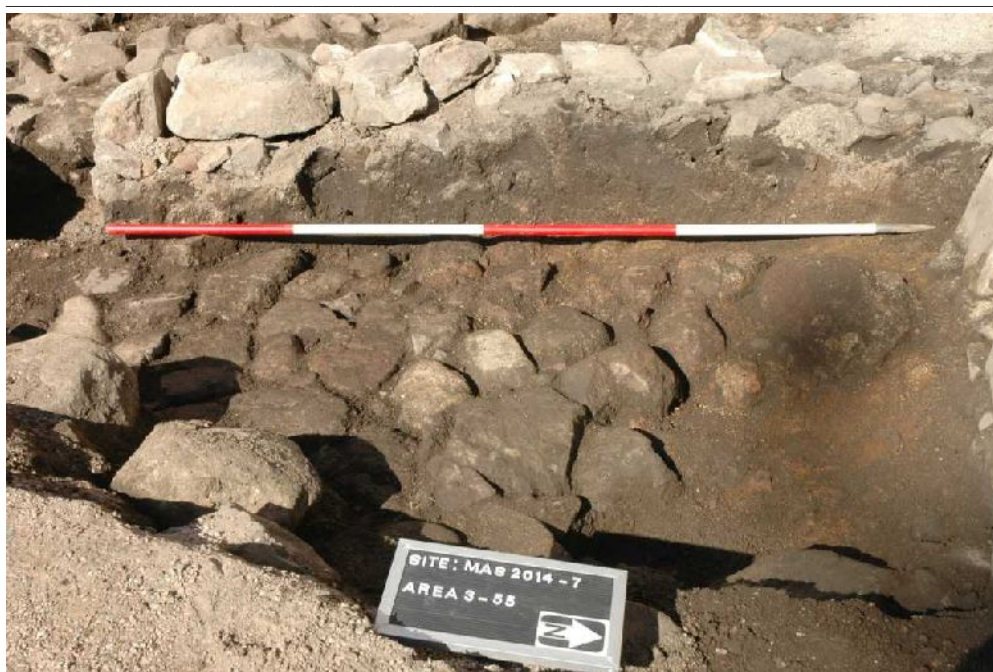
Illus 33 Area 3. Stone paving 55

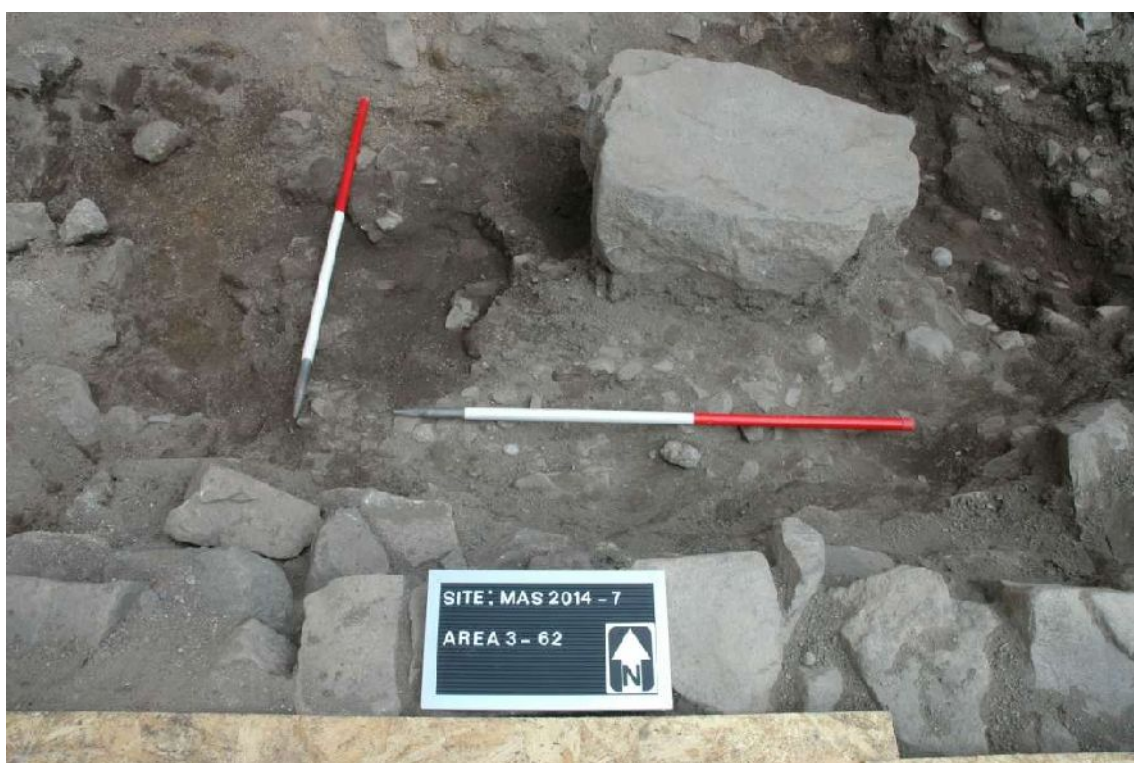
Illus 34 Area 3. Early surface 62

Further S there was no other evidence of a wall on this line, but the area had been disturbed by the concrete pillar (15), the path and later drains. However it does appear to terminate near the rather indefinite slot (53) and the earlier roughly cobbled surface (62) extended across this line. It might be more convincing to argue that a wall may have existed between the two apparently broadly contemporary but very different surfaces 62 (? inside) and 55 (? outside), although an alternative explanation might be that 62 was a general early surface in the area and 55 was a path/paving outside an original stair to the tower. This is perhaps a somewhat circular argument as there would only need to have been a more southerly stair to the tower if there was an earlier building across the position of the present stair.

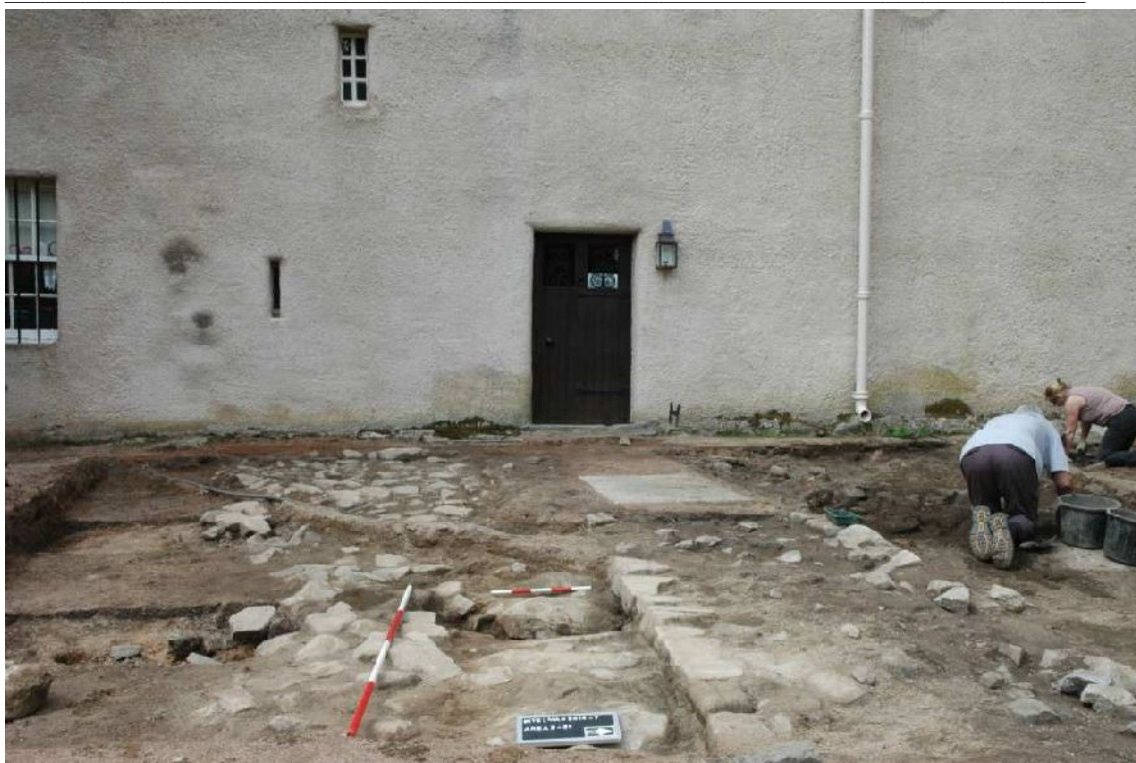
Illus 36 Area 3. Path in relation to Cross Range, looking W
