DRUM CASTLE
TOWER OF DRUM MAJOR REPAIRS PROJECT
DRUMOAK
ABERDEENSHIRE

Archaeological Excavation
Carried out May-June 2014
by
Murray Archaeological Services Ltd

Report No: MAS 2014-07
by
H K Murray and J C Murray

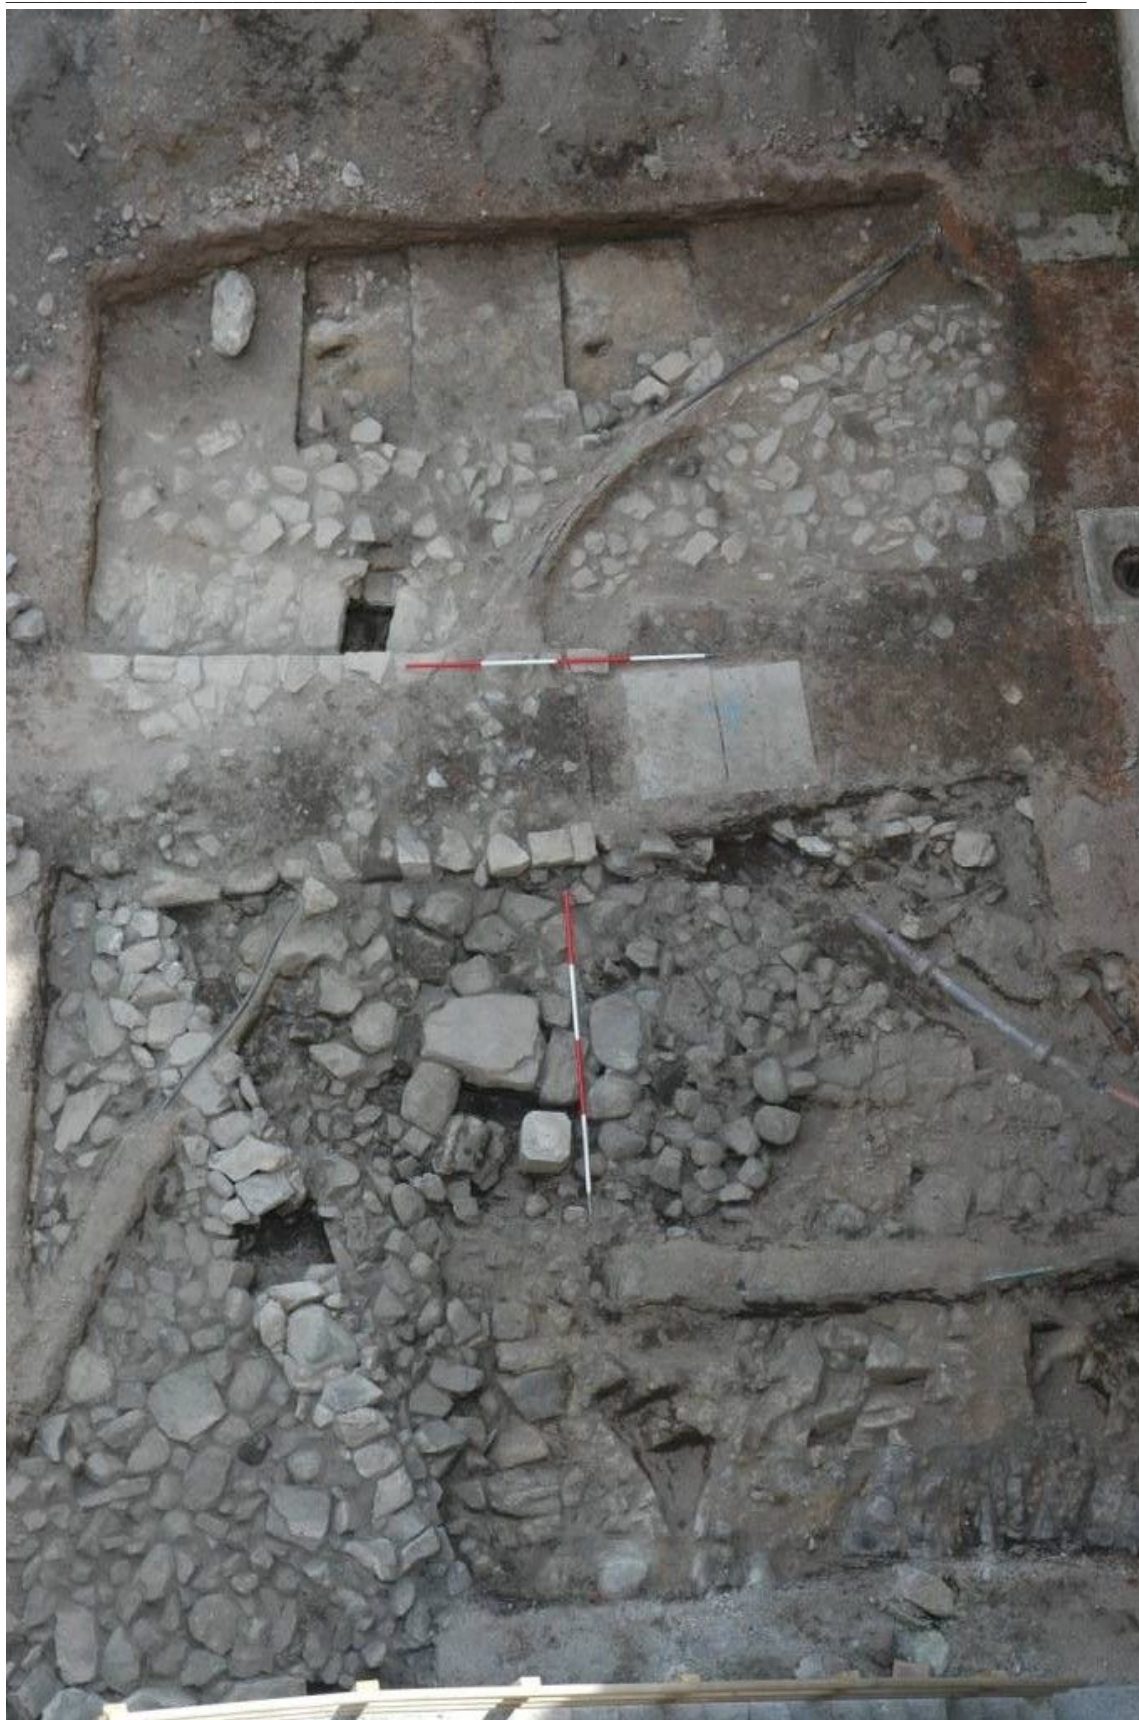
Illus 38 Area 3. Detailed view from above, looking S

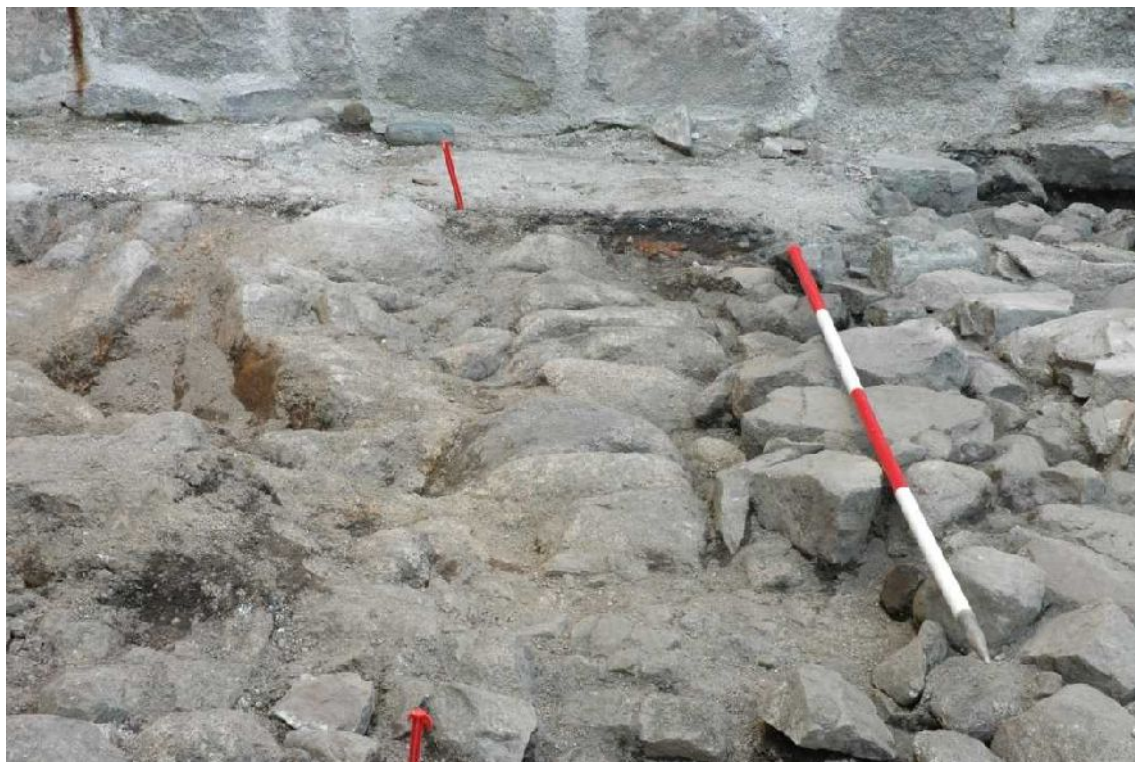
Illus 39 Line of notched bedrock (52) c. 500mm to LHS of ranging rod and to RHS of the red pegs

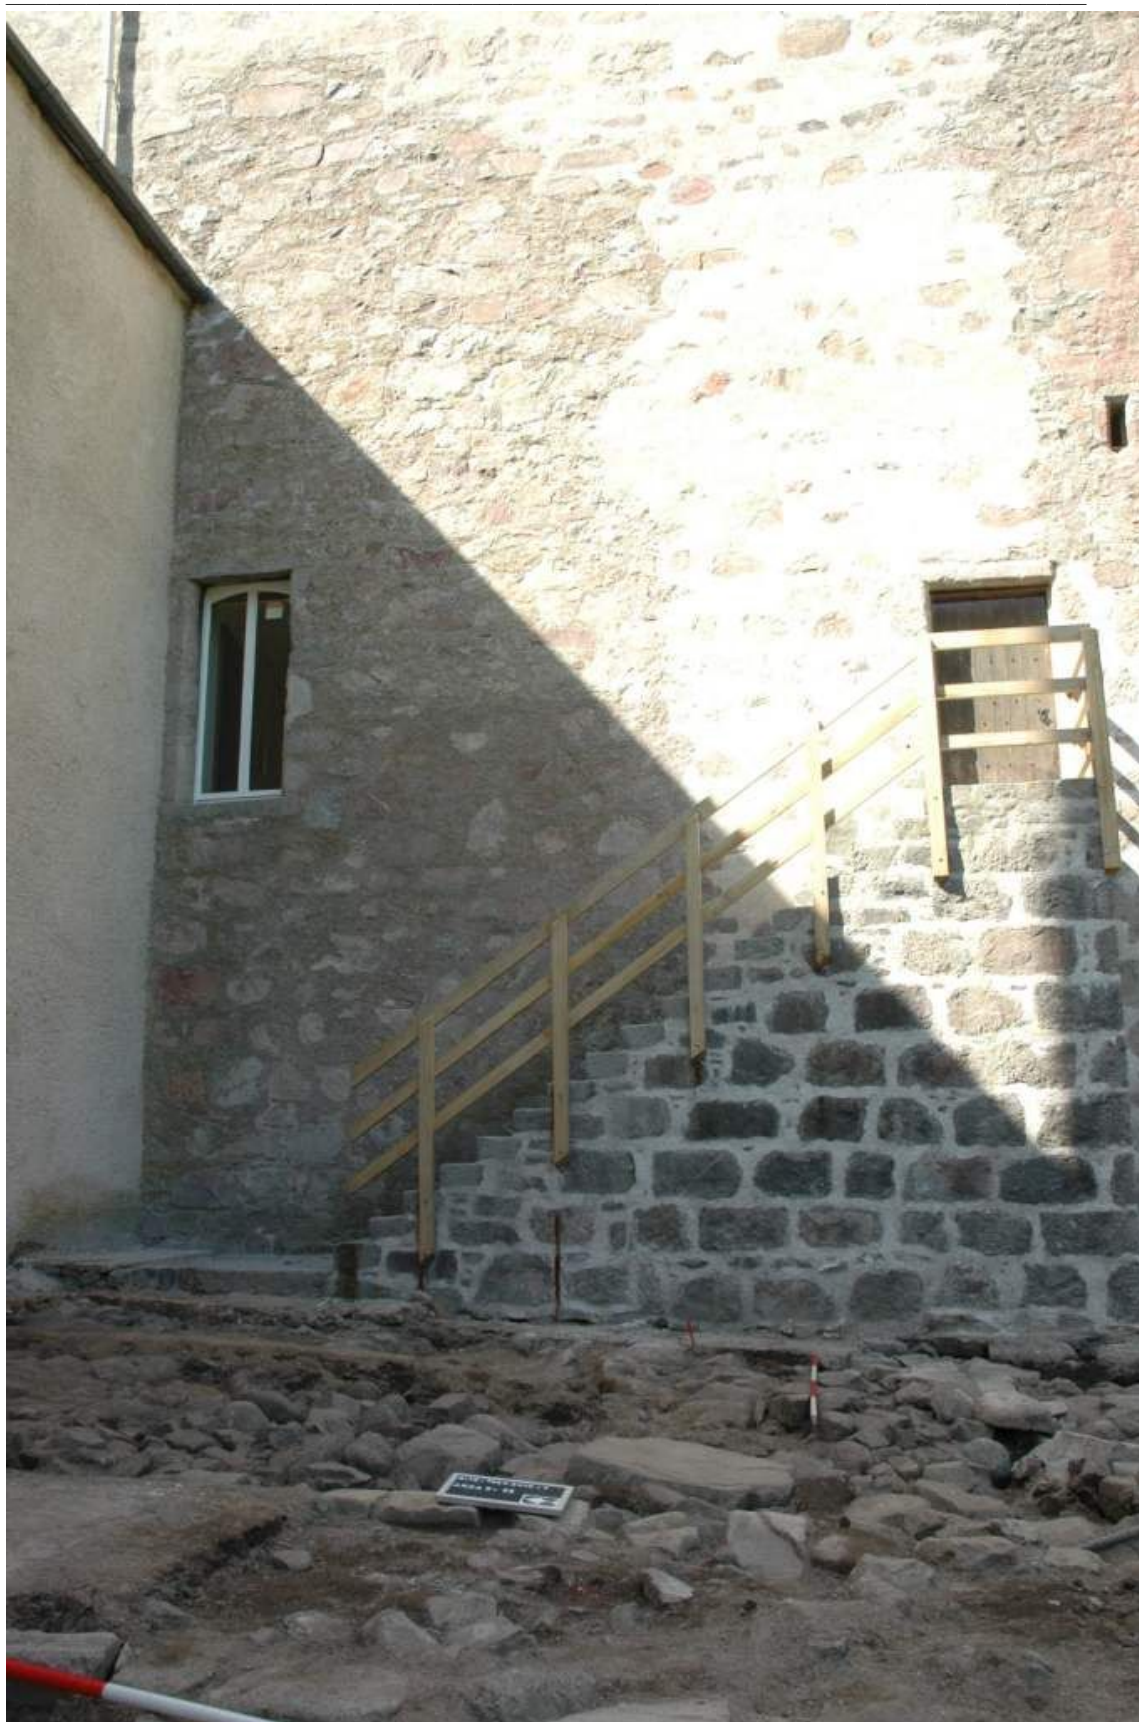
Illus 40 Area 3. Notched rock (52) in relation to tower (position of ranging rod is same as preceding illustration)

The excavation did not reveal any foundations for such a building. However this is perhaps not surprising given the very high ridge of natural bedrock- especially in the NW corner of the site. Elsewhere over much of the site, with the exception of the lower ground at the NE, the later paving had been built almost directly or directly on the natural. The only slight indication of a possible earlier foundation was a very regular line of possible notches in the surface of the bed rock (52) in a N/S band c. 500mm wide and c. 2.5m long, 4.5 to 5.0m E of the wall of the Cross Range (illus 39, 40). There is no further evidence that this had been used as a key-in for a wall, but it was noticeable and did coincide with the difference in mortar on the S wall of the tower.

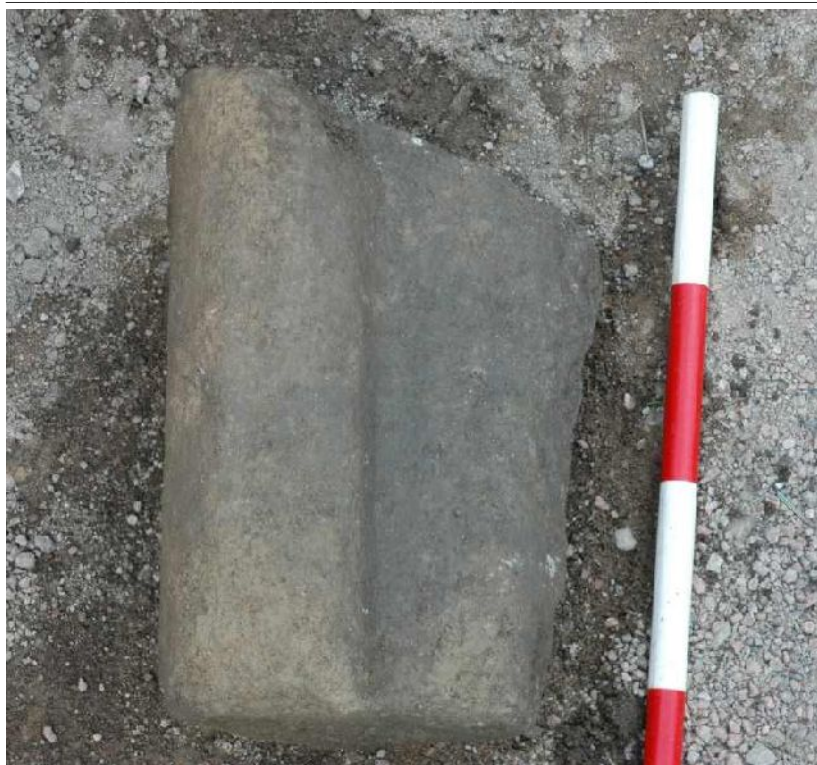
Illus 41 Stone 12 A. Replaced in path kerb.

The path was 1.55-1.6m wide with a well-built stone kerb on both sides and flat paving stones. It had been badly damaged at the W end where the later drains had cut through it and one of the drains extended E between the kerbs, cutting the centre of the path. Two of the kerb stones were re-used dressed granite stones with rolled mouldings (Illus 24: A, B shaded on plan; Appendix 4: 12A, 12B. illus 41-42. These were replaced on site).

Stones 12A and 12B were replaced in the kerb of path 12 which was preserved below the present surface.

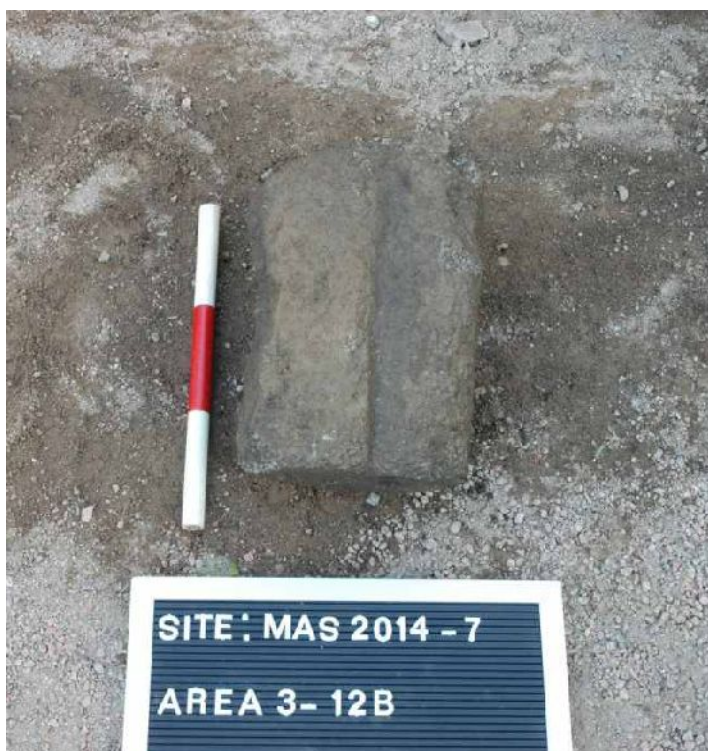
Illus 42 Stone 12 B. Replaced in path kerb.

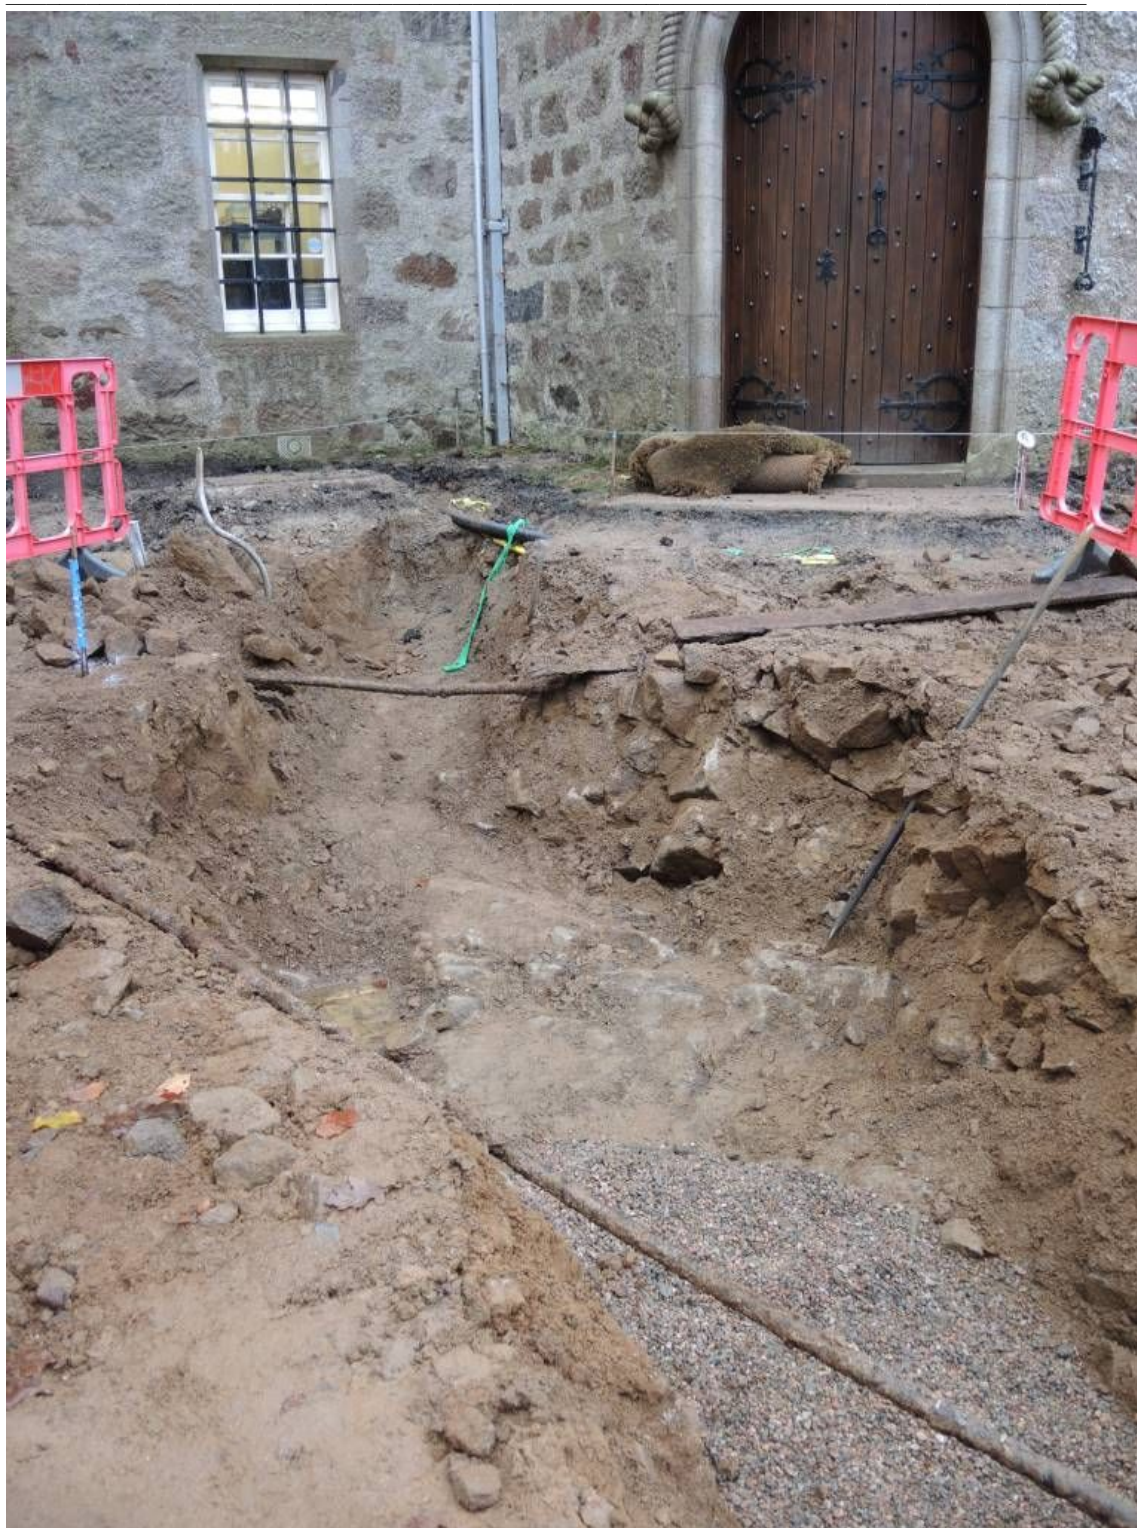
Illus 51 SE area of courtyard with natural cut for inserting drains. Note bedrock.

The tar was c.50mm thick. Below it there were patches of the hard 19th-century yard surface observed in the excavation of Area 1 (see above. Context 7); this was least disturbed in the NW corner and on the E side. Otherwise the tarmac lay over a variety of stoney and sand make-up. Much of this was infill in the backfill of the many service trenches which criss-crossed the courtyard and through the archway. Roughly in the centre of the S half of the courtyard, the contractors, while digging a trench for new drainage, encountered a large outcrop of natural bedrock. This appeared to be in line with and part of the same outcrop encountered in the N half of the excavation Area 3 (see above).

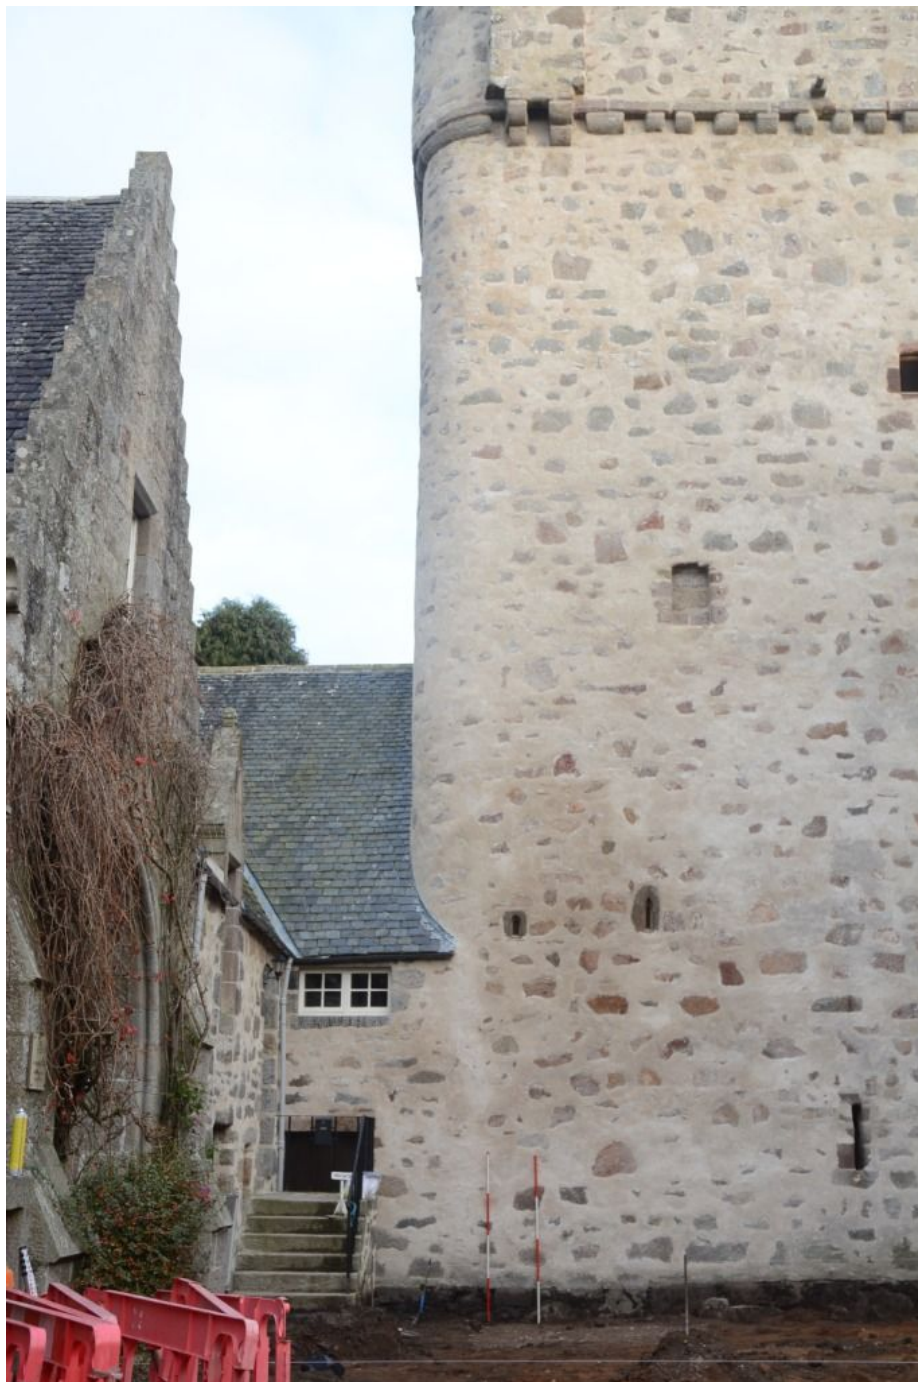
Illus 52 W wall of tower. The two vertical ranging rods flank the possible blocking of drain outlet from intra-mural garderobe

- *Possible garderobe drain outlet blocking.* At 2.7m from the S face of the Brewhouse wall a block stone 470mm N/S by c. 400mm height appeared to be

much flatter than the adjacent wall stones and roughly dressed. Its position is directly below the small window of the intra-mural garderobe and it is suggested that this was a blocking of an intra-mural drain leading into the cess pit. It has been added to the plans of the Area 1 excavation of the cess pit (illus 1, 9).

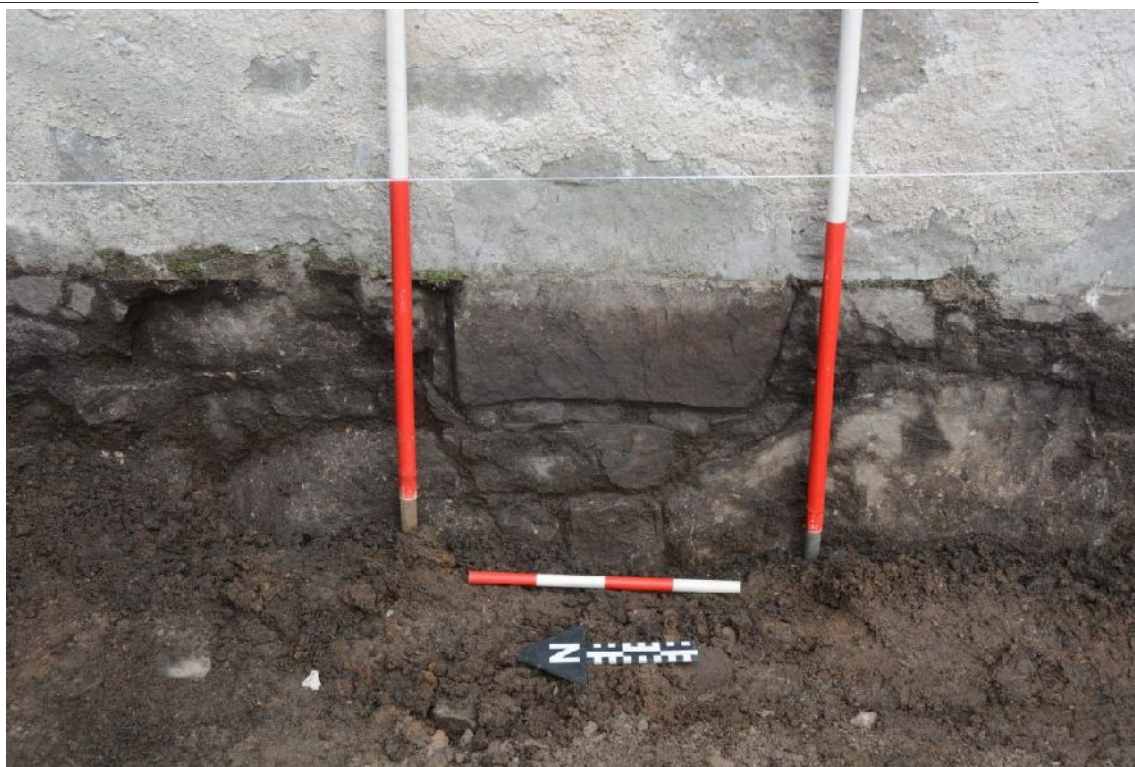
Illus 53 W wall of tower. The two vertical ranging rods flank the possible blocking of drain outlet from intra-mural garderobe. Detail of blocking

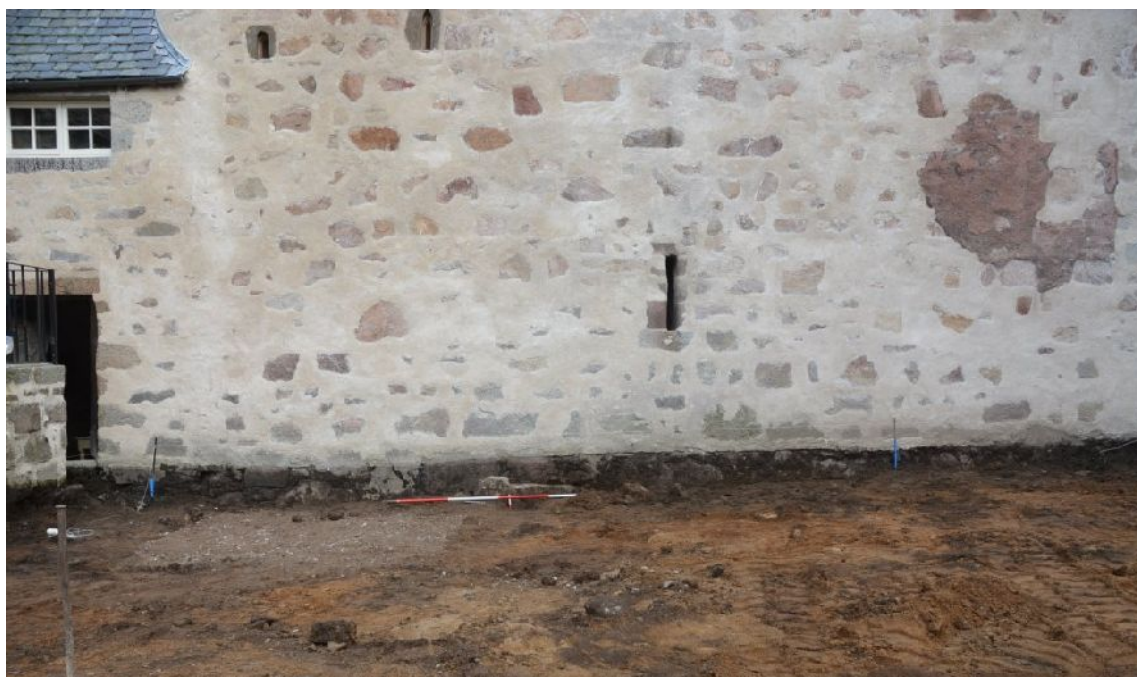
Illus 55 Tower W wall. Ranging rod indicates position of projecting natural boulders.

- *Tower foundation.* To the S of the possible garderobe drain outlet, three large natural boulders projected out from the face of the base of the wall by 300-

450mm over a N/S distance of c. 2m. Small infill stones had been used between these boulders to level up for the basal course of the tower wall.

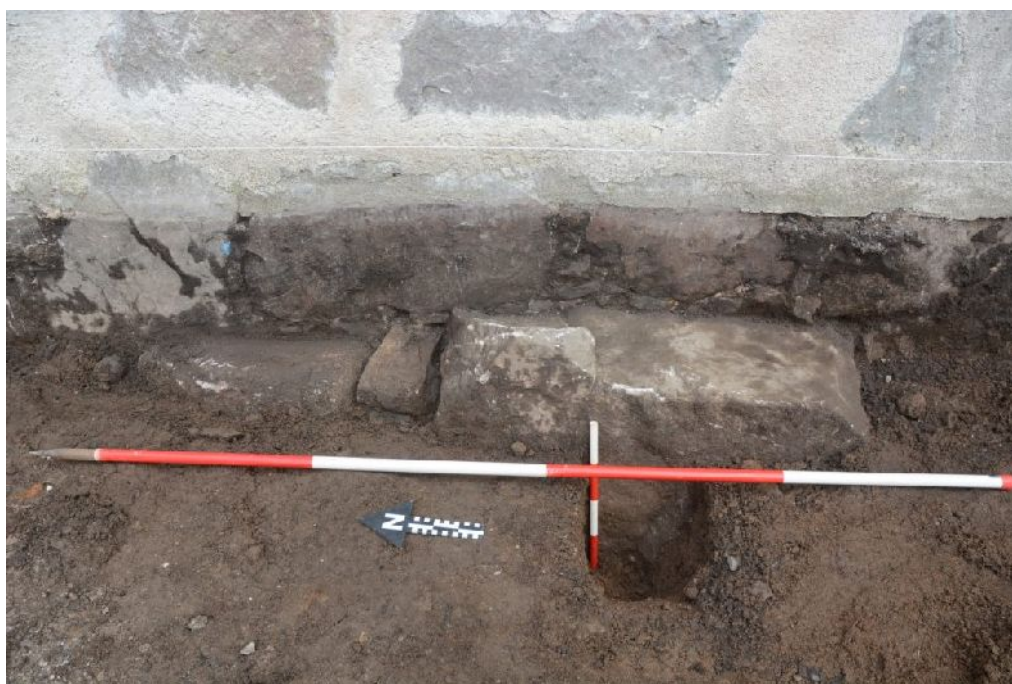
Illus 56 Tower W wall. Detail of projecting natural boulders incorporated into base of wall.

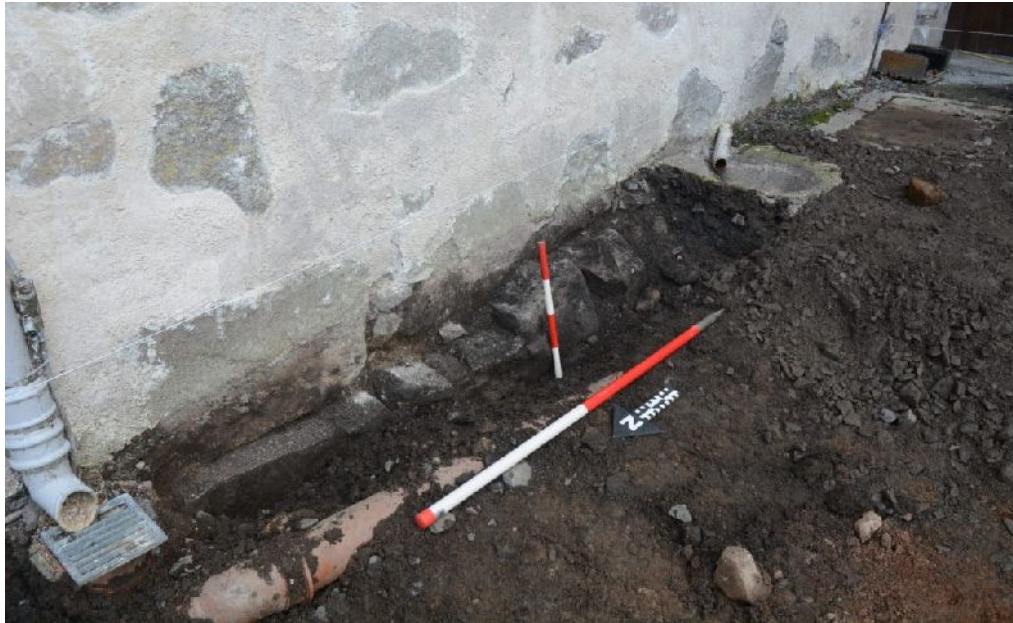
Illus 57 Cross Range W wall. Detail of exposed foundation

fairly small mortared stones (100-400mm wide) projecting c. 200mm out from the wall face.

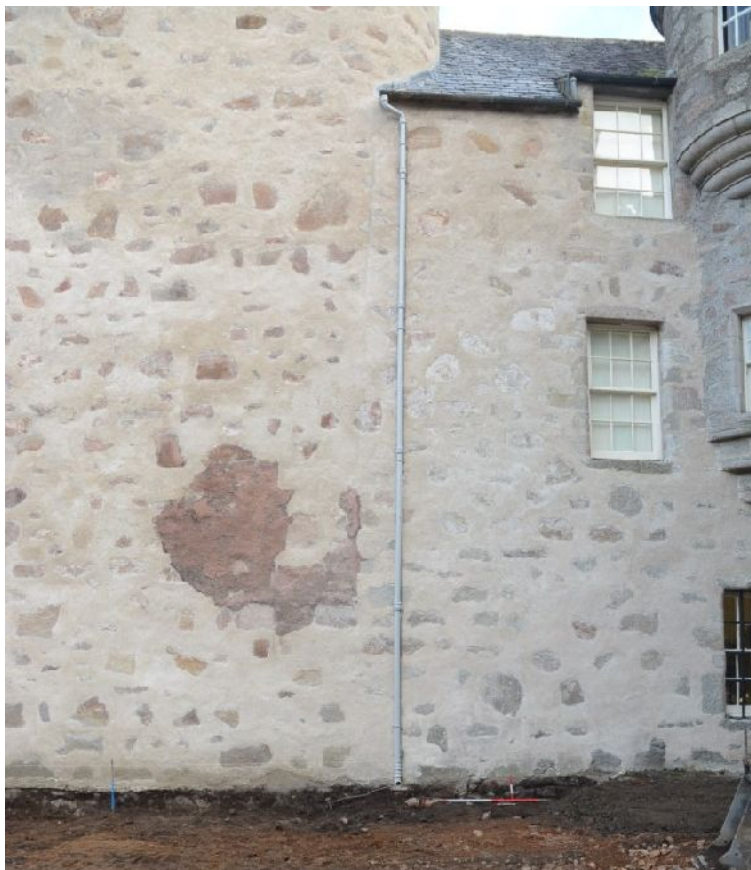
Illus 58 Cross range W wall. Ranging rod indicates the position of exposed foundation.

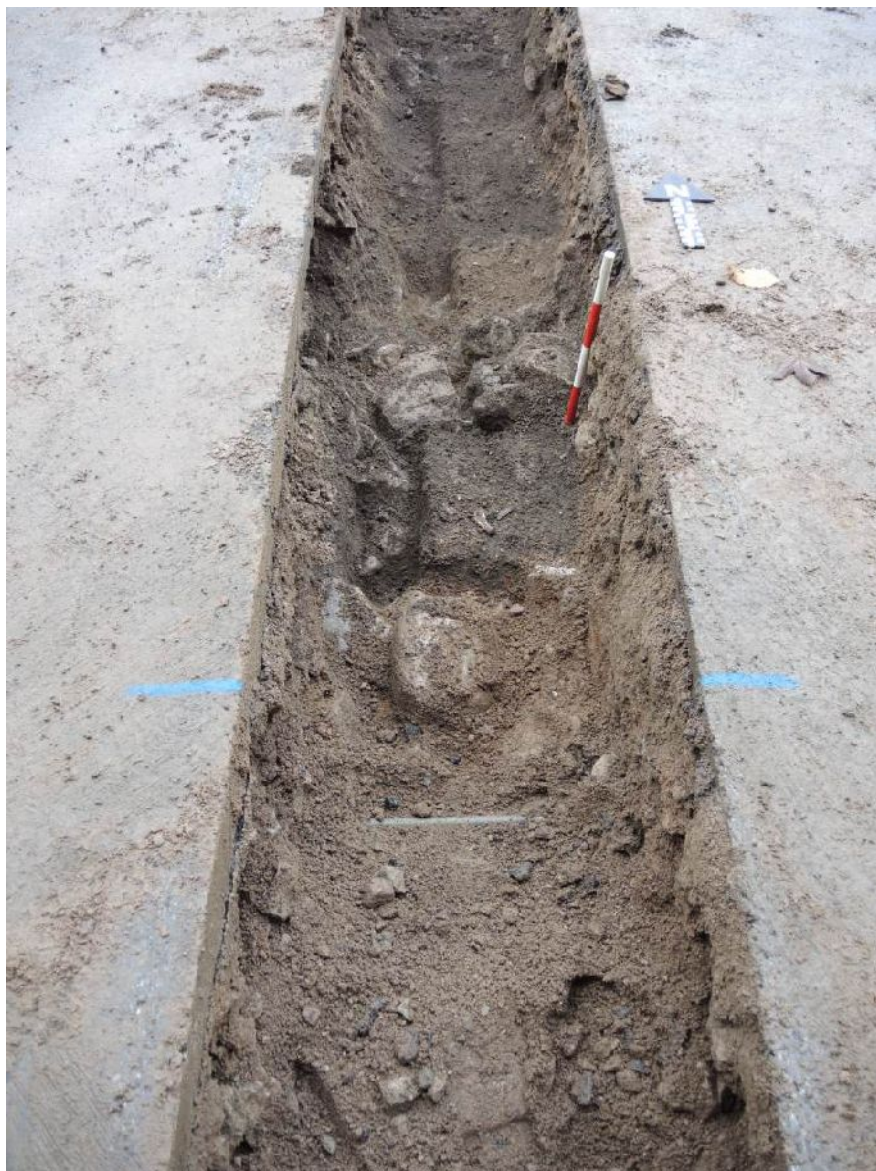
Illus 59 Backfill of pipe cut showing dark fill, possibly backfill of 19th-century layers.

- *Archway*. Observation of the pipe trench cut through the archway and out towards the drive revealed that this area was cut by the sewers from the toilets as well as a water pipe and a number of drains. Backfill included some bits of coal, a fragment of bone and slate and in places some rounded stones; this possibly suggests that the services had cut through construction levels associated with the 19th-century additions to the Brewhouse. No foundations or undisturbed layers were observed.

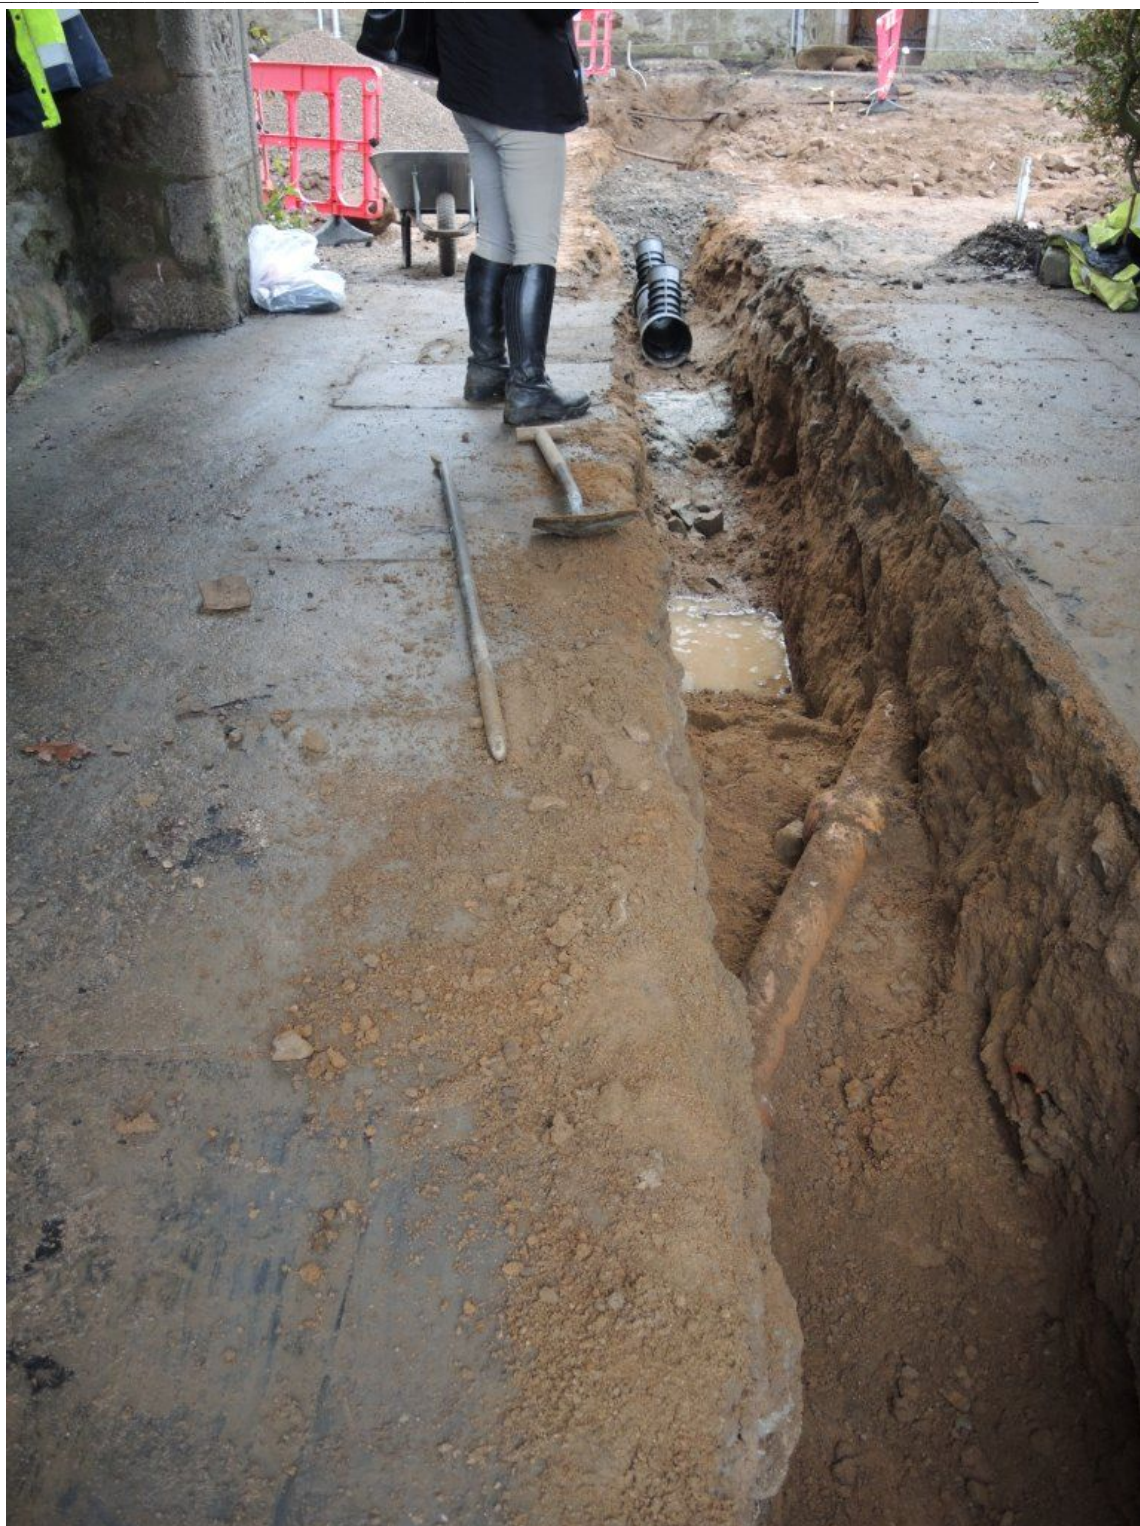
Illus 60 View S through archway showing some of pipes.
