**CRATHES CASTLE
SOUTH LAWN
ABERDEENSHIRE**

Archaeological Excavation
Carried out October 2014
by
Murray Archaeological Services Ltd

Report No: MAS 2014-08
by
H K Murray and J C Murray

-Archaeological excavation -

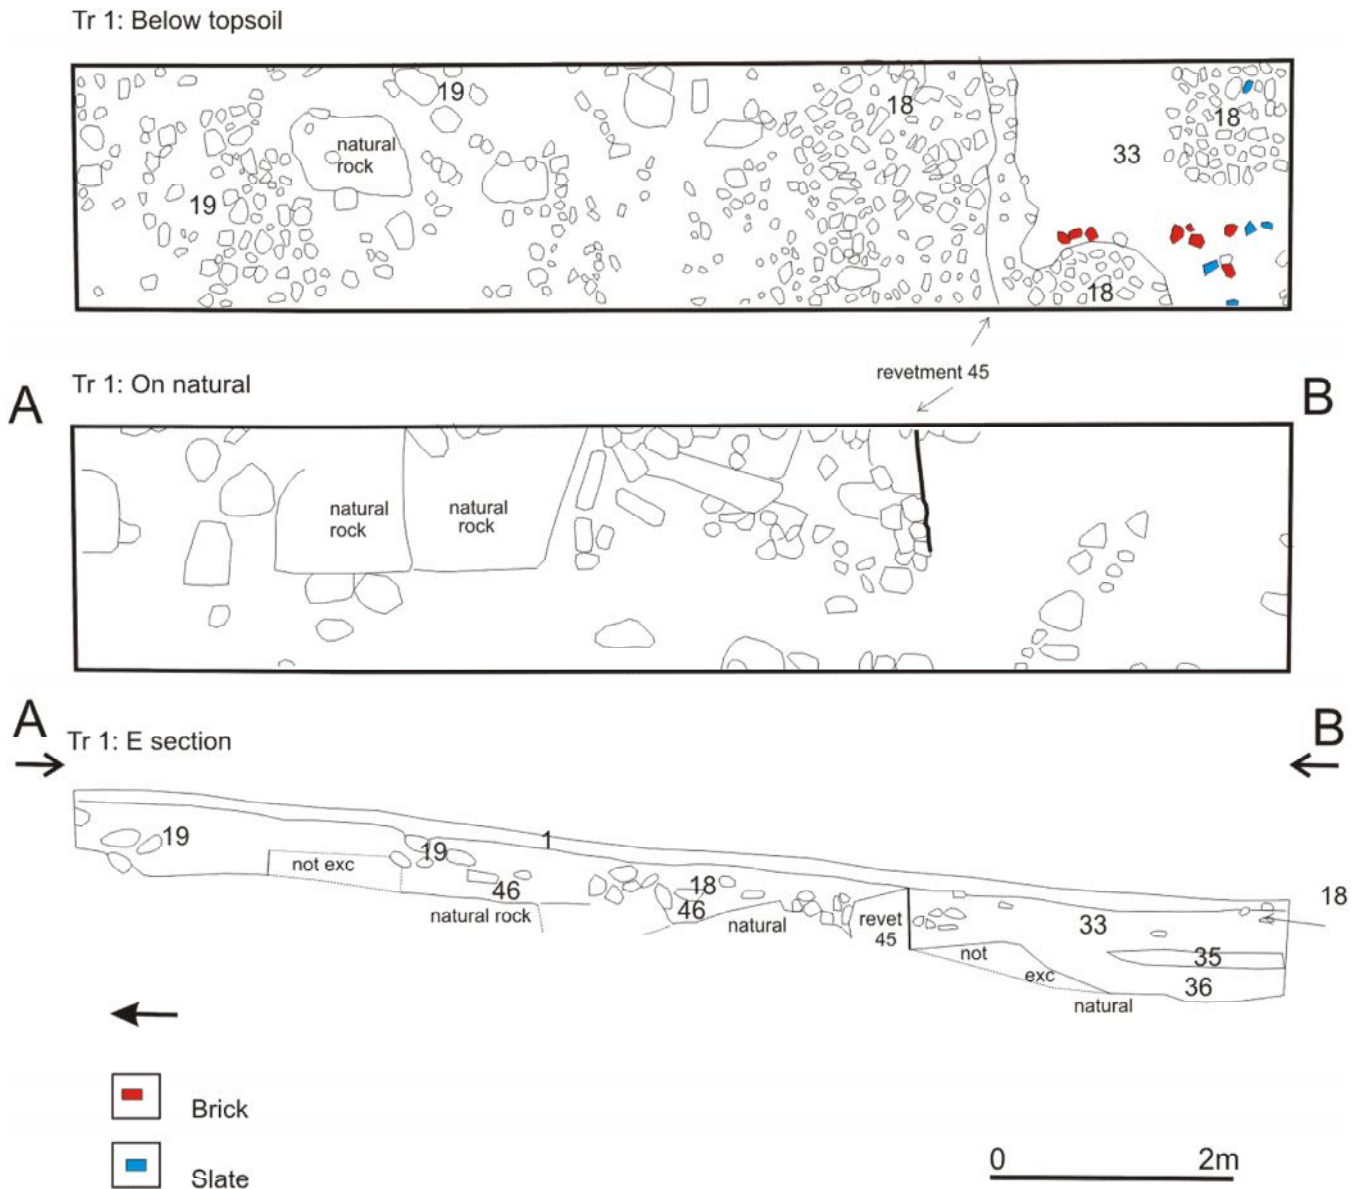
Illus 2 Plans and section of Trench 1.

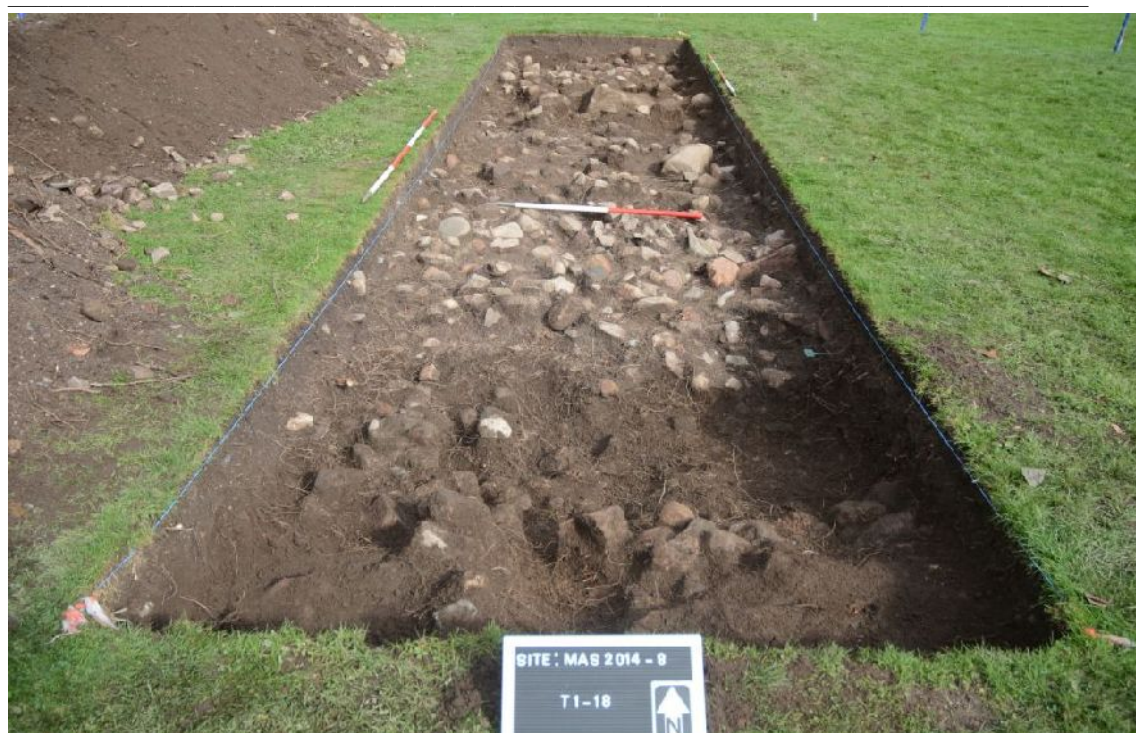
Illus 3 Trench 1 looking N after removal of the topsoil showing stone spread 18/19 to the N and dump layers 18A and 33 at the S.

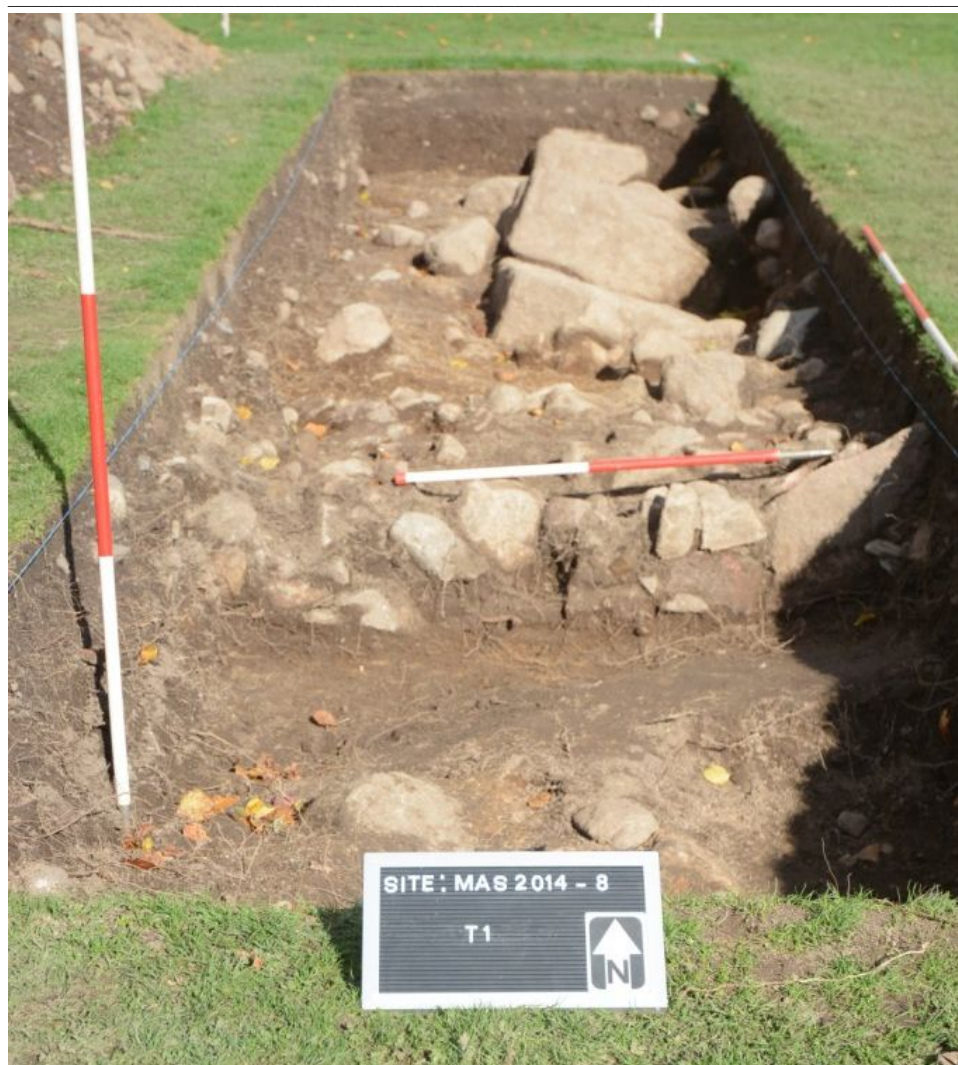
Illus 4 Trench 1 looking N showing revetment 45 with surface of natural and natural rocks to the N of it and dump layer 35 in the foreground, S of the revetment.

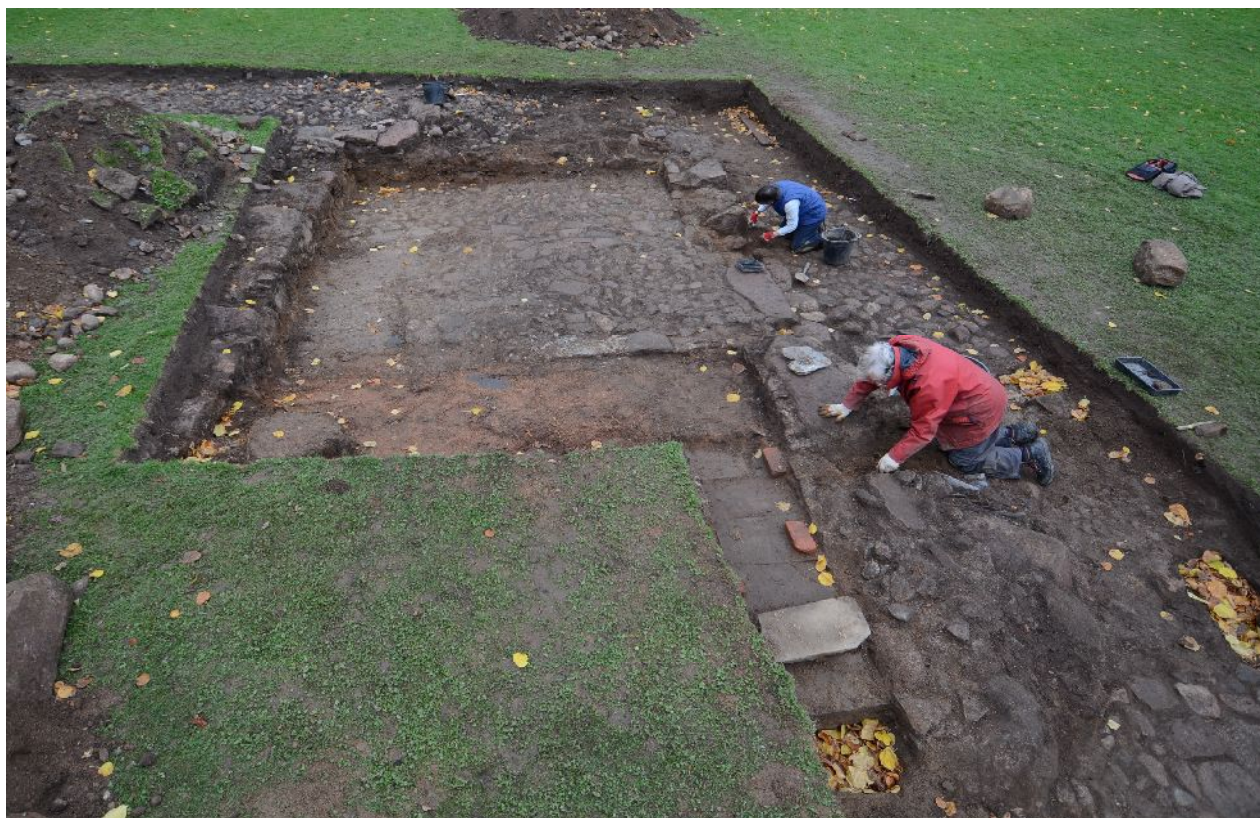
Illus 5 Trench 2 looking N showing the slab cover of the soakaway (62, 72) partially excavated and the S slab removed to examine underlying layers.

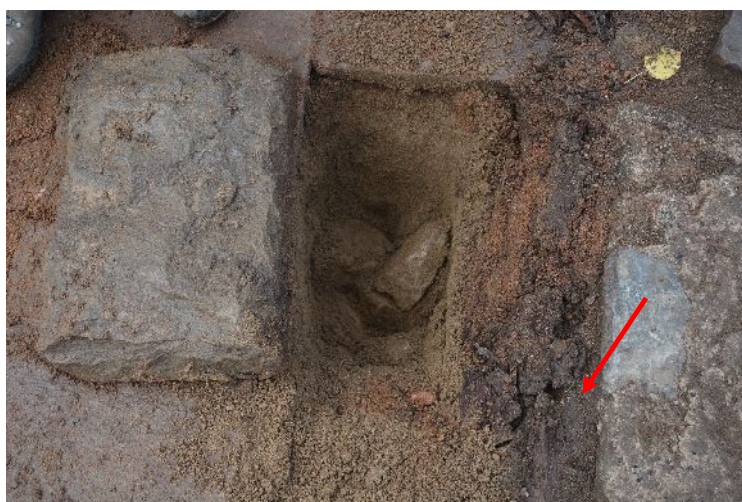
Illus 6 Slab removed from N side of cover of soakaway (62, 72) excavated to show the underlying pale yellow sand over the loose stone fill. The rotted timber can be clearly seen as a dark brown line (indicated by arrow)

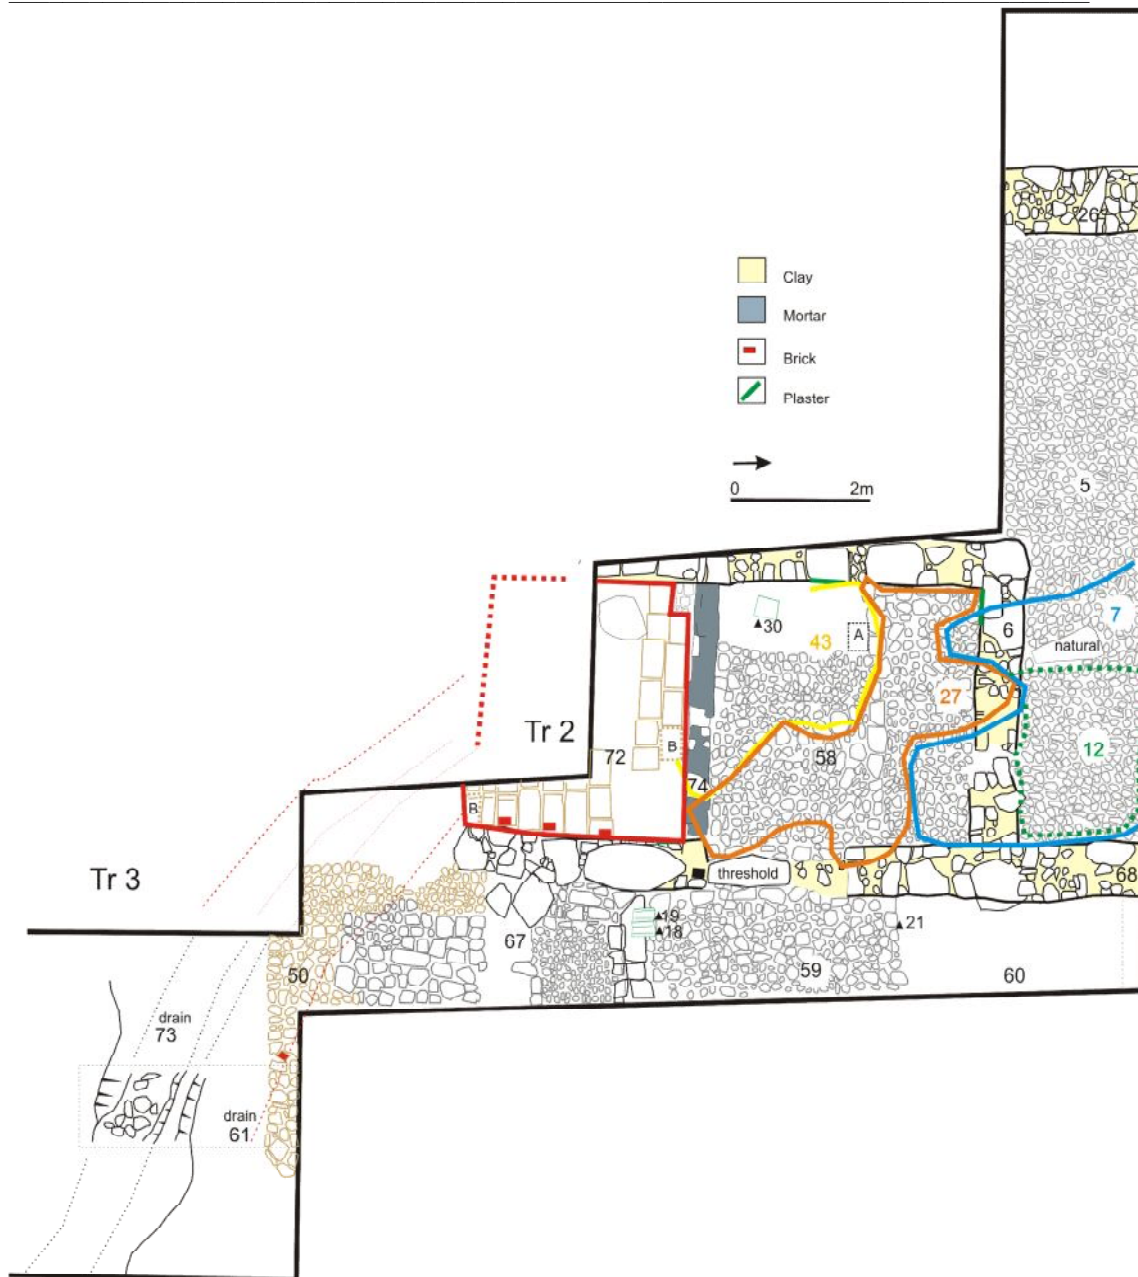
Illus 7 Plan of trench 2 with some of major dumps and soakaway

A N/S section through 56 extending S from the S edge of the paving 50 showed that all these rather disturbed layers were backfill over two drains (Illus 7, 24, 25), both running from NW to SE; either or both may have related to the soakaway (62/72. See Trench 2). Drain 61 was c 1.5m wide and c 0.5m deep with a loose stony fill and was running with water. At the N side the top of the stony fill appeared to extend below paving 50; as the paving was not excavated this must remain tentative. On the S side the stony fill of drain 61 also overlapped the edge of the cut of drain 73 (although the base of both cuts in natural did not cut each other). Drain 73 was stone filled at the base where it was 0.55m wide but the upper fill of the cut was 0.88m wide, the upper fill being indistinguishable from the clay/loam mix 56. It is considered possible that these drains, especially drain 61, cut away or were on the line of the original S wall of the courtyard.

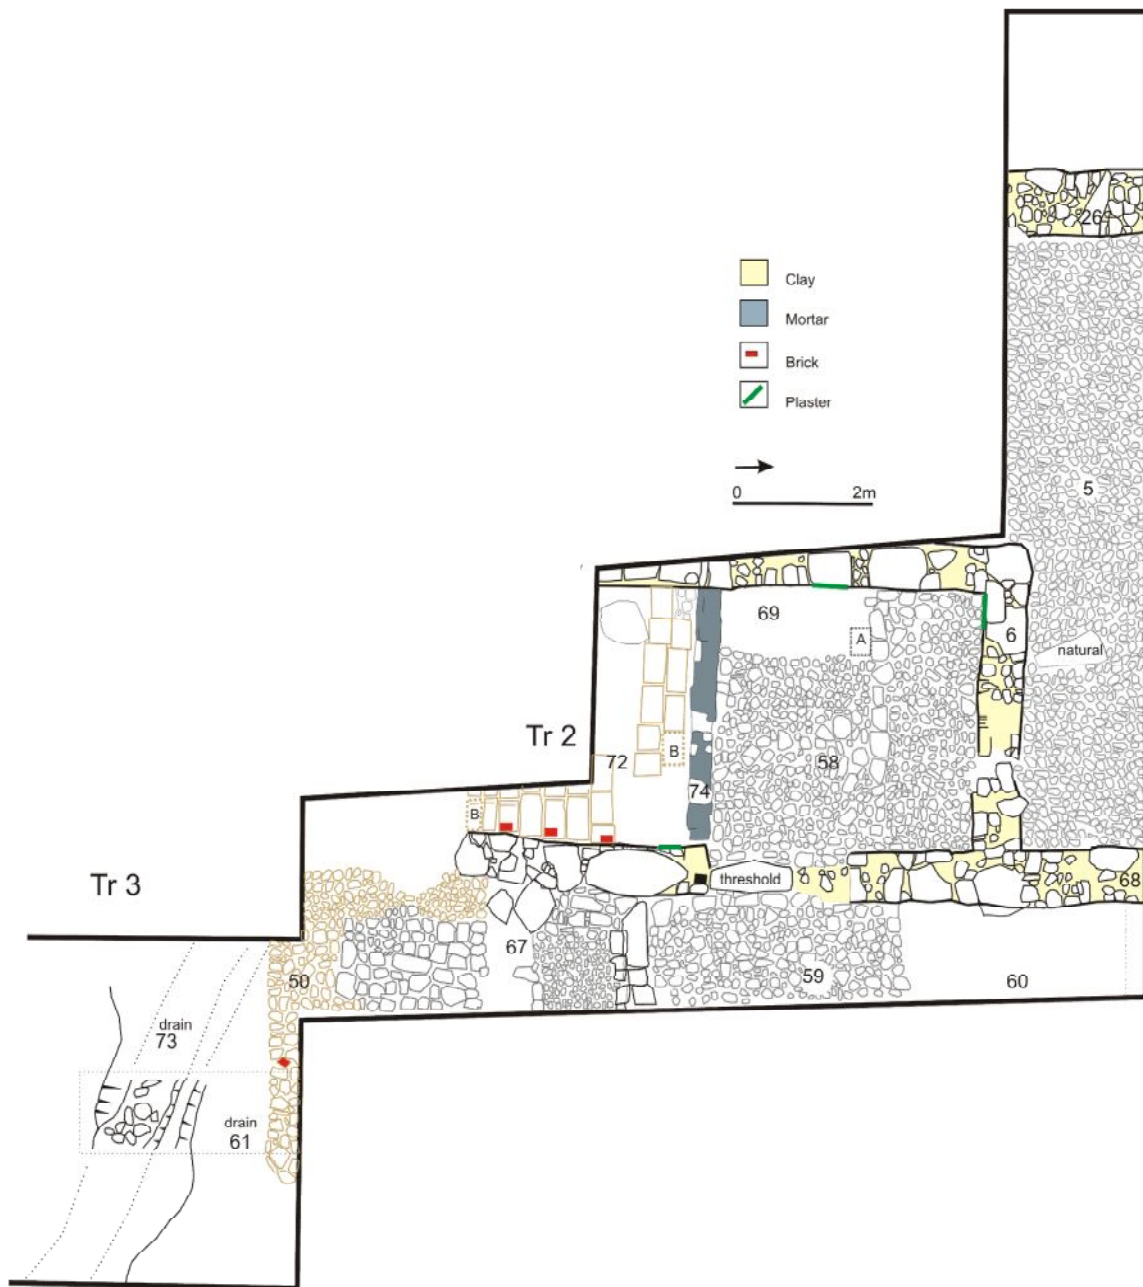
Illus 8 Plan of Trench 2 structures

As described above, the rubble both derived from and sealed the remains of a building and related structures (Illus 8). These comprised a rectangular building lying N/S with an entrance to the E, opening onto an E/W path. The E wall of the building extended N as a revetment (68), forming the E limit of a cobbled yard that extended along the N and possibly the W sides of the building and was bounded on the W by a stone wall (26), interpreted as a courtyard wall.

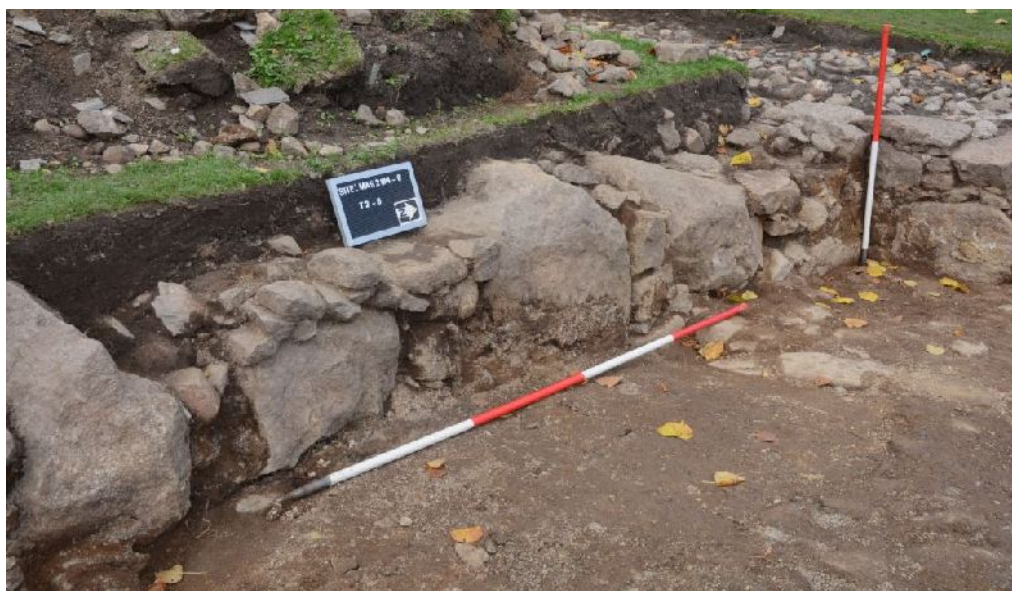
Illus 9 Looking N along inner face of W wall

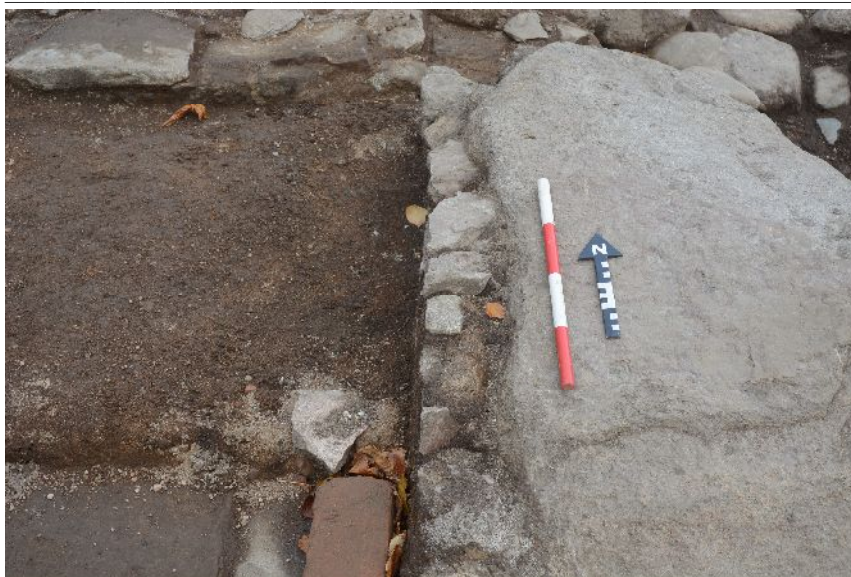
Illus 10 Detail of inside of E wall just S of entrance and of the junction with internal cross wall. Note the small stones used to face the wall

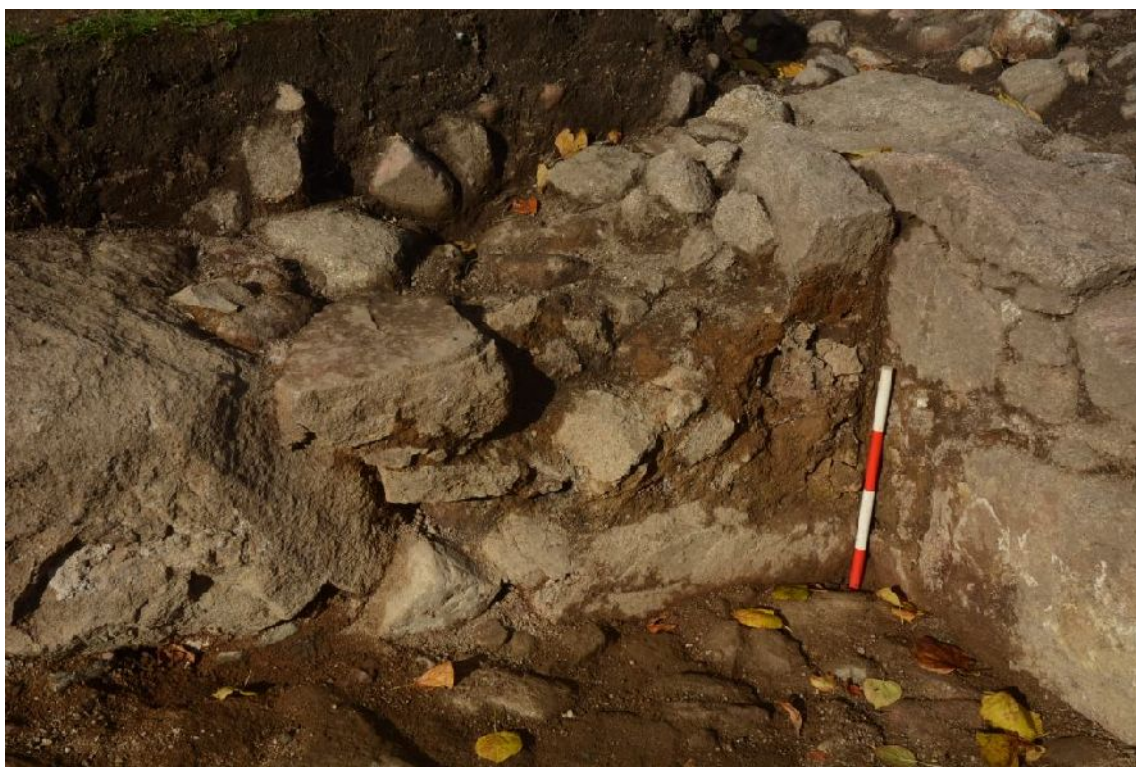
Illus 11 Detail of NW corner. Note the more regular higher courses on the N wall (RHS)

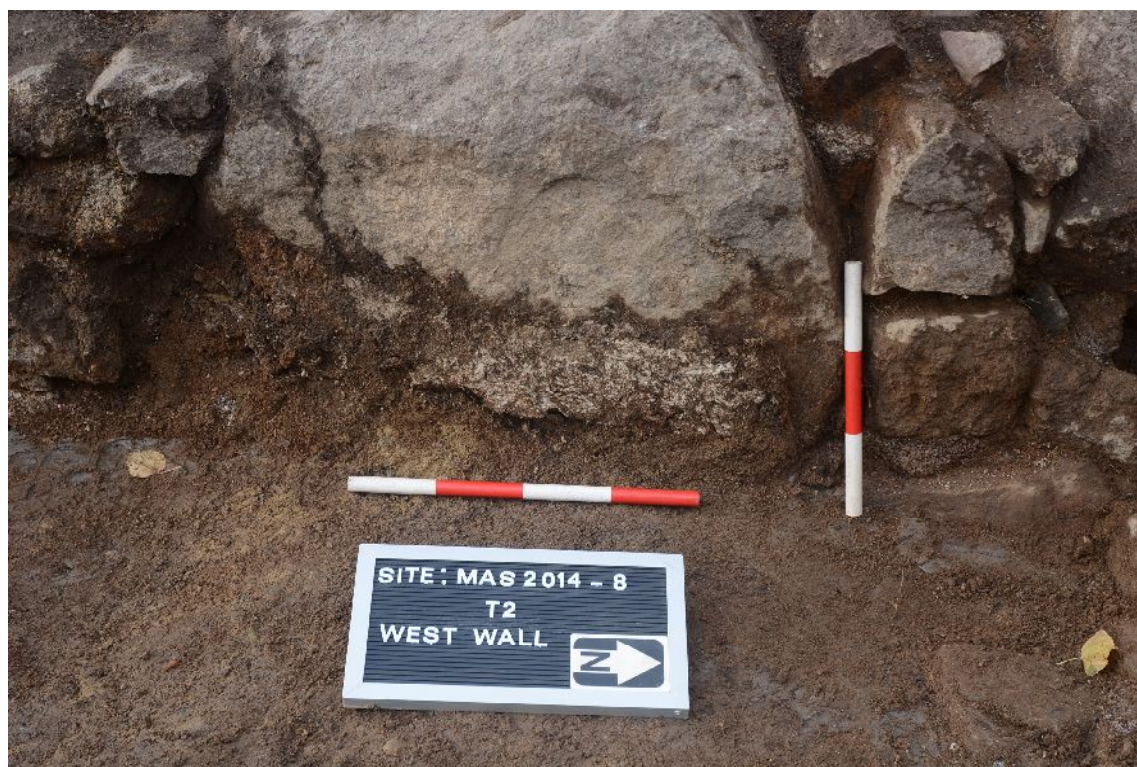
Illus 12 Detail of plaster on inner face of the W wall

At the NW corner where up to three courses survived it appeared that more regular stones were used for upper courses. The bonding was thick hard yellow clay. In places there were patches of gritty white plaster up to 20mm thick surviving on the inner face of the wall (Illus 12).

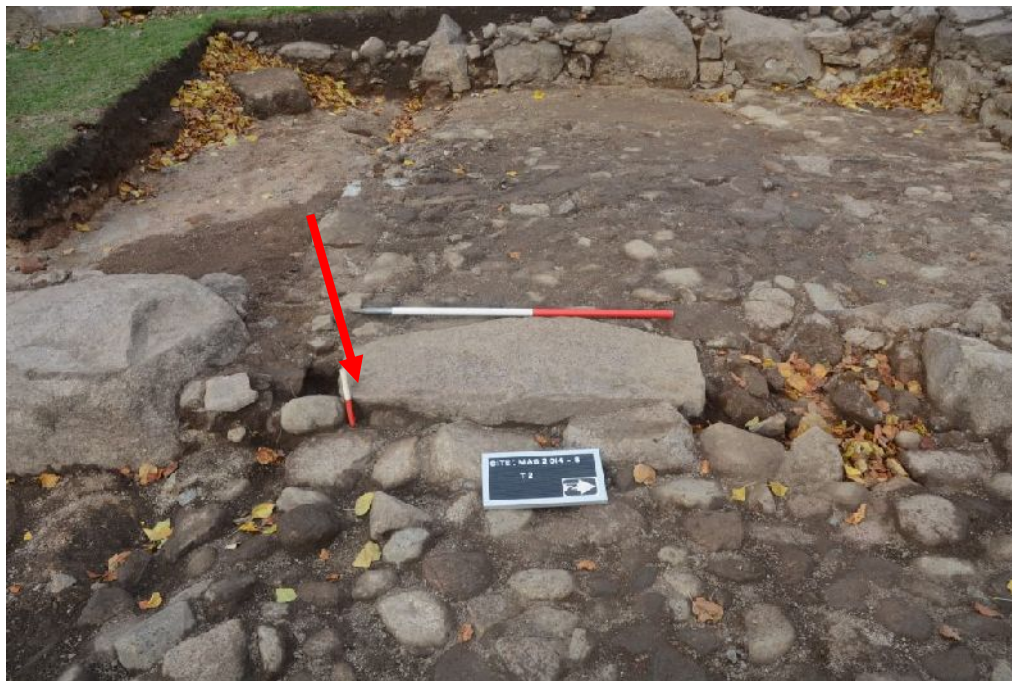
Illus 13 Threshold from outside. Arrow indicates socket

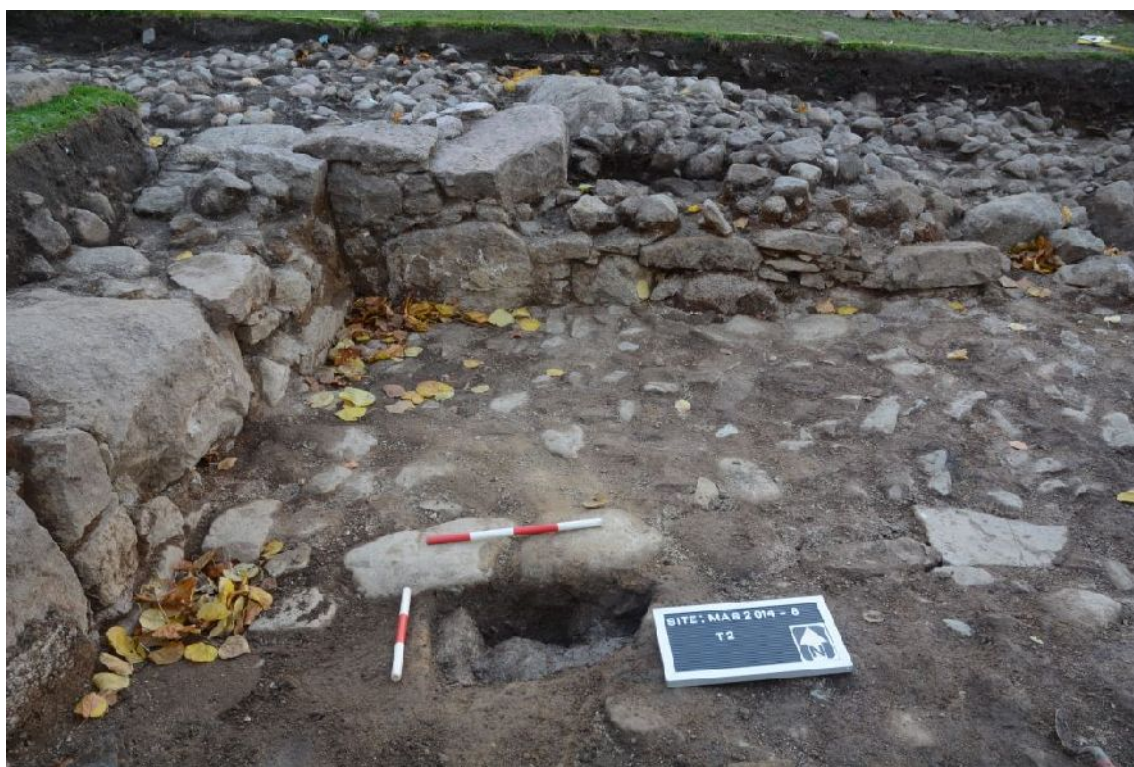
Illus 14 Position of the sondage through the cobbles

(330 x 460mm. Illus 8: A, Illus 14, 15) was cut through the floor, removing (and later replacing) two cobbles. In this area the cobbles had been leveled with small pieces of slate and set on the clay which incorporated some stones and lay directly on undisturbed natural.

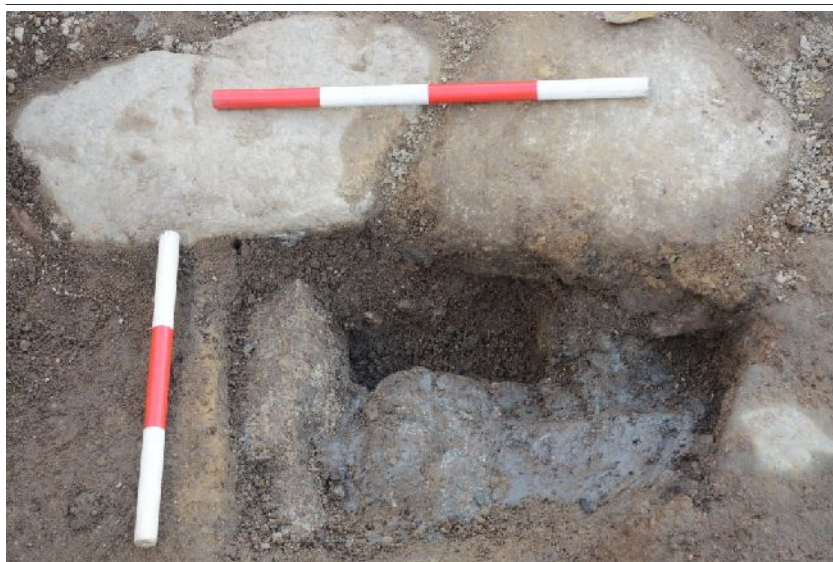
Illus 15 Detail of the sondage through cobbles

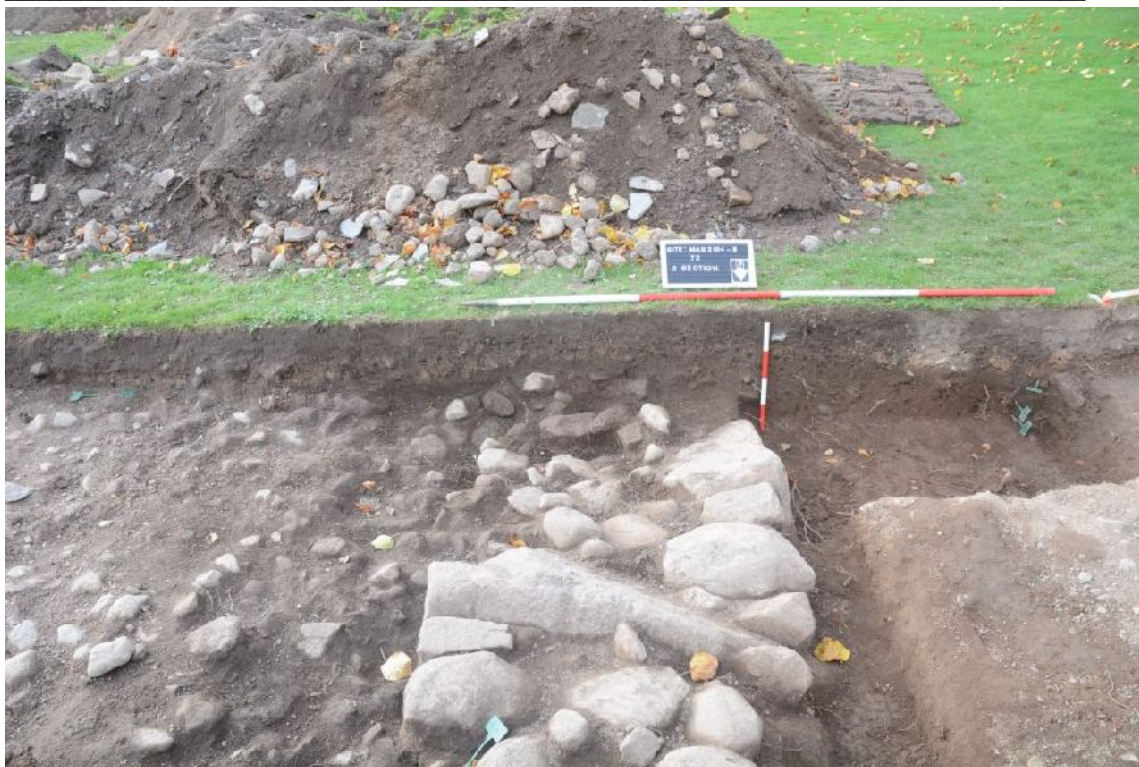
Illus 17 S section of W end of Trench 2 showing courtyard wall 26 and the internal (LHS) and external (RHS) stratigraphy.

The W end of the trench exposed a wall (26) 900mm wide. On the inside, the cobbles (5) were laid up to the wall face. A sondage (Illus 17) cut at the S section outside the wall showed that below the topsoil there was a thin layer of yellow gritty sand and clay thought to be from demolition of the wall (21 = 22 see above). Below this, the sondage cut through fine dark grey silty soil (23) containing 2 slate fragments and a sherd of glass and a brown grey silty layer with pebbles (24) which might be the original topsoil outside the wall. The only find from 24 was a piece of slate at the interface of 23 and 24. This wall is clearly on the line of a linear anomaly which extends some 35m from level with Trench 1 to the N to nearly 10m S of this excavated section, parallel with the N end of Trench 3 (see Illus 47 and Appendix 4).

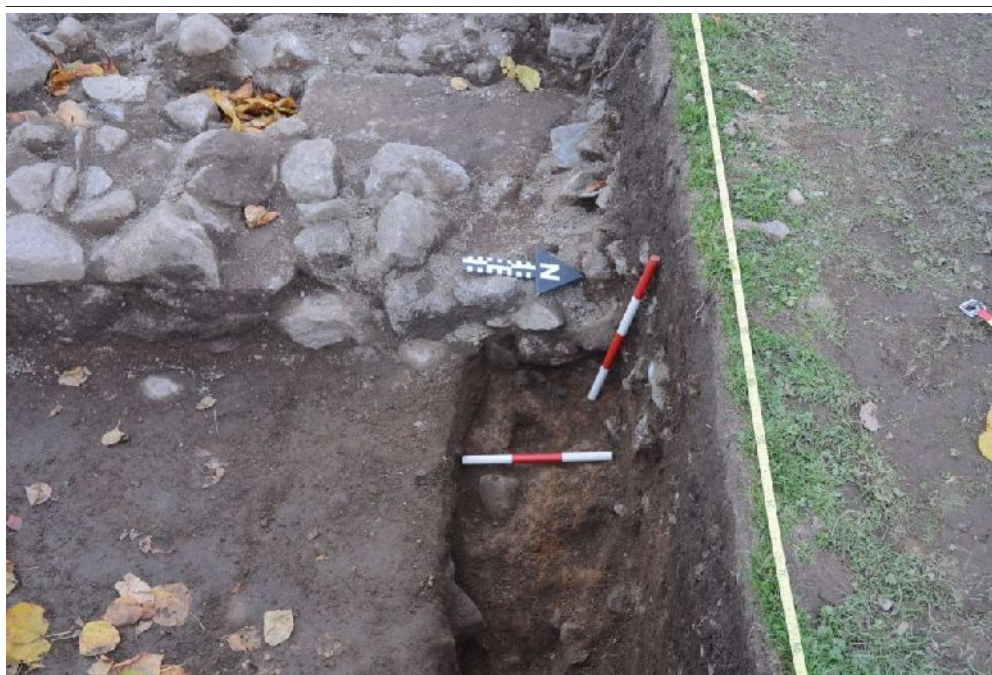
Illus 18 Revetment 68, with sondage through context 60 at RHS foreground

In the area E of the building there was an E/W path outside the entrance and, to the N of the path, an area of light/mid-brown gritty loam (60. Illus 18, 19). This extended E from the E wall of the building and from the E face of revetment 68. A sondage showed that the loam ranged in depth between 100 and 300mm and extended down to a very irregular surface on the yellow natural clay. This may have been a garden bed with planting holes.

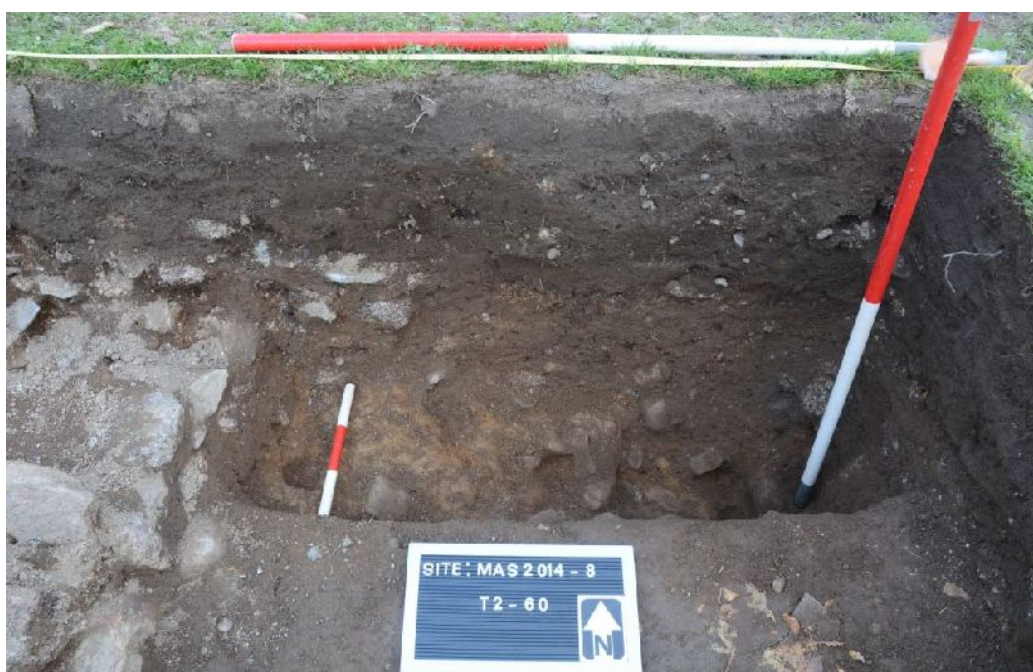
Illus 19 N section of Trench 2 showing sondage through possible garden bed 60. Revetment wall 68 on LHS.

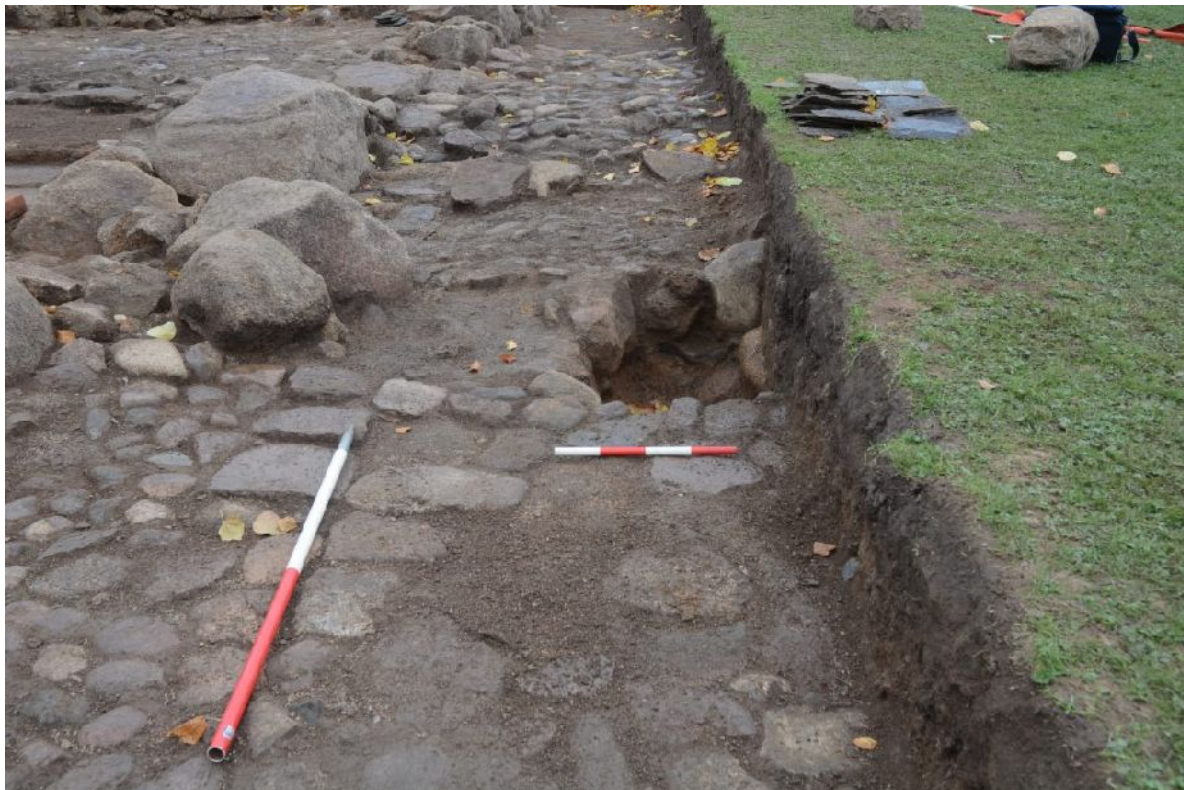
Illus 20 E side of Trench 2. The small ranging rod lies alongside cut 67. Note the stone drain in the cobbles beyond.

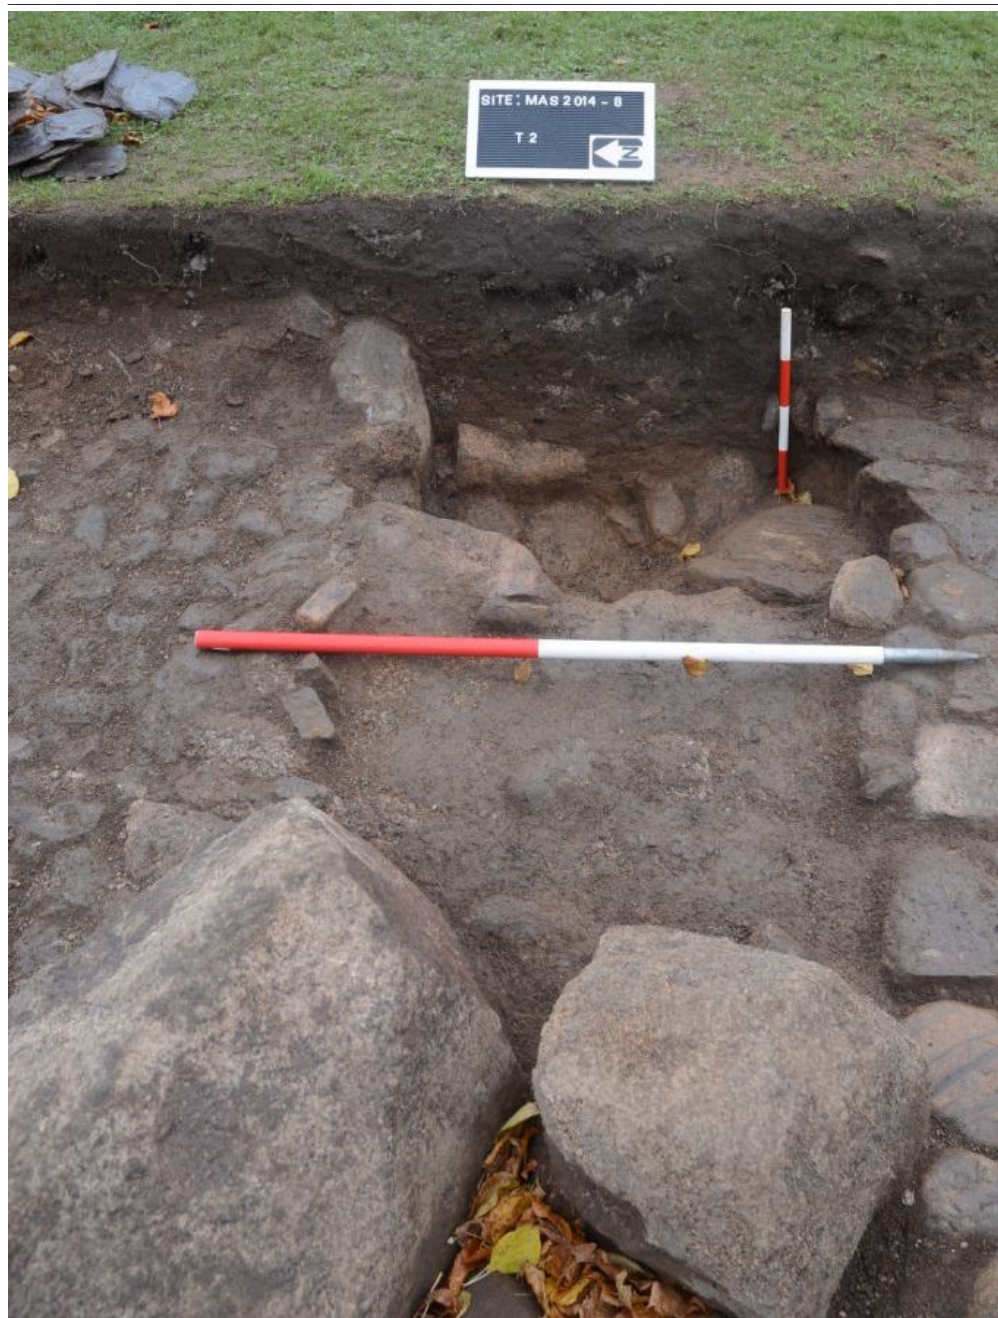
Illus 21 Trench 2. Detail of cut 67 and section through it.

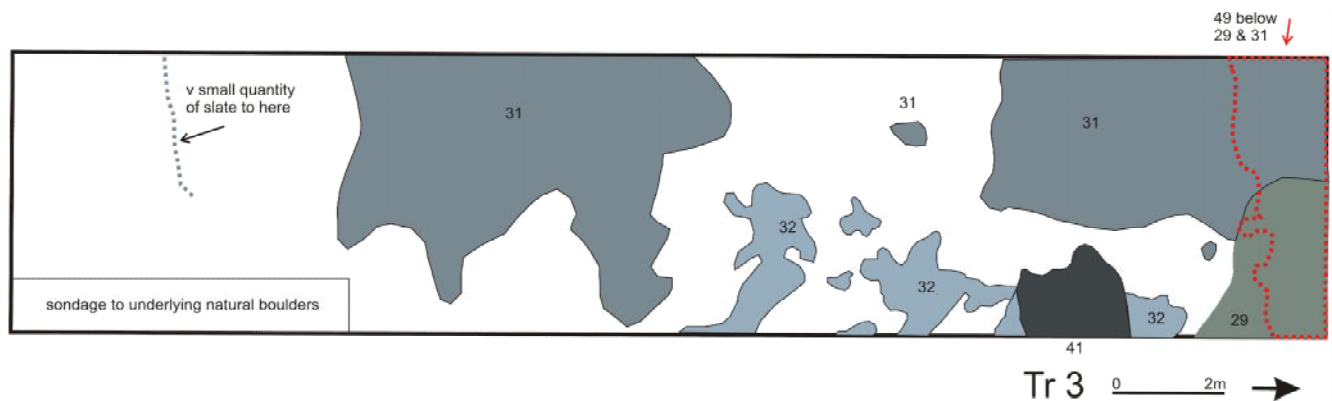
Illus 23 Plan of Trench 3 before the removal of contexts 29 and 31

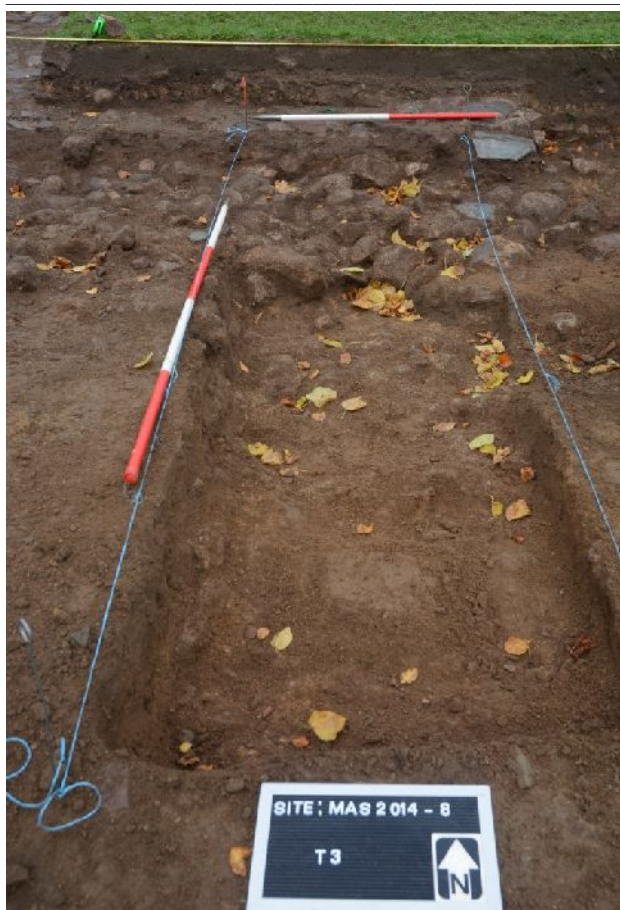
Illus 24 Sondage through layer 56 (foreground) showing stone fill of drain 61 extending to/below the paving (50) at the section (E/W ranging rod lies on the paving).

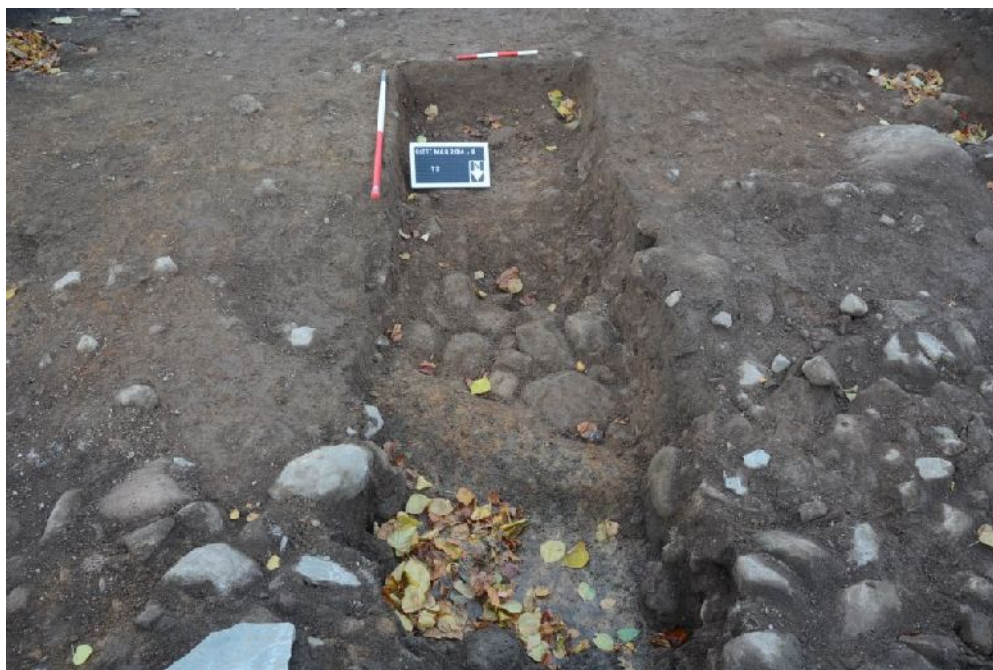
Illus 25 Sondage looking S with drain 61 in foreground with water flowing in it (among the leaves) and drain 73 behind. In the RHS section it is possible to see the stony fill of 61 overlapping the backfill of drain 73.

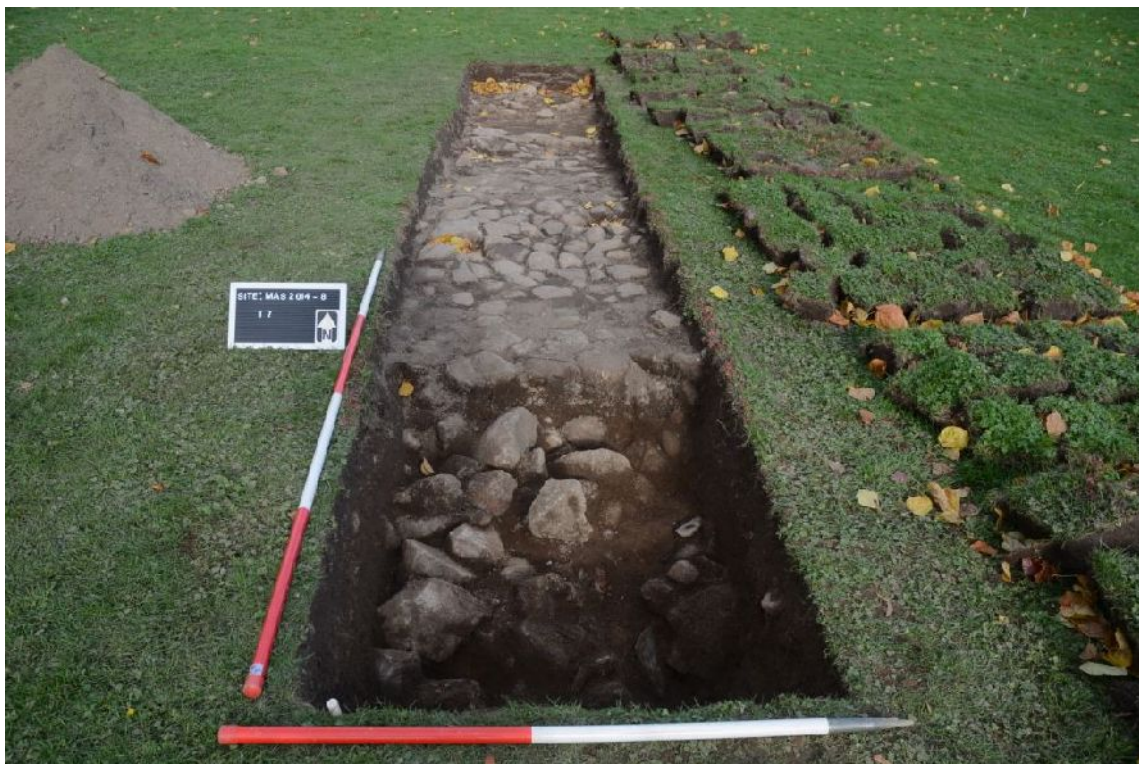
Illus 33 Trench 7 looking N. Disturbed area (70) in foreground with paving 75 behind.

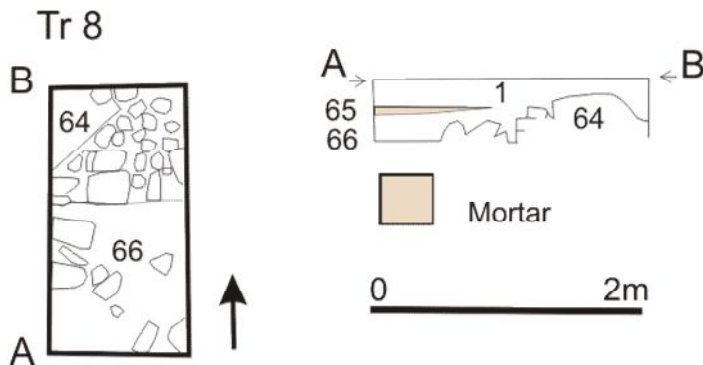
Illus 34 Plan and section of Trench 8

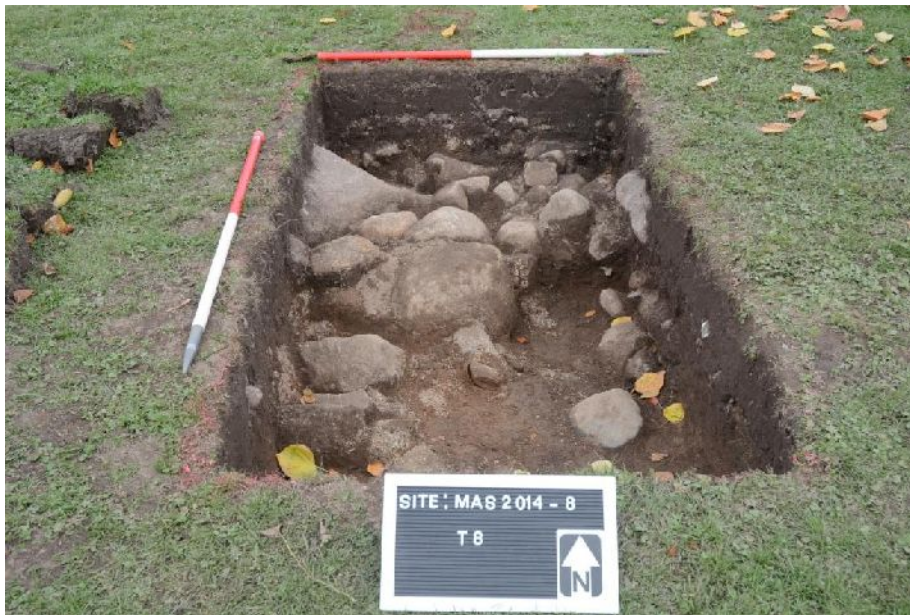
Illus 35 Trench 8 looking N. Stones 64 at N end of trench.

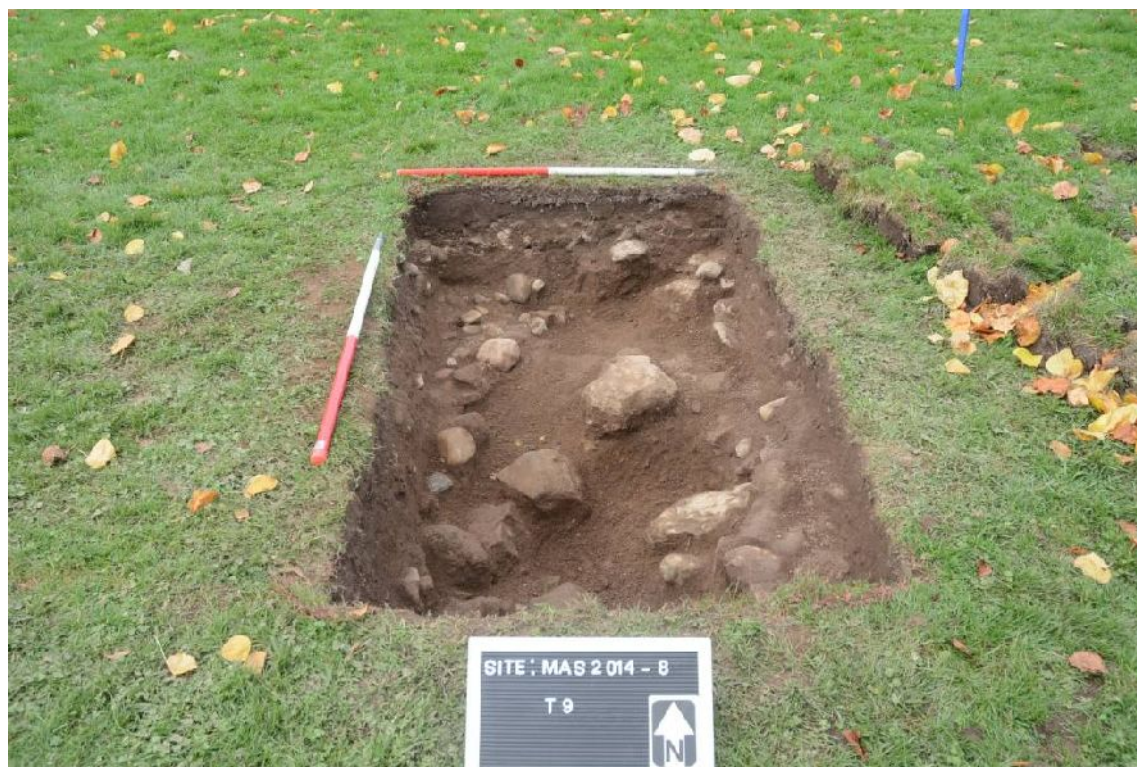
Illus 37 Trench 9 looking N. Stones 77 visible in NW corner

The very enigmatic features in Trench 9 can not be interpreted with any certainty. They do however show that possible structural surfaces and some depth of building rubble do survive at relatively shallow levels below the grass on the E side of the lawn.
