**CRATHES CASTLE
SOUTH LAWN
ABERDEENSHIRE**

Archaeological Excavation
Carried out October 2014
by
Murray Archaeological Services Ltd

Report No: MAS 2014-08
by
H K Murray and J C Murray

-Archaeological excavation -

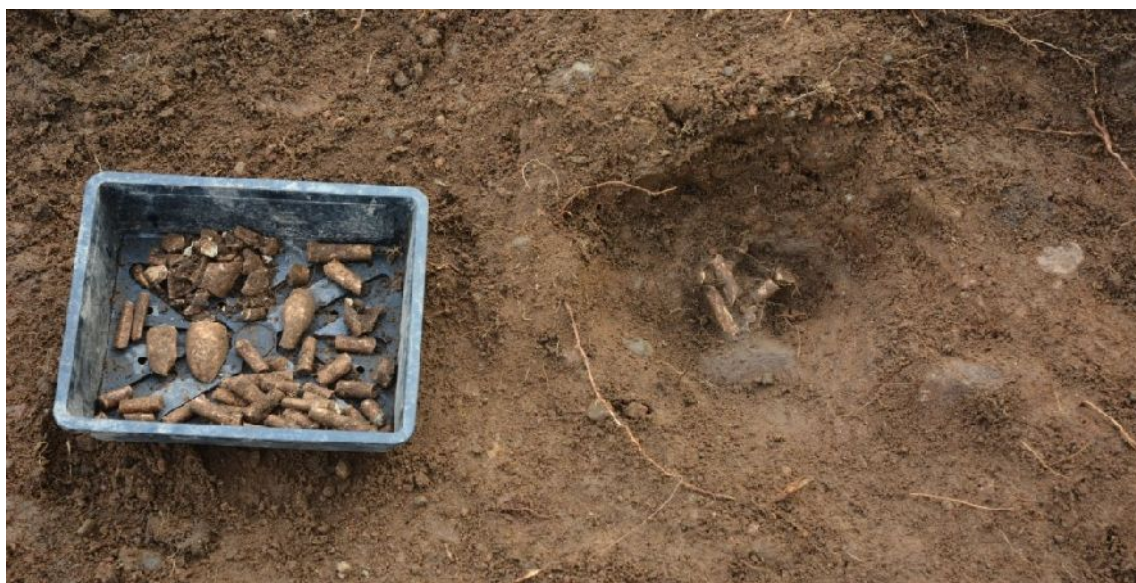
Illus 40 SF 6 during excavation

One small intriguing feature was an irregular hole between natural boulders. The hole which had a top diameter of 120 x 200mm tapered to 50mm diameter at a depth of 200mm. It was entirely filled by a collection of fragmented clay tobacco pipes (SF 6) which had been broken prior to burial and were placed over a small iron object (SF 6) in the base of the hole (Illus 40). The clay pipes were of 19th-century date.

The pipe fragments are generally very small and all very abraded on the edges and appeared to have been broken up before deposition, with stem fragments packed in side by side very tightly. It has not been possible to reconstruct any of the pipes. The total count is based on 5/6 mouthpieces and 6 bowl base/stem junctions. A small iron object, now a corroded lump, had been placed in the base of the hole below the pipe fragments (The base of a container??).

The pieces comprise stems (59), mouthpieces (5, possibly 6), bowl/stem junctions (6) and both plain and decorated bowl fragments (29 decorated, 60 plain). 19 of the bowl pieces are decorated with cross-hatched hearts. Ten bowl fragments seem to bear initials in an oval cartouche (none complete) on the upper face of the bowl; the first initial may be an 'M' but the other is very indistinct, possibly 'O'. In two cases the initials occur with heart decoration. Pipes with

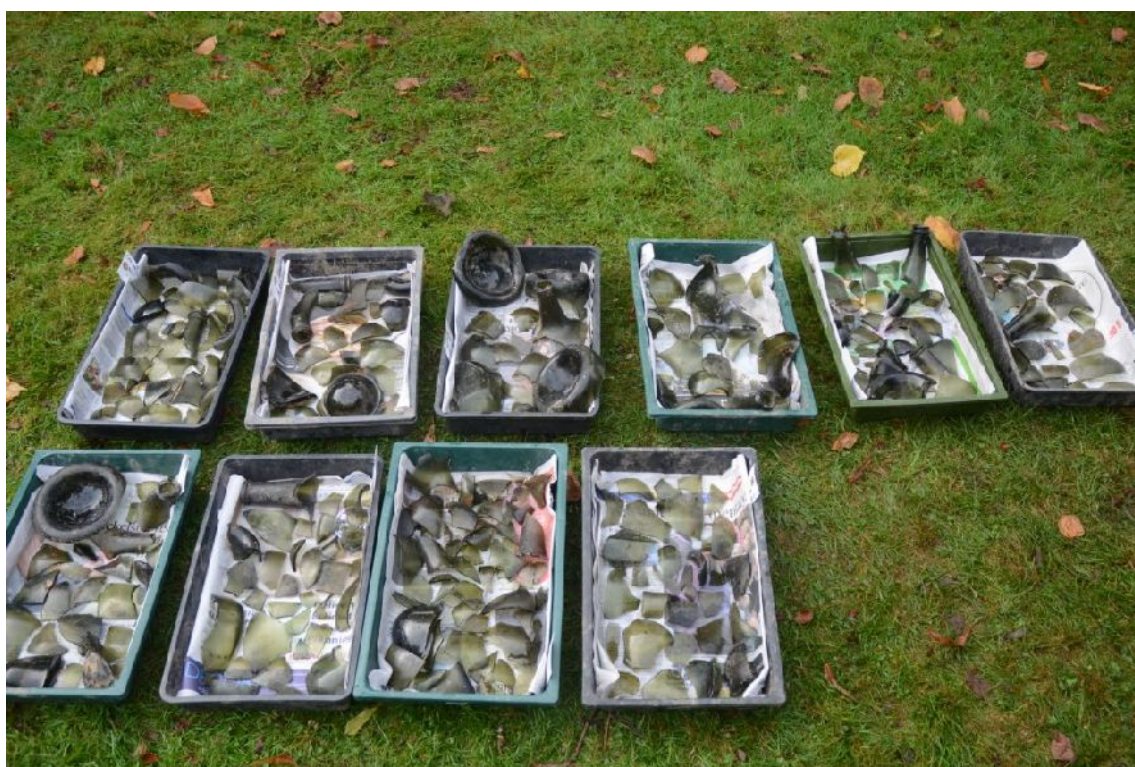
Illus 41 Some of the glass from Trench 2, context 12 drying after washing

Almost all the bottle glass was from Trenches 1 and 2, with only between 1 and 11 sherds in any of the other trenches. In Trench 2, the glass appears to have been dumped while the retaining wall 68 was still upstanding as it was concentrated on the cobbles to the W of the wall.

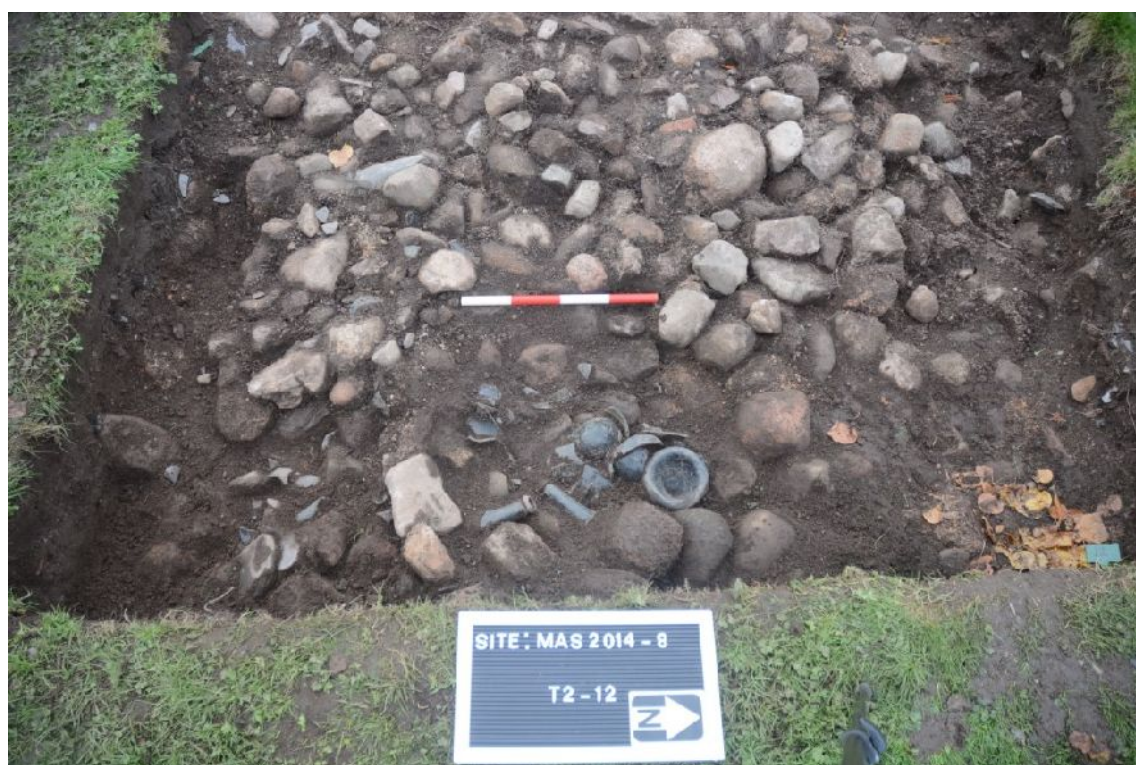
Illus 42 Some of the bottles dumped in Trench 2, context 12 on top of cobbles.

A minimum vessel count was undertaken based on the complete rims/necks and the complete bases. In Trench 1 there were 6 rims and 1 base. In Trench 2 there were 44 rims and 29 bases. The overall minimum bottles represented would therefore be c. 50. Of these, 29 bottles were in Trench 2 context 12 which seems to have been the primary deposition. Many of the other contexts can be seen as deriving from this as demolition

Base diameters ranged between 100 and 130mm, most being in the range 120-125mm. They had pronounced basal kicks, 20-45mm in depth. The sides directly above the base were straight. Necks ranged in length between 65 and 110mm. They seemed to be a majority 70-80mm long with the neck gently expanding to a rounded shoulder. Two with longer necks (100-110mm) appeared to have a slightly straighter neck with a very rounded shoulder. All the necks had an applied collar below the rim.

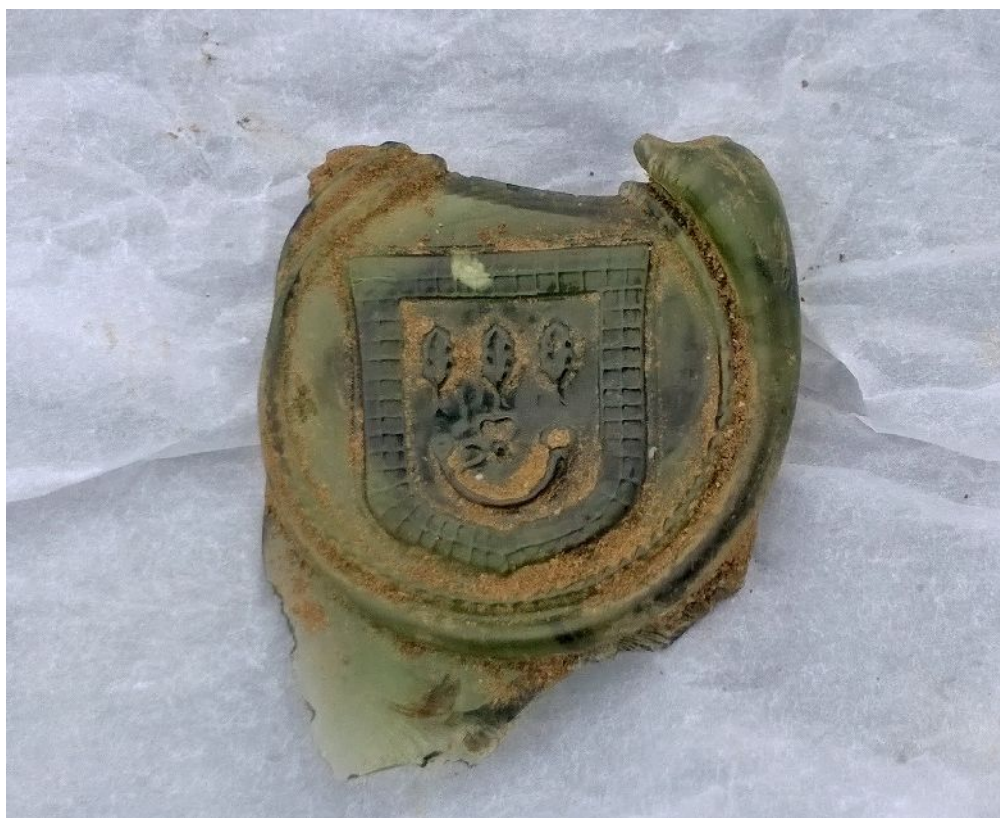
Illus 43 Blob seal SF4 with Burnett coat of arms

Three blob seals with the Burnett coat-of arms from glass bottles were found- all in Trench 2, context 12. (SF 4, 5 and 31). SF 4 and 5 were just the seal, broken from the bottle. On SF 31 the seal was on part of a squared bottle. A fragment of a rectangular-sectioned bottle with the same family seal is on display in the castle.

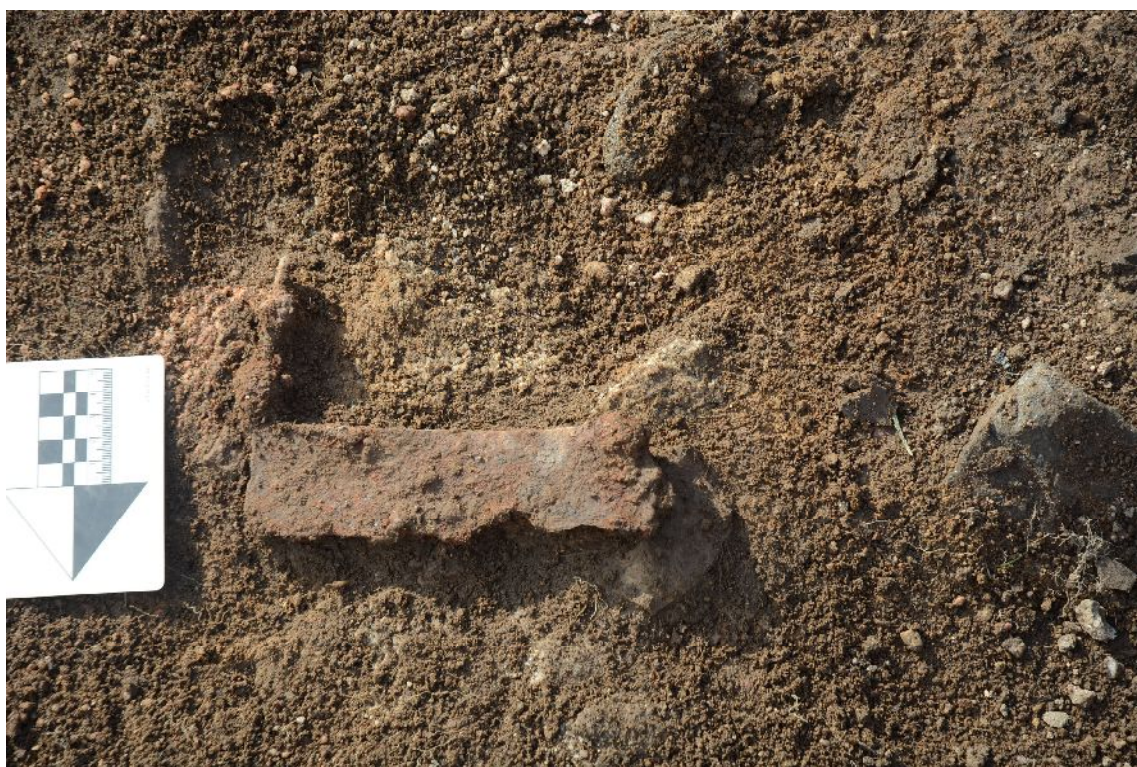
Illus 44 SF 21 in situ outside doorway of building prior to lifting.

SF 21 *Boot scrape or architectural fragment*. Blade with tang at one end, other end broken. Blade L: 170mm W: 45mm Th: 110mm to 2mm thick at top and bent double so

SF 25 Almost certainly the broken end of SF21. Blade L: 70mmW: 45mm. 2mm thick at top and bent double so that base is two sheets of iron 10mm apart. V corroded. Tr 2, (52)

Together SF 21+25 would have been c 235mm long with a sharp edge to top and folded edge to base with a tang at either end. Both were in demolition rubble found c 500mm apart. in overlying layers outside the building to N side of doorway.

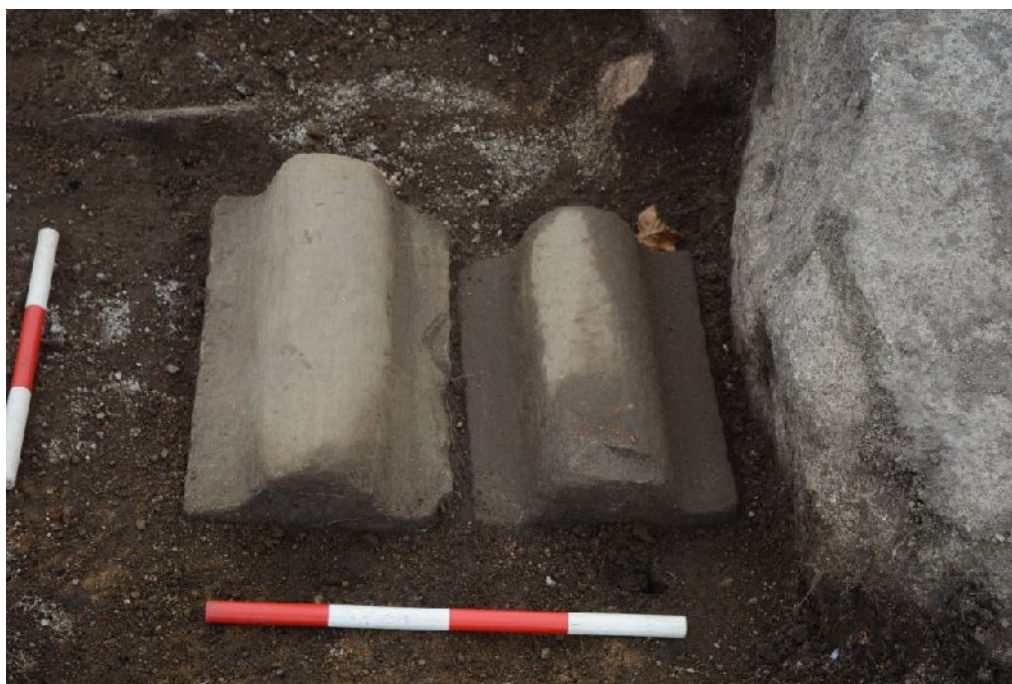
Illus 45 Rolled mouldings SF18 and SF19 in situ outside wall of building prior to lifting.

As noted above, the rubble included both slates and dressed stones that almost certainly derive from this building and the associated structures. Three stones with a simple roll moulding (SF 18, 19 Illus 45 and SF 28) may have been coping stones from a low wall (pers. comm. T Addyman), possibly even from the top of revetment wall 68, or from a balustrade alongside steps which may have existed between different terraces within the court.

There is little evidence concerning the appearance of the upper area. Its S edge was bordered by the wall revetting the drop to the lower terrace and it is reasonable to postulate steps (perhaps bordered by a balustrade with the moulded coping stones found in Trench 2) or a sloping path between the levels. There is some slight evidence in Trench 1 that there was a cobbled yard/path along the upper N side of the revetting wall. Some cobbling was found in association with a short kerb/wall in 2013 at the SW corner of the tower; however as this could not be dated it may be later (Murray & Murray, 2013).

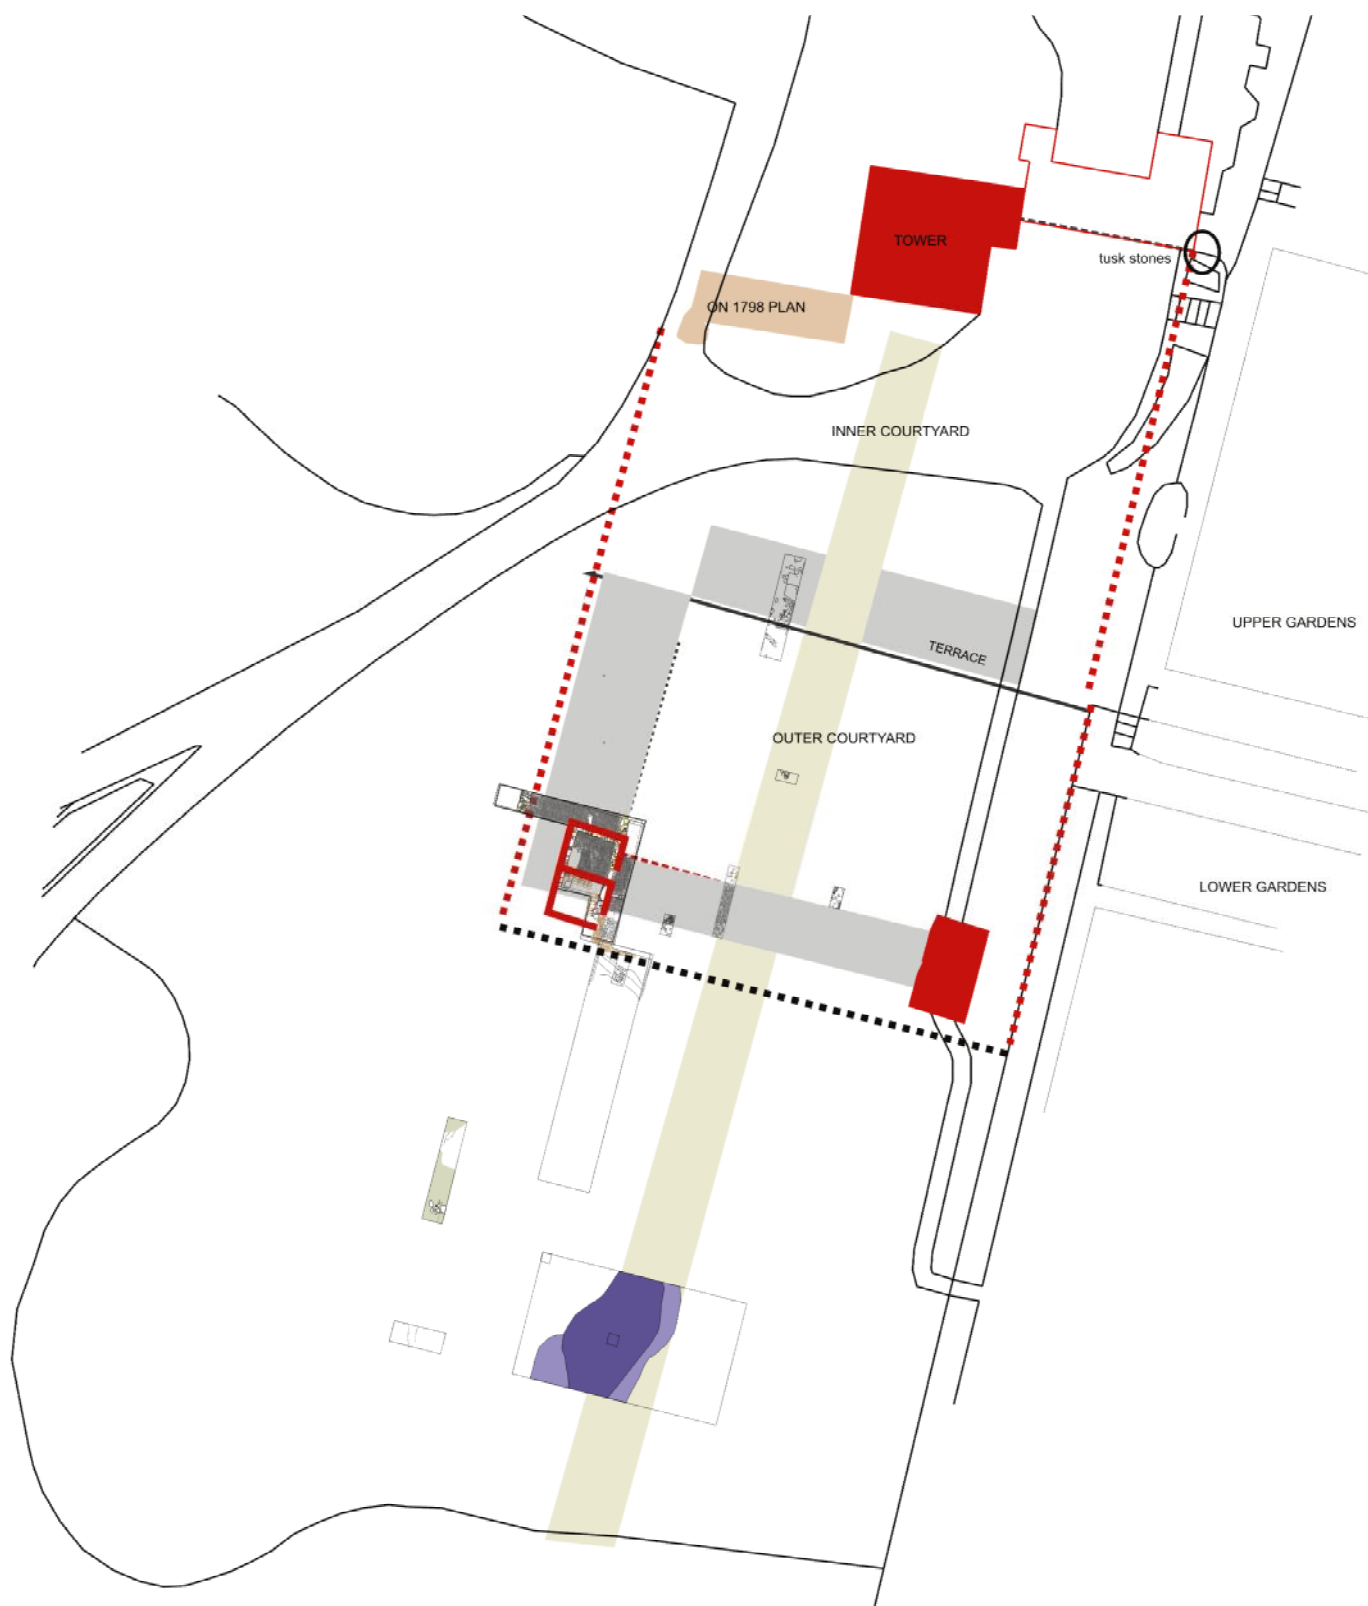
Illus 46 Hypothetical reconstruction of pre-1798 layout based on the excavation results supported by the geophysical and documentary evidence (see also Illus 47). Red dotted lines show the fairly certain E and W courtyard walls. Black dotted line shows the most probable line of the S end of courtyard.

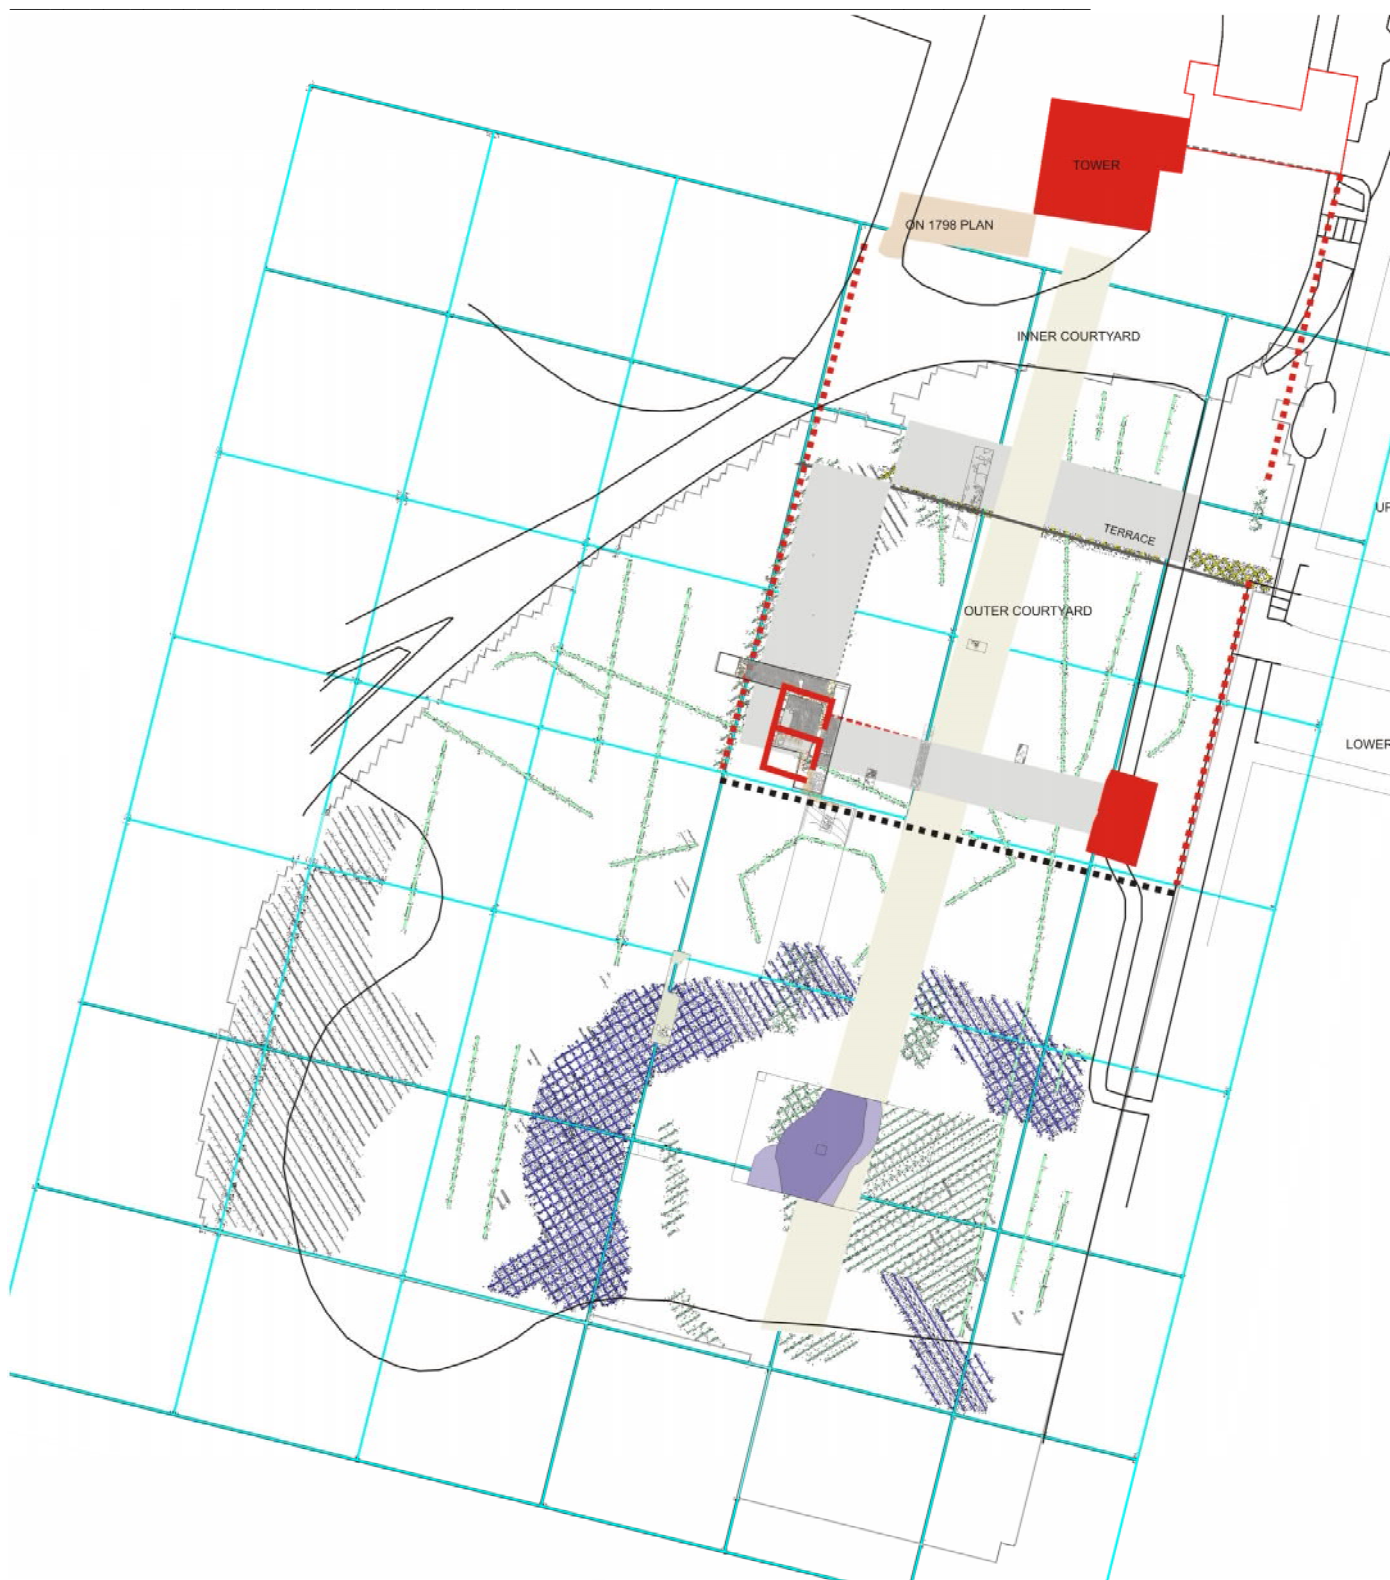
Illus 47 Hypothetical reconstruction of pre-1798 layout based on the excavation results supported by the geophysical and documentary evidence (see also Illus 46). Underlay of geophysical results (after Ovenden 2012)

The W end of the trench exposed a wall (26) 900mm wide. On the inside, the cobbles (5) were laid up to the wall face. A sondage (Illus 17) cut at the S section outside the wall showed that below the topsoil there was a thin layer of yellow gritty sand and clay thought to be from demolition of the wall (21 = 22 see above). Below this, the sondage cut through fine dark grey silty soil (23) containing 2 slate fragments and a sherd of glass and a brown grey silty layer with pebbles (24) which might be the original topsoil outside the wall. The only find from 24 was a piece of slate at the interface of 23 and 24. This wall is clearly on the line of a linear anomaly which extends some 35m from level with Trench 1 to the N to nearly 10m S of this excavated section, parallel with the N end of Trench 3 (see Illus 47 and Appendix 4).

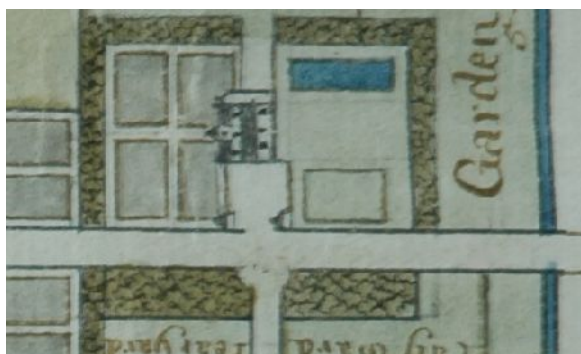
Illus 48 Detail of 1758 plan of Leith Hall (Courtesy of National Trust for Scotland).

In 2007 a pavilion was excavated at Leith Hall which was 5.5 x 11m externally – this is shown on an Estate map of 1758 (Illus 48) as one of a pair of pavilions flanking an open entrance of an outer court leading towards the main entrance into the inner courtyard enclosed by the buildings. It is not shown on a map of 1797 so may have been removed by that date. The Leith Hall pavilion had two rooms with a fairly elaborate water feature/cistern in the inner one (Murray & Murray 2007). Apart from the 1758 estate plan there was no evidence of date.

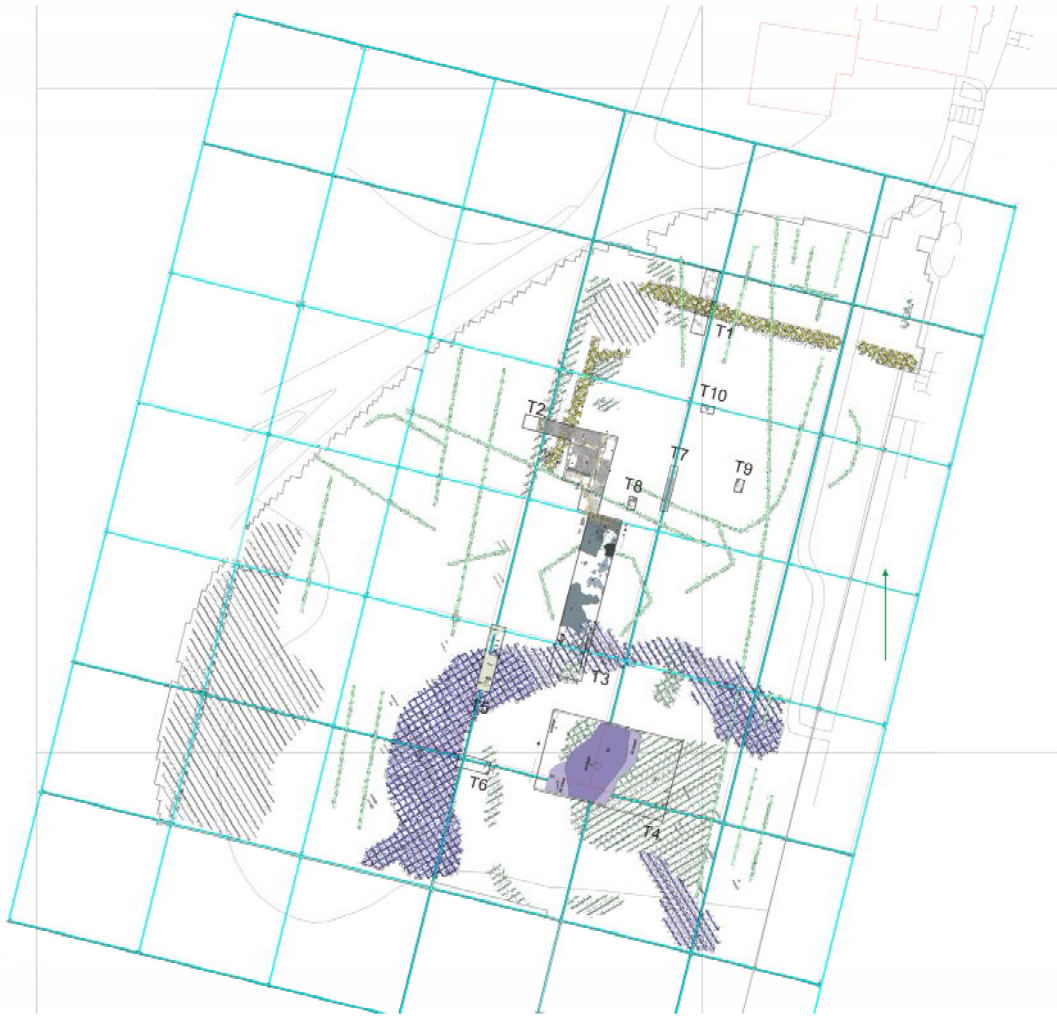
Appendix 4. Excavation results shown against interpretation of geophysical results (after Ovenden 2012).

Trench 2 appears to cover part of the SW corner of a courtyard enclosed on the W by a stone wall. The S side has been badly damaged by the construction of a soakaway and associated drains but it is clear that the S edge of the courtyard was either at cut 67 or at the edge of the paving because further S in Trench 3 the relative lack of deposits strongly indicates this was outwith the courtyard. An additional strand of evidence is that the S limit of the geophysical anomaly which can be identified with the W wall does not extend further S than this approximate line (see Appendix 4).
