MARYWELL
STONEHAVEN ROAD
ABERDEENSHIRE

Standing Building Survey
Carried out 23rd April 2015
by
Murray Archaeological Services Ltd

Report No: MAS 2015-17
by
H K Murray and J C Murray

- Standing Building Survey -

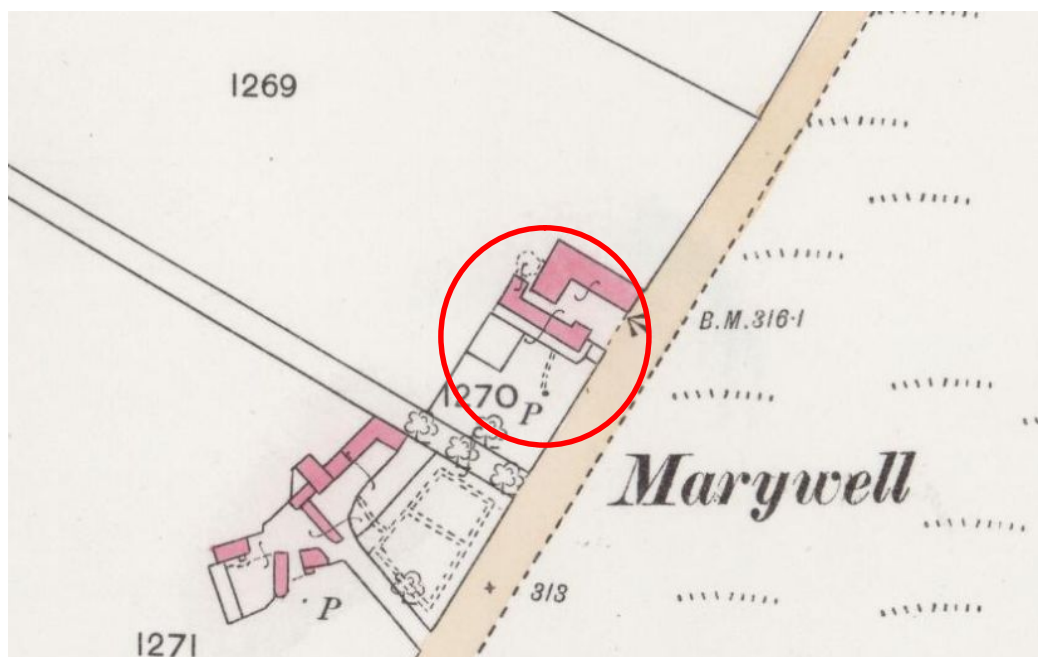
Illus 1 Detail of the 1st edition Ordnance Survey 25" map, surveyed in 1865 (published 1868) Kincardine sheet VIII.2 www.nls.ac.uk

4.1 **Kincardine Sheet VIII.2 (combined) 1865 (pub 1868)** shows two buildings lying at right angles to the road; the larger N building being L-shaped with a narrower building to the S with two short projections on the N facade. A horse mill is shown on the W end of the N building.

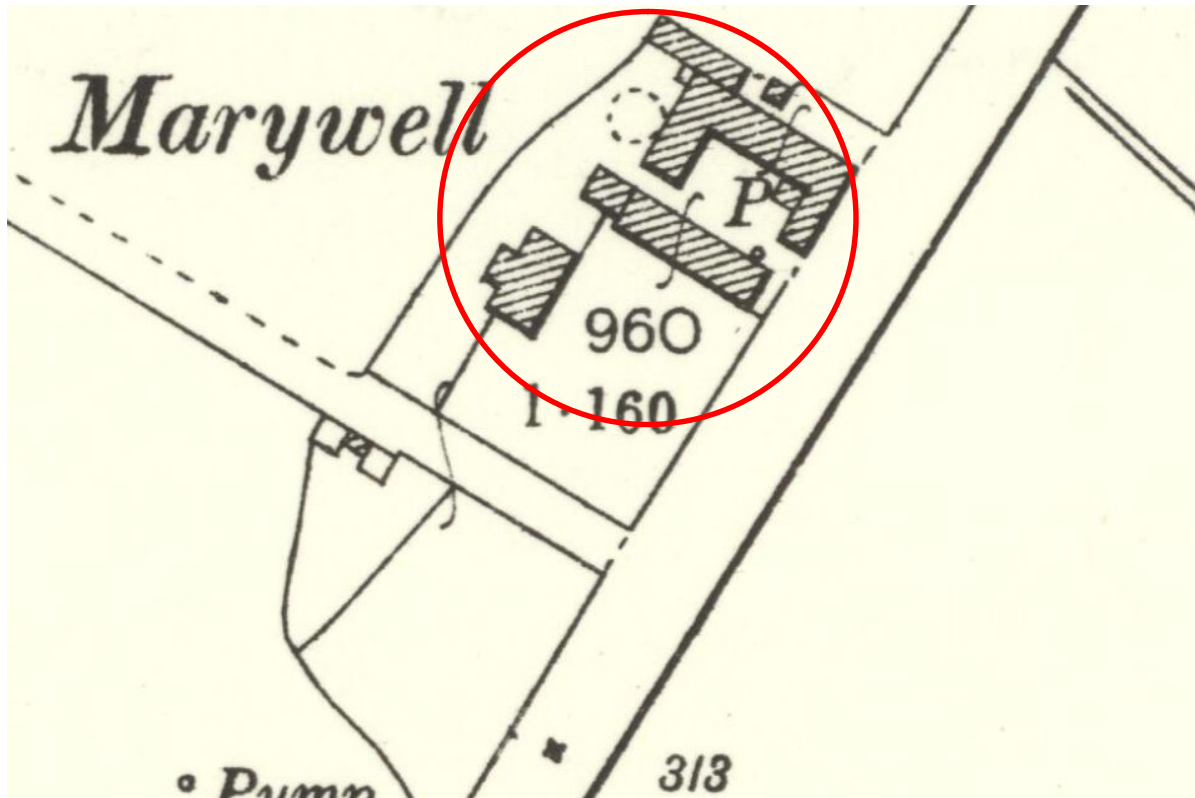
Illus 2 Detail of the 2nd edition 25"/mile Ordnance Survey of 1902 (published 1903. Kincardineshire 007.15) www.nls.ac.uk

4.2 By the 2nd edition 25"/mile Ordnance Survey of 1902 (published 1903. **Kincardineshire 007.15**) the original N building remains and has an additional E wing and another building abutting its NW corner. The S building

has been replaced or partially rebuilt to a wider, rectangular plan. A dwelling house has been built SW of the steading.

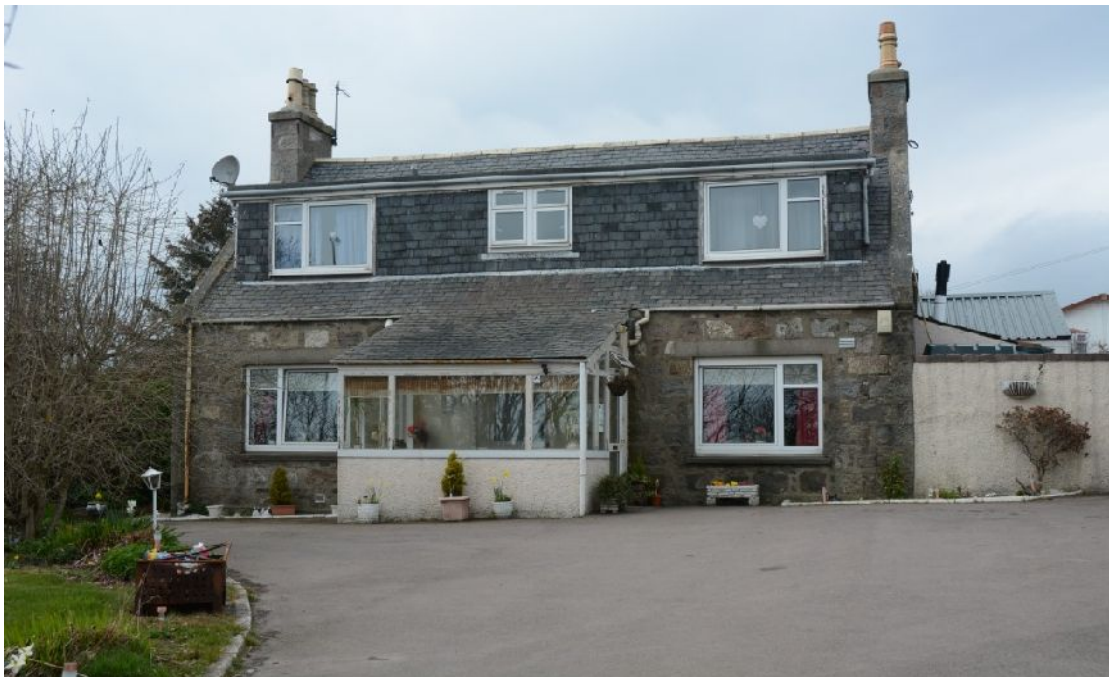
Illus 6 Building 1. House. E elevation (Photo 26)

Dimensions c. 7.5m x 11.5m externally (the original core), with several modern additions.

Walls The original parts of walls built of squared rough dressed rubble stone. Additions harled- probably concrete blockwork.

Roof Slate on main building and part of additions. One outshot with corrugated iron roof.

Chimneys Rectangular granite with plain table. Ceramic pots.

Windows and doors All windows and doors were modern replacements. Not detailed.

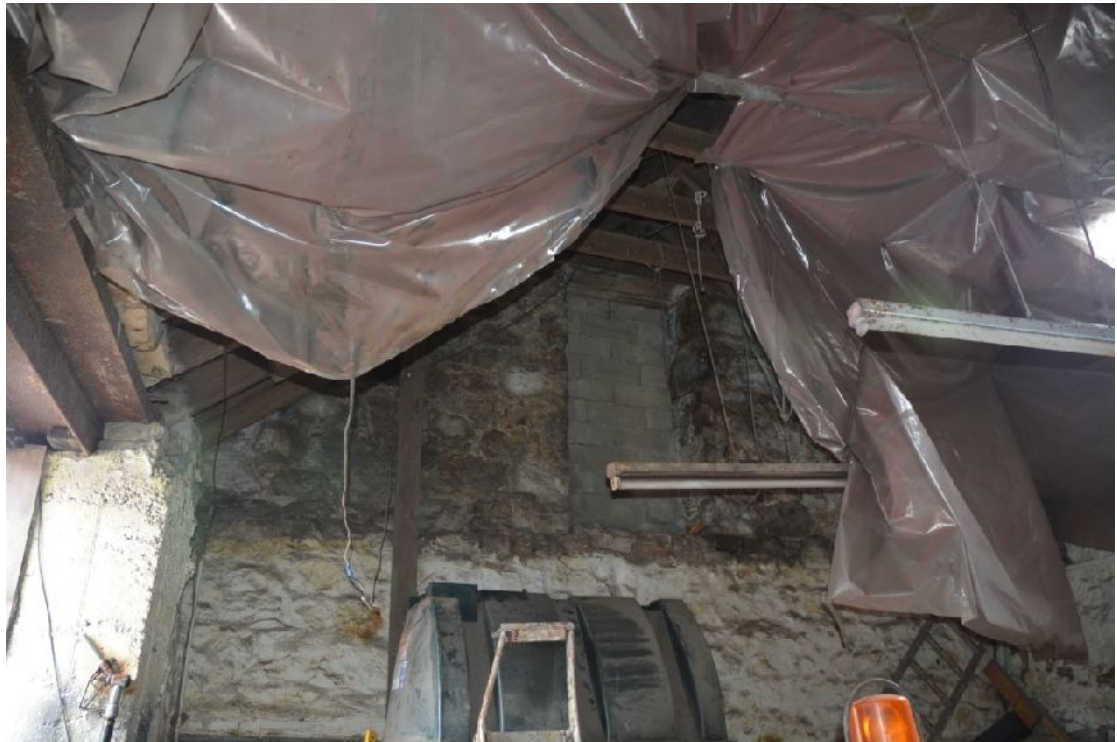
Illus 9 Building 2. S steading. Internal view of internal wall and part of loft at E end (Photo 2)

Original use The E end had had a loft and may have been a grain store.

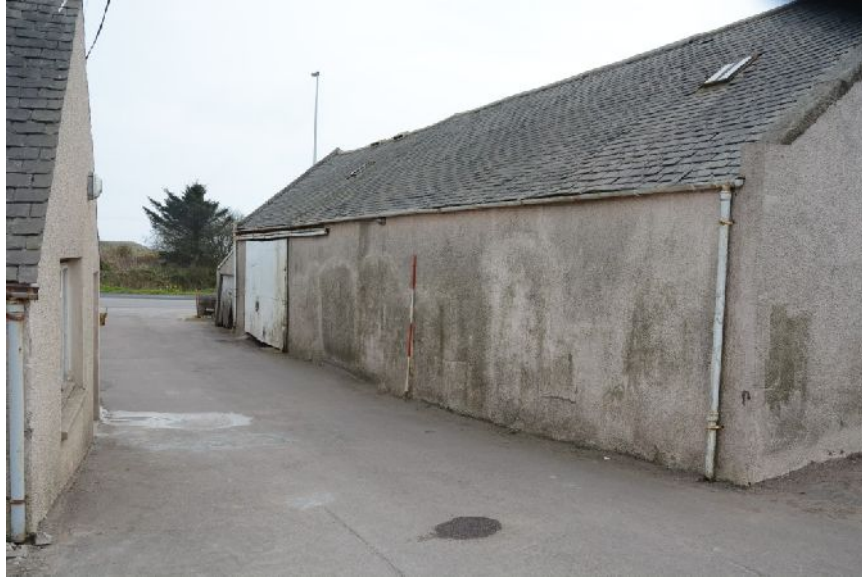
Illus 10 Building 2. S steading. N elevation. (Photo 20)

D1 W: 4.2m H: 2.75m Sliding metal doors.

D2 Into outshot. W: 2.35m H: 1.70m Wooden door.

F1 Bulge in foundation course of stones between 6m and 7m from W end could indicate an opening or a former wall but does not tally with anything on early OS maps.

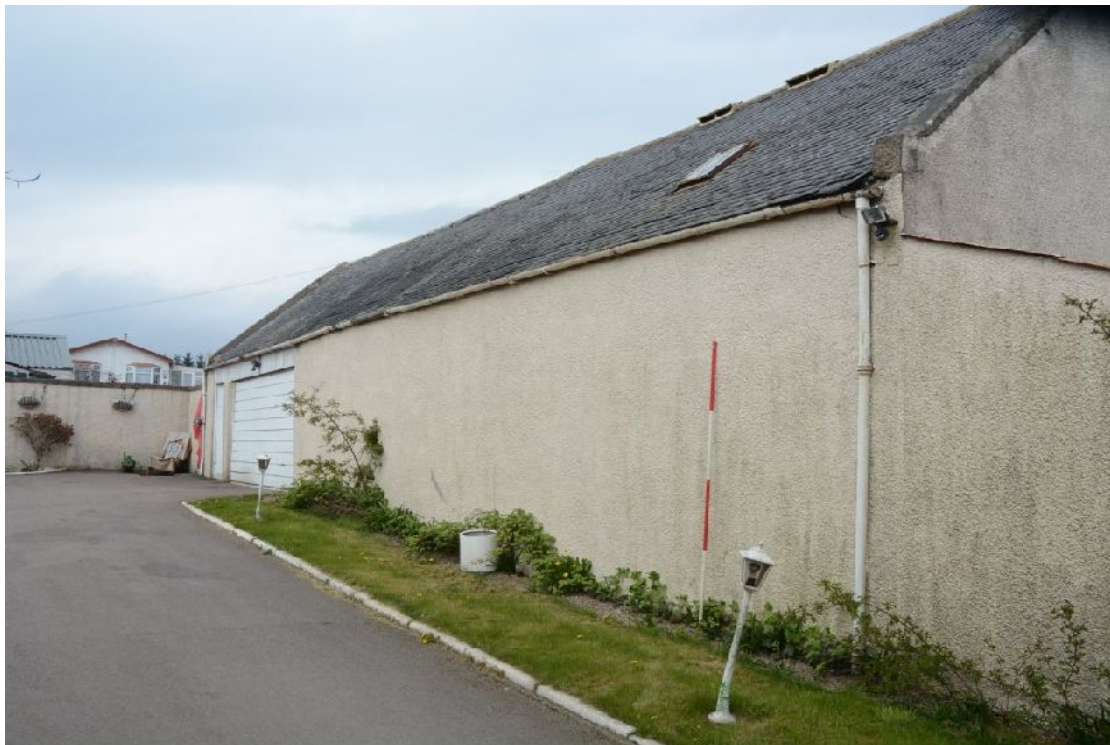
Illus 11 Building 2. S steading. S elevation. (Photo 24)

S wall Modern garage door and 'shed' door at W end within garden of house. Not surveyed.

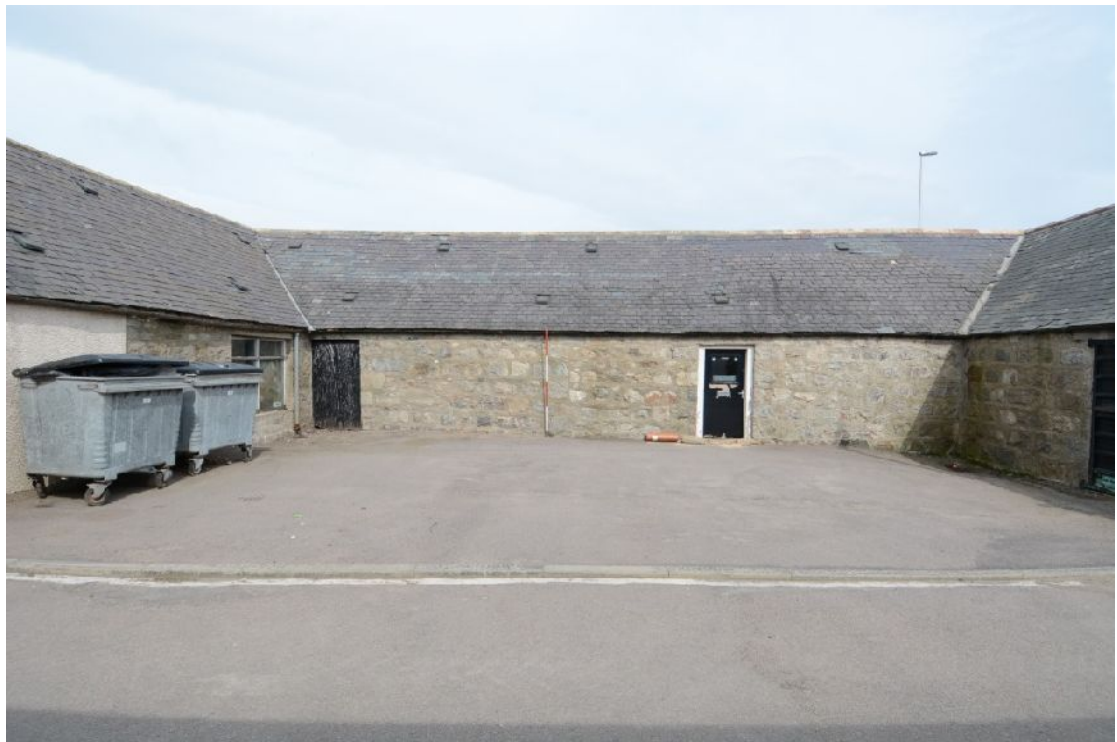
Illus 12 Building 3. N steading. S wall main block. F1 to RHS of ranging rod. (Photo 6)

D2 W: 1.05m H: 1.85m Granite lintel.

D3 W: 1.05m H: 1.85m Granite lintel.

F1 Vertical join in wall (illus 16)

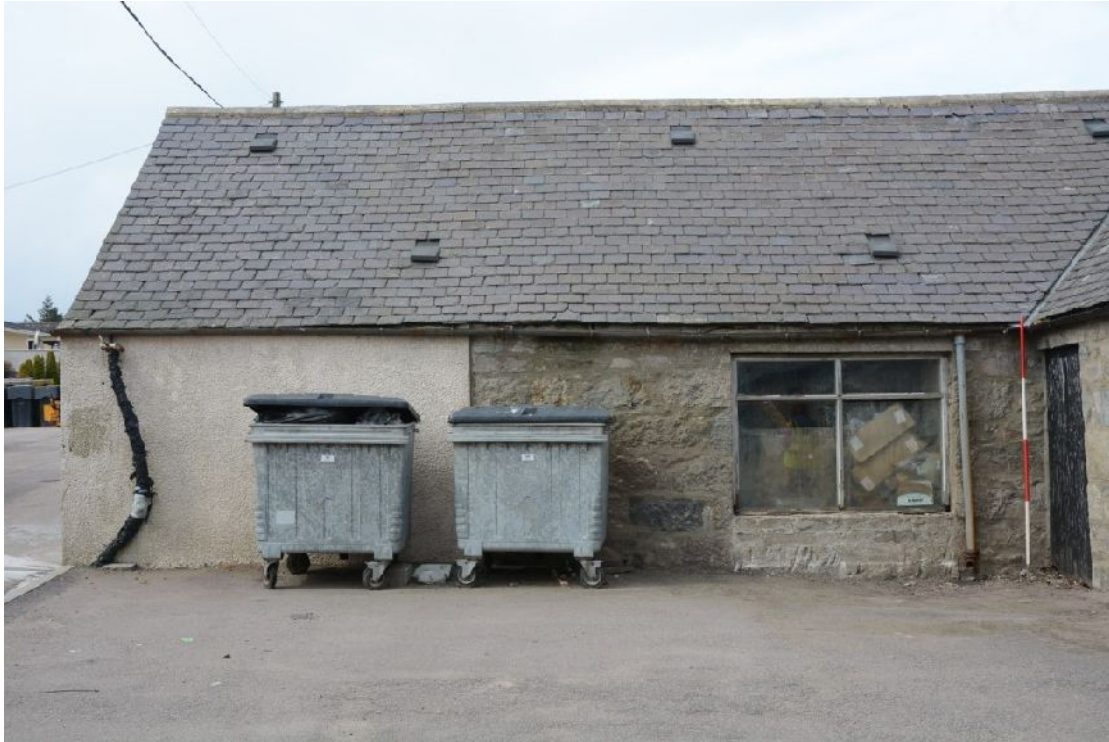
Illus 13 Building 3. N steading. E wall of W range. Shows window W1 built in earlier opening. (Photo 12)

W1 W:1.85m H: 1.35m Modern window set into full height original opening-possibly cart opening (illus 13).

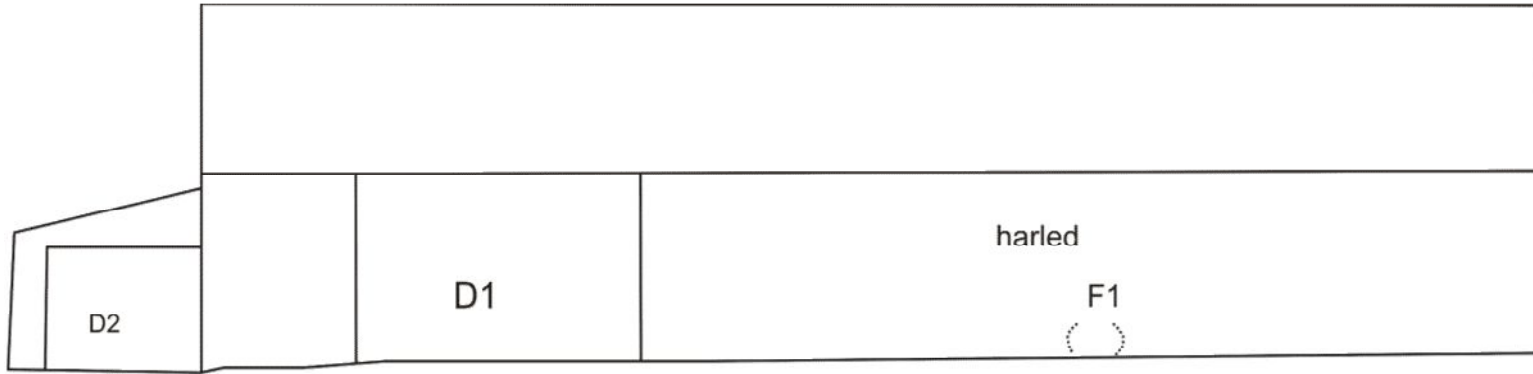
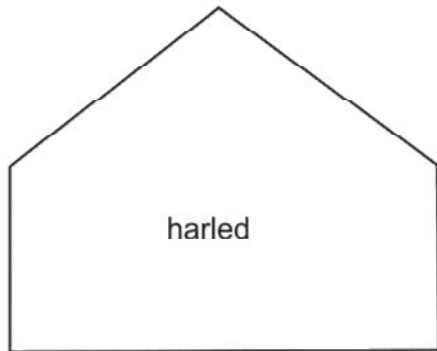
Illus 15 Elevations of Building 2 (South stading)

NORTH ELEVATION

WEST ELEVATION
