DUNNOTAR CASTLE STONEHAVEN ABERDEENSHIRE

- Archaeological Watching Brief -

Report No: MAS 2015-15

DUNNOTTAR CASTLE, STONEHAVEN ABERDEENSHIRE

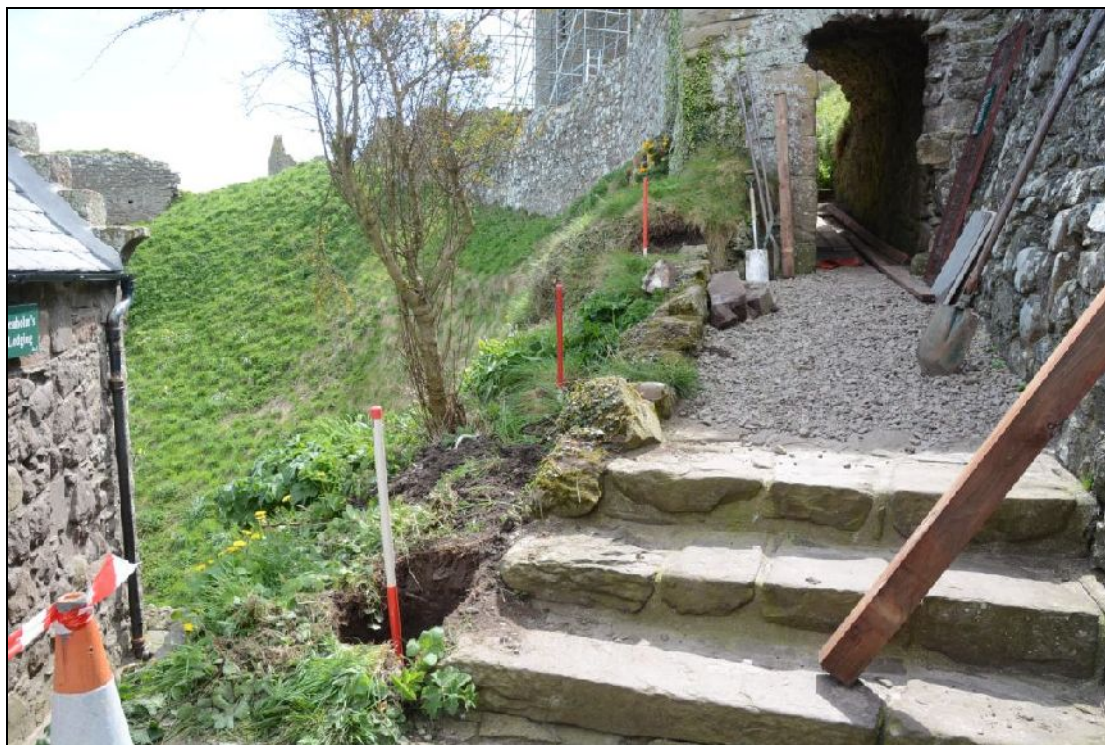
Three post-holes were excavated on the E side of the steps and the pathway over a distance of 4.5m. They were excavated into the side of a steep bank which is retained at the NW end by a low wall and further up to the SE by wire mesh.

Hole 1: was at the bottom of the four steps and measured 500mm x 400mm and was 600mm deep. The fill consisted of brown soil mixed with small stone and some animal bone and one piece of clay tobacco pipe stem.

Hole 2: was located 1.9m SE of Hole 1 with the same dimensions and fill.

Illus 2: Steps at Site 1, looking SE.

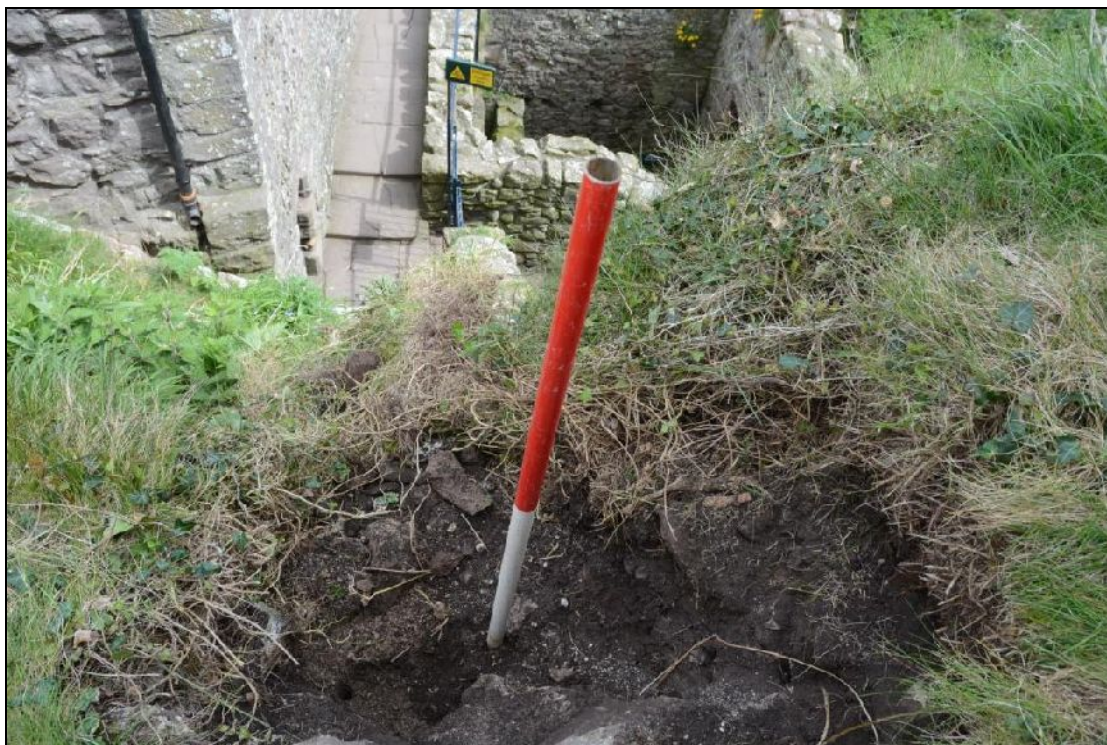
Hole 3: was located 2m SE of Hole 2. It was 400mm x 400mm and was only 500mm deep as the revetting at this point consisted of vegetation, stone and some earth.

No archaeological features or finds were evident at Site 1.

Illus 3: Hole 3 at Site 1, showing the stoney nature of the bank, looking NE.

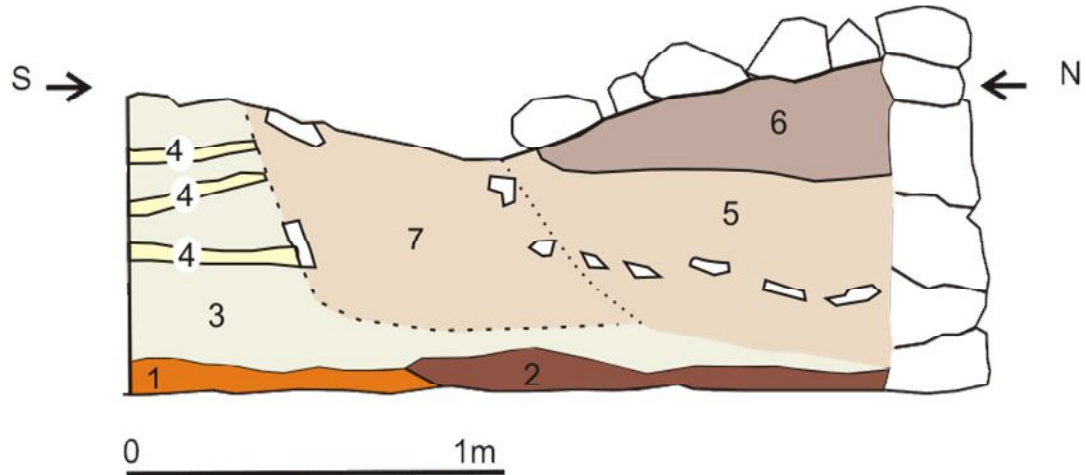
At the base of the cut, a 200mm layer of red slightly silty burnt material (1) may represent red ash from the smithy fires deposited in the corner between the two buildings (Illus.4). It merged with (2), a layer of red ash mixed with charcoal and soil. These base layers contained much animal bone and a single body sherd of late medieval/early post medieval pottery possibly 16th century in date. The red ash (1 and 2), on the S side of the cut, was overlain by a 700mm deep deposit of brown soil and charcoal with three distinct layers of mortar (3 and 4). These layers also contained animal bone, clay tobacco pipe stems and a portion of a pipe bowl of possible 17th - century date.

Layers (7) and (5) cut the mortar levels and consisted of brown soil mixed through with much small stone. Above (5), a 300mm layer of cleaner brown soil (6) and stone may represent gradual collapse of material from the wall abutting the NE corner of the Store building.

Illus 4: Section through the soil and rubble at Site 2.

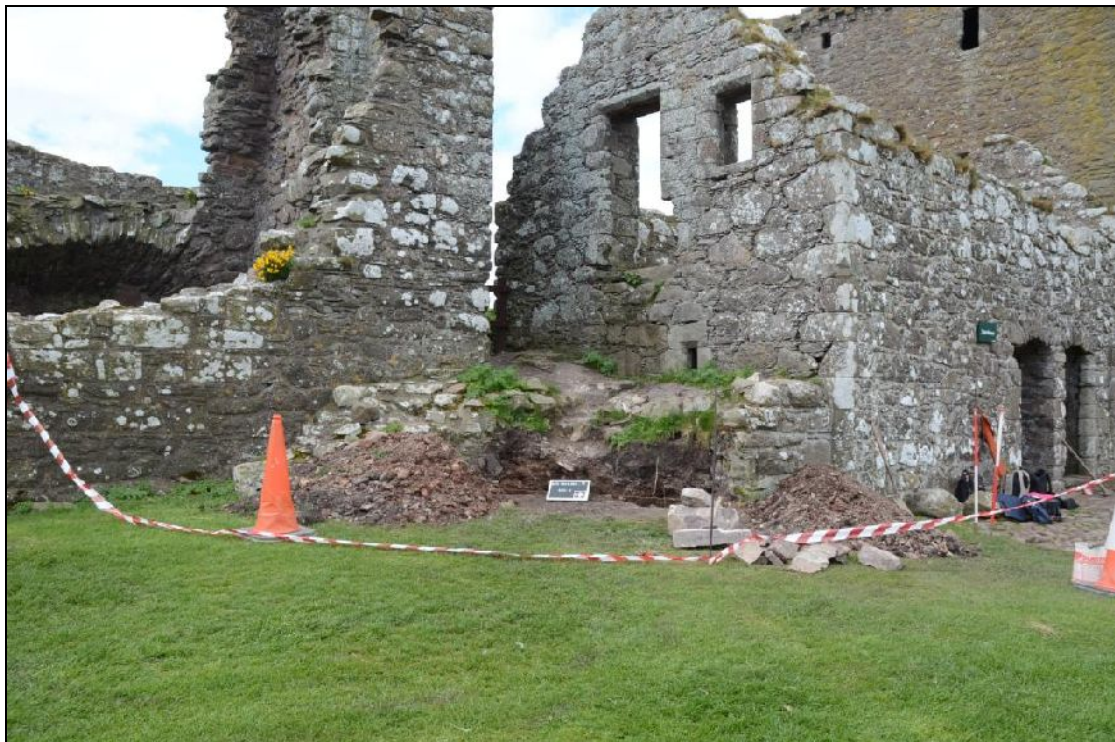
Between the NW corner of the Smithy and the NE corner of the Store, a slope had built up between the two buildings. In order to deter visitors from accessing the slope, the soil and rubble bank was cut back just enough to enable the construction of a small retaining wall. The slope was cut back c.600mm over a distance of 1.9m, with a foundation trench 300mm deep. The face of the cut was c.800mm high at its N and S ends dipping to c.600mm in the centre.

Illus 5: Location of Site 2, looking SW.

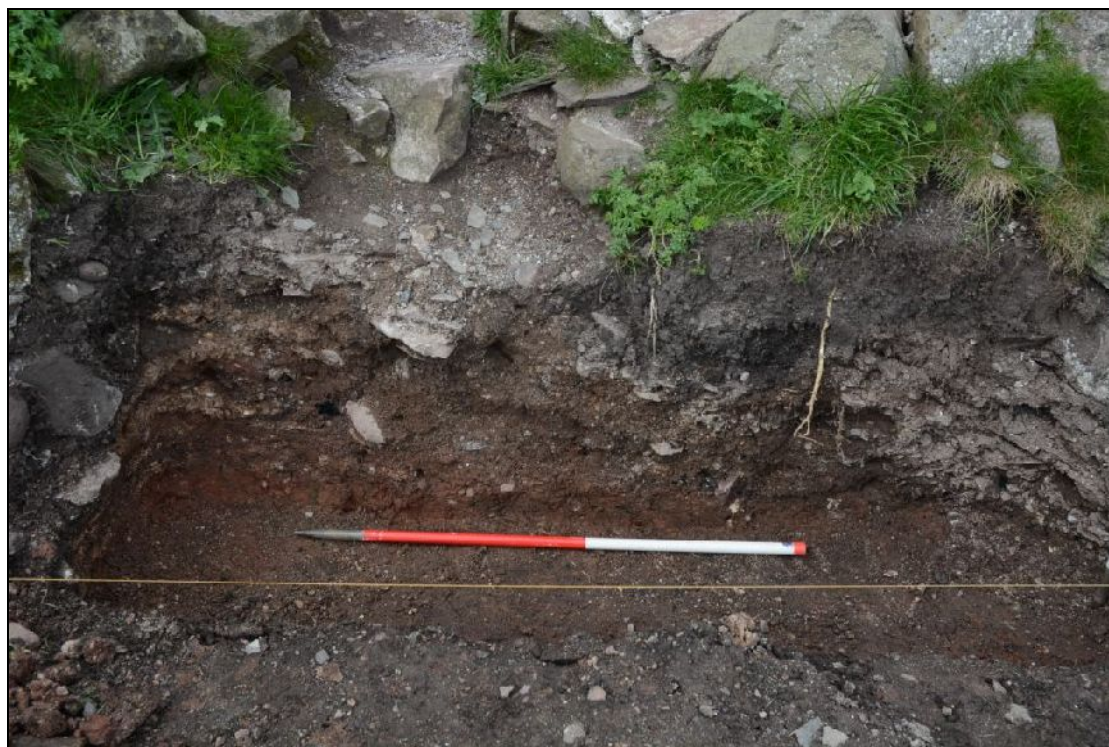
Illus 6: Detail of section, Site 2.

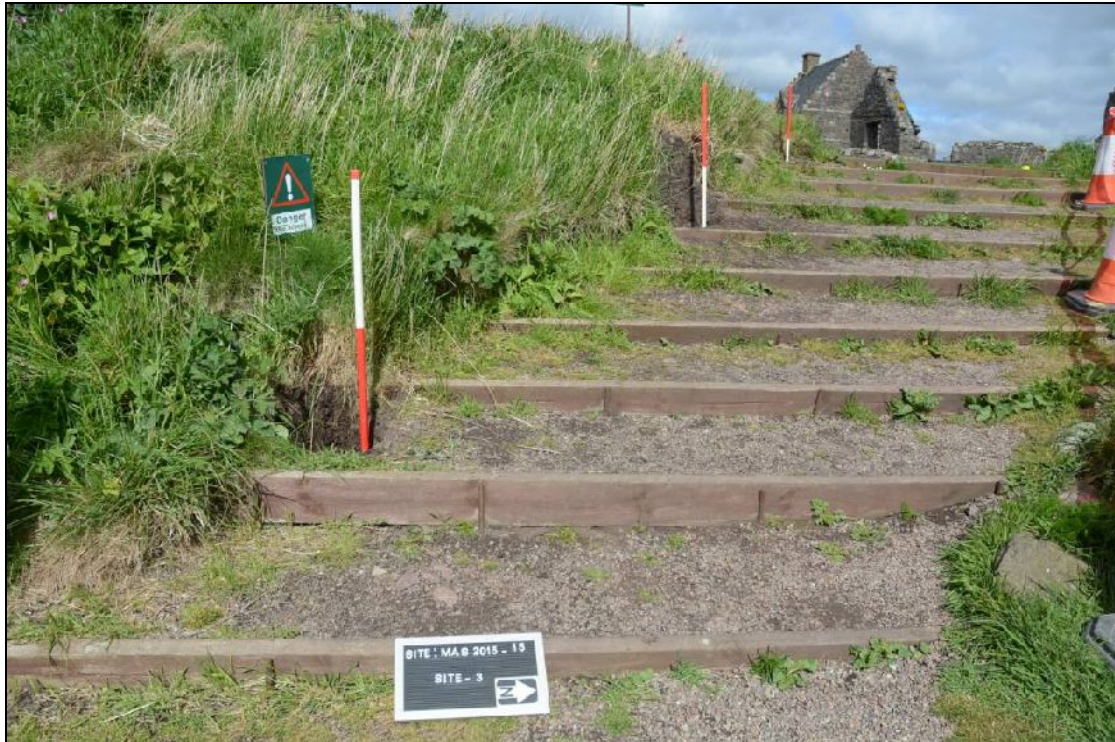
On the SE side of the graveyard a series of nine steps, measuring 7.8m from top to bottom, lead down to the Guardhouse.

Illus 7: Site 3 steps, looking NW.

Although it was initially intended to install five posts to hold the safety rail, only three were deemed necessary, at steps two, six and nine.

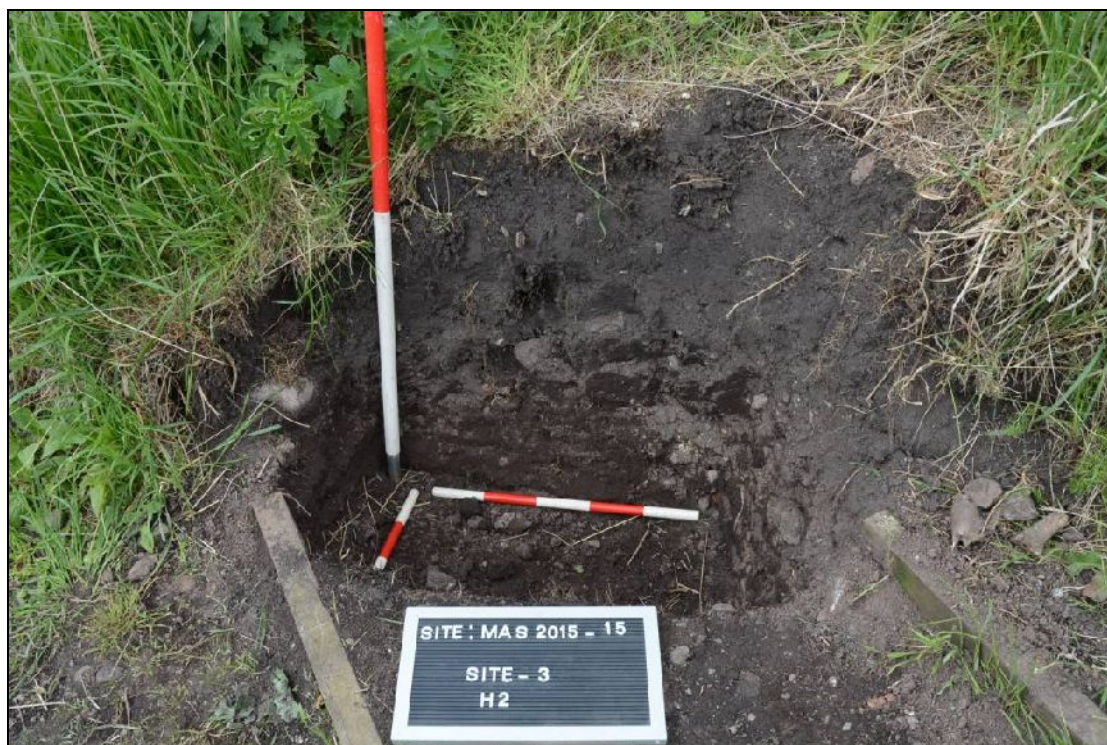
Hole 2: was 3.1m NW of Hole 1 and measured 500mm x 400mm x 200mm deep. At the rear of the post it cut into the bank to a depth of 750mm. The fill was the same as Hole 1.

Illus 8: Site 3, Hole 2, looking SW.
