**SOUTH NITTANSHEAD
WIND TURBINE
NEW PITSLIGO
ABERDEENSHIRE**

- Archaeological Watching Brief -
Carried out 30th April 2015
by
Murray Archaeological Services Ltd

Report No: MAS 2015 - 6
by

**SOUTH NITTANSHEAD WIND TURBINE
NEW PITSLIGO
ABERDEENSHIRE**

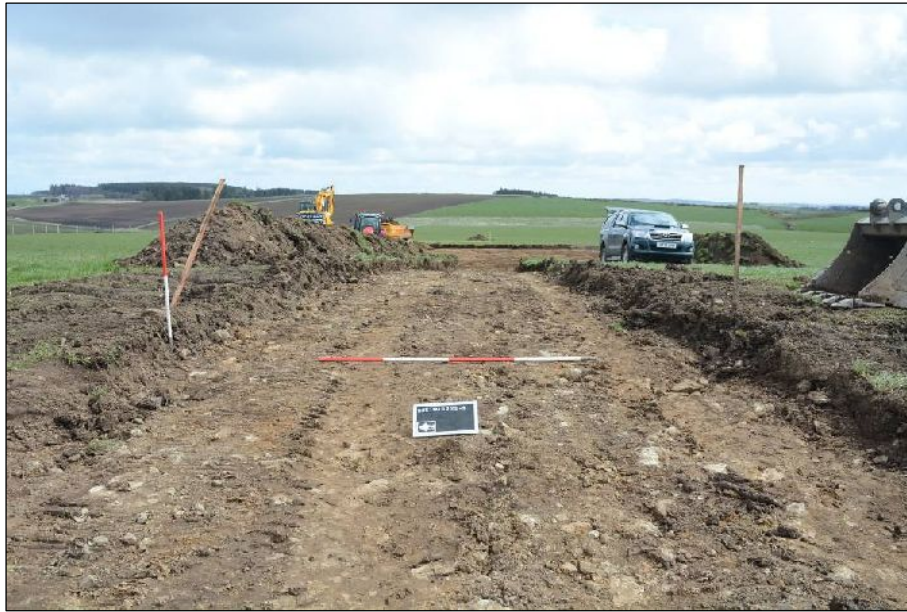
3.2 The W end of the access track leads from an existing N-S farm track down a gentle slope to the E for a distance of 48m. Where it led from the farm track it was c.16m wide to facilitate vehicles turning but narrowed gradually to 3.5m wide c.14m E of the farm track. For the first 32m of the access track c.300mm of grass and topsoil overlay a hard and very stoney natural in a slightly silty and sandy matrix. From the 32m point eastwards to the area of hard standing, the depth of topsoil increased to c.400mm over a less stoney, yellow/reddish sandy and slightly silty natural.

Illus 3: Access track, showing the stoney nature of the ground, looking E

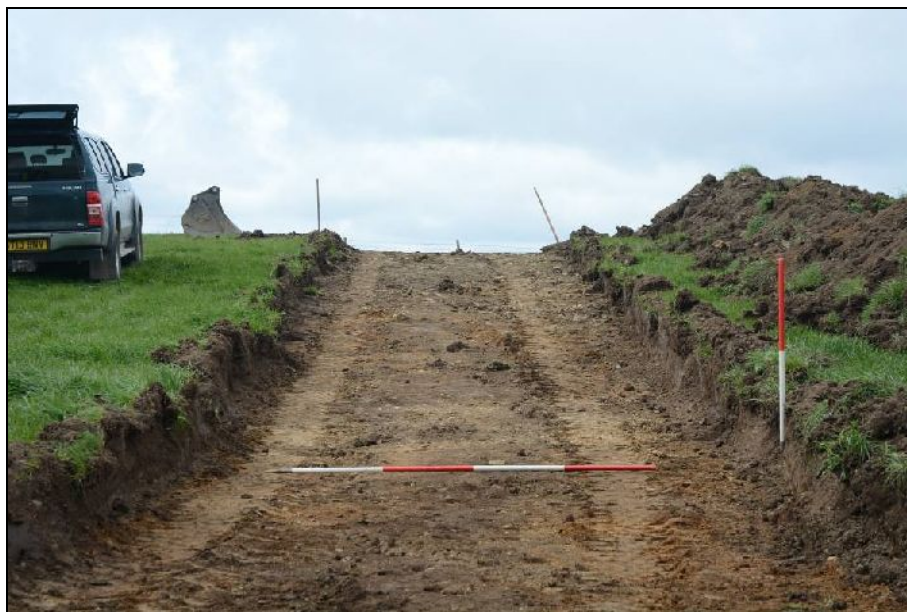
Illus 4: Access track, looking W up the slope

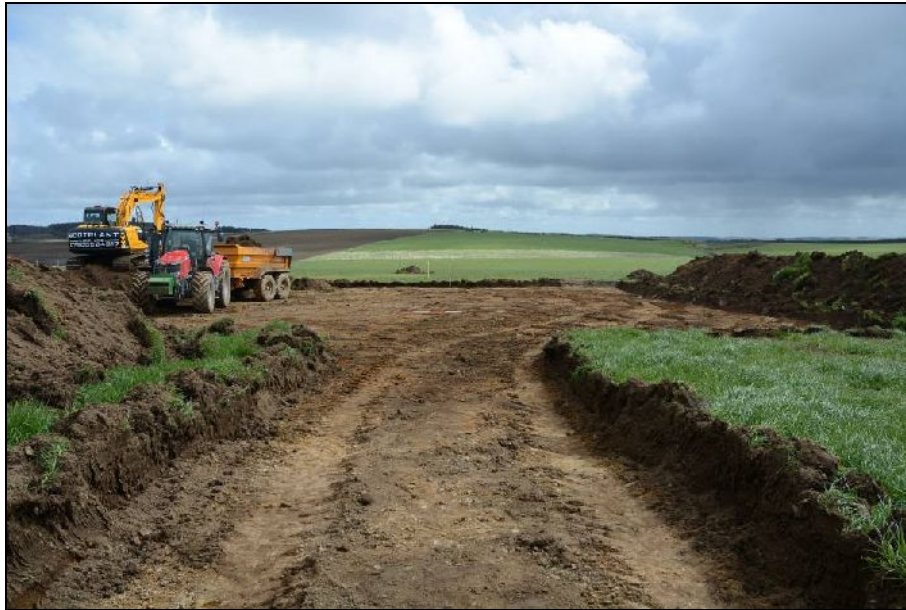
Illus 5: Junction of access track and area of hard standing

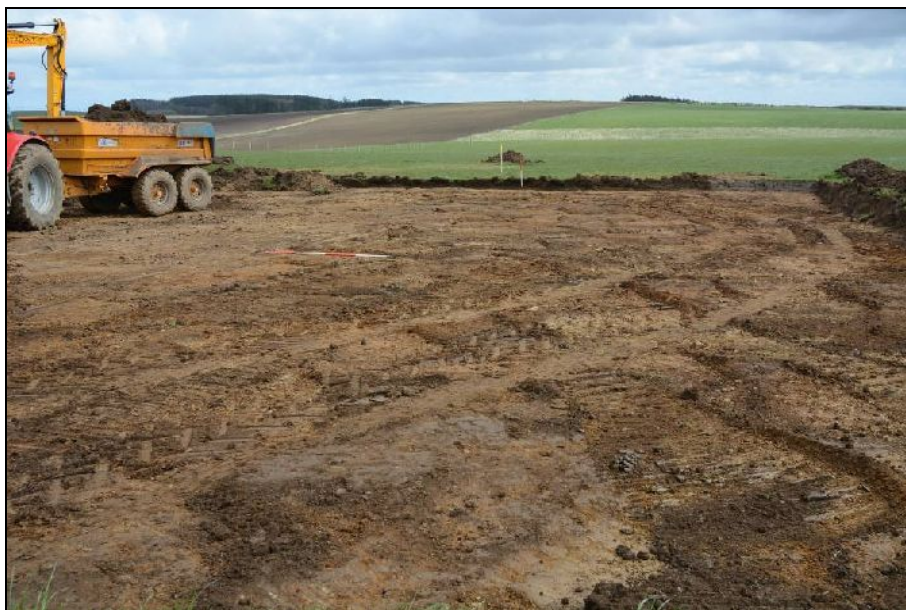
3.3 The area cleared for the hard standing was 20.5m (N-S) x 25.5m (E-W). Over this whole area the depth of grass and topsoil was c.400mm and overlay yellow/reddish sandy and slightly silty natural with some small stones mixed through.

Illus 6: Area of hard standing, looking NE

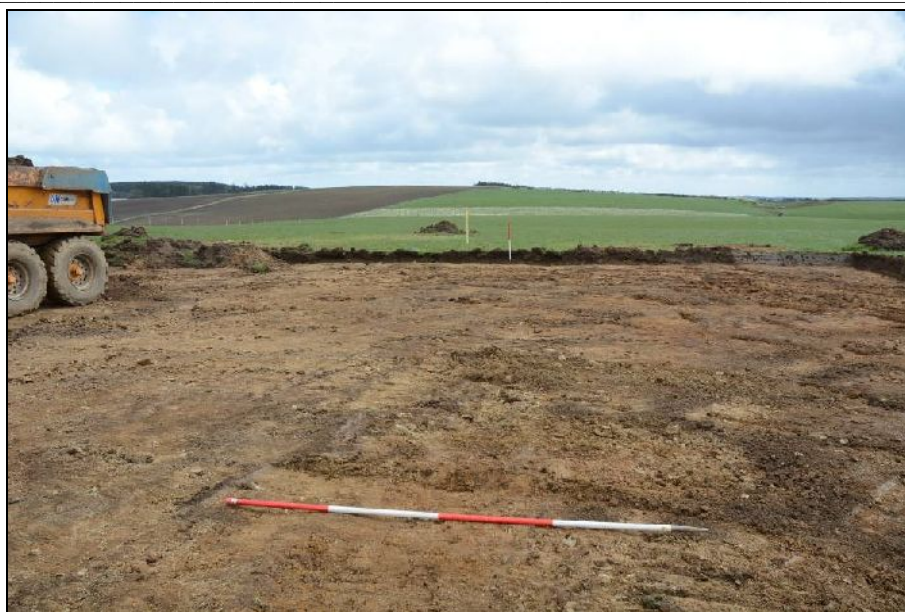
Illus 7: Area of hard standing, looking E. The upright stick E of the hard standing marks the location of the turbine base
