FARM STEADING CRAIGMYLE KEMNAY ABERDEENSHIRE

## **Standing Building Survey**

Carried out 20<sup>th</sup> July 2015 by **Murray Archaeological Services Ltd**

## **Report No: MAS 2015-23** by H K Murray and J C Murray

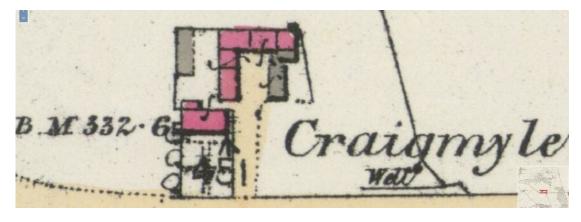
Illus 2 Detail of the 1<sup>st</sup> edition Ordnance Survey 25" map, surveyed in 1864 (published 1869. Sheet lxiv.3 (Kemnay) <u>www.nls.ac.uk</u>

4.1 1<sup>st</sup> edition Ordnance Survey 25"/mile Aberdeen Sheet LXIV.3 (Kemnay)
1864 (pub 1869) shows a main L-shaped steading with N and W ranges. A smaller L-shaped building (grey shaded ? iron/wood) formed the E range. A freestanding rectangular building lay to the W. The house is shown in its present position but as a plain rectangular block with a small outshot at the NW.

This identification is supported by the position of the lade shown on the 1864 and 1899 maps (Illus 2, 3). Part of the lade remains as a sunken drain running below the road.

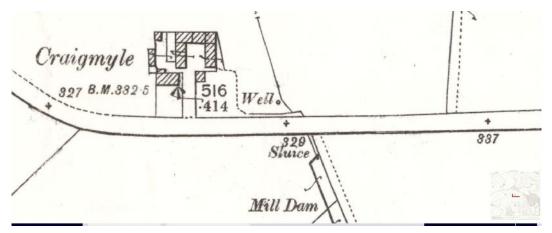
Illus 3 Detail of the 2<sup>nd</sup> edition 25"/mile Ordnance Survey of 1899 (published 1900. Aberdeenshire Sheet 064.03) <u>www.nls.ac.uk</u>

By 1899, the N and W ranges remain with a new E range transforming this into a U-shaped steading. Three smaller freestanding buildings lay to the W and S. The house remains as it was in 1864.

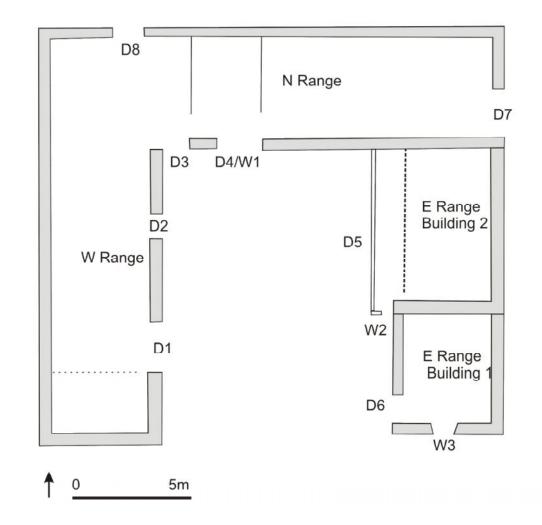
**Illus 4 Plan of buildings**

- 5.1 The ground plan (Illus 4) and elevations (Illus 20) have been annotated to show details and to indicate differences in the building materials which may help in understanding the development and history of the building.
- 5.2 The areas recorded were photographed. The full set of photographs will be supplied for the archive and an annotated plan in the present report (Illus 19) indicates the position of each.

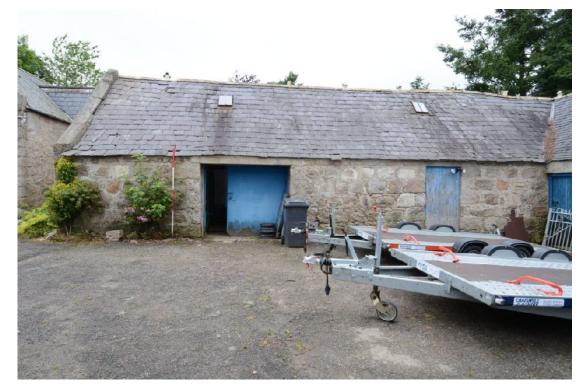
#### Illus 5 E wall of W range

D1 H: 1.80m W: 1.25m Replacement concrete lintel. Sliding metal door. Granite rybats at side suggest this was the original width (Illus 5)

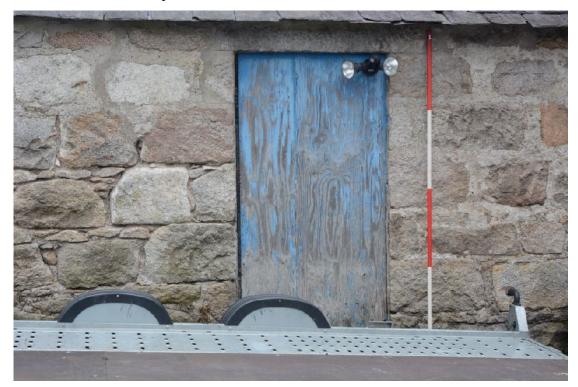
Illus 6 W Range. Door D2

D2 H: 1.93m W: 1.00m Granite lintel and rybats. Wooden door.

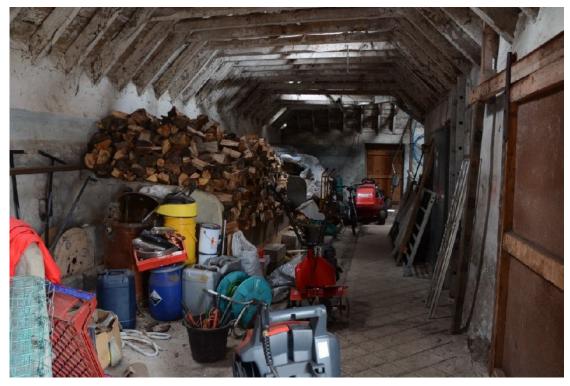
<u>Interior</u> Concrete trevises for 6 double stalls for tied cows.. The S stall has been re-used to form a partitioned area.

Illus 7 W Range. Interior looking N showing concrete cow stalls.

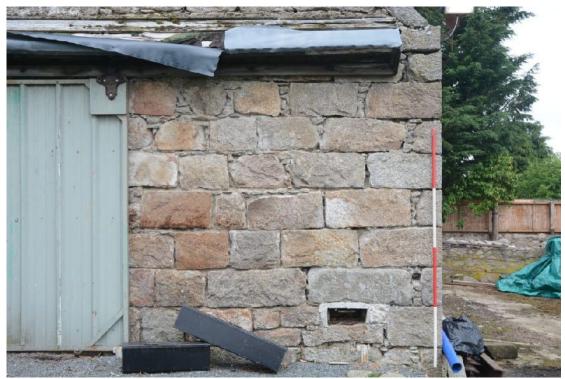
<u>Walls</u> Rubble stone wall. E gable is noticeably finer with good rectangular blocks.

Illus 9 Detail of E gable of N range. Note blockwork. Concrete blocking at base of wall appeared to be modern knock-through.

The good stonework on the E gable of the N Range was noteworthy. It is possible that this was the original position of a mill as better stonework was often used to counter the movement of a mill wheel. The small blocking in the

gable appeared however to be a modern break-through and any other details would have been removed by the insertion of the large gable door.

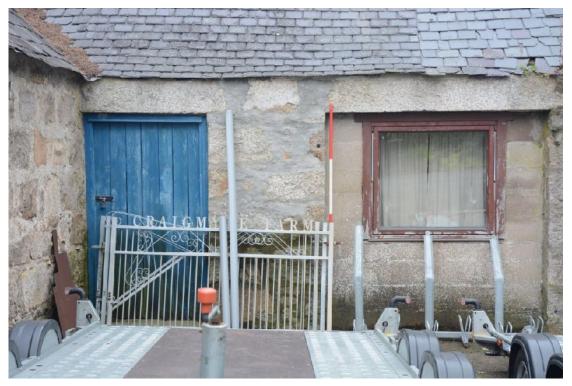
Illus 11 N Range, S wall. Door D3 and D4 with W1 inserted.

D3 H: 1.92m W: 1.15m Granite lintel and rybats. Wooden door.

D4 H: 2m W: 2m Granite lintel. Blocked with concrete blocks. W1 inserted.

W1 H:1.18m. W: 1.30m. Secondary modern window.

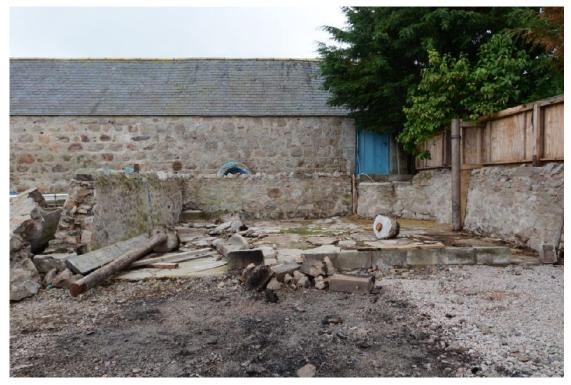
D8 H: 2.10m. W: 1.18m Wooden lintel, concrete blocks at sides. May originally have given access to a building to N (now only visible as wall stubs Illus 12).

Illus 12 N wall of N Range with door D8 and foundation of building to N

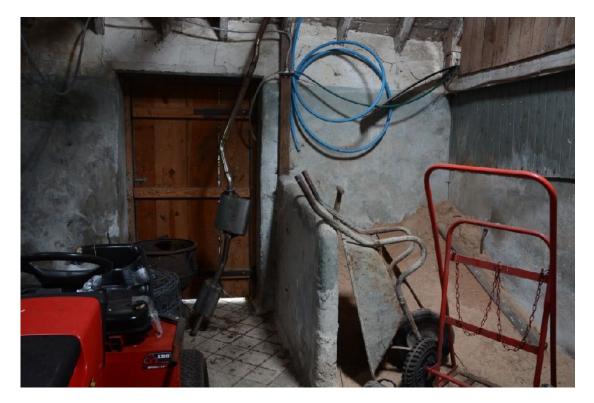
<u>Interior</u> One double cow stall against the N wall, E of door D8. Two recent concrete and wooden partitions in central area.

Illus 13 N Range, door D8 and cow stall from interior

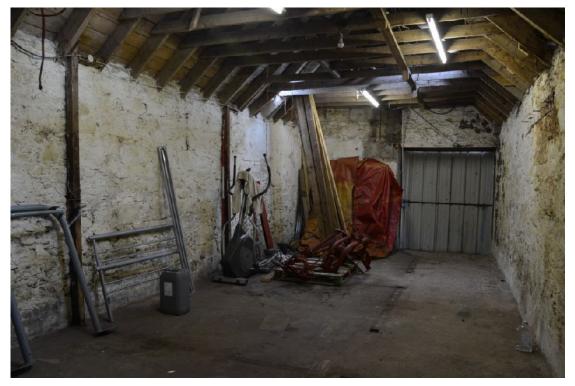
#### Illus 14 N Range interior looking E to D7

D7 H: 2.3m. W: 2.05m. Sliding metal door

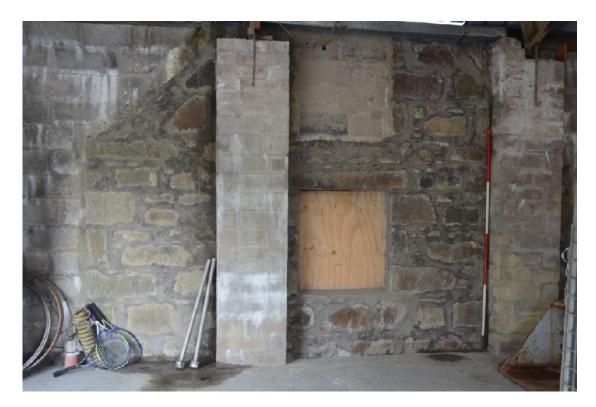
#### Illus 15 S gable of E Range Building 1.

The S wall was only visible from within the modern garage and was much obscured (Illus 15).

W3 H: 1.90m W: 1.2m Granite lintel. The height suggests this may havebeen a door but it spalyed to the inside, which is more usual for a window.Blocked with stonework. Part of a blocked window above W: 1.2m. H: 0.98m

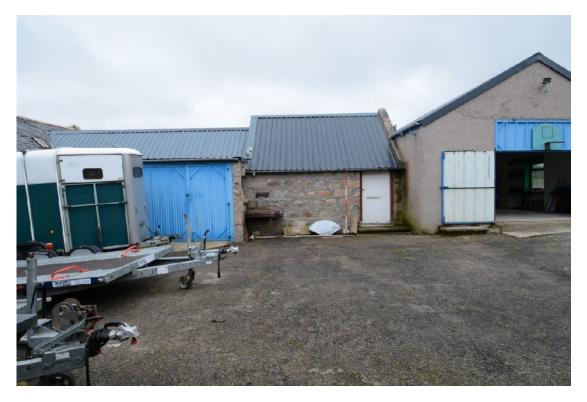
Illus 16 E Range, W wall (Building 2 on LHS, with Building 1 in centre and modern garage on RHS)

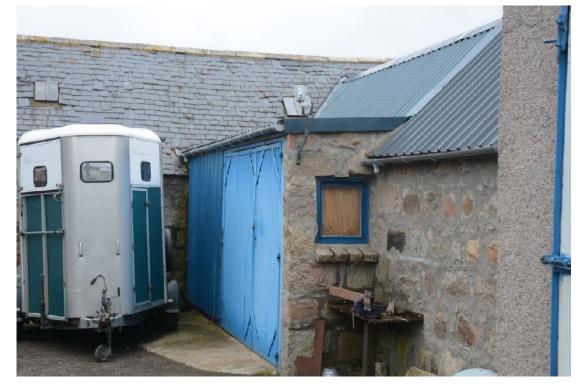
<u>Dimensions</u> 5.6m x 6.5m externally. The width of the original building appears to have been c. 4m with an additional flat roofed extension c. 1.5m wide built extending the W side.

<u>Walls</u> Rubble stone to E. W wall mostly made up with sliding doors D5 and corrugated sheeting. S wall of concrete blocks.

Illus 18 E Range Building 2.W wall showing flat-roofed extension, D5 and W2

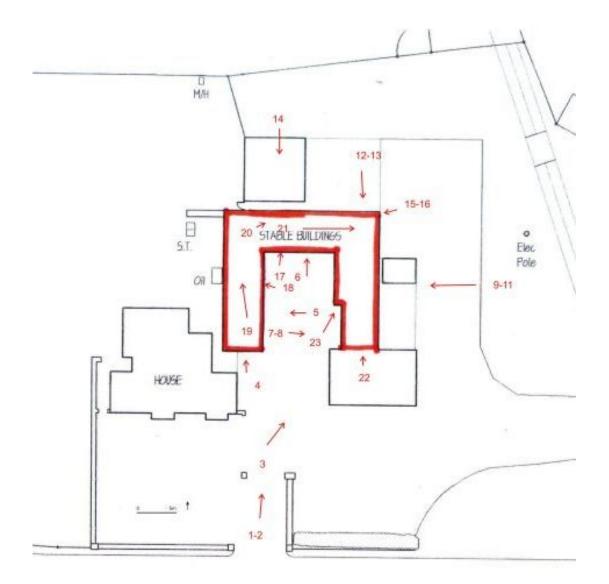
Illus 19 Photographic references. Plan annotated from drawing courtesy of Squire Associates (Aberdeen) Ltd
