41-43 NEW STREET ROTHES MORAY

Standing Building Survey

Carried out 28th July 2015 by Murray Archaeological Services Ltd

Report No: MAS 2015-24 by H K Murray and J C Murray

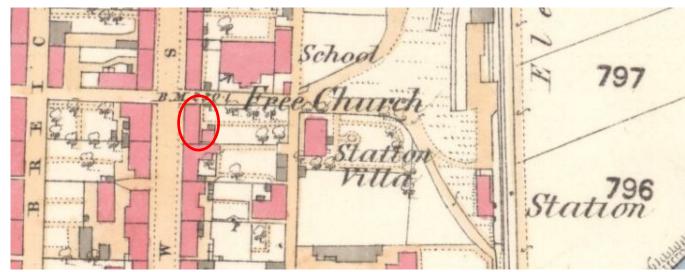
1874) shows a rectangular stone building on the New Street frontage with a small, almost square, outhouse abutting the back wall. The remainder of the plot is shown as open garden ground.

Illus 2 Detail of the 1st edition Ordnance Survey 25" map, surveyed in 1871 (published 1874. Elgin sheet xviii (Rothes) <u>www.nls.ac.uk</u>

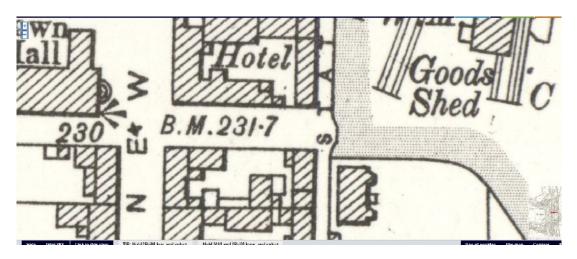
By 1902 the property is considerably built up, with a separate set of buildings fronting on Station Street. The building on the New Street frontage remains but has an extension at right angles, fronting on the lane between New Street and Station Street. In the back yard, the earlier outbuilding appears to have been replaced by a small structure at the junction of the two main buildings, and a series of small sheds along the S boundary.

Illus 3 Detail of the 2nd edition 25"/mile Ordnance Survey of 1902 (published 1905. Banffshire sheet 018.03) <u>www.nls.ac.uk</u>

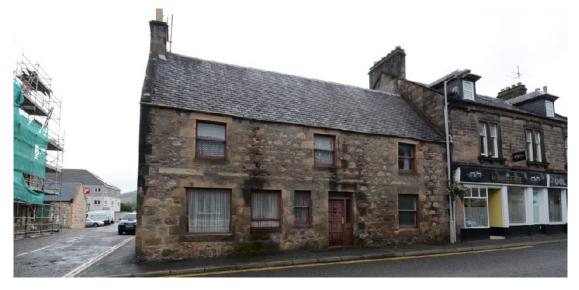
Externally the W wing is c. 13.7 x 6m. To the S it abuts nos 35-39 New Street. The walls are of rubble stone, with a wide range of stone, including quartzite stone. Rybats at openings and at the corners are of dressed sandstone. The roof is slate with a metal

ridge. There are two metal skylights in the E side. The single rectangular chimney, at the N gable, is of sandstone with a plain table and two ceramic pots.

Illus 4 W frontage on New Street

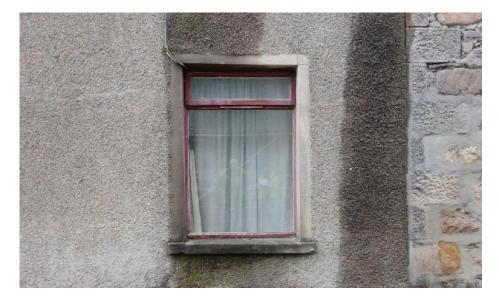
Externally the E wing is c. 7.5 x 5.2m and it abuts the W wing. The walls are externally pebble-dashed rendered, but internally several areas of the wall face have been stripped and it can be seen to be of mass concrete construction. In appearance it is very coarse and it is almost certainly 'no fines concrete', common in the late 19th century (Urquhart, 2013, 8-9). Window margins are of precast concrete (Illus 5). The roof is of slate with a metal skylight on the S side. The chimney is a plain rectangle. It is pebble-dashed but likely to be of concrete block construction.

Illus 5 Window W10 with concrete surround. Note on RHS junction between the earlier stone building and the later concrete building.

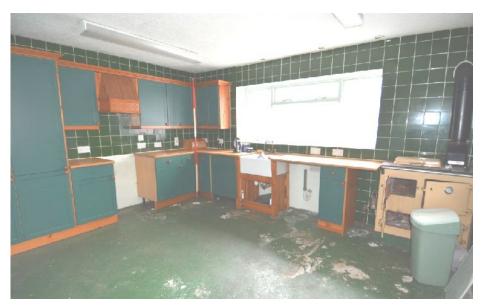
Room 1: Kitchen. Plaster board lining. Modern tiling and cupboards.

W12 H: 1.00m W: 2.32m Modern window with fixed central pane with small hinged pane above and larger hinged panes on either side.W19 H: 1m W: 1m. Modern window. 2 panes. Not opening.

Illus 8 Room 1: Kitchen

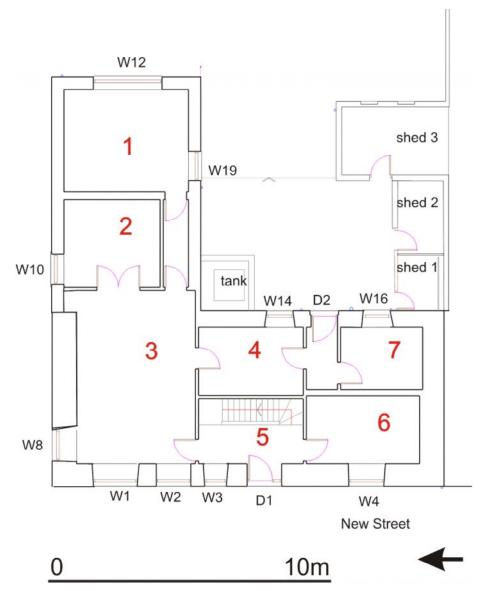
Illus 9 Ground floor plan annotated from plan courtesy of Ken Mathieson architectural design Ltd.

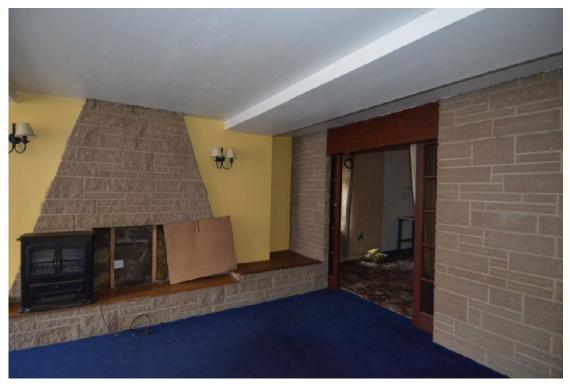
Large modern fireplace unit on N wall. Narrowing of E end of N wall indicates the original back of the W wing. The original wall line of the E wall can be seen in the

Illus 10 Room 3, looking towards NE corner. Note narrower external wall in corner and the line of original E wall across the ceiling.

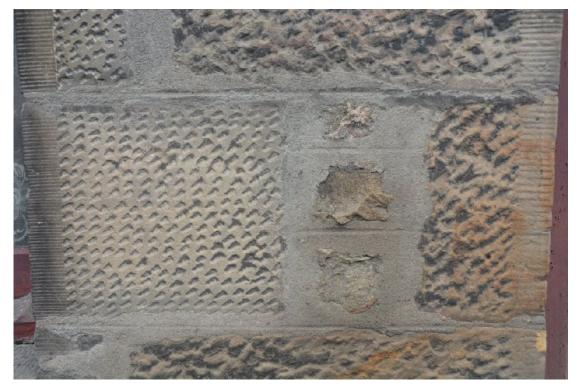
W3 H: 1.28m W: 0.72m Splays internally. Externally tooled sandstone rybats with margin draft. This appears to be a secondary window, possibly after the blocking of the door at W2. The tooling on the sandstone is different from all other windows (see illus 11).

Illus 11 Detail of rybats on W3 (LHS) and D1 (RHS). Note the less weathered and more separated tool marks on window W3.

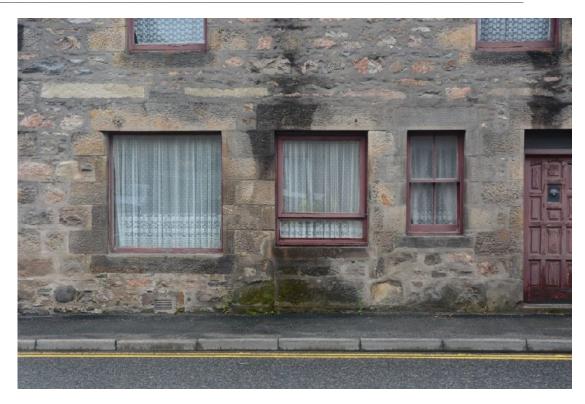
W2 H: 1.43m W: 1.19m No internal splay. Externally tooled sandstone rybats with margin draft. Externally it is clear that this was originally a door, with the lower section stone blocked and the upper part made into a window. This also accords with the lack of splay.

Illus 12 W elevation from LHS: W1, W2 with blocking below and W3

The blocked doorway (W2) and large window (W1) on the N side of the New Street frontage might indicate that in its original form this end of the building may have been a shop or workshop. It certainly appears to have been two separate occupancies, each with a door to New Street. There is an odd line of thin horizontal stones in the frontage above the level of the door which might suggest this had originally been a single-storey building. Tentative confirmation comes from the very much more worn nature of the rybats at the NW corner below the level of this line (Illus 20). It can also be argued that the upper windows on the New Street frontage appear to be of a slightly different colour of sandstone (although they could not be examined close-up). However there is no obvious break in the stonework on the side street N gable.

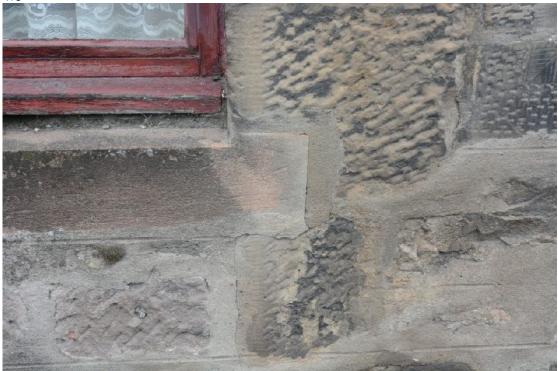
Illus 13 Detail of bottom RHS of W2 showing new sill breaking across rybats of earlier door.

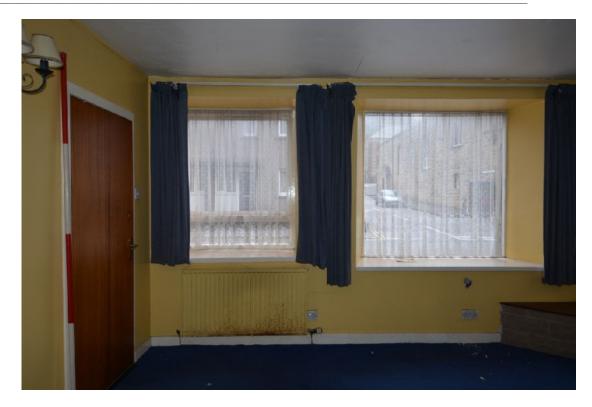
Illus 14 Room 3 Window (blocked door) W2 (LHS) and W1 (RHS)

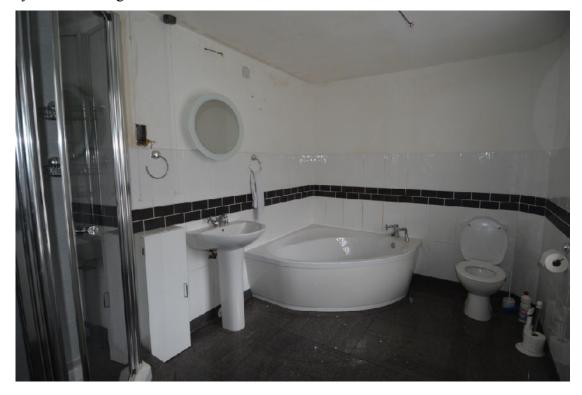
W4 H: 1.55m W: 1.2m Splays internally. Externally tooled sandstone rybats with margin draft.

Illus 15 Room 6: bathroom

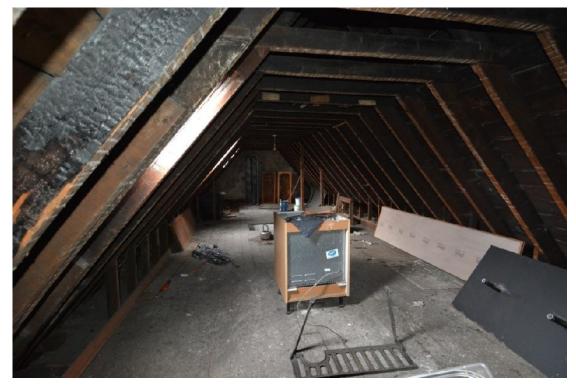
Floored attic over front W wing of building. A frame roof with sarking. Traces of lathe and plaster. Some charring on some rafters.

Illus 16 Attic of W wing looking S. Note charring on rafter in foreground

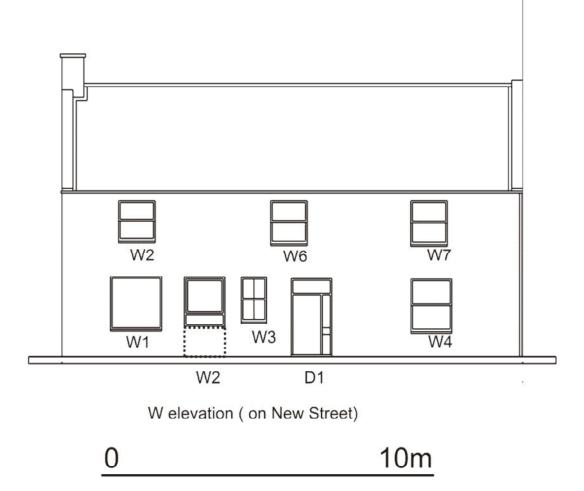
Illus 18 W elevation annotated from plan courtesy of Ken Mathieson architectural design Ltd.

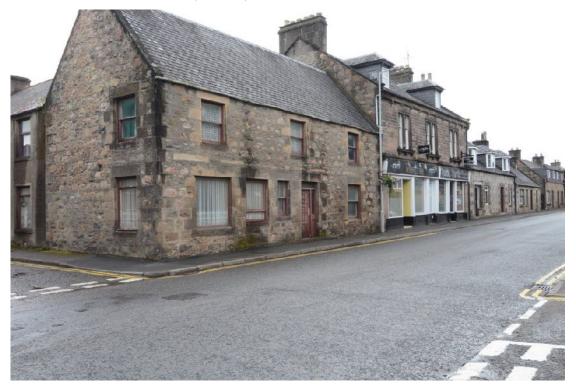
The frontage of 41 New Street, as shown on the 1871 OS map, fits within Groome's description. It is a well-built stone house, with some element of sophistication in the detailing of the sandstone around the windows and door. Although less pretentious than the neighbouring building to the S (Nos 37/39), it is considerably larger than the smaller buildings further S along the street- many of which show a distinct stonework that is different from No 41 (Illus 19).

Illus 19 Looking S along New Street

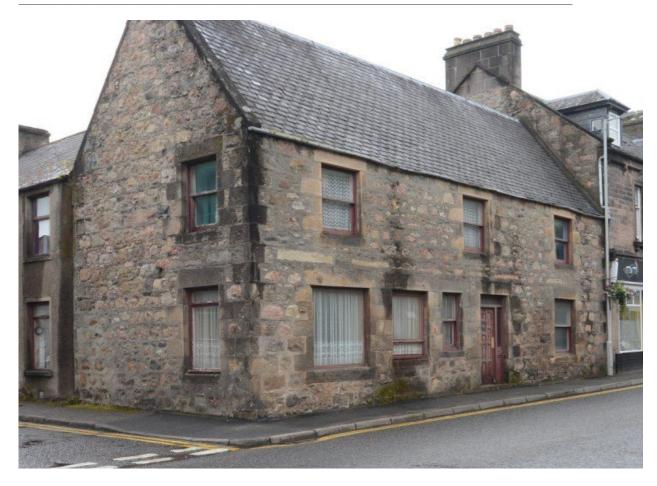
Illus 20 Detail of NW corner

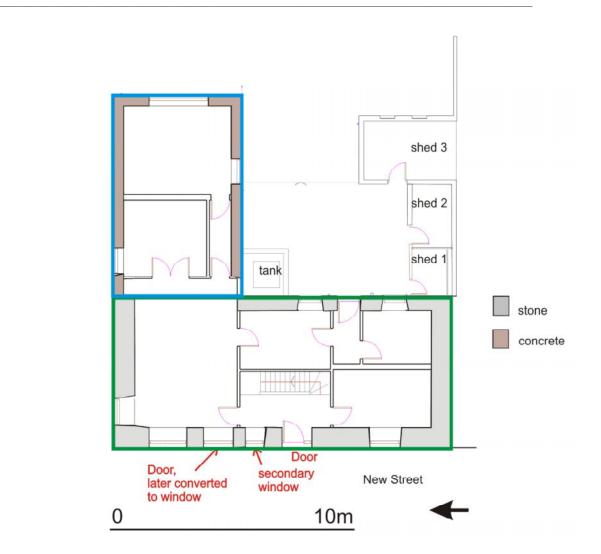
The New Street frontage appears to be the building shown on the 1871 OS map (Illus 2). The date of any alterations is not known but clearly it was the 2-storied structure it is today by the time the E wing was built abutting it, along the side street. (Illus 21) This later 19th century extension at right angles to New Street appears to have been of mass concrete construction, with the very coarse appearance on inner wall faces suggesting it was a 'no fines concrete. Urquhart (2013, 8-9) notes that this was common in use for domestic buildings in the late 19th century. It is of interest that areas such as Speymouth in Moray, where mass clay construction was common, were also areas where mass concrete construction was developed fairly early (Urquhart, 2013, 6). It appears to have been built between 1871 and the later OS map of 1902 (Illus 3).

Illus 21 Interpretation. Based on plan courtesy of Ken Mathieson architectural design Ltd. Green outline is the earlier building. Blue outline is the late 19th-century addition.

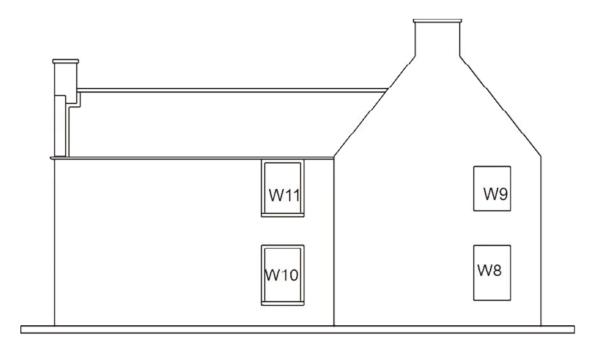
Illus 24 N elevation. Courtesy of Ken Mathieson architectural design Ltd.

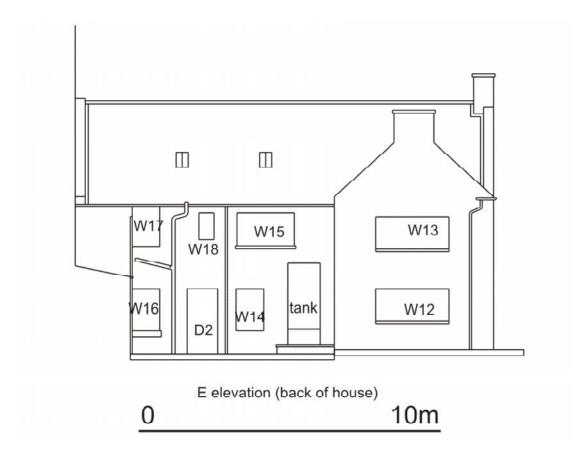
Illus 25 E elevation courtesy of Ken Mathieson architectural design Ltd.

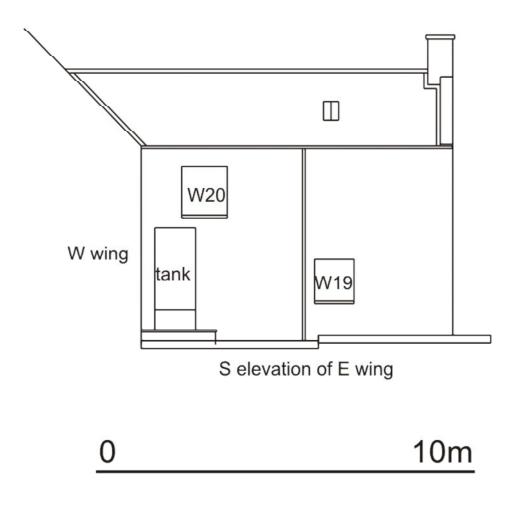
Illus 26 S elevation of E wing courtesy of Ken Mathieson architectural design Ltd.

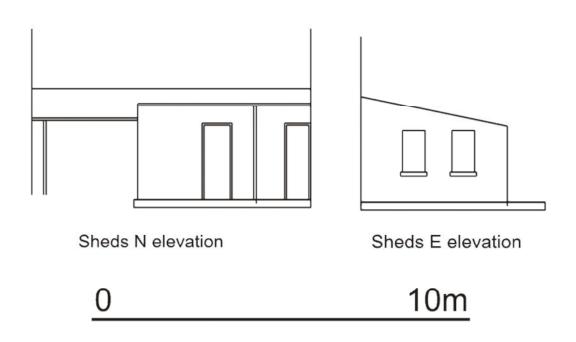
Three sheds abut the boundary wall on the S side of property. They are built of a mixture of cement blocks and brick, pebble-dashed. Corrugated tin roof. No evidence of original function.

Illus 27 Elevation of sheds courtesy of Ken Mathieson architectural design Ltd.
