# UPPER MILL INVERBERVIE ABERDEENSHIRE

### **Standing Building Survey**

Report No: MAS 2015-34 by H K Murray and J C Murray

- 1.1 A standing building survey was required for the mill buildings at Upper Mill, Inverbervie, Aberdeenshire, prior to their partial demolition and conversion into a dwelling.

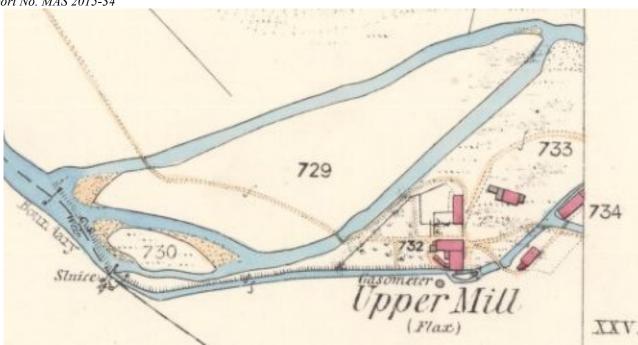
Illus 2 Detail of the 1<sup>st</sup> edition Ordnance Survey 25" map, surveyed in 1864 (published 1868). <a href="https://www.nls.ac.uk">www.nls.ac.uk</a>

- 4.3 1st edition Ordnance Survey 25"/mile Kincardine Sheet XXV.2 (with insert XXV.1) (Arbuthnot) surveyed in 1864, published in 1868 shows a cluster of five buildings. The mill itself was an L-shaped building, with an E/W building abutting the N end of the main mill structure which was by the mill lade. Several small structures abut the outside of the W side of the mill. N and NE of the mill lie two further buildings on the N side of the lade, with two other buildings S of the lade.

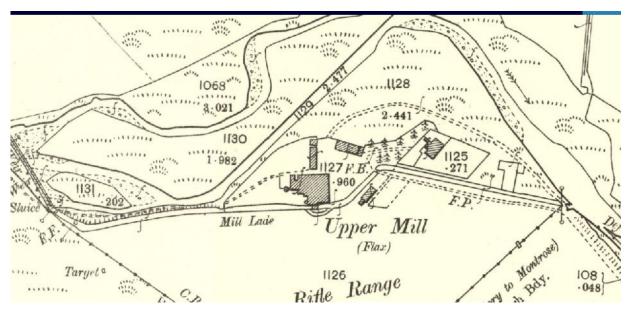
Illus 3 Detail of the 2<sup>nd</sup> edition Ordnance Survey 25" map, surveyed in 1902 (published 1903). <a href="https://www.nls.ac.uk">www.nls.ac.uk</a>

**Kincardineshire 025.14 (includes Bervie).** Considerable changes occurred in the period between 1864 and 1902. Significantly, there was an extension along the E side of the main mill block and some alterations to the W side of the N section of the building. The two buildings N of the lade remain and for the first time the manager's house is shown. One of the buildings S of the lade has been removed.

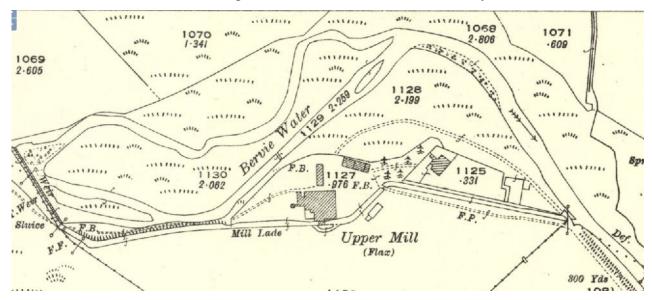
Illus 4 Detail of the Ordnance Survey 25" map, surveyed in 1922 (published 1925). <a href="https://www.nls.ac.uk">www.nls.ac.uk</a>

There appears to be no significant change to the mill buildings between 1902 and 1922, but the second of the buildings S of the lade had become roofless by 1922.

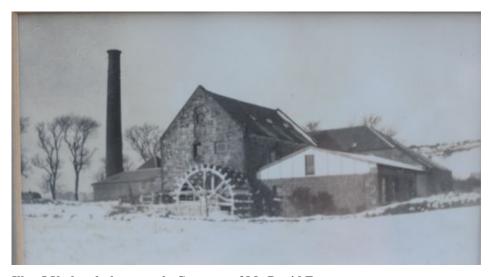
Illus 5 Undated photograph. Courtesy of Mr David Evans

This is a general view of the mill looking N from the S side of the lade. The main mill building retains its water wheel. A lower building with pitched roof abuts it to the E, extending to an E/W building to the N. A further building is shown on the W side of the mill, with a brick chimney beyond.

F5 H: c. 0.70m W: c. 1m. No stone rybats. Concrete blocked. This shows clearly as a window on the 1940s (?) photograph (Illus 5, 6)

F6 Unclear blocking above W1. On 1940s (?) photograph (Illus 5), this appears to be a possible window set into a door-sized blocking.

Roof The original roof was pitched; this can be seen clearly on the 1940s (?) photograph (Illus 5). Oddly this seems to be at a shallower pitch than the stone gable that can be seen incorporated into B3 (Illus 21) which would appear to have been another, possibly earlier, roof line of B2.

W5 Possibly original. Is visible on 1940s (?) photograph (Illus 5)

W6-W8. All have sandstone rybats, lintels and sills. They appear to be glazed on the 1940s (?) photograph (Illus 5).

Roof Present corrugated roof is pitched. 1940s (?) photograph (Illus 5) shows a slate roof, hipped at the E end.

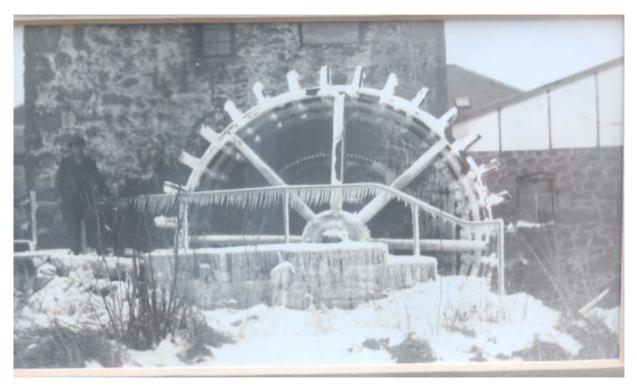
Illus 6 Undated photograph. Courtesy of Mr David Evans

This appears to have been taken on the same, very frosty, snowy day. It is a close-up of the mill wheel with the mill manager standing on the LHS. It shows significant detail of the position of the wheel at this time and details of the windows in the S gable of the mill.

F1 H: 0.28m W: 0.20m at top, tapers to base. Angled through wall. Brick blocked. Comparison with the photograph (Illus 6) shows a metal railing which angled to the wall at this point, so F1 was probably the socket which held the end of the railing.

Comparison with photograph (Illus 6) shows that this was the wheel axle position at that point. The 1864 OS appears to show wheel central; by 1902 and 1922 it appears to be more to the E side of the gable. It is possible that F4 and F3 have been axle positions at different times.

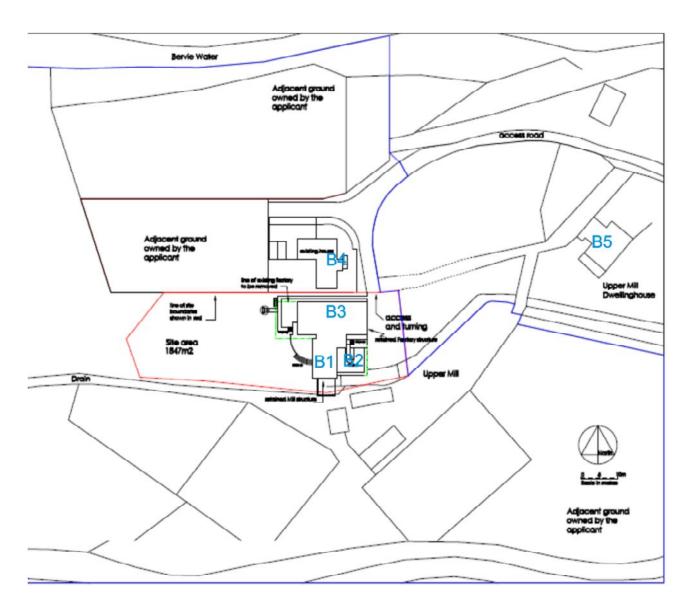
Illus 7 Location. Site outlined in red (Buildings B1-B3). B4 and B5 are not part of the application but were associated with the mill in their original form. Adapted from plan by DS Beckett, Architect. Accessed on Aberdeenshire Council Planning website.

The present application refers to three attached buildings B1-B3 (Illus 7). Two buildings that have been previously converted (B4 and B5) had also been part of the mill in their original form. B4 is shown on OS maps from 1864. Building B5, the former Manager's House, is shown on OS maps from 1902. Both have been converted to modern dwellings and are not part of the present report.

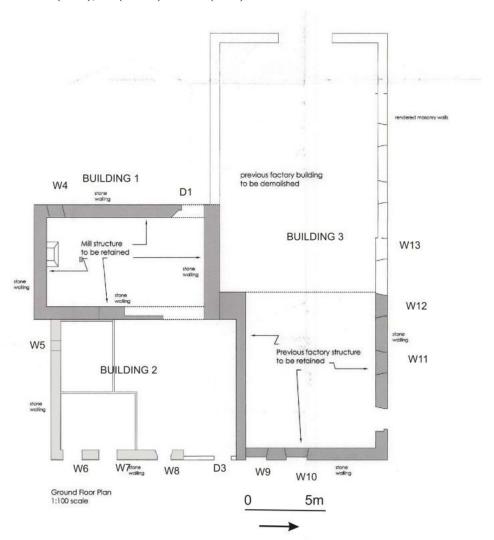
Illus 9 Plan of buildings 1-3. Adapted from plan by DS Beckett, Architect. Accessed on Aberdeenshire Council Planning website.

Within the present site (Illus 9), only the main mill building B1, which survives with a significant part of its original structure, is reported below in some detail. The adjoining buildings B2 and B3 are on the footprint of buildings shown on the early maps but have been re-used and converted first as a Shoddy (Flock) Mill (c. 1945-

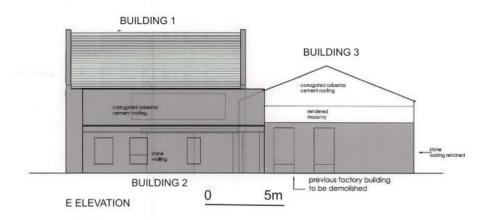
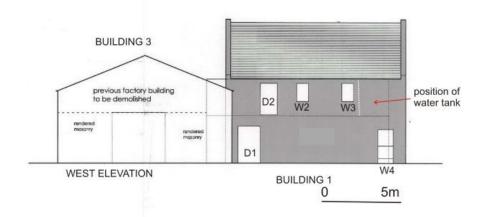
Illus 10 E and W Elevations. Adapted from drawing by DS Beckett, Architect. Accessed on Aberdeenshire Council Planning website.

<u>Walls</u> Irregular red sandstone rubble blocks. Partially harled on W wall. E wall almost completely removed and replaced with brick and modern glass windows during conversion to factory and the opening up between B1 and B2. <u>Roof</u> Pitched slate roof.

D1 H: 2.16m W: 1.4m. Harled externally with modern sliding door.

Internally the angled masonry on N side suggests it was an original doorway.

D2 H: 1.85m W: 1.06m. This appears to have been an internal door, possibly giving access at 1<sup>st</sup> floor level to the original building on the footprint of B3. A small extension to B1 is shown at this point from the 1864 OS map onwards.

W4 H: 1.05m W: 0.92m Modern window in larger opening, lower part of which is blocked. Harled so no detail of lintel etc. H: 1.60m W: 0.92m with acutely angled N side.

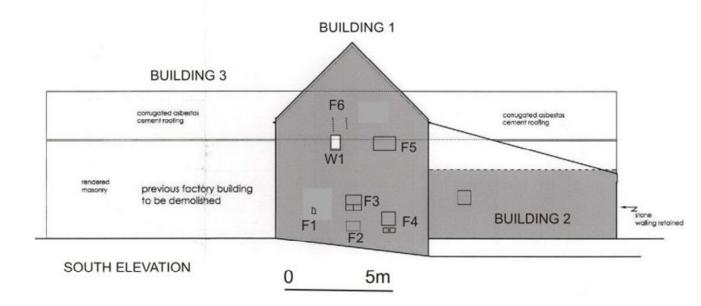
Illus 11 S Elevation. Adapted from drawing by DS Beckett, Architect. Accessed on Aberdeenshire Council Planning website.

This is the wall beside the lade, where the wheel had been attached.

W1 H: 0.70m W: 0.50m. Stone sill

F2 H: 0.36m W: 0.60m. Grey sandstone on all 4 sides. Brick infill.

F3 H: 0.65m W:0.59m. Cast iron housing through thickness of wall (0.50m to blocking). Blocked with breeze blocks. Grey sandstone sill and part of sides, concrete around top.

F4 H: 0.60m W:0.63m. Through thickness of wall (0.62m) Brick blocking. Dressed sandstone lintel, sill and rybats. Central axle shaft groove W: c. 0.12m. Two smaller sockets below, each H: 0.20m W: 0.23m and depth into wall: 0.30m. Sandstone between.

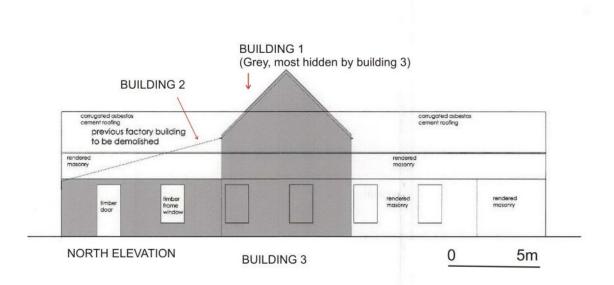
Illus 16 N Elevation Adapted from drawing by DS Beckett, Architect. Accessed on Aberdeenshire Council Planning website.

The N wall was masked by the converted building B3.

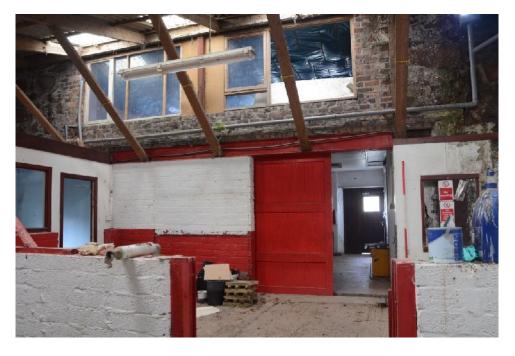
Illus 17 E wall of Mill B1 as seen from inside B2

Most of the E wall of building B1 had been rebuilt in brick with modern windows added at 1<sup>st</sup> floor level when the roof of B2 was raised and rebuilt as a lean-to against the top of the B1 wall.

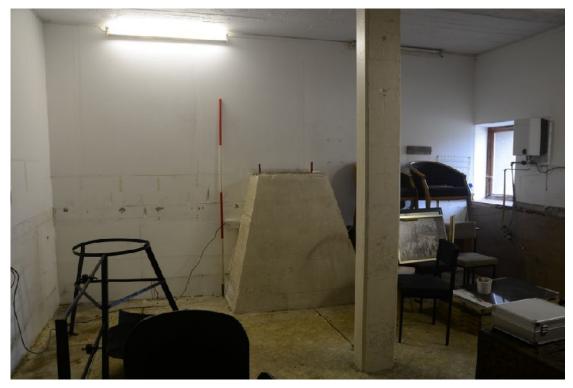
Illus 18 Interior of S end of Building B1

At the centre of the inside of the S wall there was a pyramidal stone buttress with two threaded bolts on the upper flattened surface. (Top: 0.74 x 0.45m. Base splays to: 0.70 x 1.45m. H: 1.35m.). This appears to be almost in line with F3 on the exterior of this wall and at much the same height as the main central horizontal surface of the casting. It would appear possible that at some stage a horizontal wheel shaft passed through F3 and rested on this pyramid. However, no other associated features survived as the rest of the interior had been restructured during the period that the mill was in use as a Shoddy Mill (c. 1945-1960s). At this period, a large cement water tank was built on the 1<sup>st</sup> floor at the N end of B1, with a reinforced ceiling to the ground floor built to support it, with a central concrete pillar (centre foreground Illus 18). An electric motor beside door D1 would have been the switch gear for pumping water by electricity up to this tank (Illus 19). The water may have been used for washing the shoddy.

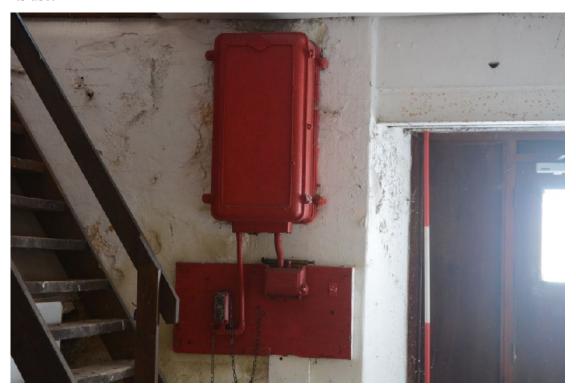
Illus 19 Building B1. Inside of door D1 and electric motor. Stair to 1st floor.

A steep wooden stair rose from beside door D1 up to the 1<sup>st</sup> floor. The blockwork of the water tank cut off the N end of the interior (Illus 20). The remainder was lined out but there had been a fireplace (no chimney remains visible) at the S end (pers. comm. David Evans). This had been the mill Manager's office, at least in the later stages of its use.

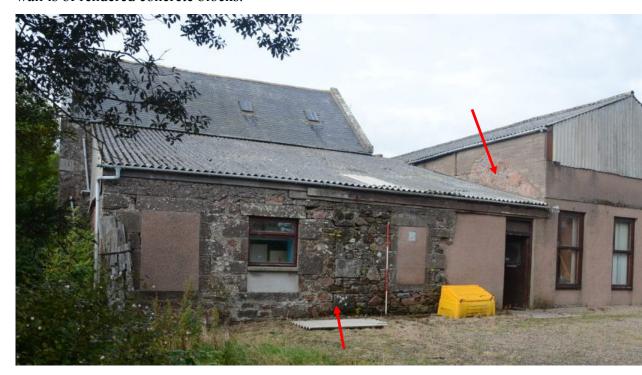
Illus 21 B2 E wall. Note rybats in stonework to LHS of ranging rod. Note also preserved stone gable in wall of B3 to RHS

<u>Walls</u> S wall and S part of E wall are of red rubble stone. However even this section of wall displays two phases of work with a line of rybats between windows W7 and W8 indicating a break in construction. The N end of the E wall is of rendered concrete blocks.

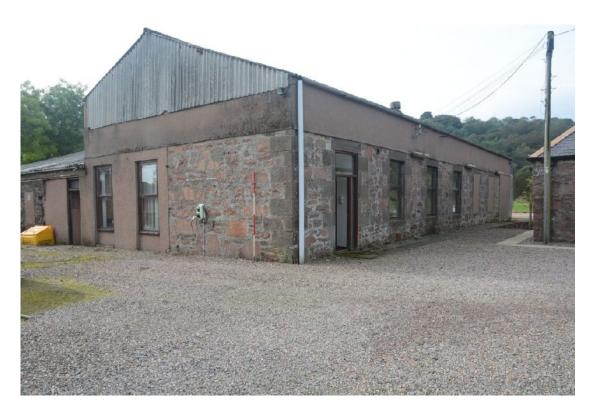
Illus 22 Building B3 seen from NE

Building B3 has been almost totally restructured during its use as a factory.

<u>Walls</u> The lower part of the N end of the E wall and of much of the N wall are of red rubble stone. This part has dressed stone rybats at the NE corner and similar dressed stone has been used or re-used around windows in the N wall. However, the wall height has been raised with blockwork and rendered walling at the S end of the E wall and at the W end of the building may also include rebuilt sections with blockwork.

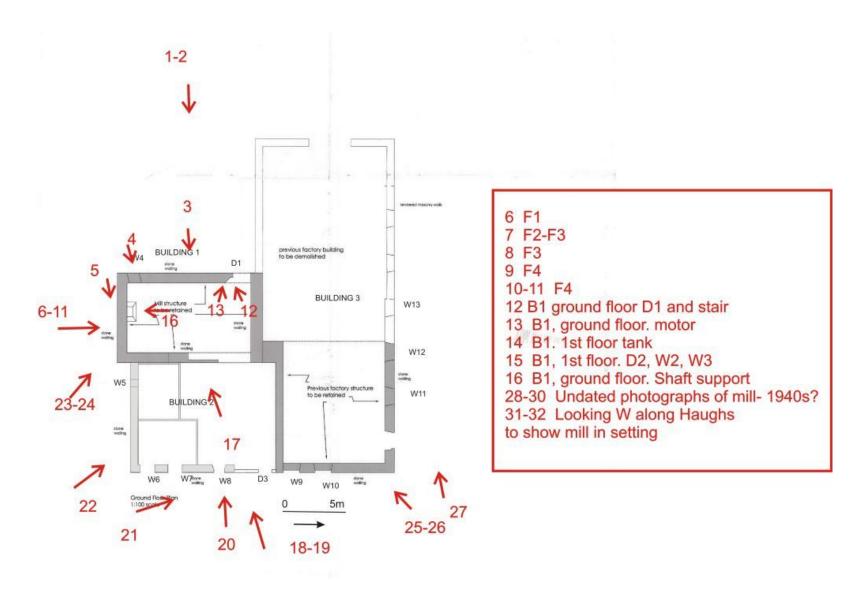
Illus 23 Photo layout plan

A full set of photographs with the photo location plan (Illus 23) will be supplied to the Aberdeenshire SMR in Aberdeen and to the NMRS.
