**SITE EAST AND WEST OF CANMORE
PLACE
KINCARDINE O'NEIL
ABERDEENSHIRE**

Archaeological Evaluation

Carried out October 2015

Report No: MAS 2015-32

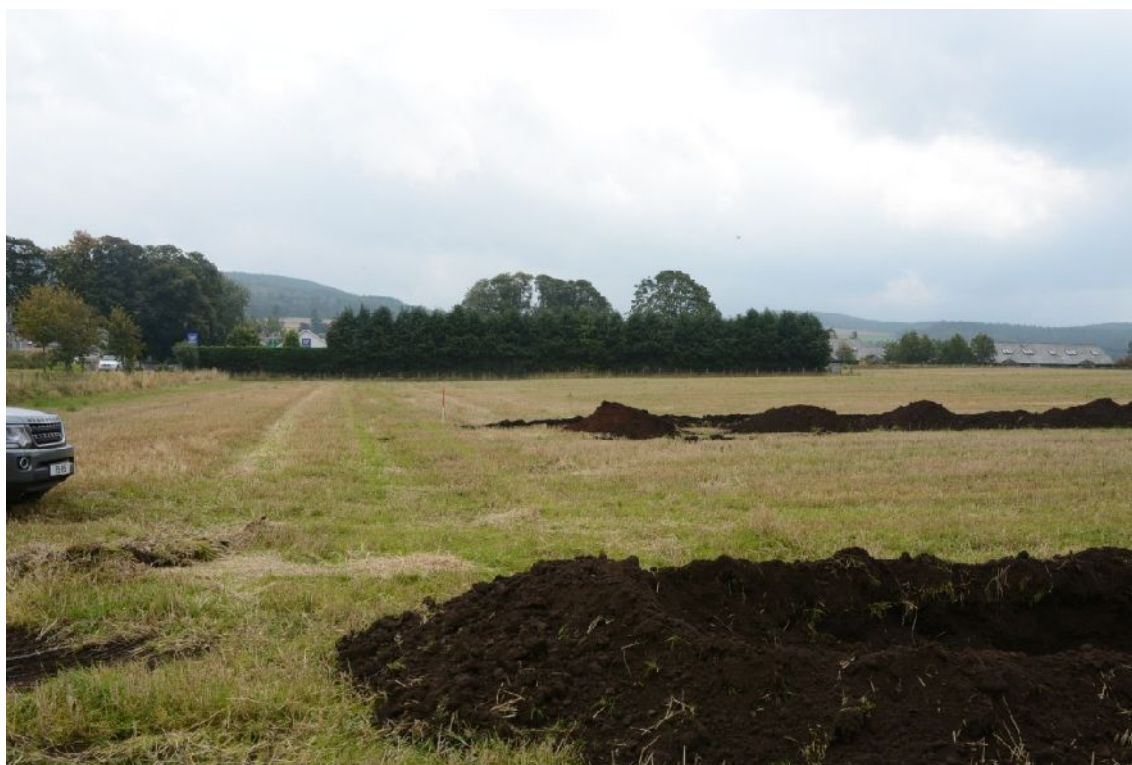
Illus 2 General view of W end of site looking E towards Canmore Place.

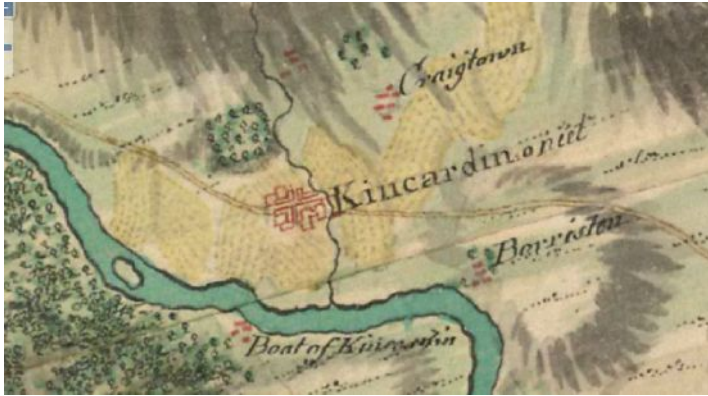
Roy shows the settlement of Kincardin O Neel (*sic*) on either side of the Deeside road and W of the Neil burn. The ground which includes the present site is shown as largely rig and furrow.

Illus 3 Roy Military map. 1747-55. www.nls.ac.uk

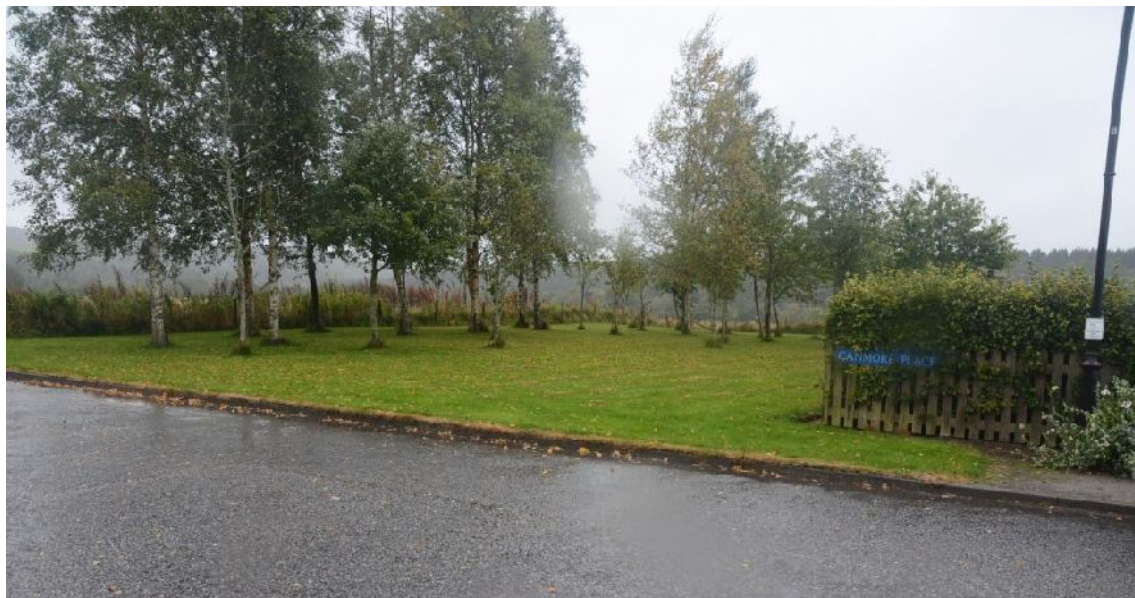
Eleven evaluation trenches were excavated in total (Illus 7). No evaluation could be undertaken in the area between E side of Canmore Place and the present boundary fence as this area is currently landscaped and in trees (Illus 6). The landscaping suggests there is little likelihood of archaeological survival.

Illus 6 E end of Canmore Place. Not trenched.

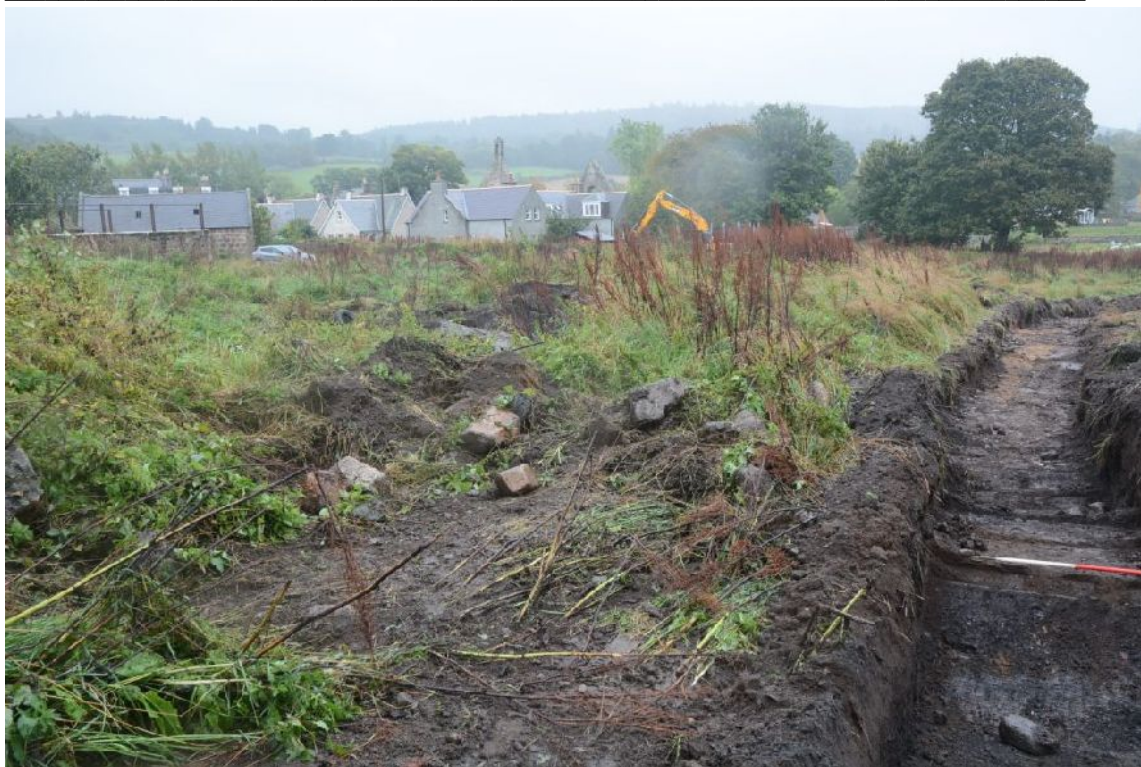
The area to the E of the boundary, behind the former steading of Haugh Farm was very disturbed, with areas of dumping and deep trackways through it (Illus 8). This limited the possibilities of trenches but did confirm that much of the area had been significantly disturbed by a sandpit in use from the late 19th century (Illus 11).

Illus 8 Looking E across land E of Canmore Place. Trench 9 on RHS. Medieval church ruin visible in centre background.

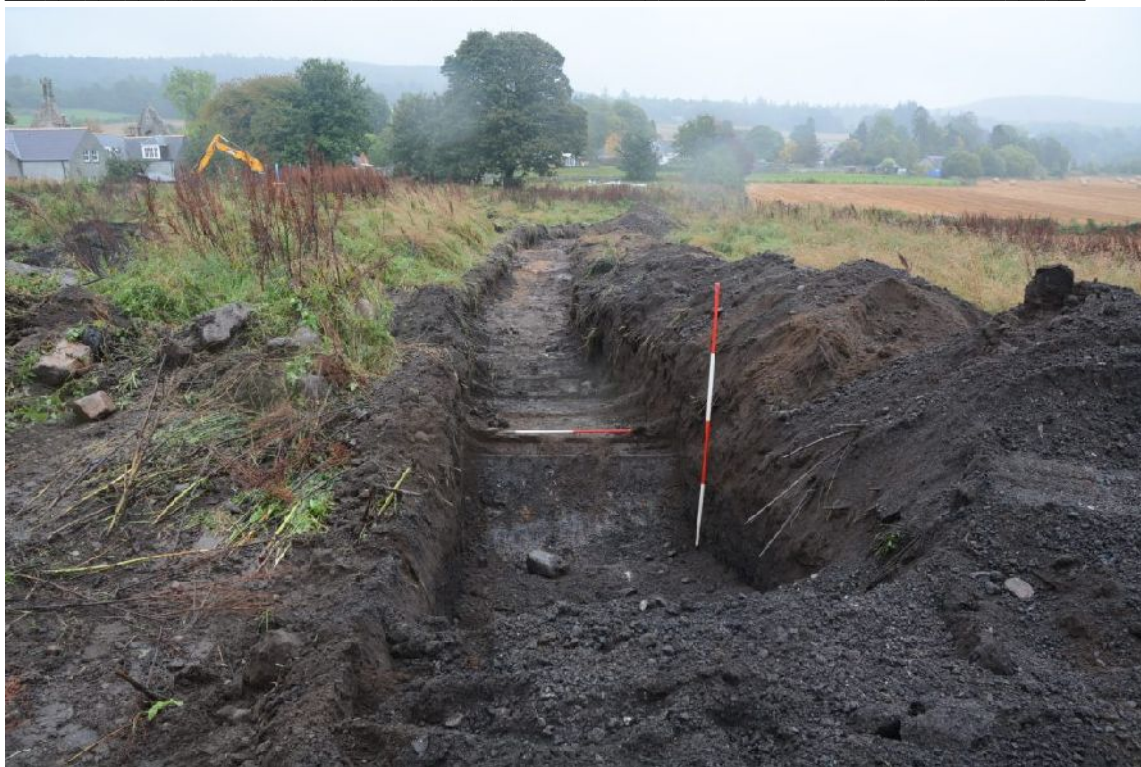
Stratigraphy: Earlier pit infilled with 19th/early 20th-century rubbish layers covered by topsoil.

Features: Sand pit from 359098,799562 (angle of trench) to W end of trench. Also in Trench 10. Shown on 1899 OS map near the angle of trench but appears to have been extended W after 1899. The sand pit had been backfilled with dumped cinders and domestic rubbish including animal bone, glass and china of late 19th-20th-century date.

Illus 9 Trench 9 looking E showing dump layers at W end (foreground).

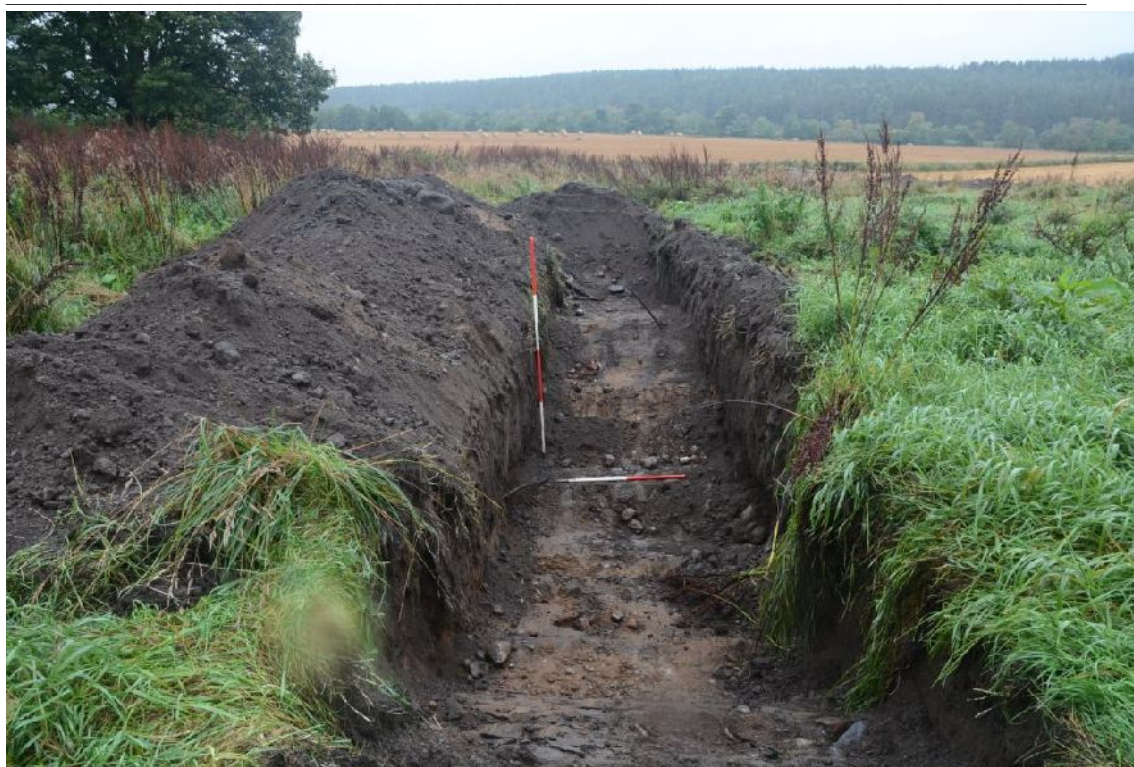
Stratigraphy: Water pipe and clay drain at 1.5m depth at 359129, 799600. Small amounts of modern rubbish (including plastic) and 19th/20th-century material such as a stoneware bottle in redeposited topsoil to this depth. Sandy gravel natural.

Illus 10 Trench 11 looking S
