**MASTRICK FARM
OLD RAYNE
ABERDEENSHIRE**

Standing Building Survey

Carried out 1st October 2015

Report No: MAS 2015-30

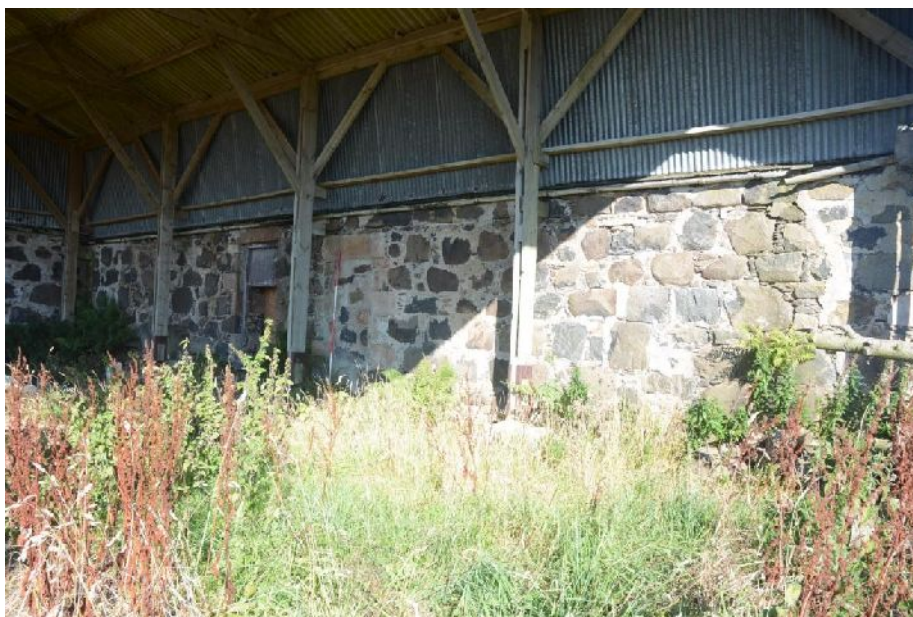
Illus 7 S wall of N range

S wall

D4 H: 1.88m W: 1.14m Pink granite lintel and rybats.

F2 H: 1.50m W: 0.76m. Pink granite lintel and rybats. Stone blocked.

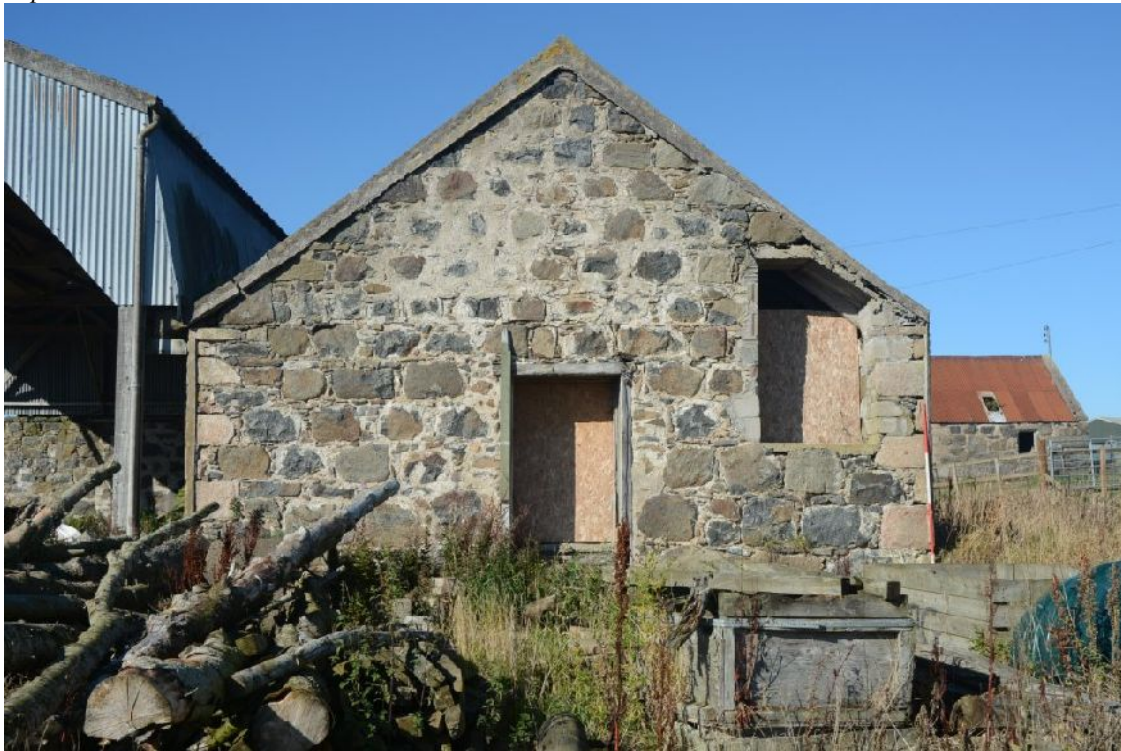
Illus 8 E wall of N range (truncated between 1867 and 1899)

D3 H: 2.50m W: 1.30m No rybats. Wooden lintel. This may originally have been an internal doorway as the building was foreshortened between 1867 and 1899.

F1 H: 1.50- 1.90m. Modern break-through with cement block surround. Probably for access to feed pass.

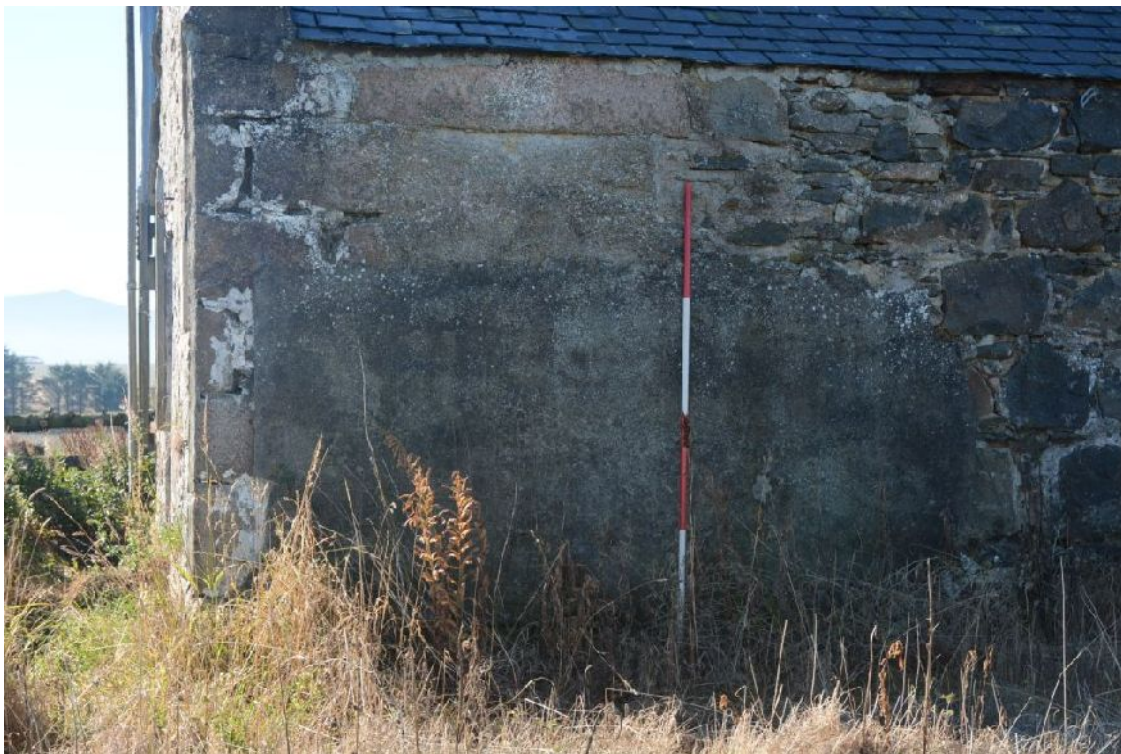
Illus 9 N wall N Range. Blocked opening F4

D2 H: 1.90m. W: 1.17m. Rybats and upper lintel pink granite. Lower lintel slate. Blocked with concrete.

F4 Pink granite lintel and rybats W: 1.20m. Only 0.60m of height visible as lower part obscured by concrete render. (Could not be viewed internally as blocked by feed pass and bales).

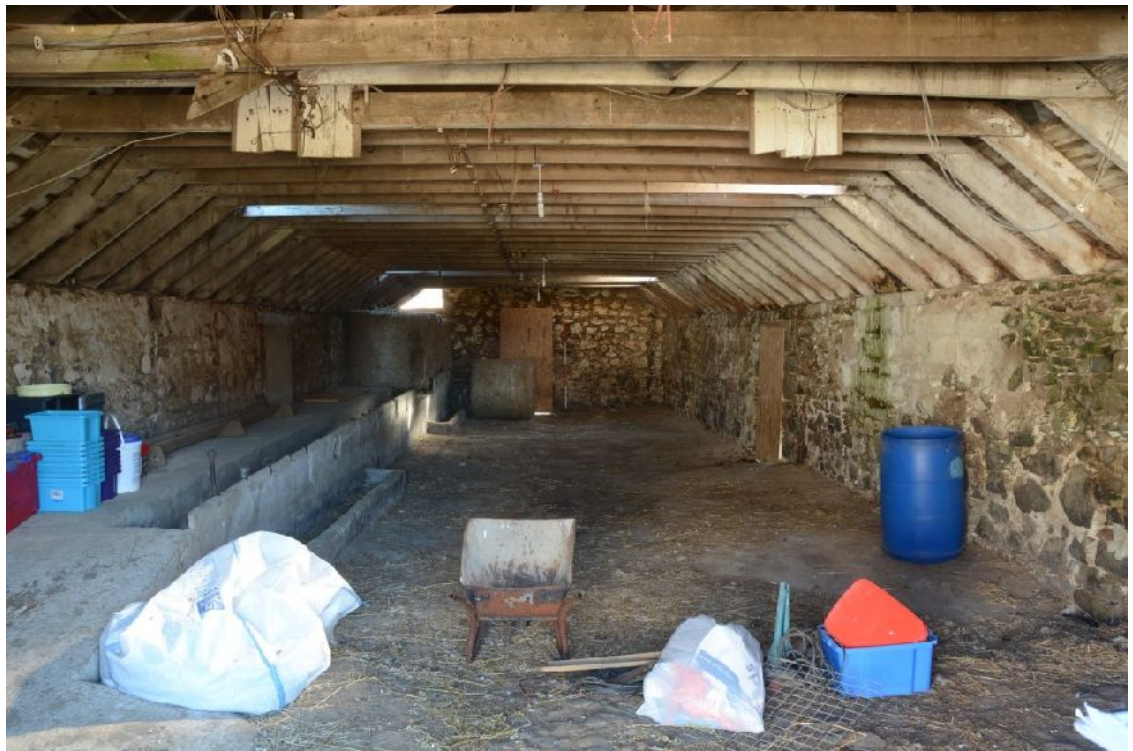
Interior Part of cobbled floor remains but largely restructured with a concrete feed (1.4m wide) pass along the inside of the N wall. One remaining tethering ring suggests the space was originally used for tied cow stalls.

Illus 10 Interior N Range looking E

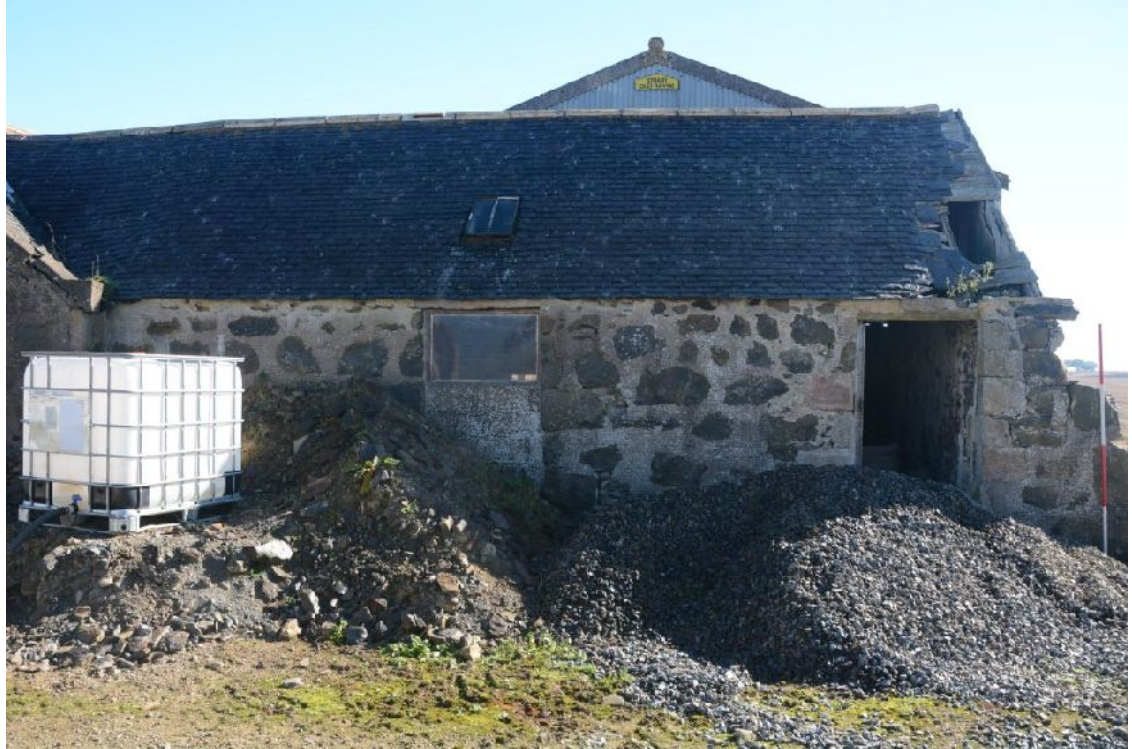
Illus 11 W range, W wall

D5 H: 1.85m W: 1.10m Pink granite rybats. Lintel obscured by cement render.

W1/F3 Original opening (F3) H: 1.85m W: 1.05m. Sides splay internally suggesting this might have been window rather than a door. Modern window inserted H: 0.60m with concrete blocks below.

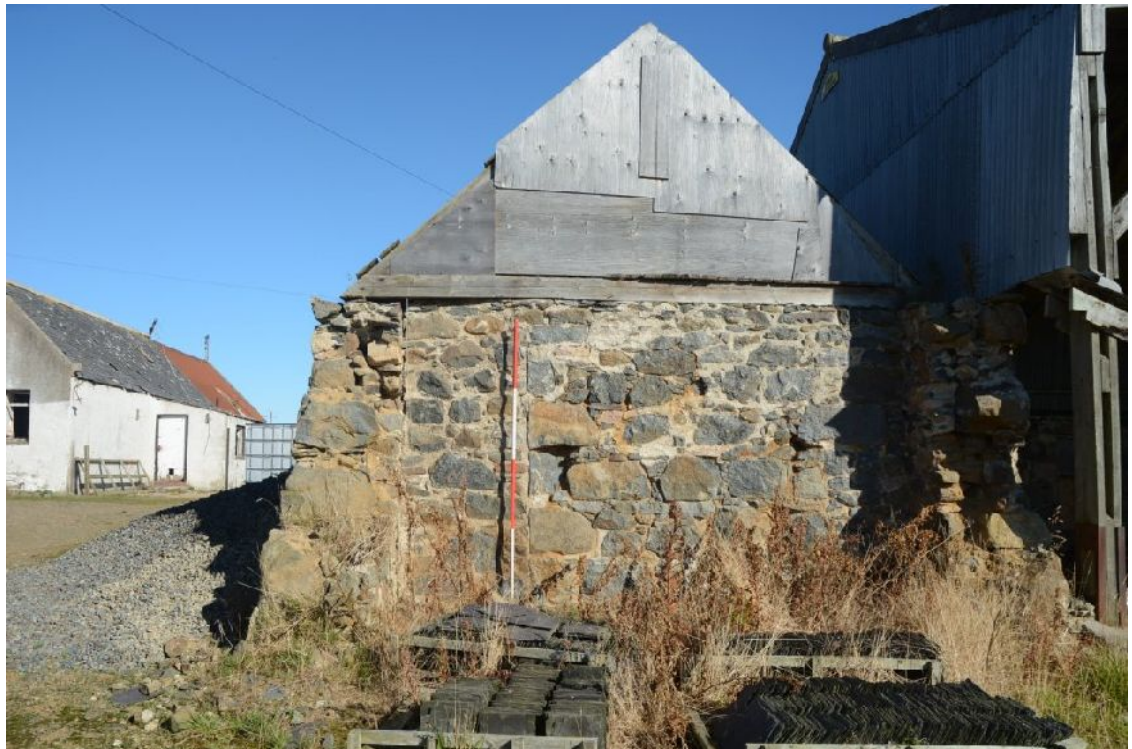
Dimensions 4.7m x 9.5m+ externally The S end has been demolished in the past with only stubs of the walls remaining.

Illus 12 W Range. Truncated S wall

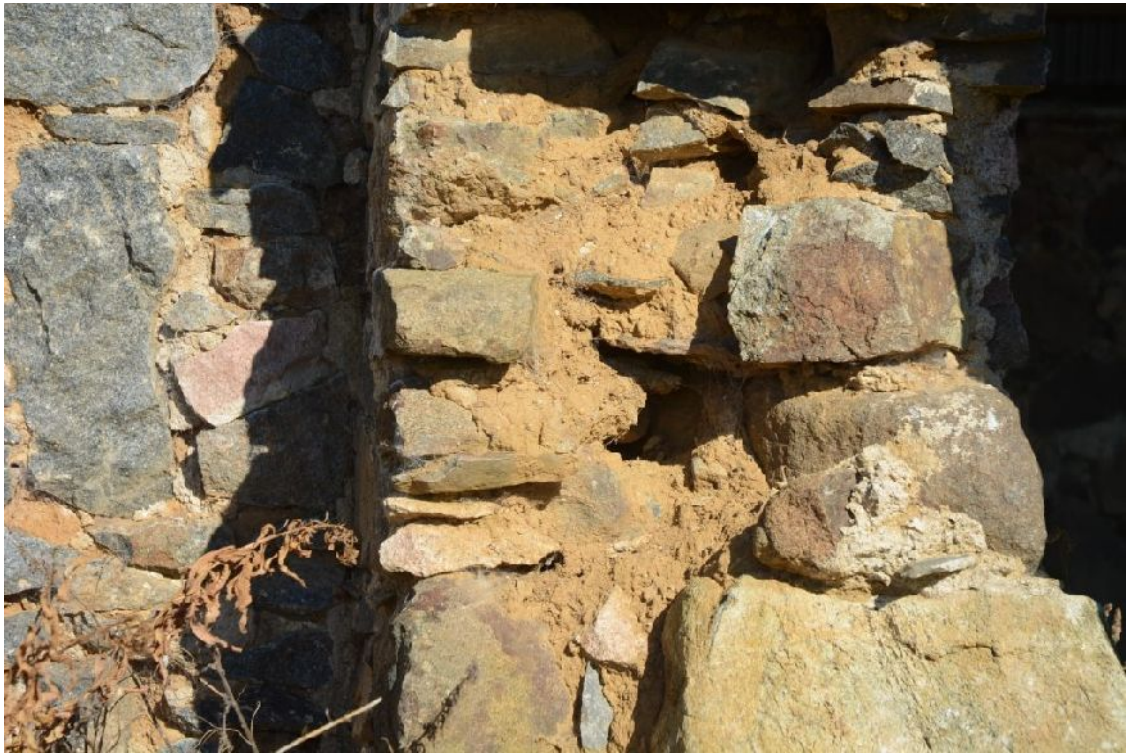
Walls Stone. The broken section through wall at S end shows use of clay bonding in core (Illus 13).

Illus 13 Detail of core of broken S end of wall of W range showing clay binding in core.

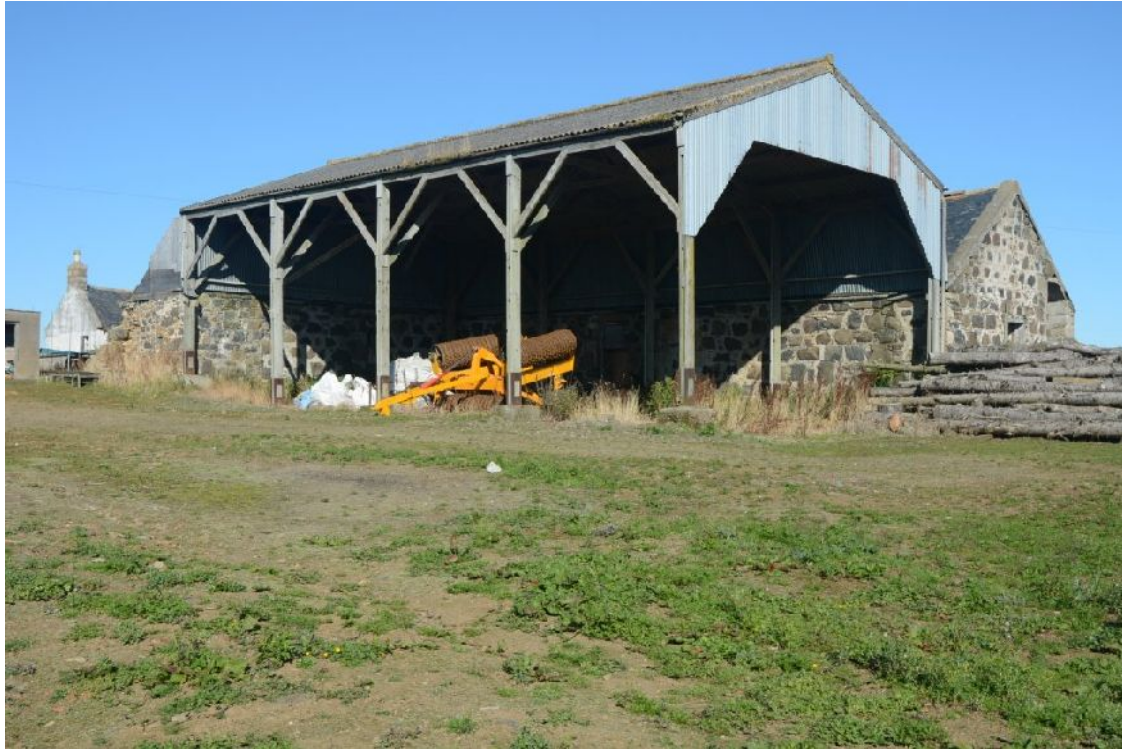
A modern Dutch Barn with timber supports and a corrugated iron roof had been built in the angle between the N and W ranges. The ground level had been reduced in this area, exposing the foundations of the older buildings.

Illus 14 Dutch barn looking N

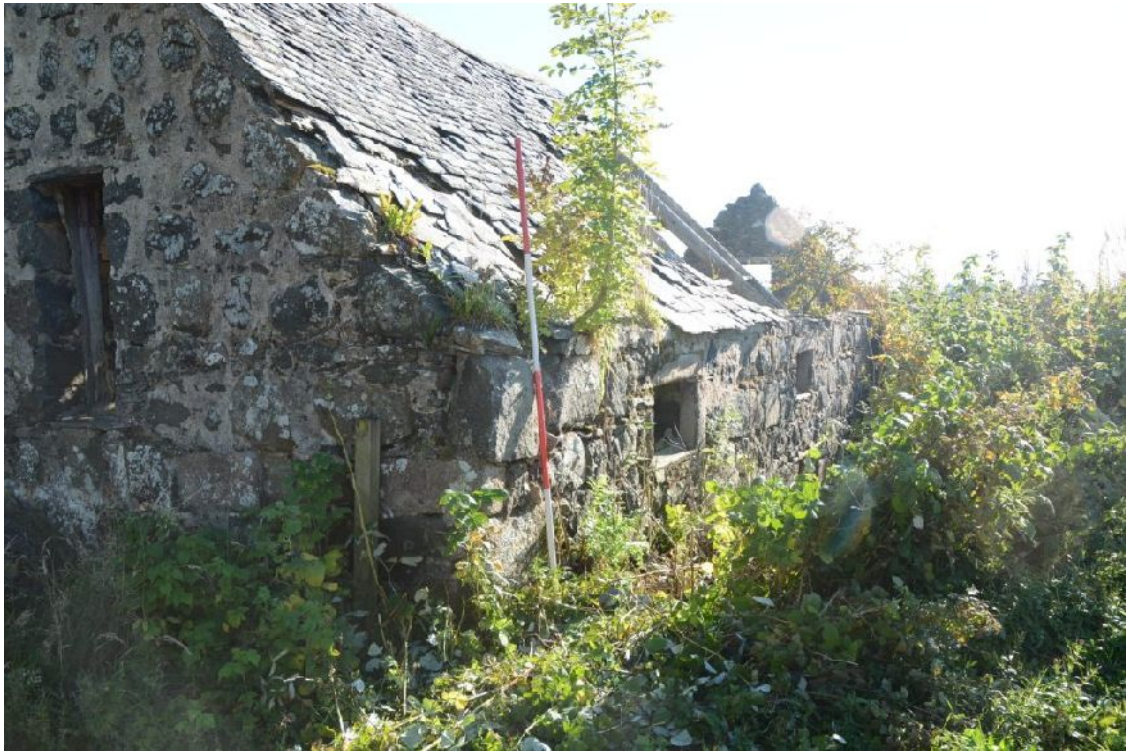
W1-W2 H: 0.47m W: 0.78m Slate sill and fieldstone lintel and rybats. Splay internally. Light the upper/loft floor.

D1 H: 1.50m+ (base blocked by rubble) W: 1.07m. Granite rybats and slate lintel. Access to ground floor.

Illus 19 Mill. W wall, looking S

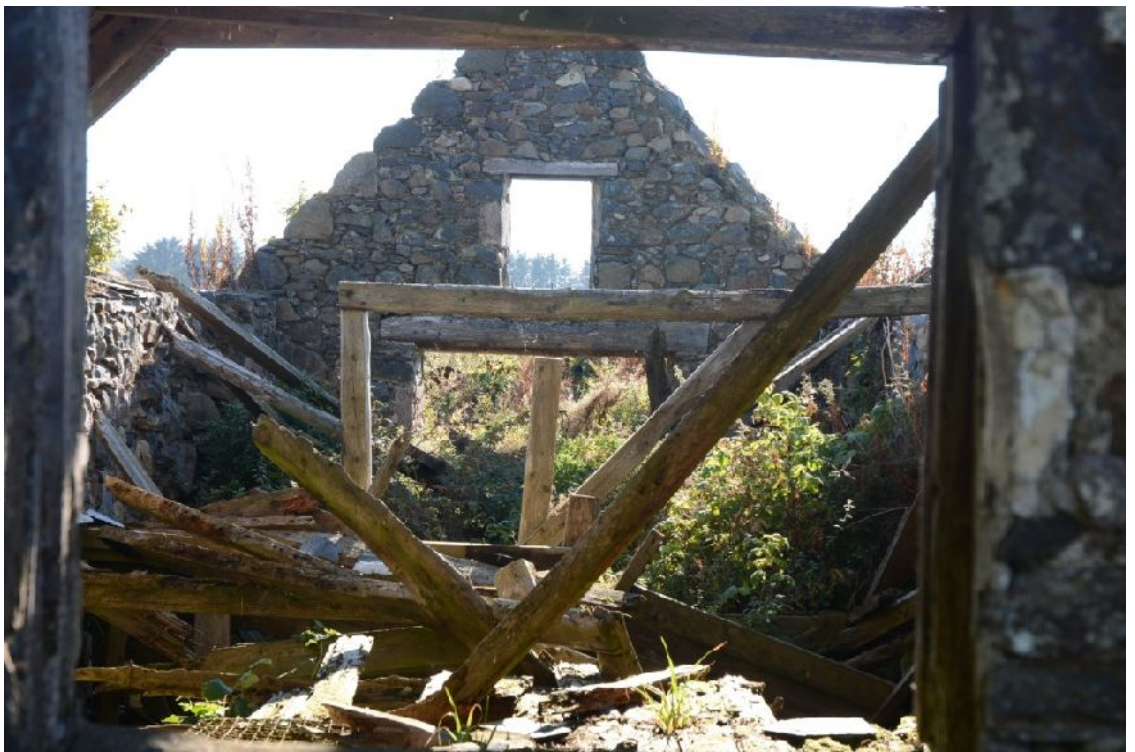
Illus 20 Mill interior looking S through W3

Interior The interior was unsafe. Viewed through D2 and W 3. Wooden loft partly survived at N end.

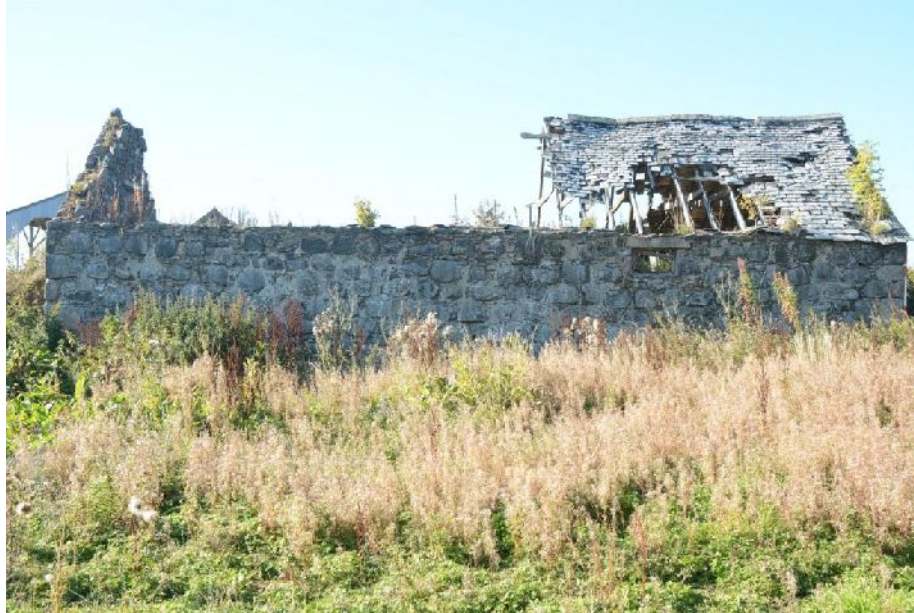
W5 H: 0.48m W: 0.29m Stone lintel sills and rybats (not slate). Lights ground floor.

W6 H: 0.47m W: 0.78m Slate sill and fieldstone lintel and rybats. Splays internally. Lights the upper/loft floor.

Illus 21 Mill. E wall

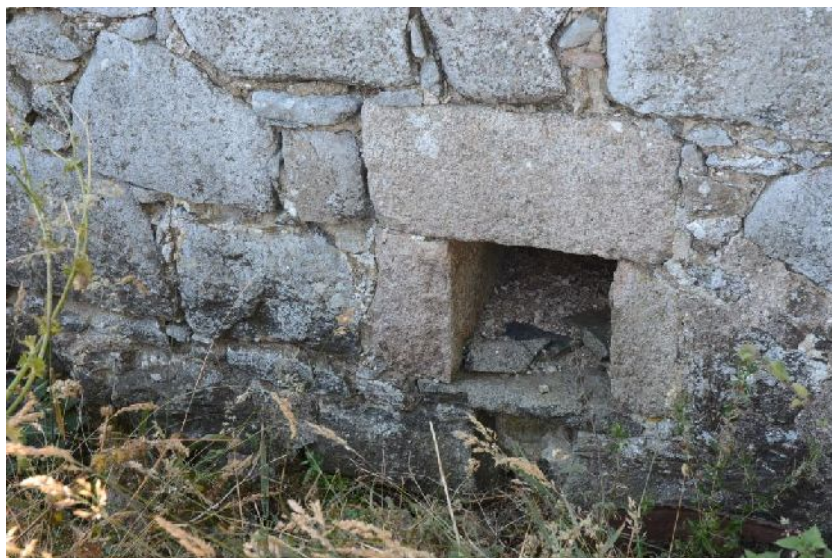
F1 Fittings for axle of mill wheel. Two openings. Upper opening H: 400mm W: 370mm. Pink granite lintel, sill and rybats. Goes through wall thickness (600mm). Internally blocked partly with wood, partly glass. Lower hole. H: 350mm. W Splays 200-250mm. Stone blocked.

Illus 22 Mill wheel axle hole (F1)

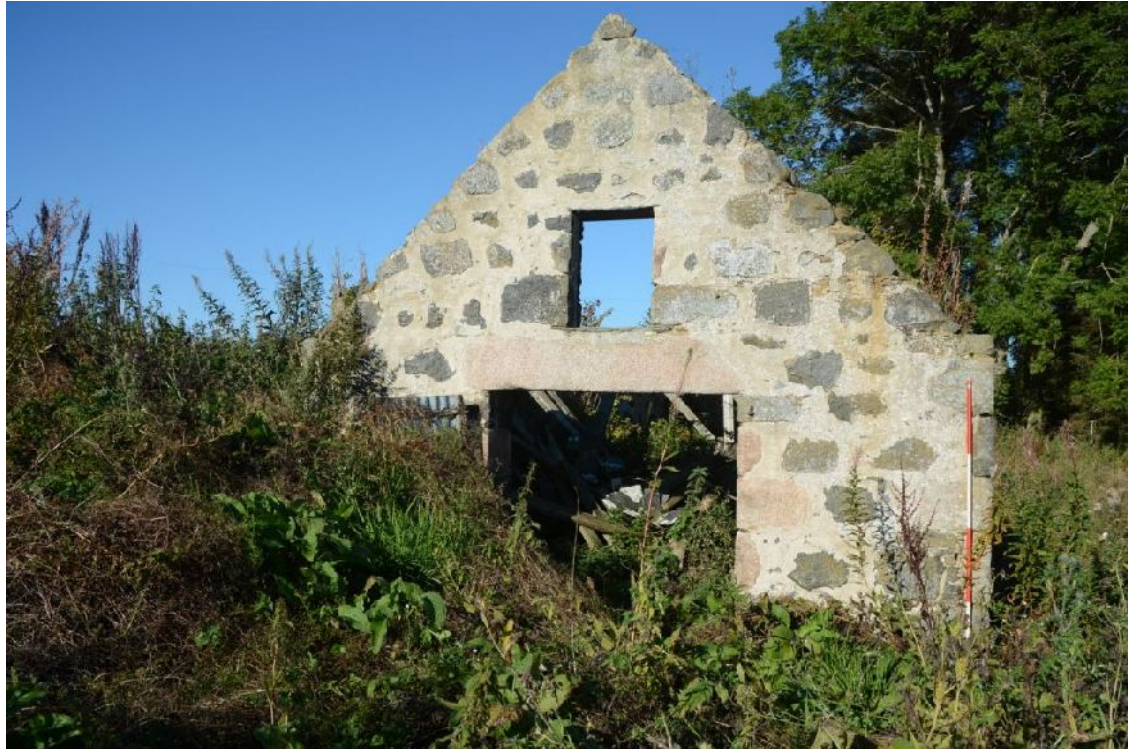
D2 H: 1.95m + W: 2m Pink granite lintel and rybats.

W4 H: 0.92m. W: 0.72m. Slate sill and lintel. Stone rybats. Lights upper/loft floor.

Illus 23 Mill. S wall

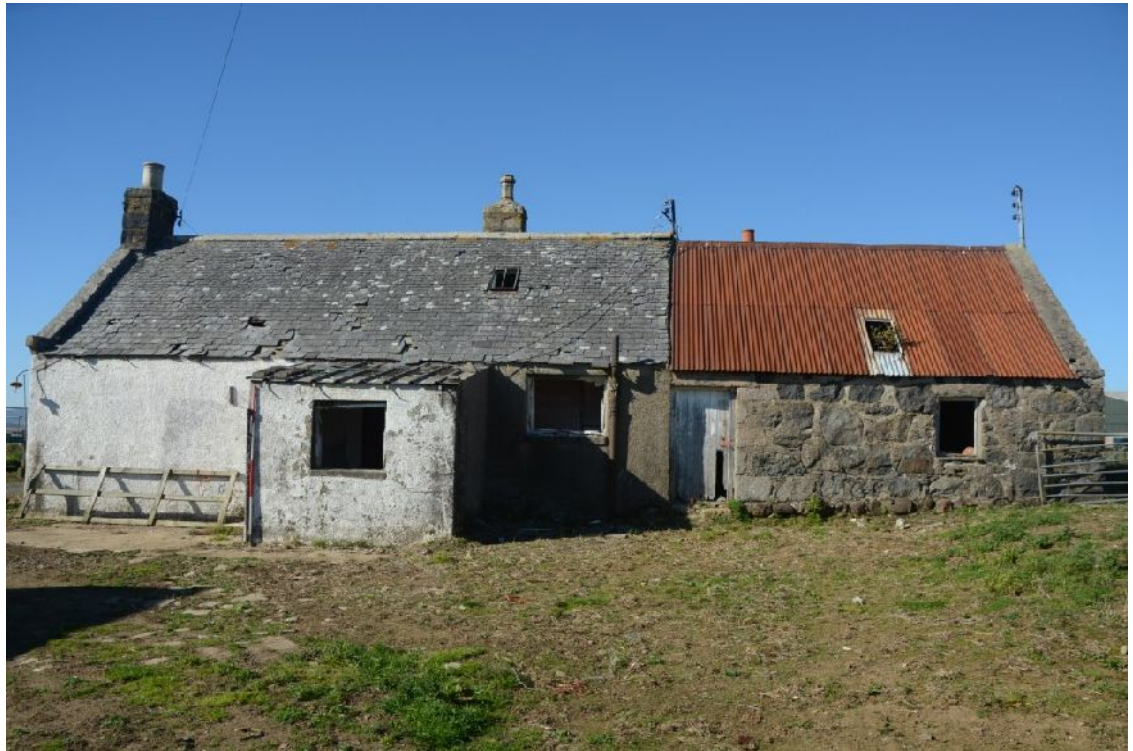
Walls S end: harled stonework. N end: rubble stone, large slabs similar to steading. Not harled.

Roof S end: slate with ceramic ridge. Chimney at S gable: rectangular stone with plain table and ceramic pot. Carved skewputts at S gable match those on B2 and B3. N end roof: corrugated iron.

Illus 27 Building 1 E wall

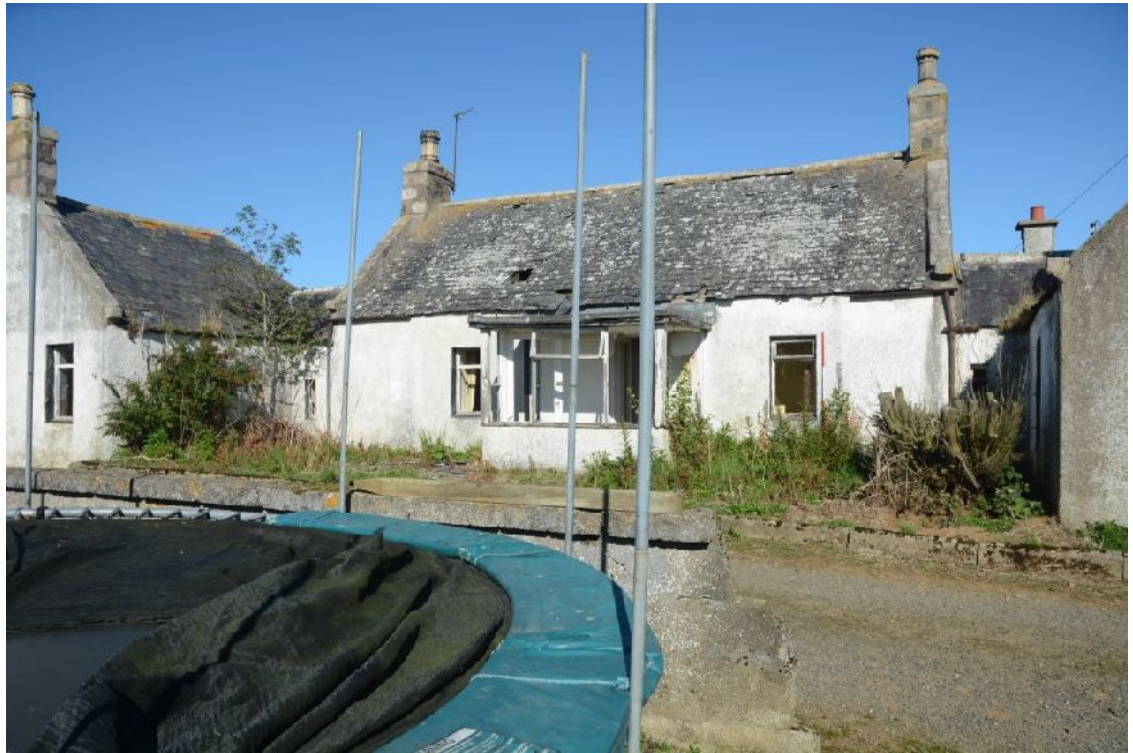
Walls Harled stonework. Wall thickness 660mm.

Illus 28 Building 2, S wall

- D4 W: 1.2m with modern porch
W7 W: 0.30m Internally splayed, probably original.
W8 W: 0.80m Internally splayed, probably original.
W9 W: 0.80m Internally splayed, probably original.
W10 W: 0.30m Internally splayed, probably original.

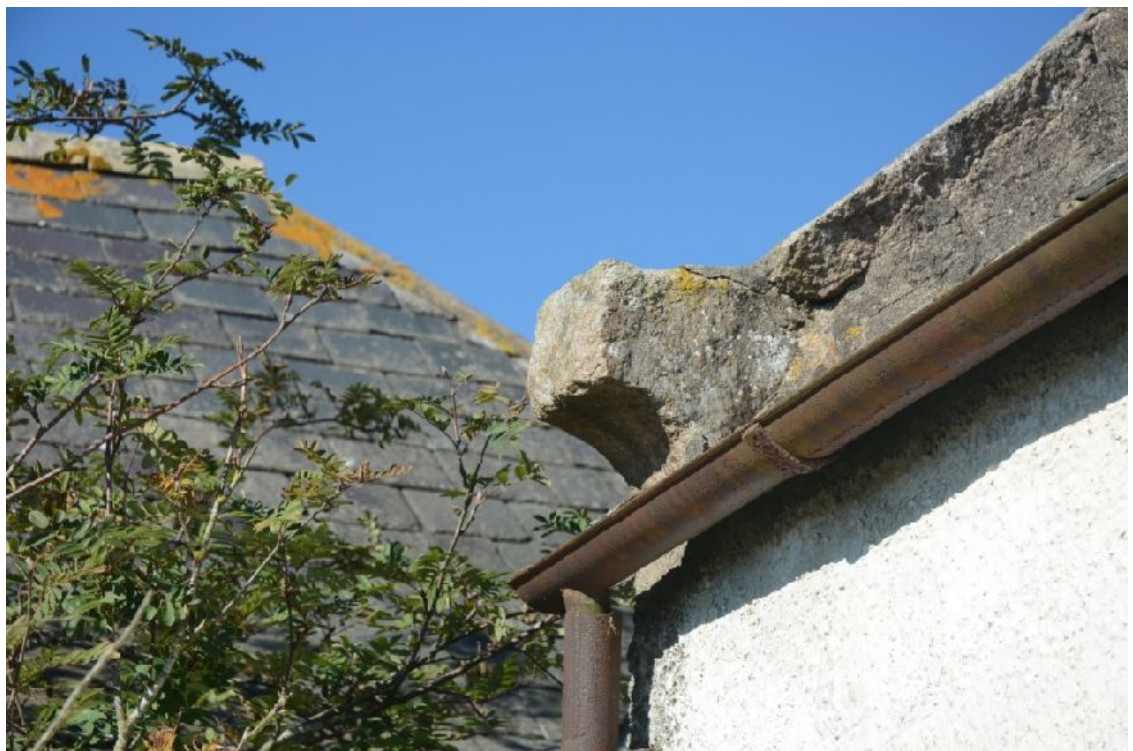
Roof Slate with ceramic ridge. E and W gables chimneys: rectangular stone with plain table and ceramic pots. Carved skewputts at both gables.

Illus 29 Building 2, detail of skewputt

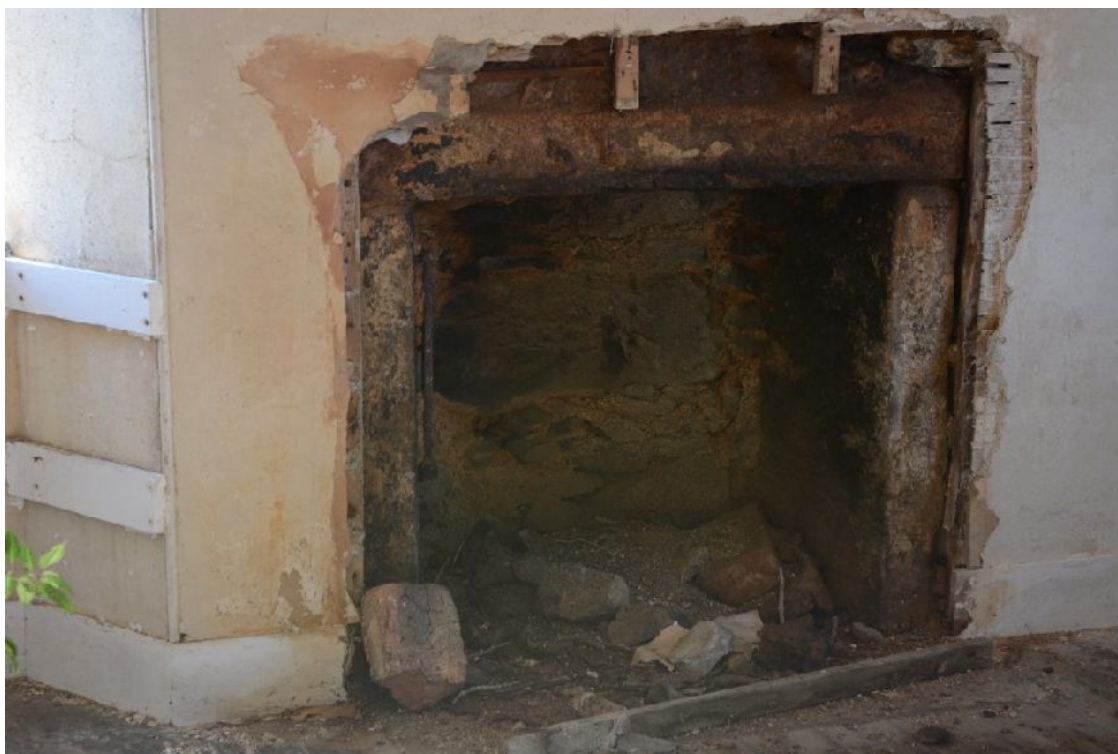
Illus 31 Building 3 S room, detail of fireplace. Swey on LHS

Building 1 was subdivided into the N part which appears to have been a byre with an interconnecting door to the S part. The S part comprised a room with a kitchen range at the S end and a smaller lobby behind with a stair to the attic. Building 2 comprised a living room with fireplace at the W end and a smaller back room on the N side of the W end, with a passage in front of it. Narrow passages (0.90m wide internally) connected B2 with both B1 and B3; it was not possible to see if these were part of the original design as they were lined internally and harled externally. B3 had a front room with a hearth on the S gable with a swey for cooking still remaining. There was a smaller back room the width of the building.
