**19-21 HIGH STREET  
STRICHEN  
ABERDEENSHIRE**

**Standing Building Survey**

Carried out 15<sup>th</sup> August 2015

**Report No: MAS 2015-29**

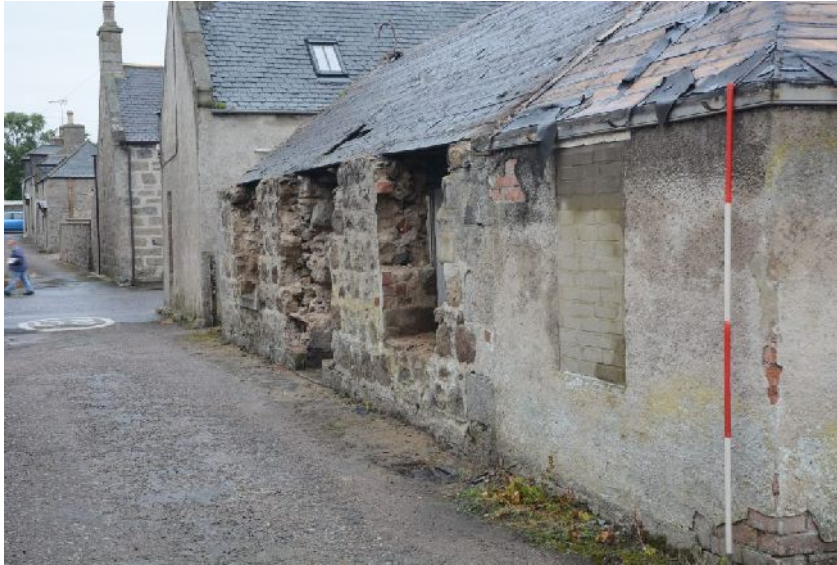
**Illus 1 Cottage looking towards High Street**

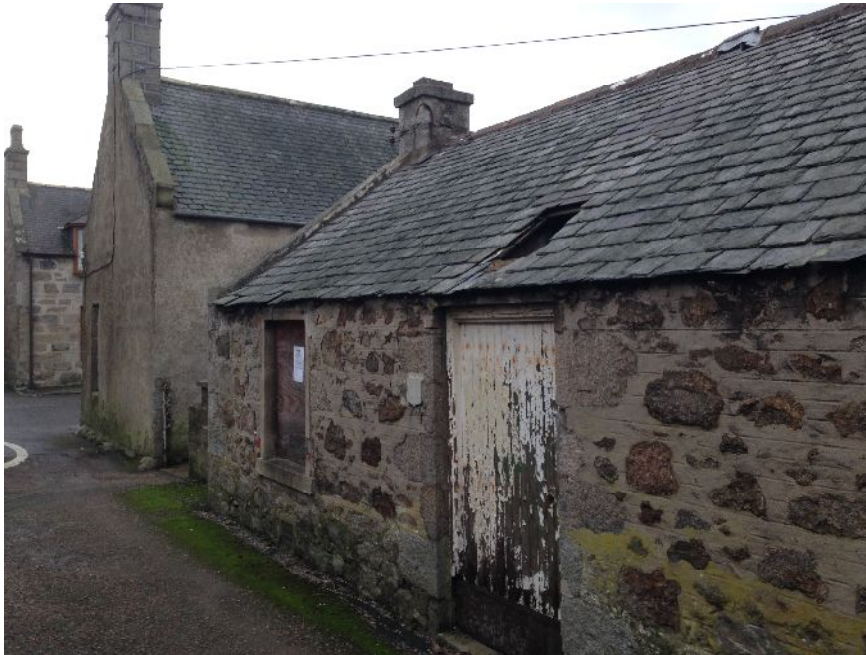
**Illus 2 Cottage looking towards High Street prior to partial demolition (Photograph courtesy of Baxter design)**

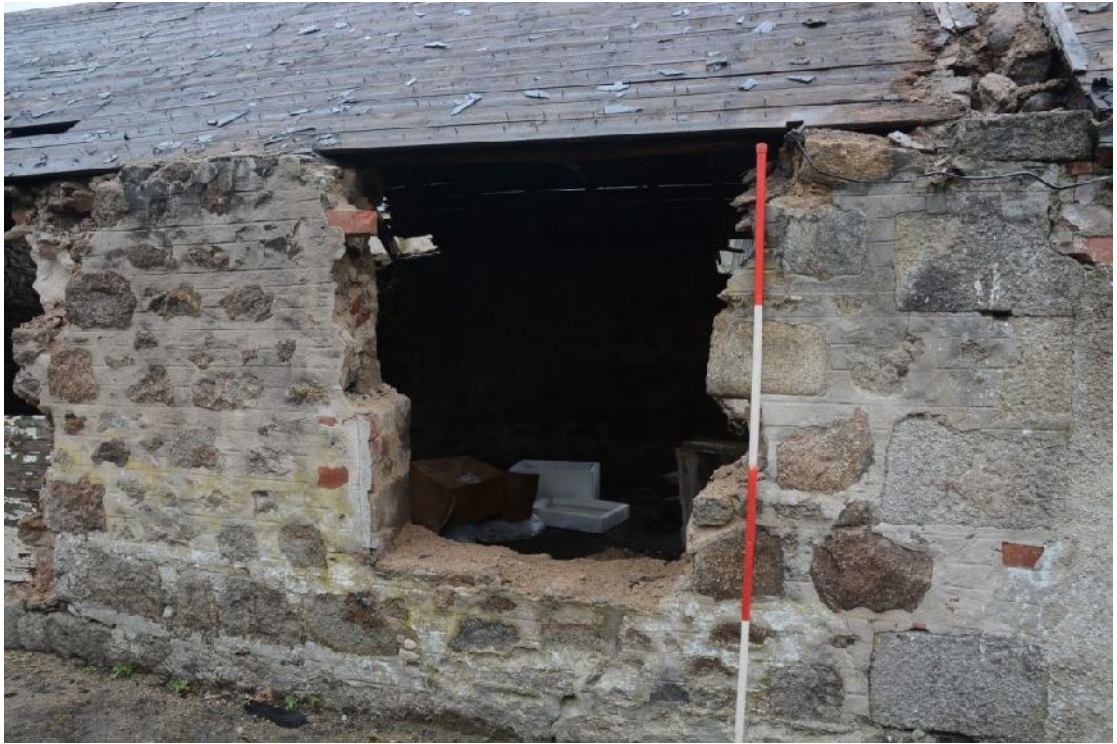
**Illus 8 Window W1**

W1 Broken out. Could not be measured. Splayed internally so was an original opening. Broken sash window on floor probably from this window.

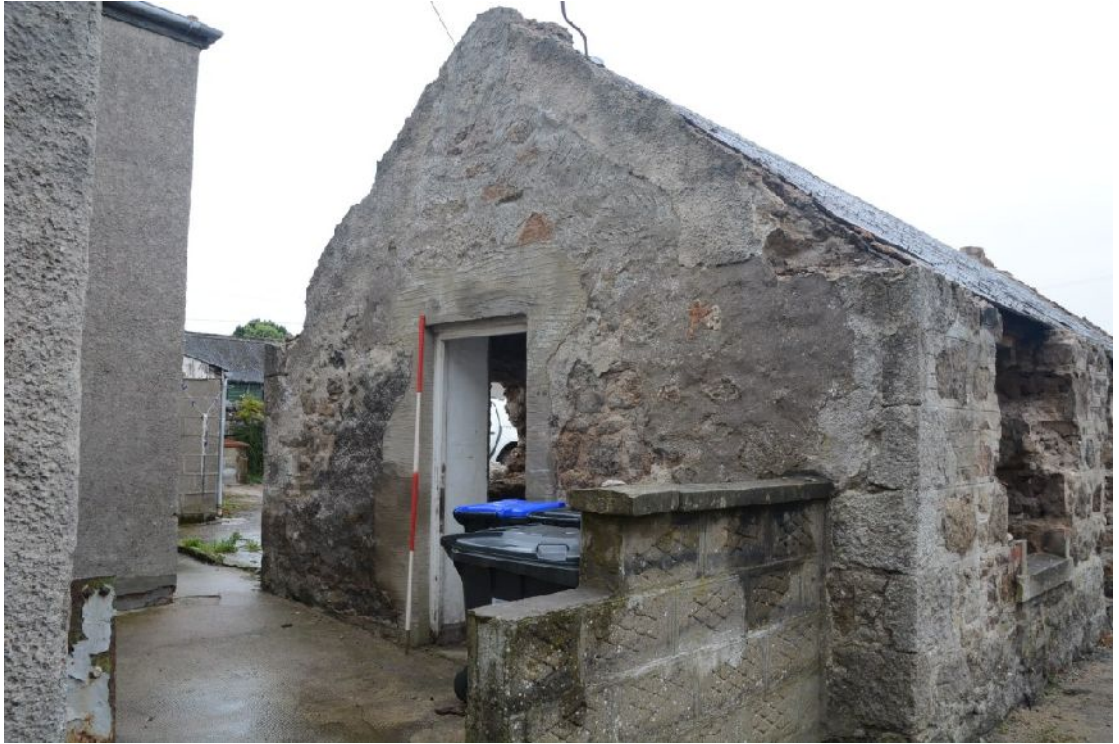
D2 Secondary door. This had been punched through S gable, removing S fireplace. W: 0.94m. H: 2.07m. Concrete margins.

**Illus 9 SW gable and secondary door D2**

The door in the SW gable (D2) is recent, presumably for ease of access as a store. Although in very poor condition this was an interesting example of the smaller homes that were probably common in many Aberdeenshire villages throughout the 19<sup>th</sup> century.

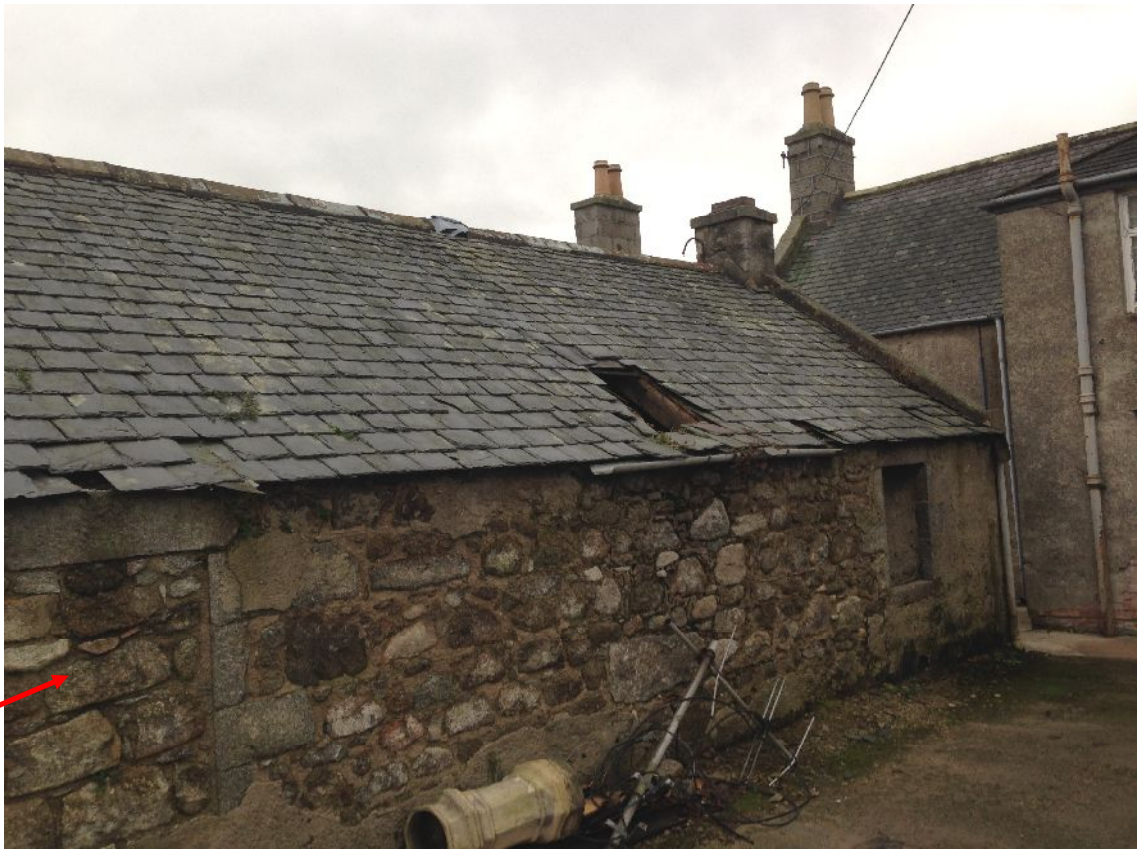
D3 Broken out. Could not be measured. Shown on photographs to have had granite rybats and lintel. It was stone blocked.

**Illus 10 NW wall looking W. Arrow indicates D3. Photograph prior to partial demolition  
(Photograph courtesy of Baxter design)**

At some point a door was built in the back wall (D3). This had stone lintel and rybats and is likely to be of 19<sup>th</sup>-century date but appears awkward in relation to the fireplace and may be secondary after some change in the function of the property. It was later blocked.

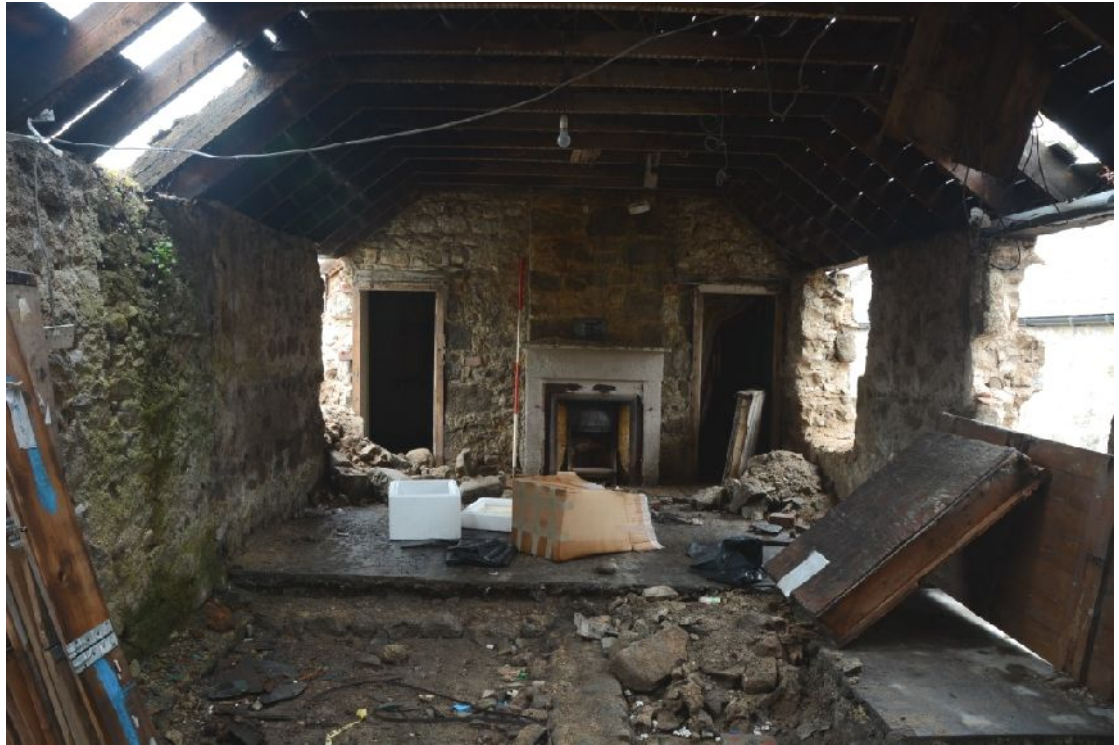
**Illus 11 Interior looking NE**

On either side of fireplace there are secondary doors into NE extension, rooms B1 and B2.

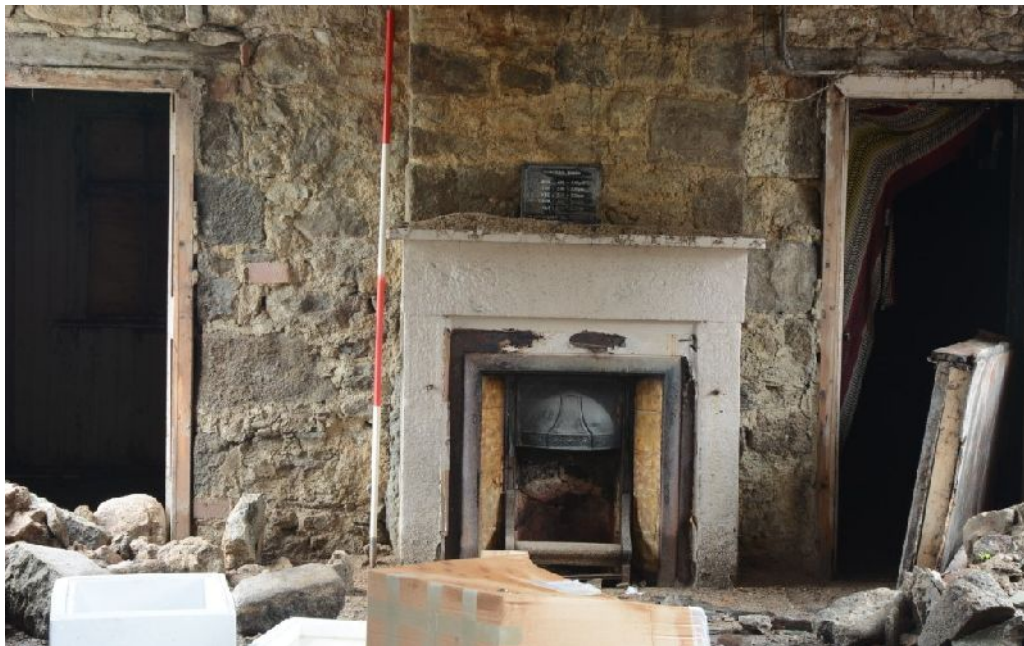
**Illus 12 Fireplace**

Surviving fireplace at N end. Cast iron grate with mottled yellow tile surround.

Stone mantelpiece and surround. Yellow tiles on floor in front of fireplace.

Stone chimney breast 1.27m wide.

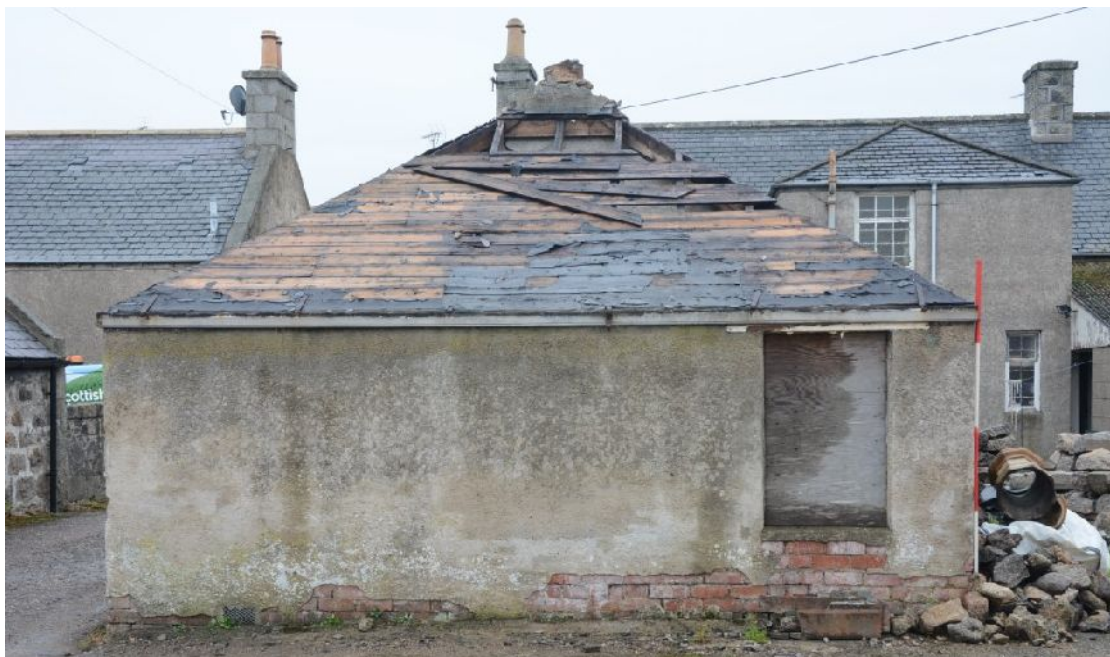
Illus 13 NE extension.

Roof Photographs show lean-to against NE gable of main building.

Demolition survey records roof as having asbestos tiles.

W4 W: 0.76m H: 1.17m Concrete sill. Wooden lintel. Wooden blocking.

W5 W: 0.77m H: 1.25m Concrete sill. Wooden lintel. Blocked with bricks.

The brick extension is clearly secondary but the careful timber lining suggests it was still used for primarily domestic purposes.

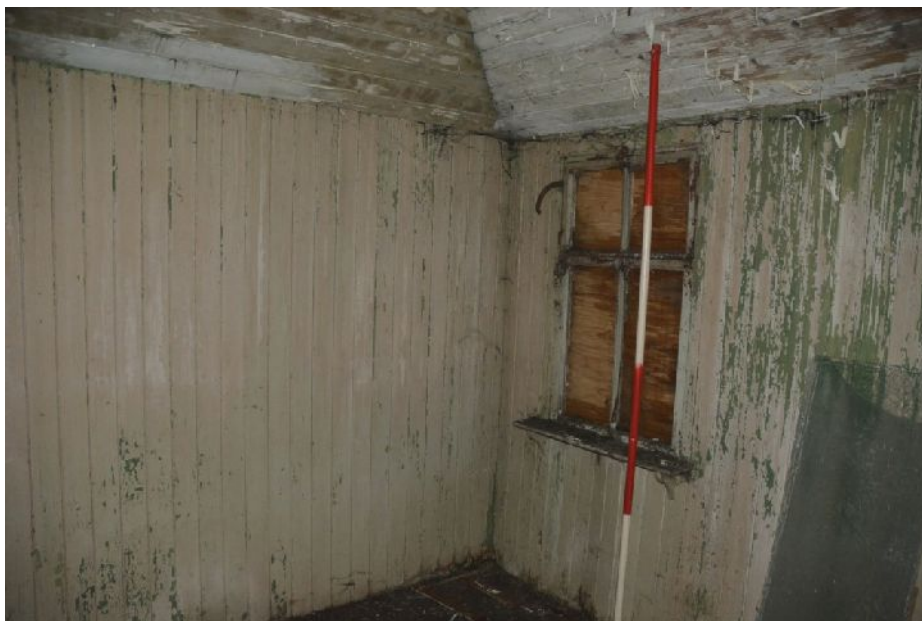
Interior (B on plan). Internally divided into two rooms. Both were lined in vertical pine planks and had horizontal pine plank ceilings. B2 had tap and sink.

Illus 14 Interior NE extension. B1.
