**NETHERFIELD
OLD CHAPEL ROAD
INVERURIE
ABERDEENSHIRE**

Standing Building Survey

Carried out 15th August 2015

Report No: MAS 2015-28

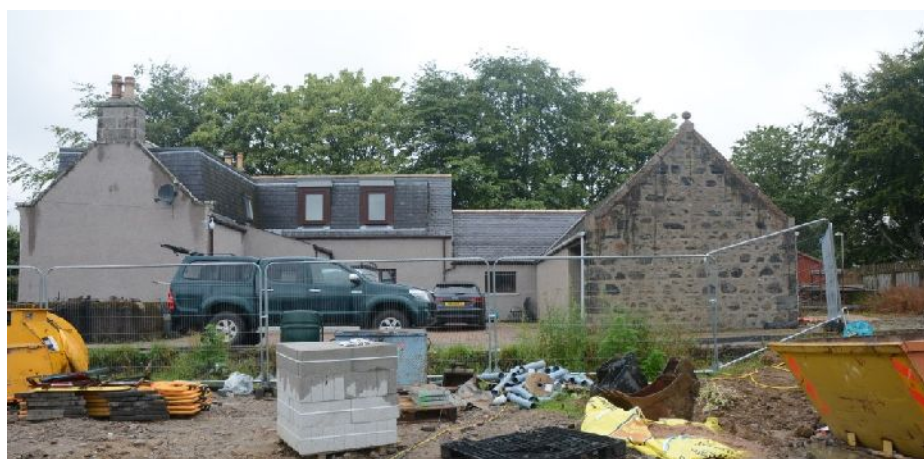
Illus 2 View of buildings looking W. The steading is on RHS with stone gable.

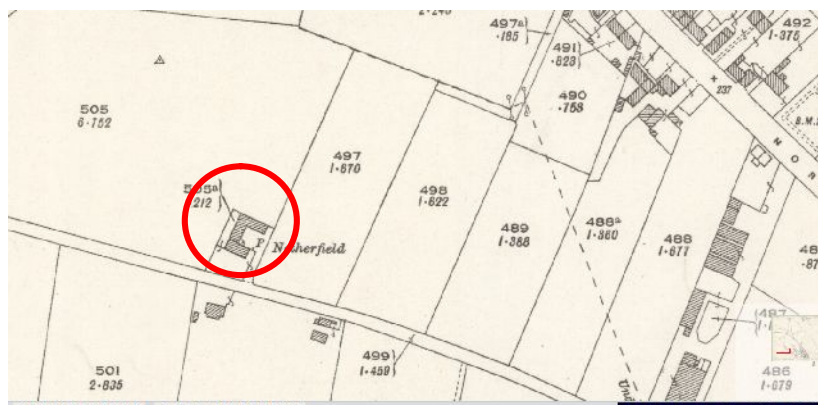
4.3 The 25"/mile Ordnance Survey of 1924 (published 1926. Aberdeenshire 054.04) shows no change of plan.

Illus 4 Detail of 25"/mile Ordnance Survey of 1924 (published 1926. Aberdeenshire sheet 054.04) www.nls.ac.uk Red circle indicates the building.

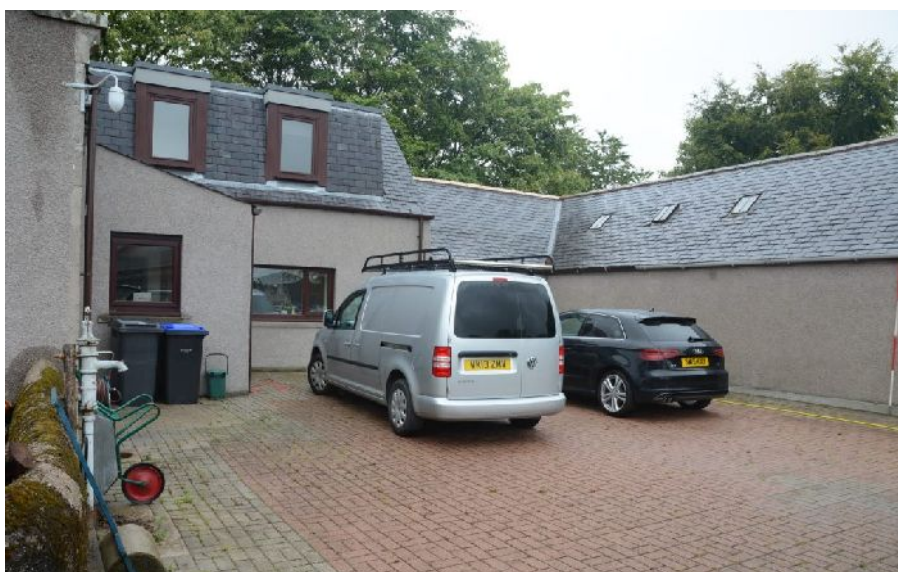
To the rear, an extension of the house (Illus 7) appears to have been built on the footprint of part of the range of buildings shown on the 1899 OS map.

Illus 7 Looking W at extension of house into line of former steading. The steading in the survey is on RHS

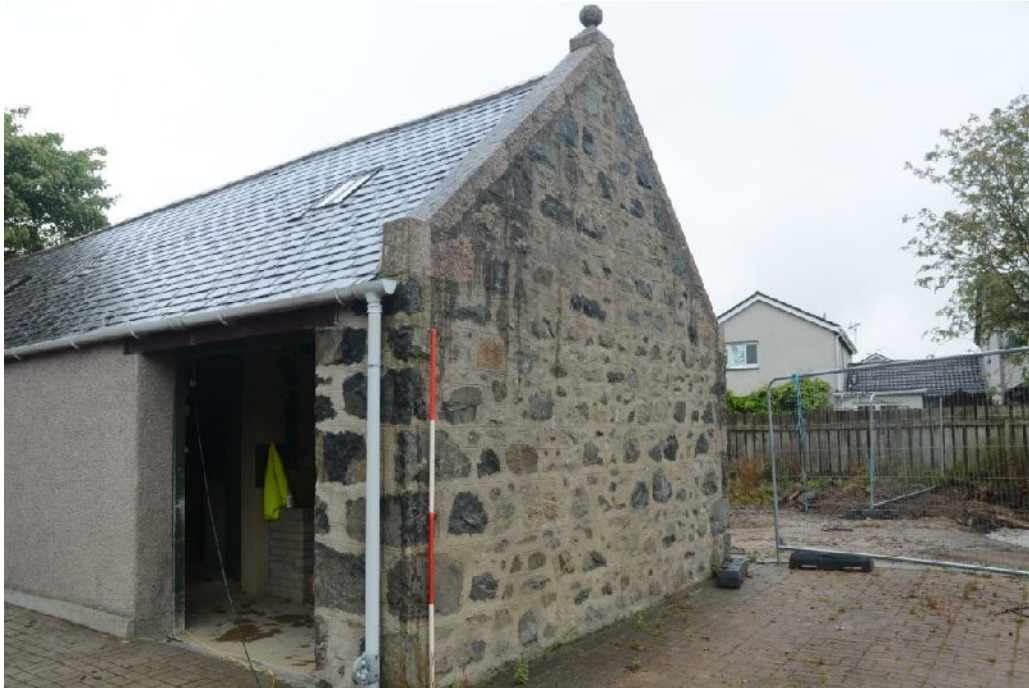
Roof Slate with ceramic ridge. Dressed granite skewes and ball finials at each gable.

Illus 9 E gable of steading showing ball finial

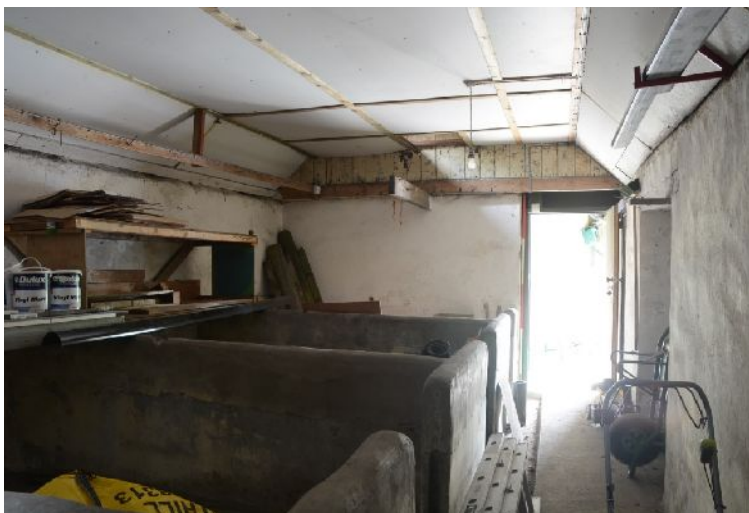
Room A: Now a workshop/store. Probably originally a cart shed. Has loft above with vertical timber loft wall above the stone wall between rooms A and B. A projecting timber may have had some function as part of a hoist?

Illus 10 Looking E from room B towards room A. Shows base of the timber loft wall and position of projecting timber.

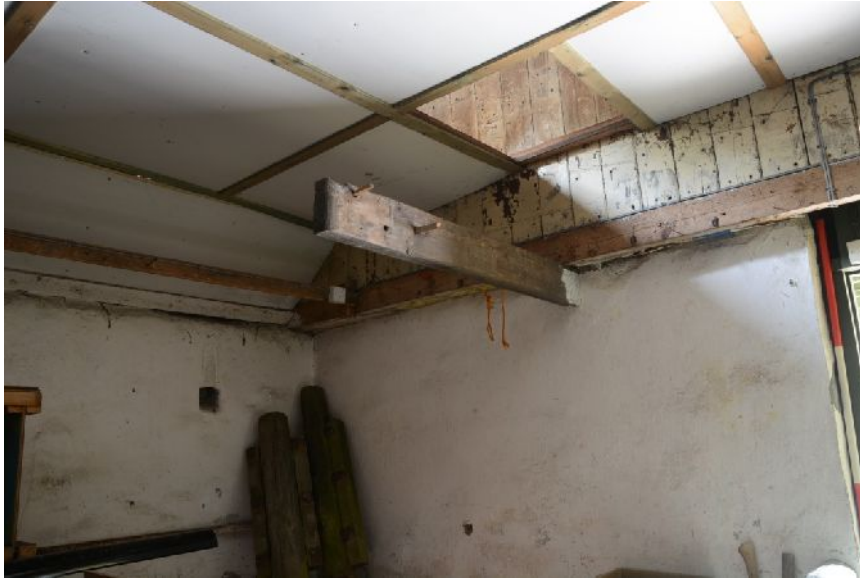
Illus 11 Detail of the timber loft wall and projecting timber.

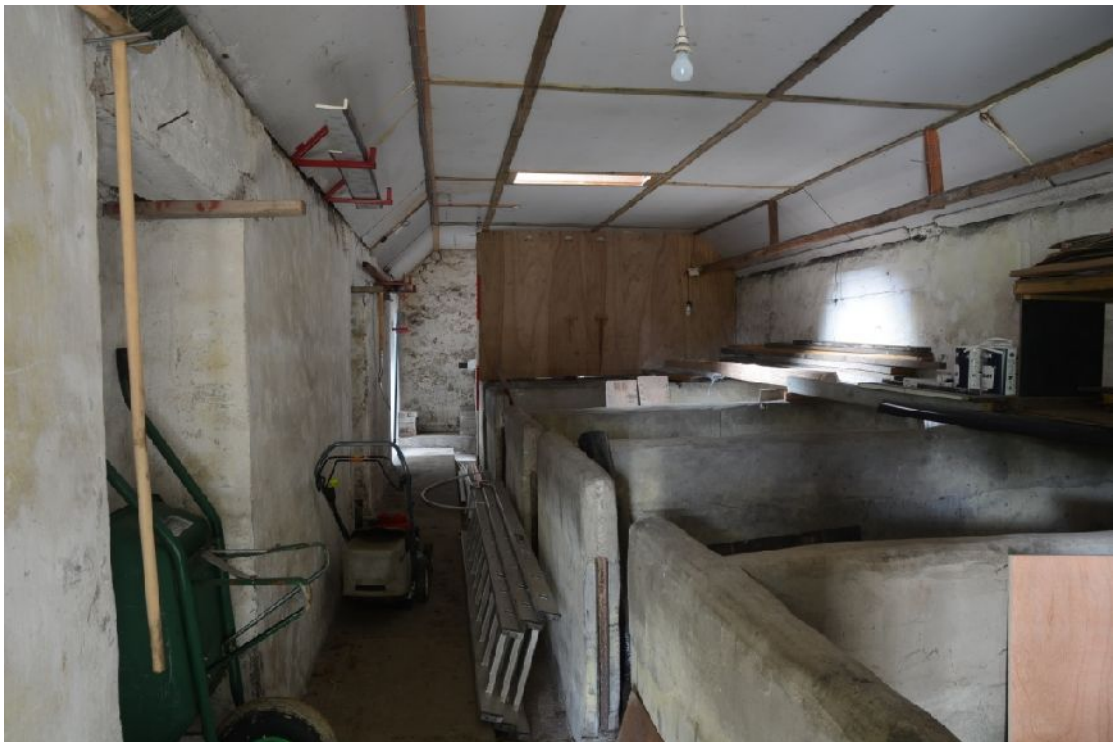
Room B: Now used for miscellaneous storage. In the fairly recent past this had been used for pigs with 6 concrete pig stalls and a drain running along the outside of the stalls. A false ceiling had been inserted.

The original use of this area may have included 3 cattle pens or horse stalls as there were three air vents built into the N wall around sections of pipe. As they did not correspond to all the pig pens it is likely they are from an earlier use.

Illus 12 Looking W through room B showing raised concrete floor and pigs stalls.

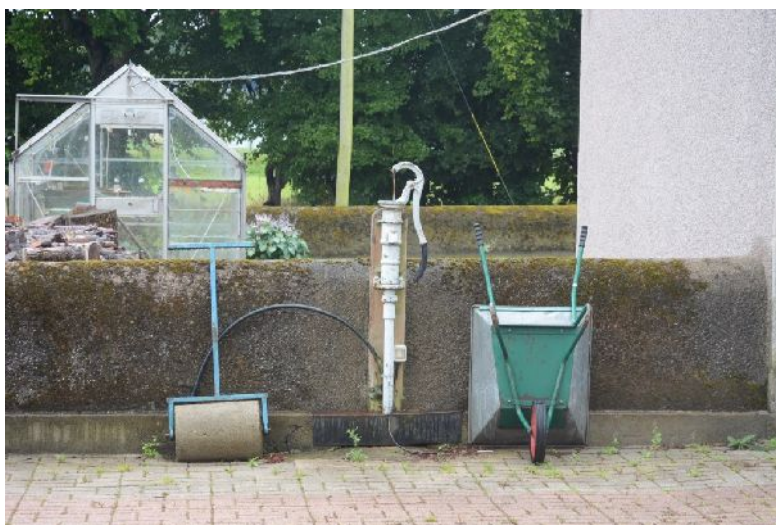
A rare survival, the pump shown on the 1899 OS map, is still in situ to the E of the house (Illus 15).

Illus 15 Pump in original position as shown on 1899 OS map.
