**DRIVEWAY REPAIRS  
CRATHES CASTLE  
ABERDEENSHIRE**

**Archaeological Watching Brief**  
Carried out between February and March 2015  
by  
**Murray Archaeological Services Ltd**

**Report No: MAS 2015-10**  
by  
H K Murray and J C Murray

**-Archaeological watching brief-**

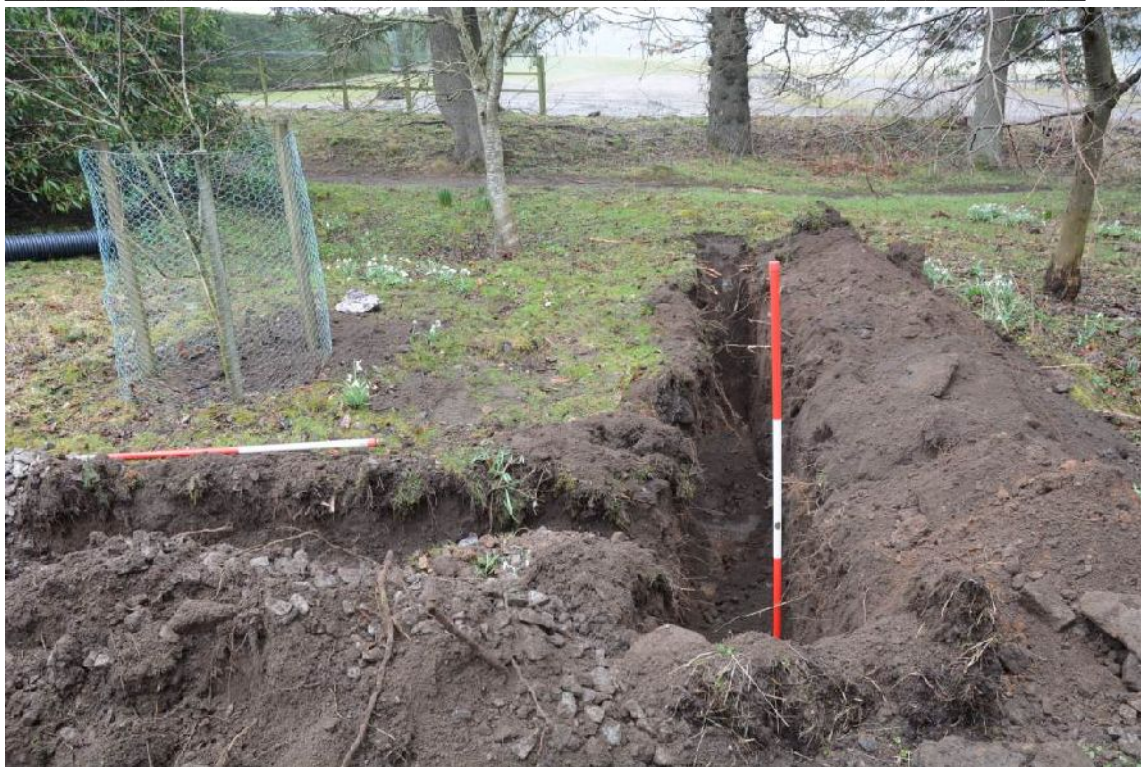
With the exception of one sherd of undiagnostic prehistoric pottery in location 1, there was no evidence of any survival of prehistoric activity in any of the observed locations along this section of drive. The sherd was near the Overflow Car Park, where evidence of Early Neolithic activity was found in 2005 (Murray, Murray & Fraser 2009, 71), however it was in dumped earth so this may have derived from the Overflow Car Park area, rather than indicating that the Neolithic activity extended to this point.

**Illus 4 Drain location 1 with Overflow Car Park in background, looking N**

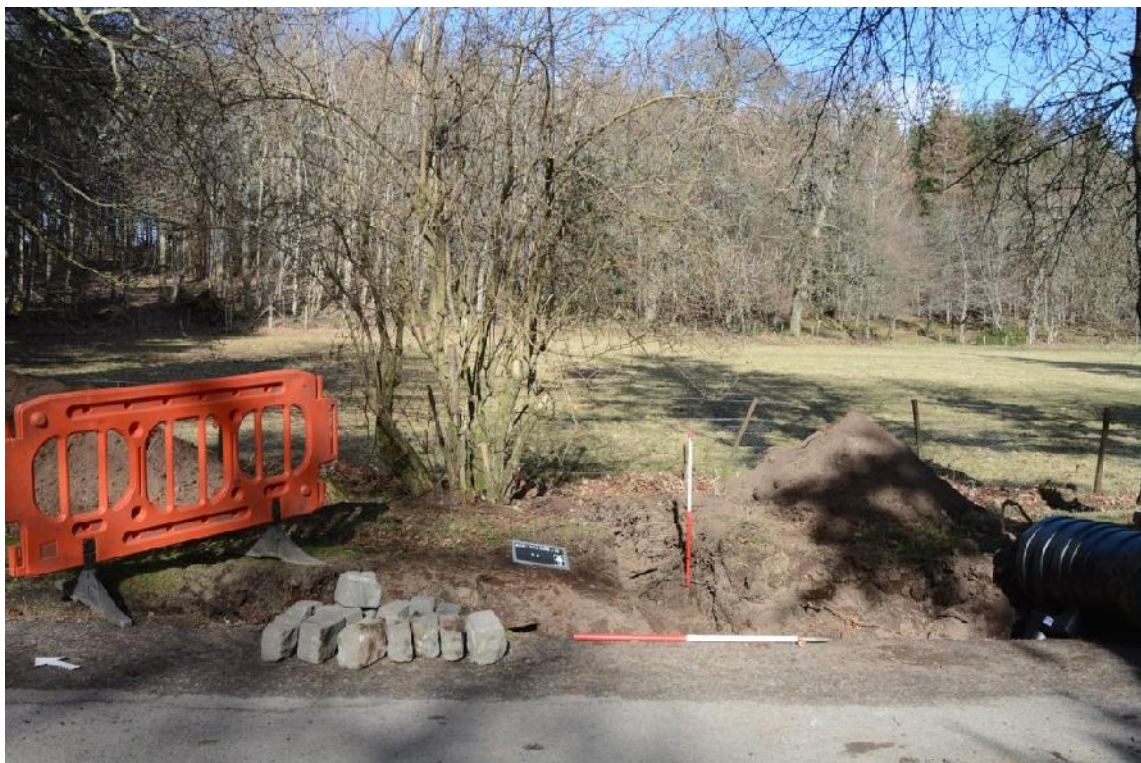
**Illus 5 Drain location 14 looking N across Warren Field**

In general there was shallow topsoil over sand or clay natural. On the lower side of the drive there were stones and boulders used to support the road edge (locations 7, 13, 14).

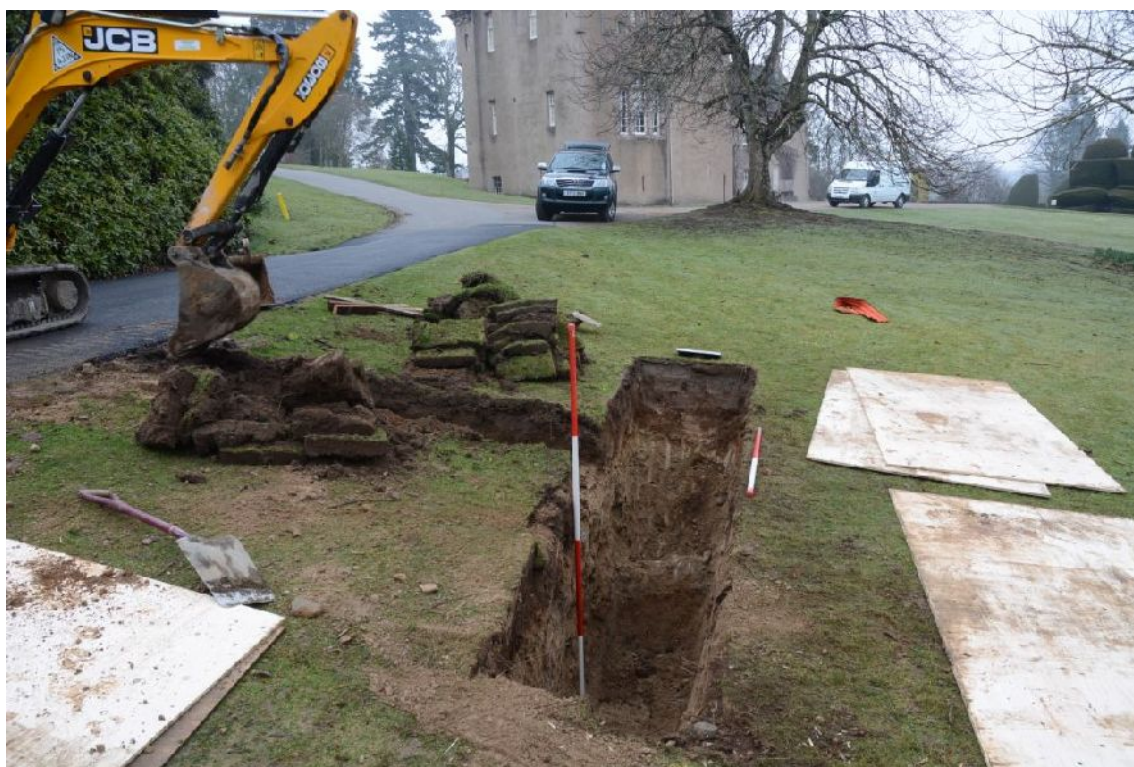
Drain location 17 lay c12m to the NW of the wall (feature 26. Murray & Murray, 2015, 51-53) excavated in 2014 and interpreted as forming the W wall of a courtyard of L17<sup>th</sup> / E 18<sup>th</sup> –century date. The lack of any dumped material or building demolition debris (in drain location 17), both of which were common within the enclosed area of the courtyard, gives additional support to the interpretation of the excavated wall as a barrier between the area of activity and the surroundings.

**Illus 6 Drain location 17 in relation to castle and S lawn**

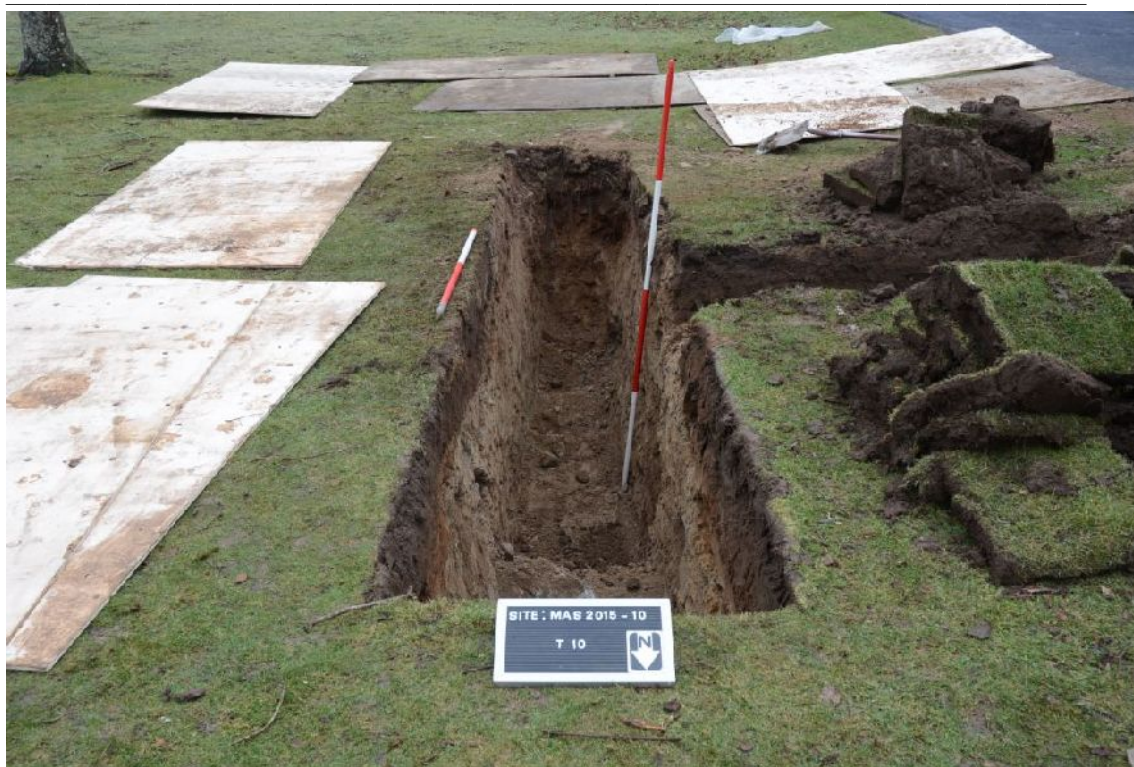
**Illus 7 Drain location 17 looking S (originally numbered T10)**
