**SOUTH GARDEN AREA
CHAPLAIN'S COURT
20 THE CHANONRY
OLD ABERDEEN**

Test pits and recording

Carried out 16th and 21st July 2015

Report No: MAS 2015-22

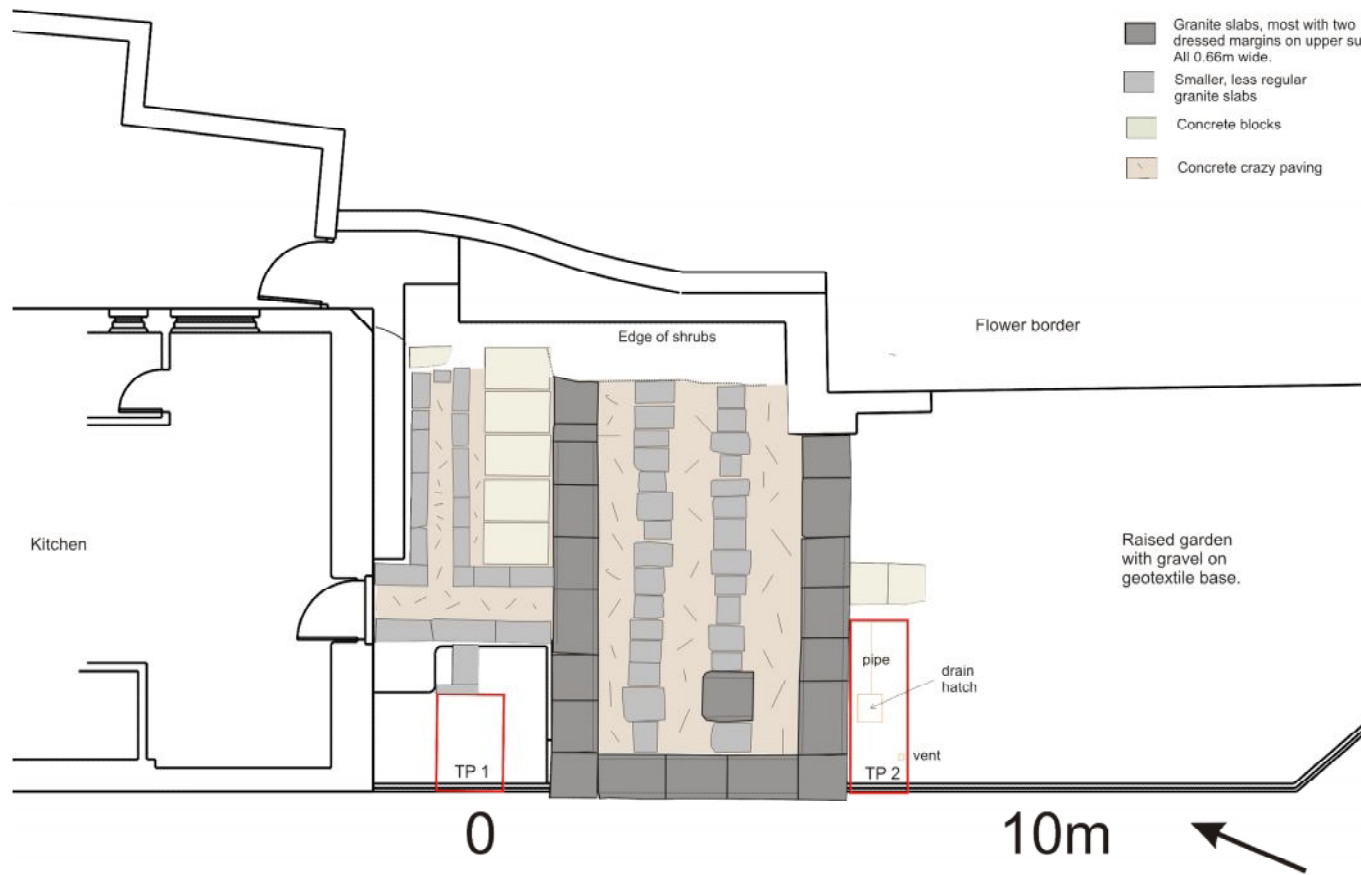
Illus 3 Plan of paving and location of test pits TP1 and TP2

- 4.1 Two test pits were excavated by hand, both on the line of the Chanonry frontage and TP2 also near the possible line of the N wall of the S tower. The details of the test pits were recorded and are detailed below.
- 4.2 The ground plan of the existing paving was also planned and recorded in some detail.

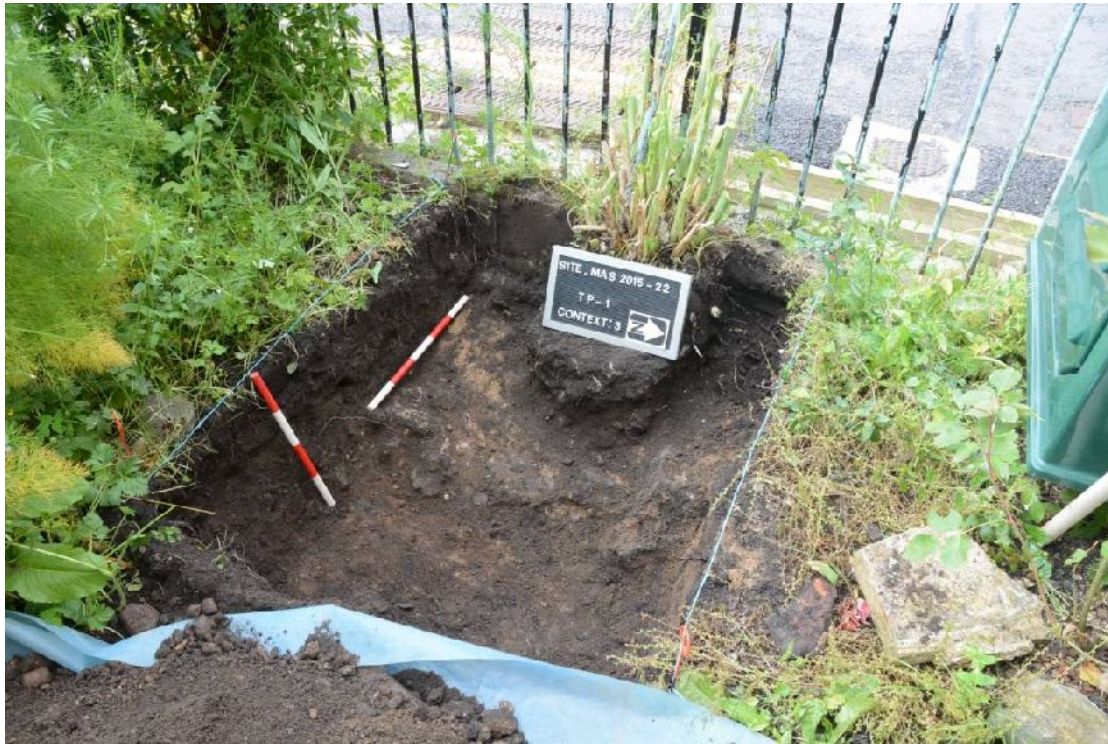
Illus 4 TP 1 looking W to Chanonry. Context 3&4 along W side

TP1 was located along the Chanonry frontage, its N edge being c.0.90m from the end wall of the house.

N/S: 1m x E/W: 1.2m

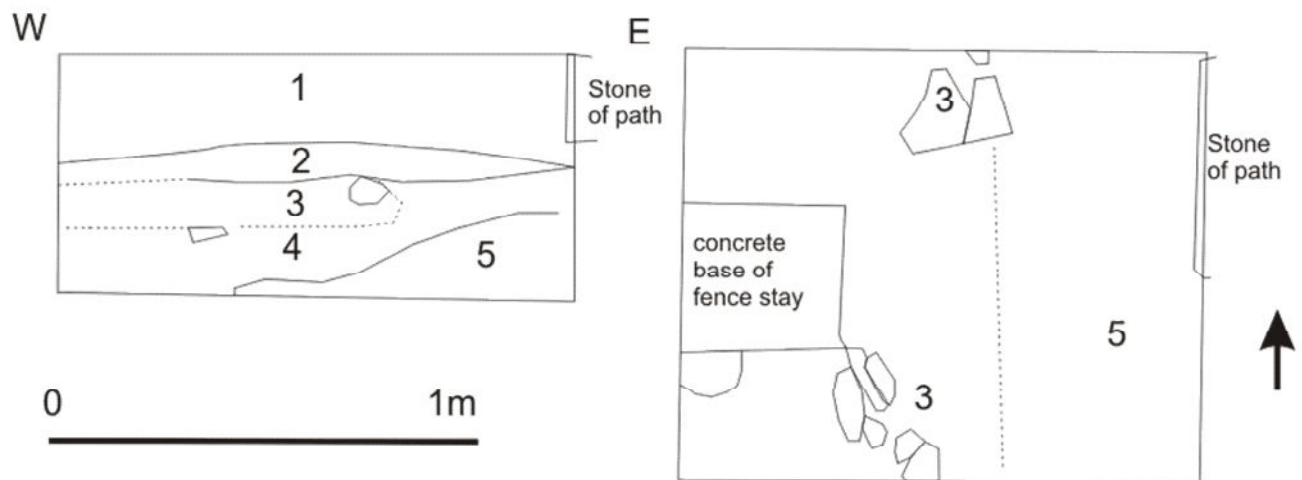
Illus 5 TP1 Plan and section

- 1 Topsoil 200-240mm
- 2 Sandier mixed loam with cinders, some glass. <80mm
- 3 Harder sand with small stones. Appeared to form N/S band but disturbed on W (dotted) and very mixed with 4. May be a dump within 4. <80mm

- 4 Yellow sandy mix with some slate and pantile. Disturbed to W and mixed into 3. <120mm
- 5 E side only. Cut or overlain by 3 & 4. Dark soft loam, some animal bone. <200mm. Extends below paving to E.

Natural- hard yellow clay.

At E side one of path stones was 200mm thick.

Topsoil (1) overlay a thin spread of domestic rubbish (2), probably cinders from a kitchen range. The topsoil would have been spread when the area became formalised into a garden, probably in the 20th century.

This overlay the very mixed layers 3 and 4. While the top of 3 appeared to be quite compact, the two layers were possibly parts of a levelling dump of material produced when the single storey kitchen extension was built, probably in the 19th century (It appears on Wood's map of 1828 (Murray & Murray 2014,15).

It is possible that the apparent dip or cut in which 3 and 4 are deposited may indicate the robbed out line of the front wall of the 16th-century building. However the evidence is ephemeral and interpretation depends more on the knowledge of the wall line than on the evidence of the stratigraphy.

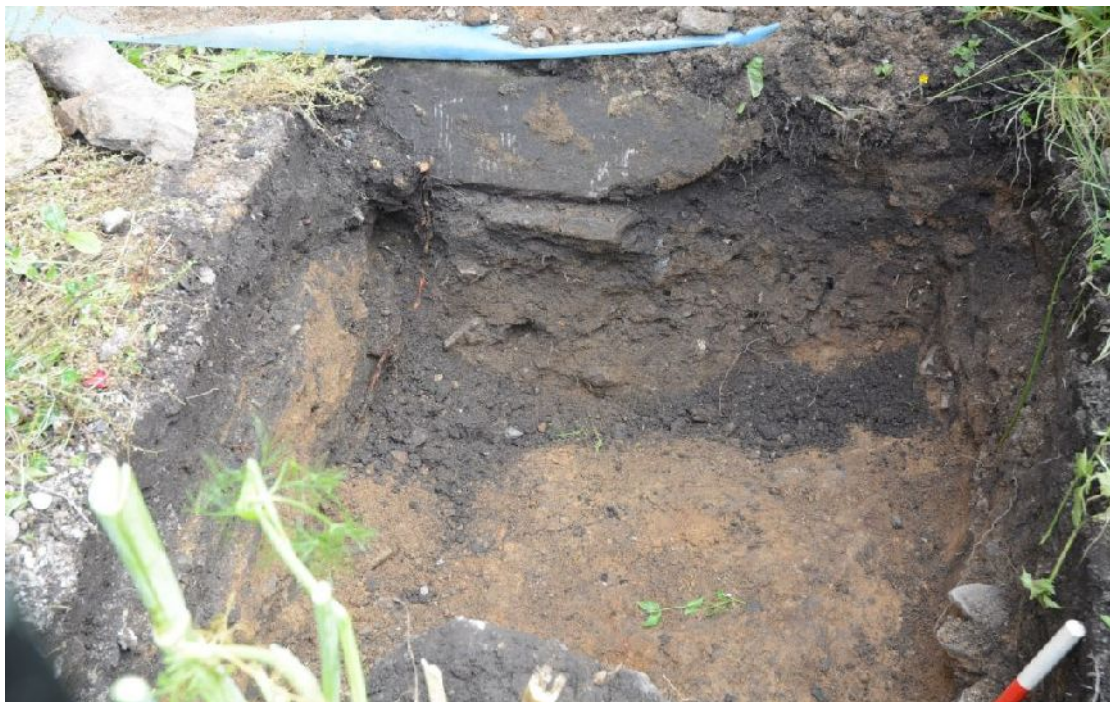
Illus 7 TP 1. E section showing context 5 below paving

Layer 5, which appears to have been cut by layers 3 & 4, contained no datable material but the presence of animal bone from domestic waste is very much what might be expected if this was part of a waste-land spread on land between buildings. This appears to extend below the paving and would be worth observing when the paving is removed.

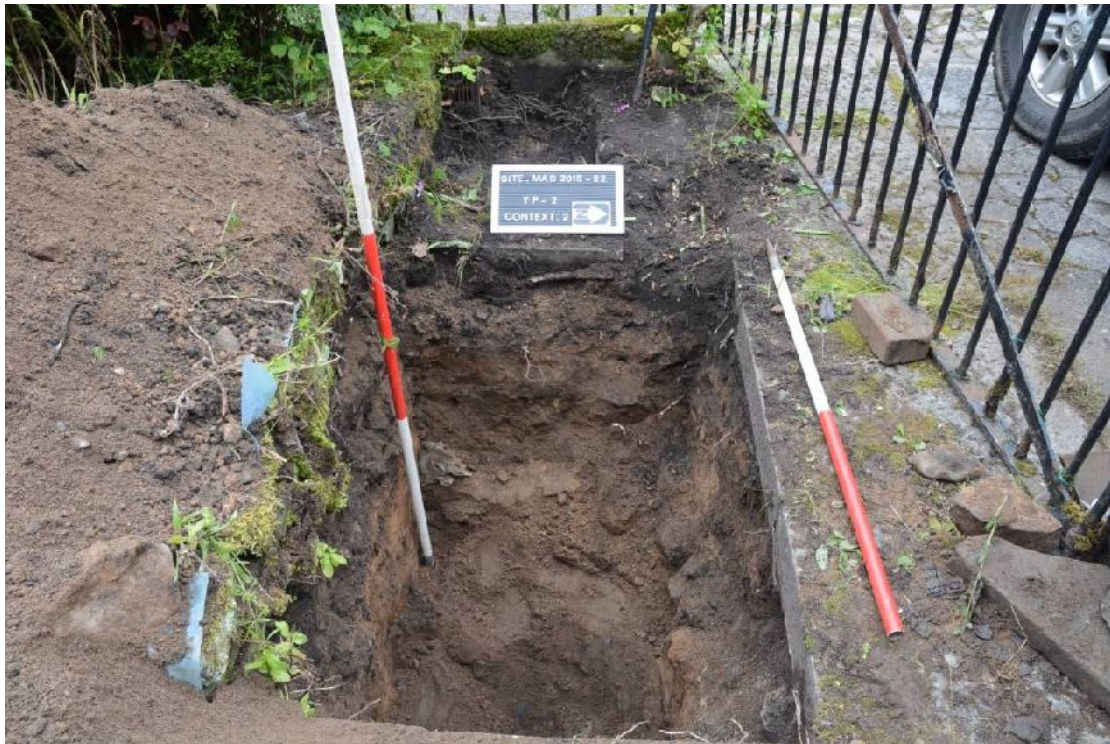
Illus 9 TP 2 in relation to The Chanonry, looking W

TP2 was located at right angles to the Chanonry frontage, its W edge being c.6.9m and 7.8m from the end wall of the house. Its N edge lay alongside 4 of the stones in the S line of granite paving slabs.

N/S: 0.90m x E/W: 2.4m

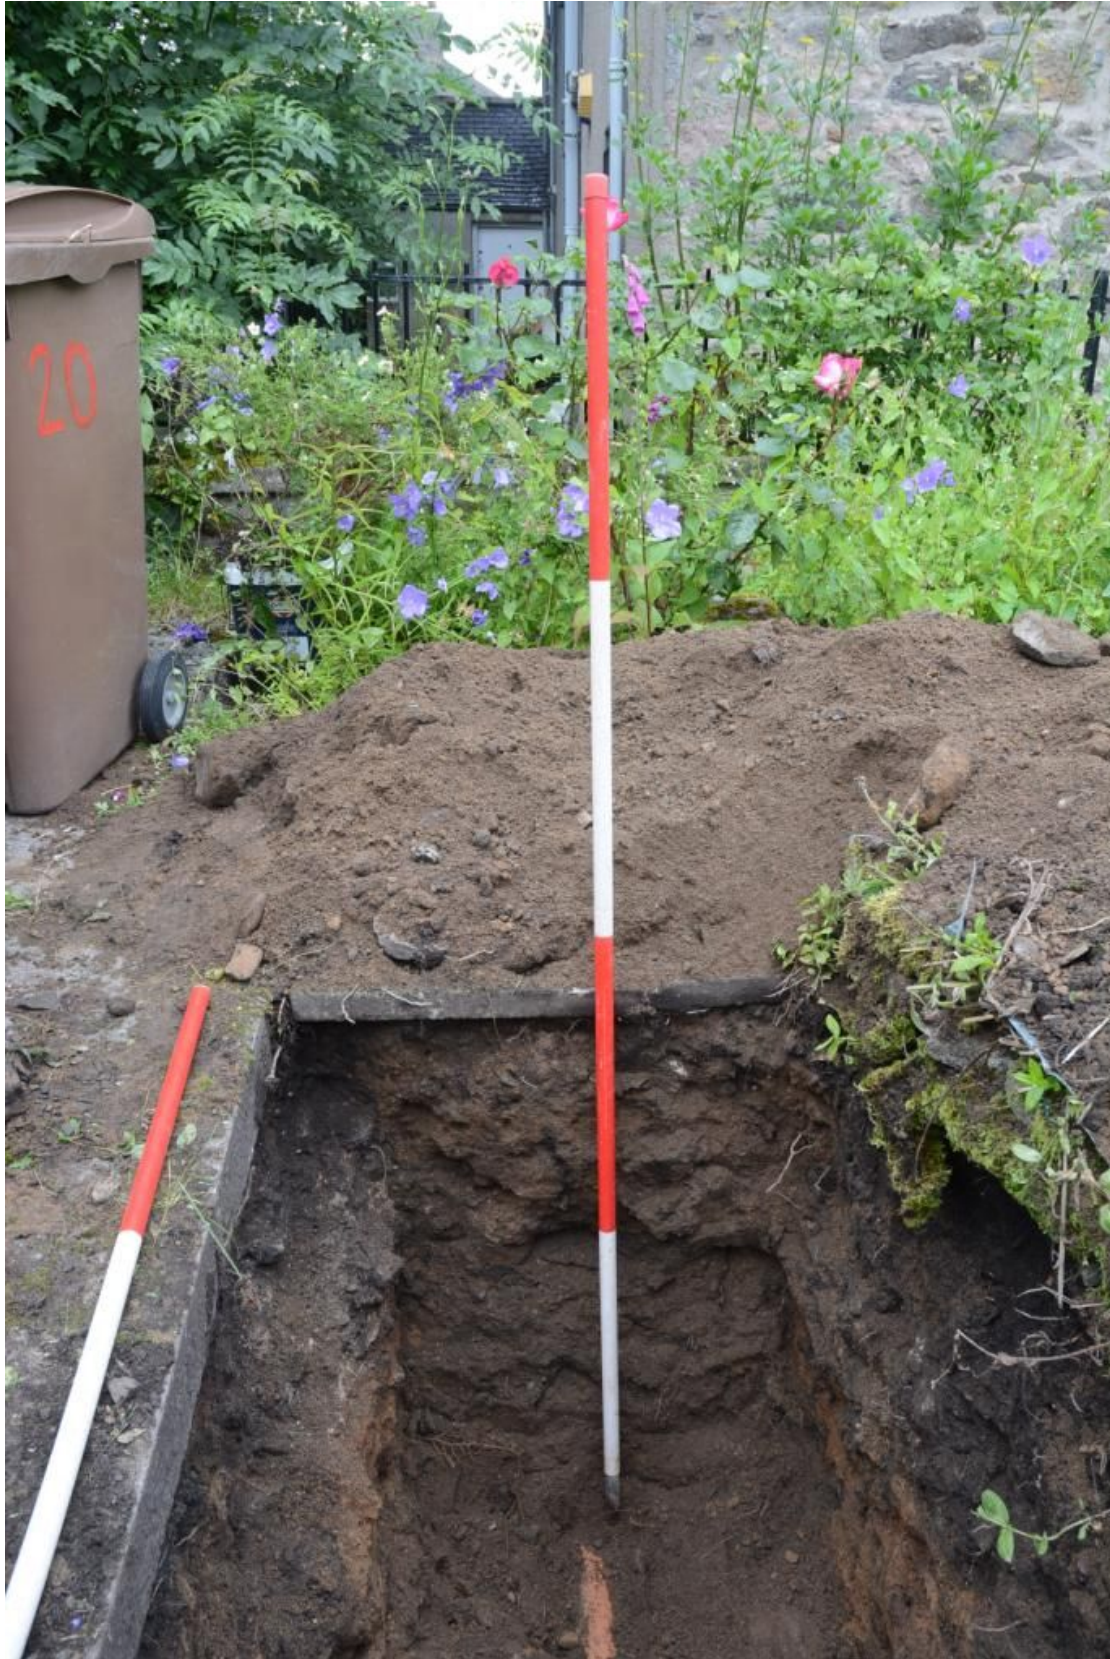
Illus 10 TP 2. Drain in relation to Don Street houses

With the exception of c.200mm projecting from the E end of the N side of the test pit, below the granite slabs of the paving, all of TP 2 proved to be backfill (2) into the

trench of a ceramic drain running E/W at right angles to the Chanonry. A drain hatch and gas vent related to the pipe, were also exposed. The pipe cut, which was 700mm wide, had been cut into natural yellow clay. The natural was at c.600mm below the present surface. The top of the pipe itself was at 1.05m below the top of the present paving.

- 1 Topsoil
- 2 Disturbed backfill of pipe trench
- 3 Pipe trench

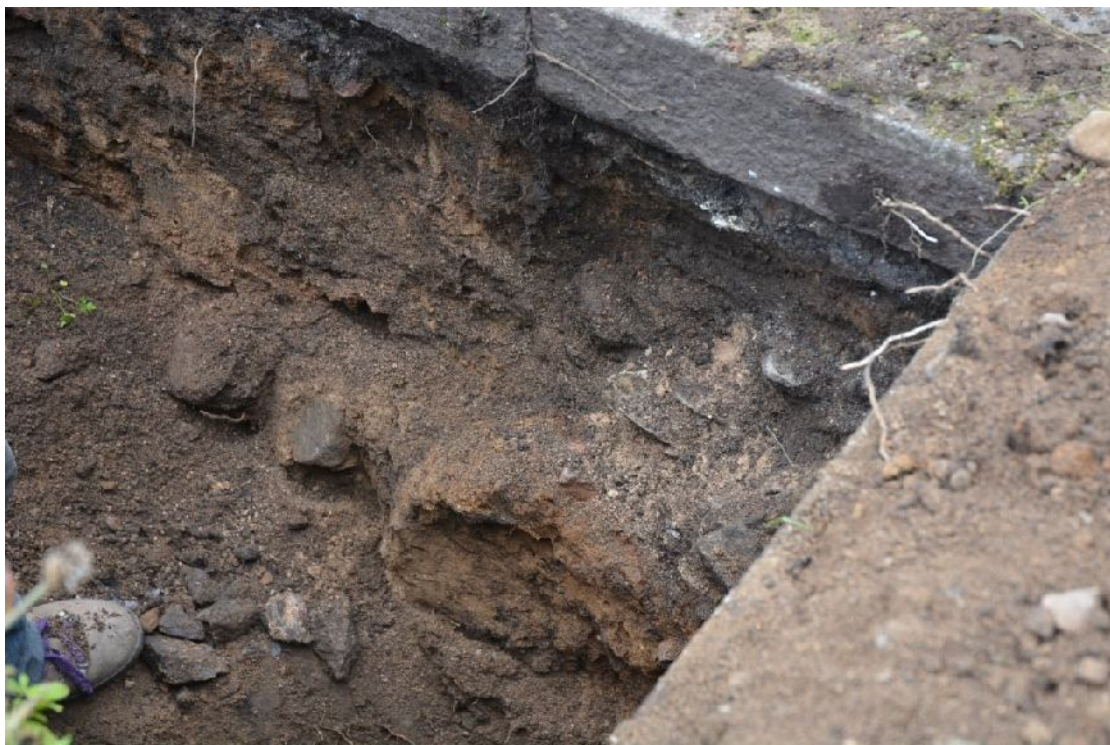
Illus 11 TP 2 Context 4 & 5 below paving (RHS) in N section

The small area at the E end of the N side, below the paving showed:

- 4 c. 280mm of dirty garden soil with some ashes and domestic waste, similar to TP1, layer 2.
- 5 Below this there was c.200mm of mortar and small stone fragments directly onto natural. A single small rimsherd of post-medieval pottery was found in this layer.
Rimsherd of a bowl, Scottish Redware, internally glazed. 15th-16th century.

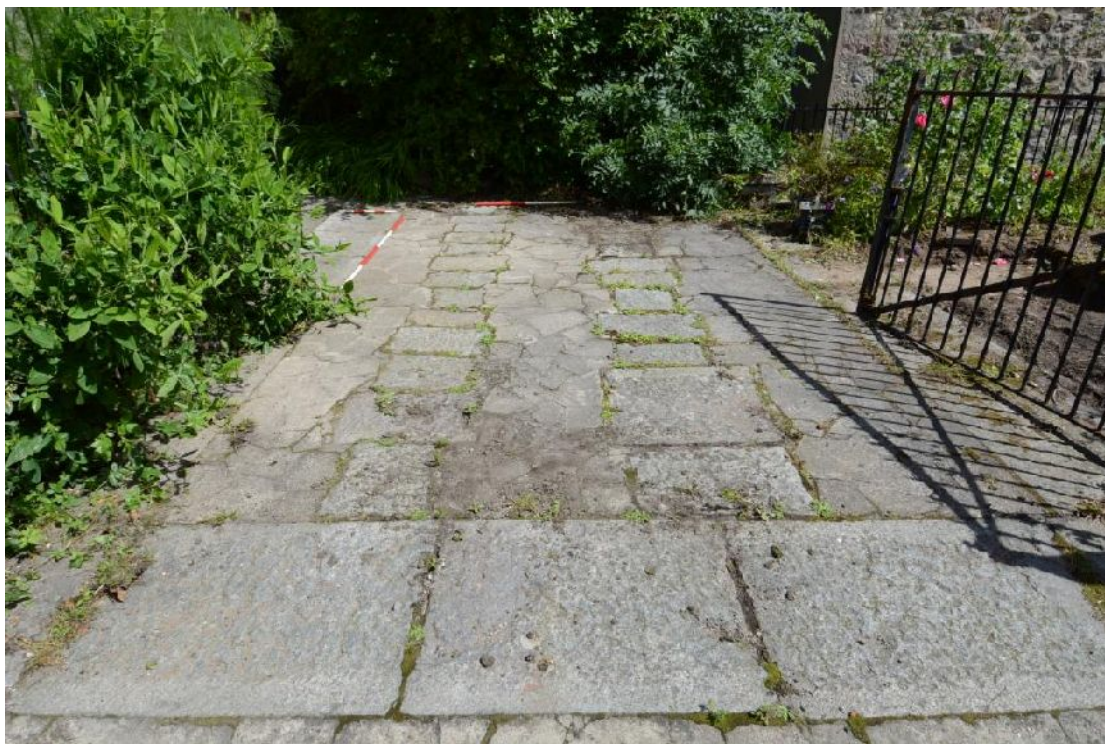
Illus 12 Paving looking E from existing entrance

The paving comprised five main elements:

- 1 U-shape of large, regular, granite slabs, the base of the U along the frontage
- 2 Two less regular lines of smaller, more varied granite slabs running E/W
- 3 Smaller stone slabs bordering the path to the back door and between the door and the gate to the main gardens.
- 4 A small number of large concrete slabs
- 5 Concrete crazy paving infill

The paving does not appear to lie directly along the lines of any earlier structural remains, or be placed to mark their position. Some estimate may be made of the position of the S tower by 'mirroring' the N tower; this would indicate that the N wall of the S tower might have been near to the line of TP2 but there was no evidence to confirm this from the present investigation..

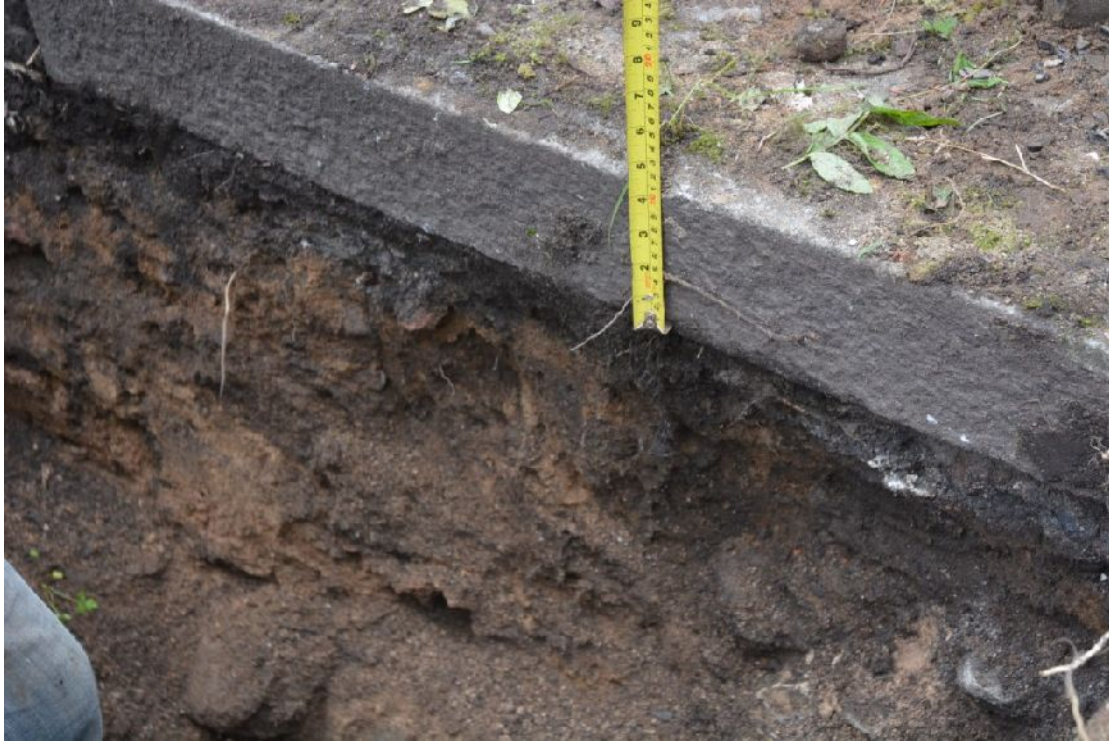
Illus 13 Depth of paving beside TP 2 N section

The well-dressed slabs on the frontage and in the two main E/W lines of paving (Illus 3: darker grey on plan- only one identified in the less regular paving) are all of the same width (0.66m) and many show signs of dressed and worn margins c.100mm wide along both 'long' sides. The three that were alongside TP2 were all a regular 130mm (5") thick. They varied in length between 0.23 and 1.06m and the total linear length was a little over 14m if set end to end. (Lengths: 0.41m+, 0.91m, 0.72m, 0.71m, 0.59m, 0.99m, 0.71m, 1.06m, 0.90m, 0.96m, 0.68m, 0.73m, 0.68m, 0.72m, 0.69m, 0.79m, 0.67m, 0.23m, 0.64m+, 0.70m.).

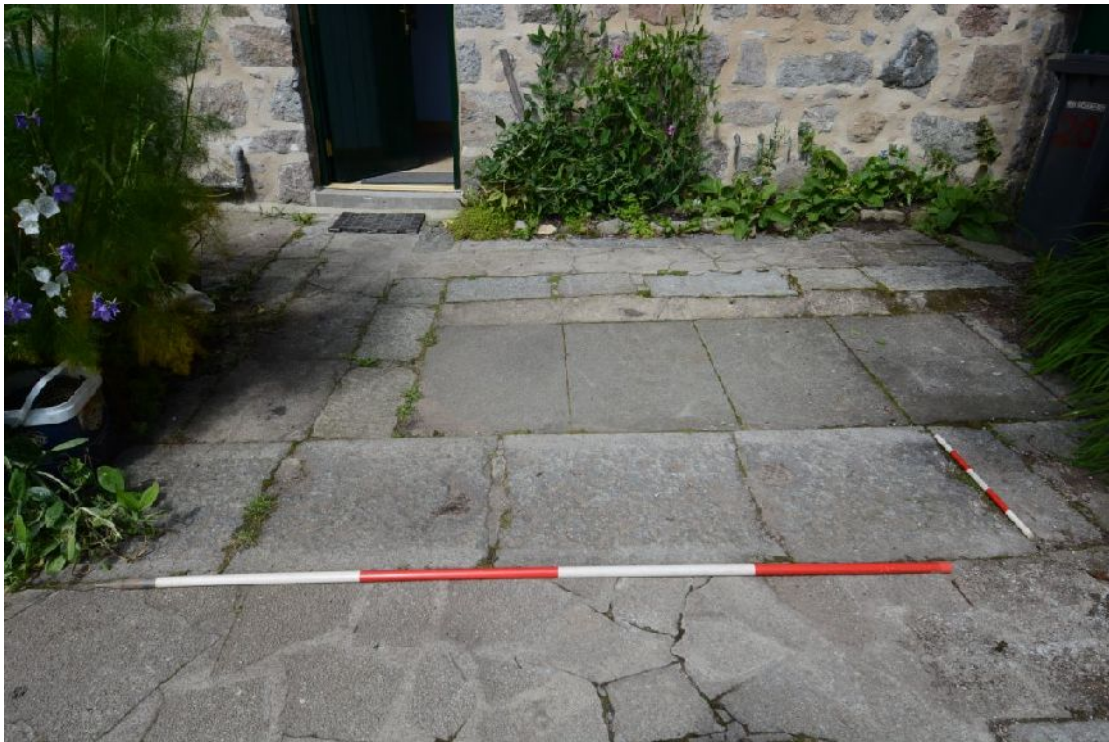
Illus 14 Paving looking N. Dressed margins visible on stone slabs above ranging rod

It is possible that they were a projecting foundation for a slightly narrower wall but this is purely speculative.

The large stone slabs with dressed margins do not appear to be paralleled on the standing building and their origin is unknown. They may have come from some demolished part of Chaplain's Court but could equally have been imported to the site from elsewhere, not necessarily in Old Aberdeen.

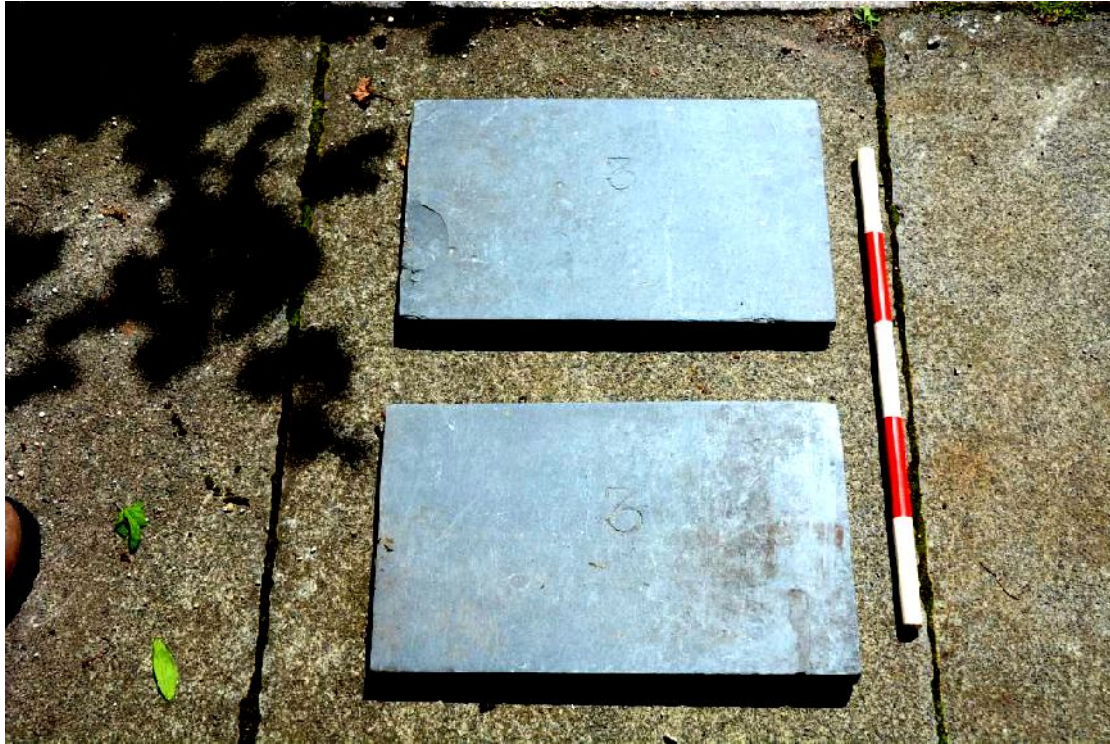
Illus 16 Slate slabs. Front

Two slate slabs found in the garden were also recorded. Both are of very fine grey slate. Their relationship to the Chaplain's Court is not known. As the number '3' is of different size on each slab, it is perhaps less likely that they were a matching pair.

Slab 1 (top in both photographs. Illus 16, 17)

425 x 260 x 30mm

3 incised on front: 40mm high

Slab 2 (bottom in both photographs. Illus 16, 17)

425 x 255 x 30mm

3 incised on front: 45mm high

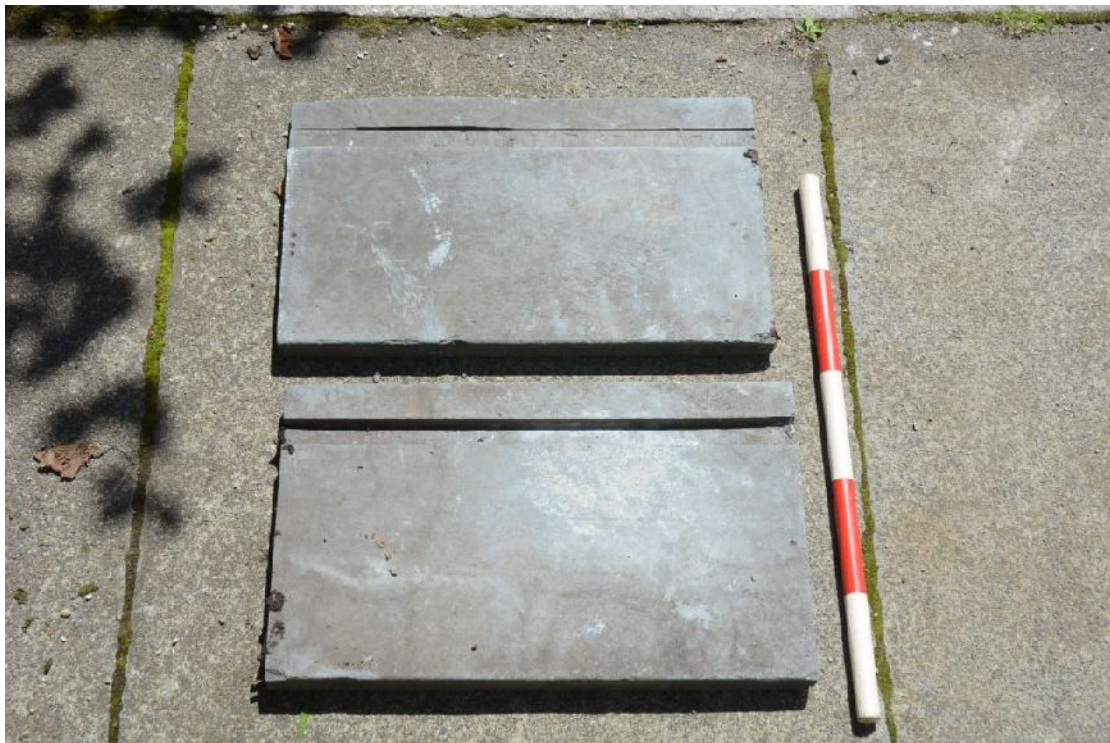
Illus 17 Slate slabs. Reverse

Reverse : groove 30mm wide and 10mm deep. Broken

Reverse: groove 25mm wide and 10mm deep.
