BLACKHILLS RORA MINTLAW ABERDEENSHIRE

Standing Building Survey Carried out 12th November 2015

Report No: MAS 2015-38 by H K Murray and J C Murray

- Standing Building Survey -

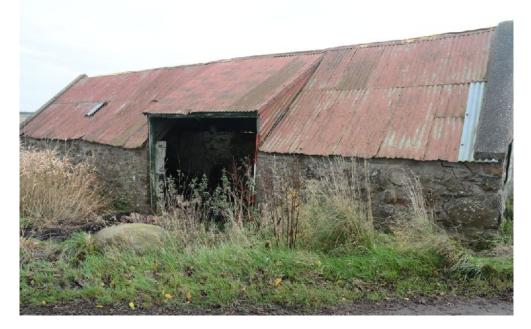
Illus 5 N wall and door D1

D1 W: 3.1m H: 2.25m Projects into roof line. This height appears to have been raised as there is concrete on either side (blue on elevation).

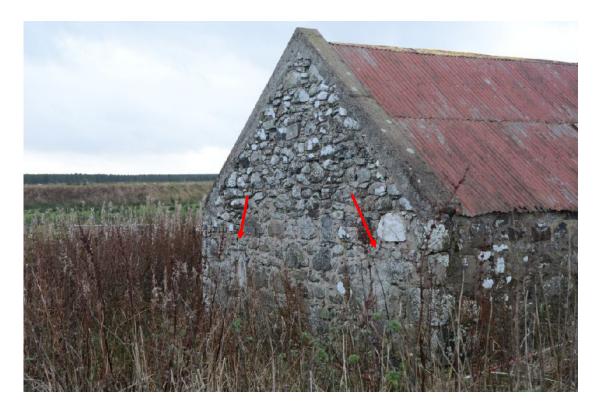
- F1 Blocking, probably small window. Stone lintel. Concrete blocked.
- W: 400mm H: 400-500mm
- F2 Blocking, probably small window. Stone lintel. Concrete blocked.
- W: 400mm H: 400-500mm

Illus 6 E wall with blockings F1 and F2 (marked by arrows)

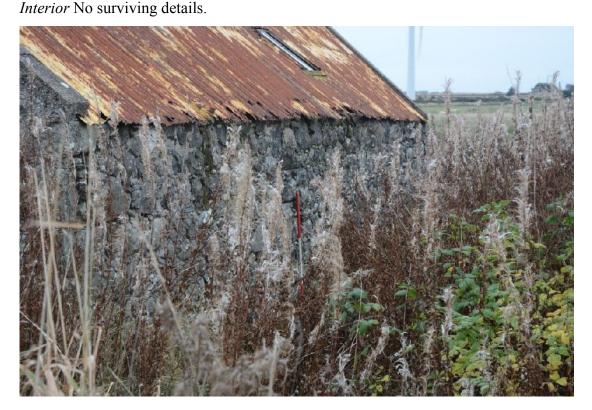
F3 Externally stone lintel with rectangular, stone-blocked, opening 400mm high and 600mm wide over a wooden batten. Below the batten there was a narrower blocked opening c.400mm wide. Internally access to the blocking was difficult but they appeared to be splayed internally. The lower blocking was 330mm high from base of wooden batten and splayed from c.300mm wide at

Illus 7 S wall. The rod marks the position of blocking F3

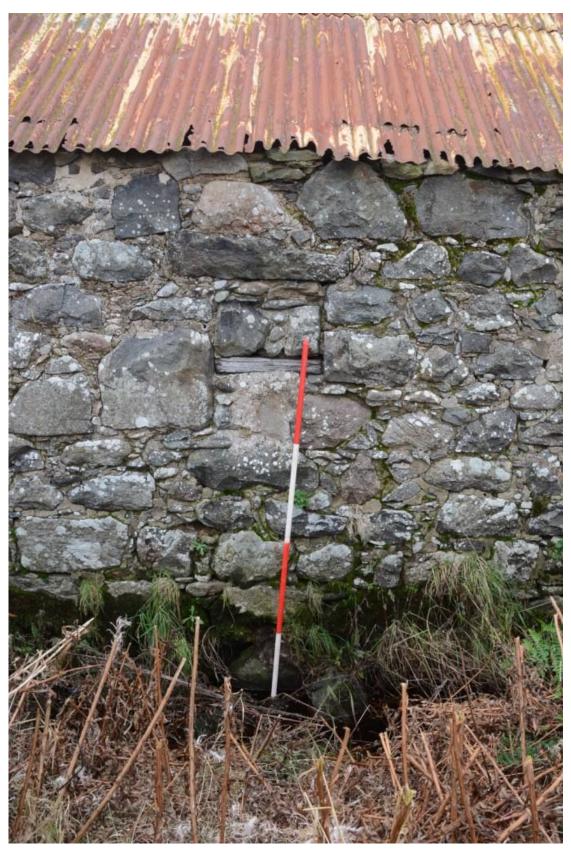
blocking to 570mm wide at internal wall face. There was a large stone at the base which projected out from the inner wall face.

Illus 8 S wall. Blocking F3. The lade runs along the base of the wall.

The building had been a small mill. The function of the mill is unclear. The mill pond and sluice shown on the 1^{st} OS map of 1869 indicate it was water-powered and Blocking F3 on the S wall above the mill lade may have held a wheel axle-however this seemed high in the wall in relation to the level of the lade and line of the roof. Internal blocking F4 may have held the end of a beam/ metal beam to support machinery. The building seems to have fallen out of use as a water-powered mill by the 2^{nd} OS map of 1900.

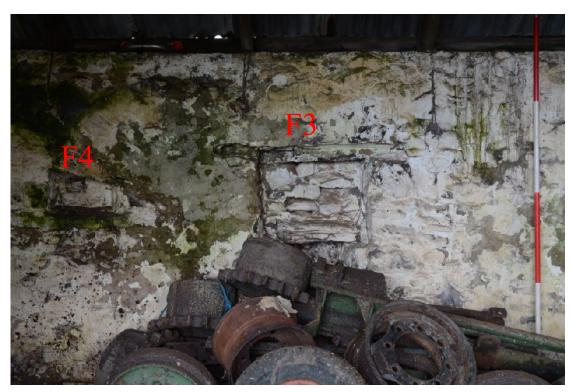
F4 Oblique slot on inside of wall only. 700mm between F3 and F4.

W: 200mm H: 180-250mm. Depth into wall:120mm. Wooden batten across top. Small rectangular slot below it W: 300mm H: 120mm. Depth into wall; 80mm.

Illus 9 Blocking F3 and slot F4 on inner face of S wall.
