**COLDWELLS STEADING**  
**INVERURIE**  
**ABERDEENSHIRE**

**Standing Building Survey**  
Carried out 14<sup>th</sup> January 2016  
by  
**Murray Archaeological Services Ltd**

**Report No: MAS 2016-06**  
by  
H K Murray and J C Murray

## **- Standing Building Survey -**

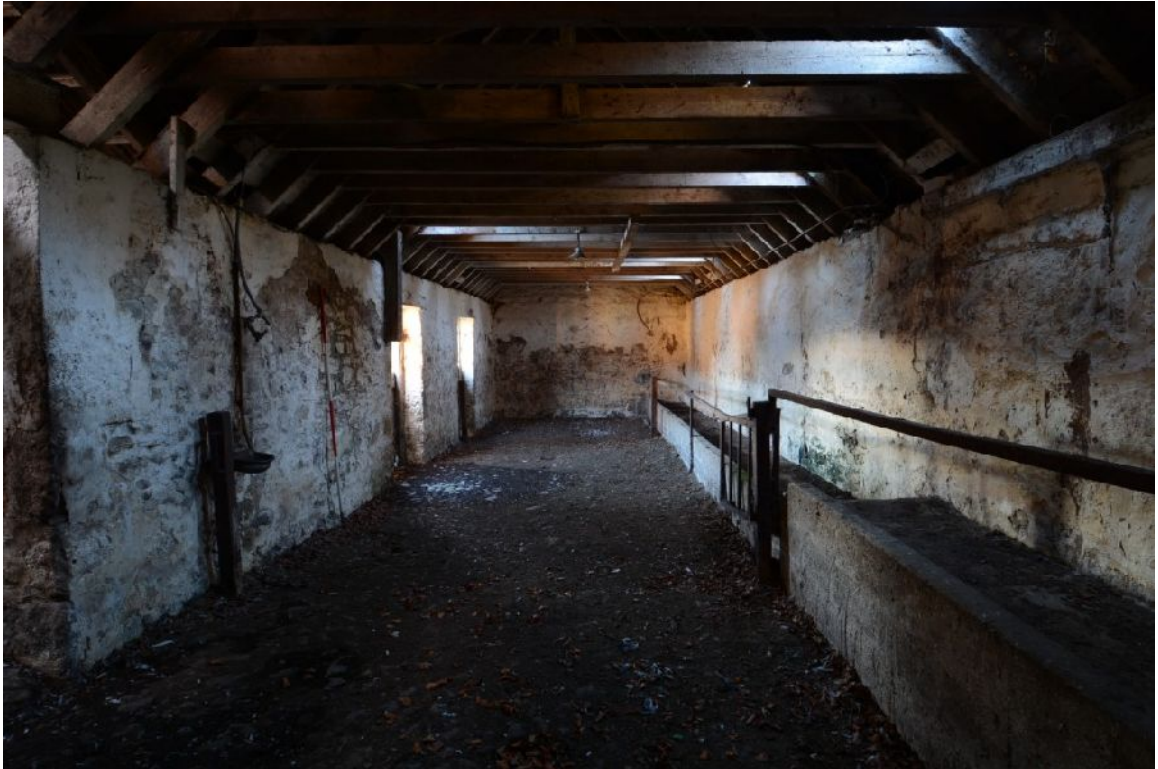
**Illus 6** Looking S along W range

Interior Concrete feed pass built along W wall. Floor cobbled with original drain visible (Illus 6). Marks of tied cow stall trevise along W wall; they would have made 8 double pens, each approx 2m wide.

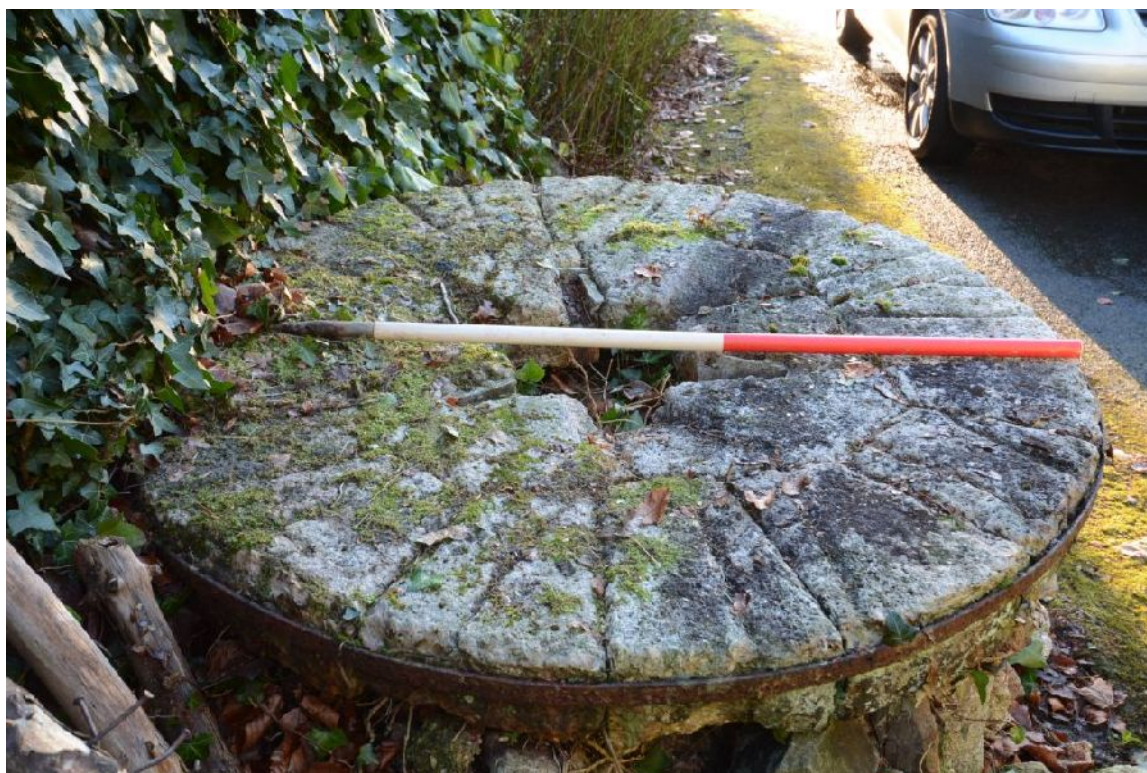
F4 Mill stone- not in situ (Illus 7, 8). This was removed from garden of house during present owners' occupancy. It may or may not derive from the steading- although it probably does.

It appears to be a runner stone, probably for grinding oatmeal. It is formed of a number of individually cut quartzitic stones set in an iron band. Diameter of iron band: 1.36m. Diameter of stone setting: 1.32m. The stones vary in depth from 115-120mm.

Central socket square : 280mm x 280mm with three radial slots each c100mm long 50mm wide and 30mm deep. There are also three roughly triangular chamfers. The tops of the outer stones are grooved. A close parallel to this stone is

**Illus 7 Oatmeal grinding stone (F4)**

At the N end of this range, the sockets (F1) coincide with the position of the horse mill shown on the OS maps from 1867- 1899 so it is probable that the mill was inside, with its framework supported in these sockets- and possibly using the oatmeal grinding stone now repositioned outside the W range (F4). A shaft would have gone through the wall to the horse mill outside but this part of the wall was obscured by the modern lean-to Building 2. The horse mill has been removed by the 1924 OS map- reflecting the change from horse power after the loss of horses in WW1.

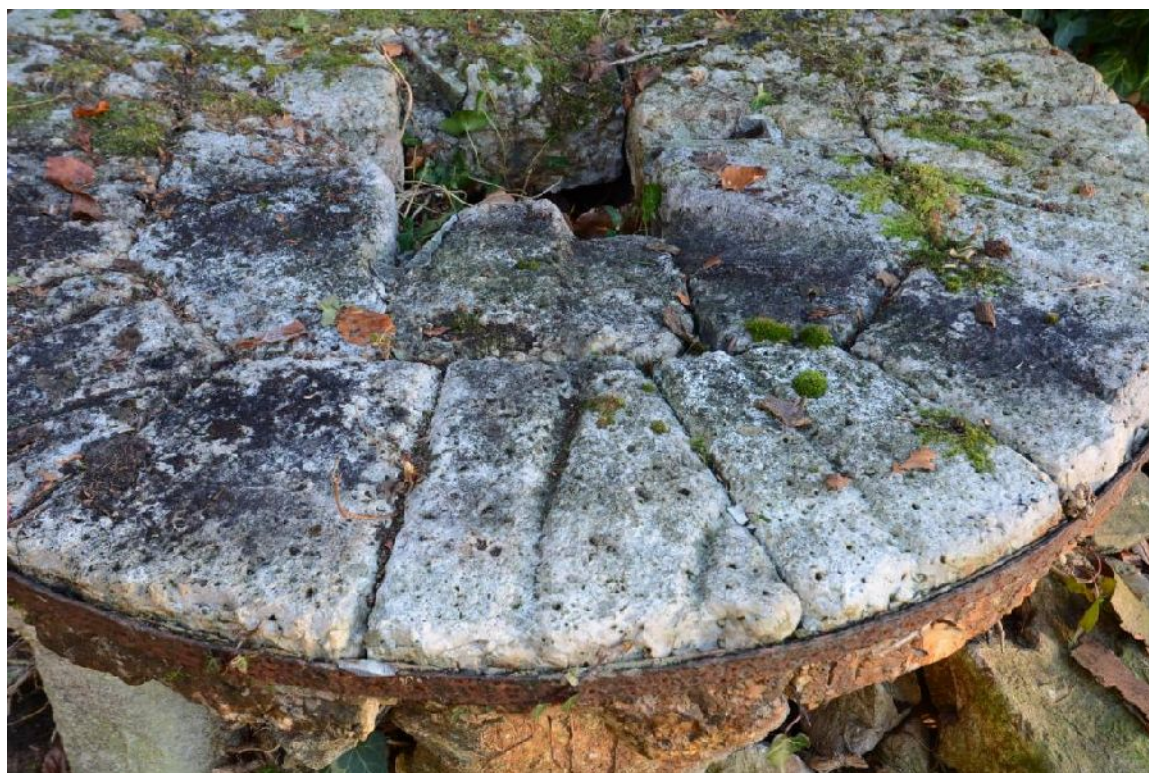
**Illus 8 Detail of F4**

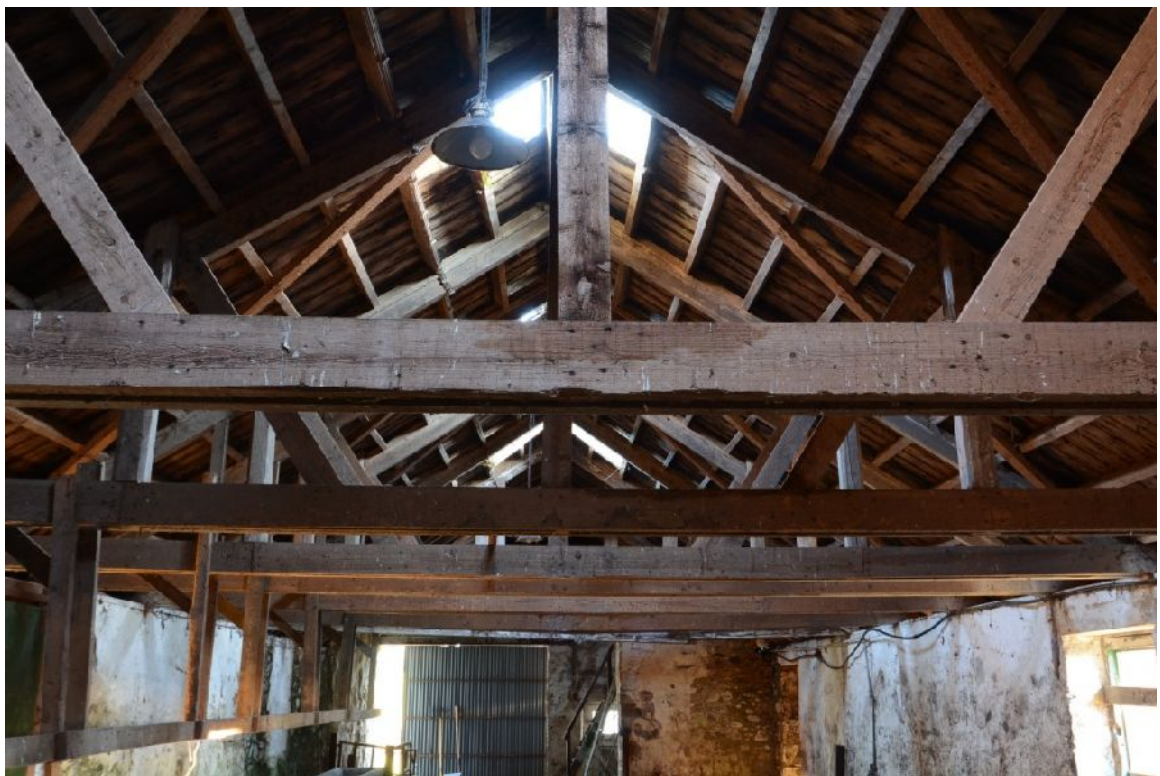
Roof Slate with skylights and ceramic ridge. King post from tie beam to ridge, flanked by diagonal braces; roof structure probably reflects greater width of this range (Illus 9).

**Illus 9 Detail of roof of N range**

At some point between 1867 and the second OS map of 1899, the farmhouse was built and the steading was considerably extended. The S wall of the existing N range was rebuilt some 3m further S, allowing for an increase in cattle accommodation. The N wall was unchanged as the horse mill was retained at the E end. The widening of this range resulted in the need for the more complex king post roof structure.

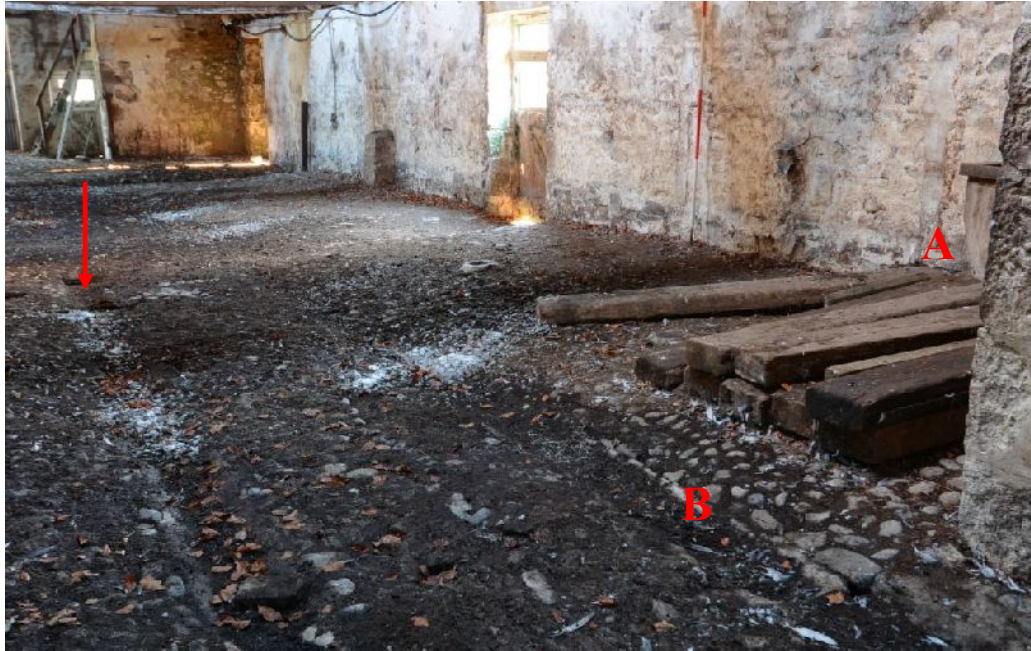
Interior Traces of raggles from trevices between cattle stalls visible on walls (Illus 10, 11). Cobbles show central drain with outlet to drain below floor. More recently the trevices had been cleared and the N part of the E wall of W range and the N part of W wall of E range knocked through into N range for open cattle byre with a feed pass and concrete trough along the N wall (Illus 12).

**Illus 10** Looking E along centre and S of N range. Arrow indicates drain in cobbles. A= trevis raggles. B= cobbles change at back of stalls

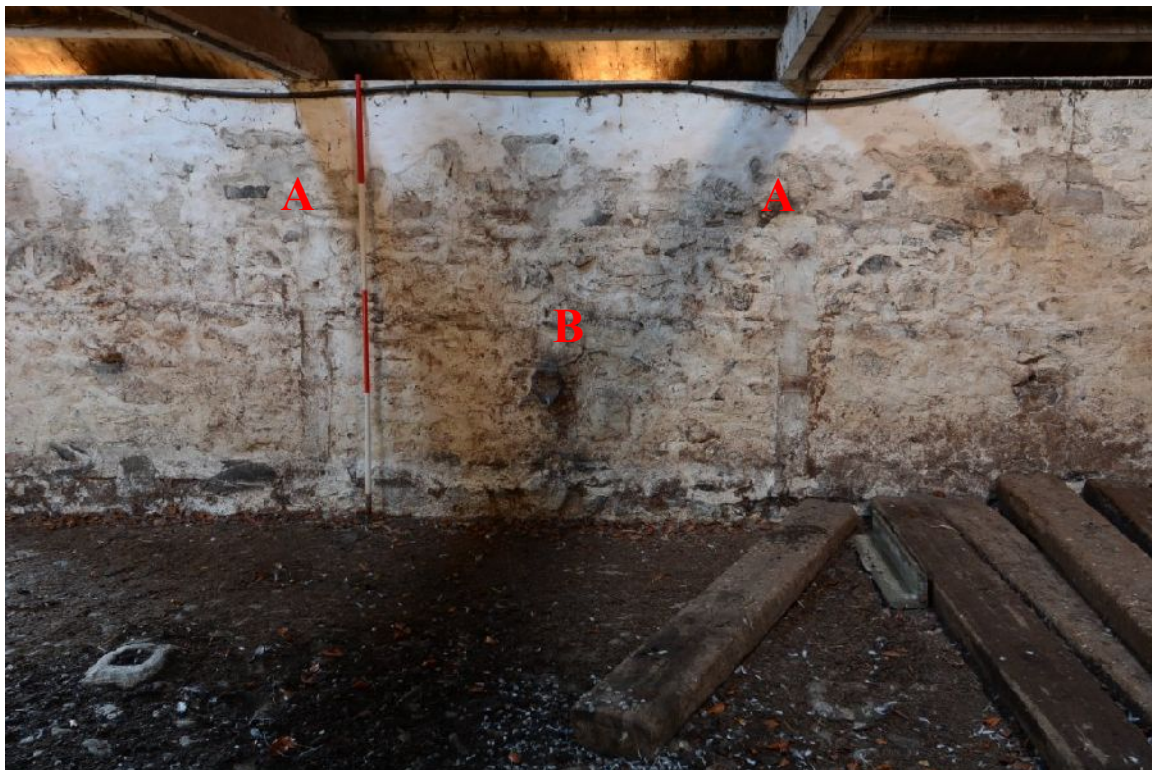
**Illus 11** Detail of trevis scars (A) of cattle pens on S wall of N range (For position compare to preceding photograph). Note drinker brackets (B)

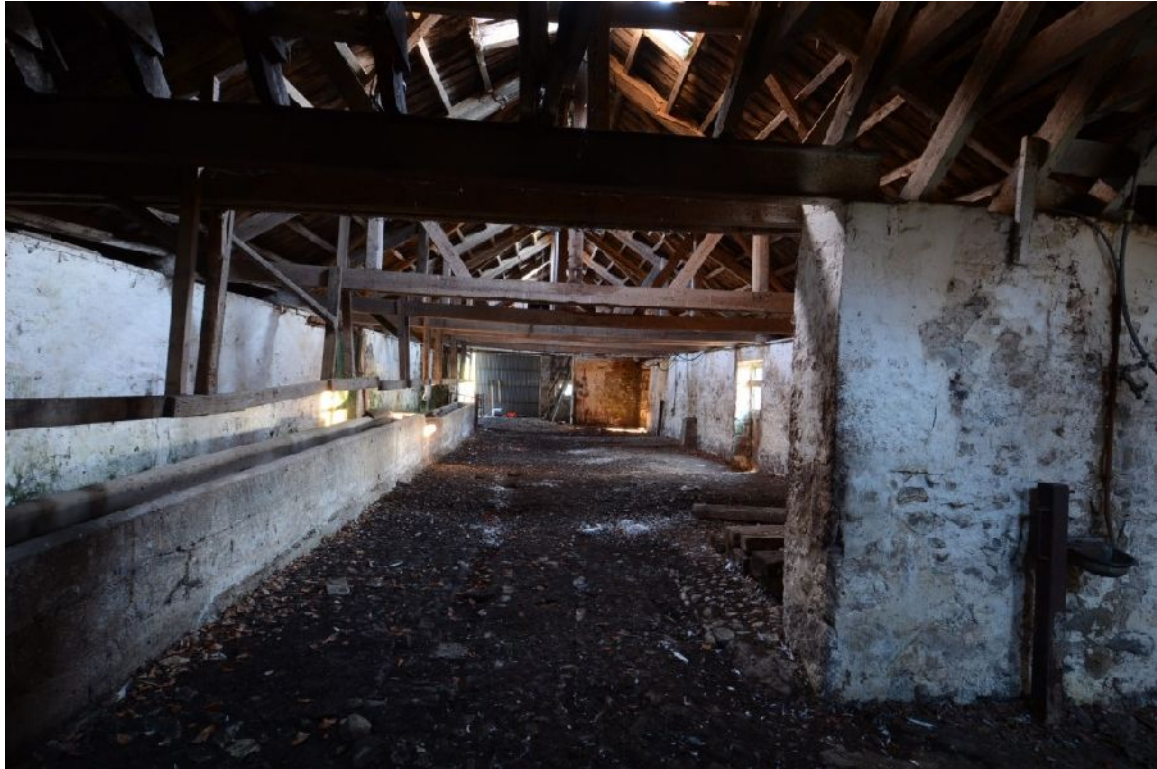
**Illus 12 Looking E along N range. Stub of E range wall on RHS. Concrete feed trough and pass on LHS**

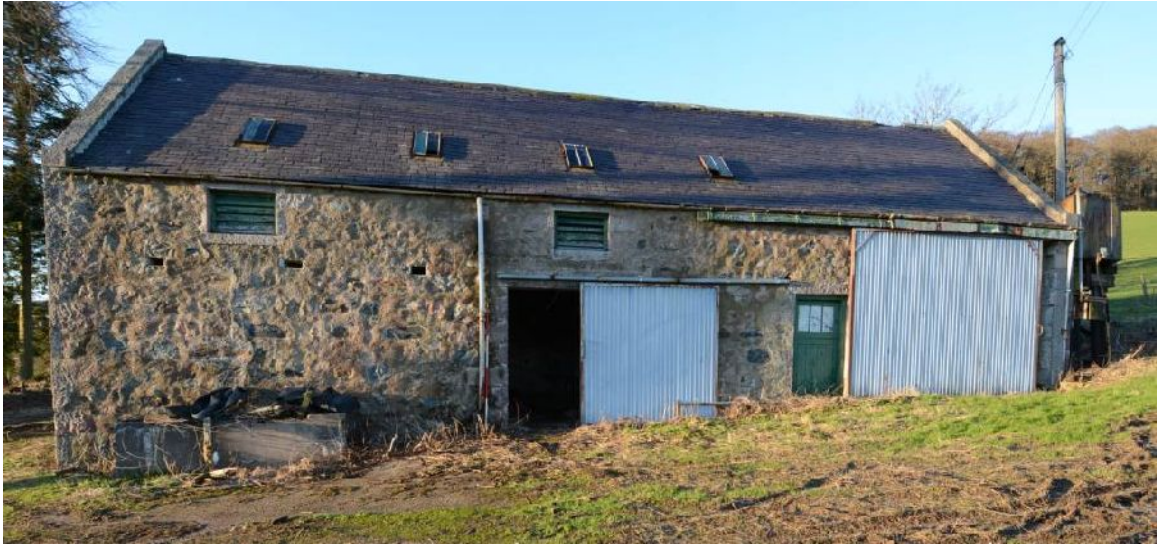
**Illus 13** E wall of E range showing cart bay (D3) in centre, windows into loft above (W1, W2) and 3 stable vents

W1 & W2 into loft above stable and cart bay. W: 0.80m H: 0.60m. Granite rybats, lintels and sills. Wooden slats.

V Three vents in top of wall above stalls. Each c 100 x 250mm.

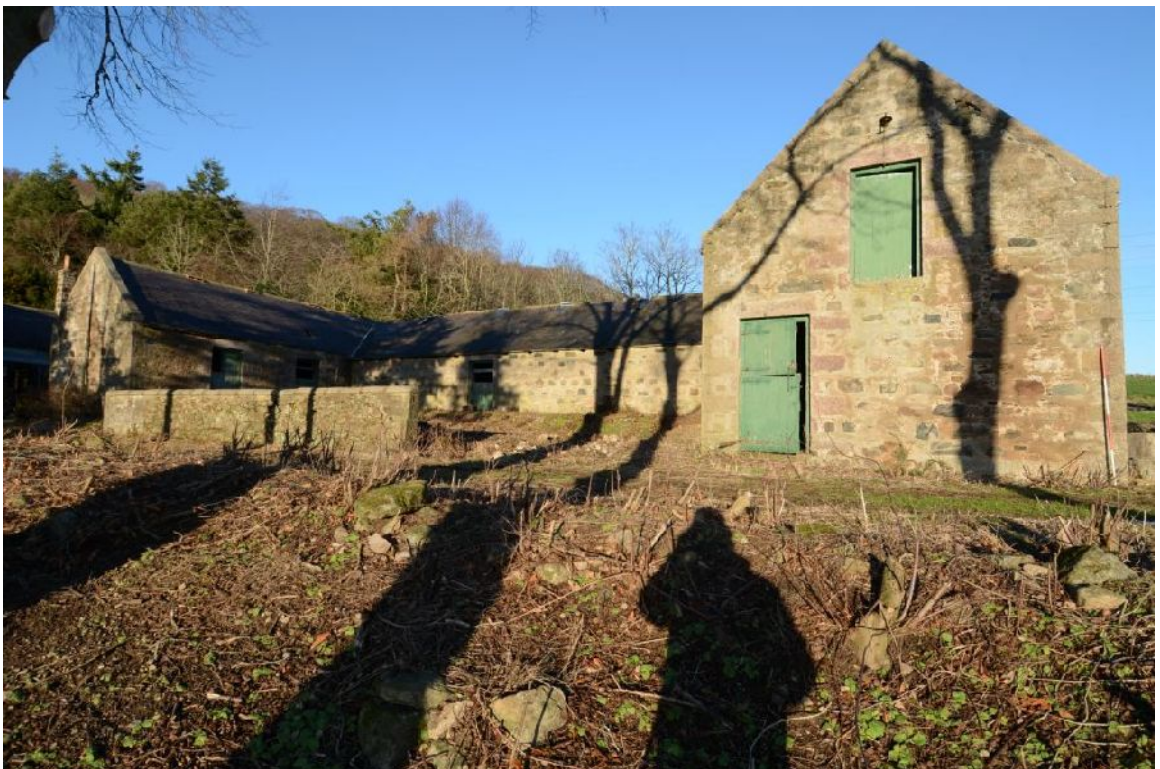
D4 W: 1.22m H: 2.46m Granite rybat, lintel and sill. Wooden half doors.

D5 W: 1.10m H: 2.000m. Granite rybat, lintel and sill Wooden door into loft.

**Illus 14** General view of S side/ On RHS = E range with stable door D4 and loft door D5 above.

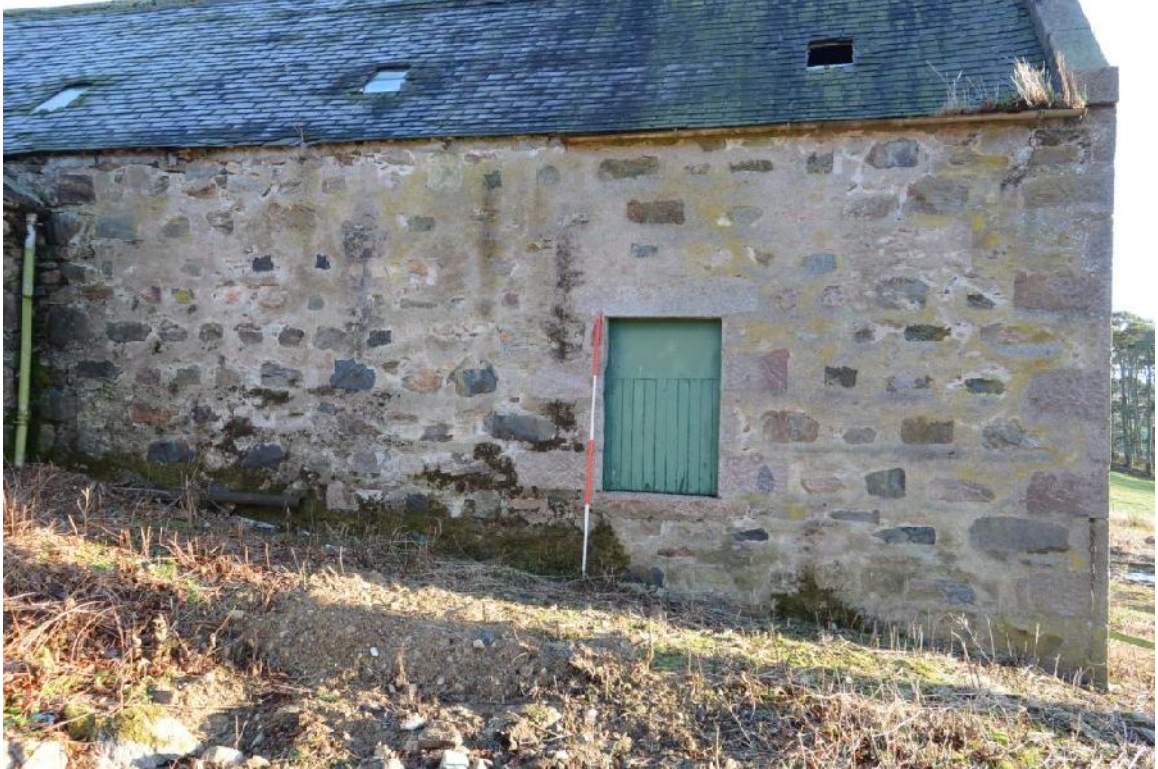
D6 W: 0.92m H: 1.40m. Sill 0.77m above ground. Granite rybat, lintel and sill. Wooden blocking. Not clear if this was originally a window or an opening for mucking out direct to the dung court.

**Illus 15 W wall of E range with 'door' D6**

In the E range, there was a stable for 3 horses (possibly a pair of plough horses and a horse or pony for the horse mill and other lighter work). The stable appears to have been mucked out through the W opening (D6). The single cart bay retains its original doorway, although with a modern metal door.

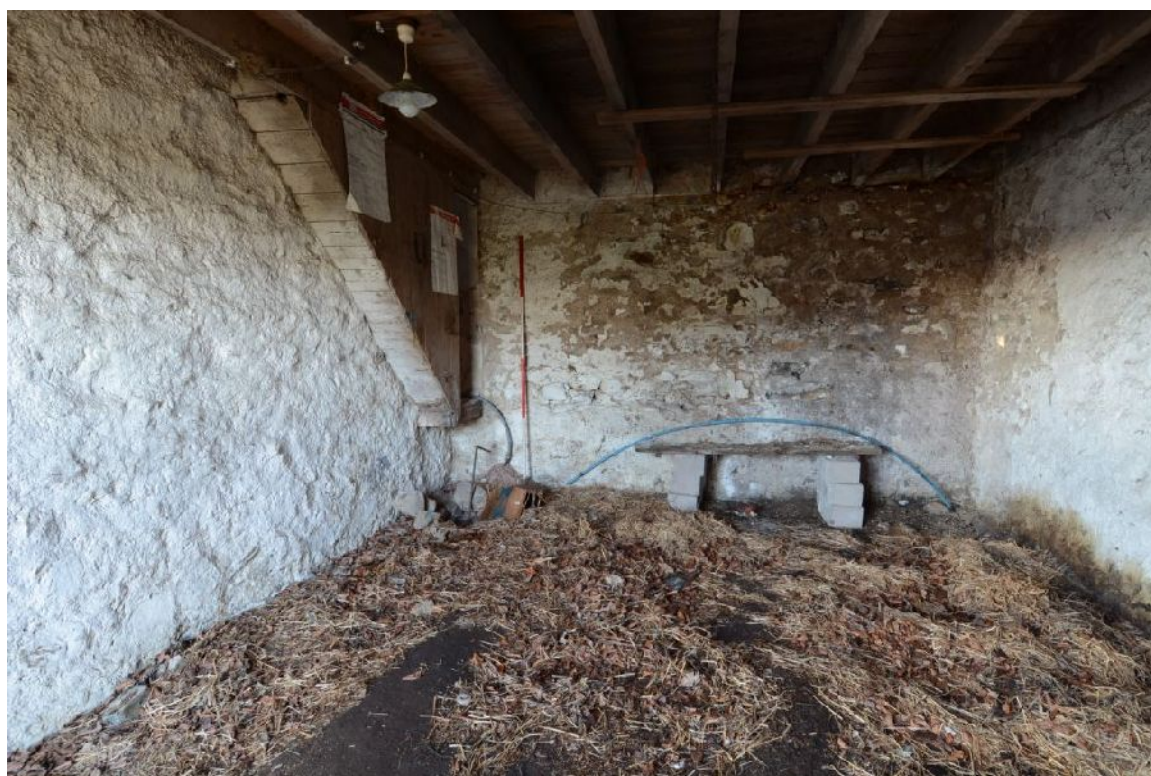
An opening at the NW corner gives access to a wooden stair that leads up, on the line of the wall between the stable and the cart bay, to the loft above. The framework of this stair projects into the cart bay (Illus16).

**Illus 16 Stair framework visible in cart bay**

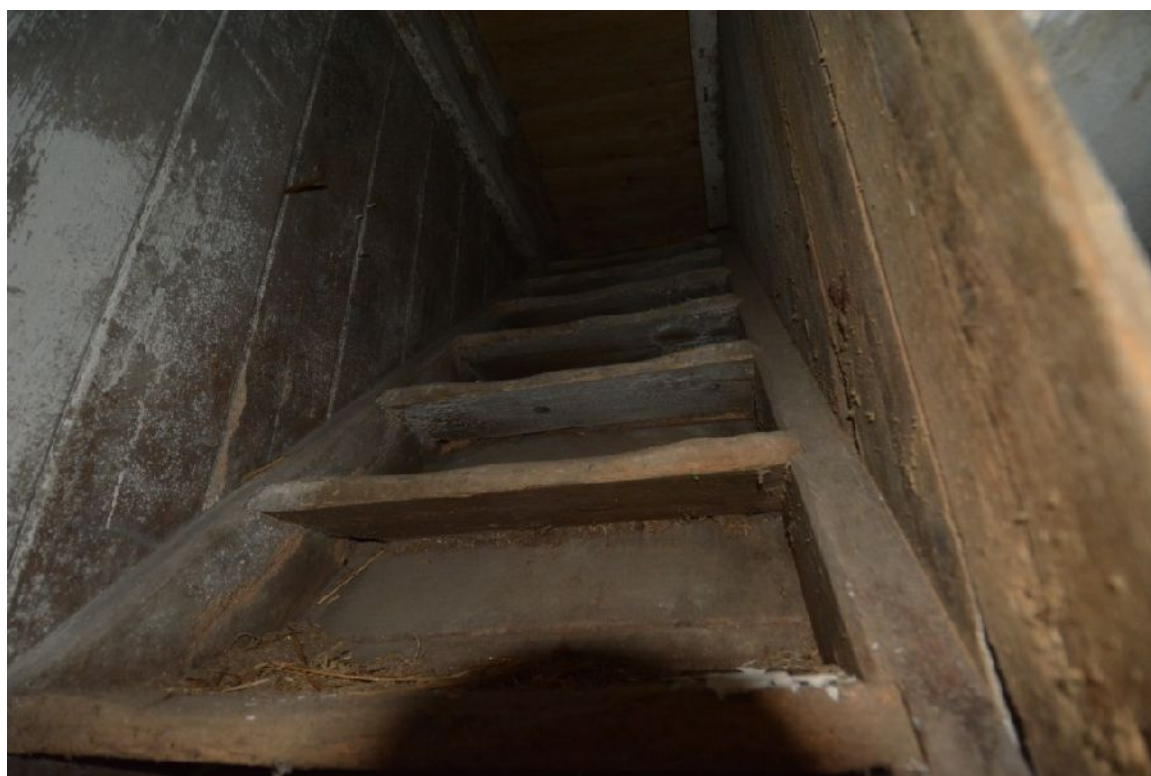
**Illus 17 Looking up stair from stable**

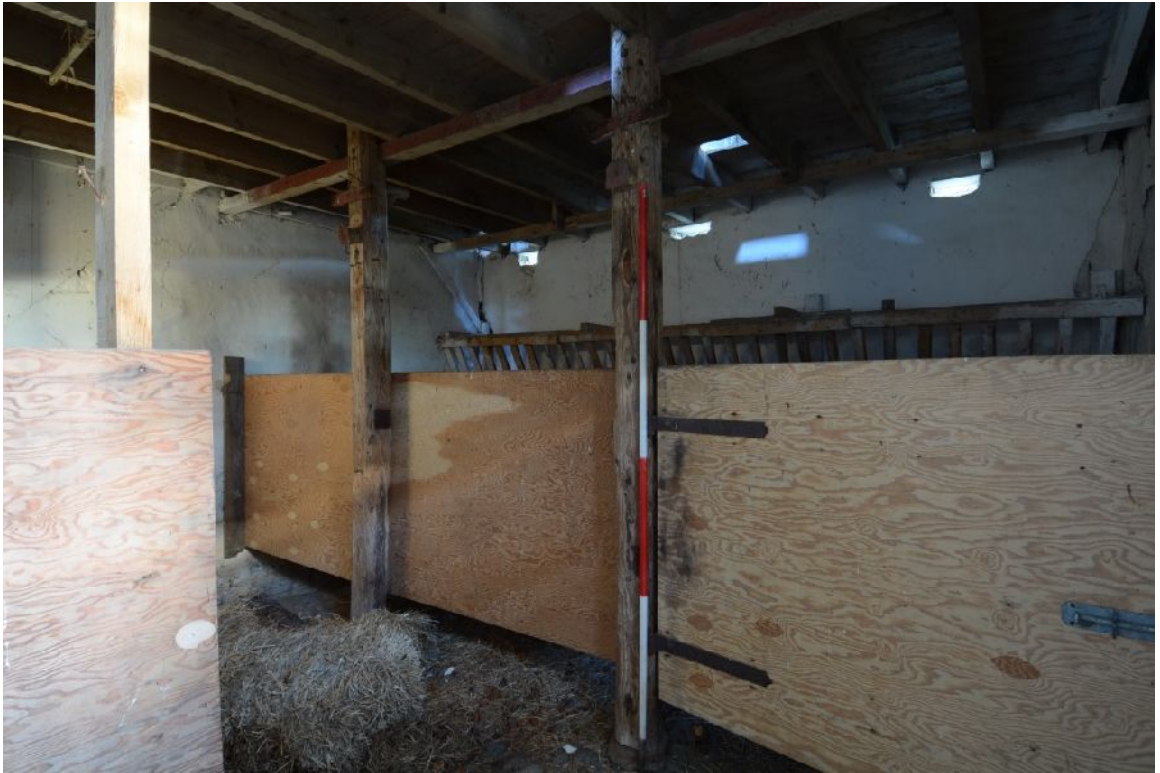
F5 Three horse stalls against E wall (Illus 18-20). Although the present divisions are recent, the original trevis hind posts survive (posts roughly squared 160mm, on base stones 230mm diameter. Inner (E) side of posts grooved to hold trevis timbers), as do the sockets for the central trevis supports.

The original stalls were 1.65m wide. The cobbling shows a drain at the back of the stalls. The wooden hay rack survives on the E wall.

**Illus 18 Stable looking E/NE. Although plywood doors are modern, the hind posts of trevises are original. Not hay rack and air vents.**

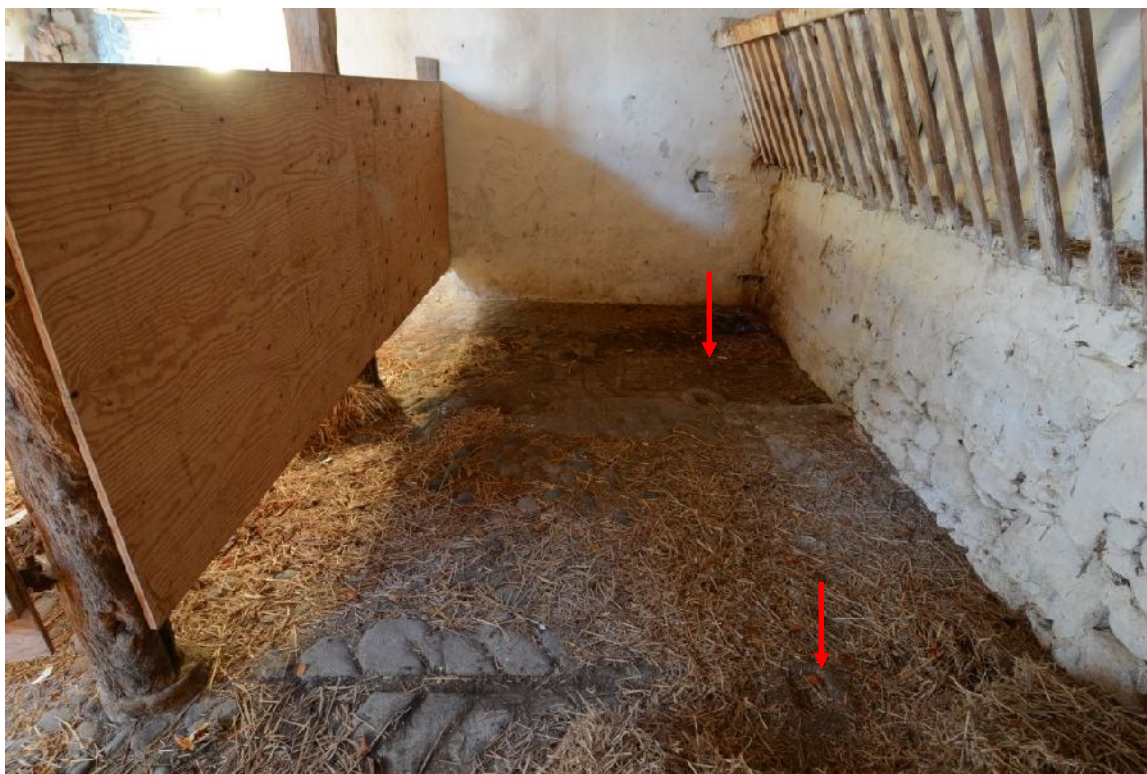
Illus 19 Looking N in stable.. Arrows indicate the central supports of trevises

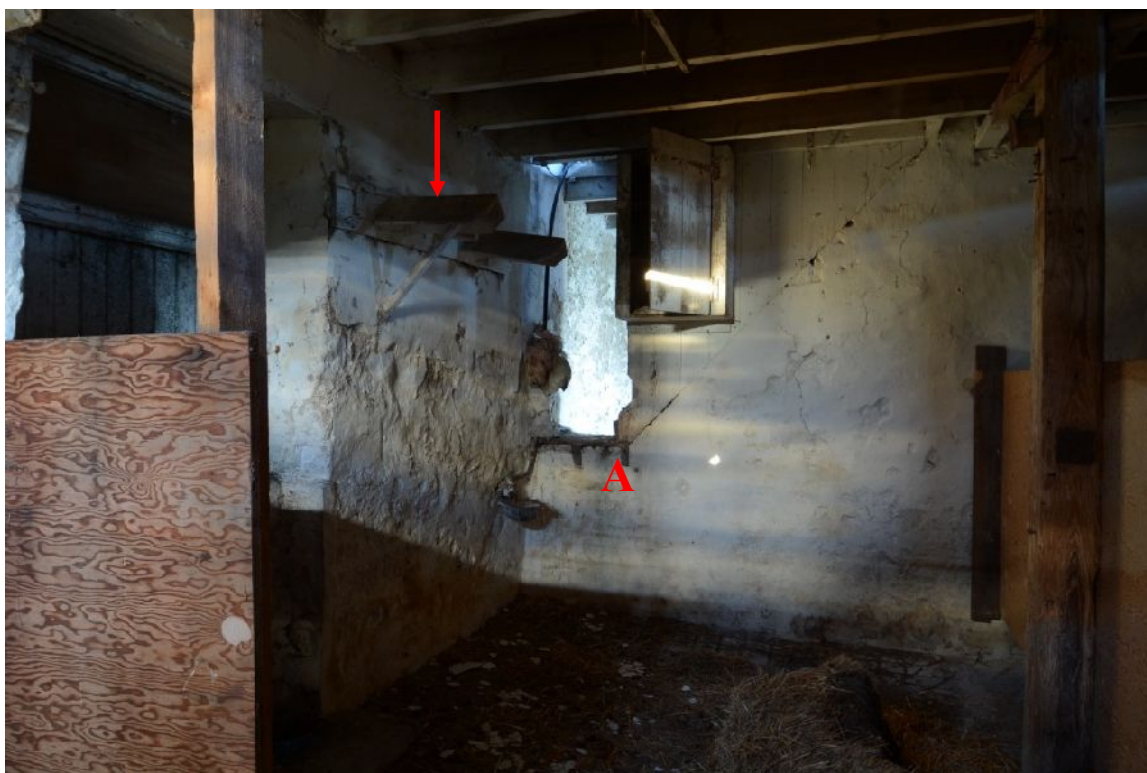
F6 Three harness supports for the work horse harness survive on the W wall.

Illus 20 looking NW in stable. Arrow indicates harness supports. A= opening to stair to loft

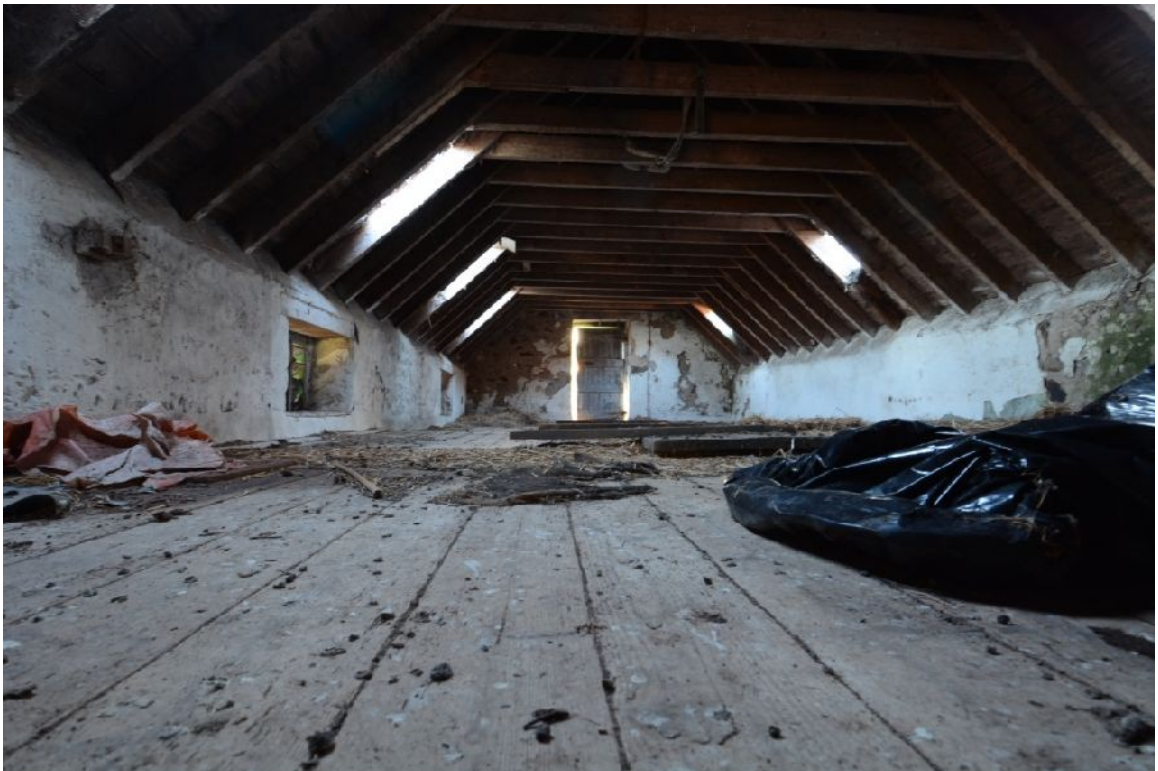
**Illus 21** Loft looking S

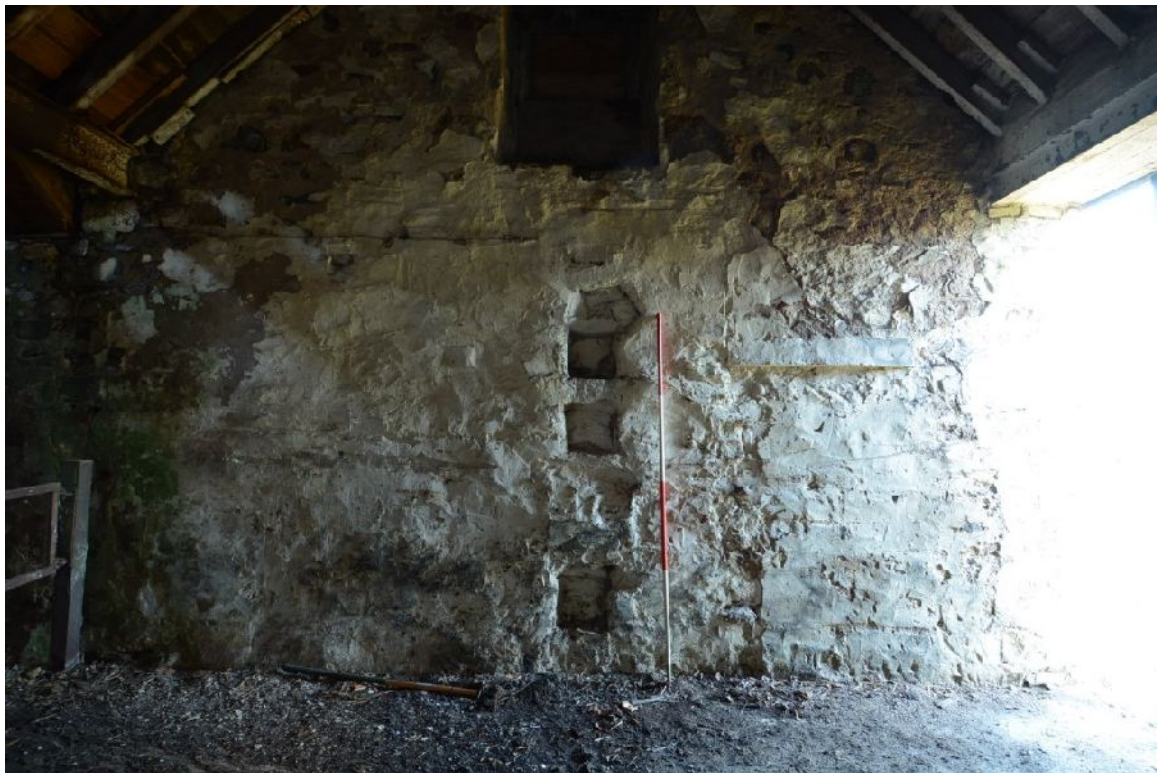
F1 3 rectangular sockets in a vertical stack set into *inner* face of N wall, c3m from E end of building (Illus 22).

- a) 300x300mm Depth into wall: 280mm. Base 1.71m from floor
- b) 300x300mm Depth into wall: 130mm. Base 1.25m from floor
- c) 300x350mm Depth into wall: 130mm. Base 0.23m from floor.

**Illus 22 Mill fittings F1**

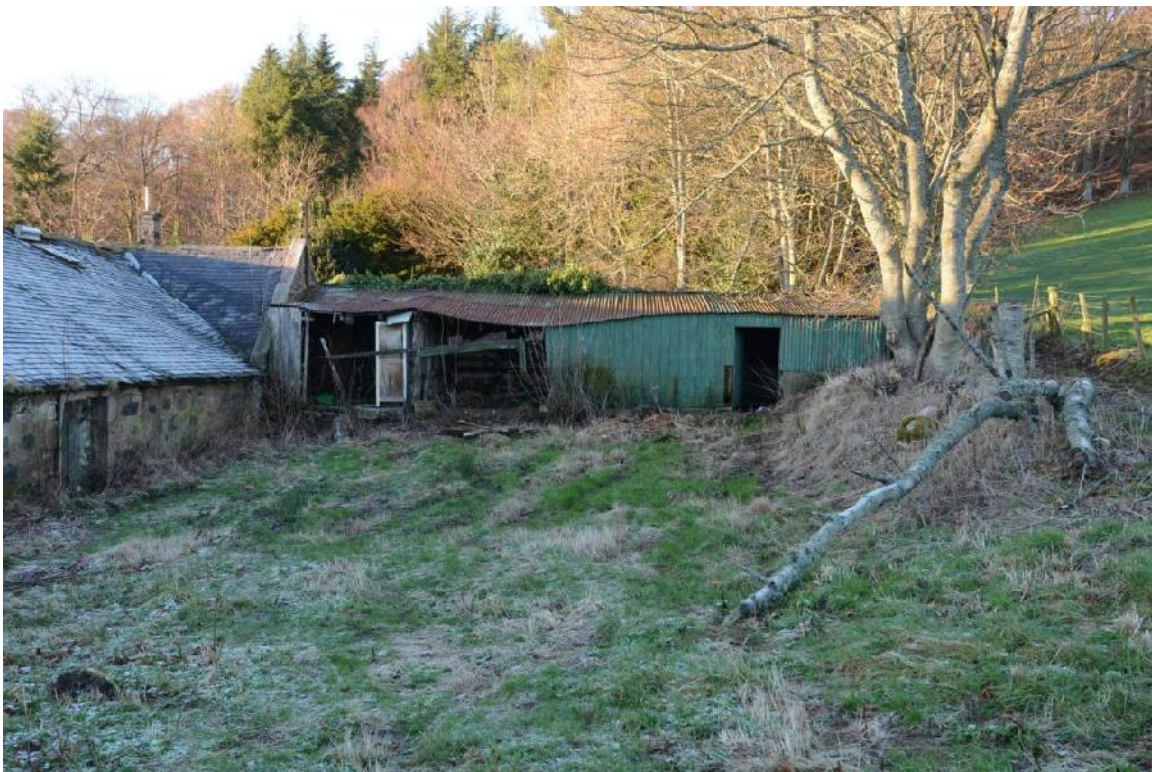
Orientation NE/SW Abuts N gable of original W range (Illus 23).

Walls Wood and corrugated iron, apparently on concrete block foundation.

Corrugated iron roof, sloping down from W to E.

**Illus 23 Building 3- looking E**

Building 2 appears to be a recent addition. However, Building 3, although in its present condition appearing to be recent, is on the footprint of a building that is shown from 1899 onwards. It was not possible in its present condition to ascertain if any of the structure was original.

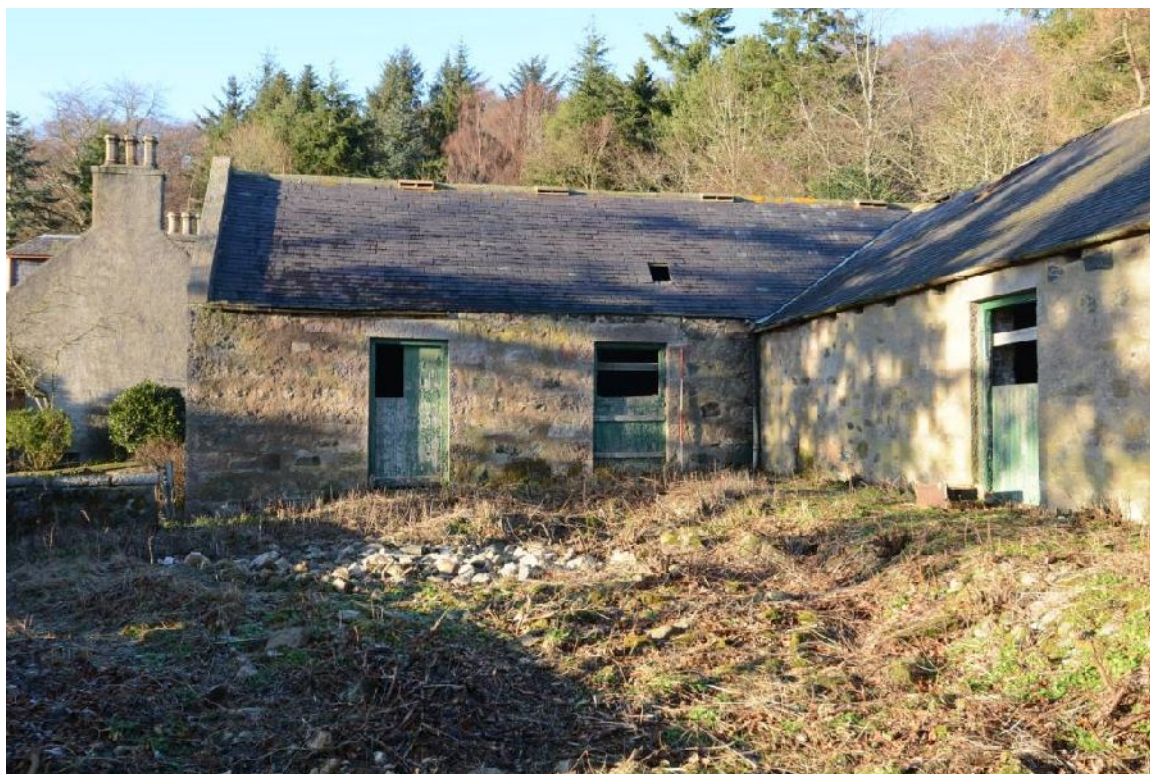
A lower dung court some 15 x 9m was enclosed between the ranges at the S side of the buildings (Illus 24, 25). On the N, E and W it was surrounded by a raised cobbled path some 2m wide. On the S and SW there was a stone wall 1.2m high and 290mm wide with a domed coping. This may be a remnant of the wall of a building shown in this position on the 1899 and 1924 OS maps.

**Illus 24 N and W range with house behind. Note lower level of dung court. Cobbled path around.**

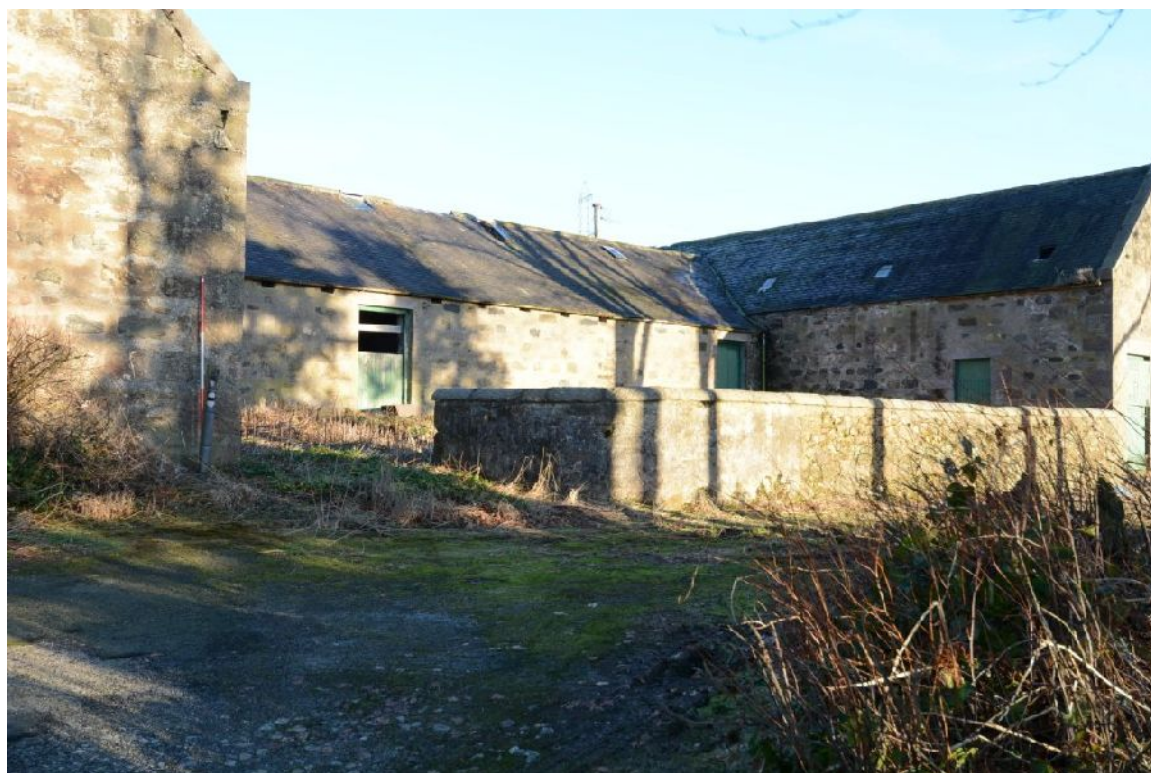
**Illus 25 Looking NE into court. Note wall at S side- possibly re-use of part of wall of earlier building**

The small building shown across the S end of the dung court on the 1899 and 1924 OS maps no longer exists but the wall on this side may be its S wall. This structure is likely to have been a pig shed.
