**WREATON
ABOYNE
ABERDEENSHIRE**

Standing Building Survey

Murray Archaeological Services Ltd

Report No: MAS 2016-07

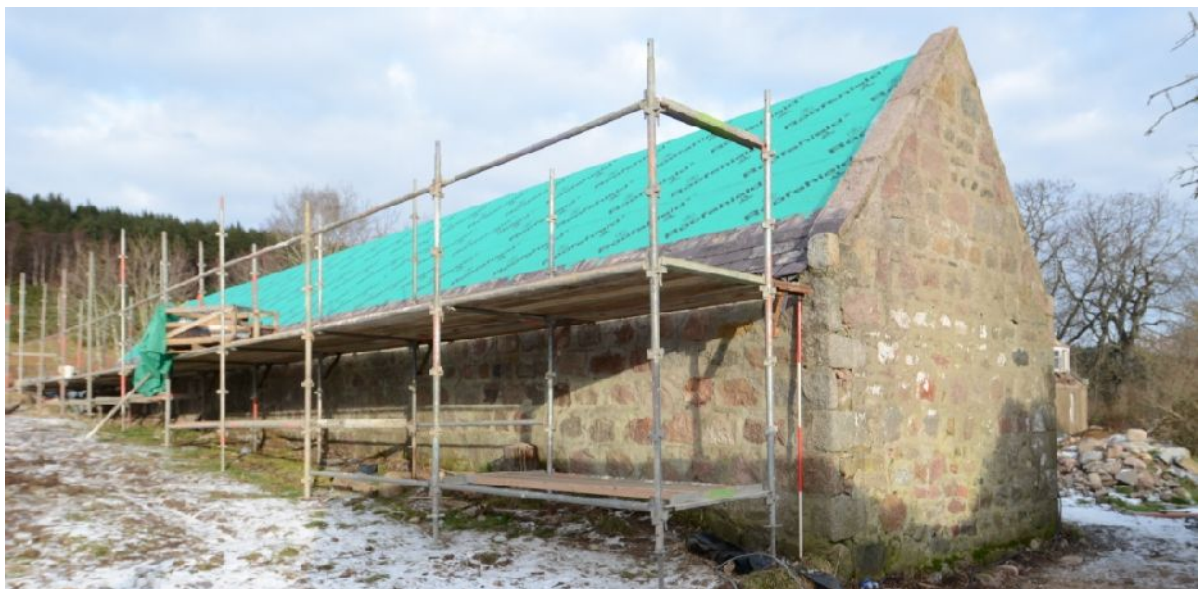
Illus 7 Looking N along W wall of W range. January 2016

Walls The S 16.4m were of squared rubble stones. The N 7m were of a smaller rubble stone. This end section had been rebuilt since the 2015 photographs, although the N gable is original.

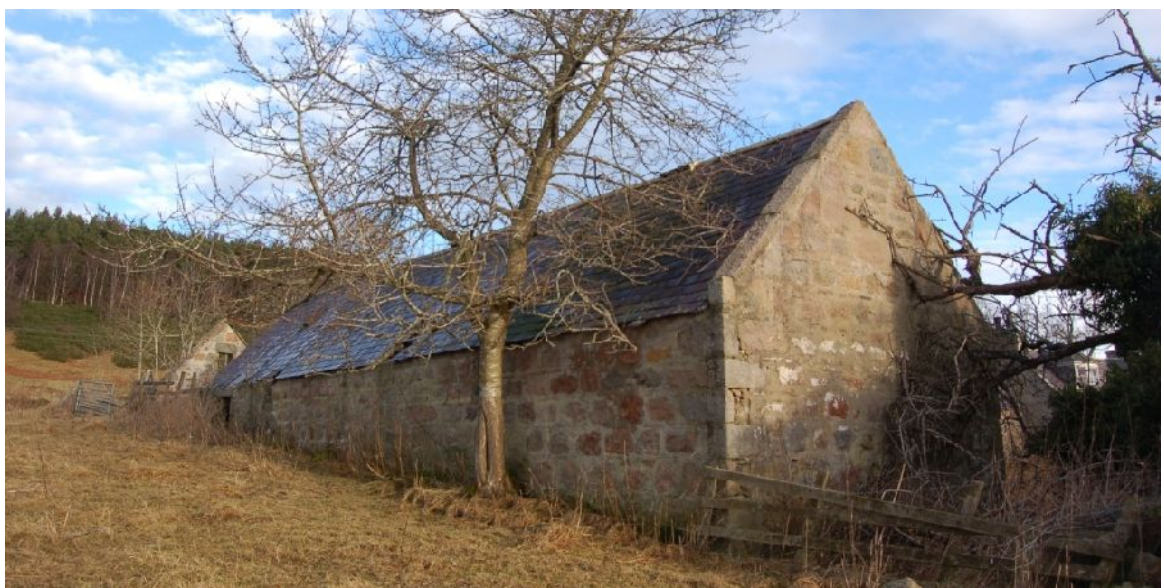
Illus 8 Looking N along W wall of W range. January 2015 (Photograph courtesy of Acanthus Architects Ltd)

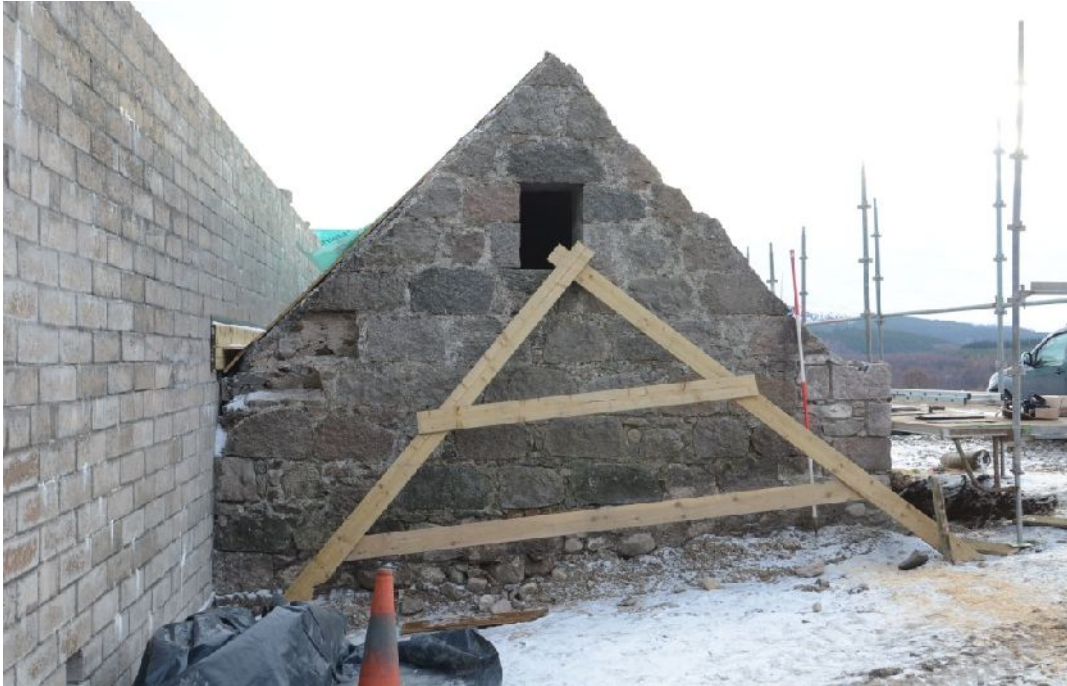
Illus 9 N gable of W range with blockwork infill to E. January 2016

W2 W: 450mm H: 640mm Granite lintel, sill and rybats.

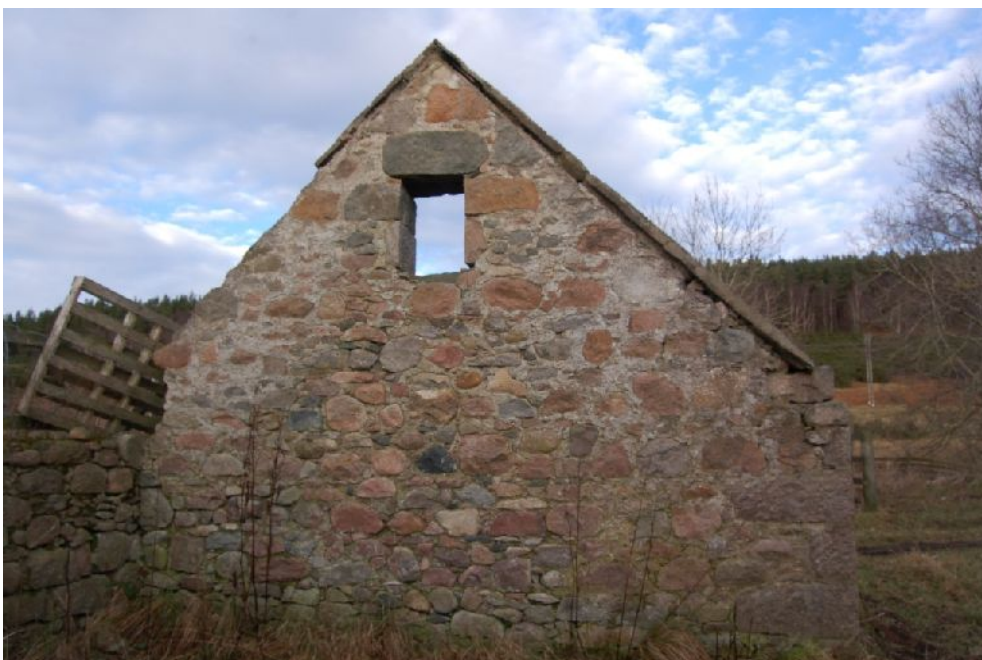
Illus 10 N gable of W range. From inside. January 2015. (Photograph courtesy of Acanthus Architects Ltd)

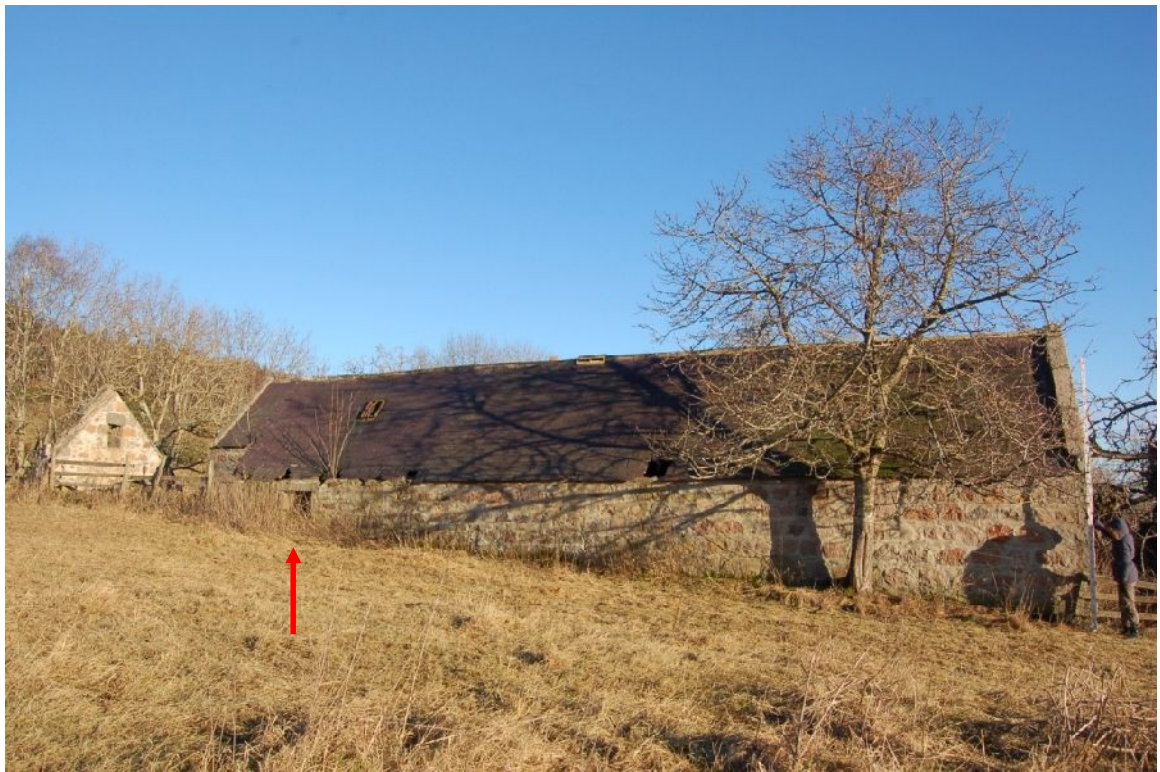
D? Door shown on 2015 photographs (Illus 11). Not shown on original elevations or plan and not visible in 2016.

Illus 11 Looking N along W wall of W range. January 2015 (Photograph courtesy of Acanthus Architects Ltd). Arrow marks door D?

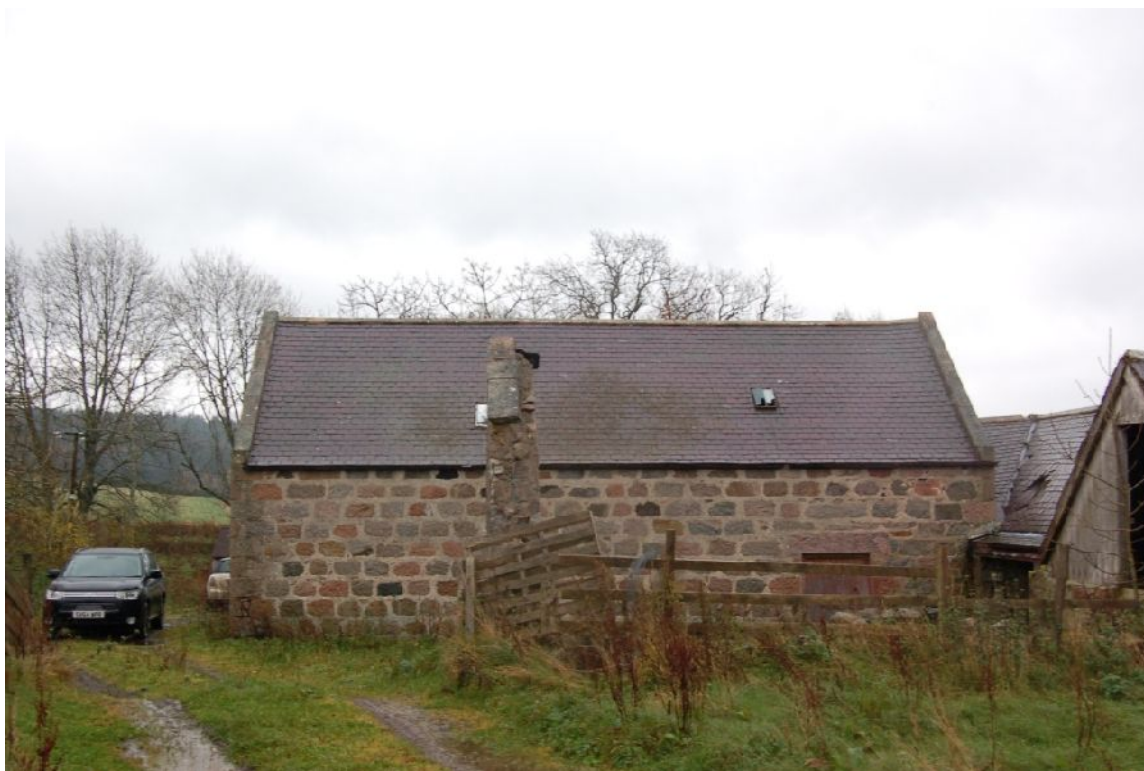
Illus 12 N end of W range. January 2015 (Photograph courtesy of Acanthus Architects Ltd). By 2016 walls rebuilt.

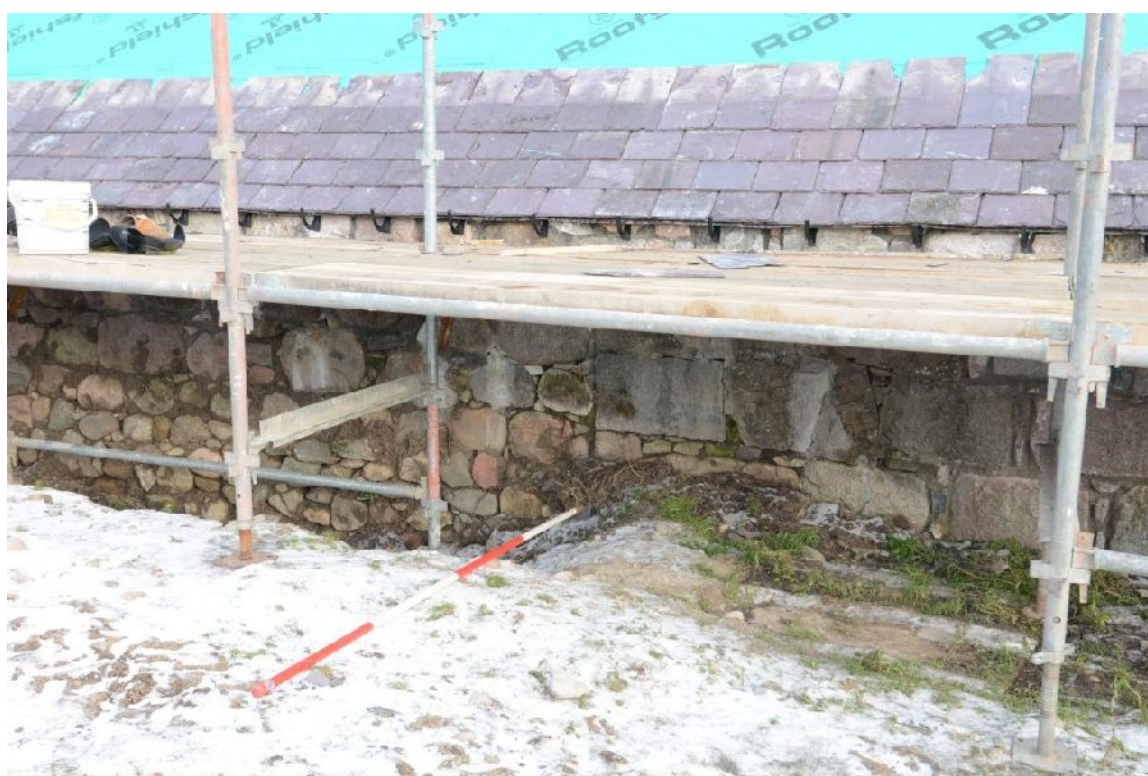
Illus 13 W wall of W range showing difference in stonework at rebuilt section. January 2016

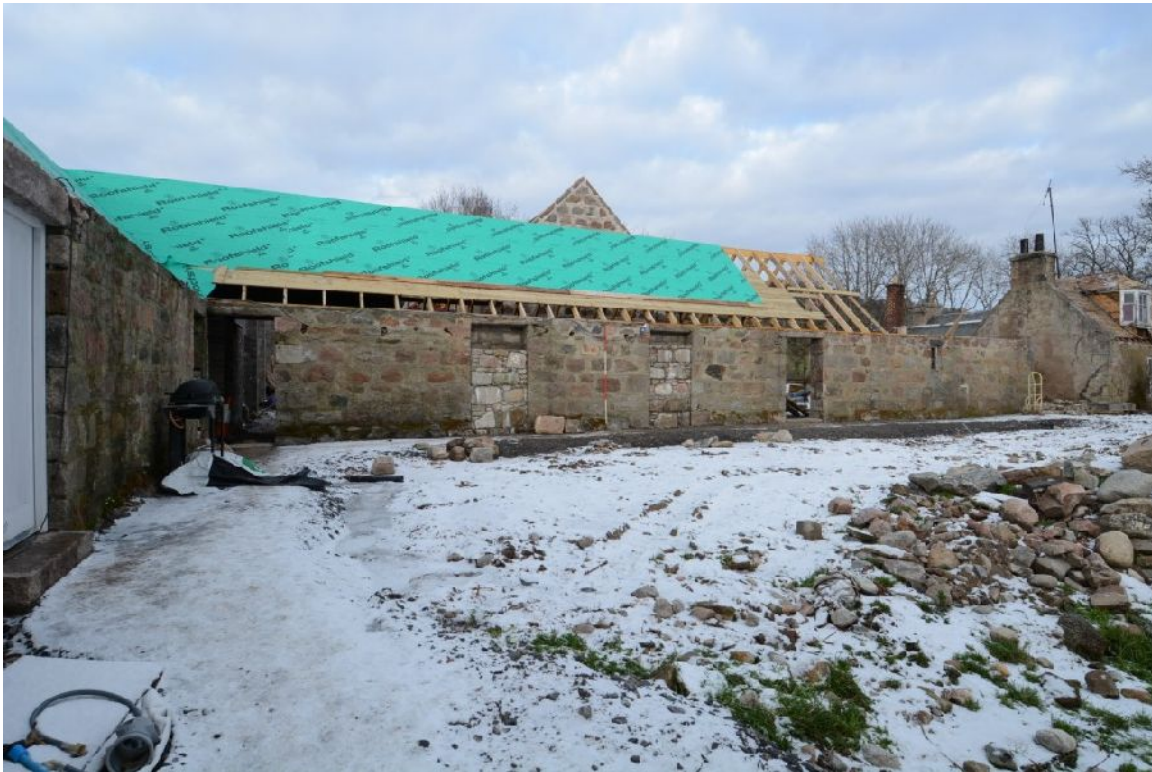
Illus 14 S wall S range. January 2015

Walls Squared rubble stones

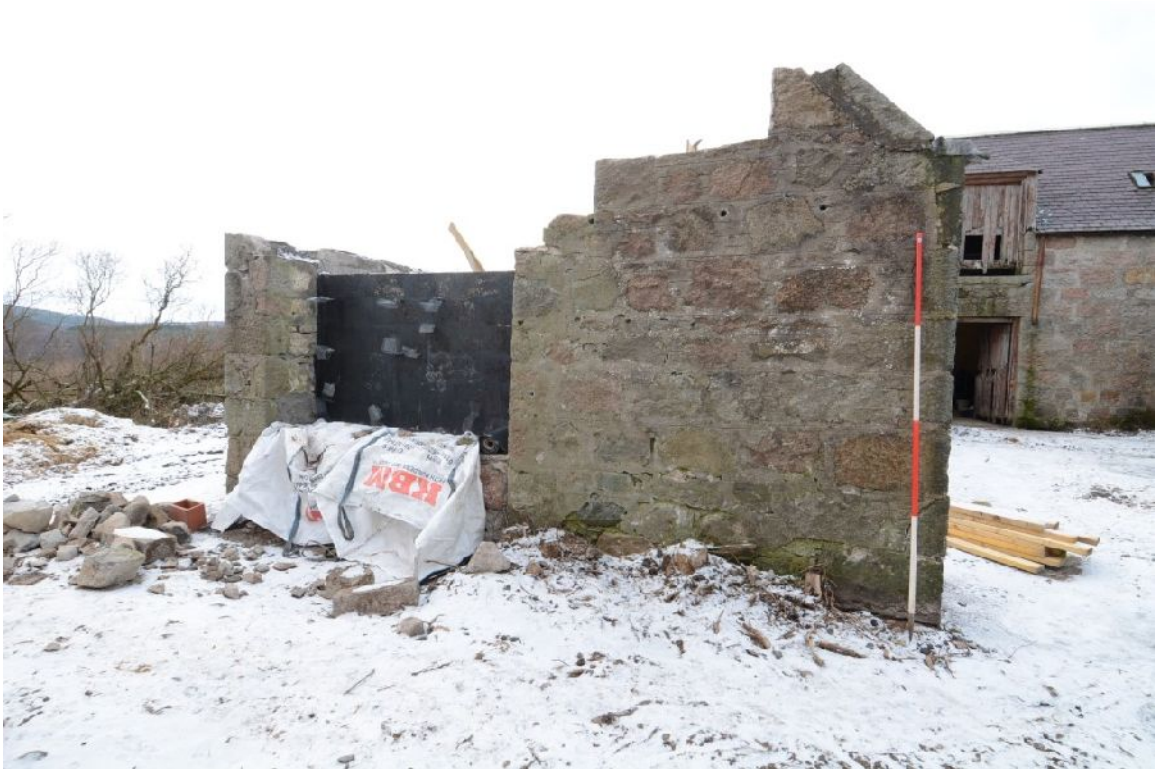
D5 W: 2.18m H: Not known. Granite rybats.

Illus 15 S range. E gable. January 2016.

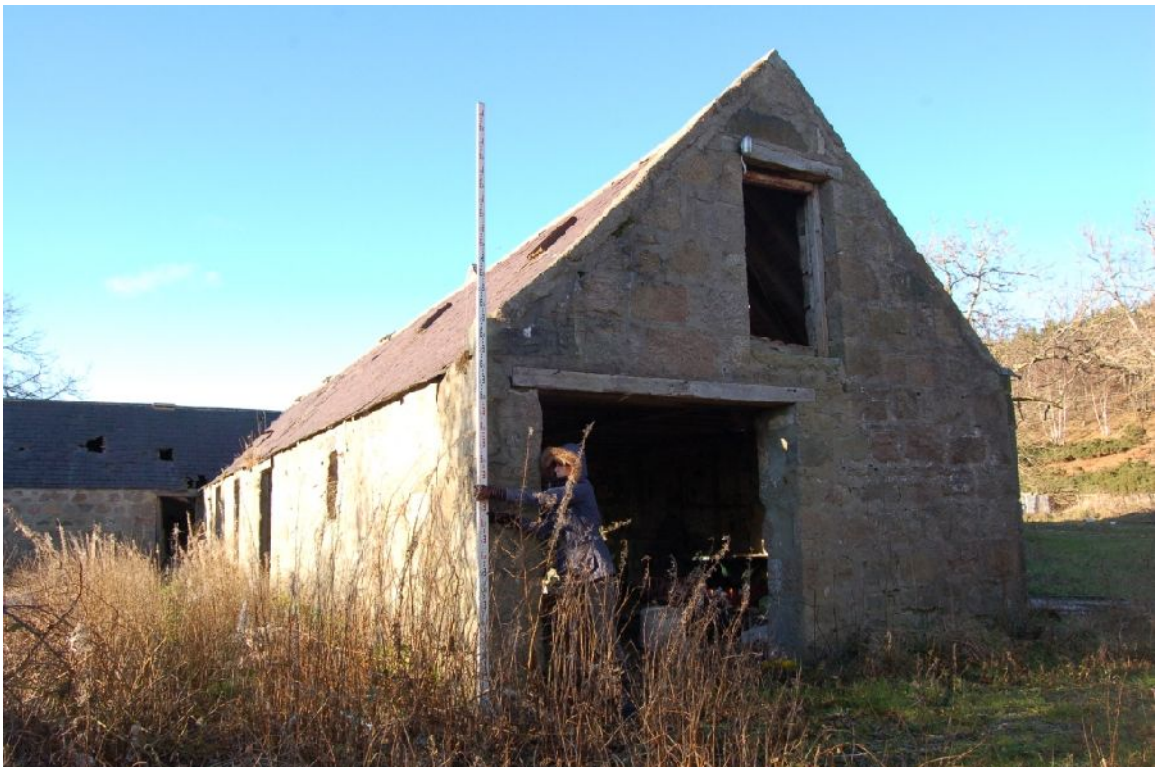
W3 Window above shown on photograph (Illus 16) but not on original elevation.

No longer extant.

Illus 16 S range. E gable. January 2015. (Photograph courtesy of Acanthus Architects Ltd).

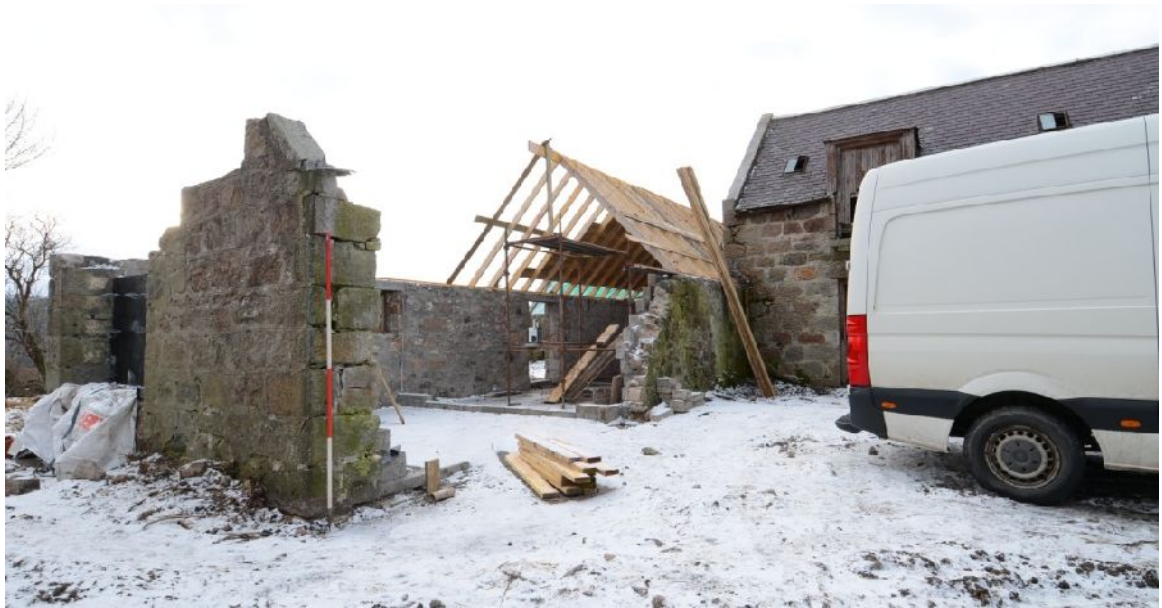
Illus 17 N wall of S range, E of E range. Partially demolished. January 2016.

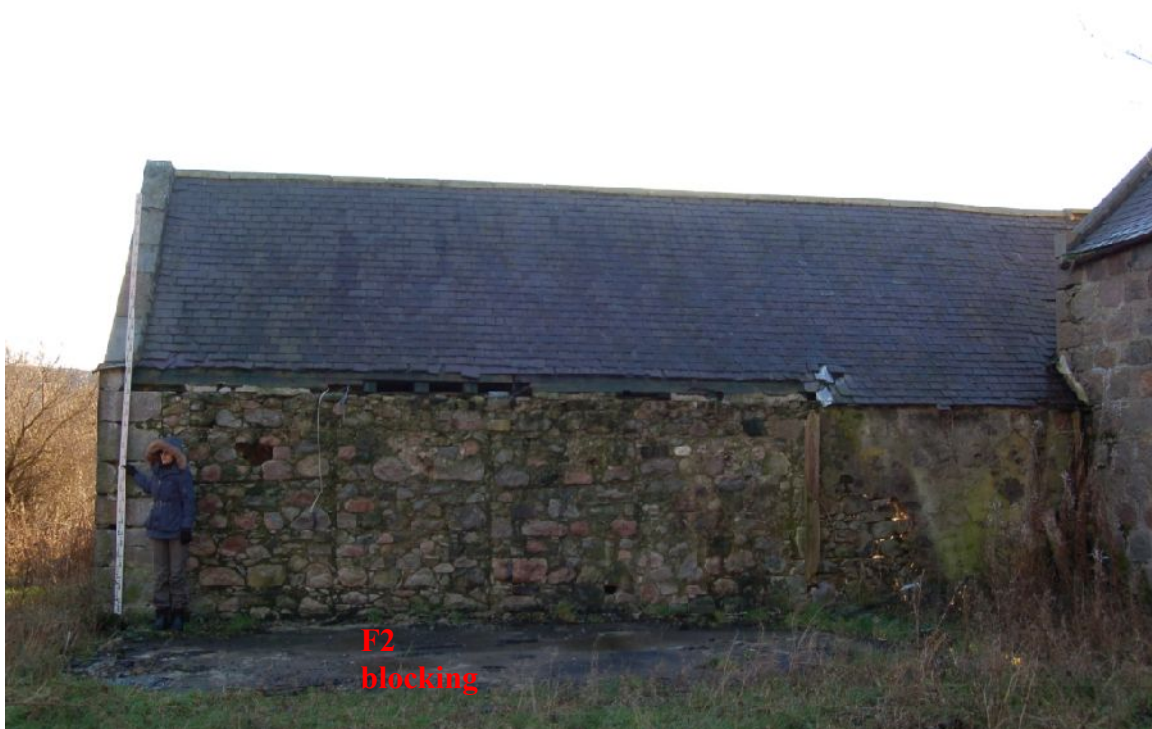
F2 Apparent blocking on 2015 photograph (Illus 18).

Illus 18 N wall of S range, E of E range.. Note smaller rubble stonework and blocked doorway(?).January 2015 (Photograph courtesy of Acanthus Architects Ltd).

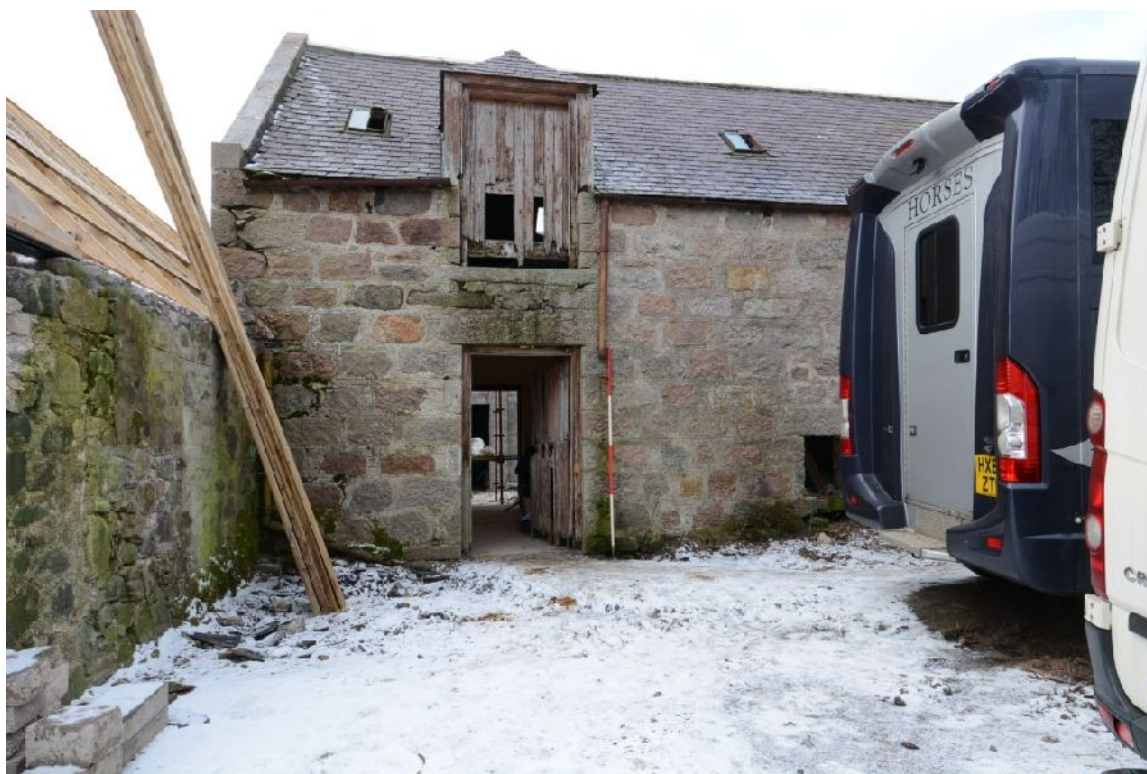
Illus 19 E range January 2016

Walls Squared rubble stone

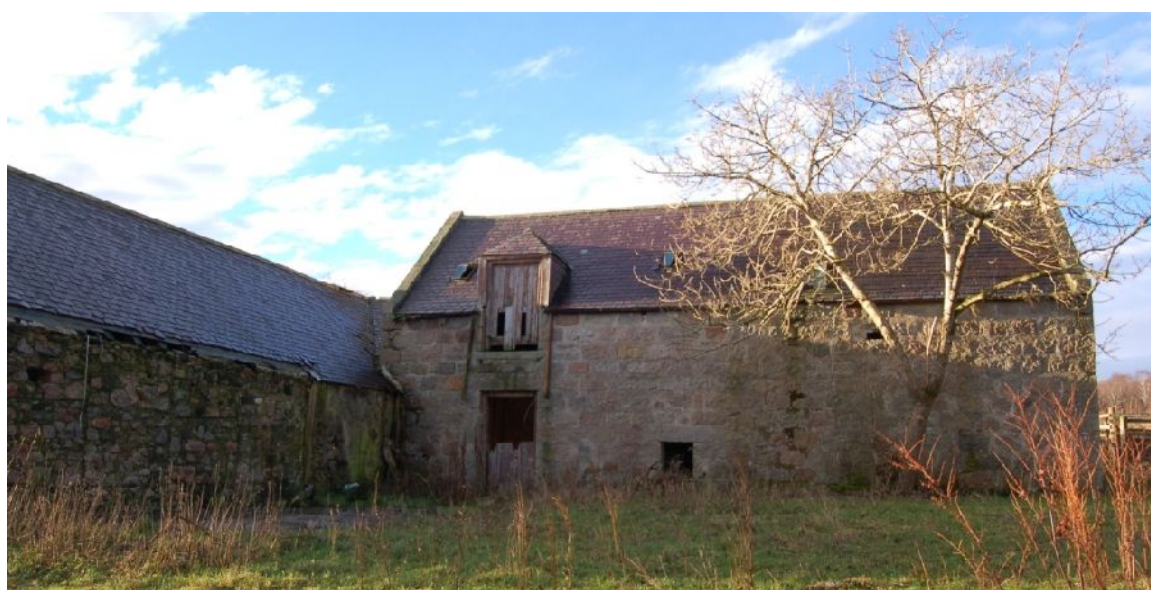
Illus 20 E range January 2015. (Photograph courtesy of Acanthus Architects Ltd).

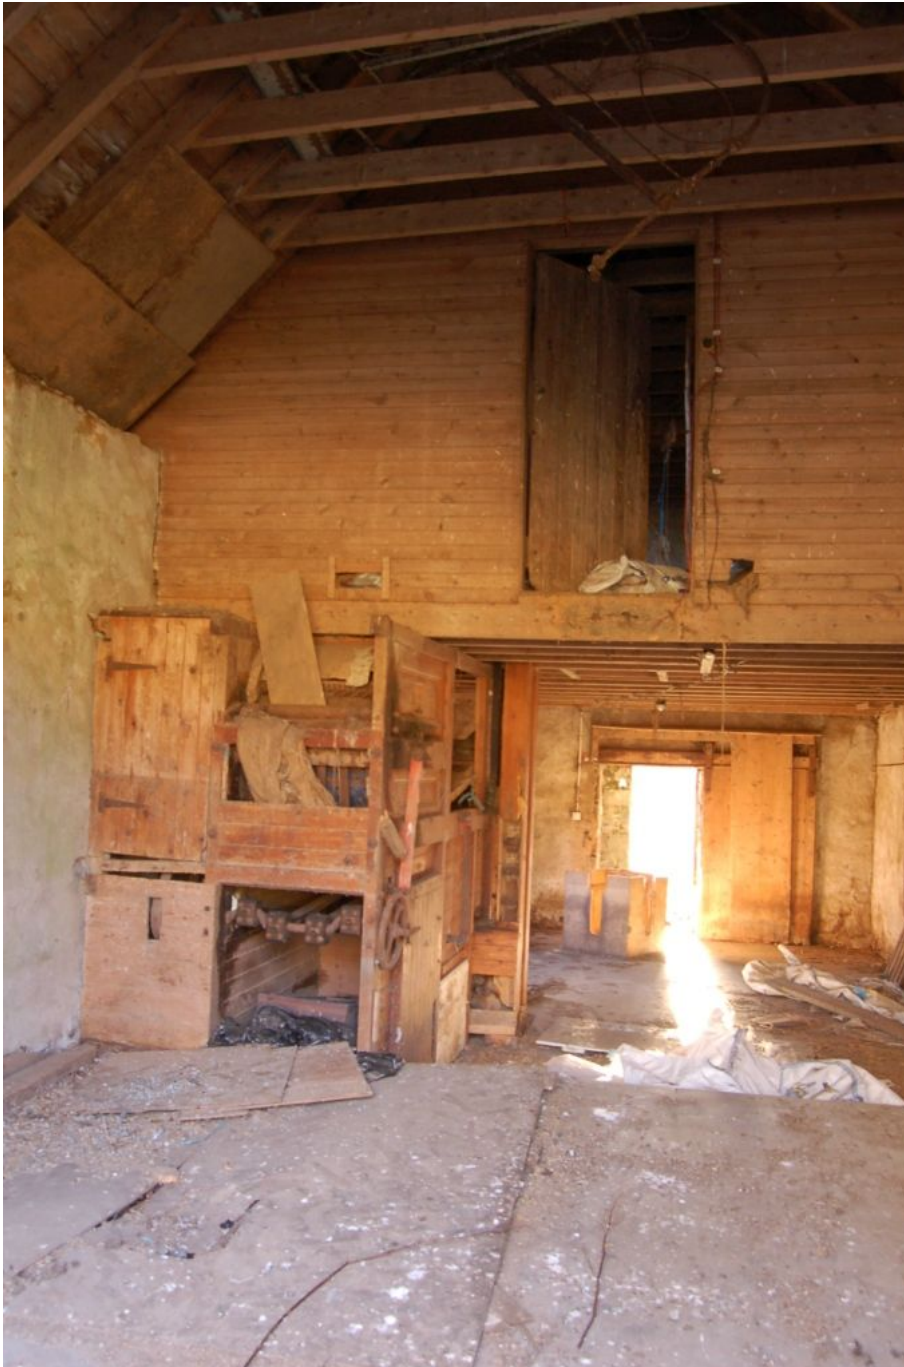
Interior No original features remain. 2015 photographs show threshing machine (Illus 21-22) with drive shaft through original opening F1 (Illus 24). It appears very similar to late 19th/early 20th century type illustrated by Fenton and Walker (1981, fig 171), suggesting that this was put in when this building replaced the water mill after the 1899 OS map was drawn.

Illus 21 Threshing machine still in situ in E range in 2015. January 2015 (Photograph courtesy of Acanthus Architects Ltd).

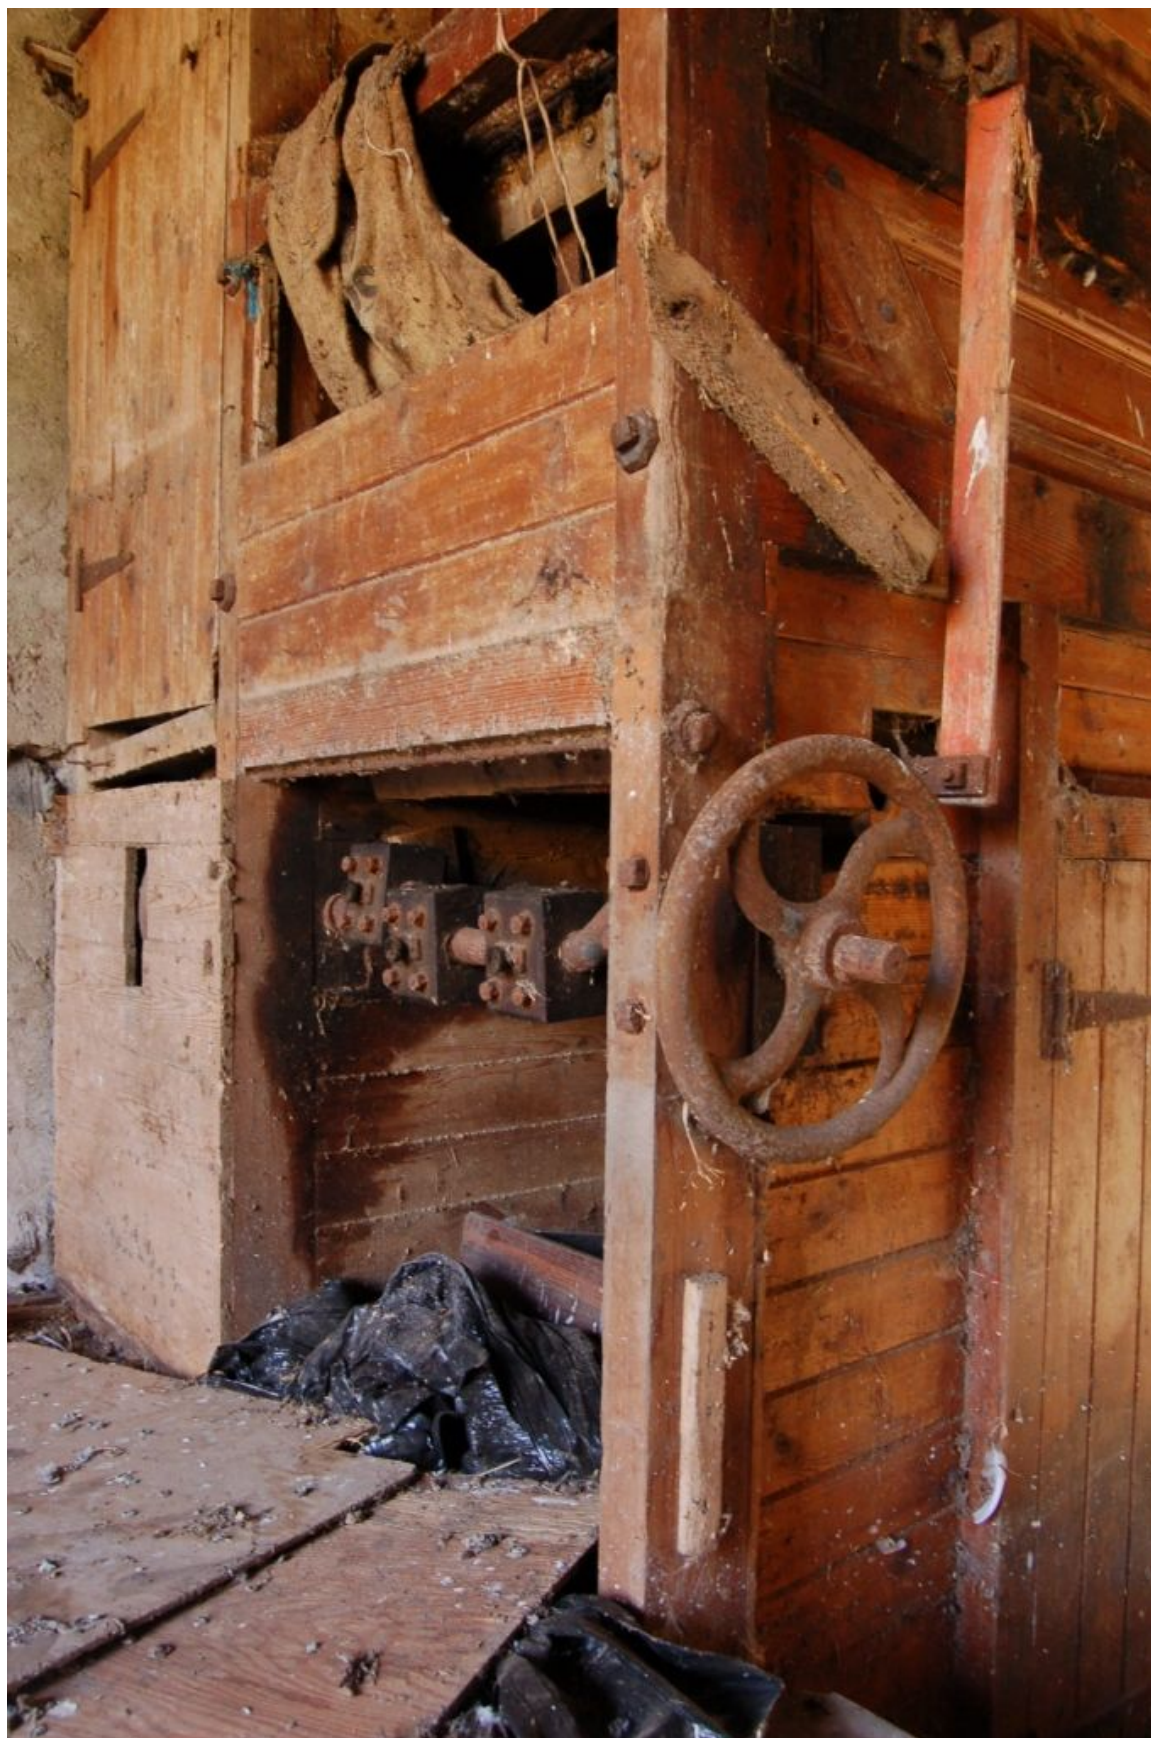
Illus 22 Detail of threshing machine still in situ in E range in 2015. January 2015 (Photograph courtesy of Acanthus Architects Ltd).

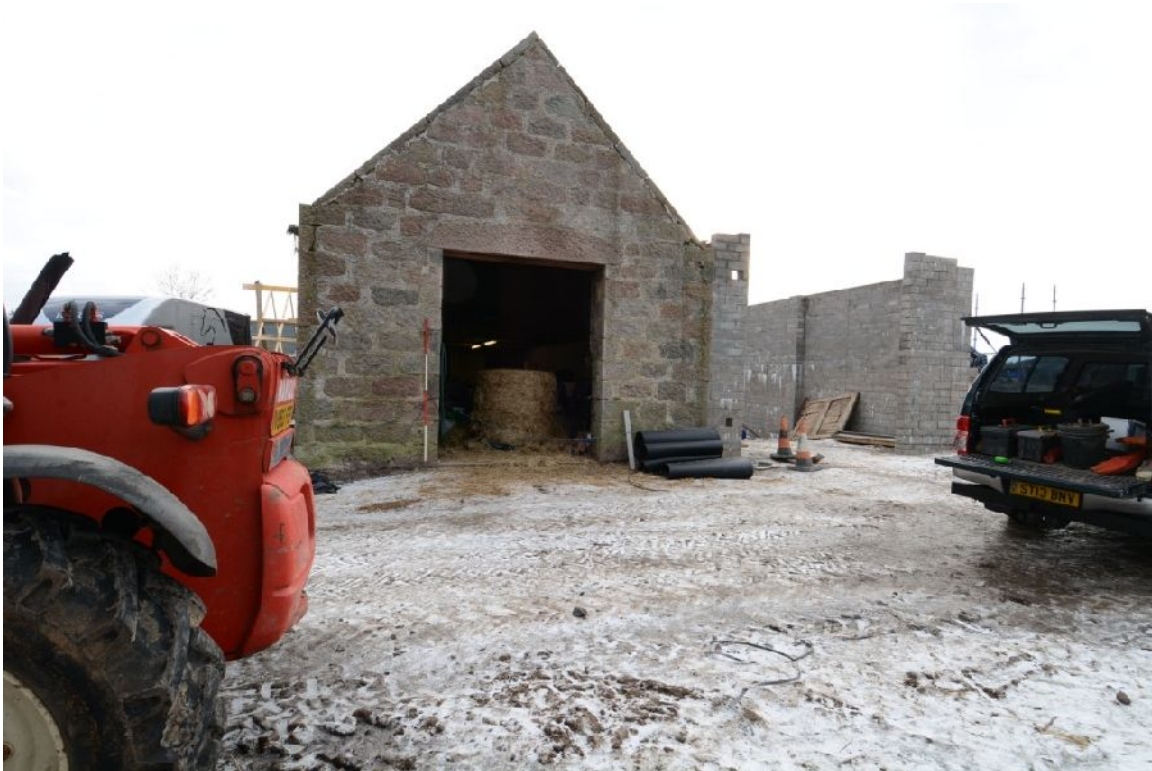
Illus 23 N gable E range January 2016. Note concrete block infill between E and W ranges.

D1 W: 2.45m H: 3.05m. Granite lintel and rybats. Wooden sliding door.

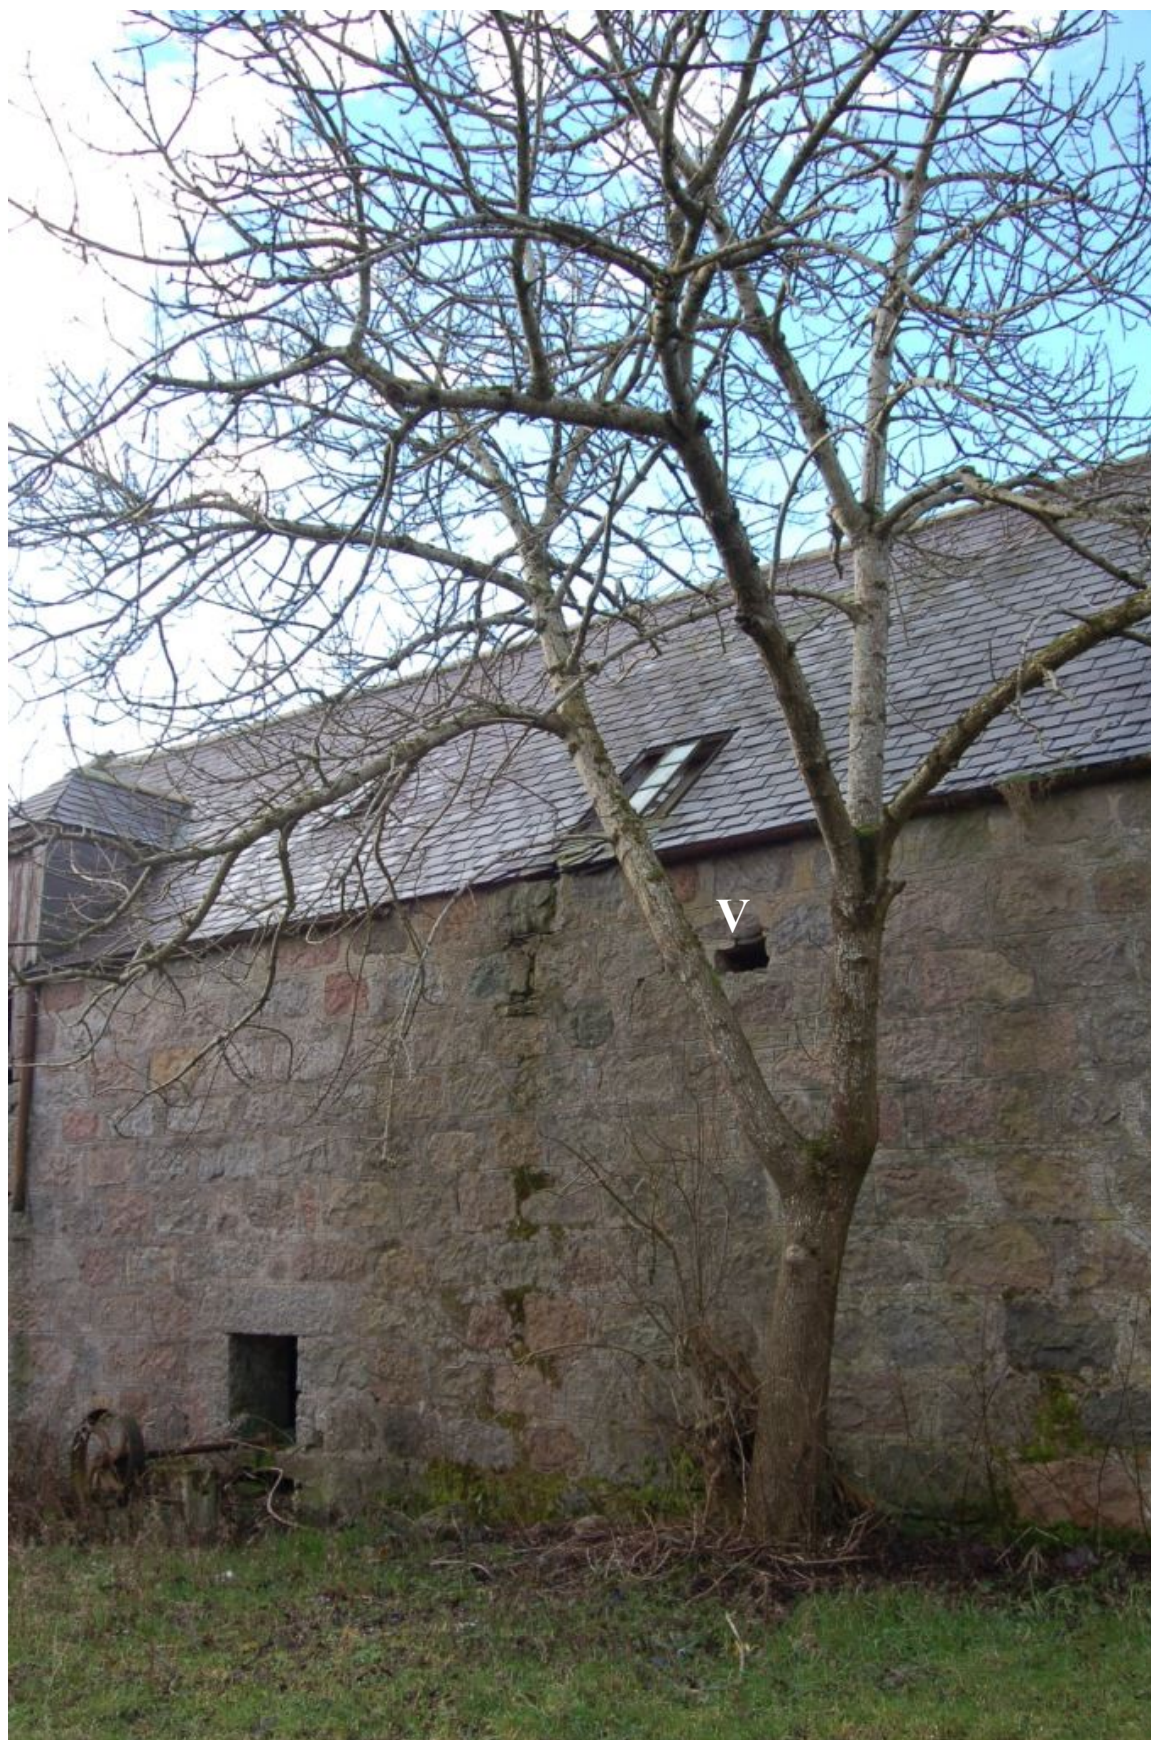
F1 W: 0.60m H: 0.68m Granite lintel, sill and rybats. Opening for drive shaft for threshing machine.

V : vent 180 x 300mm (Illus 24)

Illus 24 E wall of E range showing drive shaft of threshing machine in situ in January 2015.
(Photograph courtesy of Acanthus Architects Ltd). V= vent

This appears to have been a moderately prosperous medium-sized farm. The quality of the squared rubble stonework is good and the house appears to have been at its present, fairly generous, extent by the 1st OS map of 1867. The farm, with its freestanding water mill to the N, appears to have remained more or less the same up to the 1899 2nd edition OS map. However at some point, probably in the early 20th century, the water mill was abandoned and the E range built with a threshing machine (and possibly other machinery) driven by mechanical power from an engine standing in the yard E of the new range, with the drive shaft running through the wall. The opening for the drive shaft appears to be part of the original construction of this range.

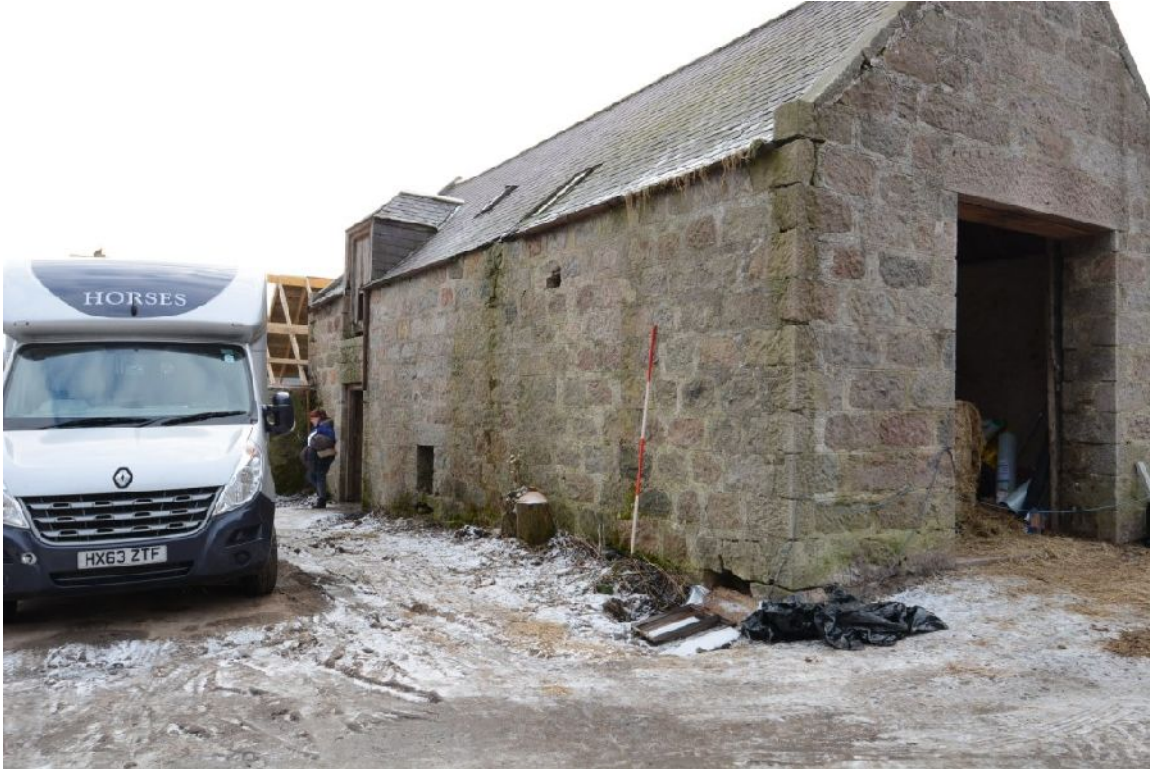
Illus 25 E wall of E range. January 2016

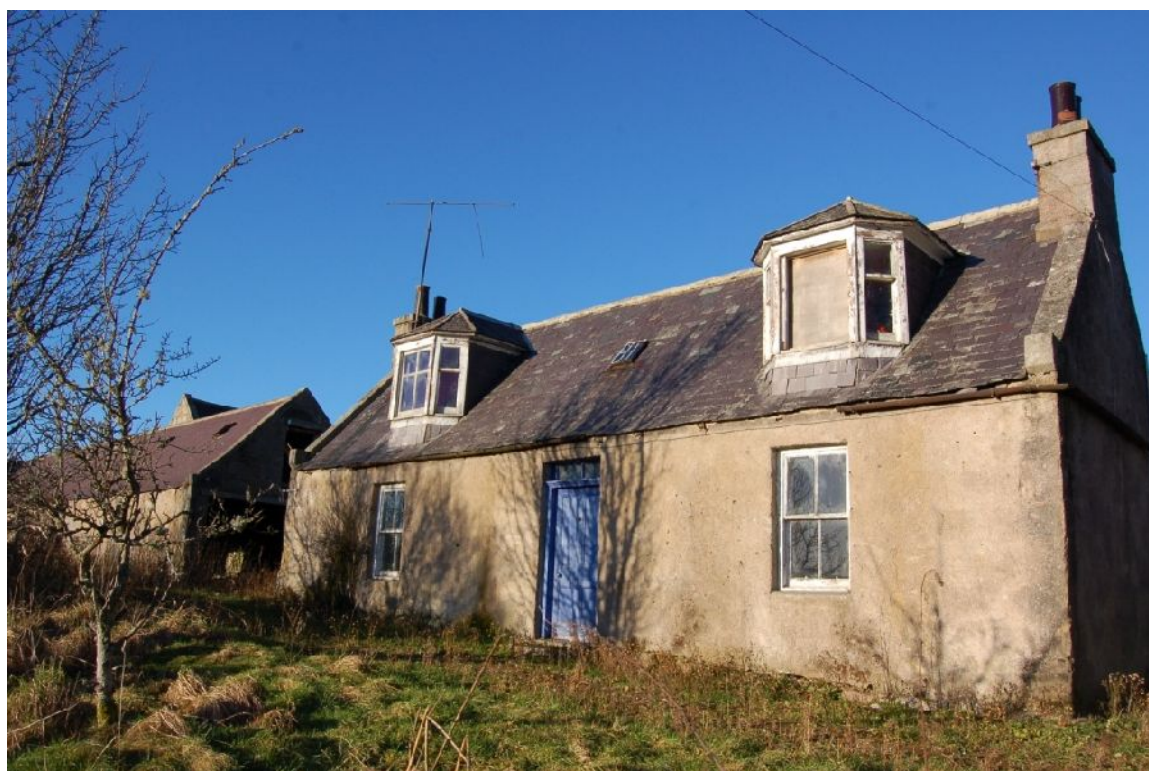
Illus 27 S facade of house January 2015 (Photograph courtesy of Acanthus Architects Ltd).

Central door (W: 1.06m H: 2.33m. Wooden door with 2-paned glass light above) flanked by two windows (W: 0.90m H: 1.53m. 2/2 sash). Dormers into upper floor, originally slated and with partially slated sides.

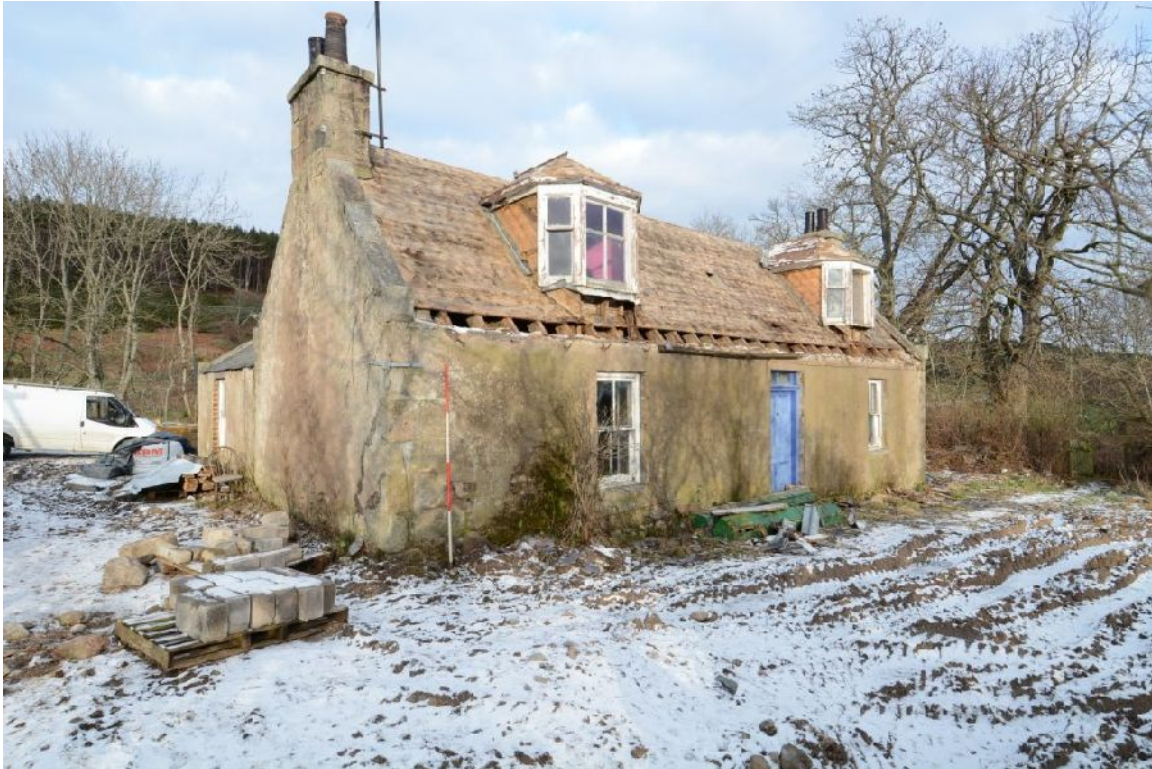
Illus 28 S facade of house January 2016

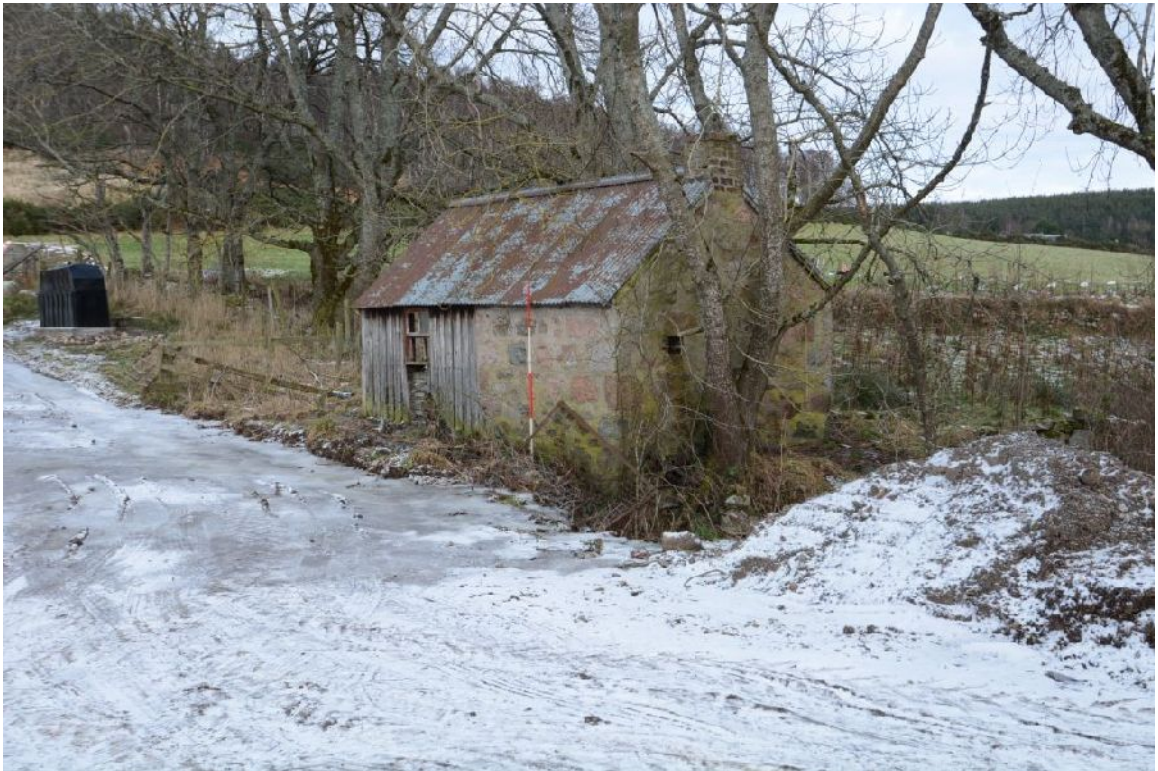
Walls S end of stone, N end of timber

Roof Corrugated iron with brick chimney

Illus 30 Building 3 from SW

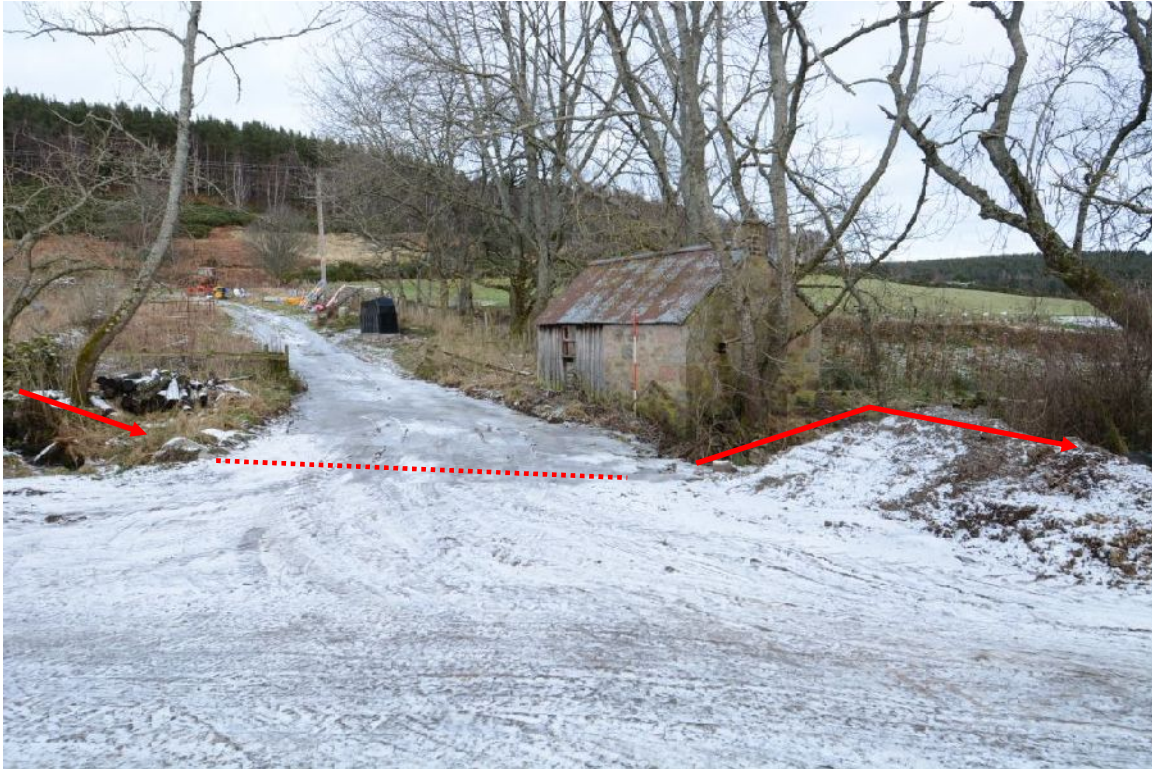
Small freestanding building to NE of house, on N side of mill lade where it runs below track (Illus 1).

Illus 31 Building 3 in relation to mill lade (red arrows)
