MONYMUSK HOME FARM
MONYMUSK
ABERDEENSHIRE

Standing Building Survey

Report No: MAS 2016-10

- Standing Building Survey -

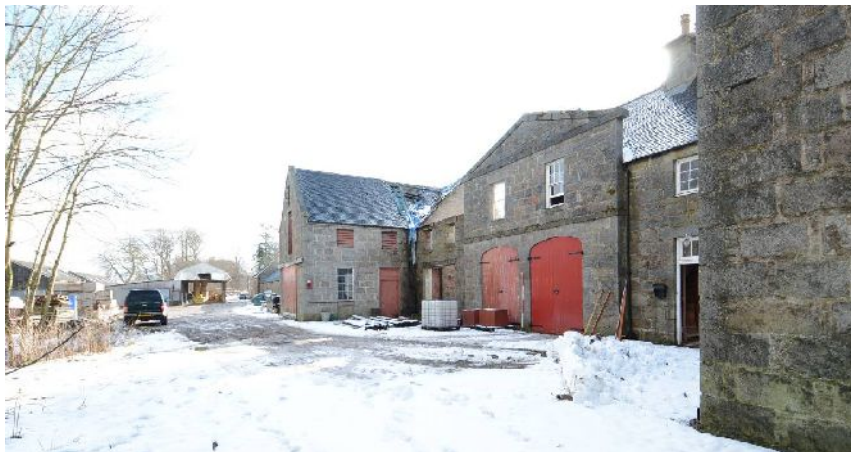
Illus 2 General view looking E along front of Home Farm range. Stable at RHS

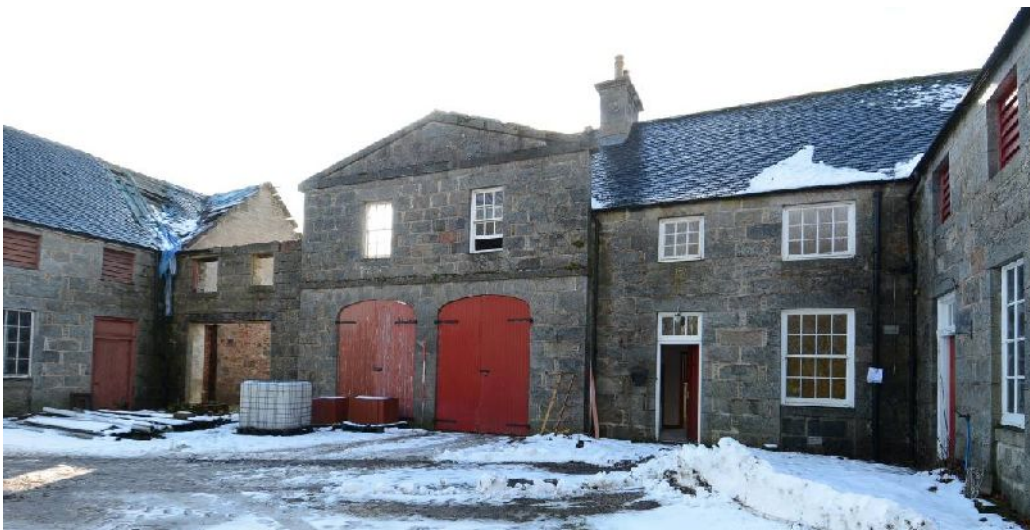
Illus 5 Front of building

Walls The front (N) wall is of rustic dressed granite blocks with stacks of small pinnings; this is true of the frontage of the whole mid-19th century W range but not of the earlier E range. The facade has a central pediment over the coach house door arches and projects 300mm in front of the main wall line.

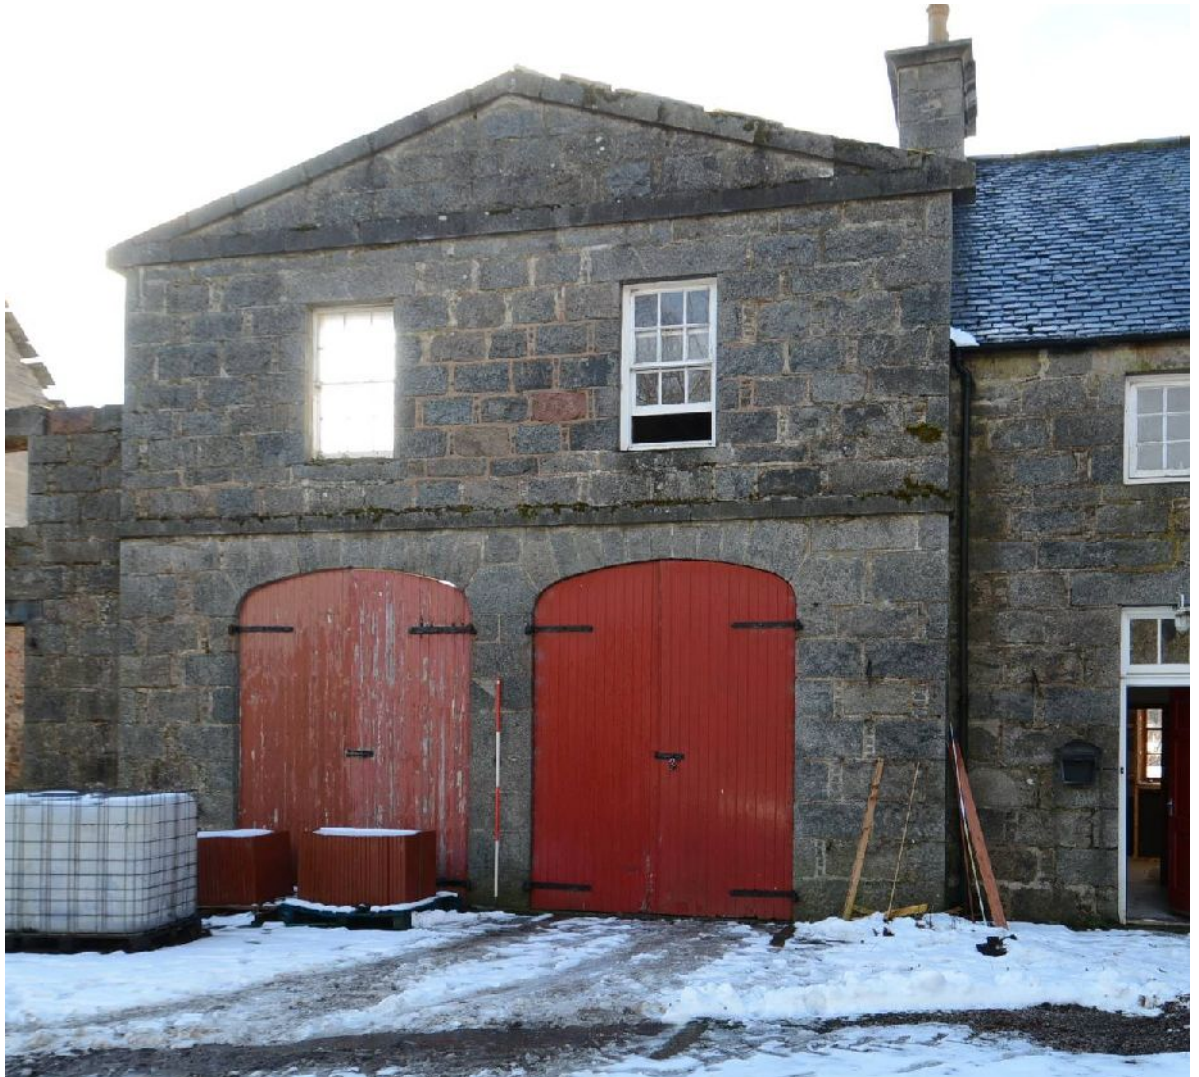
Illus 7 Detail of front (N) wall

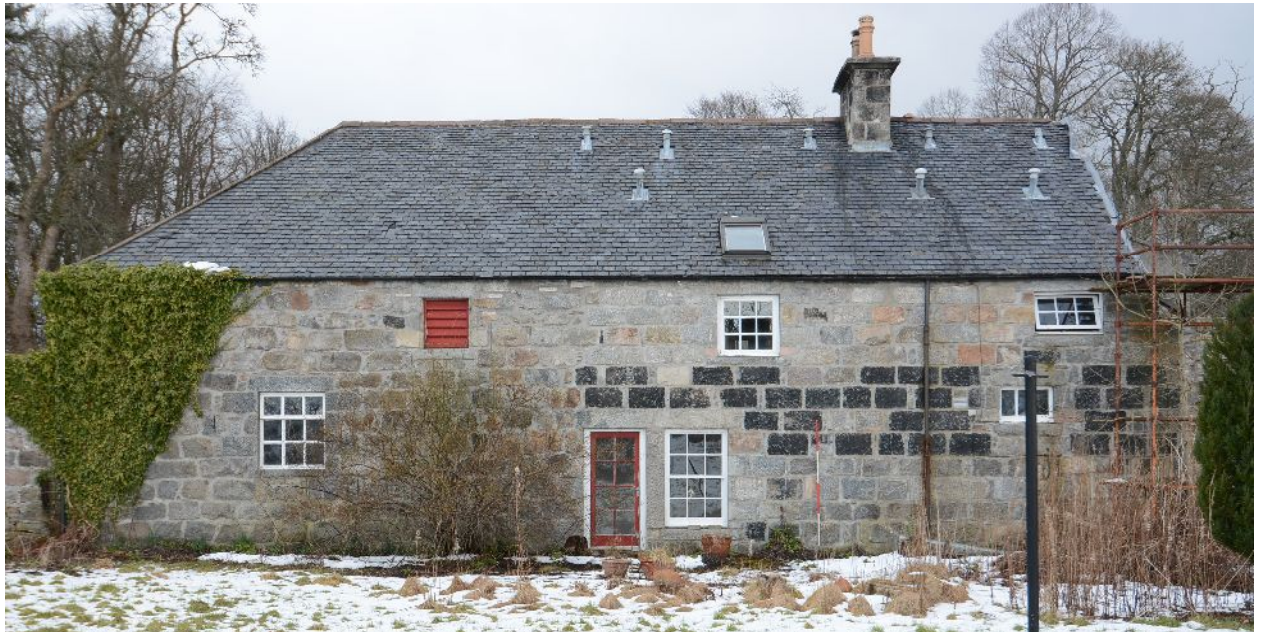
Illus 8 Back (S) wall of Stable (LHS) and No 1 (RHS)

The back (S) wall of No 1 appears to have been considerably rebuilt using salvaged stone. The rectangular blocks are of more varied stone and appear less regular than the wall of adjoining stable (Illus 8). The demolished S wall of No 2, of which only the base remains, appears to have been all or largely, built of (old) brick. This extends further E and appears to have been an earlier repair (Illus 9). As a result of stabilisation after the fire in No 2, and the conversion of No 1, many internal walls are of concrete block construction (Illus 6).

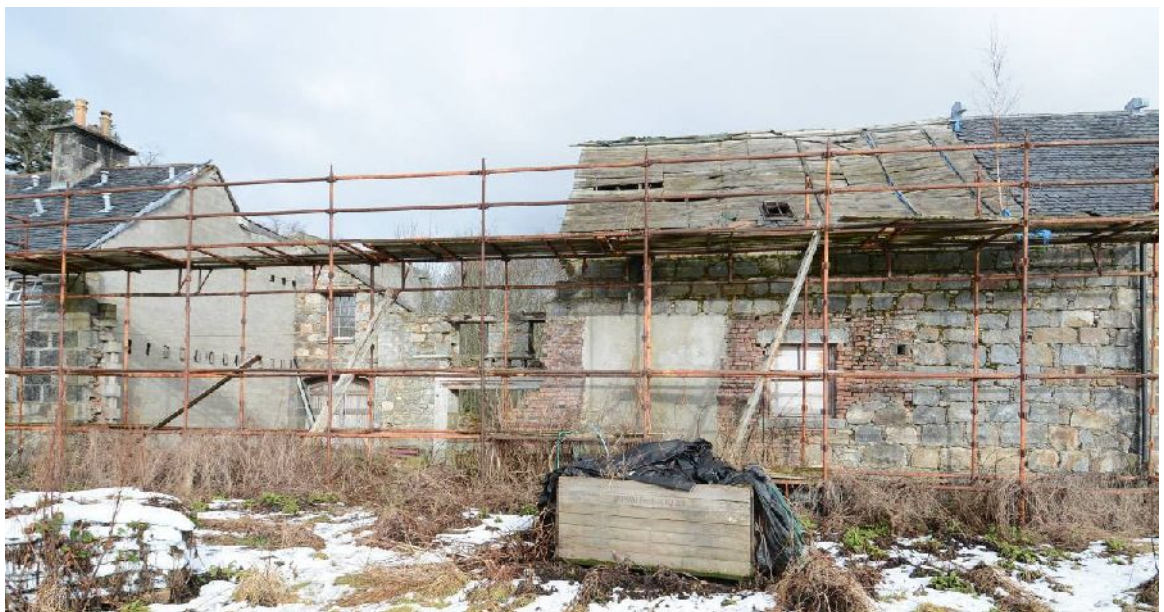
Illus 9 Back (S) wall of range adjoining No 2, showing brick infill

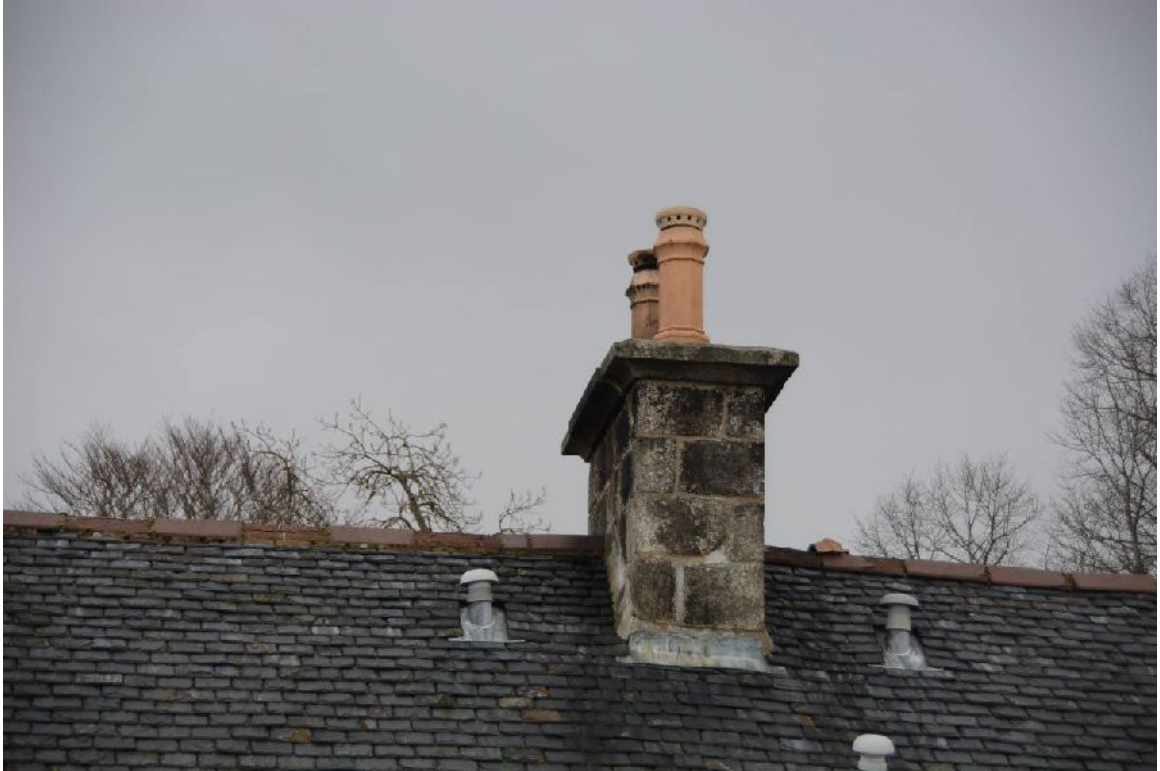
Roof Slate with ceramic ridge. Slates graded- smaller at ridge, larger below.
Chimney At E end of No1; any matching chimney for No 2 has been destroyed by the fire. Rectangular of granite blocks with flat table. Ceramic pots (Illus 10).

Illus 10 Chimney from S

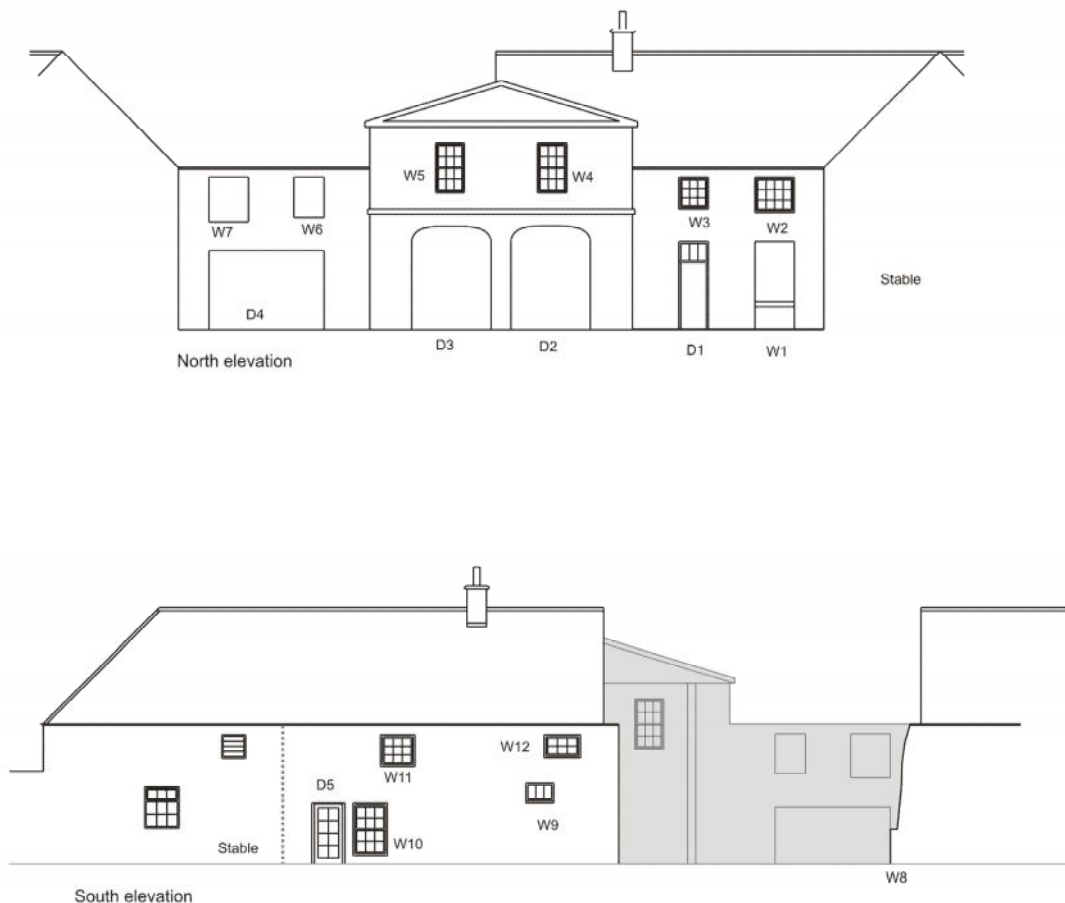
D1 W: 0.92m H: 2.7m. Granite lintel and rybats. Wooden door with 3 pane fanlight above.

D2, D3 (Coach doors) W: 2.45m H: 2.7m to base of arch. Granite rybats. Wooden doors.

D4 W: 3.54m H:2.72m. This is a break-through to form a cart entrance with a steel beam as a lintel. The sides of the opening appear to be the outer sides of a door and window mirroring D1 and W1.

W1 W: 1.23m H:1.84m. Sash window 6/6 panes. Granite lintel and rybats.

D5 W: 1.02m H: 2m. Granite lintel and rybats. Modern door

Illus 11 Elevations. courtesy of Morris Tait Architectural Design and annotated by MAS Ltd.

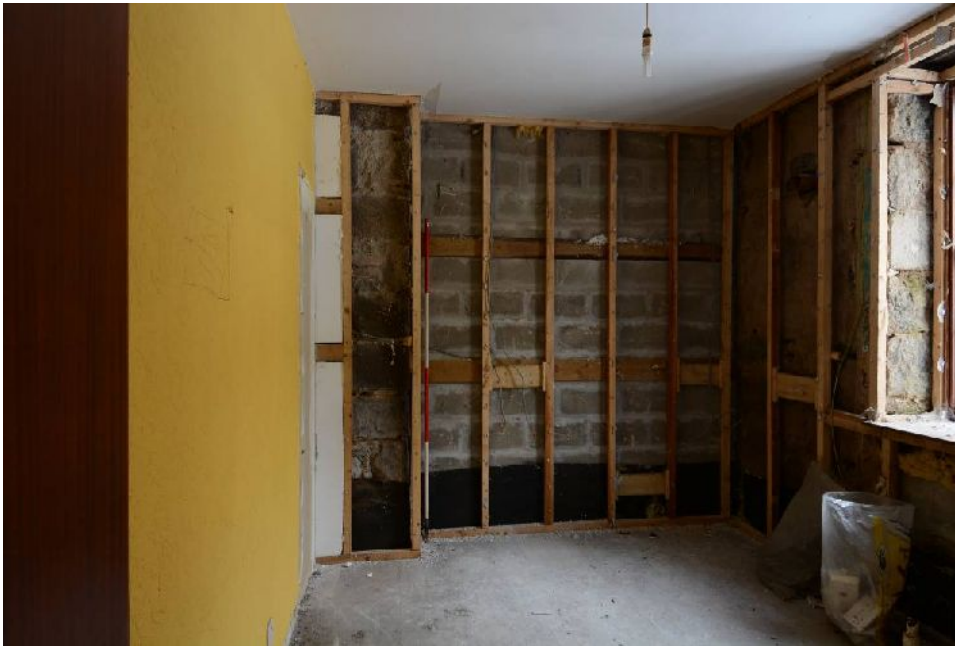
At ground floor there was a concrete blocking between the front (N) room and the stable block; this appear originally to have been open (Illus 12, 13). Possibly there was originally more stabling at ground level with the coachman's accommodation above.

Illus 12 Concrete blocking at ground floor between No 1 kitchen and stable

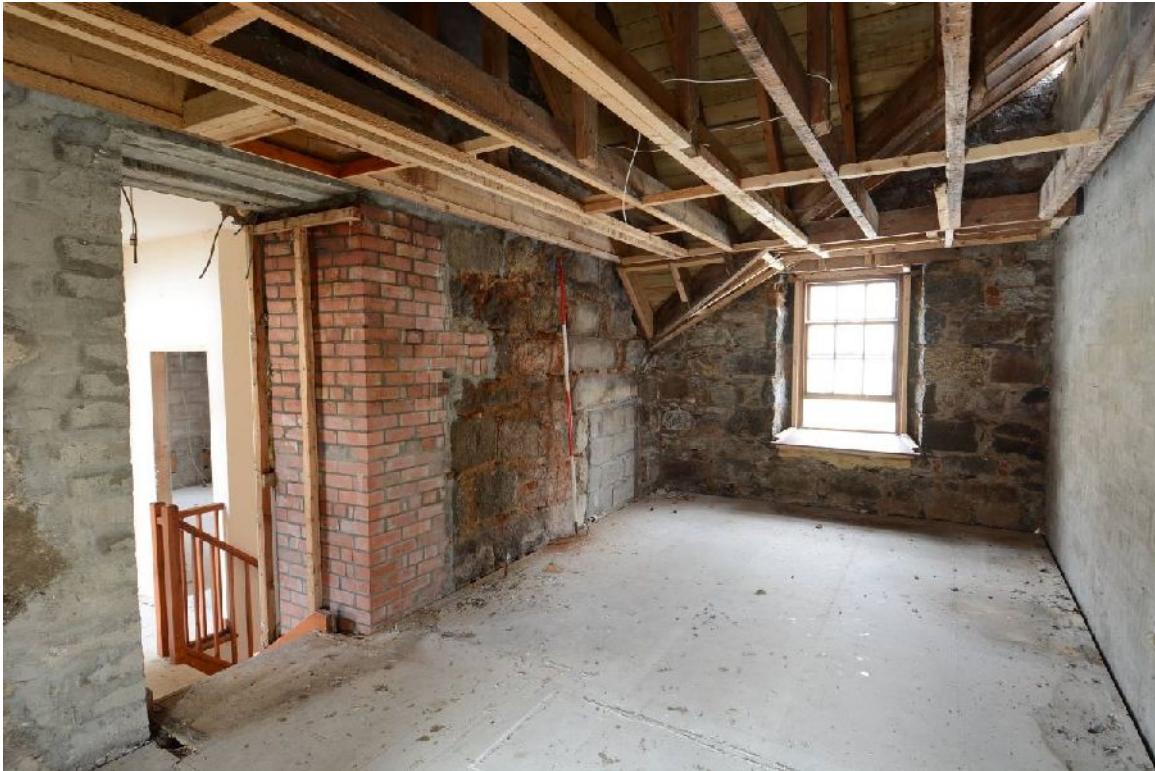
In the E bedroom at the front of the building on the first floor, there was a blocked fireplace in the E face of the W wall (Illus 14, 15).

Illus 14 Location of blocked fireplace

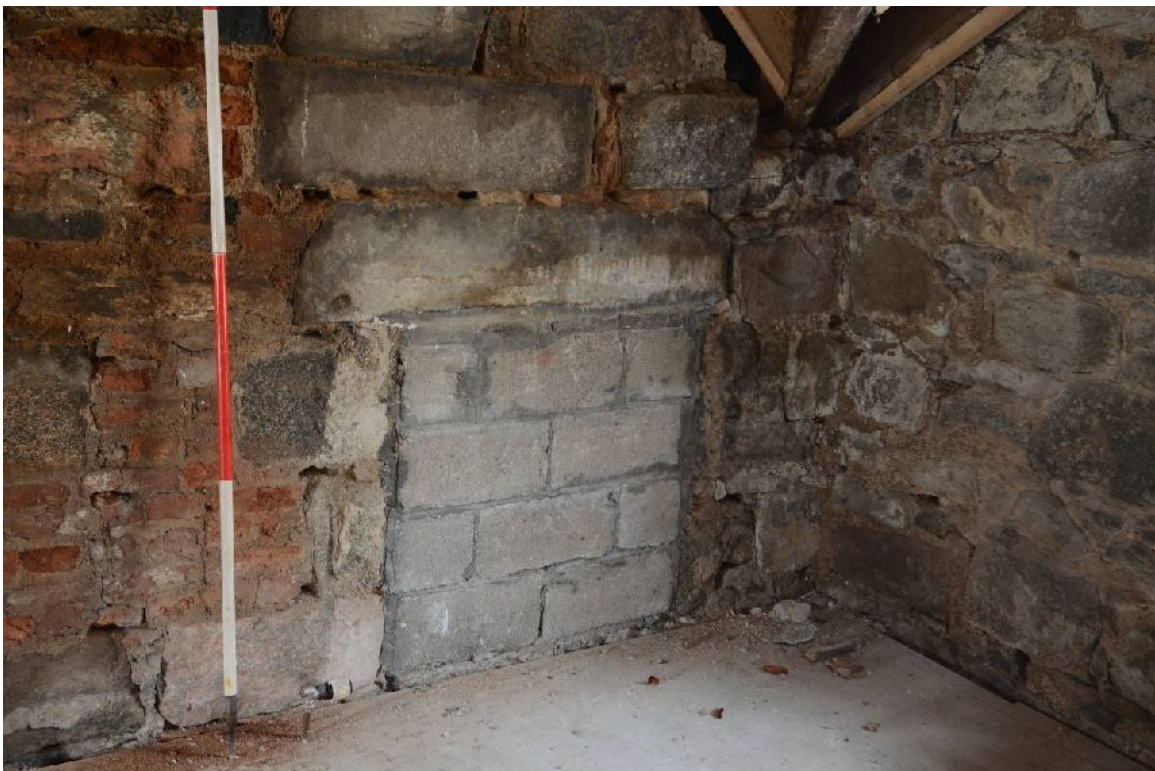
Illus 15 Detail of blocked fireplace
