**SEAFIELD HOTEL
CULLEN
MORAY**

Standing Building Survey

Carried out 7th April 2016

Report No: MAS 2016-15

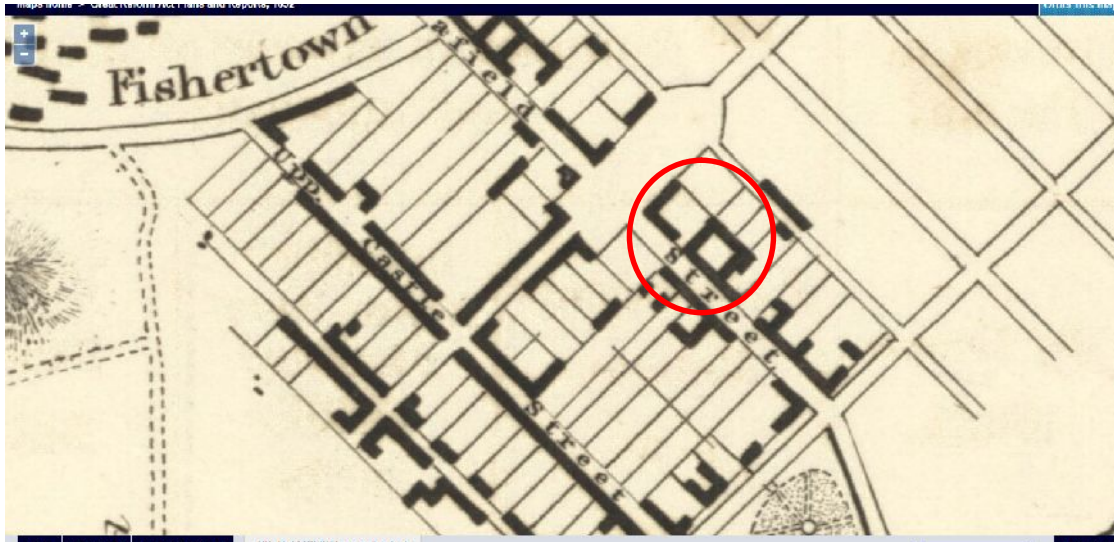
4.1 **1832 Great Reform Act plan** shows the L-plan of the frontage buildings of the hotel and the town hall, with stable courtyard to E. The wing to be demolished is on the footprint of the W wing of stable court.

Illus 2 1832 Great Reform Act plan. www.nls.ac.uk Site marked by red circle

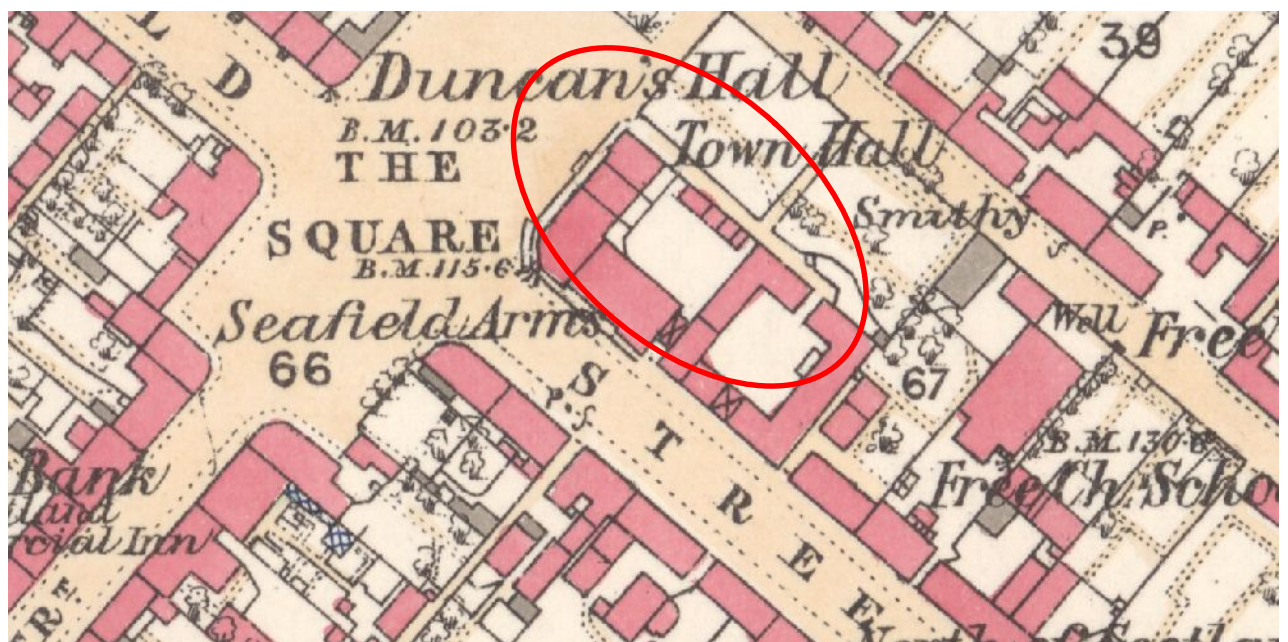
4.2 **Banff Sheet III.5 (Cullen) 1866 (pub 1871)** shows a more detailed view of the plan shown on the 1832 plan.

Illus 3 Detail of the 1st edition Ordnance Survey 25'' map, surveyed in 1866 (published 1871) Banff sheet III.5 www.nls.ac.uk Site marked by red circle

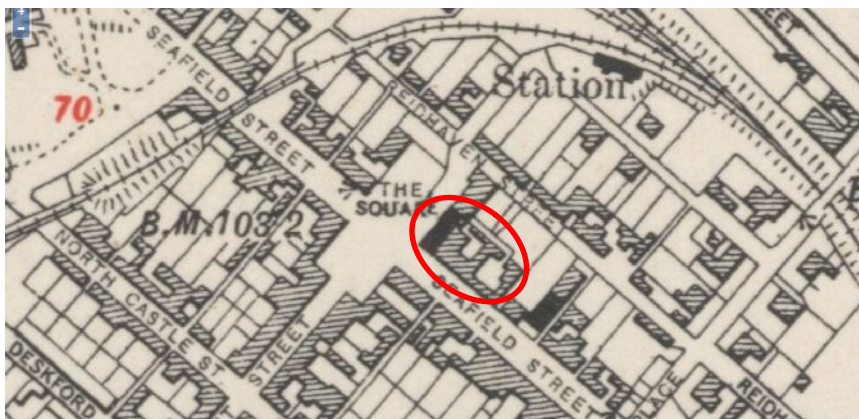
4.4 By the c1949 edition Ordnance Survey map. Banffshire Sheet III.NW) the W wing of stable court had been extended N to the line of outbuildings.

Illus 5 Detail of the c1949 Ordnance Survey (Banffshire Sheet III.NW) www.nls.ac.uk

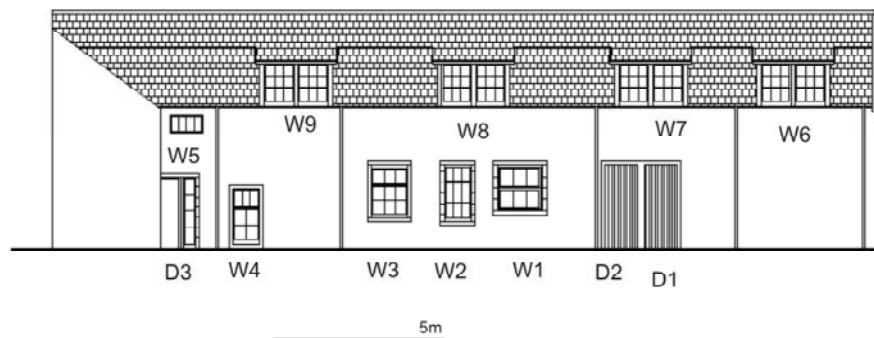
Illus 9 E elevation courtesy of Milne Property Developments Ltd and annotated by MAS Ltd.

- D1 (Blocked) W: 0.88m H: 2.20m. Concrete margins
- D2 Splays externally on N side. W: 1.12m H: 2.15m Concrete margins
- D3 W of opening: 1.40m H:2.20m. Width of door : 0.85m. Ashlar at S side and lintel, N side abuts main range of building.
- W1 W:1.23m H: 1.26m Concrete lintel and sill. Ashlar rybats. Boarded up.
- W2 W:0.77m H: 1.53m Concrete lintel and sill. Ashlar rybats. Boarded up.
- W3 W: 1.05m H: 1.46m Concrete margins
- W4 W: 1.00m H:1.46m Concrete margins. Safety glass
- W5 W: 0.82m H:0.40m. Single hinged pane
- W6-W9 W: 1.75m H: 1.32m. Dormers with slightly sloping top and straight sides slated. Double sash windows, 6/3 panes. Concrete margins
- NW wall*
- F1 Fire door at 1st floor level, leading to steps against the wall of building.

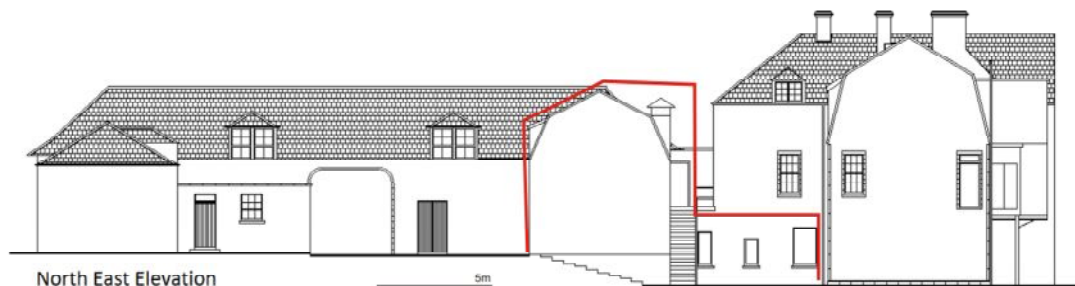
Illus 10 N elevation courtesy of Milne Property Developments Ltd and annotated by MAS Ltd. Red outline indicates area of Standing Building Survey

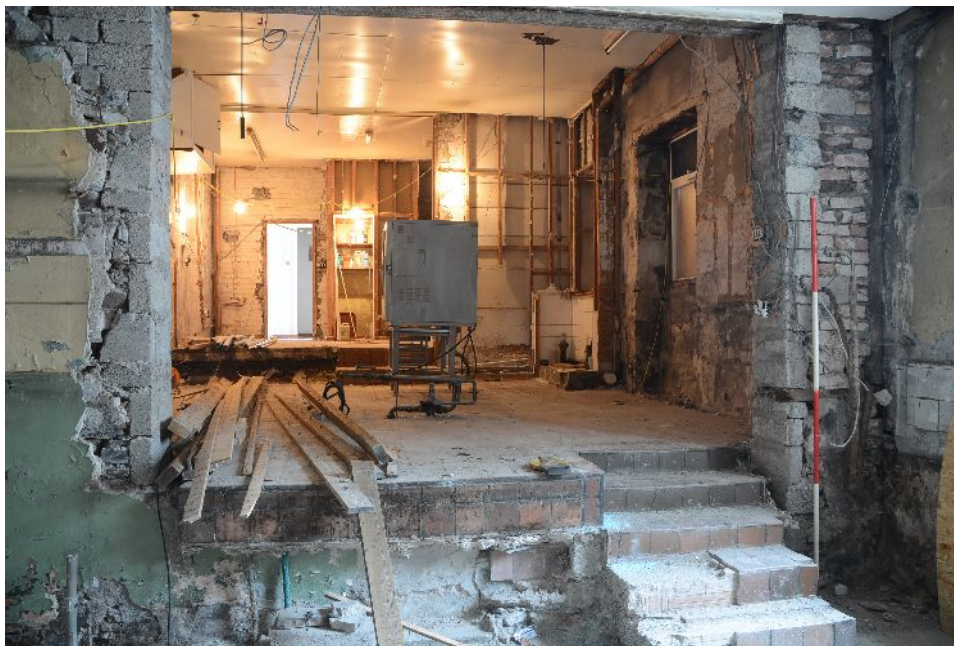
No internal details prior to 1972 remained. The kitchen, servery and various stores had been stripped out but were as shown on illus 8. There were steps up between the servery and kitchen and between kitchen and stores. A pre-1972 wall on the line between the kitchen and the servery had been broken through in 1972 and a steel beam resting on brick and concrete side walls held the upper floor.

Illus 11 Ground floor looking N from servery to kitchen

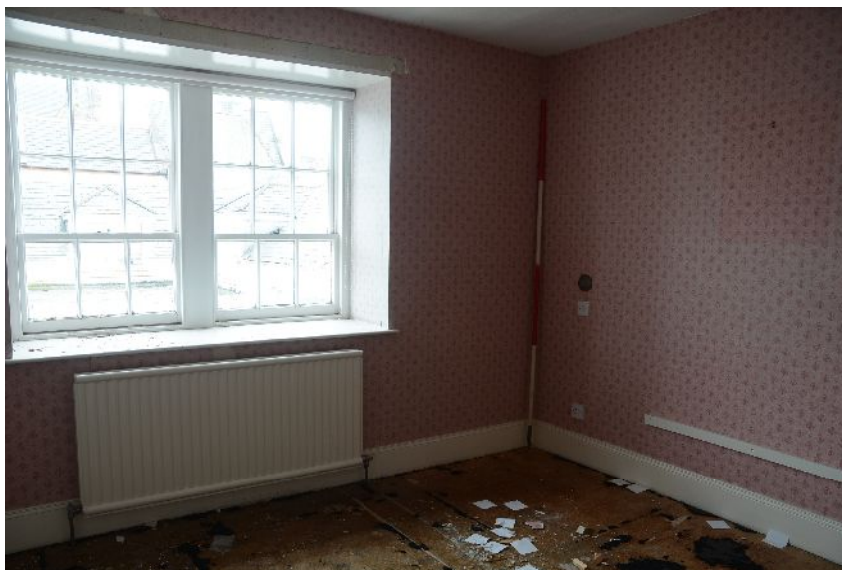
Illus 12 Bedroom on 1st floor

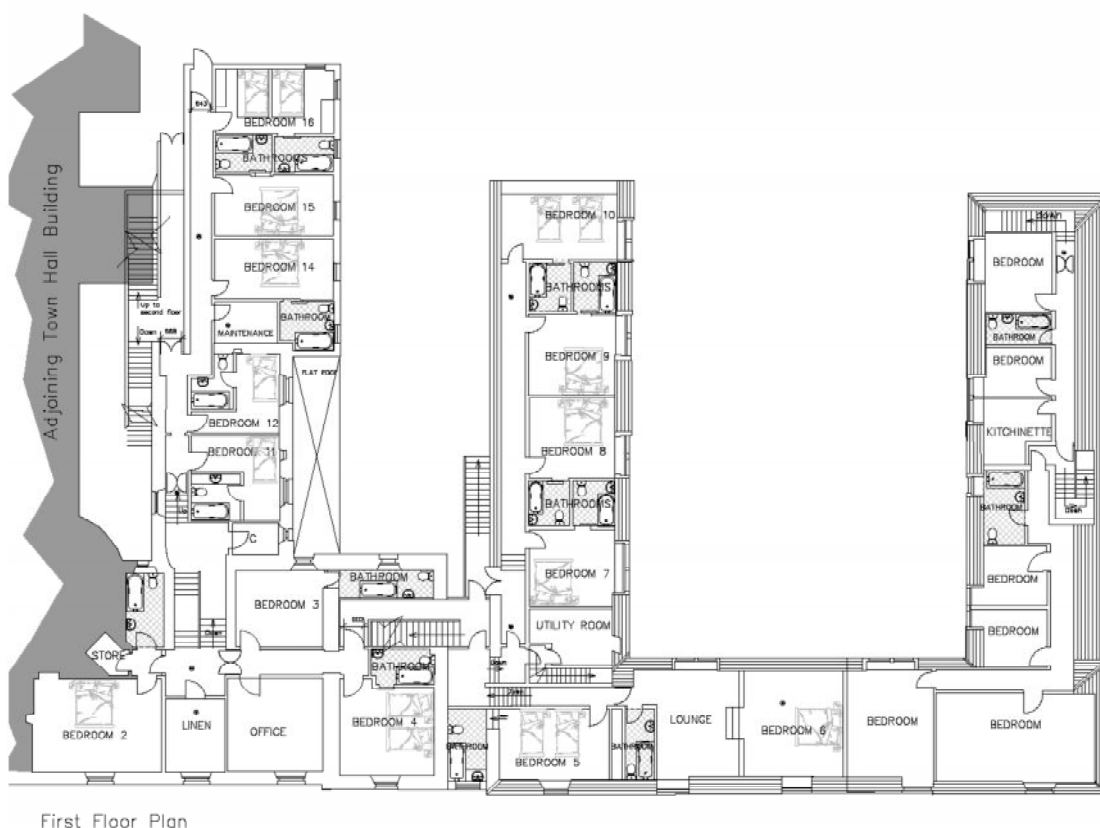
Bedrooms, passage and store as shown on illus 13.

Illus 13 1st floor plan courtesy of Milne Property Developments Ltd

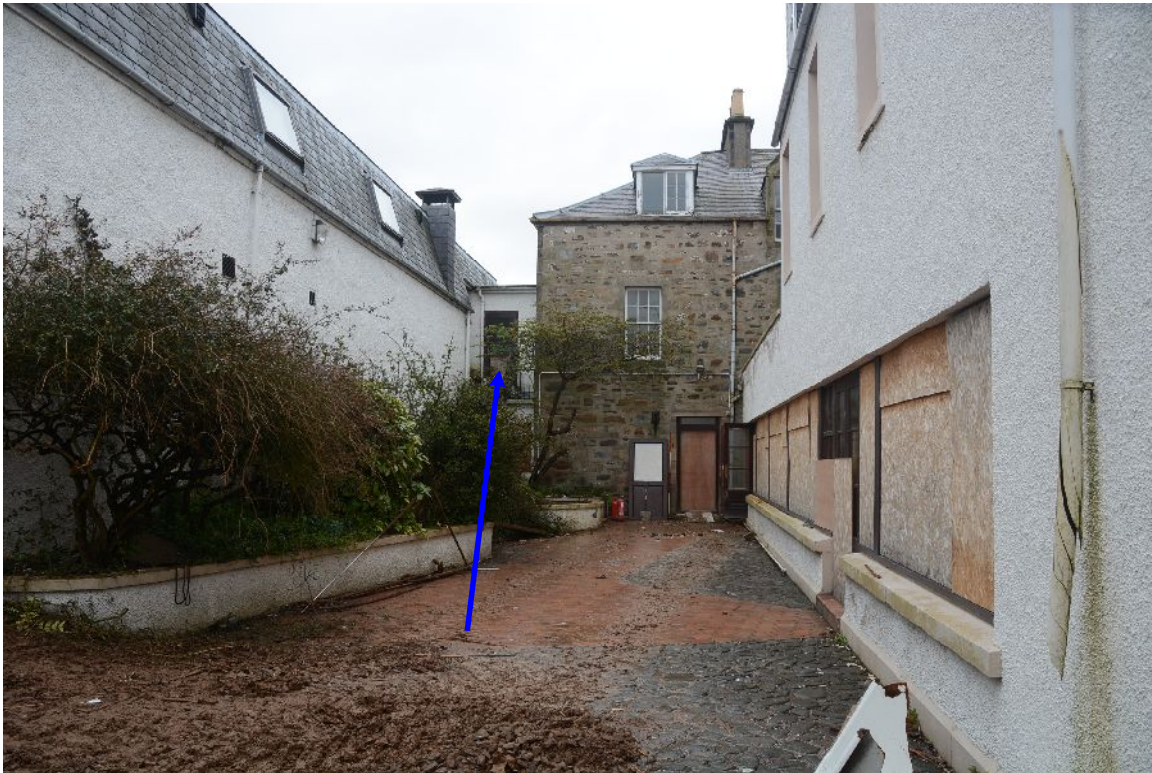
Part of the back wall of the main frontage block just to the W of the wing to be demolished will be obscured by the new bar area. The original pend from the street between the main hotel and the stable court (with its separate arched entry), would have lain on the line to W of the servery (illus 8, 14, 15: blue arrow). To the W of this there was a window (F1: concrete blocked) and a door (D4 set in a wider opening which had been infilled with stone and brick (illus 14).

Illus 14 External view of wall NW of wing to be demolished. . Blue arrow marks position of pend in original building.

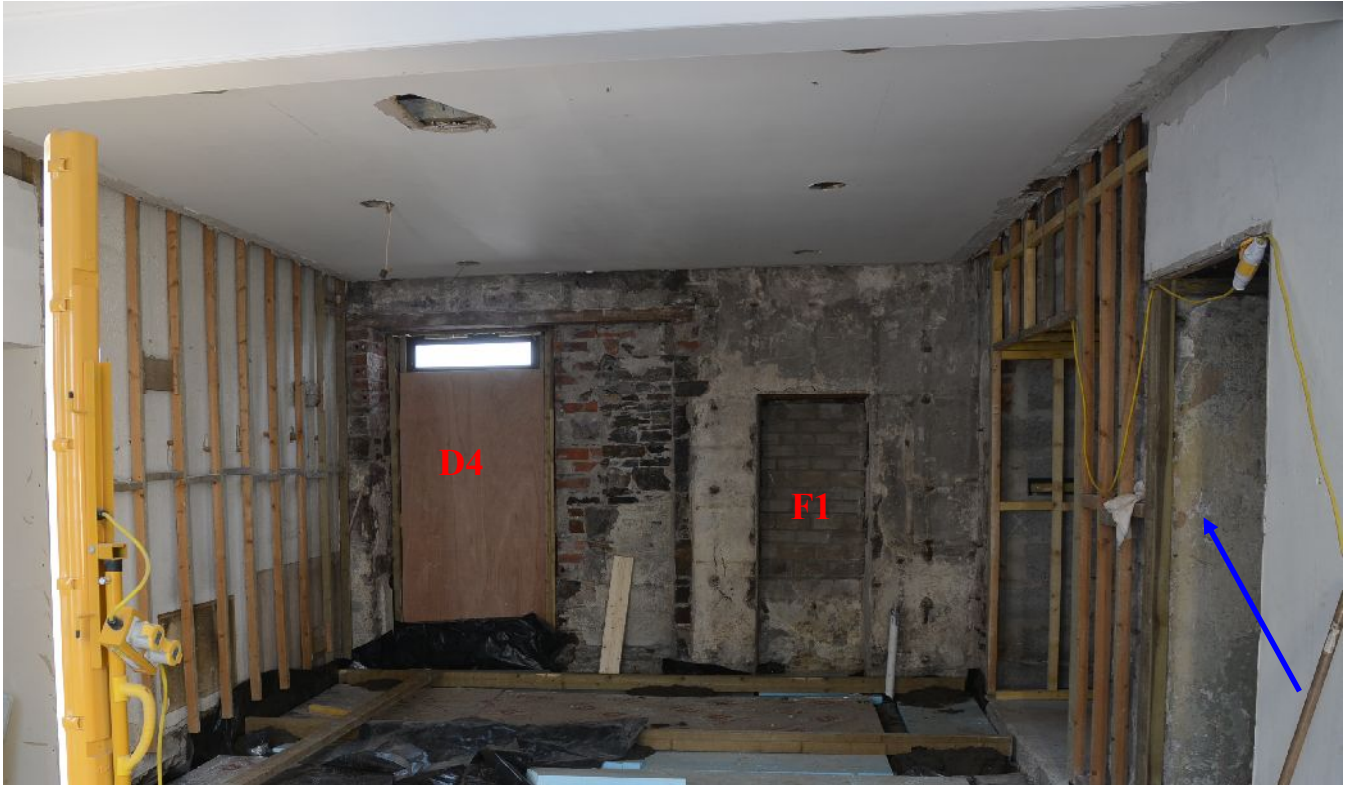
Illus 15 Detail of wall NW of wing to be demolished. Blue arrow marks position of pend in original building.

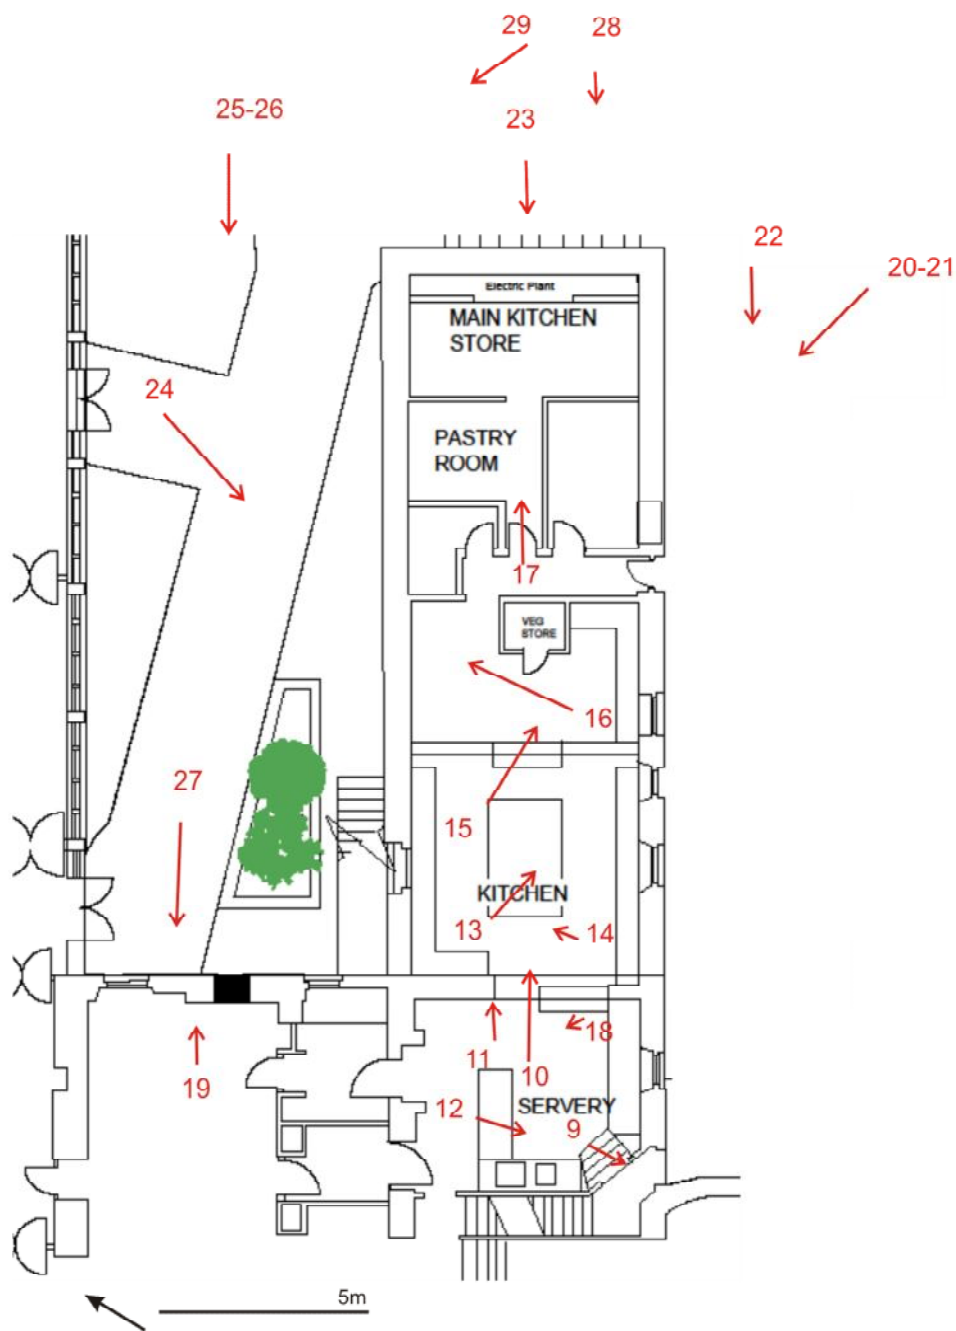
Illus 16 Photo reference plan ground floor (photos 9-29)

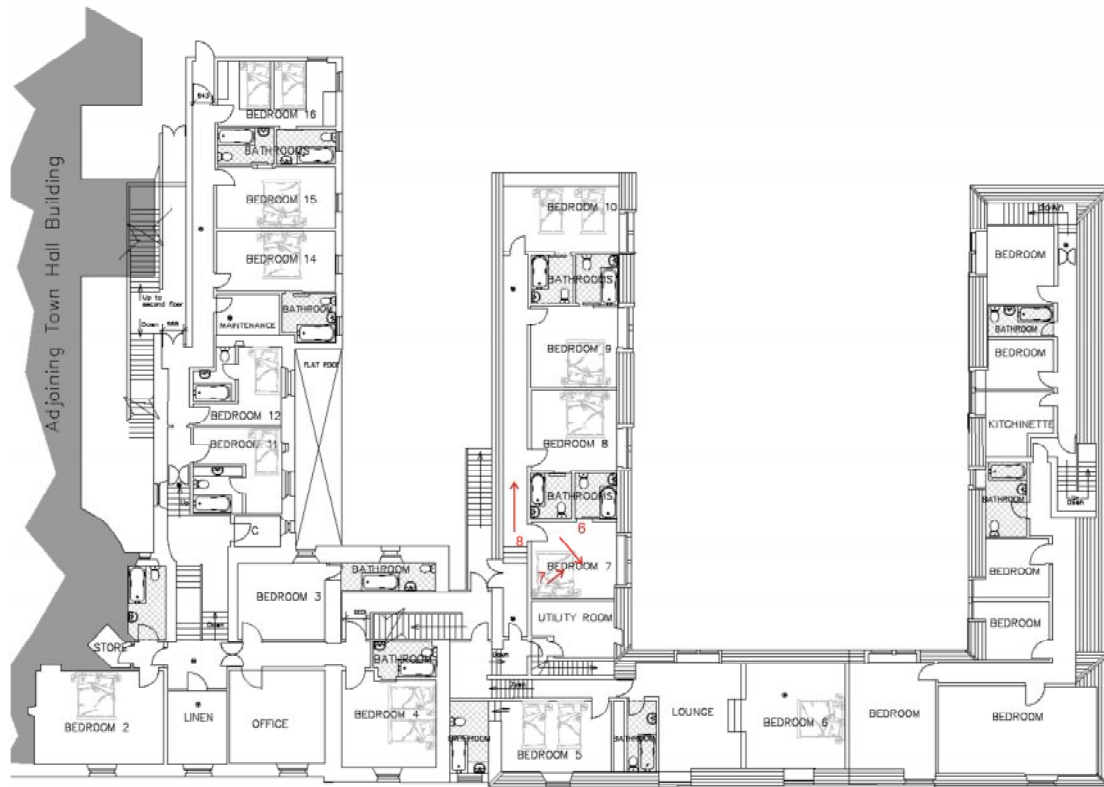
Illus 17 Photo reference plan 1st floor (photos 6-8)
