**MEIKLE HADDO
FOVERAN
NEWBURGH
ABERDEENSHIRE**

Report No: MAS 2016-23
by
H K Murray and J C Murray

- Standing Building Survey -

1. Background
 - 1.1 A standing building survey was required for part of the steading at Meikle Haddo Farm, Foveran, Newburgh, Aberdeenshire which is the subject of a planning application for its demolition and replacement by a new agricultural shed.

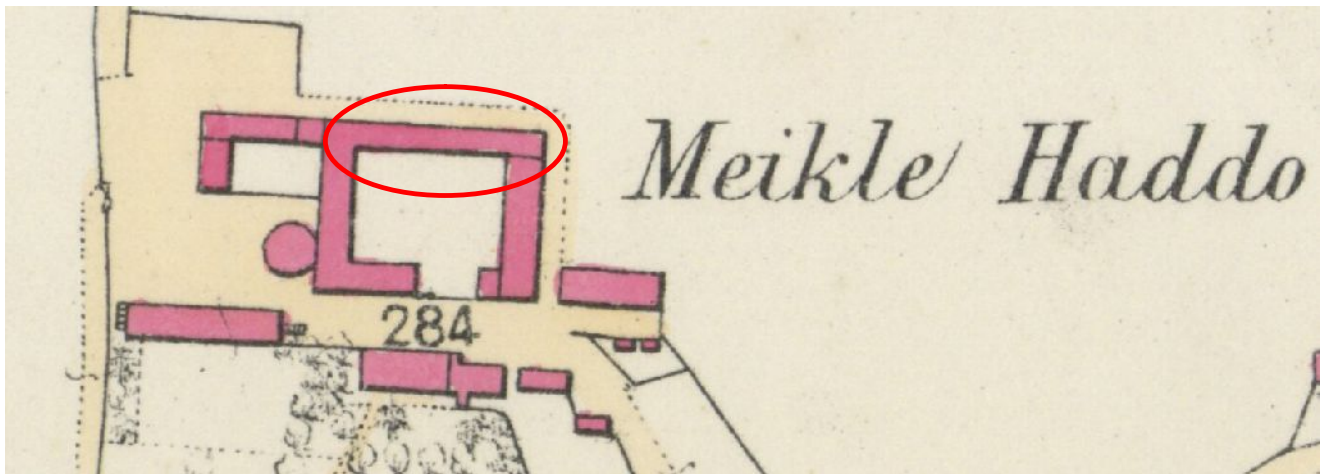
Illus 2 Detail of the 1st edition 25''/mile Ordnance Survey of 1867 (published 1870). Aberdeen Sheet XLVIII.9 www.nls.ac.uk

4.1 **Aberdeen Sheet XLVIII.9 of 1867 (published 1870)** shows a quadrangular steading around a court. A horse mill is shown on the W wall of the W range. An L-plan extension is shown at the W end of the N range. A number of other buildings including the house lie to the S and E. Only the N range (the byre) is part of the present survey (illus 2: outlined in red).

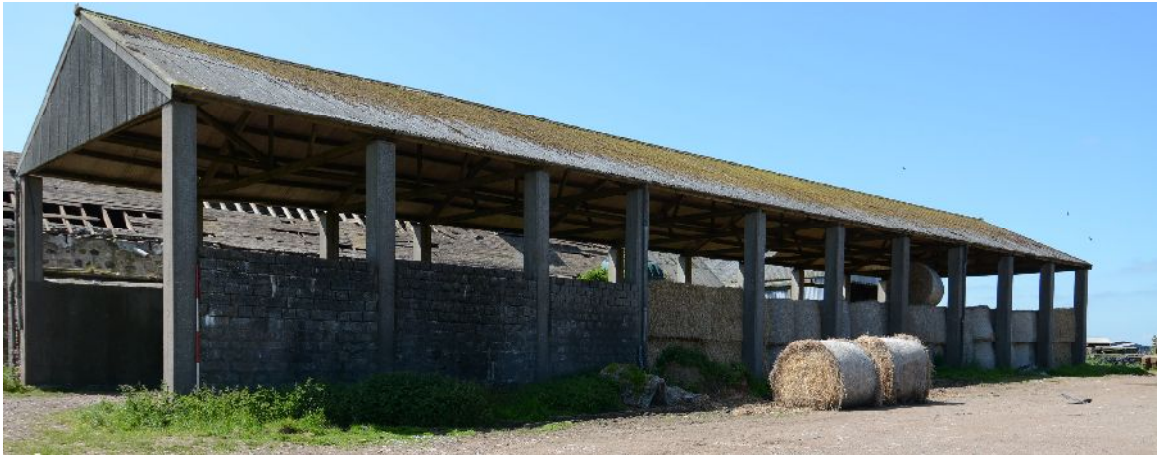
Illus 5 Dutch barn looking SW

Walls Concrete blockwork at E end. Open sides with concrete pillars W end.

Roof Corrugated asbestos

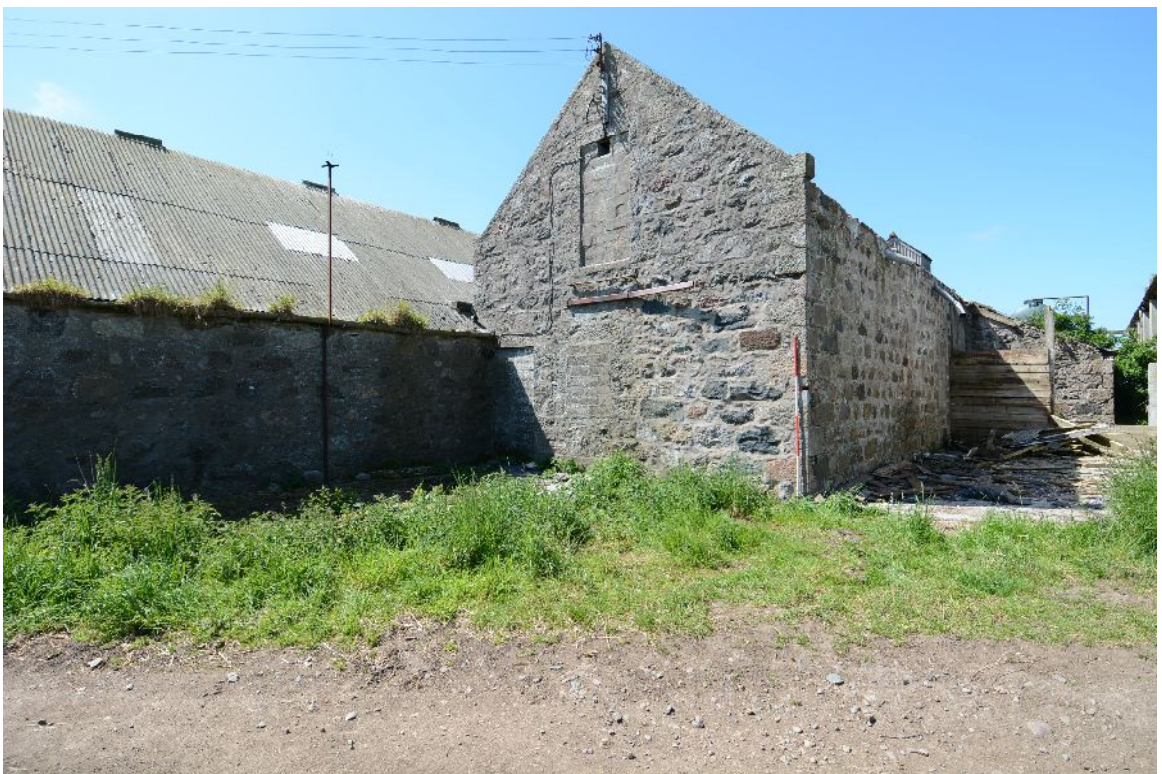
Illus 6 Grain store from E end, abutting N range/byre. Note lean-to outshot against N wall

Walls Rubble stone with granite rybats. N outshot stone walled. At W end modern extension c.6m long with concrete wall to N and utilising existing stone wall to S

Roof Originally slate over sarking on A-frame couples. Slates now removed. W extension corrugated asbestos. Lean-to tin roof to N outshot.

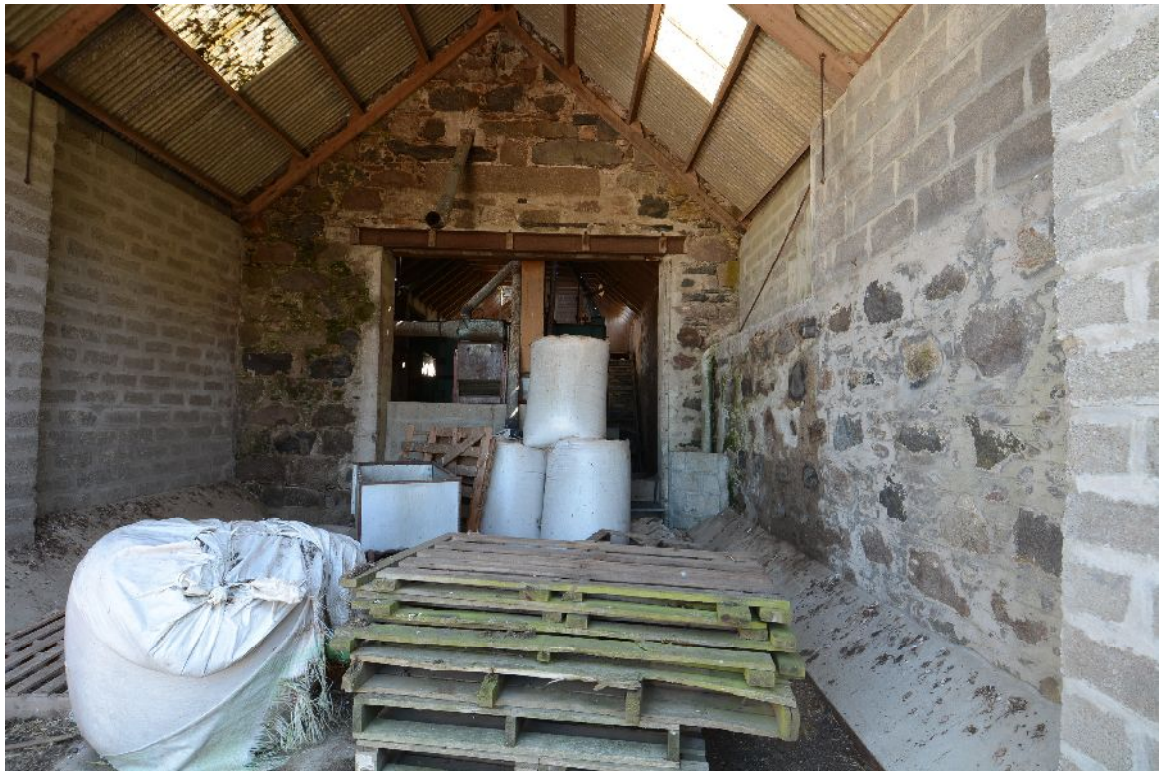
D11 W: c.3.5m. Modern break-through opening with metal lintel in W gable.

Illus 10 W gable of grain store from inside modern extension at W end

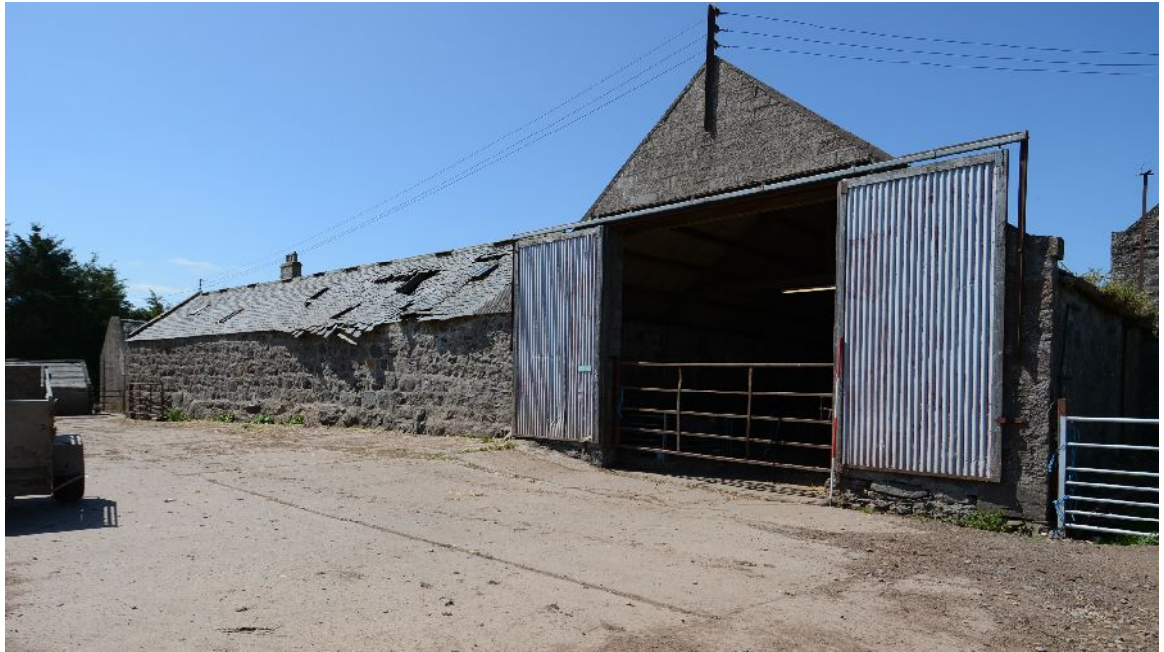
Illus 11 E gable of byre with modern opening and concrete upper wall. Abuts E range.

D5 W:3.8m. Modern break-through with metal lintel. Metal sliding doors.

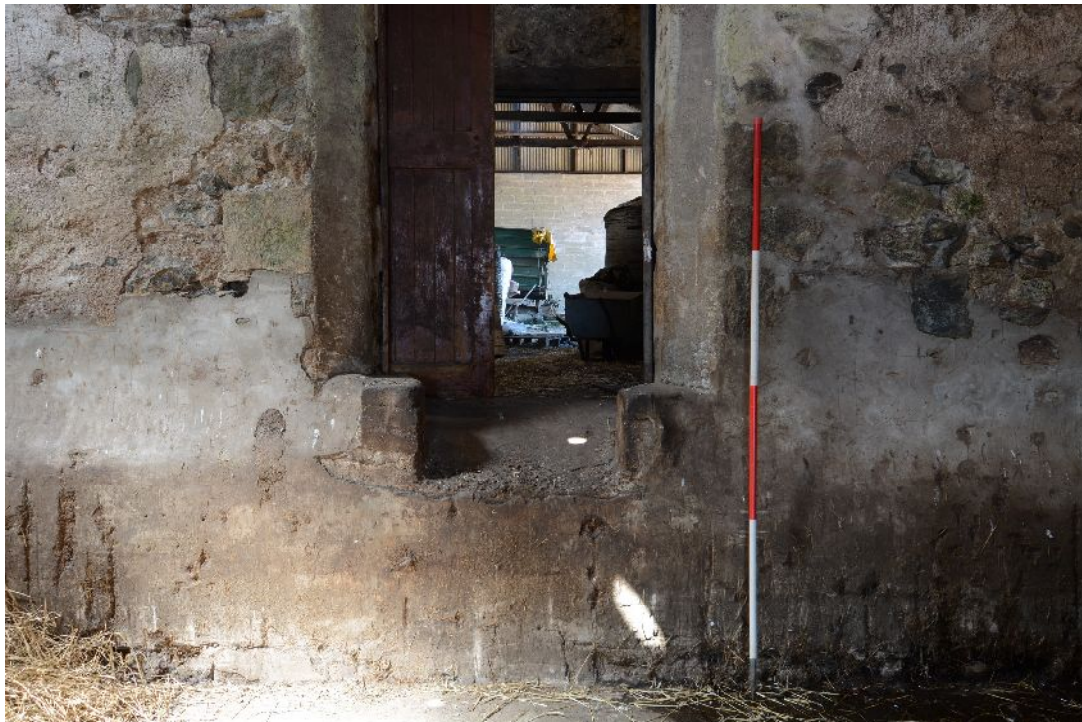
Walls Rubble stone with granite rybats. As floor levels had been dropped and height raised at W end, there was concrete reinforcing at base of wall and concrete blocks at wall head and E gable.

Illus 12 Door D9 showing lowered floor at W end

D9 W: 1.18m H:2.10m Base 750-900mm above existing floor due to lowering of levels

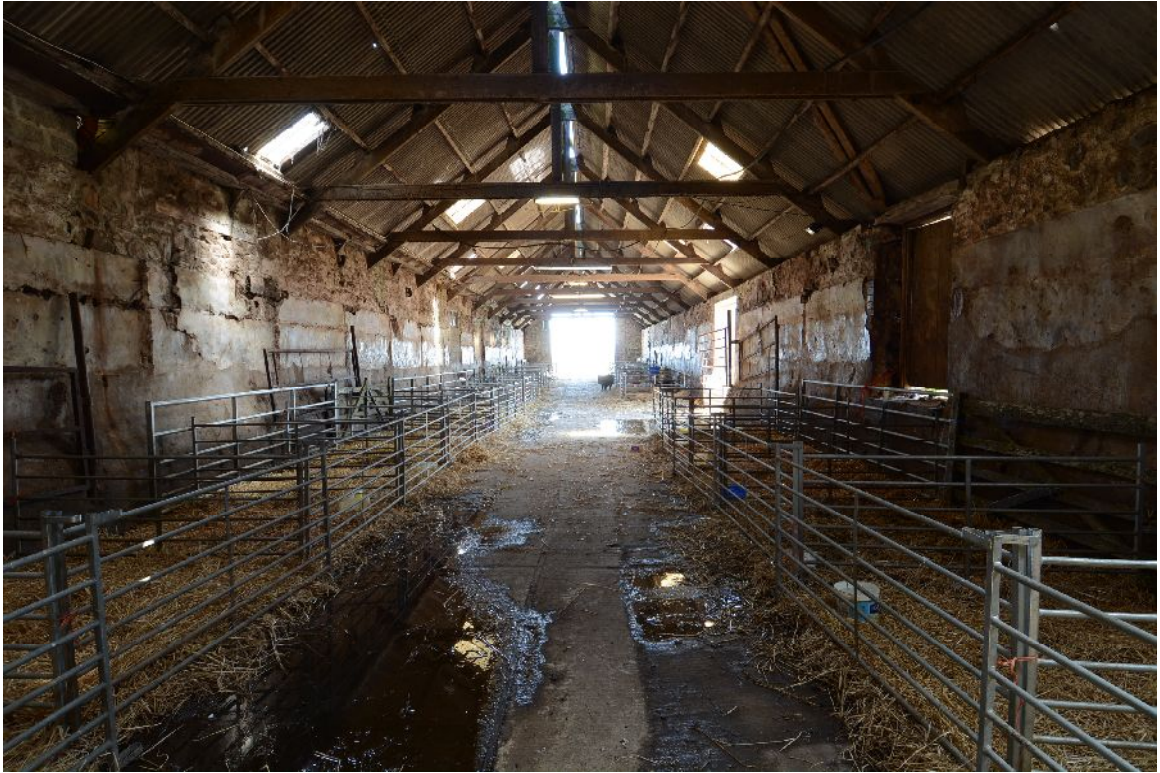
Illus 13 Interior of byre looking E

Roof Corrugated asbestos over king post couples

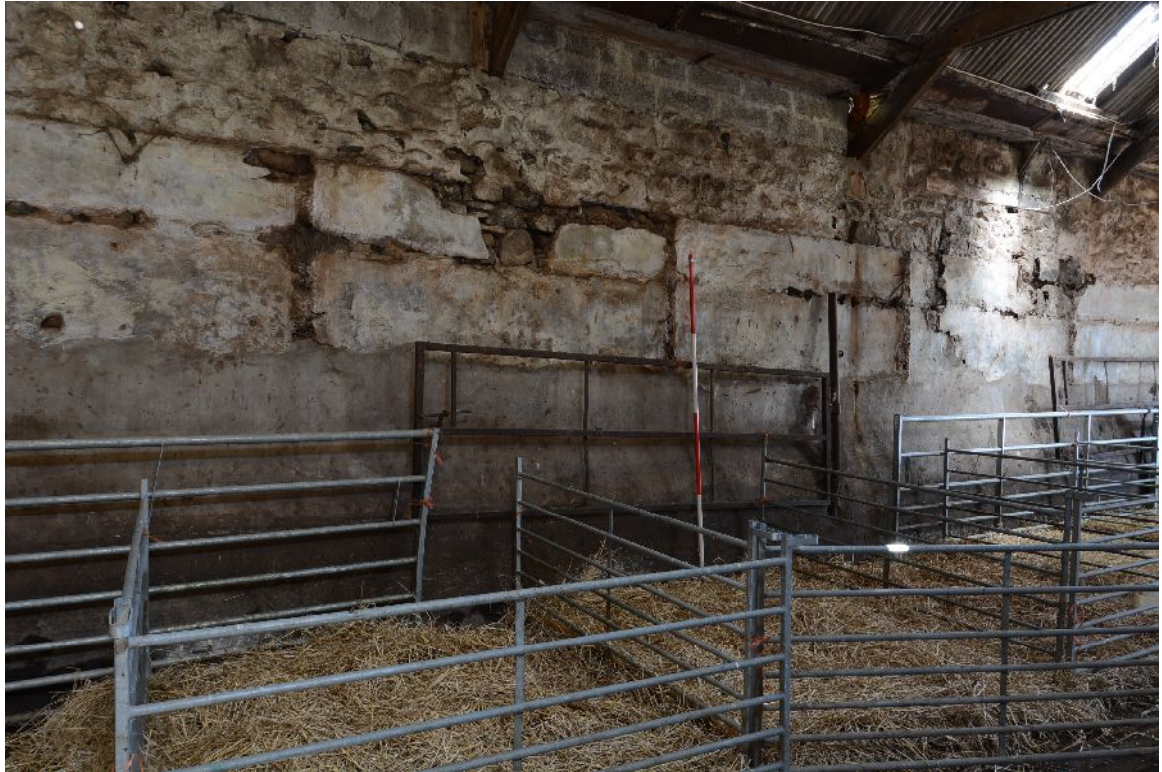
Interior Floor lowered by up to 900mm at W end, reducing to E..

Scars of trevies of double cattle stalls visible on inside of N and S walls above level of original floor. Stalls c.2.2m wide. Approx 12 double stalls by N wall and 9 clear on S wall. E end possibly open as no clear trevis scars.

Illus 14 Trevis scars (eg by ranging rod) of cow stalls above level of original floor. Note lowered floor level.

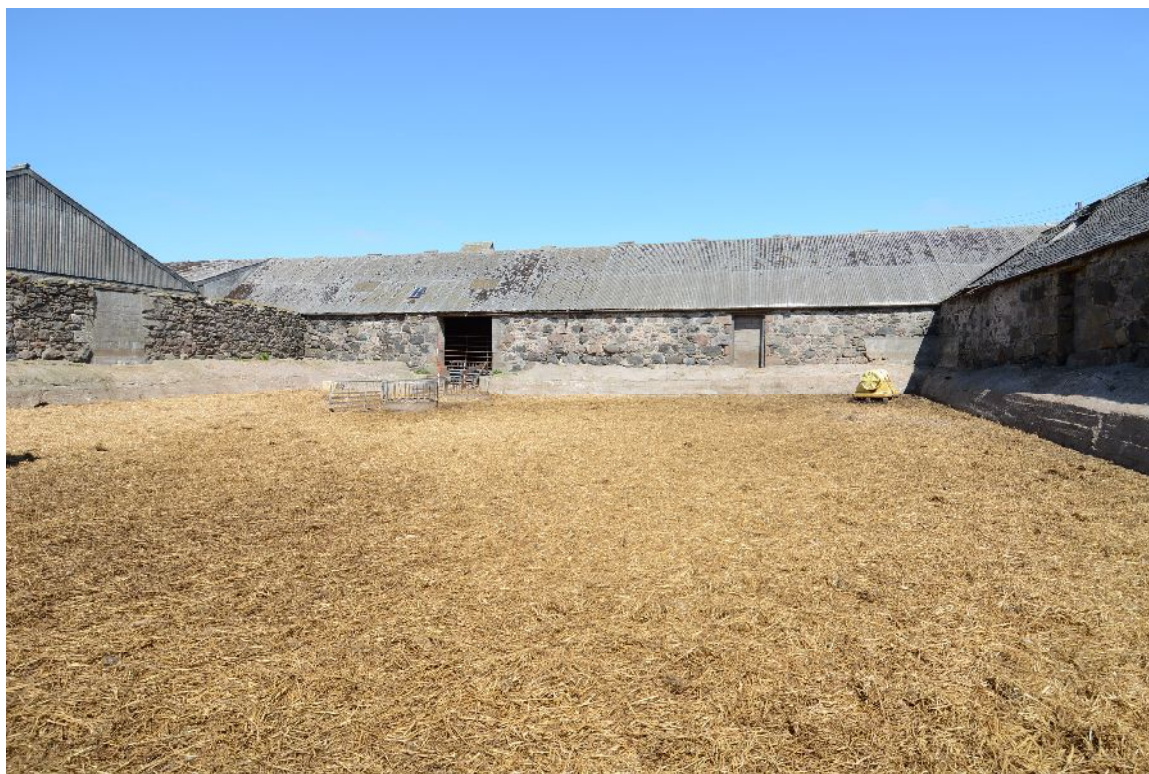
Illus 15 S wall of N Range/Byre from within the early 19th-century court

The scale of the buildings (Illus 15) and the number of tied cattle indicated by the trevis scars indicate a fairly prosperous farm and underline its original estate ownership.
