**EAST MAINS OF FOLLA  
ROTHIENORMAN  
ABERDEENSHIRE**

**Standing Building Survey**  
Carried out 4<sup>th</sup> August 2016  
by  
**Murray Archaeological Services Ltd**

**Report No: MAS 2016-25**  
by  
H K Murray and J C Murray

**- Standing Building Survey -**

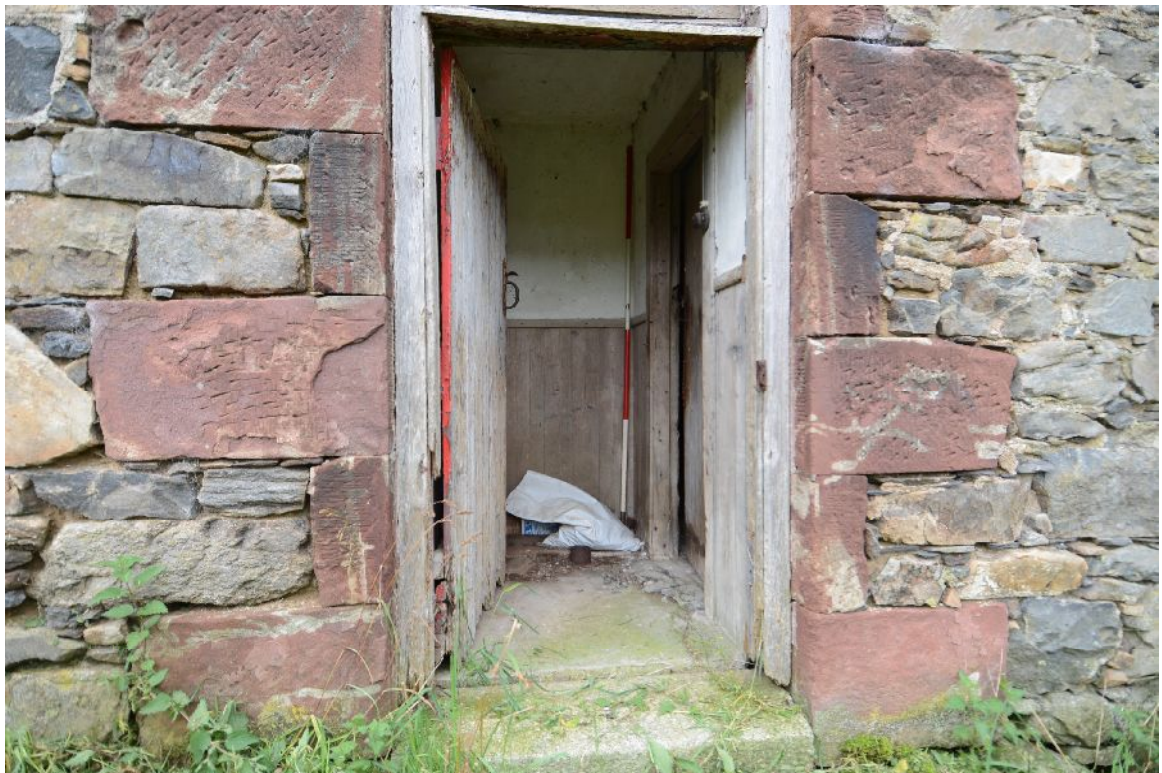
Bothy at E end entered through D1 into small wood-partitioned lobby, then through D4. Walls wooden panelled to 1.25m, plastered above. Fireplace in centre of E wall. W: 1.16m, H: 1.12m with stone surround and wooden mantelpiece.

**Illus 9 N Range. Lobby into bothy**

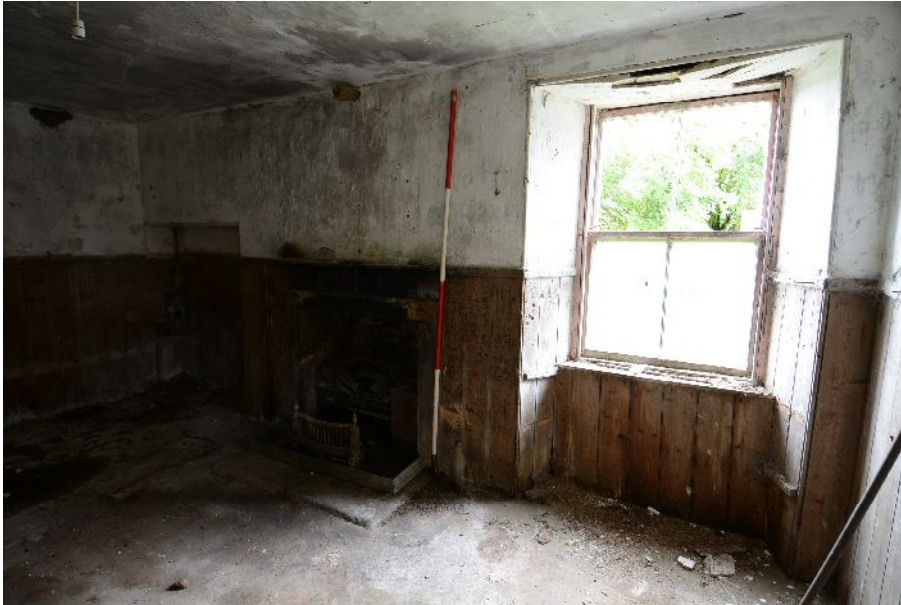
Cast iron grate.

Recess to W of fireplace, 0.27m deep.

Concrete floor. Electric light.

**Illus 10 Bothy looking E**

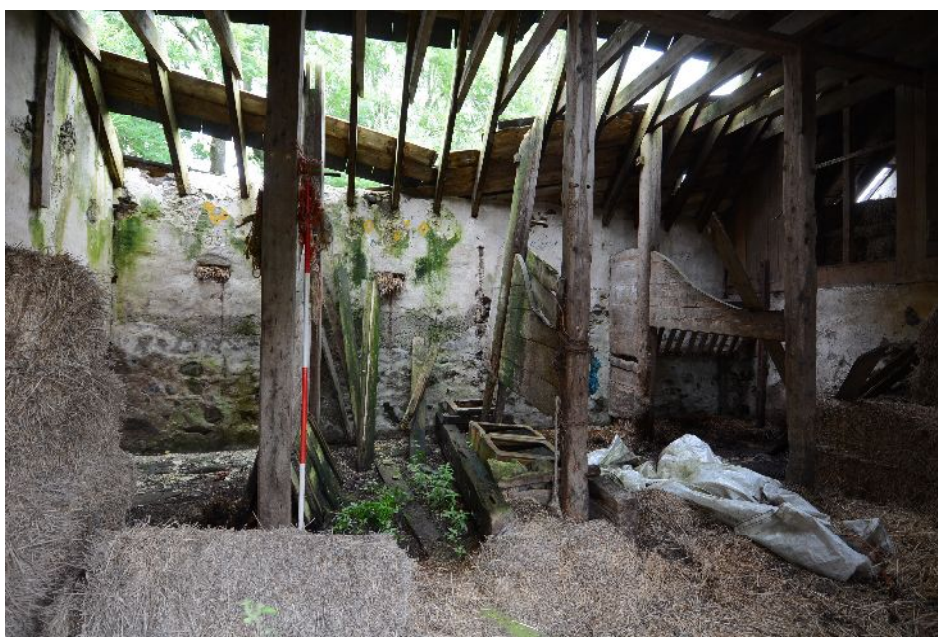
Stable at W end with four horse stalls with timber trevises. Each stall W:1.70m L: 2.55m. Wooden end posts, horizontal plank trevis sides with iron band along top. Vent in wall above each stall. Hay hake surviving over E stall. Traces of painted names above stalls- only the W stall legible “ Rose”, with yellow (?) heart above. 2<sup>nd</sup> stall yellow diamonds. Floor cobbled.

**Illus 11 Stable from door D2**

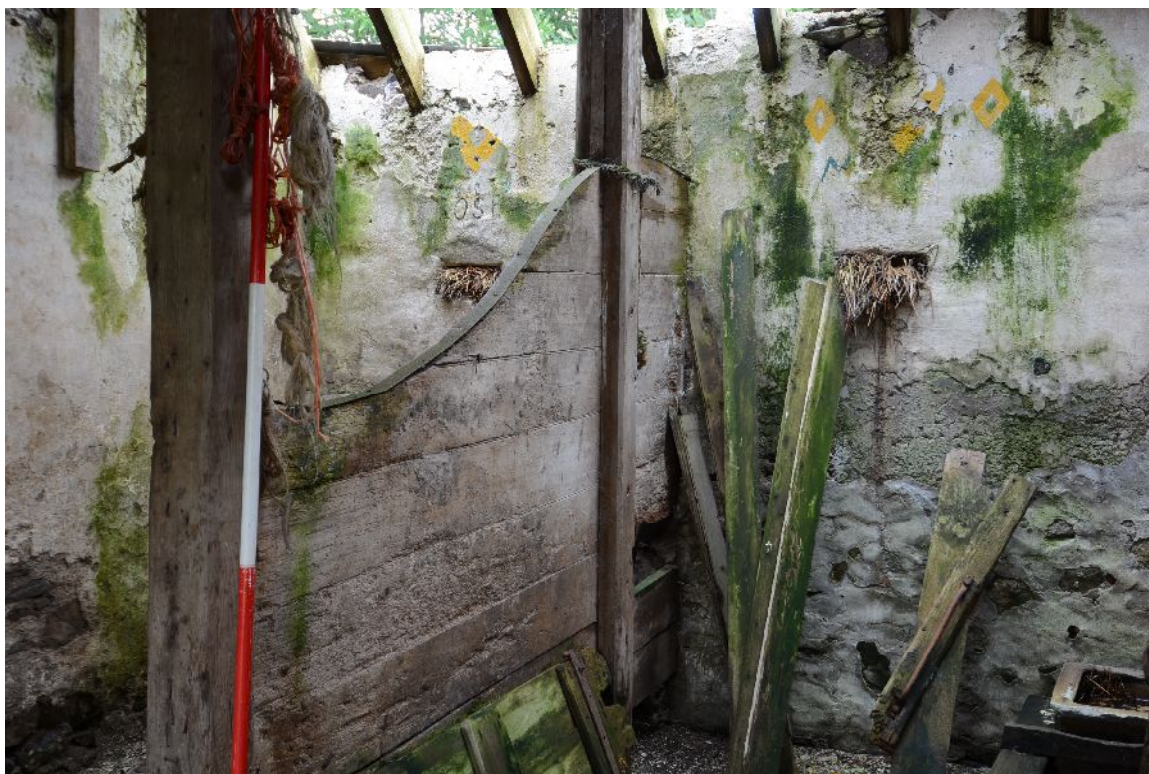
**Illus 12** Detail of trevis

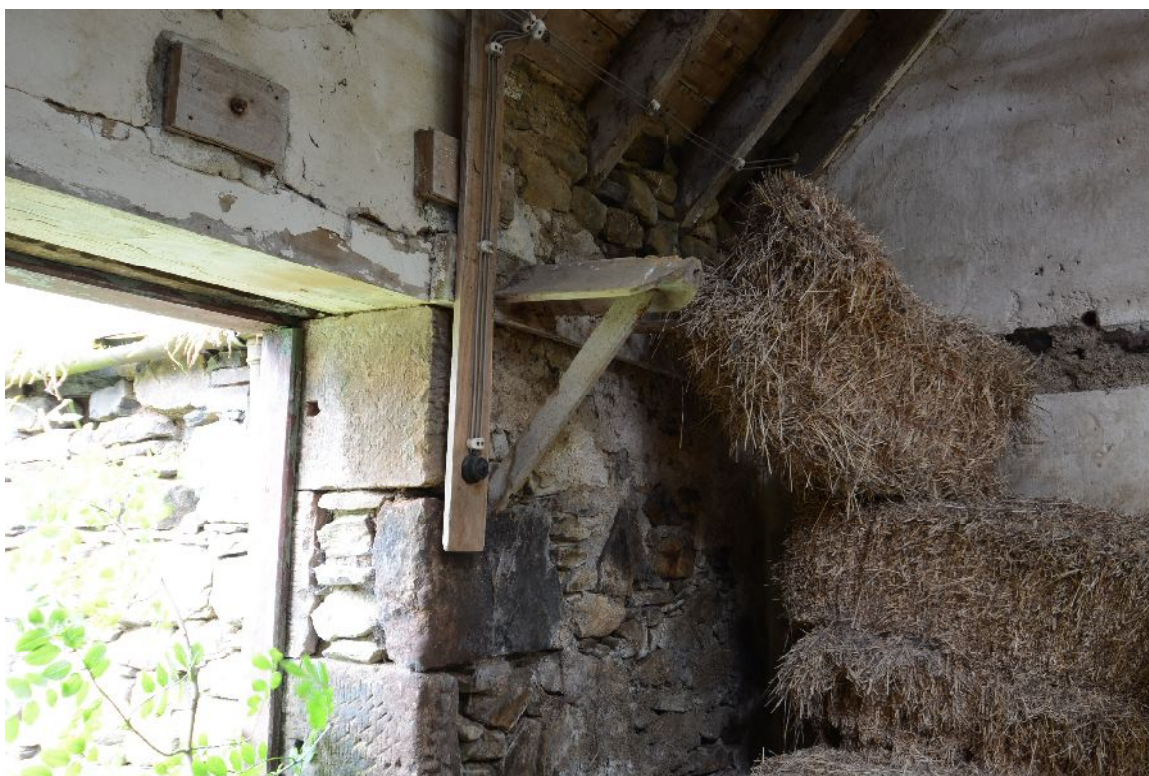
Surviving harness peg on inside of S wall, W of door D2.

**Illus 13** Harness peg

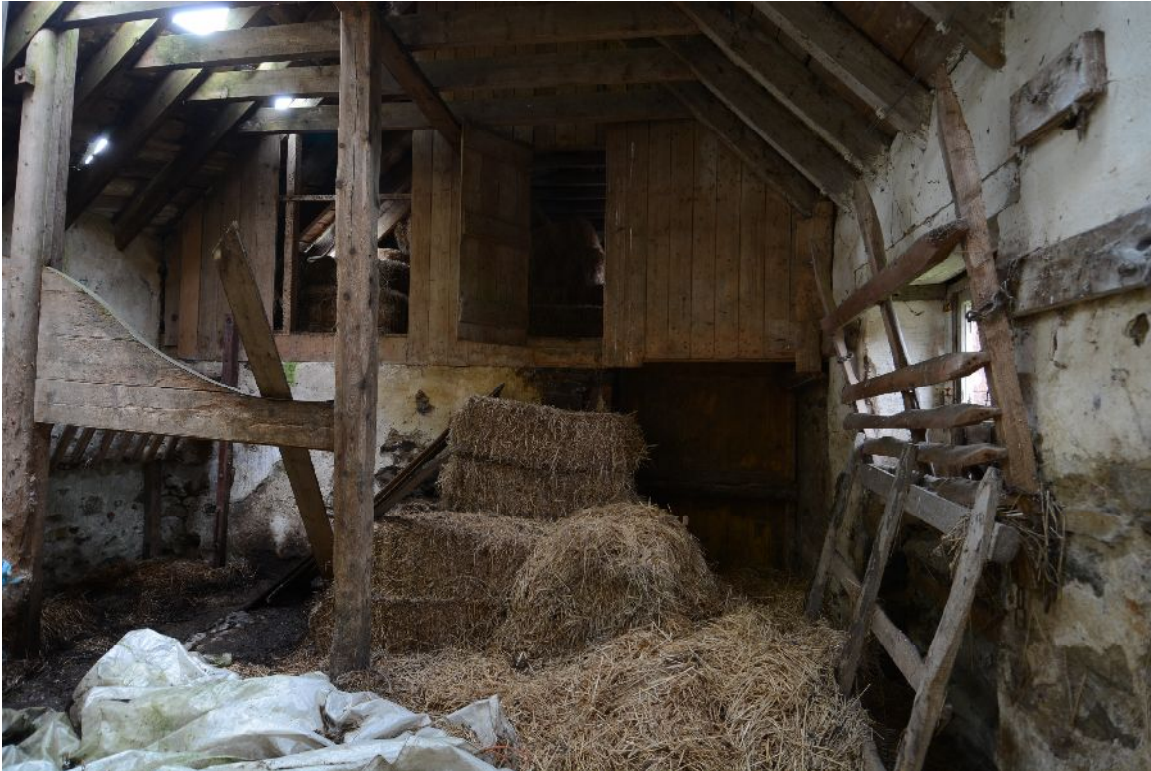
Wooden loft partition above stone wall between stable and bothy, plank door D3 between stable and loft at loft level.

**Illus 14 E end of stable and loft over bothy**

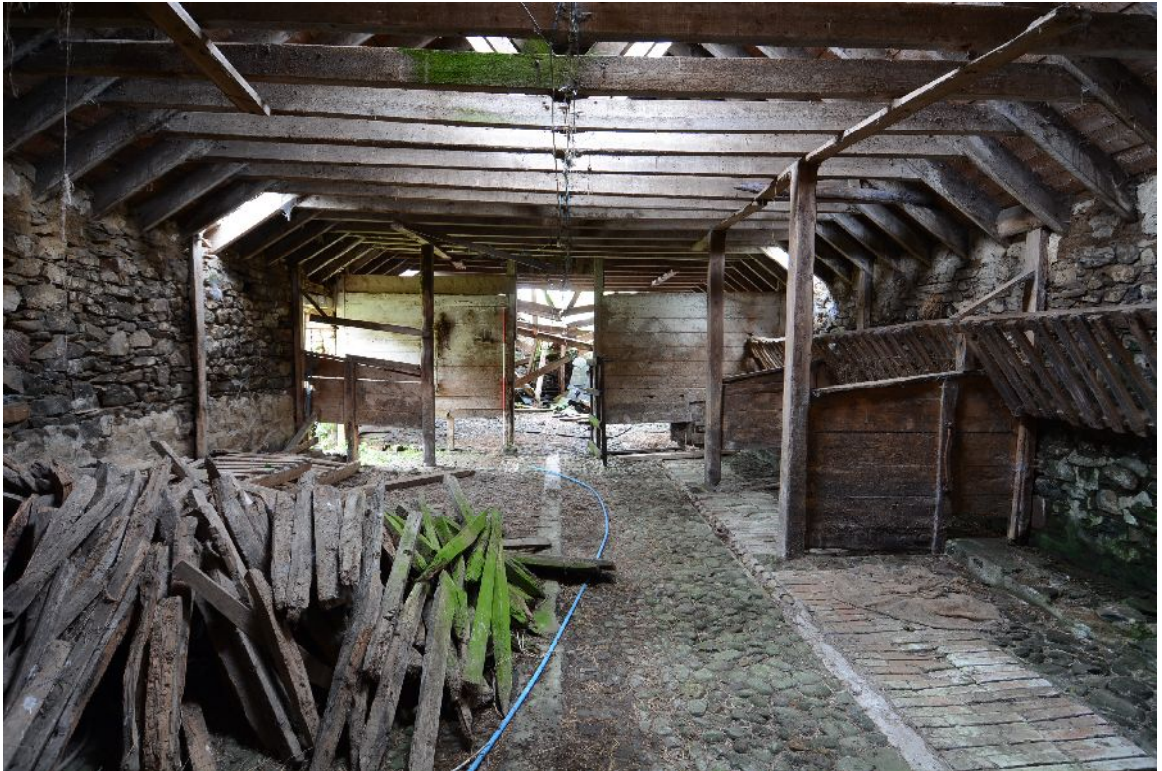
N half of range had double tied cow stalls surviving on W side. Each stall  
W:2.34m L: 1.75m Floor cobbled and brick with drain behind cows. Hay hake.

Iron cow ties. Skylights over stalls 1 and 4. Small air vents over each stall.

E side of building has no drain or surviving stalls but does have vents so possibly  
an open pen for young stock.

Illus 15 W Range Cattle byre looking S

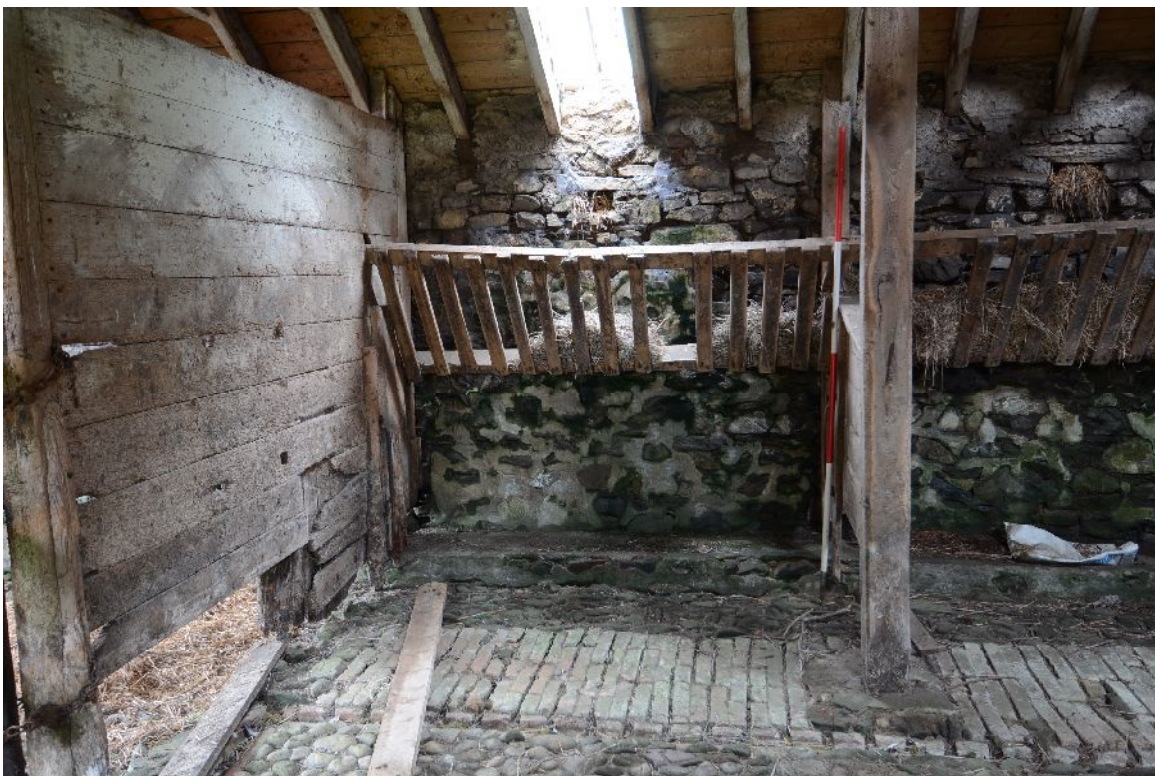
Illus 16 Detail of double tied cow stall

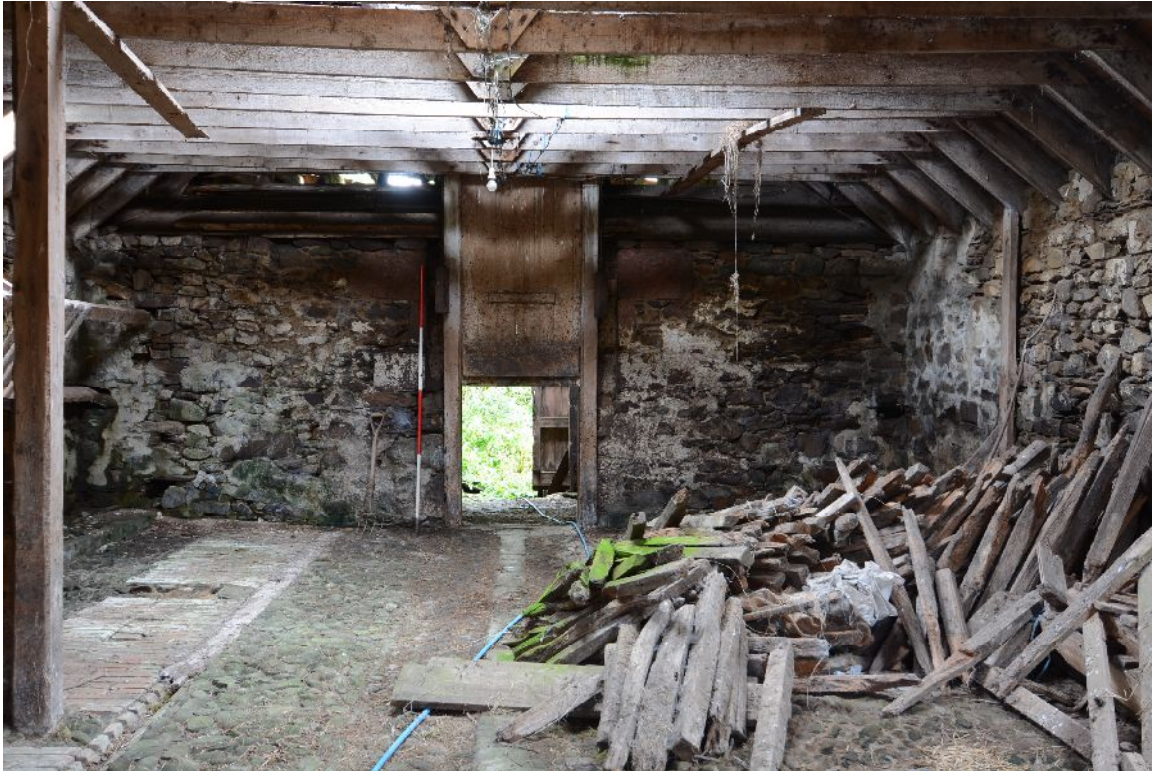
Sliding door at N end possibly used for mucking out.

**Illus 17** Sliding door at N end W Range, note counter weights at level of top of ranging rod

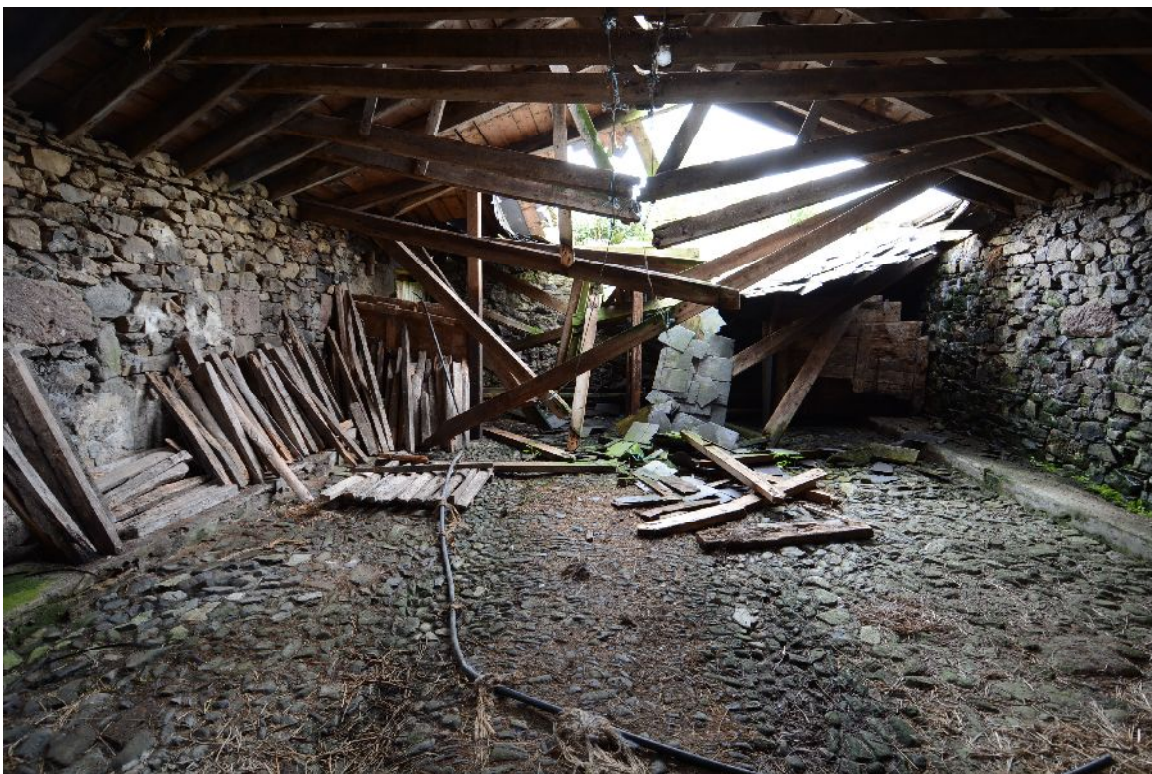
S half of range could not be entered but appeared to have air vents. Probably also for cattle.

**Illus 18** S end of W Range

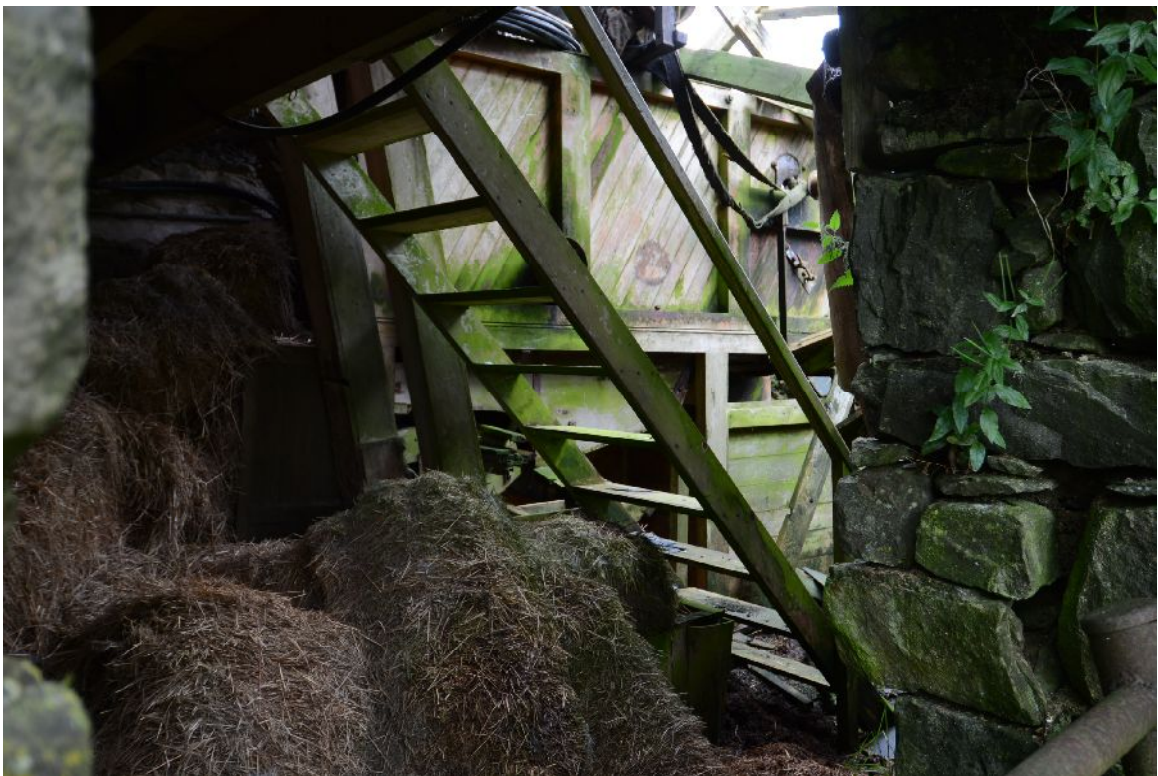
Building unsafe to enter but threshing machine visible in centre with stair to grain loft beside it.

**Illus 20 Threshing machine visible behind stair to grain loft in centre of S Range**

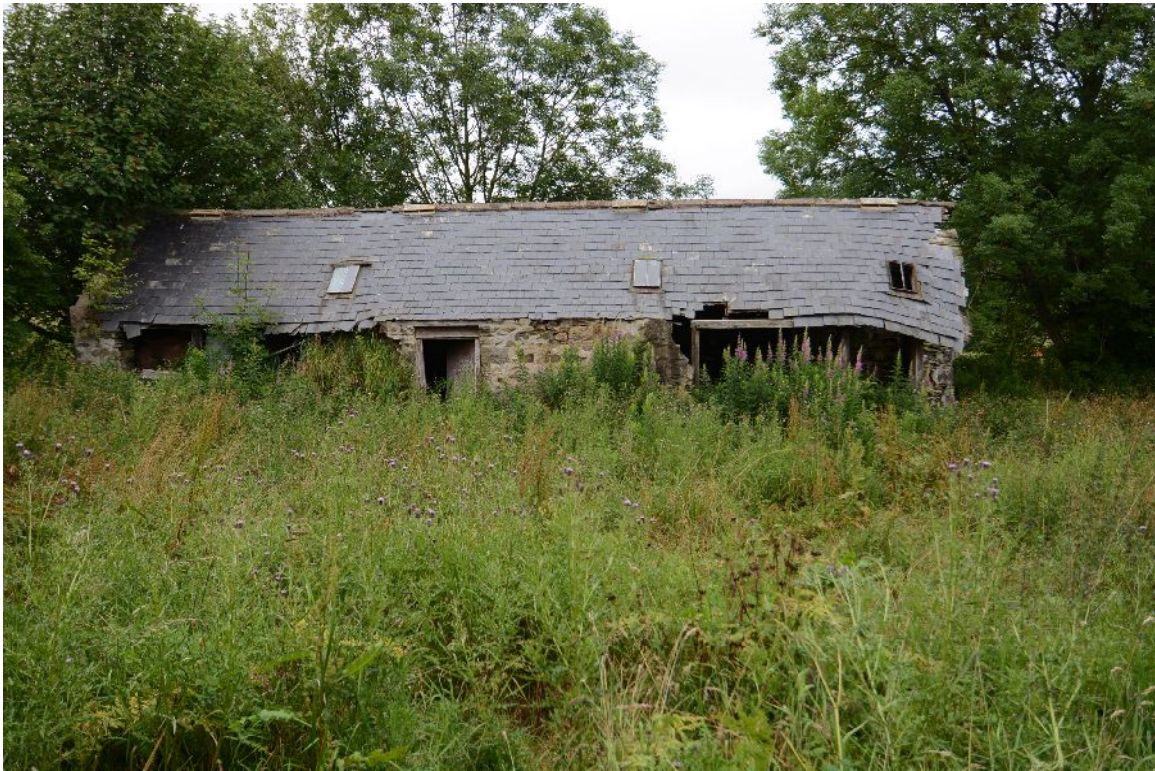
Illus 21 Building 2 W wall

The roof of Building 2 was collapsing so it was not entered and could not be planned in detail.

Walls Rubble stone – estimate c600mm thick.

Roof pitched roof with skylights

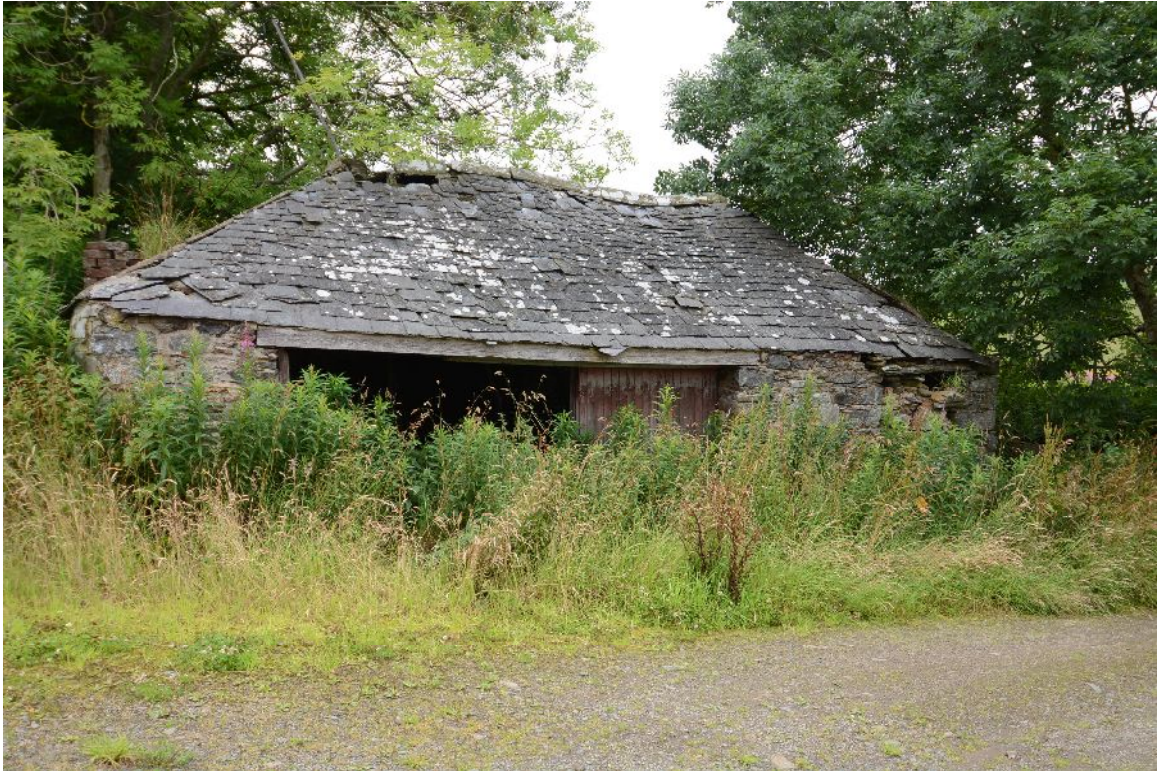
**Illus 23 Building 3 S wall**

The roof of Building 3 was collapsing so it was not entered and could not be planned in detail.

Original use Unknown but chimney, possibly for boiler ( no fireplace), at W end.

Walls Rubble stone. Wide doorway in S wall.

Roof Hipped slate roof, brick chimney in centre of W wall.
