**LOGIE FARM  
FINTRAY  
ABERDEENSHIRE**

**Standing Building Survey**  
Carried out 1<sup>st</sup> September 2016  
by  
**Murray Archaeological Services Ltd**

**Report No: MAS 2016-26**  
by  
H K Murray and J C Murray

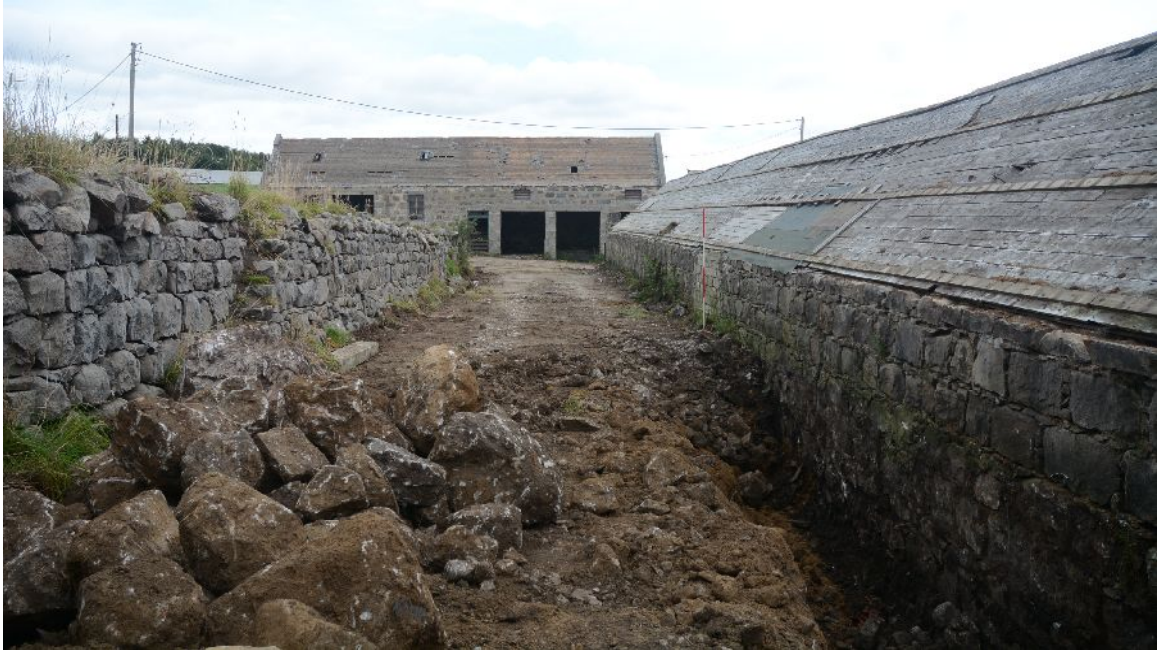
**Illus 8 Building 1 N wall of N range . Blocked door D13 visible by ranging rod. Retaining wall to slope on LHS. Building 3 in background**

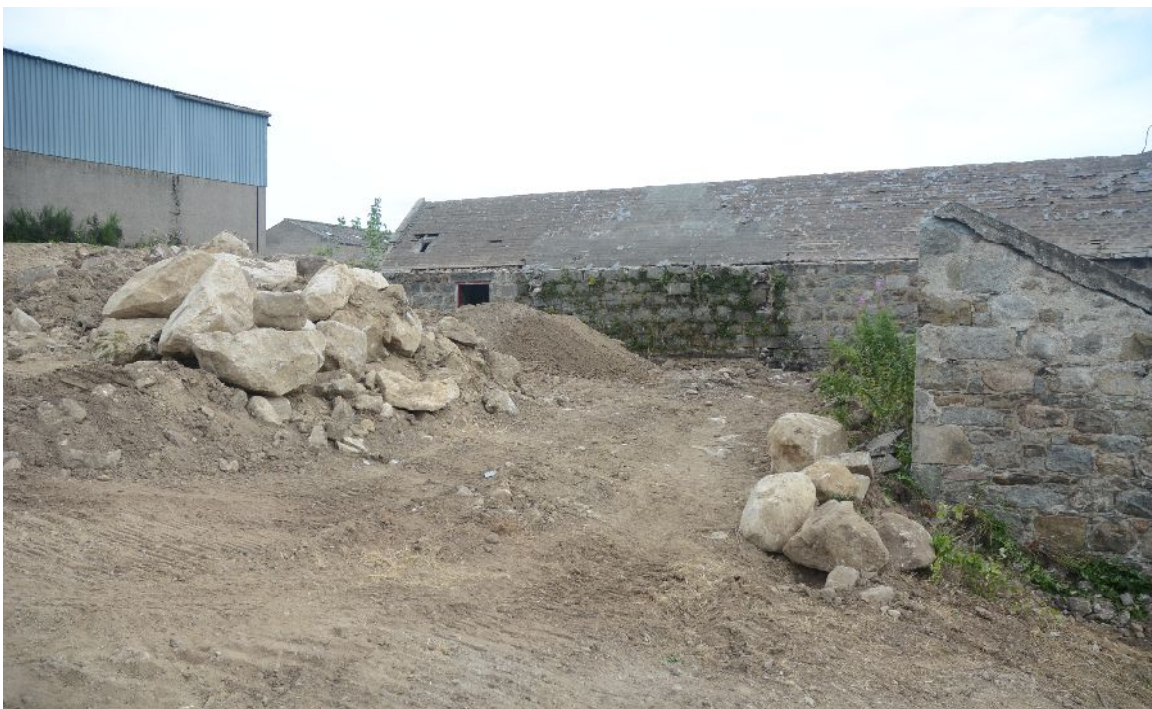
The building had been constructed on a slope, so the back wall had been cut into the slope with a retaining wall behind. The slope had also clearly caused problems to the W of the W range as the ground here had been built up, blocking windows in Building B1a. Part of this infill had been removed prior to the survey.

**Illus 9 W of Building 1 built up ground, partly removed.**

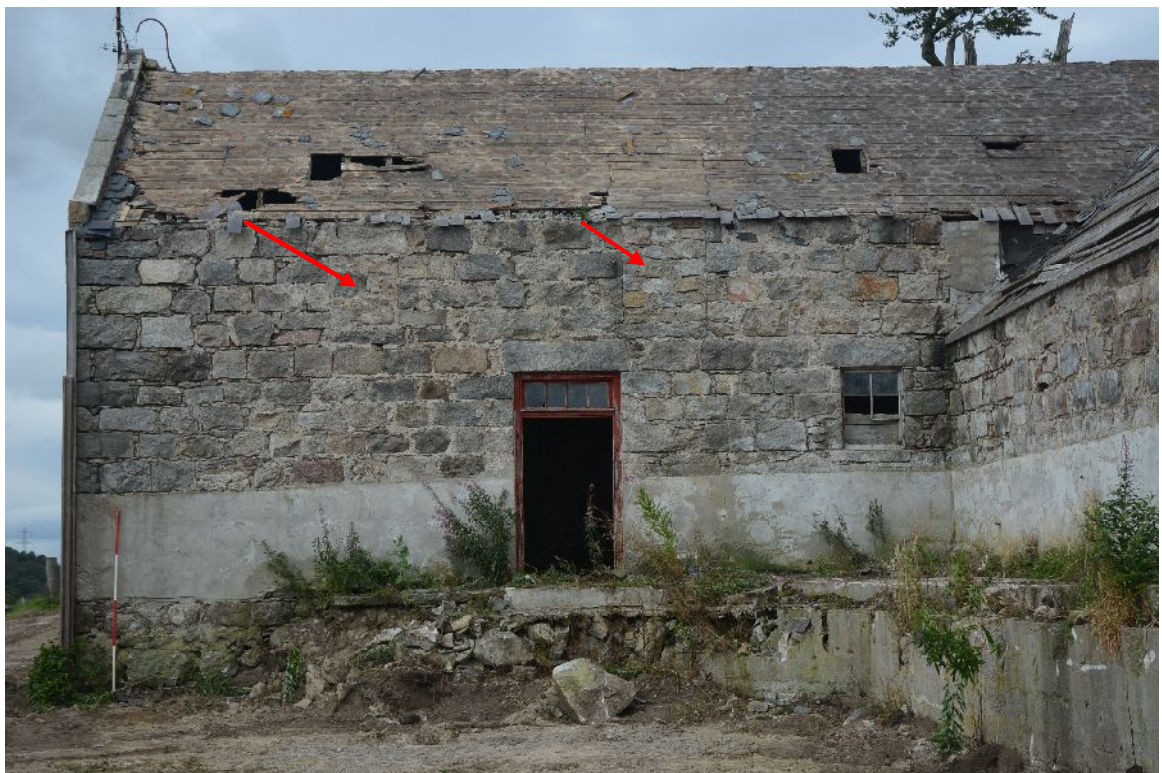
W3 W: c 0.80m H: c 0.90m Blocking at loft level. Blocked with stone.  
Granite sill, lintel missing.

W4 W: c.0.80m H: c 0.90m Blocking at loft level. Granite lintel, sill

**Illus 13 Building 1. Wall 4. E elevation of W Range. Note blockings W3 & W4 (arrows)**

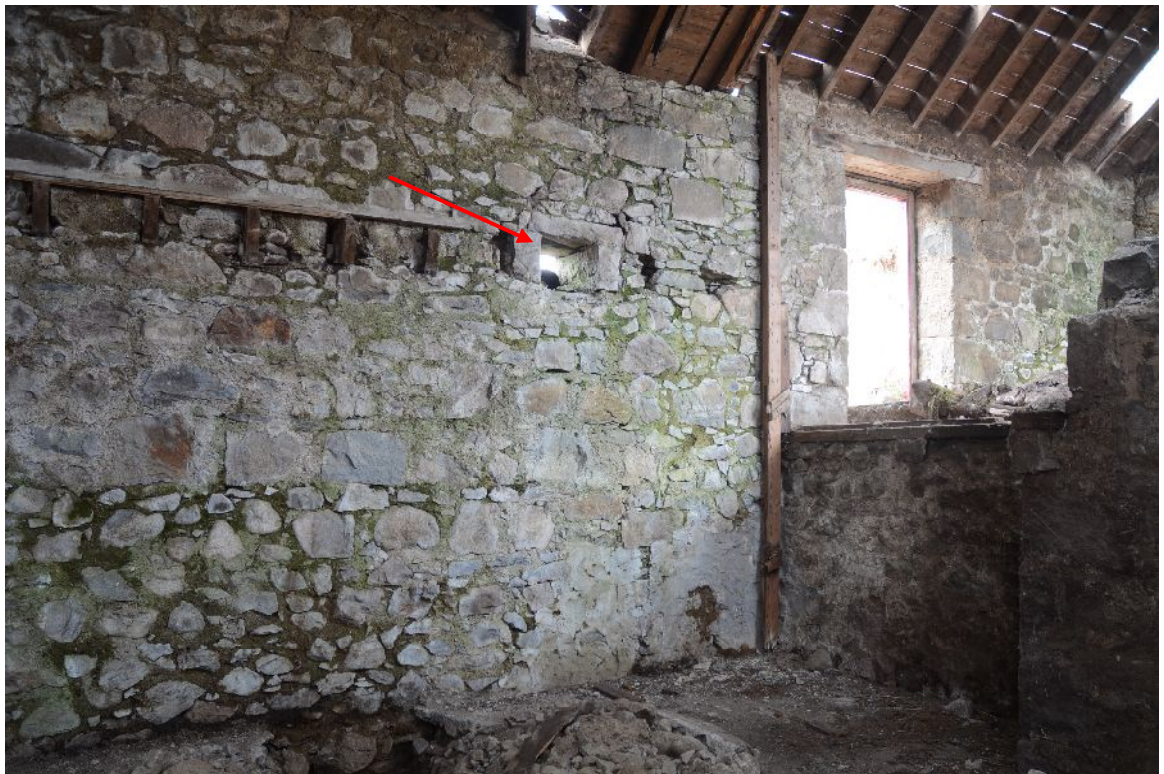
- D11 W: 1.20m H: 2.05m. Granite lintel and rybats
- F1 c 300mm square. On floor level of original loft (now removed). Metal drive shaft through wall between W range and B1b.
- F2 Similar size to F1. Blocking at wall top (not accessible)
- F3 Double blocking, upper 300 x 350mm, lower 550 x 500mm.

**Illus 14 Building 1. F1 in W wall at level of loft floor.**

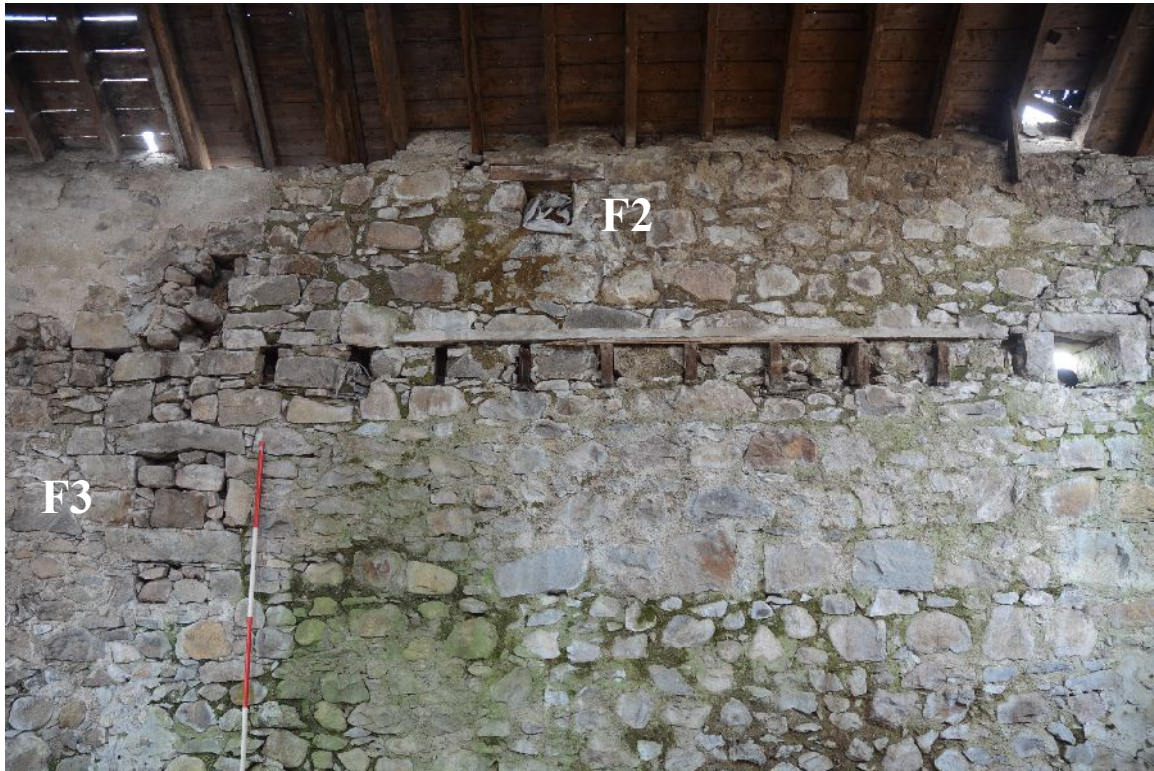
**Illus 15 Building 1 interior. W wall of W range. F2 and F3 marked.**

The floor at the S end of the range was c150mm lower than the N end. The blockings F1- F3 in the W wall would have held shafts for a threshing machine, originally one powered by a horse mill outside the wall, later by an engine that would have been in the demolished extension B1b.

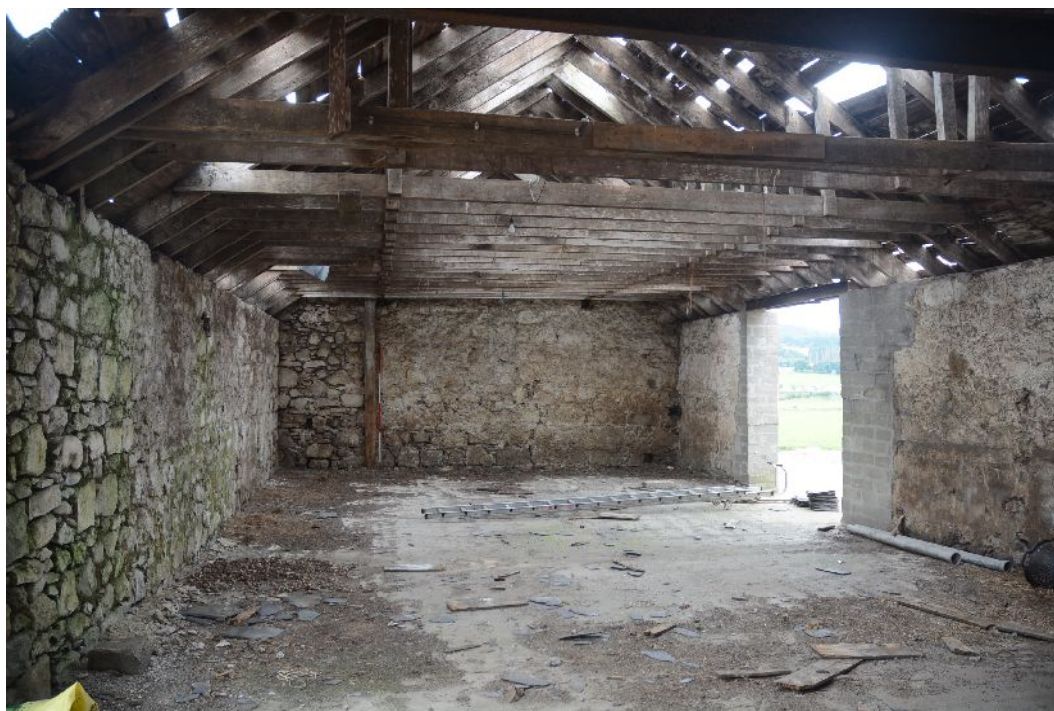
This had been opened through into the E end of N Range and the break-through supported with steel uprights and a beam. No internal details survived. The vented window (W1) in S gable suggests a loft may have existed but no evidence survived.

**Illus 16 Building 1. Interior E range looking S**

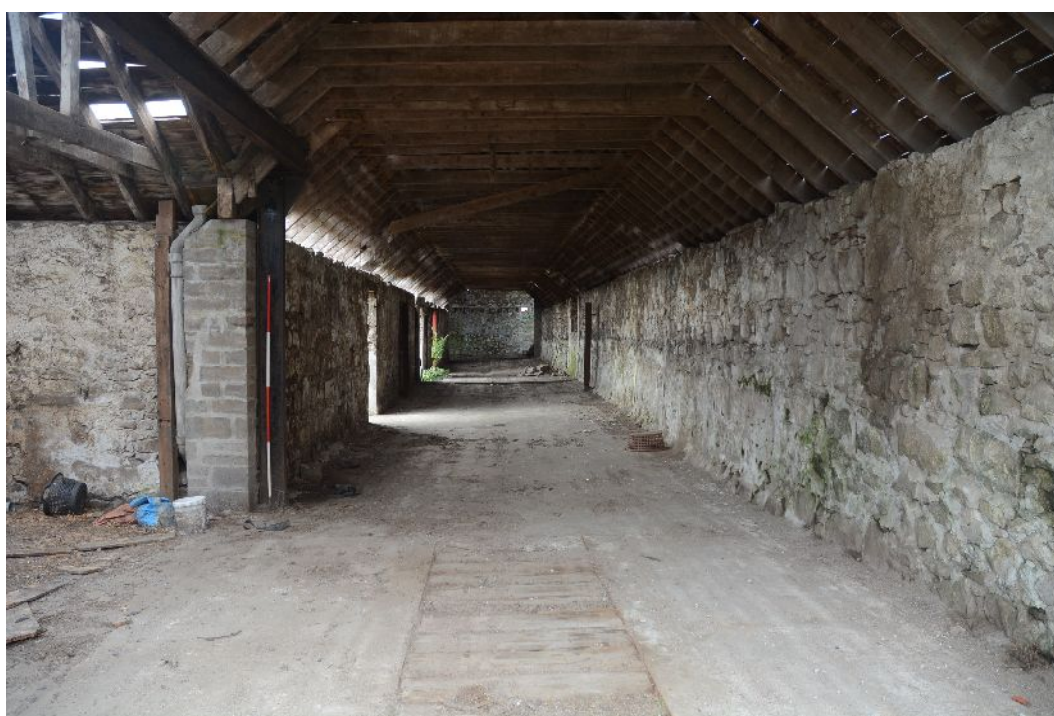
The N range was open from the E gable, through into the W range. At the E end, wooden planking across a central pit would suggest that in the recent past this was an inspection pit area used for servicing tractors. This may also explain the widening and raising of the gable door D14.

**Illus 17 Building 1. Interior of N range looking W. Inspection pit in foreground.**

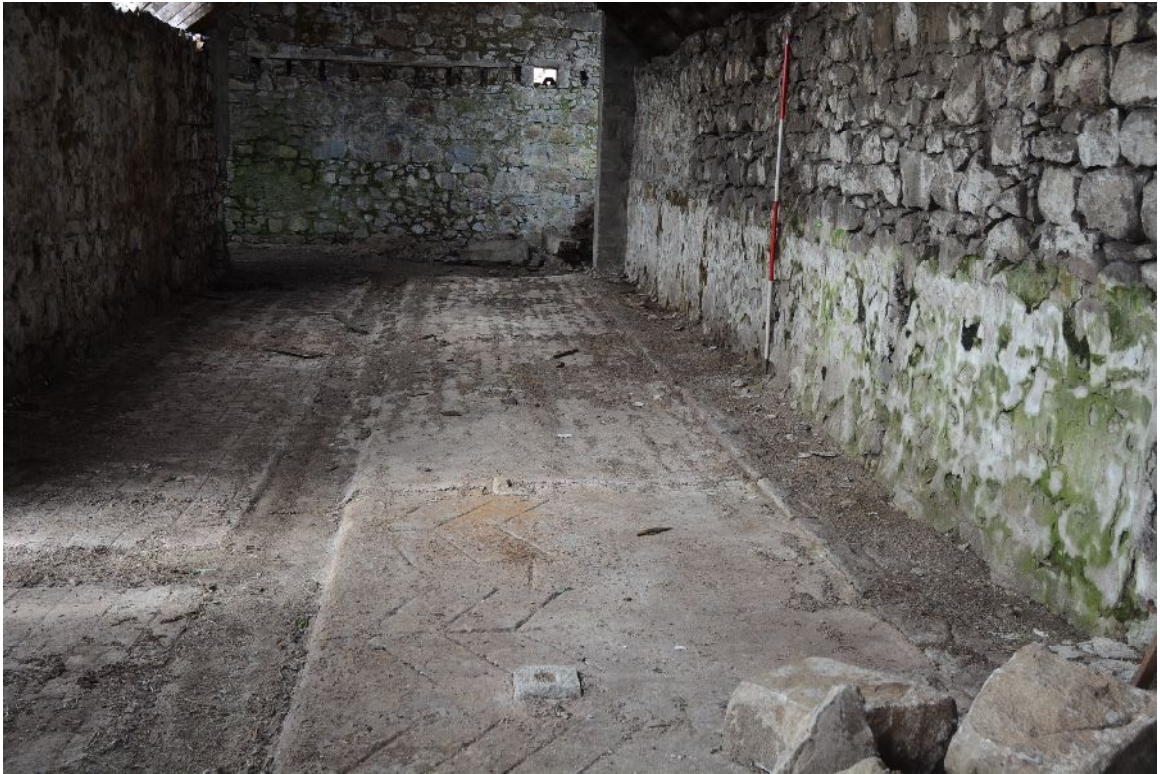
The remainder of the N range had originally had double tied-cow stalls along the N wall, with just the trevis scars remaining. W of blocked door D13, there were 6 double pens (W: c 2.10m) with a concrete floor with a central drain behind the cattle. Stubs of the trevis back posts are still visible. E of blocked door D13 there appeared to have been 7 double pens (W: c2.25m). The floor at this end had been concreted over so no other details survived.

**Illus 18 Building 1. Interior of N range. Scars of trevises of double cow pens on wall (RHS). Drains in floor behind cattle (LHS) and trevis post end stubs (centre foreground).**

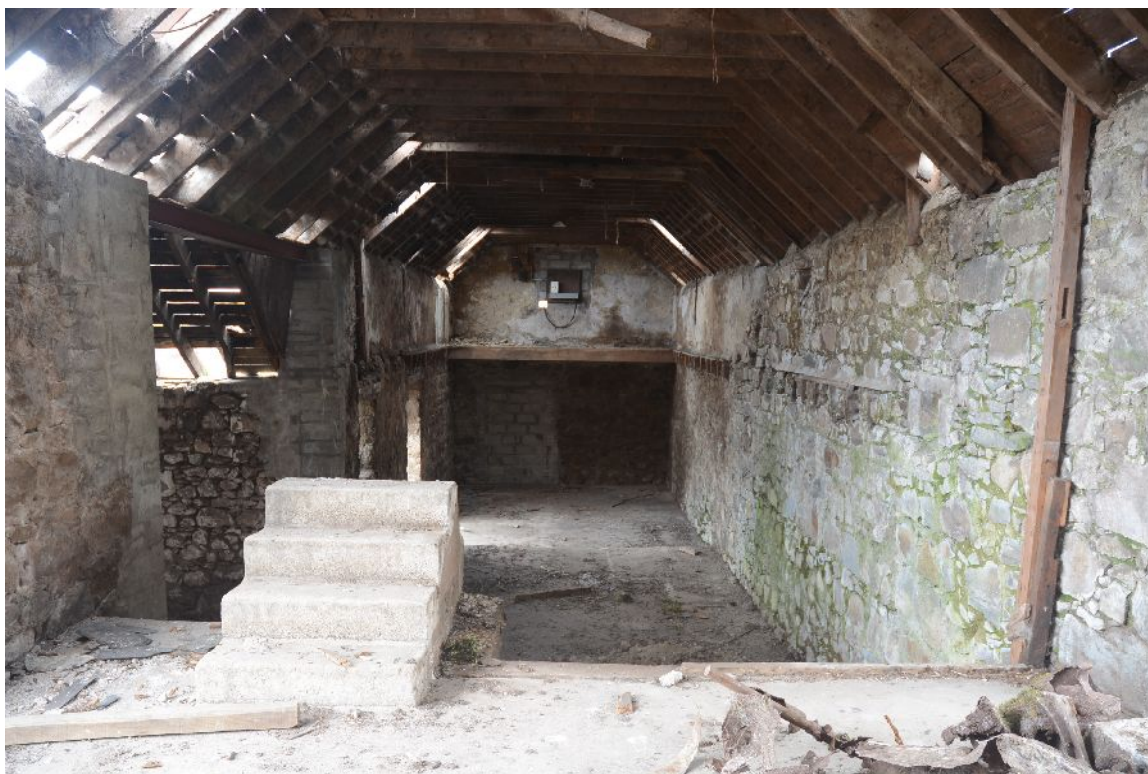
The loft floor had been removed so the entire range was open to the roof.

**Illus 19 Building 1. W Range looking S from B1c**

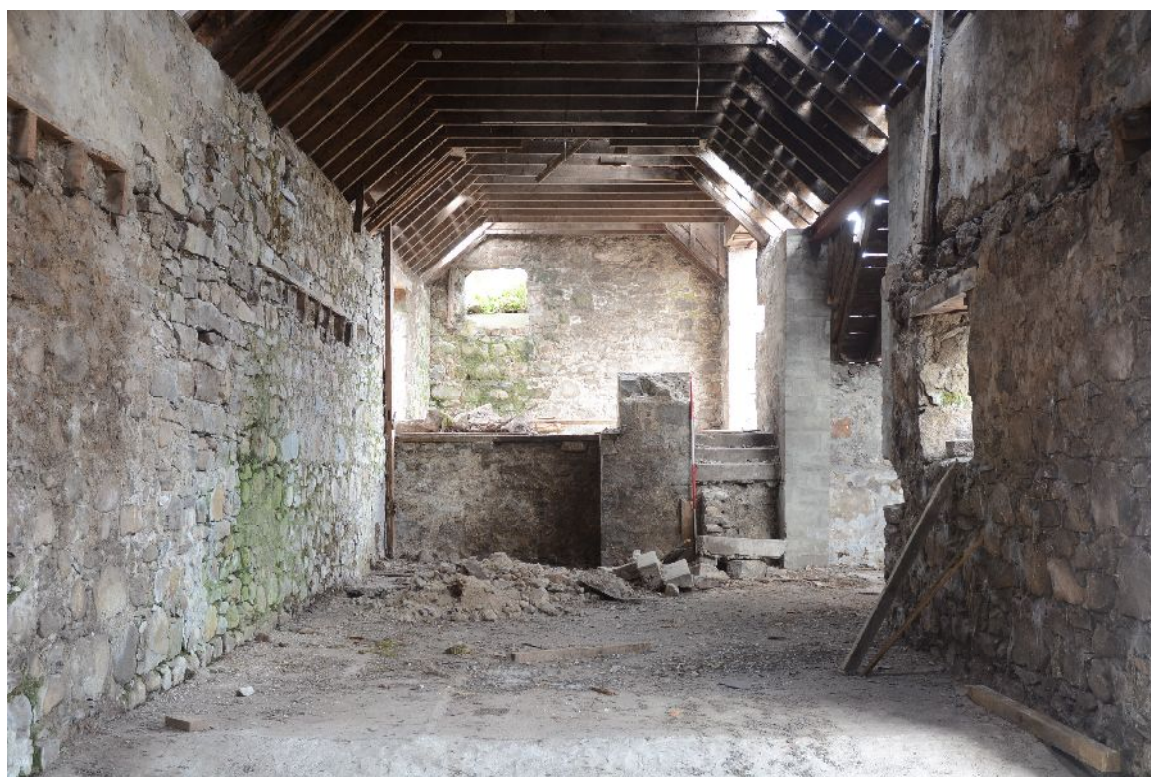
Steps from the N end led up to into the extension building B1c, the floor of which was c 1.50m higher than the rest of the range. Further steps had led from this higher area into the loft.

**Illus 20 Building 1. W Range looking N towards B1c**

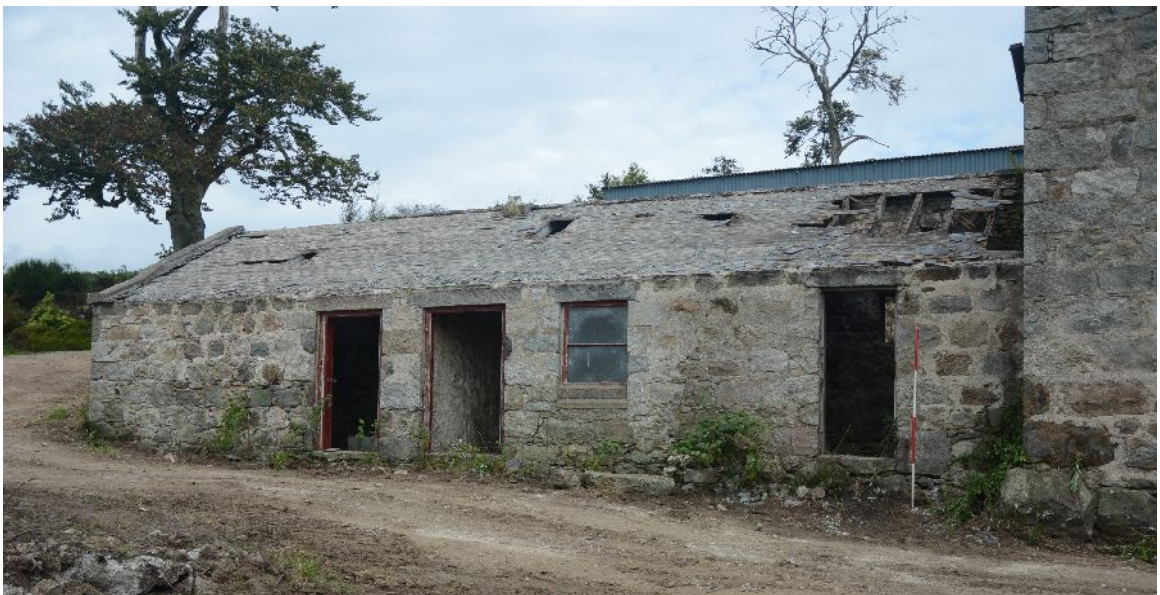
**Illus 21 Building B1a looking N. S elevation**

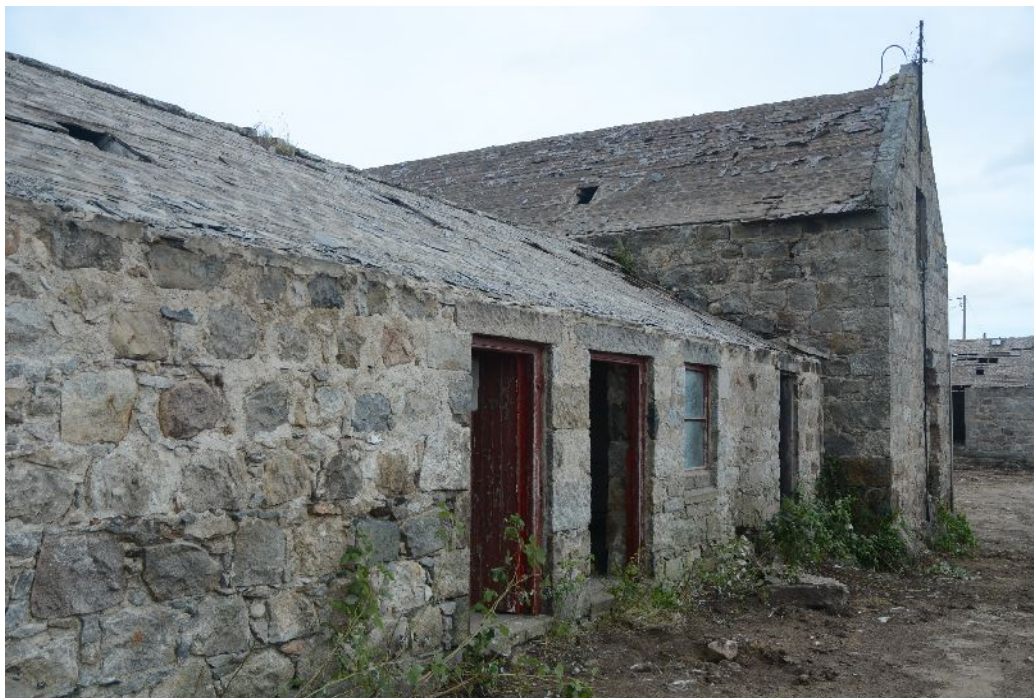
**Illus 22 Building B1a abutting W wall of W Range of Building 1**

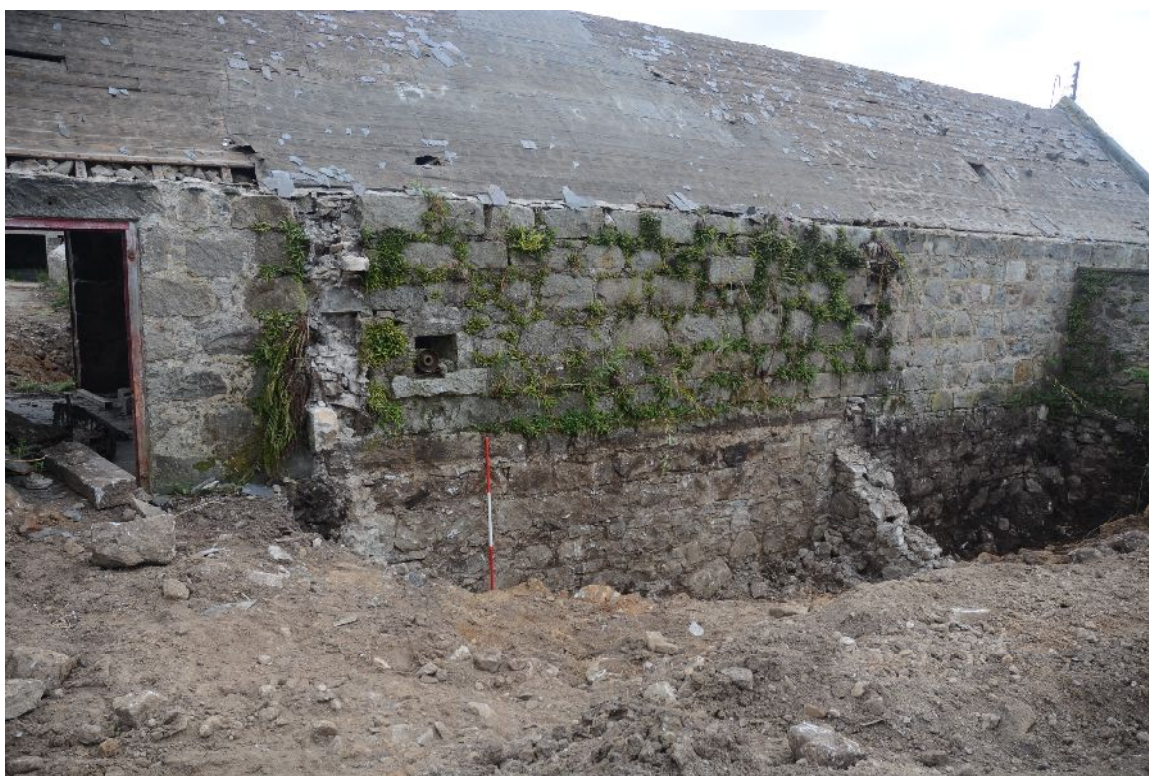
Demolished prior to survey during works to examine foundations of Buildings 1 and B1c.

**Illus 23 W wall (wall 6) of Building 1 with scar of Building B1b and shaft of F1 (above ranging rod)**

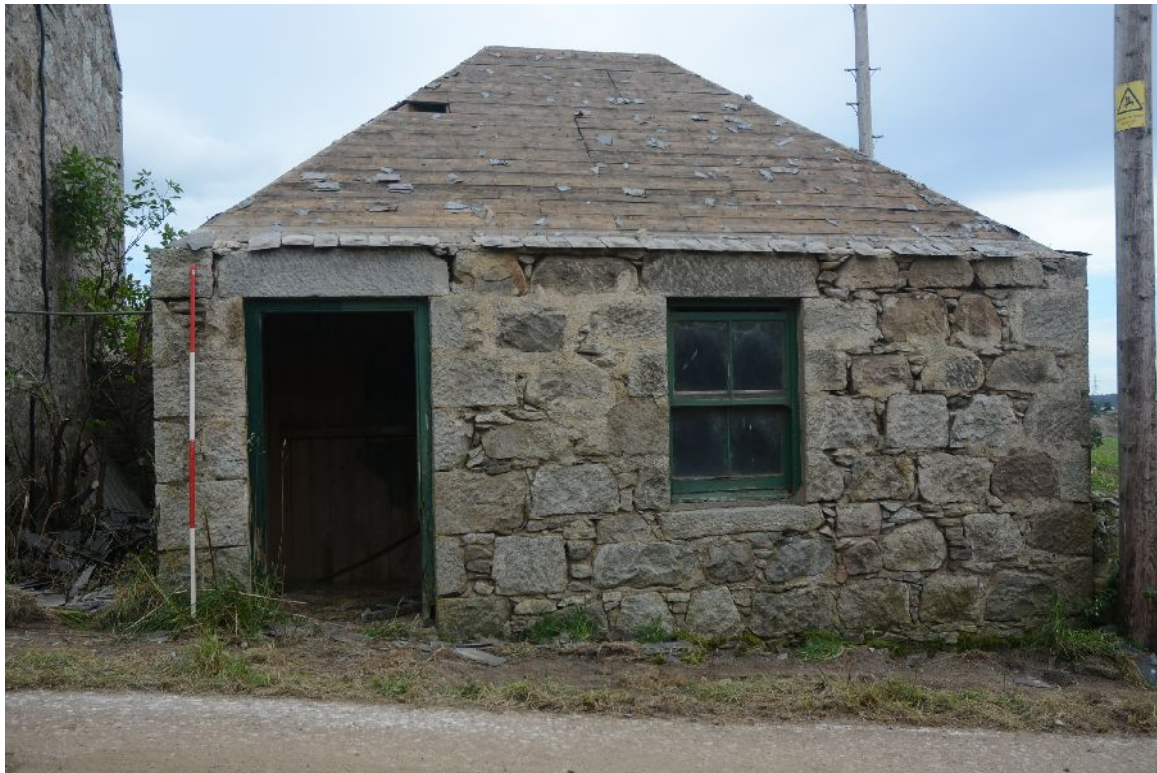
Illus 24 Bothy (B2) W elevation

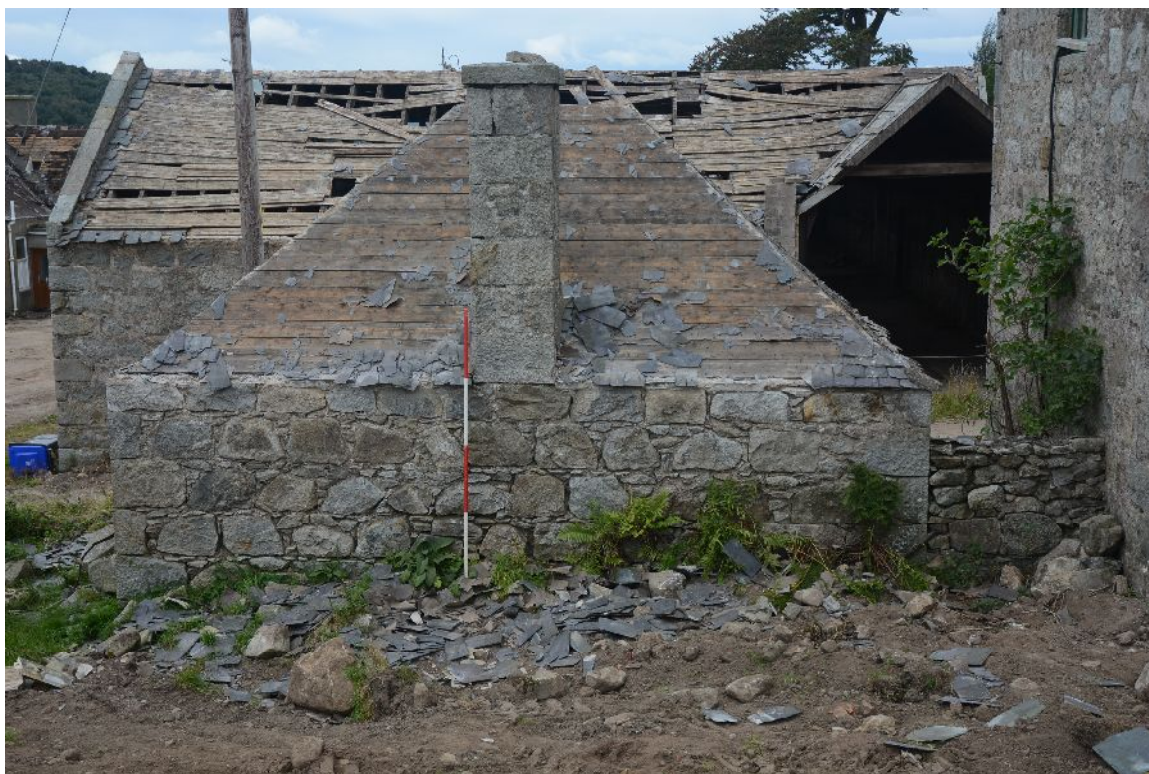
**Illus 25 Bothy E elevation**

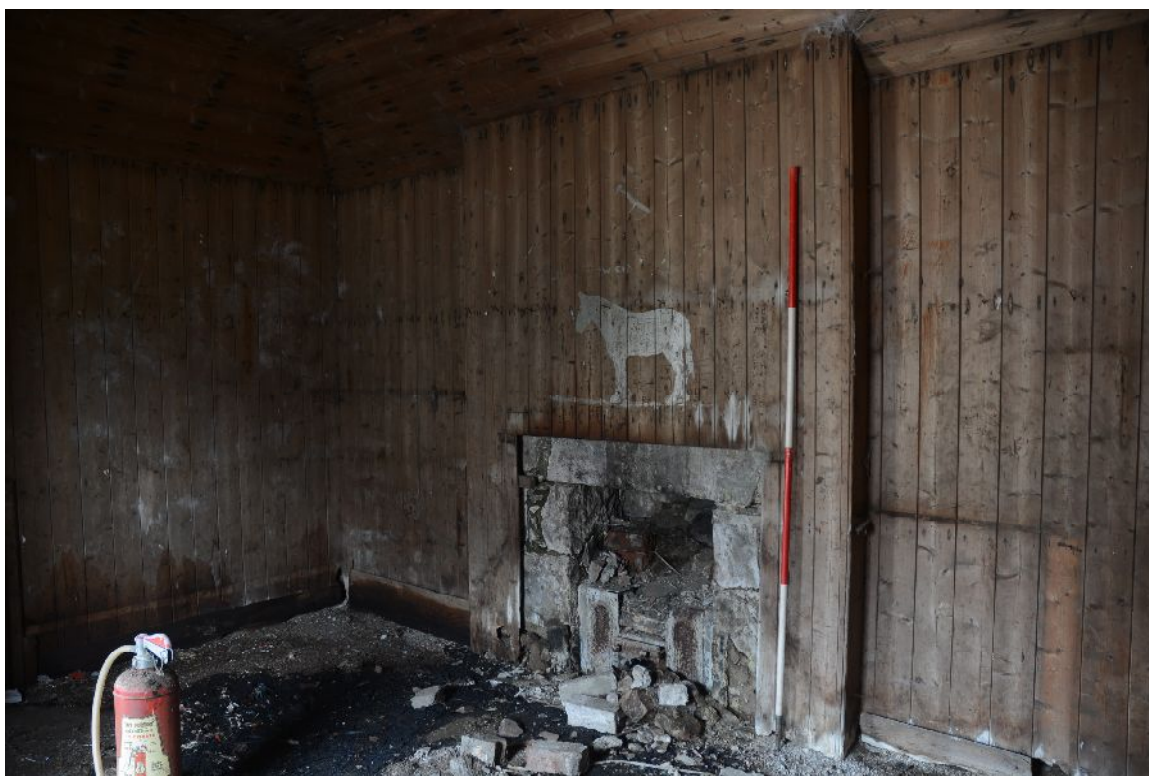
Room has cast iron fireplace in middle of E wall with granite mantel. (W: 0.64m H: 0.90m. Graffiti initials carved into walls. White painted work horse on wall over fireplace. Vertical grooved timber against N wall is possible fitting from box bed. Floor concrete. Electric light installed.

**Illus 26 Bothy, interior of room looking towards NE corner**

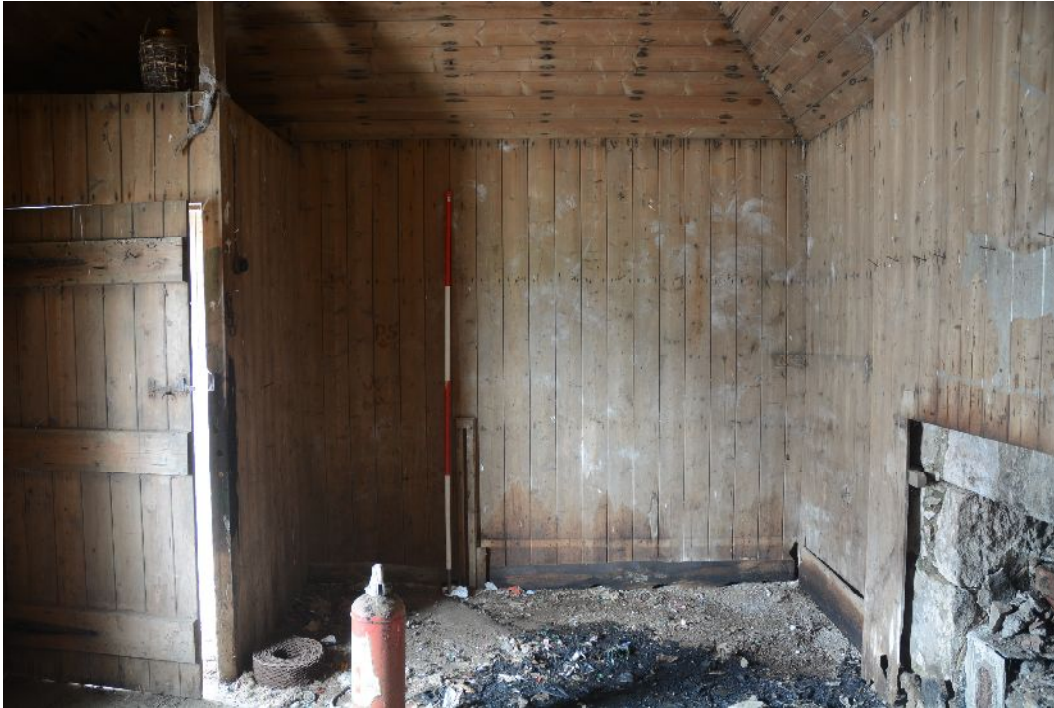
Illus 27 Bothy Interior, looking N. Ranging rod stand beside grooved timber- possibly for box bed. Door to lobby on LHS

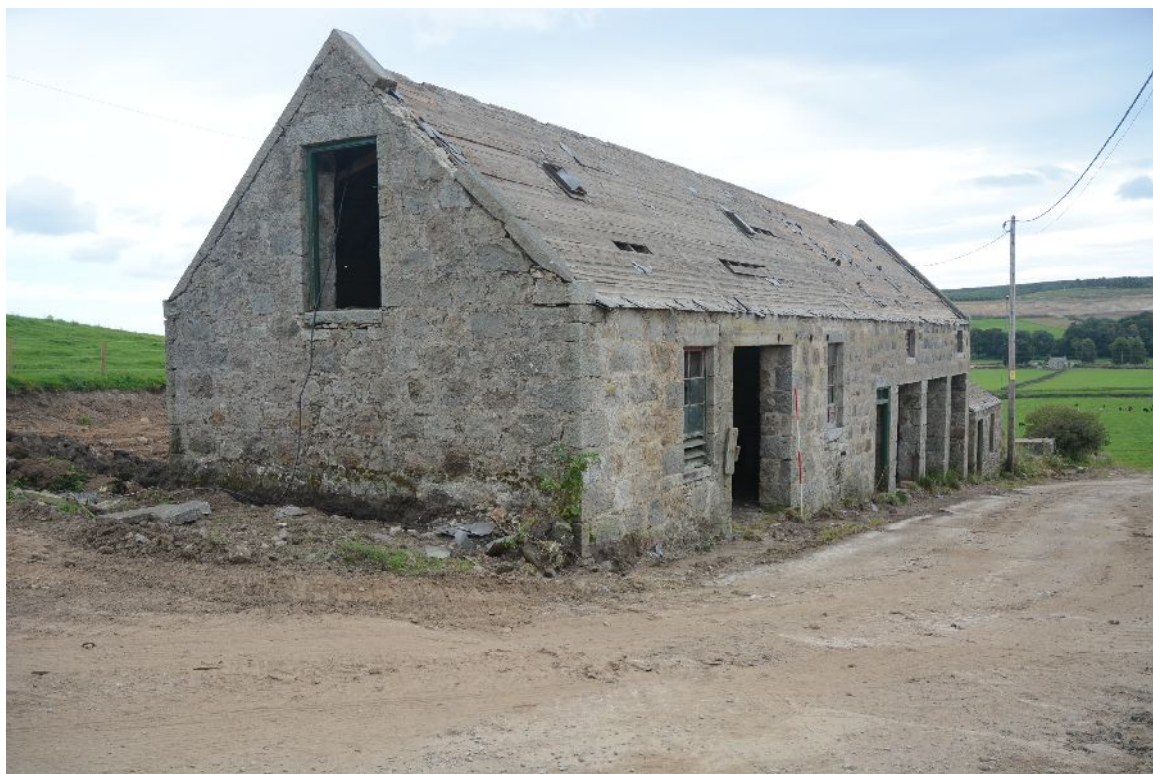
**Illus 31 Building 3. N and W elevations**

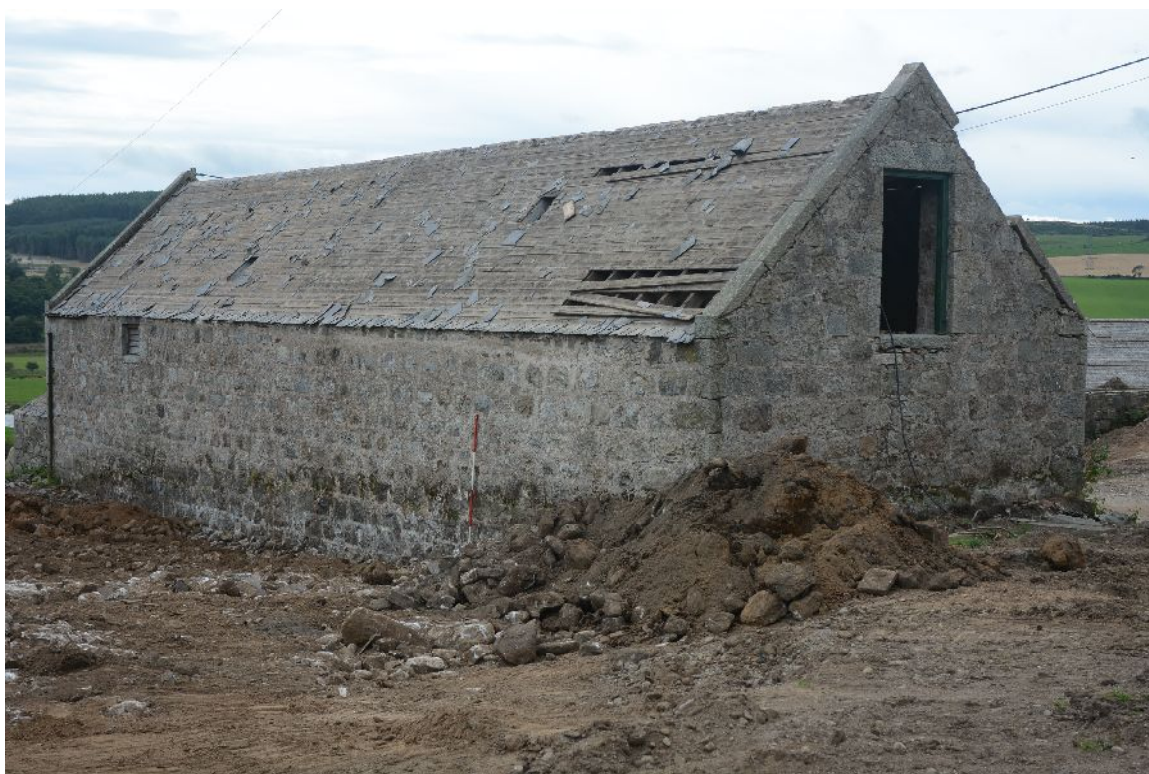
**Illus 32 Building 3 N and E elevations**

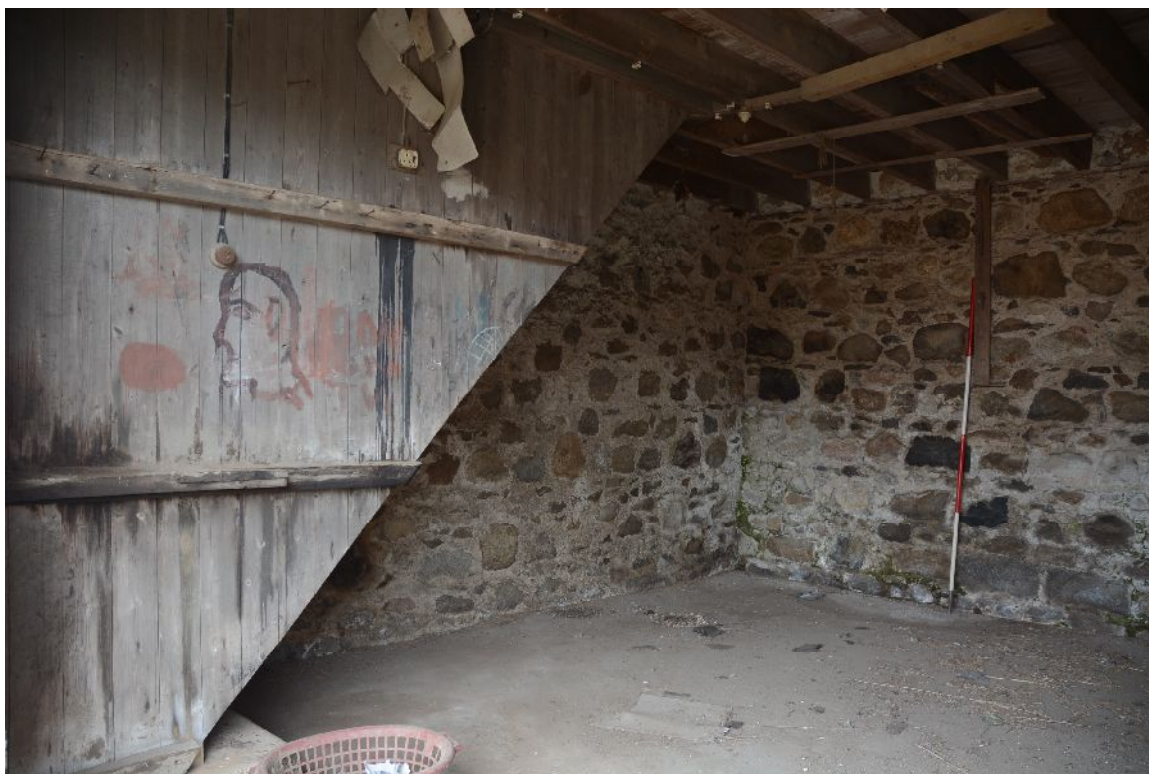
**Illus 33** Building 3. N cart bay with underneath of stair on LHS

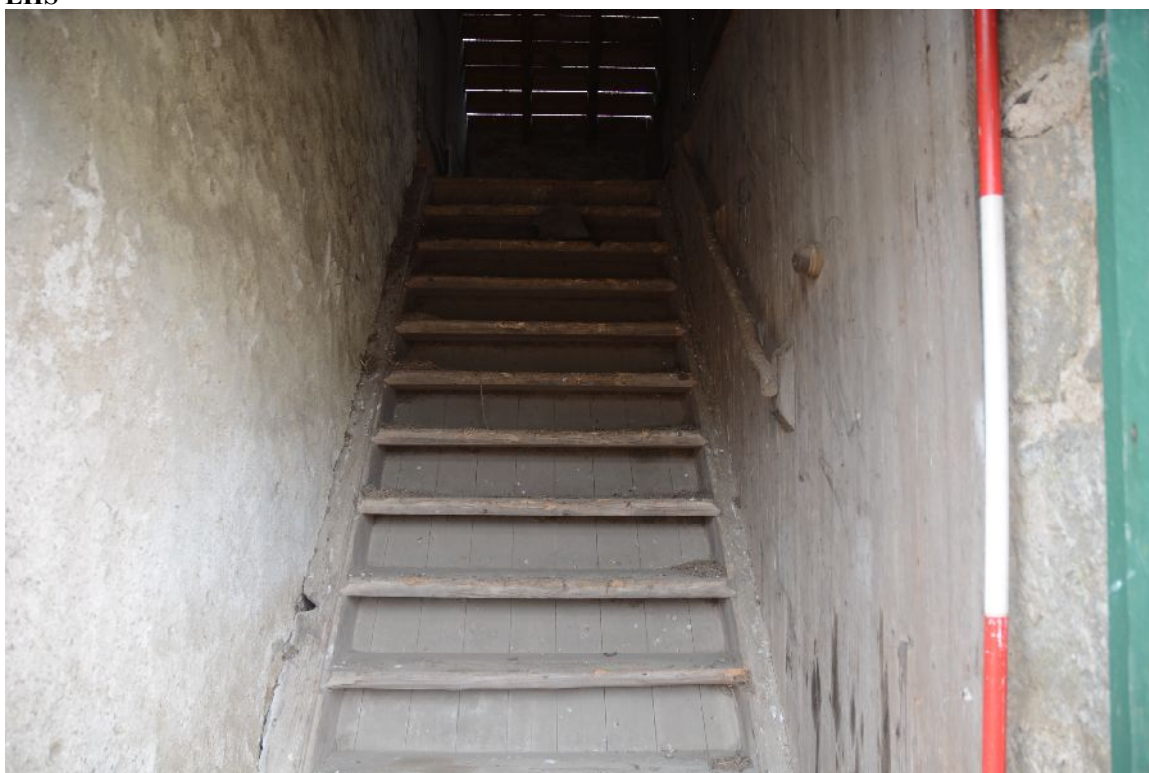
**Illus 34** Building 3. Stair to loft in centre of W wall.

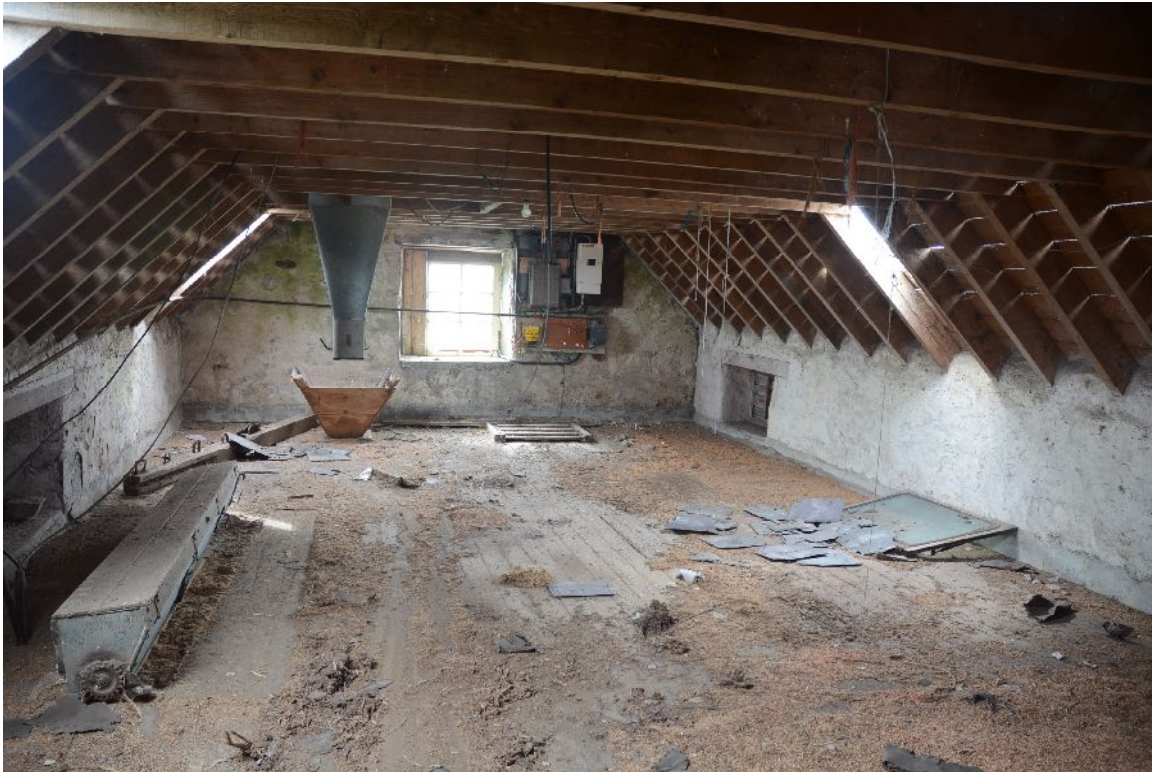
Louvered vents give ventilation. Hopper (?) to cart bay 3 below. Seeder (?) box.

**Illus 35 Building 3. S section of loft looking S from top of stair**

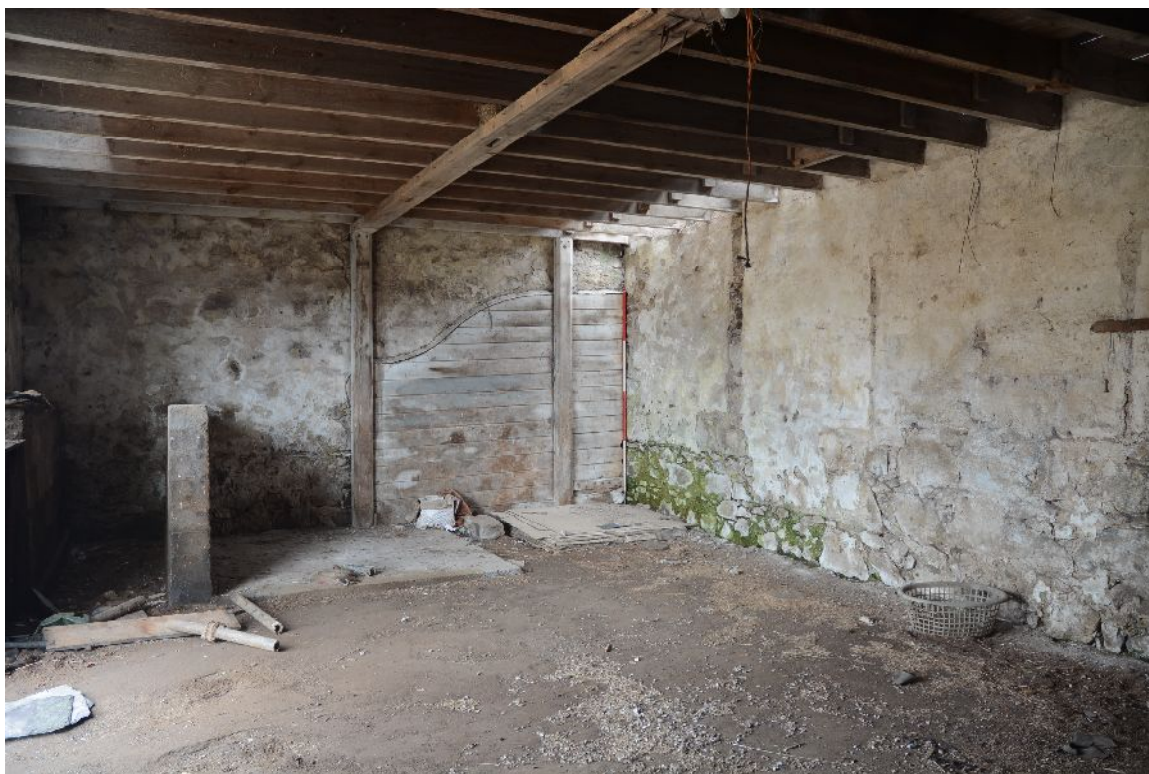
*Stable:* The stable had been cleared internally but trevis scars showed there had been 6 horse stalls 1.40-1.70m wide (stalls at S end with names above were widest- probably the farm heavy horses). The end trevises in the N and S walls survived. They were 2.77m long with plank sides protected on the top line by a metal band.

**Illus 36 Building 3. Trevis in N wall and trevis scars on back (E) wall**

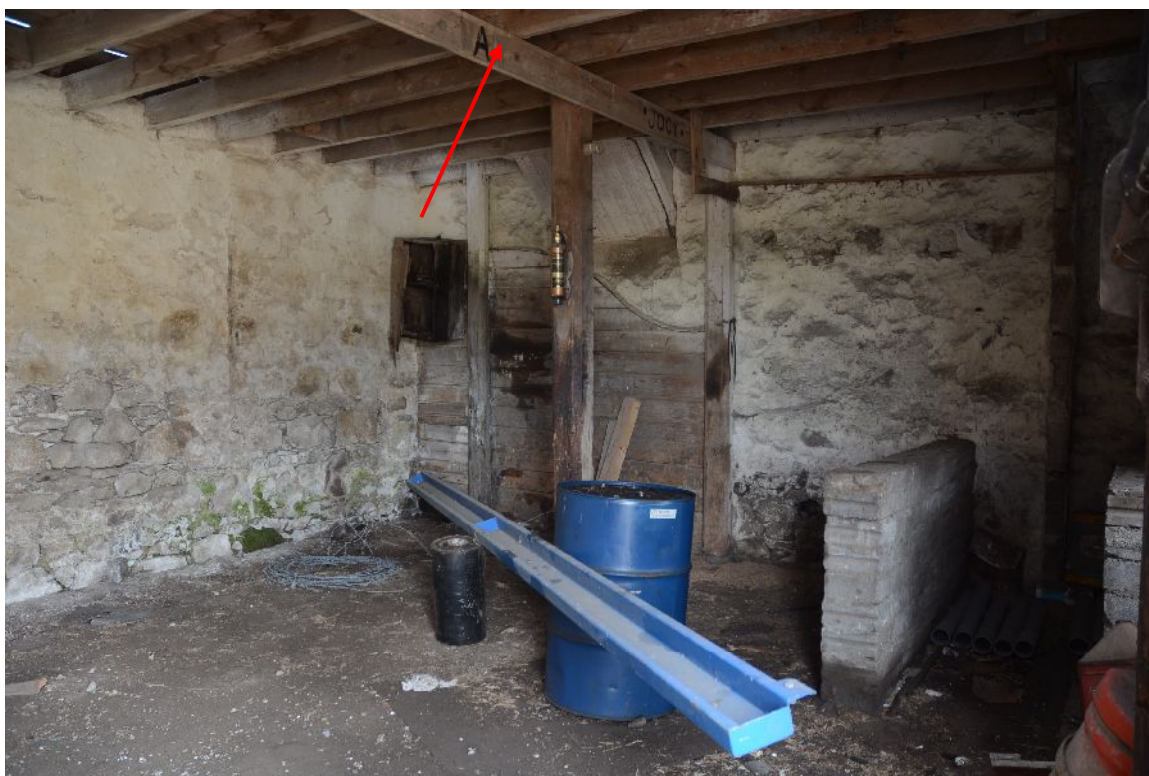
Horse names 'Nan' and 'Jock' were painted on a beam above the two S stalls. A piece of harness- a saddle/back pad with terrets from draft horse harness -remained over a beam on the W wall.

**Illus 37 Building 3. Stable looking S. Names on beam above (red arrow)**

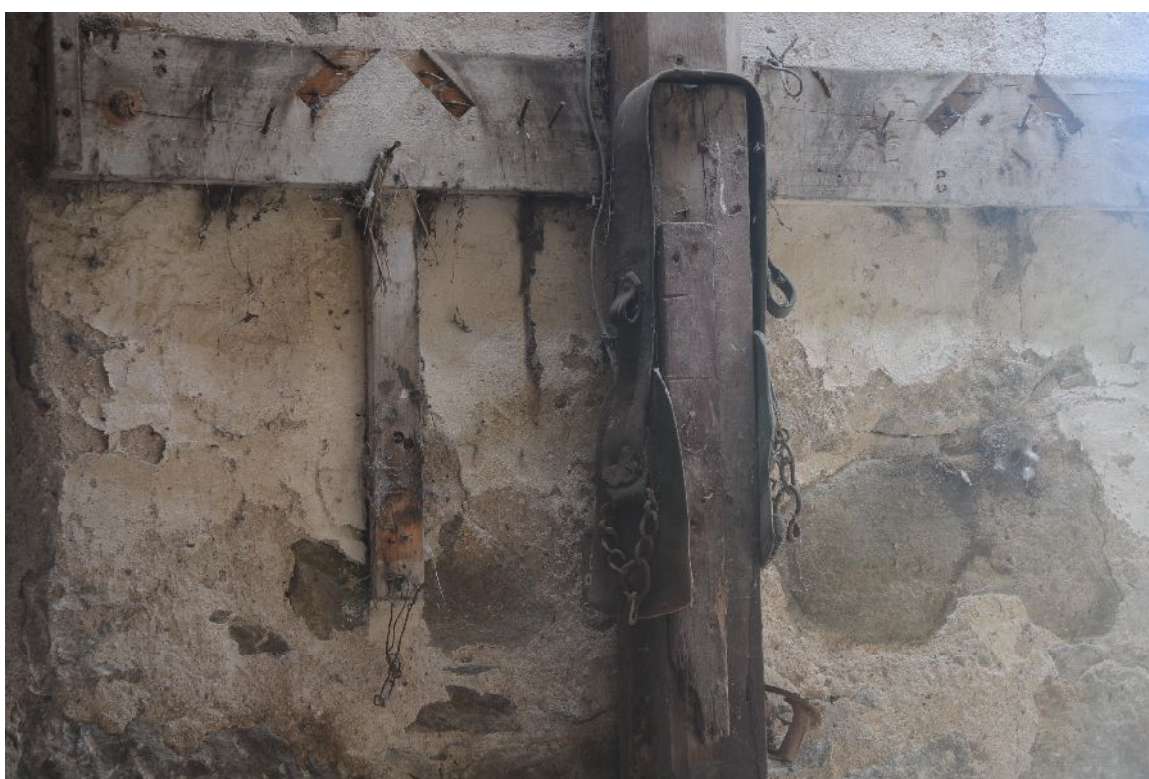
**Illus 39 Building 3. Harness remaining on hook. Saddle/back pad with terrets- from draft horse harness.**
