**YONDERTON FARM
HATTON
ABERDEENSHIRE**

Standing Building Survey

Carried out 8th December 2015

Report No: MAS 2015-37

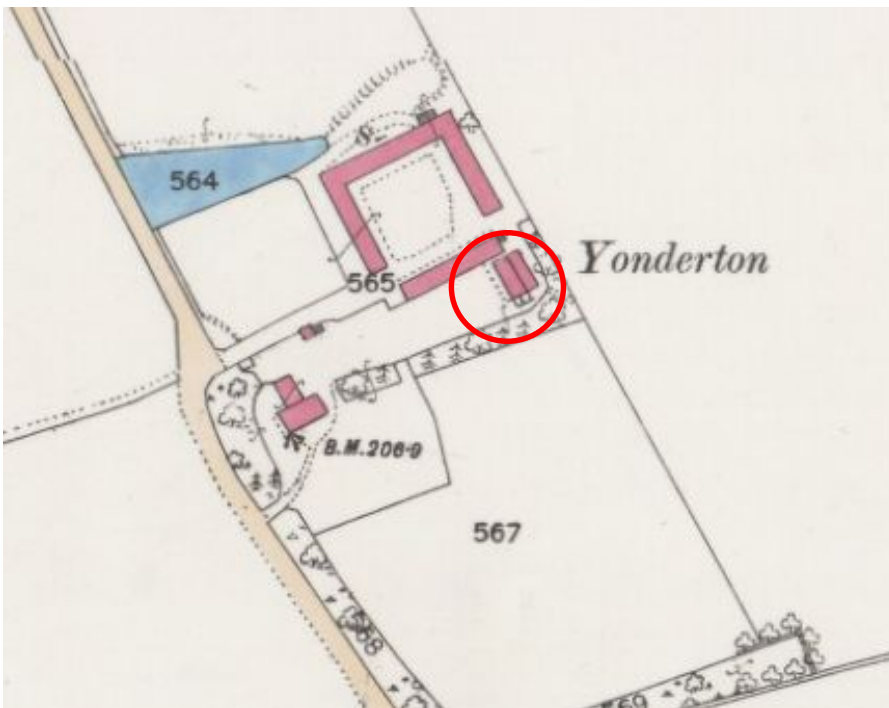
Illus 2 Detail of the 1st edition Ordnance Survey 25" map, surveyed in 1870 (published 1872)
Aberdeen sheet XXXI.11 www.nls.ac.uk Red circle indicates the buildings referred to in this report.

4.1 **Aberdeen Sheet XXXI.11 1870 (pub 1872)** shows a U-shaped steading with a separate S range forming a rectangular yard. The mill is in the N range. The E end of the S range has a small external structure, probably a stair to the upper floor. The house, which is T-shaped lies to the SW. The buildings which are the subject of the present report lie to the SE corner of the steading. They lie on the same NNW/SSE

axis as the steading. They are clearly shown as two roofed structures of equal length, but with the W building slightly wider. Two small, unroofed enclosures are attached to the S wall of the W building.

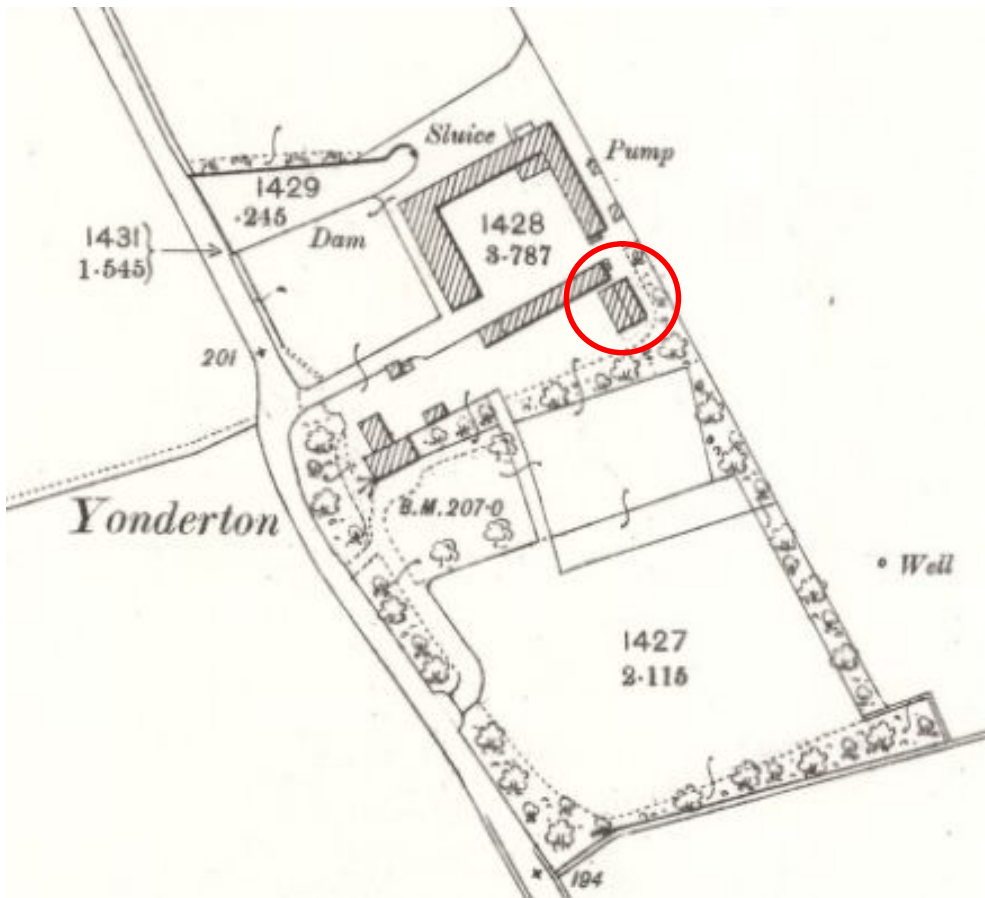
4.2 The 2nd edition 25"/mile Ordnance Survey of 1899 (published 1901).

Aberdeenshire Sheet 31.11) shows the overall layout of the farm as the same as in 1870. The only change to the buildings discussed in this report is that the enclosures attached to the W building are no longer shown.

Illus 3 Detail of the 2nd edition 25"/mile Ordnance Survey of 1899 (published 1901). Aberdeenshire Sheet 31.11 www.nls.ac.uk Red circle indicates the buildings referred to in this report.

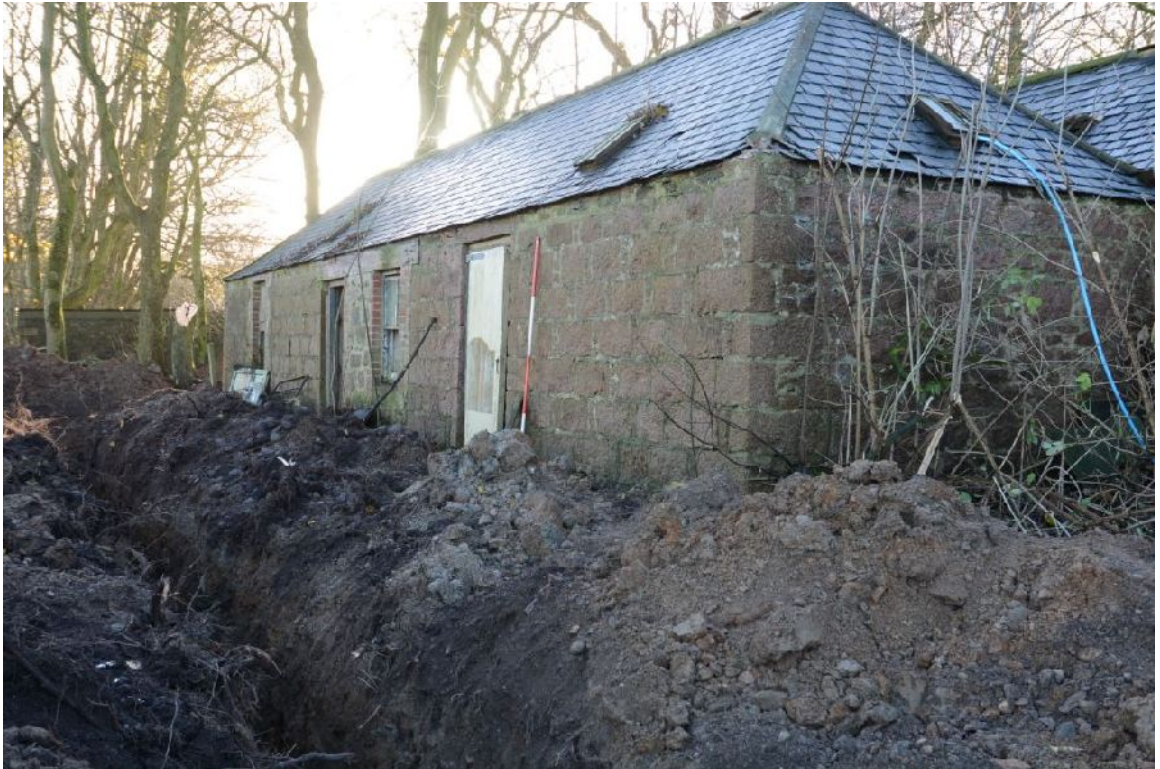
Walls Front and NW walls of well squared red granite blocks with small stacks of pinnings between blocks. SE wall and S end of NE wall of more mixed stone, with red granite rybats at corner. The S end of SW (back) wall appears to abutt the wall of Building B2 (Illus 21). Wall thickness: 600mm

Illus 5 NE (front) facade of Building 1, looking S.

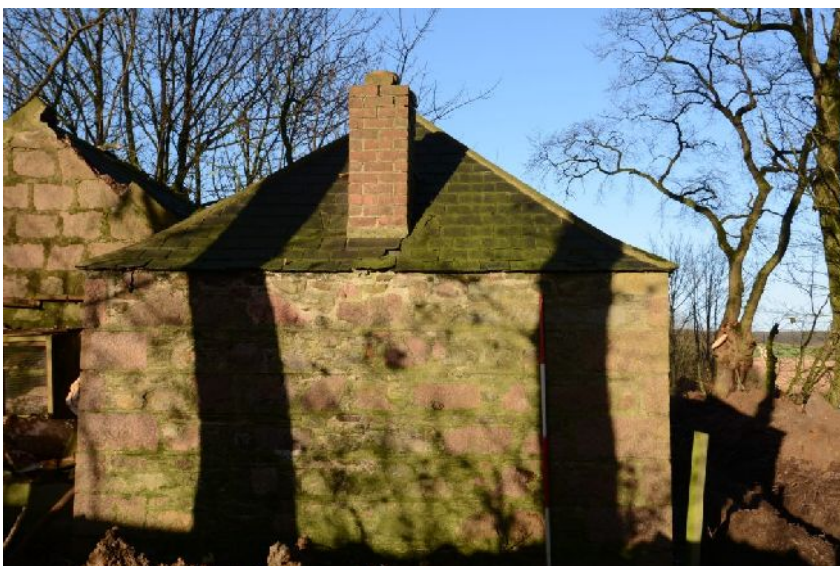
Roof Hipped roof. Slate with ceramic ridge ventilators. Secondary brick chimney at SE end. A-couples with sarking. Metal skylights into Areas A, rooms B and C and lobby.

Illus 6 Building 1 Chimney at SE end

The changes to Building 1 may have taken place when it was converted to use as farm workers' accommodation. At this point a brick chimney was inserted, and as argued above, the SE end of the building extended by c2.8m. At the same time, or possibly as

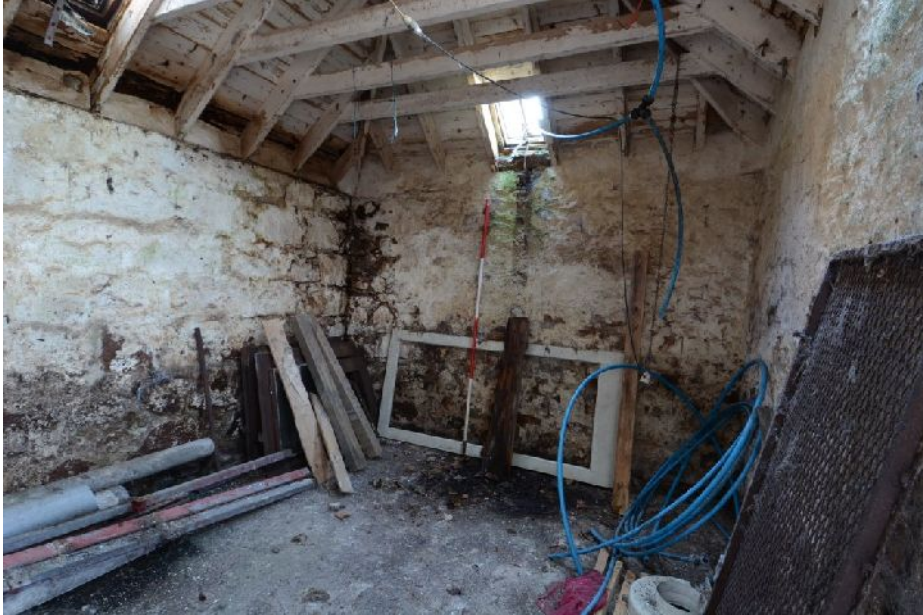
Divided into two main areas. Area A most recently used for pigs. Two metal skylights. Concrete floor. No blockings and no evidence this had ever had a chimney/hearth.

Illus 7 Interior of Building 1, 'Room' A, looking W

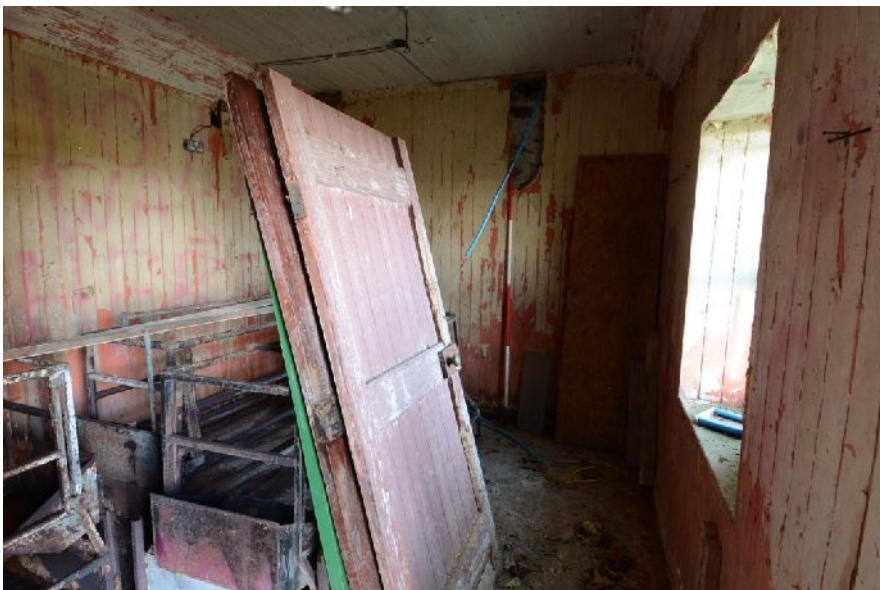
Areas B and C A two-roomed bothy with small entrance lobby. Walls and ceiling lined with pitch-pine throughout. The N room (B) has a window to front and skylight in back of roof- this appears to be of same date as the wooden lining. No evident blockings and no evidence of a hearth. Possible bed alcove at S end. S room (C) is as room B but with a cast iron range in a concrete fire surround at S end. Cupboard alcoves on either side. Possible bed alcove at N end.

Illus 8 Interior of Building 1, 'Room' B, looking W

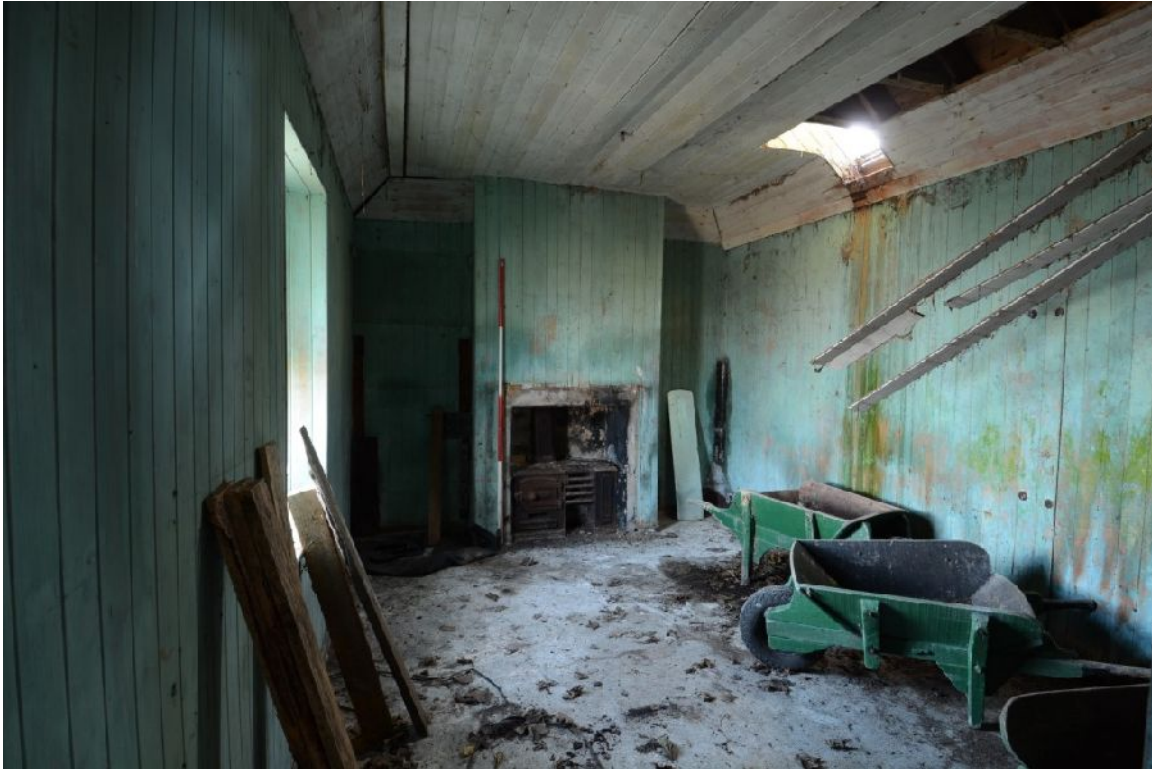
Illus 9 Interior of Building 1, 'Room' B, looking E to range

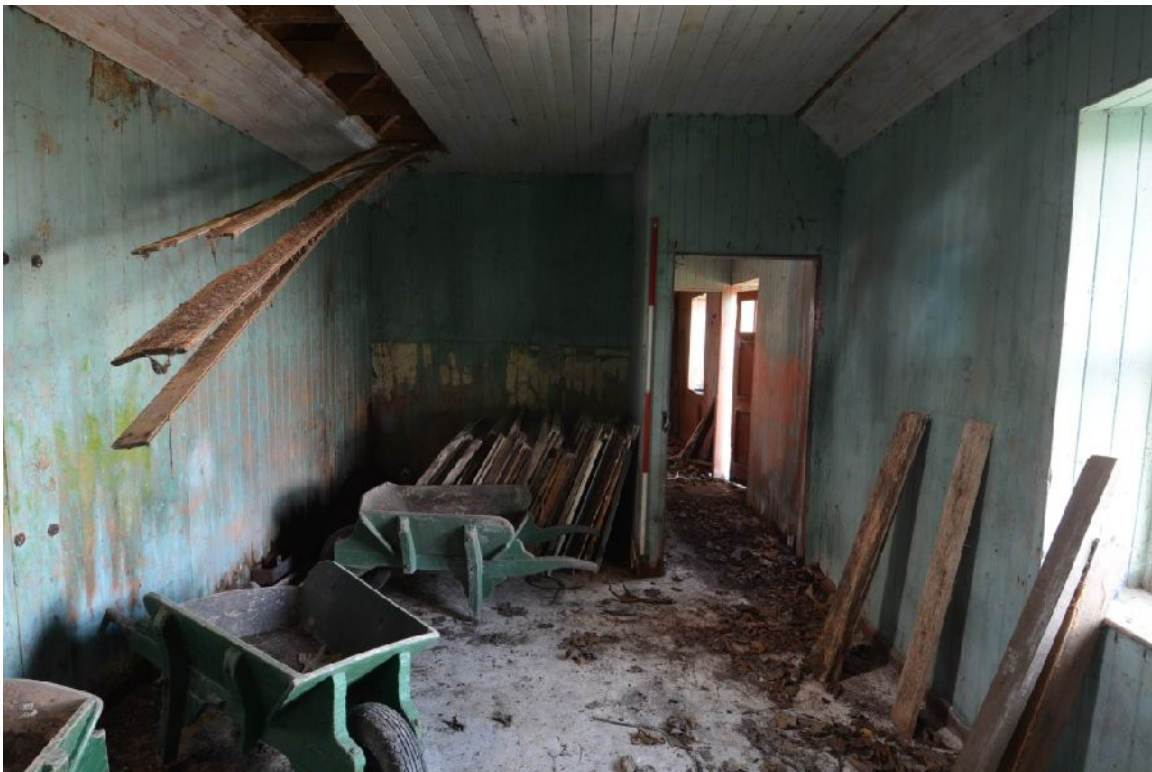
Illus 10 Interior of Building 1, 'Room' B, looking W to lobby (RHS) and bed alcove (LHS).

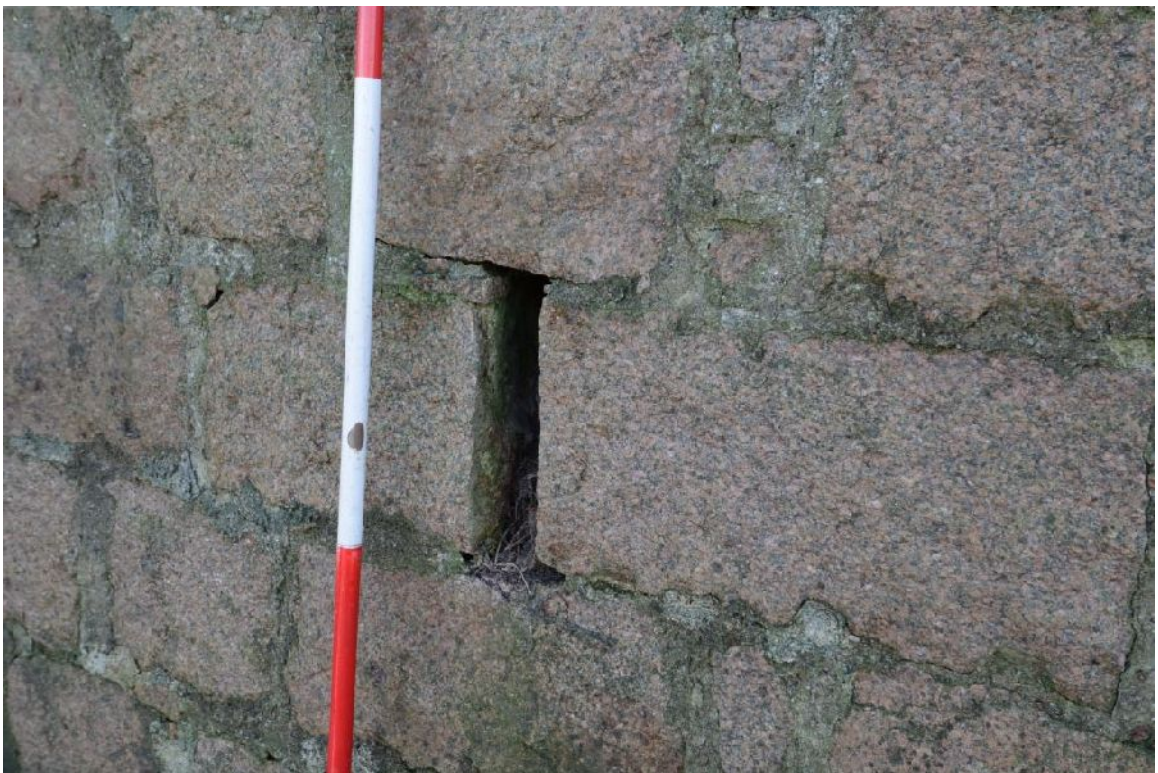
F1 Small vertical slit vent H: 330mm. W: 70mm. Originally this probably went through the full thickness of wall- brick and cement blocking visible from outside. Not visible on inside of wall as it is covered by wooden lining. This looks like a livestock vent- similar vents can be seen in the building (not part of survey) which formed S range of steading (see illus 24).

Illus 13 Building 1. Blocked vent F1

Clearly in the 20th century Building 1 was used as farm workers' accommodation, as was the upper floor of the S range (Pers.comm. Mr Henderson). However, the blocked slit vent (F1) suggests that the original function of the building may have been for livestock. Fenton and Walker (1981, 145) quote a report of 1871 which notes that many farm workers' cottages were converted from livestock buildings.

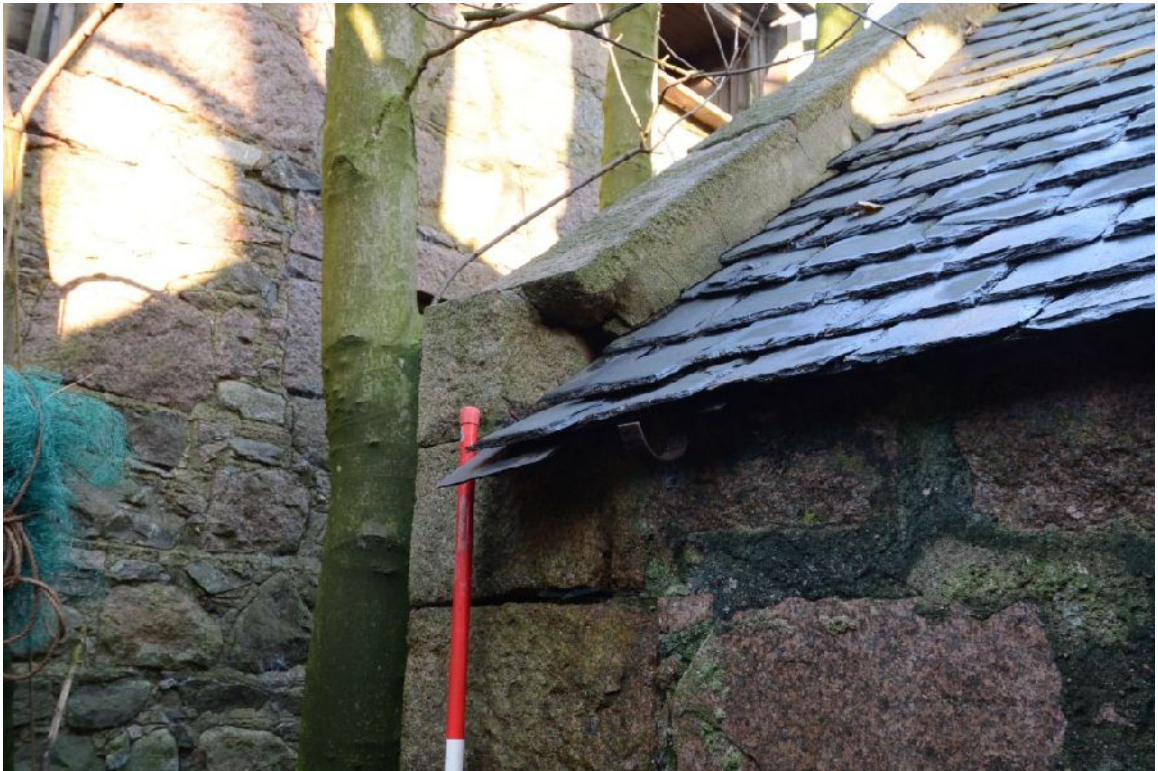
Roof Pitched slate roof with gables to NW and SE. Granite skew with simple moulded skewputts surviving at NW gable. No evidence of chimneys having formerly existed. The S end of the SW side of roof is disturbed by the roof of later Building 3 being inserted onto wall head of Building 2.

Illus 14 Building 2 NW corner showing skew and skewputt

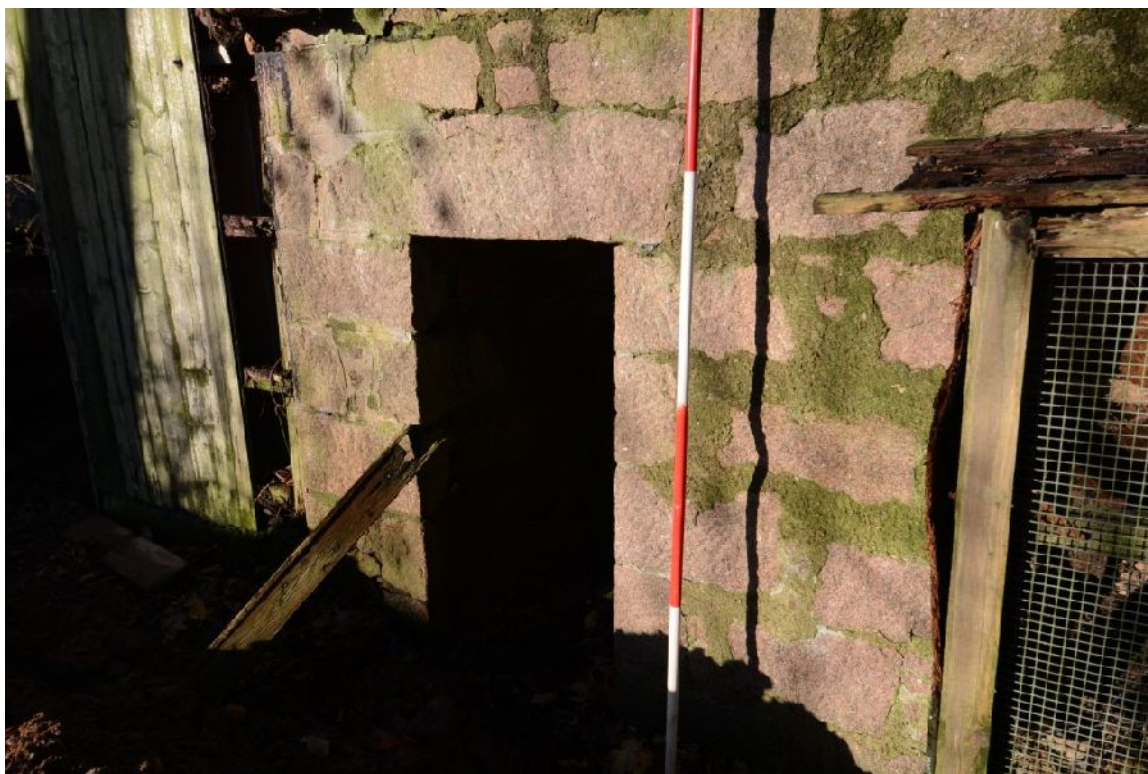
Area D Low original doorways D3 and D4 (Illus 15) open into a 'room' 2.1m x 3.9m divided from the rest of Building 2 by a wall that is stone to the wall head at 1.68m and timber above. The interior is divided into two pens c 2m square by a rough timber and post partition (Illus 16). The 1st OS map of 1870 (illus 2) shows two small unroofed enclosures outside this gable- almost certainly open air yards for the pigs. These are not shown in 1899 (fig 3).

Illus 15 Pig doorway D4

D4 W: 0.74m H: 1.45m Granite rybats and lintel

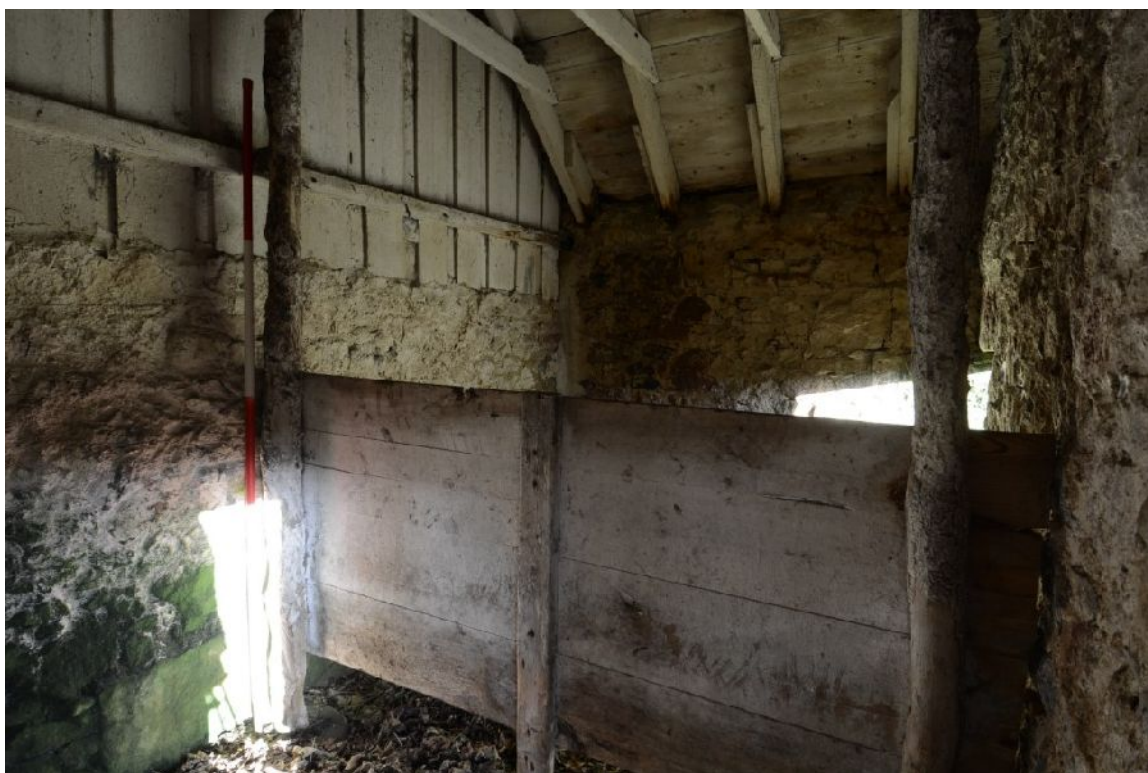
Illus 16 Timber partition between the two pig stalls in Building 2, area D

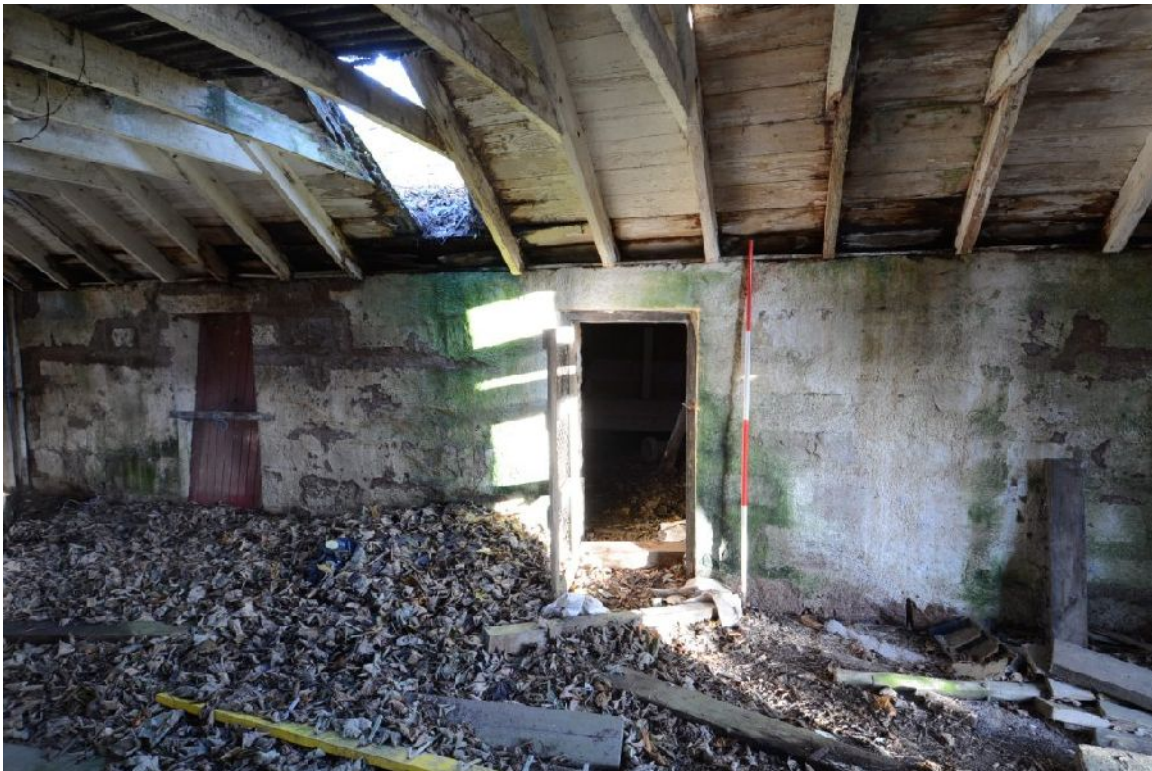
Illus 17 Original outer wall of Building 2 seen from inside Building 3. Ranging rod stands beside door D5

D5 W: 0.92m H: 1.70m Granite rybat and lintels. Secondary wire mesh door

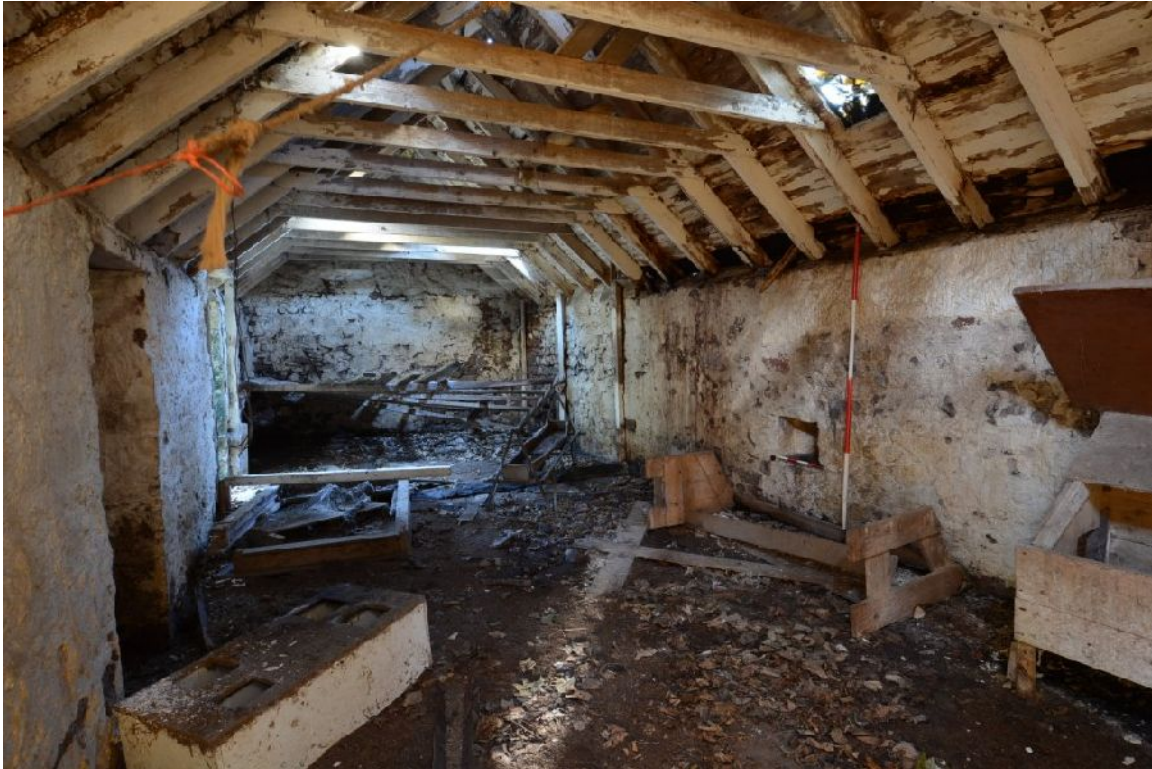
Area E is c10.2m long, with traces of a timber partition just S of door D7 dividing off the N end into an area 3.6m wide. An intermediate upright against the inner side of the NE wall may indicate the former presence of a trevis dividing this area into two stalls. The height of the doorway would suggest these were for horses.

F2 Small semicircular alcove on inner face of wall W: 400mm H: 300mm Depth into wall 300mm. Top is 1.15m below wall head. The base is formed of slate.

Illus 18 Building 2, Area E, looking NW to possible stable. Door D6 on LHS foreground. Alcove F2 beside ranging rod.

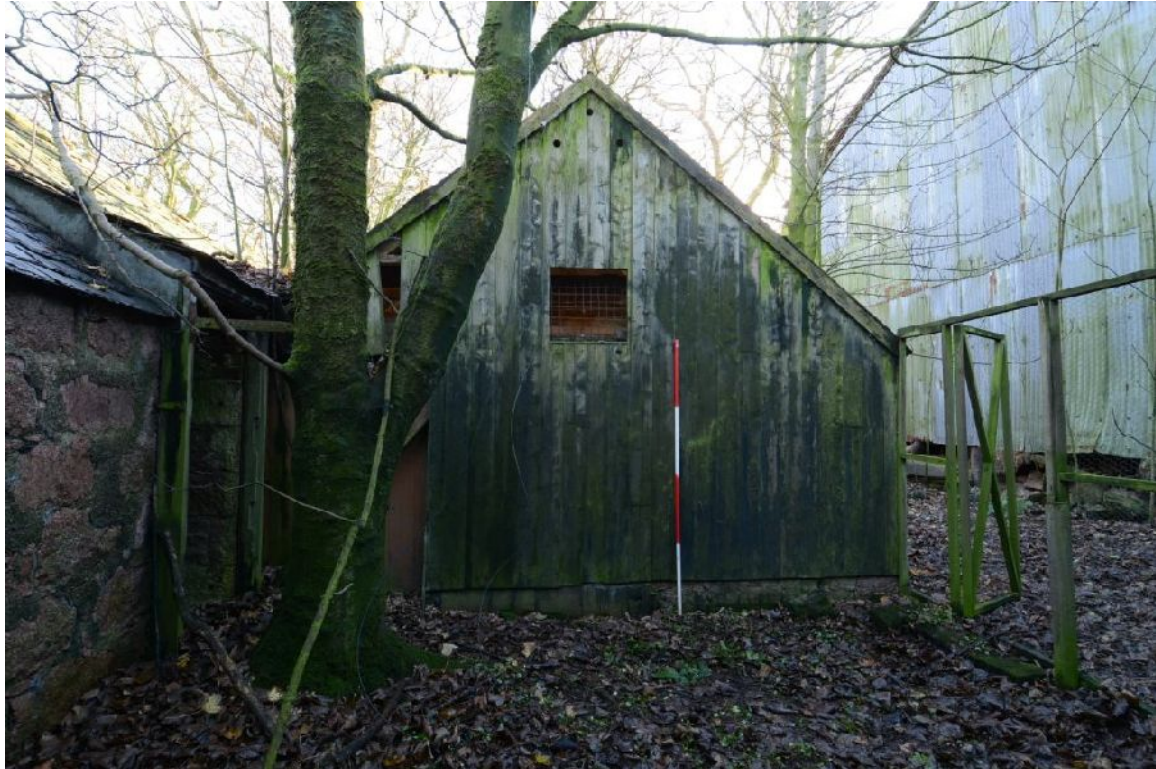
Building 3 is a fairly modern poultry house 9.9 x 4.8m externally. It is built of timber set on a stone foundation and with a corrugated iron roof. The rafters of the NE side of the roof had been supported on the outer side of the wall head of Building 2.

Illus 20 Building 3 abutting Building 2, looking SE

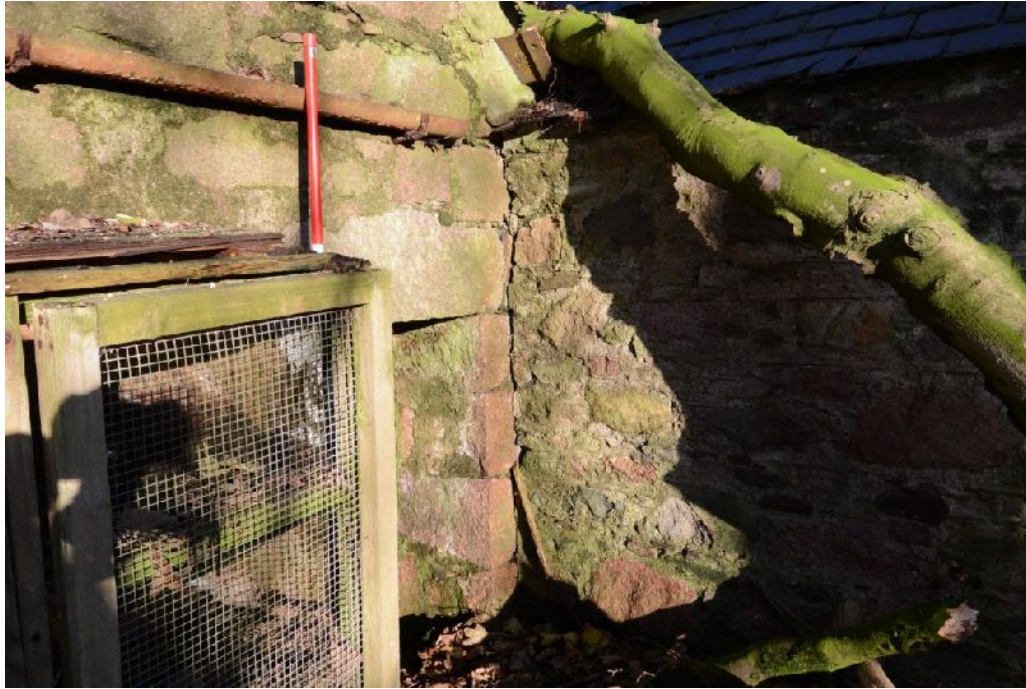
Illus 21 S end of back wall of Building 1 abutting SE corner of Building 2

Building 1, which appears to have shared a common wall with Building 2, is also probably largely of early-mid 19th-century construction. However the 1870 and 1899 maps both clearly show the two buildings to be the same length. So, since c1900, Building 1 has been extended on the SE end; this can be seen in the poorer quality of the stonework abutting Building 2 at the SE. It is less clear in the front (NE) wall, but it is possible to see some difference in the wall construction on either side of window W2 (illus 22).

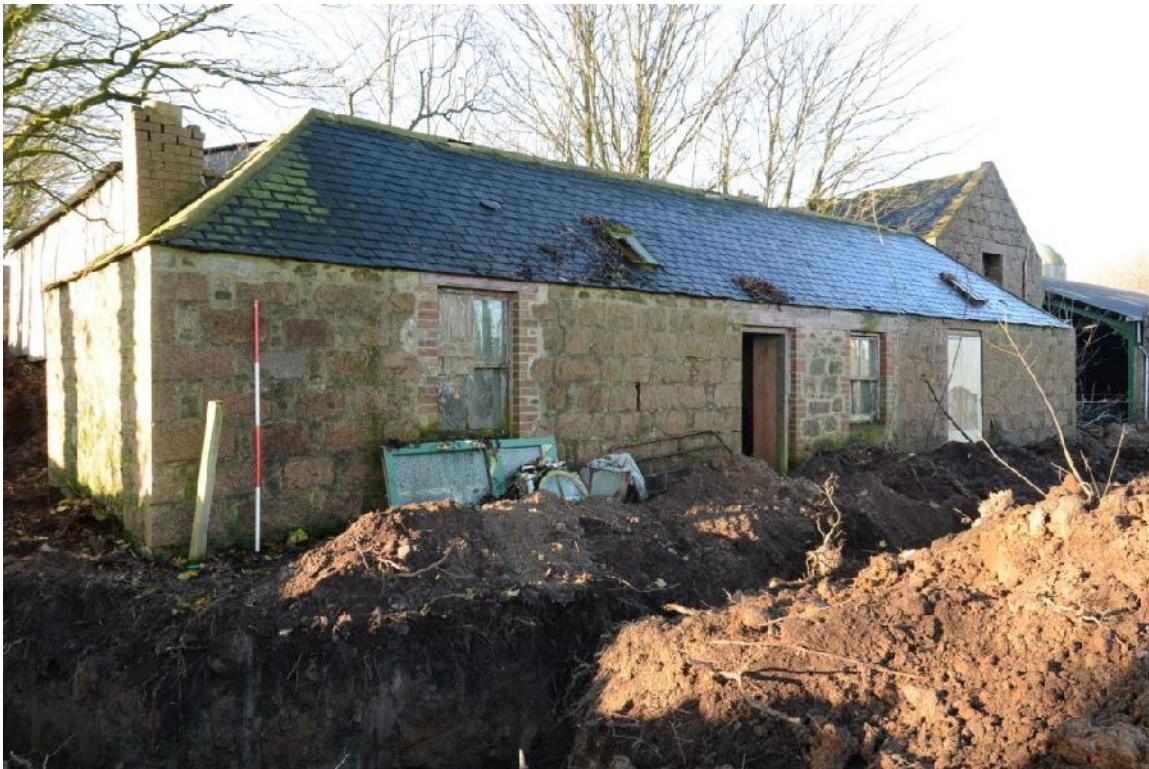
Illus 22 Building 1 NE frontage showing secondary insertions

later alterations, window W1 was inserted, probably into an earlier doorway, door D2 was altered/widened from an earlier doorway and window W2 was inserted. The interior of rooms B and C was lined and ceilinged with pine and a range and bed alcoves built in.

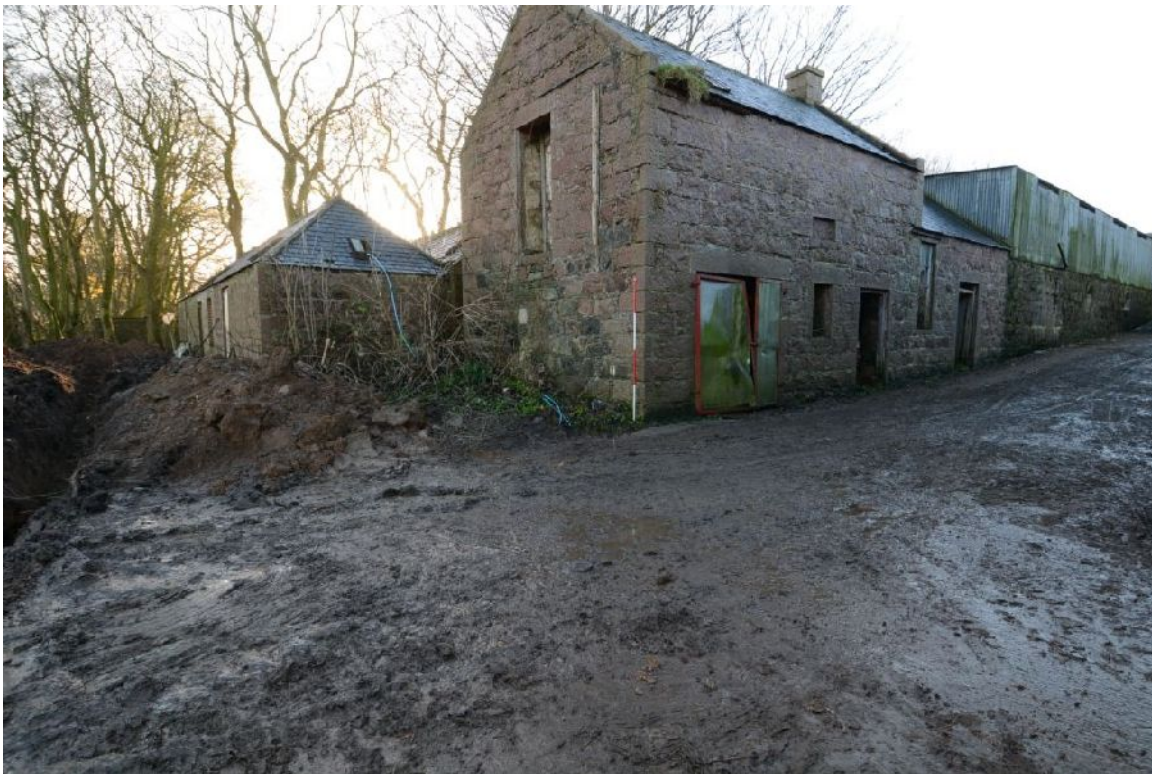
There is no direct evidence that any of the other parts of Buildings 1 (Area A) or Building 2 were used as dwellings. There is however an oral tradition that this may have been the case. The upper floor of the S range was also housing for a married couple with single men's quarters elsewhere in the building (pers. comm. Mr Henderson).

Illus 23 Building 1 (LHS) in relation to the S range of steading.

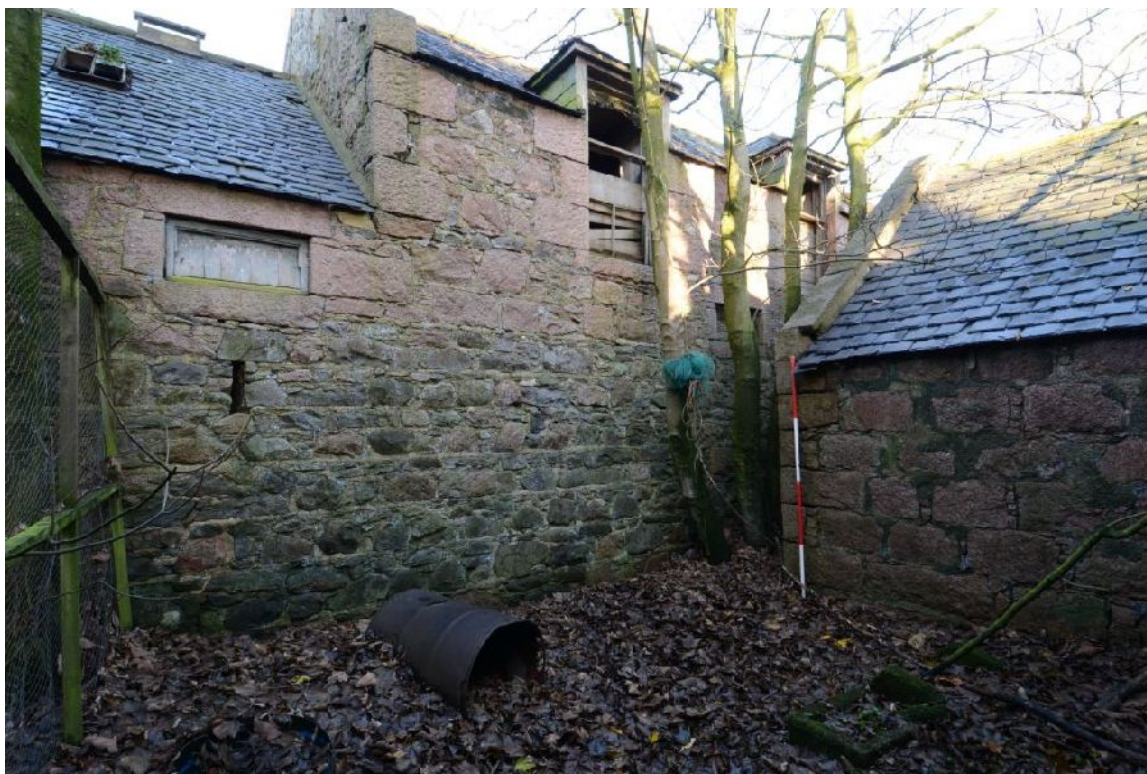
Illus 24 Building 2 (RHS) in relation to back of S range of steading. Note slit vent comparable to blocked vent in Building 1
