**BOIG STEADING
TARLAND
ABERDEENSHIRE**

Standing Building Survey

Carried out 1st May 2017

Report No: MAS 2017-07

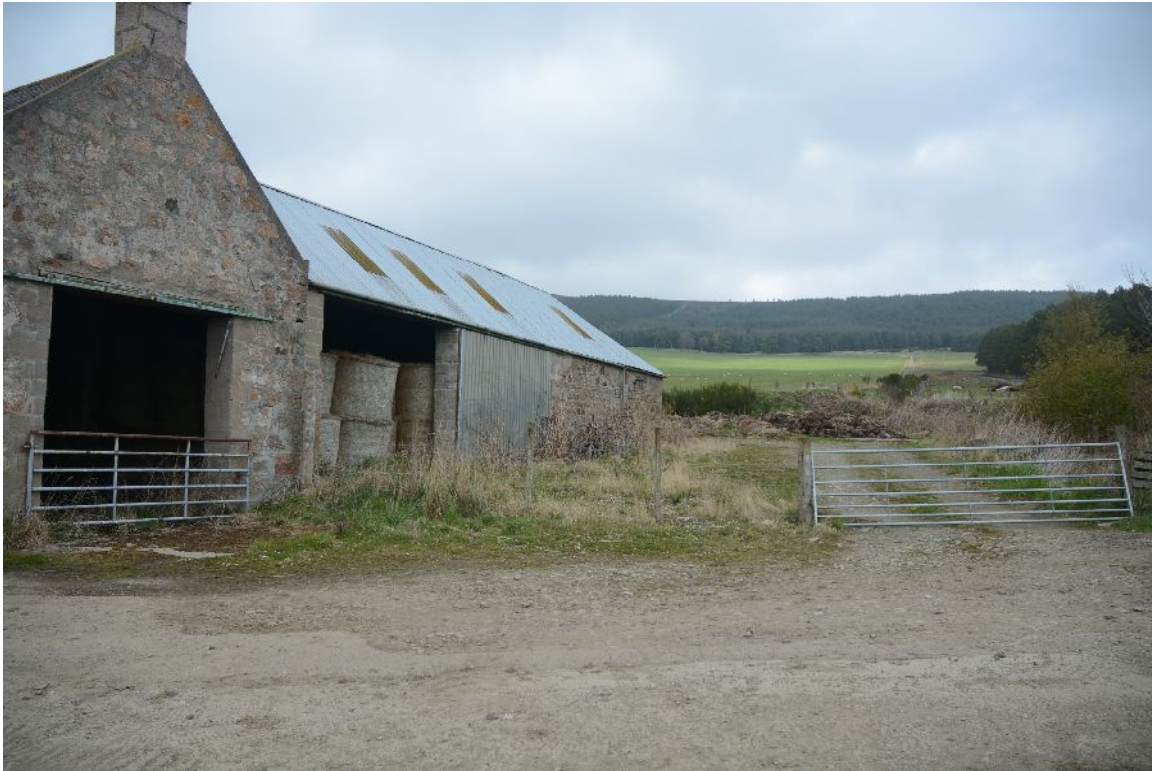
Illus 2 The E end of the steading showing higher ground to N

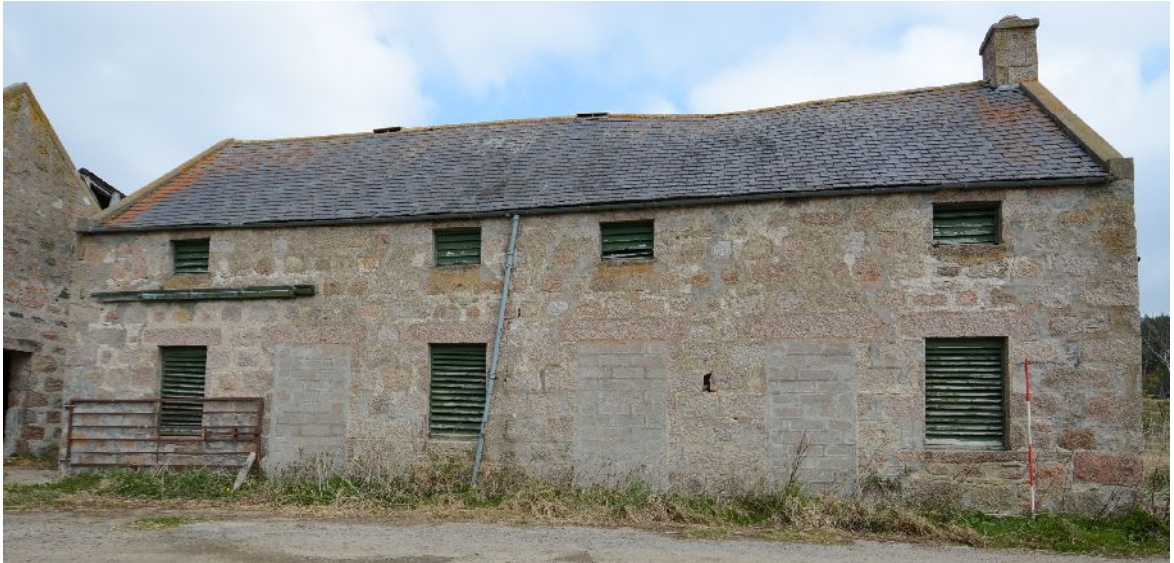
Illus 14 S wall of Building A

W1-W3 W: 0.90m H:1.40m. Pink granite lintel, sill and rybats. Slatted wooden louvres.

D17 W: 1.20m H:2.30m Pink granite lintel. Blocked with concrete blocks.

D18 W 1.20m H:2.30m Pink granite lintel. Blocked with concrete blocks.

D19 W:1.10m H:2.30m Pink granite lintel. Blocked with concrete blocks.

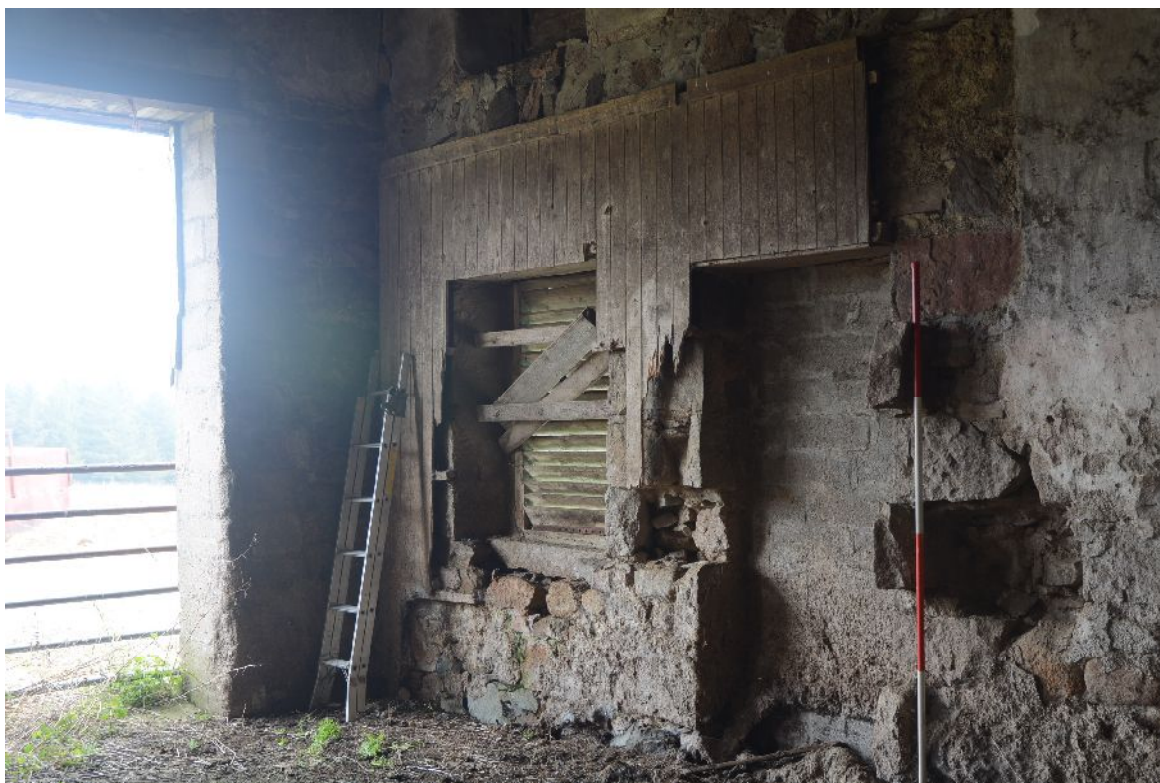
The sawn off joists of a loft floor could be seen in both N and S walls. The E end of the loft was clearly a chaumer with a blocked fireplace (this could not be photographed because of light from door below) in the E gable. A stub of a dividing wall (just W of D19- black on plan) indicated the extent of the chaumer. Traces of pine lining remain on the inner face of the S wall in this area (Illus 15).

Illus 15 Pine paneling inside S wall art E end of Building A. Ranging rod indicates remains of cross-wall.

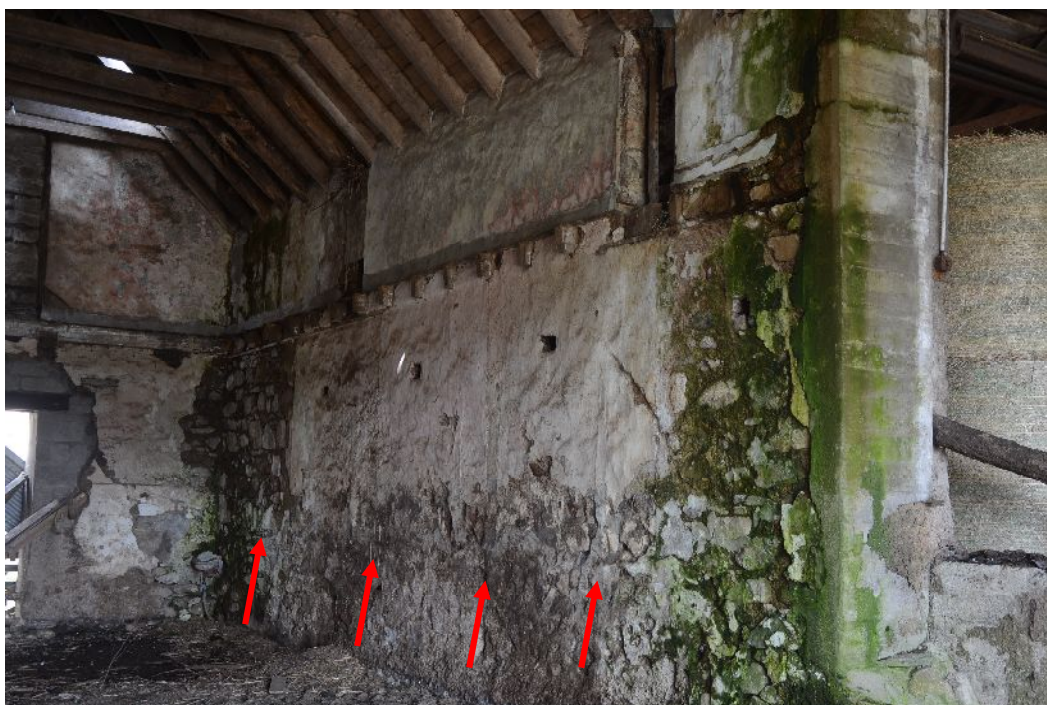
Illus 16 Interior of Building A looking W along N wall. Note joists of loft floor. Arrows mark trevis scars. Modern break-through to Building B on RHS

The W end of the building appears to have been the stable. Scars (c150mm wide) of trevises remain on the inner face of the N wall indicating 5 stalls, c 1.7m wide (Illus 16).

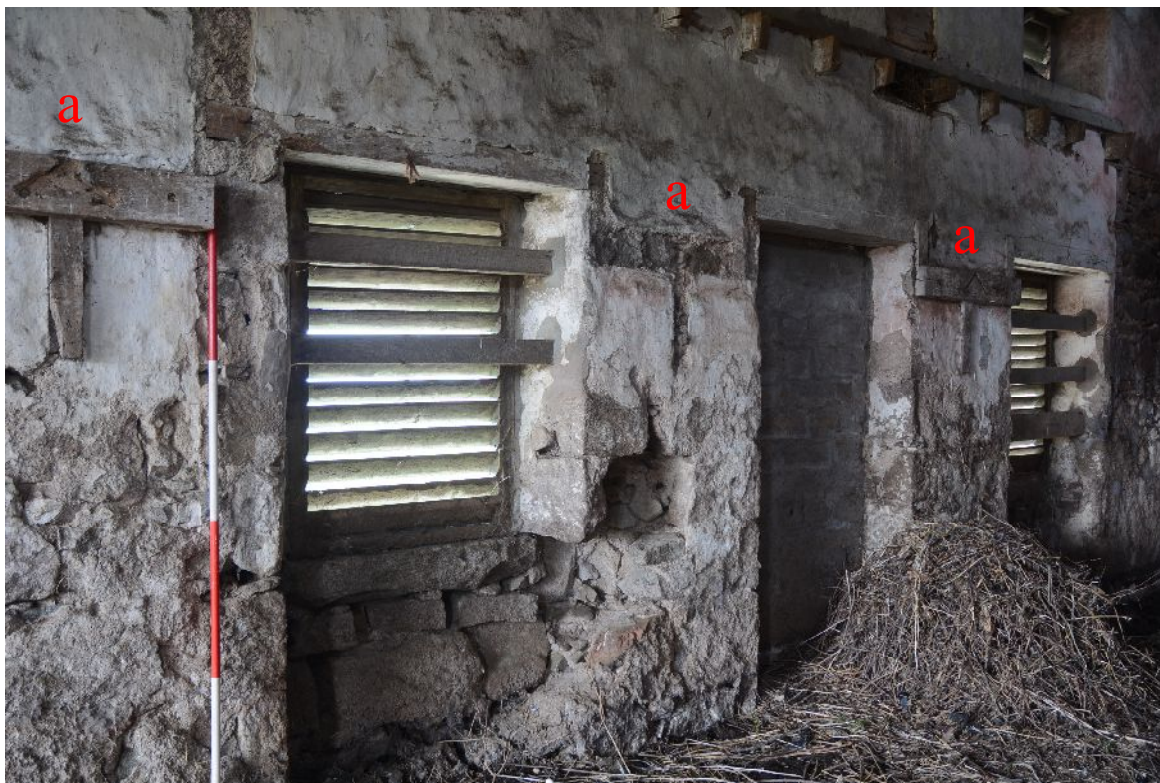
The remnants of inverted V-shaped fittings to hold harness were visible on the inner face of the S wall (red dots on plan and Illus 17).

Illus 17 Interior of Building A looking W along S wall. Scars of harness supports marked (a).

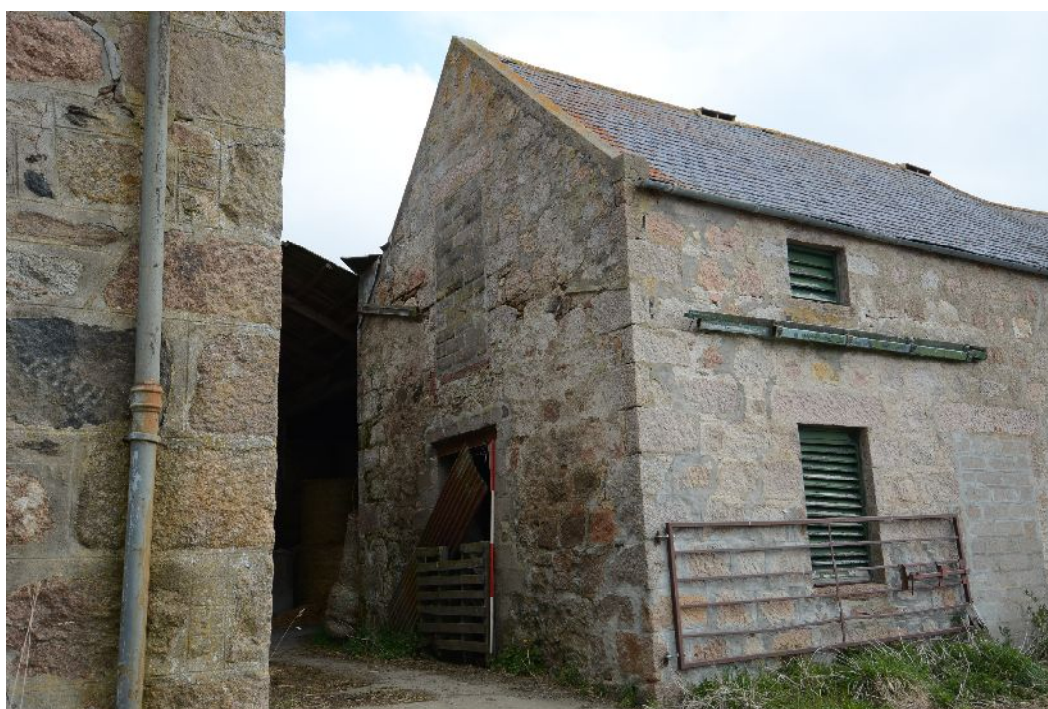
The loft above the stables had an external 1st floor door in the W gable and louvered ventilation windows. Chutes ran between the loft and the stables below (Illus 19).

Illus 18 W gable of Building A showing blocked door to hay loft.

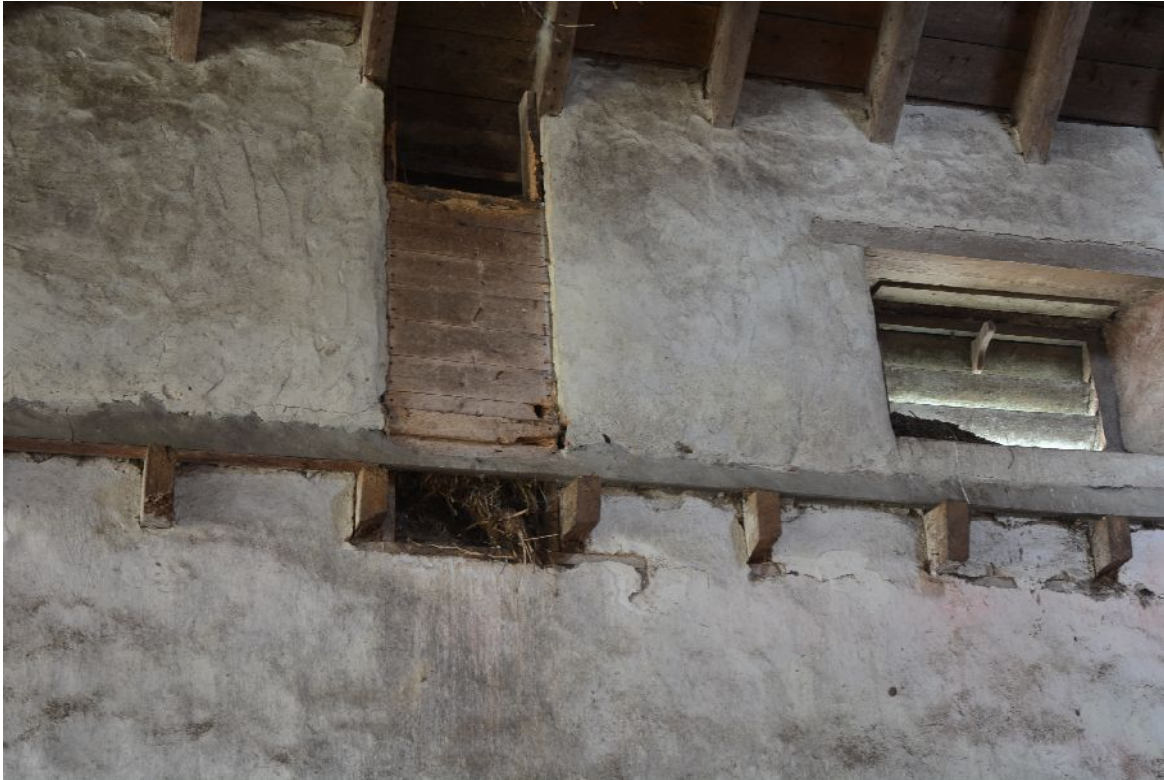
Illus 19 Inside S wall of building A showing chute from loft to stable

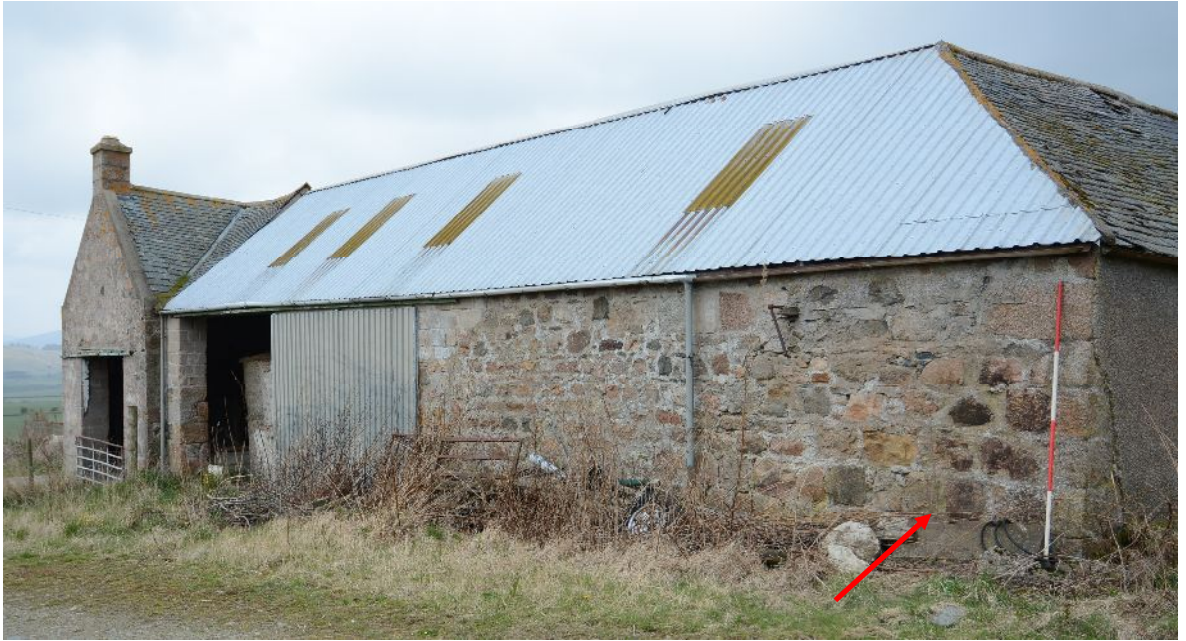
Walls Mostly quite small, mixed colour rubble stone with pinkish and grey granite rybats. N end of wall – in area C the rubble stones are squared (Illus 20) – this is typical of walls where a mill wheel has been attached. N wall of C harled. Some modern patching with concrete blocks.

D4 W: 4.3m H:3.15m S side granite rybats at base, concrete above, N side widened and rebuilt with concrete blocks.

Illus 20 E wall of Buildings B and C, looking S. Note larger, squared blocks in wall where mill wheel shown on 1st OS map (arrow)

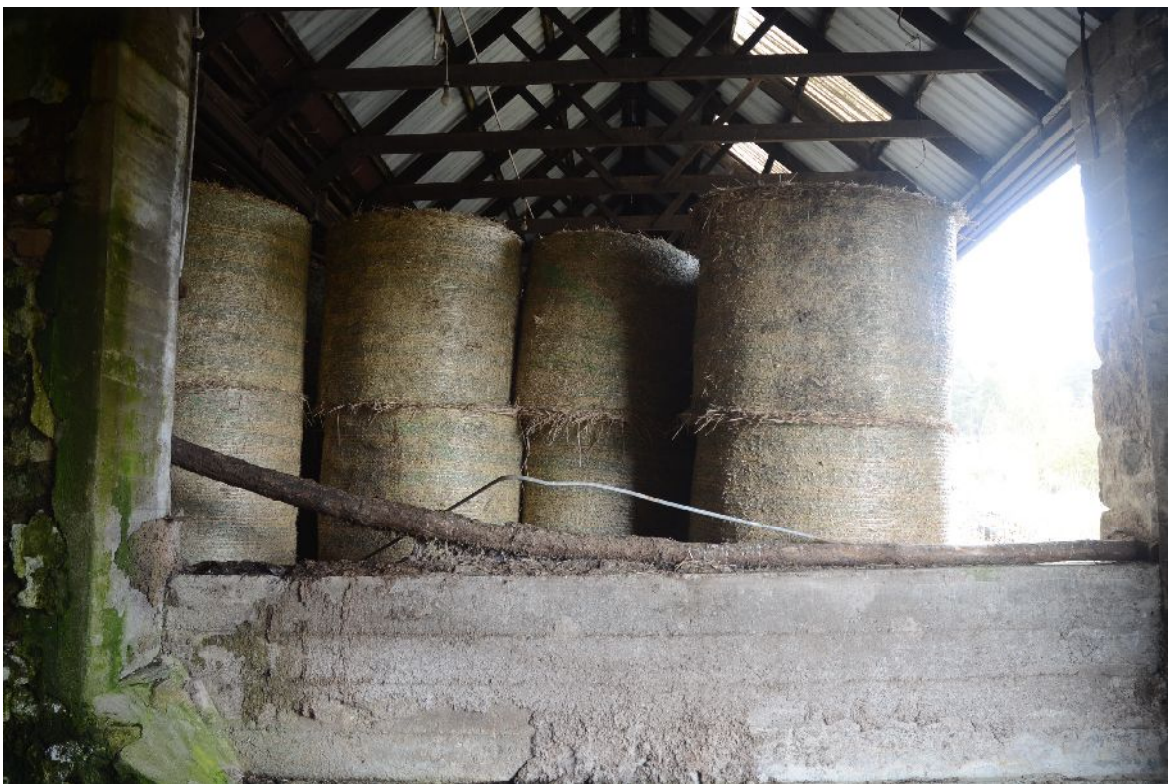
Interior Could not be entered as full of big bales of straw.

Illus 21 Inside of Building B blocked with bales

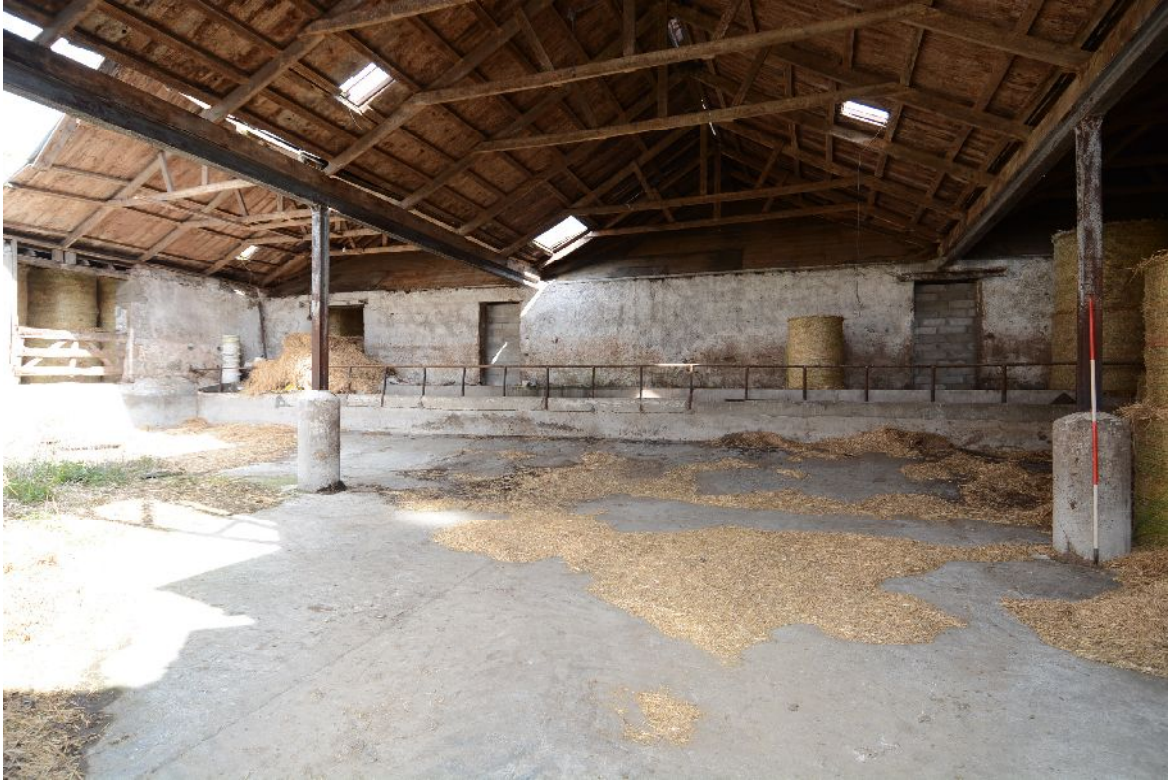
Court enclosed by the N, S, E and W ranges. Roofed in late 20th century as an open cattle court.

Roof Tin roof- much collapsed at time of survey. Wooden framework supported by metal beams on steel pillars with concrete around bases.

Illus 22 Court E looking N

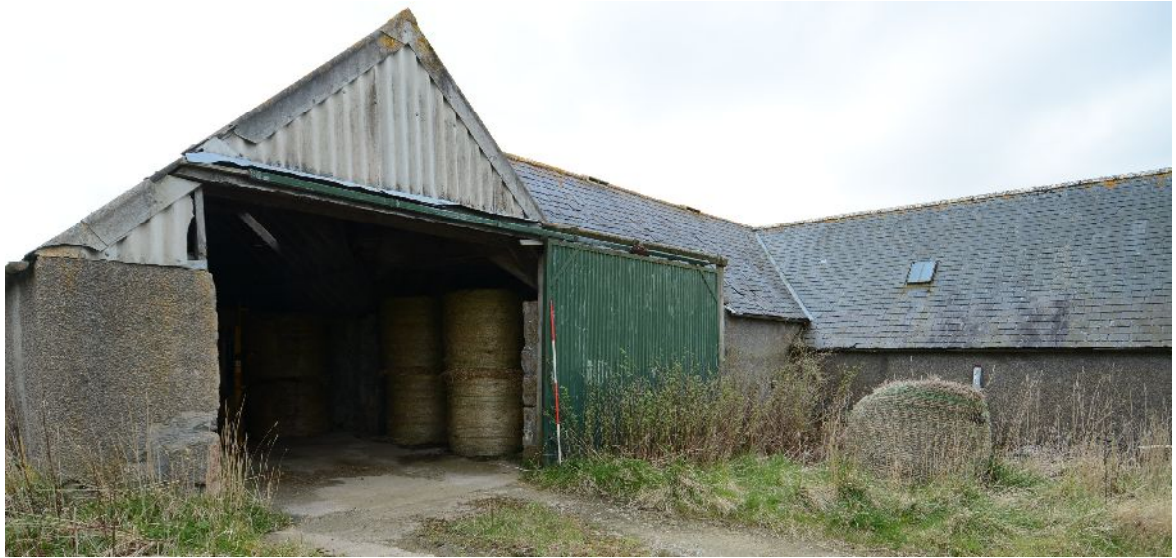
Illus 23 Steading viewed from W, with gable of Building D on LHS, roof of Building H on RHS and Building F between.

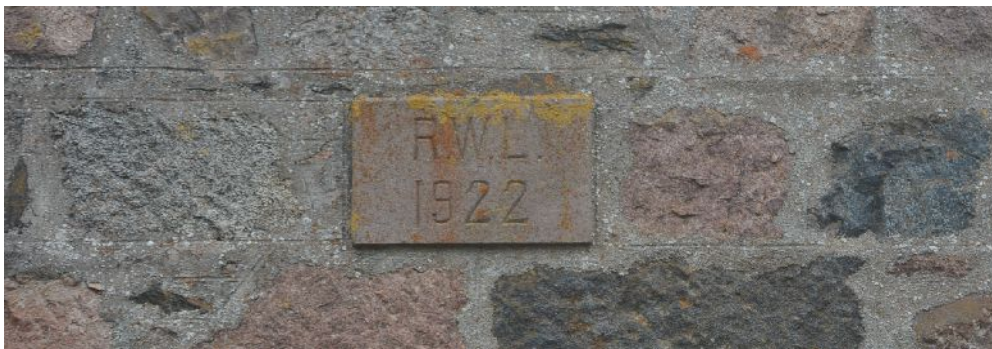
A date stone on the W gable dates this building to 1922. The initials R W L are likely to refer to Richard Lewis of Melgum, the then owner of the estate (Richard Lewis of Melgum is listed as a member of the Royal Highland Agricultural Society of Scotland in Transactions of RHASS 1924. (<http://archive.rhass.org.uk/archive/transactions-of-rhass>).

Illus 24 Date stone on W gable of building G

F2 Date stone in gable “RWL 1922”

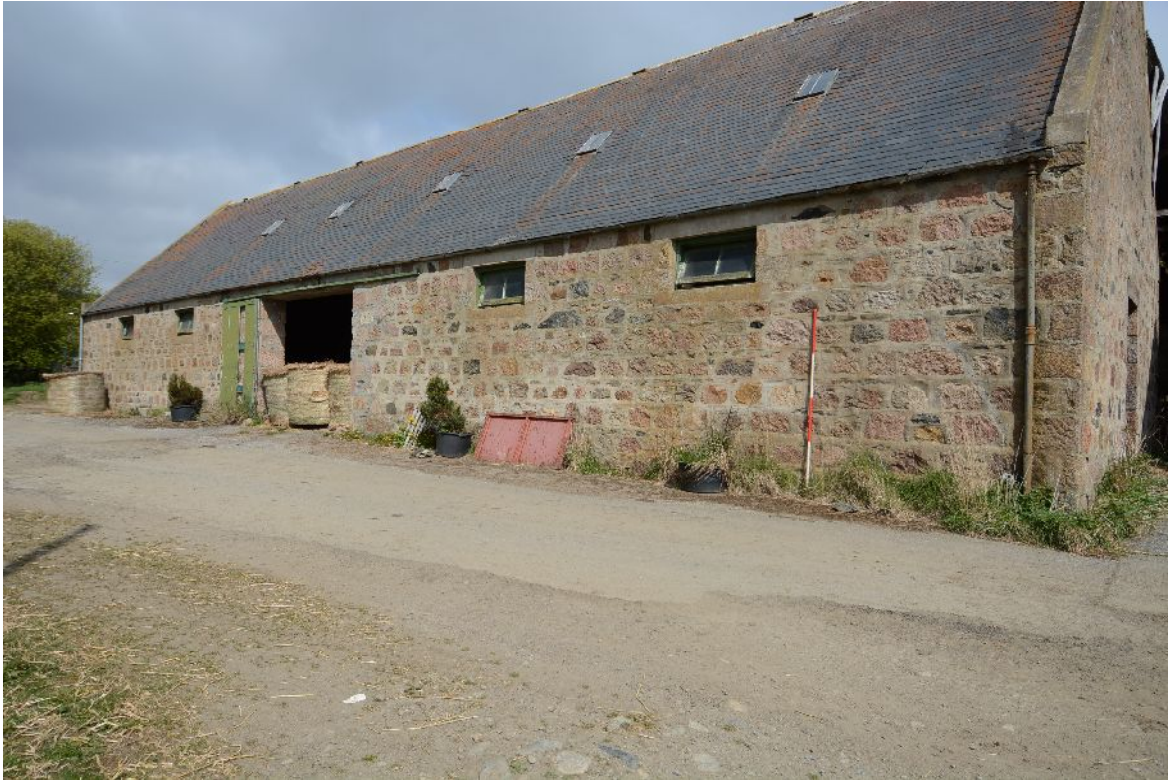
Illus 25 Exterior of S wall of Building G

W8-W11 W: 1.22m H: 0.68m 2 pane swing windows. Granite sills, lintels and rybats externally these are concrete rendered.

D6 W: 3.65m H: 2.80m. Granite rybats, concrete lintel. Sliding wooden door.

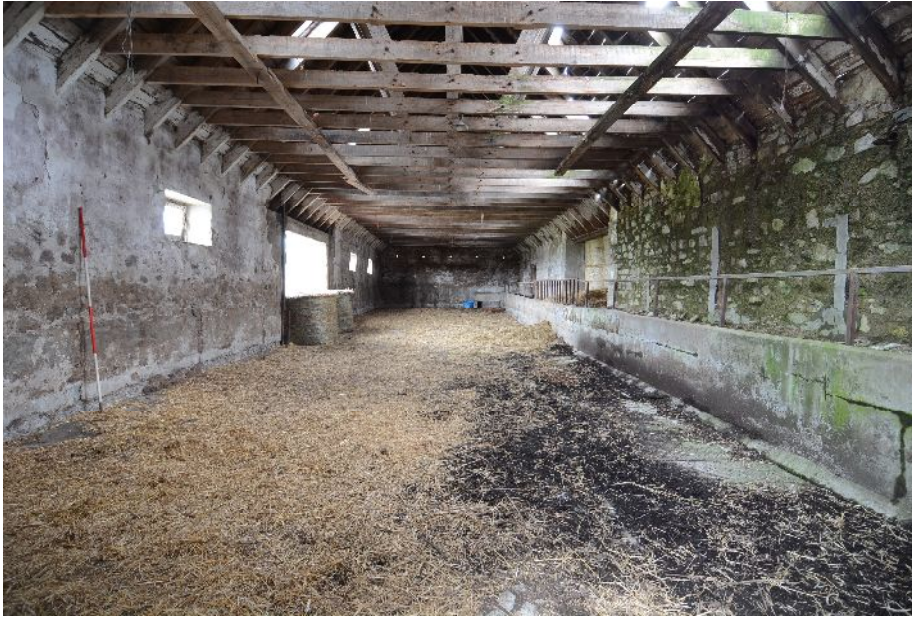
Illus 26 Building G looking W. Feed pass on RHS. Ranging rod beside scar of tied cow stall on LHS
Interior Although converted into a modern open cattle building with a raised concrete feed pass along the N wall, scars on the inner face of the S wall suggest that it had originally been used for tied cattle with pens along the S (and probably the N) wall.

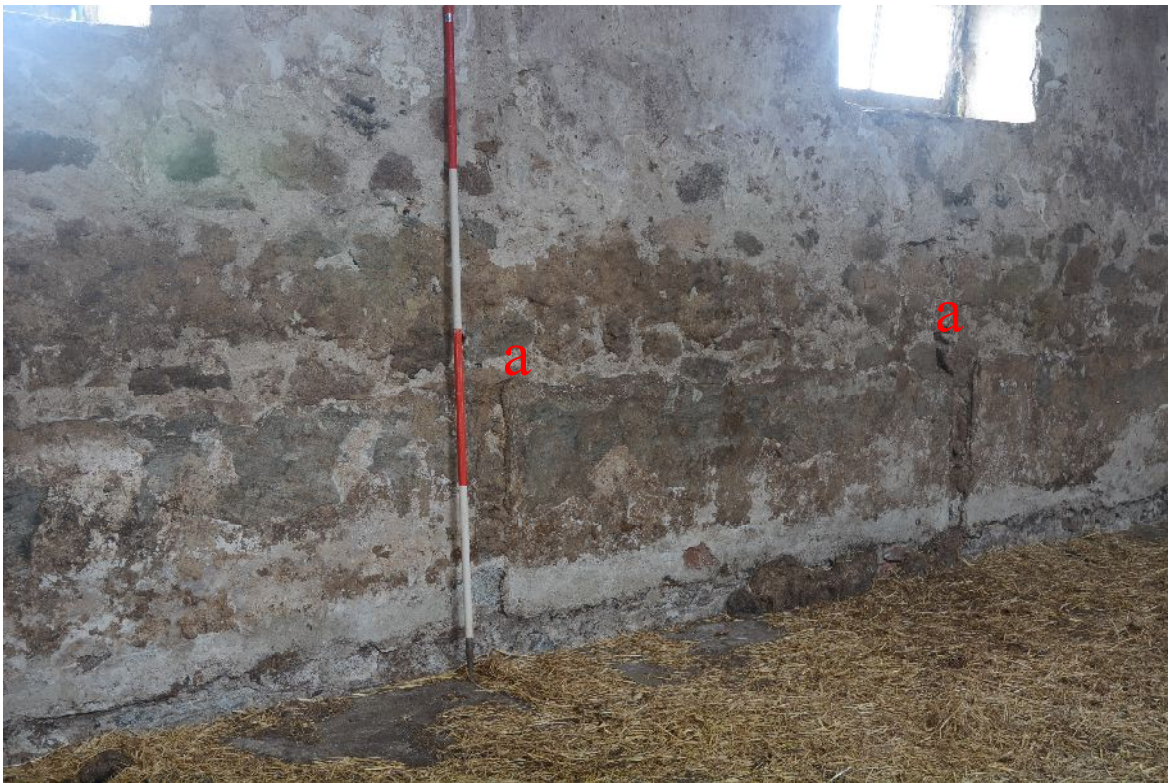
Illus 27 Detail of interior S wall of Building G with scars of original tied cow stalls (a)

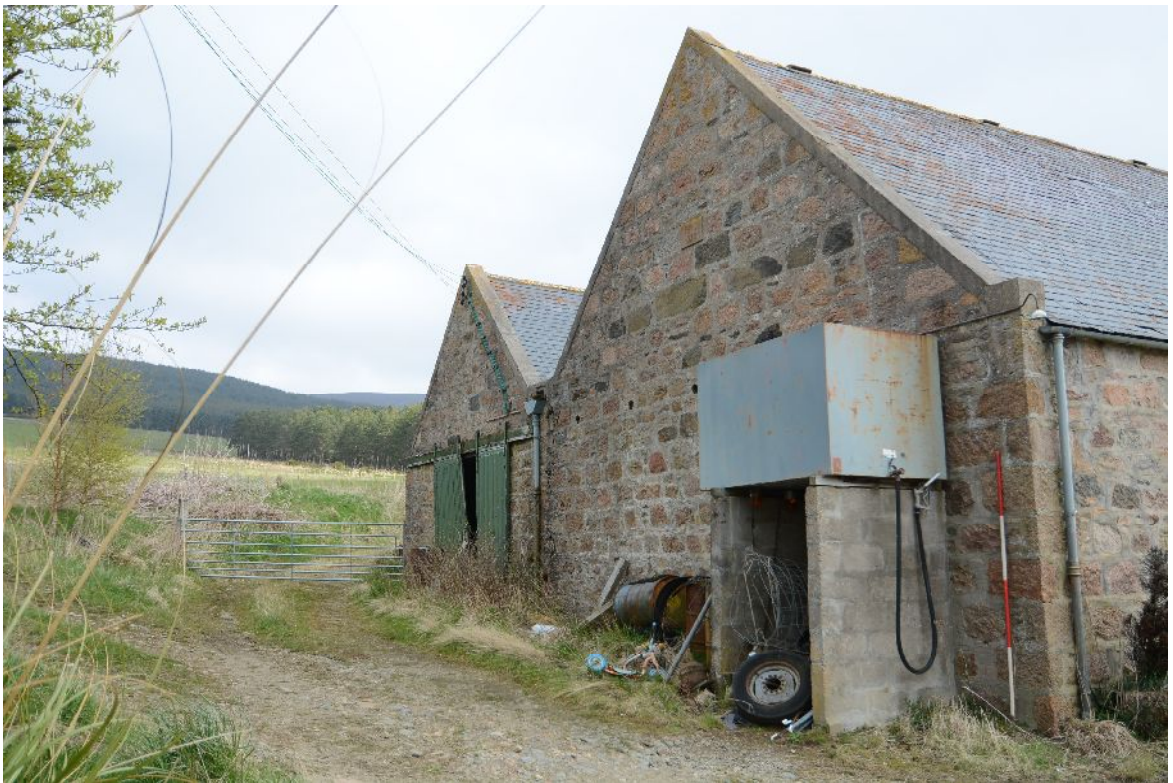
D9 W:2.48m H:2.45m. Stone rybats. Present lintel metal and concrete. Sliding wooden door.

Illus 28 W gables of Buildings G (foreground) and H (with green doors)

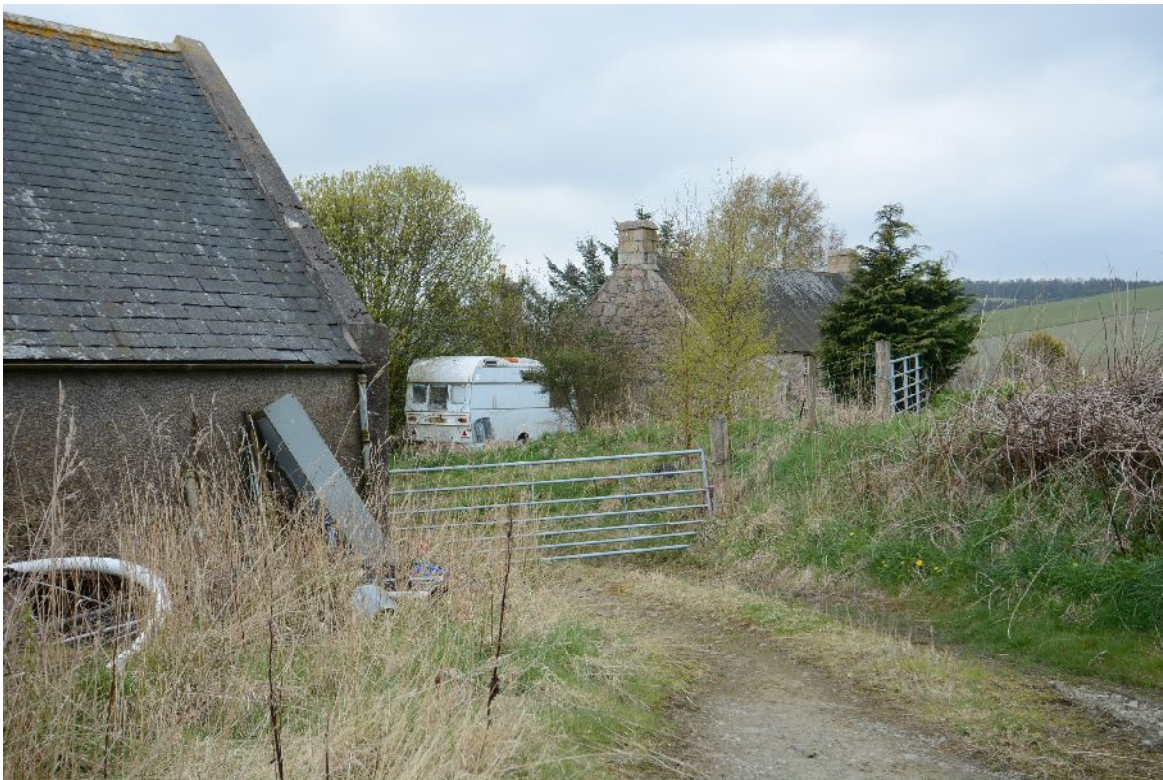
This is an interesting example of an Aberdeenshire steading in estate ownership. The earliest map evidence shows that the N, E and W ranges, including the mill, were in use by 1868. However, the original farmhouse, now used as a shed (Illus 29), is of 18th-century date, and the present steading on the 1868 map must have replaced some earlier buildings. The 1913 newspaper account of the Donaldson memorial suggests that the Donaldson family had been tenants at Boig for around 200 years (to 1891 when Mr Donaldson retired)- suggesting they had farmed there for much of the 18th and 19th-centuries.

Illus 29 The original 18th-century cottage (RHS by caravan) in relation to W end of Building G

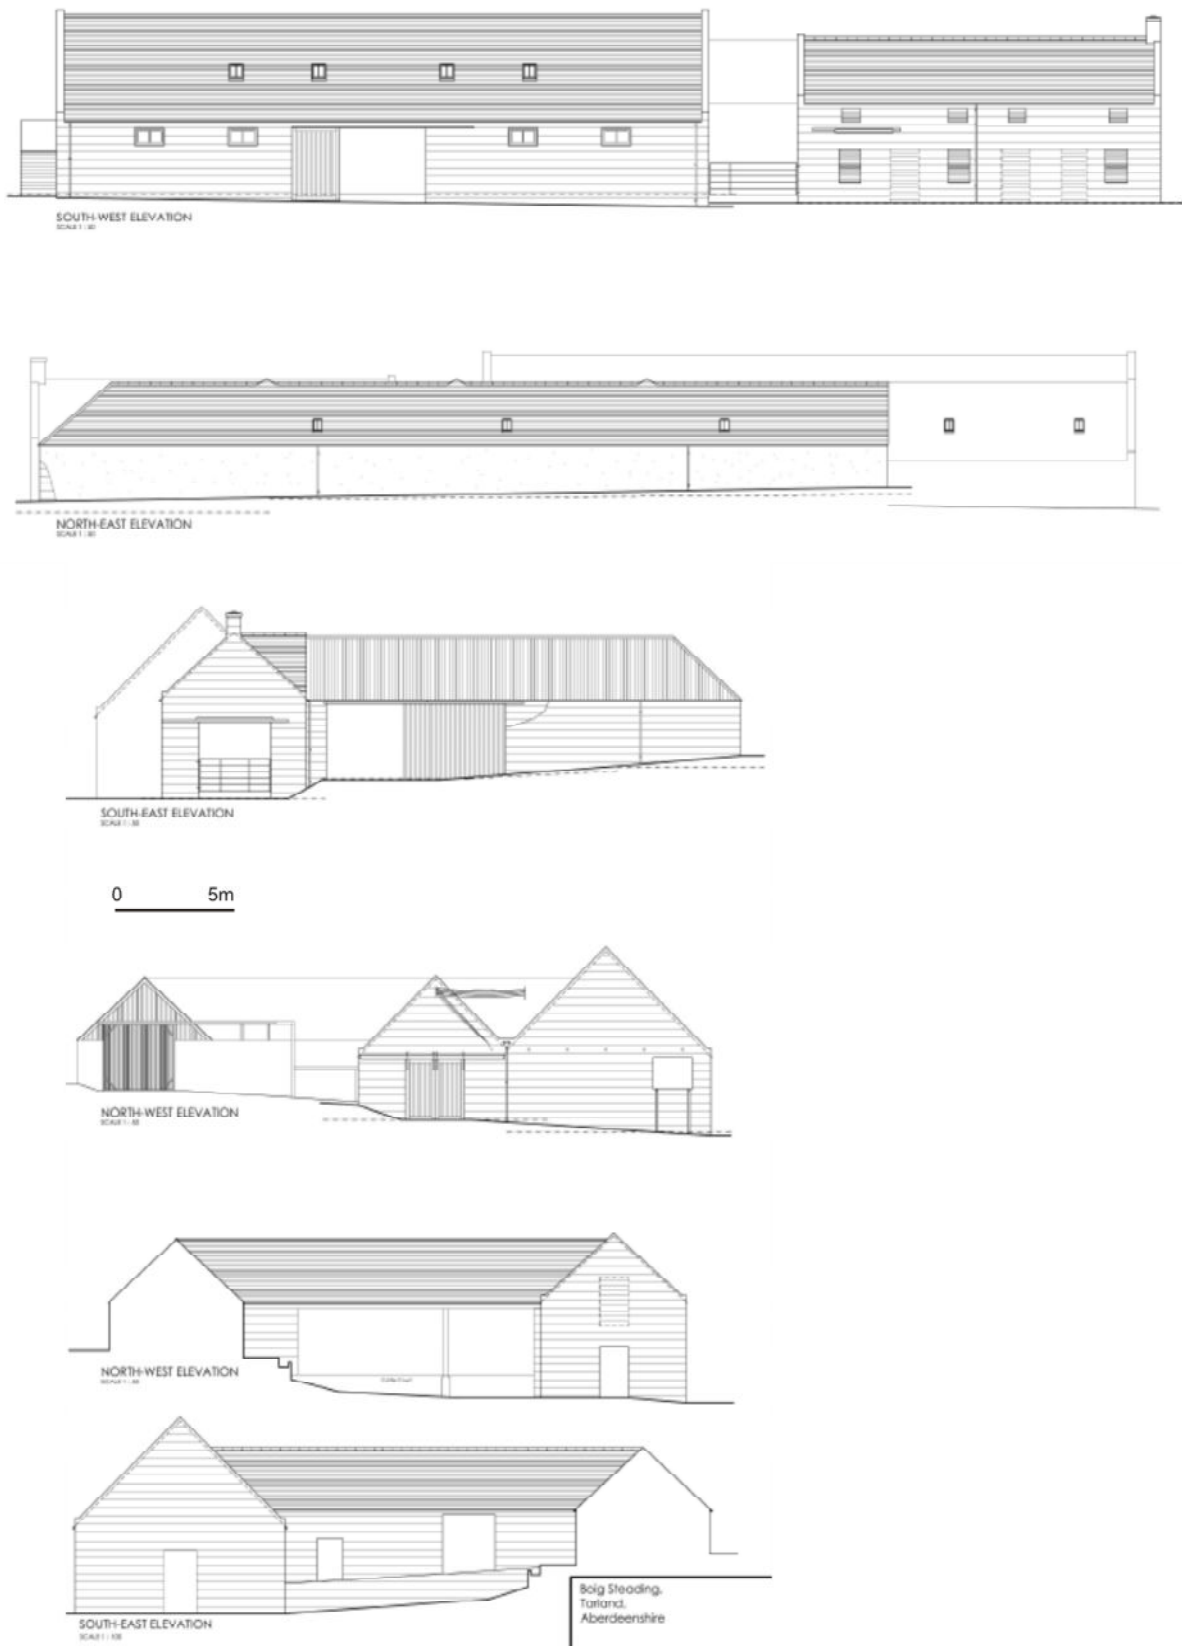
- 5 Methodology
- 5 Methodology
- 5.1 The ground plan (illus 13) and elevations (illus 31) have been annotated to show details which may help in understanding the development and history of the building.
- 5.2 The areas recorded were photographed. The full set of photographs will be supplied for the archive and an annotated plan in the present report (illus 30) indicates the position of each.

Illus 31 Elevations courtesy of Gerry Robb
