**BOWLING CLUB EXTENSION
KINTORE
ABERDEENSHIRE**

Watching Brief and Evaluation

Carried out 9th May 2017
by
Murray Archaeological Services Ltd

Report No: MAS 2017-10
by
H K Murray & J C Murray
H K Murray BA, PhD, MCI(A), FSA Scot
J C Murray BA, MCI(A), FSA Scot, FMA
Hill of Belnagoak, Methlick, Ellon, Aberdeenshire AB41 7JN
Telephone: (01651) 806394 e-mail: cmurray@btinternet.com

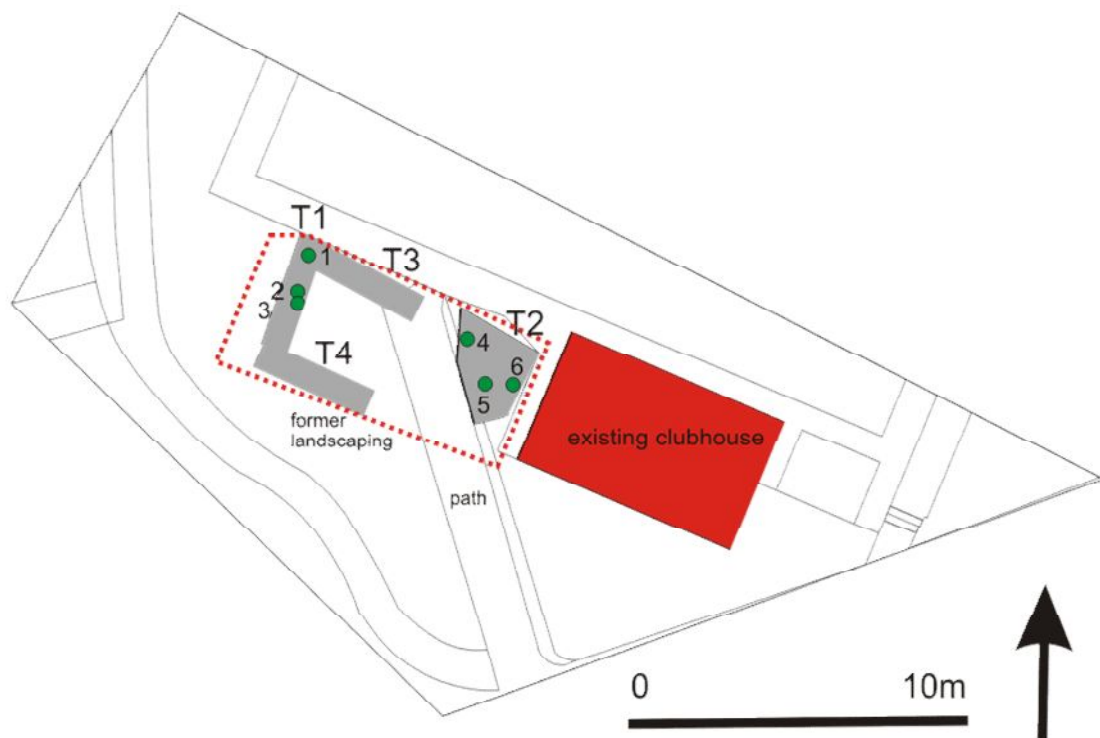
Illus 2 Plan of site. Site outline dotted in red.

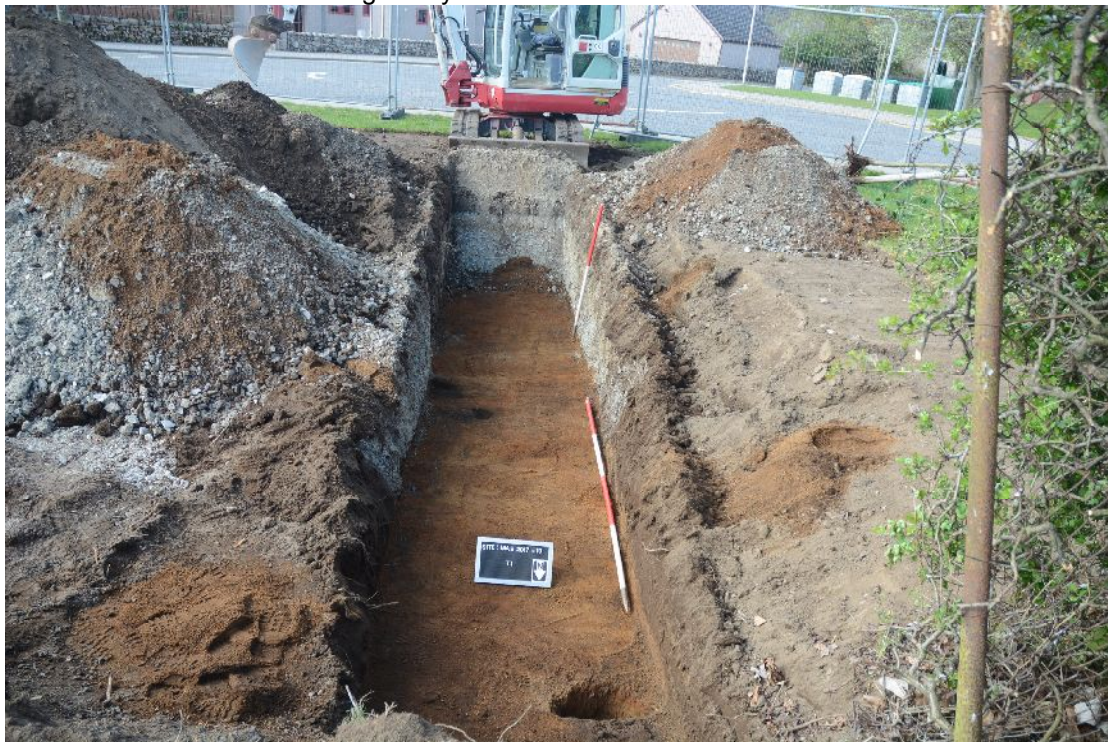
Stratigraphy: At N end redeposited topsoil from ground surface to top of natural. For much of trench and S end there was c300mm redeposited topsoil over up to 800mm grey stony sub-base. Natural was fine yellow gravel.

No	Easting	Northing	Feature	Comment
1	379041	815927	Hollow 400mm diameter, 120mm deep cut into natural. Fill compact mid brown silty topsoil	Possibly stone hole
2	379040	815925	Hollow 300 x 250mm. 60mm deep. Fill dark brown gravelly silt	Possibly stone hole
3	379040	815924	Hollow 300 x 200mm. 100mm deep. Fill dark brown gravelly silt.	Possibly stone hole

Illus 3 Trench 1 looking S. Contexts 1-3 shown excavated. Grey sub-base visible in sections.

No artefacts were found on the site and the few features appeared either to be natural (contexts 1-3) stone holes etc) or possibly related to the earlier building and site stripping works (contexts 4 & 5). Only an area of in situ burning (context 6) could have been earlier but there was no evidence of date to support this possibility.

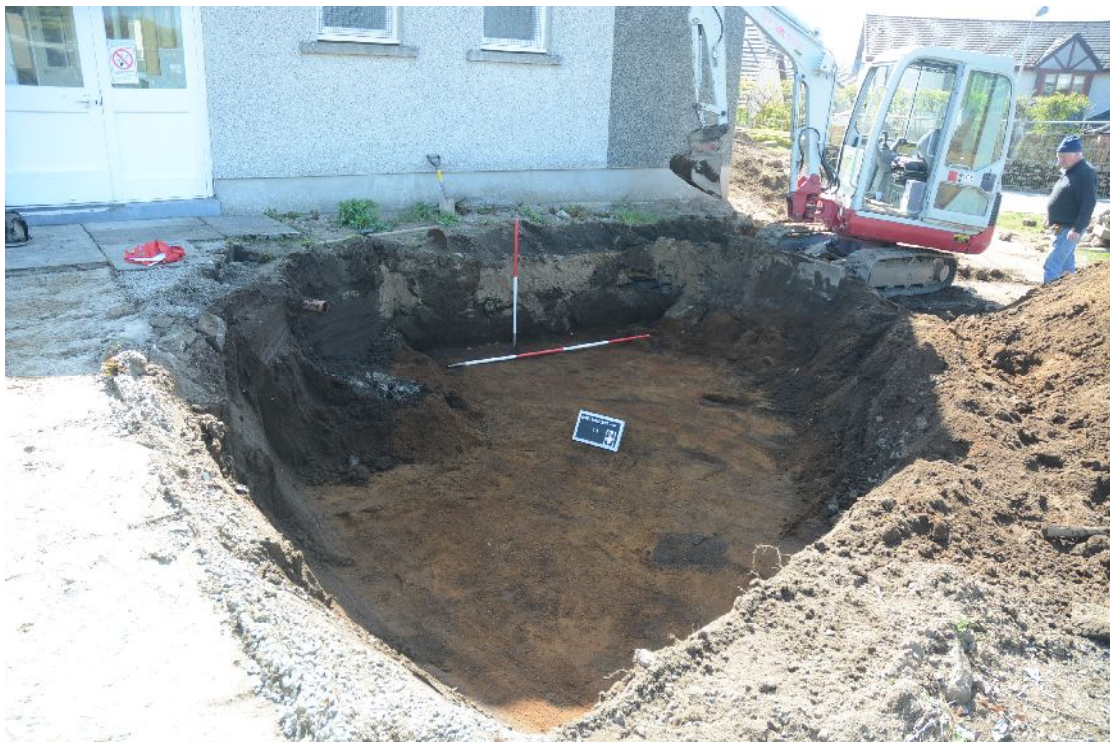
Stratigraphy: At the E (clubhouse) end there was a considerable amount of buried building rubble, presumably buried when the clubhouse was built in 1980. Elsewhere there was redeposited topsoil over fine yellow gravel natural.

Illus 4 Trench 2 looking E to existing clubhouse

The area nearest the existing clubhouse, which it had been hoped would have been less disturbed, proved also to have been previously largely stripped to natural, with some infilling with building rubble around 1980 when the clubhouse was built.

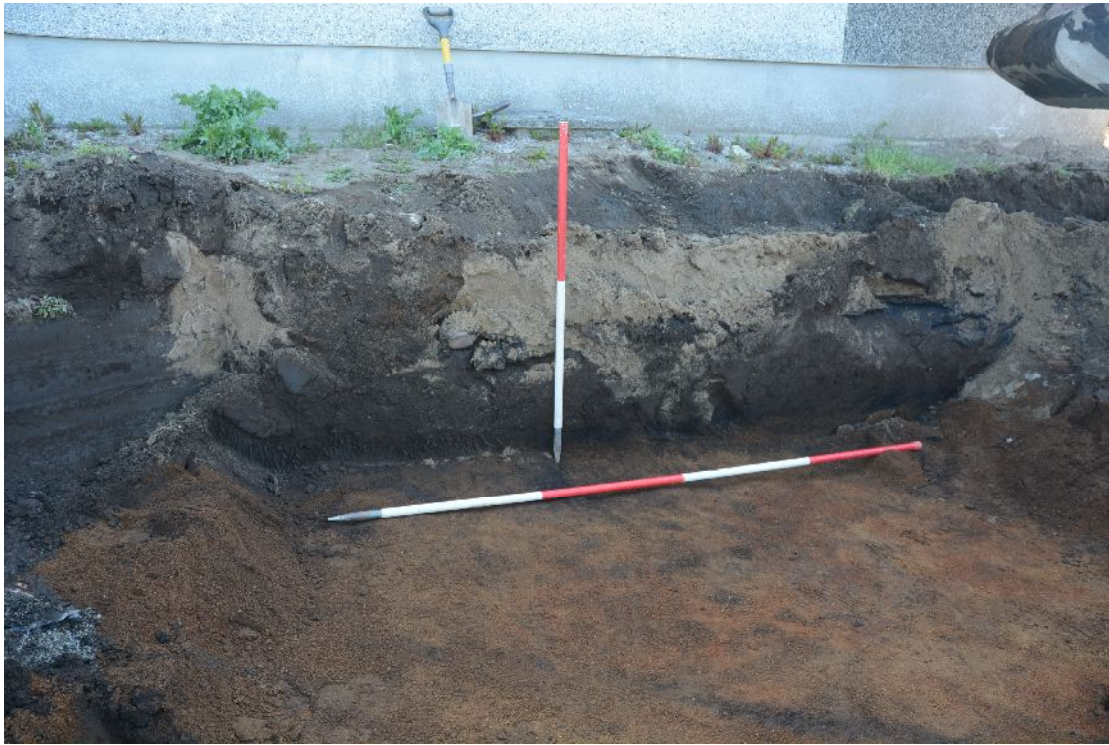
Illus 5 Trench 2, E section, below existing clubhouse, showing buried building rubble in section.

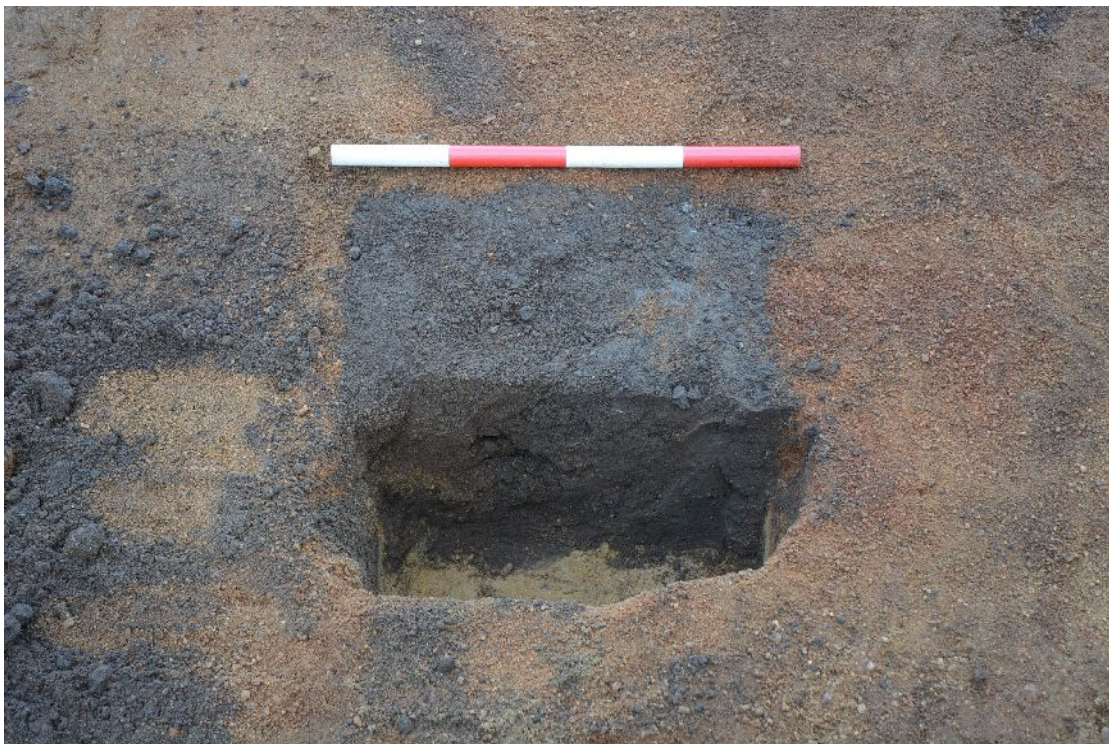
No	Easting	Northing	Feature	Comment
4	379049	815922	Square, vertically sided cut 350 x 350mm and 220mm deep. Fill grey v compact silt.	Contexts 4 & 5 appeared so regular that they are more likely to have been created mechanically- for example the 'legs' of a machine during clearance.
5	379050	815920	As 4 (above)	As (4)
6	379052	815920	Patch of gravel 1.2m diameter burnt reddish, with smaller patch black charcoal dust c 800mm across and c50mm deep. No chunks of charcoal.	No evidence of date

Illus 6 Trench 2, context 4

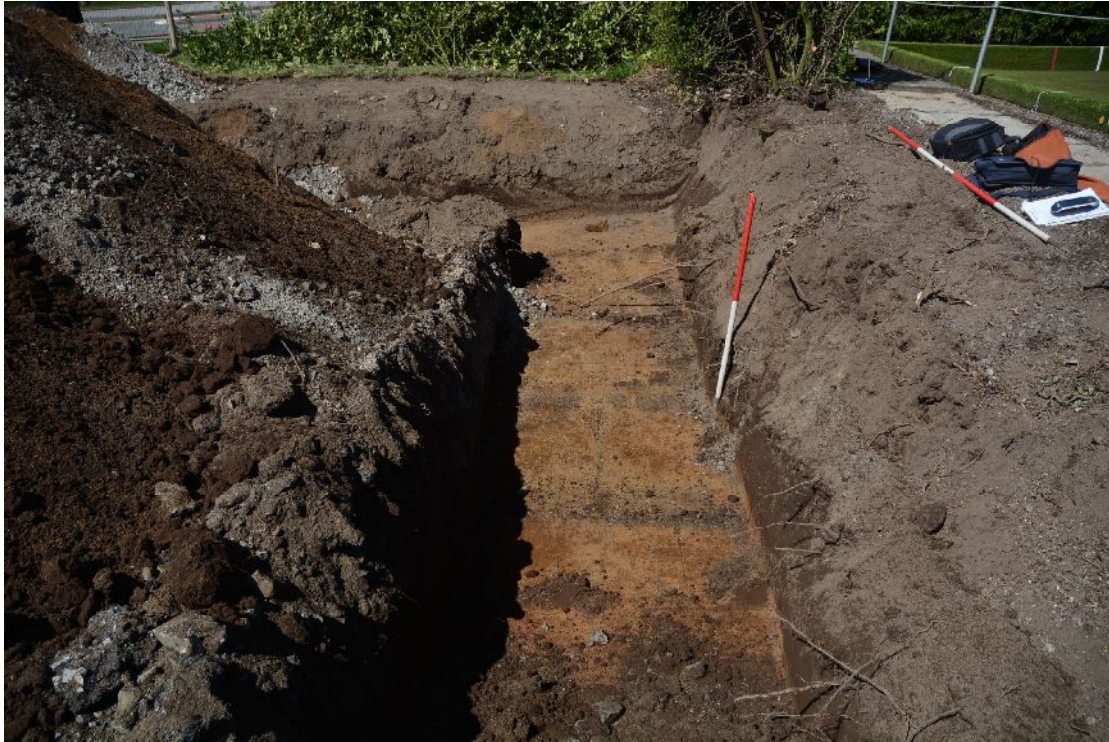
Stratigraphy: N side : topsoil where a hedge had been removed. On S side up to
600mm sub-base with chunks of buried tarmac etc

Illus 7 Trench 3 looking NW

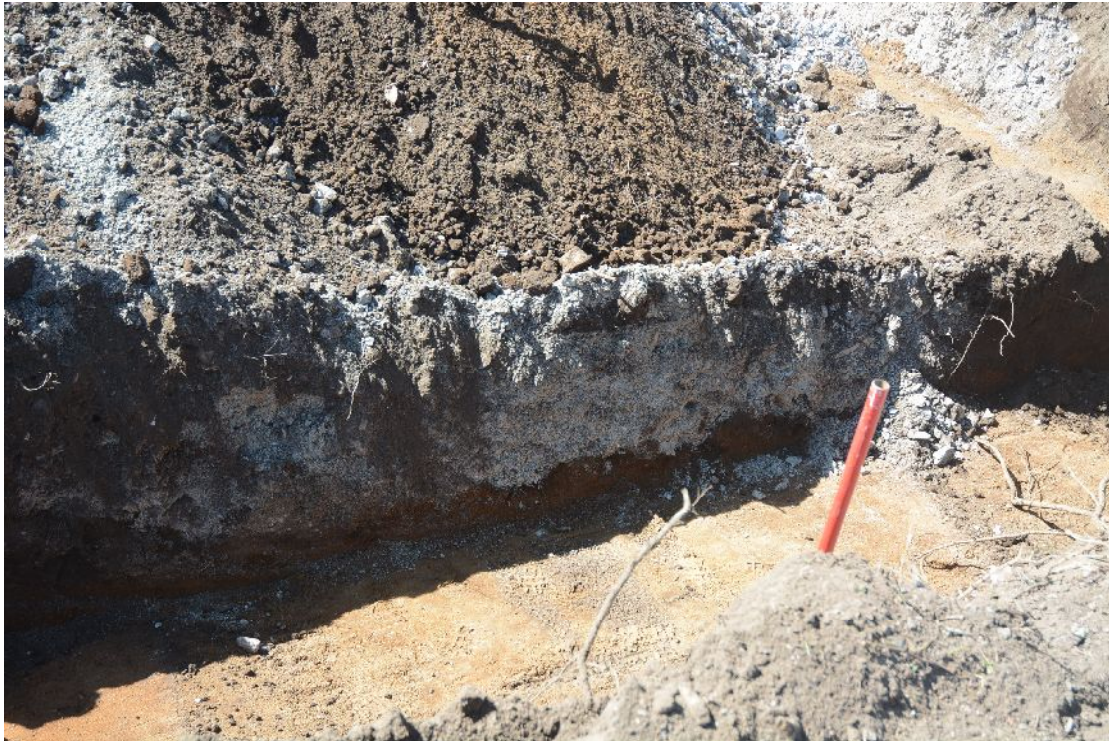
Illus 8 Trench 3 W section with sub-base to natural

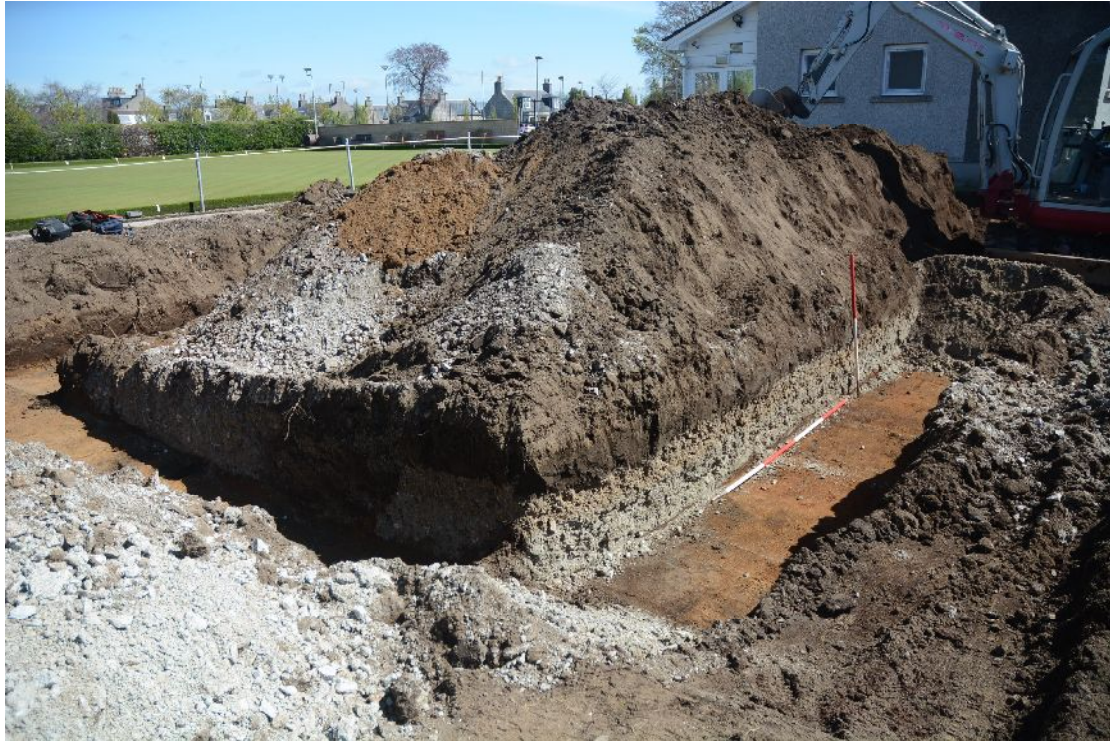
Stratigraphy: 300-500mm of redeposited topsoil over 400mm grey stony sub-base on to natural.

Illus 9 Trench 4 looking SE
