**HOWE OF ANGUSTON  
PETERCULTER  
ABERDEEN**

**Standing Building Survey**  
Carried out 25<sup>th</sup> May 2017  
by  
**Murray Archaeological Services Ltd**

**Report No: MAS 2017-11**  
by  
H K Murray and J C Murray

#### **- Standing Building Survey -**

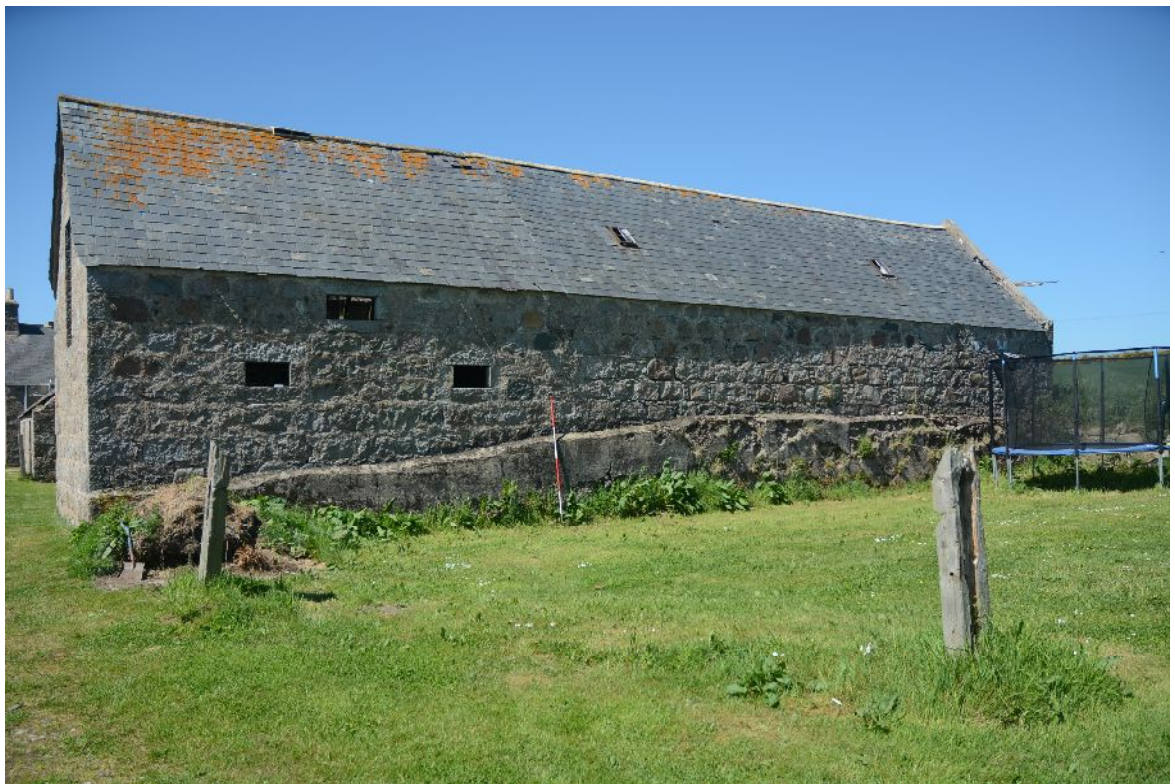
**Illus 7 E elevation of E range.**

**W1-W3** W: 0.63m H: 0.35m Grey granite rybats, lintels and sills. W1 & W3 into stable. W2 into loft. Traces of tilting windows.

A revetting against much of the lower half of the outside of this wall obscured any external indications of the blockings associated with the mill wheel shown on the historic maps. The lade is still visible to the N of the steading but the mill pond has been filled in.

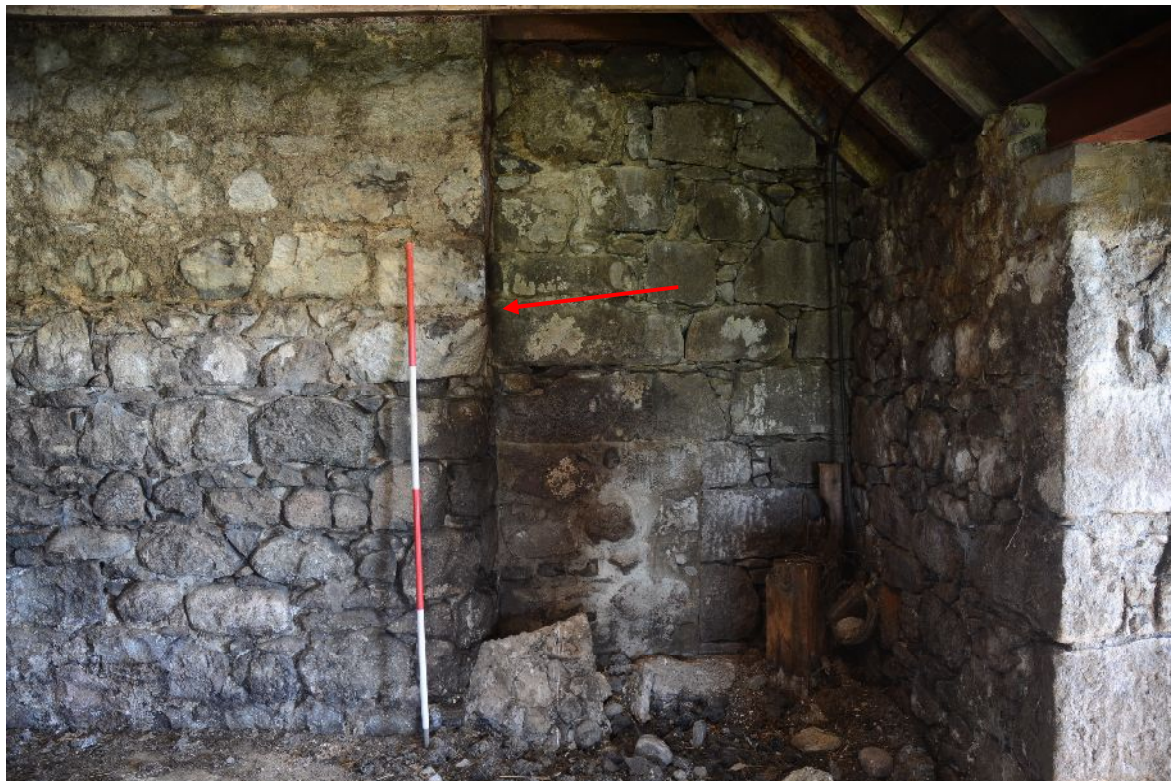
**D5** W: 0.98m H: 1.65m External lintel and rybats granite. N side curved with angled top. Opened between mill and N range. Stone blocked. (illus 8 & 9)

**Illus 8** D5 N side (LHS) curved at top (arrow)

Door D5 from the mill had a curved side which may have been intended to make an easier access for men carrying grain sacks.

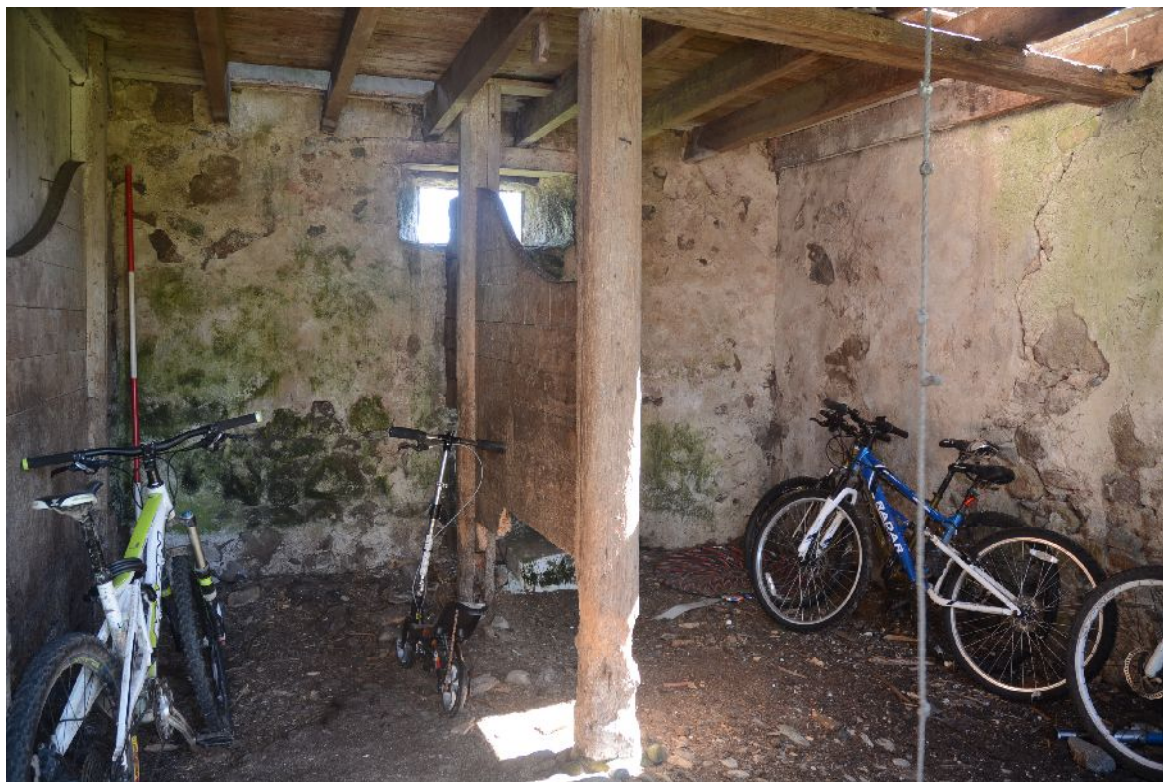
The stable (4.45 x 6.2m internally) was divided into 3 stalls with original wooden trevices (illus 10) which had metal strip along tops to discourage chewing. From S to N stalls W: 1.98m, 1.68m and 2.5m. Trevis H at tail: 1.46m, H at head: 2m. There was a surviving cobbled floor with a drain behind the horses (illus 11).

**Illus 10 S and central stalls in stable with wooden trevis**

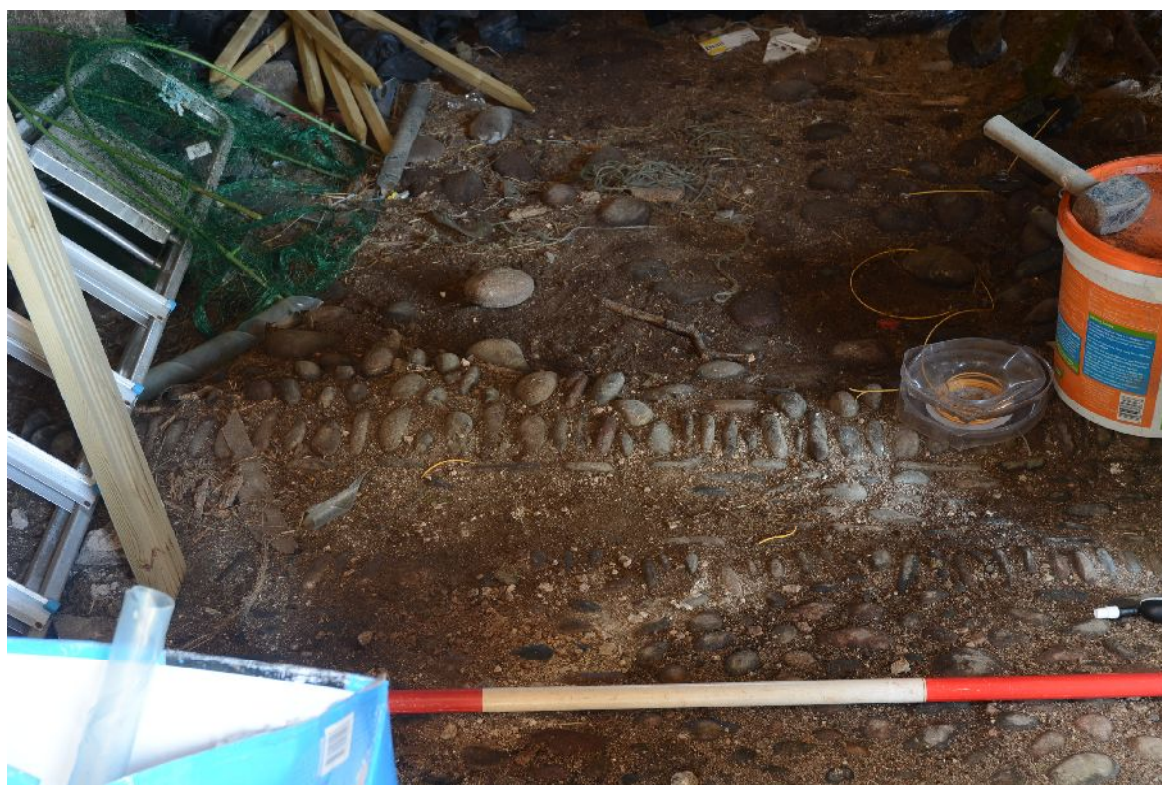
**Illus 11 Drain in cobbles in stable- behind N stall**

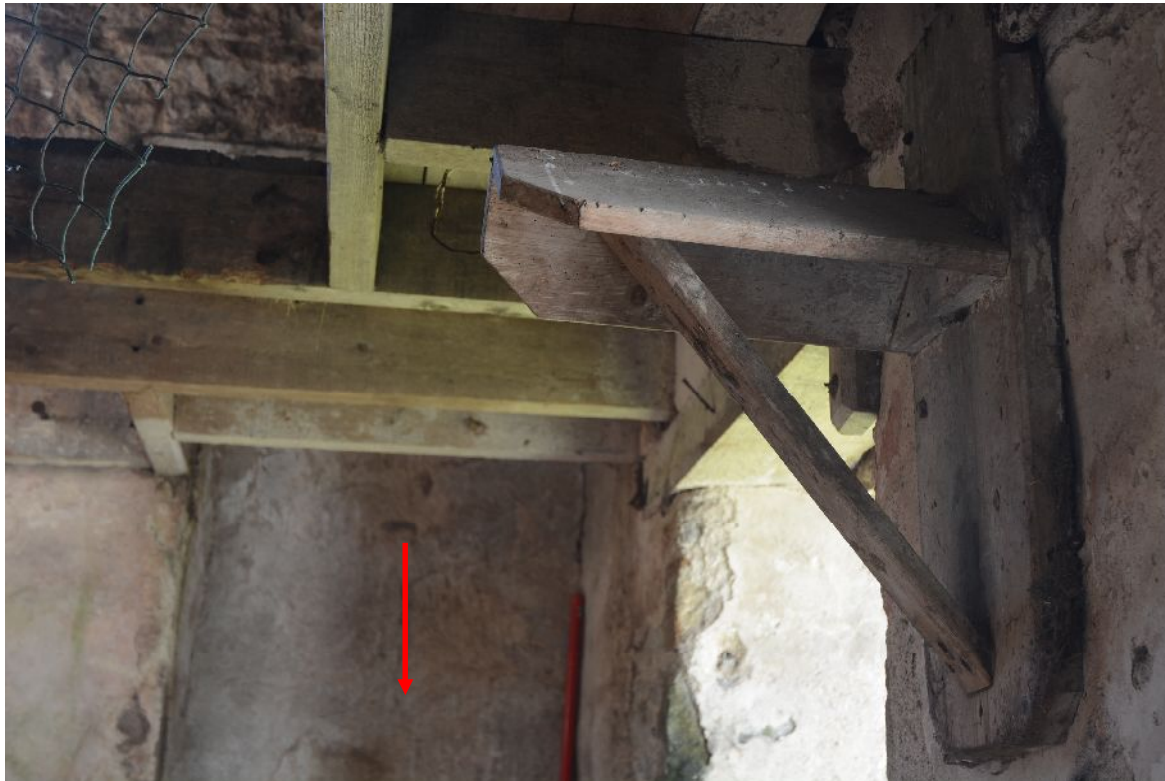
**Illus 12** Harness support on inside of W wall of stable. Hay chute from loft (arrow) in background

**F1** Alcove 280mm deep and 0.93m wide in W side of S wall. Wooden lintel above level of loft floor. Can be interpreted as hay chute from loft to stable (illus 12).

Harness support on inside of W wall S of D2 (illus 12).

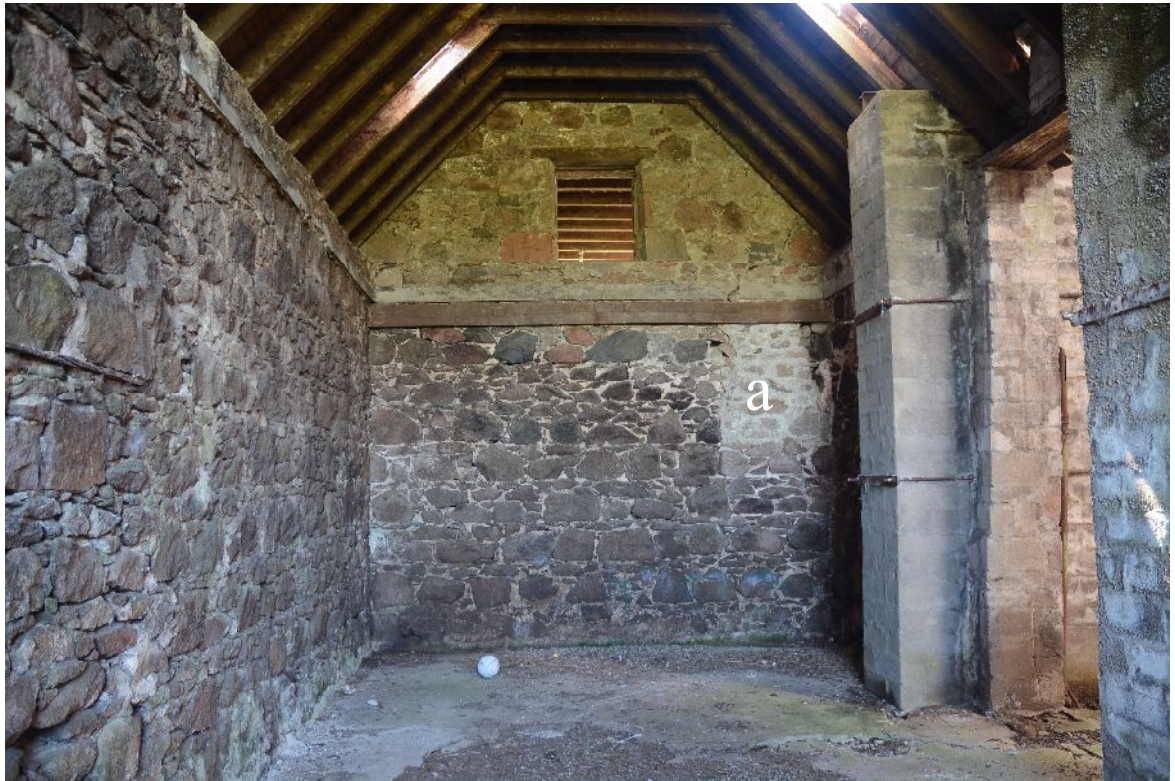
The grain loft over mill (12.6m x 4.45m internally) was accessed from gable door D6. No loft floor remained. A window with ventilation slats (could not be measured) was at loft level between the mill loft and the hay loft above the stable (illus 13).

**Illus 13 Interior S wall of mill showing slatted window to hay loft. Pale rectangle on mid wall RHS (a) appeared to be render/patching rather than a blocking**

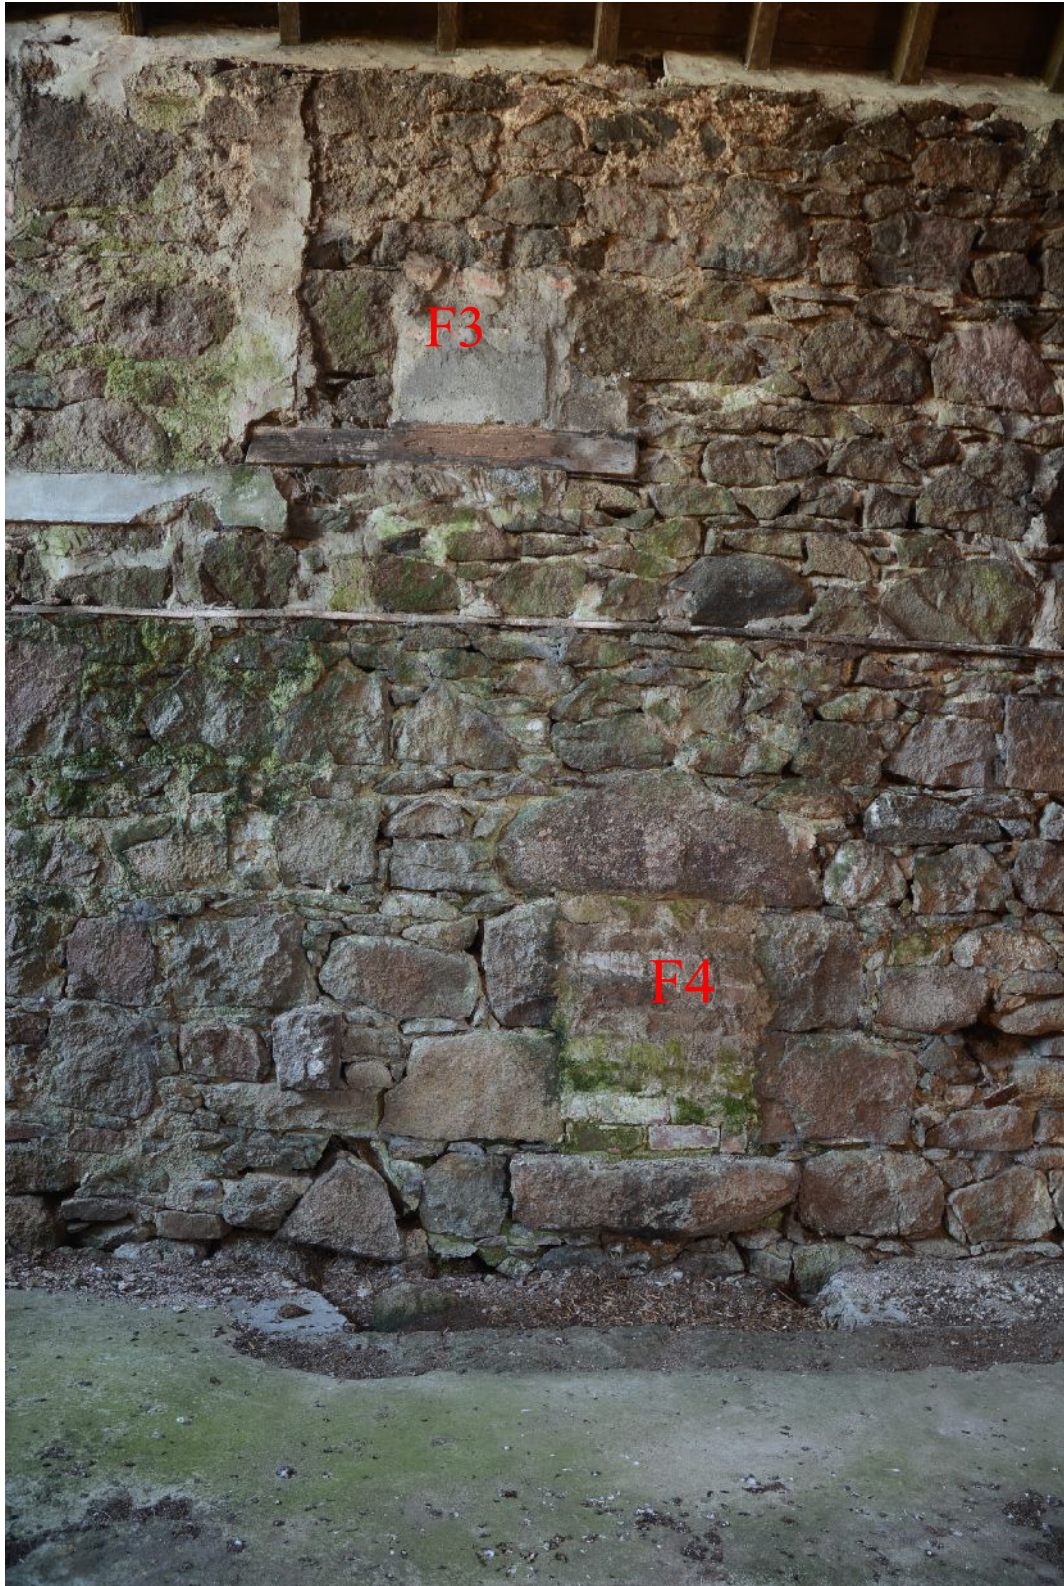
Mill fittings F3 and F4 on inside of E wall (illus 14) were not visible on the outer face of the wall because of external buttressing; however they coincide with wheel position shown on 1899 OS map.

**F3** Opening into loft of mill. Not measured. Concrete and brick blocked.

**F4** W: 0.60m H: 0.80m Brick blocked. Large triangular lintel and heavy granite sill. 0.25m from ground to top of sill. Recess (filled) in floor in front of F3. Can be interpreted as having held mill shaft. (illus 14)

**Illus 14 Mill. Inside of E wall showing blockings for mill shaft**

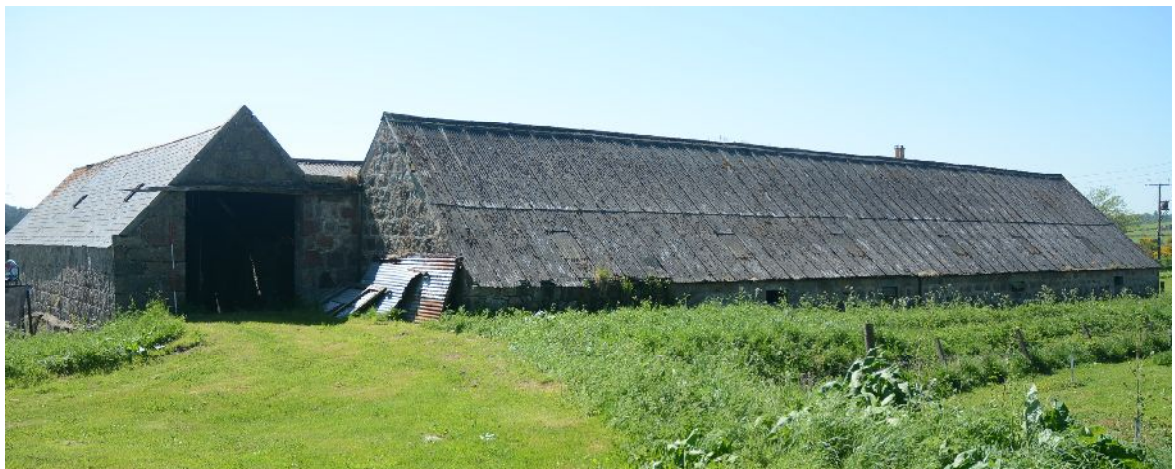
Illus 16 N wall of N range, cut into slope

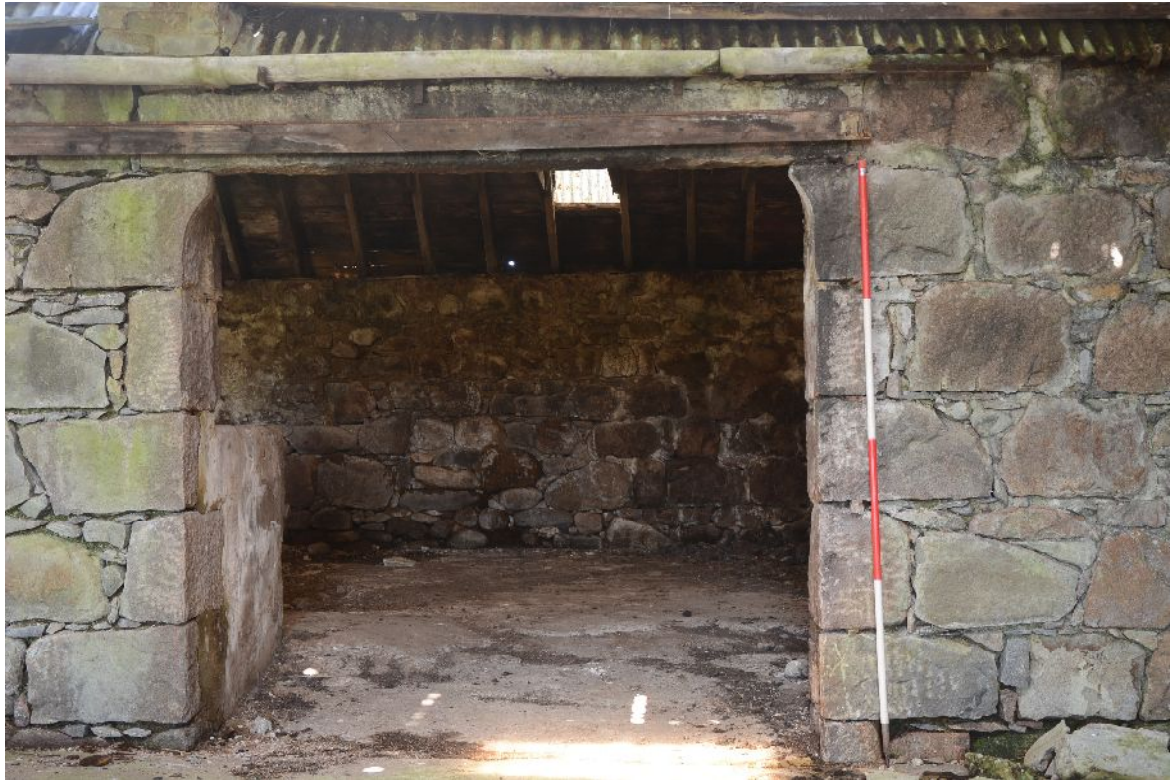
**D9** W:2.29m H: 2.10m (to present raised floor). Wide granite lintel. Granite rybats, curved by lintel. Can be interpreted as original cart bay. (illus 17)

**Illus 17 D9 from S looking into N range**

Door D9 indicates that the E end was a cart bay.

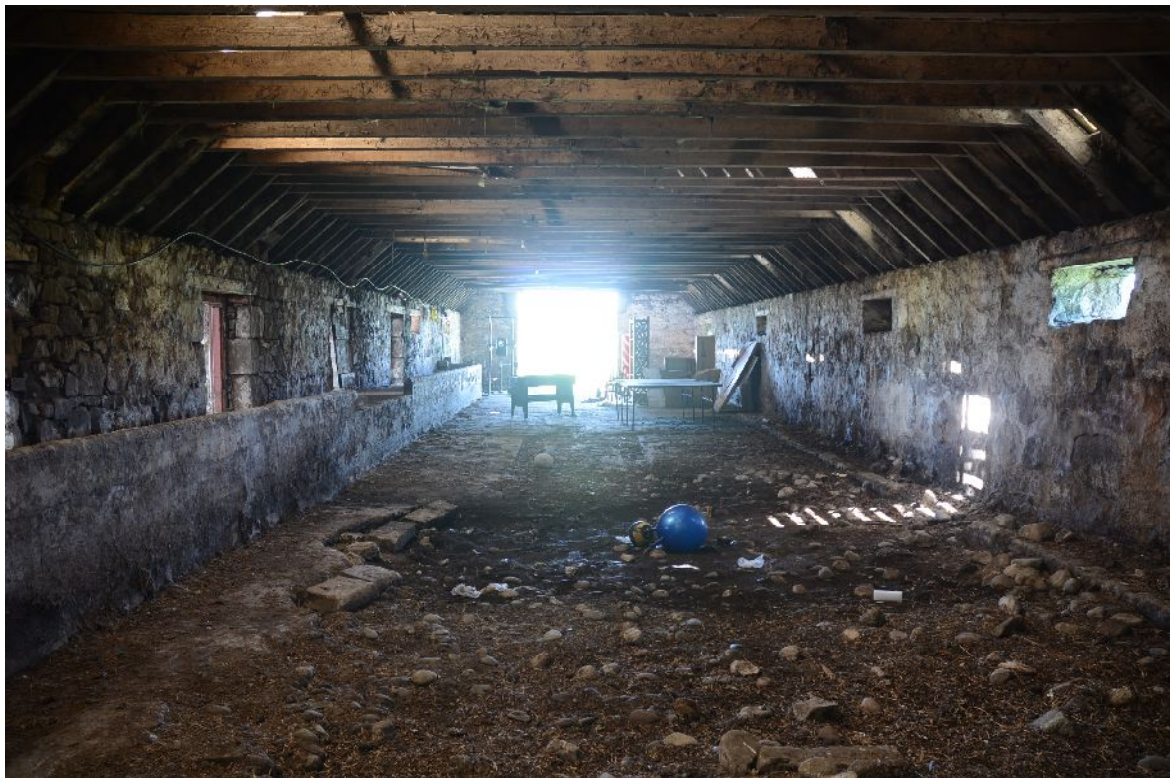
The interior had been opened out to form an open cattle court with a concrete trough and feed pass. Most of the floor was concrete but cobbles showed at the E end (illus 18).

**Illus 18 Interior of N range looking W. Cobbles in foreground**

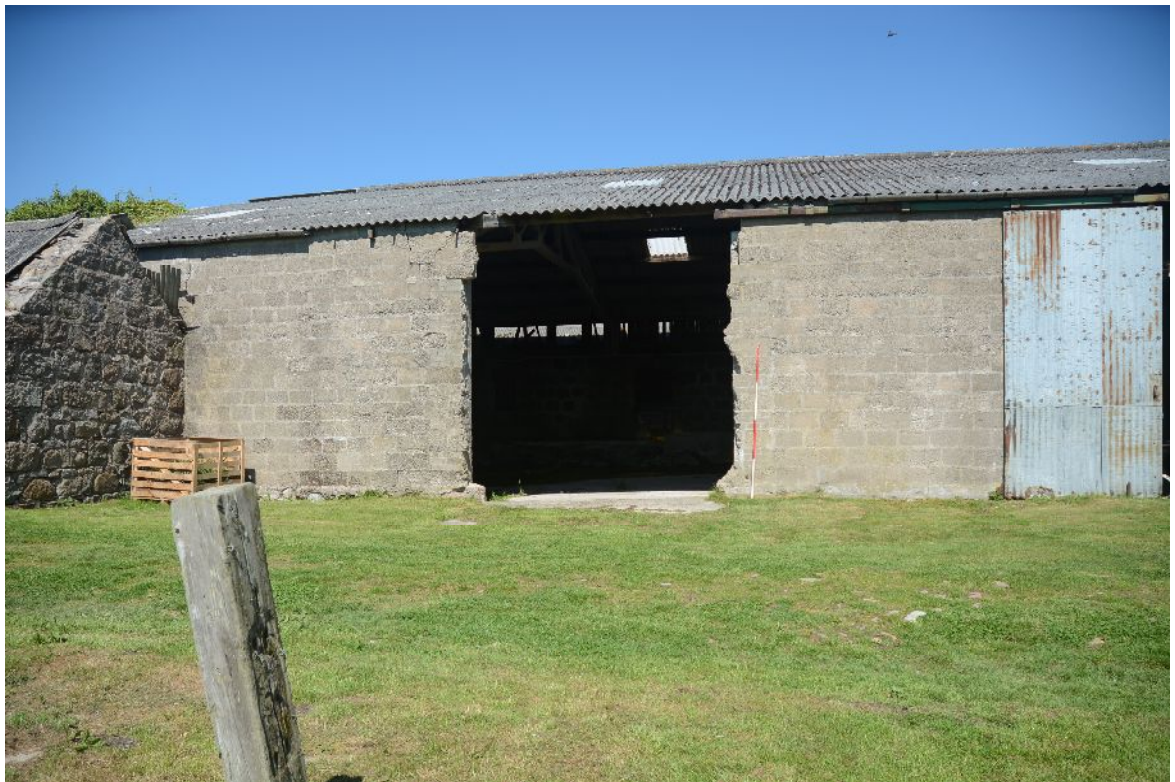
The original dung court extended across to the farmhouse in the N range, with the bothy added across part of the S side between 1865 and 1899. More recently a concrete block W wall and S wall were added to make an enclosed cattle court (illus 19).

**Illus 19 S wall of court built against and using N wall of bothy.**

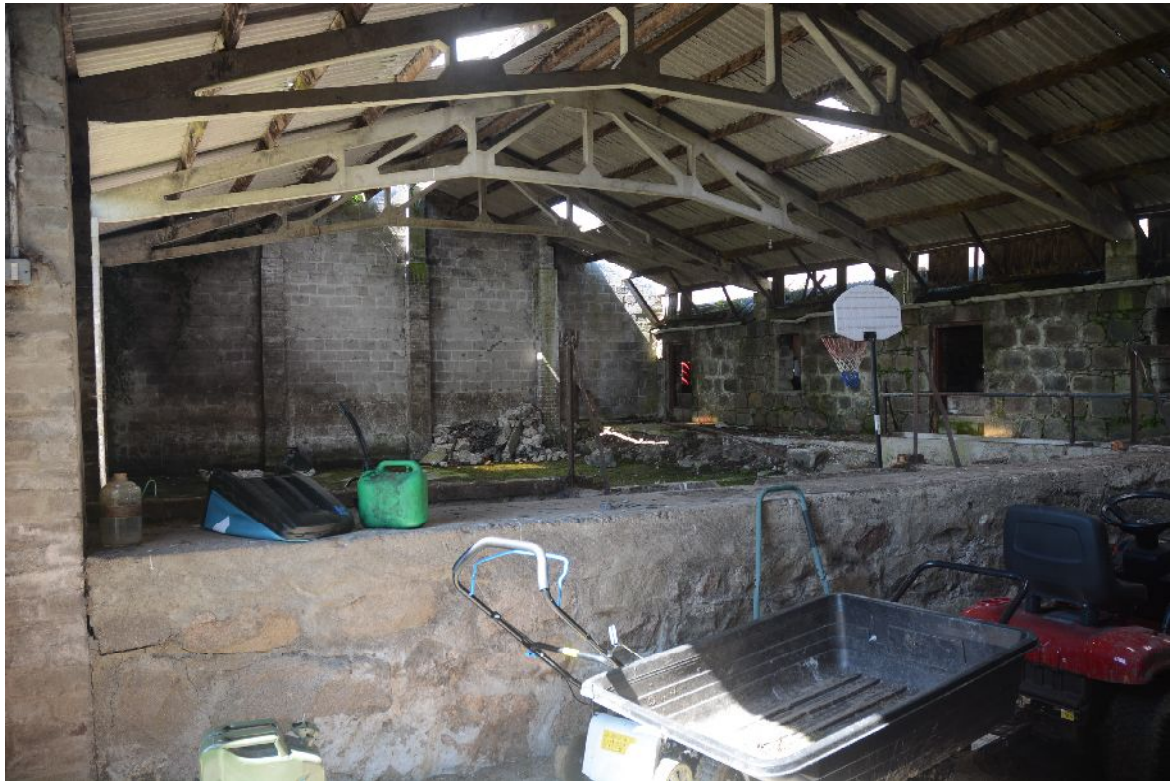
**Illus 20 Interior of court looking W. Note concrete roof trusses.**

Roof Corrugated asbestos on precast concrete roof trusses (illus 20).

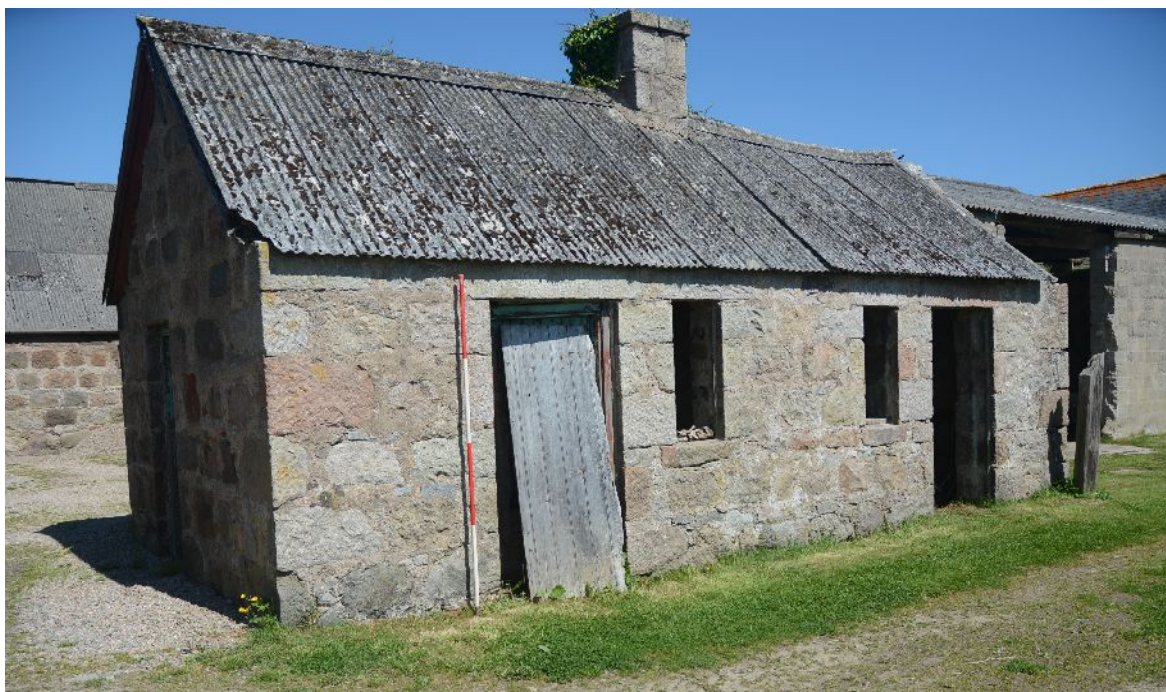
**Illus 22** S wall of bothy

**D13** W: 0.90m H: 1.85m Granite rybats and lintel

**D14** W: 0.90m H: 1.85m Granite rybats and lintel

**W13** W: 0.45m H: 0.80m Granite rybats, sill and lintel

**W14** W: 0.45m H: 0.80m Granite rybats, sill and lintel

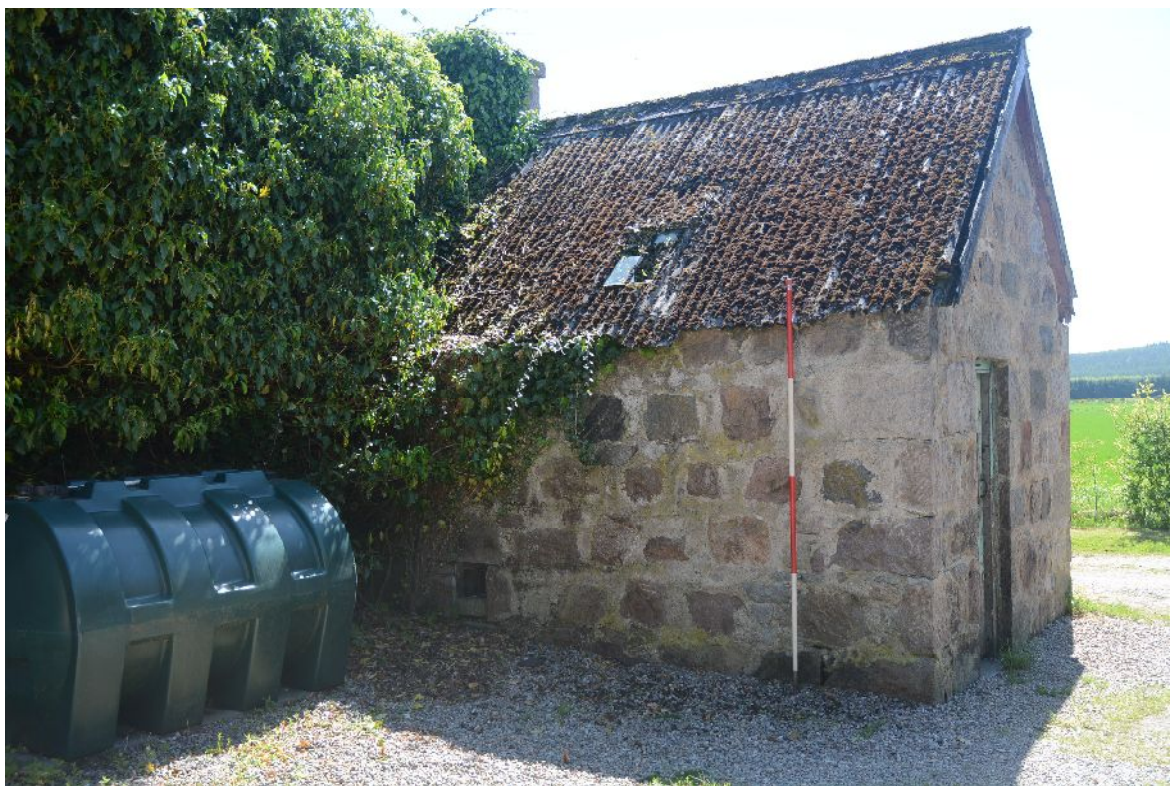
**F5** W: 0.33m H: 0.38m Granite surround wooden framed. Base c. 400mm above internal floor level.

**Illus 23** N wall of bothy. Arrow marks F5 opening

The E room had a fireplace with a granite mantel and granite sides. There did not appear to be any evidence of a fireplace in the W room-although as it was being used for storage the central wall was not easy to see. It is possible that this was originally an unheated bedroom. The low opening (F5) at the base of the back wall may suggest it was later used for hens. The large window in the front wall makes it unlikely that this W room was a privy.

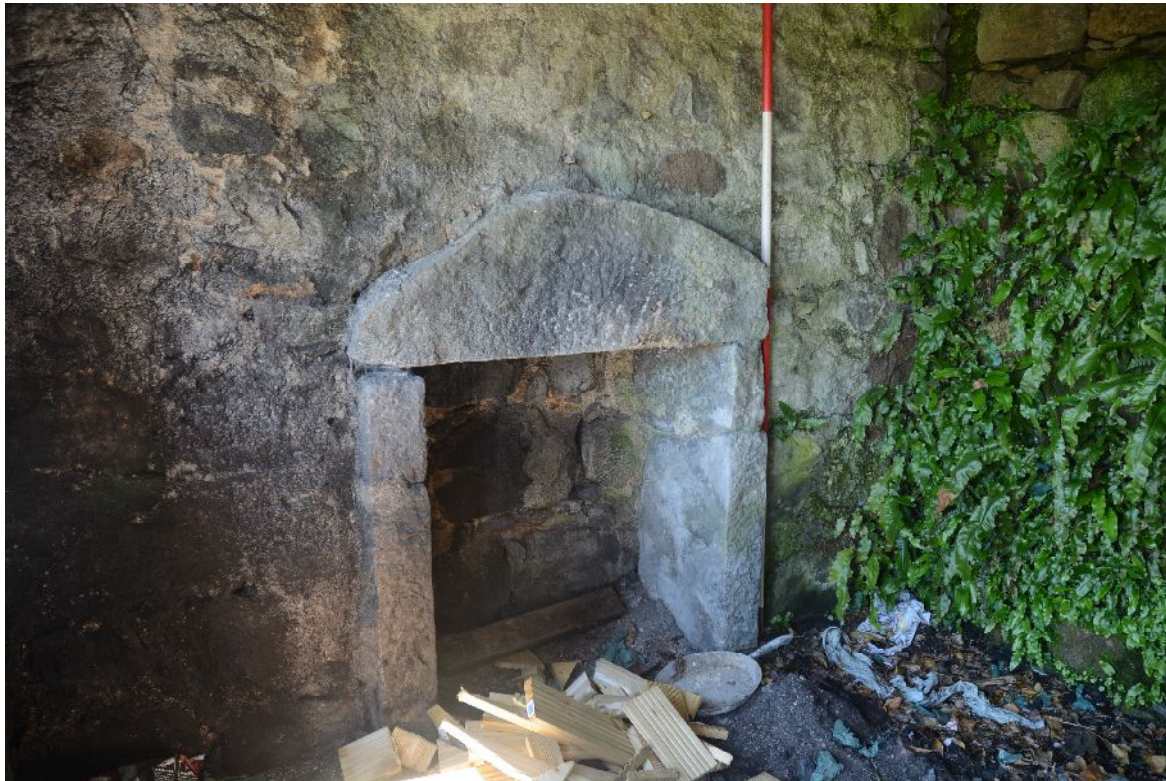
**Illus 24** Fireplace in E room of bothy

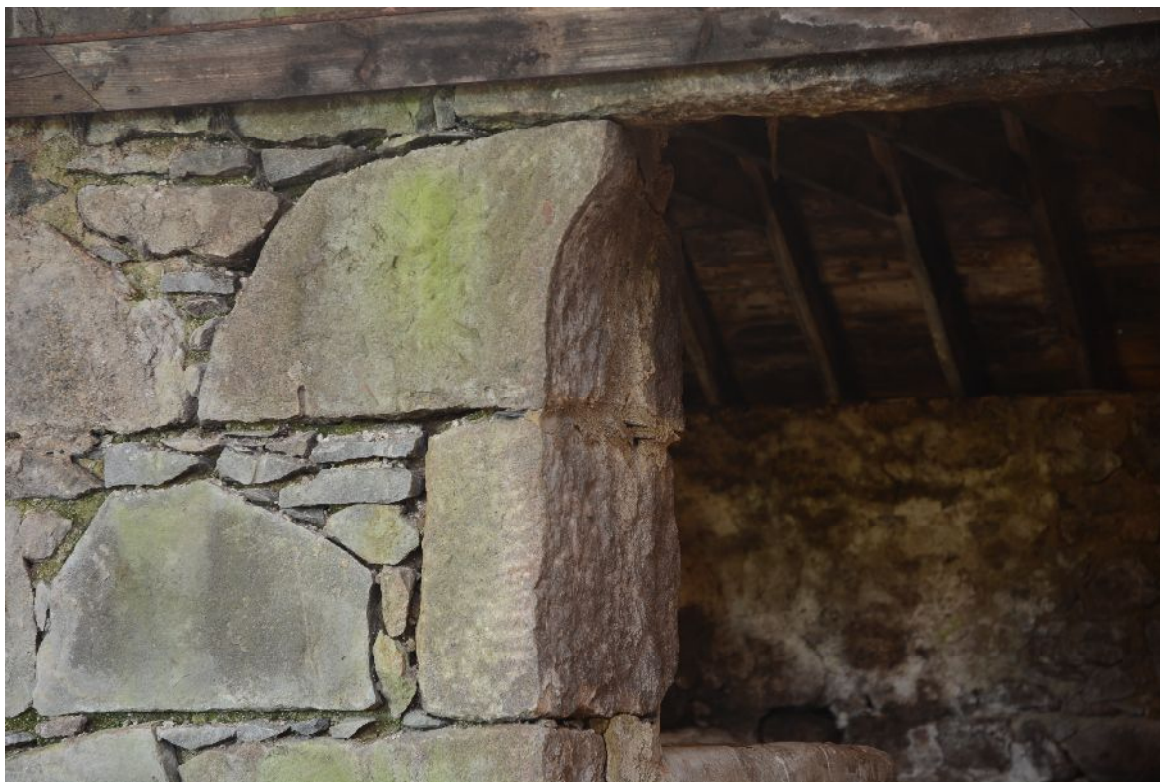
Illus 25 Detail of arch over cart bay
