**GORDONSHILLOCK  
ROSEHEARTY  
ABERDEENSHIRE**

**Standing Building Survey**

Carried out 7<sup>th</sup> October 2017

**Report No: MAS 2017-14**

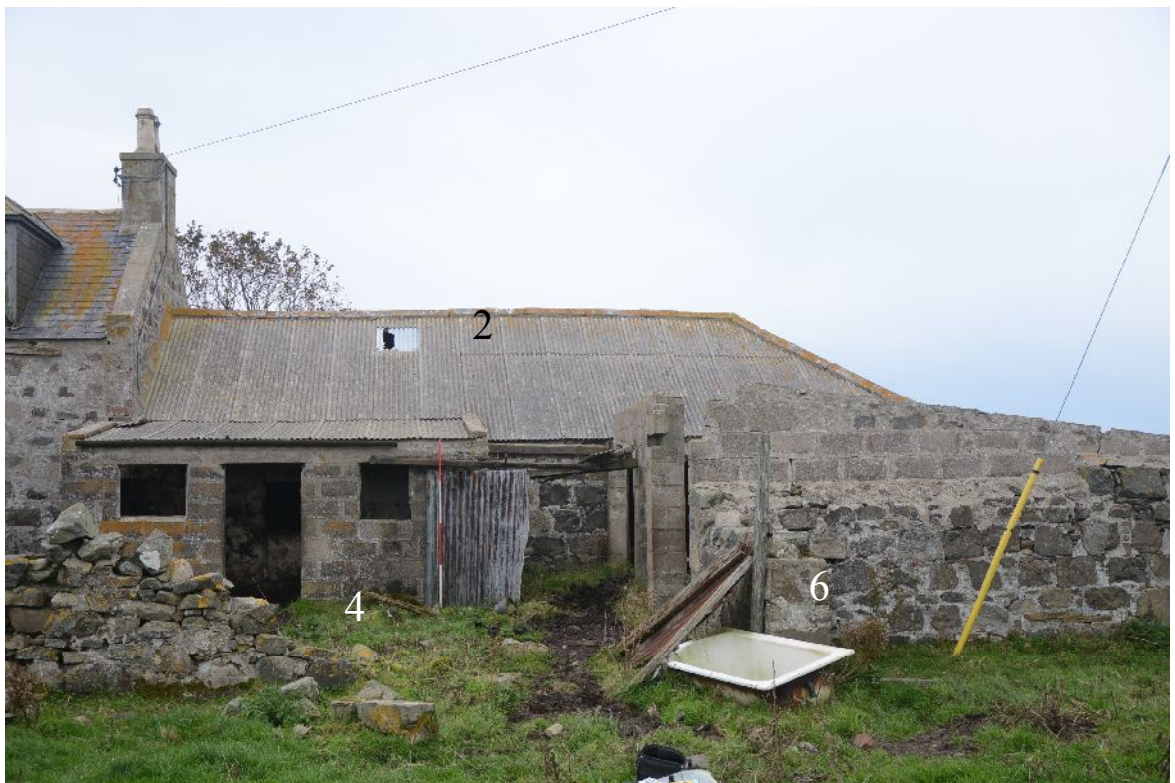
Walls Rubble stone. Abuts N wall of house. Structures 4 and 6 built against front (E) wall.

**Illus 8 Building 2 in background, with buildings 4 and 6 abutting its E wall.**

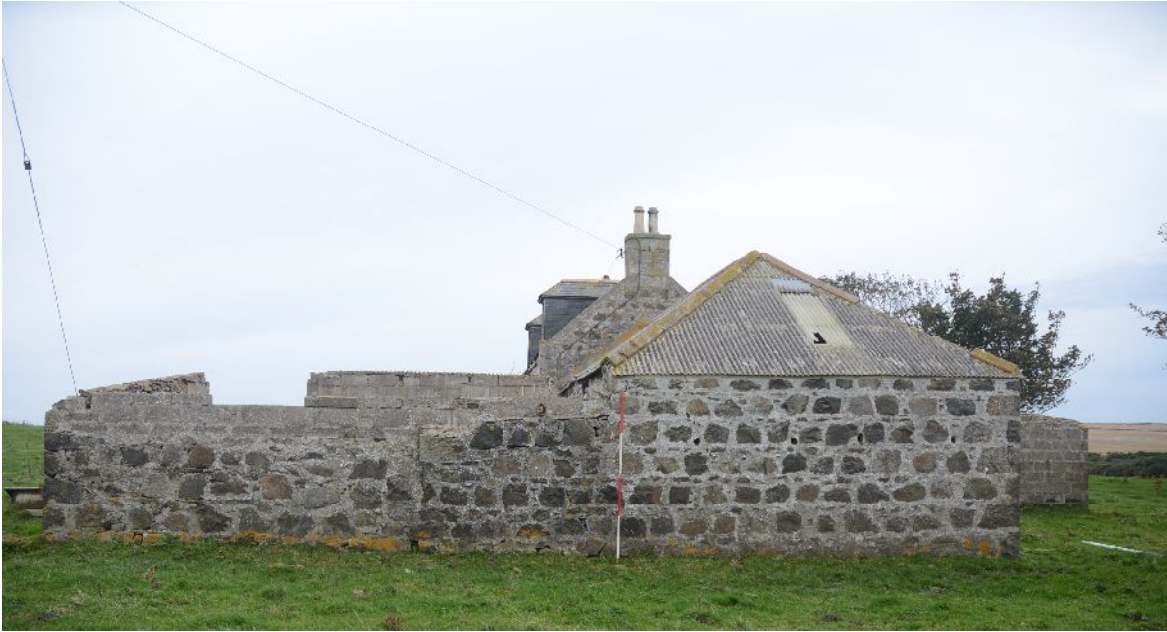
**Illus 9 Building 2 from N with Building 6 abutting it on LHS beside ranging rod.**

Ceramic pipes through wall for ventilation.

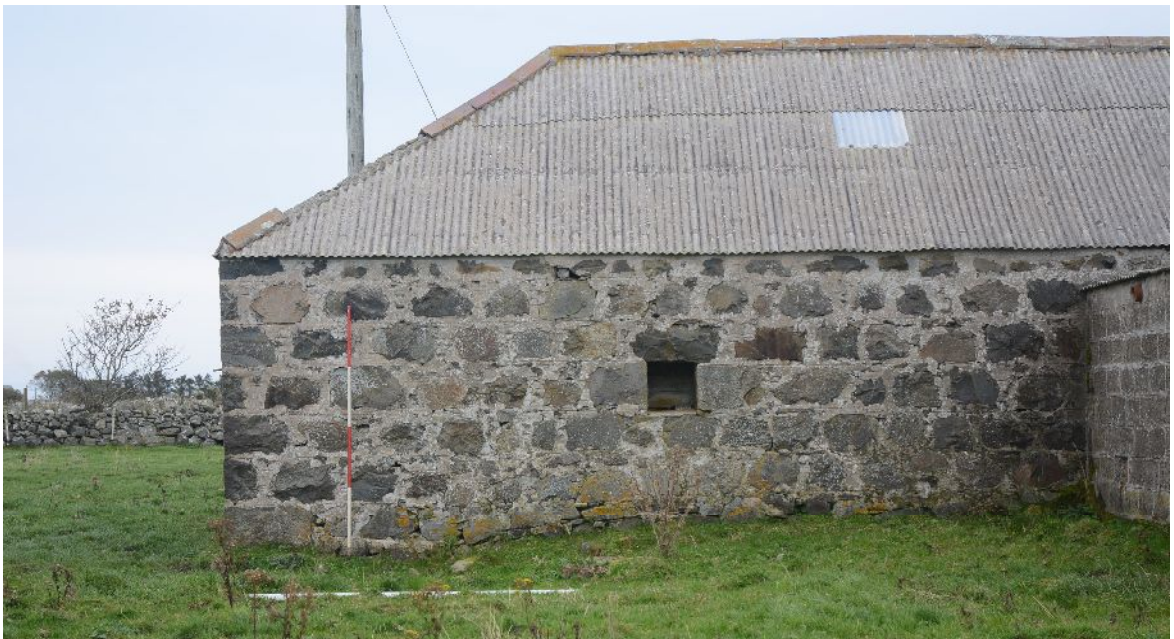
**D5** W: 1.14m H: 1.80m. Wooden lintel, rubble rybats. Plank door.

**F1** W: 0.42m H: 0.42m. Rubble surround, shutter on inside.

**Illus 10 Building 2. W wall with F1.**

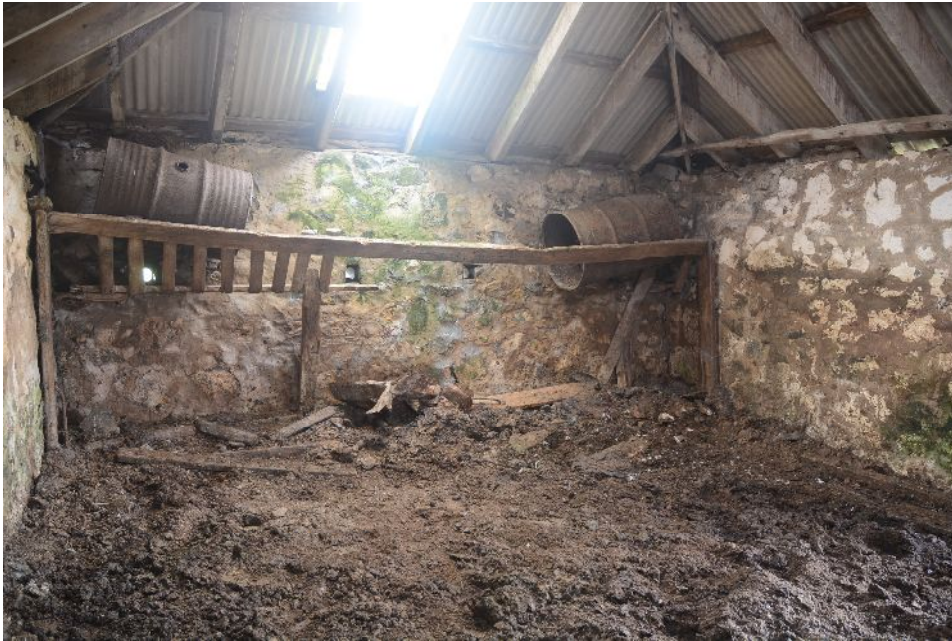
Divided into two by wooden partition. Wooden hay hake along inside of N wall.

**Illus 11 Building 2. Interior looking N, in N room**

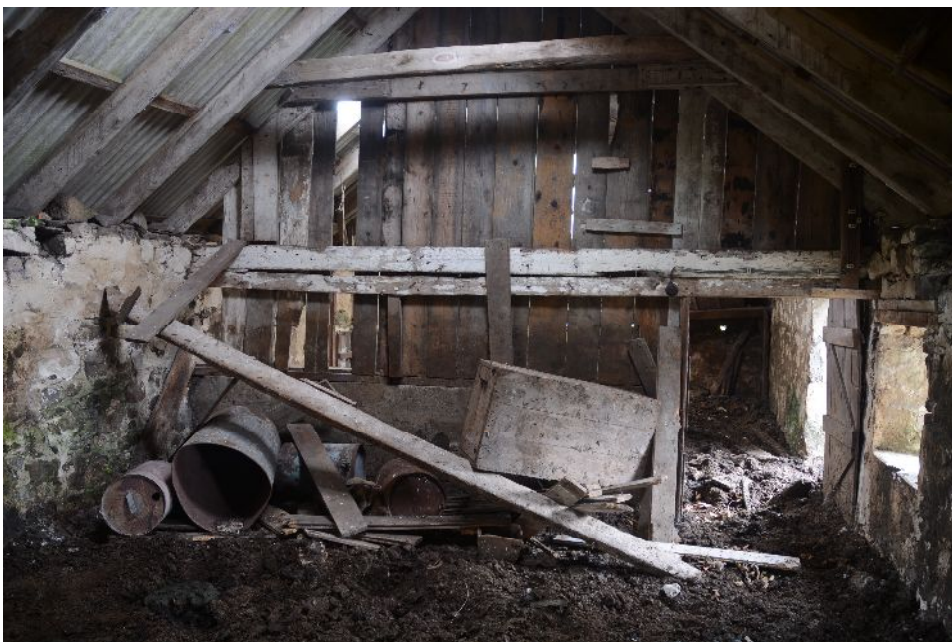
**Illus 12 Building 2. Interior from door D5 looking N to partition.**

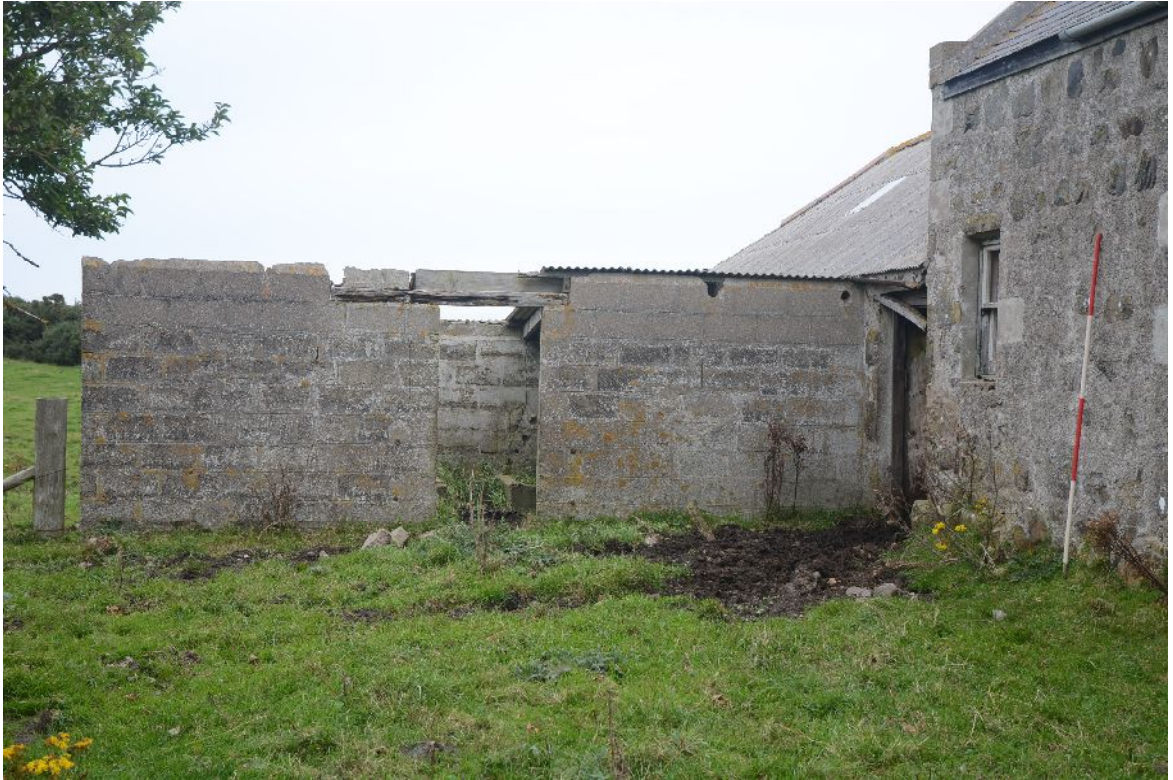
**Illus 13 Building 3 looking N**

Walls Concrete blocks. Abuts W wall of byre (Building 2).

Roof Single pitch, sloping down to N. Corrugated asbestos.

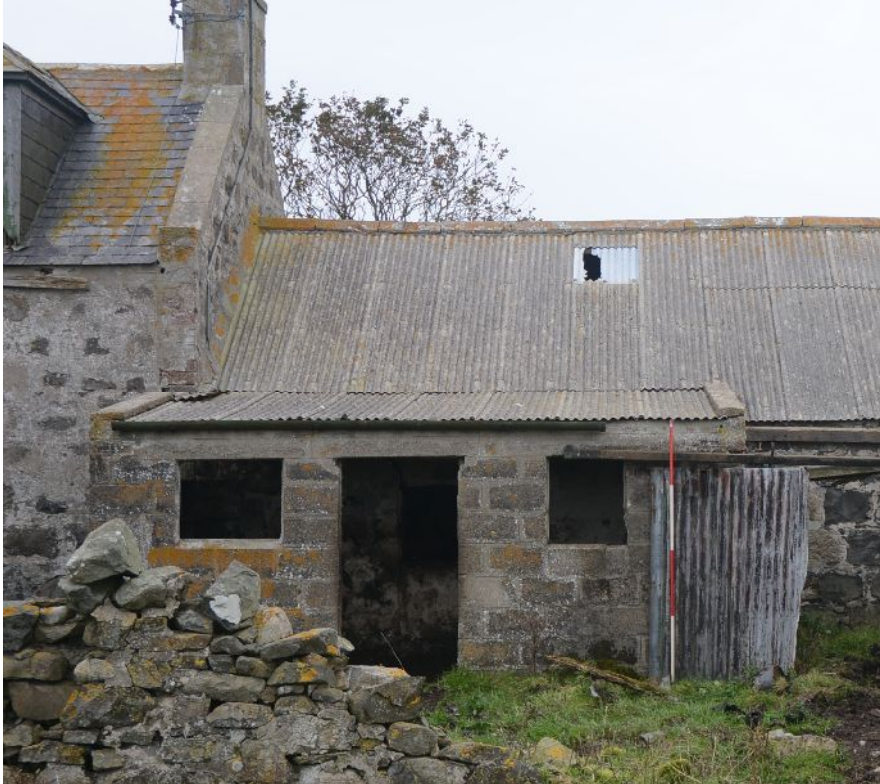
**Illus 14 Building 4. E wall.**

**D8** W: 0.90m H:1.80m. Concrete lintel and rybats.

**W12** W: 0.79m H:0.65m. Concrete lintel, sill, and rybats.

**W13** W: 0.79m H:0.65m. Concrete lintel, sill, and rybats.

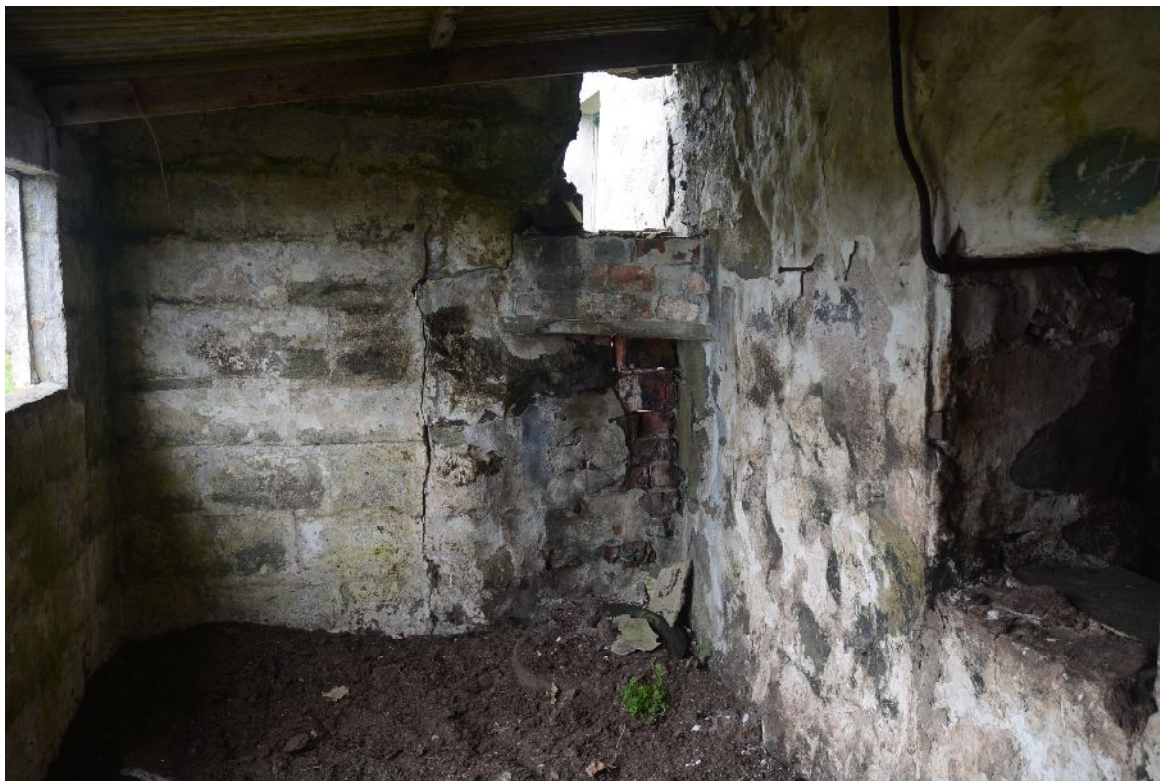
In SW corner, the wall had been broken through and a small, brick-built canopy appears to have formed a smoke vent. No chimney pipe survived.

**Illus 15 Building 4, Interior SW corner. Window into byre at RHS.**

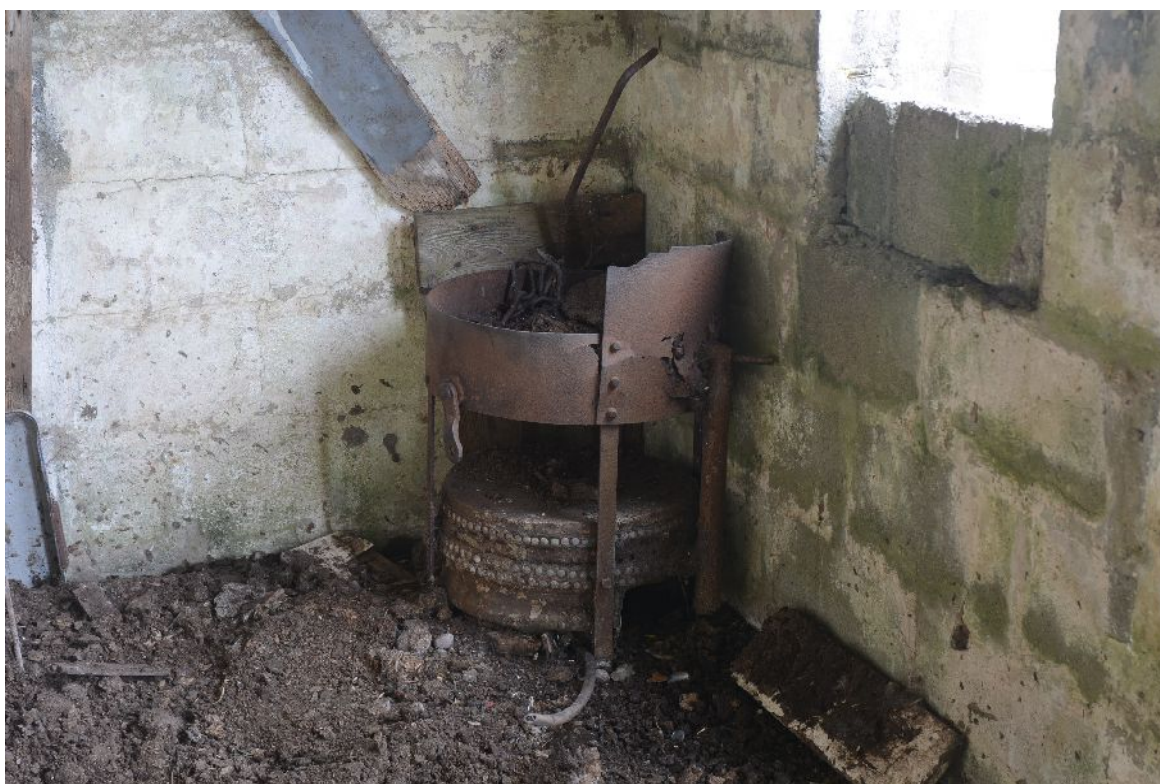
In the NE corner there was a small portable blacksmith's forge with integral bellows.

The size of the forger would have been suitable for farrier's work or small items.

**Illus 16 Building 4, Interior. NE corner. Portable blacksmith's forge**

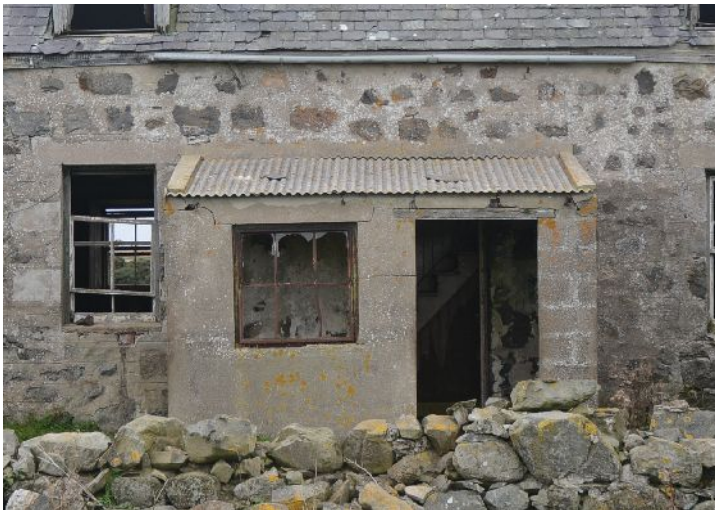
Walls Concrete. Abuts E wall of house, sheltering the main door (D1).

Roof Corrugated asbestos, low pitch lean-to, sloping down to E.

**Illus 17 Porch from E.**

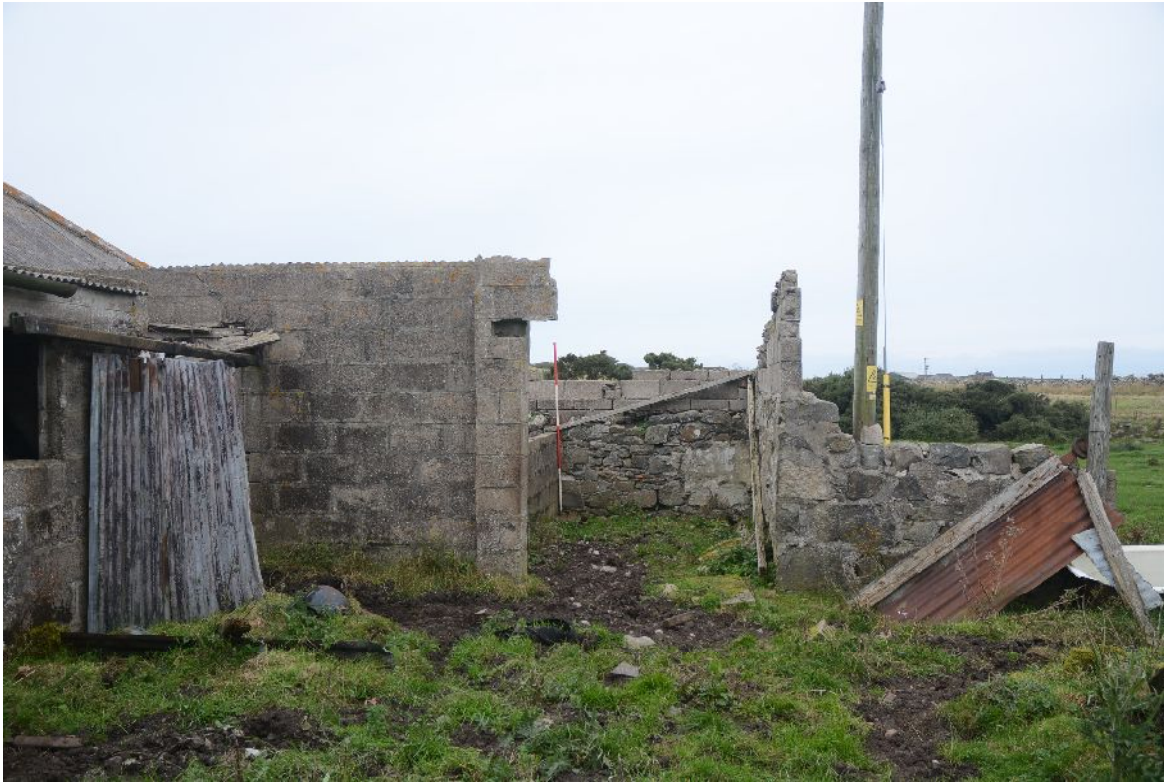
A stone wall had continued the line of the N wall of Building 2, turning S to form a rectangular stone-walled yard in front of the house and byre. The W end, in front of Building 2 had at some point been divided of with a concrete block wall and the outer stone walled raised with concrete blocks. This area had been roofed (now missing) and internally divided by low concrete walls into what were probably pig pens.

**Illus 18** Looking W to Building 6
