**BROAD MOSS  
ROSEHEARTY  
ABERDEENSHIRE**

**Standing Building Survey**

Carried out 6<sup>th</sup> October 2017

**Report No: MAS 2017-15**

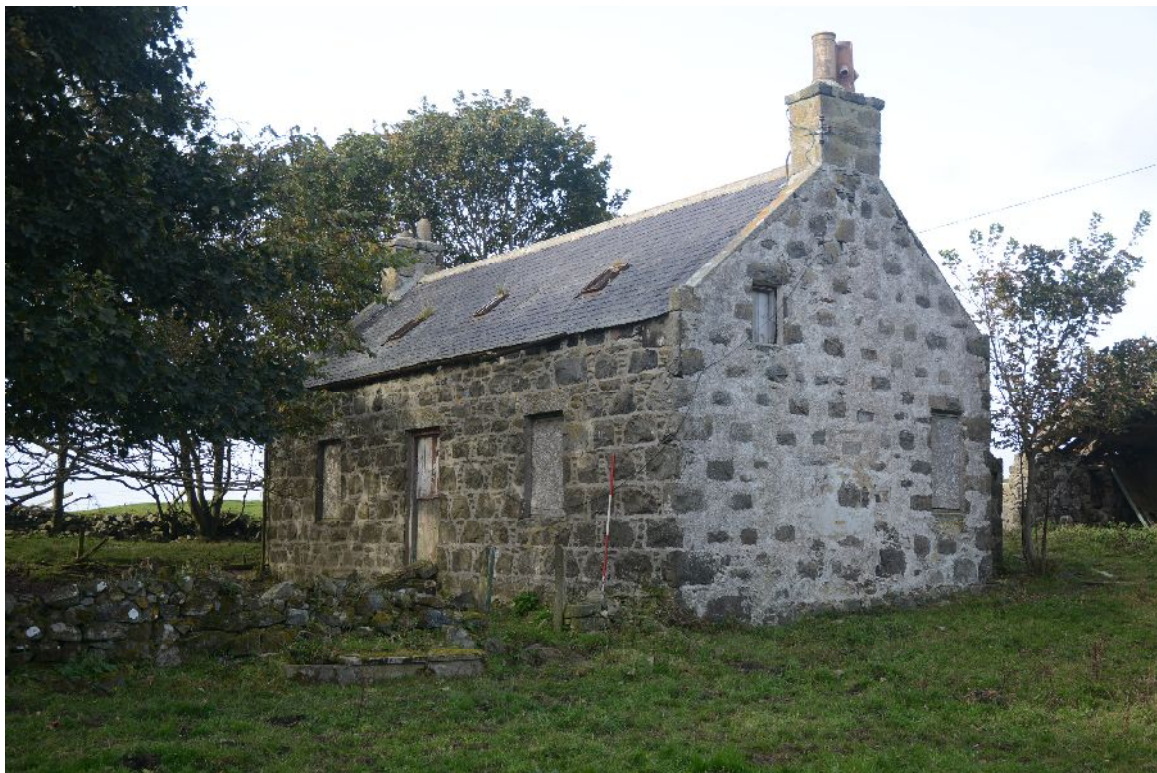
**Illus 6 Building 1: House. S and E walls.**

Orientation S facing

Dimensions 11.70 x 5.85m ext.

Present/recent use Derelict (entry not possible).

Original use. Dwelling

Walls Rubble stone. Stonework very like N wing of steading Building 3.

Roof Slate. 3 metal skylights to S. Square chimneys to E and W gables each with 2 ceramic pots and smaller square chimney in centre of N wall. Granite. Flat tables.

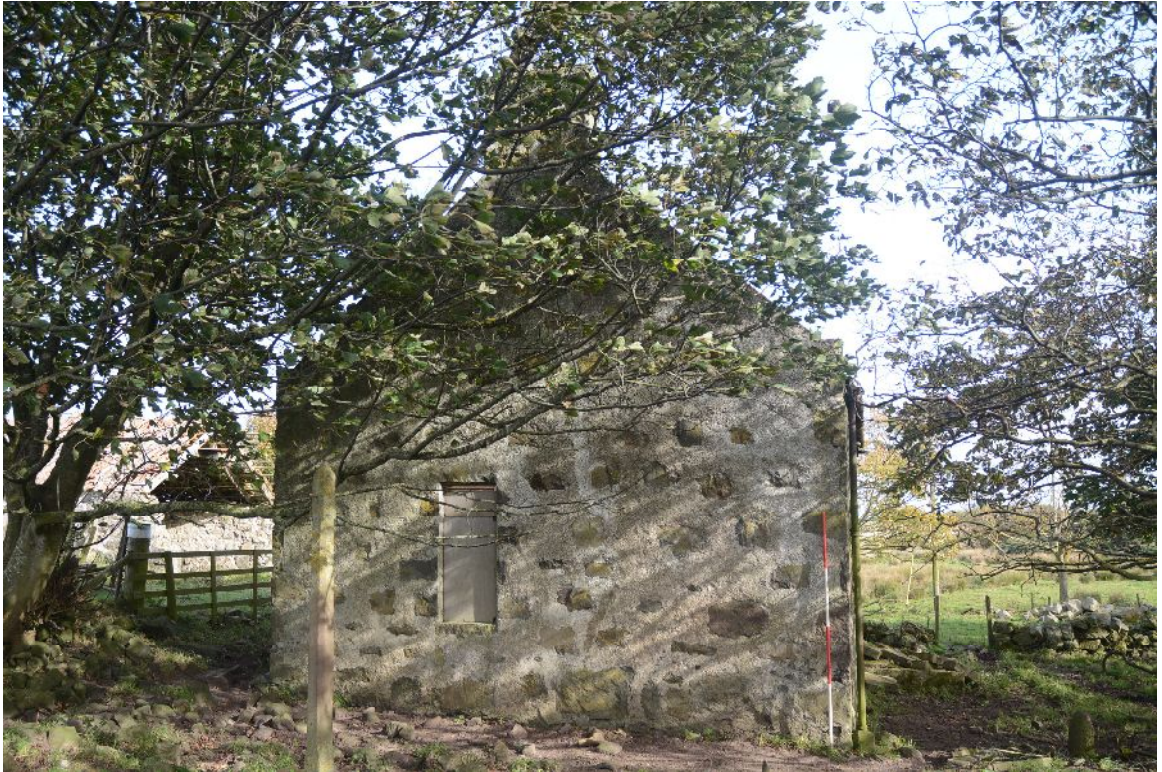
**Illus 7 Building 1: House. W wall.**

S wall. Central door flanked by windows on either side. Granite lintels but rubble rybats.

W wall. Window to ground floor.

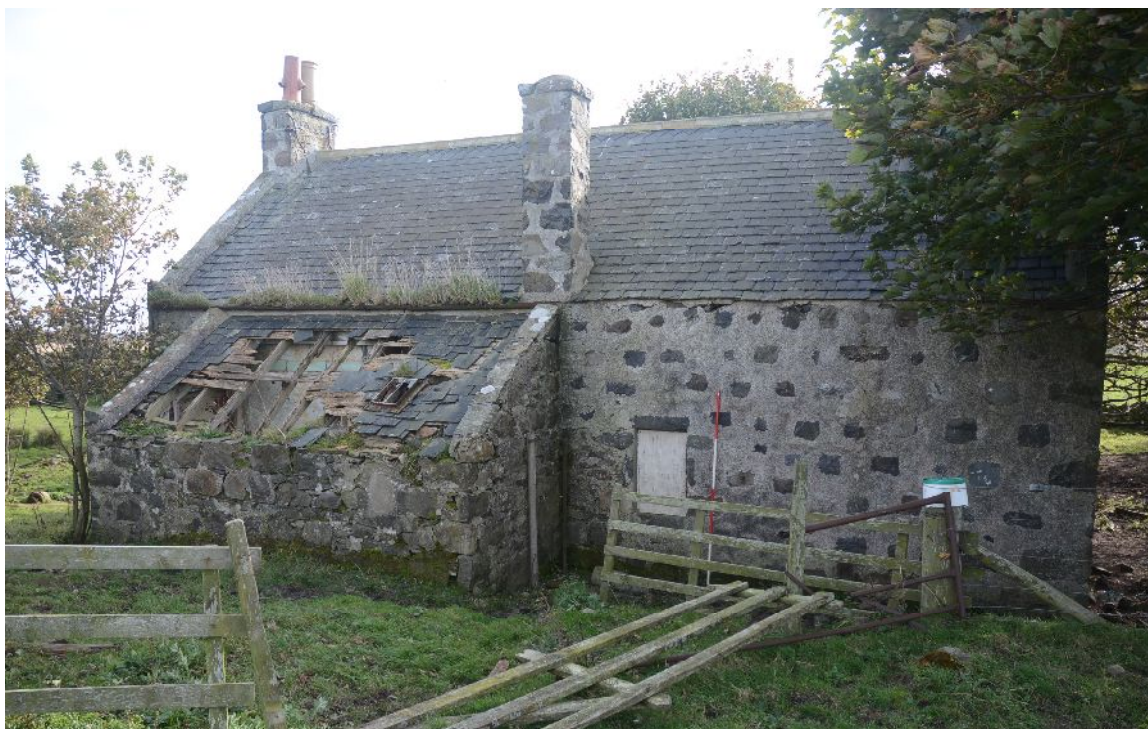
N wall Central chimney. Ground floor window to W of it.

Small outshot porch and toilet with stone wall and lean-to slate roof against N wall.

**Illus 8 Building 1: House. N wall and outshot**

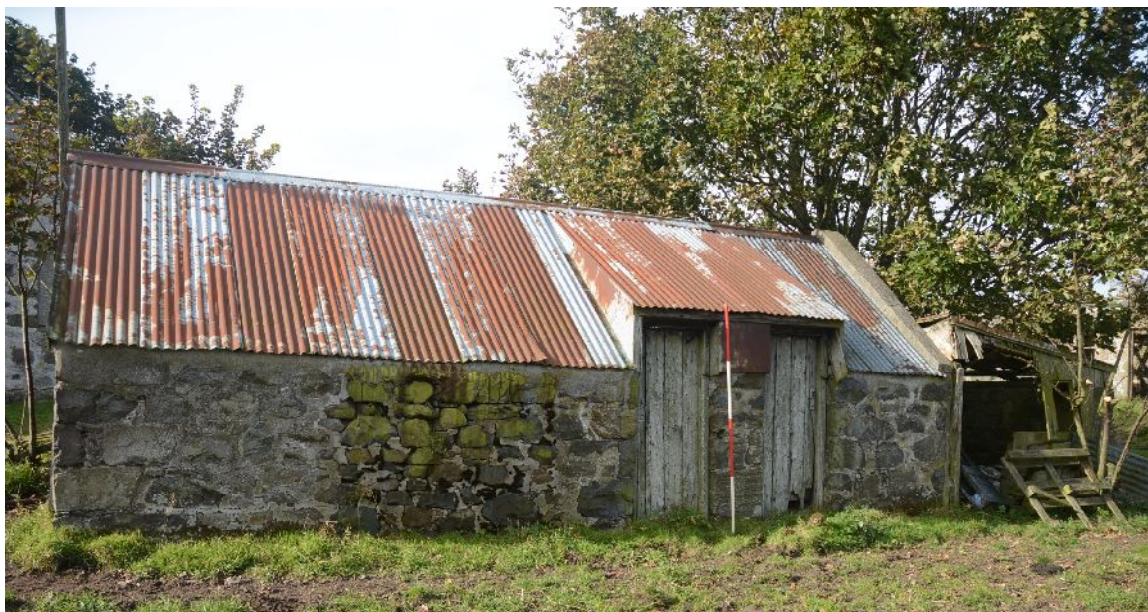
Orientation NNE/SSW

Dimensions Main structure: 8.2 x 4m. Total length including lean-to at N end: 11.2m. W side built into slope. (Illus 10, 11).

Present/recent use Derelict

**Illus 9 Building 2. E wall**

Original use. S room possibly poultry. N room possibly pigs.

Walls Rubble stone with tin and some timber at S gable and in lean-to at N end.

Roof Corrugated iron over A frame couples. Lean-to corrugated, sloping down to N.

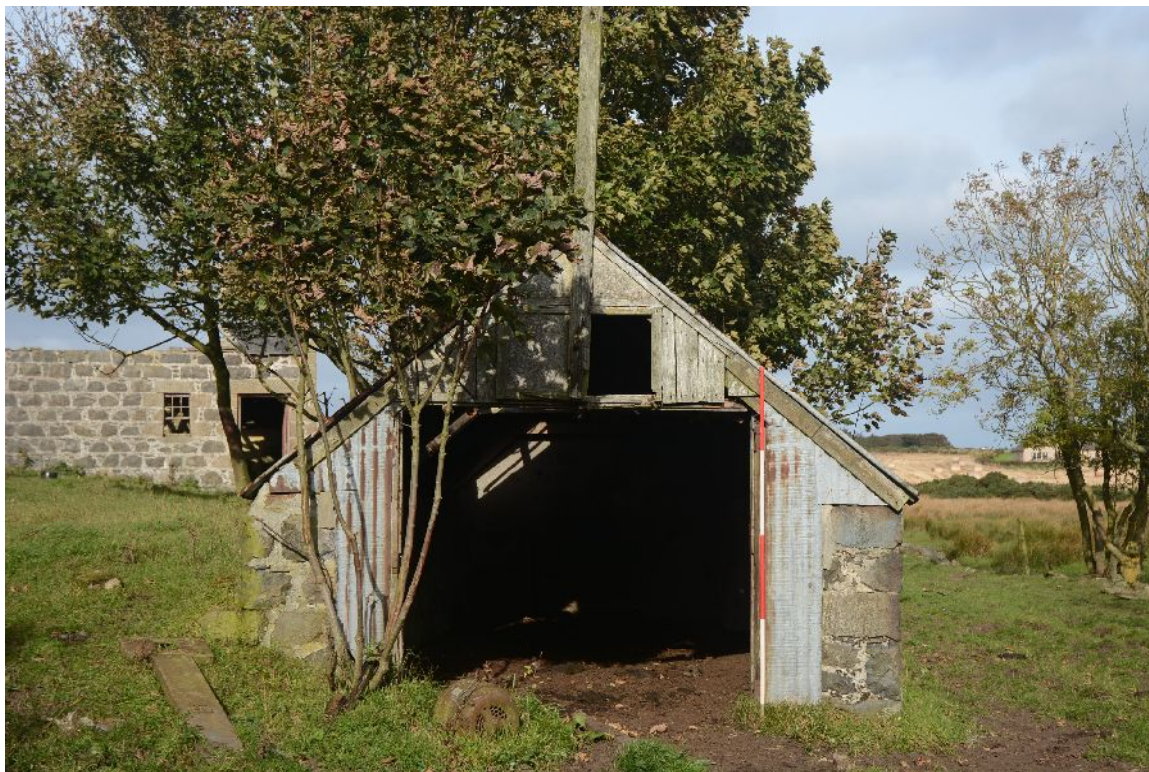
**D4** W: 2.11m H: 1.90m. Hinges remain of a pair of door. This appears to be a secondary door opened to convert the use of the building.

**Illus 12 Building 2. S wall, D4**

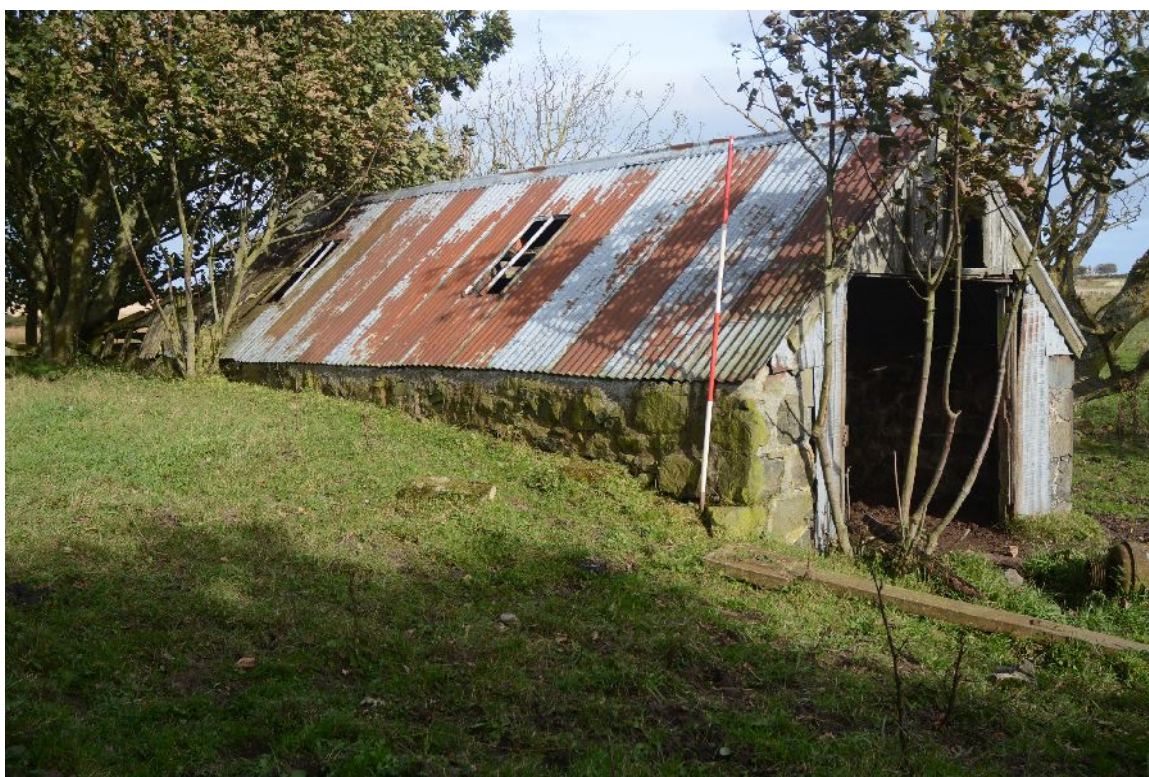
**Illus 13 Building 2, W wall built into slope of hillside**

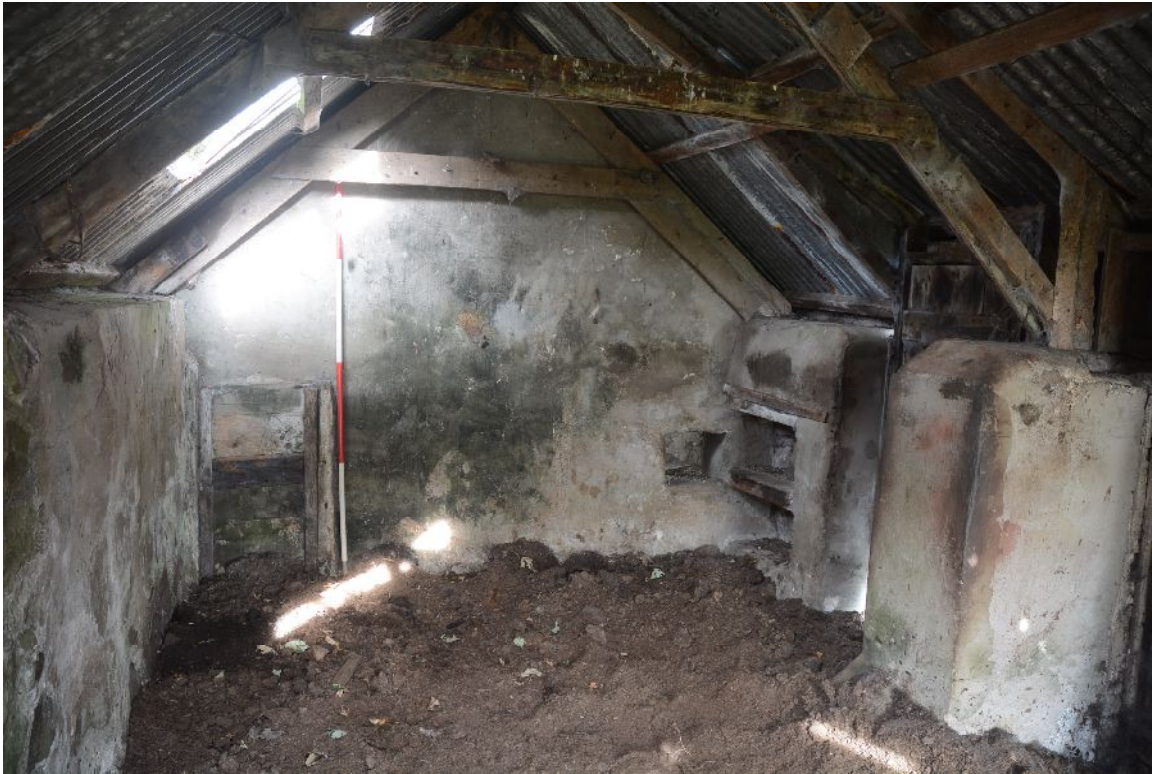
The main structure is a single open space but a stub of wall between the two doors in the E wall (D1 & D2) indicates that it was originally divided into two.

**Illus 14 Building 2. Interior looking N**

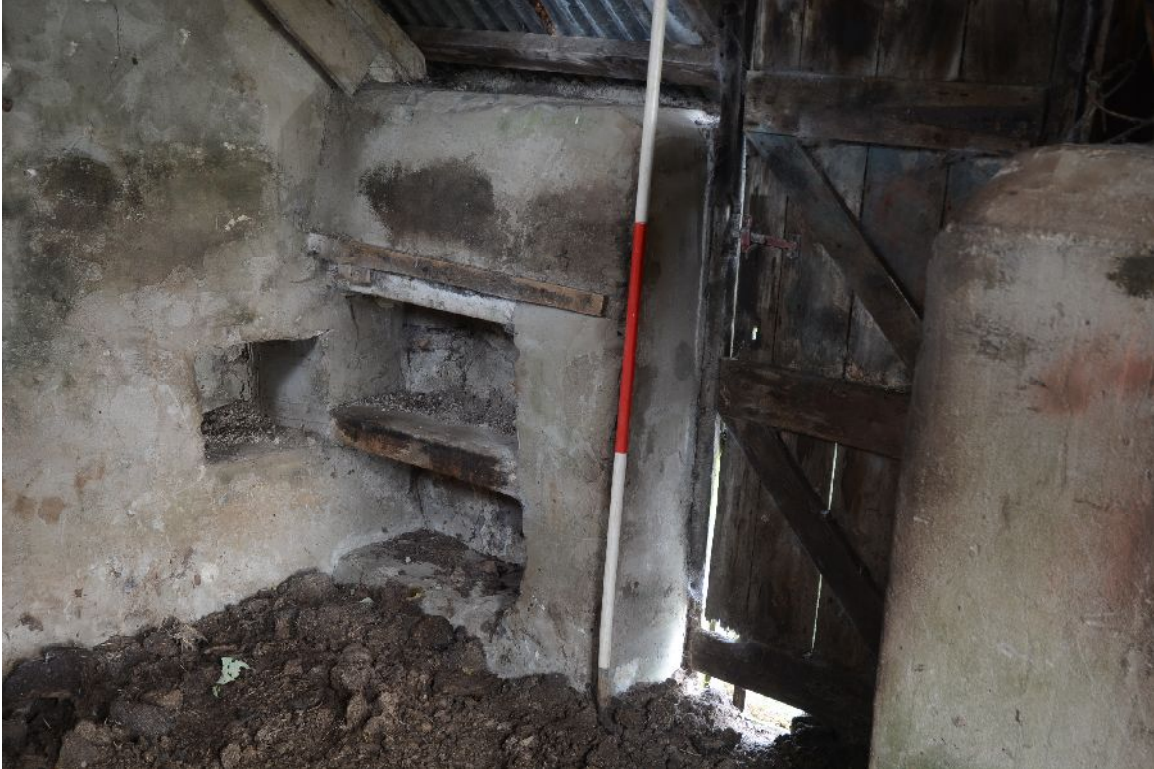
In the NE corner of the main part of the structure, there were three alcoves built into the inner face of the wall (F2, F3), all wood framed with a cement skim over the wood.

F2 W: 360mm H: 330mm. Depth into wall: 260mm. Height of base above present floor: 400mm.

F3 Two alcoves one above the other. Top: W: 670mm H: 360mm

Lower W: 670mm H: 360mm. Depth into wall: 260mm.

The size and height of the alcoves suggests that they may have been nesting boxes.

**Illus 15** Alcoves, F2 and F3. Probable hen nest boxes

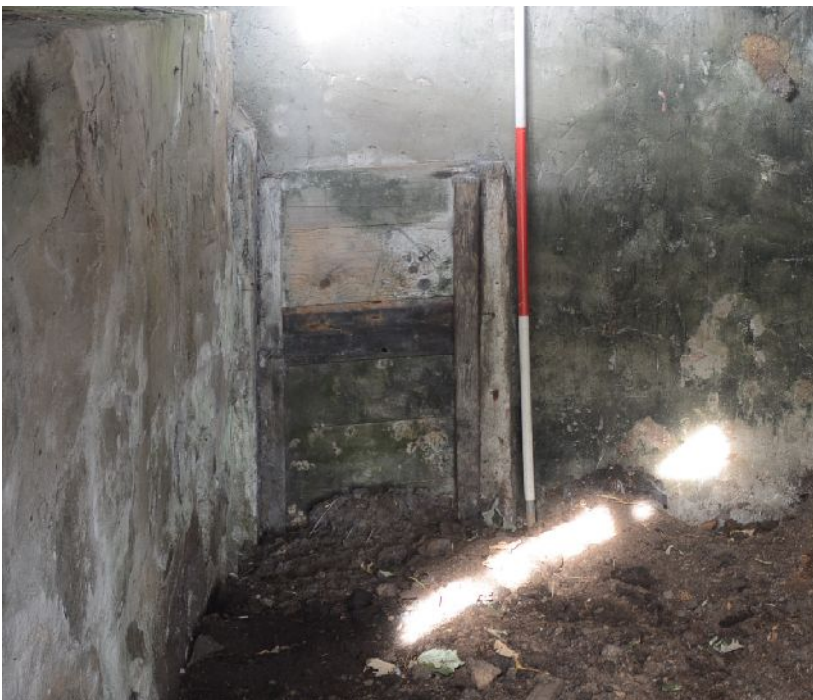
There was also a low, shuttered, opening (F1) in the W end of the N wall between the main structure and the N lean-to.

**F1** W: 700mm. H: 1.05m. Wood framed, with wooden shutter. This is blocked on the N side into the lean-to.

**Illus 16.** Detail of F1

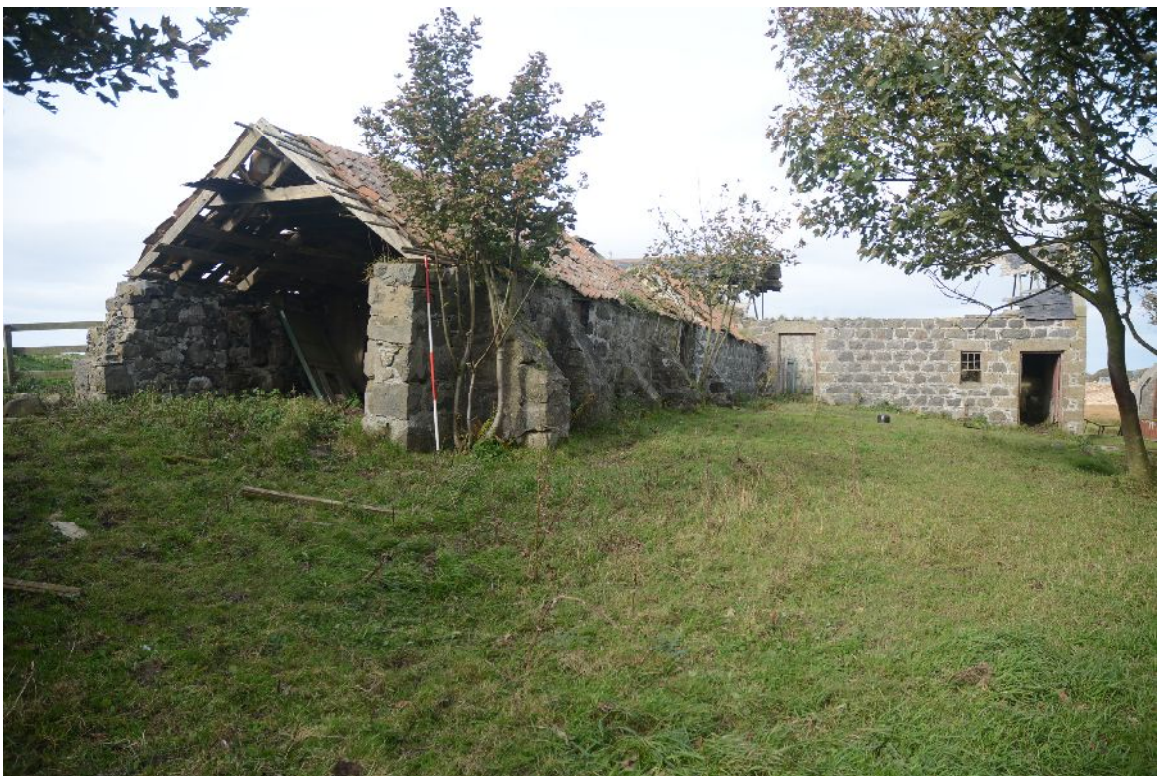
**Illus 17 Building 3 general view from S end of S range**

Dimensions N Range: 13.8m x 5.5m. S range: 18.5m x 5m.

Present Derelict

Original use /recent use N range mill and stable. S range cattle byre

Walls N range. Rubble stone in good horizontal courses. Granite quoins, skews and rybats.

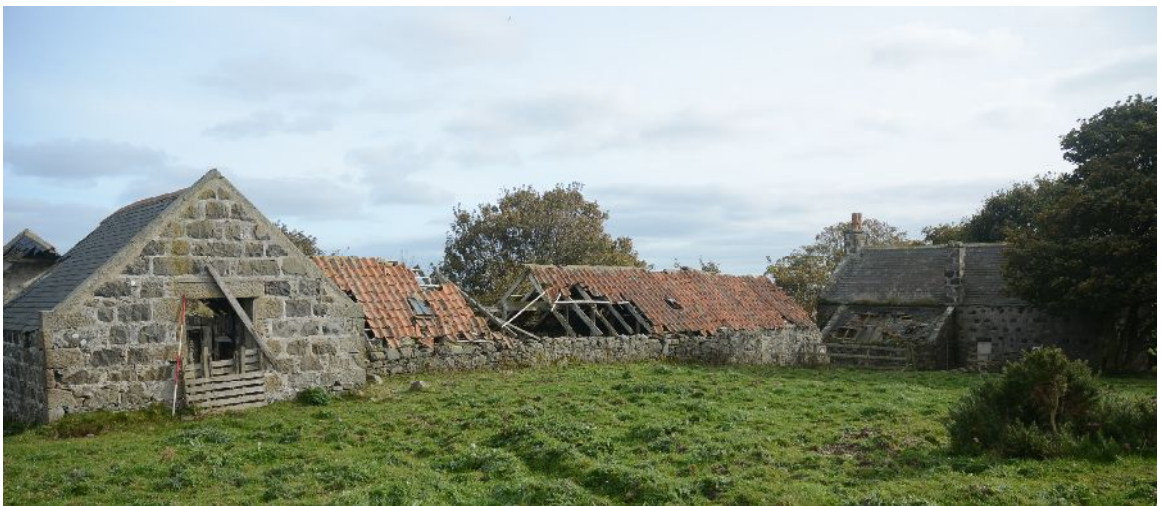
**Illus 20 Building 3 from W with house (Building 1) on RHS background.**

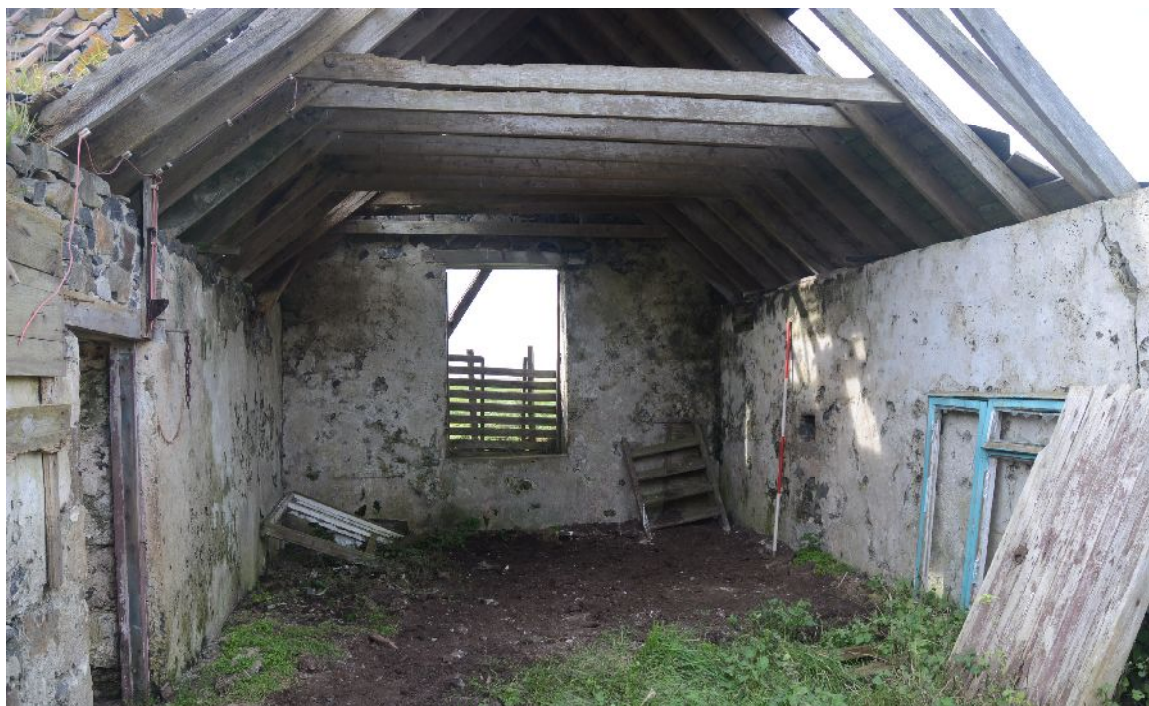
**F2** At ground level externally near centre of horse mill platform, internally c1m above floor level. W: 250mm H: 250mm. Stone blocked.

**Illus 21 Building 3. N range, general view looking W to door D4. Ranging rod beside F2 (mill shaft hole)**

The interior of the N range is divided by a rubble stone wall into two unequal rooms. The W room was the mill with the opening F2 being for the shaft drive from the horse mill, and the higher F3 related to it. The E room may have been a stable, with loft above.

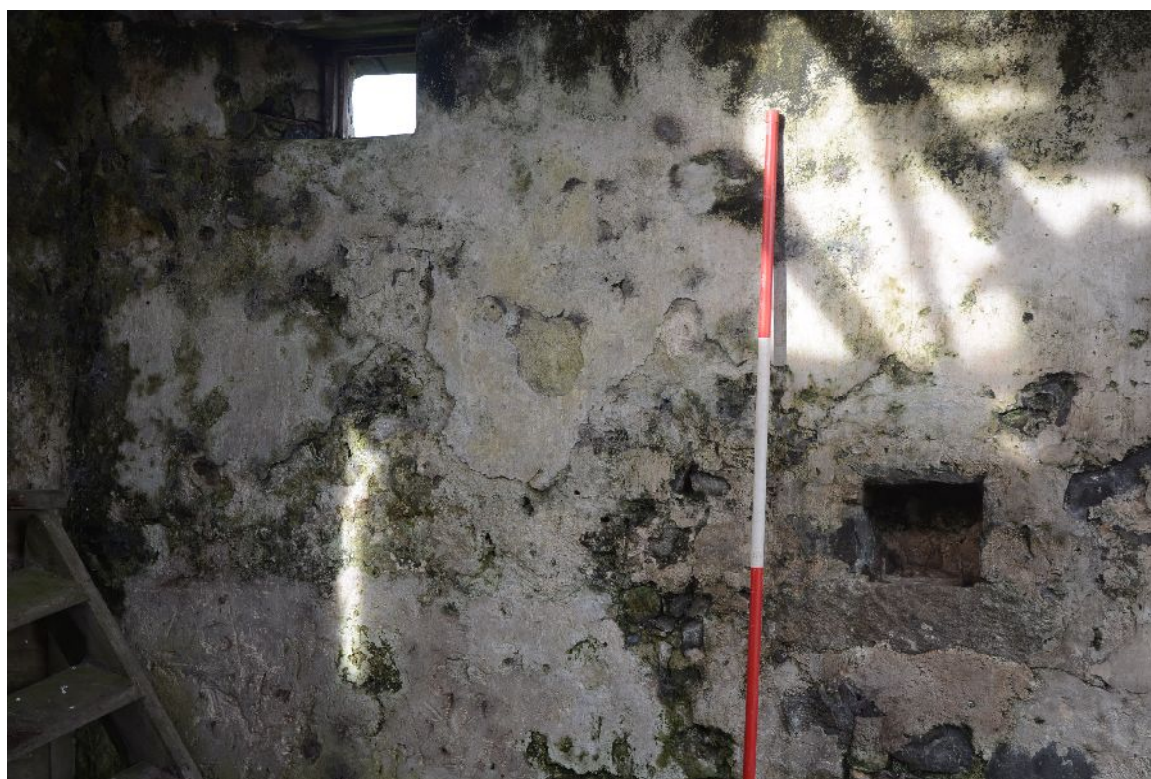
**F3** At top of wall. Externally W: 300mm splays to 550mm internally. H: 300mm. c2m above internal floor.

**Illus 22 Building 3. N range F2 and F3 (RHS by rod).**

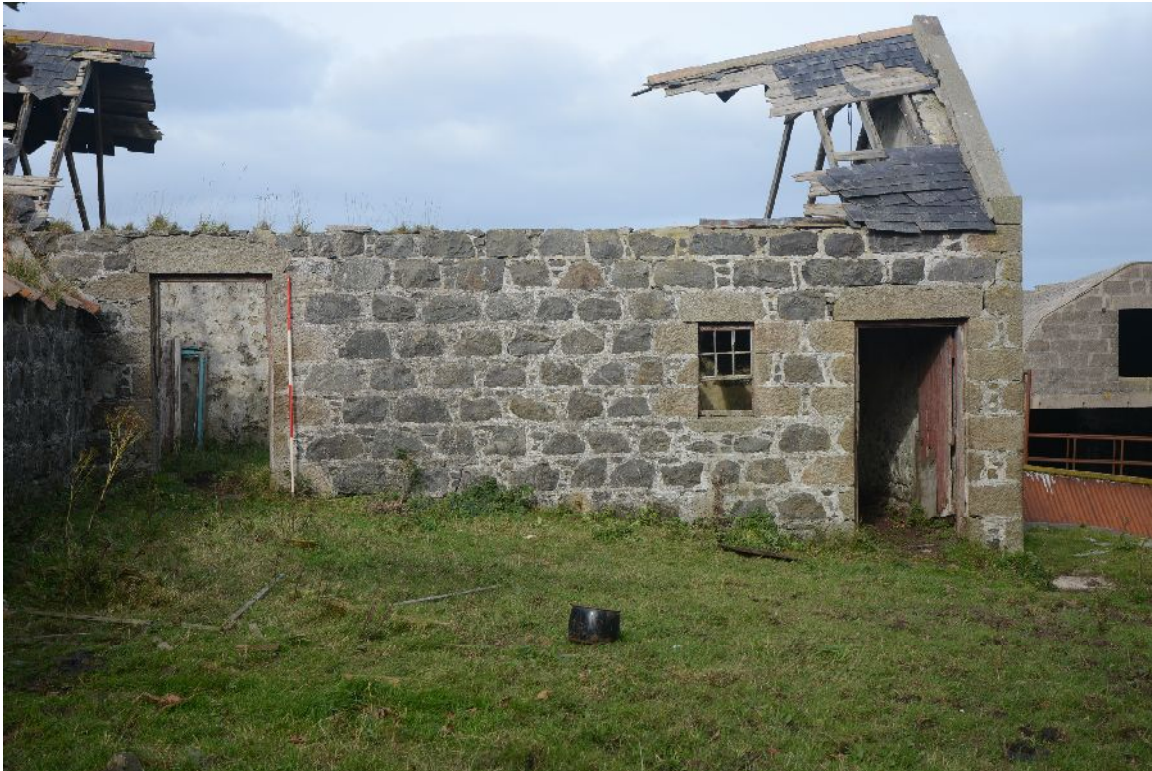
**D2** W: 1.12m H: 2.08m Granite lintel, sill and rybats

**D3** W: W: 1.13m H: 2.20m Granite lintel, sill and rybats. Plank door

**W2** W: 0.56m H: 0.93m. Granite lintel, sill and rybats

**Illus 23** Building 3 N range S wall

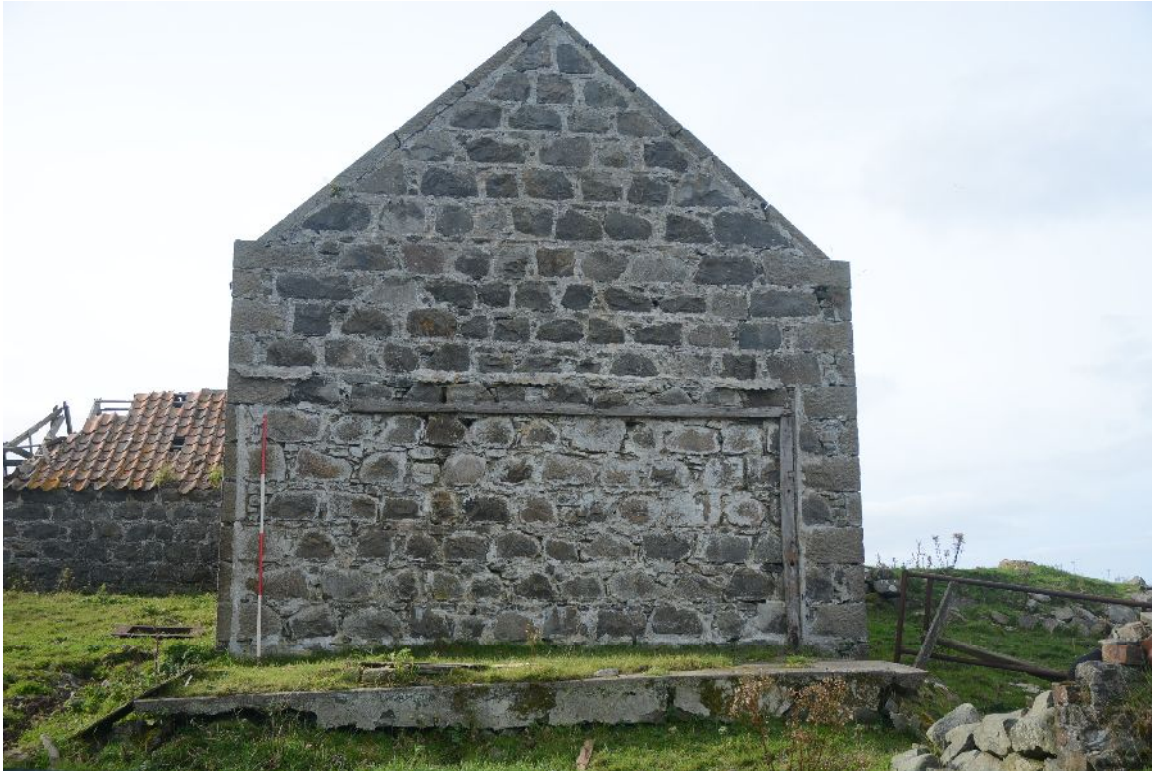
**Illus 24** Building 3. N range, E wall with raggle of a lean-to.

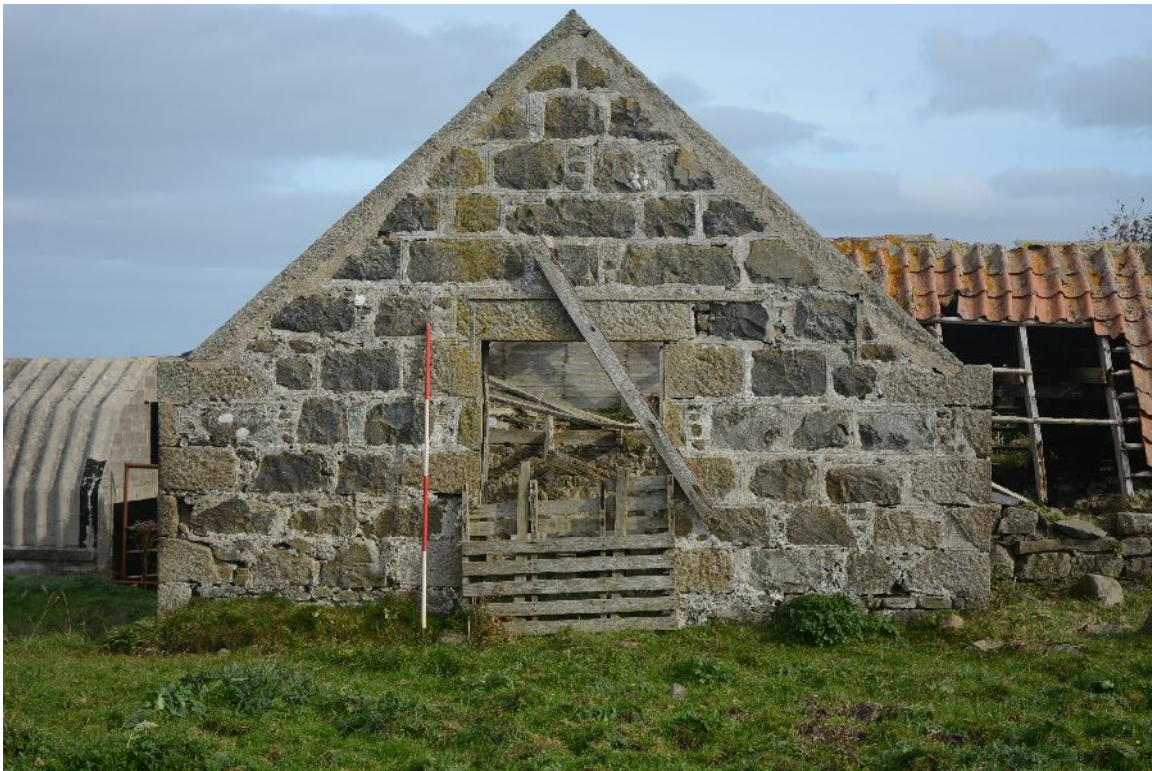
**D4** W: 1.21m H: 1.95m. Granite lintel and rybats. Ground outside is higher than interior with base of D4 0.76m above internal floor. Wooden steps.

**Illus 25** Building 3. N range W wall and door D4

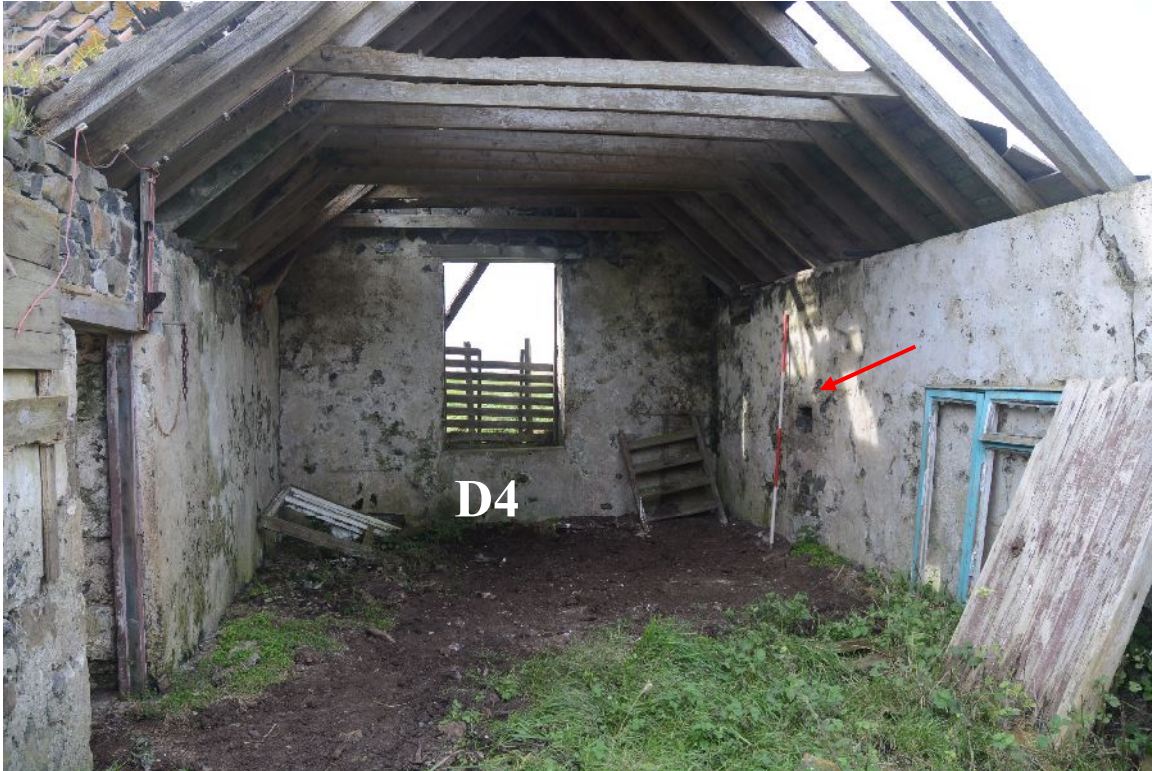
**Illus 26 Building 3. Interior of N range (Mill) looking W. Arrow marks mill position (F2)**

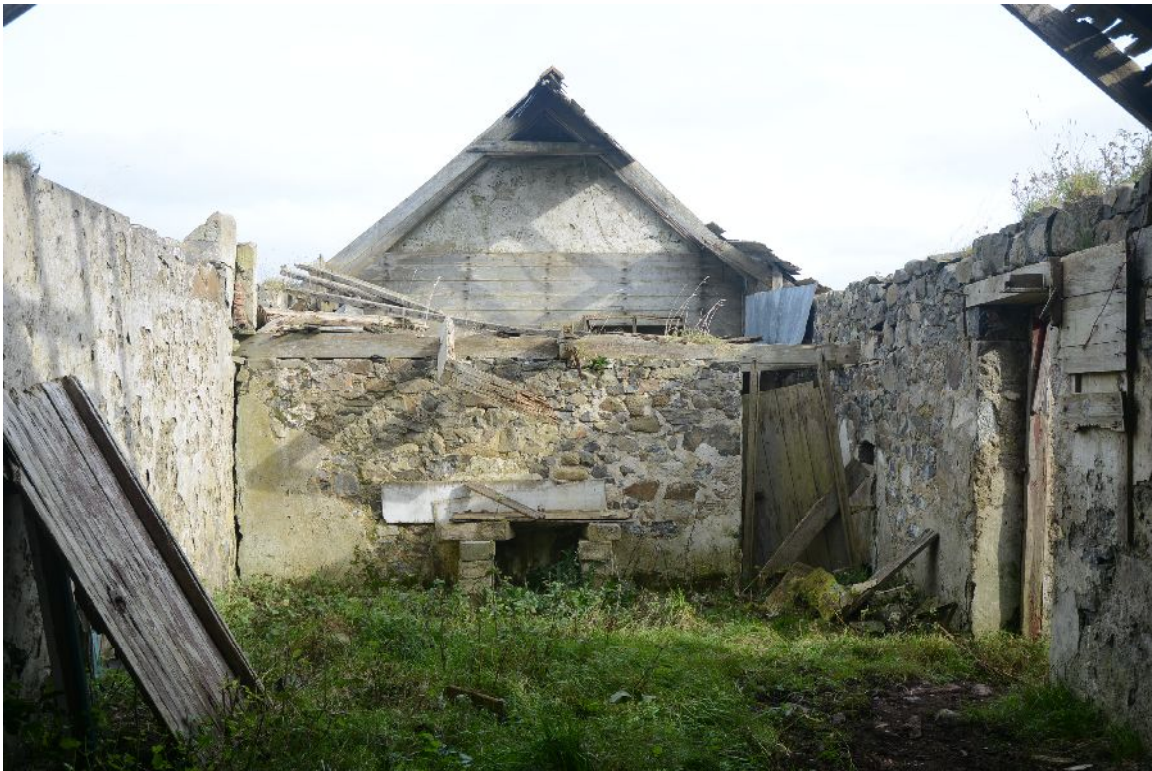
**Illus 27 Building 3. Interior of N range looking E to partition**

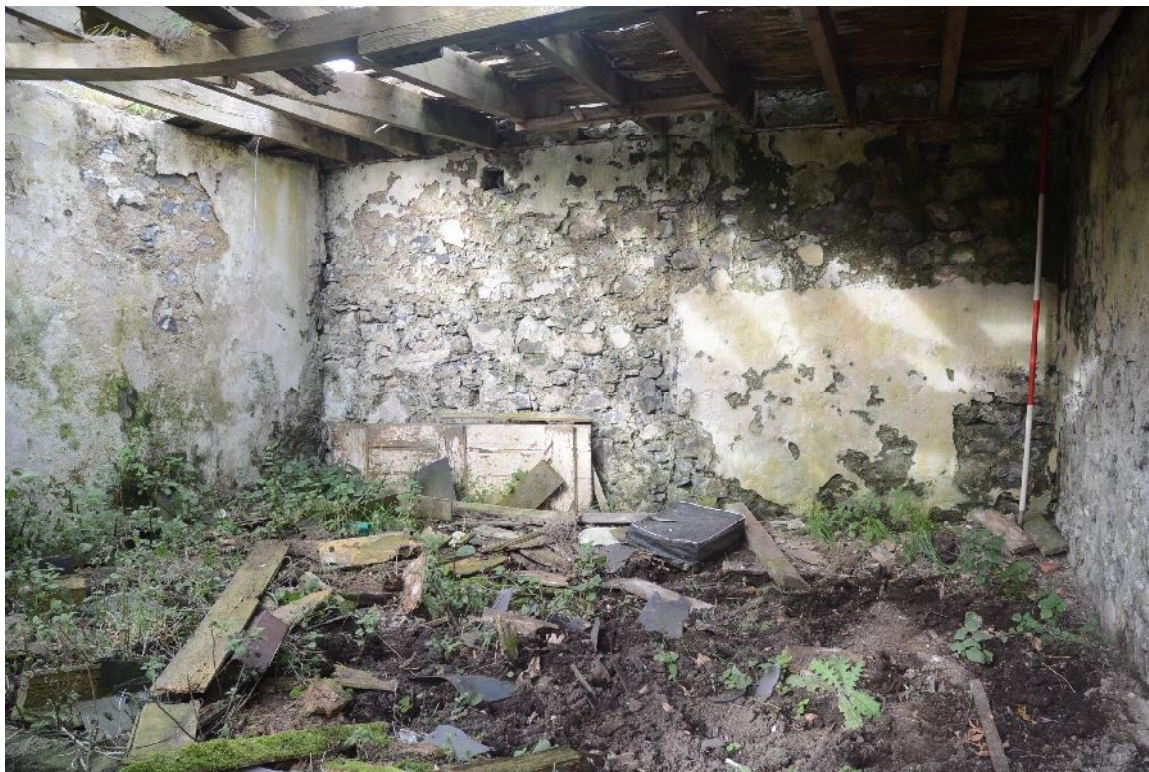
**Illus 28 Building 3. N range, E room- probable stable with loft above.**

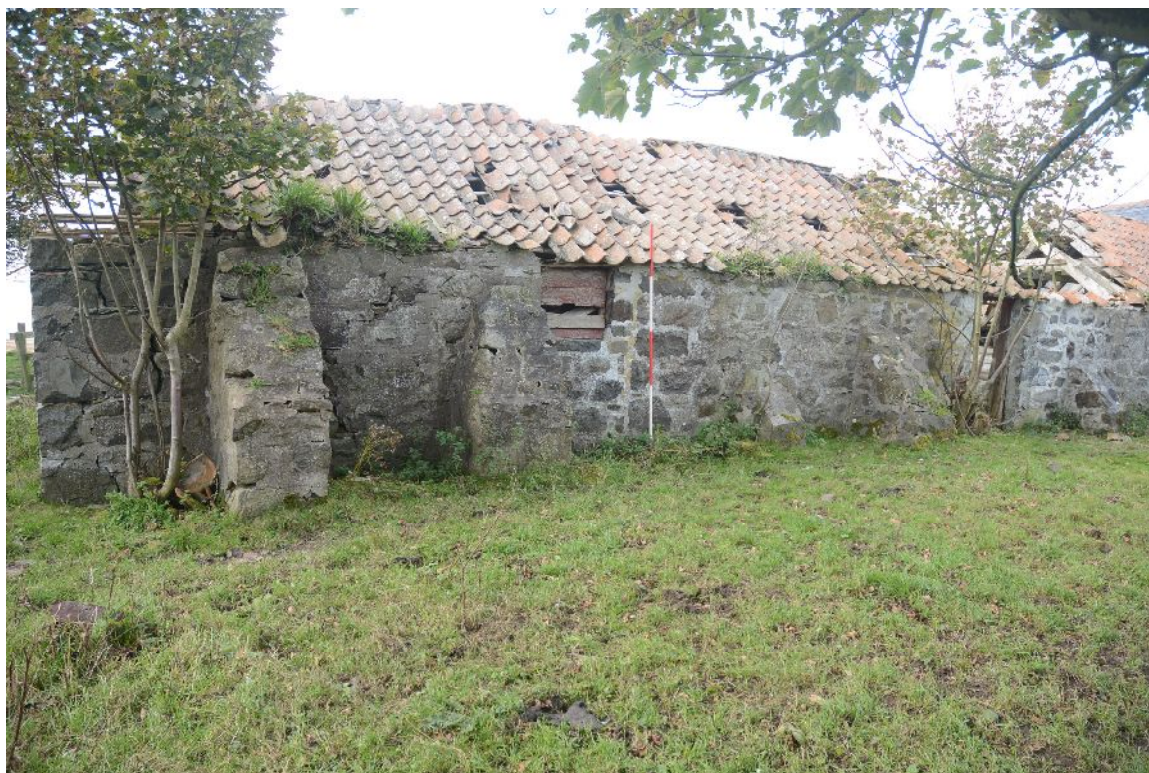
**Illus 29 Building 3. S range E wall**

**D1** W: 1.05m H: 1.75m. Rubble rybats. Wooden lintel.

**W1** W: 0.74m H: 0.70m Rubble sill and rybats. Wooden lintel.

**F1** W1 was set into a blocking of an earlier door (F1) W: 0.97m H: 1.90m. Clear internally. Position suggests this was blocked when the internal wooden partition erected.

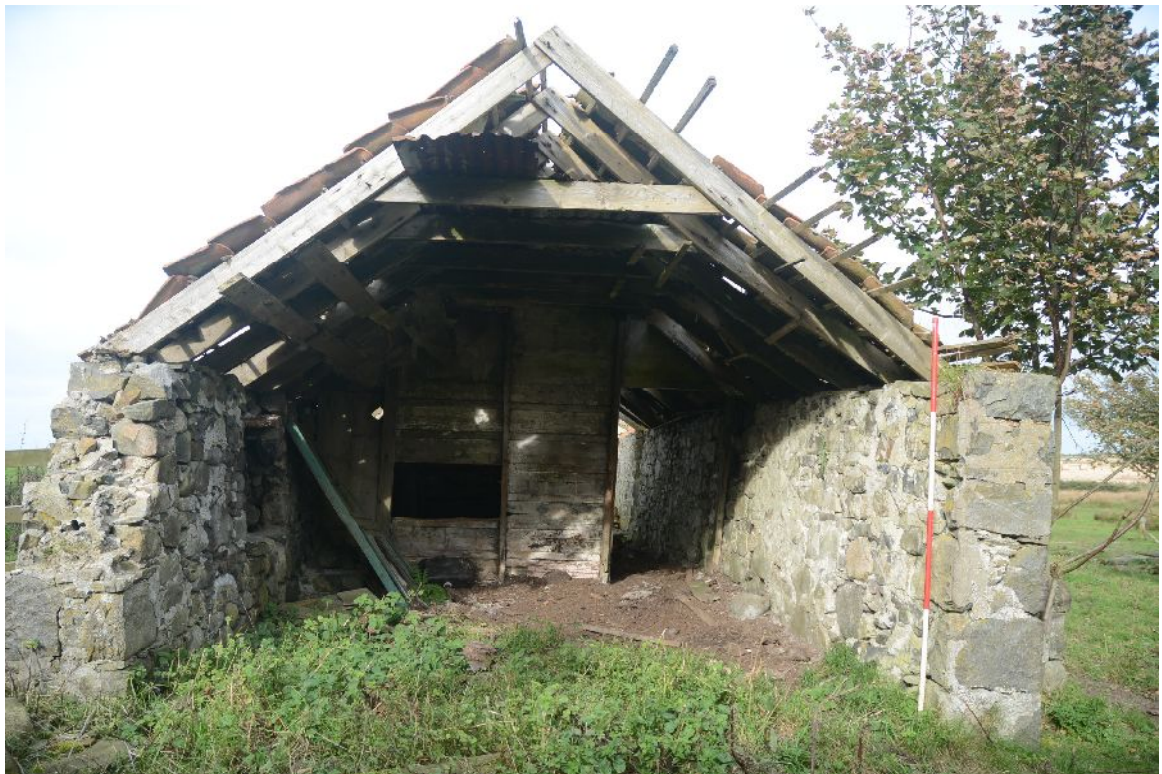
The S wall had been broken through.

**Illus 30 Building 3. S range S wall broken through.**

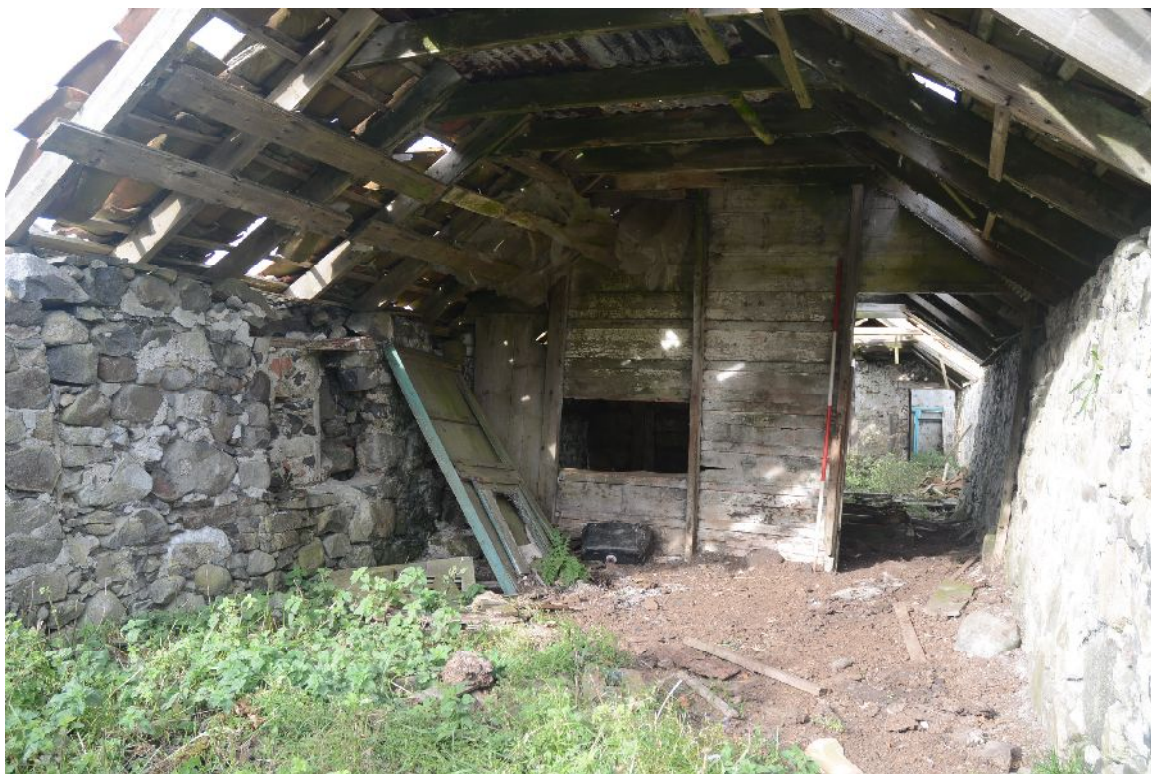
The S range was divided into two areas. The S end, entered originally from door F1 was 4m long and had had a window in the W wall. The N end, entered through door D1, had been divided by wooden trevises into 7 double tied-cow stalls 1.65 to 2.30m wide. Parts of a wooden feed trough and a wooden hay hake survived. A ceramic drain segment set in the W wall would have provided some ventilation.

**Illus 31 Building 3. S end of S range**

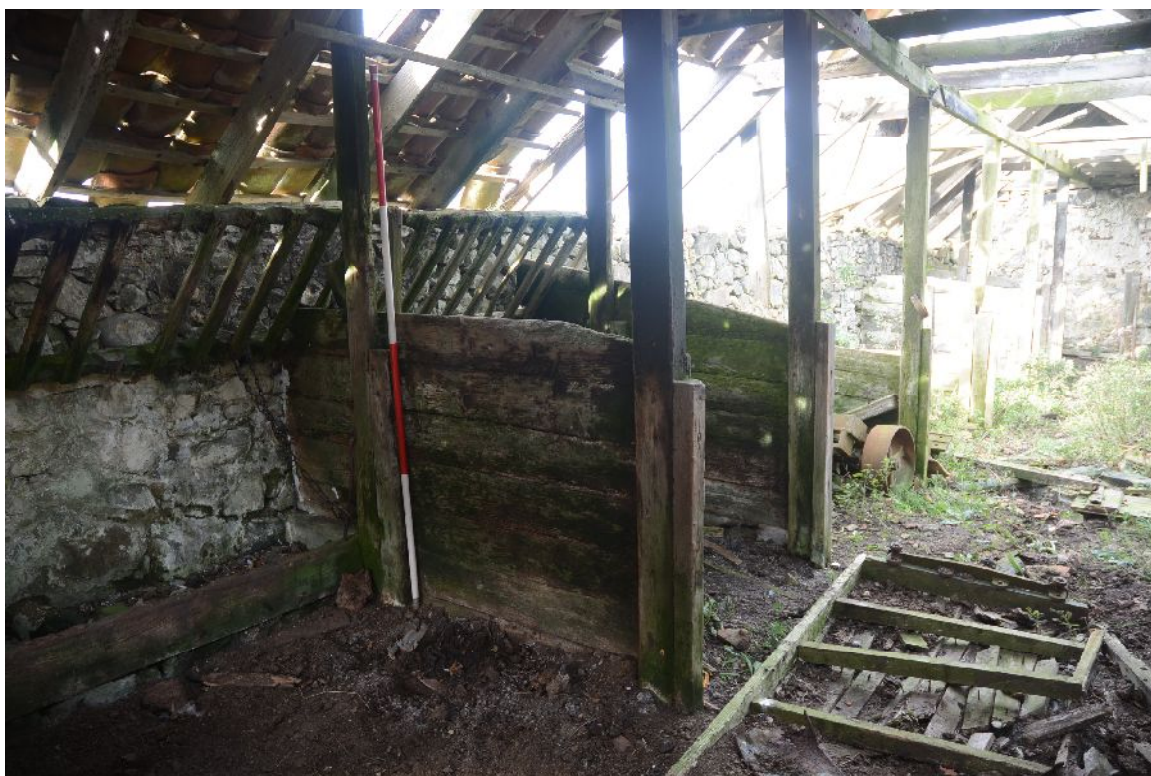
**Illus 32 Building 3. Cow stalls in N end of S range, looking N**

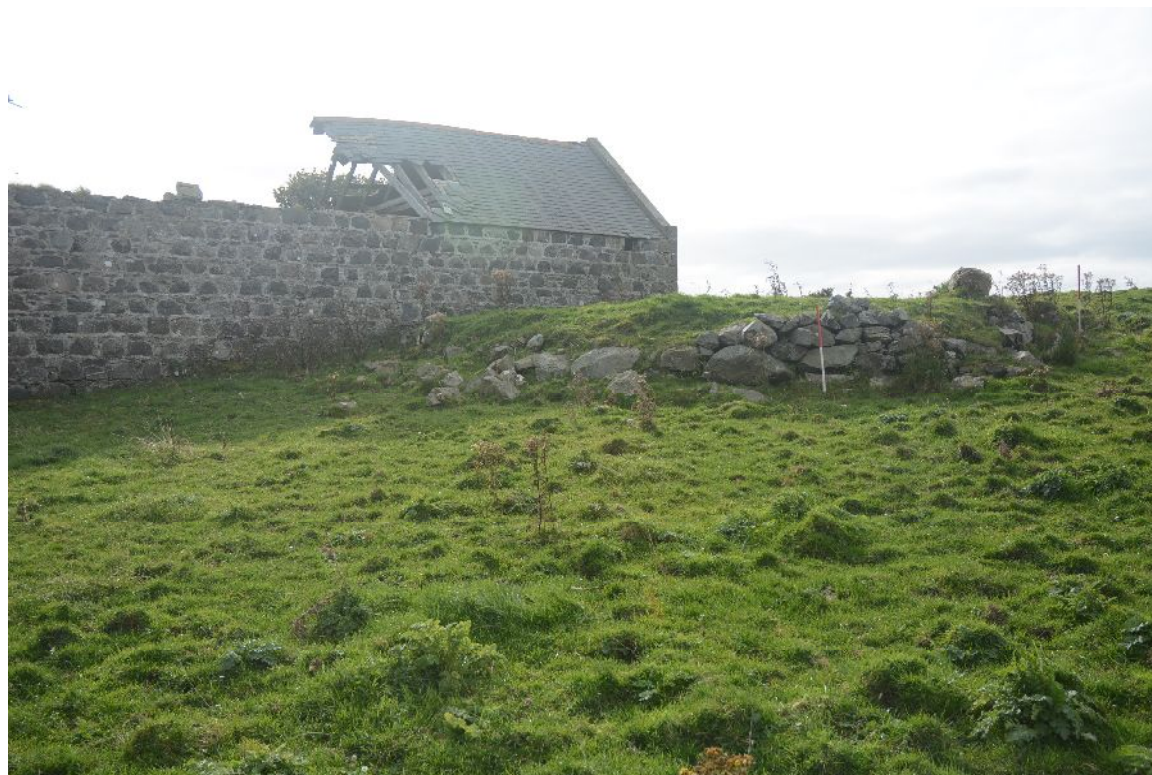
Outside the W end of the N wall of the N range there was a surviving stone-revetted roughly circular platform 8.8-9.6m in diameter that would have housed the horse mill. The revetting survived to 1.10m in places.

**Illus 33 Platform of horse mill, looking W**

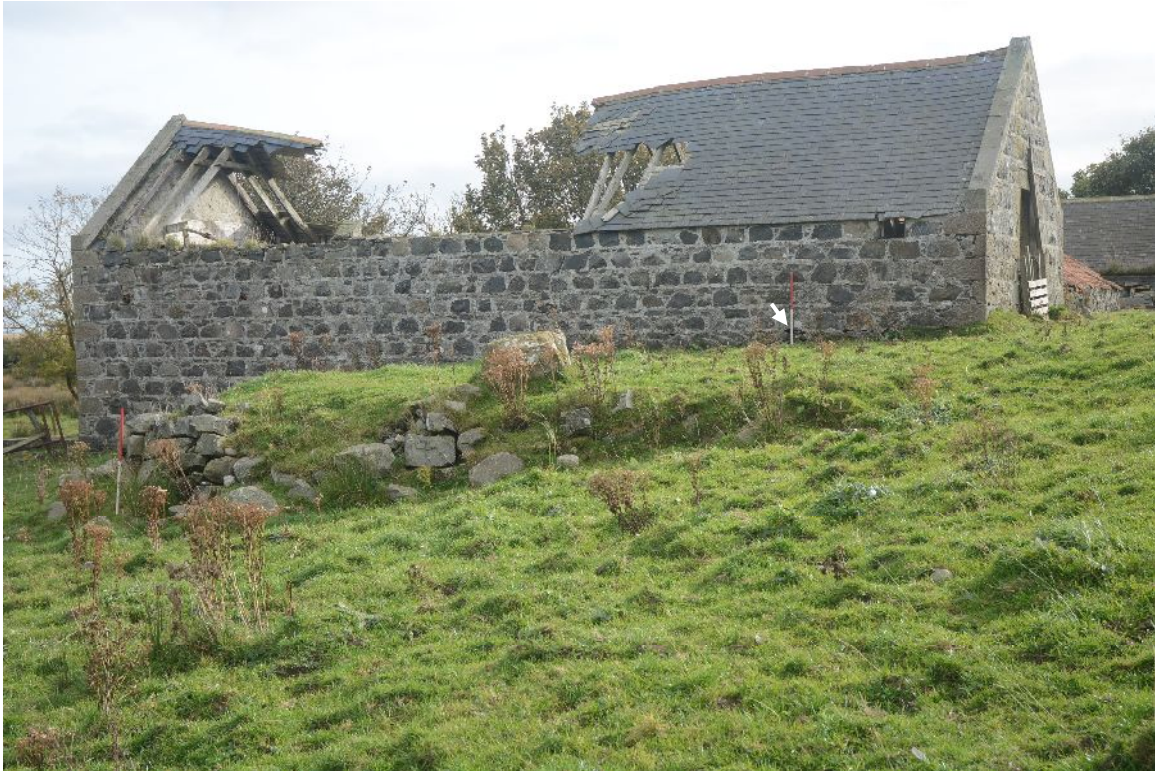
**Illus 34 Platform of horse mill with Building 3 behind. Ranging rod stands beside shaft hole F2**
