**BROAD MOSS  
ROSEHEARTY  
ABERDEENSHIRE**

**Standing Building Survey**

Carried out 6<sup>th</sup> October 2017

**Report No: MAS 2017-15**

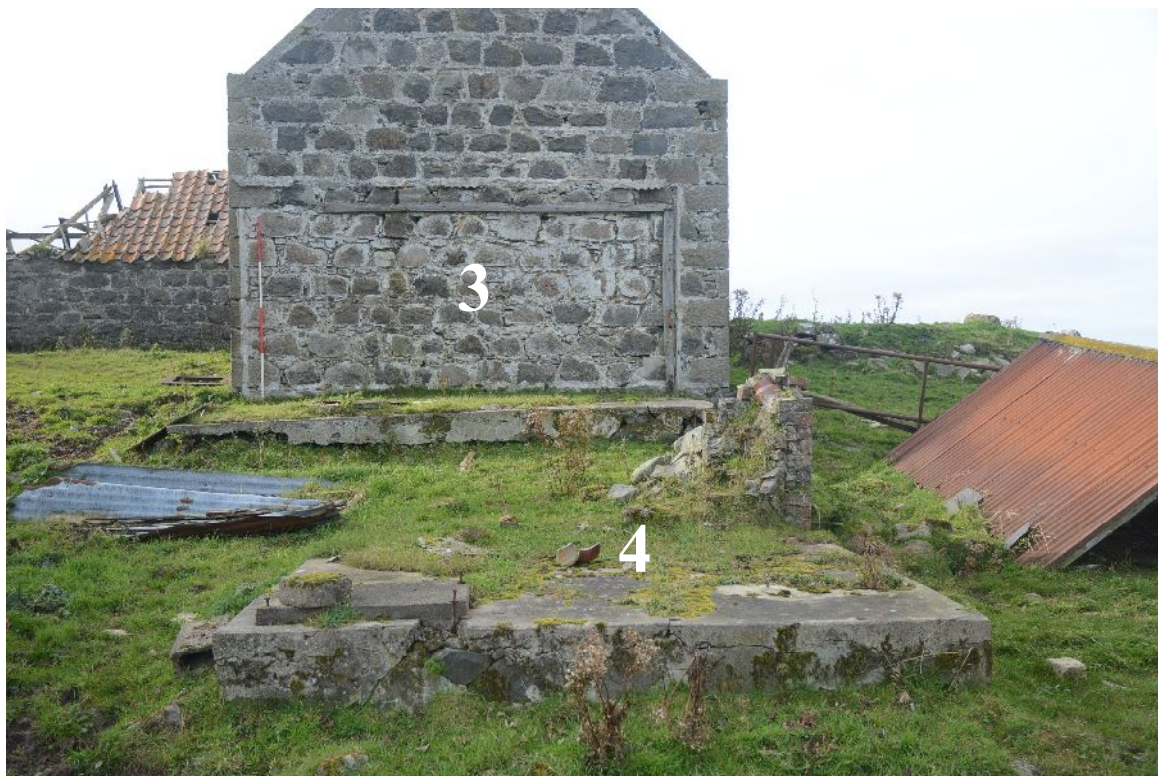
Only a concrete floor remained of this building.

**Illus 35 Concrete floor of Building 4**

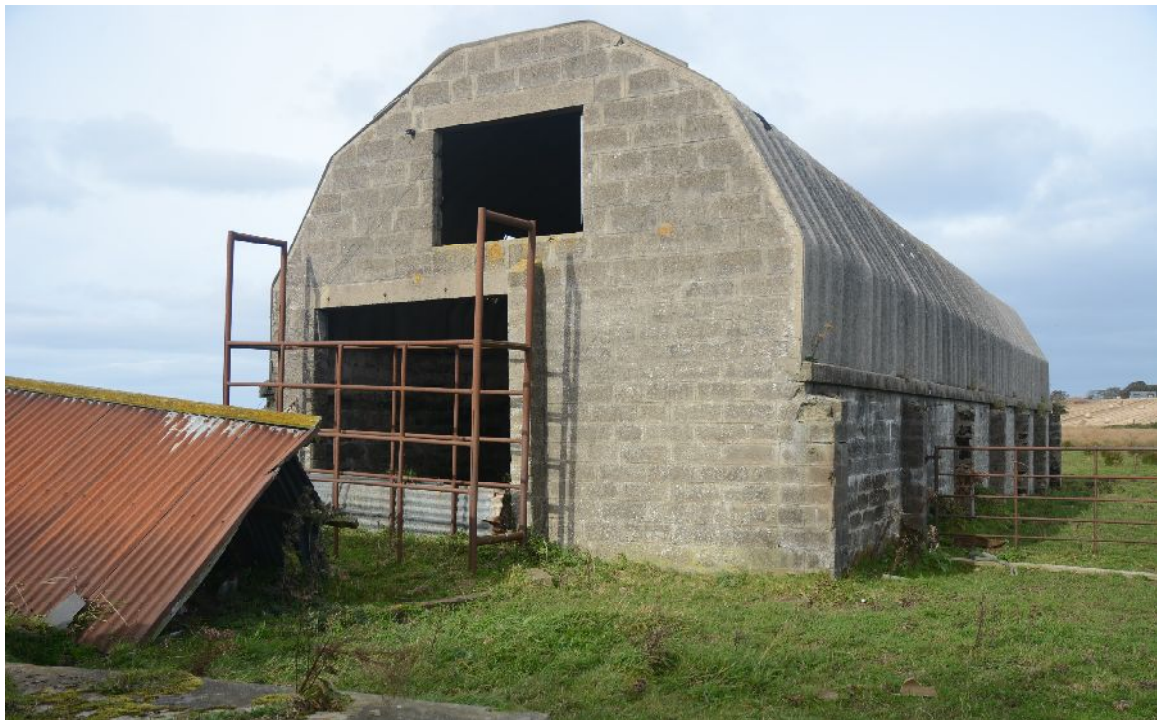
Barn with arched asbestos roof over concrete block walls.

**Illus 36 Building 5 looking N**
