**STATION FARM  
LONGHAVEN  
PETERHEAD  
ABERDEENSHIRE**

**Standing Building Survey**

**Report No: MAS 2017-25**

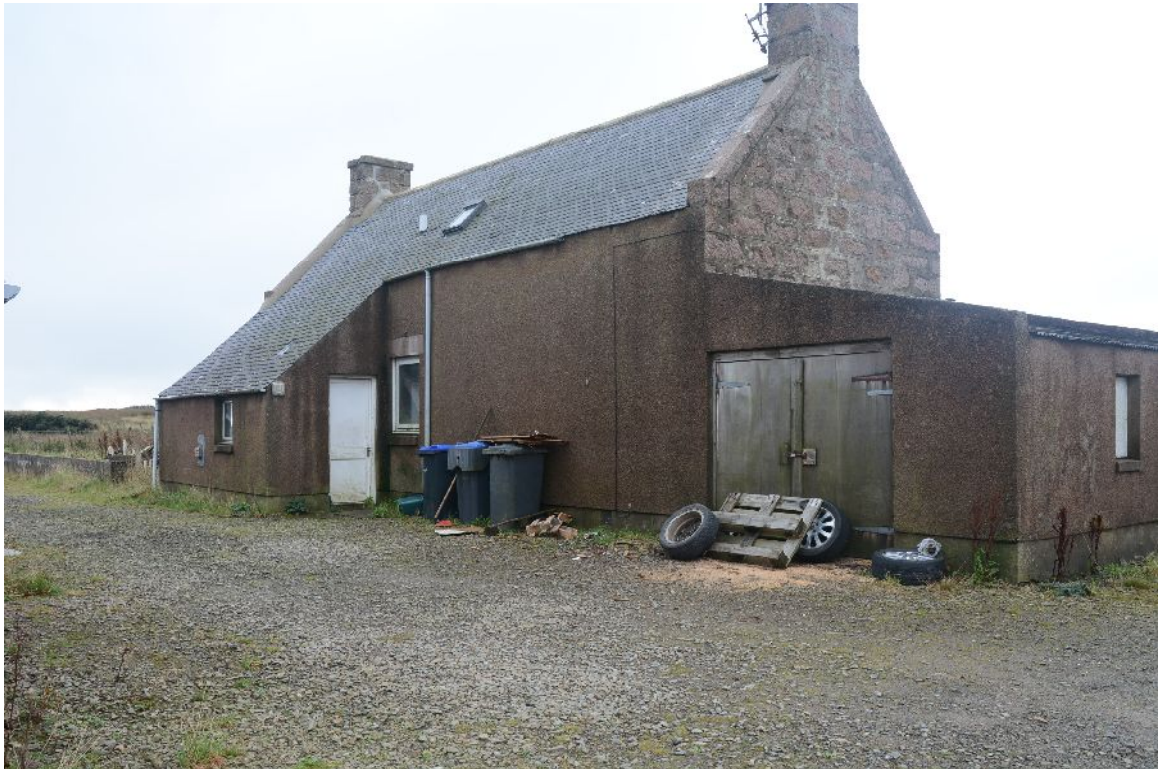
**Illus 6 Farmhouse from steading.**

The farmhouse, which was not part of the planning application, is 1 ½ storied granite building, partly harled and with a slate roof. A lean-to outshot against the S end of the E wall was probably the original milk house. A garage abuts the N gable. The 1970 advertisement (illus 5) describes the original internal layout.

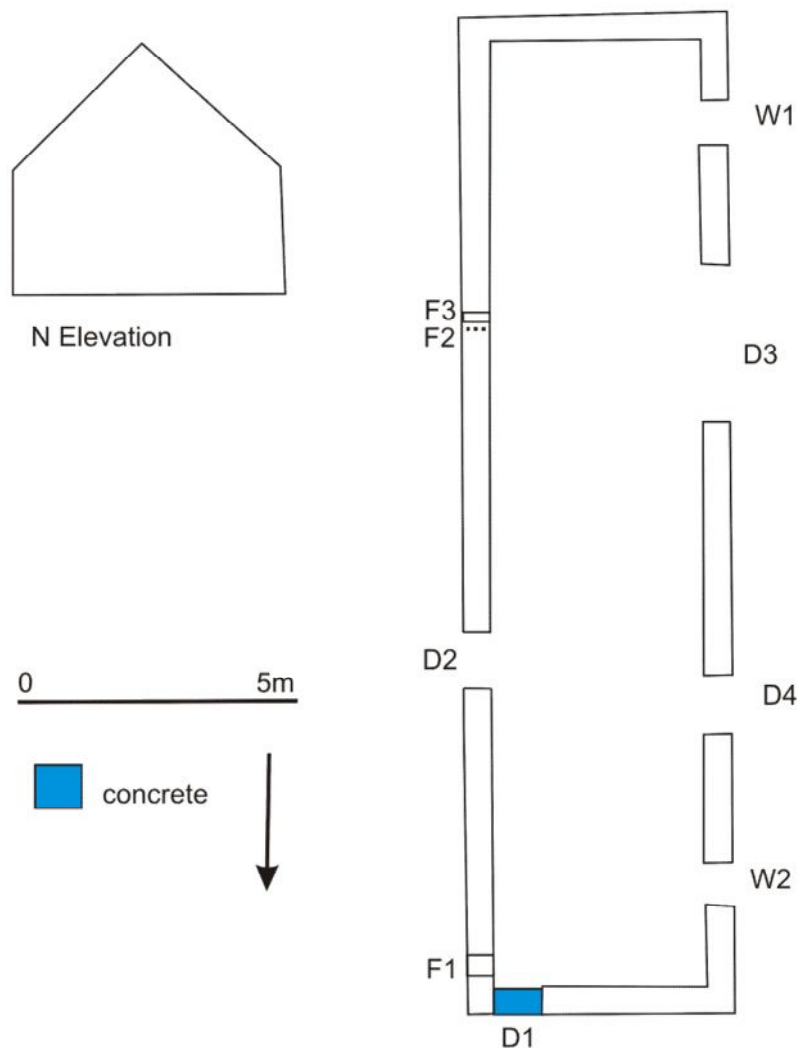
Illus 7 Plan and elevation Building 1

Orientation Approx N/S

Dimensions 4.75 x 18m

Present/recent use Has previously been converted for domestic use with new windows and doors and blocking of some of original openings.

Original use Steading

Walls Squared granite blocks, more regular stonework at gables, more varied rubble in side walls.

Roof Corrugated asbestos. Modern pipe chimney out of E side of roof.

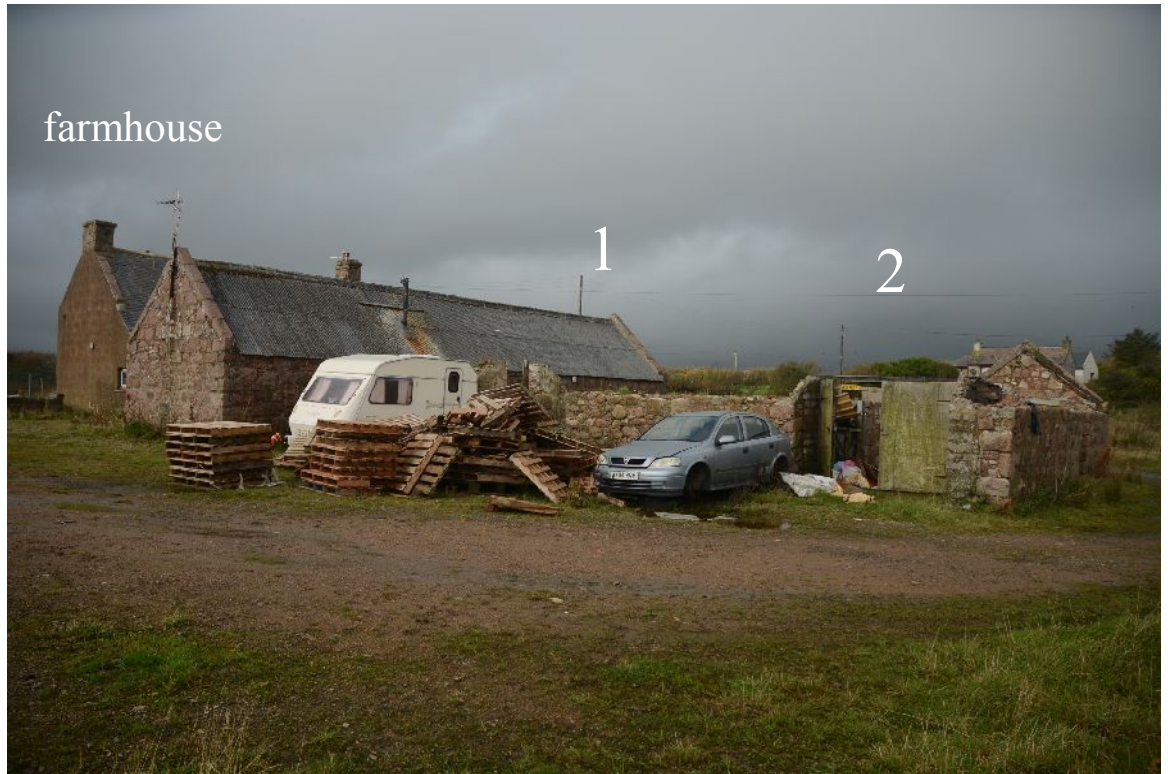
**Illus 8 Buildings looking NW with Building 2 (roofless) in foreground, Building 1 (behind caravan) and farmhouse in background. The chimneys are on the farmhouse.**

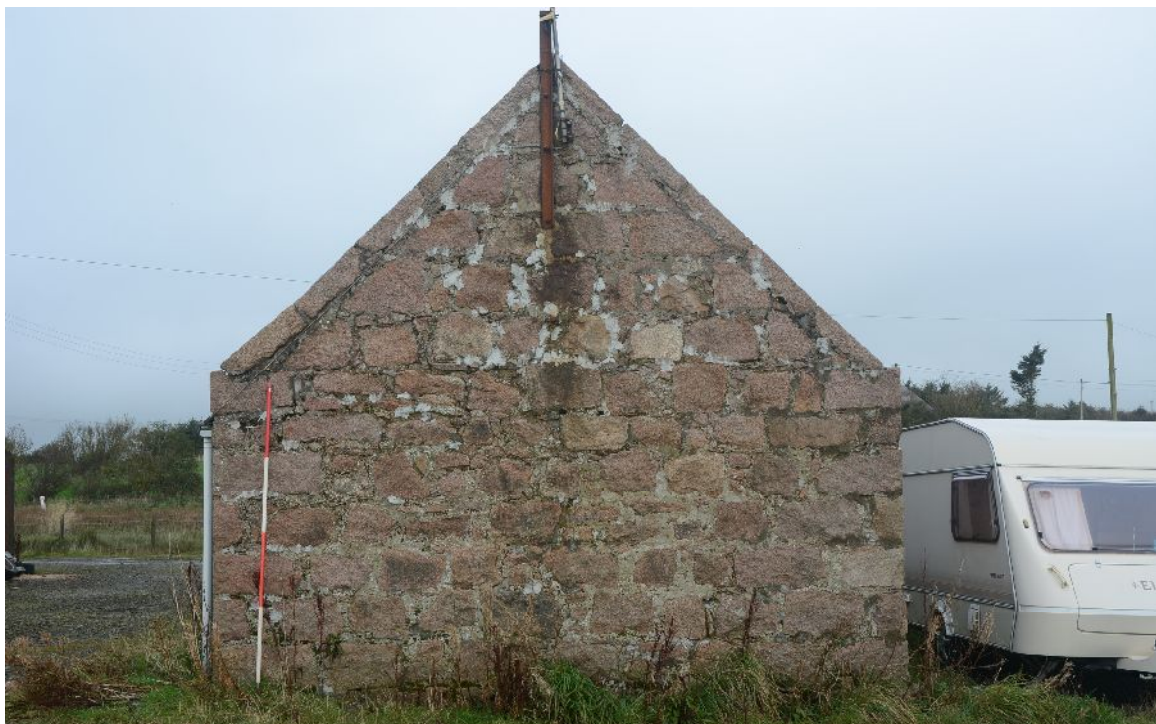
**Illus 9 Building 1. S gable**

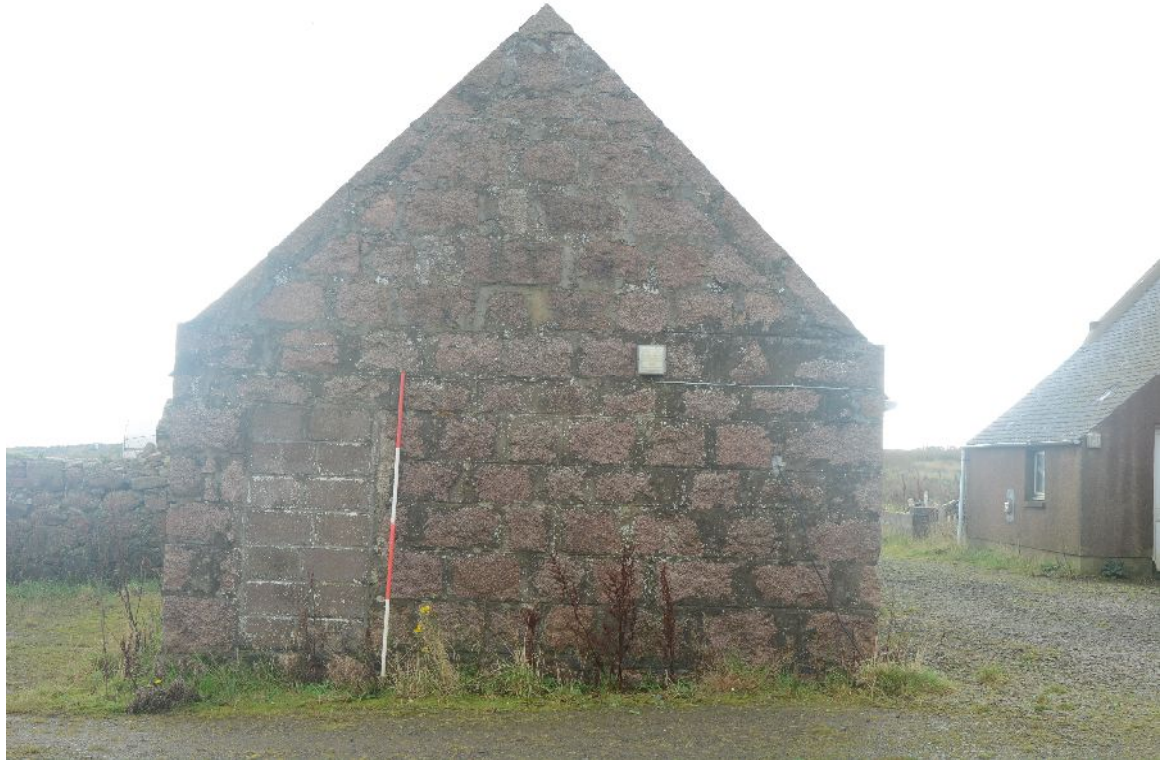
**D1** W: 0.85m H: 1.65m. Concrete blocked doorway.

**Illus 10 Building 1. N wall. Door D1.**

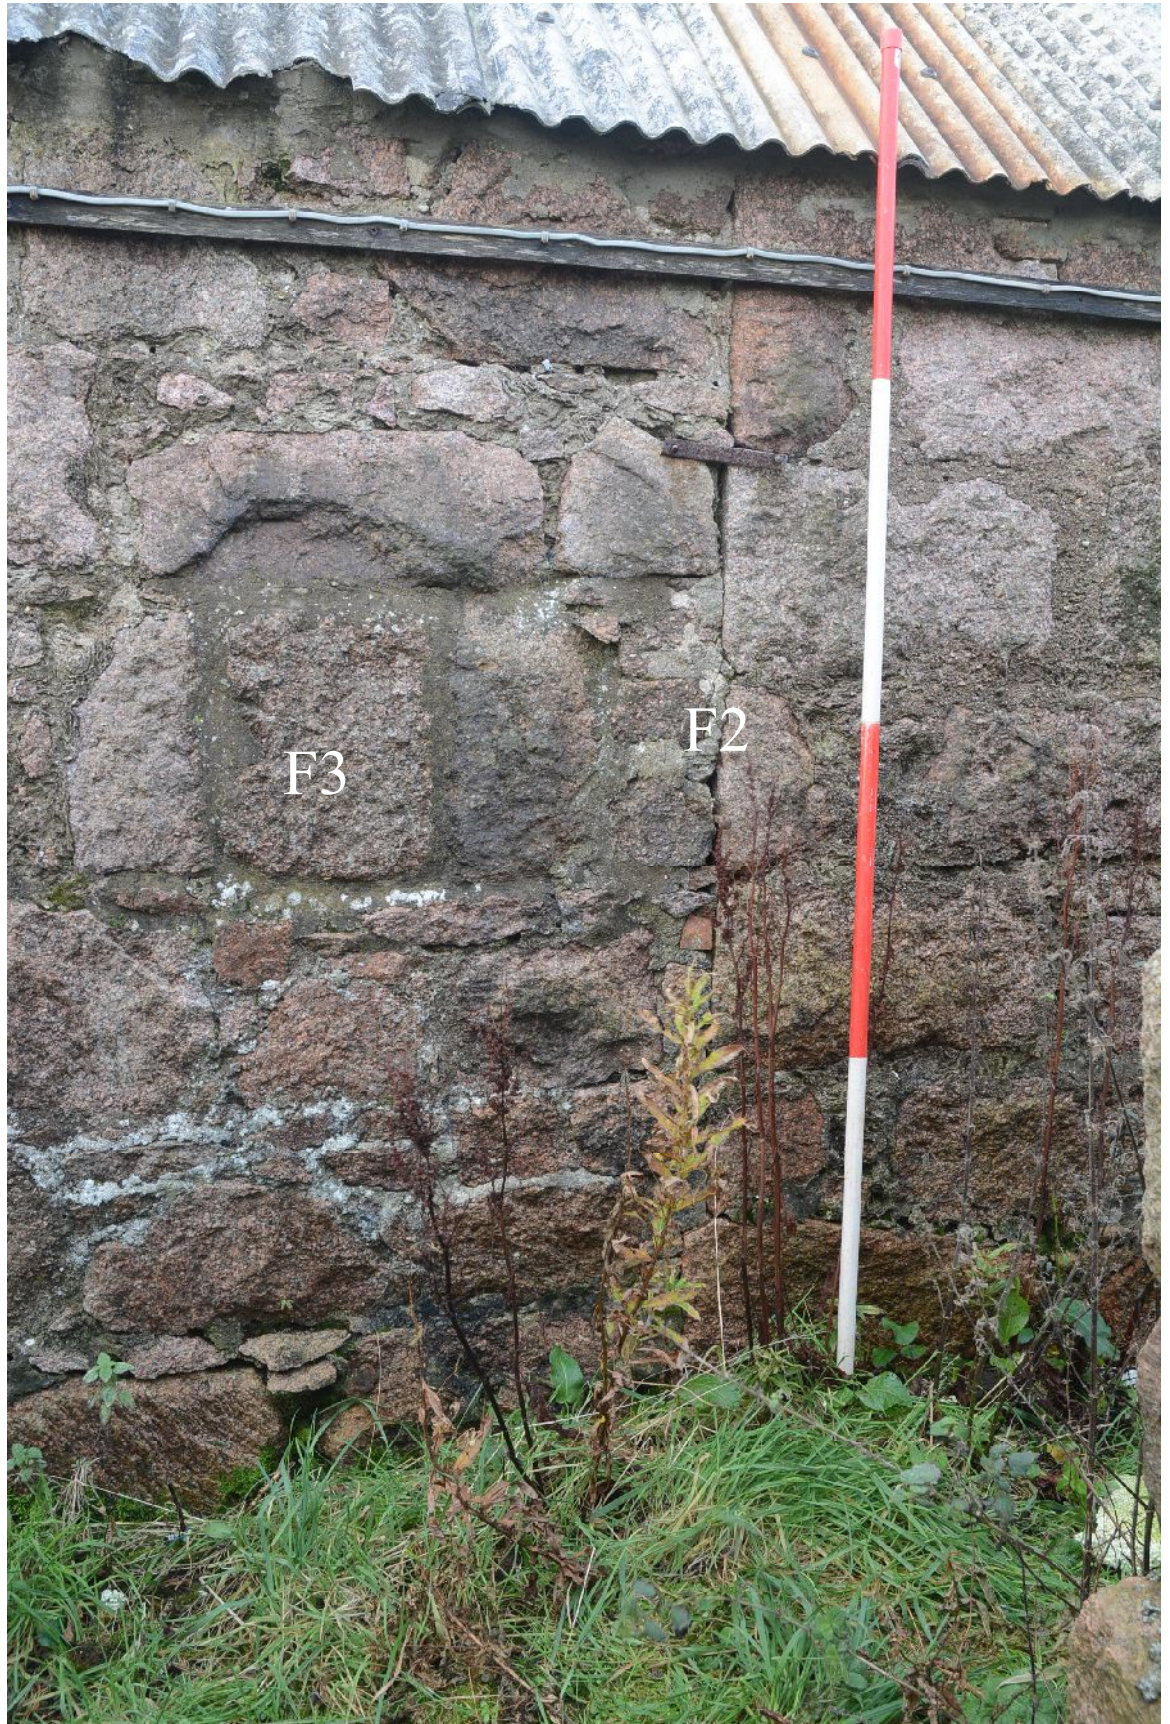
**F2** Vertical build line. Rybats to N of line suggest the building had been extended to S.

**F3** Blocked opening. W: 0.35m. H: 0.50m. Stone rybats, lintel and sill. Appears to have been blocked with a single stone.

**Illus 11 Building 1. E wall. F2 building line and F3 blocking. Ranging rod lies against original rybats.**

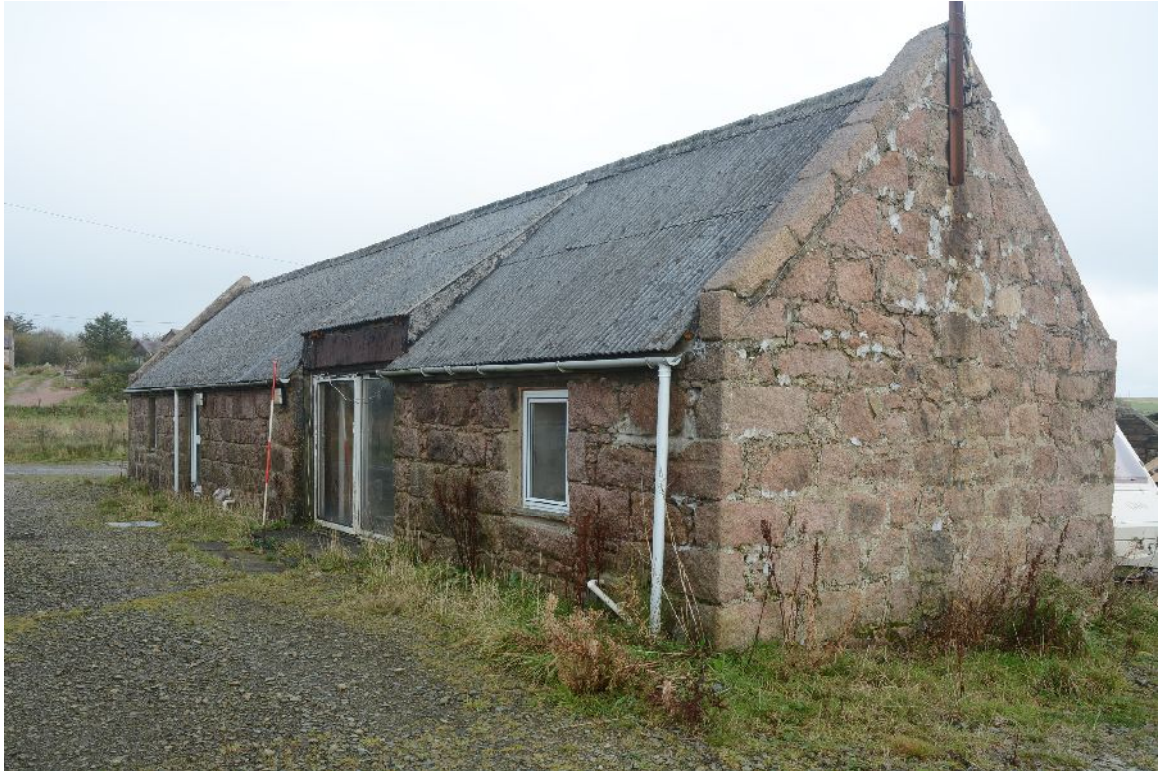
**Illus 12** Looking N along W wall with modern windows and doors

**D3** W: 2.85m H: 1.90m. Red granite rybats, metal lintel set into roof line. Modern sliding glass doors.

**D4** W: 1.02m H: 1.80m. Concrete lintel and red granite rybats . Modern plastic door.

**W1** W: 0.82m H: 1.05m. Red granite lintel, sill and rybats. Modern plastic window.

**W2** W: 0.81m H: 1.08m. Red granite lintel and sill. Modern plastic window.

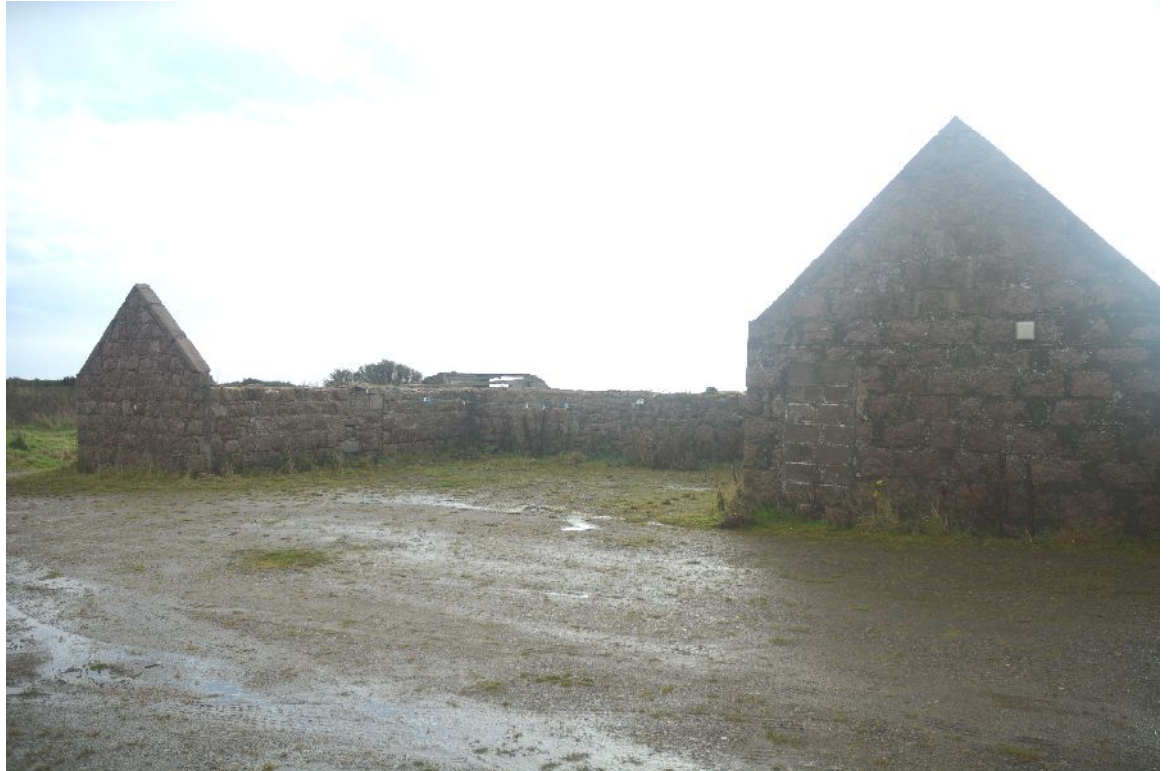
**Illus 13 Building 2 (background LHS) with gable of Building 1 (RHS) looking SE**

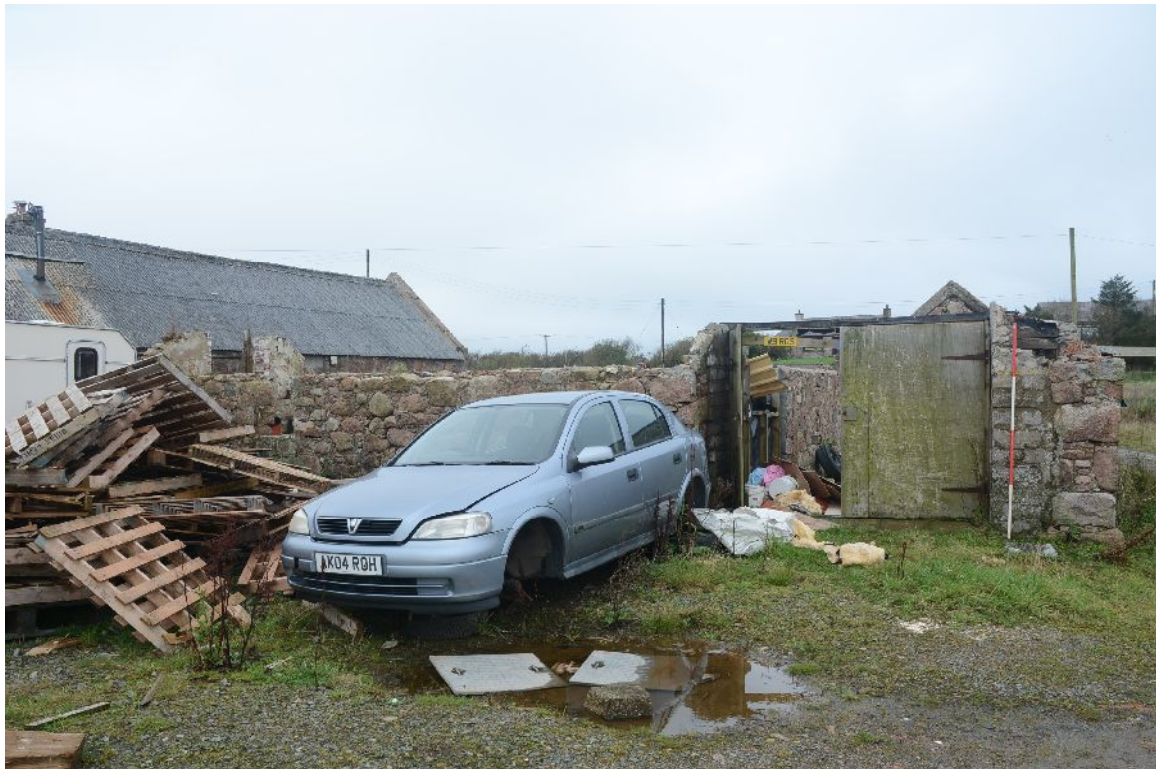
**Illus 14 Building 2 S elevation**

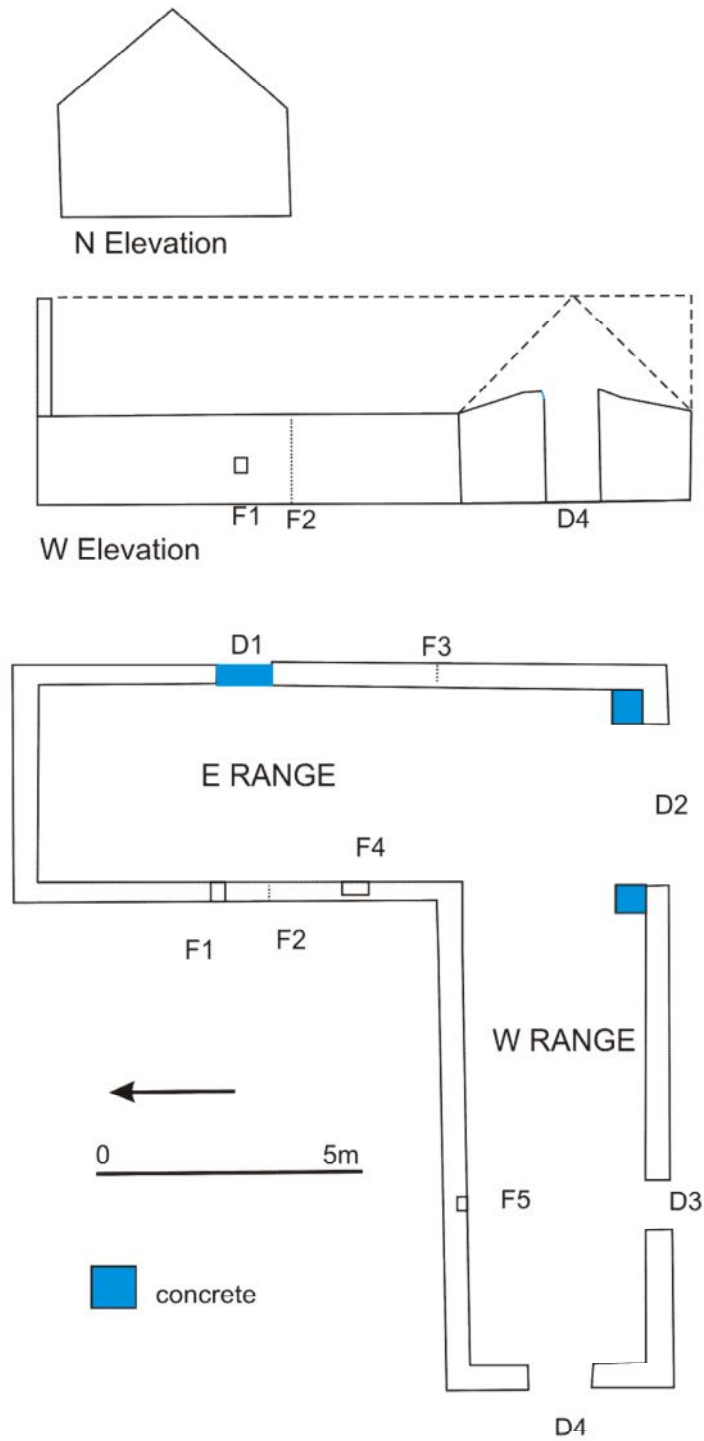
Illus 15 Plan and elevations Building 2

Orientation L-plan. E range orientated N/S, W Range orientated E/W

Dimensions 12.4 x 13.6m max.

Present/recent use Derelict

Original use Byre and mill

Walls Red granite rubble.

Roof Missing

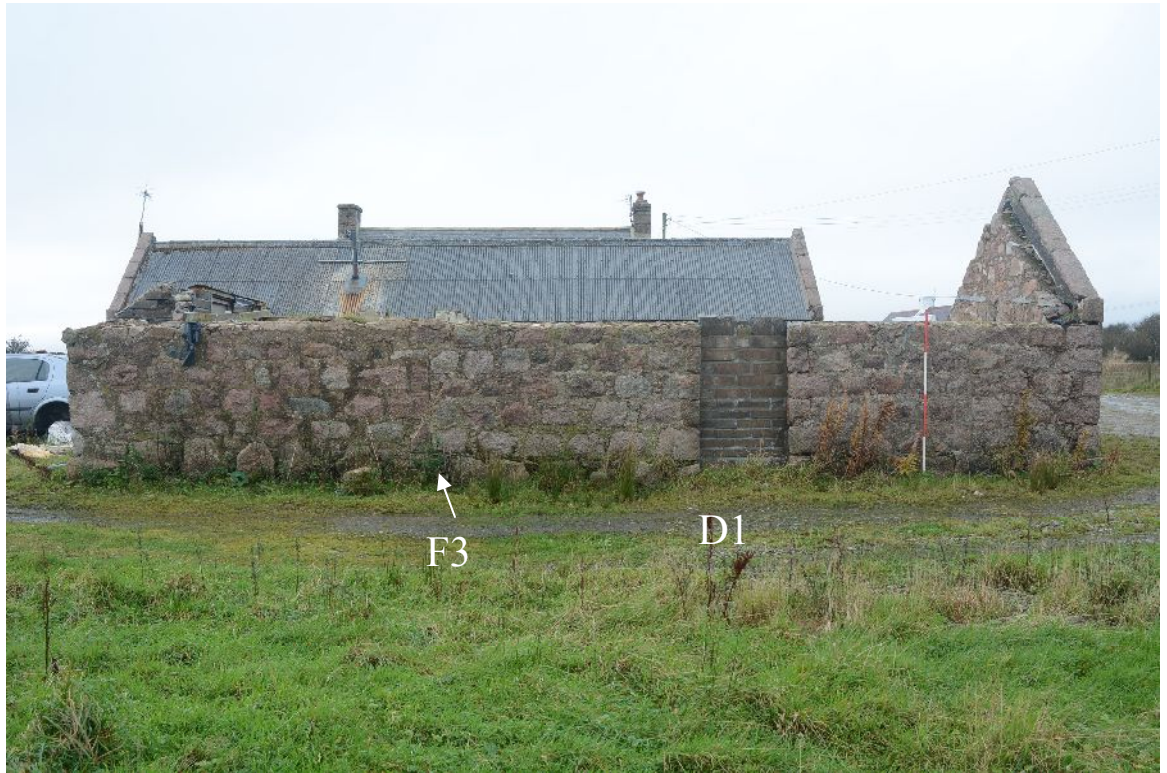
**Illus 16 Building 2, E wall**

**D1** W: 1.06m H: 1.80m. to wall head. Pink granite rybats. No lintel.

Concrete blocked.

**F3** Roughly vertical building line.

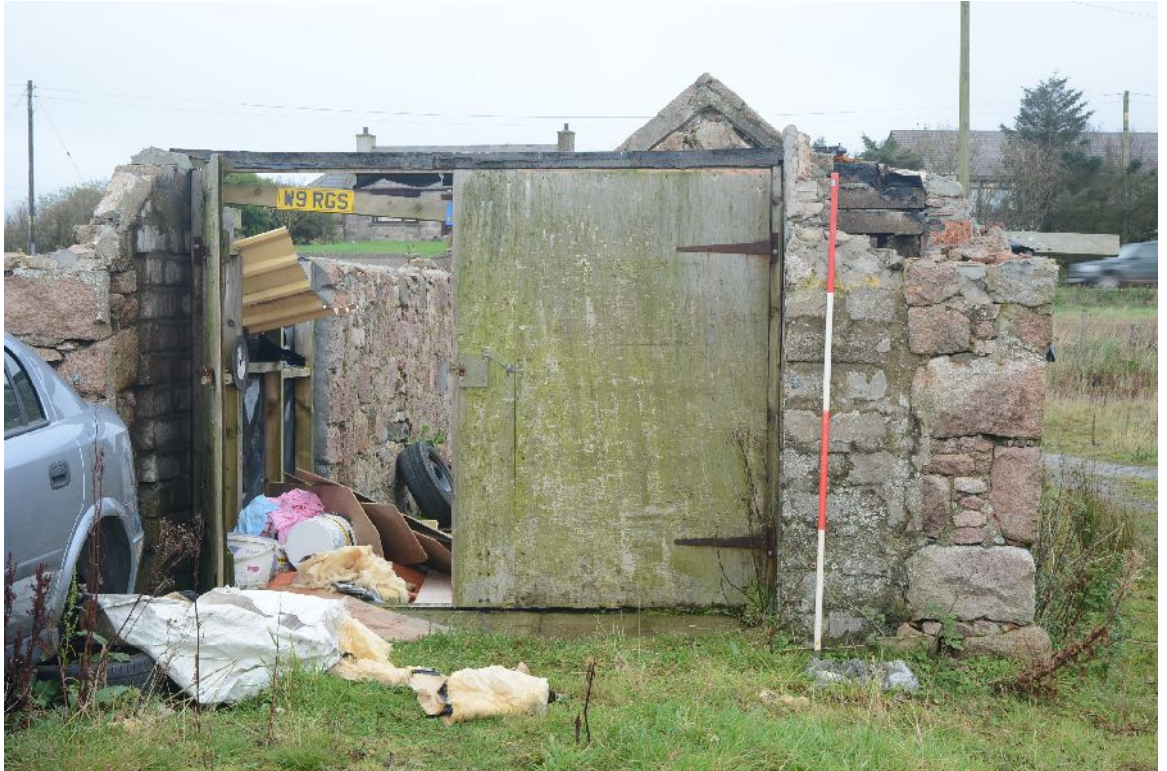
**D2** W: 3.52m to stone (2.96m to concrete). H: 2.35m (to wall top) Knock through at gable with concrete and brick sides.

**Illus 17 Building 2. Door D2**

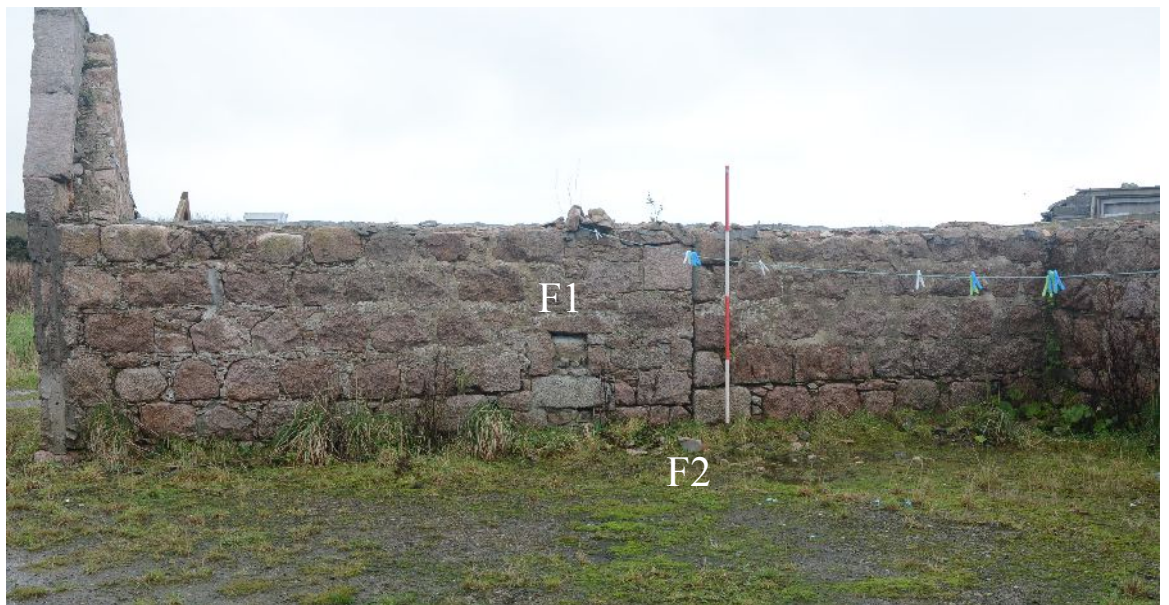
**F1** W: 0.29m H: 0.34m. Height above ground 0.50m. Rubble stone lintel, sill and rybats. Stone blocked. Visible inside with wooden sill.

**Illus 18 Building 2. F1 and F2 external.**

**F2** Vertical build line. Rybats on S side suggest the building was extended N.

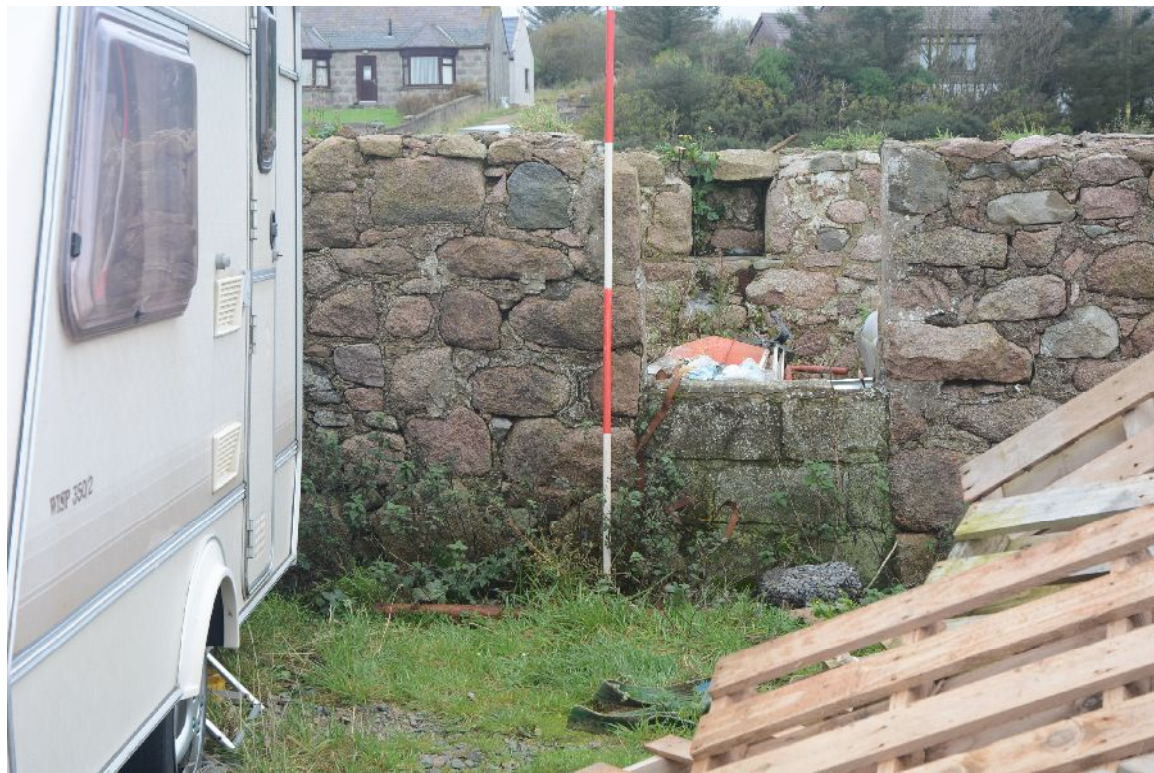
**F5** W: 0.30m H: 0.30m. (estimate). Recess in inner face of wall, approx 0.25m deep. Stone sill and rybats.

**Illus 19 Building 2. Recess F5 seen through partly blocked door D3**

**D3** Partly blocked with concrete blocks to form window. W: 0.87m H: 0.75m (to blocking). Original height 1.50m (to wall head). Rubble rybats.

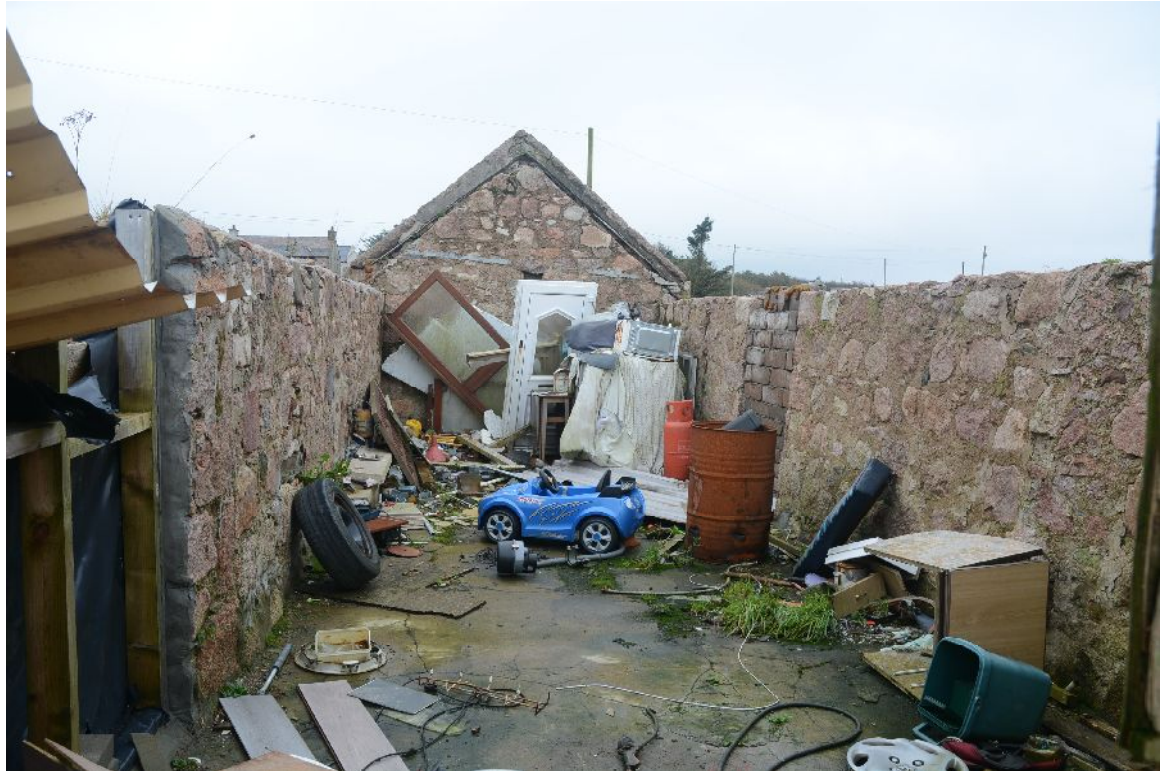
Interior The interior was full of rubbish and difficult to access. Apart from the blockings noted above, no original features were evident.

**Illus 20 Building 2. Interior of E Range from door D2**

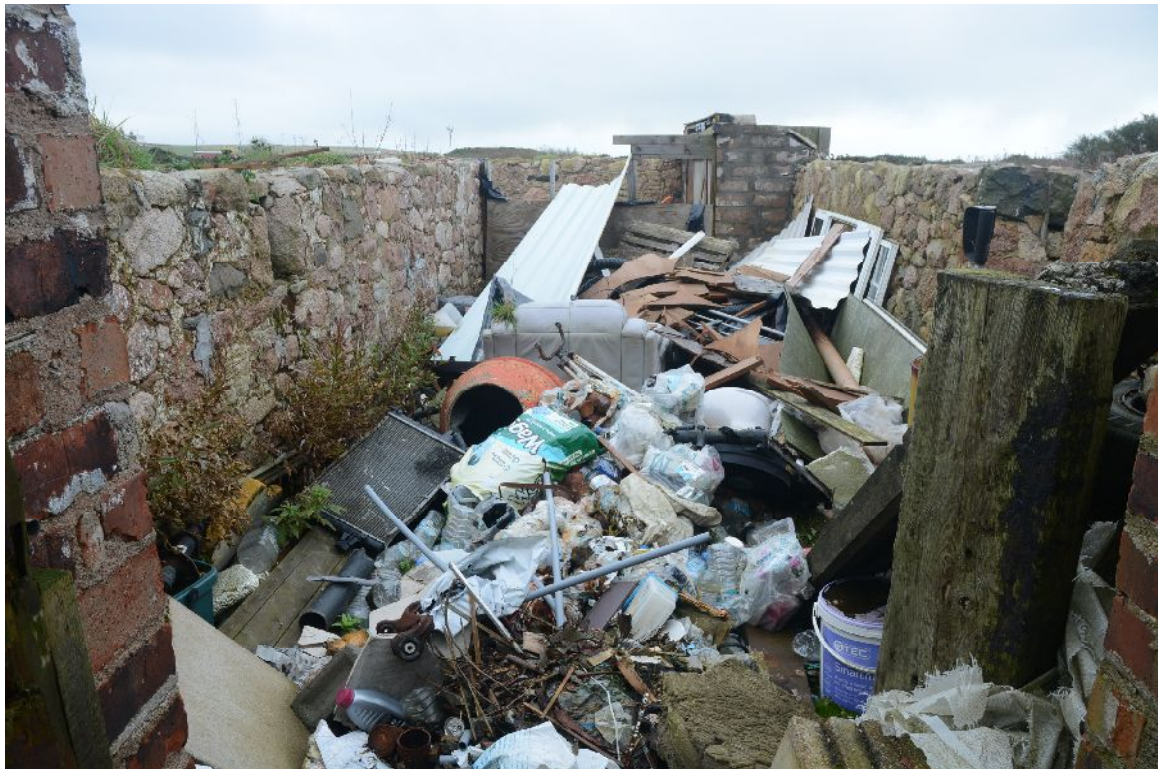
**D4** W: 1.22m H: 2.16m. Sides built up with brick. No surviving lintel.

**Illus 21 Building 2. Interior of W Range from door D4**
