FIRE ALARM UPGRADE PITMEDDEN HOUSE ABERDEENSHIRE

**- Archaeological Watching Brief -
Carried out 13th January 2017
by
Murray Archaeological Services Ltd**

**Report No: MAS 2017-1
by
J C Murray**

PITMEDDEN HOUSE ABERDEENSHIRE FIRE ALARM UPGRADE

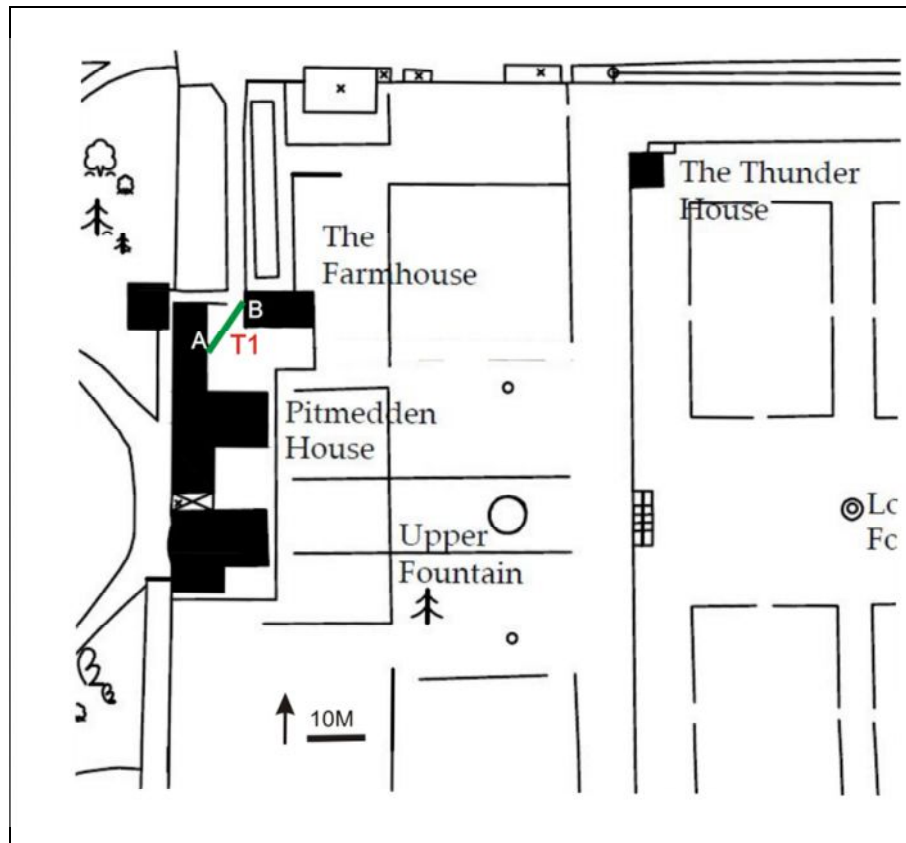
Illus 1: Location of cable trench T1 (trench line green)

- 2.1 The cable trench ran SW - NE across the courtyard the between the smiddy/garage and the farmhouse (Illus 1, 2), while floor boards were lifted in certain rooms at first floor level within the House (Illus.3).

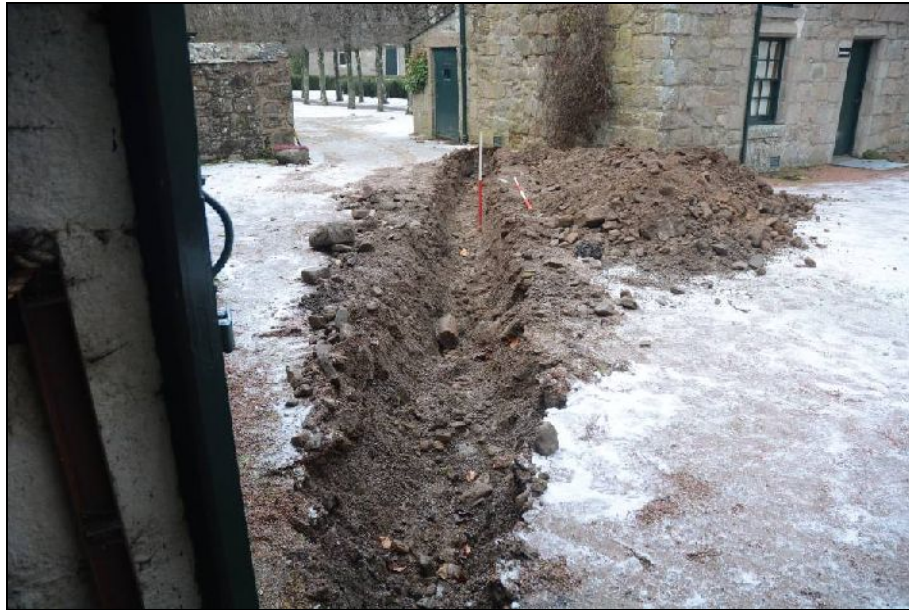
Illus 2: Cable trench, looking NE

The cable trench ran SW-NE between the N end of the door into the smiddy/garage (A, GPS: 388444 828066) and the E gable of the farmhouse (B, GPS: 388443 828071). The trench was 11m long, 700mm wide and c.400mm deep. The fill of the trench was uniformly made up of rubble stone, gravel and sandy soil with some discarded pieces of ceramic drain below a thin surface of sandy gravel. At c.2.5m NE of the smiddy/garage door, a cast iron water pipe

ran E-N across the trench. At c.6m NE of the smiddy door, a beige sandy natural was evident at a depth of 400mm.

No archaeological features were evident in the rubble fill of the cable trench.

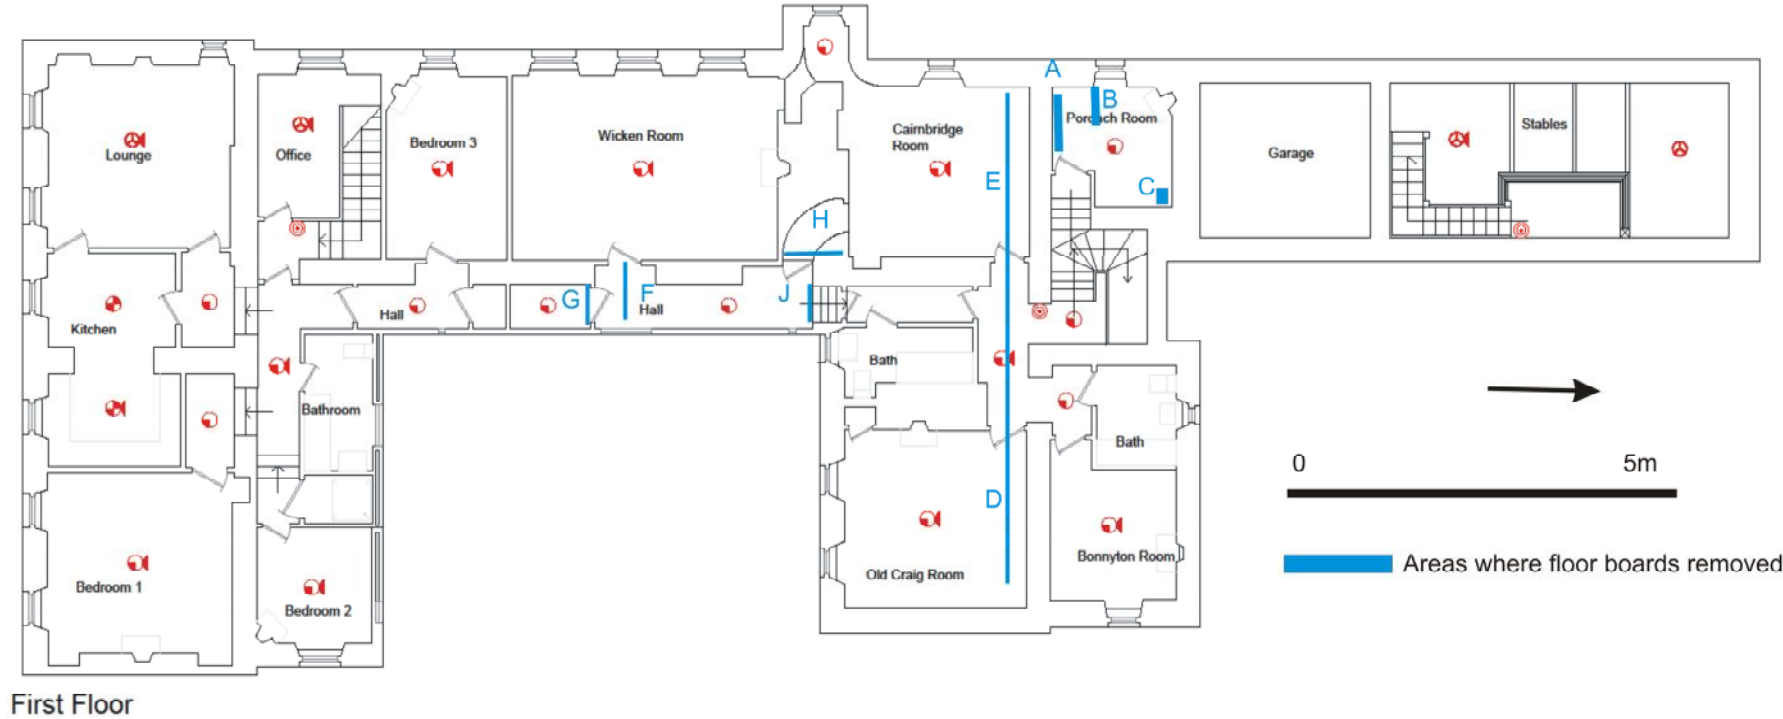
3Illus 4: 1st Floor Plan showing where floorboards were lifted (blue)

Floor boards were raised in some of the rooms and corridors of the first floor of the House to facilitate access for fire alarm cabling.

In general, the floorboard width was 135mm. The floor joists measured c.150mm x 65mm were spaced at intervals of c.400-450mm.

Boards were lifted in the following areas (see Illus.3):

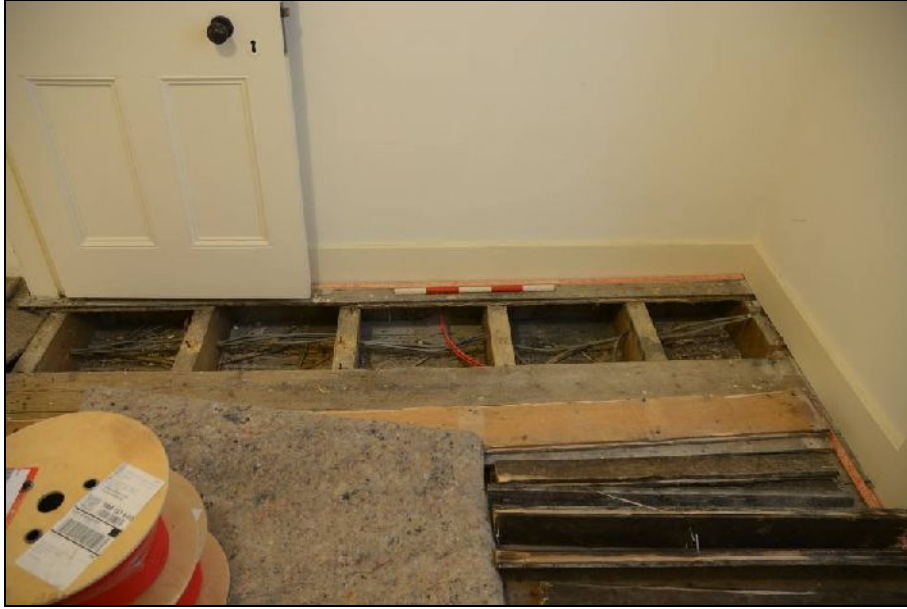
Illus 5: Pordach Room, view to S wall

Pordach Room: Boards were lifted along the S wall (A), E of the window in the W wall (B) and in the NE corner (C).

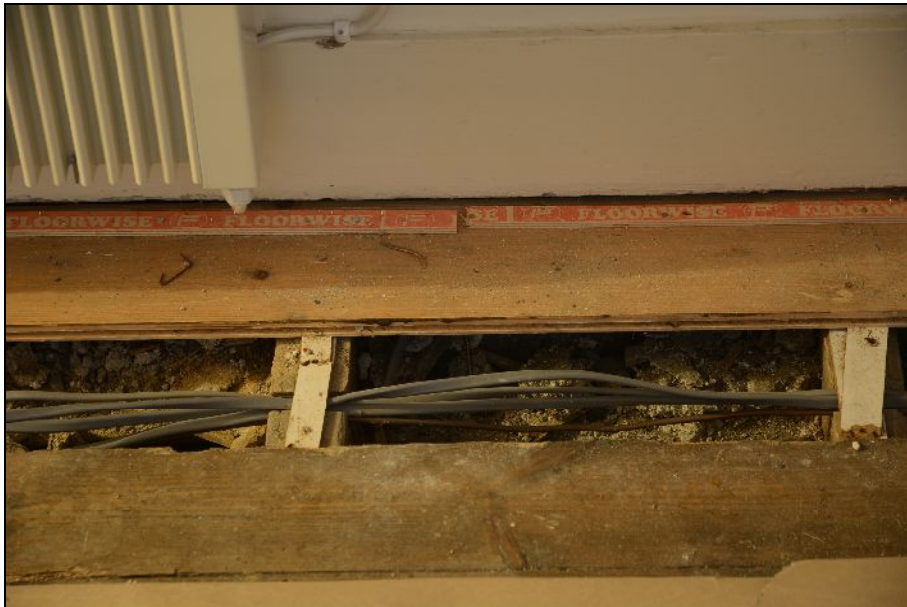
Illus 6: Floorboards along N wall of Old Craig Room

Floorboards were lifted along the N wall of the room (D).

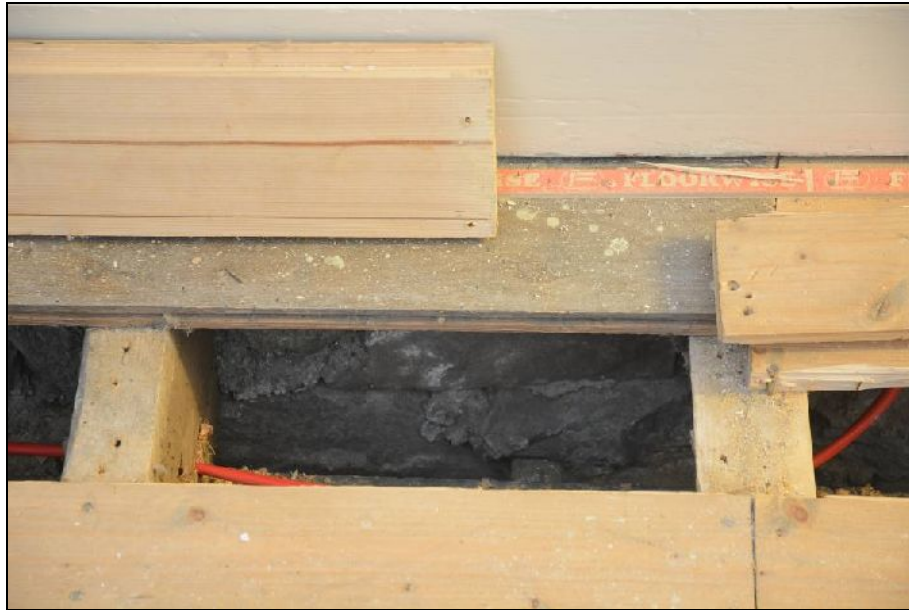
Illus 7: N wall of room visible, looking N

Floorboards were lifted along the N wall (E) of the room and the N wall itself was visible below.

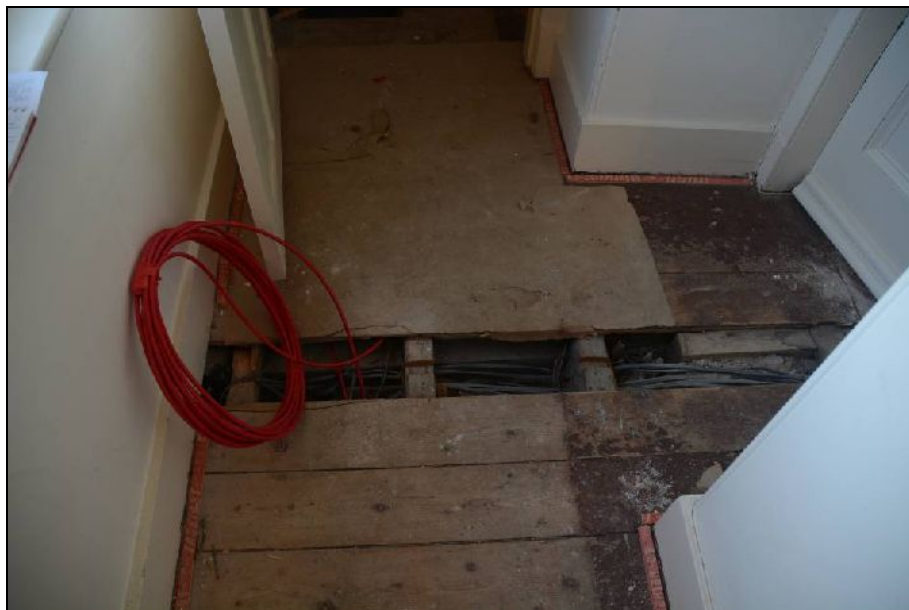
Illus 8: Entrance to Wicken Room on right, looking S

Only one floorboard was lifted which crossed the hallway at the entrance to the Wicken Room (F) but did not enter it. Boards were also lifted in the cupboard at the S end of the corridor (G).

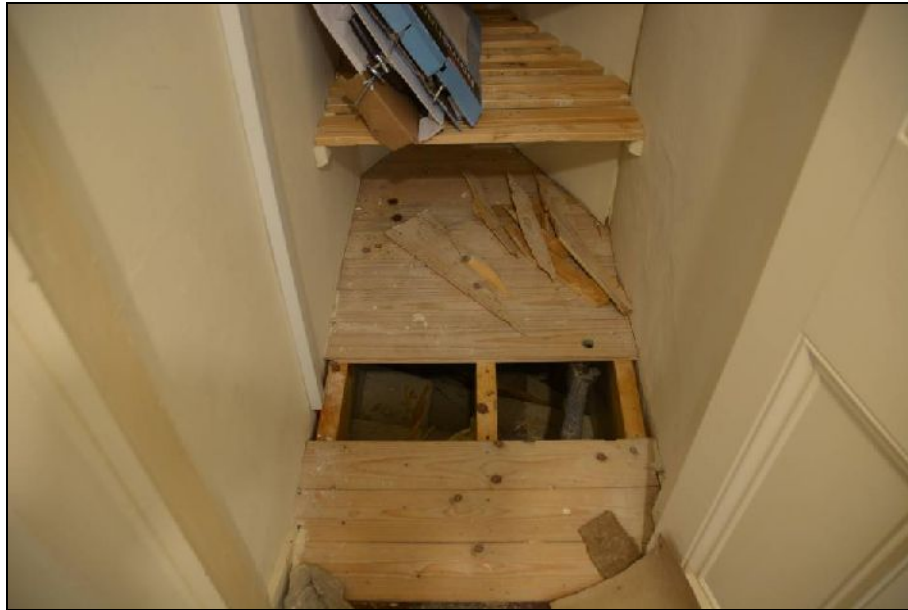
Illus 9: View of spiral stair in cupboard, looking W

Floorboards were lifted across the N end of the corridor leading to the Wicken Room (J) and in a cupboard on the E side of the corridor (H). Beneath the boards in the cupboard (H), three steps of what was a wooden spiral stair leading down to the ground floor were just visible. Although difficult to observe properly in the narrow confines of the cupboard, it was evident that the remainder of the stairs had been disassembled. It is probable that the stair would have emerged on the ground floor on the S side of the entrance hall.

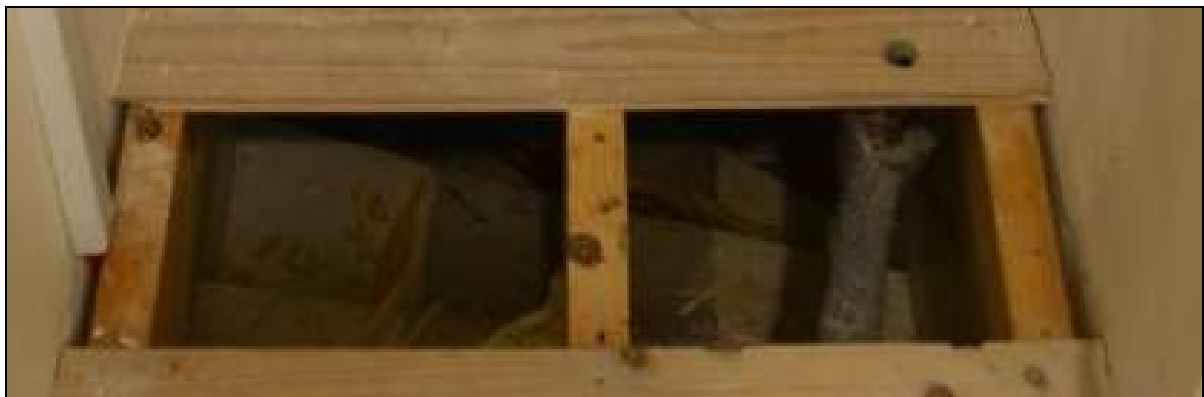
Illus 10: Detail of stair

- 5.1 With the exception of the wooden stair (Illus 10) observed in the cupboard at the N end of the corridor leading to the Wicken Room which led down to the

ground floor, but now dismantled, no other architectural features or evidence of earlier activity was evident.
