DUBSTON STEADING
INVERURIE
ABERDEENSHIRE

Standing Building Survey

Carried out 9th November 2017

Report No: MAS 2017-30

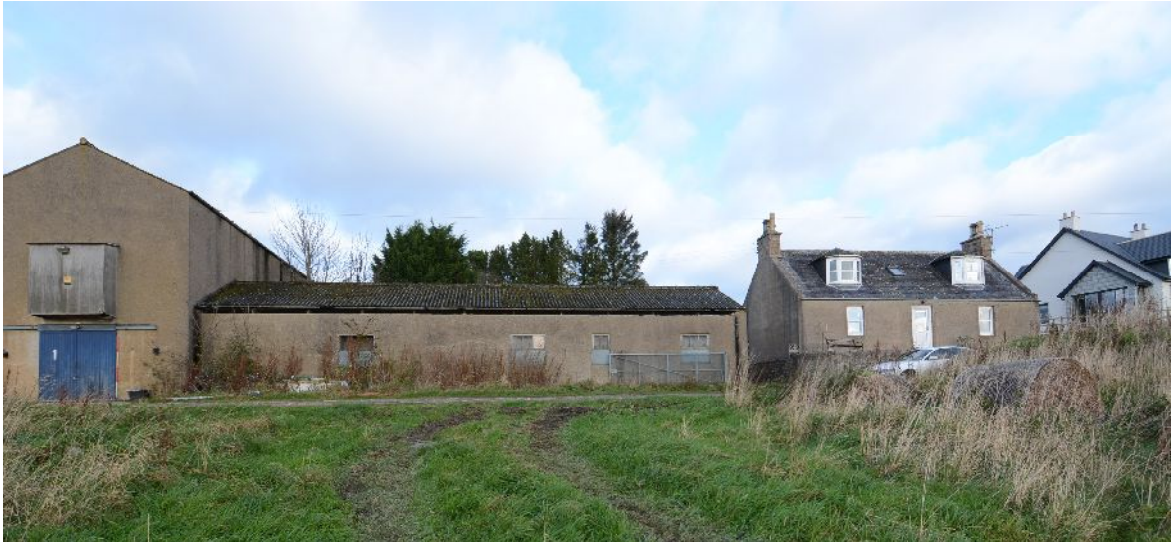
The farmhouse, is T –plan. The earliest rectangular block of 1 ½ storeys which is S facing, is shown on the 1867 OS map, with two extensions added to the N side shown on the 1899 and 1924 maps respectively. It is of harled rubble stone with ashlar detailing. The roofs are slate. Windows and doors are modern.

Illus 8 The farmhouse (RHS) in relation to the steading.

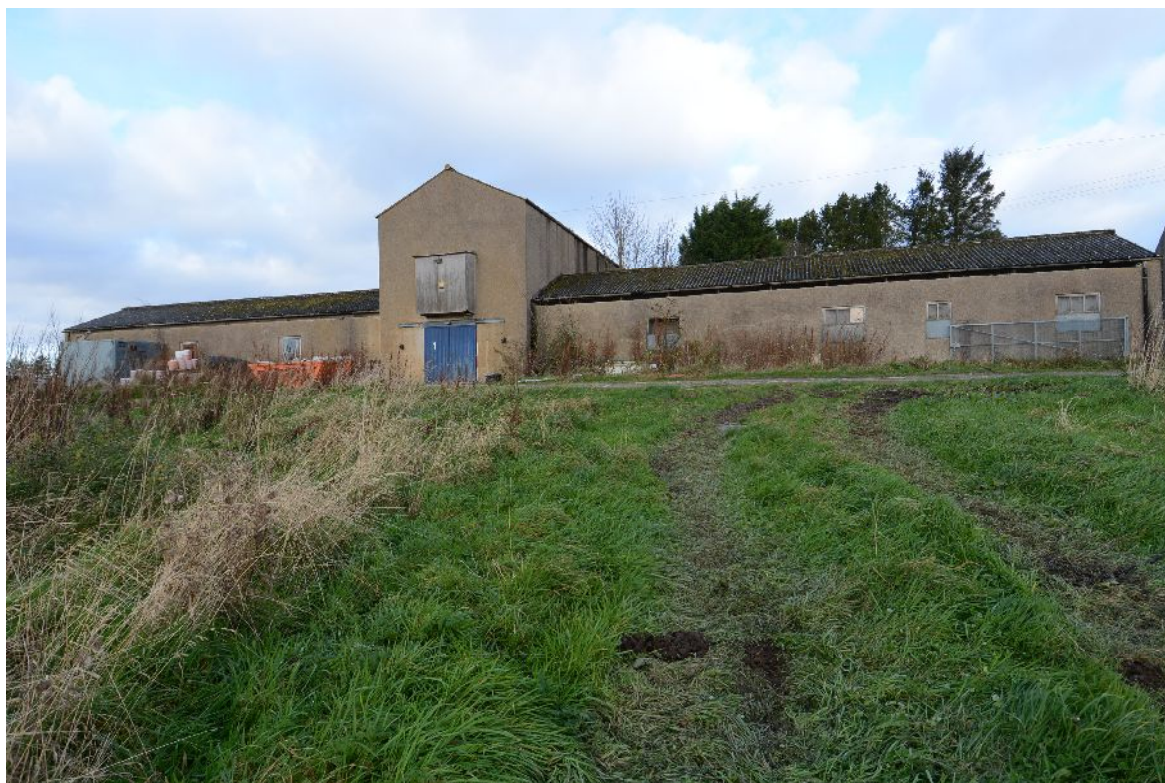
Illus 9 S elevation Building B

Orientation The steading is an inverted T-plan, facing S, with the central N/S range flanked by E and W ranges, also facing S. The steading is built on a slope so that at the back (N) side the upper floor of the central range is entered at ground level.

Dimensions Central range: 22 x 7m. E range: 20 x 7m. W Range: 20.5 x 6.5m.

Original use Mill with loft above (Central range), with probable cattle byres in the E and W Ranges.

Walls Rubble stone with cement harling. Details obscured externally by harling. Internal view of central range shows the walls of the original loft have been raised with concrete block construction (Illus 11-12).

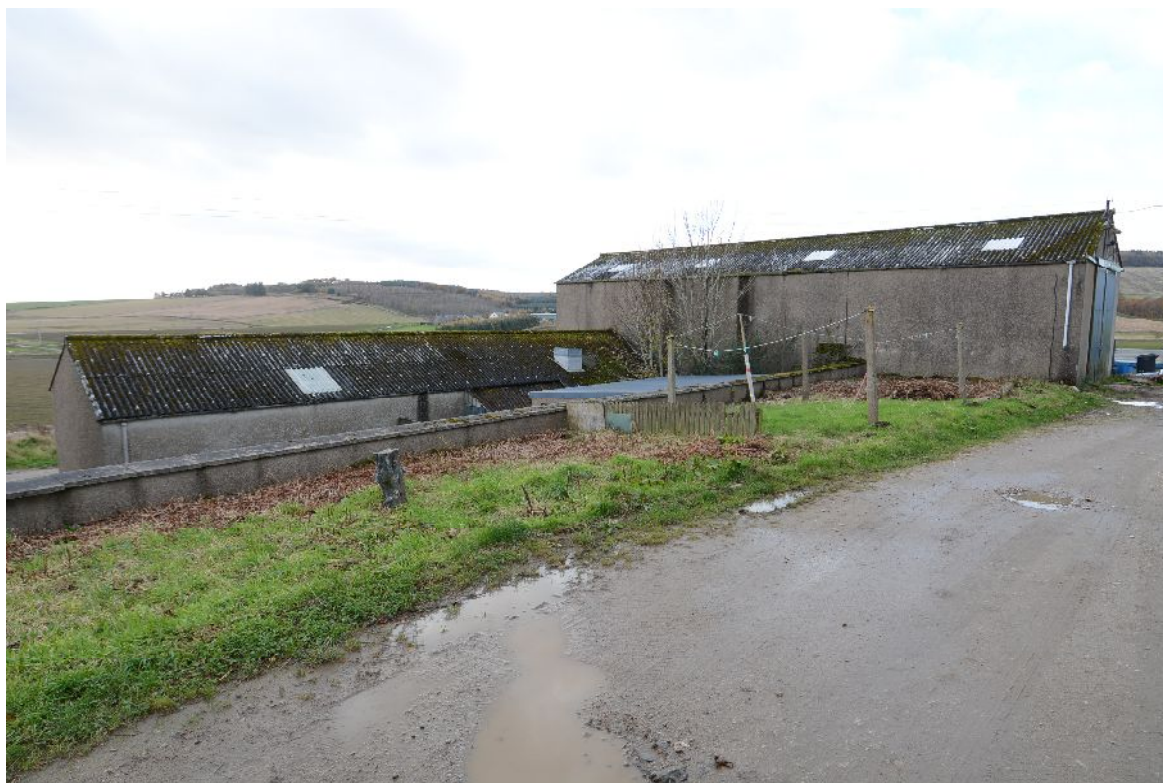
Illus 10 N elevation of Building B looking W

D2 opens into first floor from high ground at back. W:4.5m. H: c. 3.5m.

Metal sliding doors.

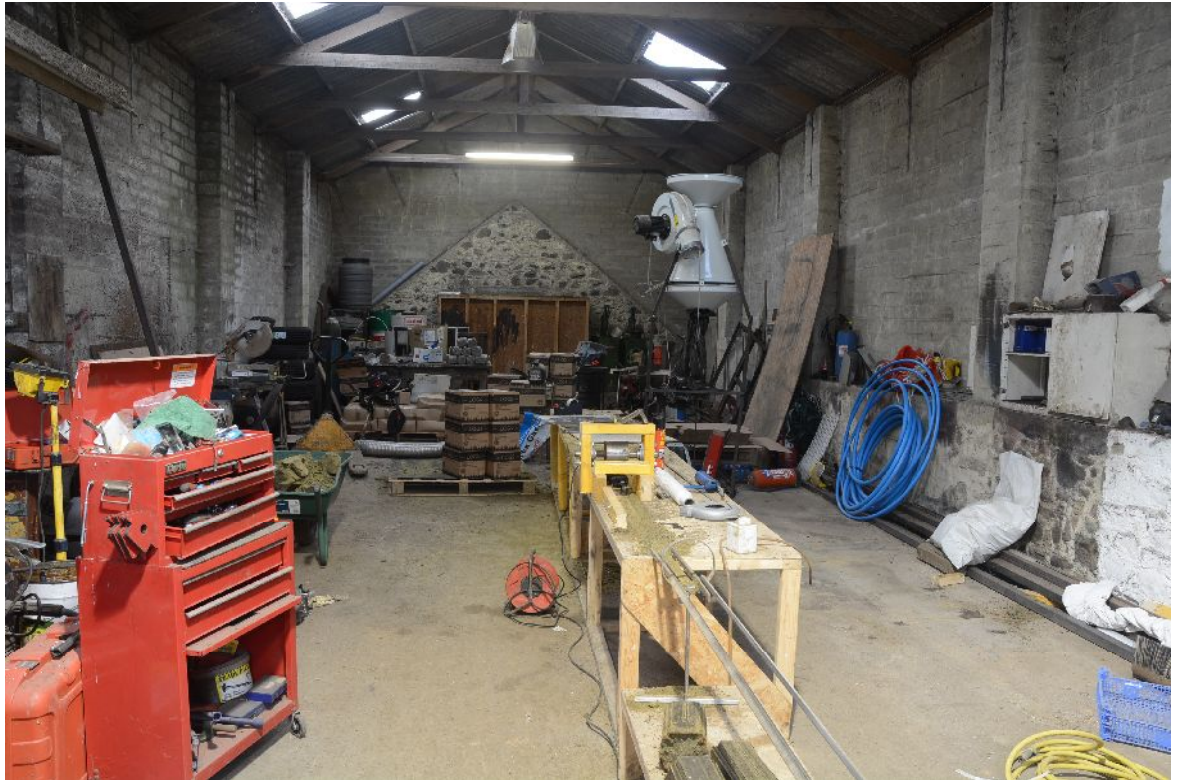
Illus 11 Looking S inside the upper floor of the central range of Building B. Note the original S gable of the loft, with walls raised with concrete blocks.

Subsequently the walls of the mill loft have been raised with concrete block construction and a tractor-height door inserted in the N gable from the higher ground at the back of the building.

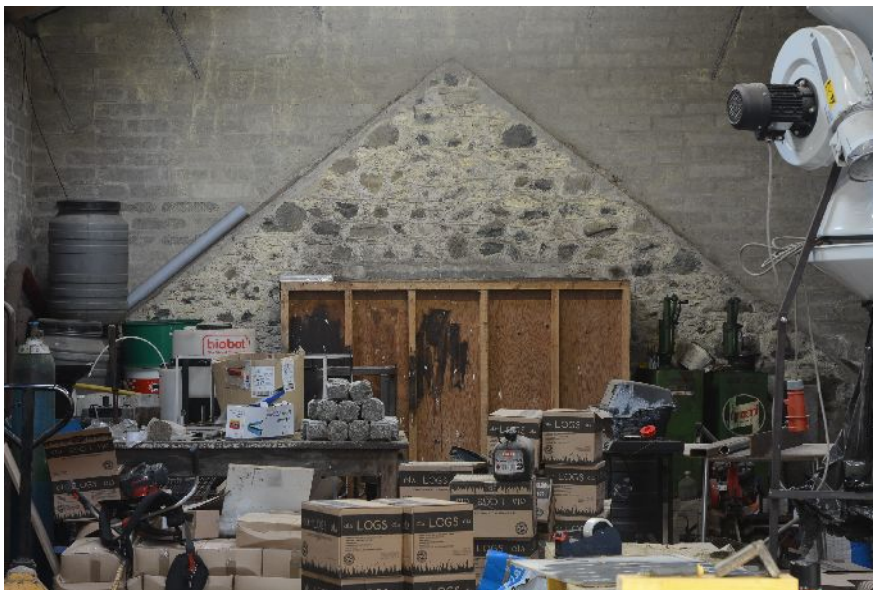
Illus 12 Detail of Building B original S gable of loft

The steading appears to have been of mid 19th-century date. Originally the central range was a mill- as shown by the horse mill on the 1867 and 1899 OS maps. With the possible exception of blocking F4, there was no surviving evidence of this former horse mill which had been removed by 1924. This is fairly typical of the transition from horse-driven mills to oil engines, partly an effect of the loss of horses in WW1 but also a trend prior to the war (as described in an article in the *Aberdeen Press and Journal* 19th September 1911 (www.britishnewspaperarchive.co.uk)). It is probable that at Dubston the horse mill was replaced by a motor. The original loft over the mill is illustrated by the surviving original S gable with loft door D3.

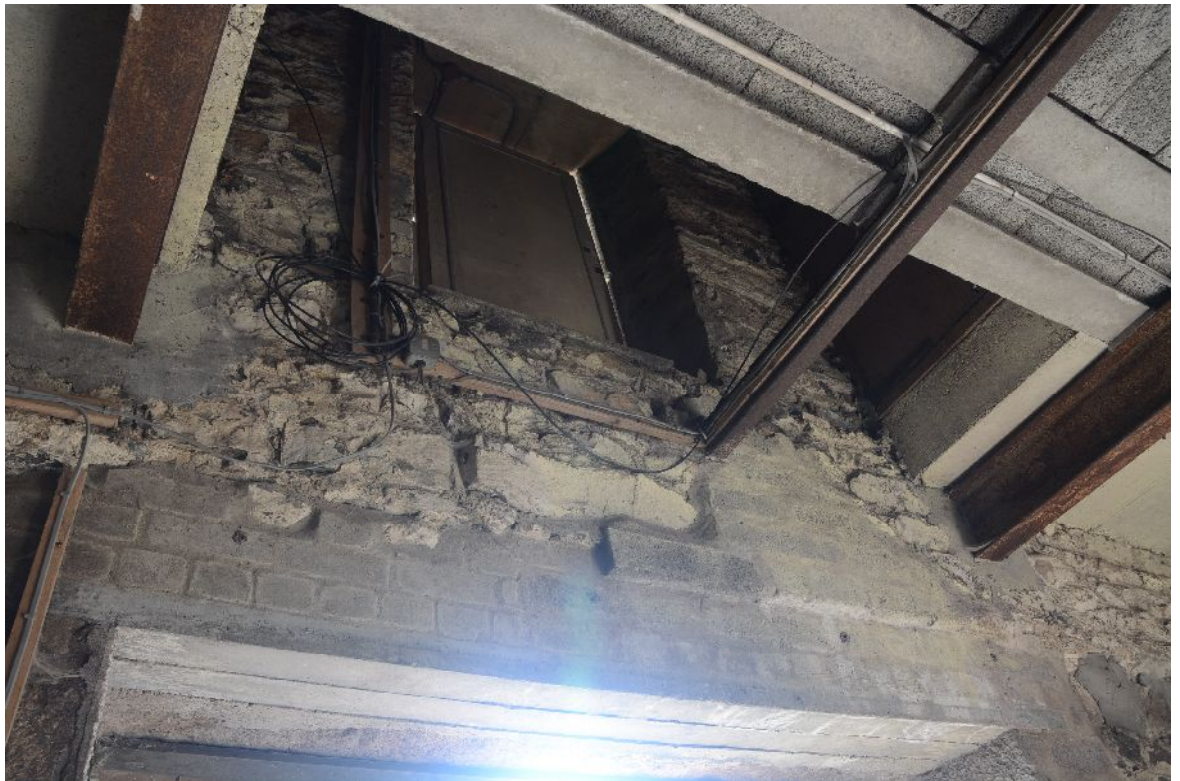
Illus 16 Looking at original loft door D3, above door D1 in S gable of Building B, central range

D1 W: 2.26m H:2.30m Wooden sliding doors.

At loft level D3. Estimated width c. 1m. Covered externally with wooden boxing.

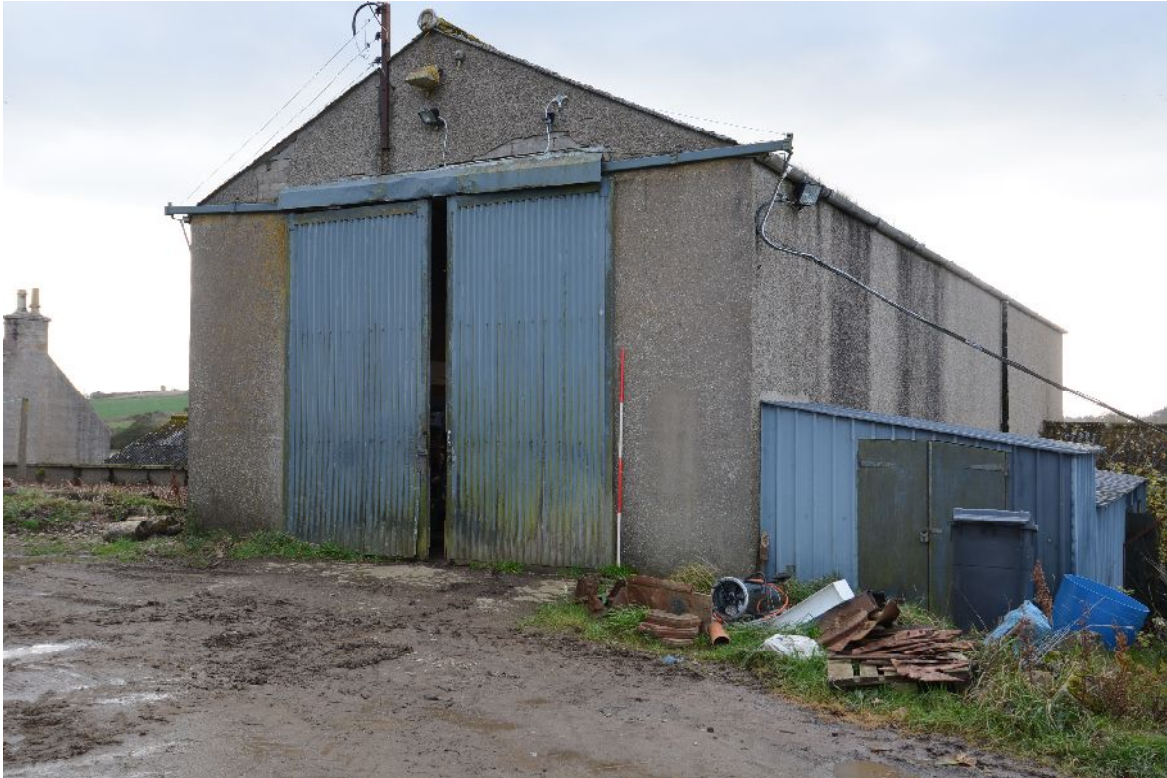
Illus 18 Building B central range with modern door D2 into heightened loft/first floor

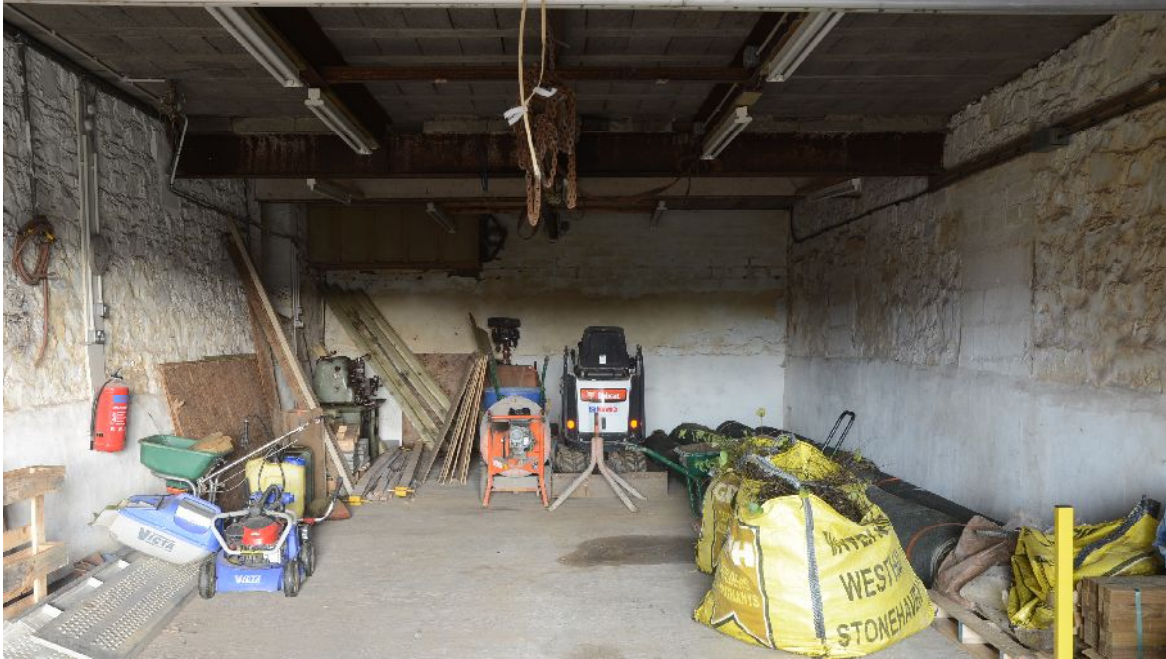
F2 W:1.3m H: unknown as lower part of wall concrete lined internally. Concrete blocked.

F3 W:1.0m H: unknown as lower part of wall concrete lined internally. Concrete blocked.

Illus 19 Building B central range. Interior at ground level looking N. Blockings F2 and F3 on RHS

It is probable that the E and W ranges were used for cattle but the interior has been gutted and the lower parts of the walls lined out, so no details remain. A few blockings (F1, F2, F3, F5) are partially visible on the inner faces of the walls but are not visible externally because of the harling and can not be interpreted.

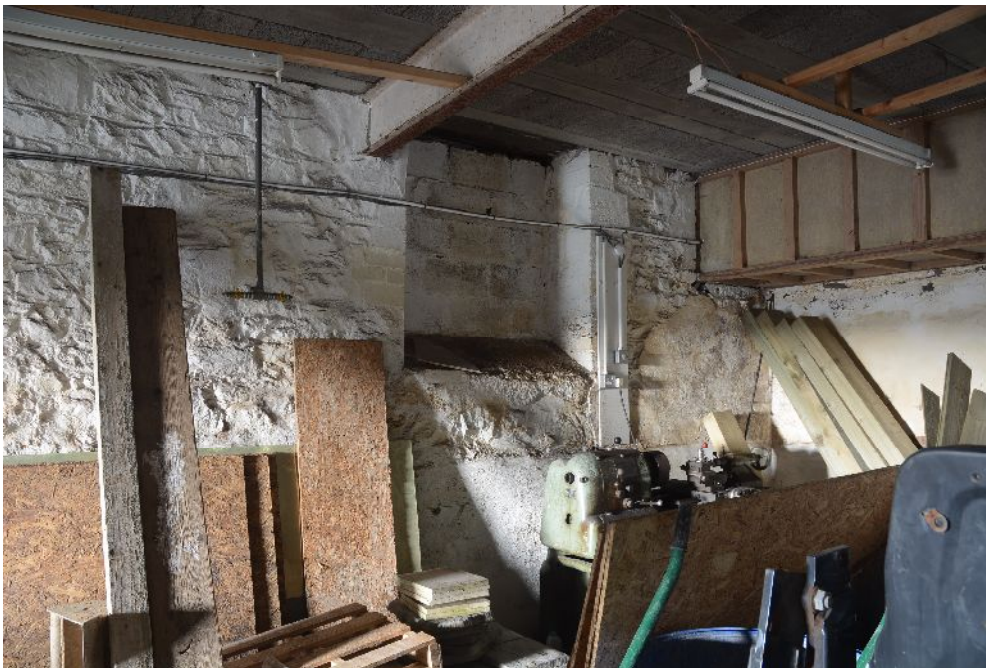
F4 W:1.1m. H: unknown. Concrete blocked. Base half way up wall. Possibly related to former horse mill.

Illus 20 Building B central range, blocking F4
