**STEADING  
OPPOSITE 16 MARSHALL MACKENZIE  
DRIVE  
KINGSEAT  
NEWMACHAR  
ABERDEENSHIRE**

**Standing Building Survey**

**Report No: MAS 2018-03**

**- Standing Building Survey -**

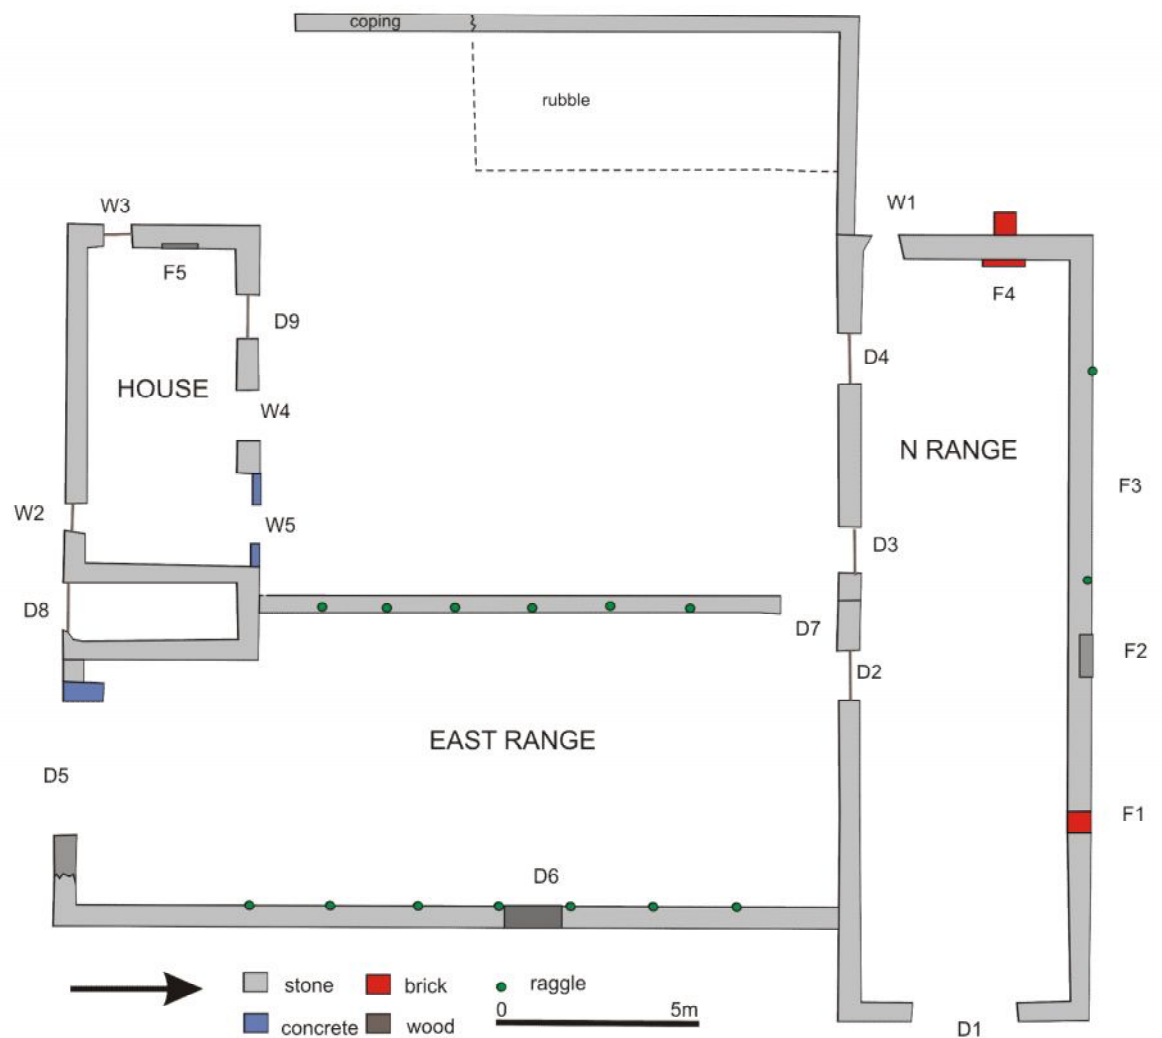
**Illus 5 Plan**

Orientation The steading is a U plan, facing West.

Walling The walls are generally of mixed rubble field stone, with dressed stone for skewes etc. Much of the walling is of fairly poor construction, especially on the internal faces. The more visible E and S facades and the walls visible from inside the open court are constructed of squared blocks with more regular courses. (Illus 6).

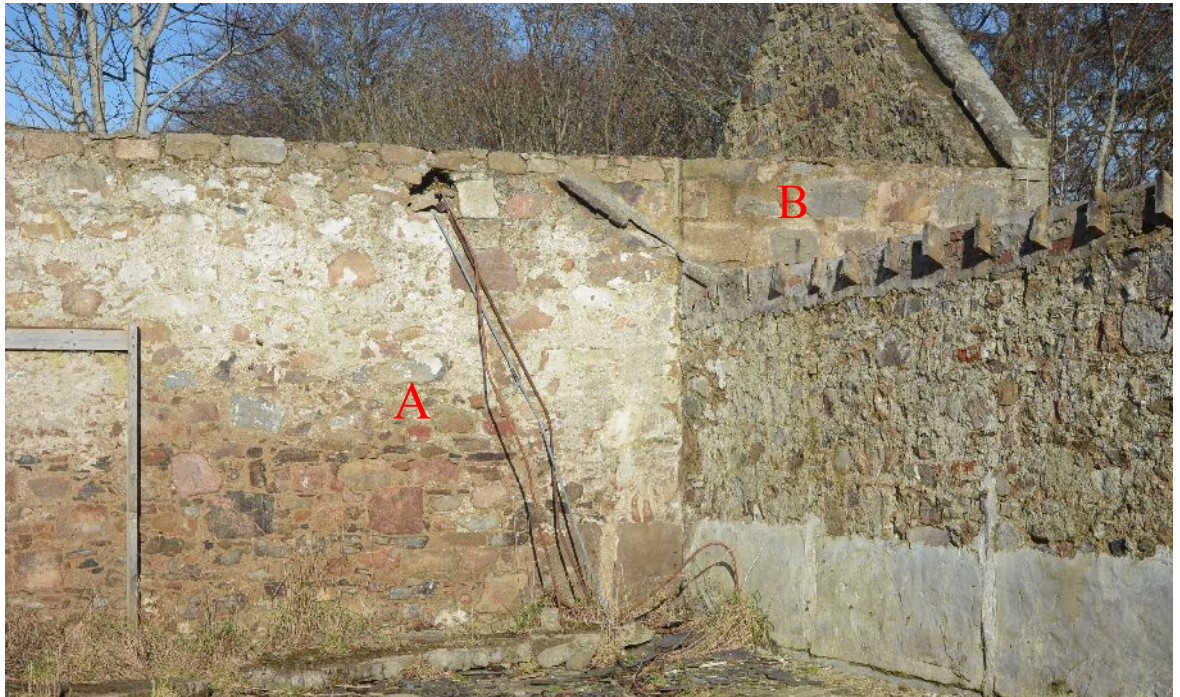
**Illus 6** Looking N inside the E range. Note the difference in stonework inside (A) and outside in the E facade (B).

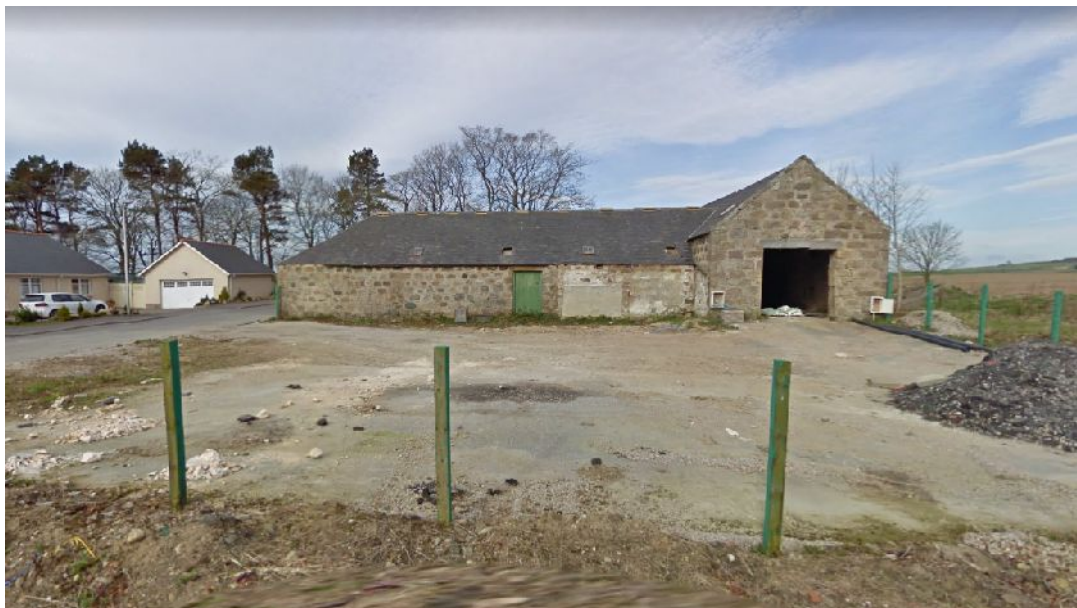
Roofs The roofs had been removed prior to the survey. Photographs from Google Street View dated 2011 show slate roofs with ceramic ridge tiles and metal roof lights. The S end of the E range is shown hipped over door D5.

**Illus 7** Roofs in 2011 as shown on Google Street View. Copyright [www.google.co.uk](http://www.google.co.uk)

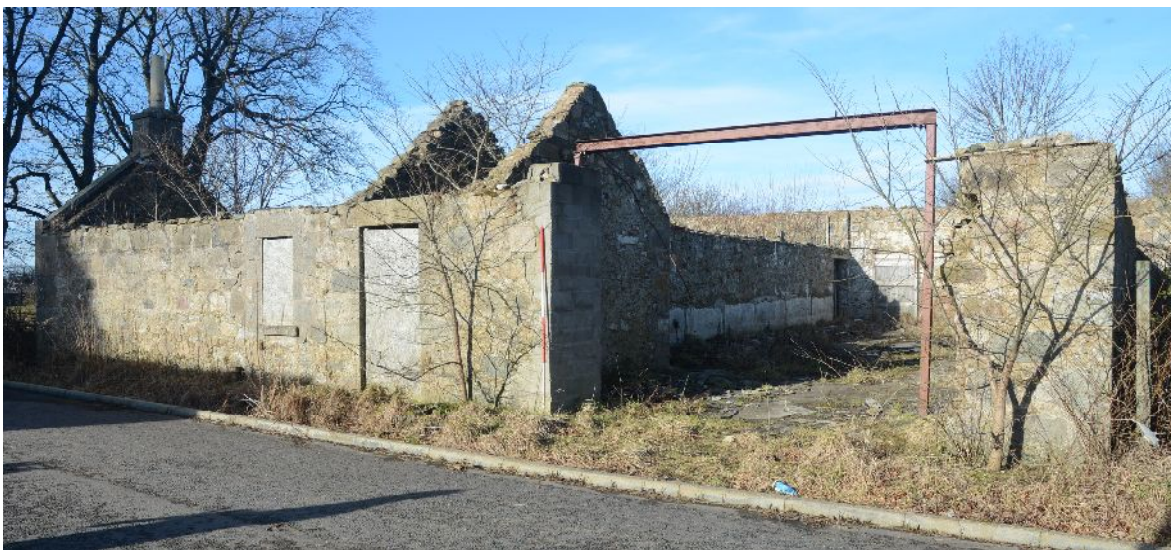
Illus 8 South Range. The house, looking W along S elevation

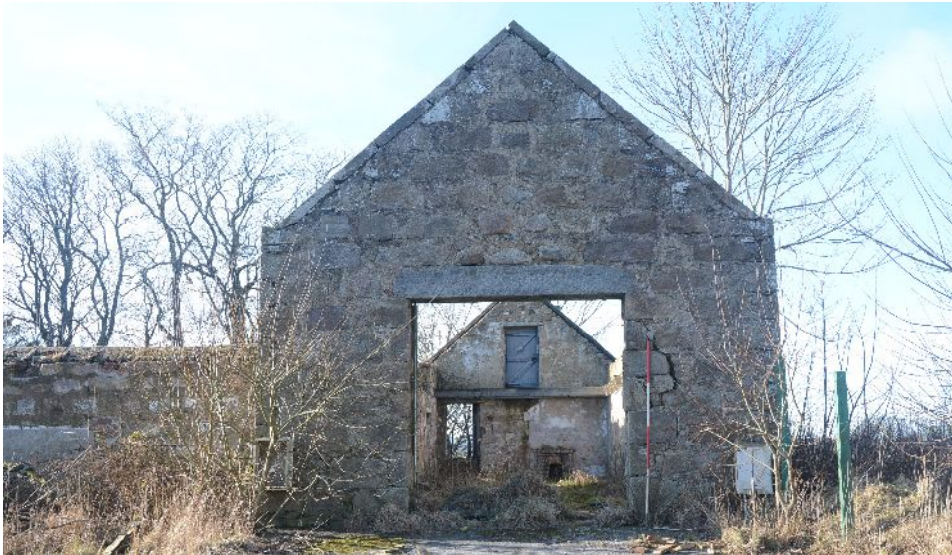
**Illus 9** N Range, E elevation.

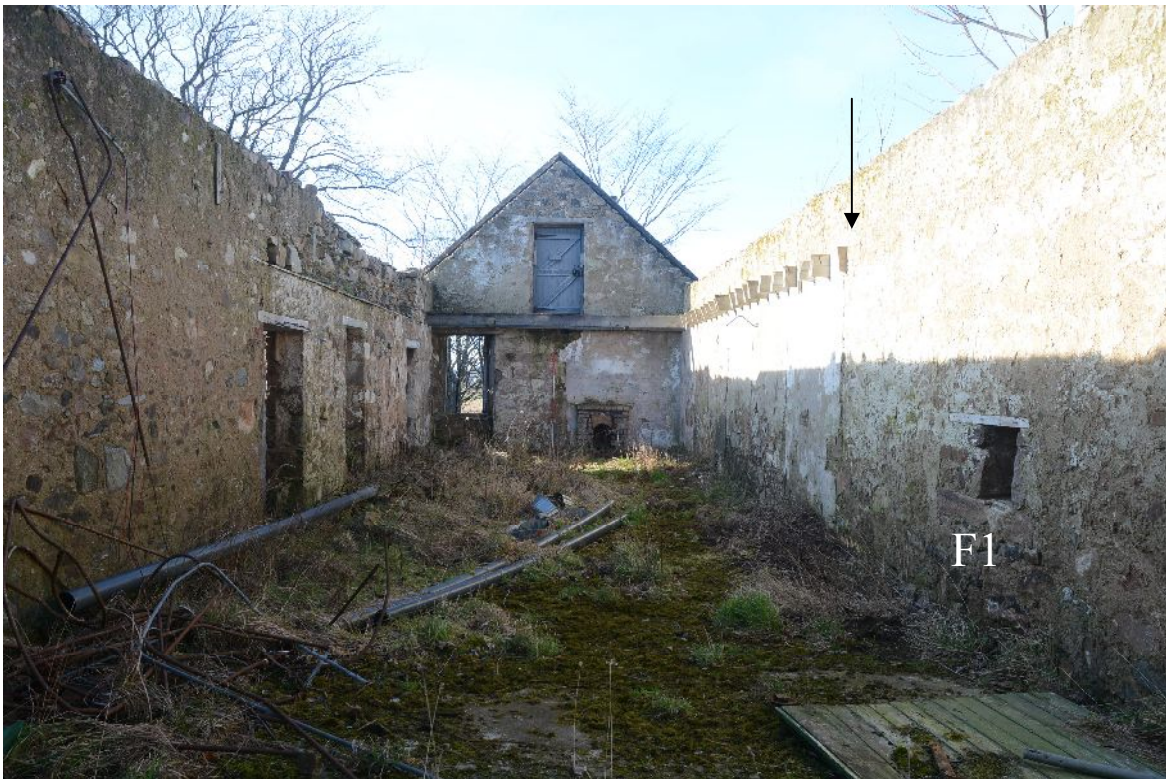
**Illus 10** N Range, interior looking W. Arrow shows E limit of loft. F1= horsemill shaft hole.

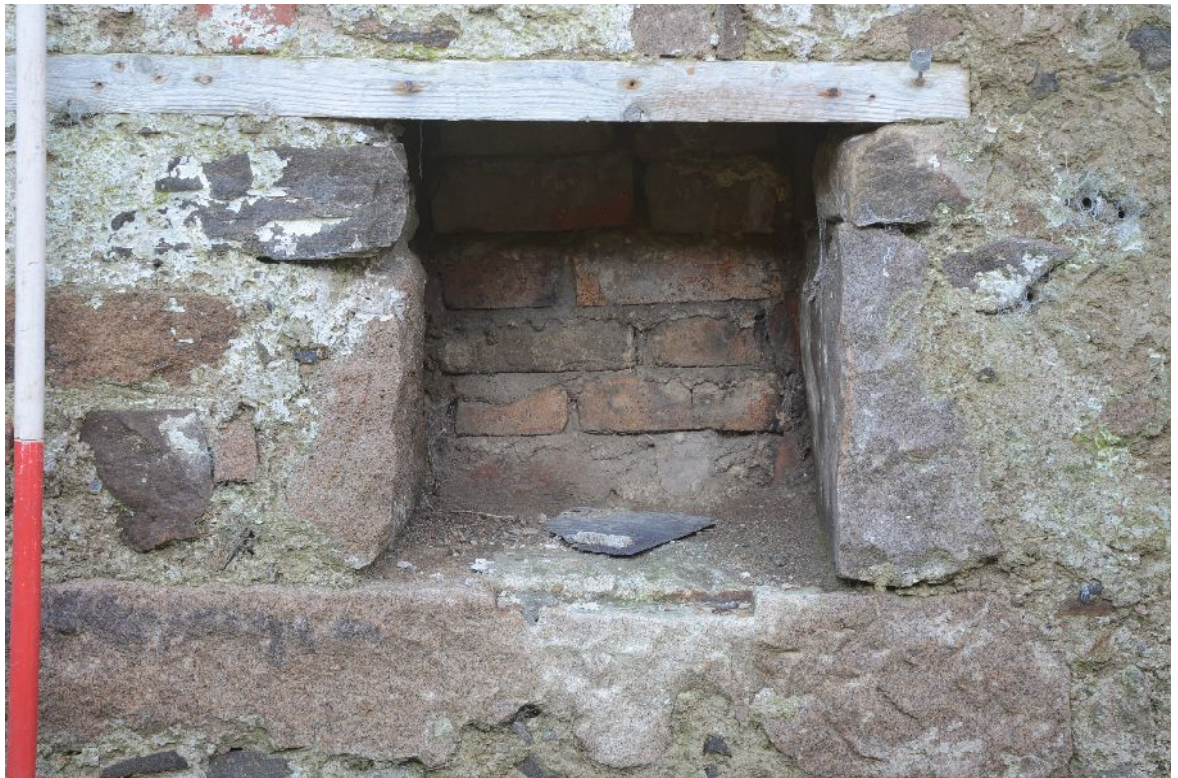
**F1** Squared hole through wall. Brick blocked. W: 440mm H: 490mm. Base at 0.90m above present floor. Shaft hole for horsemill mechanism.

**Illus 11** Detail of blocked shaft hole F1

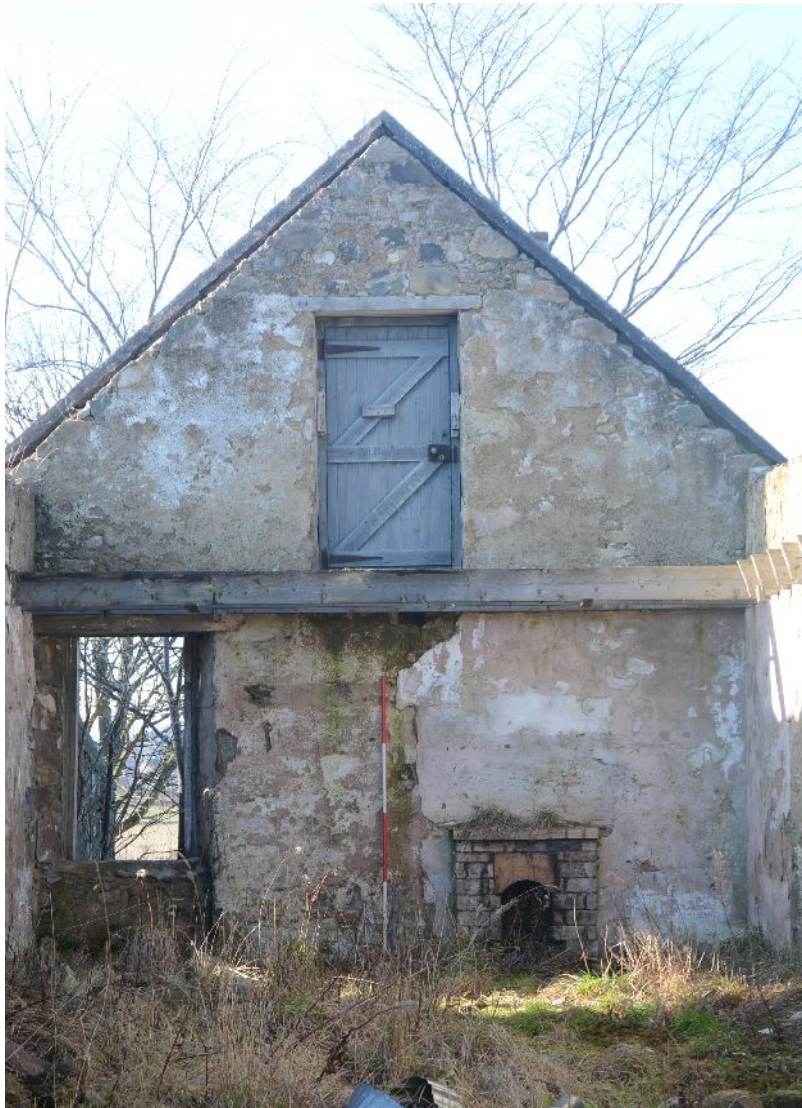
**F4** Secondary brick fireplace W: 1.10m H:0.99m. Projecting 180mm from wall. Secondary brick chimney built against outside of stone gable.

**Illus 12 N Range, Interior of E end showing secondary fireplace**

The interior of the lower part of the walls at the W end was plastered. Vertical scars in the plaster could be interpreted as the scars of stable trevices. The fireplace suggests that at some point this was converted to additional living accommodation.

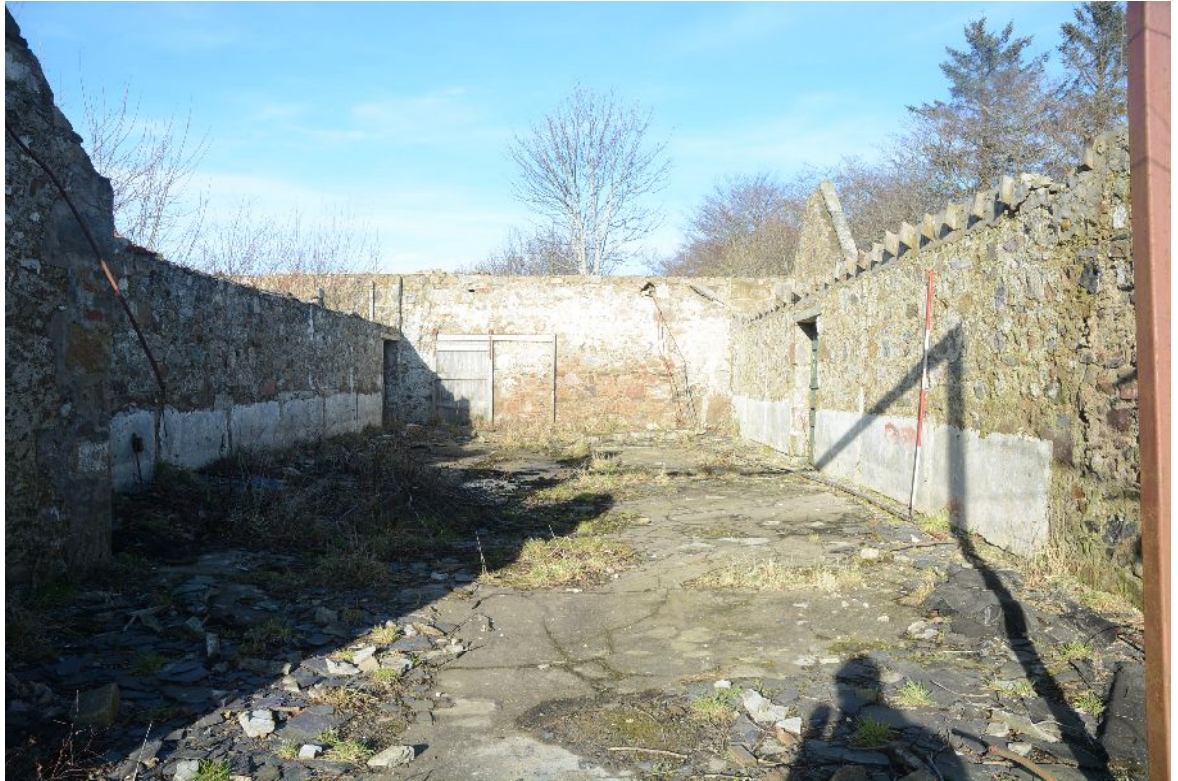
**Illus 13** E Range. Interior looking N

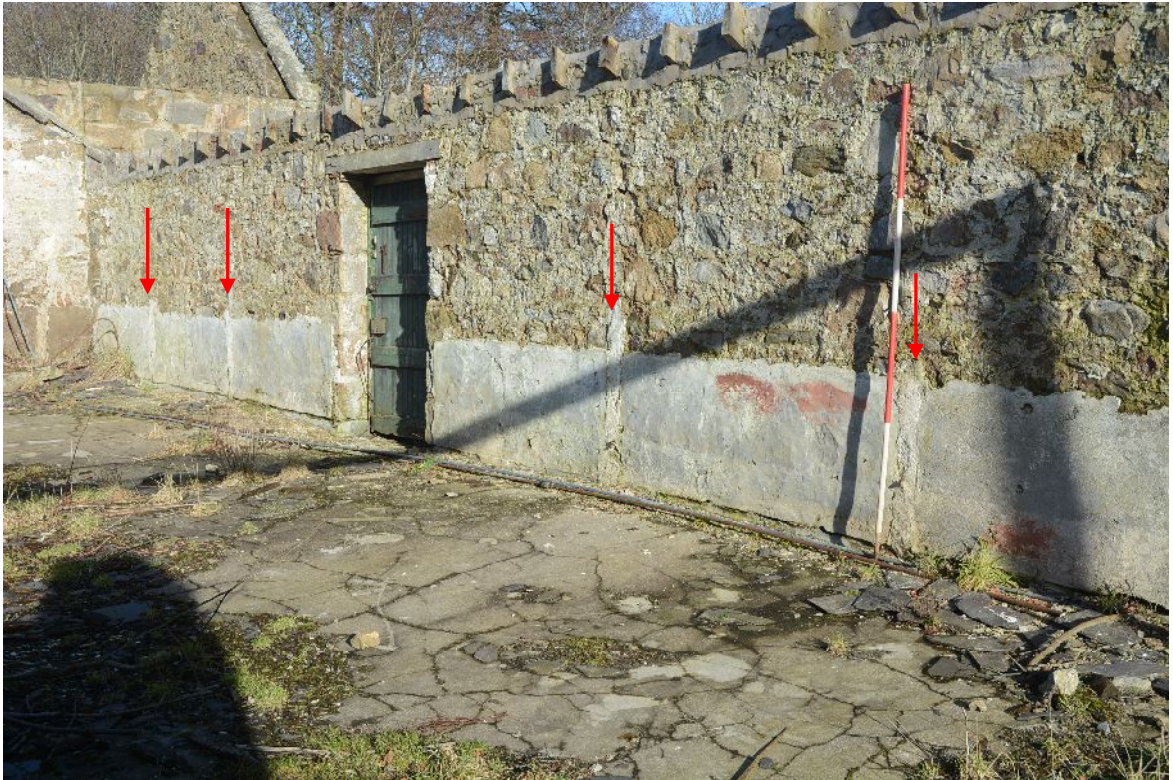
**Raggles** of double tied cow stalls show in the render on the inner faces of the E and W walls. Stubs of iron indicate where the tying bars have been removed.

There appear to have been 12 or 13 double stalls. Unusually, there is no indication of ventilation.

**Illus 14 E Range. Inside of E wall. Arrows mark raggles of the divisions between the cow stalls.**

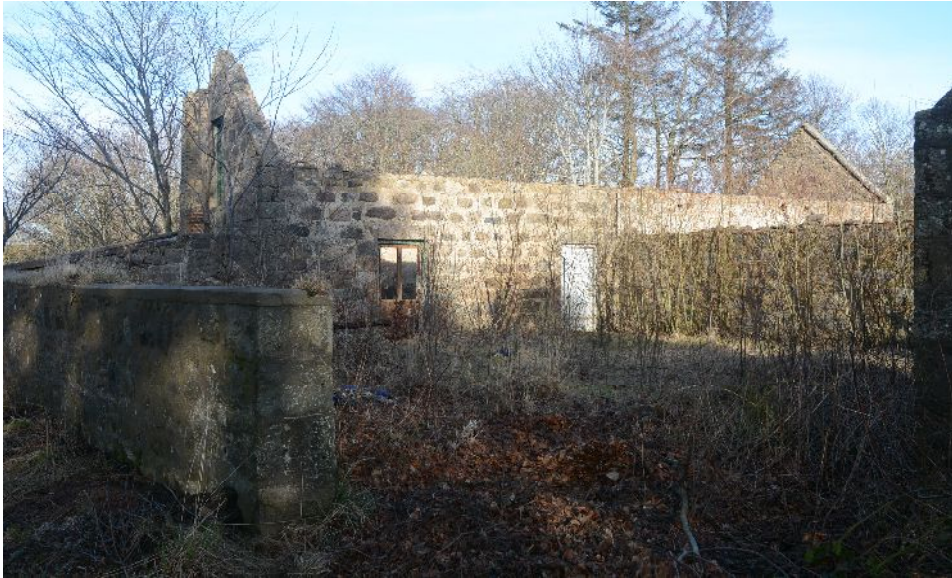
A wall blocked off most of the W side of the open court, with access to the court through a gap at the SW corner. The S 4.5m of this wall had coping stones, indicating their original height.

**Illus 15** Opening into the court. The coping is visible on the nearest section of the W wall.

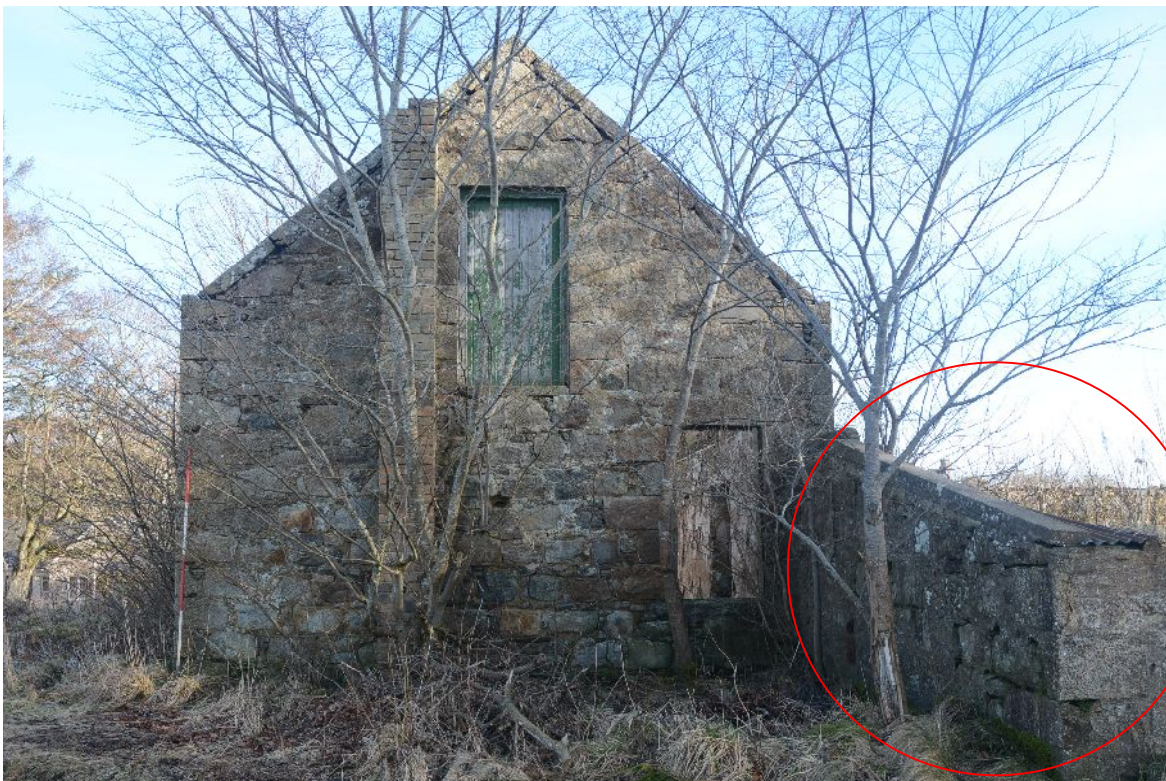
However, the rest of the wall was unfinished on top and coincided with rubble stretching for c.9m alongside the remainder of the wall. A remnant of a low lean-to roof at the NW corner of the court (Illus 16) suggests that there had been a fairly low narrow building with a lean-to roof built against the inner face of the court wall.

**Illus 16** W gable of the N range and NW corner of the court wall with indication of low lean-to roof (inside red circle).
