STEADING
UPPER MIDDLETON OF BALQUHAIN
INVERURIE
ABERDEENSHIRE

Standing Building Survey

Carried out 21st February 2018

Report No: MAS 2018-05

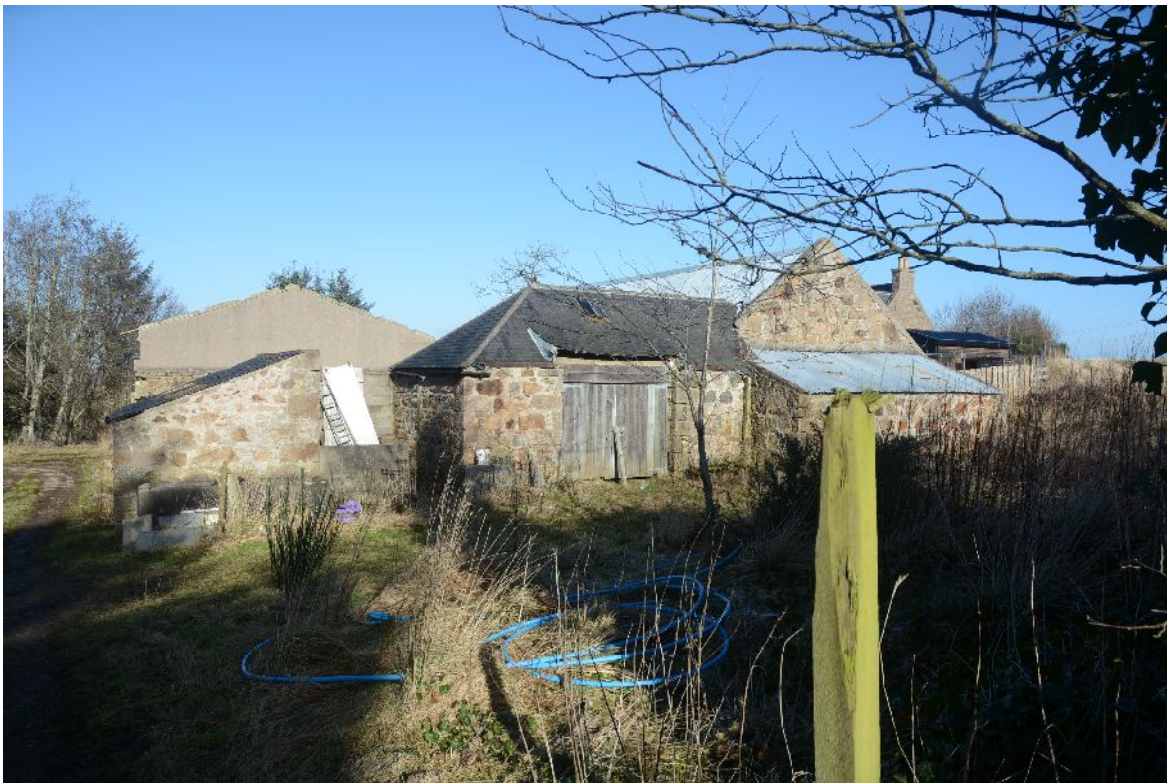
Illus 2 The steading from the S with the gable of the farmhouse visible at extreme right.

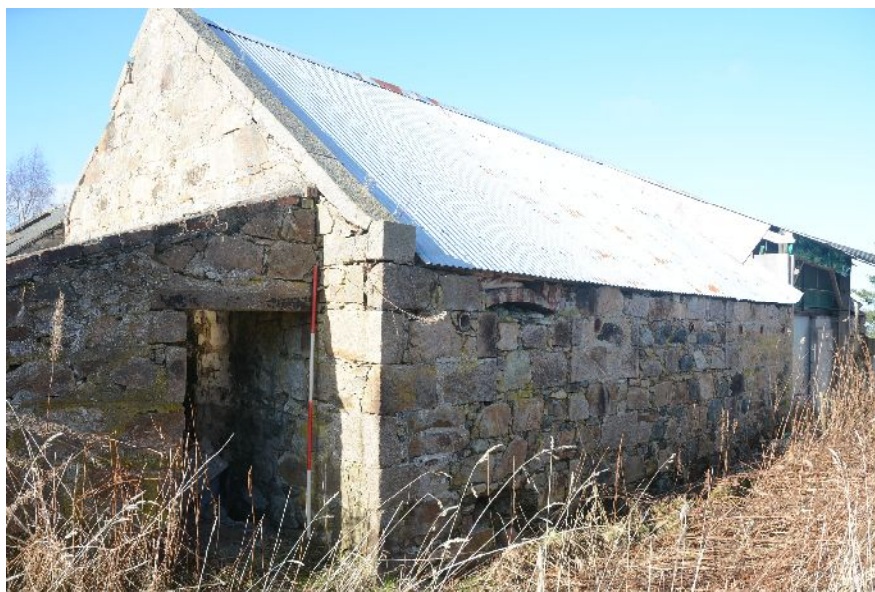
Illus 8 General view of the steading - E elevation looking N

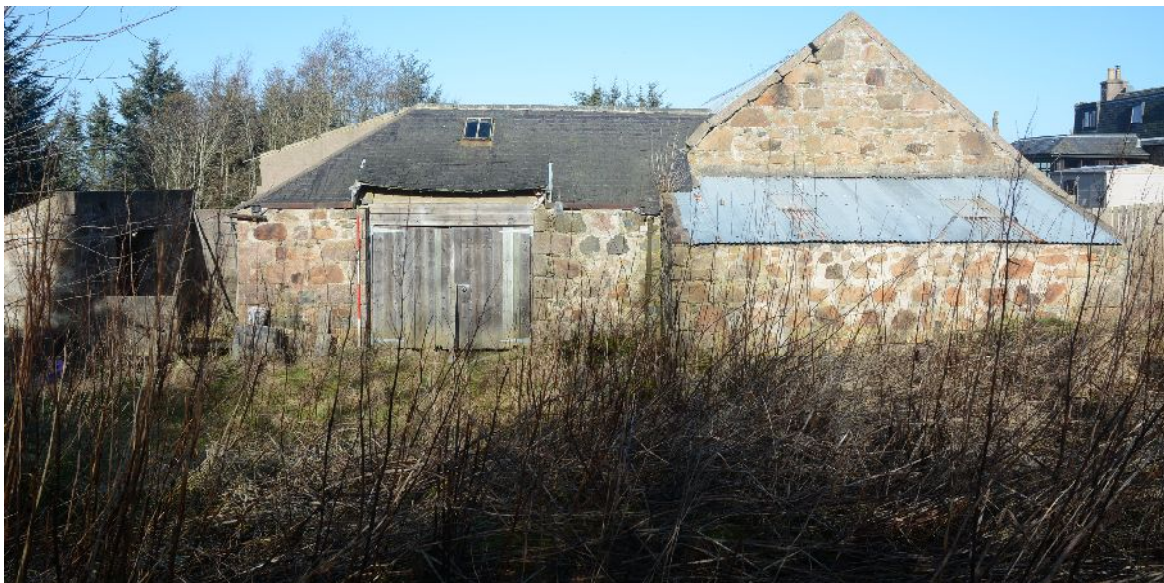
Illus 9 General view of the steading - S elevation

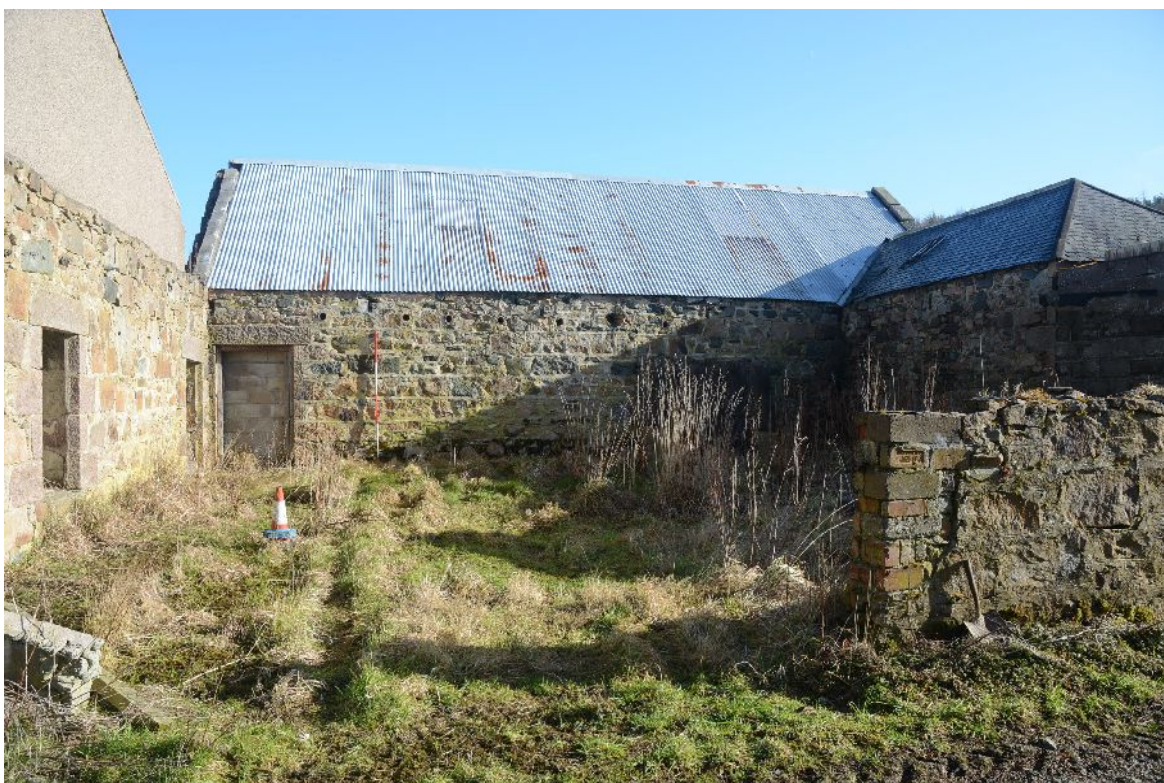
Illus 10 General view of steading looking W into Court

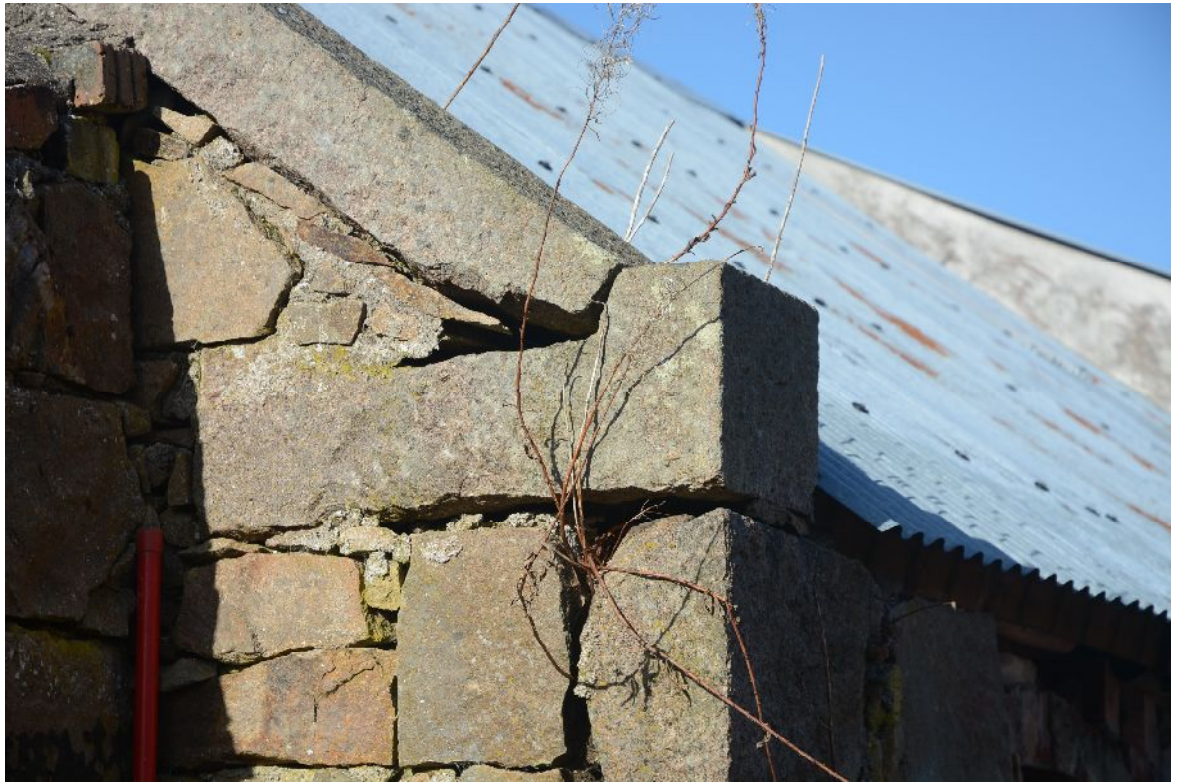
Honey coloured rubble stone, c500mm thick. Granite quoins and skews (Illus 12).

Illus 12 Granite skeuputt at SE corner of East Range.

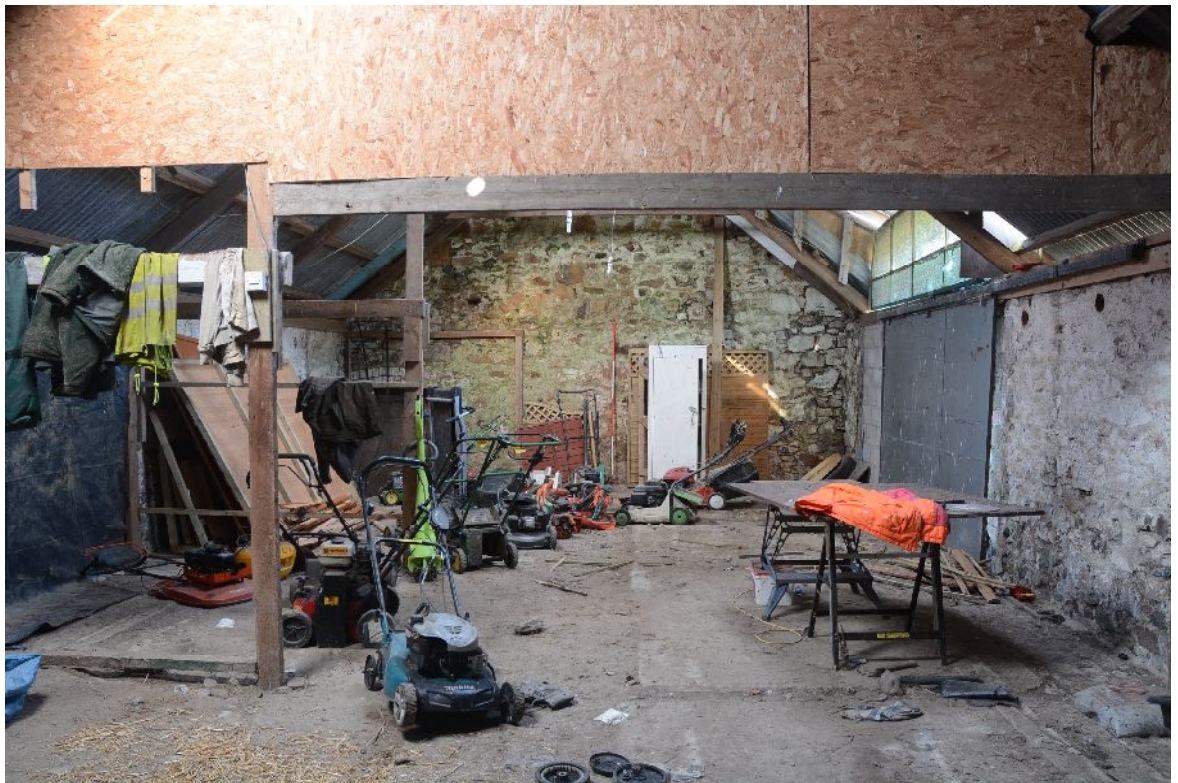
Illus 13 Interior of E Range, looking N

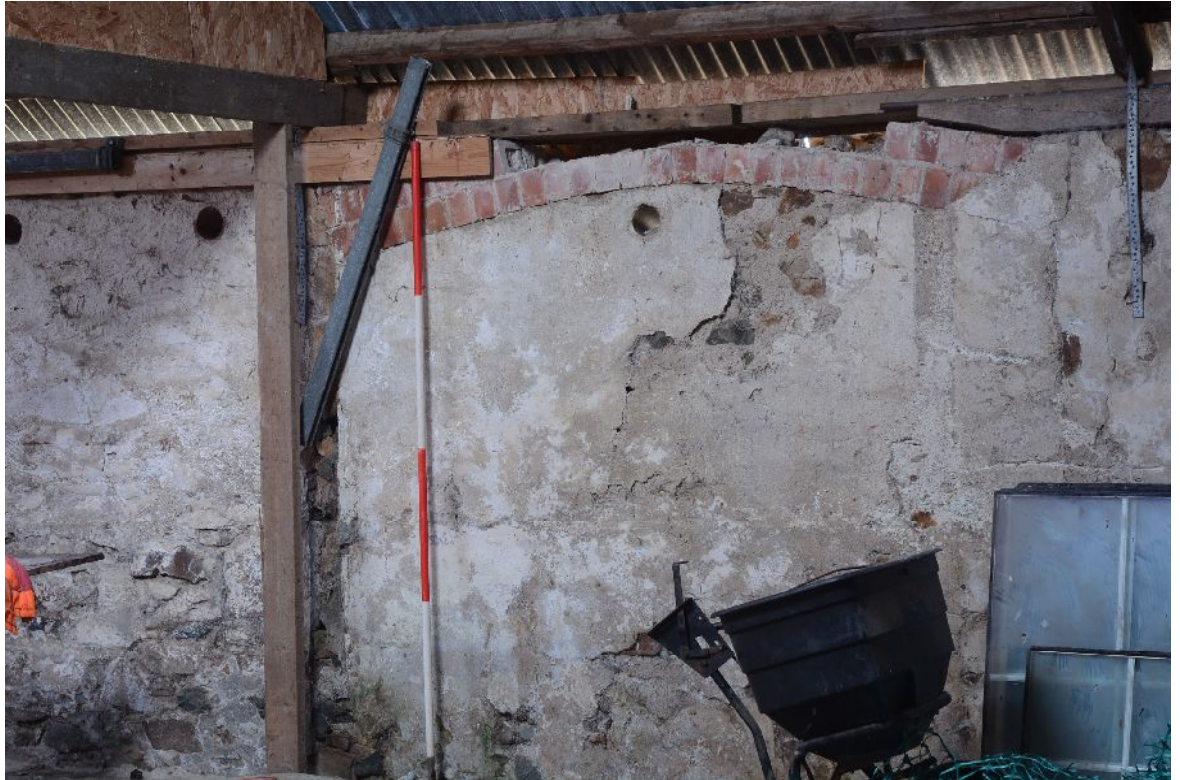
Ventilation Clay pipes had been set through the wall at intervals to provide ventilation for livestock; one of these was set through the blocking of F3, indicating that these were secondary.

Interior The interior floor level has at some stage been raised, with the result that there was a ramp down to doors D6 and D7. This later concrete floor has some appearance of a central drain. The inner faces of the walls have been plastered, after the insertion of the pipe ventilation (Illus 14), with vertical scars indicating former pens/divisions.

Illus 14 Interior of E Range, detail of inside of E wall, blocking of F3, plastering, ventilation pipe and scar of former partition (L of ranging rod).

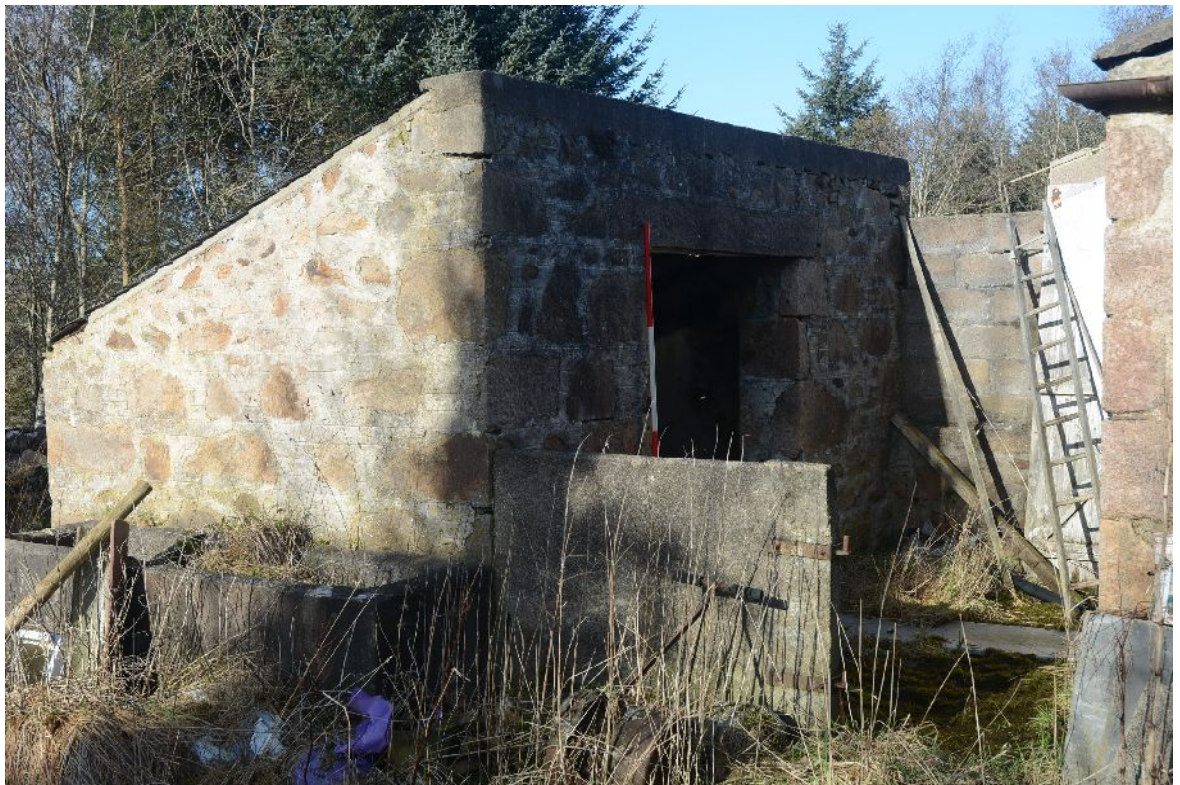
Illus 15 Pig sty and yard, looking NW.

Dimensions Sty 3 x 4.6m externally (approx 2x 3.5m internally. Yard 2 x 4m.

Walls Rubble stone, c400mm thick.

Roof Lean-to slate roof with 2 metal skylights.

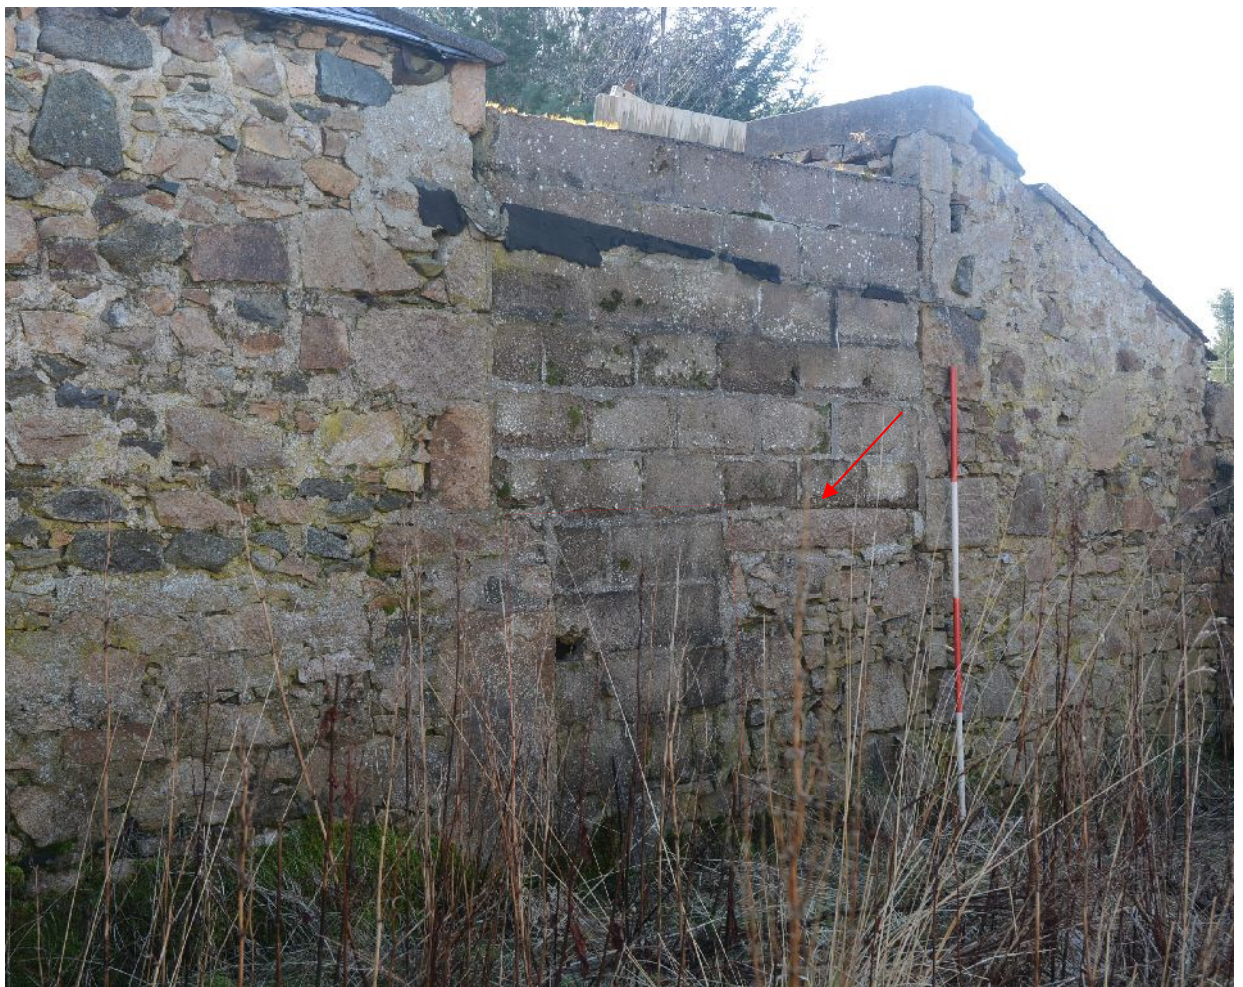
F1 W: 0.91m H: 1.2m. Blocked with concrete blocks. The wall on this side of the pig yard had also been raised with concrete blocks over the original stone wall.

This opened into dung court. A granite lintel rebuilt into wall may have been moved from its original position as lintel of a pig 'gate' into dung court. (Illus

Illus 16 N wall of pig yard seen from inside dung court. Dotted line marks the blocked opening. The original , now displaced, lintel is marked with arrow.

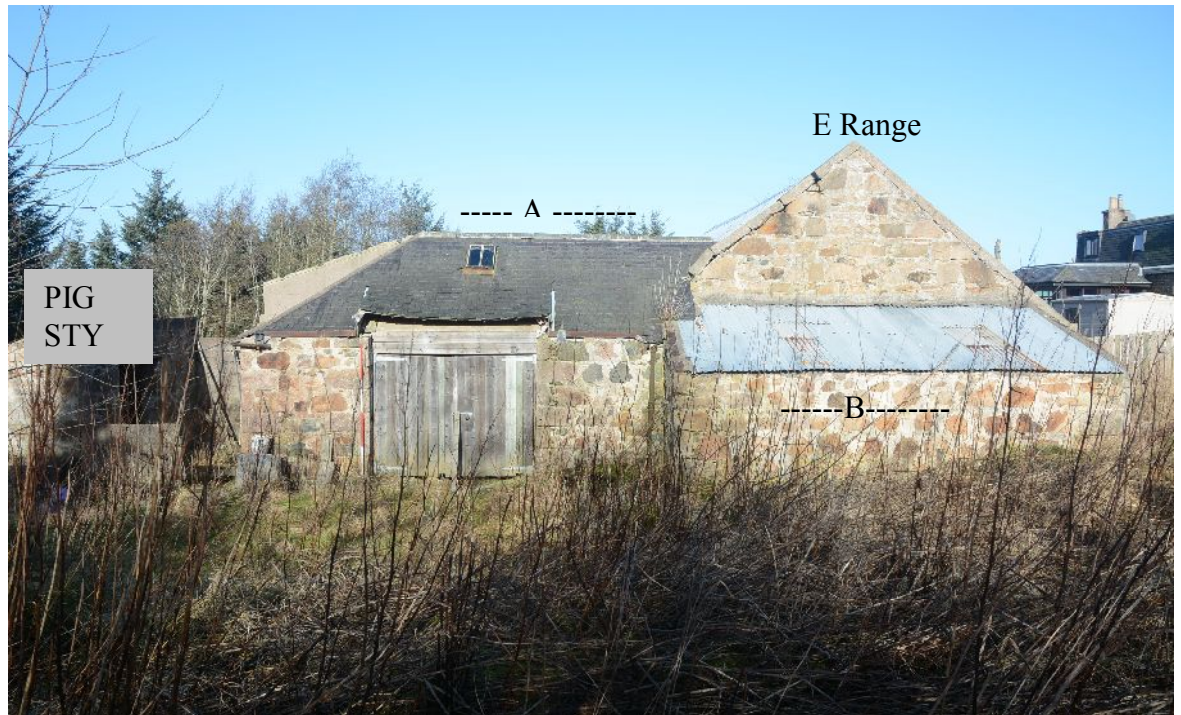
Illus 17 S elevation showing Buildings A and B.

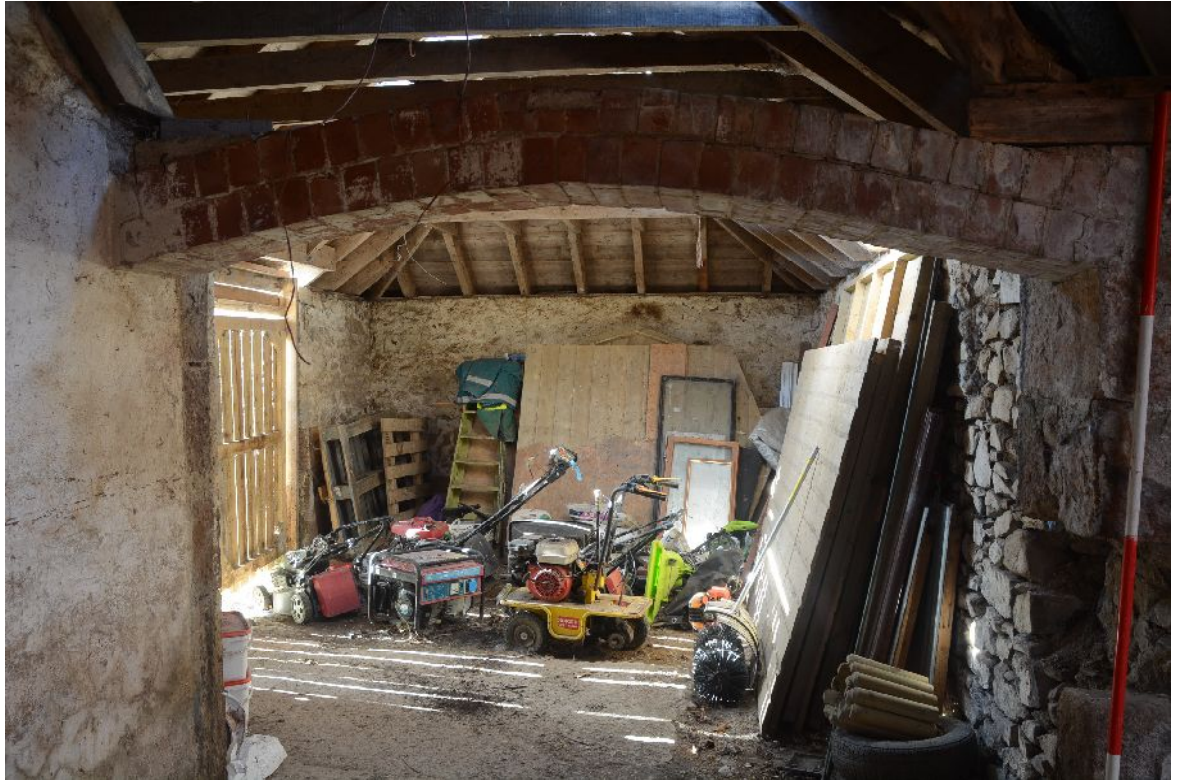
F4 The wall between Building A and the E Range has been knocked through at some stage, with a brick arch inserted.

Illus 18 Looking into Building A through brick arch F4

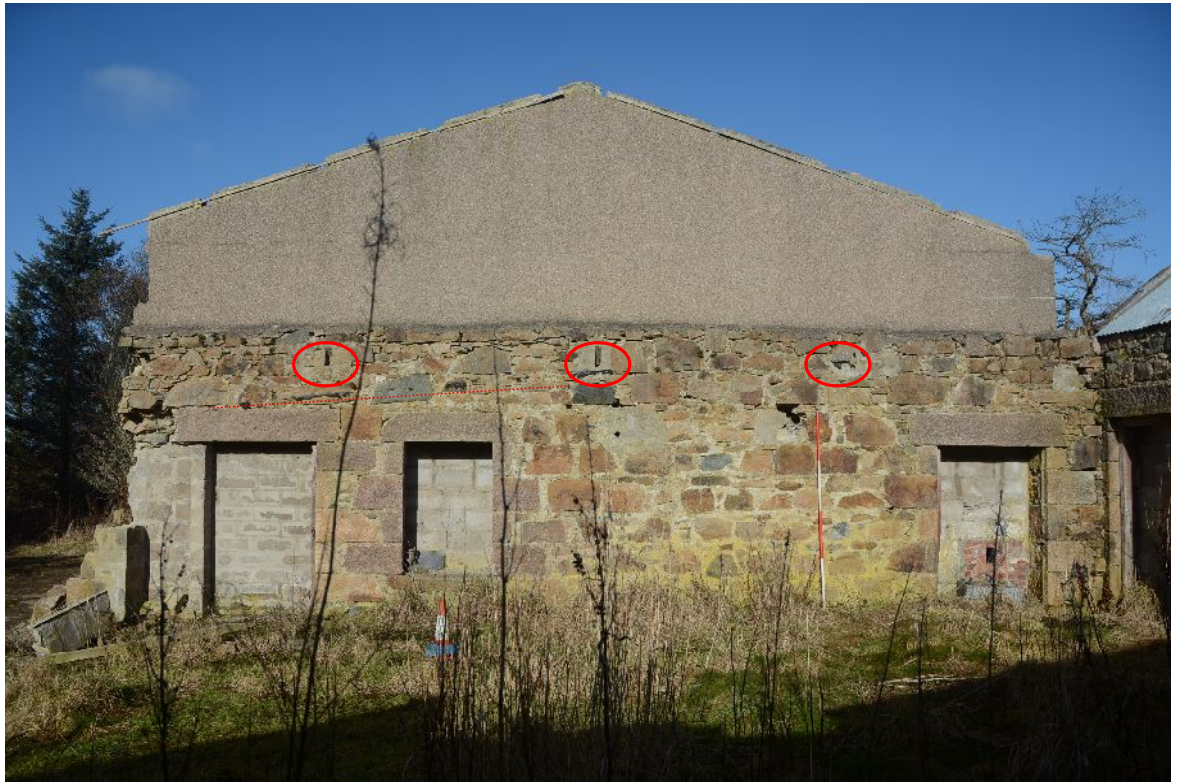
Former use Open Dung court, later roofed, probably in the mid-late 20th century

Illus 19 S face of the N wall of the Dung Court with the gable of the secondary N building built on it. The red circles mark timber slots associated with a roofing of the Court. The dotted line below them appeared to be tar or felt, presumably also associated with the Court roof.

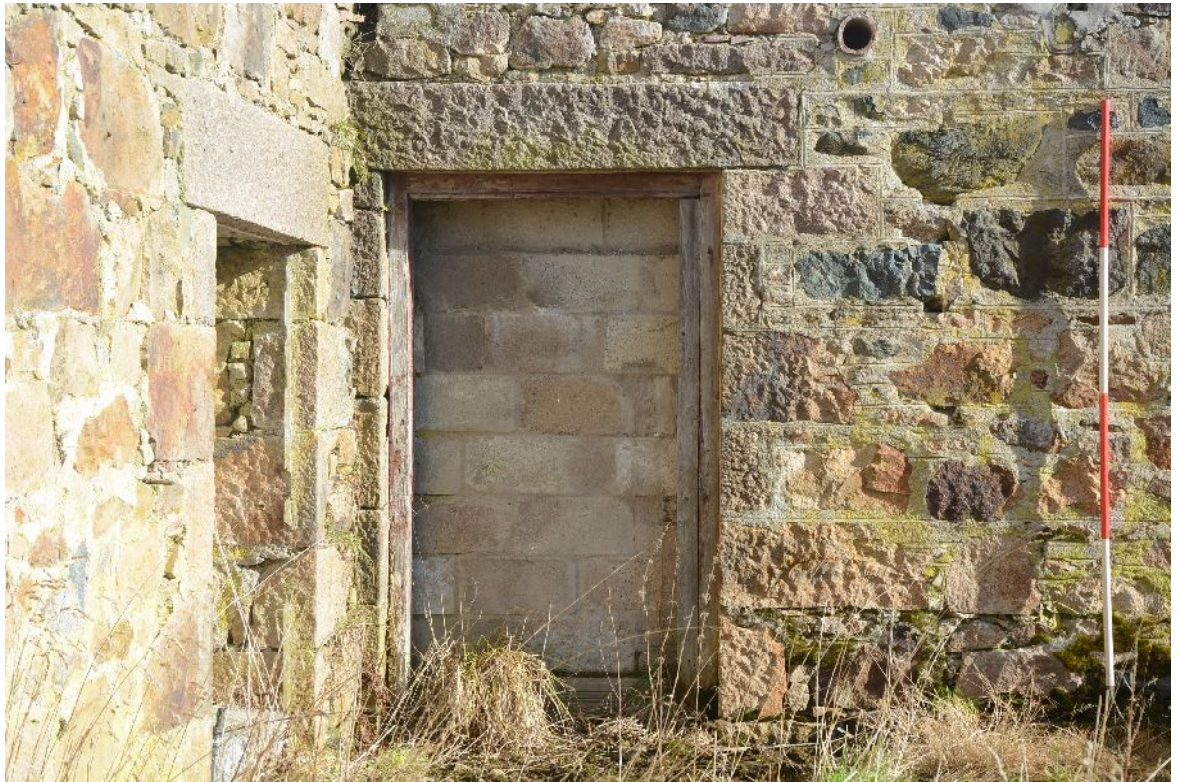
D6 W: 1.22m H: 1.95m. Granite lintel and rybats into court (Illus 20). Brick arch internally. Blocked with concrete blocks.

D8 W: 1.23m H: 1.80m. Granite lintel and granite and rubble rybats. Blocked with concrete and brick. Brick arch on N side (inside former N Range).

Illus 20 Detail of D8 (LHS) and D6 (RHS) from inside court

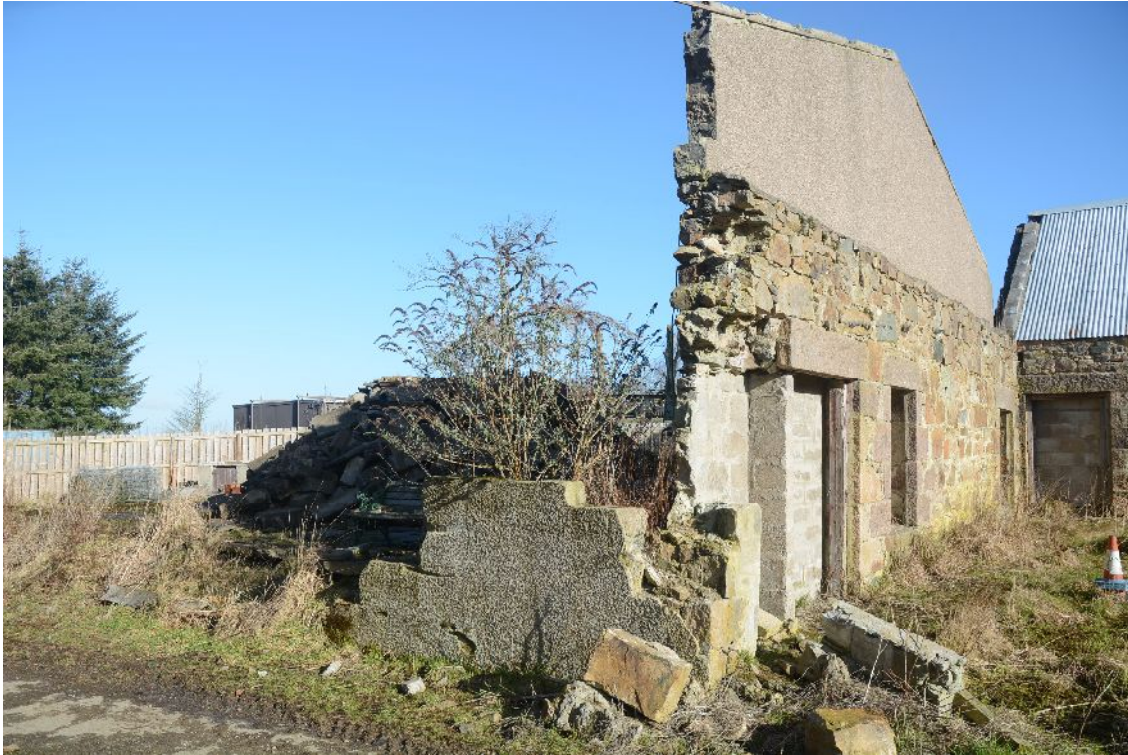
To the N of the Dung Court there was an area of concrete flooring and traces of concrete walling which appear to have been the remnant of a 20th-century building on the original site of the N Range. The S gable of this later building survived, built in concrete blocks on the wall head of the N wall of the Court (Illus 21).

Illus 21 View looking N of the rubble of N Range and its surviving S gable
