**NORTH BOGTON STEADING,
FORGLEN
TURRIFF
ABERDEENSHIRE**

Standing Building Survey

Carried out 15th March 2018

Report No: MAS 2018-07

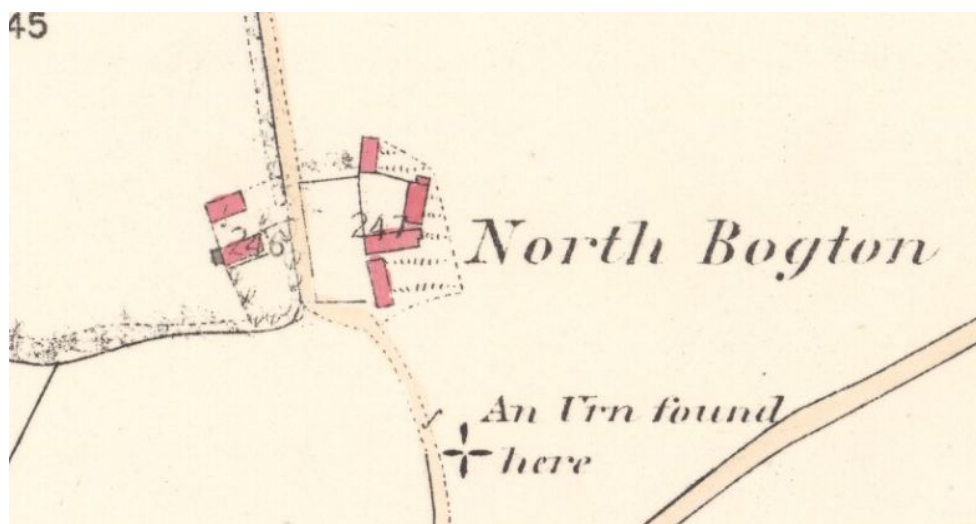
1866 The 25”/mile OS map Banffshire XVI.12 (Forglen) 1866 (published 1867) shows four buildings to the E of the road in what appears to be the Building E of the existing steading. Two buildings are shown W of the road (outwith the present property).

Illus 2 The 25”/mile OS map Banffshire XVI.12 (Forglen) 1866 (published 1867) www.nls.ac.uk

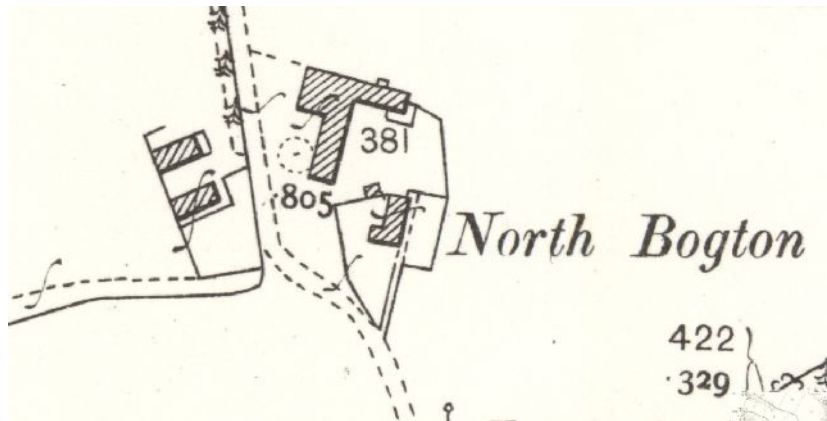
1902 The 25”/mile. OS map Banffshire XVI.12 (Forglen) (published 1904) shows the steading rebuilt, with a T-plan, having a horse mill on the W side of the S range. The farmhouse is shown on its present footprint. The two buildings W of the road are still shown.

Illus 3 The 25"/mile. OS map The 25"/mile OS map Banffshire XVI.12 (Forglen) 1902 (published 1904) www.nls.ac.uk

With the exception of infill structures, Building B and F, most of the steading comprised the buildings which are shown on the 1902 OS map (Illus 3). Identification of the function of Building A1 as the mill is based on the map evidence which shows the former position of a horse mill on the W wall of Building A1 and the existence of the drive shaft and former position of an engine on the E wall of the same building. There was no access into the building but a photograph taken earlier by Mantell Ritchie Architects (Illus 16) also shows a loft in this Building.

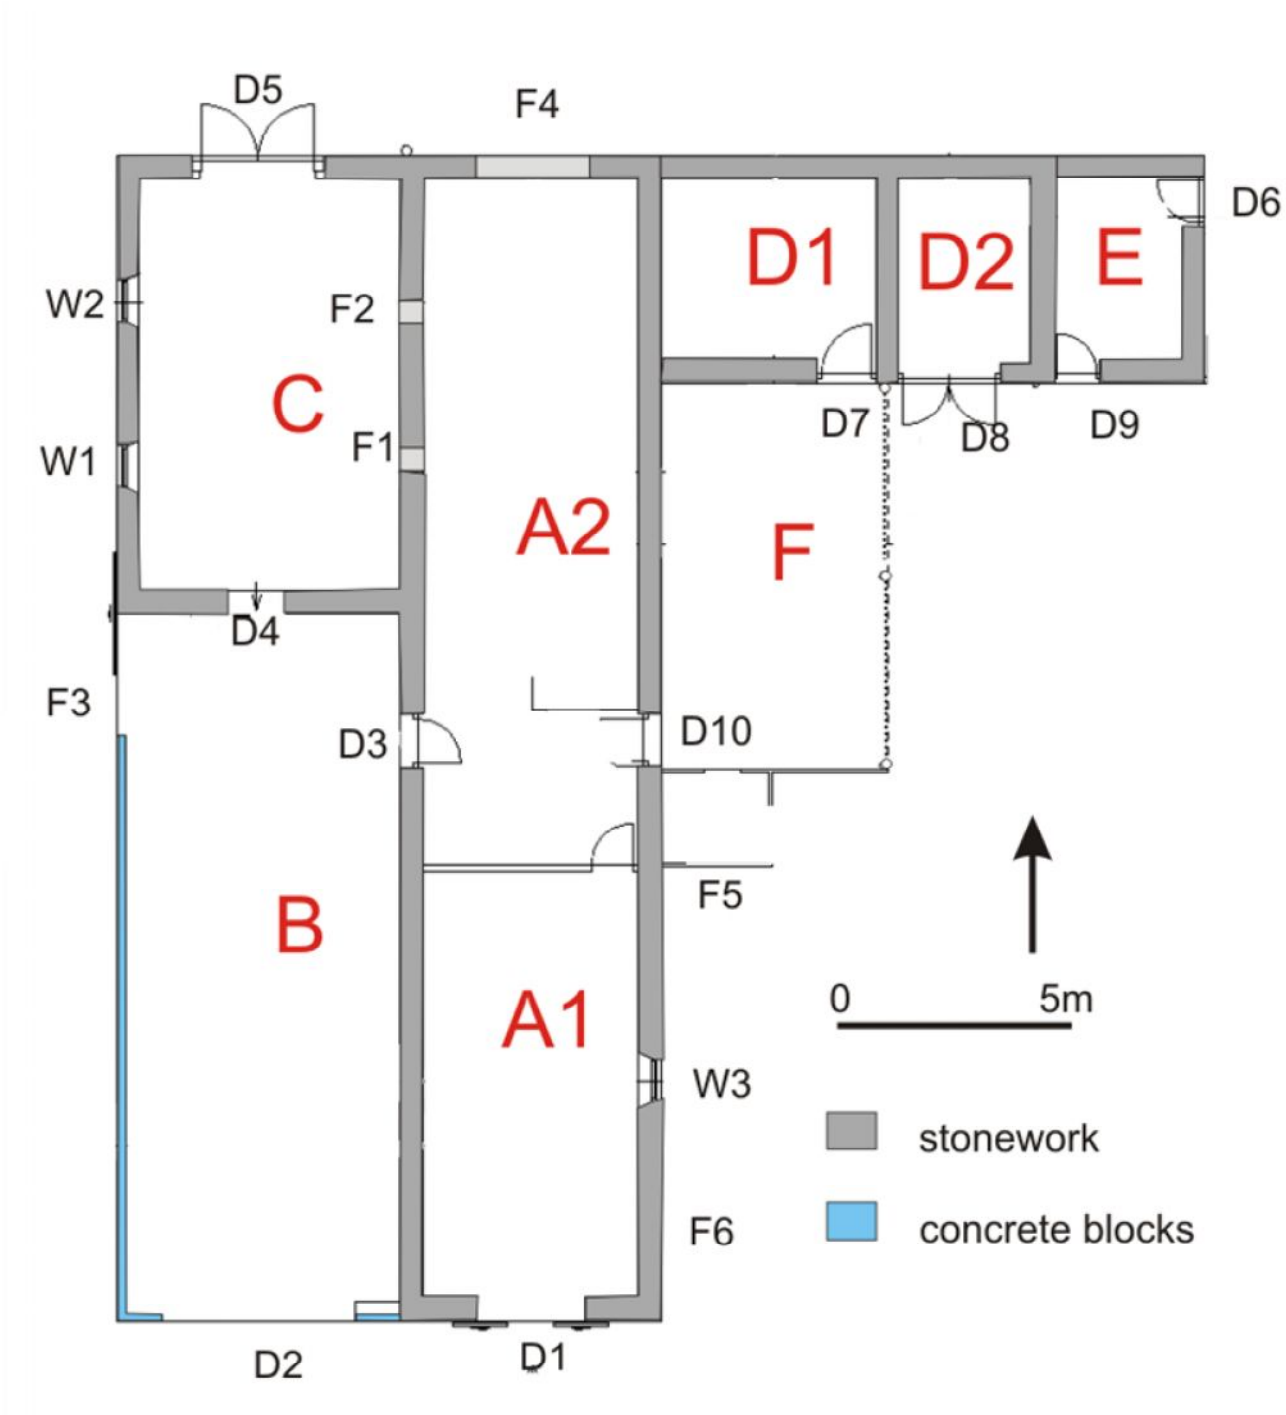
Illus 5 Plan courtesy of Mantell Ritchie Chartered Architects, annotated by MAS Ltd

The West Range comprises of a narrow range (A), with a wider building (C) lying alongside and abutting the W side of the N end. The area between A and C had been filled by a later concrete and wooden building (Building B)

Former use A1 appears to have been the mill, probably with loft above. The 1902 OS map shows a horse mill alongside the W wall of this building. This would have been destroyed by Building B and, at that point or earlier, a mechanical engine to run the mill was installed beside the E wall of A1; the sawn-off bolts for this remain (F5) with the raggle of a lean-to which would have sheltered it. The shaft of the drive belt still exists at F6 (Illus 5).

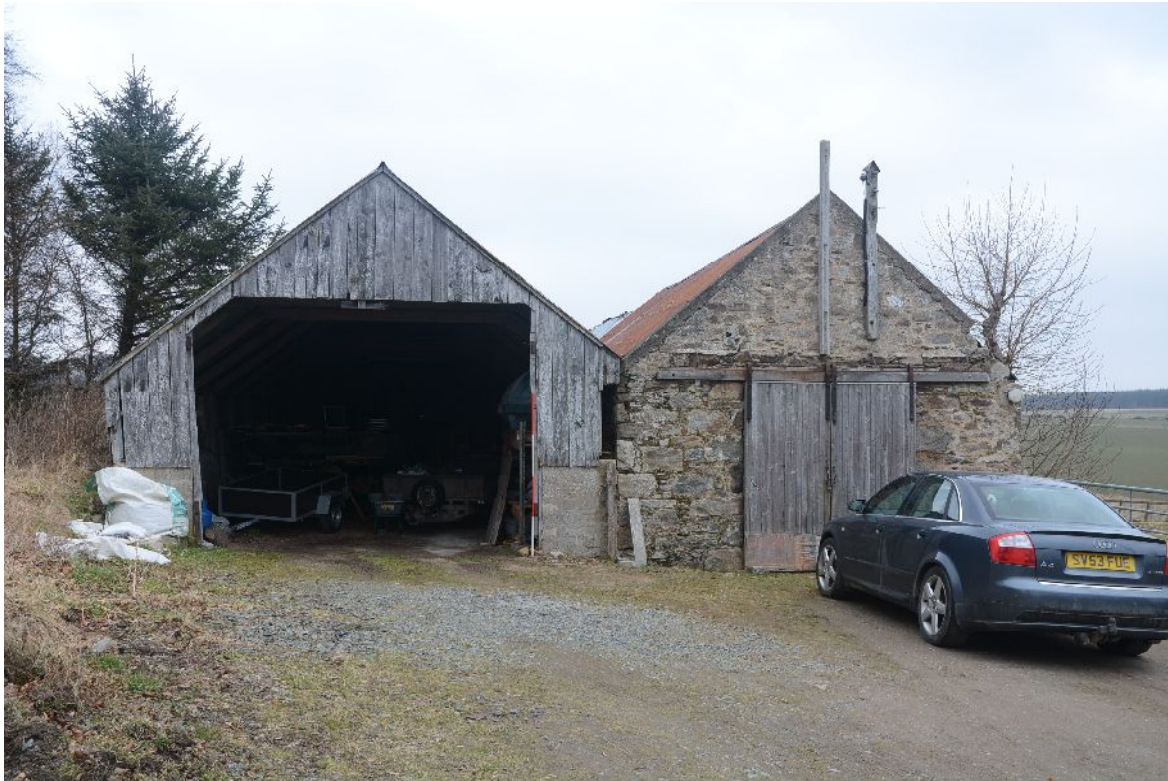
Illus 6 S elevation of W Range. Building B to LHS, Building A to RHS

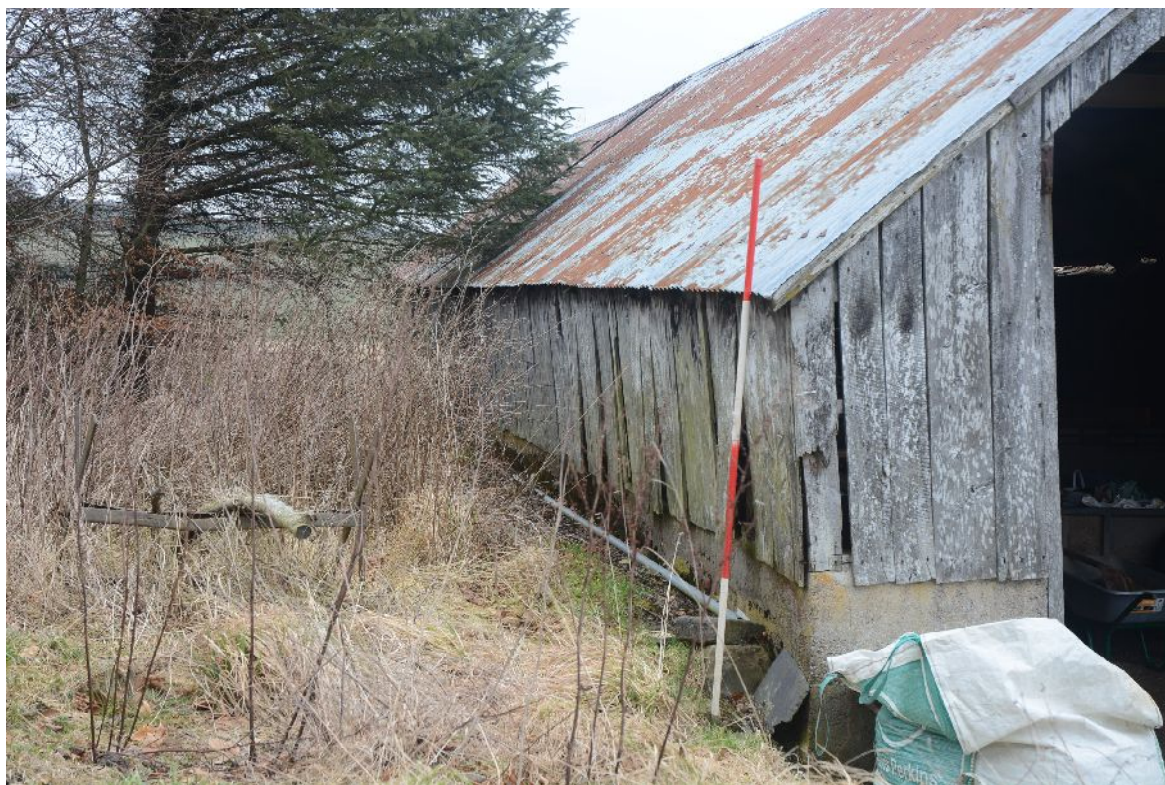
Walls Buildings A and C have rubble stone walls. The later infill Building, B, has plank walls set on a base of concrete blocks approximately 1m high.

Illus 7 W Range, looking N along W wall of Building B

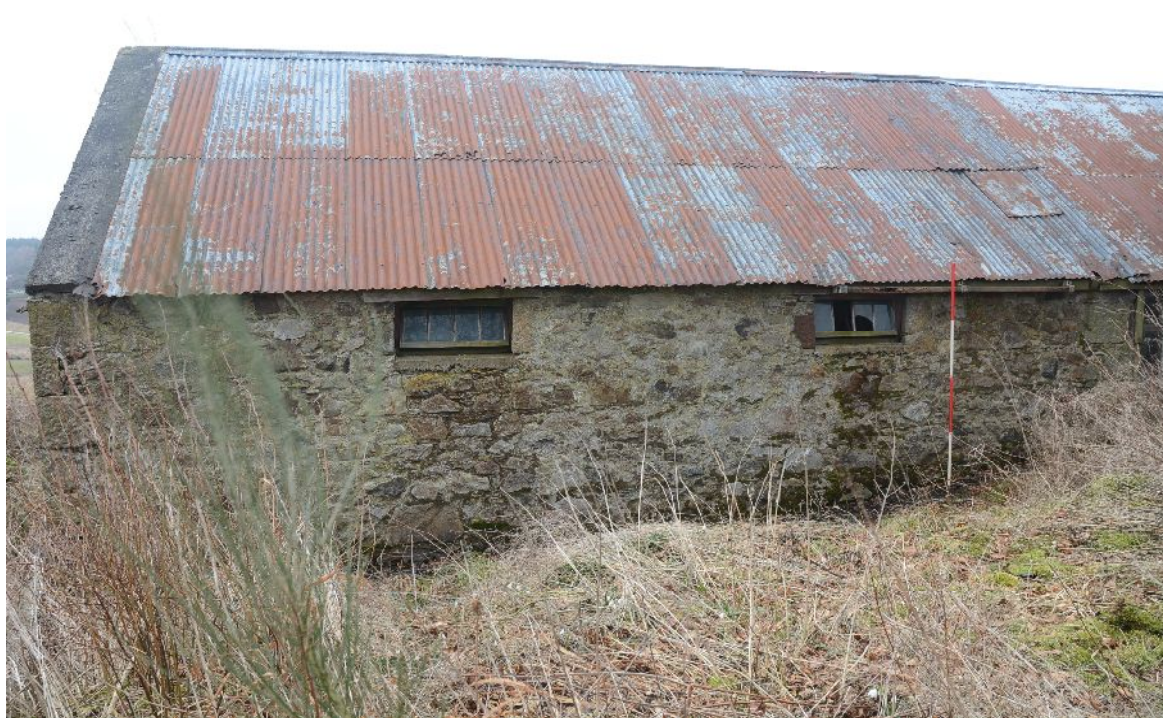
Illus 8 W Range. W wall of Building C

W1, W2 W:1.13m H: 0.43m internally. Splay internally. Metal windows. Sills are concreted but rybats are a mix of rubble, with several pieces of re-used sandstone. They are high in the wall to give ventilation.

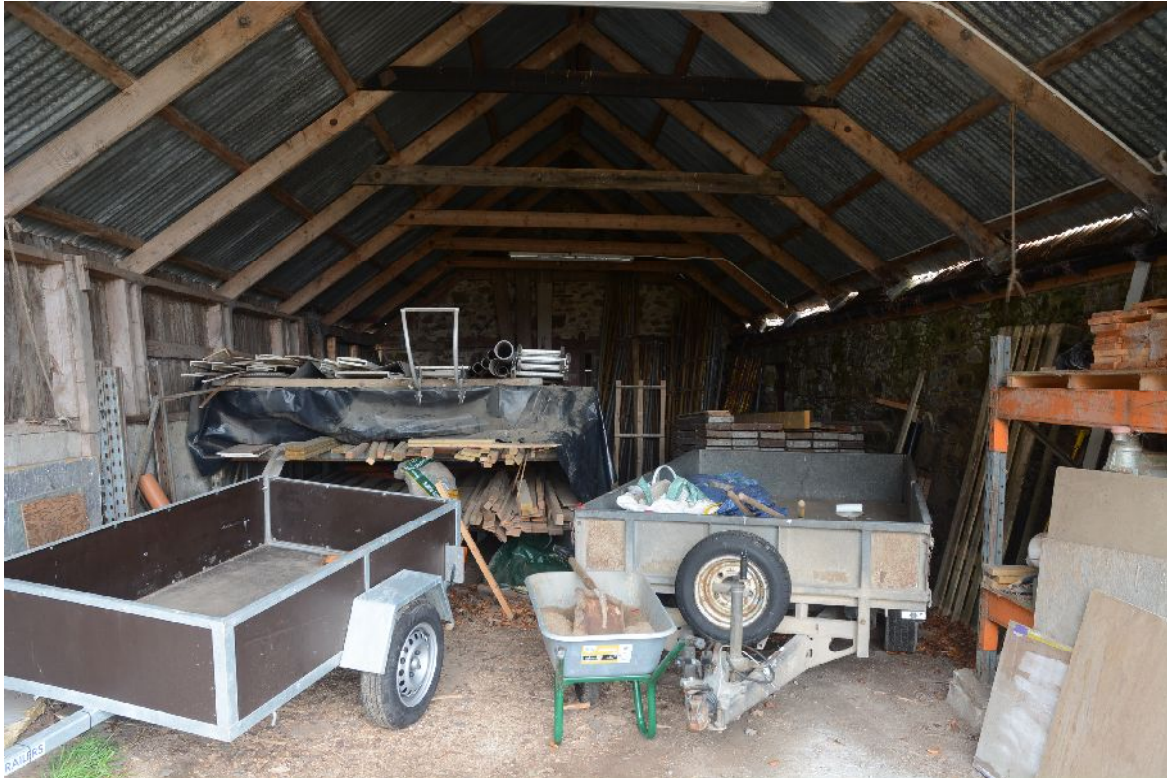
Illus 9 Interior of Building B looking N from door D2

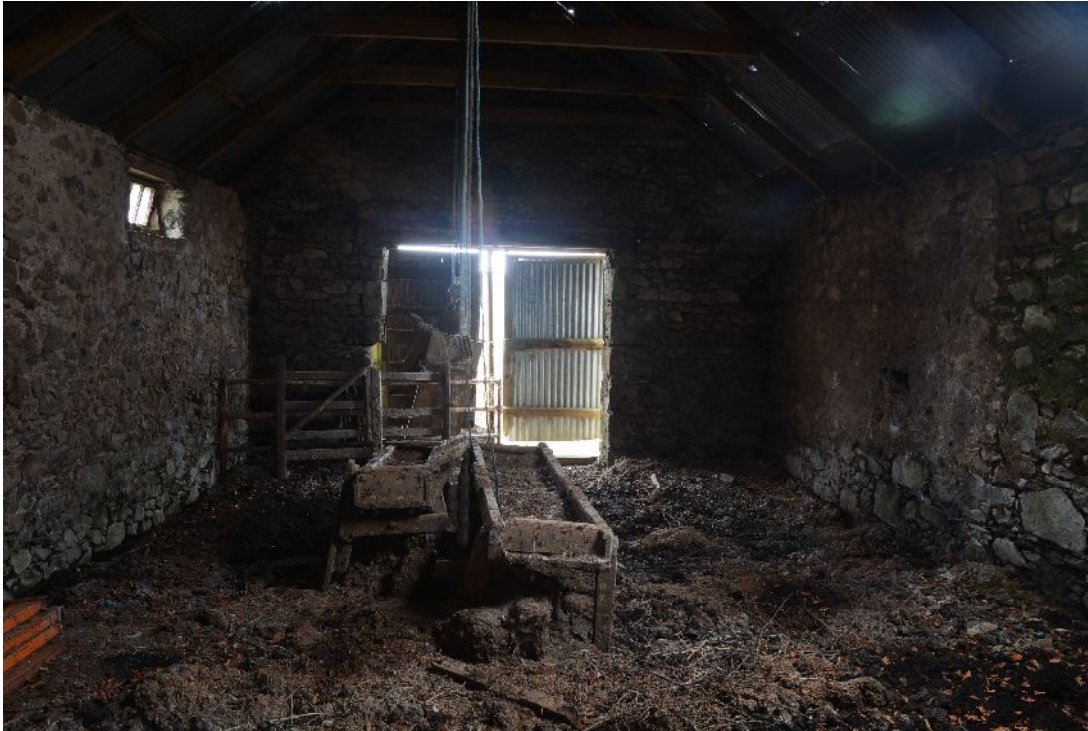
D5 W: 2.46m. H: 2.40m. Rubble rybats. Lintels timber. Sliding corrugated iron doors.

Building C: Appears to have been used as an open cattle court. Troughs remain.

Illus 10 Building B, looking N to door D5, window W2 in wall on LHS

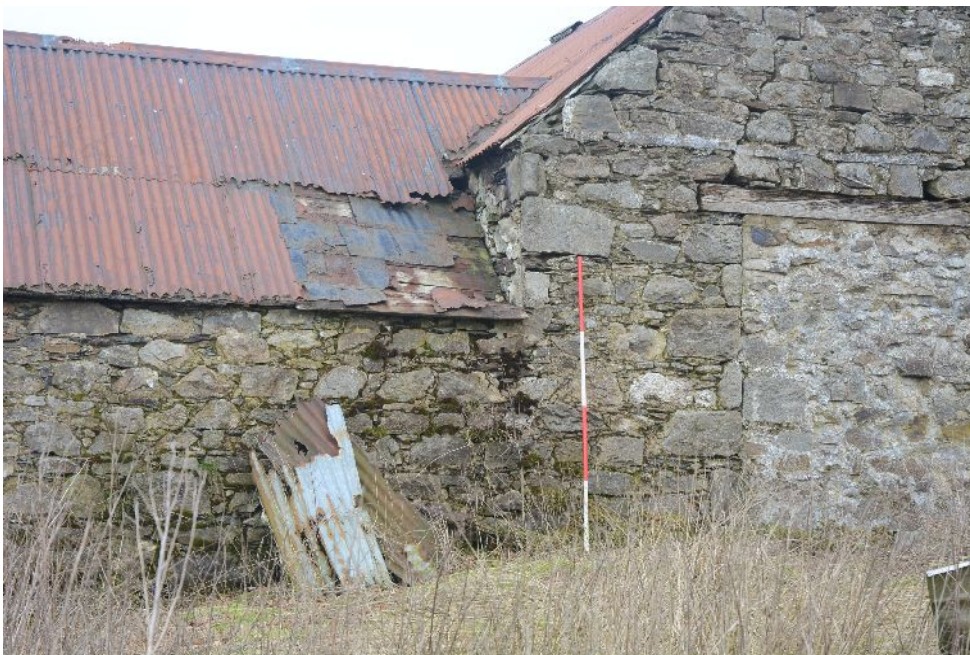
Walls Rubble stone. No clear break in N wall between D and A, so probably both had been built at the same time.

Roof Corrugated iron. The roof of Building D clearly abuts the roof of Building A.

Illus 11 N wall of D and junction with N wall of A.

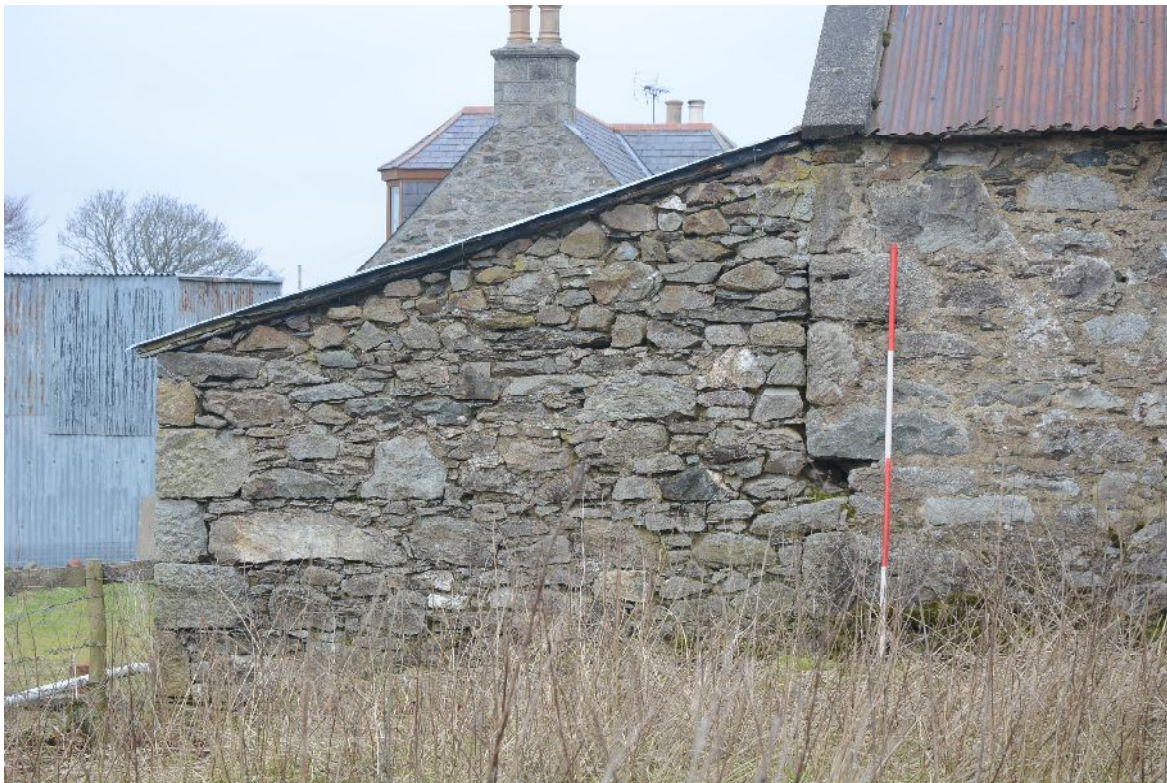
Roof Corrugated iron, lean-to abutting D.

Illus 12 N wall of Building E (LHS) abutting Building D

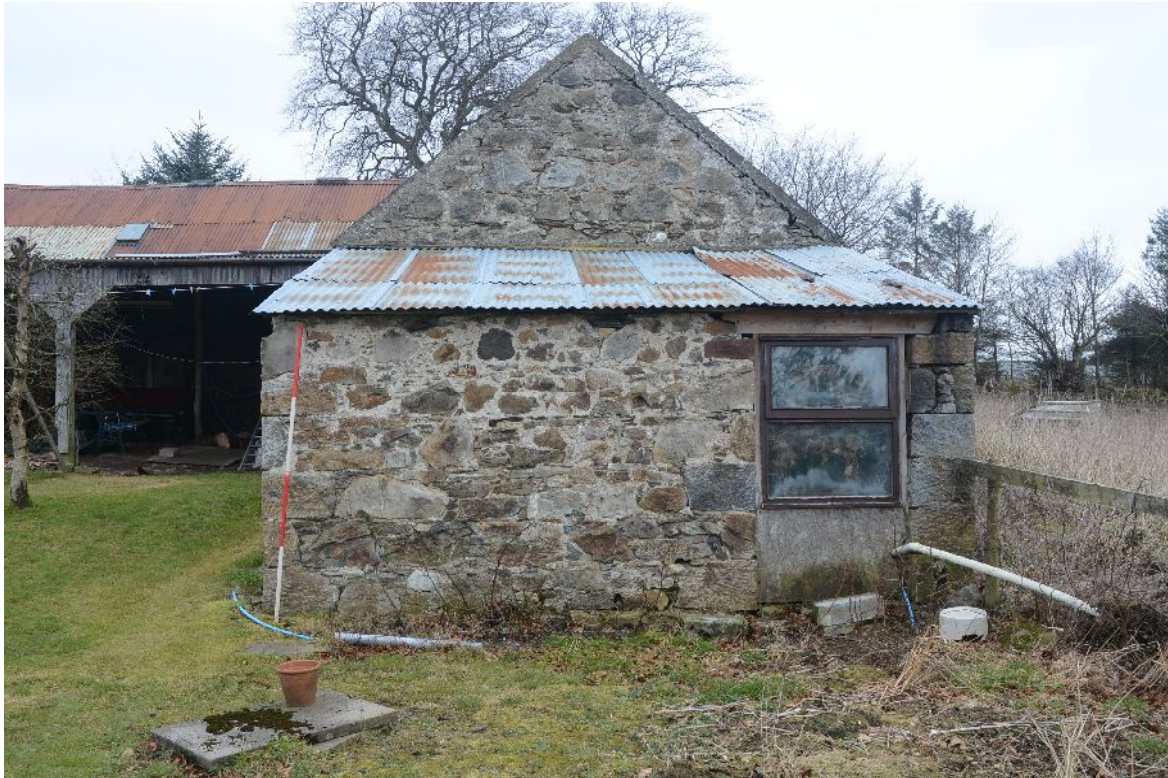
D9 W:1.10m H: 1.90m. Rybats granite rubble and 1 sandstone. Modern blocking with window. Originally door.

Illus 13 S wall of Building E with blocked door D6.

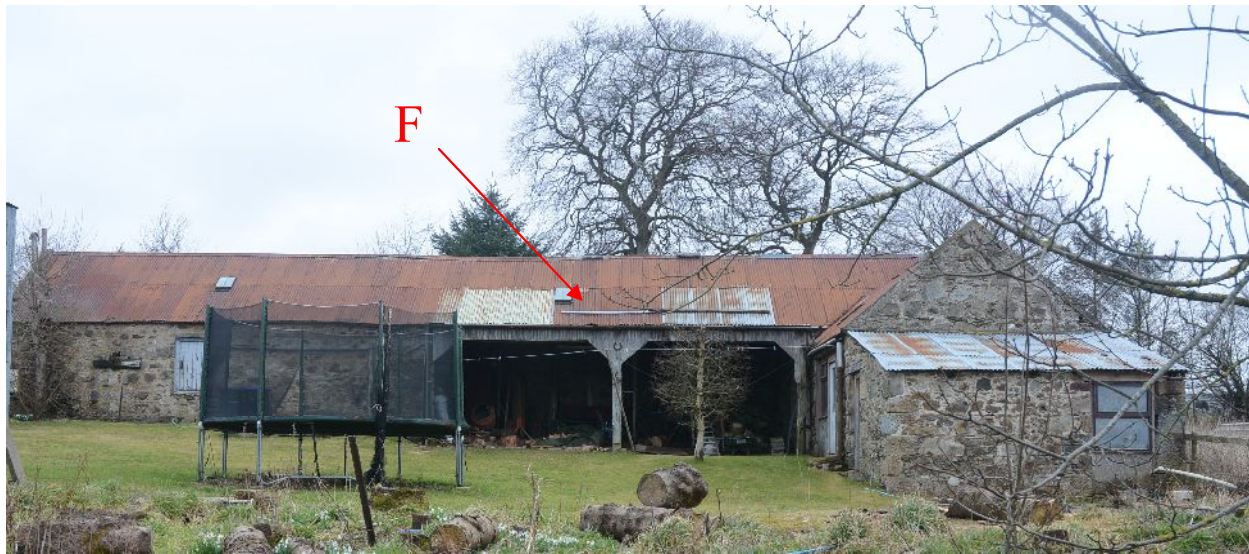
Walls Open fronted to E, S wall corrugated iron with modern composite board blocking.

Roof Corrugated iron lean-to, supported on front (E) side with three telegraph poles or similar.

Illus 14 E elevation showing infill building F.

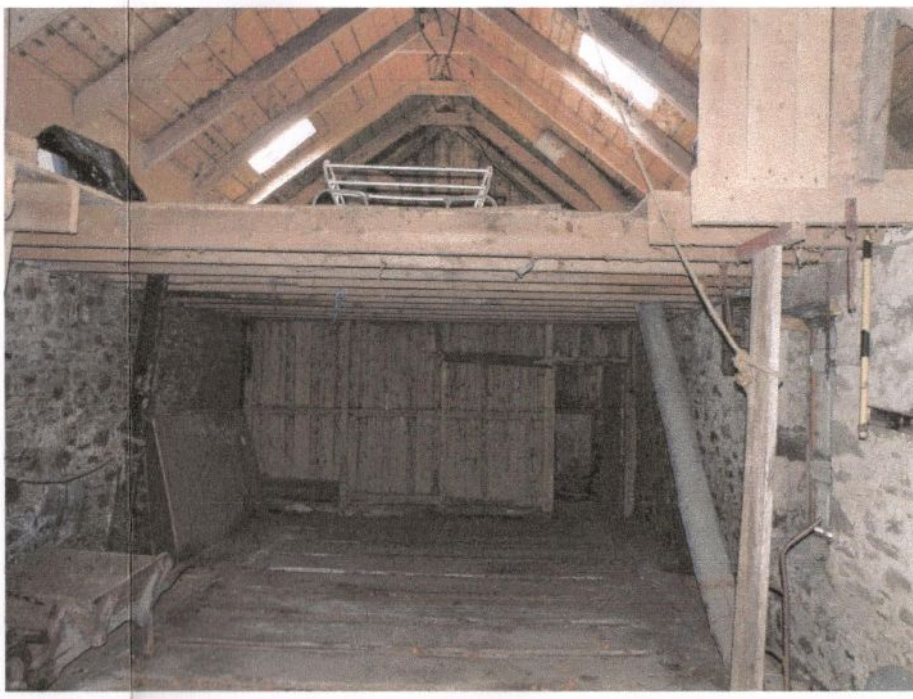
Illus 16 Interior of Building A1, looking S to door D1 Photograph courtesy of Mantell Ritchie Chartered Architects

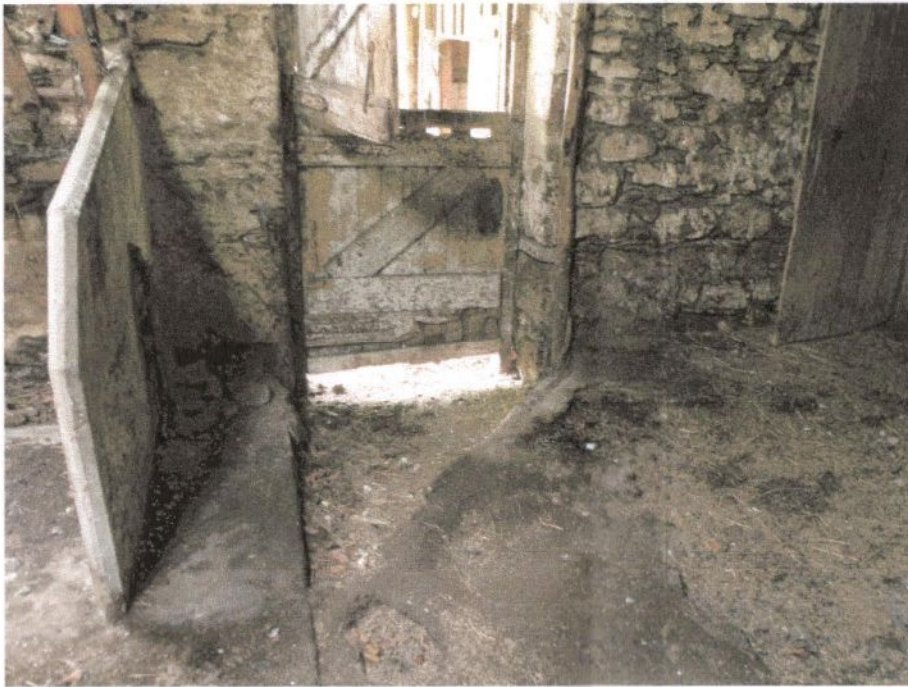
A photograph of the interior of Building A2, also taken earlier by Mantell Ritchie Architects (Illus 17) shows a concrete partition, probably one side of a tied cow stall, just to the N of door D10. This suggests that this end of the building had been for cattle, probably with ties cow stalls on either side of a central passage. This makes sense of the two blockings in the W wall (F1, F2) which may have been small windows for light and ventilation.

Illus 17 Interior of Building A2, looking E to door D10, with tied cow partition to the N (LHS) of it. Photograph courtesy of Mantell Ritchie Chartered Architects
