**BROOMBANK STEADING  
TARLAND  
ABERDEENSHIRE**

**Standing Building Survey**

**Report No: MAS 2018-08**

1. Background
  - 1.1 A standing building survey was required for a small farm steading at Broombank, Tarland, Aberdeenshire, prior to its demolition and replacement by a dwelling and garage.

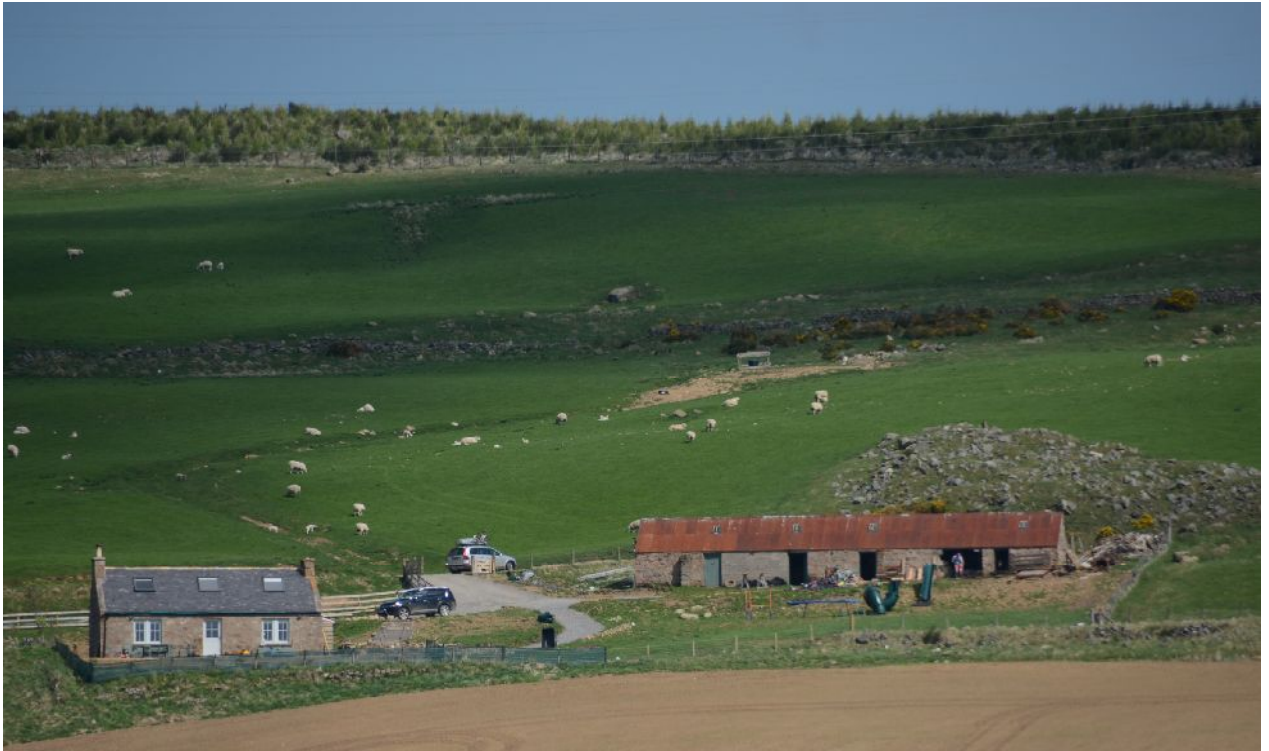
**Illus 4** The farmhouse and steading viewed from the S

The farmhouse was not part of the present survey and has been extensively renovated. It lies slightly SW of the steading, also facing S/SW. Although modernised, the original single-storey and attic rectangular plan cottage is still evident.

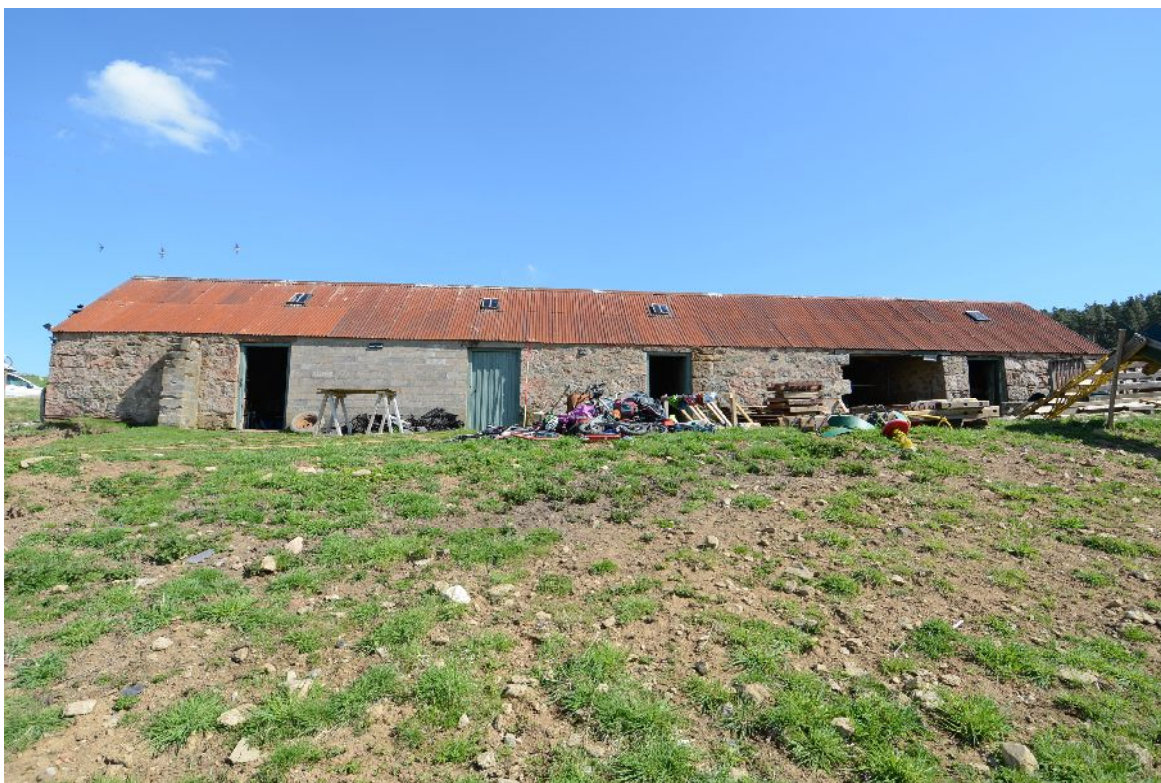
**Illus 5 S elevation of the steading**

The steading is a long, narrow, rectangular structure, facing S/SW with the N side cut into the hillside behind. There appears to have been levelling and terracing of the slope behind the steading to create a trackway and it is possible that the ground was not originally as high close to the back wall of the steading.

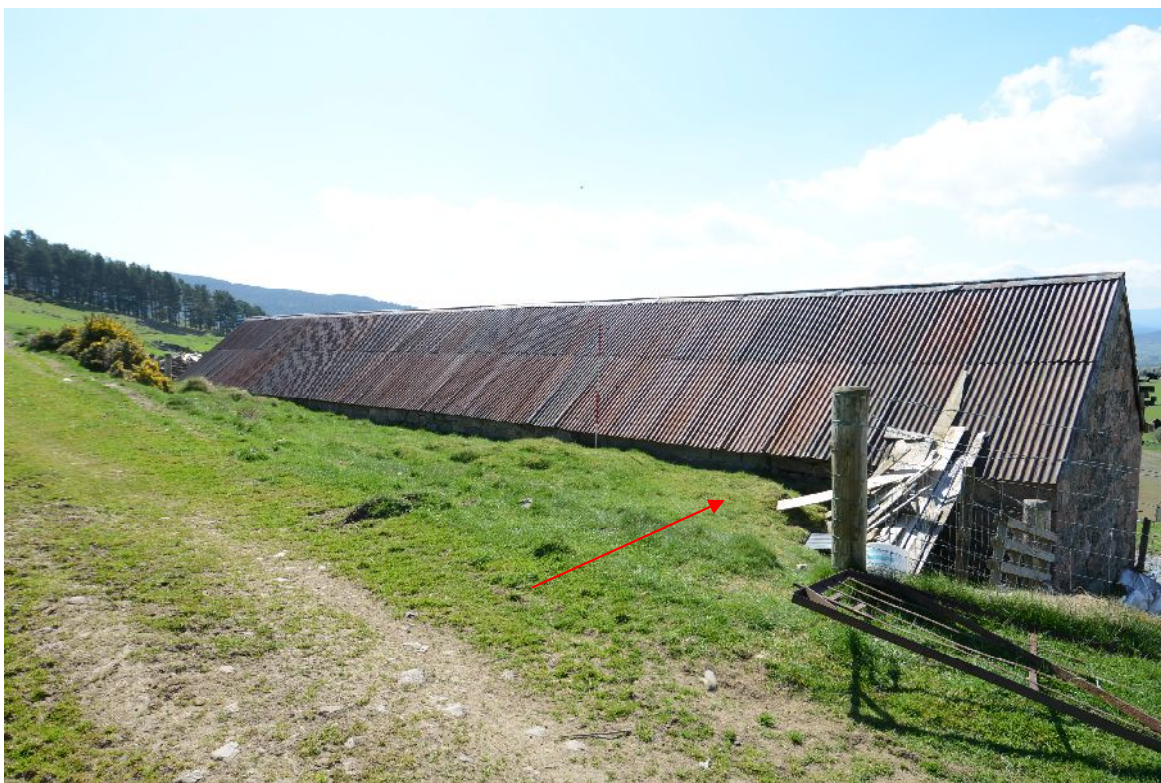
**Illus 6 N wall of the steading, looking E. The approximate position of the horse mill shown on the 1899 OS map is indicated by a red arrow.**

Walls Pink and grey rubble walls c.500-550mm thick, with roughly dressed rubble quoins. Two sections of the wall have been rebuilt with concrete blocks. Significantly, one of these is in the N wall near the location of the horse mill shown on the 1899 OS map; vibrations from the mill may have caused damage to the original wall at this point. There is a visible difference in the construction of the S wall to the E of door D5, with rows of small wedge-shaped pinnings between the rubble courses (Illus 8,9); this difference may indicate that the E end was an extension- or possibly a repair. The corresponding part of the N wall was obscured by the higher ground behind the building.

Area A, at the W end of the building appears to have been a grain store with a horse mill shown outside the N wall on the 1899 OS map, which would have driven a small threshing machine set inside the building. Little physical evidence of the mill remains as the part of the N wall where the horse mill is shown on the 1899 map has been rebuilt with concrete

blocks (it may well have become unstable with the vibrations of the mill). However, a socketed stone (F1) in Area A may relate to the fixing for some part of the mill mechanism- possibly the threshing machine. In light of the higher ground on the N side of the steading, the drive shaft of the mill would have to have been culverted underground, with a vertical spindle outside the N wall around which the horse-driven shaft rotated.

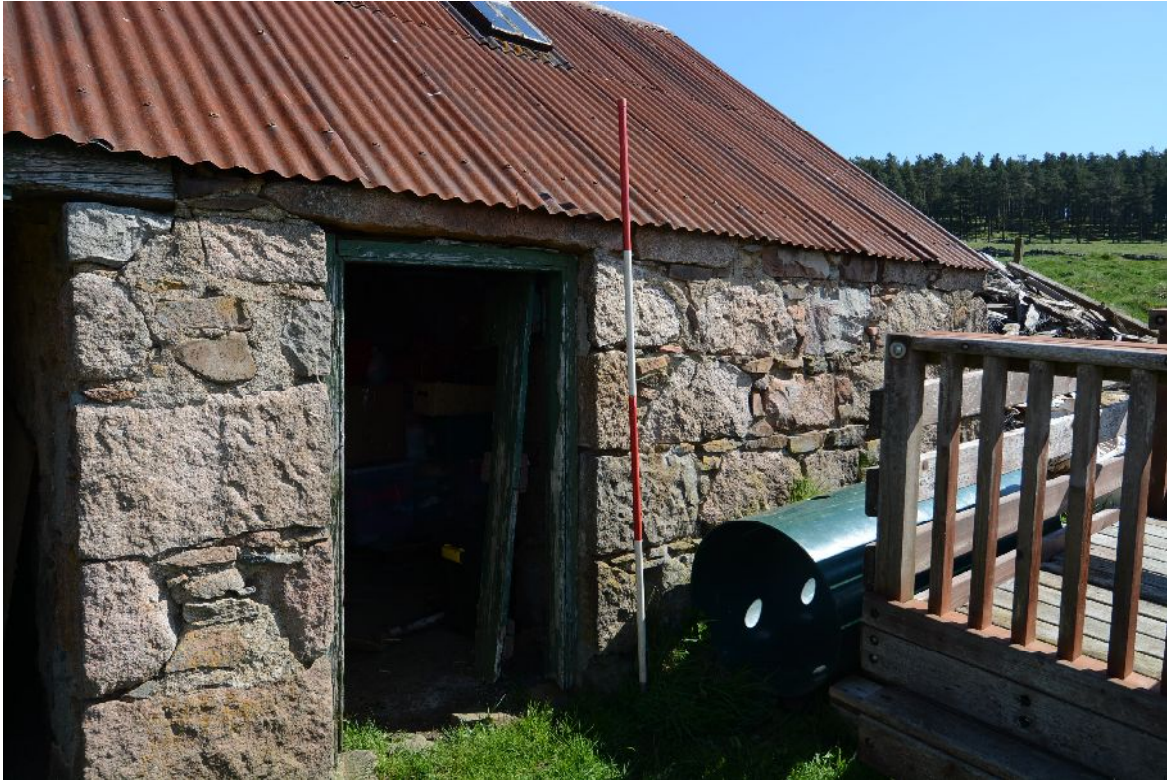
**Illus 8 Door D5 and wall structure of E and of S wall.**

**D5** W: 0.95m. H: 1.65m Rubble rybats. Red granite lintel. Cobble step. Plank door

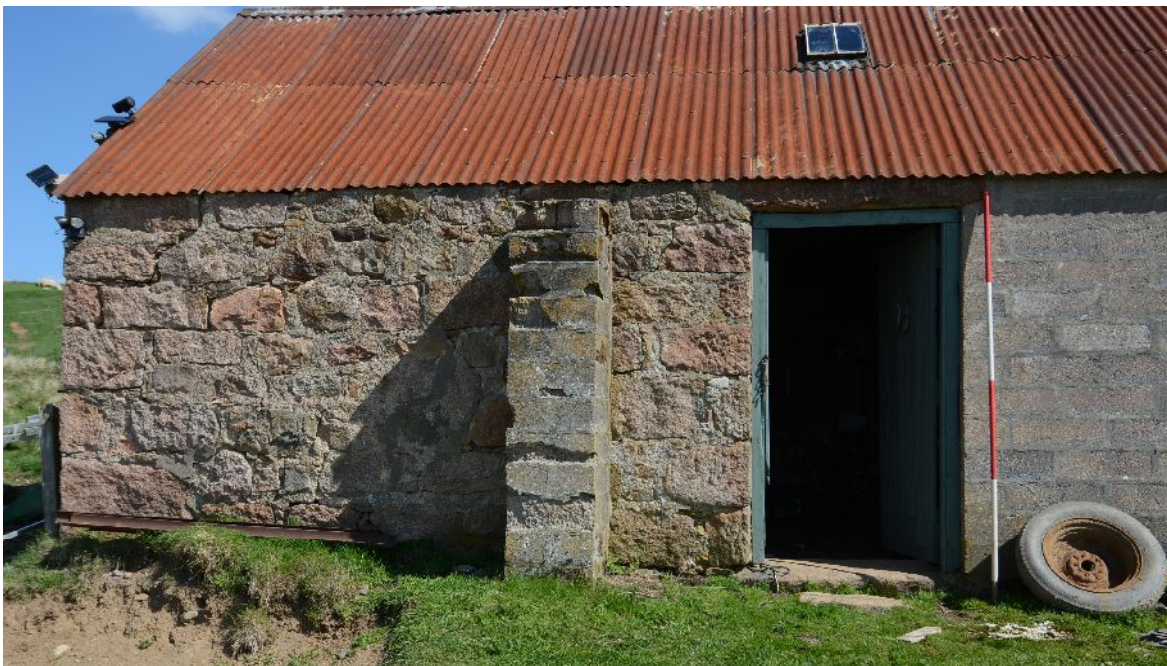
**Illus 9 Door D1 and wall structure of W end of S wall**

**D1** W: 1.09m. H: 1.94m W side rubble rybats. E side rebuilt with cement blocks. Red granite lintel and sill. Plank door.

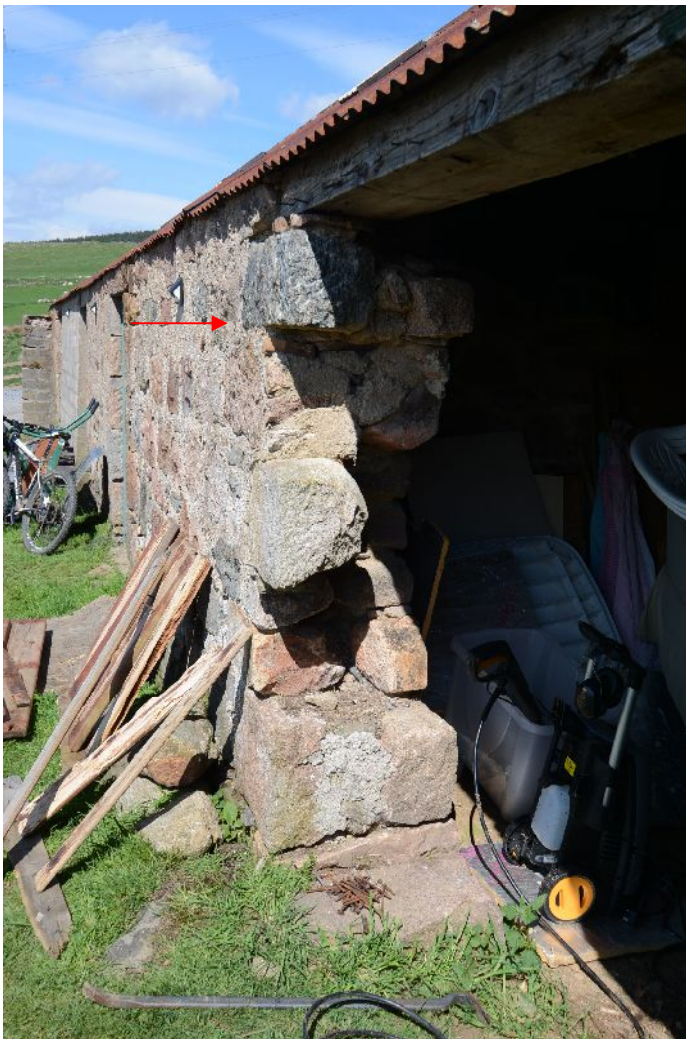
**Illus 10** W side of door D4. Arrow shows change in stonework at top of wall

**D4** W: 2.30m maximum, although foundation on W side may indicate this was originally 1.90m. E side, between D4 and D5, appears originally to have been built as a free-standing column, later abutted by the internal stone partition wall between compartments D and E. (Illus XX).

H: 1.80m. Timber lintel. It is possible this lintel has been raised as on both sides of the door there is a difference in the stonework at the top of the wall (Illus 10-11).

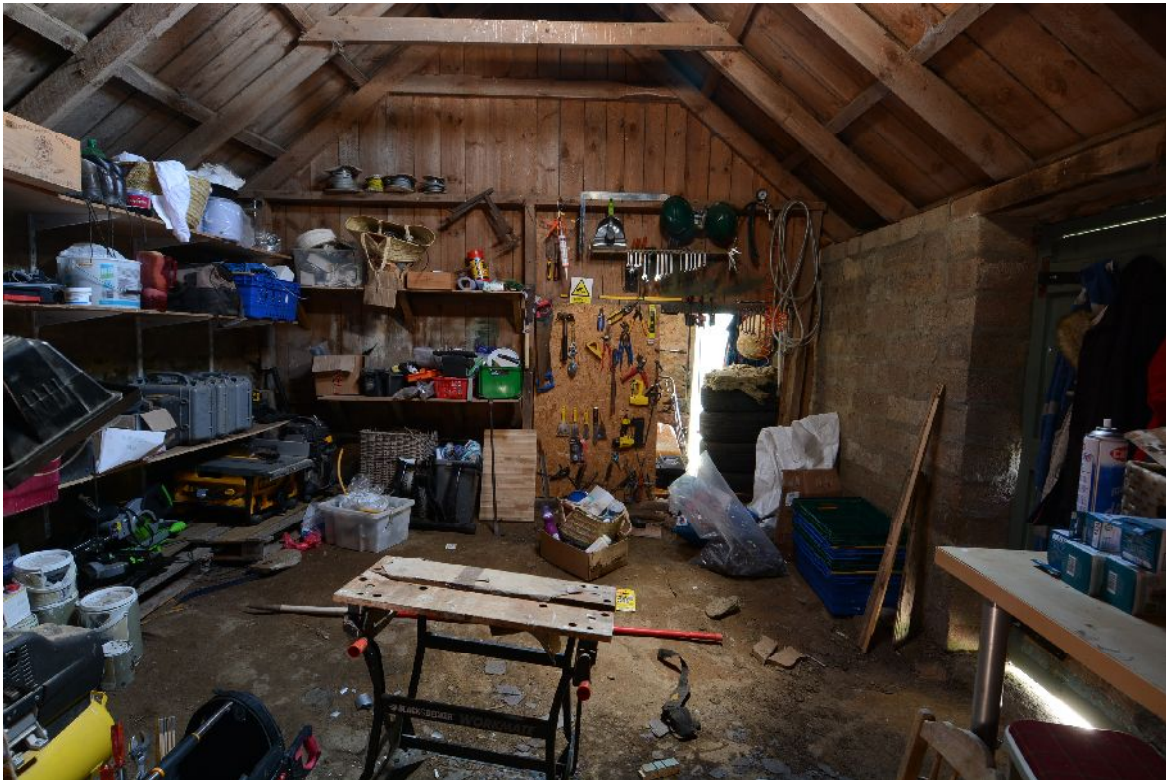
**Illus 12 Interior of A, looking E to partition between A and B.**

Compartments A and B were divided by a vertical pine plank partition with an opening at the S end (possibly secondary).

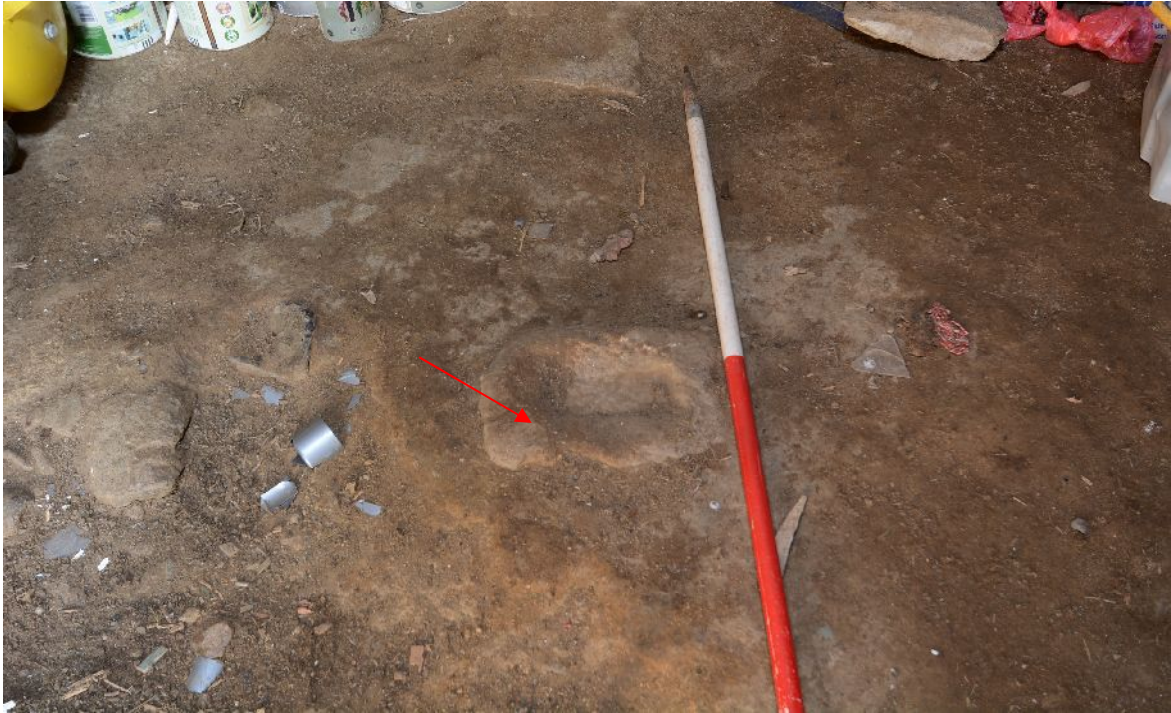
**Illus 13** Floor of Area A, showing stone F1 (marked by arrow).

Some traces of cobbling remained in A, the most significant feature was a stone (Illus 7: F1, Illus 13), c. 300 x 200mm, set in the floor, in line with the E side of door D1 and 2.46m into the room. There was a rectangular socket c. 70 x 160mm and c.20mm deep cut in its upper surface. The position of this stone may indicate it was associated with the machinery (thresher and/or bruiser) run by the horse mill.

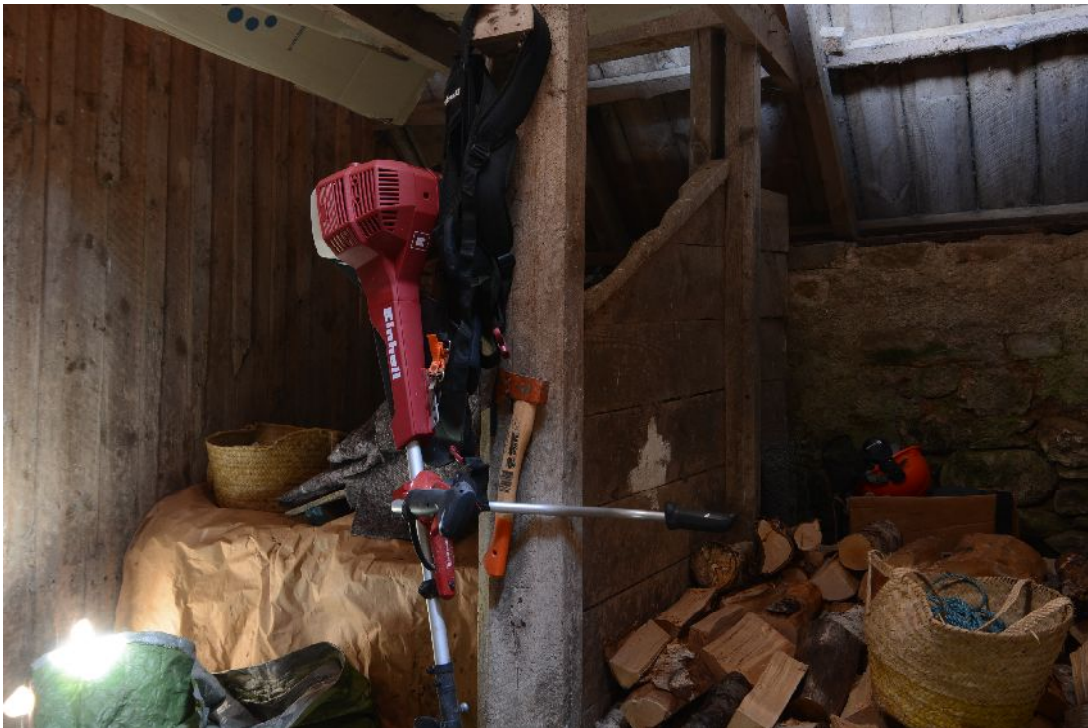
**Illus 14** Interior of B. Stable showing trevis between stalls.

Floor cobbled. A timber trevis attached to the N wall formed two horse stalls, c. 1.95m long and 1.7m (W) and 1.58m (E) wide. The trevis was of horizontal planks set in vertical grooves in the head and hind posts. The hind post was octagonal.

Area B, next to the mill, was clearly a stable for two horses; these would have been used for cultivation, as well as the horse mill and carting. Two horses would be fairly typical of a croft of some 30-60 acres or so

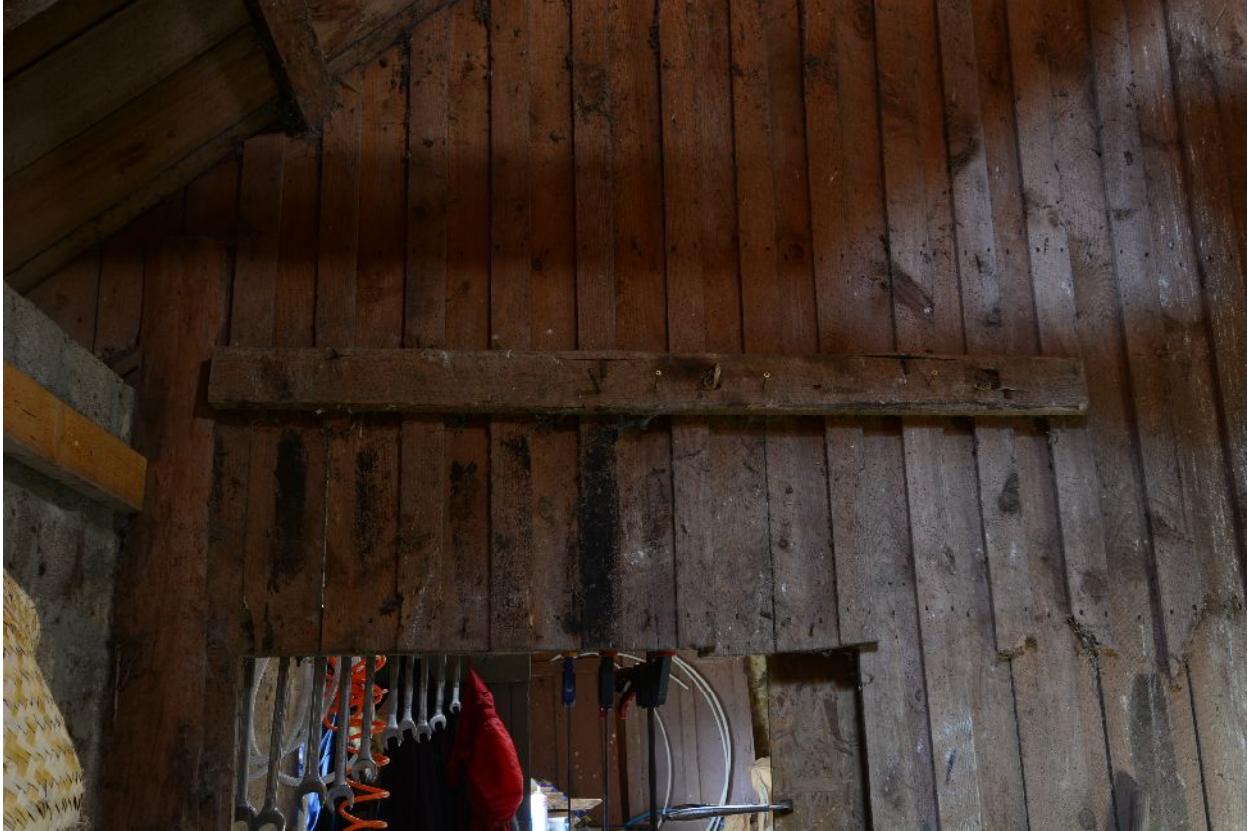
**Illus 15 Interior of B. Possible position of harness pegs.**

A horizontal timber on the face of the partition wall appears to have broke-off harness pegs (Illus 15).

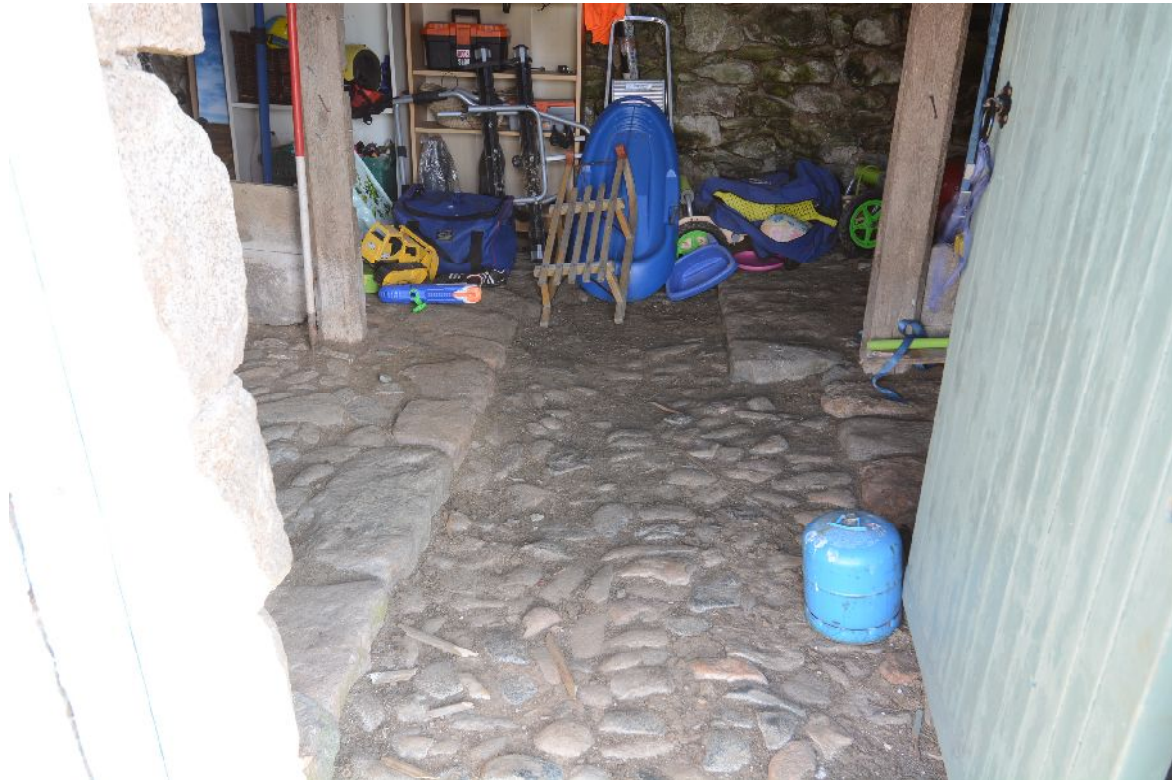
**Illus 16 Interior of C showing central drain in cobbled floor.**

Compartment C had a cobbled floor with a central drain and trevise attached to the E and W walls forming four tied-cow stalls, each probably originally for 2 cows. The trevise were of horizontal planks set in vertical grooves in the head and hind posts. The hind posts were octagonal. The stalls ranged in width between 1.84m and 2.06m and in length between 1.65m and 1.75m. A stone setting, 500mm wide, at the head end of the W stalls is likely to have formed the base of a feed trough, with a horizontal plank remaining from the hay hakes.

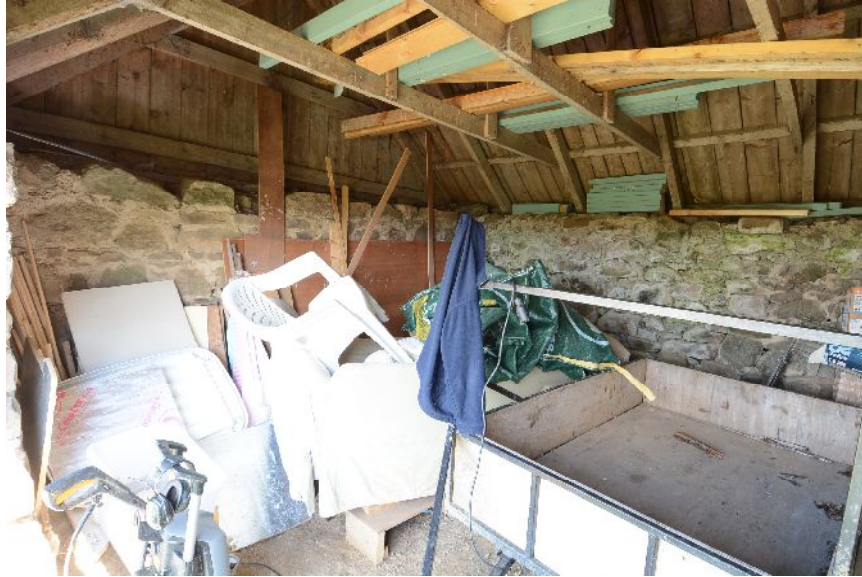
**Illus 19 Interior of D**

No surviving detail.

There is little direct evidence for the function of areas D and E, but the wide doorway into Area D suggests it was originally a small cart bay. However, at times both of these areas may also have been used for young store cattle or other livestock overwintered inside.

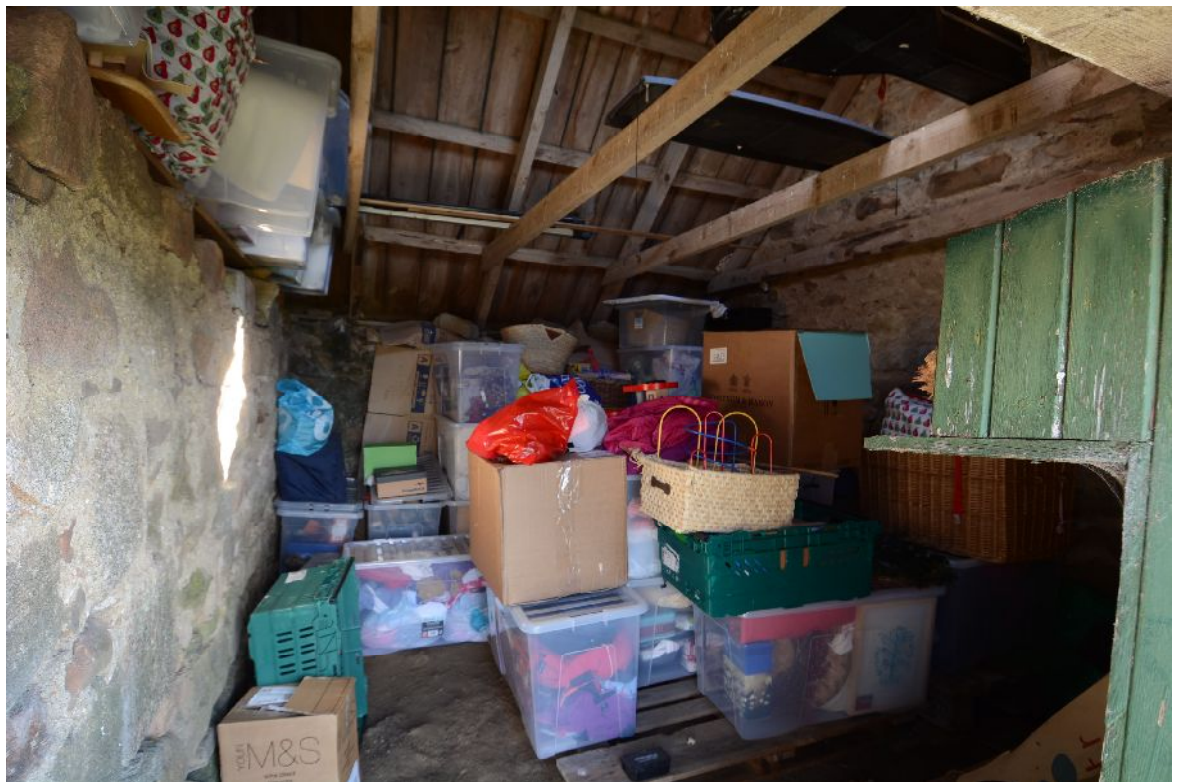
**Illus 20 Interior of E**

No surviving detail.

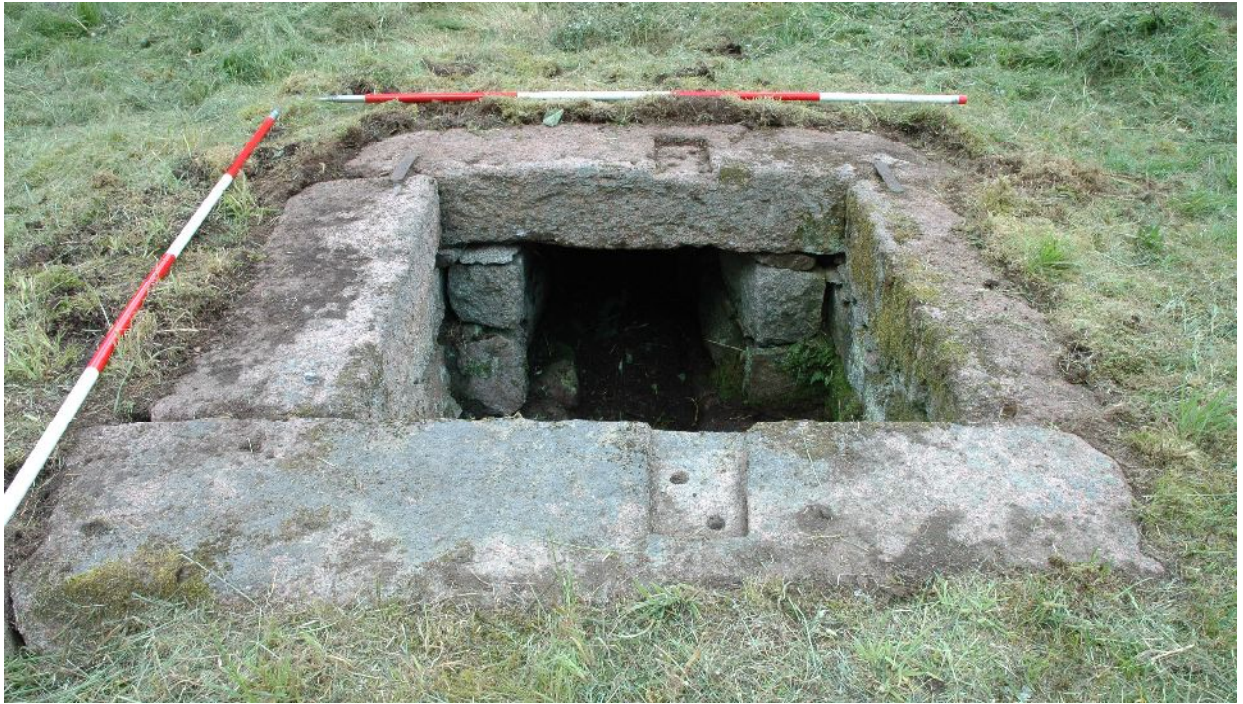
**Illus 22 Top of engine setting of horse mill at Tillychardoch, Tarland, Aberdeenshire (Murray & Murray 2007, illus 15)**

The nearby horse mill at Tillychardoch, Tarland (Murray & Murray 2007), also originally part of the Earl of Aberdeen's Cromar estate, had a similar arrangement, with a rectangular stone-lined hole 1.2m square and 0.90m deep to house the engine mounting in the centre of the circular horse walk. Although there is no visible evidence of the equivalent setting outside the N wall of the Broom bank steading, its former existence is attested by two long granite slabs which have been built into a garden wall; they can be paralleled by the top slabs from the top of the engine setting at Tillychardoch (Illus 22).

The slots in the top of these slabs are likely to have held an A-frame to stabilize the upper part of the mechanism, around which the horse walked (Illus 23). As the two crofts are only some 1.5km apart and both were tenancies of the Cromar Estate, it is even probable that both horse mills were built by the same people.
