**EDINTORE MILL  
DRUMMUIR  
KEITH  
MORAY**

**Standing Building Survey**

Carried out 22<sup>nd</sup> May 2018

**Report No: MAS 2018-11**

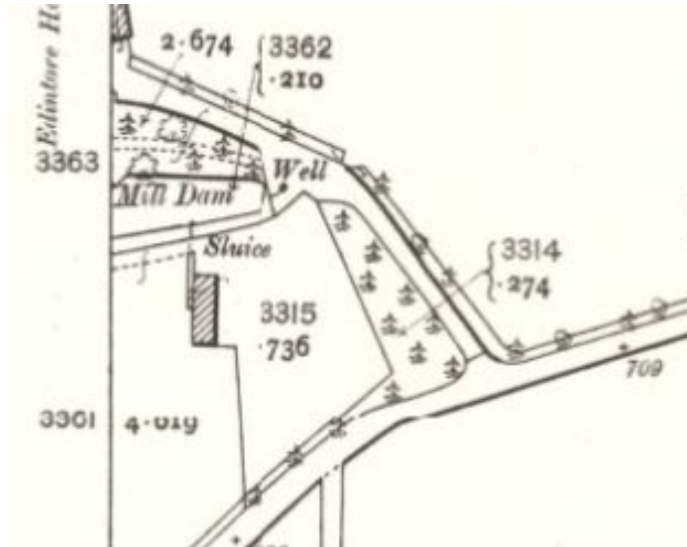
Illus 4 The 25"/mile. OS map The 25"/mile OS map Banffshire xx.10 (Cairnie, Keith) 1900 (published 1902) [www.nls.ac.uk](http://www.nls.ac.uk)

**1900** The 25"/mile. OS map Banffshire xx.10 (Cairnie, Keith) 1900 (published 1902) shows the mill unchanged.

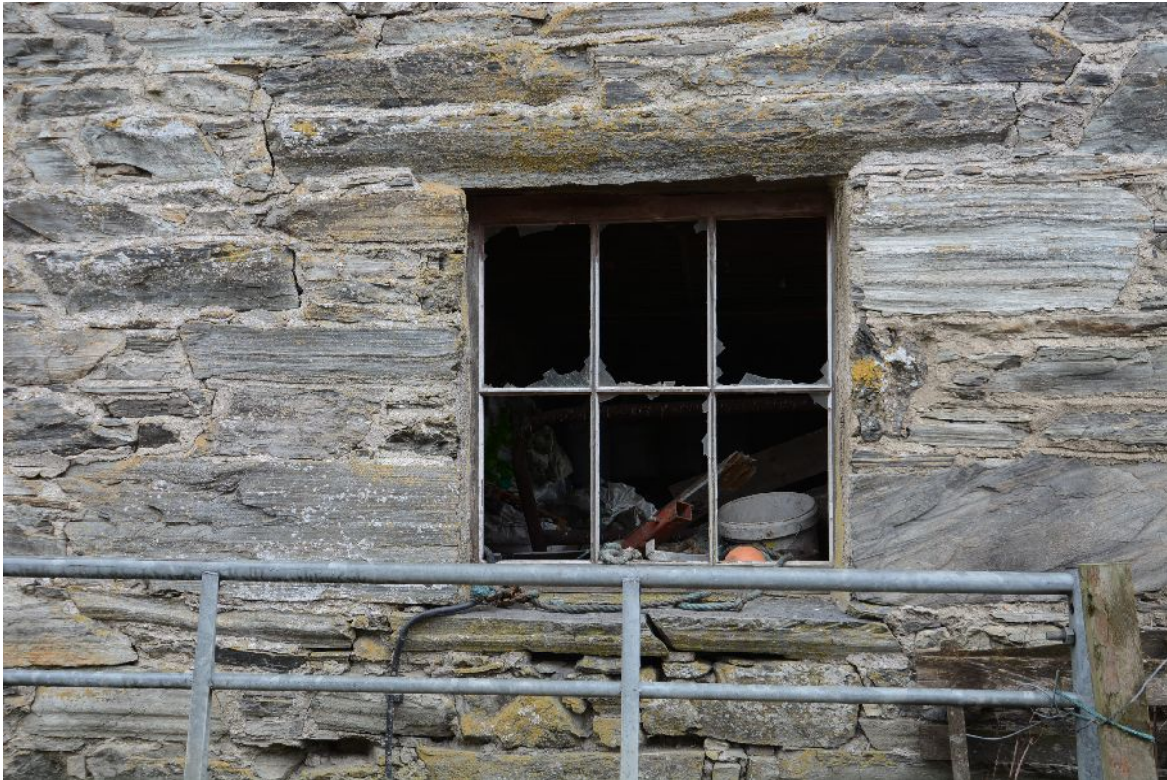
Walls Rubble stone. The stone appears to be a schist, grey in colour and with strong horizontal lamination. A single granite slab was noticed as the sill of the now blocked opening for the horizontal axle of the water wheel (F1); this was presumably used for greater strength against the stresses created by the movement of the wheel.

At a number of places the walls have been raised or repaired with concrete blocks.

**Illus 7 S wall and window W5 showing detail of stonework**

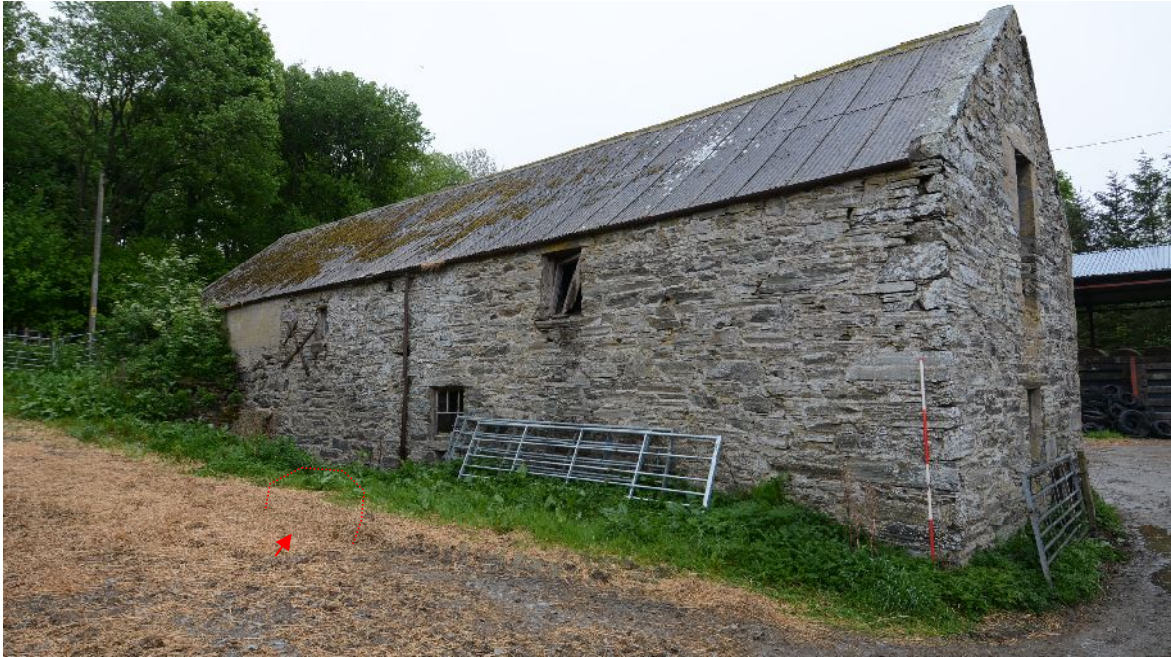
Wheel pit The wheel pit was almost fully in-filled with rubble but it appeared to have been c. 6.7m in length alongside the N end of the W wall. The visible N end of the wheel pit was stone lined (Illus 9) but the other sides could not be observed.

**Illus 8** W elevation looking N. Dotted line indicates the approximate position of the water wheel, just visible in the differential weathering of the stone. The arrow indicates F1, the blocked axle hole.

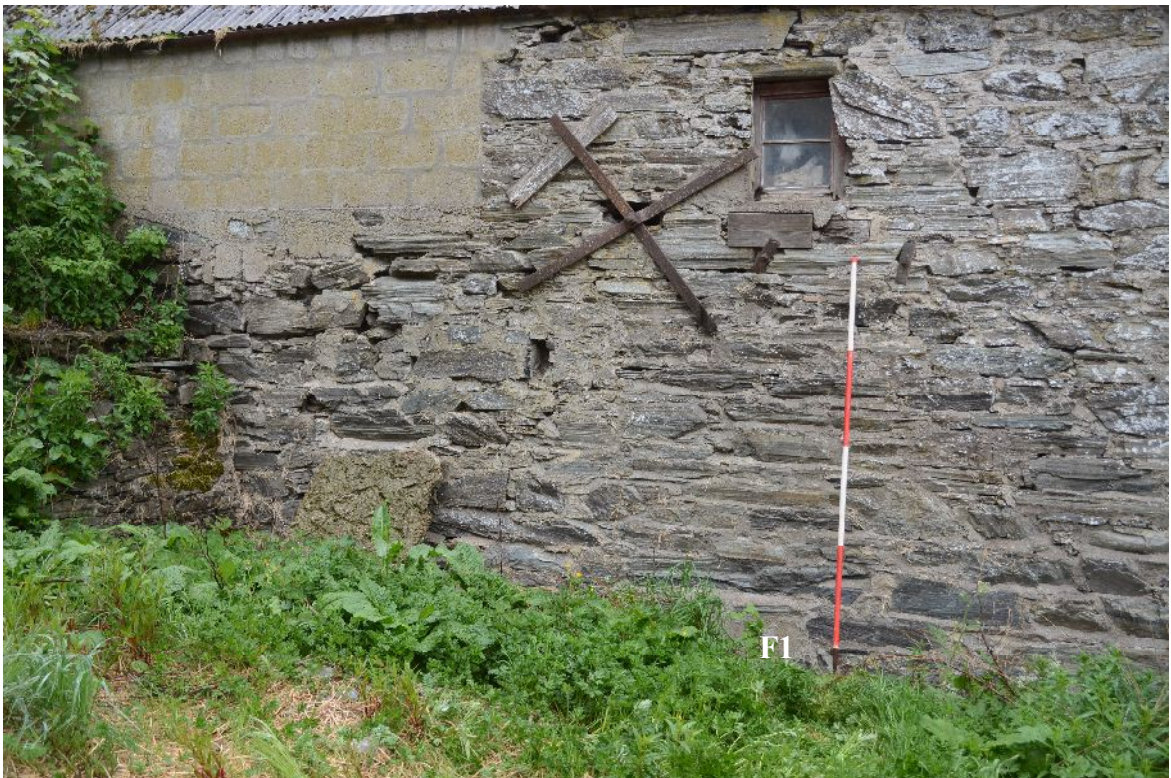
**Illus 9** Detail of N end of wheel pit

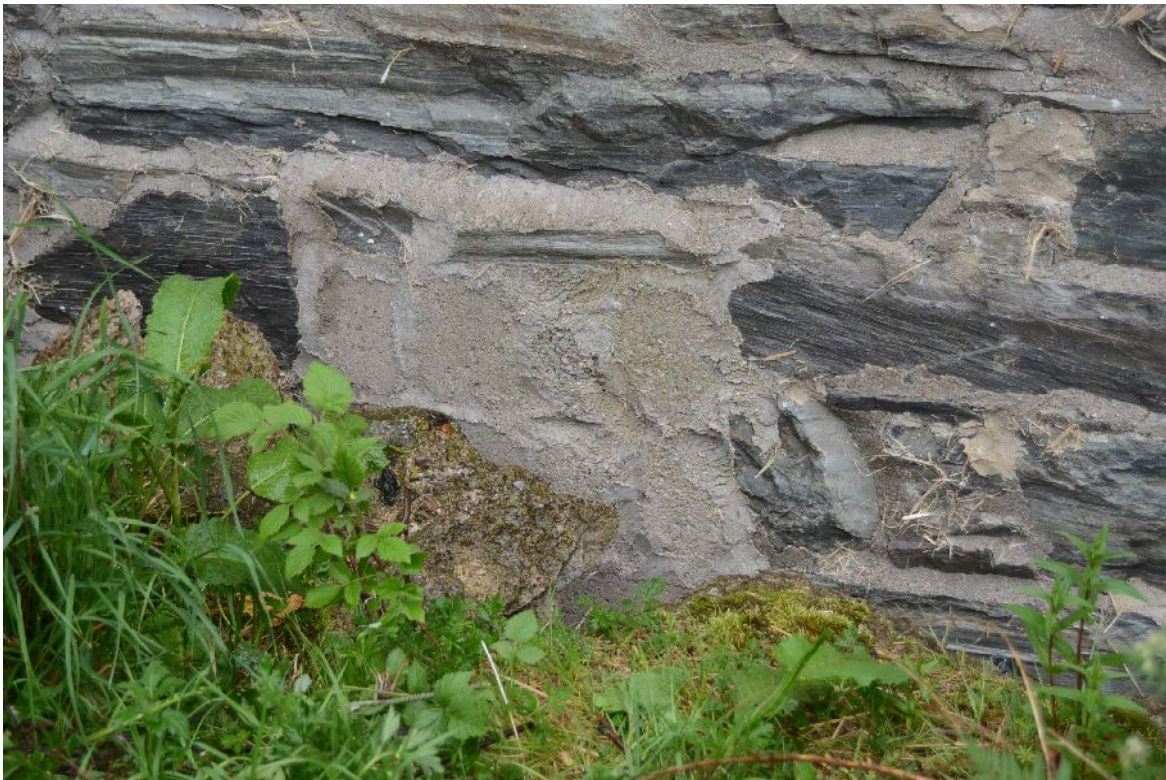
- W2** W: 0.30m H:0.40m (estimated) Stone lintel and rybats. Concrete at sill. 1/1 panes. Looks out on wheel pit. Opens into loft.  
**W3** W: 0.92m H:0.94m Stone lintel, sill and rybats.3/3 panes.  
**W4** W: 1.01m H:1.00m. Stone lintel, sill and rybats. Wooden plank blocking. Opens into loft.  
**F1** W: 0.60m H: 0.70m Rectangular opening blocked with concrete blocks (Illus 10). Base sill appears to be granite. Wheel axle hole. Internally there was a metal clamp that would have held the axle. (Illus 11)

**Illus 10 Blocking F1 external view: wheel axle hole**

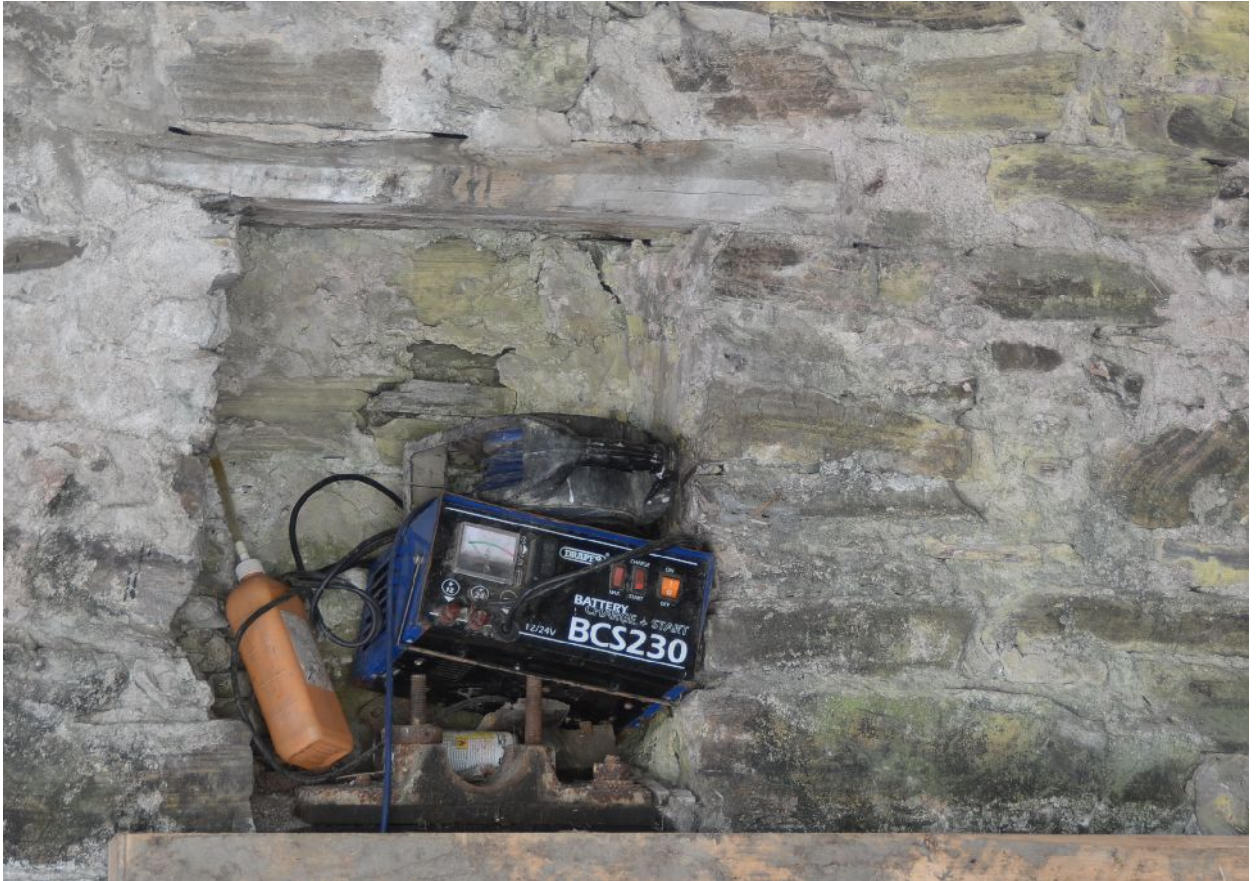
**Illus 11** Blocking F1 interior with part of axle clamp in position

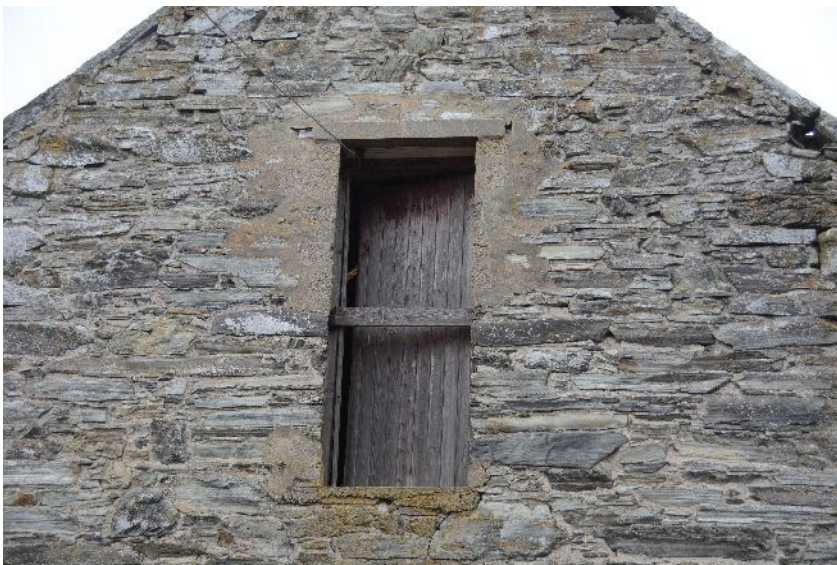
**D4** W:0.80m H:1.97m. Lintel and upper parts of sides concrete. Lower sides stone.  
Opens into loft. Plank door.

**Illus 12** S wall, detail of loft door D4

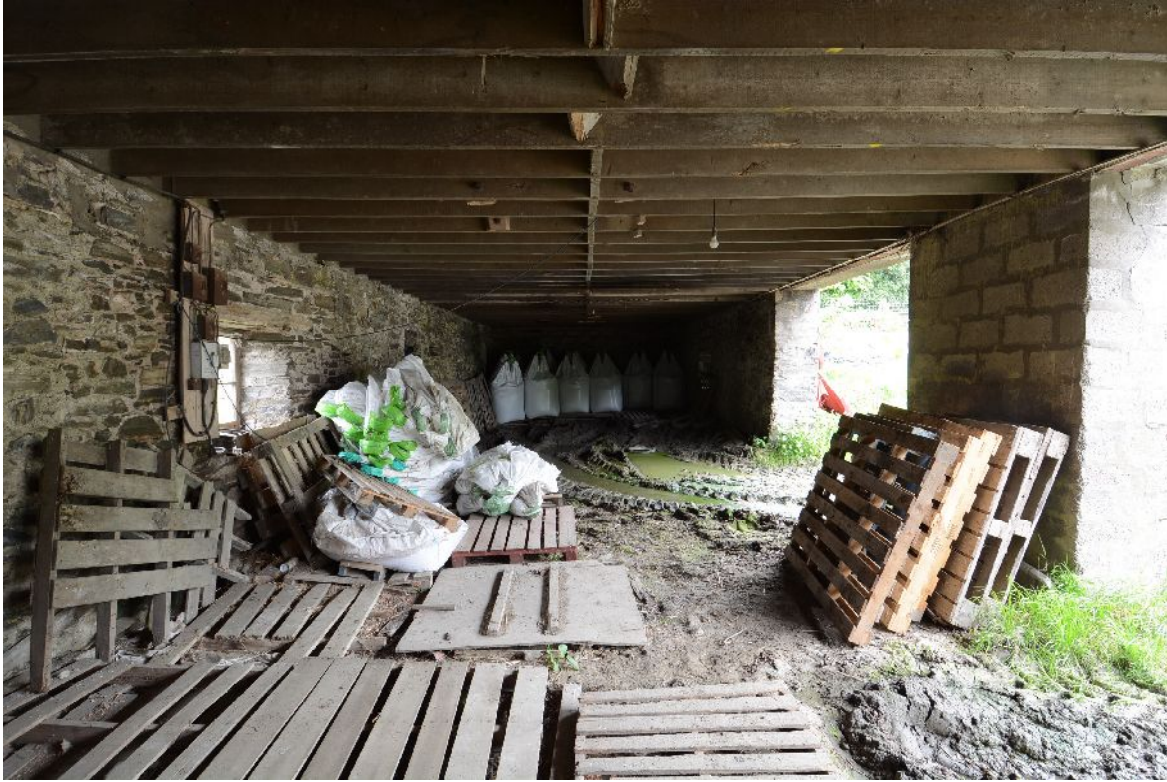
At ground level the only feature visible inside the mill was the inside of blocking F1 (Illus 11, 13). The loft was timber floored and was in use for storage. (Illus 14).

**Illus 13 Interior at ground level looking N**

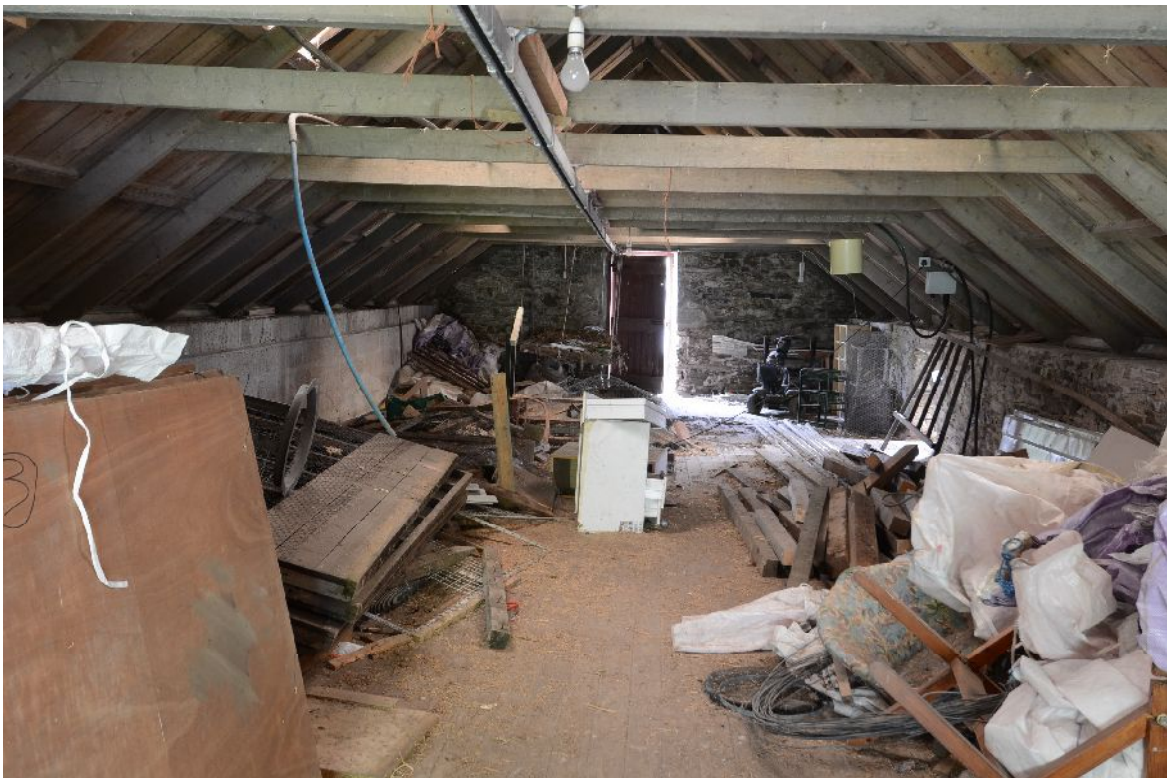
**Illus 14 Interior of loft looking S from door D3**
