**UPPER ALLALOTH
CLOCHAN
BUCKIE
MORAY**

Standing Building Survey

Carried out 9th October 2018

Report No: MAS 2018-24

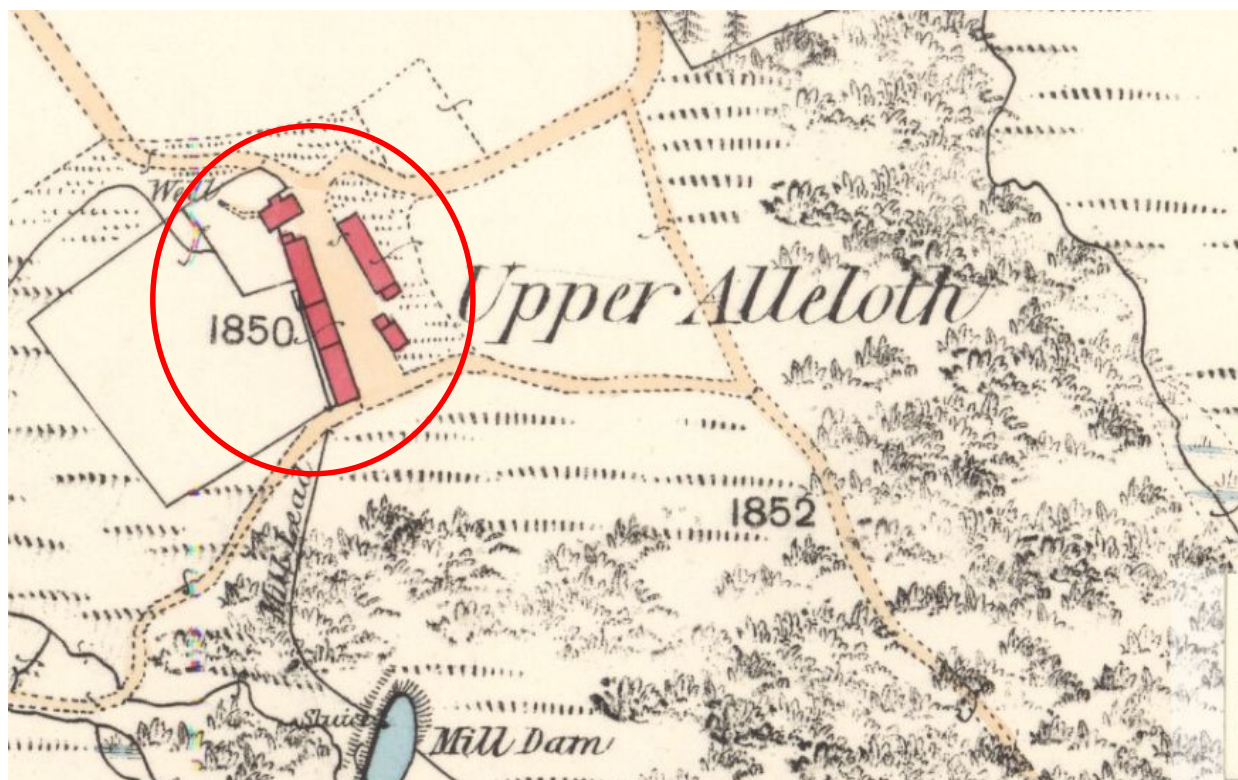
1866 The 25th/mile 1st OS map **Banffshire VIII.9 Rathven 1866 (published 1868)** shows a long N/S range of 3 conjoined buildings, with a mill lade clearly running along the W side to a wheel by the northermost building. A small outshot is shown at the N gable. Two smaller buildings lie to the E of this range across a yard. The house, shown as a rectangular block with a central porch on the N side, lies N of the steading.

Illus 2 Detail of the 1st edition Ordnance Survey 25th map, surveyed in 1866 (published 1868) Banffshire VIII.9 Rathven www.nls.ac.uk

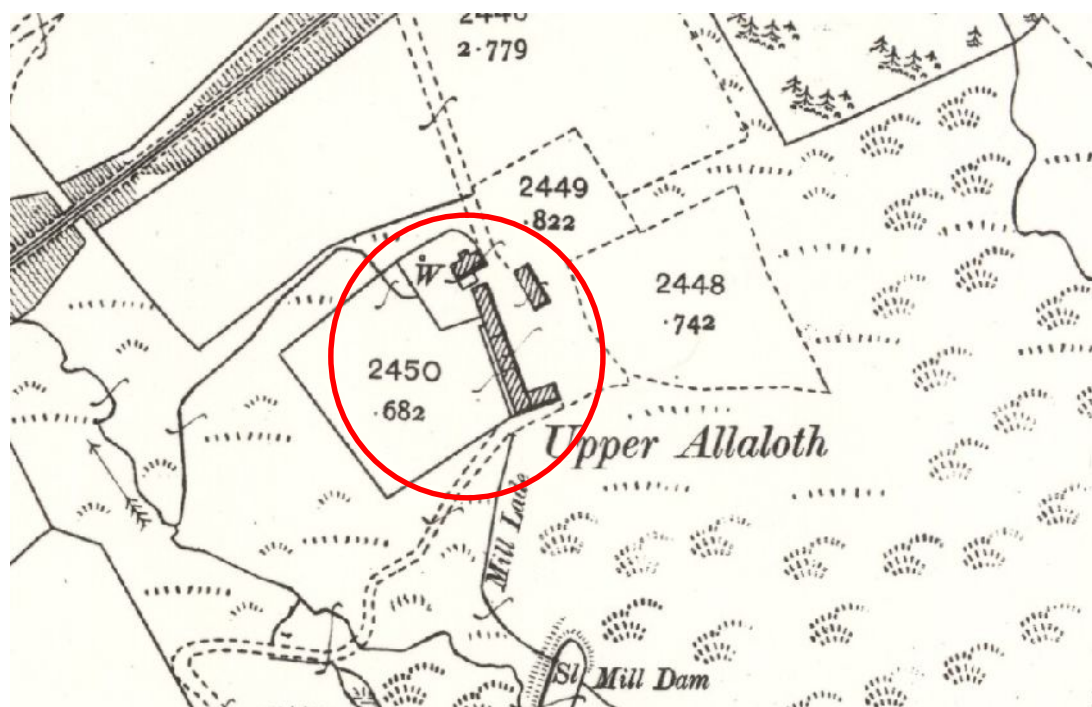
1902 By the 2nd edition 25"/mile Ordnance Survey of 1902 (published 1905.

Banffshire VIII.9 (Rathven)) the main N/S range has been extended by an E/W block at the S gable. (This may be the addition referred to in the 1901 advertisement) The house appears to have an outshot (? unroofed) at the S

side. The buildings to the E have been reduced to one, possibly part of the former N building on this side.

Illus 5 Detail of the 2nd edition 25th/mile Ordnance Survey of 1899 (published 1900. Aberdeenshire Sheet 062.03) www.nls.ac.uk

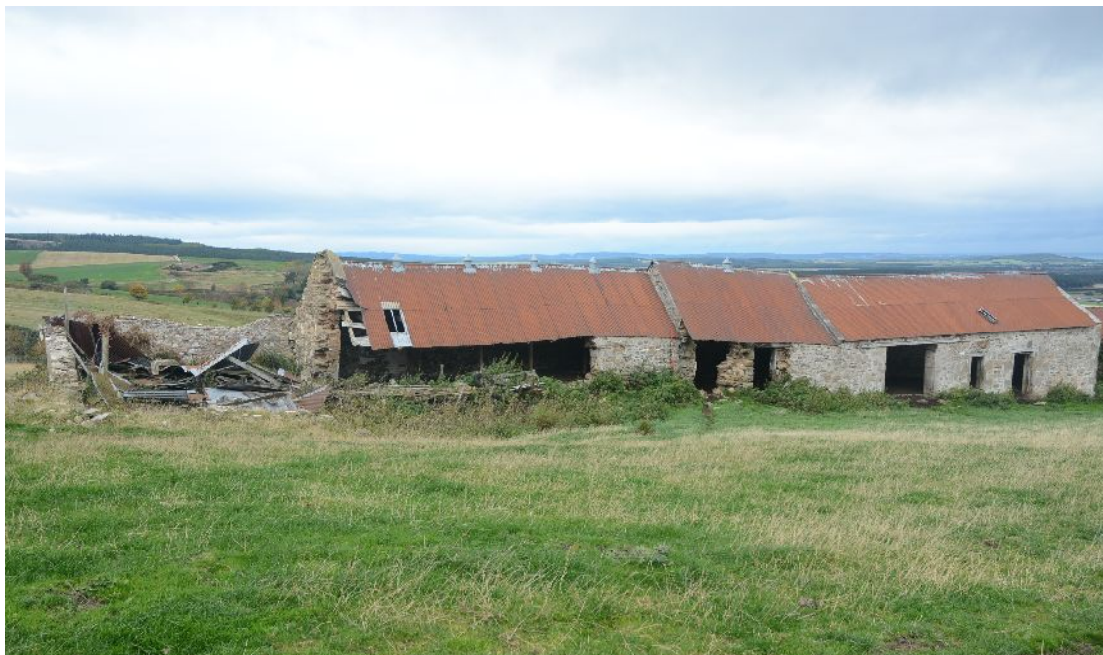
Illus 10 E Elevation of steading

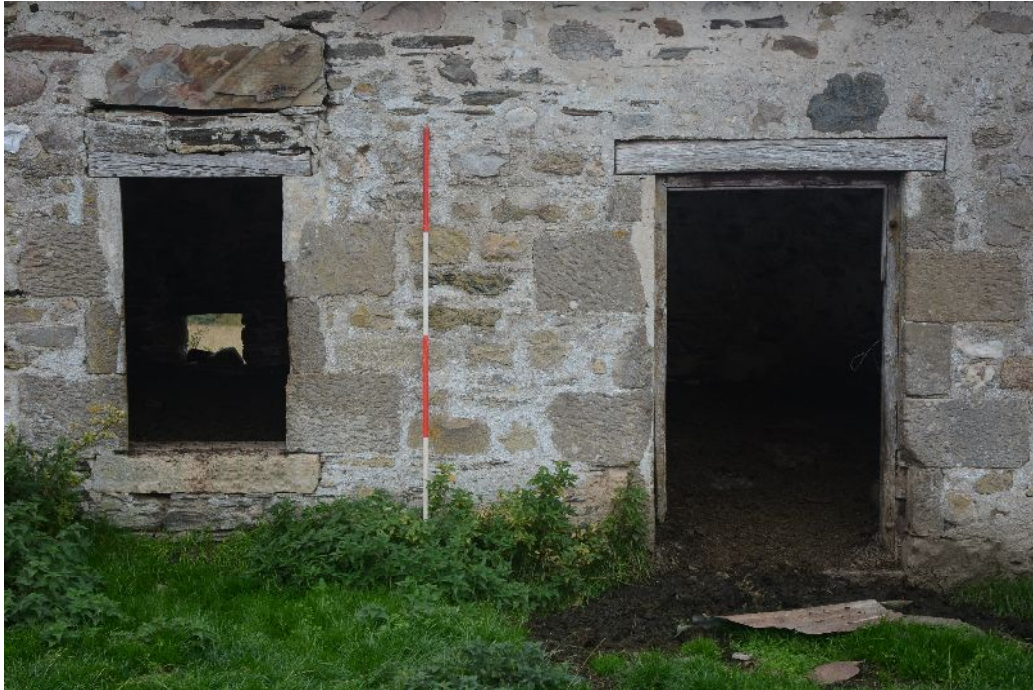
E wall D1 W:1.26m H: 1.90m Dressed granite rybats. Replacement wooden lintel

W1 W: 0.78m H: 1.37m. Splays internally. Dressed granite rybats and sill. Replacement wooden lintel below cracked original lintel.

Illus 11 Steading, Building A, E elevation. W1 and D1

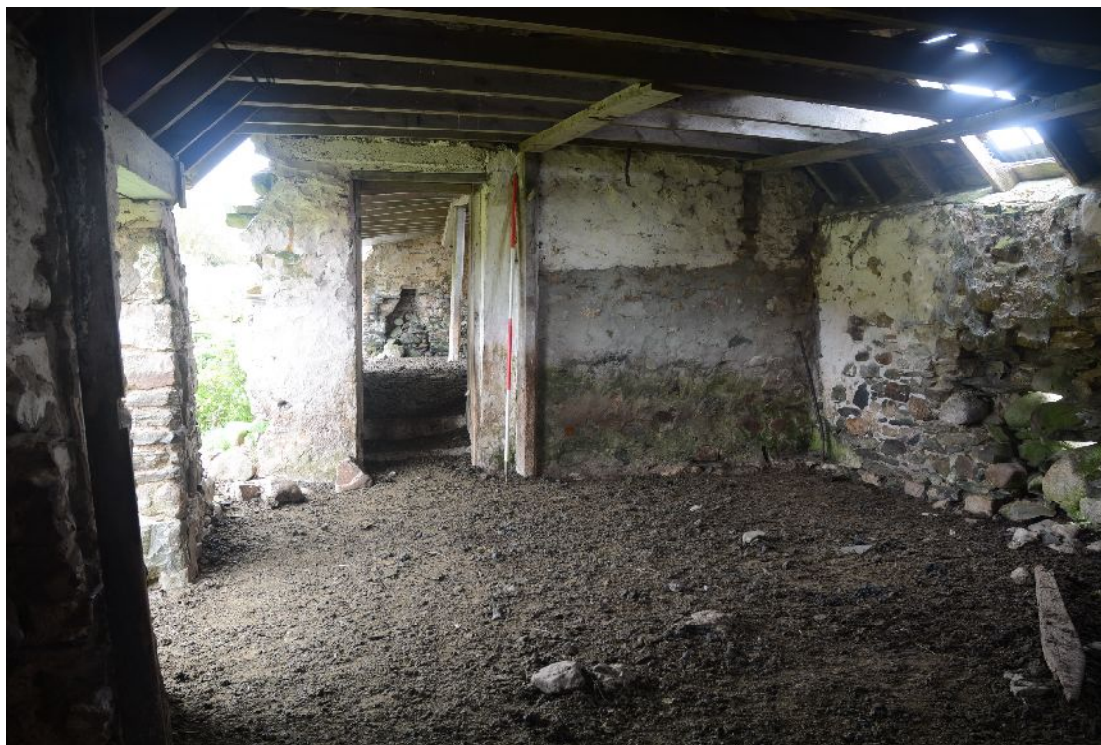
Although on the same width as Building A, Building B has a separate, higher roof line and there is a clear join line in the E and W walls where it has been added on to A. However, the only wall between the two is a vertical plank partition.

Illus 12 Looking S in Building B through internal door (note 2 steps up) into Building C.

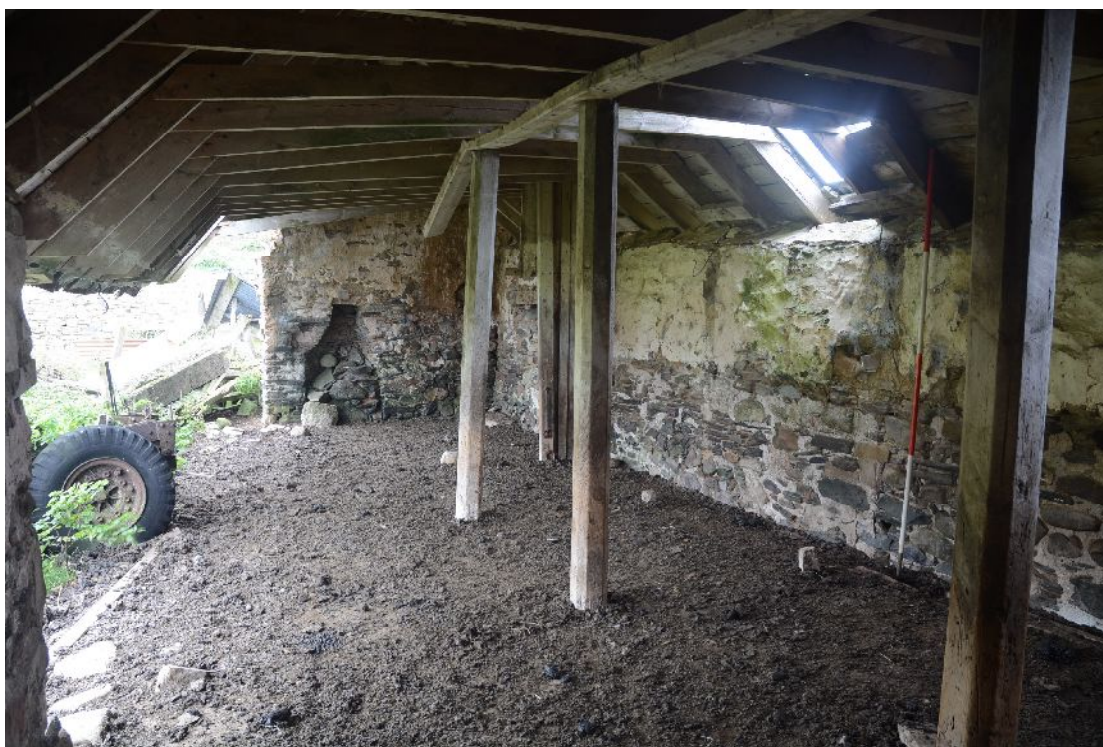
The interior had been divided into two by a wooden partition, part of which survives. To the S of the partition an area c3.5m long appears to have been a bothy as there is a fireplace in the gable and window W2 in the W wall.

To the N, three octagonal posts with vertical grooves on the W faces are the remains of trevices and correspond to scars on the inner face of the W wall.

There were 4 pens, either stables or more probably double tied cow pens (cow chain slide bars survive in two places).

Illus 13 Building C looking S. Fireplace visible on back gable. Trevis hind posts along centre line in foreground

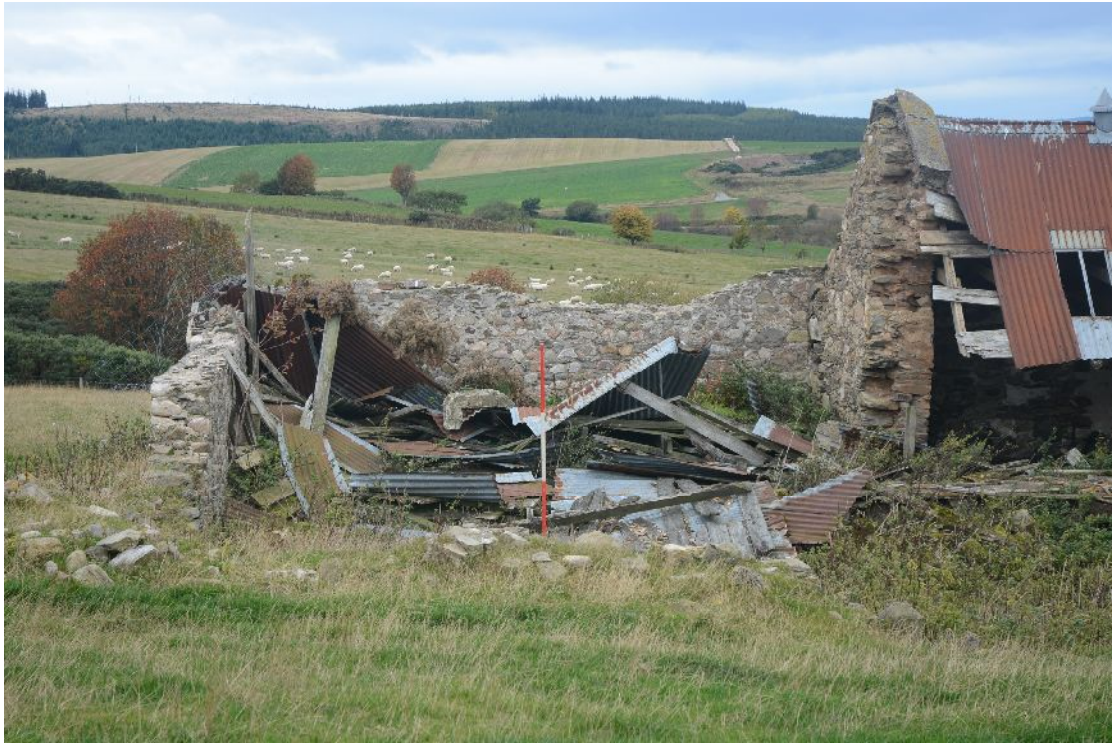
Walls Rubble stone- only the W and part of the S wall are standing

Roof Collapsed, appears to have been corrugated tin.

Illus 14 Building D looking W.

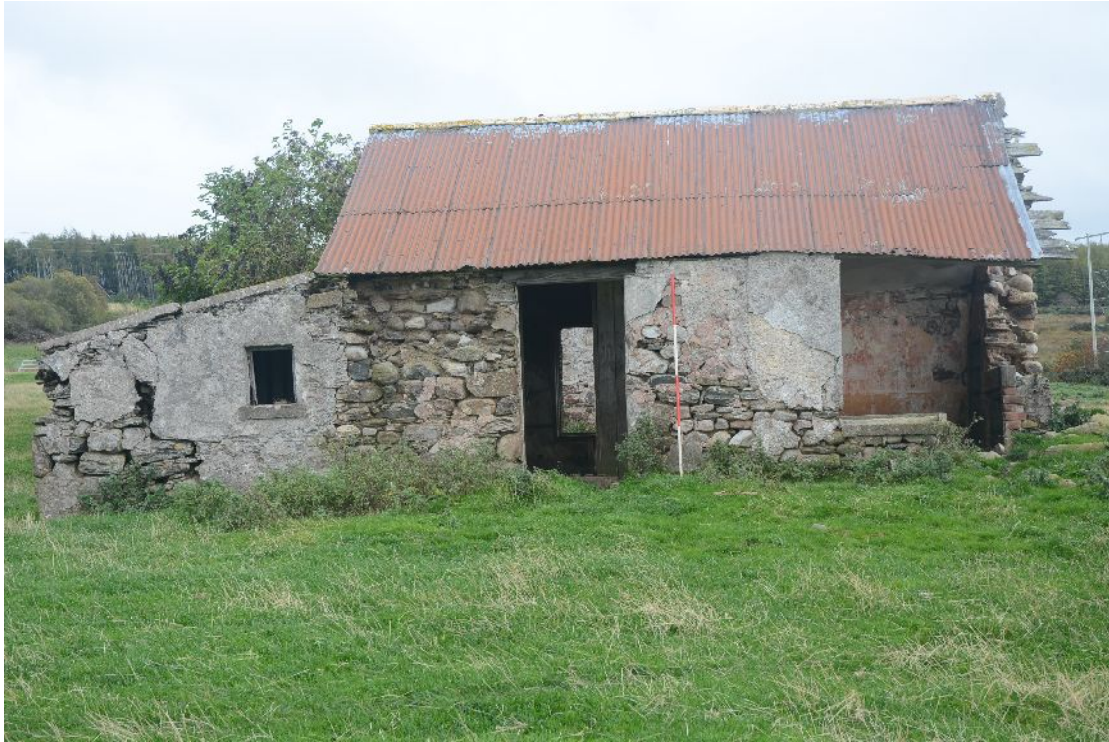
Illus 15 House. N elevation

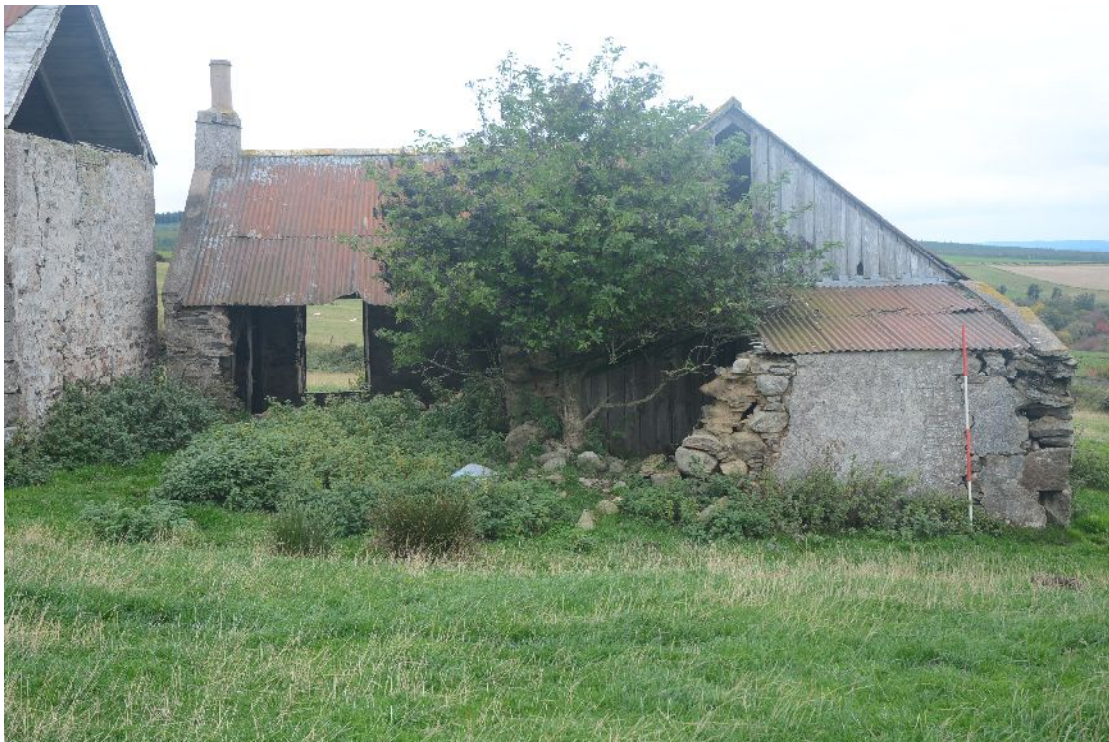
Walls Rubble stone. The E lean-to is of rougher stonework .

Roof A frames with sarking and corrugated tin. The E end is a low lean-to, also with a tin roof.

Illus 16 House. E elevation

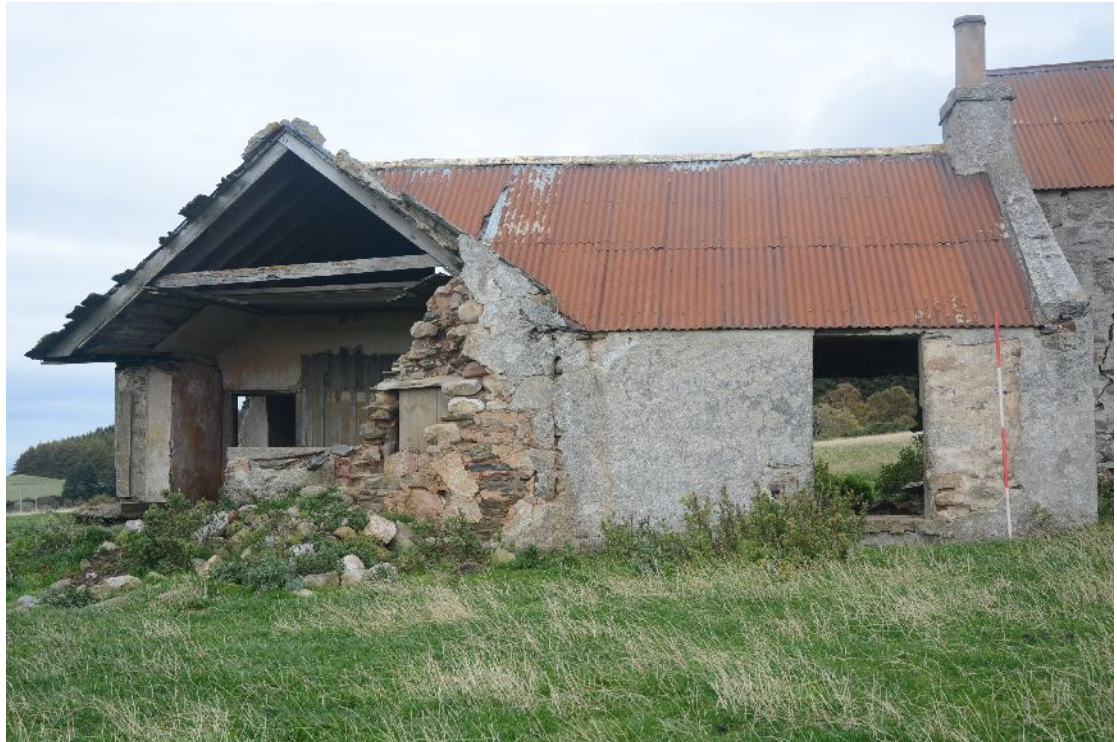
W1 W: 0.94m H:1.55m. Concrete sill

Illus 17 House W elevation

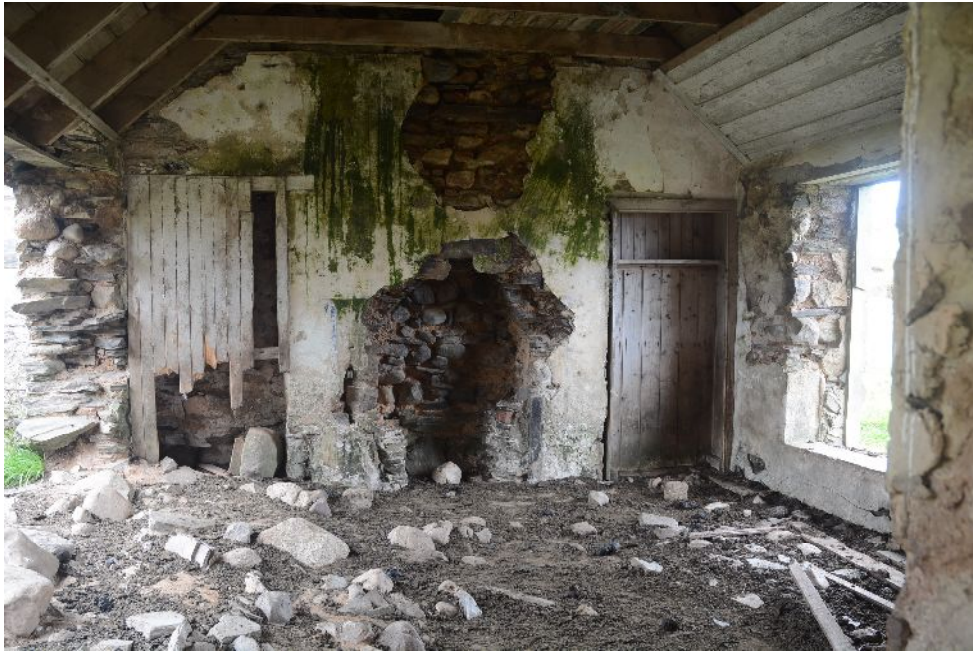
Room 1 had a fireplace in the S gable, flanked by wooden cupboards.

Illus 18 Room 1 looking S

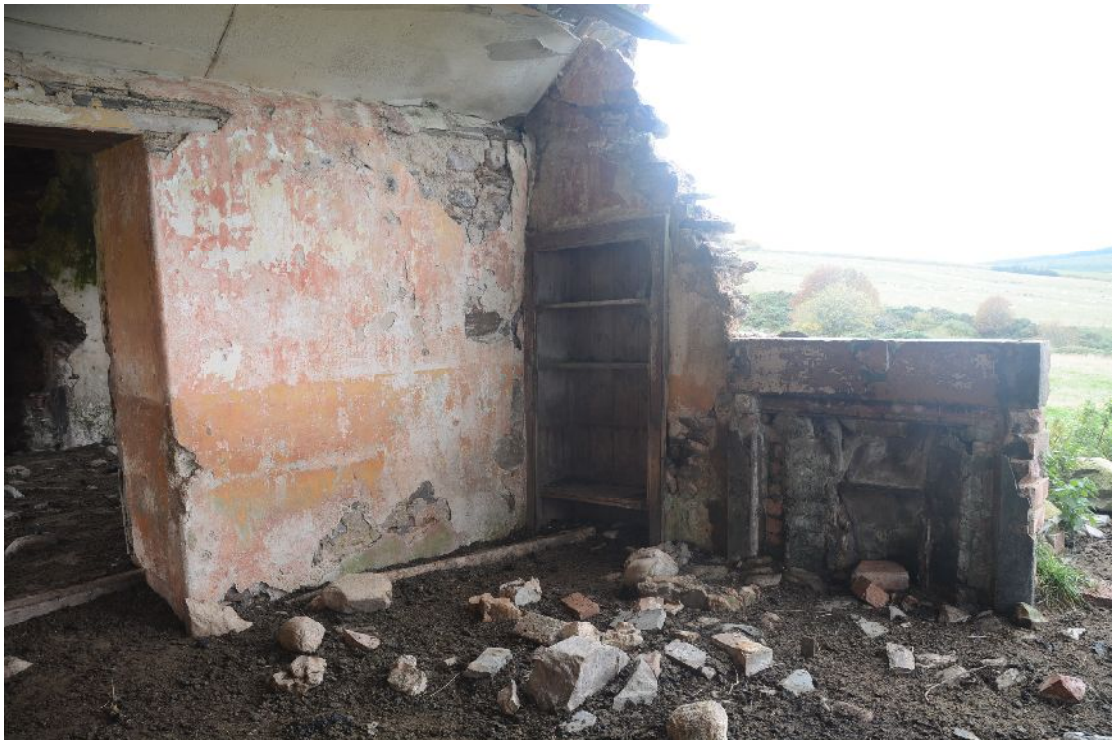
Room 2 also had a fireplace, in the W wall, this may have been the original kitchen.

Illus 19 Room 2 looking W

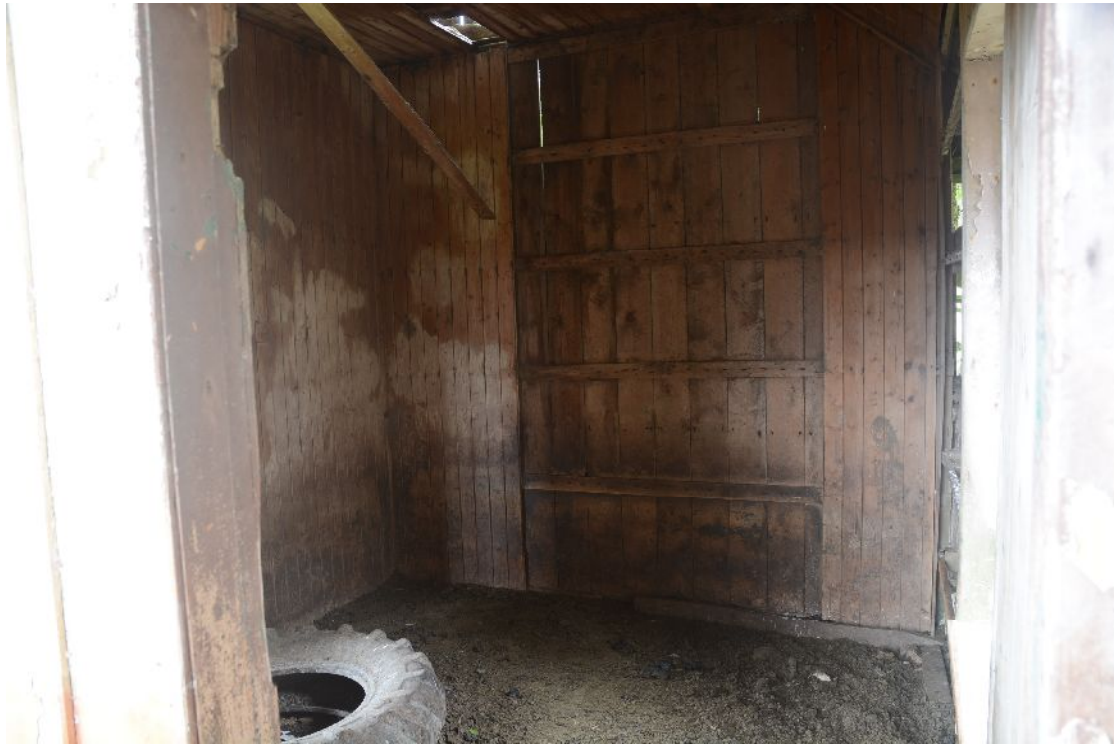
Room 3 was lined and partitioned in pitch pine planking.

Illus 20 Room 3 looking S

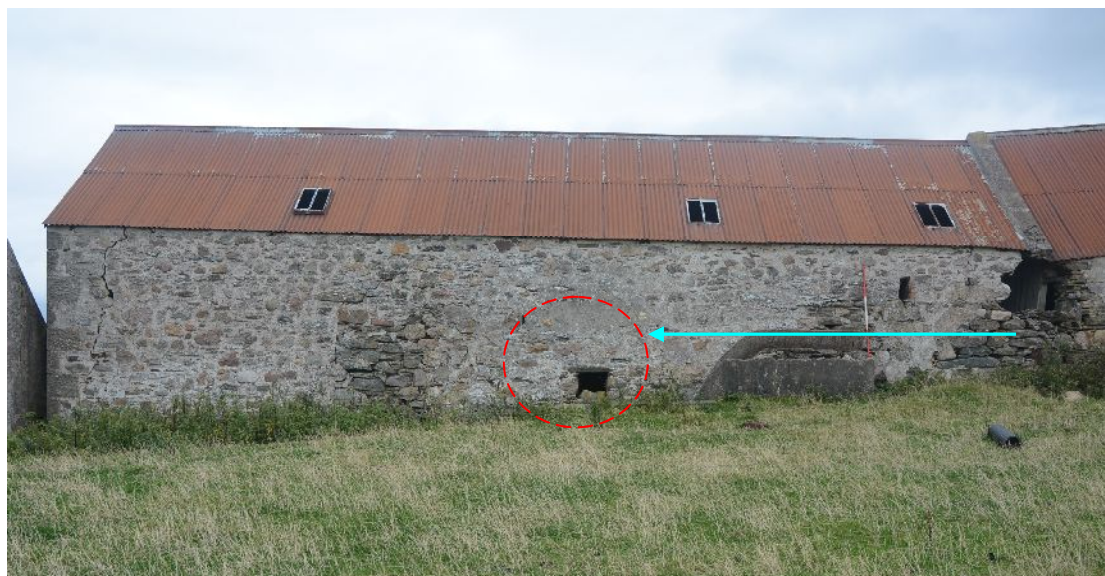
The steading is of mid 19th century date, with a fairly elaborate water mill for the size of croft (50 arable acres). The water ran from a mill pond shown on the OS maps uphill to the S and would appear to have powered a breastshot fed wheel (cf Watts, 2006, 22). The lade would have to have run along a (probably timber) launder or channel above ground to feed in at the level of the concrete setting that remains. Although the launder does not survive, a ridge c 1m wide alongside the outer face of the W wall indicates its position.

Illus 22 Position of waterwheel (red circle). Blue line shows direction of water.

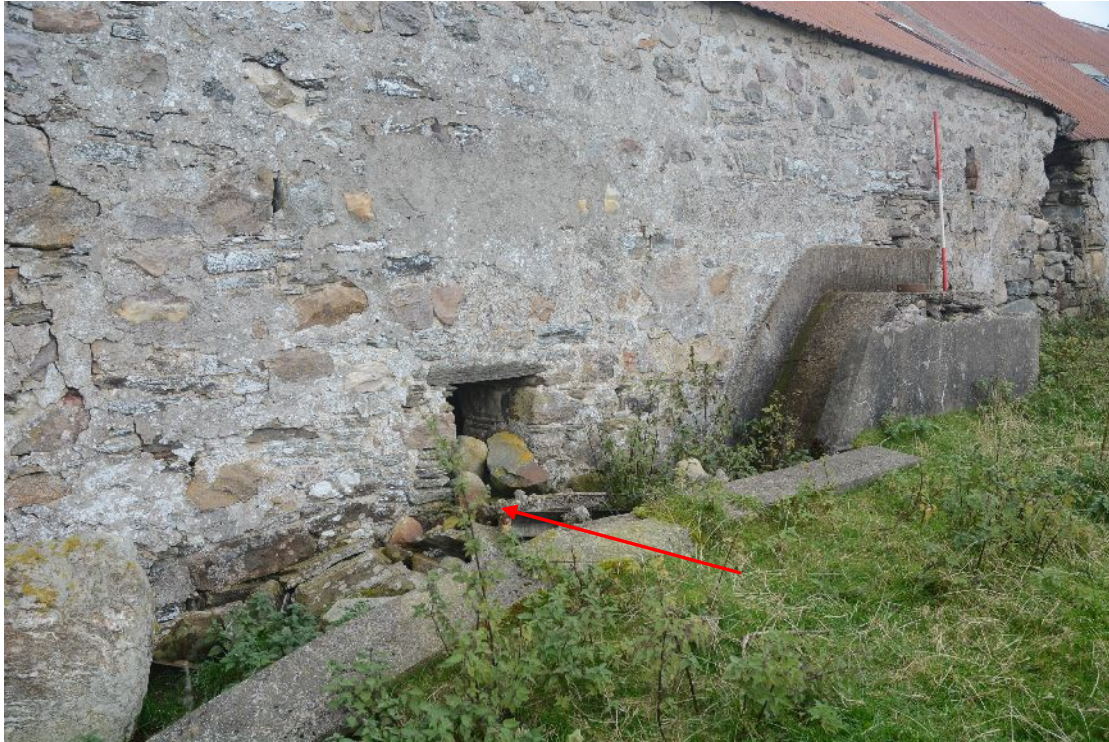
F2 W:0.48m H: 0.44m. Slate lintel, stone sill. At ground level inside. This is mill wheel axle shaft hole.

Illus 23 Position of water wheel. Arrow indicates the wheel axle hole.

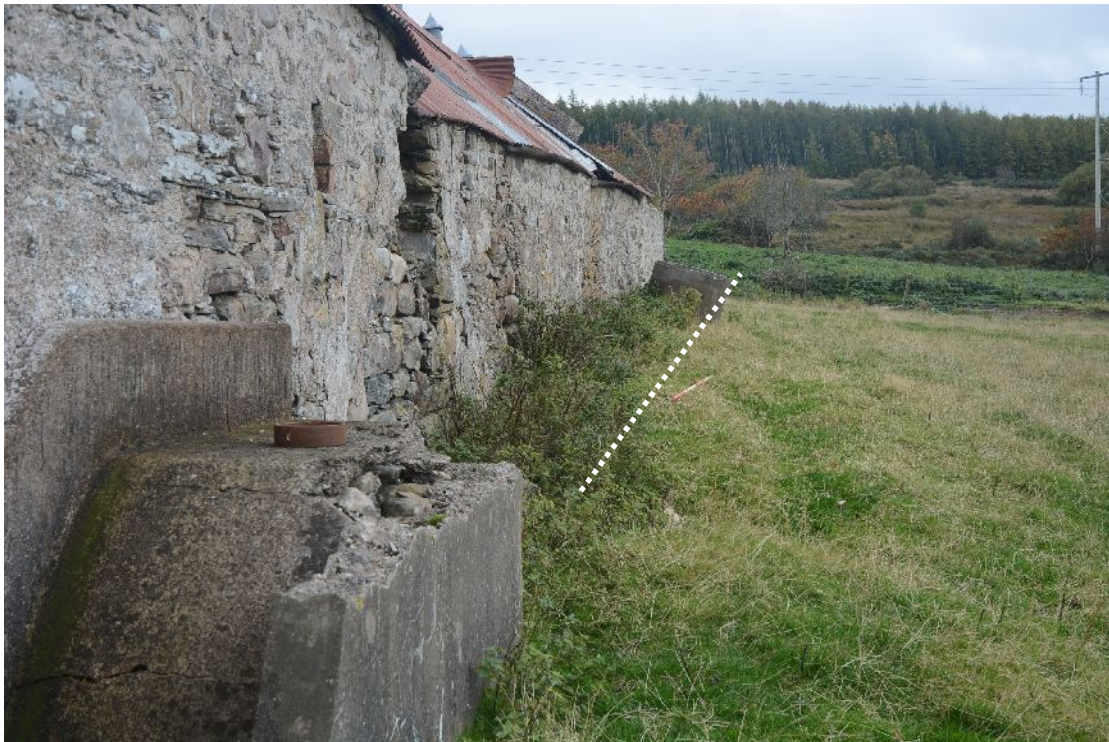
Illus 24 Looking S along line of water chute with ridge showing launder position (dotted)

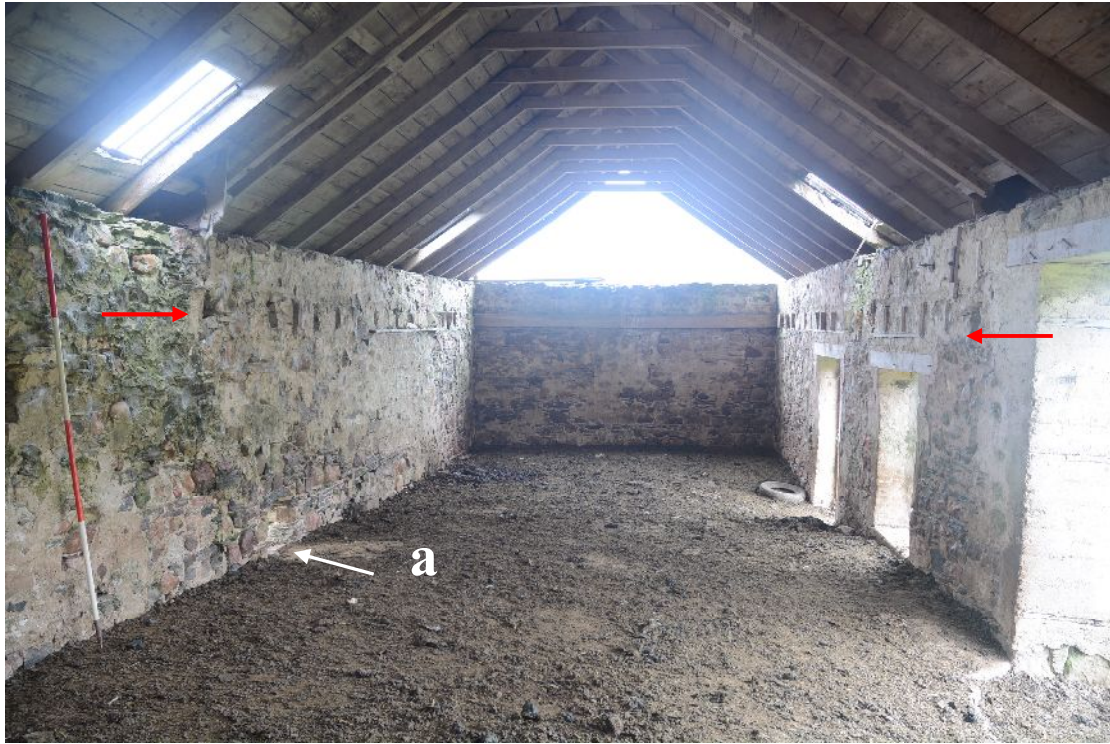
Holes for floor jambs indicate the former position of a half loft at the N end (Illus 25).

The mill building (A) had a half loft, evidenced by the holes to hold the floor joists at c. 2m above the present floor level.

Illus 25 Building A (mill) looking N. Red arrows indicate the position of the loft. A= axle hole to wheel.

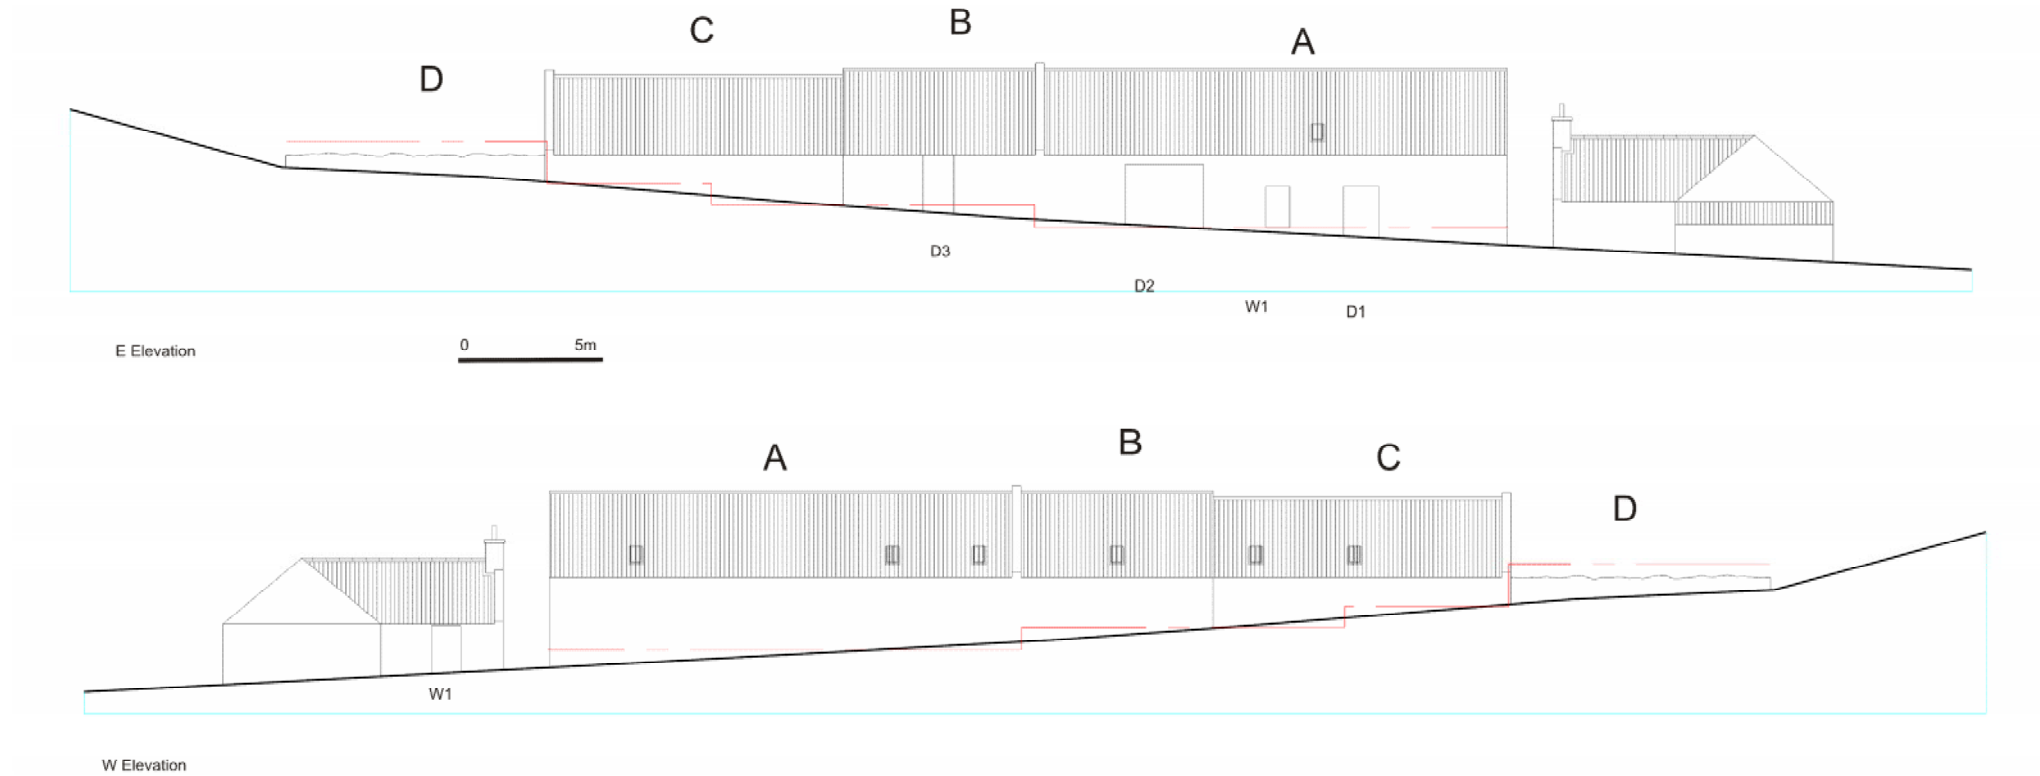
Illus 28 E and W elevations courtesy of John Wink design annotated by MAS Ltd

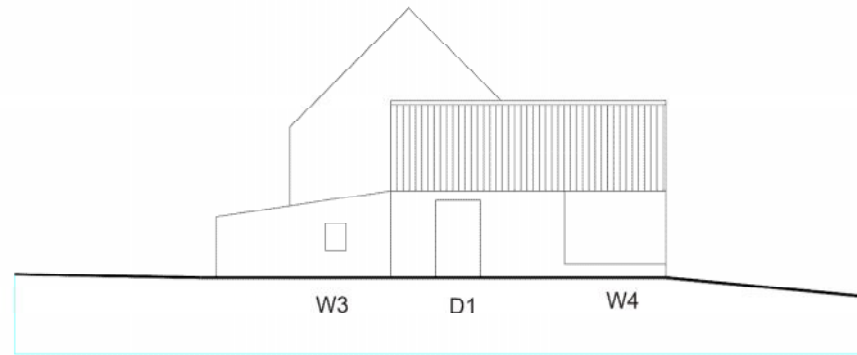
Illus 29 N and S elevations courtesy of John Wink design annotated by MAS Ltd
