**LAND NORTH OF DUBSTON
FINZEAN
BANCHORY
ABERDEENSHIRE**

Standing Building Survey

Carried out 8th October 2019

Report No: MAS 2019-24

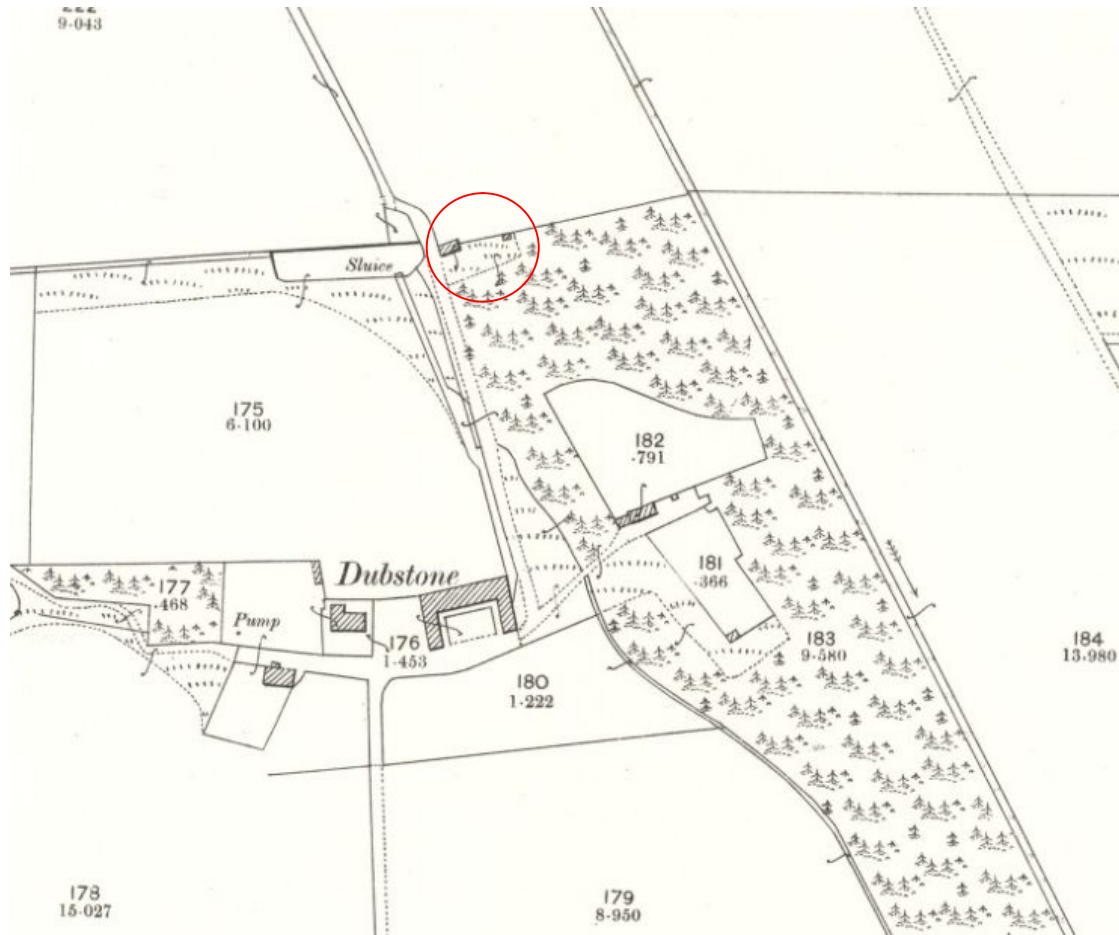
1899 The 25"/mile OS map Aberdeenshire XCIV.14 (Birse) of 1899 shows the farm name changed to Dubstone (sic). The cottage is then shown in a small enclosed area, with a tiny outbuilding (possibly a toilet) to the E.

Illus 4 Detail from 25"/mile OS map Aberdeenshire xciv.14 (Birse) 1899 (published 1900 www.nls.ac.uk)

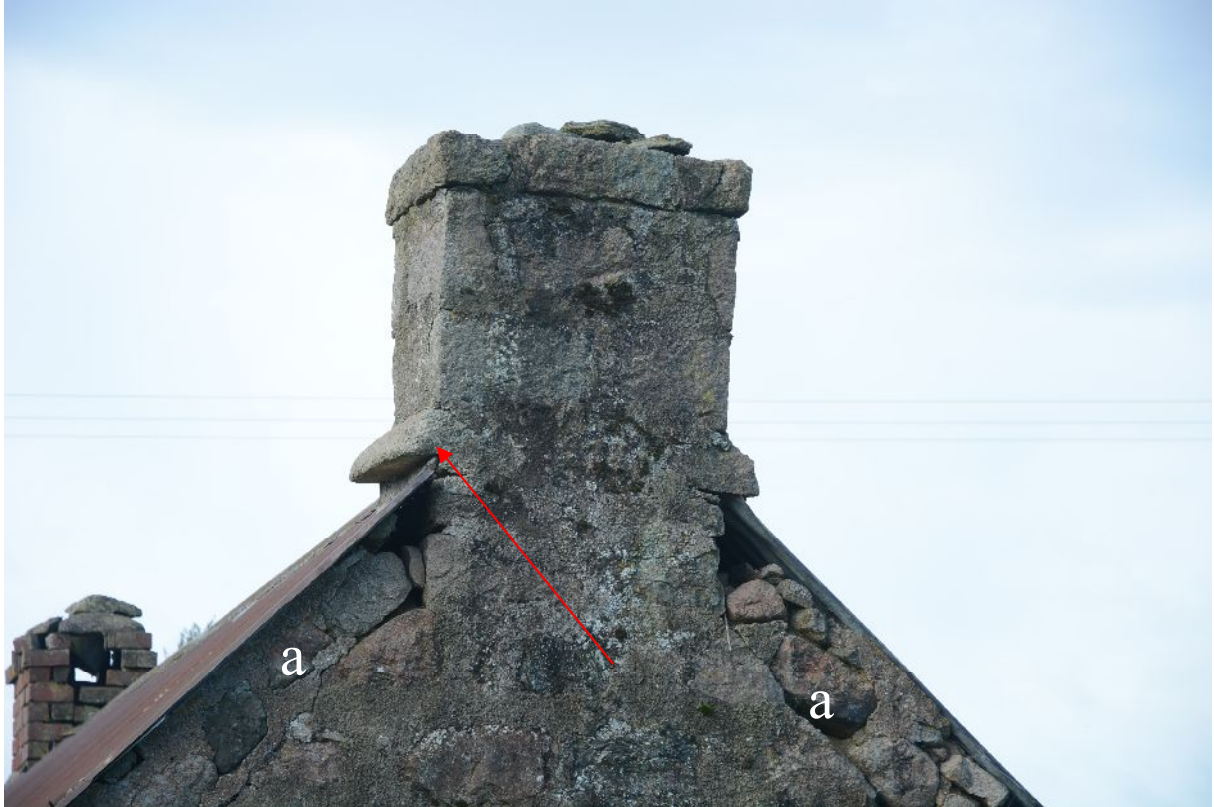
Illus 7 E Chimney with thatch protection (red arrow) and infill stonework (a)

Roof The existing roof was of corrugated iron but this had clearly replaced thatch as the earlier stone chimney at the E gable indicates (Illus 7). At both gables there was an infill of c.300mm stonework when the thatch was replaced. Examination through the hatch through the lobby ceiling revealed turves that had been below the thatch were still in situ. These lay directly on split rounded timbers that had been used as purlins (Illus 8).

There were chimneys at each gable. The E chimney of stone retains projections that would have protected the edge of the thatch around the chimney base (Illus 7); this is likely to have been the earlier chimney. The W chimney was of brick.

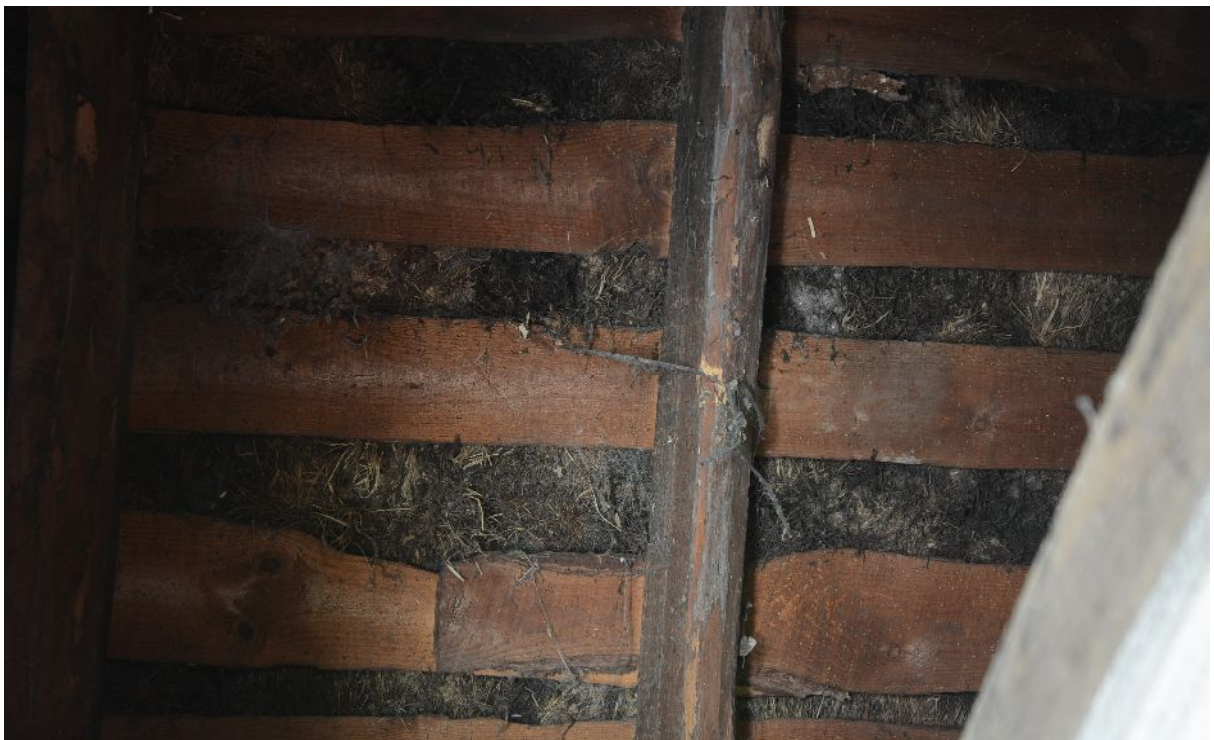
Illus 8 Turves visible below corrugated iron, seen through hatch in ceiling in lobby.

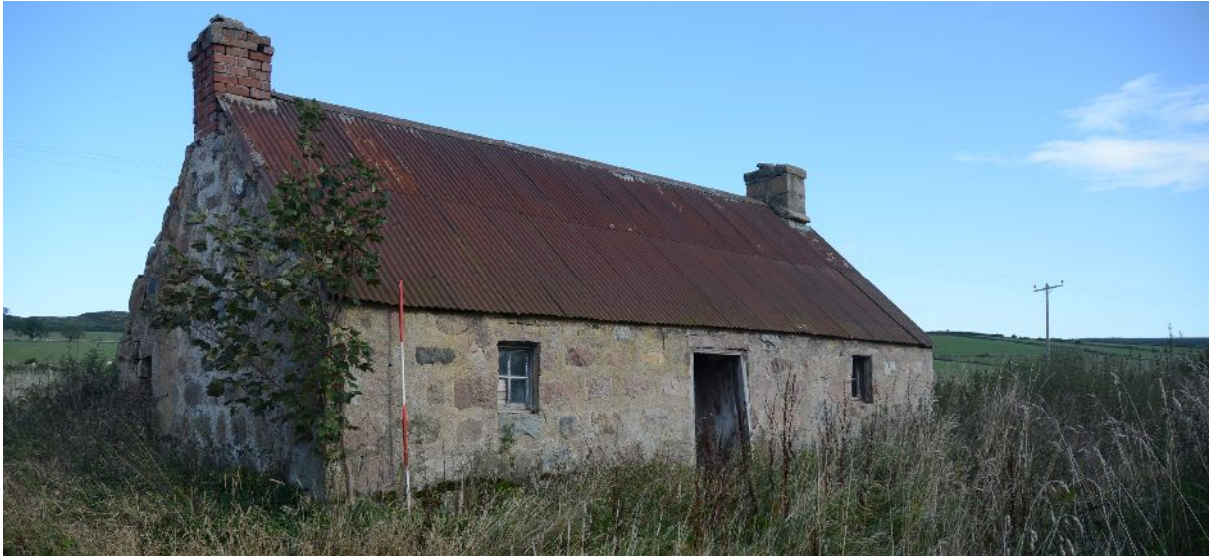
Illus 10 S elevation

D1 W:1.02m H: 1.60m. Rough cut granite lintel. Field stone rybats.

W1 W: 500mm H: 660mm. Rough cut granite lintel. Field stone rybats. 4 pane window

W2 W: 470mm H: 660m. Rough cut granite lintel. Field stone rybats. 4 pane window

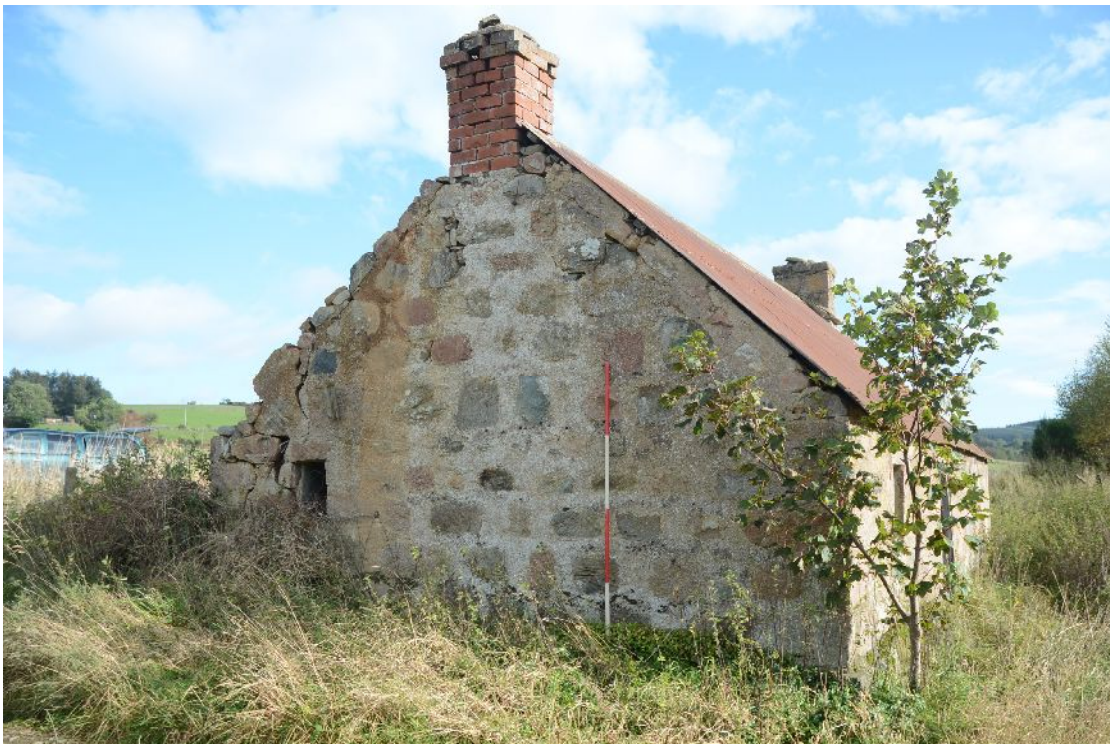
Illus 11 W gable

W3 W: 370mm H: 520mm.

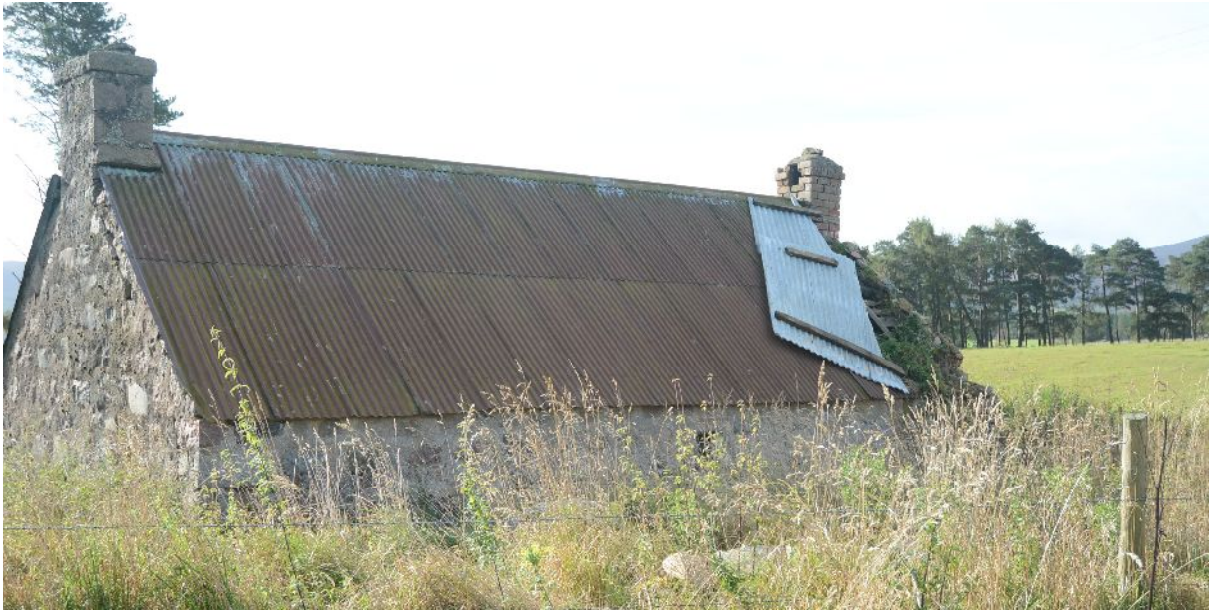
Illus 12 N elevation

W4 W: 300mm H: 450mm.

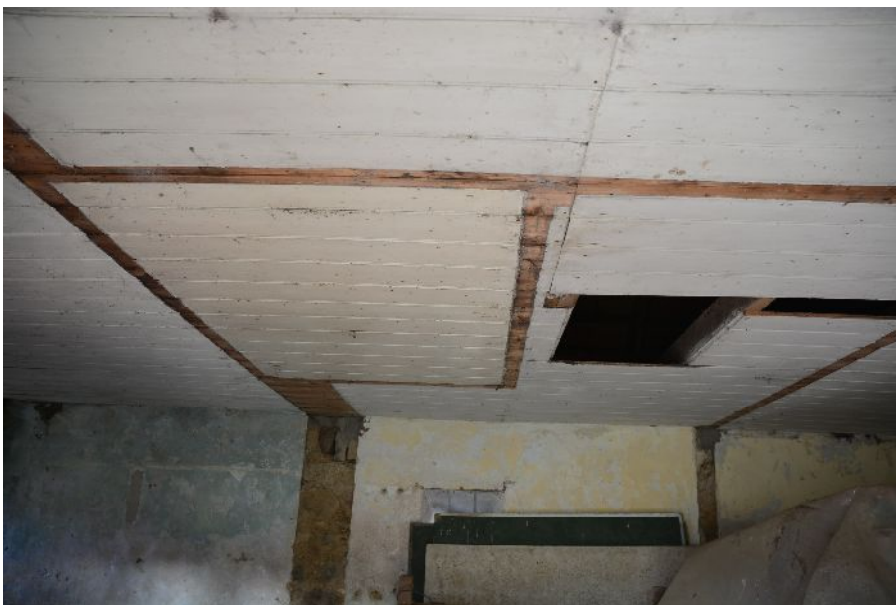
The interior was full of stored furniture etc and not very accessible. All internal partitions had been removed but the position of the partitions was marked in the paintwork on the plank ceiling and has been plotted. This indicates that the interior had been divided into a small lobby just inside the door (D1) with a room on either side and a small mid-closet or additional bedroom at the back (lit by W4). A hatch in the ceiling above the lobby gave access to the loft but no stair survived.

Illus 13 Interior. Looking from D1 at paint lines in ceiling which indicate former internal walls

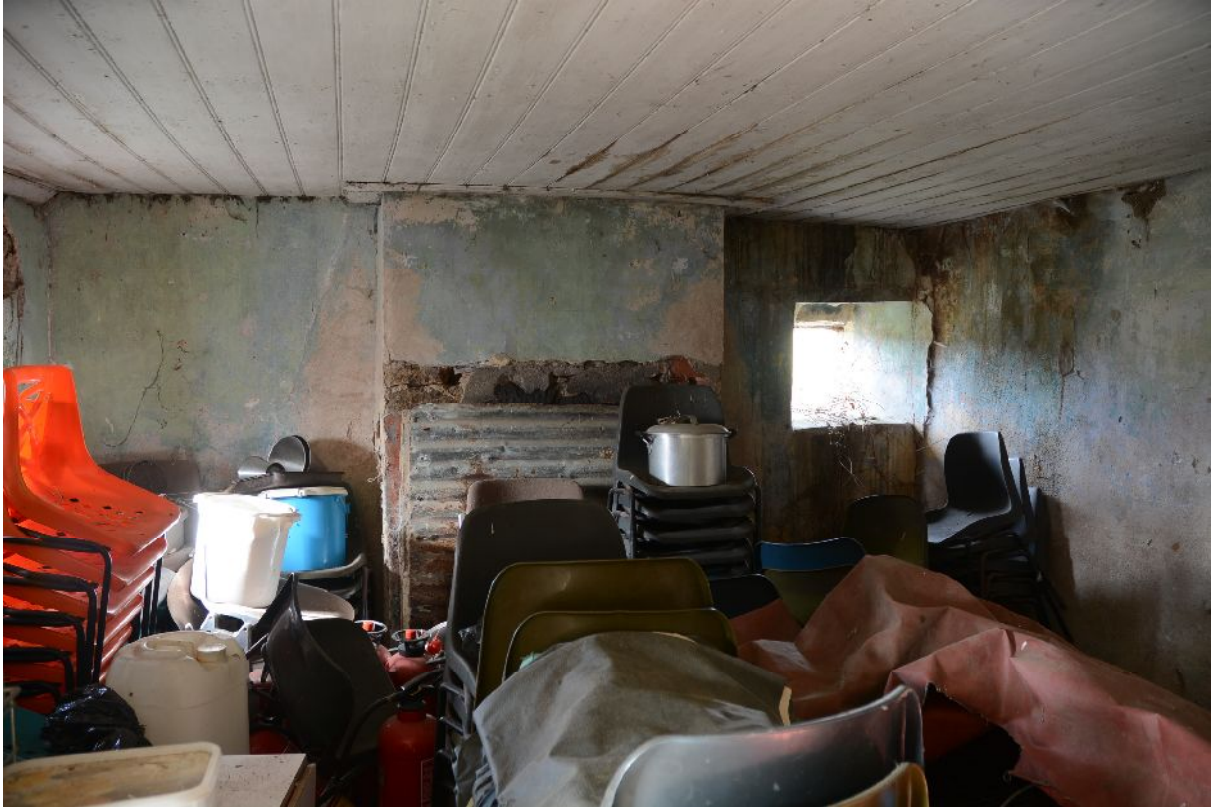
Both fireplaces had been blocked off, but scarring on the wall above the W fireplace (Illus 14) indicates a mantelpiece had been removed so it is perhaps likely that this was the parlor/room, with the kitchen at the E end of the building.

Illus 14 Interior looking towards W fireplace
