LANCASTER UID, LANCASTER, LANCASHIRE

WATCHING BRIEF REPORT

CP. No: 10024/11

24/04/2012

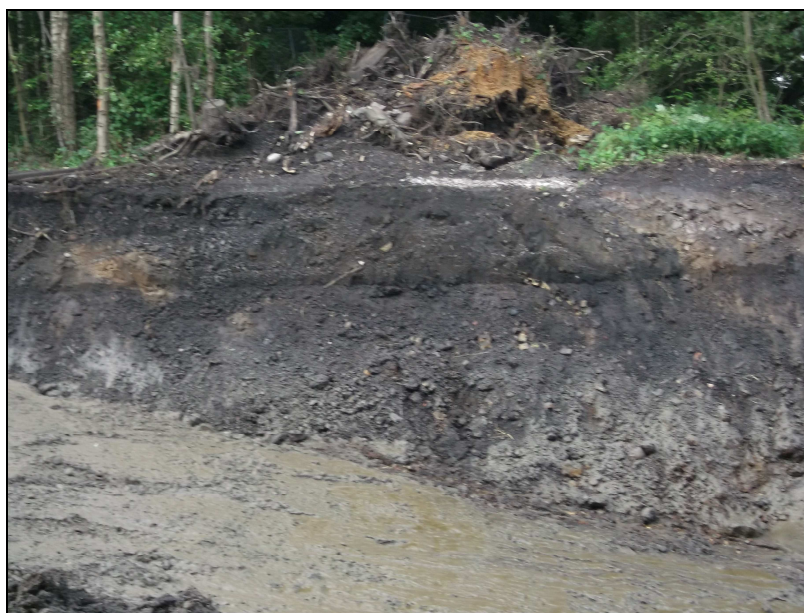
4.2.2 The topsoil was stripped by a JCB tracked excavator. The topsoil (**100**) was comprised of dark bluish grey/black sandy gravelly soils with frequent ash and coal inclusions (Plate 1). It contained 19th and 20th century pottery sherds, fragments of rail track, bricks and electrical cable. This obviously indicated 20th century made ground associated with the old railway, and it was present across the whole of the site to a depth of c.0.5m-1m. Beneath this made ground, the natural drift geology (**101**) a reddish brown alluvial sandy silt was visible. Underneath this layer, in a small area right adjacent to the river, river gravels (**102**) were uncovered and this is where excavation ended.

Plate 1: View into the section of the strip on the south side of the River Lune

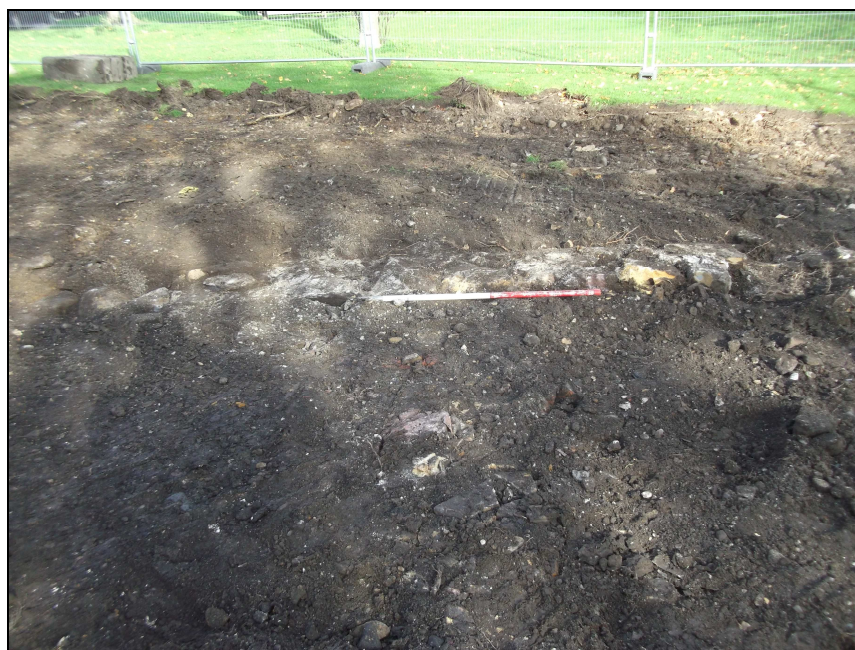
4.5.1 The area between the Skerton Bridge and high-rise and the River Lune and Mainway was stripped of topsoil with a tracked 360 degree excavator (Figure 4). The topsoil (001) was comprised of mid-brown loamy soils with inclusions of modern rubbish and building material and was around 15cm deep. Beneath this, showing through in places, was a compact light red-brown silt (002) with inclusions of stones around 10cm diameter. After the 15cm layer of topsoil had been removed at the north end of the area a stone wall was recorded [006] partly consisting of sandstone blocks. The wall measured 4.9m in length by 0.6m in width, was aligned west north west – east south east, and was bonded together with mortar and with flat outer faces (Plate 2).

Plate 2: Photograph of stone wall [006] at north end of north bank of Area C from south

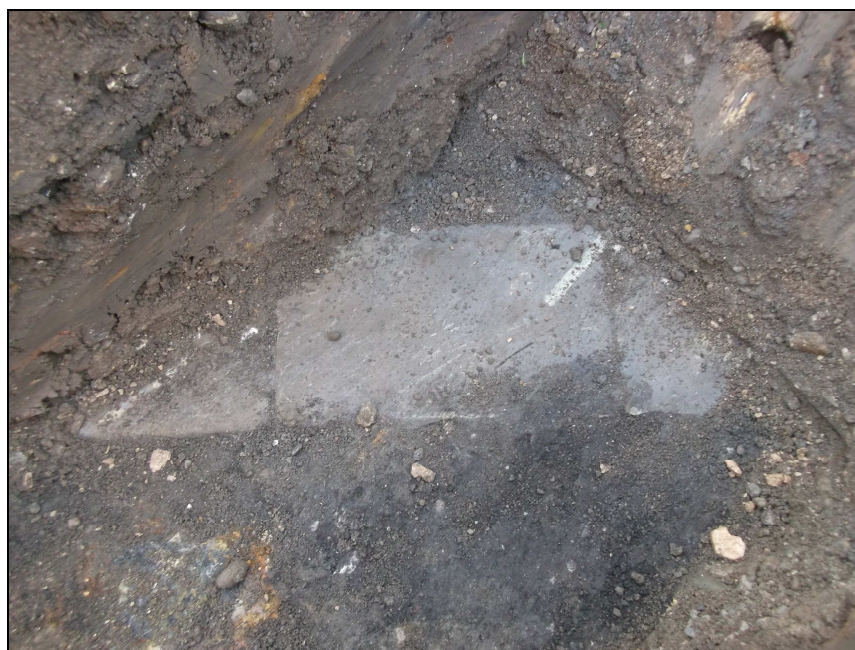
4.5.2 Further south in the same area a stepped shaft was excavated 4.5 m wide south east to north west by 4 m for a concrete chamber (Figure 4). This went through c.1.5 m of (003), a mix of yellow-brown pebble and brown soil with inclusions of stone 10 – 15cm in diameter which was a modern deposit. Beneath this was revealed [005] three concrete blocks around 1.8m deep aligned east to west 77cm long by 31cm wide with a worn surface (Plate 3), (004) oily black soil to the north of [005], and [008] a large sandstone 1m by 70cm. [005] had a square shaped rust mark which may indicate the position of the remains of a metal fixture immediately beneath. These features were taken to be remains of the housing and associated streets demolished in the 20th century for redevelopment.

Plate 3: Photograph of (005) concrete curbs at south west end of Area C

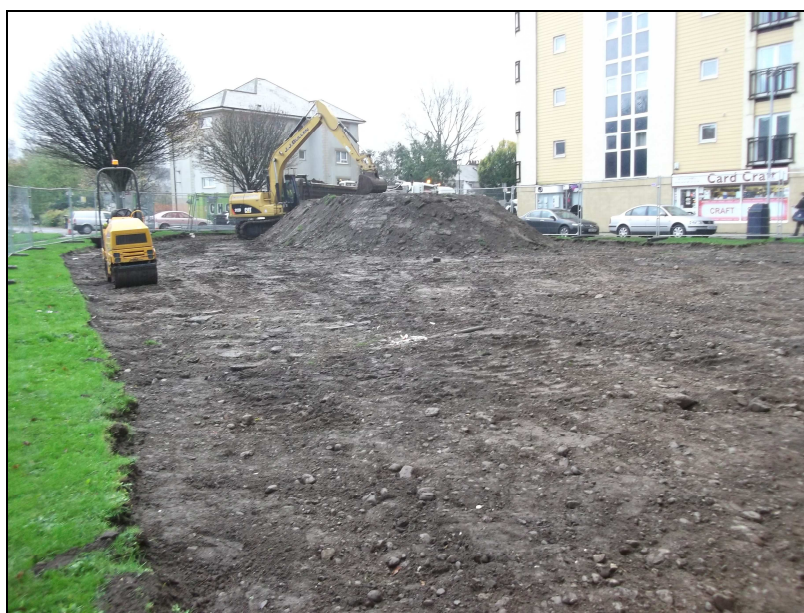
- 4.6 Area B**
- 4.6.1 The watching brief covered the controlled stripping of around 15cm of topsoil on the corner of Owen Road and Lune Street (Figure 3) with a tracked 360 degree excavator to create a compound area as a base for further works (see plate 4). Some 20th century rubbish was found in the form of pottery and brick fragments.

Plate 4: General photograph of works at north end of Area B next to Owen Road

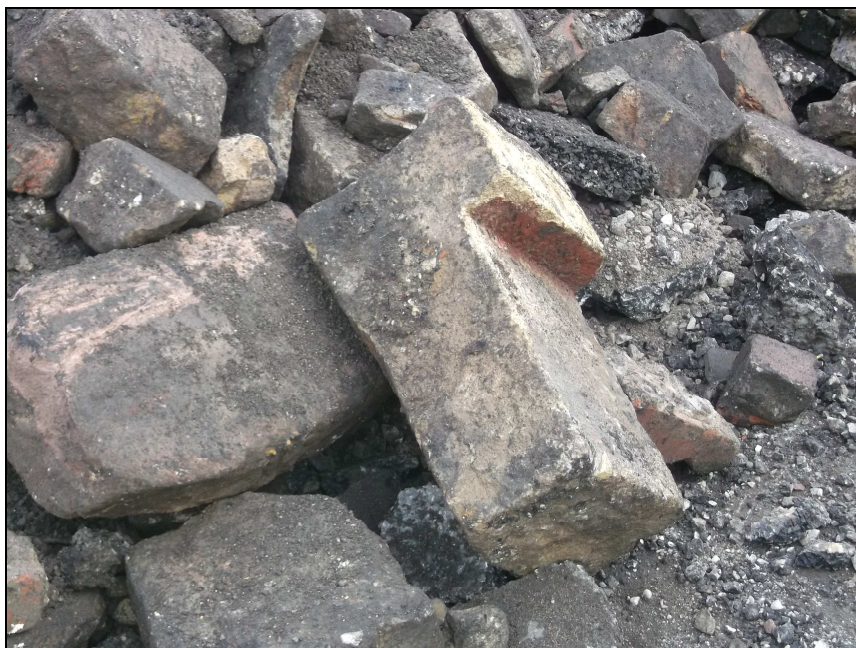
- 4.6.3 Beneath the modern road surface and a 10cm layer of hardcore was (009) a layer of demolition rubble was observed, at least 1m thick and partly composed of brick but mainly of fragments of sandstone masonry. Some of these pieces were very large (Plate 5). Within this rubble two brick walls [010] were found within the chamber excavation at the north end of Lune Street (Plate 6). One was aligned east to west and was at the north end of the excavation and one was aligned north to south and was at the east side of this excavation. These walls had a plaster rendered face and they were thought to be the remains of a house cellar from the 20th century.

Plate 5: Photograph of sandstone masonry from (005) rubble beneath road surface of Lune Street

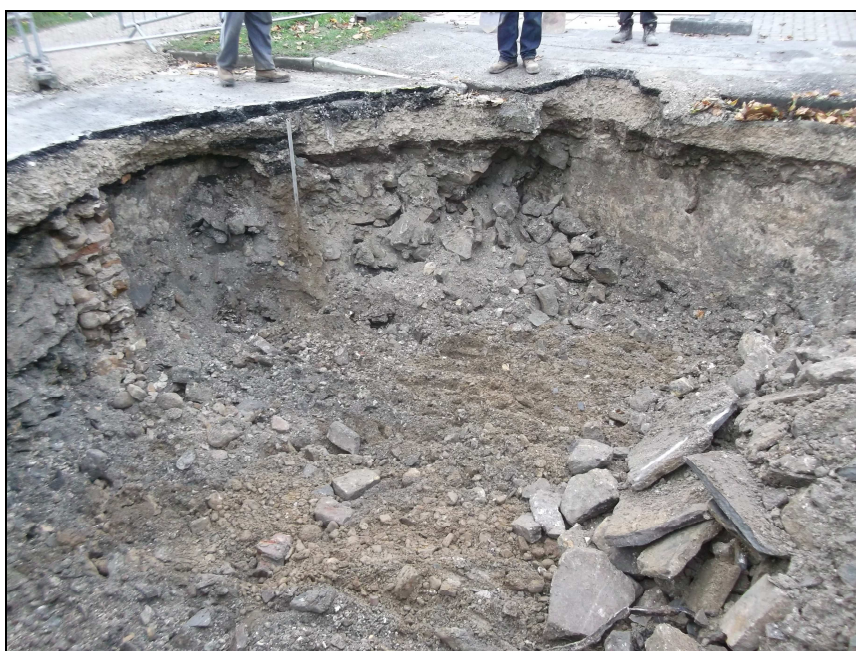
Plate 6: Photograph of brick walls [010] in rubble (009) beneath road surface of Lune Street

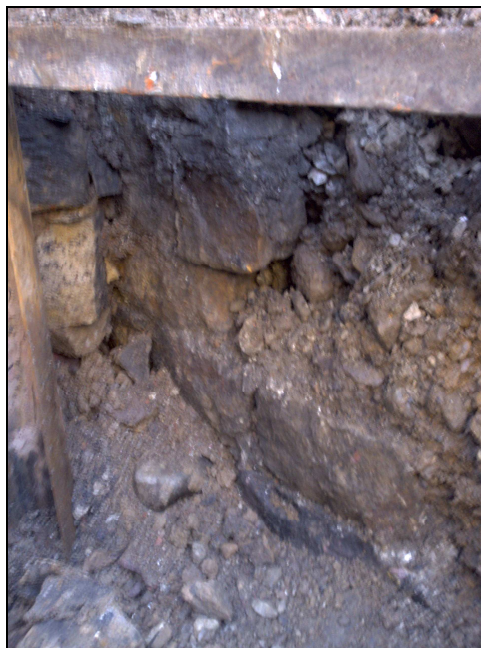
- 4.6.4 Around 6m south of this shaft in the south east section of the trench another stone wall [013] was discovered (Plate 7). This one had a concrete floor surface [014] 40cm by 30cm in surface area and 20cm thick. The relationship between these two structures was unclear but the concrete surface was probably the floor surface of a cellar. The layer of rubble (009) beneath the road could be from the demolition of housing that took place in the 20th century during the redevelopment at the north end of Lune Street. Beneath (009) was (018), a red-brown clay silt with masonry and brick fragments. Beneath context (018) was (019) which was mid-brown silt-sand with stones up to 30cm in diameter and had no demolition material or rubbish. It started 3m below the surface of the road but its bottom was not reached. It may be a natural deposit. Due to the lack of archaeological features and deposits it was decided that monitoring should cease until excavation was taking place at the south end of Lune Street as a further check for archaeology.

Plate 7: Shot of stone wall (013) in Area B beneath Lune Street from north west
